**\*\*\*Update\*\*\***

Previous buyer terminated contract after they received the report from their home inspector but before negotiations took place. This is the original report with recent repairs noted.

# Inspection Report

2214 Pathway Dr  
Chapel Hill NC 27516

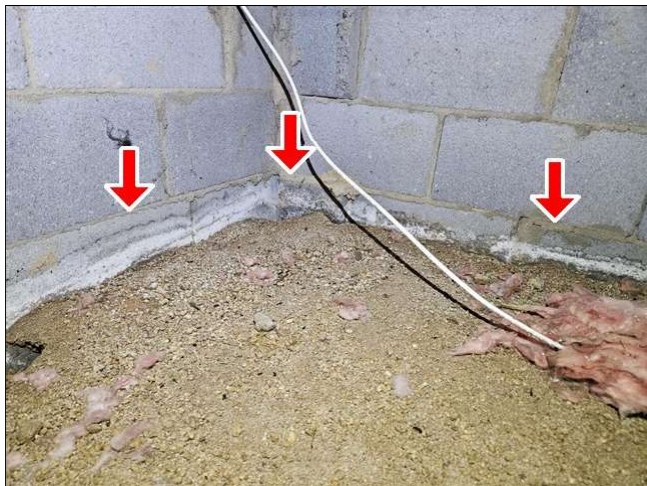
1.0 Item 1(Picture)

**1.0** Efflorescence (salt stains) was noted on the foundation walls. These stains indicate the foundation has been cyclically wet and dry. Direct water penetration damages the foundation, the wood structure, and creates an undesirable environment that encourages insects and fungal growth such as mold/mildew. Water in the foundation walls can be an indication of absent or damaged waterproofing and foundation drainage issues. These stains are common in most houses but are an indication of a deficiency. If you are concerned, consult a licensed general contractor for further evaluation to determine the source of the moisture and to make repairs as necessary.

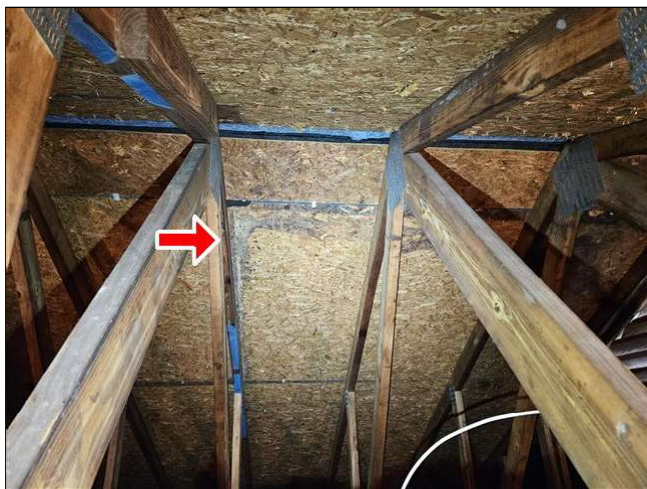
1.5 Item 1(Picture)

**1.5** (1) Evidence of leaks were noted in the attic in one or more areas. These were noted from the discolored sheathing. The wood was dry at the time of the inspection which could mean these leaks are historical, or they could be active. Attic sheathing dries out very quickly making it hard to determine if leaks are active or not when it is not raining. The wood in these areas was discolored in a manner typical of a long term leak. Leaks should be repaired as soon as possible to keep the damage from getting worse. All adjacent areas should also be evaluated for any hidden damage and repaired. A licensed general contractor or roofing contractor should be consulted to fully evaluate the roof and the sheathing and to repair as necessary.

Leaks were noted in the following areas:

1. In the attic above the master bedroom.
2. On the ceiling above the rear storage room. There is no access to the attic above.

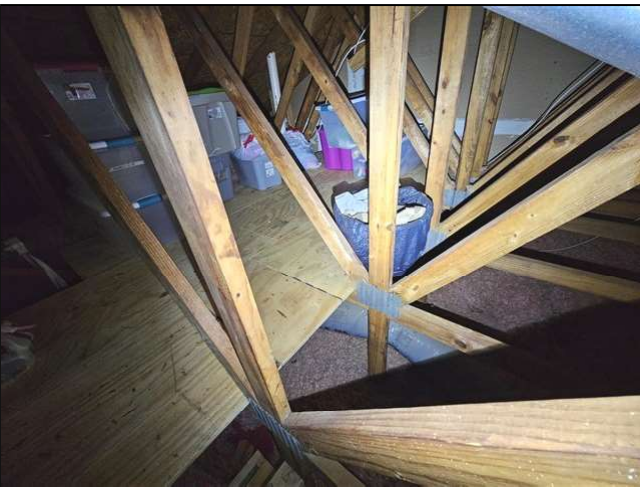
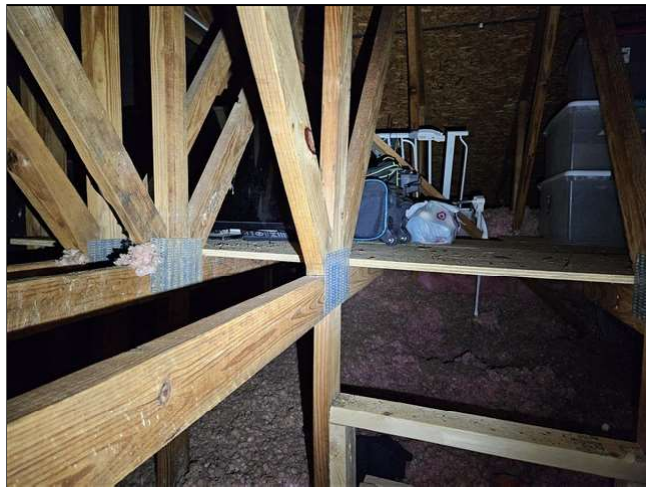
**1.5** (2) Shelves have been added to the trusses in the attic. Trusses are engineered components and cannot be altered without engineering review/approval. These shelves could affect how the trusses support the roof loads as top loading of these truss webs is almost certainly outside of the design parameters. An engineer should be consulted to determine the significance of the concern and to make determine if repairs are needed. IF repairs are needed, a licensed general contractor can be consulted as needed.

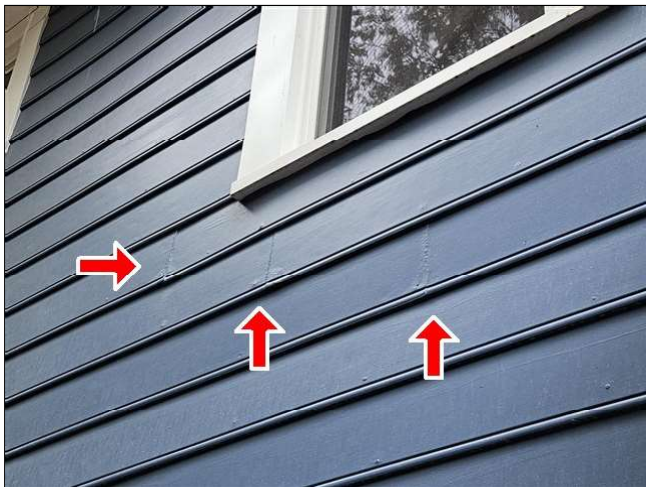
2.0 Item 1(Picture)

**2.0** Portions of the hardboard siding are decayed/damaged from exposure to moisture. The damage was noted on all sides of the home along the bottom edges of the siding, at face nails, and at joints. Hardboard siding needs to be properly maintained to keep water and pests from entering the home. Damaged/decayed siding can lead to property damage and undesirable living conditions. A licensed general contractor or siding specialist should be consulted for a complete evaluation of the siding and adjacent components and for repair where necessary.

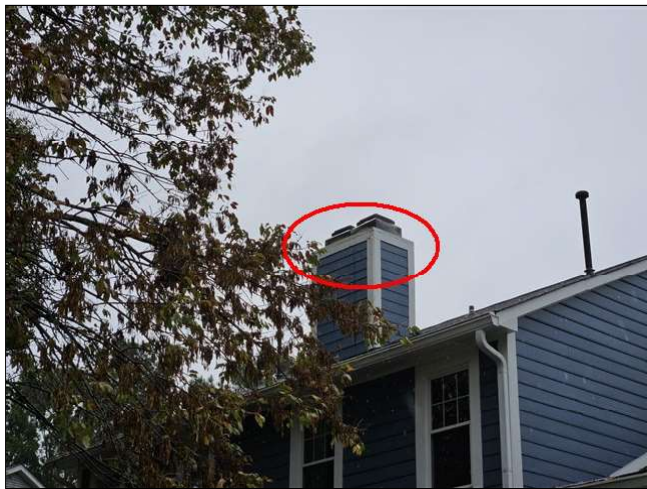
2.1 Item 1(Picture)

**2.1** Sections of the wood trim/fascia/soffit are soft and decayed in a manner typical of water penetration. Water penetration can lead to property damage and undesirable living conditions and should be repaired as soon as possible. A licensed general contractor can be consulted to fully evaluate the trim and to repair any areas needed.

Soft/damaged wood was noted in the following locations:

- 1. The top of the chimney.

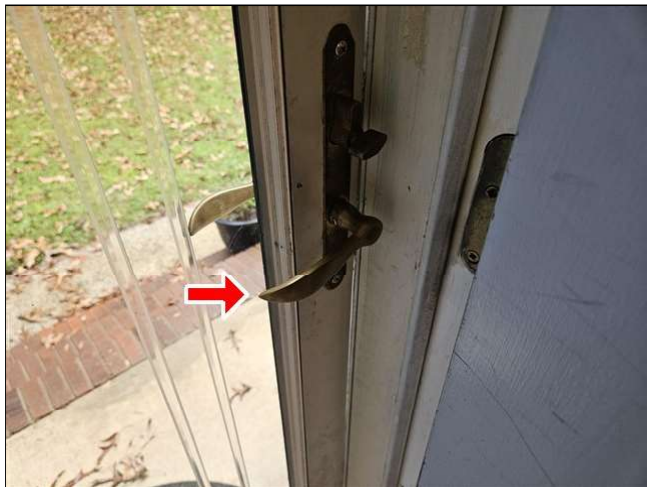
2.2 Item 1(Picture)

**2.2** (1) The door handle for the front storm door does not operate properly. The handle does not turn downward, only upward, to recess the strike pin. This is backwards from normal. Also holes were not cut into the door frame to allow the latch pin or the deadbolt to properly seat to secure the door. These items need to be repaired for the door to function as intended. A general repair specialist can be consulted as needed.

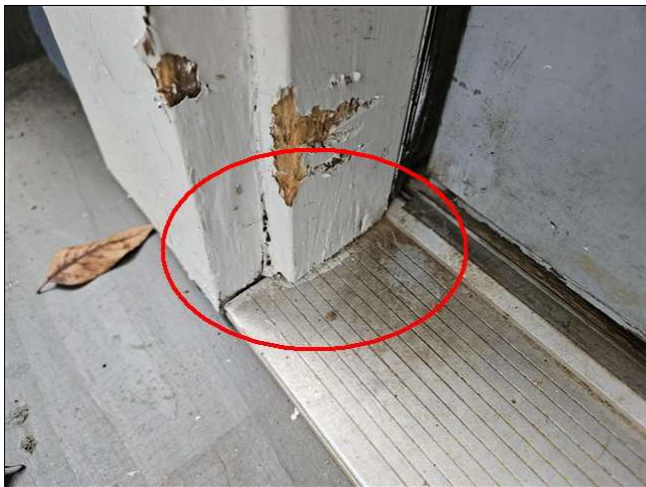
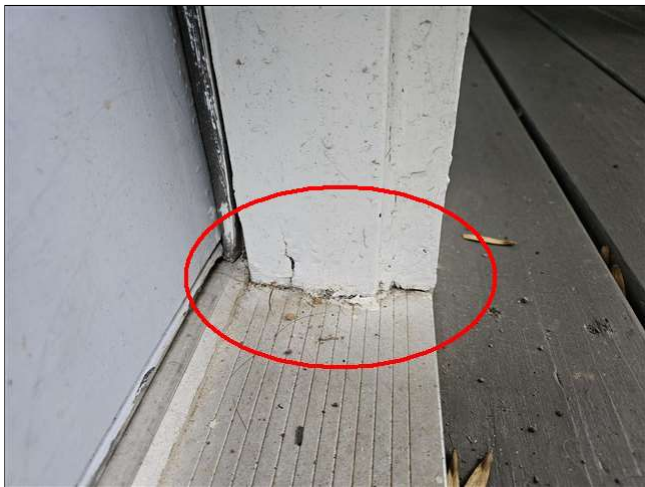
**2.2** (2) The door frame on the rear door has some soft and decayed wood at the bottom edges where the frame meets the ground. Decay in the door frames can result in leaking and water penetration and should be repaired as soon as possible. All doors should be inspected for similar damage as repairs are made. A general repair specialist or licensed contractor should be consulted for evaluation and repair.

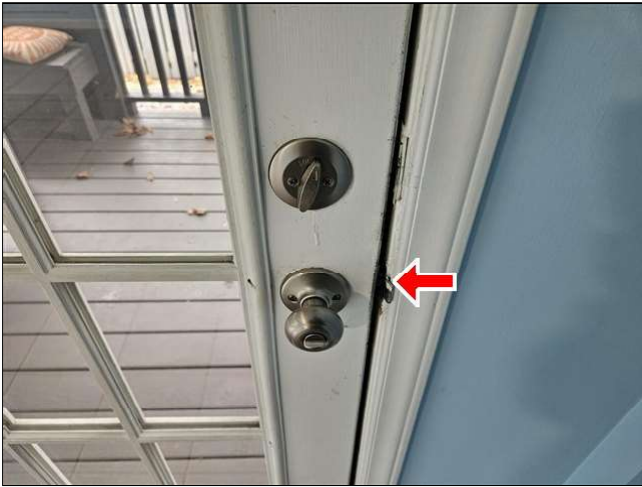
2.2 Item 6(Picture)

**2.2** (3) The main latch for the rear door did not function to latch the door securely shut. The dead bolt worked fine. The main latch needs to be adjusted or repaired to function as intended to secure the door. A general repair specialist should be consulted for repair.

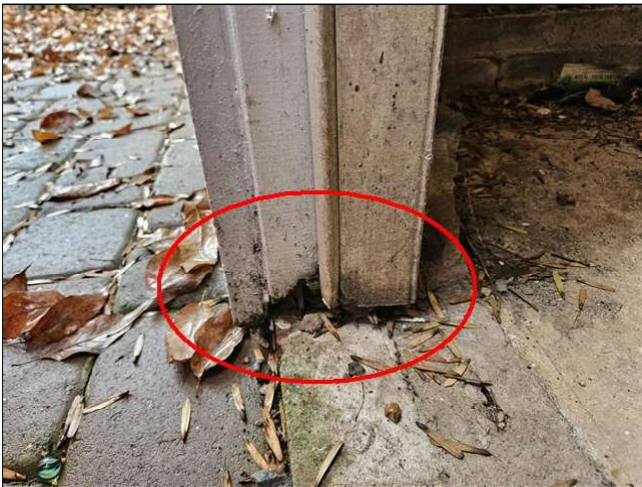
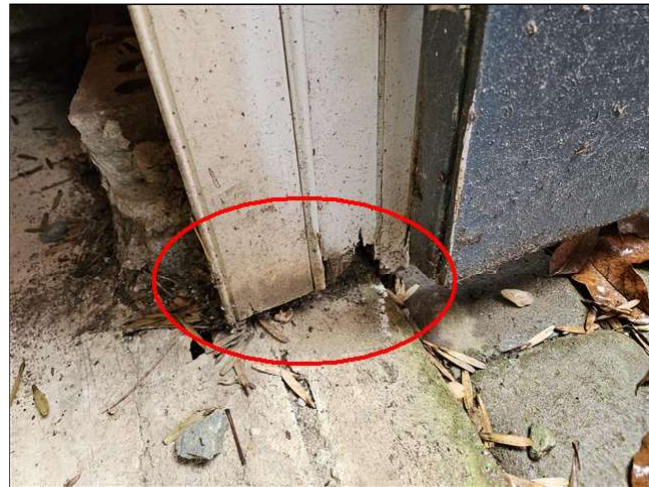
2.2 Item 8(Picture)

**2.2** (4) The door frame on the rear storage room door has some soft and decayed wood at the bottom edges where the frame meets the ground. Decay in the door frames can result in leaking and water penetration and should be repaired as soon as possible. All doors should be inspected for similar damage as repairs are made. A general repair specialist or licensed contractor should be consulted for evaluation and repair.

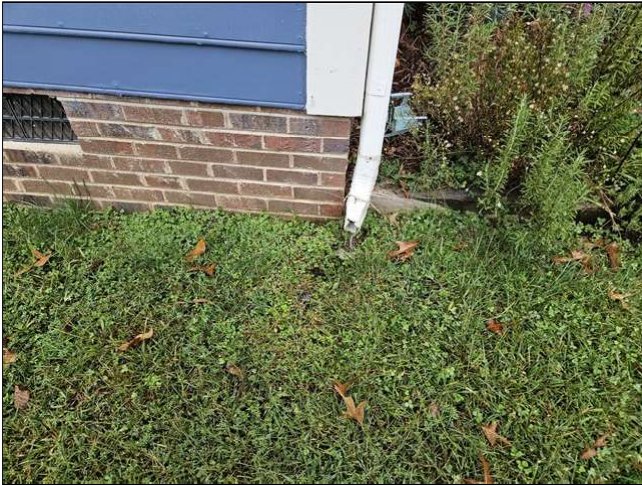
3.3 Item 1(Picture)

**3.3** Some of the gutter downspouts are not extended or piped to direct roof drainage away from the foundation. Direct drainage from the gutter system can result in water penetration into the foundation area and foundation deterioration. It is typically recommended for downspouts to be piped 5 or 6 feet away from the homes foundation. A gutter specialist should be consulted for evaluation and to make necessary repairs.

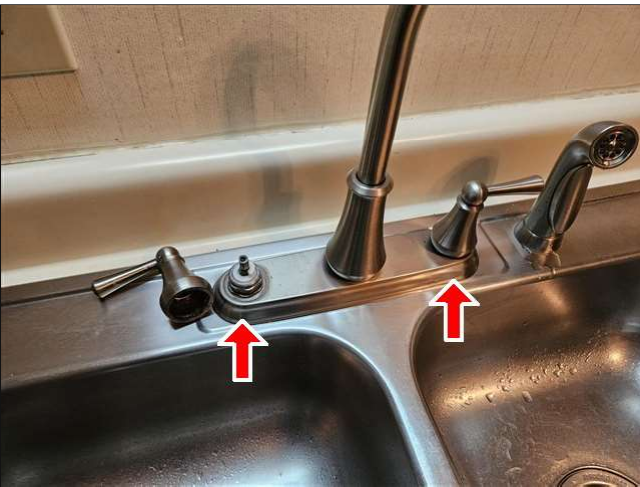
5.0 Item 2(Picture)

**5.0** (2) The handles on the kitchen sink faucet are loose and need to be tightened. The hot water handle pulled off. This is a simple repair, requiring a set screw to be tightened. A general repair specialist can be consulted as needed.

**Item 5.0 (2) was repaired by plumber on 10/11/2025 after buyer backed out.**

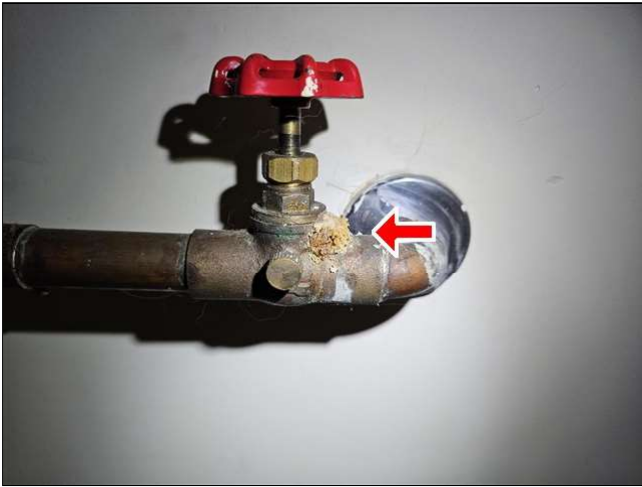
5.0 Item 3(Picture)

**5.0** (3) There is evidence of an old pinhole leak at the main valve in the hall closet. It does not appear to be actively leaking at the time, but sometimes these pinhole leaks will come and go. A licensed plumbing contractor should be consulted for further evaluation and repair/replacement as needed.

**Item 5.0 (3) was repaired by plumber on 10/11/2025 after buyer backed out.**

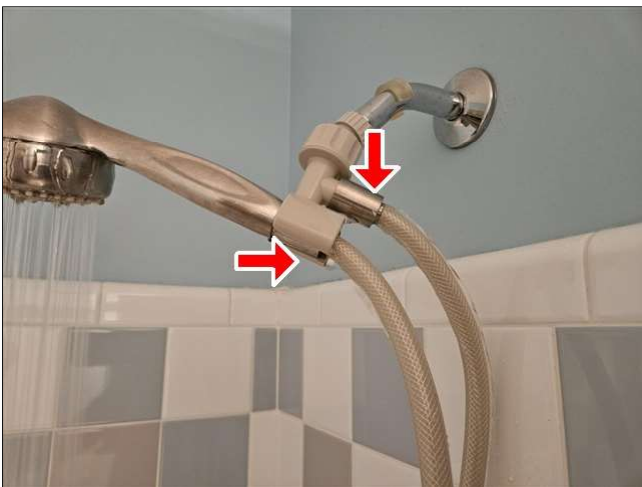
5.0 Item 4(Picture)

**5.0** (4) The rear upstairs bathroom shower wand leaks where the hose is connected to the shower arm and to the shower head. This needs to be repaired. Consult a general repair specialist for repair/replacement.

**Plumber inspected item 5.0 (4) after buyer backed out and found there to be no leak at this section.**

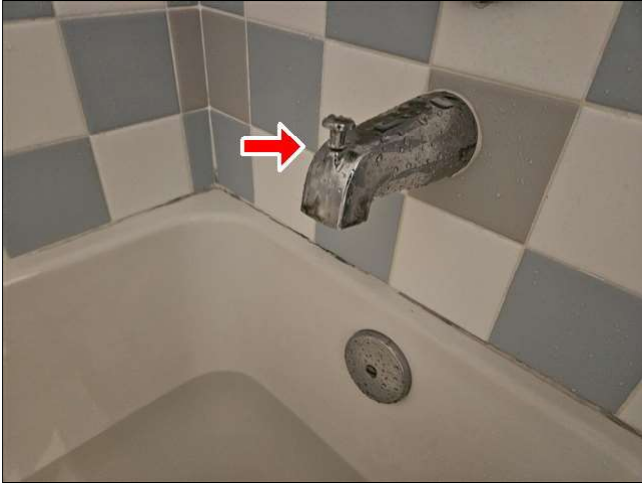
5.0 Item 5(Picture)

**5.0** (5) The shower diverter valve in the rear upstairs tub-shower is does not fully convert the water flow and should be serviced. A licensed plumbing contractor should be consulted for evaluation and repair.

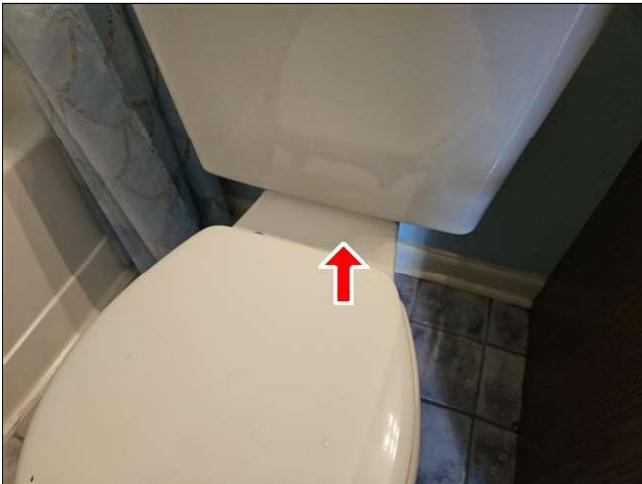
5.0 Item 6(Picture)

**5.0** (6) The rear upstairs bathroom toilet leaks significantly from between the toilet tank and base when flushed. This is an indicator that the seals between the two pieces are damaged and no longer functioning properly. This will lead to property damage and undesirable living conditions if not repaired. A licensed plumbing contractor should be consulted for repair.

Note: there is damage to the base of the vanity beside the toilet as well. This is an indicator that this leak is not a new thing, but it may be getting worse. The home inspector turned the water off to this toilet and did his best to clean up the water that spilled onto the floor.

**Item 5.0 (6) was repaired by plumber on 10/11/2025 after buyer backed out.**

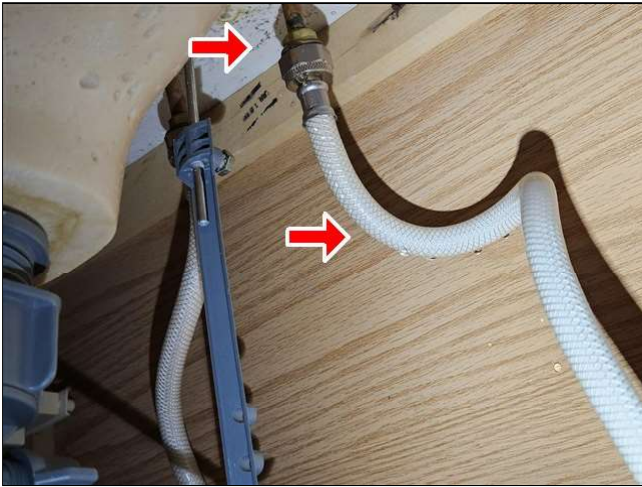
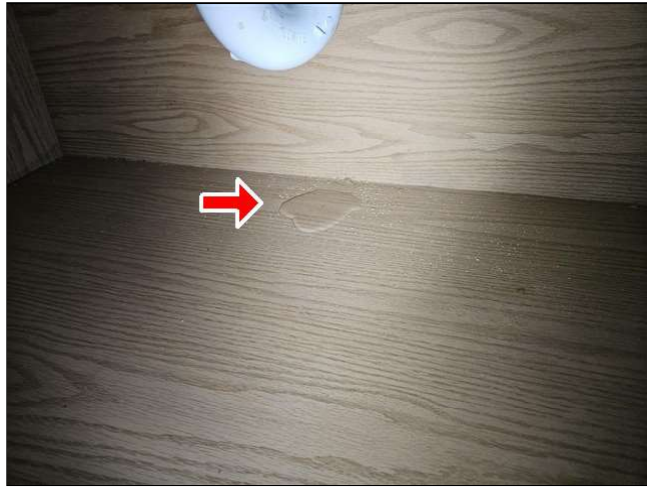
**5.0** (7) The rear upstairs bathroom sink faucet leaks under the cabinet. Repairs are needed to stop leaking water from damaging the cabinet bottom and to eliminate moisture that may contribute to fungi growth. A licensed plumbing contractor should be consulted for repair.

**Items 5.0 (7) and (8) were repaired by plumber on 10/11/2025 after buyer backed out.**

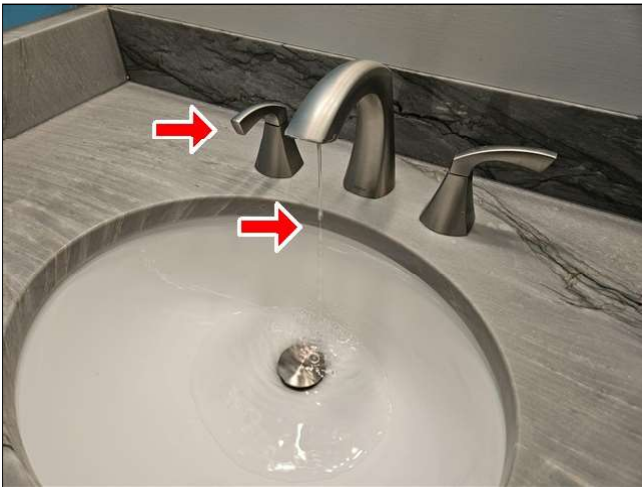
5.0 Item 10(Picture)

**5.0** (8) The hot water supply in the upstairs front bathroom sink was lower than typically expected. The other fixtures in the house seemed to have normal amounts of pressure which means there may be an issue with this fixture or the valves may not be fully opened. A licensed plumbing contractor should be consulted for further evaluation and repair.

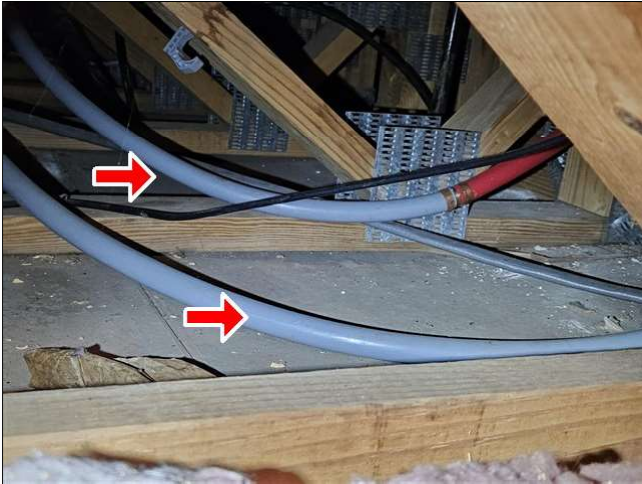
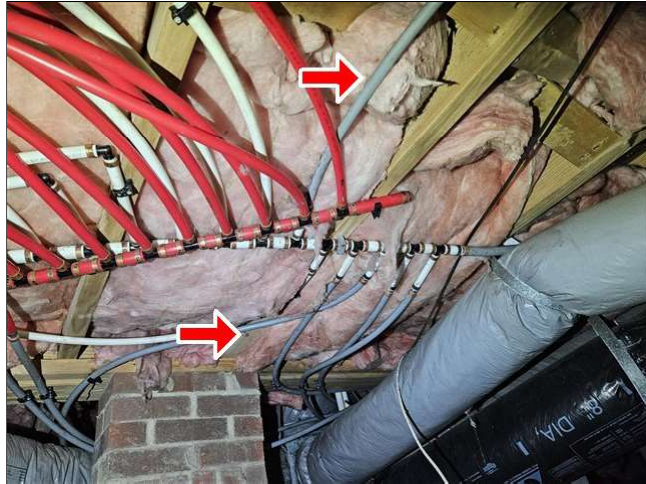
**5.0** (9) Polybutylene plumbing supply lines (PB) are installed in this house. PB was used as water distribution piping in many homes built from the mid 1980's until the mid 1990's. The piping and associated fittings have had a failure rate and subsequent leakage sufficient to have been the subject of several nationwide class action lawsuits. Copper and brass fittings used in later years seem to have reduced the failure rate, but the piping may still fail due to problems with poor installation, improper handling, or chemical reaction with the water supply. The piping in this house has Brass/Copper fittings. You may wish to have the plumbing system evaluated by a licensed plumbing contractor.

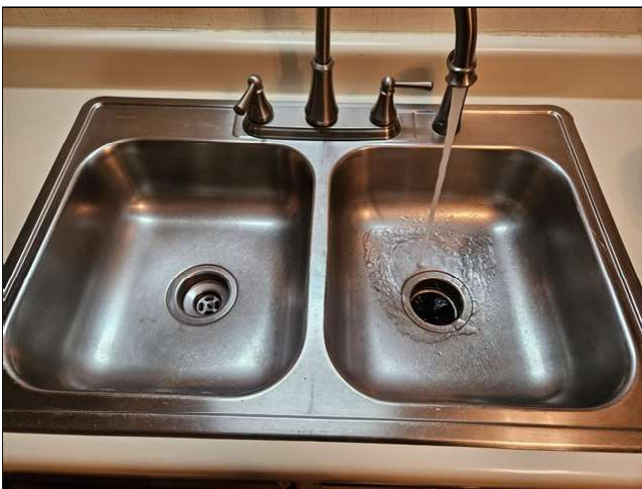
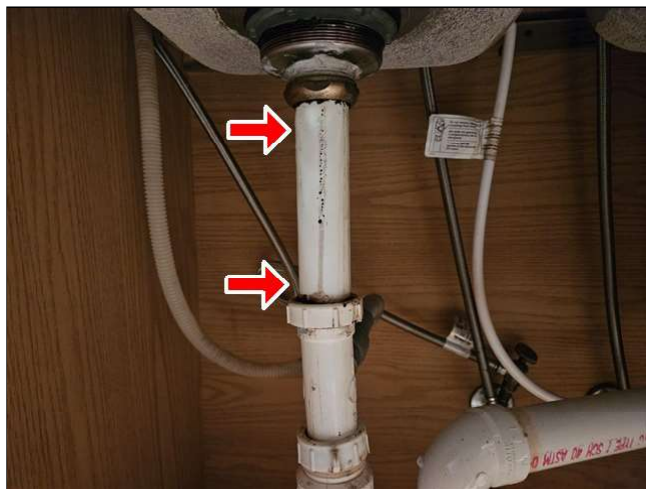
**5.1** (1) One or more of the drains were missing the stoppers and could not be fully tested. The stoppers need to be replaced and the fixtures filled and drained to ensure they are not clogged and are functioning properly. A licensed plumbing contractor can be consulted as needed.

Stoppers were missing in the following locations:

1. Both of the kitchen sinks. There is evidence of past leaks on the drain pipes.

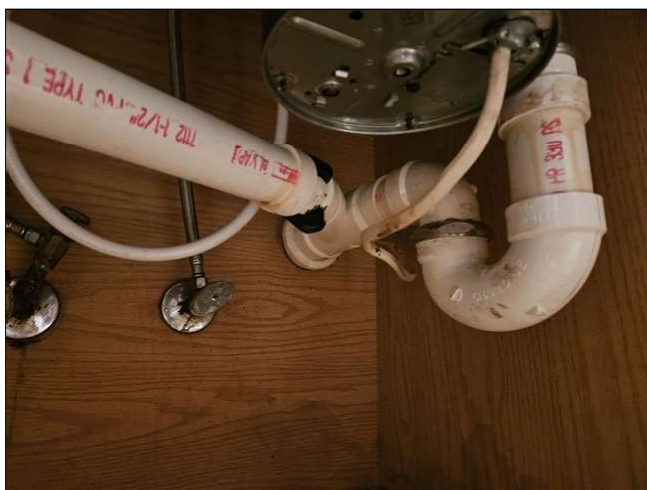
5.1 Item 3(Picture)

**5.1** (2) There is a parallel P-trap configuration under kitchen sinks. This means each drain line for the two basins has its own trap prior to joining at a wye fitting and going into the wall. When draining a lot of water, say when both basins are filled to wash dishes and then drained, this setup can allow one drain line to siphon the water out of the other trap allowing sewer gases to escape into the home. This set up is common for the age of the home, and may not cause you any issues, but is technically incorrect and not the best way of draining the sinks. If you have concerns, a licensed plumbing contractor can be consulted to properly plumb

this drain line.

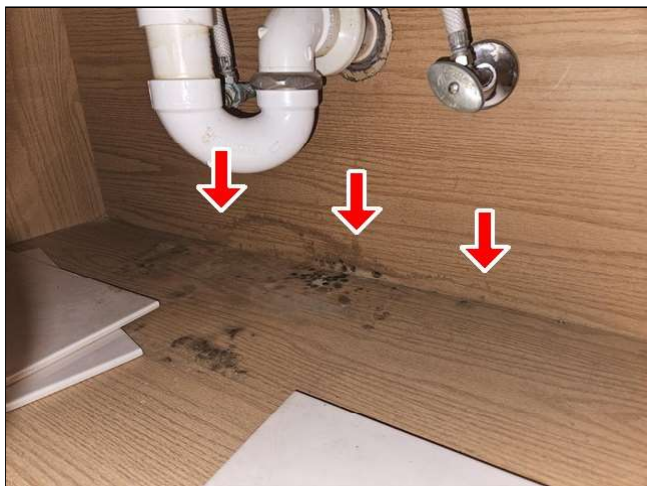
5.1 Item 4(Picture)

**5.1** (3) Evidence suggests that the drain line for the master bathroom sink was leaking in or at the wall at some point in time. There is damage/moisture lines on the cabinet in this area consistent with a leak. It was dry at the time of the inspection, but you should monitor it once the house is put into use to ensure that the leak does not show up. If you have concerns, consult a licensed plumbing contractor and ask the sellers for any information about this leak and what repairs were done.

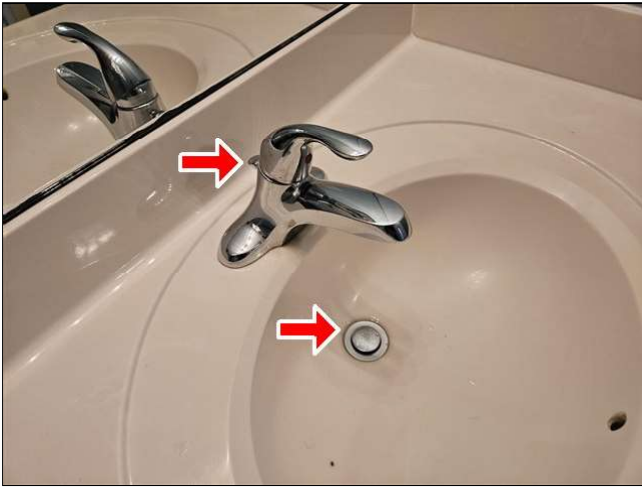
5.1 Item 5(Picture)

**5.1** (4) The rear upstairs bathroom sink stopper does not function properly and should be serviced. The actuating rod would not move the stopper up or down. The stopper needs to be repaired/replaced to function properly. A licensed plumbing contractor should be consulted for repair/replacement.

**Item 5.1 (4) was repaired by plumber on 10/11/25 after the buyer backed out.**

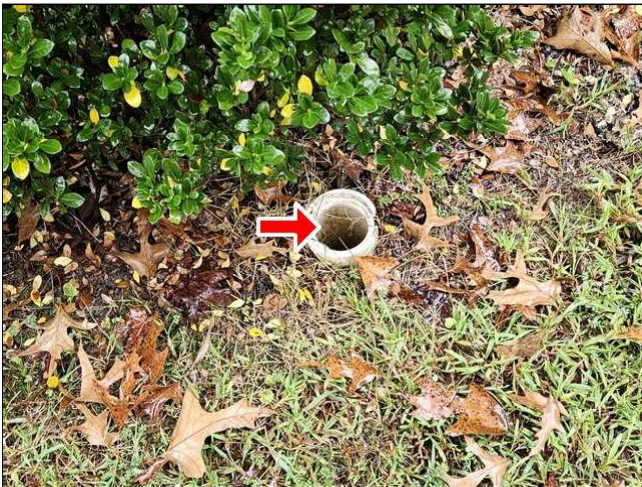
5.1 Item 6(Picture)

**5.1** (5) The main waste clean out pipe cap is damaged/missing at the front of the house. It may have been hit with a mower and you may want to have it lowered slightly to keep this from reoccurring. The cap needs to be replaced to keep rain water/debris/animals from entering the sewer pipe. Consult a licensed plumbing contractor for repair.

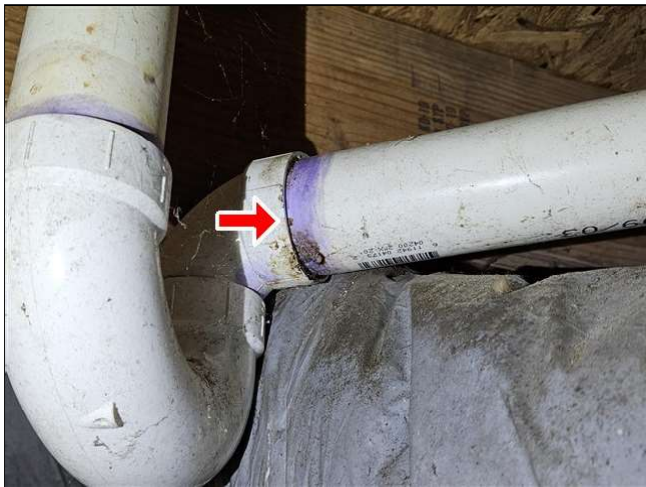
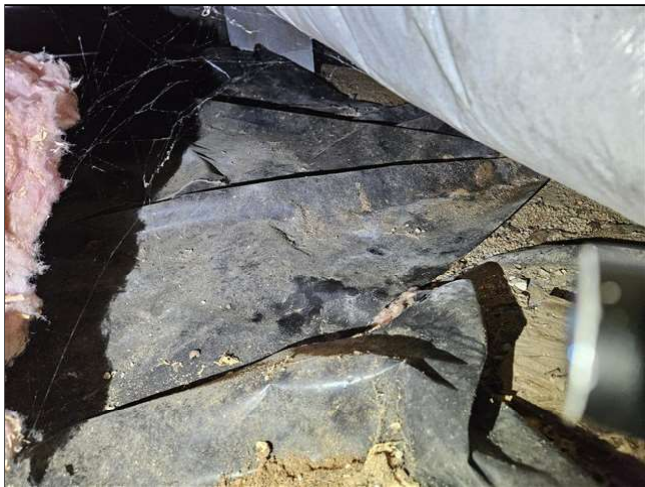
5.1 Item 7(Picture)

5.1 (6) The drain line for the shower in master bathroom was leaking into the crawlspace. It is at a joint just downstream of the P trap.. This needs to be repaired before any further damage occurs. A licensed plumbing contractor should be consulted to locate and repair the leak.

Item 5.1 (6) was repaired by plumber on 10/11/2025 after buyer backed out.

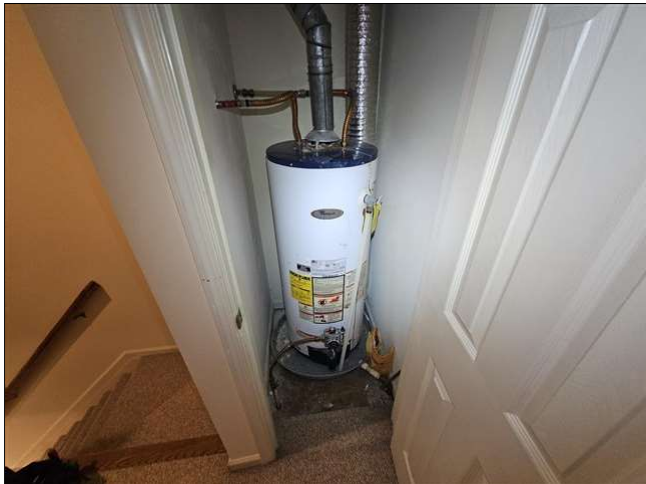
5.2 Item 2(Picture)

5.2 (2) The gas water heater for this house needs further evaluation and most likely replacement. It has several issues that need to be evaluated and addressed. For starters, when you open the door to the closet containing the water heater, a distinct odor of gas could be smelled. The gas valve/controller is corroded. This unit is older and the gas valves for these often go bad leading to a small leaks. There's also corrosion around the flu and down the side of the unit indicating leaks or poor drafting of the unit. The temperature pressure relief valve is also corroded. There is also no drip leg for the gas line. This unit is older and is not in great shape. It needs to be evaluated and most likely replaced by licensed plumbing contractor.

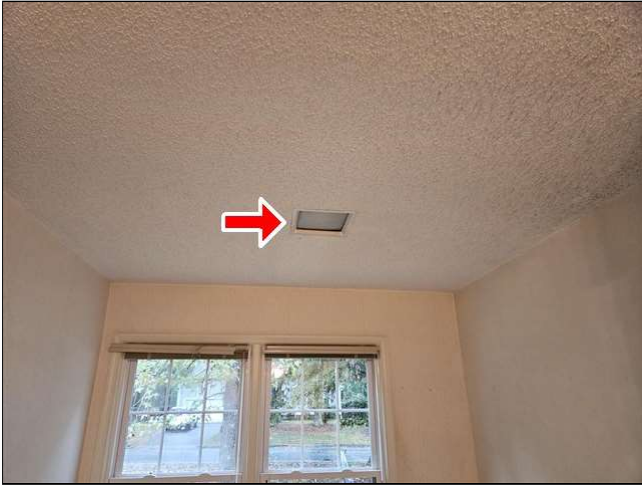
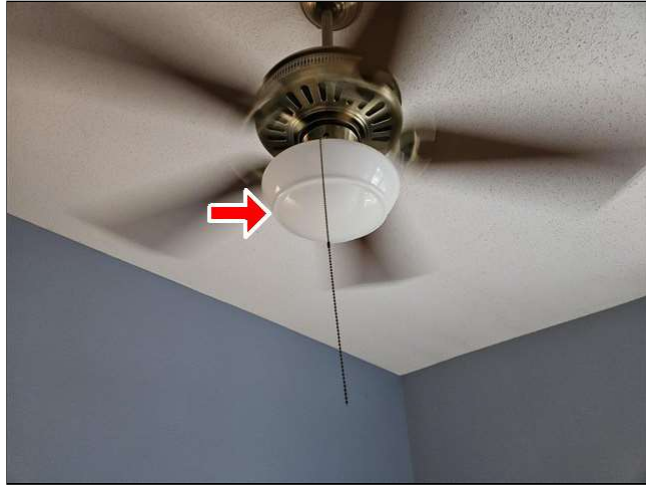
**6.3** (1) One or more of the light fixtures in the house had a bulb or bulbs that were not working or were missing. These bulbs need to be replaced to ensure the issue is with the bulbs and not the fixtures. If the fixtures do not work once the bulbs have been replaced, then a licensed electrical contractor can be consulted for further evaluation.

The burnt/missing bulbs were noted in the following locations:

1. In the dining area.
2. In the front upstairs bedroom fan light.

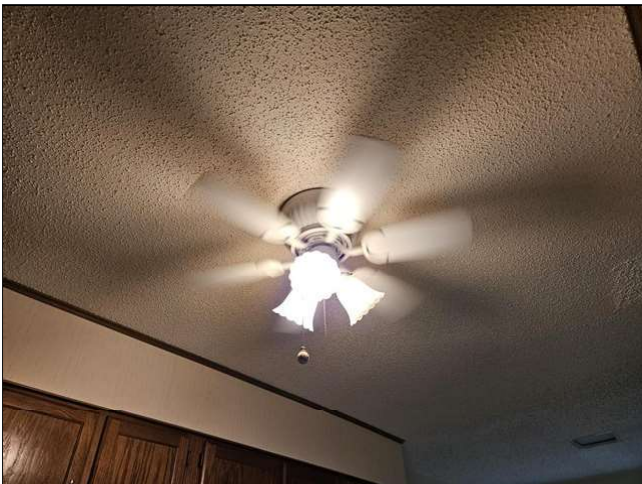
6.3 Item 3(Picture)

The off balance fans were noted:

1. In the kitchen.

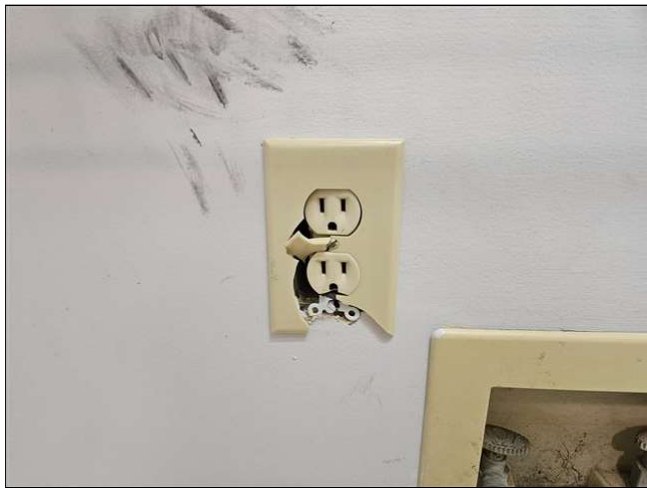
6.3 Item 7(Picture)

**6.3 (4)** The outlet in the laundry room is cracked/damaged. This is an important safety feature and keeps users from accidentally shocking themselves (especially kids). The cover plate needs to be replaced. A general repair specialist can be consulted as needed.

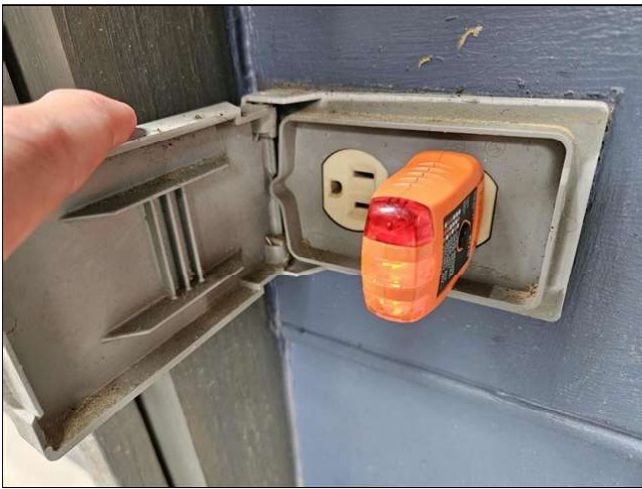
**6.5** The exterior receptacles in this house are not GFCI protected. GFCI outlets add an important safety feature to electrical systems. You should consider upgrading the electrical system to include GFCI protection. A licensed electrical contractor can be consulted to upgrade the system and ensure you are protected.

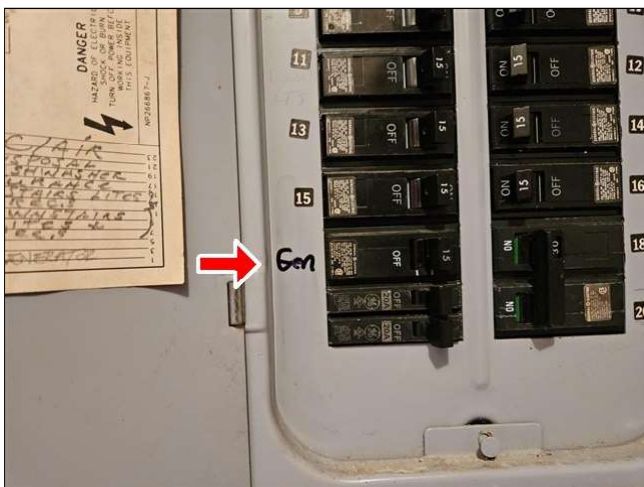
6.9 Item 1(Picture)

The wrong type of receptacle was used for the generator hookup. The plug used in this house would require a cord from the generator with a male plug on both sides, which is very dangerous. The receptacle at the panel should be a plug that accepts a female plug and is protected. A licensed electrical contractor should be consulted for a complete evaluation of the generator components and to make repairs as needed to ensure the system is safe.

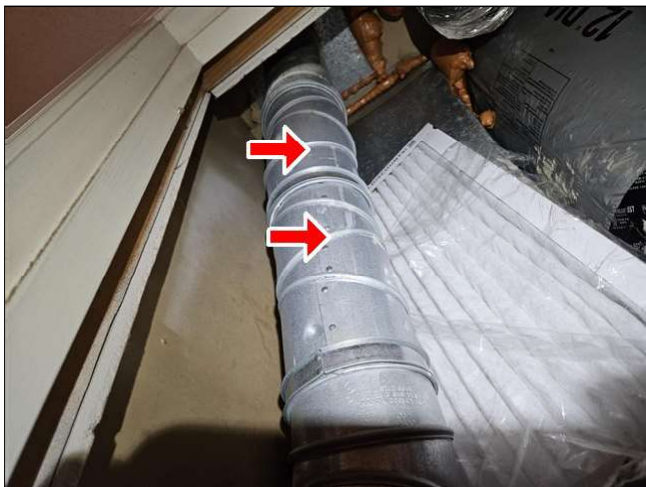
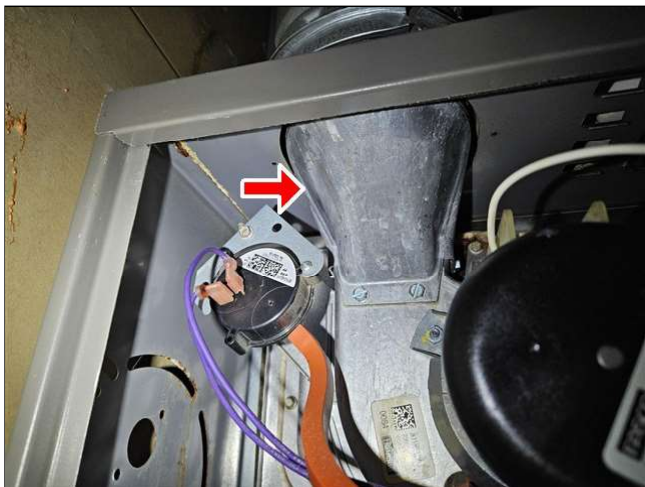
7.0 Item 3(Picture)

**7.0** (2) There are some water marks on the bottom of the flu pipe, below the bottom of the draft fan assembly, and some corrosion inside the furnace cabinet. This is an indicator that some of the exhaust gases are condensing inside the flu before they completely exit the home. This is not a high efficiency furnace and is not designed for condensate to flow back into the unit. This can lead to damage of the unit over time. No puddles of condensate were noted in the unit at the time of the inspection. You may want to have a HVAC technician evaluate the flu, draft fan, and unit in general to ensure it is functioning and drafting properly. Repairs should be made as needed.

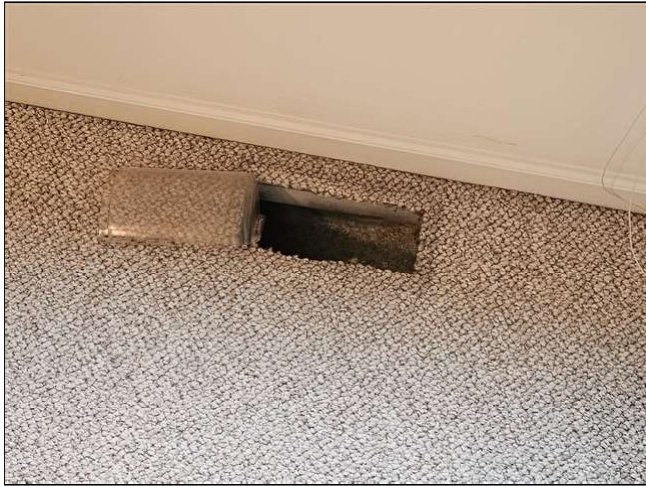
7.3 Item 1(Picture)

**7.3** (1) The right floor register grill is missing from the HVAC supply in the master bedroom. This needs to be installed to keep items from falling into the duct. A hvac contractor can be consulted as needed.

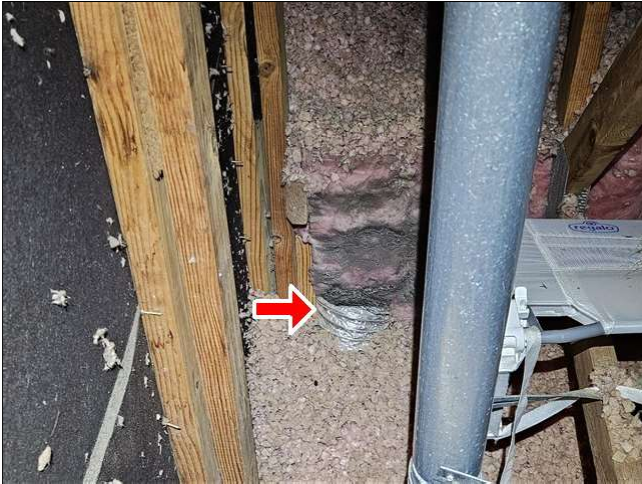
7.3 Item 2(Picture)

**7.3** (2) Both the water heater and the furnace are inside of closets in the upstairs hallway. This is okay, but does require certain amounts of intake air to be supplied. For both of these units, the intake air is being supplied by flexible duct work that goes up into the attic. All of these ducts were noted to be partially blocked by insulation in the attic which means they are not moving nearly as much air as they are supposed to. This can starve these units for air and cause them to not burn properly which could lead to carbon monoxide build up, which can be deadly. These ducts need to be adjusted so that they are free-flowing and not blocked. A HVAC technician can be consulted as needed for repair.

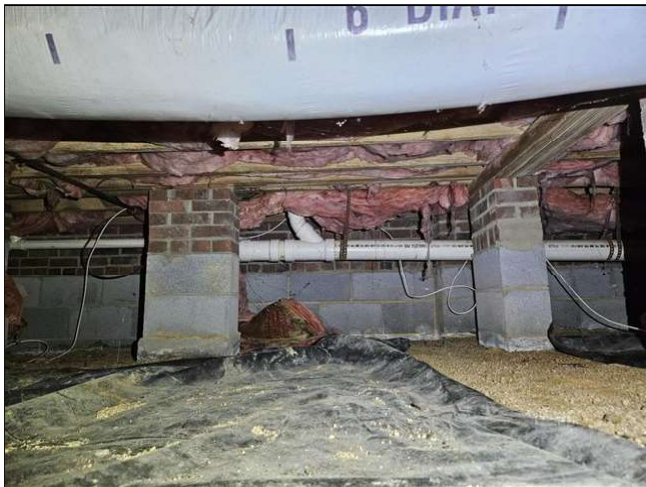
8.1 Item 1(Picture)

**8.1** Some pieces of insulation are hanging or have fallen from between the floor joists. This could lead to condensation/mold growth on the sub flooring and inadequate heating/cooling of living spaces. The insulation needs to be replaced/repared. Consult a licensed general contractor for repair.

**All new insulation added throughout crawl space on 10/10/2025 after buyer backed out.**

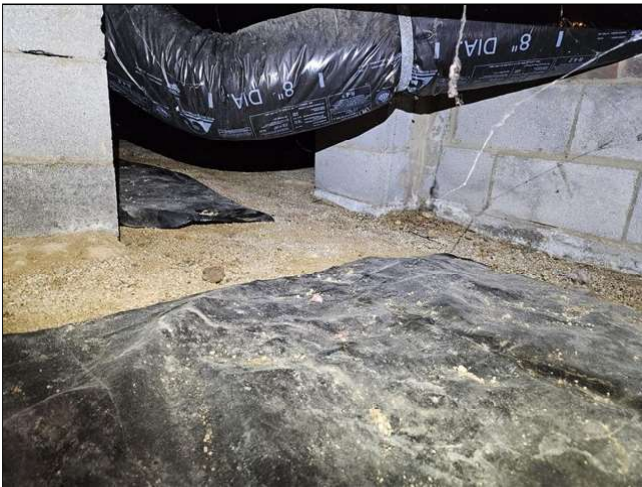
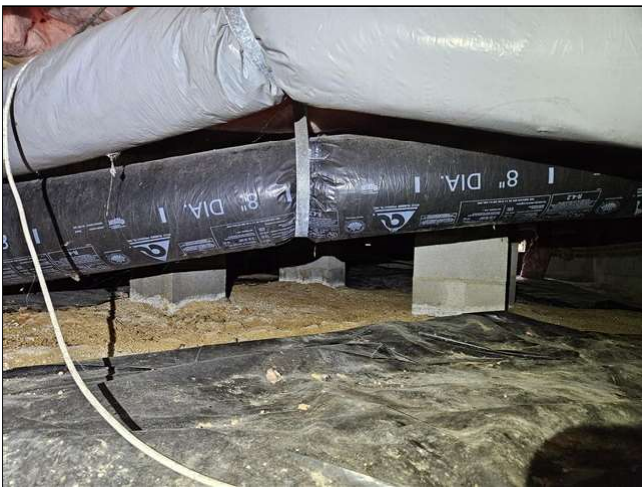
**8.2** The vapor barrier in the crawl space is missing in a few areas. Vapor barriers should cover the entire floor space to work properly. Missing sections can allow higher levels of moisture into the crawl space which can lead to undesirable living conditions. A general repair specialist should be consulted for repair.

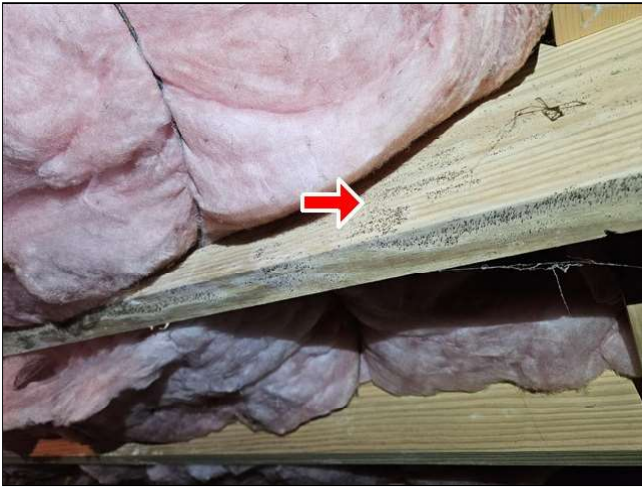
8.3 Item 1(Picture)

experience. Please note that the home inspector was concerned with the moisture issues and their effect on the house, not the health implications of mold. If you have further concerns about the mold, consult your Dr. or an industrial hygienist.

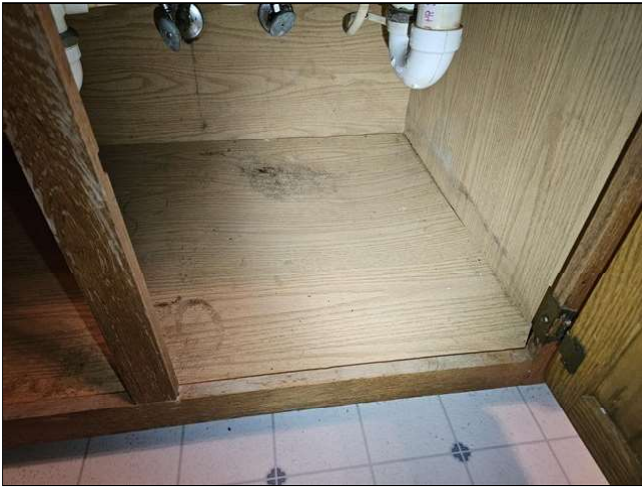
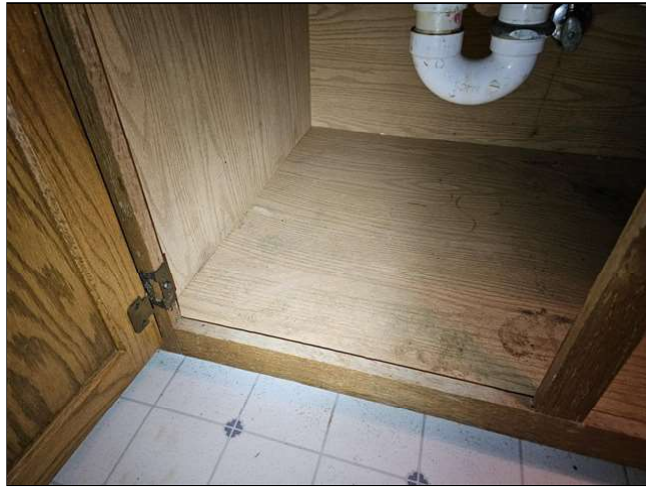
**9.4** The floor of the kitchen sink cabinet is functional, but moisture damaged. There could be hidden damage under the floor of the cabinet. IF you are concerned, a licensed general contractor should be consulted for invasive inspection and repair where necessary.

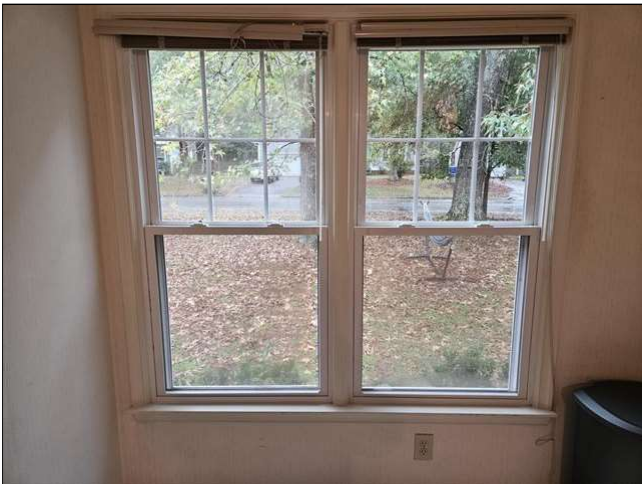
9.6 Item 1(Picture)

1. The windows in the dining area.
2. The windows in the master bedroom.
3. The side windows in the sunroom .
4. The windows in the front upstairs bedroom.

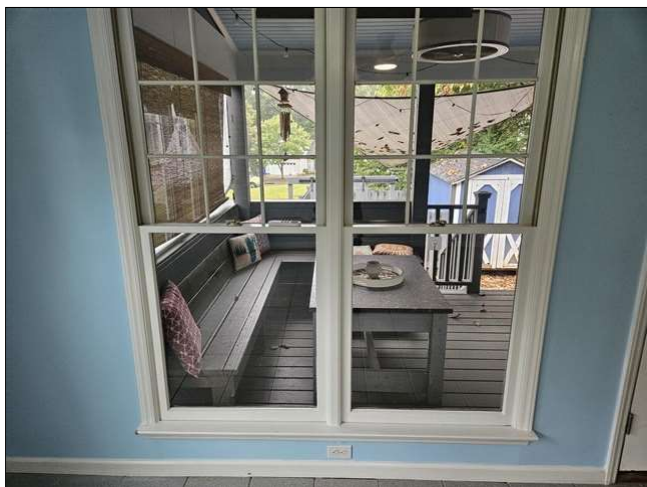
9.6 Item 5(Picture)

**9.6** (2) The two rear sunroom window panes in the house were painted shut or otherwise would not open. This limits the inspection of the windows and is a safety concern should the windows need to be opened for emergency egress. All windows should be made to move freely in order to function properly. A window specialist should be consulted for further evaluation and repair as necessary.

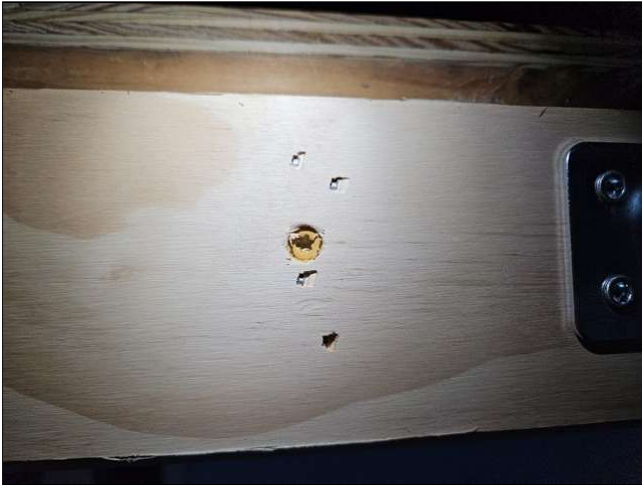
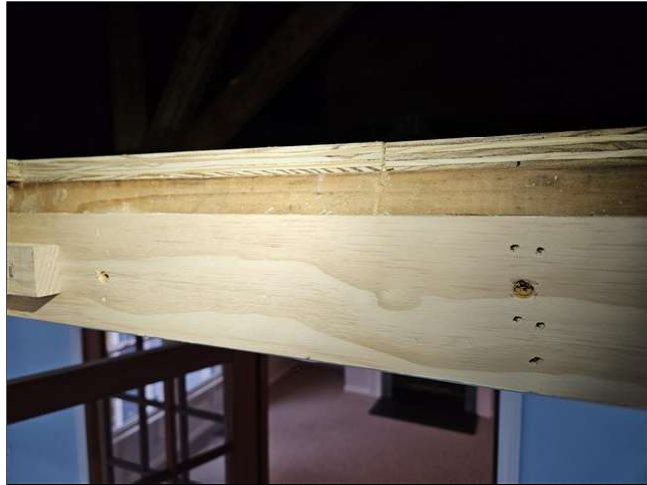
**9.7** (1) The attic access steps are installed using screws and not 16D nails which are recommended. This could be a hazardous condition and could lead to personal injury and property damage. The steps need to be evaluated and repaired to ensure they are installed properly and function safely. A licensed general contractor should be consulted for evaluation and repair.

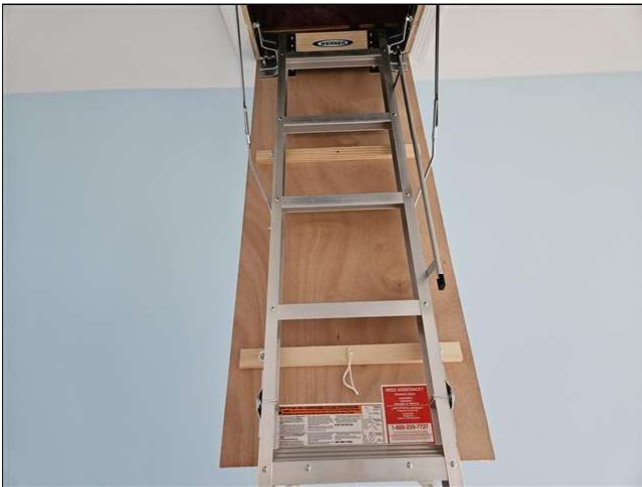
9.7 Item 3(Picture)

**9.7** (2) Insulation is missing from the attic steps. This can lead to condensation buildup on and around the steps and lead to property damage and uneven heating/cooling. The insulation needs to be replaced. A general repair specialist can be consulted for replacement as needed.

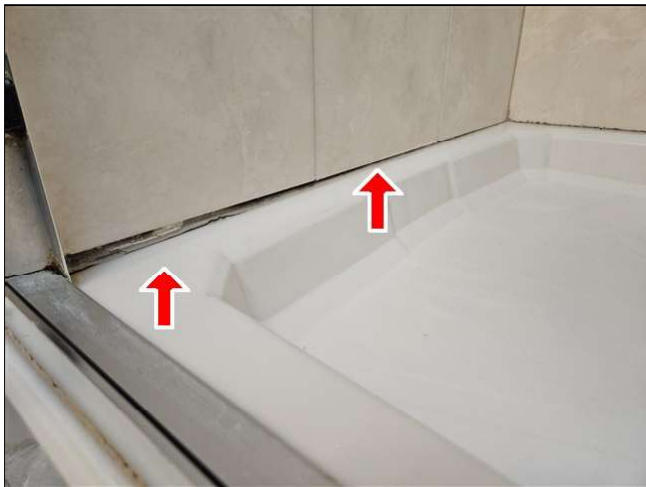
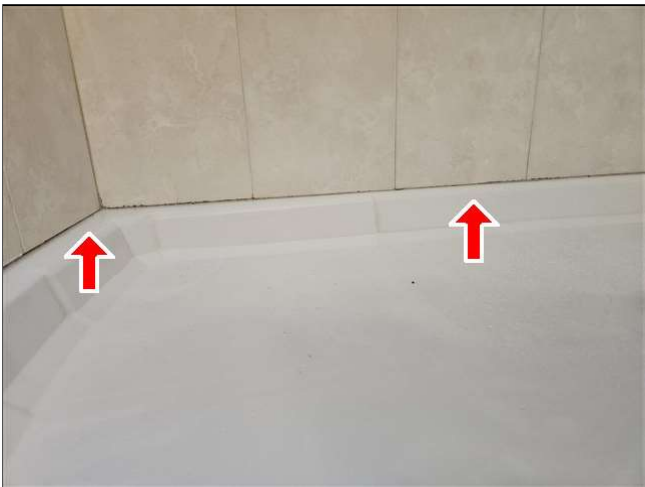
9.8 Item 1(Picture)

**9.8** (1) The stall shower in the master bathroom needs new caulk at the floor to wall junction. The grout is starting to crack and pop away and caulk will help to keep water from getting under the tile which can lead to property damage. A flooring/tile specialist can be consulted for repair as needed.
