**\*\*\*Update\*\*\***

Previous buyer terminated contract after they received the report from their home inspector but before negotiations took place. This is the original report with recent repairs noted.

# Inspection Report

2214 Pathway Dr  
Chapel Hill NC 27516

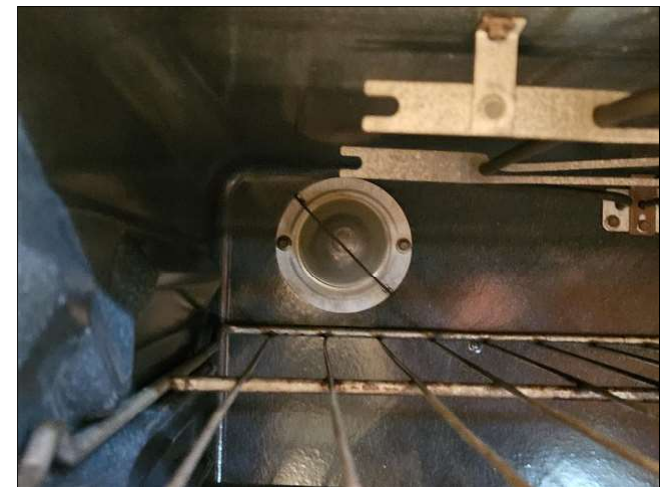
10.1 Item 1(Picture)

- 10.0 The dishwasher is functional. It was operated through the normal cycle or until a defect is discovered. The effectiveness of the cleaning was not determined.
- 10.1 (1) The electric range is functional. The range/oven elements were operated with the indicator set to high until the element was noted to be fully red or a defect was discovered. The unit calibration was not verified. If you would like to verify the temperature calibration, an appliance specialist should be consulted.
- 10.1 (2) The light for the oven did not function. This is an important feature that allows you to see in the oven to determine the progress of the items you are cooking. An appliance repair specialist should be consulted for repair.

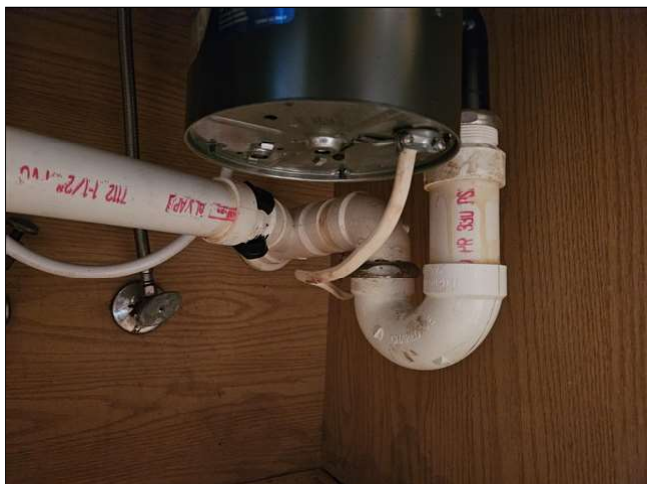
10.2 Item 1(Picture)

protected in conduit to keep it from being accidently damaged. A licensed electrical contractor or appliance specialist should be consulted for repair.
