Inspection Report

Property Address:
2214 Pathway-3
Chapel Hill NC

ODUM SQUIRES INC

1/31/2026

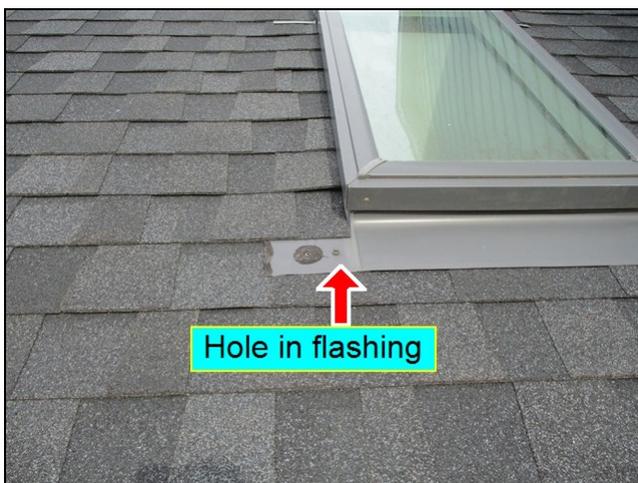
1.1 Item 2 (Picture)

(2) Noted unsealed holes in the skylight flashing, at the bottom edges. This appears to be the original mounting points, before the roof replacement. This is not uncommon and is normally acceptable, as long as no holes are present below the openings. However, it is a best practice to seal all openings in any exterior flashing materials.

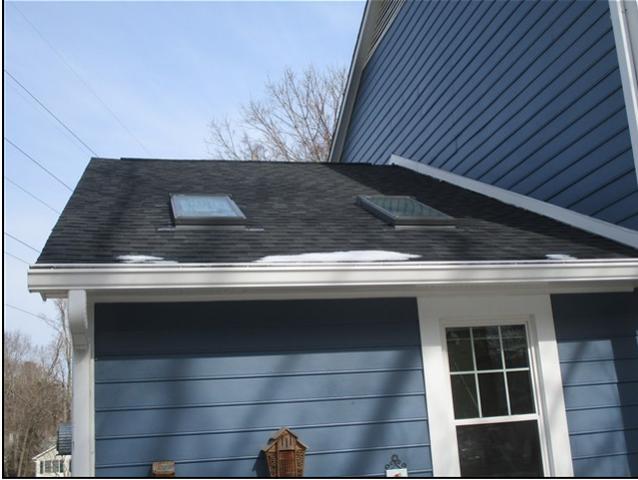
1.2 Item 1 (Picture)

At least one skylight is present on the subject home. The ceiling and surrounding area has been painted recently, this could mask damage. No leaks were detected at the time inspection. However, you should keep in mind that this is a sealed hole in the roof surface. Although it could function for years without an issue it also could begin to leak at any time. A Leaking skylight could require repairs or replacement. Temporary repairs or hidden sealant can hold out water, the inspector cannot confirm if such conditions exist. This opening will require monitoring and periodic inspection.

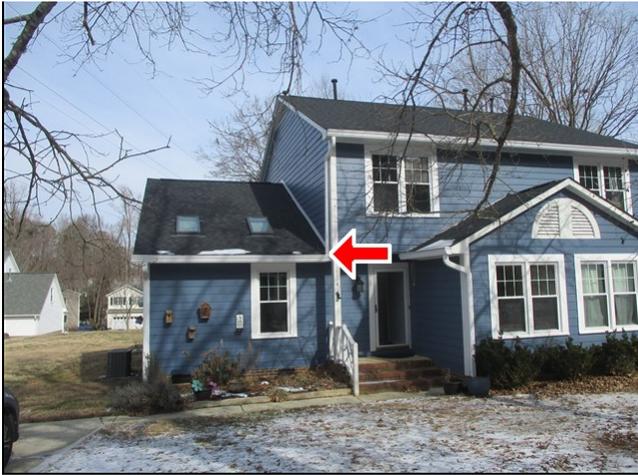
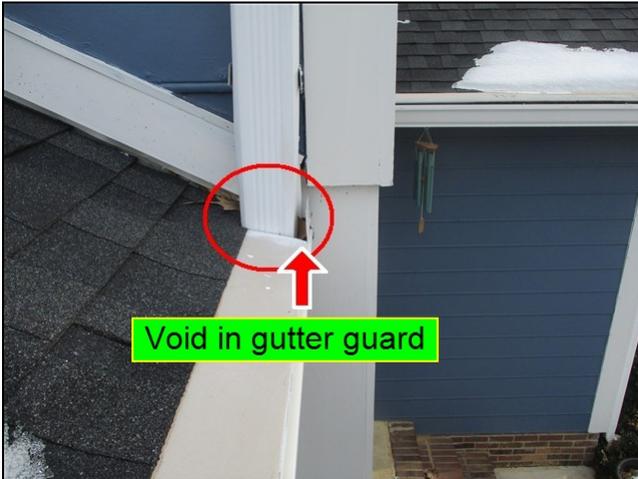
1.3 Item 1 (Picture)

These guard/s are open and/or are misaligned in this area. Large opening in the top of the gutter can allow for the entry of debris and leaves etc. which can lead to clogging. Recommend repairs and/or adjustments as needed to correct this issue.

FYI: this may be difficult to seal off and may require periodic cleaning to prevent clogging.

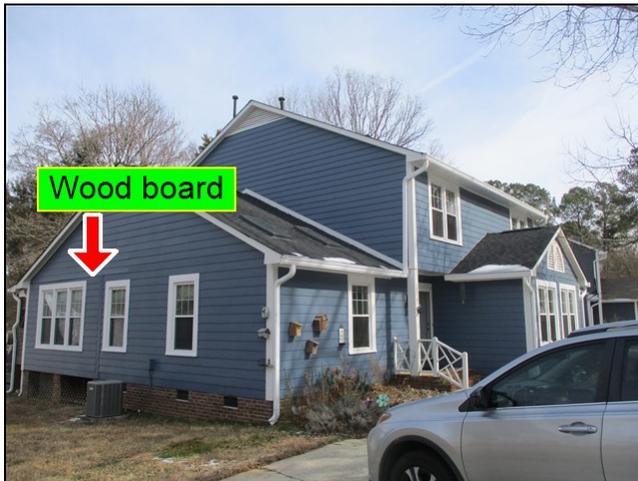
2.0 Item 1 (Picture)

(1) The caulk between the vertical wood board and the siding veneer is deteriorating/separating and/or is missing, at the vertical seam (on the left side of the home). Caulk is used to seal the transition point between these two dissimilar materials to keep out moisture. There were also a few areas where the caulk is beginning to breakdown at the siding butt joints. Recommend the transition between the wood trim board and siding material be sealed with an exterior grade sealant.

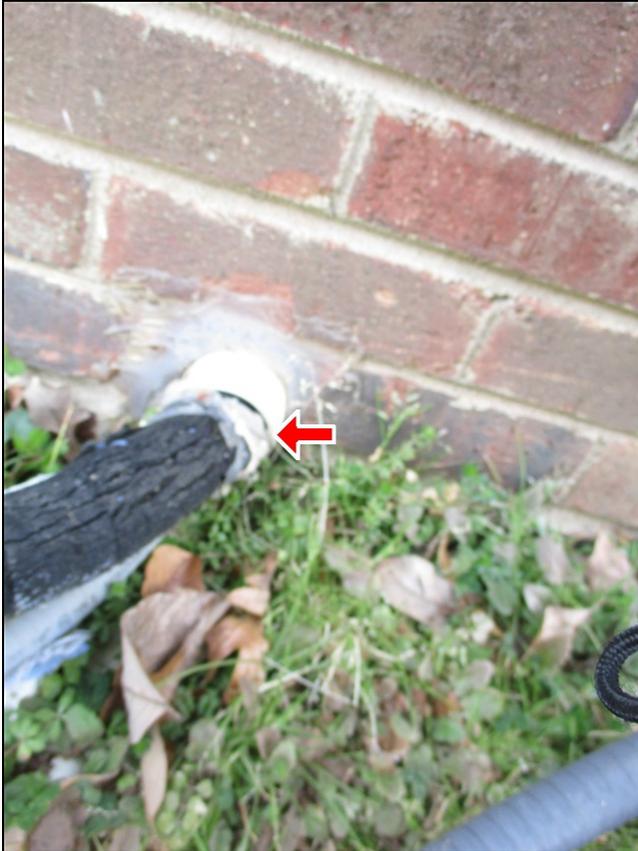
(3) NOTED voids at the foundation and veneer penetrations. This would include the perimeter of the HVAC line set penetration in the foundation wall (photo #2). Any void in the foundation or the veneer can act as an entry point for moisture. Recommend all of the exterior penetrations be sealed.

2.0 Item 2 (Picture) HVAC line set

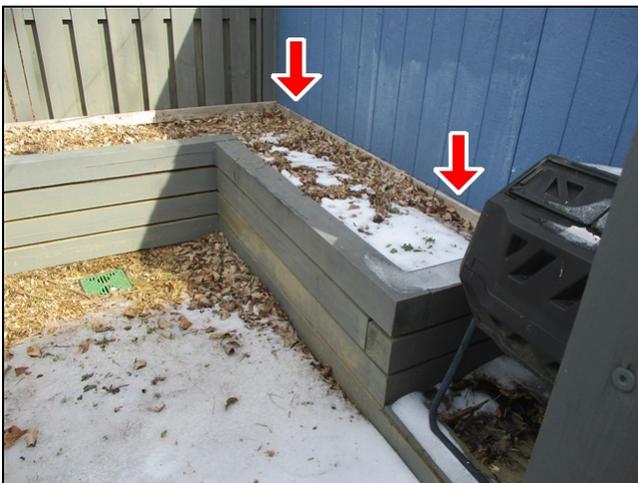
(4) The raised plant bed, at the rear of the home, is close to the shed on the left side. This can trap moisture and debris against the structure, which can lead to water entry and decay. Recommend repairs as needed/desired.

2.0 Item 3 (Picture) raised plant bed

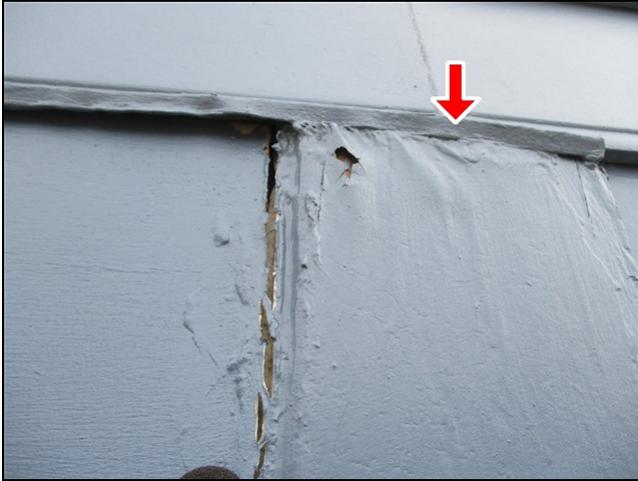
(5) Paint raiting, chipping and/or is peeling on vertical wood trim board, at the left side of the nome. Paint protects wood and other materials from the elements. Moisture exposure can lead to decay. Recommend the affected areas be prepped and painted to prevent rot and ensure the material functions as intended.

2.0 Item 4 (Picture) peeling paint

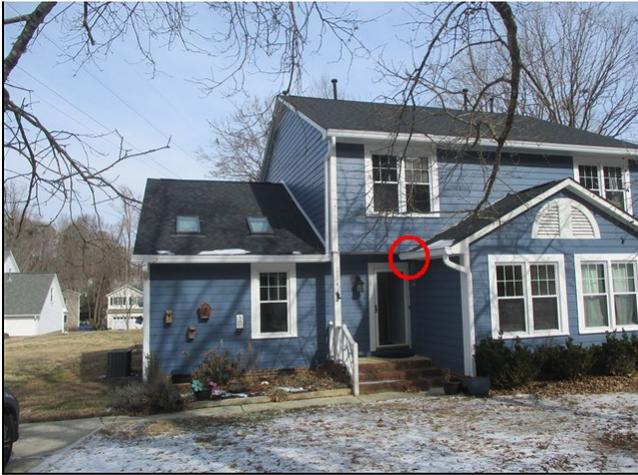
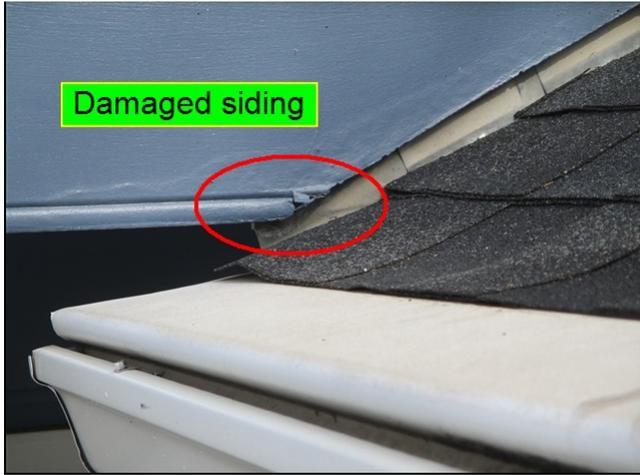
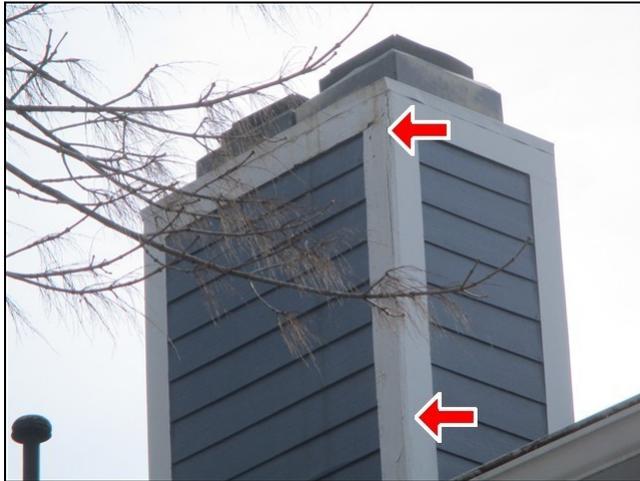
(7) Damage siding noted in the following locations:

- 1.)the bottom piece of siding at the kitchen roof (next to the porch ceiling) has decay on the cut end (photo #7,8&9)
- 2.)The chimney has loose and/or damaged siding present. The bottoms of the corner boards are breaking down at the cut edge (likely caused by water absorption due to lack of paint). (photo #10)
- 3.)at the right side of the shed: there is gaping at the repairs, un-painted siding and damage near the base. (photo #11)
- 4.)decay is present at the base of the door on the shed (photo #12)
- 6.)at the base of the front porch columns (photo #13)

Any opening in the veneer can be a potential entry point for moisture. Recommend the damaged pieces of siding be replaced.

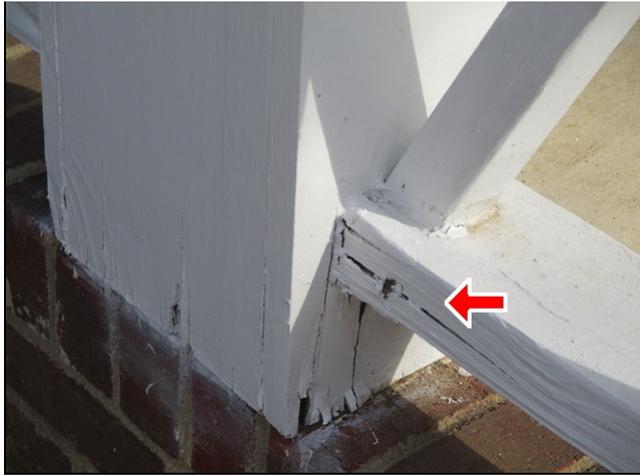
(2) The front porch railing are splitting/cracking in areas; This material is functioning. Splintering, cracking, and warping is normal and to be expected for treated lumber. However, The gaps are exposing un-protected lumber. Paint and/or stain protects wood and other material from the elements and potential decay. Voids/cracks in lumber (both treated and un-treated) can be susceptible to decay. Paint helps to protect sealed lumber but can trap moisture in the voids and can lead to accelerated wear and decay, even with treated material. These areas need prep and paint or stain.

2.3 Item 1 (Picture) front rail

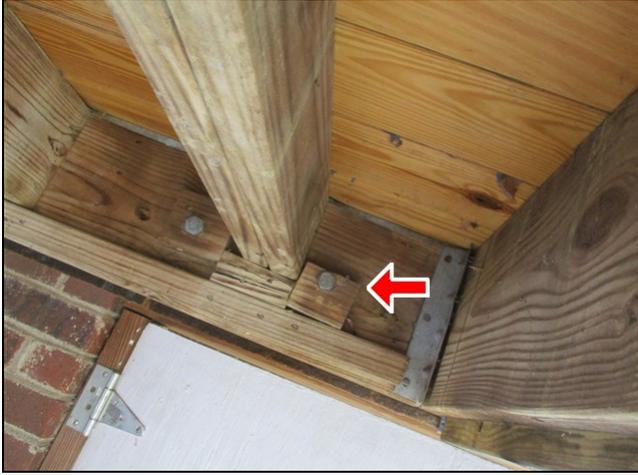
(3) The deck band/rim is attached to the home with bolts. On the subject home, makeshift wood washers are present. These wood washers appear to be functioning (at this time). However, wood washers can shrink, crack, wear and/or fail in exposure. This is a not standard installation. With a 5/8 galvanized bolt it is expected that two steel washers be used. One on the hex head end and a second at the nut side of the bolt (example Photo #5). Galvanized steel is less susceptible to the elements and wear (in exposure). Recommend repairs as needed.

2.3 Item 2 (Picture) deck bolts

Heavy gauge Structural screws and lags have also recently been approved for this type of attachment but required tighter/closer on center spacing and (depending on the screw/lag size) may required 2 screws per row.

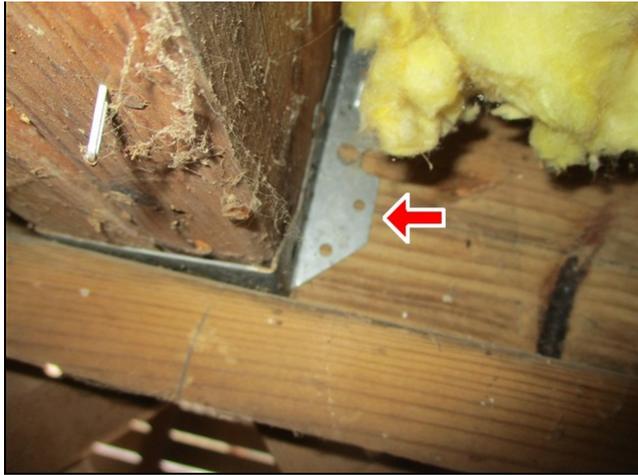
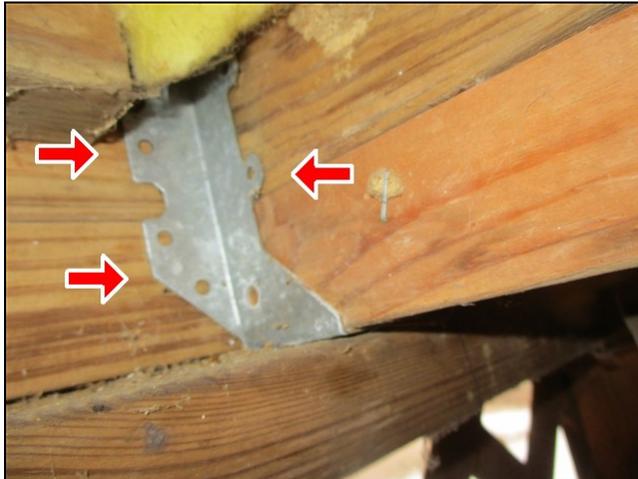
(4) Noted missing hangers nails below the sunroom floor joist connections. Hangers are required to have a nail in every nail hole to function as intended, unless otherwise noted by a licensed engineer. These hanger must be installed per-manufacture's standards. Recommend repairs by a qualified contractor.

2.3 Item 6 (Picture) missing nails

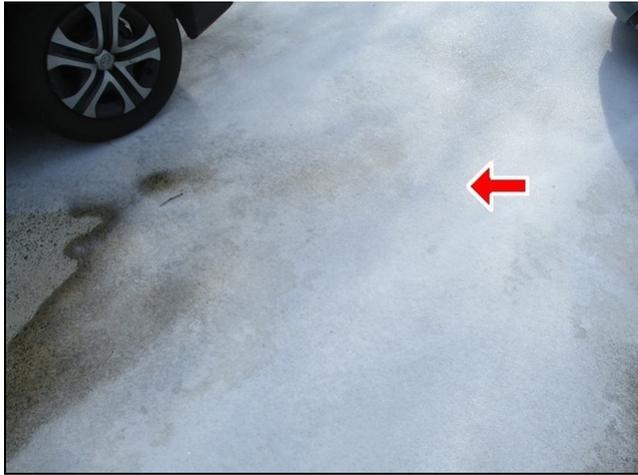
(1) The driveway is covered in ice. However, it is likely that some cracks and displacement would be present in the driveway, based on the age of the structure. Cracks in exterior concrete are normal and to be expected. Notably uneven sections, if present, can be a trip hazard. The inspector cannot verify the condition of the entire driveway surface due to the ice coverage at the time of the inspection.

2.4 Item 1 (Picture) ice and snow

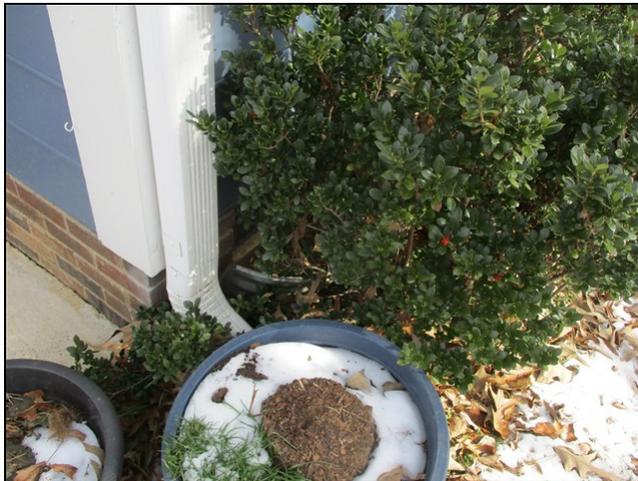
(2) Note: the plants have been cut back on the subject property but are closer than the recommend 12" in areas.

Organic growth was noted on the foundation wall and siding. Vines, trees, and plant growth can find their way behind the siding material to the structure below. Organic growth can also hold moisture against the home and cause long term damage if left in place. Recommend removal of all vines and organic growth, next to the siding and growing up the foundation wall. Bushes should be cut back away from the foundation wall roughly 12" to 18". (We did not inspect behind this siding, stucco, brick, stone or other veneers.)

2.4 Item 2 (Picture) plants close

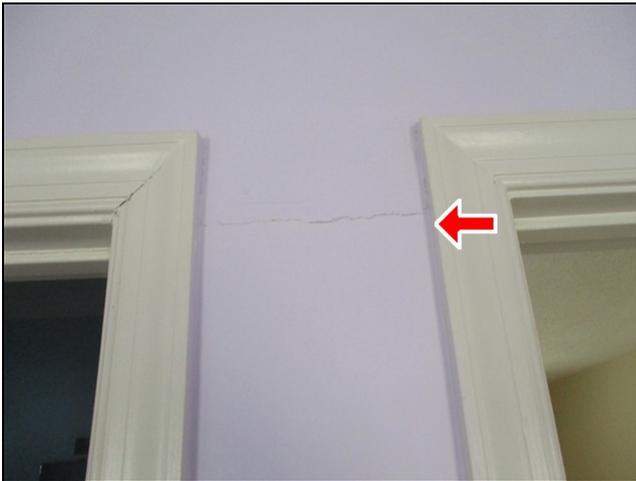
(1) Noted a crack in the sheetrock at the left side of the rear bedroom wall, between the doors. Cracks in sheet rock especially at seams are not uncommon and are frequently caused by settling in the home and shrinkage of building materials. Recommend these cracks be repaired and monitored

3.0 Item 1 (Picture) sheetrock crack

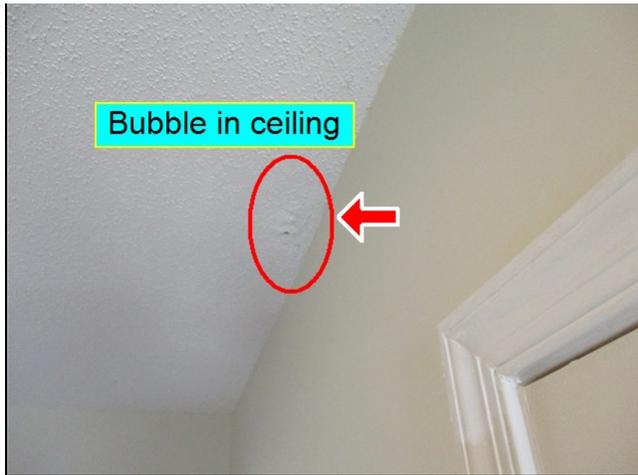
(2) The Texture on the ceiling is peeling or loose at the in the following locations:

3.0 Item 2 (Picture) 2nd floor hall ceiling

This damage is considered cosmetic. A qualified person should repair or replace as needed.

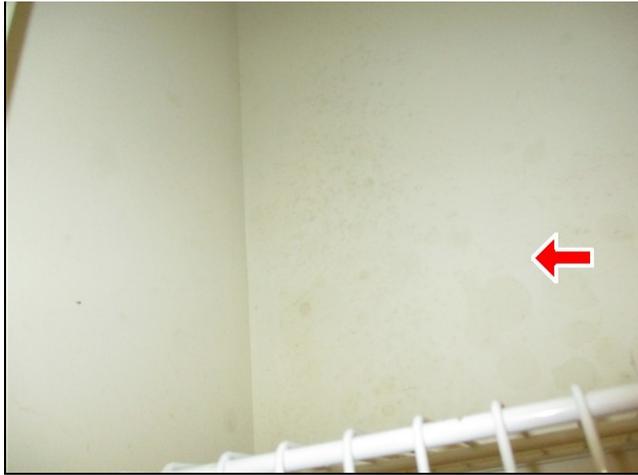
(3) Noted spotting on the pantry wall, above the top shelf. This staining could not be identified but was tested for moisture. The readings were low, at the time of the inspection.

3.1 Item 3 (Picture) pantry wall

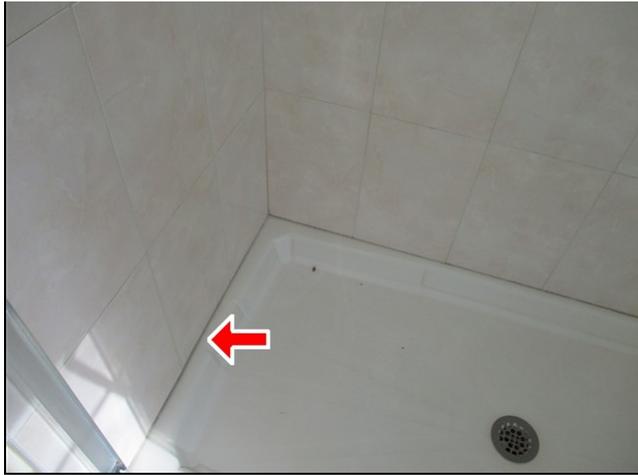
(4) Noted separating and deteriorating caulk or grout in one of more of the following locations: along the perimeter of the tub/tile transition, at the base of the shower pan outside the shower, and on the inside rear corners of the shower wall. I recommend these areas be sealed with a grout or caulk designed for use with tile to keep out moisture and prevent wood decay.

3.1 Item 5 (Picture) shower wall/pan

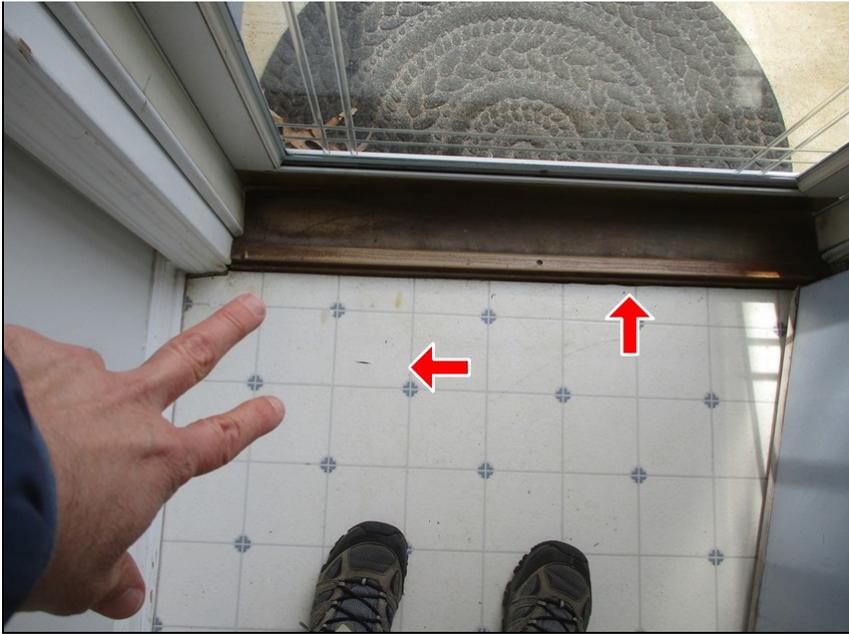
(1) Noted the following issues with the vinyl flooring:

1.)A tear is present in the foyer. This creates an access point for moisture in "wet areas" (more of an issue with wood sub-flooring).

3.2 Item 1 (Picture) foyer floor

Tear damage can often be repaired by a flooring professional with a seam sealer material. Gaping at the perimeter of the covering can be covered with shoe molding or caulking, depending on the situation. Recommend repairs to correct this issue.

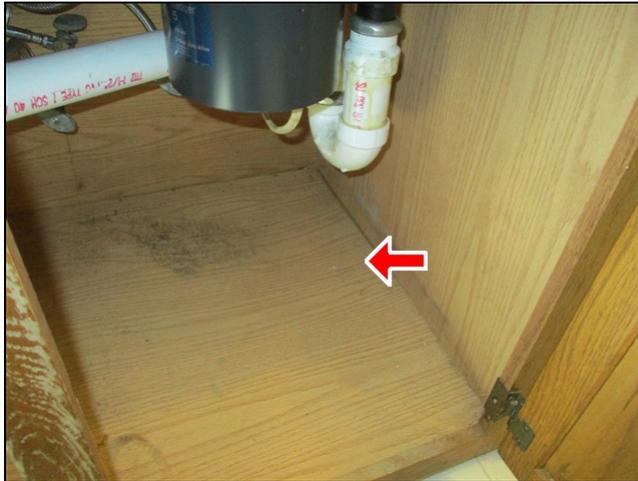
(1) The bottom panel on the kitchen sink base cabinet is damaged, sags or is warped, under sink (from a previous leak). This is a cosmetic issue for your information. However, it can affect the storage/use for this cabinet. The panel can be repaired or replaced, as desired. Recommend repair or replace as necessary.

3.4 Item 1 (Picture) kitchen sink base

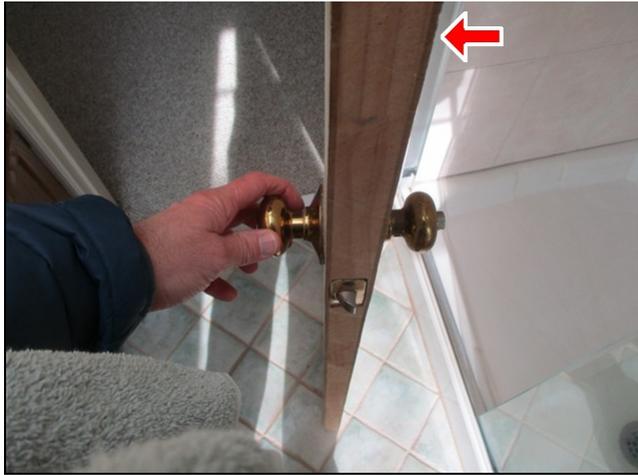
3.5 Item 1 (Picture)

(1) Some of the interior doors appear to be factory primed only or have exposed bare wood, on one or more sides. Interior doors should be painted on all sides including on the top and bottom. Recommend these doors be properly painted. A qualified person can perform this repair.

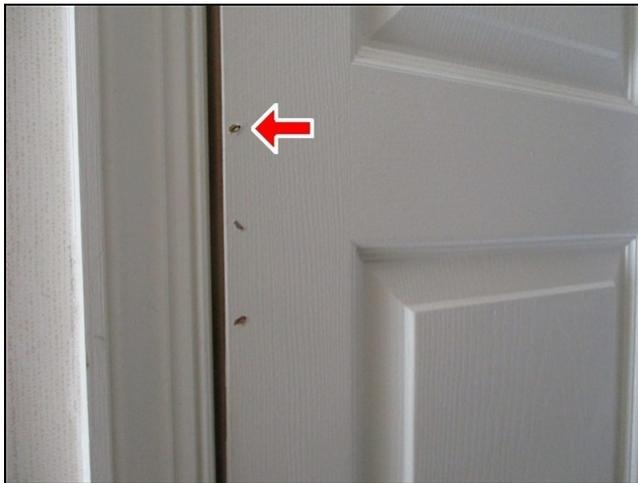
3.5 Item 2 (Picture)

(2) The pantry doors has some visible damage on the interior. This door is still functioning but can be repaired, if desired.

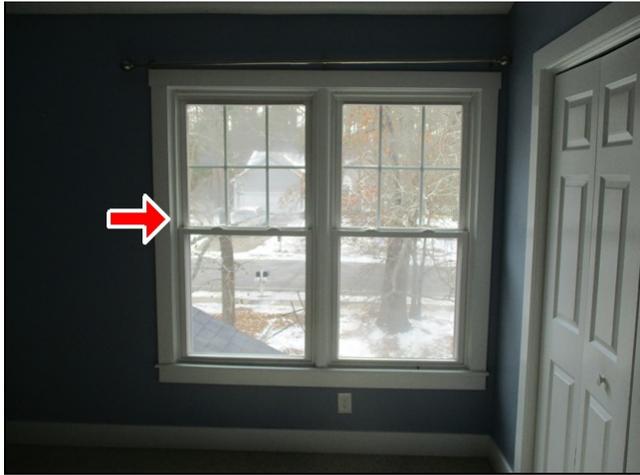
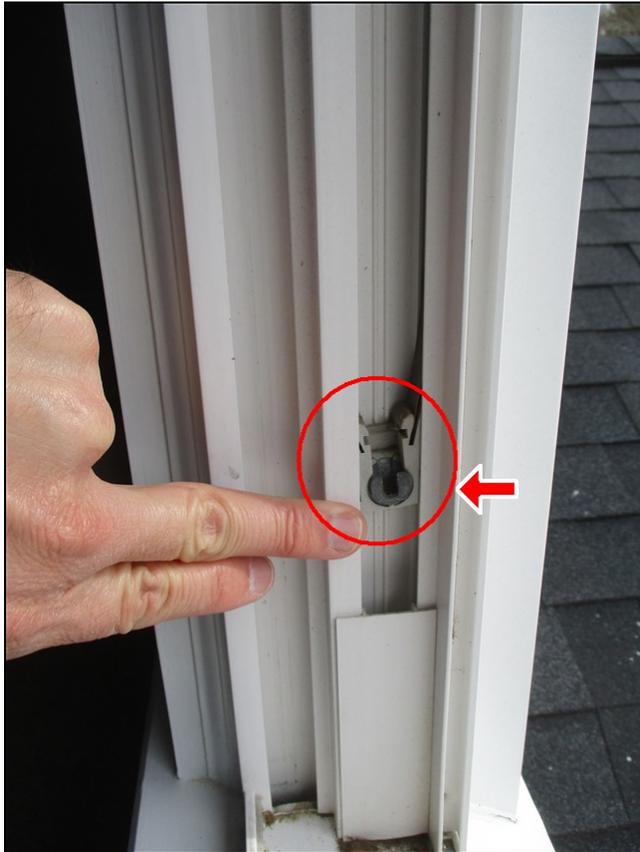
(1) The balance "spring" on the the following windows are broken or disconnected/off track:

3.6 Item 2 (Picture) disconnected balance

The balance holds the window in place when it is raised or lowered. The window can potentially fall out of the track if it is tilted and not properly connected to a functioning balance. Recommend the balance on these windows be repaired/replaced as needed to correct this issue.

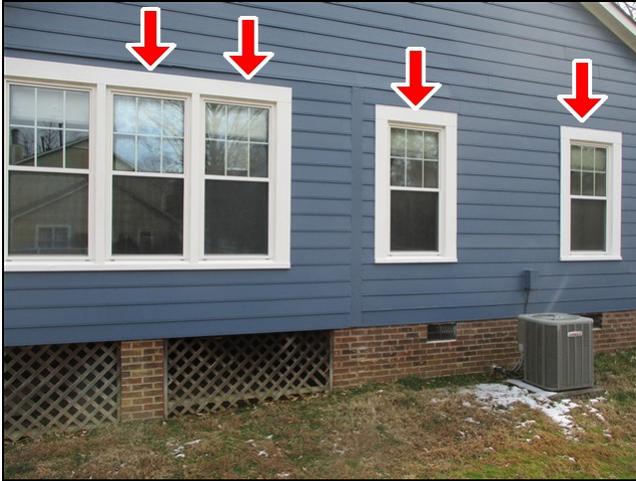
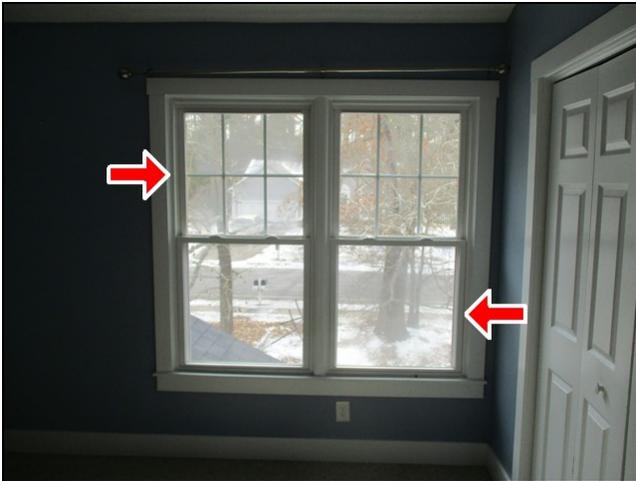
(2) The following windows are cloudy (have a lost seal "seal failure") :

This can cause some heat loss in winter and loss of cool air in summer if not corrected. A qualified person should repair or replace as needed.

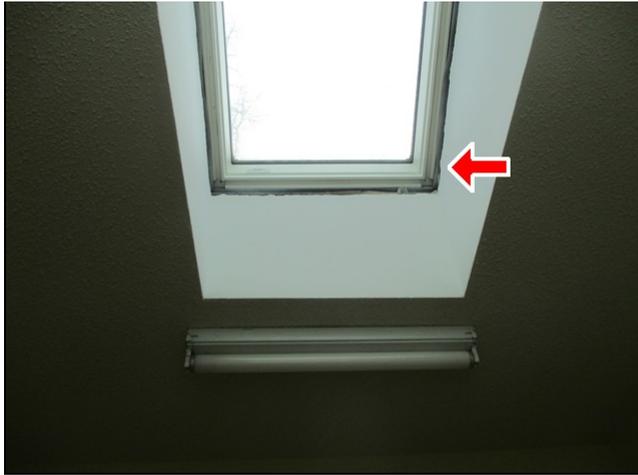
(3) Noted a gap between the sheetrock walls and the skylight frame. There is a slot designed to installed trim/jambs or sheetrock at the perimeter of the window frame. The missing trim is mostly cosmetic but can lead to some minor energy loss. The wall board or trim would help to block unconditioned airflow into this space. The missing jambs/trim can be installed, if desired.

3.6 Item 5 (Picture) skylight

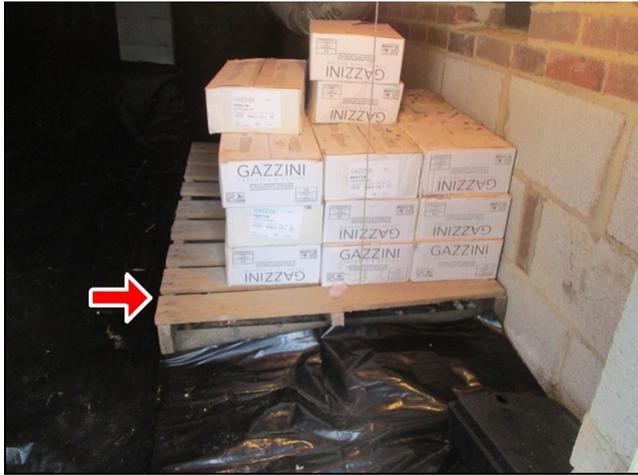
Untreated lumber should not be left on the ground inside of the crawlspace (in any location). Untreated lumber should not be on the ground within five feet of the foundation wall, at the exterior of the home. This material can decay and attract wood destroying insects. Recommend any untreated lumber be removed from the crawlspace or at a minimum be raised at least 4" above the ground level (with storage). Any exterior untreated materials should be stored a minimum of five feet away from the home.

4.0 Item 1 (Picture) pallet on ground

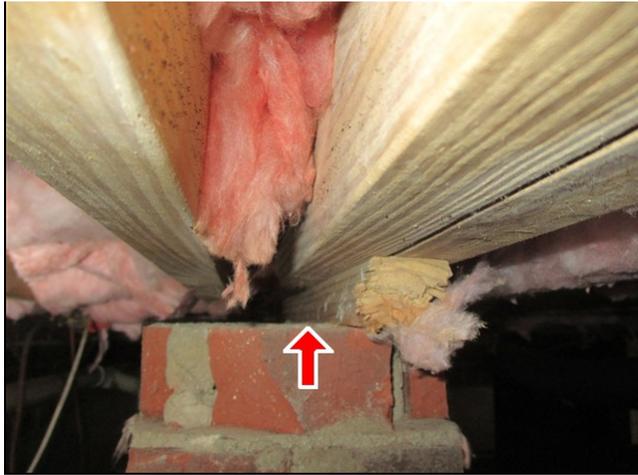
4.2 Item 1 (Picture) blocking incomplete

The area between the girder and pier should be completely filled/shimmed/ blocked solid to ensure proper load transfer. Recommend blocking be installed to ensure the weight transfers as designed.

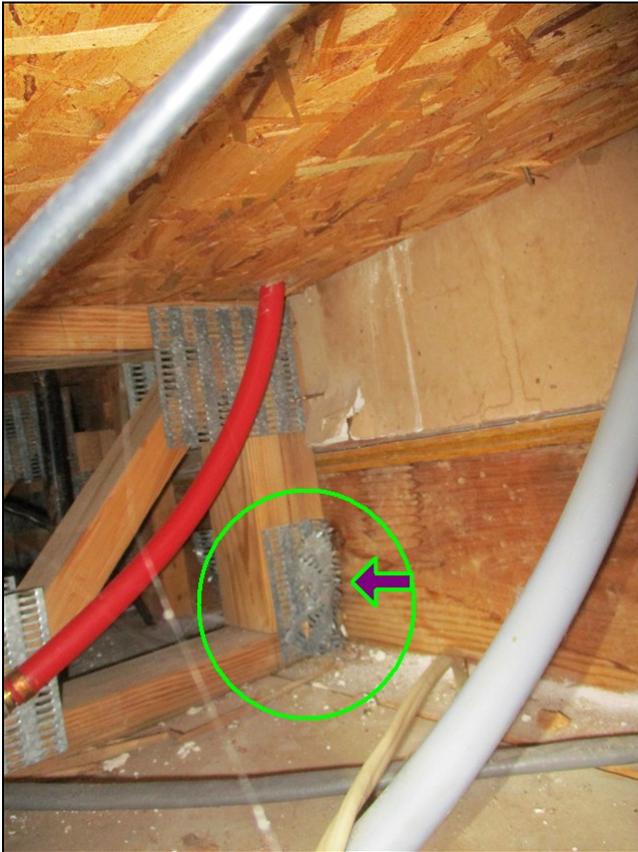
4.5 Item 4 (Picture) loose gusset

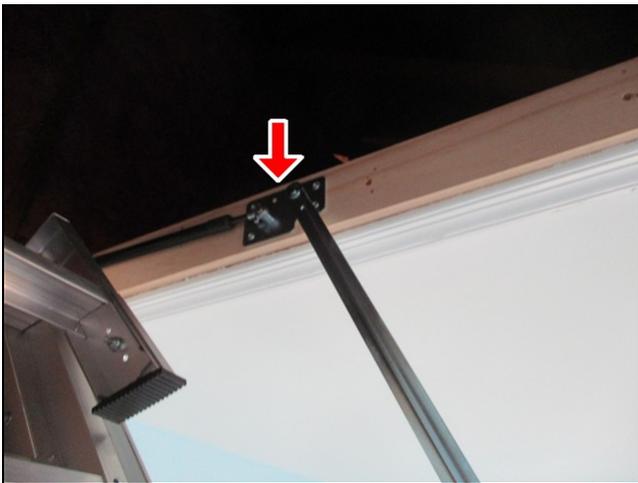
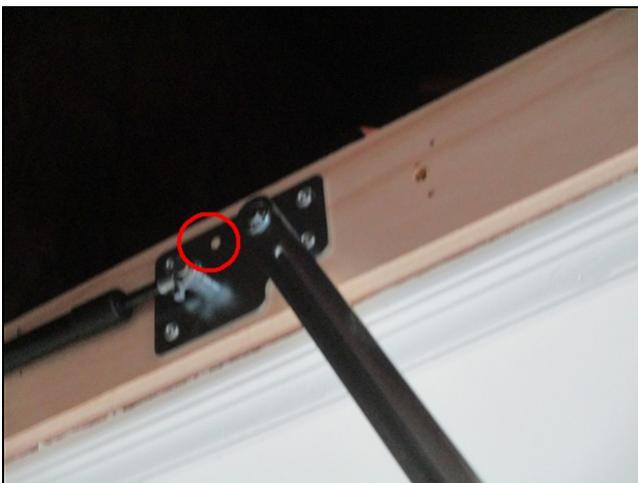
(2) Inadequate nailing observed at the pull down stair frame. Many manufacturer guidelines for folding stairs specify that nails should be installed in the holes at the side pivot Plate (locate at the top of the hinge arms). "The pivot plate mount should be shimmed and nailed through the 2 holes in the plate." Recommend nails be added to the holes in the pivot plate.

4.5 Item 6 (Picture) pivot hinge

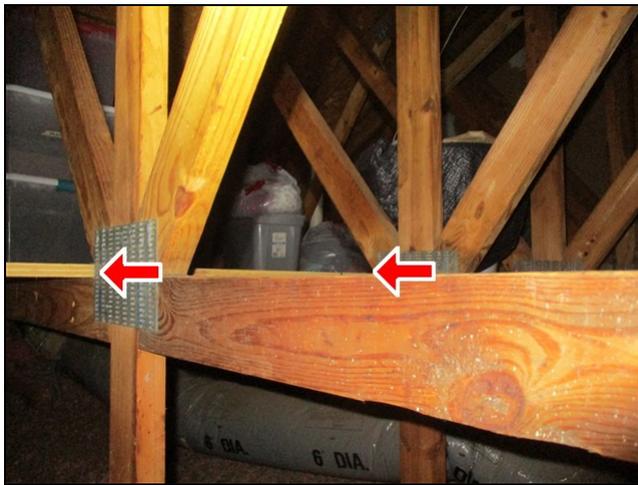
(4) Storage shelves have been built into the attic trusses. Trusses are engineered members and any repairs or alterations to a truss must have a repair letter stamped by a licensed engineer. The inspector cannot comment on these alterations or their ability to function in their current state or their ability to support this storage (which was certainly not part of the original design). An engineer's letter be provided for these alterations. Letter can clarify whether or not the platform can support additional weight for storage and if the alterations are acceptable. If clarification is provided I would not recommend this platform be used as a storage space.

4.5 Item 8 (Picture) storage on trusses

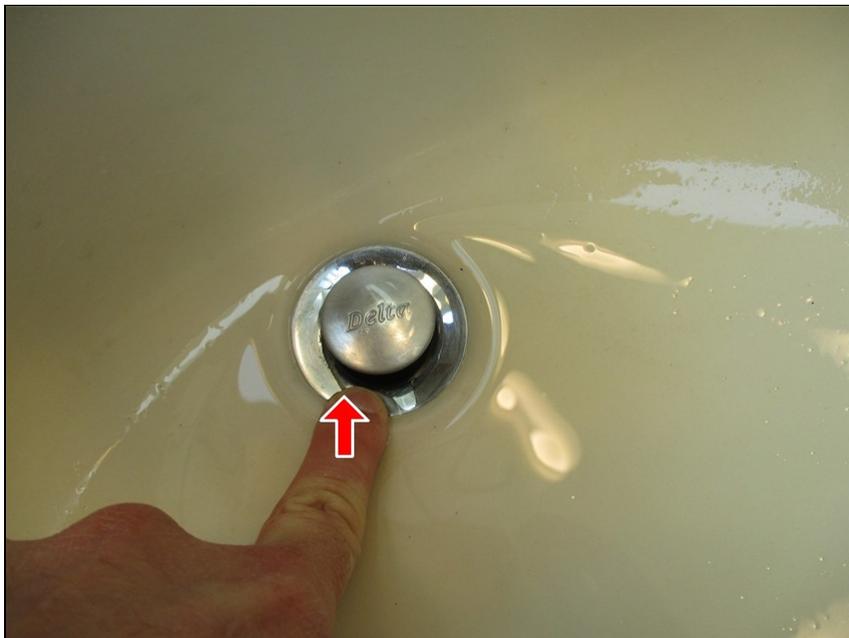
Noted a crack in the trim ring around the master bath sink drain. This drain did not leak at the time of the inspection. The cracked drain trim ring may not leak but does have a higher chance of a future leak. Recommend repairs, if desired.

5.0 Item 1 (Picture) master sink drain

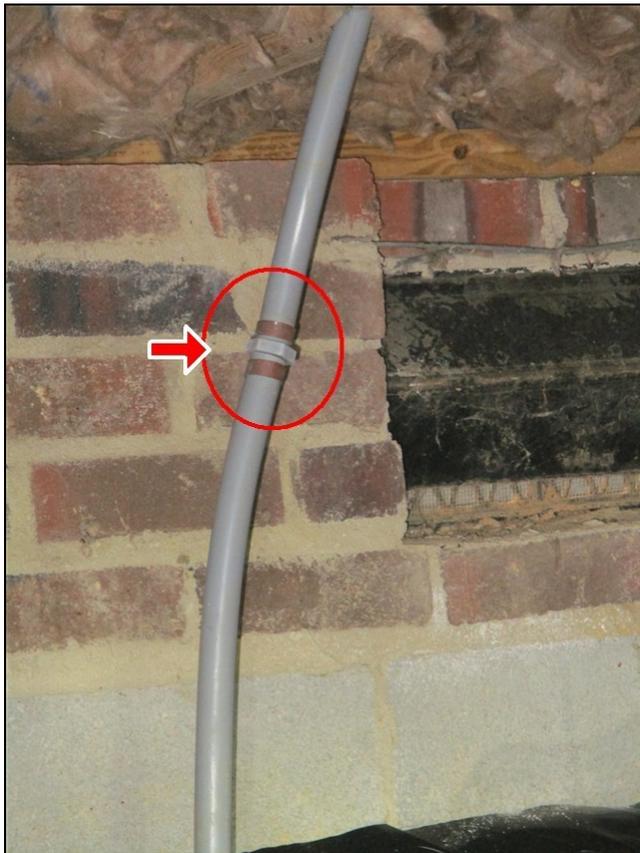
(2) FYI: There have been several updates, alteration or changes in the supply lines. The subject home has some copper and pex but still has Polybutylene piping present in areas. A large portion of the supply lines are PEX (with newer/modern plastic fittings considered "good" on PEX). However, the system still has a notable amount of Poly piping present in areas. The inspector was only able to locate one older Polybutylene fitting connection (which was plastic and is located at the main supply line). Plastic fitting on Poly have been an area of concern. The inspector cannot determine what type of piping or fittings are present inside of the wall system because it is enclosed and is not visible. This is for your information.

5.1 Item 1 (Picture) poly main feed

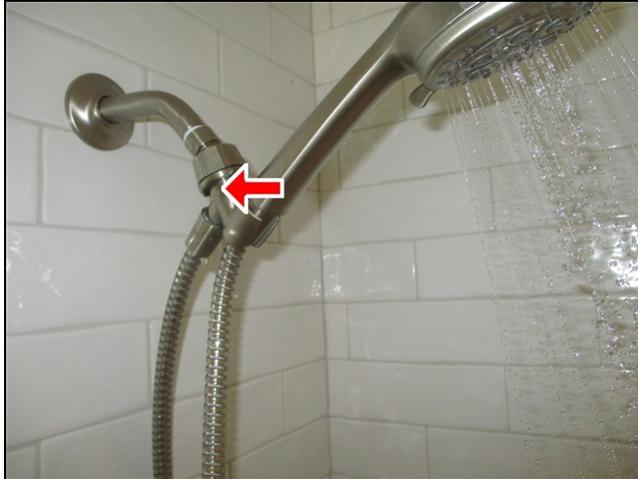
(3) The shower head leaks at one or more connection points to the arm, nose or head. This wastes metered water. In most cases this is an issue with the washer, lack of proper tension/tightening or a lack of Teflon tread tape. Recommend this leak be repaired by a licensed plumbing contractor.

5.1 Item 2 (Picture) shower hose

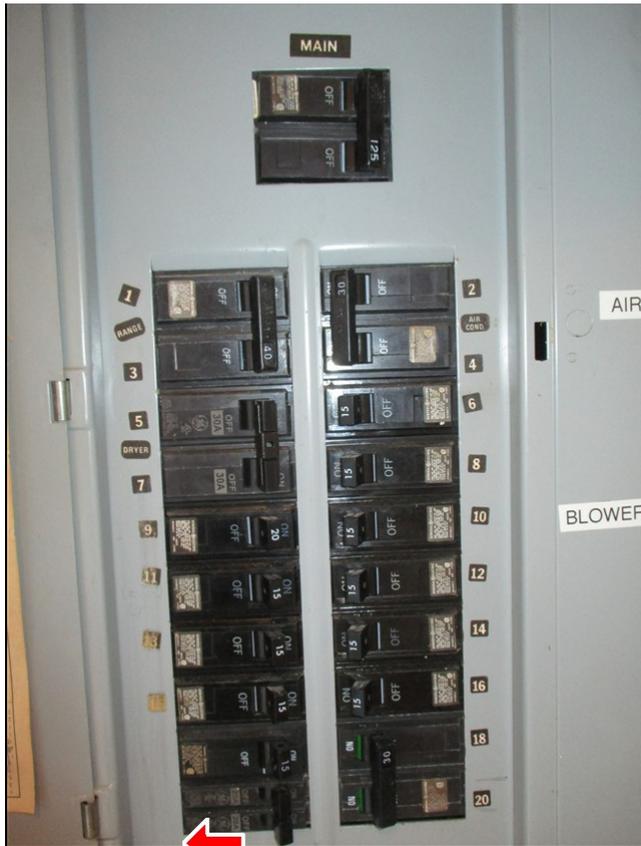
- (1) The storage room panel has circuit breakers that need labels identifying their location(s). Some or All of the label are missing or have faded. The location and purpose is unknown. Labeling is required for safety reasons. Recommend repairs by a licensed electrical contractor.

6.1 Item 1 (Picture) main panel in storage

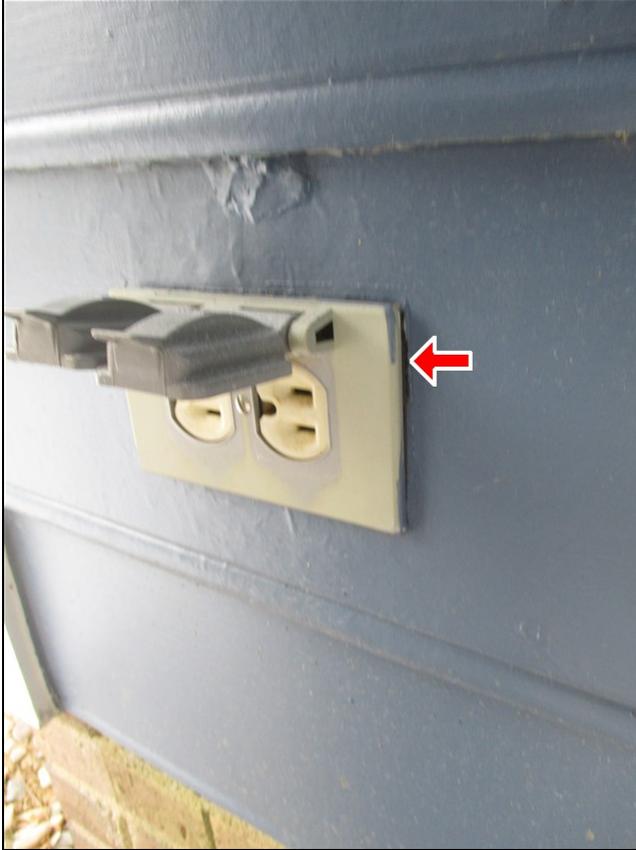
6.3 Item 1 (Picture) storage/patio outlet

Recommend these receptacles be tightened. These receptacles should be secured to the box for safety reasons; to ensure the wire connections do not come loose over time with use. Loose wires can lead to arcing and are considered a fire hazard. A licensed electrician can perform this repair

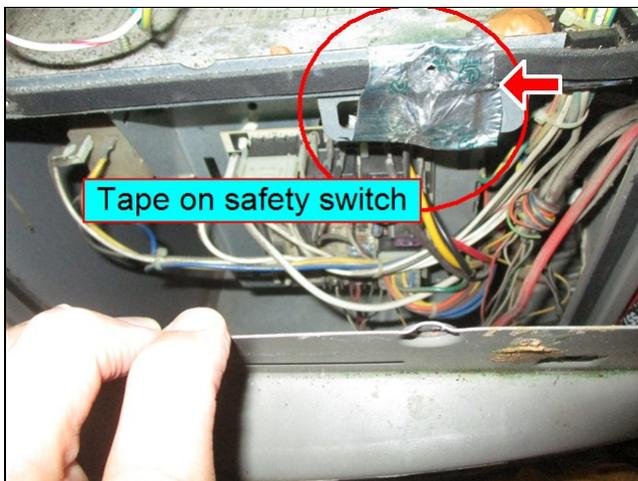
The safety switch did not shut off unit when service door was removed. The switch has been taped over and does not disengage when the cover/door is removed. This is a safety issue and should be repaired. I recommend service or repair unit using a licensed HVAC contractor.

7.2 Item 1 (Picture) tape on safety switch

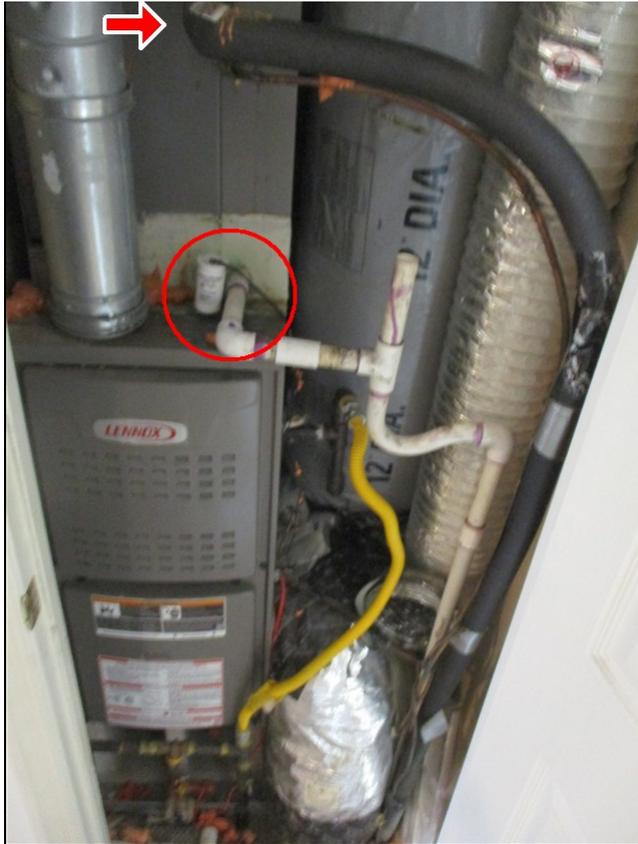
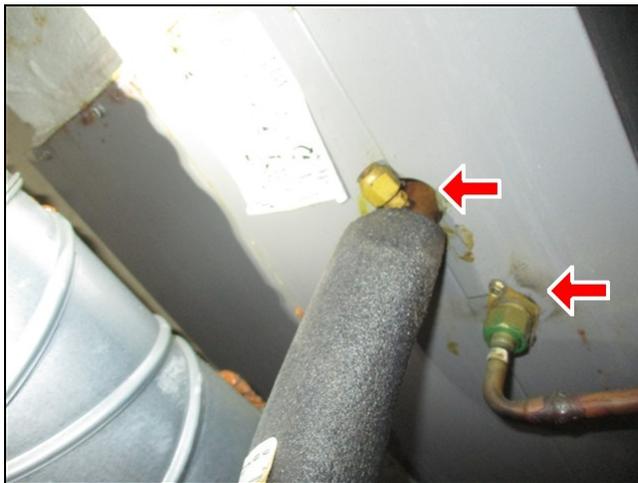
7.3 Item 1 (Picture)

(3) The HVAC refrigerant lines at the Air Handler are not properly sealed. This allows unfiltered air to enter the unit. This can also allow conditioned air to escape, a source of energy loss. The lines need to be sealed with a moisture resistant sealant like silicone. Recommend contractor repair.

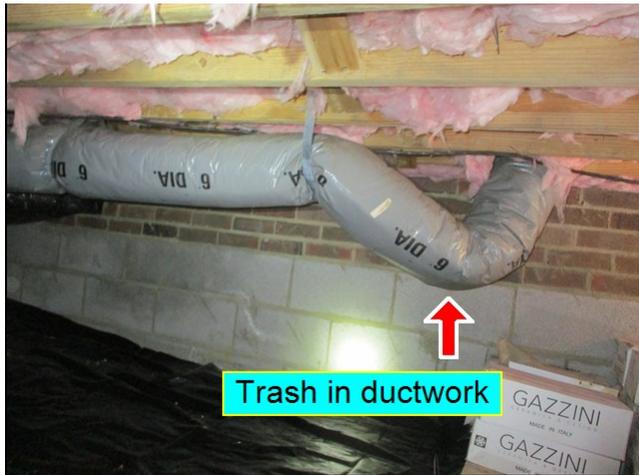
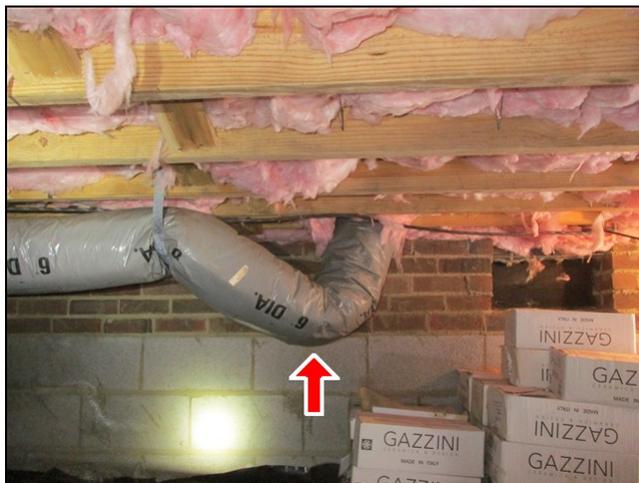
7.3 Item 3 (Picture)

(4) The duct closest to the crawlspace entry has trash inside of the supply line, at the dip (above the pallet of tile). This duct should be cleaned out at the section/dipping area. Recommend repairs by a license HVAC contractor.

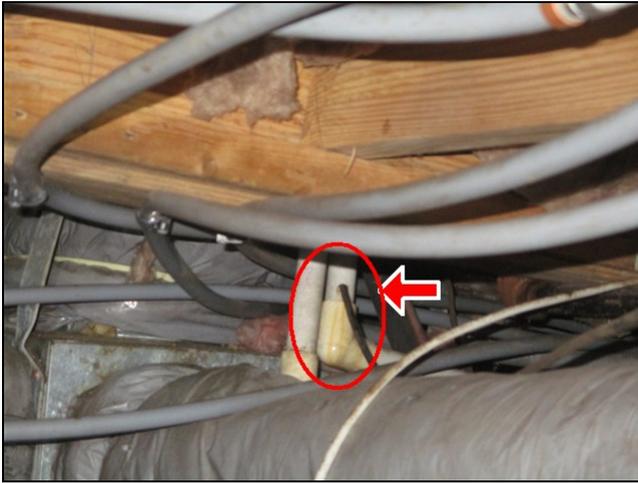
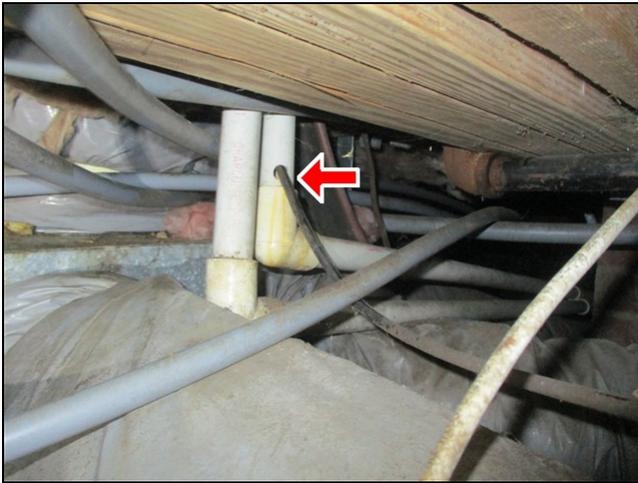
Note the hole in the line is near the HVAC distribution box, roughly in the center of the crawlspace.

7.3 Item 8 (Picture) Condensation line

7.3 Item 9 (Picture) hole in pipe

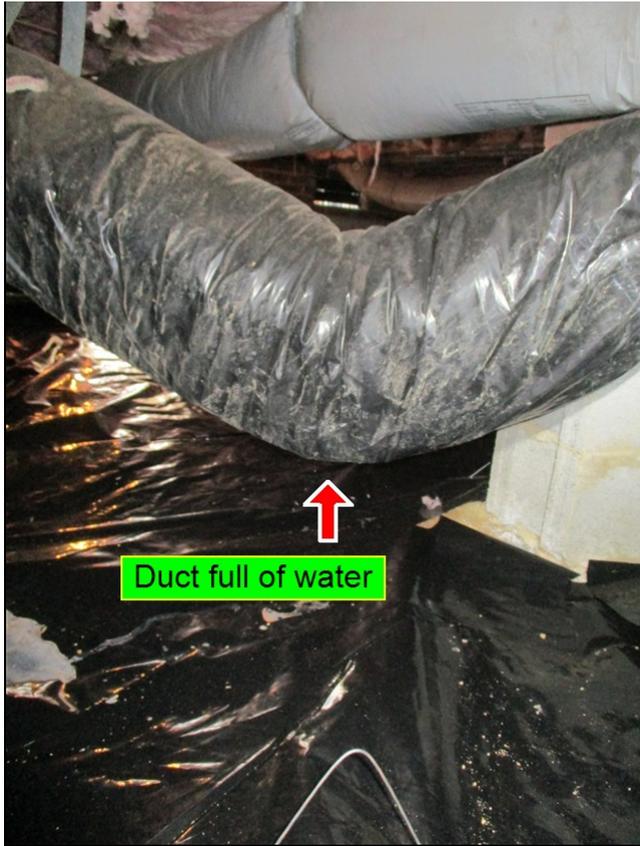
7.3 Item 12 (Picture)

(8) The duct work at the right side of the foundation is full of water, near the pier and girder closest to the tile (in the crawl space) . Potential causes include slow airflow due to a dirty filter,dirty evaporator, low charge, potential air leak and/or snagging duct. This has roughly between 1 to 2 plus gallons of water trapped inside of the duct. Stagnant water in a duct is also an air quality issue. Recommend inspection and repairs by a qualified HVAC contractor

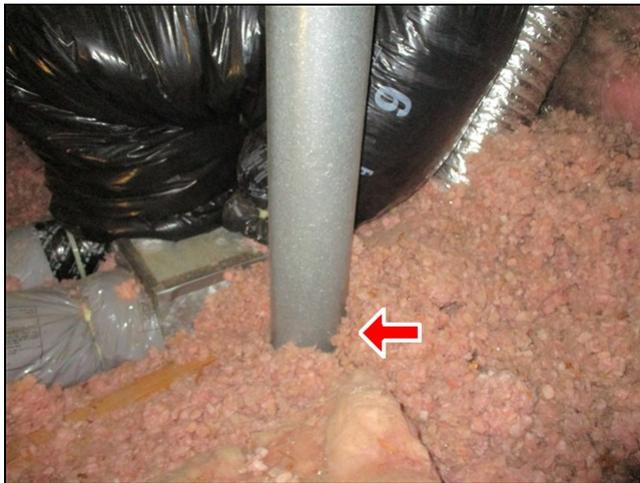
7.5 Item 1 (Picture)

(2) The heater exhaust pipe is touching the insulation in the attic. Even double walled piping would need to be a "zero clearance" exhaust, otherwise the pipe should have 1" to 2" inches of clearance from the sheetrock. Most double walled exhaust pipes require 1" to 2" inches of clearance from combustibile material (this would also include sheetrock, even fire-rated sheetrock). The pipe should be evaluated further to ensure it has a zero clearance or the sheetrock can be cut back (away from the pipe). Recommend repairs as needed.

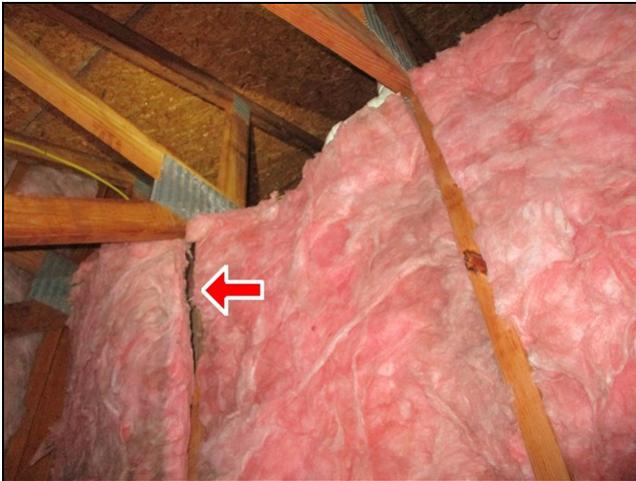
8.0 Item 1 (Picture)

(2) Some of the wall insulation on the sides of the master vault is loose. This condition creates a void in the home's insulation system and is a point of energy loss. Recommend this insulation be secured to the wall. A qualified person can perform this repair
