# ***Cornerstone Inspection***

## **Property Inspection Report**

***689 Woodland Dr, Arroyo Grande, CA 93420***

***Date of Inspection: 10/31/2025 Time: 9:00 AM***

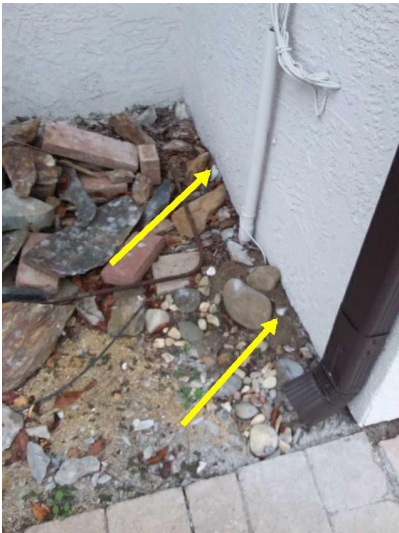
The soil is too high against the home at various areas around the home which should serviced.

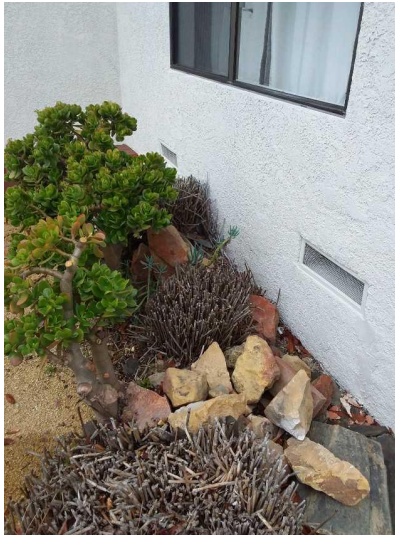
Vines, shrubs or bushes are growing on the house walls and although they are attractive they can introduce pests and rodents and accelerate deterioration. Therefore, you may wish to consider having them removed or cut back to 12 inches away from the home.

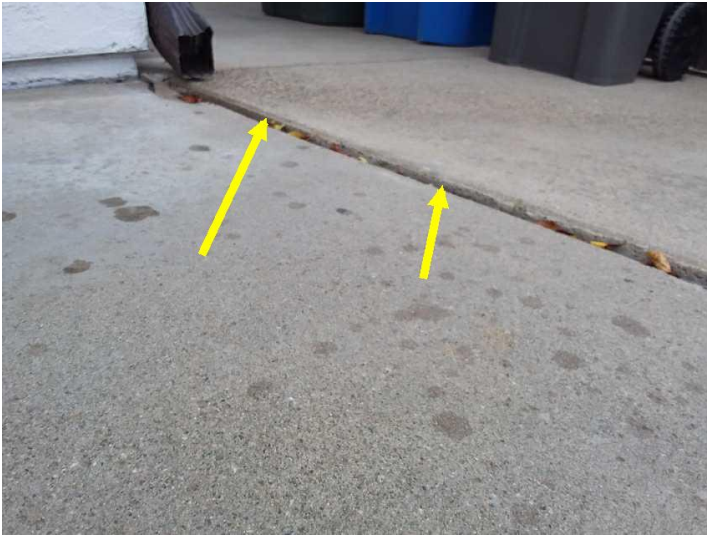
There is one or more offsets in the walkways that could prove to be trip-hazards.

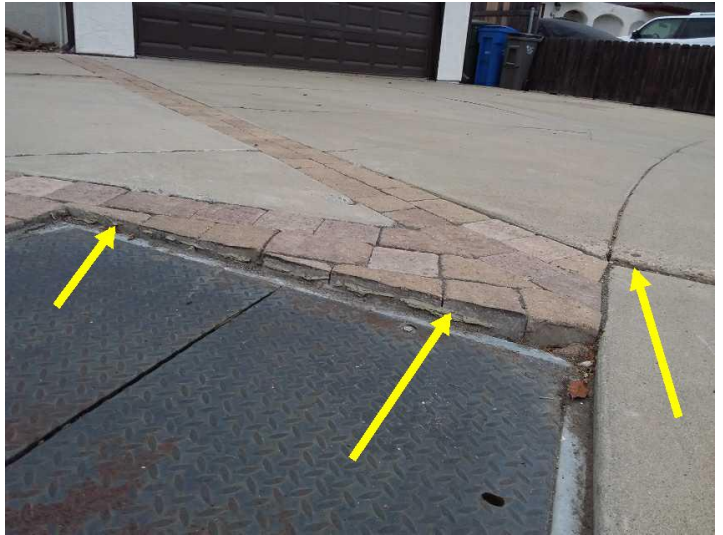
There is one or more offsets in the driveway that could prove to be trip-hazards.

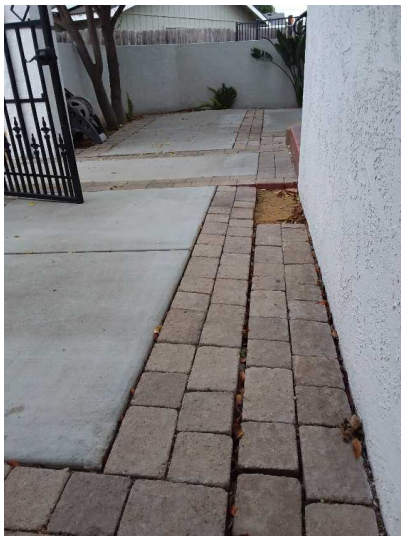
The paver patio or walkway has multiple offsets. This may be due to unsuitable soil below the pavers.

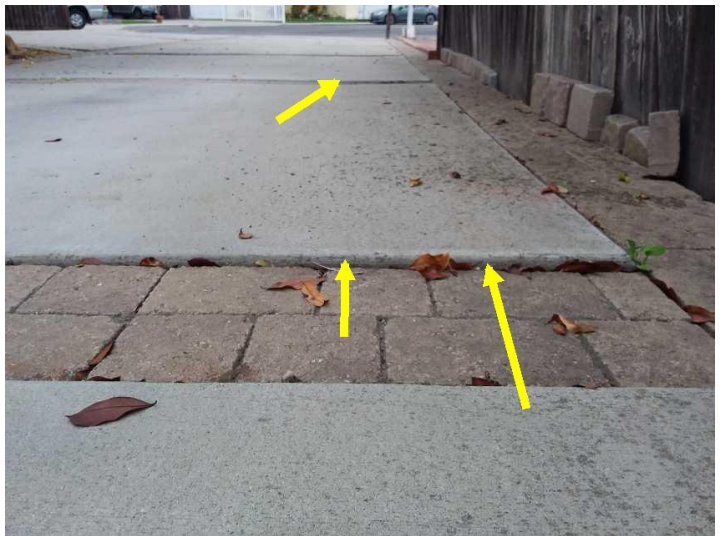
There is one or more offsets in the driveway that could prove to be trip-hazards.

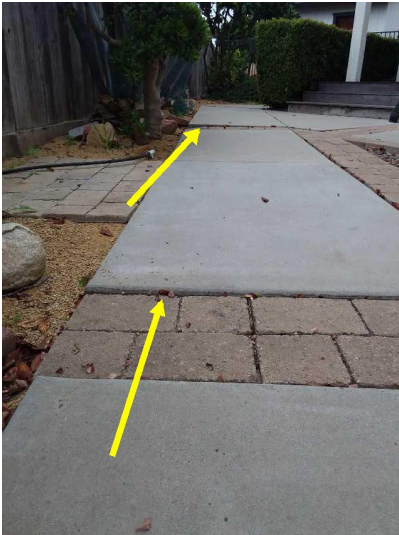
There are several offsets in the walkways that could prove to be trip-hazards.

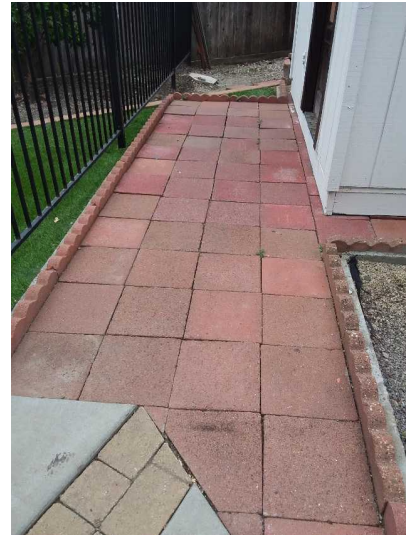
The paver patio or walkway has multiple offsets. This may be due to unsuitable soil below the pavers.

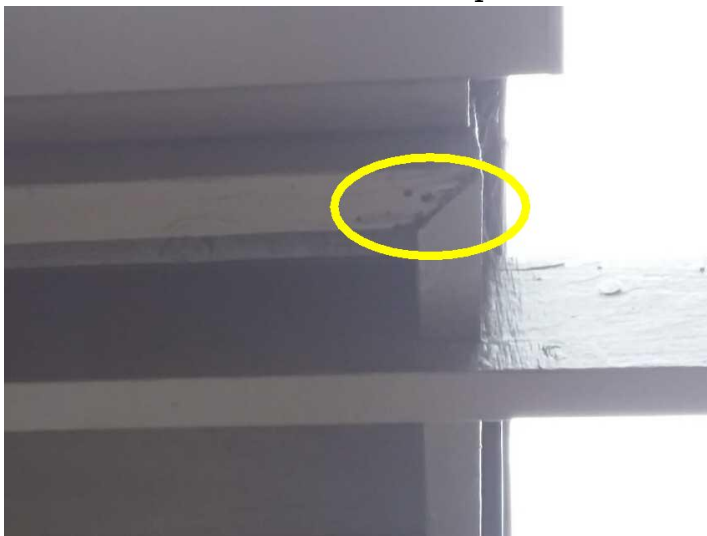
There is damage to the wood trim that should be evaluated by a termite inspector.

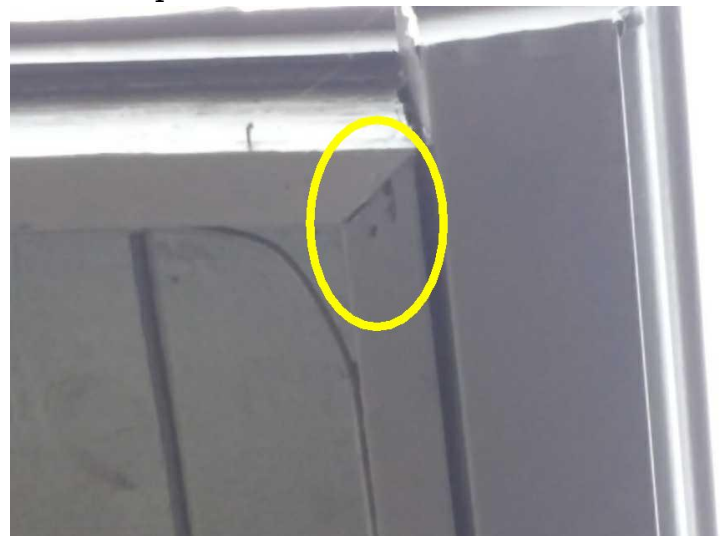
There is damage to the wood trim that should be evaluated by a termite inspector.

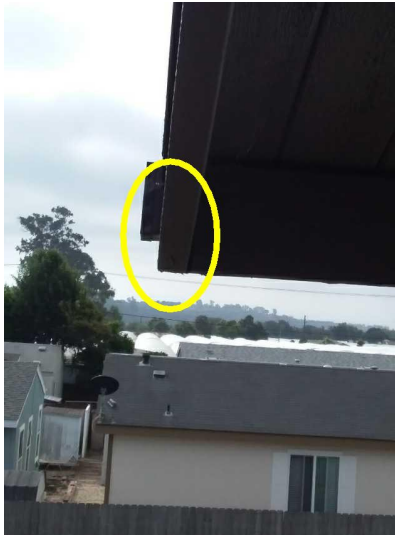
There is moisture damage or dry rot to the wood trim and or fascia on the upper roof area, which is typically not inspected by the pest inspector. The pest control company should be alerted so as to inspect and include these repairs in their estimate.

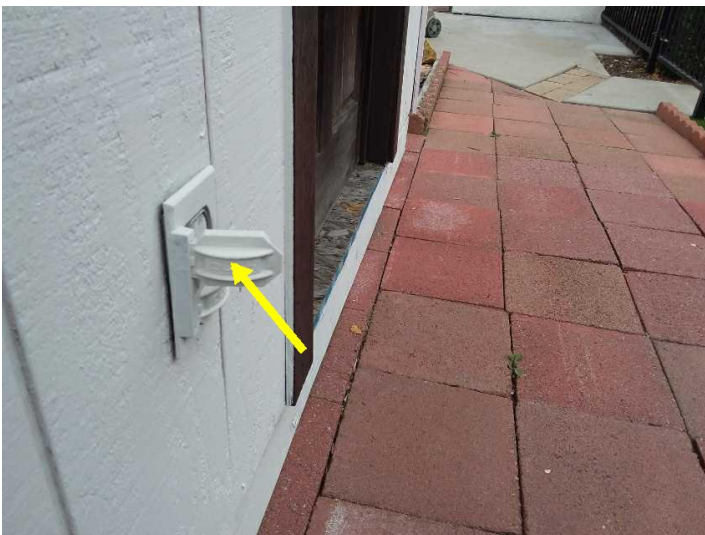
Some of the exterior outlets do not have ground-fault protection, and should be upgraded to include this modern safety feature.

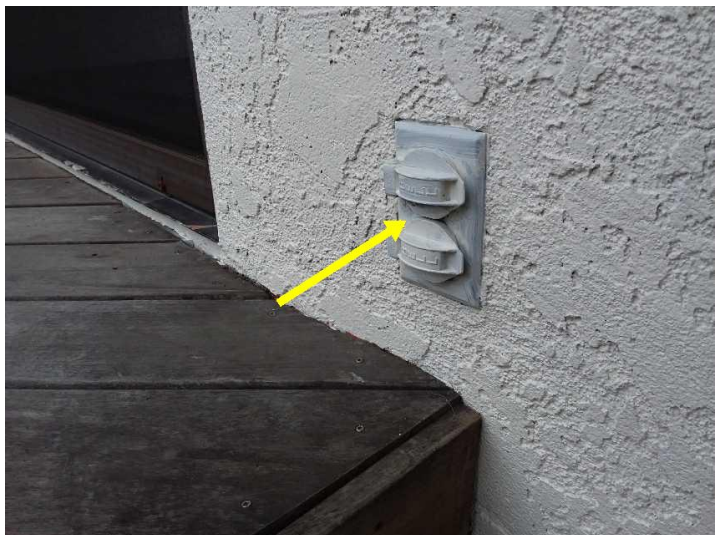
Some of the exterior outlets do not have ground-fault protection, and should be upgraded to include this modern safety feature.

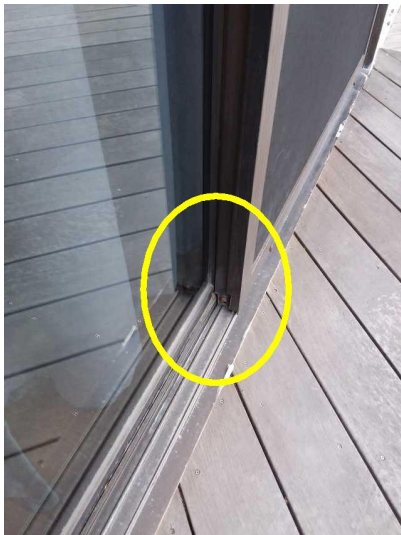
The sliding glass door or doors are mounted on the outside, which is not as secure as being mounted on the inside.

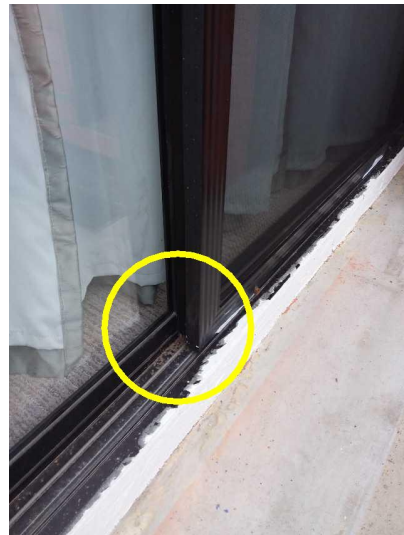
The sliding glass door or doors are mounted on the outside, which is not as secure as being mounted on the inside.

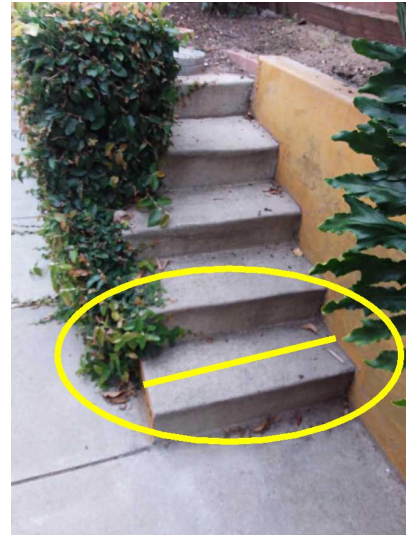
The width of the stairs is less than 36 inches, which does not meet current standards.

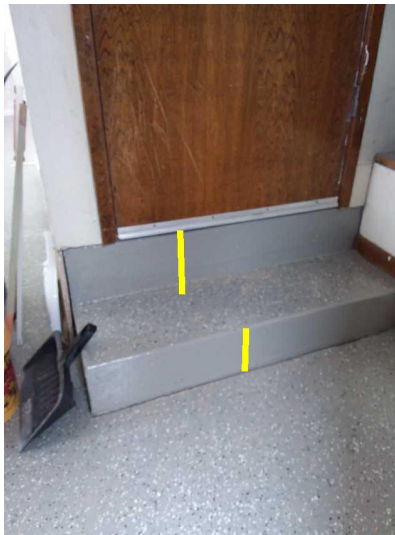
Some of the steps have unequal treads or risers. Steps are required to be uniform to prevent trip-hazards. The rise of any step should be no less than four inches and no greater than seven inches, and the run should be no less than eleven inches. Also, the dimensions of the largest step should not exceed that of the smallest by more than three-eighths of an inch.

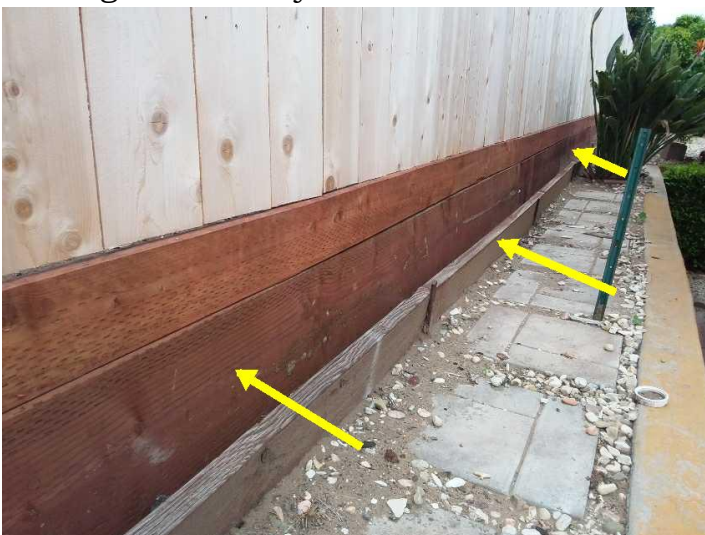
The wooden planks at the rear of the property have no structural value, and are intended to inhibit surface soil movement, and should be periodically monitored for damage or stability.

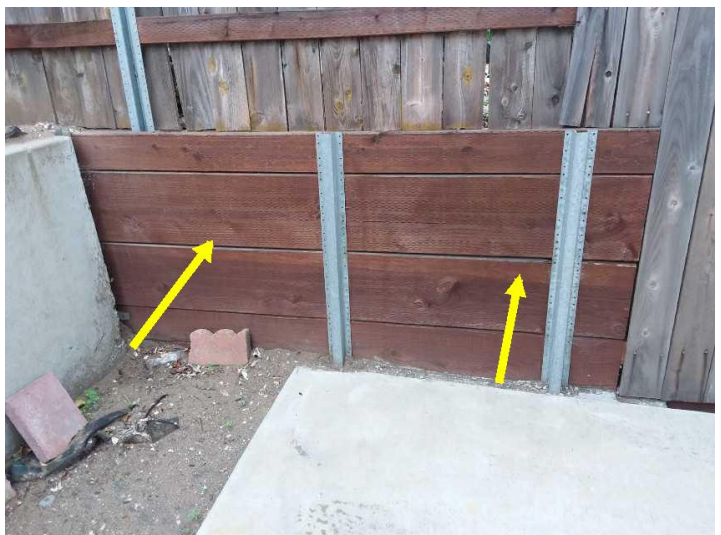
The wooden planks at the rear of the property have no structural value, and are intended to inhibit surface soil movement, and should be periodically monitored for damage or stability.

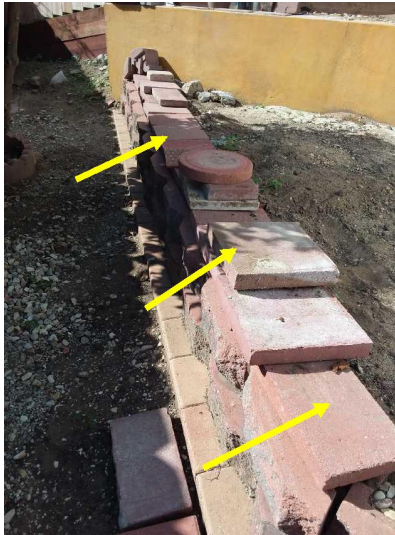
Some of the planter block-caps are loose or missing and should be serviced.

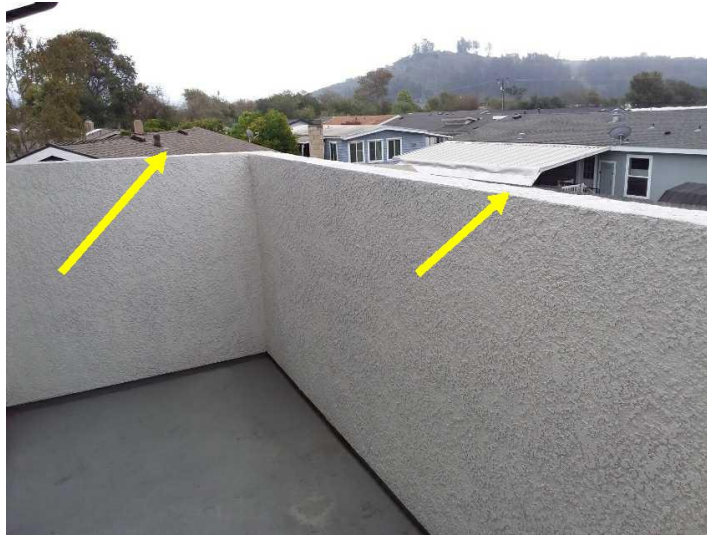
The balcony guardrail is an adequate height and in acceptable condition. However, standards for guardrails are not uniform. Nonetheless, common safety standards require them to be a minimum of 42 inches high when the standing surface is 30 inches or more above grade.

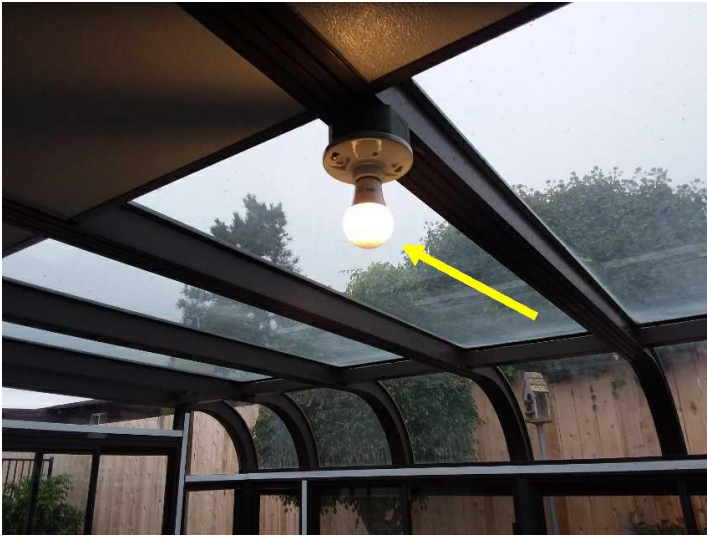
A light is missing its globe or cover and should be serviced.

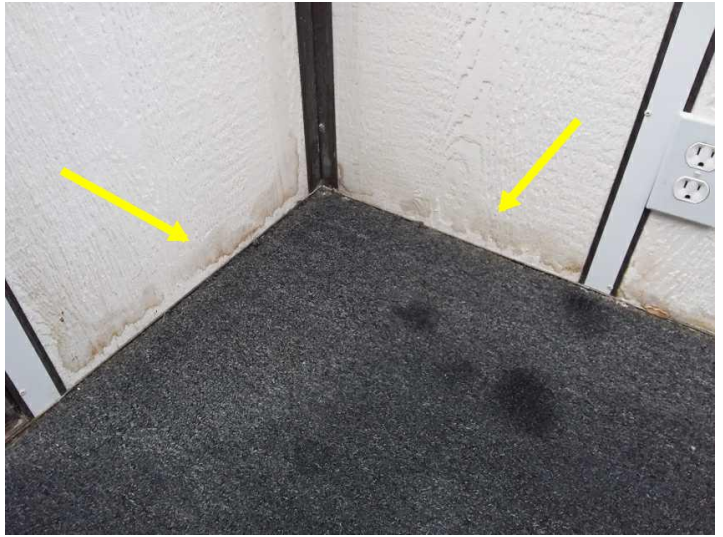
There is a moisture stain on the wall that should be explained or explored further.

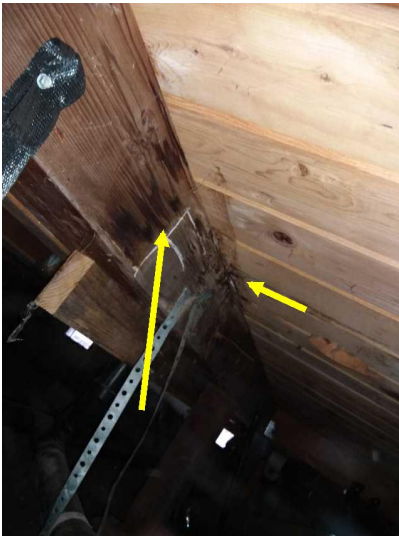
There are stains or moisture damage to the sub-floor beneath a bathroom. The termite inspector is responsible for pressure testing shower pans, and will evaluate and comment on the condition of the shower pan and any resulting damage to the intermediate floor framing.

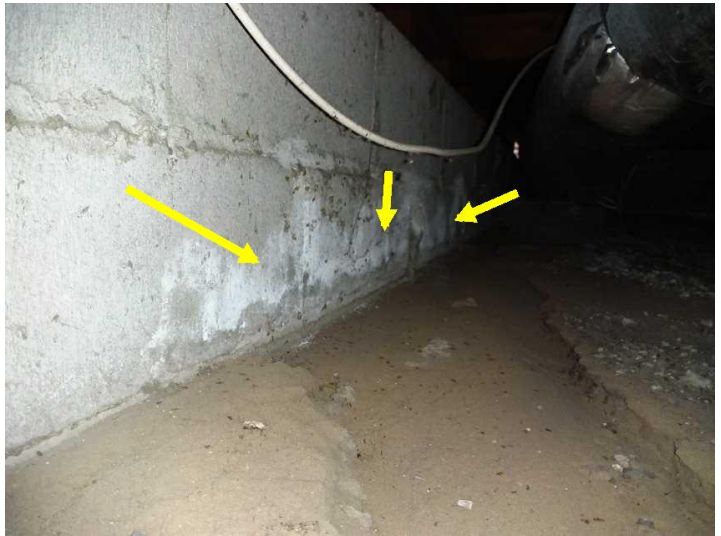
Moisture has entered the crawlspace, as is evident by salt crystal formations around the base of the stem walls. However, this is a common phenomenon that does not necessarily indicate a chronic or serious problem. The soils are currently dry, but it would be prudent to monitor this area.

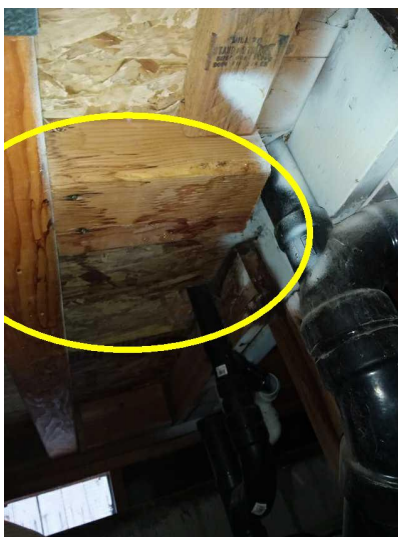
There are stains or moisture damage to the sub-floor beneath a bathroom. The termite inspector is responsible for pressure testing shower pans, and will evaluate and comment on the condition of the shower pan and any resulting damage to the intermediate floor framing.

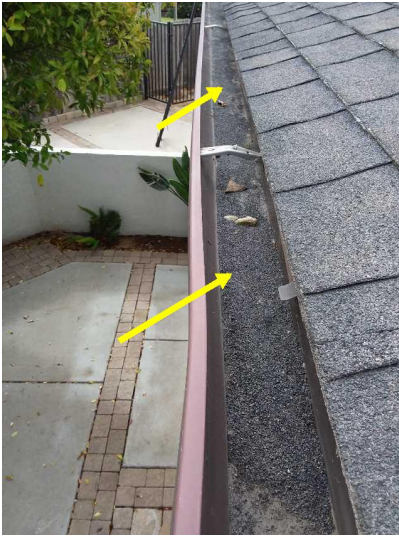
Some of the gutters need to be cleaned to drain properly.

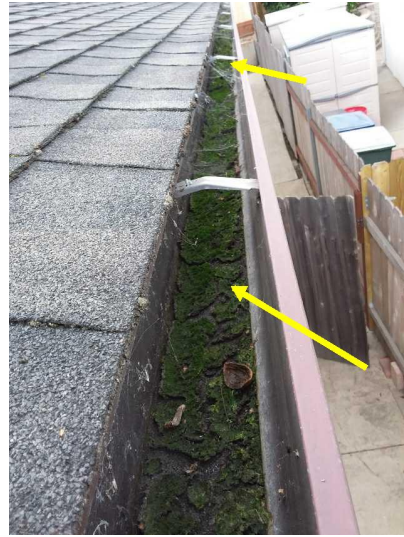
Some of the gutters need to be cleaned to drain properly.

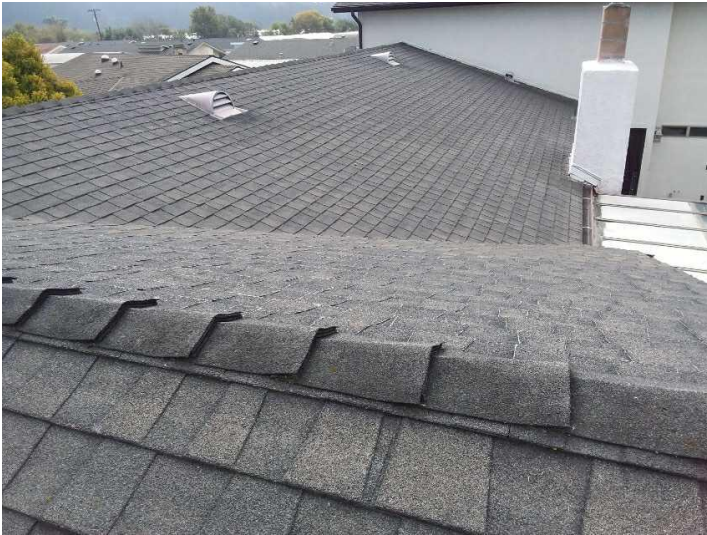
The field shingles are loosing granules, or in the primary stages of decomposition, which means that the roof will be more susceptible to leakage and must be monitored, but you may wish to have a specialist evaluate it.

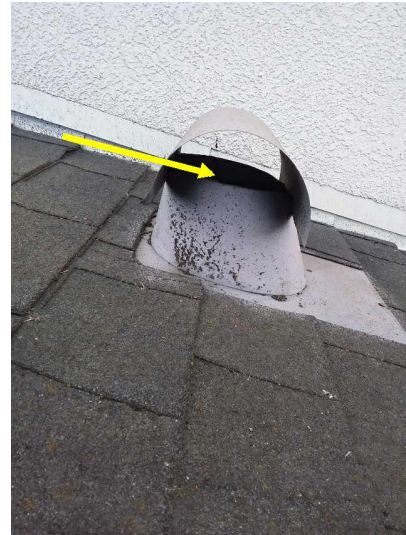
Some of the roof flashing need to be sealed or serviced. They are comprised of metal that seals valleys and vents and other roof penetrations, and are the most common point of leaks. This is particularly true of the flashing on a layered roof, which are covered by the roofing material and which are even more susceptible to leaks.

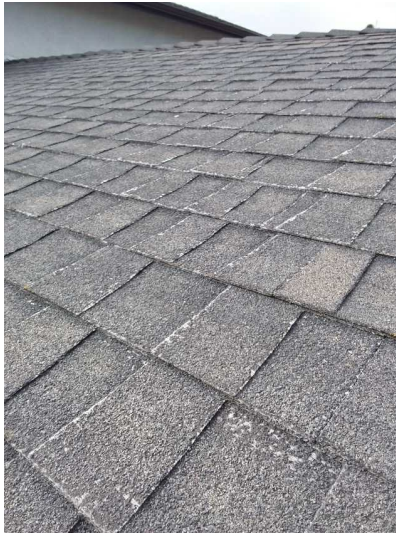
The field shingles are loosing granules, or in the primary stages of decomposition, which means that the roof will be more susceptible to leakage and must be monitored, but you may wish to have a specialist evaluate it.

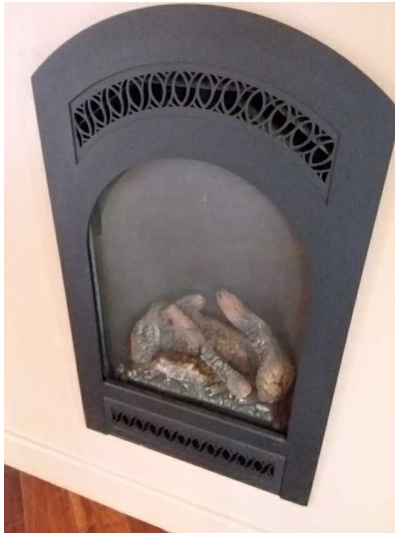
The fireplace glass is functional, however does not have a protective screen, which is required by current standards and should be installed for optimal safety.

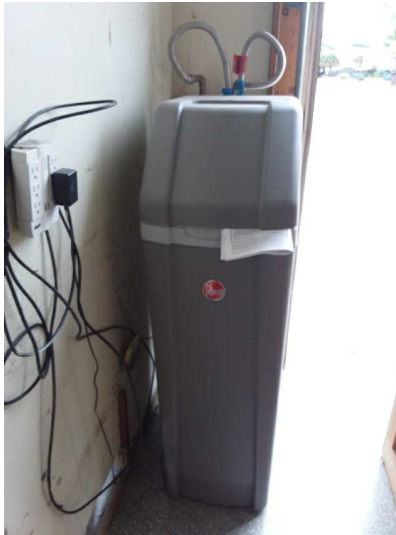
A water softener is present that we do not have the expertise to evaluate except for visible leaks. We recommend you ask the sellers if the unit was professionally installed and its service history.

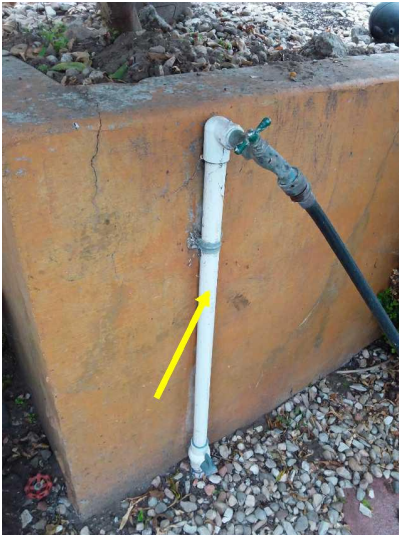
We have observed exposed PVC pipe on the exterior, which may become brittle when exposed to the sun's ultraviolet light. This pipe can become subject to breaking or leaking. We recommend painting the PVC pipes to block the UV rays and protect the pipe.

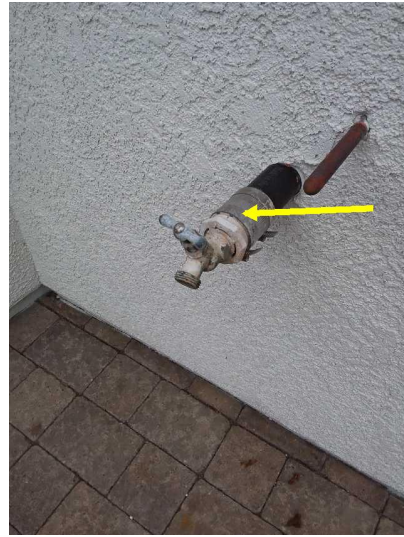
A hose bib on the rear is no longer functional or has been abandoned. However, we may not have located and tested each hose bib on the property.

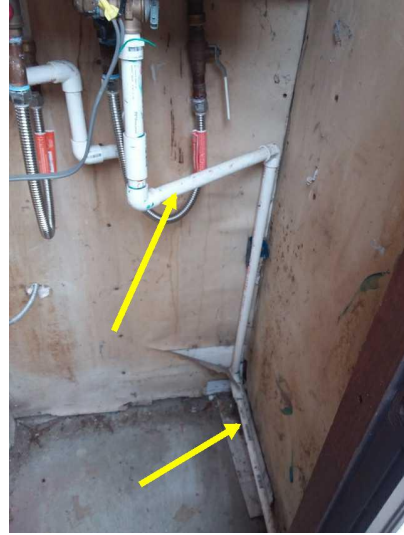
The closet TPR valve discharge pipe is PVC which is not approved for this purpose and should be replaced with metal or CPVC.

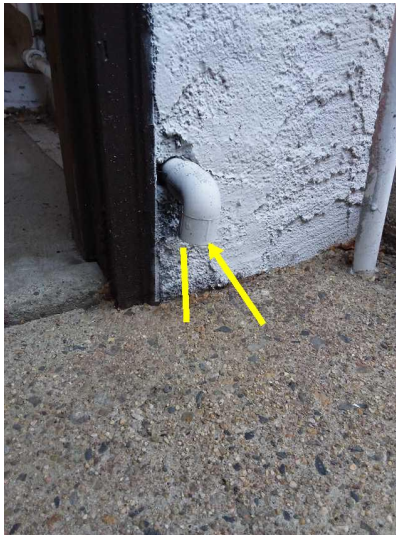
| Page 33 Item: 5 | Tankless Water Heater | 5.9. The pressure relief valve pipe has not been installed correctly. It must terminate no more than twenty-four inches above grade and no closer than six inches to it and be directed down towards the ground.<br><br>5.10. The closet TPR valve discharge pipe is PVC which is not approved for this purpose and should be replaced with metal or CPVC.<br><br>5.11. One vent pipe terminates in a closet which should be evaluated and serviced by a licensed specialist. |

The pressure relief valve pipe has not been installed correctly. It must terminate no more than twenty-four inches above grade and no closer than six inches to it and be directed down towards the ground.

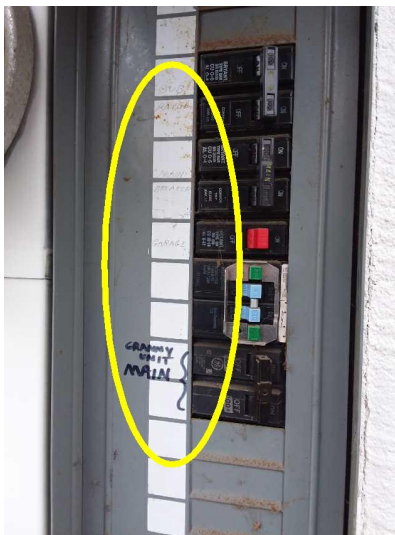
Various circuits are not labeled, which is recommended.

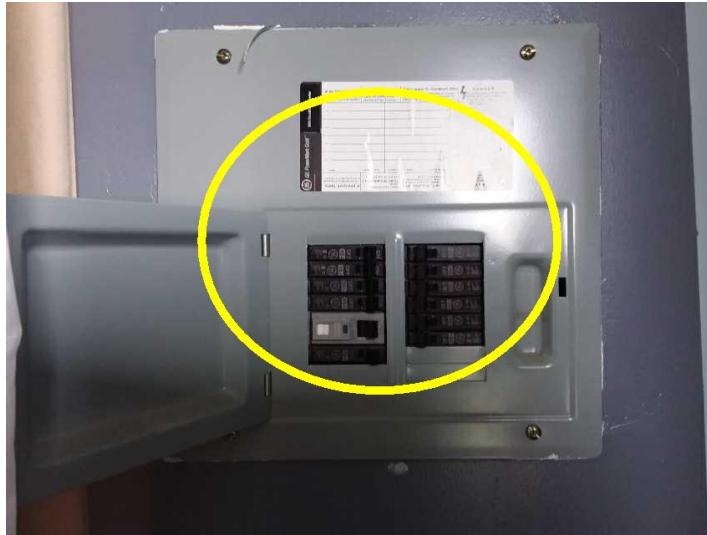
Various circuits within the sub-panel are not labeled, and should be serviced by an electrician so that the appropriate load calculations and breaker sizes could be determined.

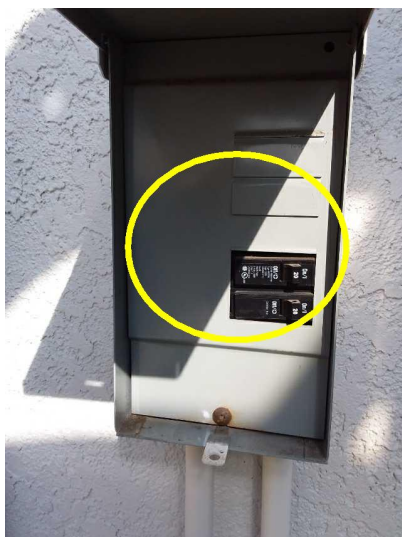
Various circuits within the sub-panel are not labeled, and should be serviced by an electrician so that the appropriate load calculations and breaker sizes could be determined.

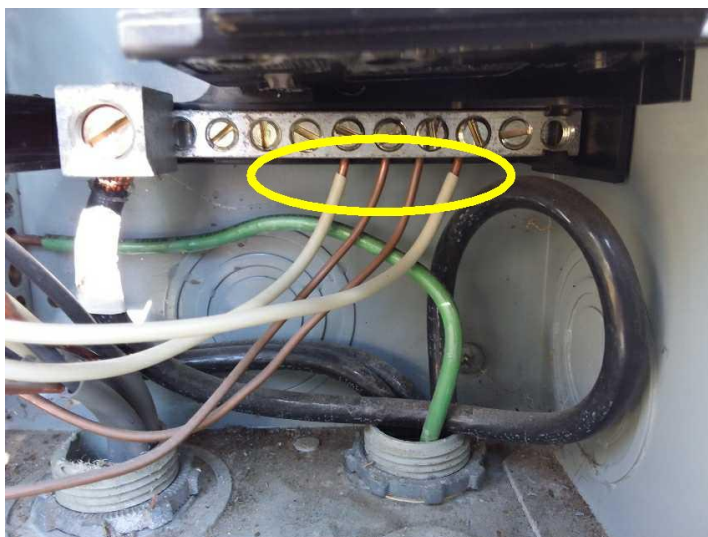
| Page 38 Item: 4 | Sub Panel #3 Observations | 4.9. The neutral and ground wires are together on the same buss bar and should be separate. The ground wires should be bonded to the panel and the neutral wires should be separate and "floating" from the panel. We recommend that a licensed electrician evaluate and service the sub panel. |

The neutral and ground wires are together on the same buss bar and should be separate. The ground wires should be bonded to the panel and the neutral wires should be separate and "floating" from the panel. We recommend that a licensed electrician evaluate and service the sub panel.

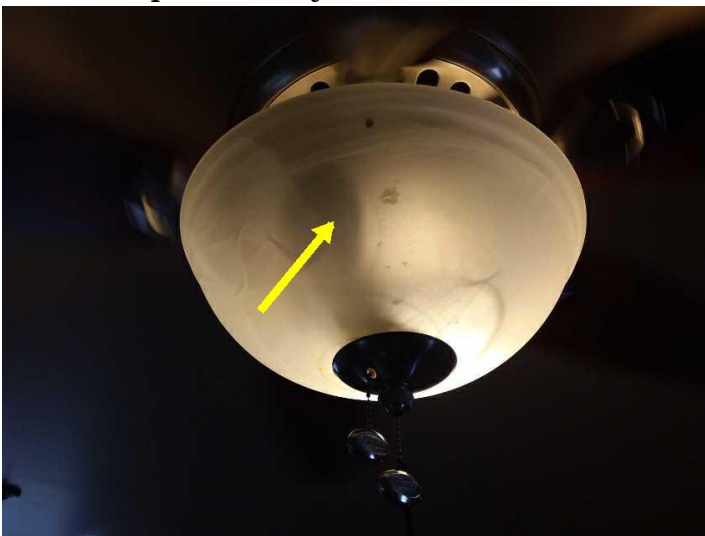
A ceiling light bulb does not respond, and should be serviced.

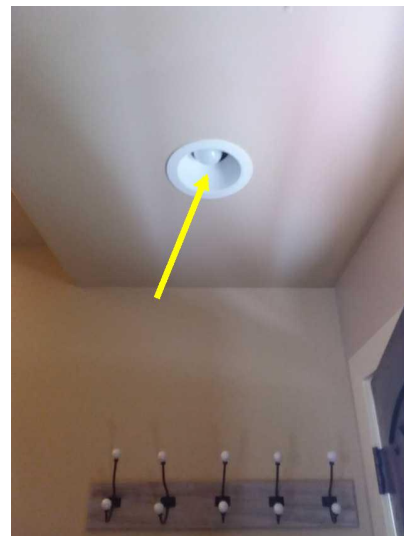
A ceiling light did not respond and should be serviced.

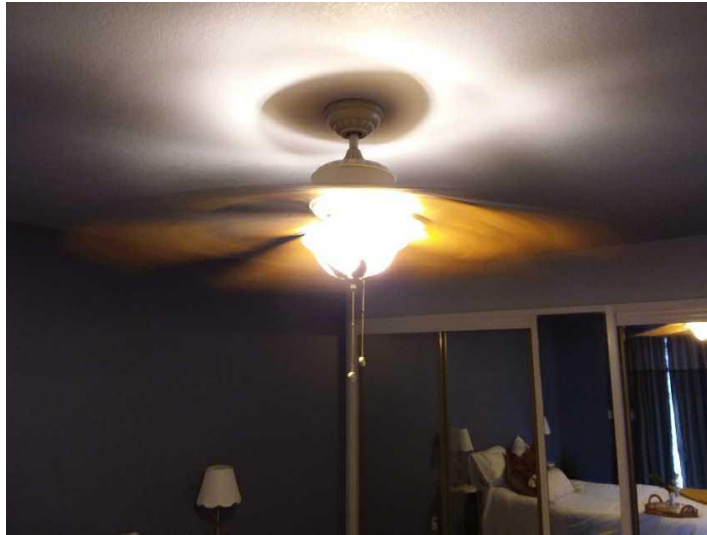
The ceiling fan is functional but rocks at high speeds and should be serviced so the fan operates smoothly.

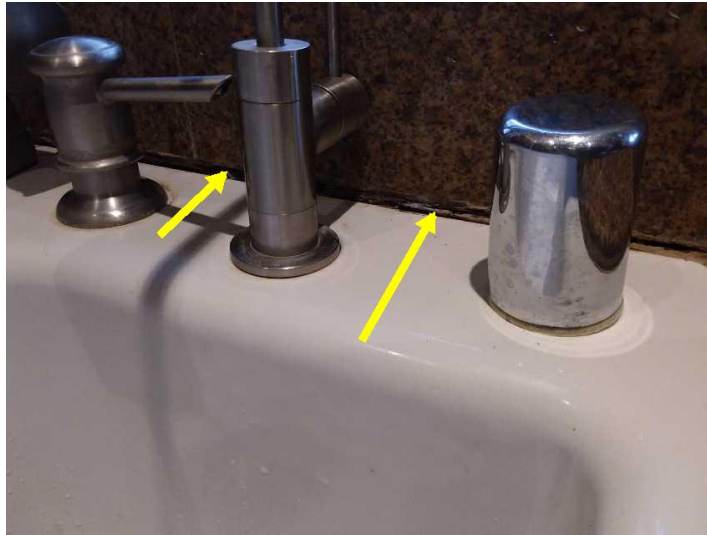
A separation between the counter top and the backsplash should be sealed.

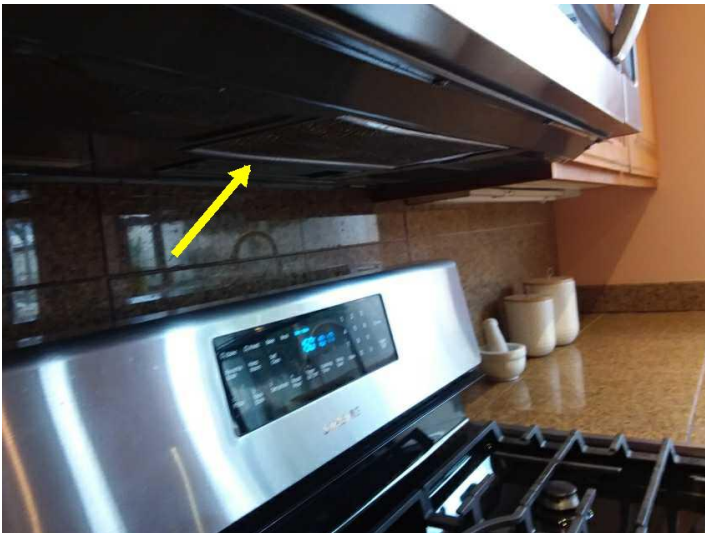
9.3. The downdraft exhaust fan light does not respond, and should be serviced.

The downdraft exhaust fan light does not respond, and should be serviced.

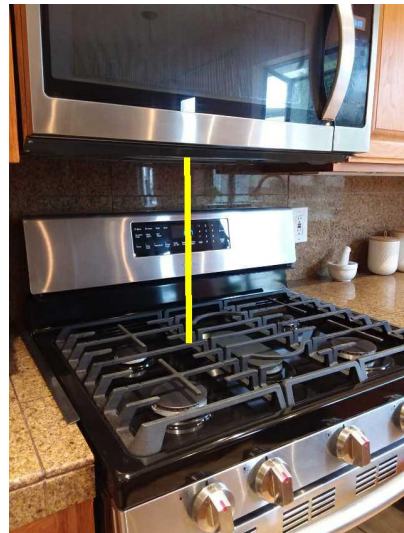
The range hood exhaust-fan is closer than the recommended 24 inches and should be used with caution.

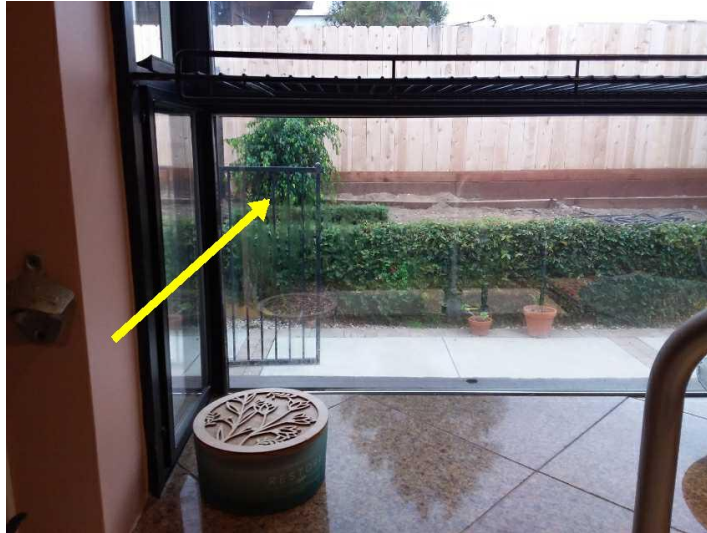
11.1. A window(s) may have a broken hermetic seal which you may wish to have replaced. This is evident from fogging, or condensation forming between the panes of glass that confirm that the seal has failed.

A window(s) may have a broken hermetic seal which you may wish to have replaced. This is evident from fogging, or condensation forming between the panes of glass that confirm that the seal has failed.

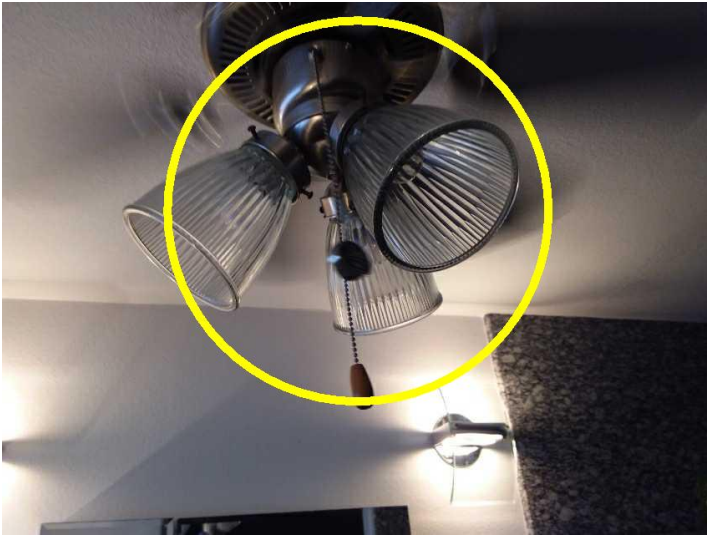
A ceiling light does not respond and should be serviced.

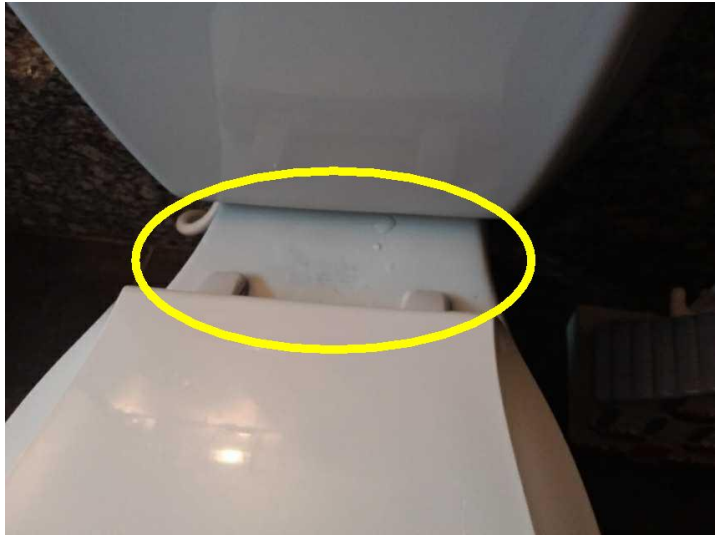
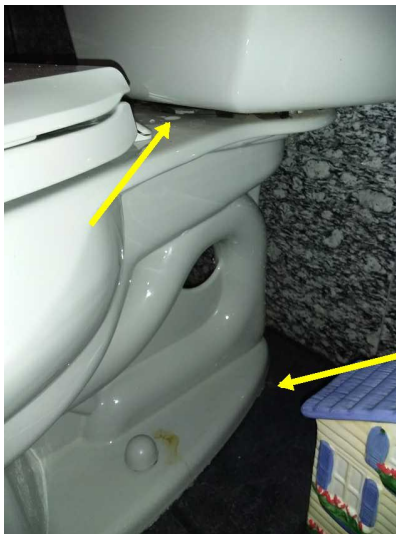
| Page 49 Item: 1 | Master Bathroom Observations | 1.13. The toilet leaks at the connection between the tank and bowl, which should be repaired. |

The toilet leaks at the connection between the tank and bowl, which should be repaired.

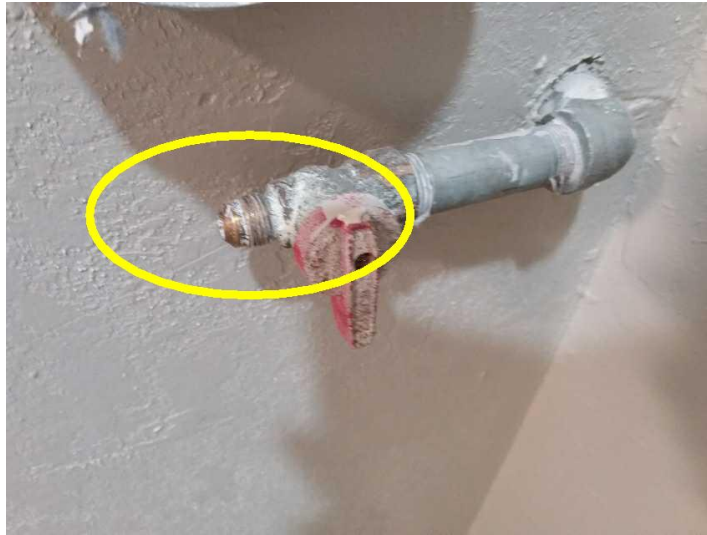
There is no cap on the gas valve. The gas valve should be capped when not in use.

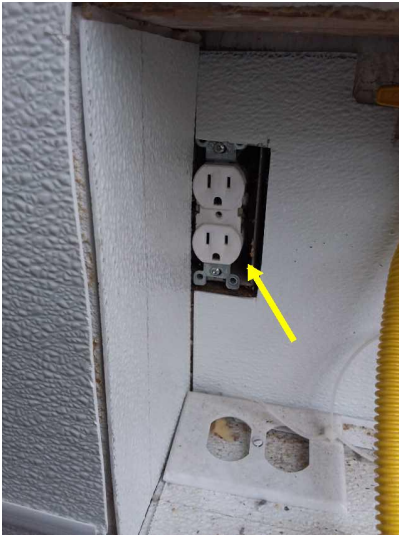
| Page 55 Item: 2 | Laundry Area | 2.11. One or more outlet covers is missing and should be installed. |

One or more outlet covers is missing and should be installed.

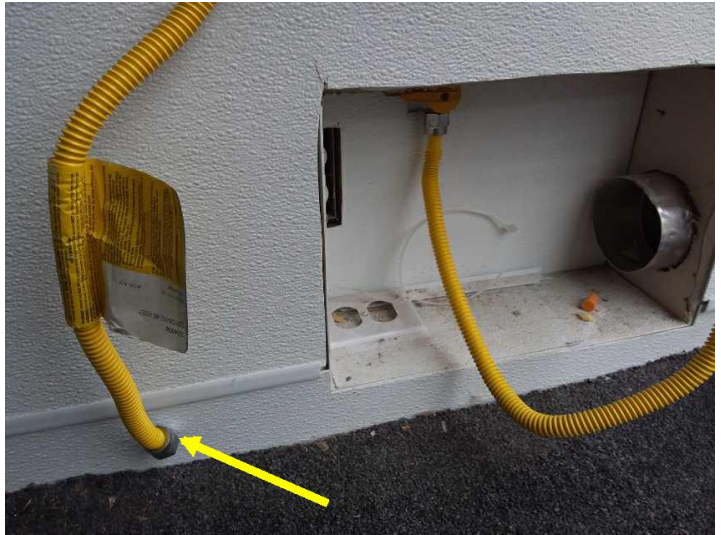
There is no cap on the gas valve. The gas valve should be capped when not in use.

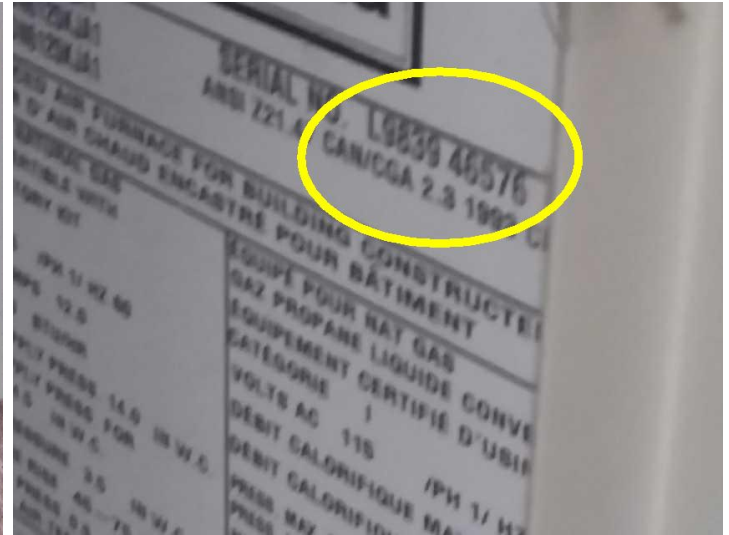
| Page 56 Item: 1 | Forced Air Furnace | 1.9. The furnace is functional. However, it is beyond the commonly accepted design life of twenty years, and will need to be monitored more closely for evidence of metal fatigue. We recommend that you have it serviced and evaluated by an HVAC contractor prior to the close of the inspection period. |

Serial number L983946576 - manufactured 1998

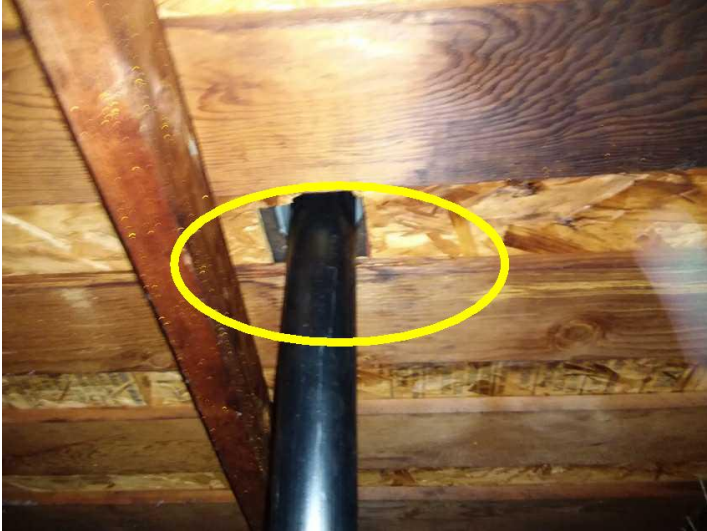
There are moisture stains on the attic ceiling at a roof penetration that indicate a past or present leak. This is a common area for leaks. We are unable to determine if the leak is current, or a past leak, in any case it should be further investigated or explained.

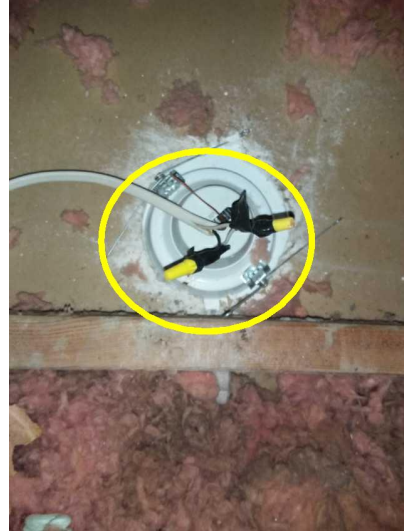
1.13. Electrical connections have been incorrectly made outside of junction boxes. All such connections should be made within junction boxes in order to contain any arcing or sparking that could occur, a task that should be completed by a licensed electrician.

Electrical connections have been incorrectly made outside of junction boxes. All such connections should be made within junction boxes in order to contain any arcing or sparking that could occur, a task that should be completed by a licensed electrician.

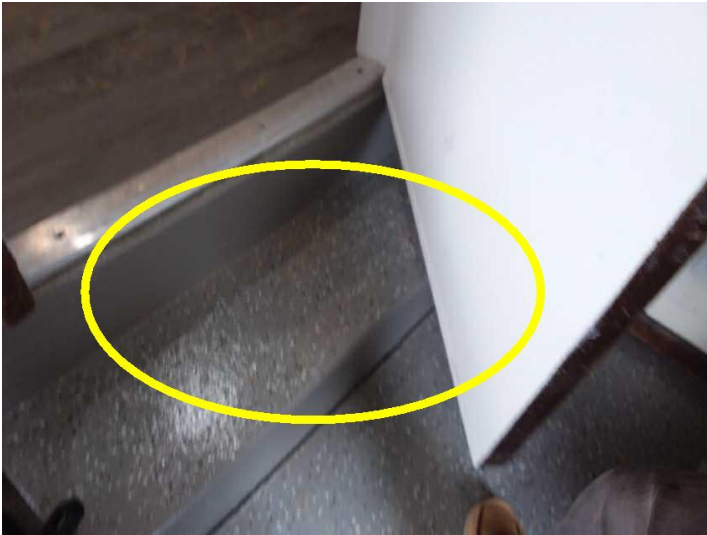
The house entry door opens incorrectly over a step, and should open over a platform the width of the door.

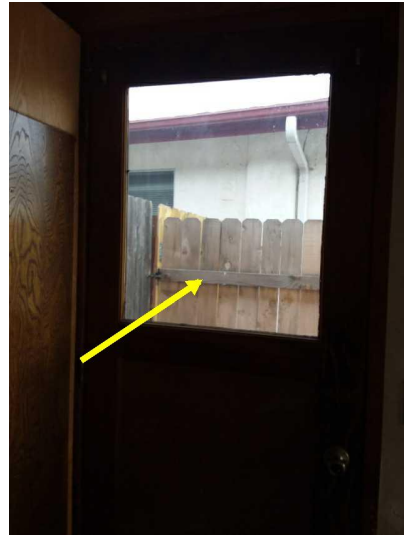
The window panes are not tempered or safety glass which is required by current standards.

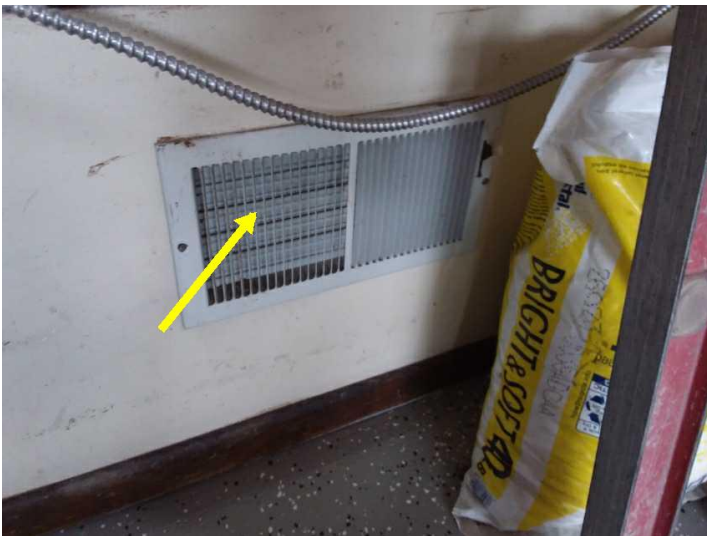
A heat register nullifies the firewall rating and should be repaired.

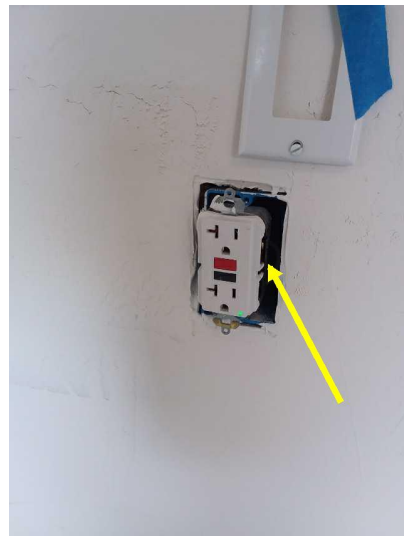
Outlet covers are missing and should be installed.

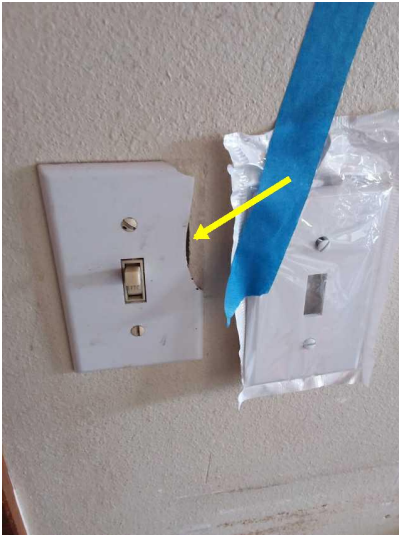
Light switch covers are damaged and should be replaced.

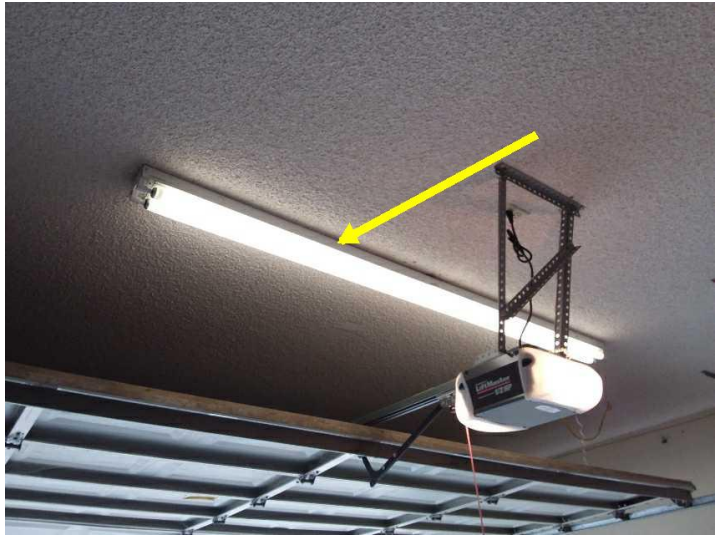
A light is missing its globe or cover and should be serviced.

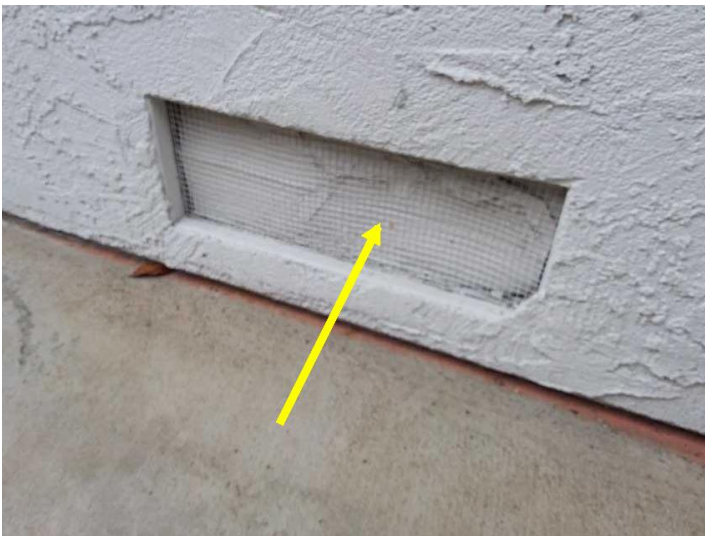
One ventilation port in the wall has been blocked or covered. If they are not uncovered, vehicle engines and combustion appliances could produce noxious by-products, including deadly, carbon monoxide.

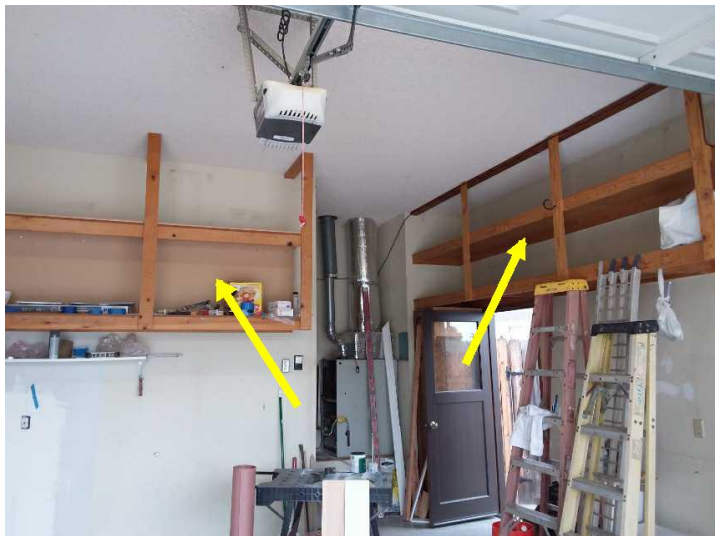
The storage space may have been added without the benefit of a permit, which could stress the roof framing. You may wish to verify this with the sellers. Regardless, you should limit the storage to lightweight items.
