# **Cornerstone Inspection**

## **Property Inspection Report**

**689 Woodland Dr, Arroyo Grande, CA 93420**  
**Inspection prepared for: Nancy Lacsamana**  
**Real Estate Agent: Shannon Bowdey -**

**Date of Inspection: 3/11/2025 Time: 9:00 AM**  
**Age of Home: 1976 Size: 2954**  
**Order ID: 11854**

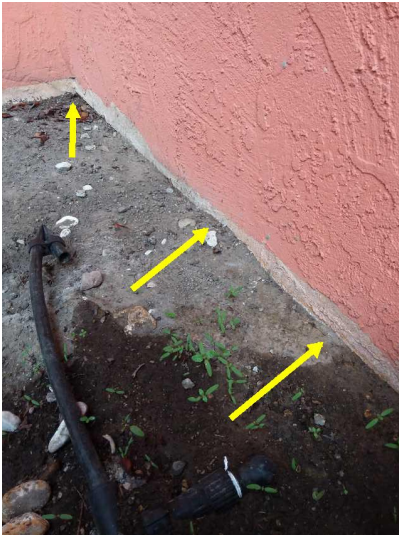
The soil is too high against the home at various areas around the home which should be serviced.

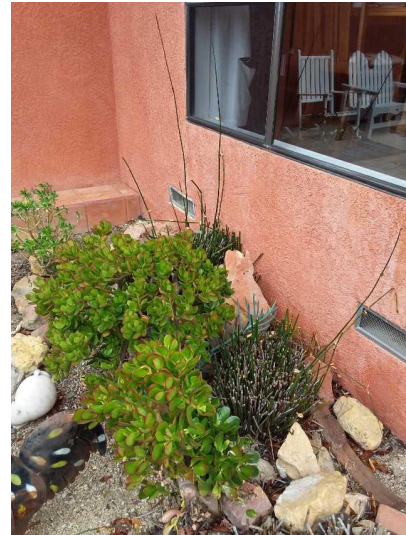
Vines, shrubs or bushes are growing on the house walls and although they are attractive they can introduce pests and rodents and accelerate deterioration. Therefore, you may wish to consider having them removed or cut back to 12 inches away from the home.

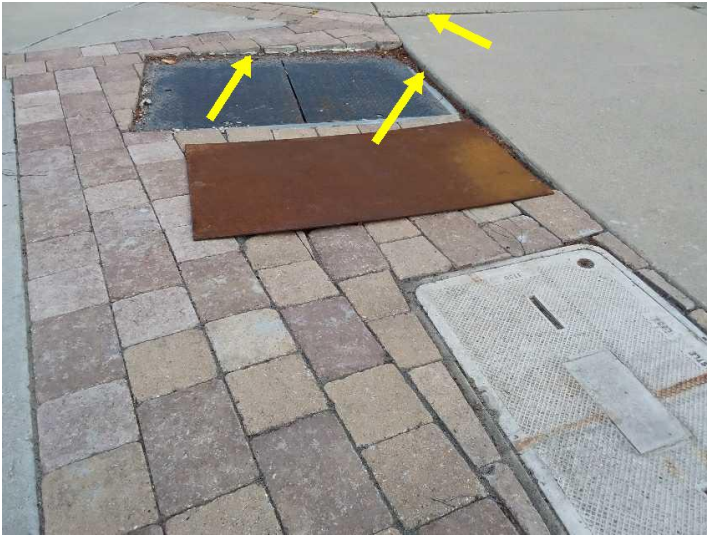
There is one or more offsets in the driveway that could prove to be trip-hazards.

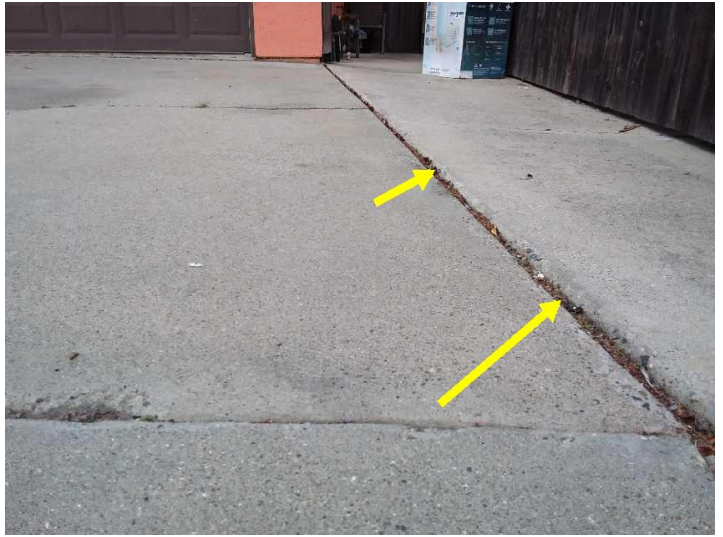
There is one or more offsets in the driveway that could prove to be trip-hazards.

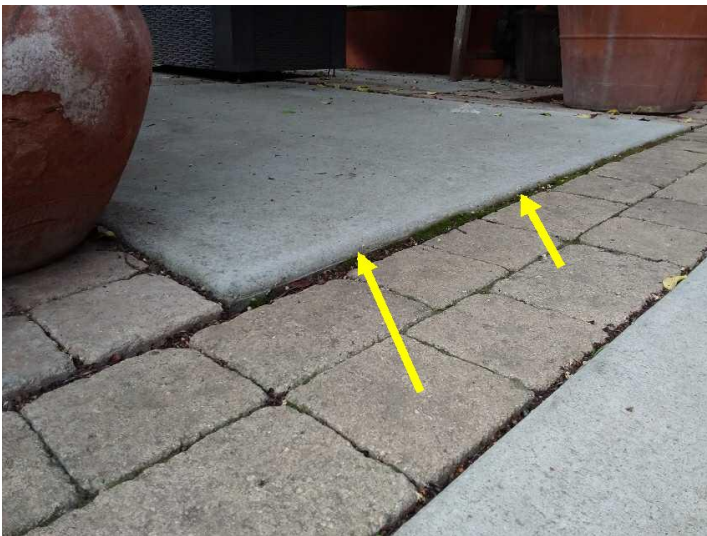
There is one or more offsets in the walkways that could prove to be trip-hazards.

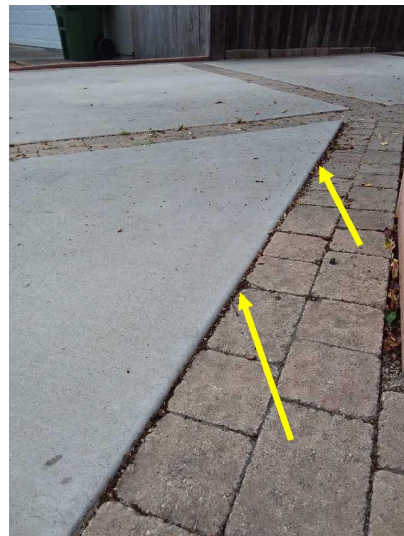
There is one or more offsets in the walkways that could prove to be trip-hazards.

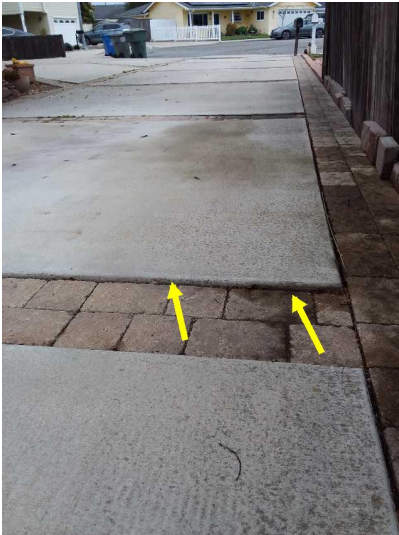
There is one or more offsets in the driveway that could prove to be trip-hazards.

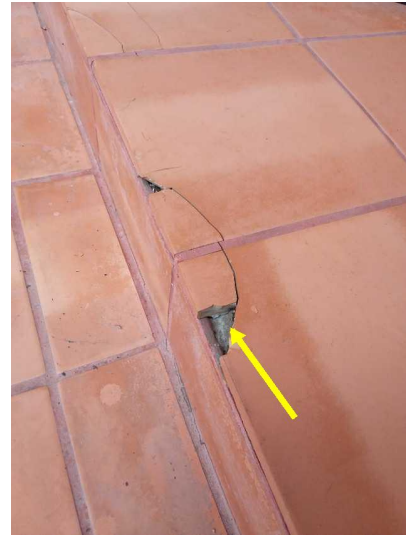
The Sautillo tiles, or Mexican pavers, are comprised of a soft, clay-based, material that can deteriorate rapidly and permit moisture intrusion if they are not kept sealed and maintained.

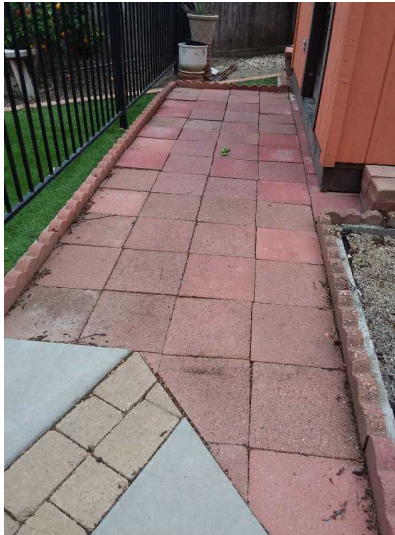
The paver patio or walkway has multiple offsets. This may be due to unsuitable soil below the pavers.

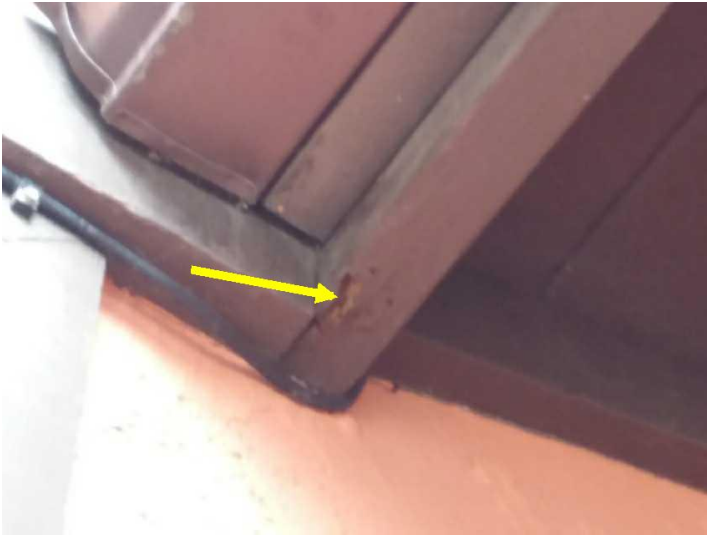
There is damage to the wood trim that should be evaluated by a termite inspector.

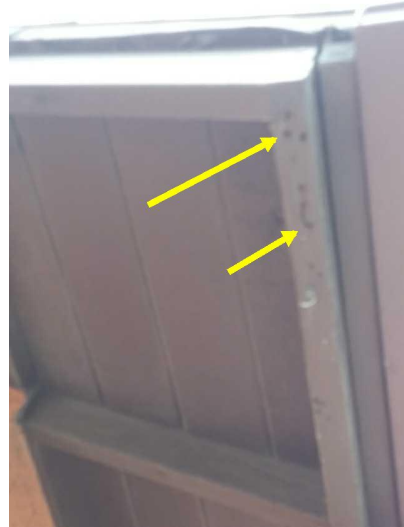
There is damage to the wood trim that should be evaluated by a termite inspector.

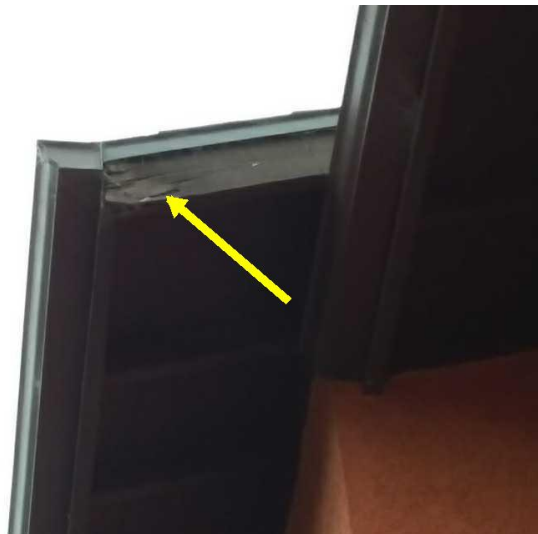
There is moisture damage or dry rot to the wood trim and or fascia on the upper roof area, which is typically not inspected by the pest inspector. The pest control company should be alerted so as to inspect and include these repairs in their estimate.

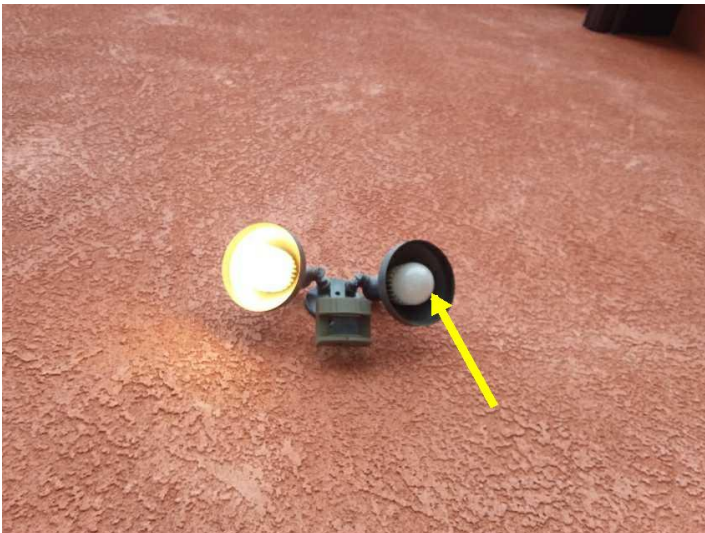
We were not able to activate some of the exterior lights which may be operated on a timer, sensors, or a light bulb that is burned out. Nonetheless, they should be demonstrated as functional by the seller.

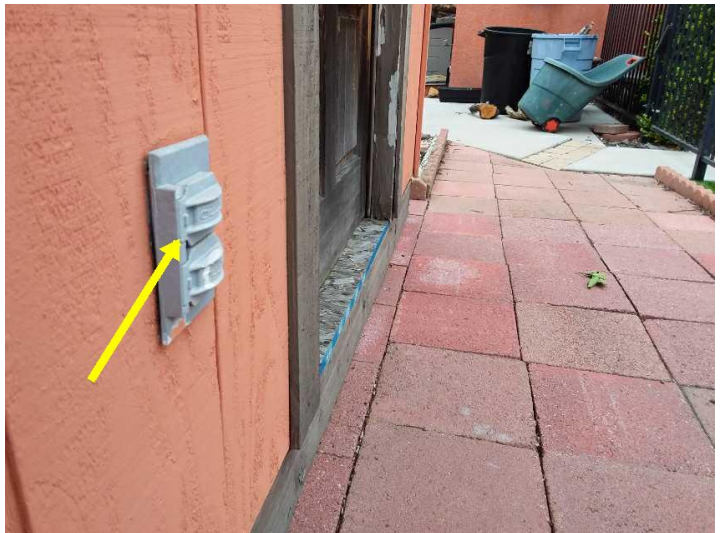
Some of the exterior outlets do not have ground-fault protection, and should be upgraded to include this modern safety feature.

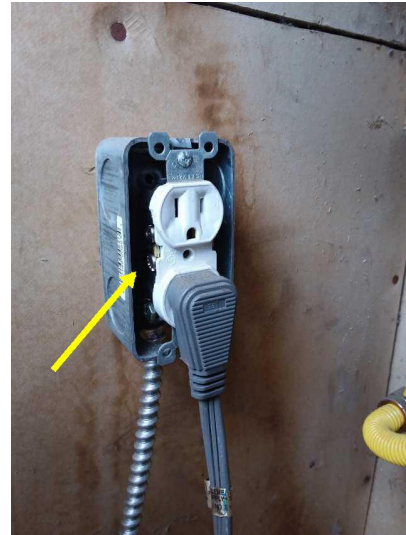
Some of the exterior electrical outlets do not have a weather rated cover or the cover is damaged and should be serviced.

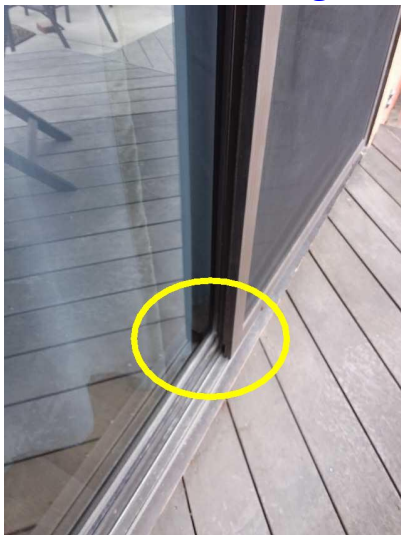
The sliding glass door or doors are mounted on the outside, which is not as secure as being mounted on the inside.

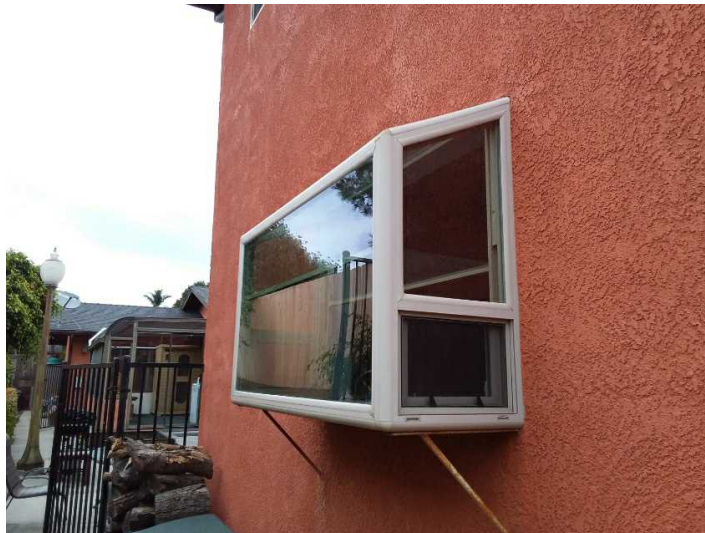
This home has one or more Garden windows. These windows can be problematic if not monitored. Leaks are common due to design factors and we advise that it be monitored regularly to prevent moisture intrusion.

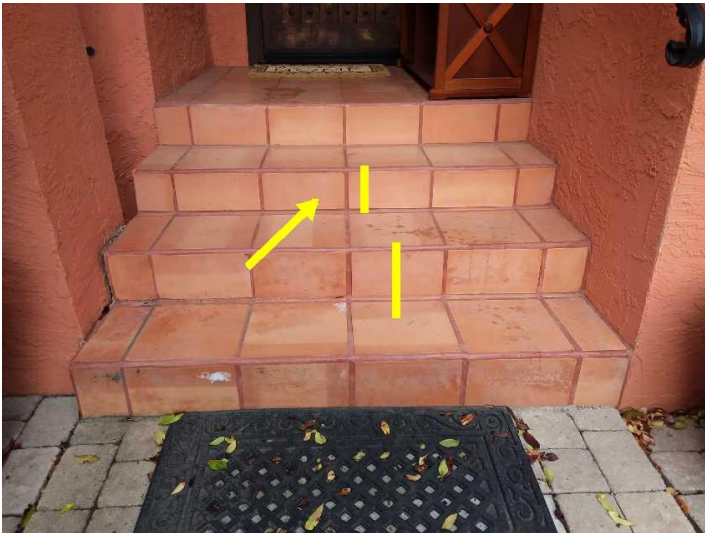
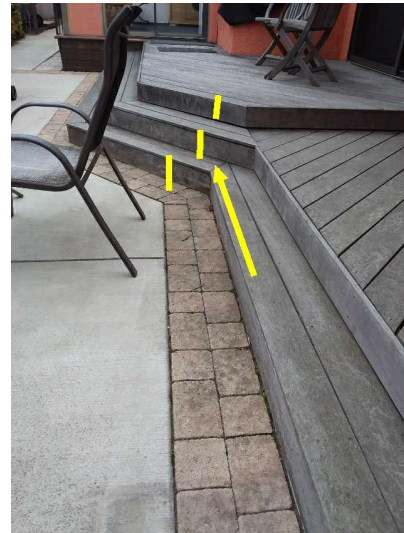
Some of the steps have unequal treads or risers.

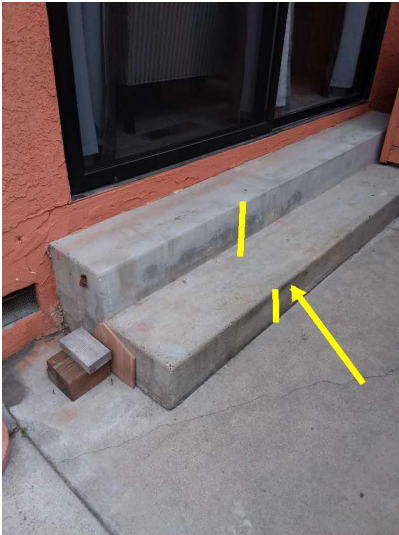
Some of the steps have unequal treads or risers.

Steps are required to be uniform to prevent trip-hazards. The rise of any step should be no less than four inches and no greater than seven inches, and the run should be no less than eleven inches. Also, the dimensions of the largest step should not exceed that of the smallest by more than three-eighths of an inch.

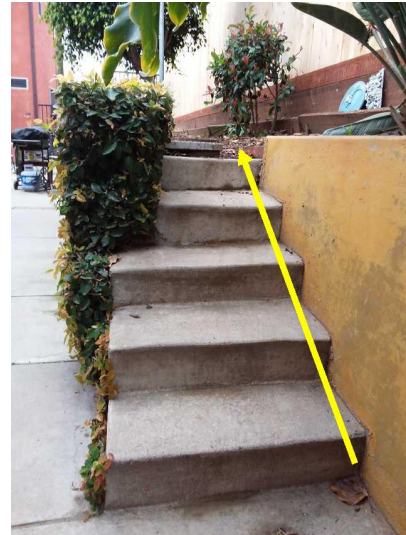
Current building standards require handrails to be installed on steps which have 4 or more risers, and particularly if children or the elderly visit or occupy this property.

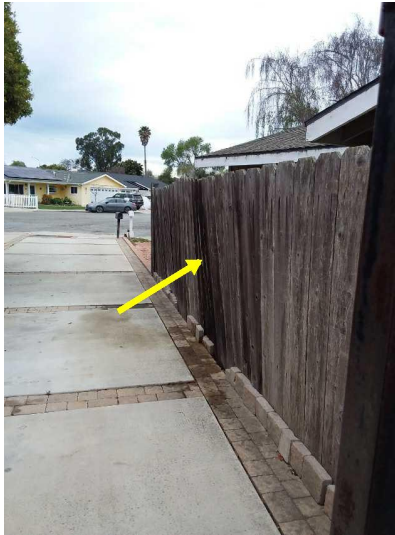
Sections of the fence are leaning or missing which you may wish to have repaired or replaced.

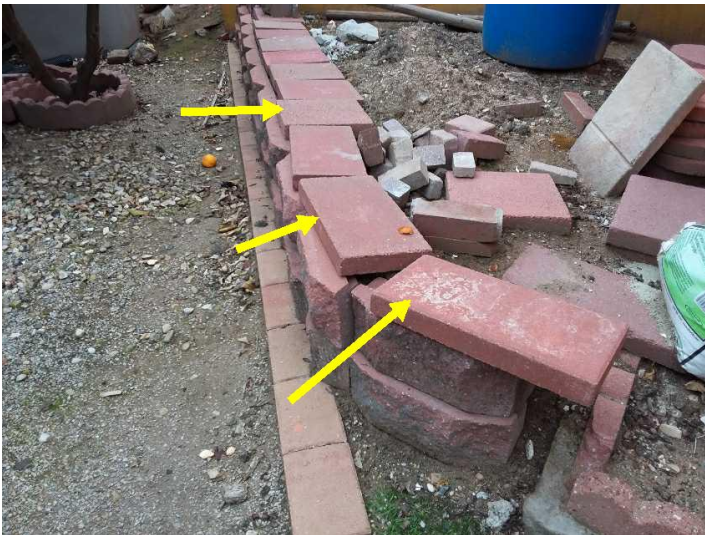
Some of the planter block-caps are loose or missing and should be serviced.

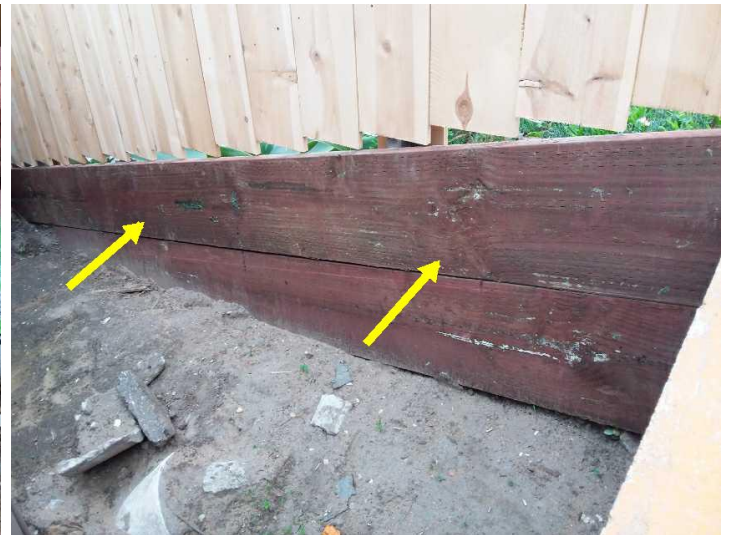
The wooden planks at the rear of the property have no structural value, and are intended to inhibit surface soil movement, and should be periodically monitored for damage or stability.

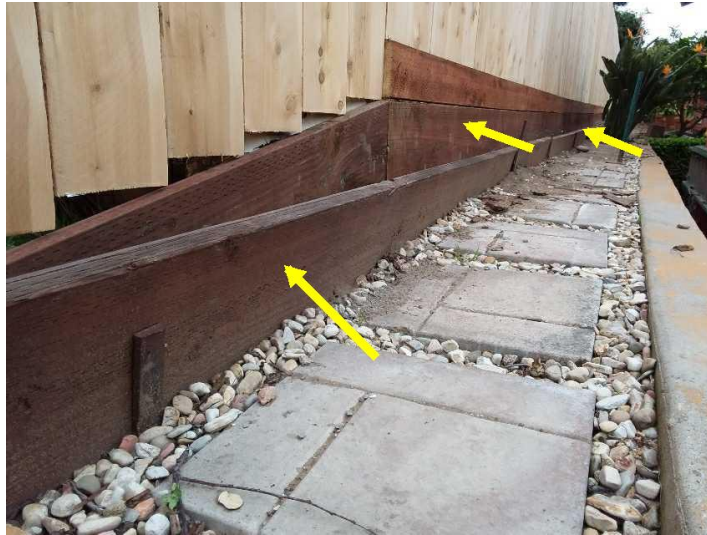
The wooden planks at the rear of the property have no structural value, and are intended to inhibit surface soil movement, and should be periodically monitored for damage or stability.

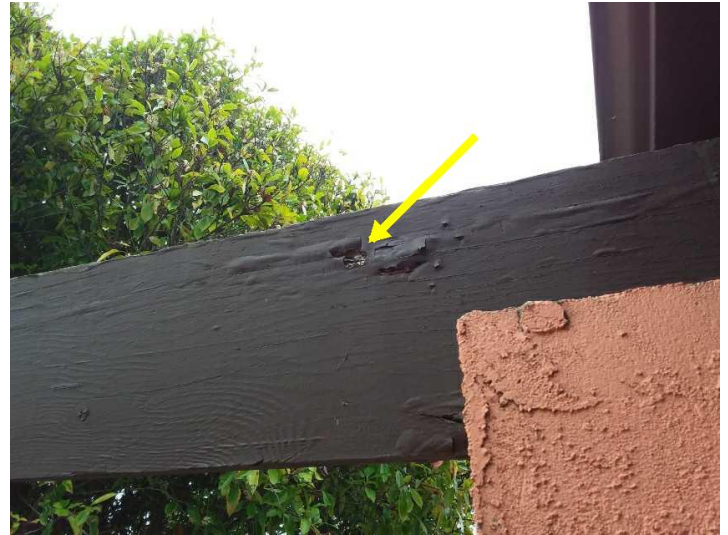
There is damage to the patio cover that should be evaluated by the termite inspector.

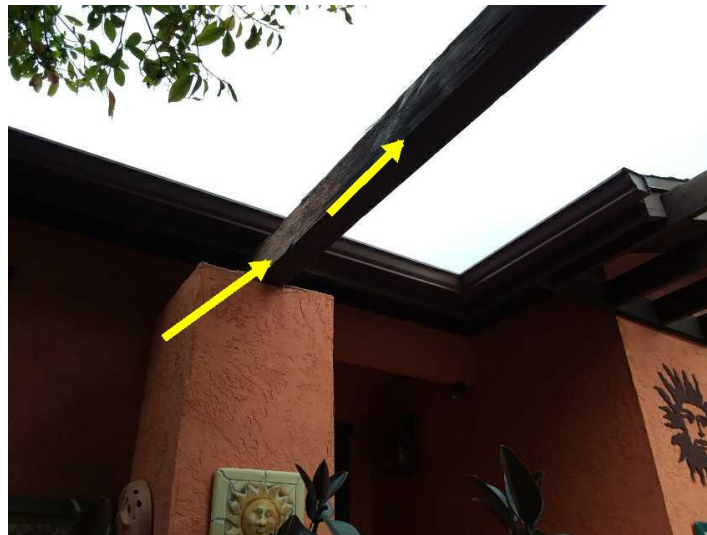
The patio roof-line or beam is deformed and should be evaluated by a licensed specialist such as a framing contractor.

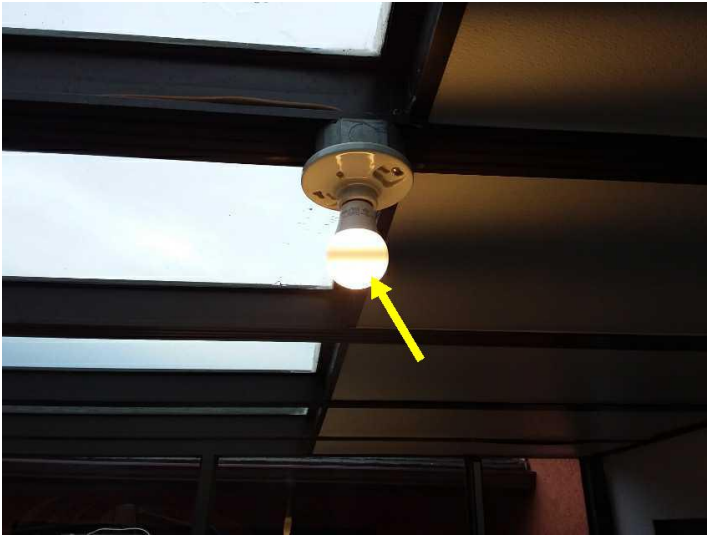
A light is missing its globe or cover and should be serviced.

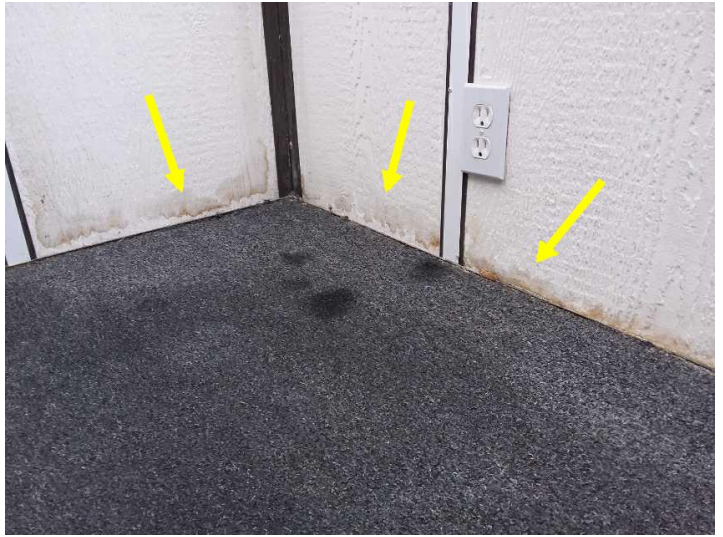
There is a moisture stain on the wall that should be explained or explored further.

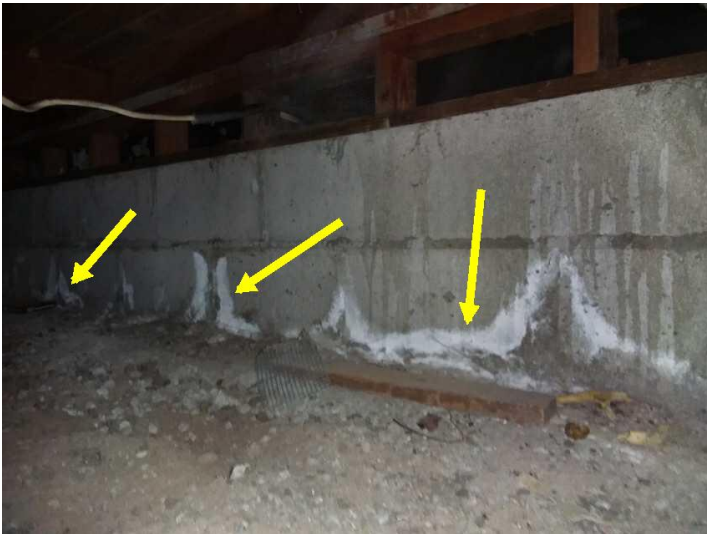
Moisture has entered the crawlspace, as is evident by salt crystal formations around the base of the stem walls. However, this is a common phenomenon that does not necessarily indicate a chronic or serious problem. The soils are currently dry, but it would be prudent to monitor this area.

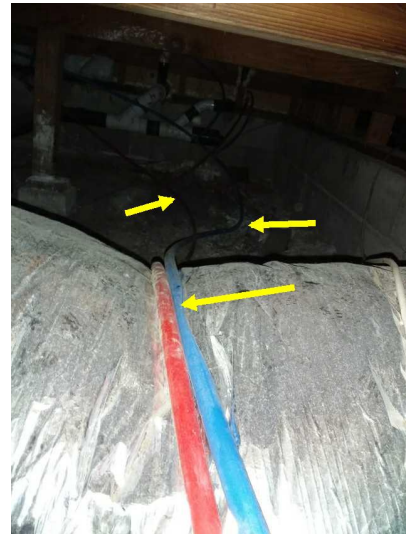
Some of the water supply lines are insufficiently supported and should be serviced.

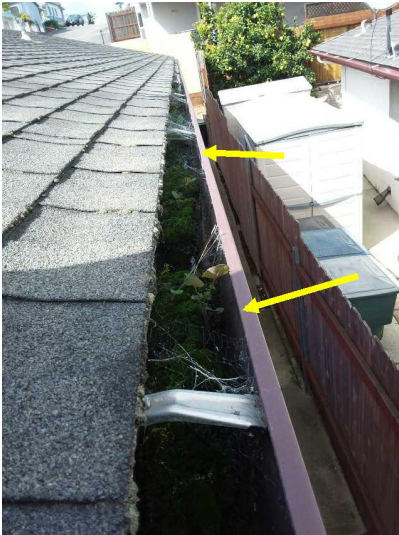
Some of the gutters need to be cleaned to drain properly.

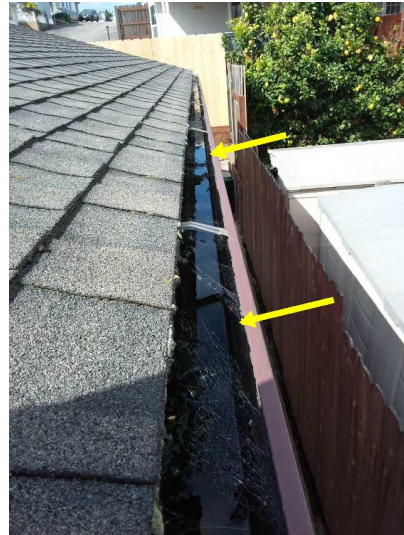
We observed standing water in some sections of the gutters which implies that it may not be properly sloped and should be evaluated and serviced.

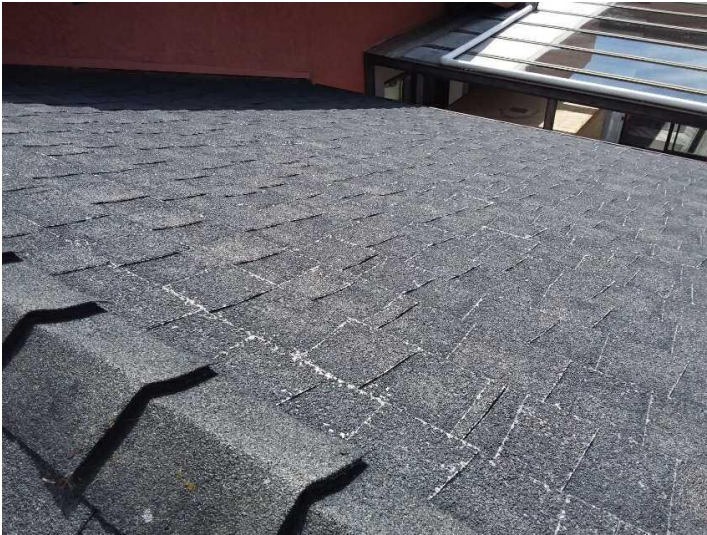
The shingles are losing granules but would not need to be replaced at this time.

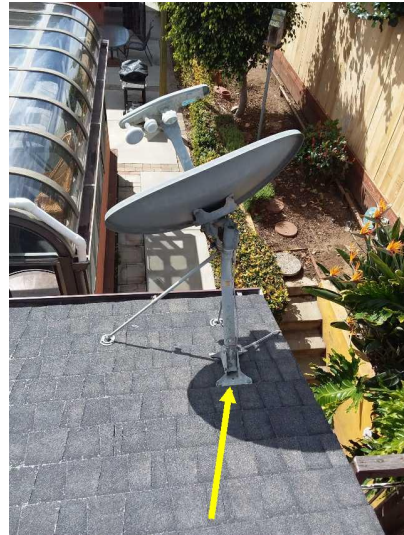
There is a satellite dish that has been installed on the roof without flashing and will need to be sealed regularly to prevent moisture from entering during rains.

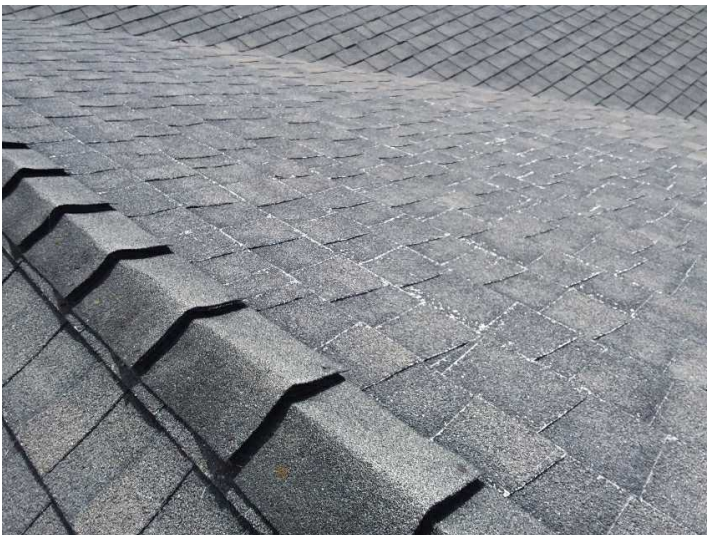
The shingles are losing granules but would not need to be replaced at this time.

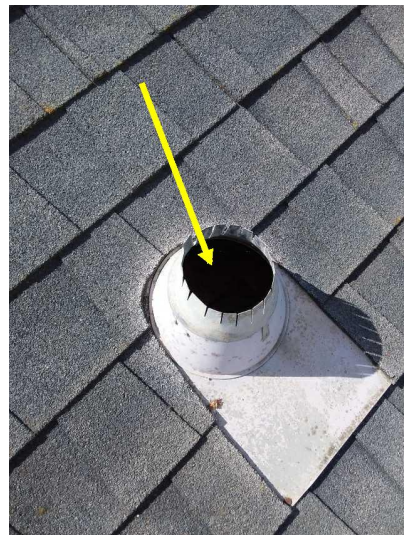
There are penetrations on the roof that are flashed but not sealed. There is a direct link into the attic which should be serviced as a termination cap was removed.

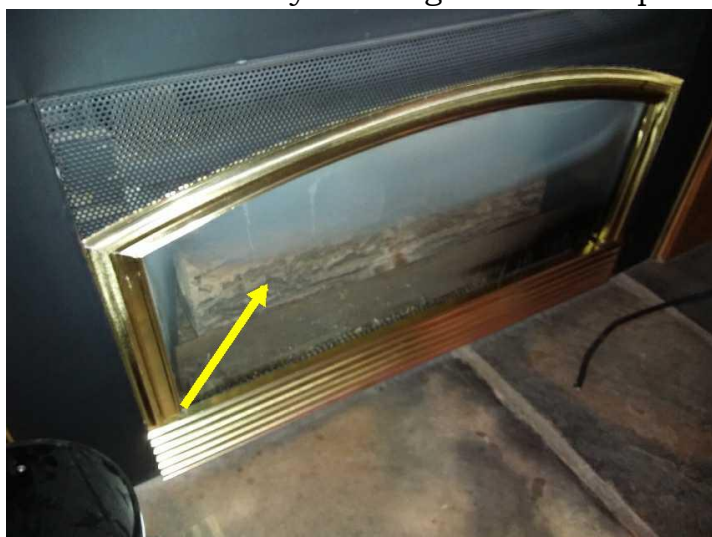
The fireplace glass is functional, however does not have a protective screen, which is required by current standards and should be installed for optimal safety.

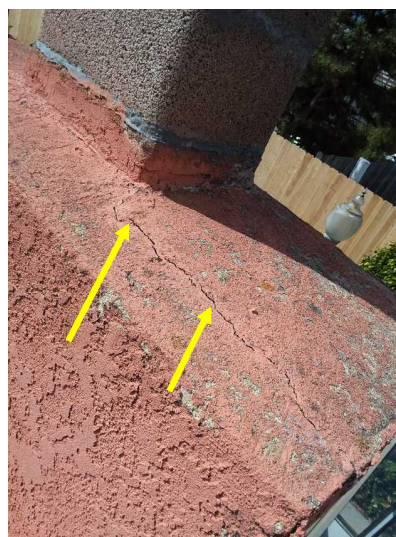
The chimney crown, which is designed to seal the chimney wall and shed rainwater, is cracked and should be sealed.

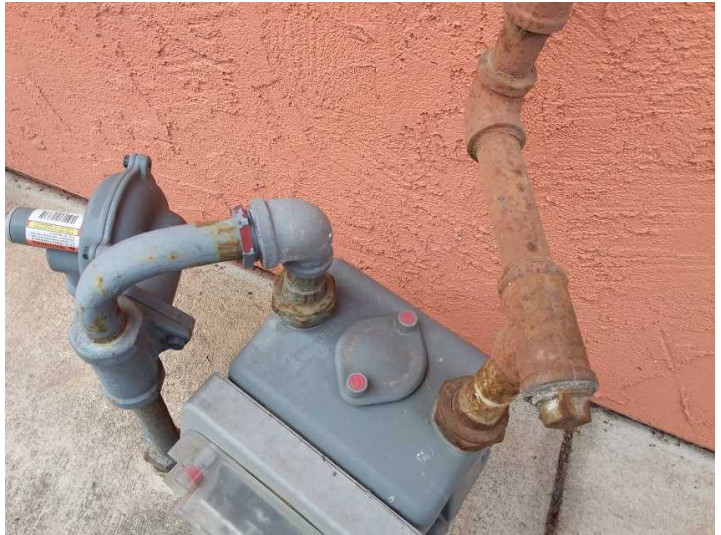
Some of the gas lines at the meter are rusted and should be painted to prevent further corrosion.

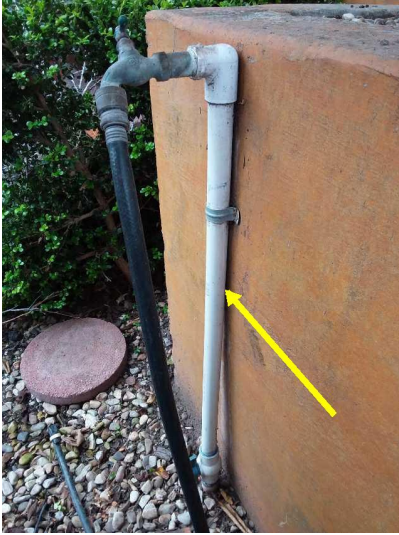
We have observed exposed PVC pipe on the exterior, which may become brittle when exposed to the sun's ultraviolet light. These pipes can become subject to breaking or leaking. We recommend painting the PVC pipes to block the UV rays and protect the pipe.

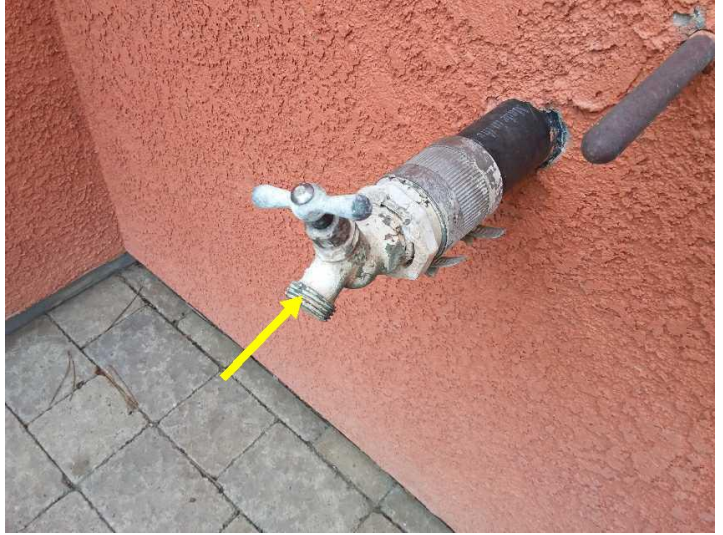
A hose bib on the rear is no longer functional or has been abandoned. However, we may not have located and tested each hose bib on the property.

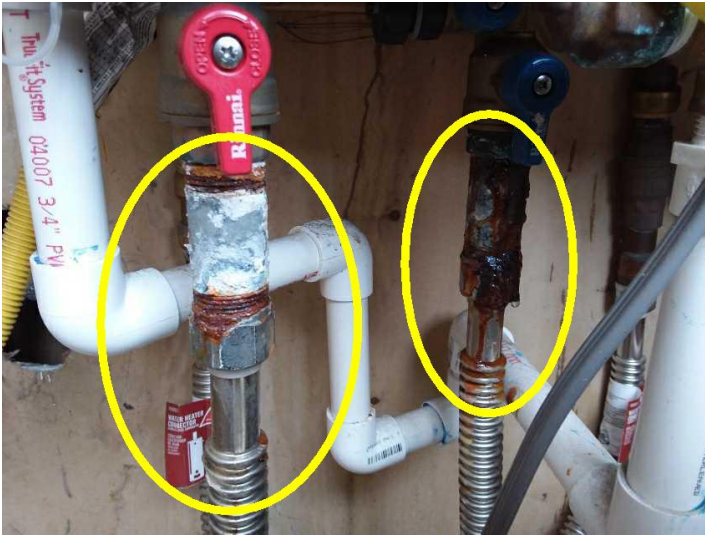
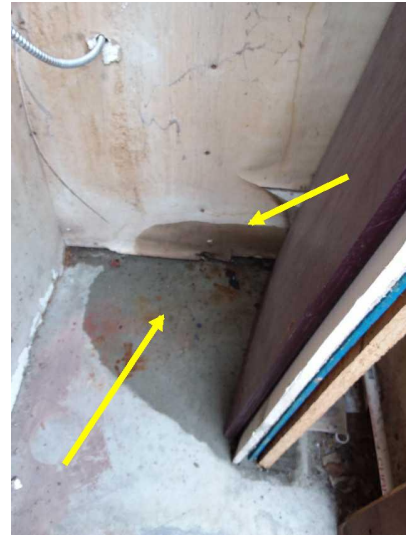
| Page 39 Item: 5 | Tankless Water Heater | 5.12. There is a leak at the right side exterior water connector on the gas water heater, which should be repaired by a plumber.<br><br>5.13. The TPR valve discharge pipe on right side water heater is PVC which is not approved for this purpose and should be replaced with metal or CPVC. |

There is a leak at the right side exterior water connector on the gas water heater, which should be repaired by a plumber.

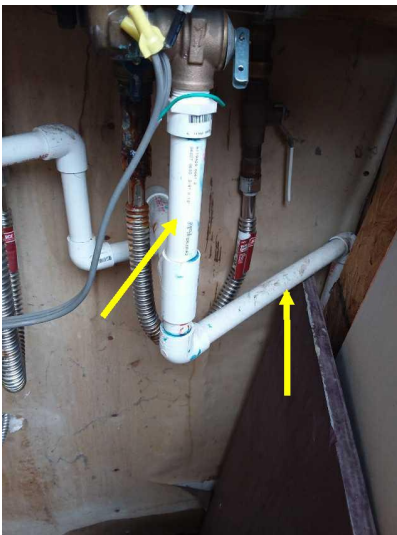
The TPR valve discharge pipe on right side water heater is PVC which is not approved for this purpose and should be replaced with metal or CPVC.

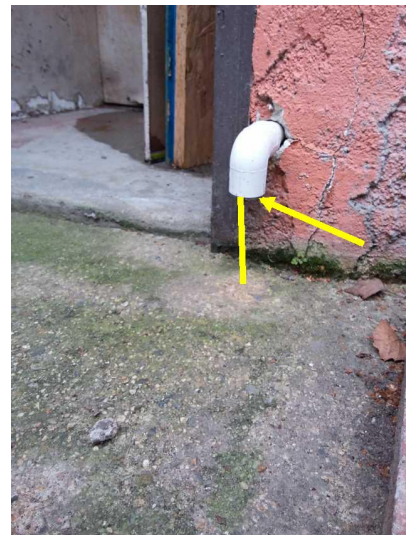
The pressure relief valve pipe has not been installed correctly. It must terminate no more than twenty-four inches above grade and no closer than six inches to it and be directed down towards the ground.

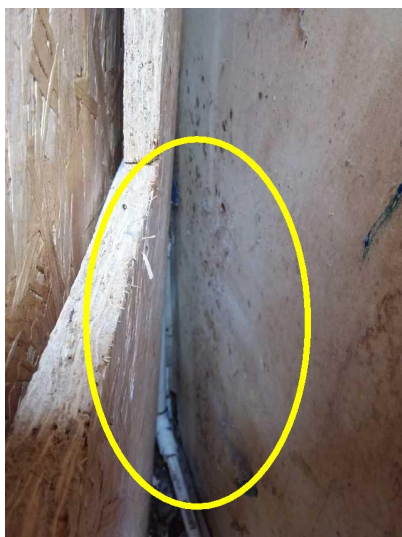
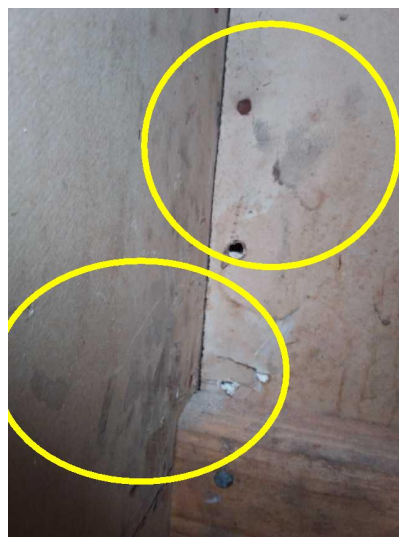
We have observed a dark stain like substance within the water heater closet that should be evaluated by a specialist.

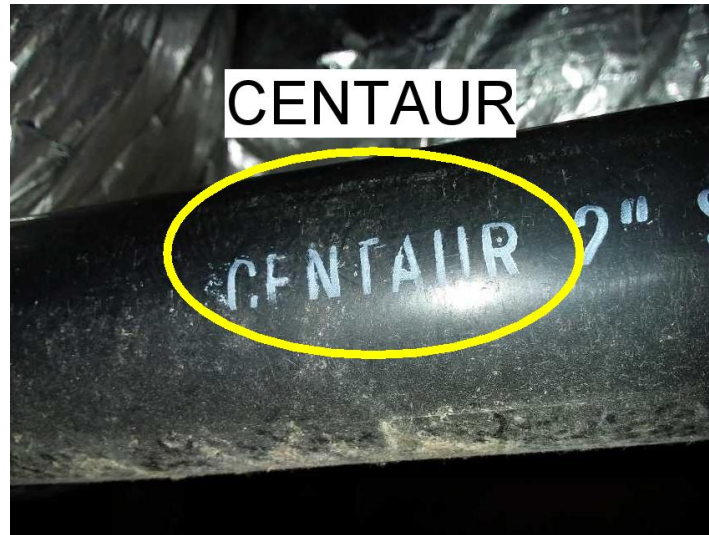
We have identified ABS pipe that is visible within the foundation crawlspace, but which could be concealed elsewhere, that was manufactured between the years 1984 and 1990, by Polaris, Gable Centaur, Phoenix, or Apache, which is alleged to be defective and the subject of a class action lawsuit. The plaintiffs allege that these pipes contain a plastic resin that contributes to circumferential cracking at the glue joints, which can result in leaks. Although we did not see any evidence of this, we recommend that the pipes be evaluated by a plumber who is familiar with this issue.

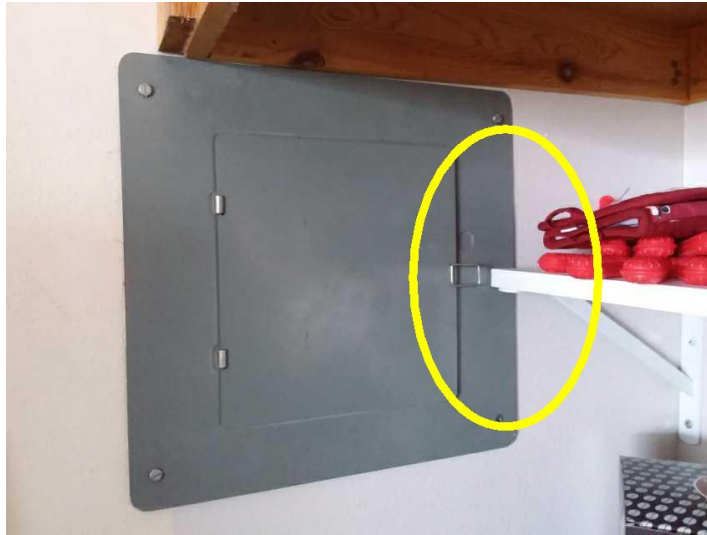
The interior of the sub panel was not accessible and was not inspected.

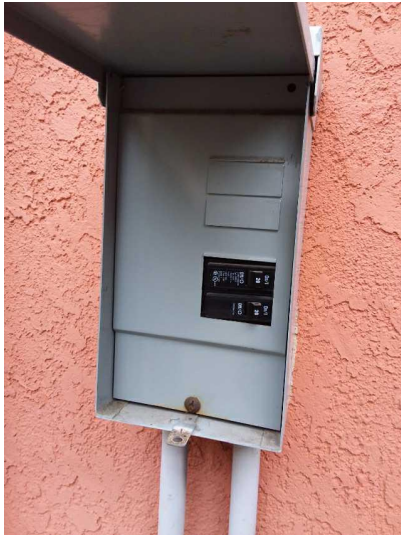
Various circuits within the sub-panel are not labeled, and should be serviced by an electrician so that the appropriate load calculations and breaker sizes could be determined.

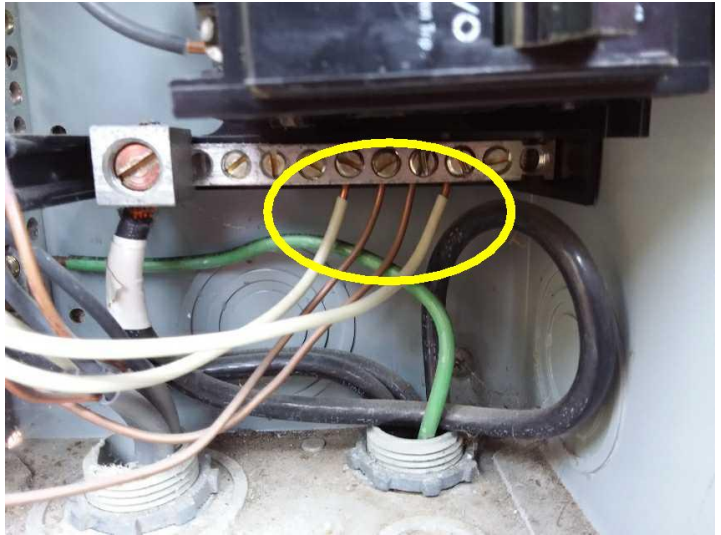
| Page 44 Item: 3 | Sub Panel #2 Observations | 3.9. The neutral and ground wires are together on the same buss bar and should be separate. The ground wires should be bonded to the panel and the neutral wires should be separate and "floating" from the panel. We recommend that a licensed electrician evaluate and service the sub panel. |

The neutral and ground wires are together on the same buss bar and should be separate. The ground wires should be bonded to the panel and the neutral wires should be separate and "floating" from the panel. We recommend that a licensed electrician evaluate and service the sub panel.

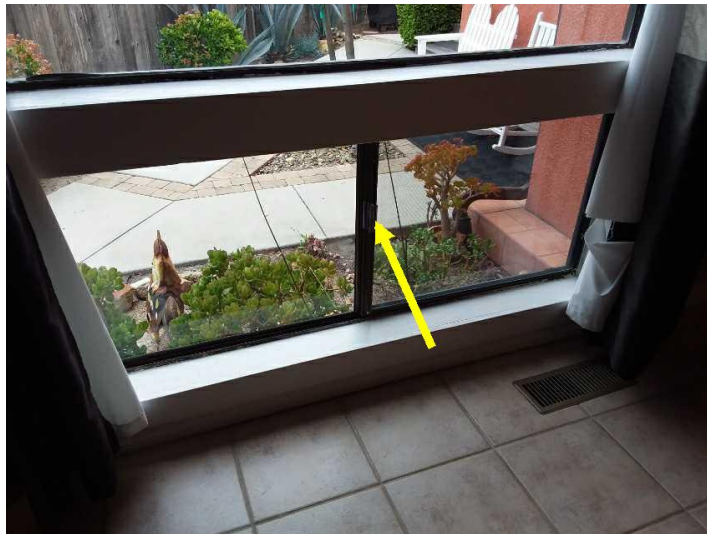
There's one or more windows installed within 18 inches of the finished floor that current standards require such windows to be tempered or safety glass.

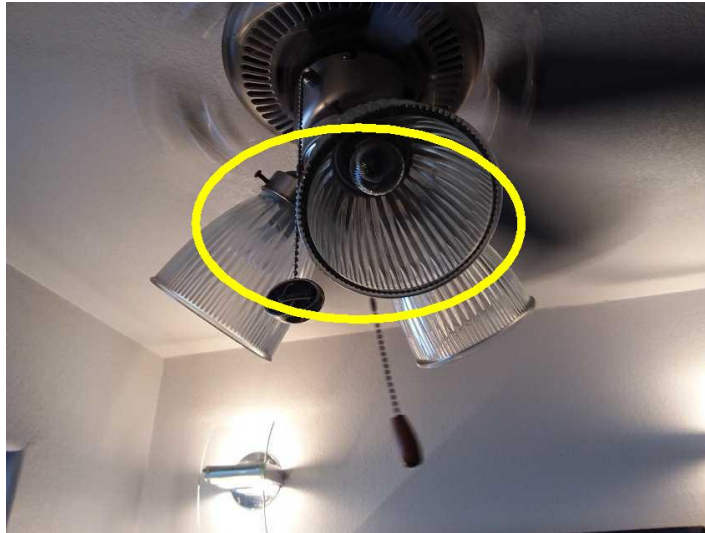
A ceiling light does not respond and should be serviced.

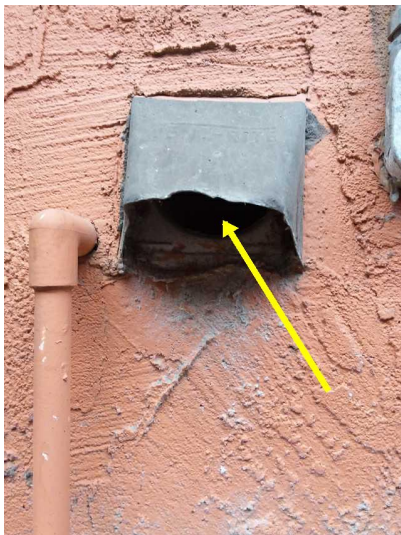
The back-draft on the exterior dryer vent cover is missing, stuck open, or incomplete and should be repaired or replaced.

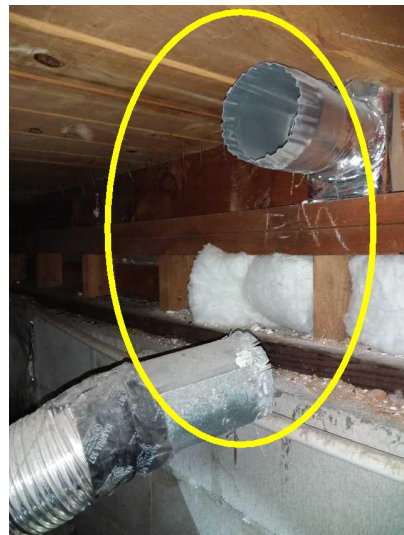
| Page 63 Item: 2 | Laundry Area | 2.9. The dryer vent is separated within the foundation crawlspace and should be repaired. |

The dryer vent is separated within the foundation crawlspace and should be repaired.

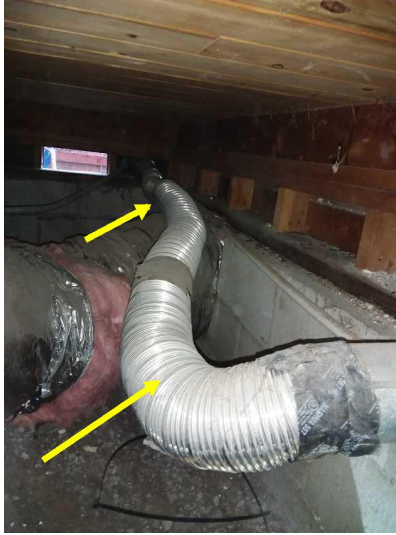
The dryer vent within the crawlspace extends more than six feet in length and therefore should be a smooth-walled metal type.

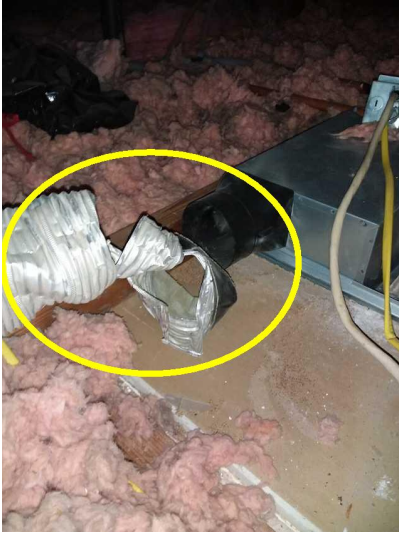
The bathroom exhaust duct is separated, and should be repaired.

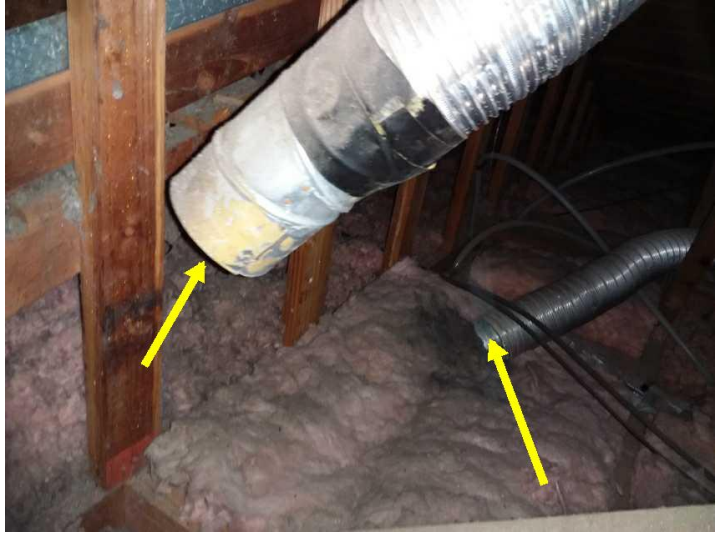
The bathroom exhaust ducts should be extended to an exterior port.

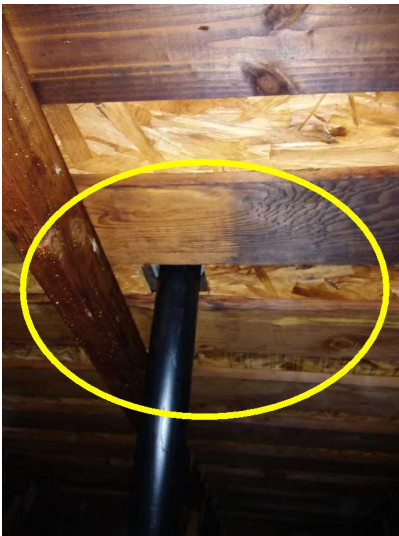
There are moisture stains on the attic ceiling at a roof penetration that indicate a past or present leak. This is a common area for leaks. We are unable to determine if the leak is current, or a past leak, in any case it should be further investigated or explained.

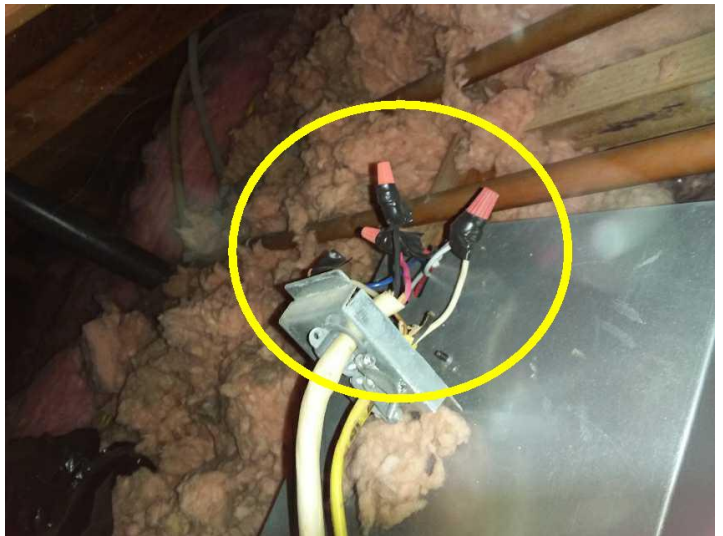
Electrical connections have been incorrectly made outside of junction boxes. All such connections should be made within junction boxes in order to contain any arcing or sparking that could occur, a task that should be completed by a licensed electrician.

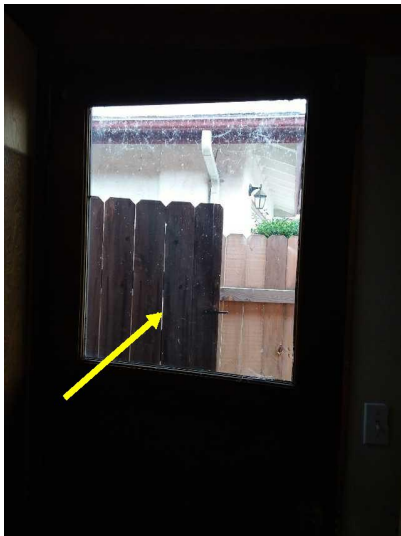
The window panes are not tempered or safety glass which is required by current standards.

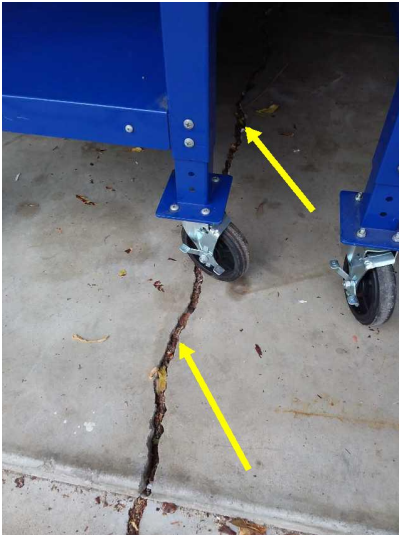
The slab floor is moderately cracked. Such cracks are common and result as a consequence of the curing process, seismic activity, ordinary settling, or the presence of expansive soils, but are usually not structurally threatening. We can elaborate, but you may wish to have a structural engineer confirm this.

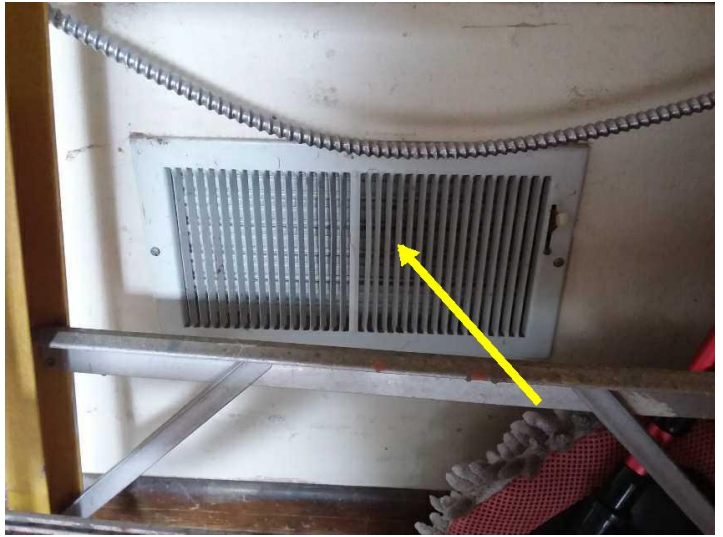
A heat register nullifies the firewall rating and should be repaired.

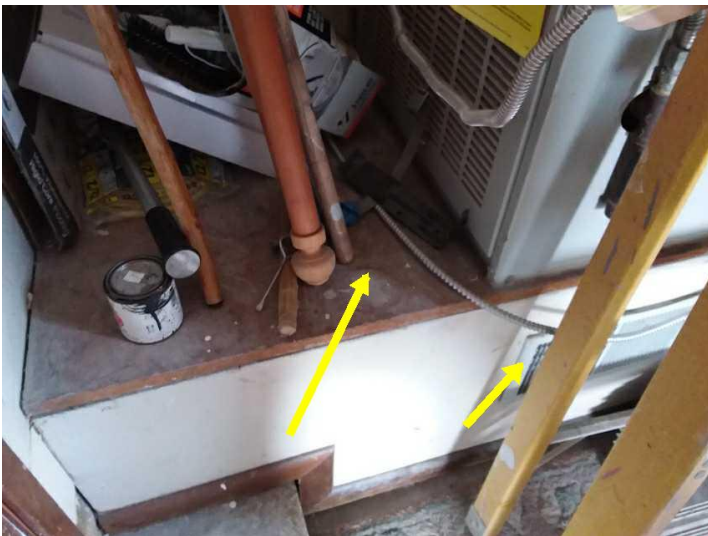
The furnace platform should be covered with drywall to maintain the required firewall protection. There may be a direct link into the interior of the home.

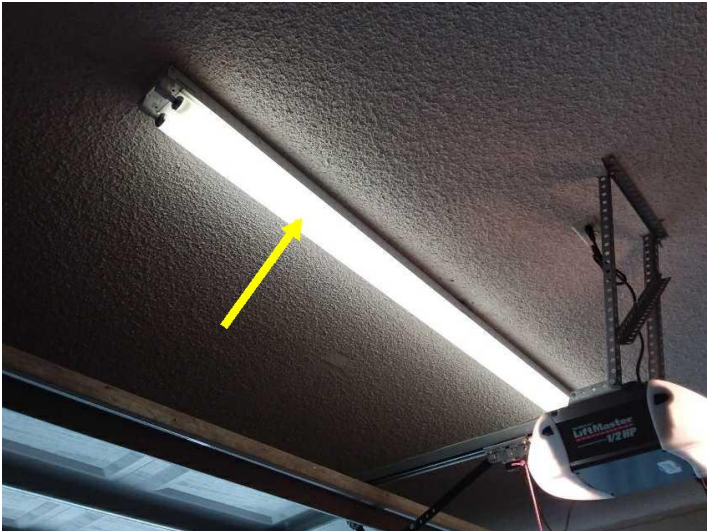
A light is missing its globe or cover and should be serviced.

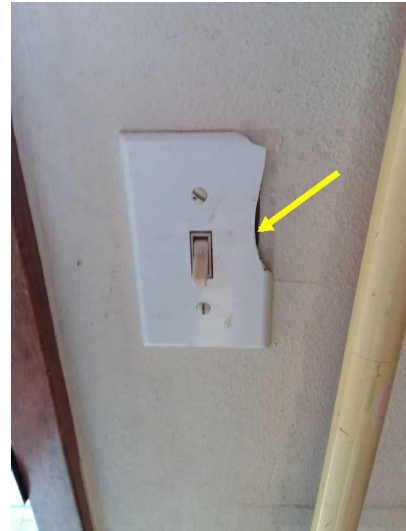
A light switch cover is damaged and should be serviced.
