360 INSPECTION SERVICES RESIDENTIAL HOME INSPECTION REPORT

1205 Willow Dr, Chapel Hill, NC 27517

06/20/2025

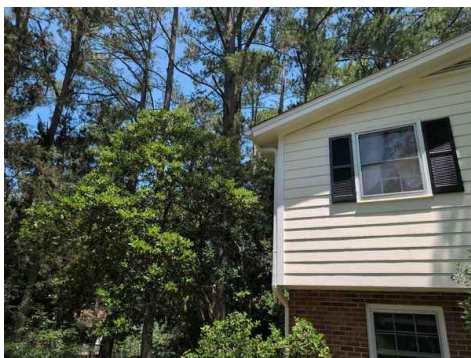
LEFT FRONT

VEGETATION CONTACTS THE HOME

Vegetation contacts the the home at the noted location(s). Any tree limbs, shrubbery, or vegetation should be trimmed back for at least 12" clearance to help prevent wicking up of moisture and an entry point for insects.

The tree that was in contact with the front left corner has been trimmed and is no longer in contact with the hole.

Contact a qualified landscaping contractor

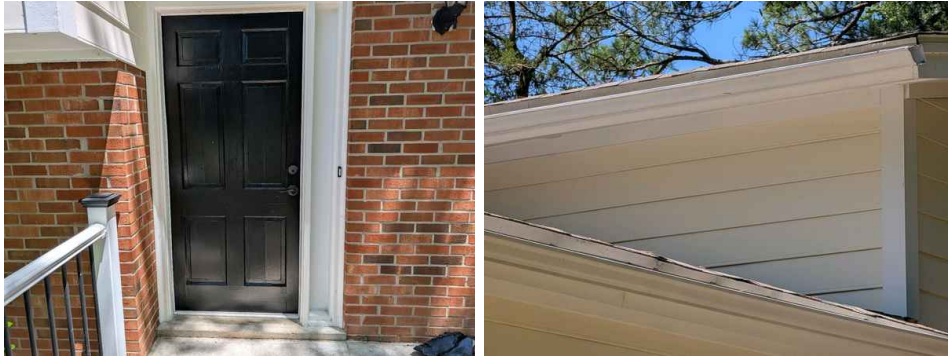
FRONT DOOR, FASCIA ON RIGHT SIDE GABLE, VARIOUS

PEELING PAINT

Paint is peeling and in poor condition at the noted locations. Exterior siding and trim with peeling paint should be repainted to avoid water damage to exterior woodwork and for proper appearance.

Peeling paint at the front door and right side gable has been repaired.

Contact a qualified painting contractor.

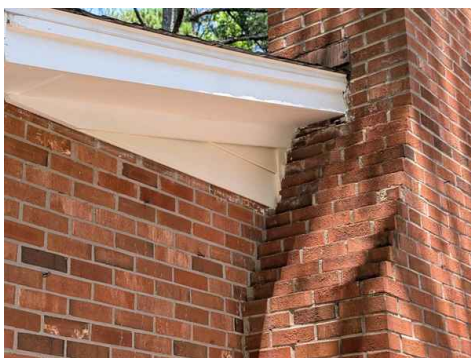
AT CHIMNEY/WALL INTERSECTION

CAULKING INCOMPLETE-DISSIMILAR MATERIALS

Caulking is incomplete between brick veneer and trim/window/door casings. Any joints between dissimilar materials should be caulked and sealed to prevent water penetration that could result in damage to the home.

Caulking/sealing at the noted area has been repaired

Contact a qualified professional.

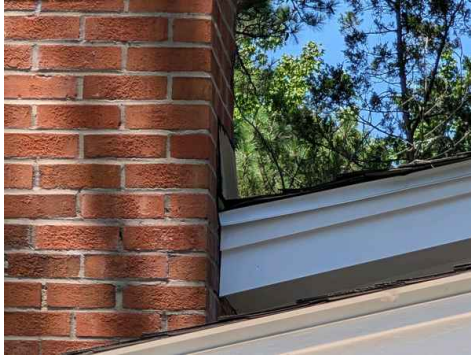
TRIM AT CHIMNEY

WOOD ROT

Wood rot was noted, but may not be limited to, the locations noted. Any rotted wood should be replaced by a professional carpenter or qualified general contractor before damage can spread to other areas of the home. When repairs are made contractors should review remaining siding and trim and make any additional repairs as needed.

Rotted trim at the noted area has been repaired.

Contact a qualified professional.

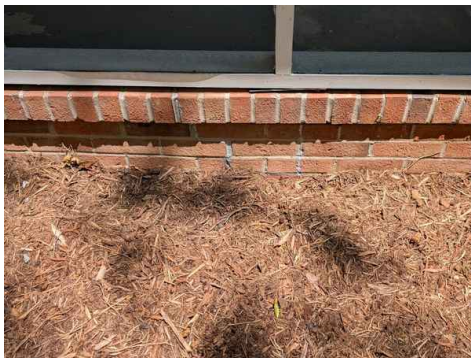
SIDE PORCH

CRACKS IN BRICK VENEER - SEAL AND MONITOR

A hairline crack was found in brick veneer where noted. It cannot be determined as part of a home inspection if movement has stabilized or will continue. You may want to have the wall investigated by a qualified structural engineer to determine if structural repairs are warranted. Otherwise cracks should be sealed to prevent water penetration and monitored for additional movement. If evidence of significant additional movement is observed you should contact a qualified professional engineer for further evaluation and recommendations for repair.

The noted crack has been repointed and repaired.

Recommend monitoring.

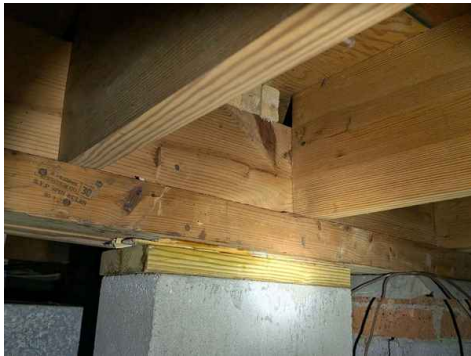
LEFT OF CRAWLSPACE ENTRANCE

GIRDER NOT PROPERLY SUPPORTED

The girder at the noted location is not properly or fully supported. The concern is that lack of adequate support can lead to sagging and movement that could damage walls and floors. The bearing point for girder should be investigated and repaired/shimmed as needed by a qualified general contractor.

The bearing point between the girder and support pier has been shimmed and full bearing was noted.

Contact a qualified general contractor.

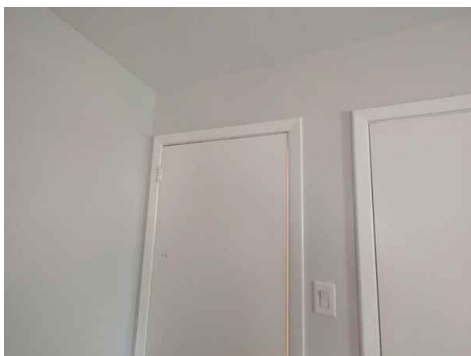
MASTER BEDROOM

INTERIOR DOORS - DOOR STICKS/RUBS DOOR JAMB

The noted door(s) stick/rub the door jamb when closed. Doors should be adjusted or repaired as needed by a qualified contractor for proper operation, privacy and security.

The master bedroom door has been adjusted and no longer sticks or rubs against the door jamb.

Contact a qualified professional.

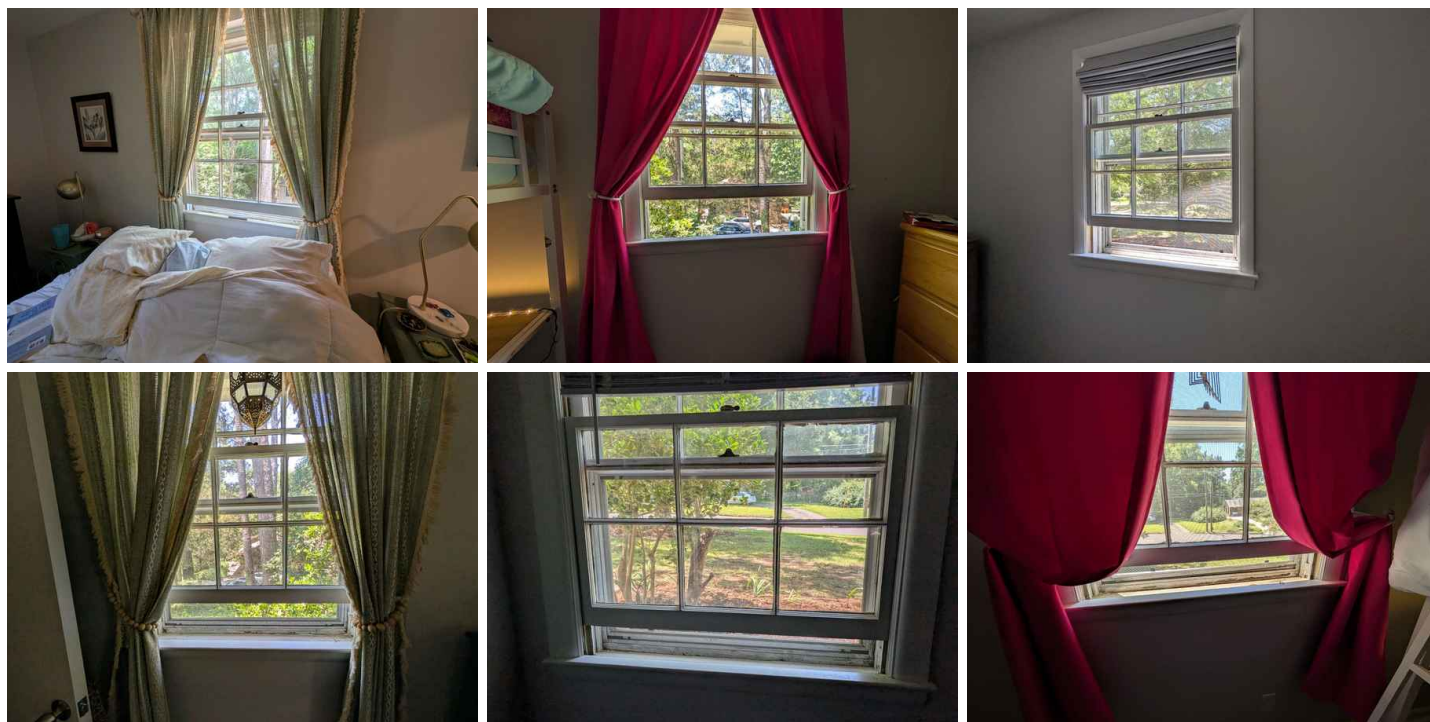
MASTER BEDROOM, FRONT BEDROOM, LEFT BEDROOM

WINDOWS - STUCK/PAINTED SHUT

Windows are stuck or painted shut at the noted location(s). Stuck or inoperative windows should be freed by a qualified contractor for proper operation. This is particularly important for bedroom windows that could be needed for emergency fire escape.

Previously stuck windows have been freed and are now operable.

Contact a qualified professional.

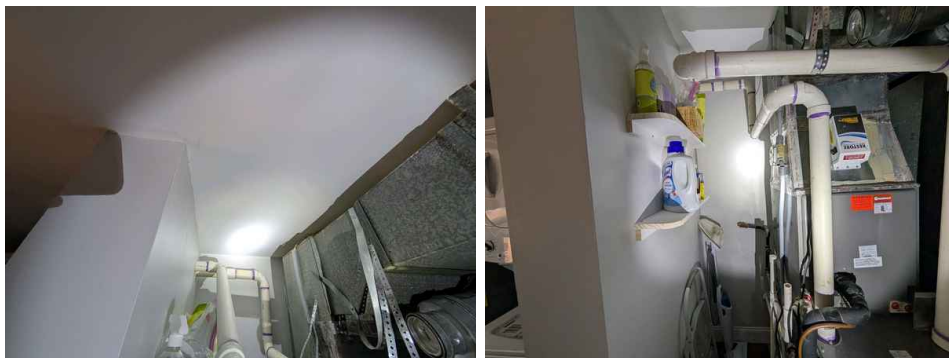
WALLS AND CEILINGS - PAINT AND DRYWALL REPAIR NEEDED

Minor paint and drywall repair will be needed in the home for proper appearance. Issues noted include nail pops, splattered paint, and open caulk joints. Repairs should be made by a qualified painting contractor.

Drywall and paint repair have been completed at the noted areas.

Contact a qualified painting contractor.

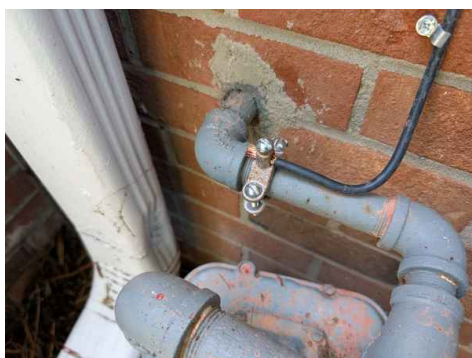
CSST BONDING

Corrugated stainless steel tubing (CSST) is used as part or all of the gas supply lines in this home. This material has been widely used for years, however problems have been reported with damage to the piping caused by lightning. While it may not have been required at the time of this home's construction, modern standards and manufacturer's installation instructions require the material to be bonded (grounded back to the main electrical service) in order to prevent electrical damage to the pipe which can result in gas leaks. Gas lines should be bonded according to manufacturer's instructions by a licensed electrical contractor. For more information visit <http://csstsafety.com/csst-faqs.html>.

A copper bonding wire has been installed from the gas meter to the main panel/electrical ground.

Contact a qualified electrical contractor.
