## SUMMARY

1205 Willow Dr, Chapel Hill, NC 27517

Erin Bennett & Bill Bennett  
05/28/2025

Brad Williams  
NCHILB License #4589  
360 Inspection Services, LLC  
984.244.1125  
[brad@360inspects.com](mailto:brad@360inspects.com)

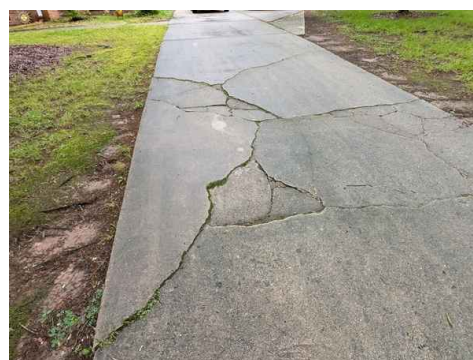
#### 2.1.1 Driveway

##### **DRIVEWAY CRACKING - MODERATE**

Moderate cracking was noted, potentially sufficient to create a potential trip hazard. Significantly cracked and broken parts of the drive should be repaired or replaced by a professional concrete contractor.

Contact a qualified concrete contractor.

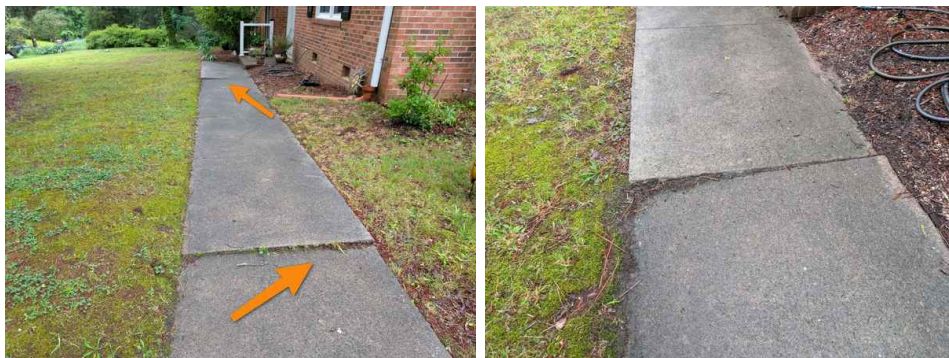
#### 2.2.1 Walkways

##### **WALKWAY SETTLEMENT**

Minor settlement was observed at the noted location(s), potentially sufficient to cause a trip hazard. If significant additional movement is noted you should contact a professional contractor for repair or replacement.

Contact a qualified professional.

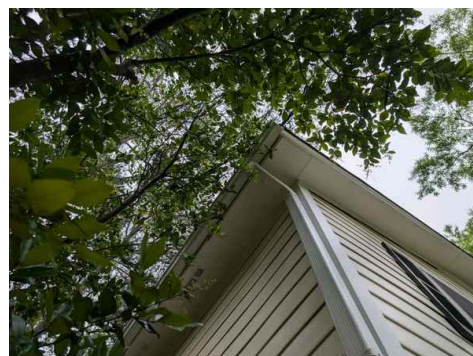
### 2.5.1 Vegetation

#### **VEGETATION CONTACTS THE HOME**

##### LEFT FRONT

Vegetation contacts the the home at the noted location(s). Any tree limbs, shrubbery, or vegetation should be trimmed back for at least 12" clearance to help prevent wicking up of moisture and an entry point for insects.

Contact a qualified landscaping contractor

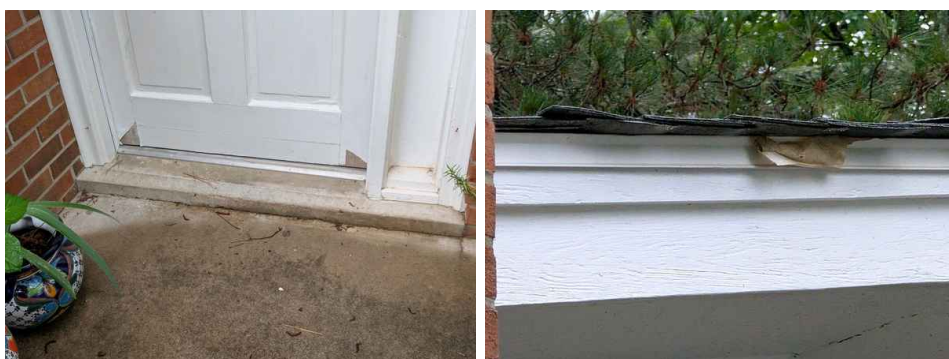
### 3.2.1 Exterior Paint

#### **PEELING PAINT**

##### FRONT DOOR, FASCIA ON RIGHT SIDE GABLE, VARIOUS

Paint is peeling and in poor condition at the noted locations. Exterior siding and trim with peeling paint should be repainted to avoid water damage to exterior woodwork and for proper appearance.

Contact a qualified painting contractor.

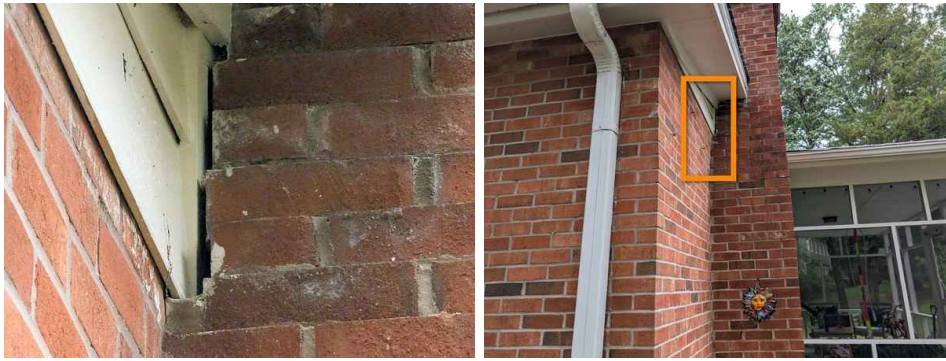
### 3.3.1 Caulking/Sealing

#### **CAULKING INCOMPLETE-DISSIMILAR MATERIALS**

##### AT CHIMNEY/WALL INTERSECTION

Caulking is incomplete between stone veneer grout and window or door casings. Any joints between dissimilar materials should be caulked and sealed to prevent water penetration that could result in damage to the home.

Recommendation  
Contact a qualified professional.

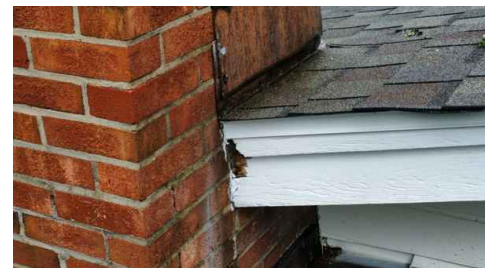
### 3.4.1 Exterior Wall Cladding and Trim

#### **WOOD ROT**

##### TRIM AT CHIMNEY

Wood rot was noted, but may not be limited to, the locations noted. Any rotted wood should be replaced by a professional carpenter or qualified general contractor before damage can spread to other areas of the home. When repairs are made contractors should review remaining siding and trim and make any additional repairs as needed.

Recommendation  
Contact a qualified professional.

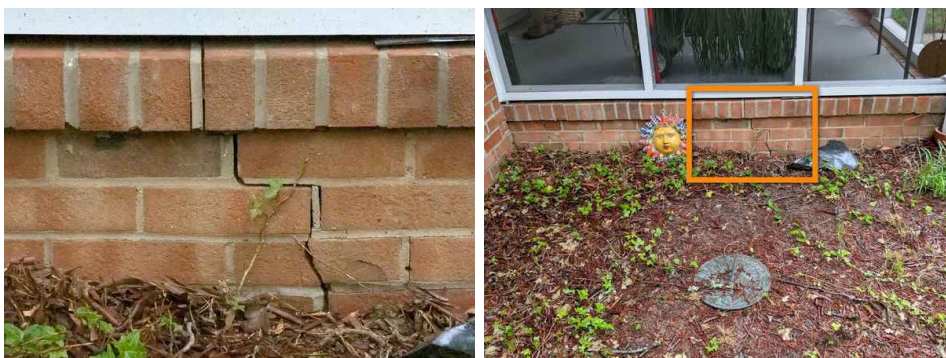
### 3.4.2 Exterior Wall Cladding and Trim

#### **CRACKS IN BRICK VENEER - SEAL AND MONITOR**

##### SIDE PORCH

A hairline crack was found in brick veneer where noted. It cannot be determined as part of a home inspection if movement has stabilized or will continue. You may want to have the wall investigated by a qualified structural engineer to determine if structural repairs are warranted. Otherwise cracks should be sealed to prevent water penetration and monitored for additional movement. If evidence of significant additional movement is observed you should contact a qualified professional engineer for further evaluation and recommendations for repair.

Recommendation  
Recommend monitoring.

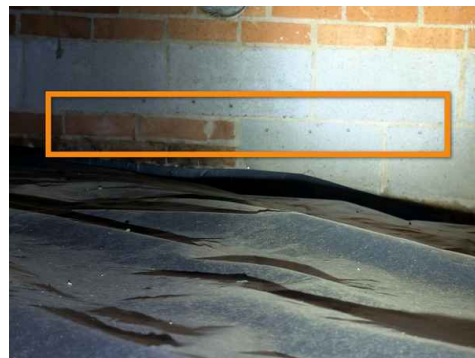
## 3.6.1 Foundation/Crawlspace/Basement

**FOUNDATION - PREVIOUS TERMITE TREATMENT EVIDENCE**

Evidence of a previous termite treatment was found at the noted location(s). No evidence of damage to the building structure was found. Inspections for wood destroying insects should be carried out on a regular yearly schedule to help prevent further infestations and damage to the home.

Contact a qualified pest control specialist.

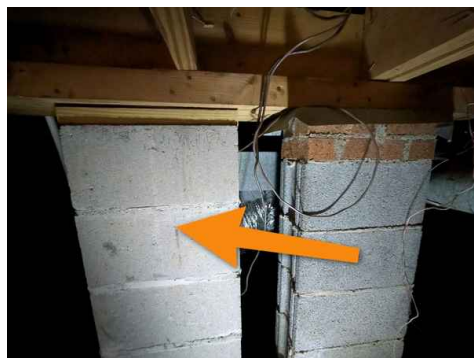
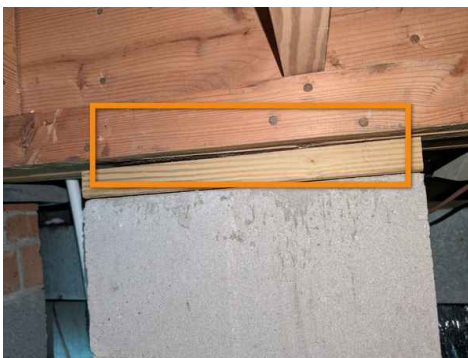
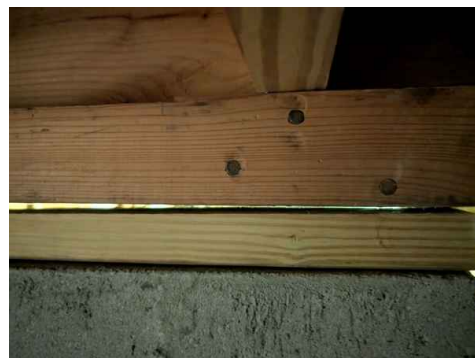
## 3.7.1 Floor Structure

**GIRDER NOT PROPERLY SUPPORTED****LEFT OF CRAWLSPACE ENTRANCE**

The girder at the noted location is not properly or fully supported. The concern is that lack of adequate support can lead to sagging and movement that could damage walls and floors. The bearing point for girder should be investigated and repaired/shimmed with non compressible/metal shims as needed by a qualified general contractor.

Contact a qualified general contractor.

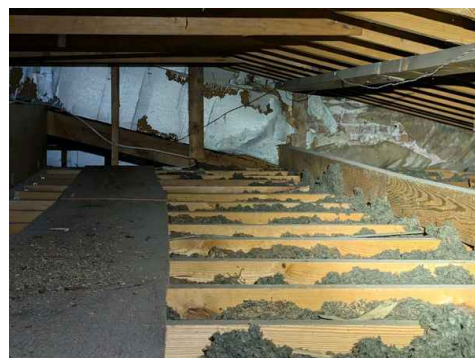
## 5.1.1 Insulation

**INSULATION - UPGRADE RECOMMENDED**

Although likely considered adequate at the time of construction, the current amount of insulation is no longer considered to be sufficient to meet modern energy conservation standards. As an upgrade you should have the attic insulated to current standards of R-38 by a professional insulation contractor.

Contact a qualified insulation contractor.

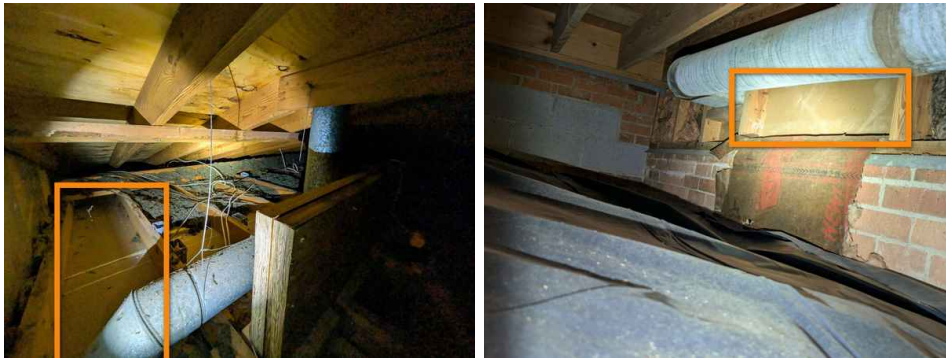
## 5.1.2 Insulation

**INSULATION - MISSING****CRAWLSPACE WALL, ATTIC**

Insulation has been moved out of place at the noted locations. Missing insulation can be a significant source of energy loss. Missing or compacted insulation should be replaced by a professional insulation contractor for energy conservation and comfort.

Recommendation  
Contact a qualified professional.

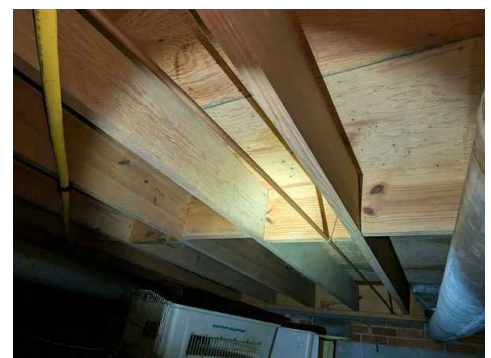
### 5.1.3 Insulation

#### **INSULATION - UNINSULATED CRAWL SPACE (OLDER CONSTRUCTION)**

##### CRAWL SPACE

The floor system is not insulated in the crawl space. While common in older construction, lack of crawl space insulation can result in a significant energy loss. Floors should be insulated to current standards of R-19 by a professional insulation contractor for energy conservation and comfort. As an alternative you may want to consider upgrading to a fully closed and conditioned crawl space with insulation located at perimeter walls.

Recommendation  
Contact a qualified insulation contractor.

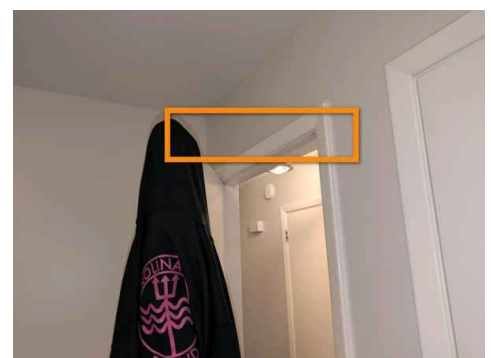
### 6.2.1 Interior Doors

#### **INTERIOR DOORS - DOOR STICKS/RUBS DOOR JAMB**

##### MASTER BEDROOM

The noted door(s) stick/rub the door jamb when closed. Doors should be adjusted or repaired as needed by a qualified contractor for proper operation, privacy and security.

Recommendation  
Contact a qualified professional.

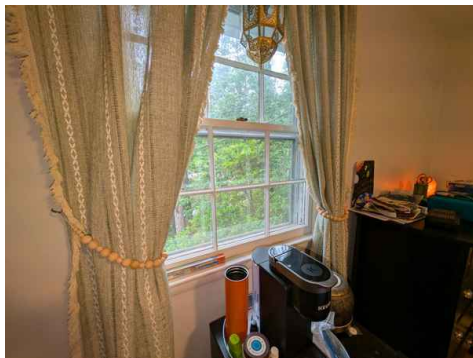
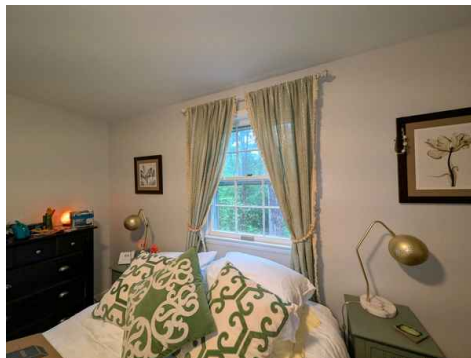
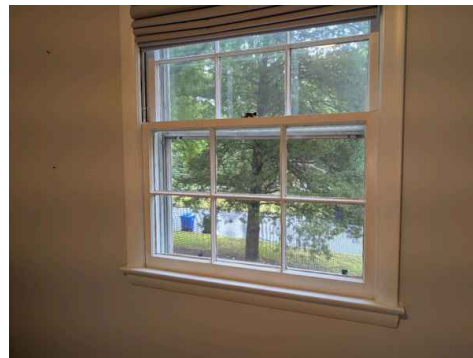
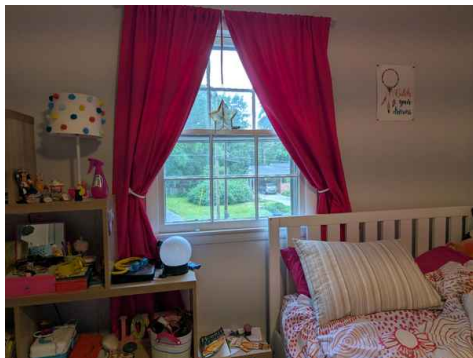
### 6.3.1 Windows

#### **WINDOWS - STUCK/PAINTED SHUT**

##### MASTER BEDROOM, FRONT BEDROOM, LEFT BEDROOM

Windows are stuck or painted shut at the noted location(s). Stuck or inoperative windows should be freed by a qualified contractor for proper operation. This is particularly important for bedroom windows that could be needed for emergency fire escape.

Recommendation  
Contact a qualified professional.

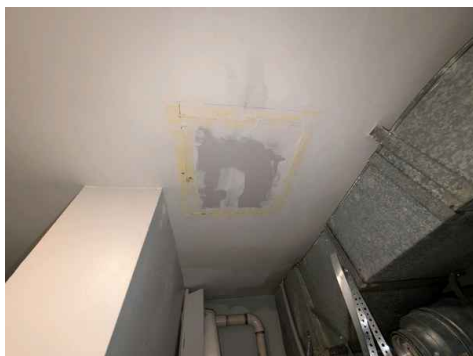
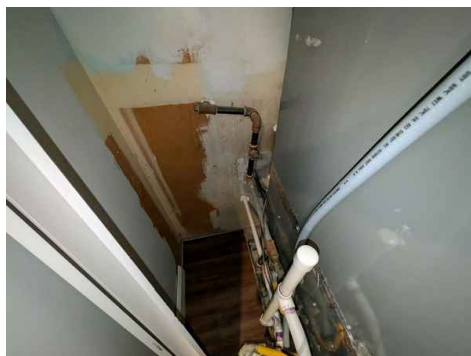
#### 6.5.1 Walls and Ceilings

### **WALLS AND CEILINGS - PAINT AND DRYWALL REPAIR NEEDED**

Minor paint and drywall repair will be needed in the home for proper appearance. Issues noted include nail pops, splattered paint, and open caulk joints. Repairs should be made by a qualified painting contractor.

Contact a qualified painting contractor.

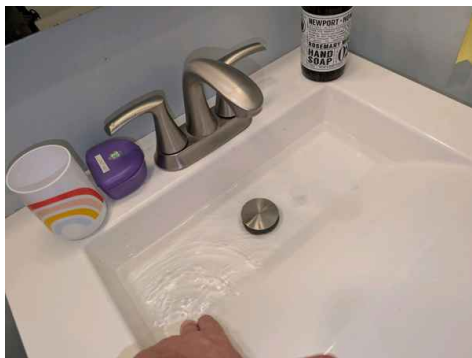
#### 9.7.1 Sinks and Lavatories

### **SINKS - SLOW TO DRAIN**

#### MASTER BATHROOM

The sink is partially clogged and slow to drain. Waste lines should be cleaned by a plumber to allow the sink to drain as intended.

Contact a qualified plumbing contractor.

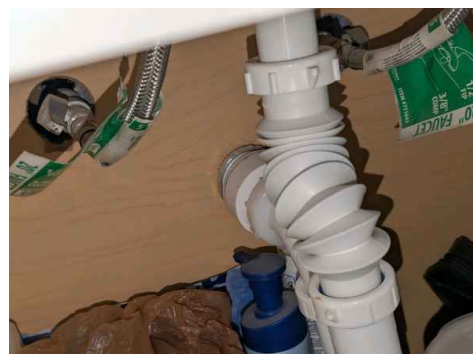
### 9.7.2 Sinks and Lavatories

#### **SINKS - CORRUGATED FLEX DRAIN**

##### MASTER BATHROOM

Corrugated flex pipe is used to connect the sink to the trap. This material is not approved for this use because uneven interior surfaces slow water flow and can result in clogging. Any corrugated drains should be replaced by a plumber.

Contact a qualified plumbing contractor.

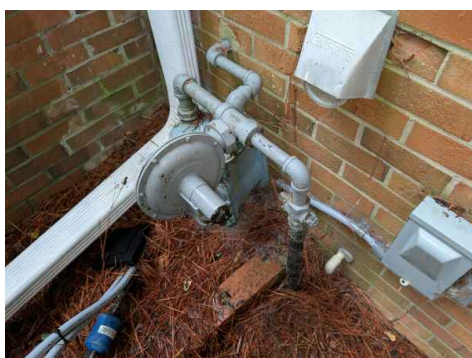
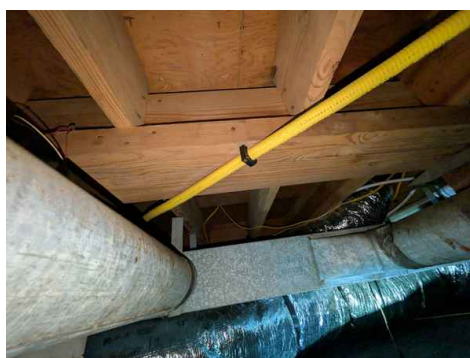
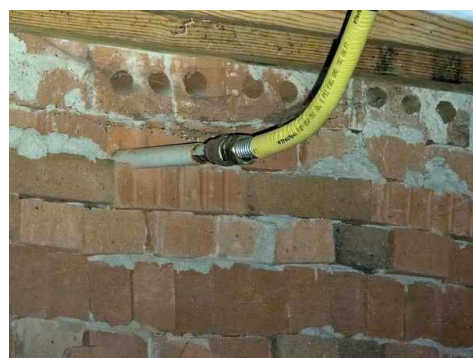
### 9.10.1 Fuel Storage & Distribution Systems

#### **CSST BONDING**

Corrugated stainless steel tubing (CSST) is used as part or all of the gas supply lines in this home. This material has been widely used for years, however problems have been reported with damage to the piping caused by lightning. While it may not have been required at the time of this home's construction, modern standards and manufacturer's installation instructions require the material to be bonded (grounded back to the main electrical service) in order to prevent electrical damage to the pipe which can result in gas leaks. Gas lines should be bonded according to manufacturer's instructions by a licensed electrical contractor. For more information visit <http://csstsafety.com/csst-faqs.html>.

Contact a qualified electrical contractor.

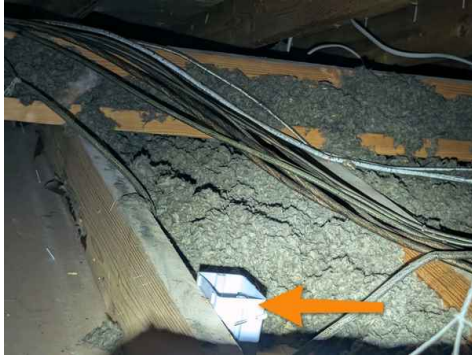
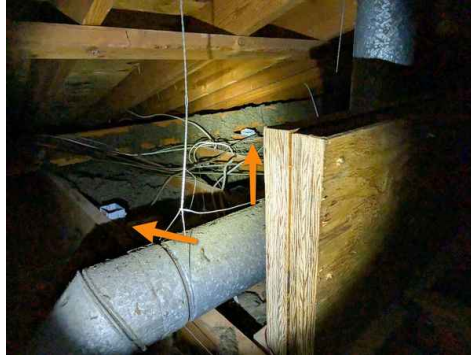
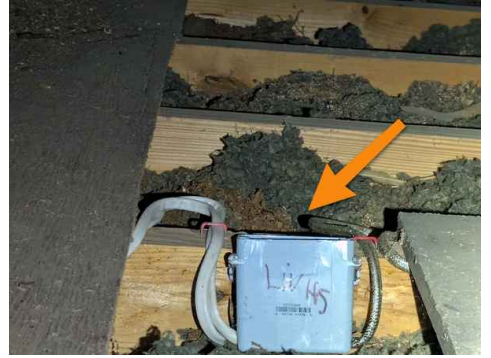
### 10.4.1 Branch Circuits

#### **OPEN JUNCTION BOXES**

##### ATTIC

An uncovered/open junction box was found in the noted location(s) . Concerns are that this can create a danger for workers and a potential fire hazard. Any electrical splices should be enclosed in an approved junction box by an electrician for safety.

Contact a qualified electrical contractor.

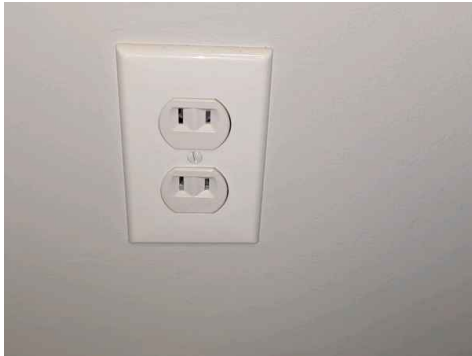
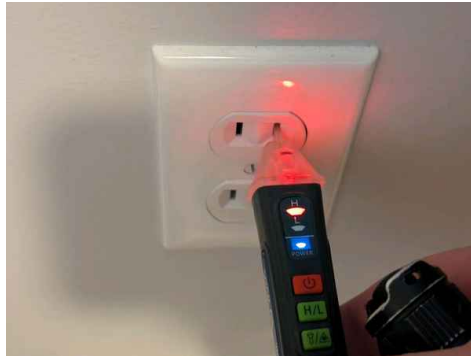
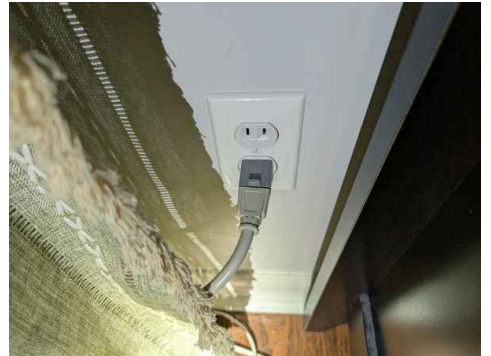
#### 10.4.2 Branch Circuits

### UNGROUNDING TWO PRONG OUTLETS

#### MULTIPLE

Ungrounded two prong outlets were found in use in the noted location(s). Although two wire circuits are common in older homes and permitted to remain in use, as an upgrade installation of ground fault protection for any ungrounded outlets is recommended for improved electrical safety and to help prevent shock.

Contact a qualified electrical contractor.

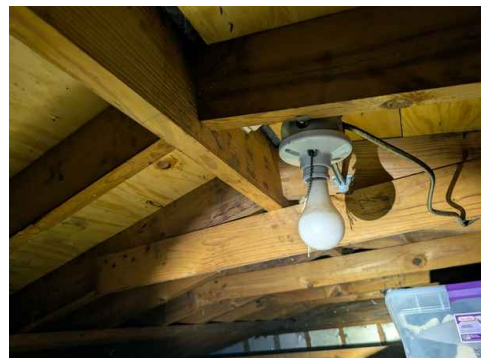
#### 10.5.1 Electrical Fixtures

### LIGHT INOPERABLE

#### ATTIC

The lights in the noted location(s) did not function when tested. Replace the bulbs and retest. If the lights do not function, the fixtures and associated wiring should be investigated by a licensed electrical contractor and repaired as needed for safe and proper operation.

Contact a qualified electrical contractor.

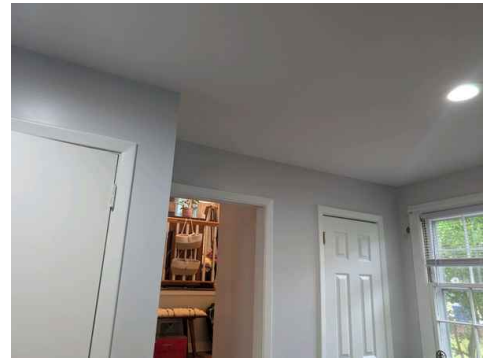
### 10.6.1 Smoke Alarms

#### **ALARMS NOT INSTALLED IN BEDROOMS**

Smoke alarms are not installed inside bedrooms. Although likely not required at the time of construction, as a fire safety upgrade you should consider having alarms installed in all bedrooms, on each level of the home and linked so that all will sound in the event of an emergency.

Contact a qualified electrical contractor.

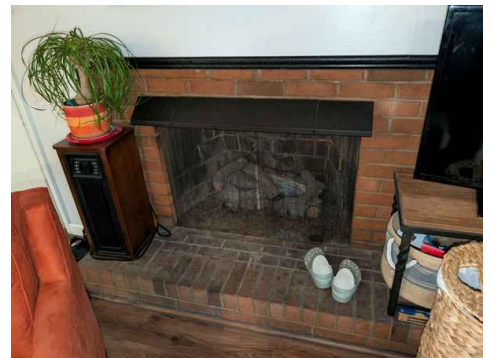
### 12.1.1 Fireplaces or other solid fuel burning appliances

#### **GAS LOGS NOT STARTED/WOULD NOT START**

Gas logs were not lit/would not start and logs could not be tested. Gas logs should be demonstrated as operable, otherwise they should be investigated and repaired as needed for proper operation by a qualified fireplace contractor.

Contact a qualified professional.
