UPDATED CAPITAL RESERVE ANALYSIS
FOR
PARC VUE MIDTOWN
ATLANTA, GEORGIA

PARC VUE MIDTOWN CONDOMINIUM ASSOCIATION, INC.
C/O FIRST SERVICE RESIDENTIAL
3340 PEACHTREE ROAD NORTHEAST
ATLANTA, GEORGIA 30326

PREPARED BY: ROBERT “NICKO” N. ROMEO, R.S.

JANUARY 2024
REVISED: JANUARY 2025

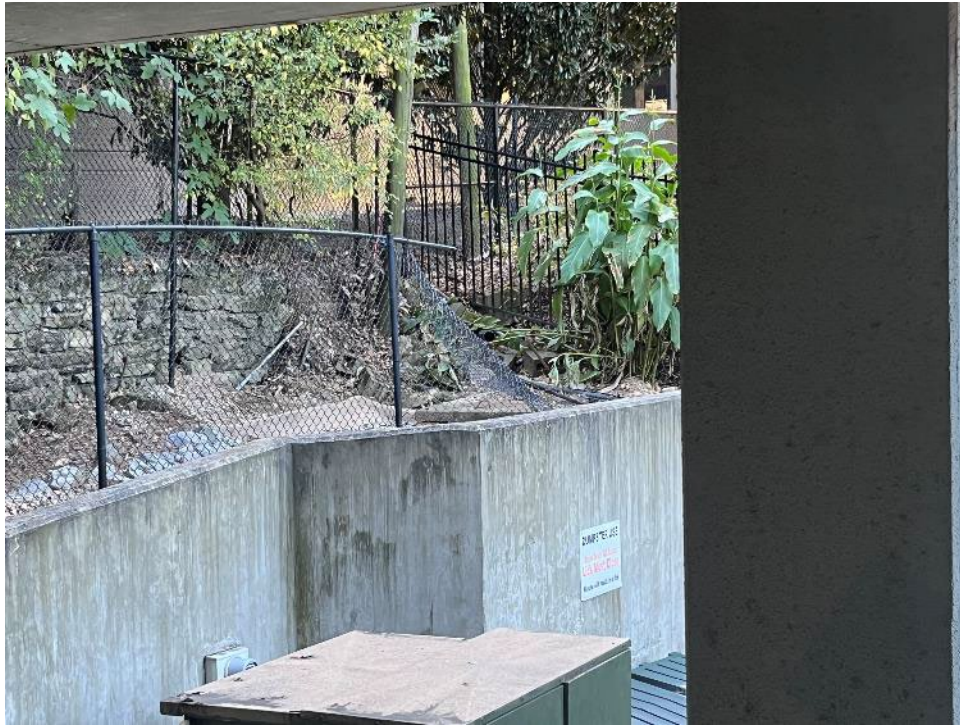
1. View of broken section of chain-link fence near the dumpsters.

| | COMPONENT DESCRIPTION/INVENTORY | UNITS | UNIT QUANTITY | UNIT COST | TOTAL COST | ESTIMATED USEFUL LIFE | ESTIMATED REMAINING LIFE | NOTES | 2024 | 2025 | 2026 | 2027 | 2028 | 2029 | 2030 | 2031 | 2032 | 2033 |
|---|--|---|---|---|---|---|---|---|---|---|---|---|---|---|---|---|---|---|
| 1 | CHAIN LINK FENCING - REPAIR/PARTIAL REPLACE | ALLOW | 1 | \$3,500.00 | \$3,500.00 | 10 | 0 | 2 | \$3,500.0 | | | | | | | | | |

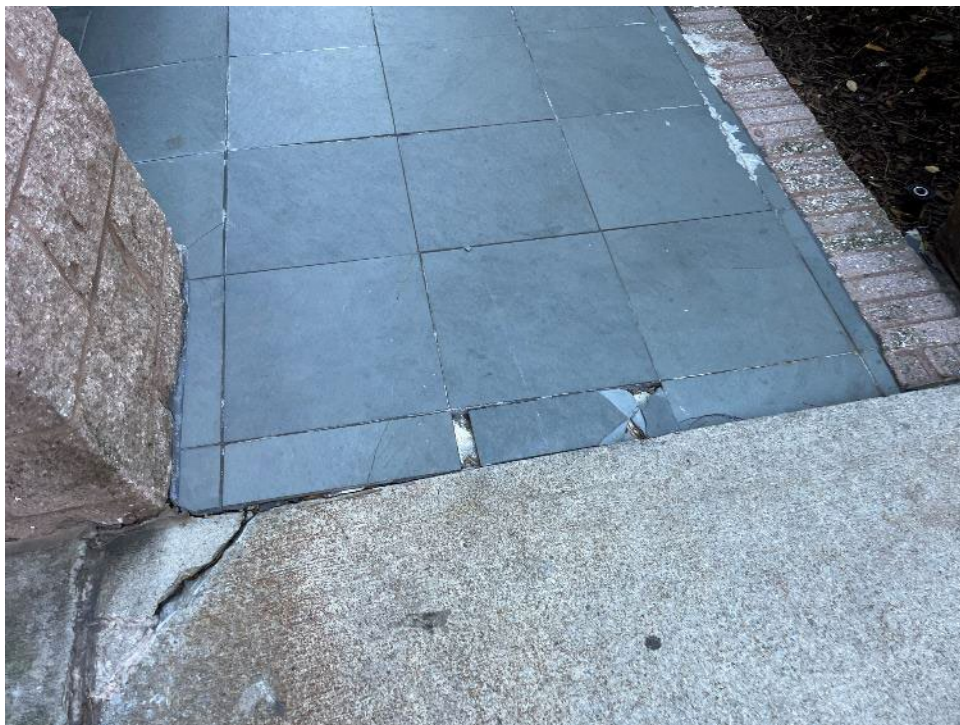
2. View of cracked tiles near the building entry.

| | COMPONENT DESCRIPTION/INVENTORY | UNITS | UNIT QUANTITY | UNIT COST | TOTAL COST | ESTIMATED USEFUL LIFE | ESTIMATED REMAINING LIFE | NOTES | 2024 | 2025 | 2026 | 2027 | 2028 | 2029 | 2030 | 2031 | 2032 | 2033 |
|---|--|---|---|---|---|---|---|---|---|---|---|---|---|---|---|---|---|---|
| 4 | ENTRY TILES/STAIRS - REPAIR/REPL. CRACKED/SETTLED SECTIONS | ALLOW | 1 | \$11,500.00 | \$11,500.00 | 10 | 0 | 3 | \$11,500.0 | | | | | | | | | |

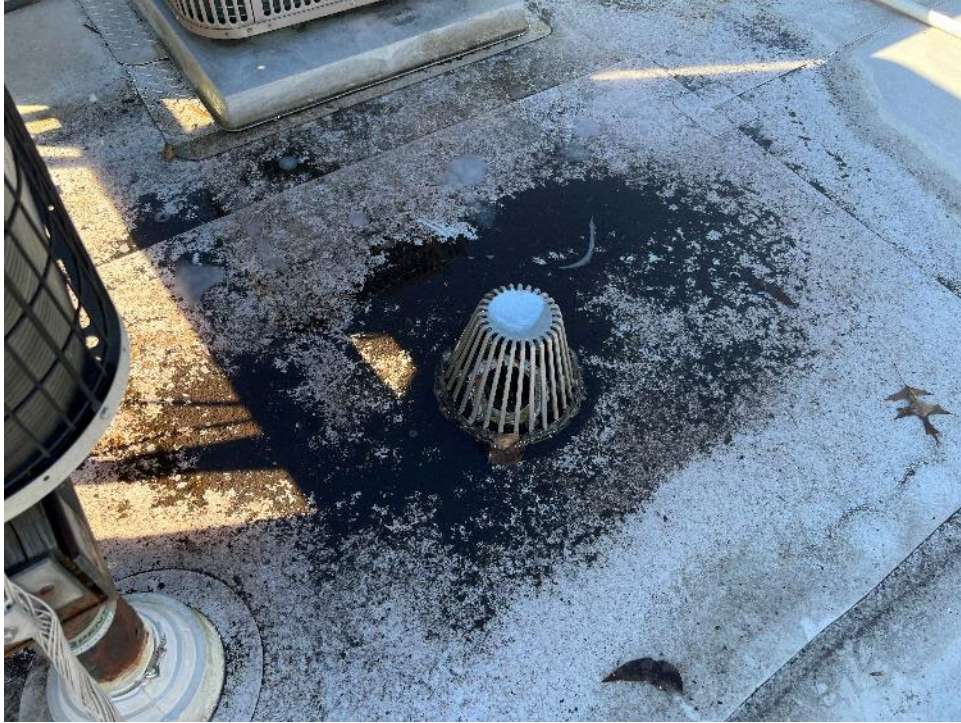
7. View of accumulated debris around roof drains.

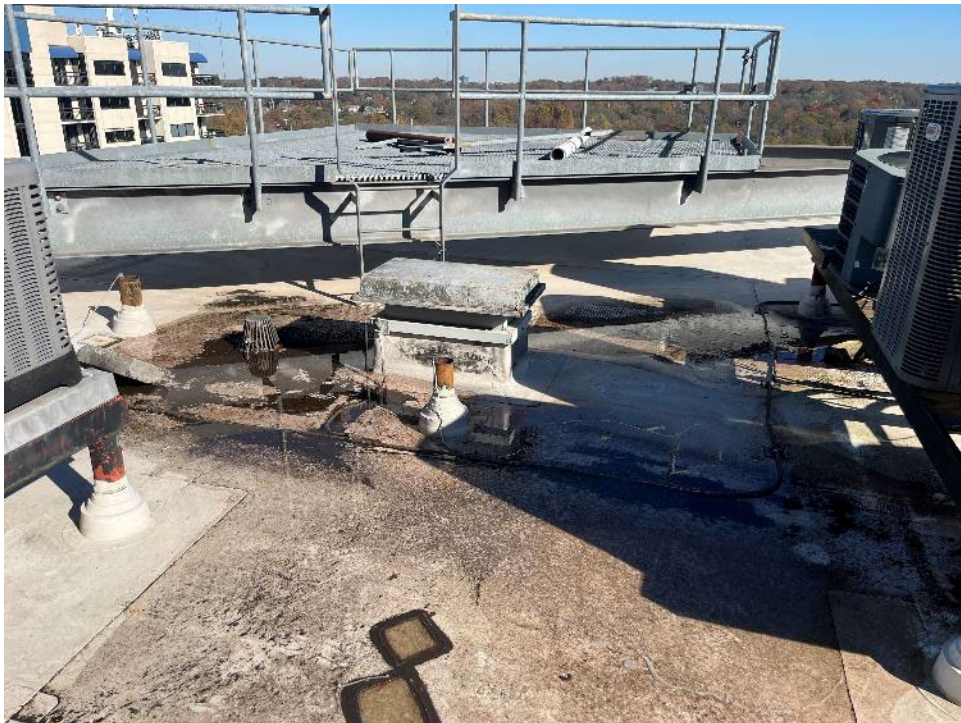
8. View of ponding water at one of the roof drains.

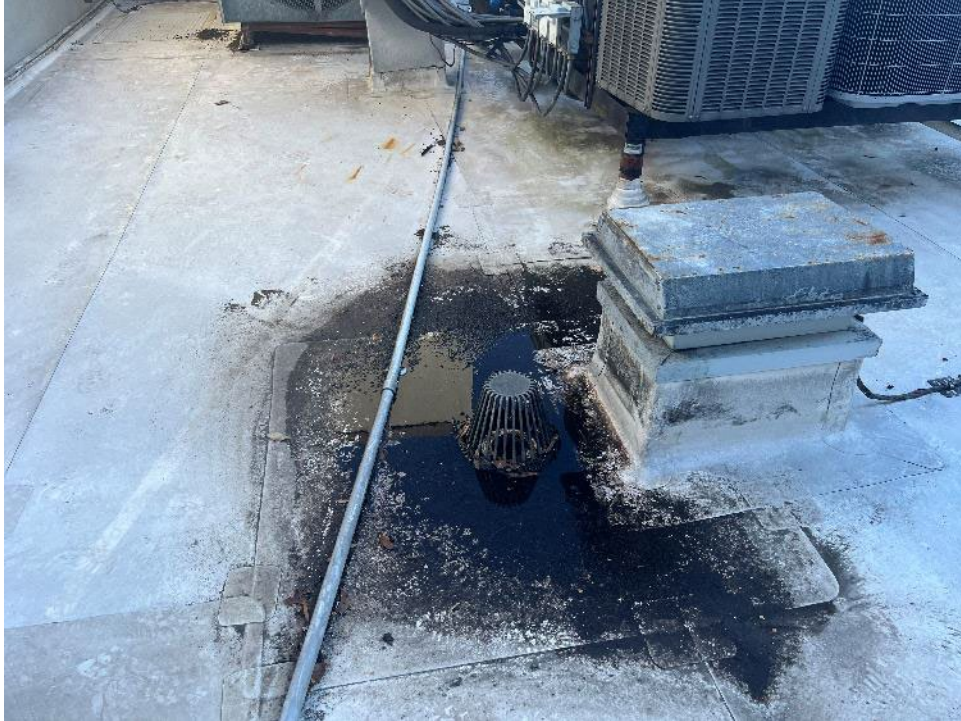
9. View of ponding water and accumulated debris at a roof drain.

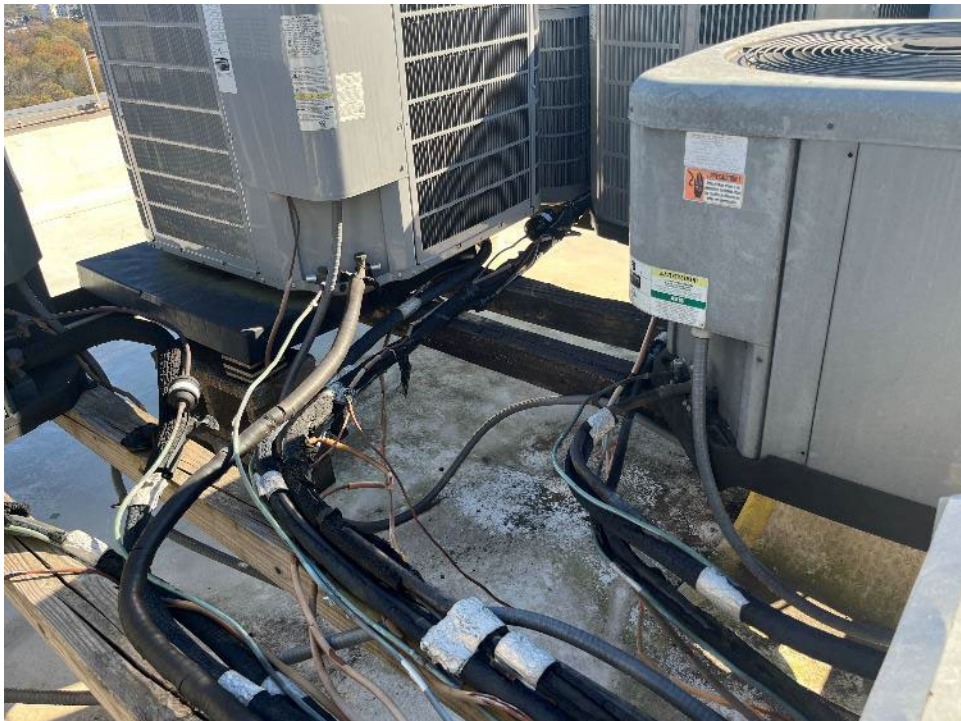
10. View of deteriorated and deflected HVAC supports.

| | COMPONENT DESCRIPTION/INVENTORY | UNITS | UNIT QUANTITY | UNIT COST | TOTAL COST | ESTIMATED USEFUL LIFE | ESTIMATED REMAINING LIFE | NOTES | 2024 | 2025 | 2026 | 2027 | 2028 | 2029 | 2030 | 2031 | 2032 | 2033 |
|---|--|---|---|---|---|---|---|---|---|---|---|---|---|---|---|---|---|---|
| 7 | METAL SUPPORTS FOR HVAC - PAINT/REPAIR/PARTIAL REPLACE | ALLOW | 1 | \$33,100.00 | \$33,100.00 | 6 | 0 | 7 | \$33,100.0 | | | | | | \$39,523.1 | | | |

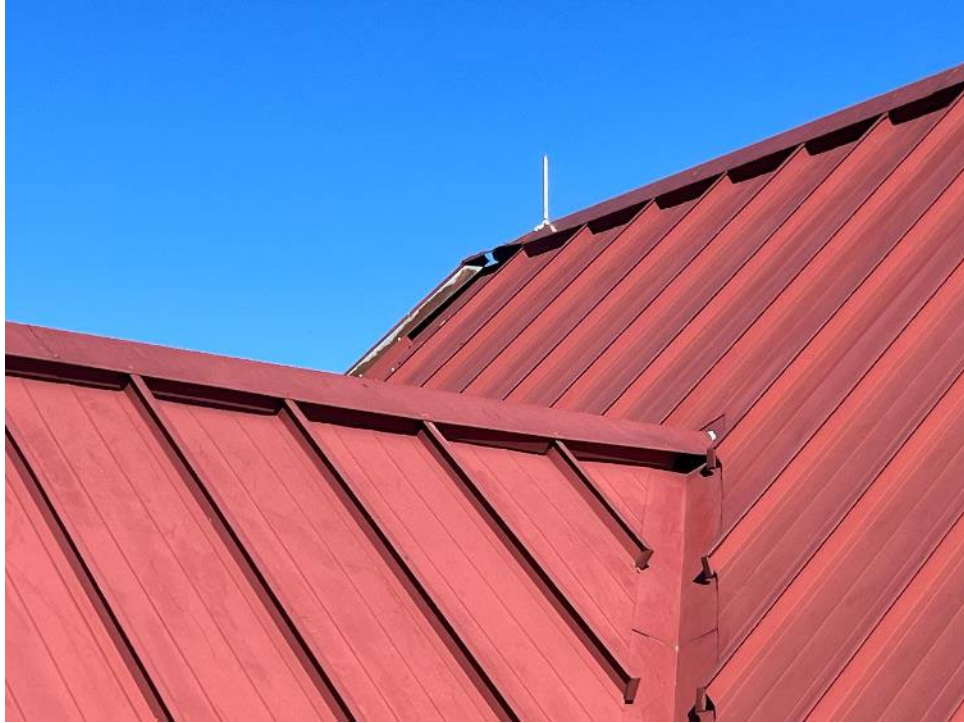
11. View of damaged metal seam roof.

| | COMPONENT DESCRIPTION/INVENTORY | UNITS | UNIT QUANTITY | UNIT COST | TOTAL COST | ESTIMATED USEFUL LIFE | ESTIMATED REMAINING LIFE | NOTES | 2024 | 2025 | 2026 | 2027 | 2028 | 2029 | 2030 | 2031 | 2032 | 2033 |
|---|--|---|---|---|---|---|---|---|---|---|---|---|---|---|---|---|---|---|
| 10 | METAL SEAM ROOF - REPAIR/SEAL/PAINT | S.Q. | 10 | \$1,500.00 | \$15,000.00 | 20 | 7 | 7 | | | | | | | | \$18,448.1 | | |

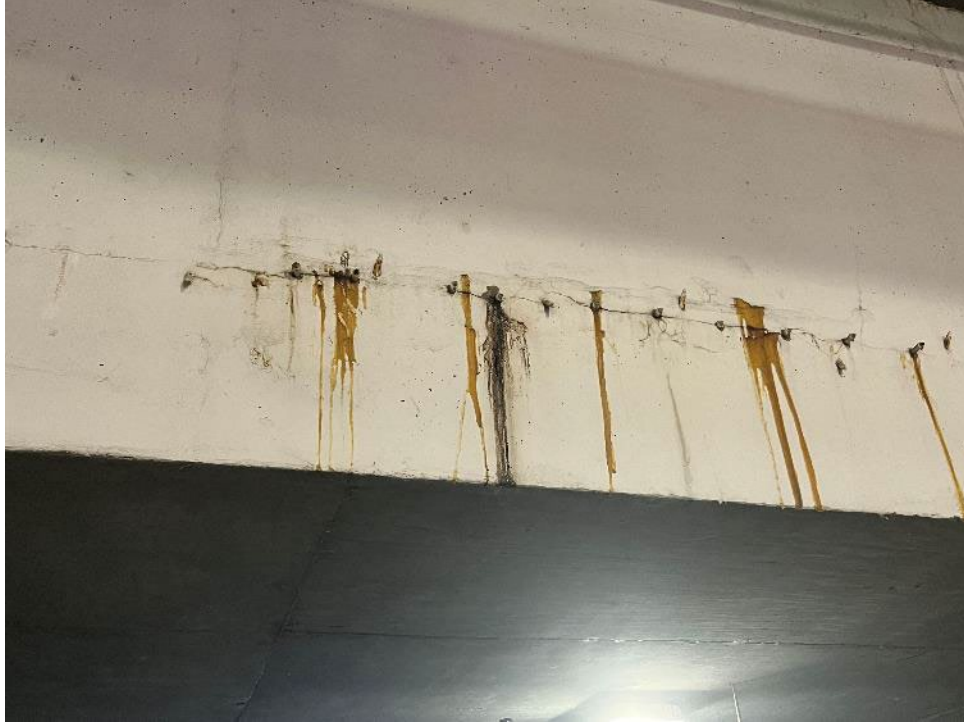
13. View of previous repairs made to the parking structure.

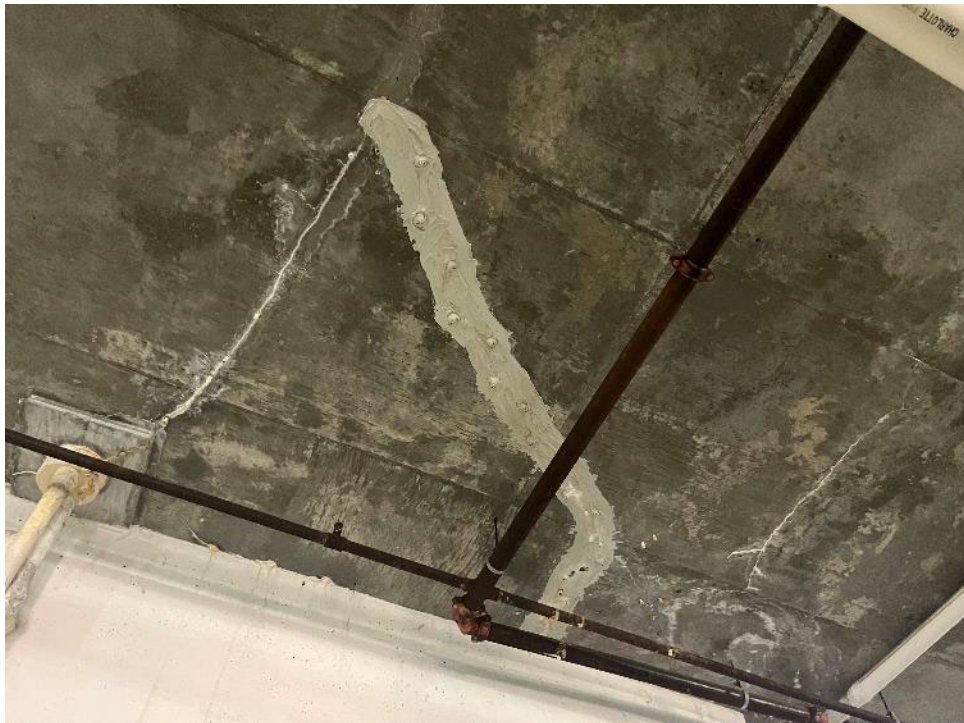
14. View of hairline cracks in the ceiling of the parking garage that were previously sealed.
