## Home Inspection Report

PROPERTY INSPECTED:  
**513 Pennsylvania 271**  
**Ligonier, PA 15658**

**Date of Inspection: 08/19/2025**

Inspection No. 21279-1637

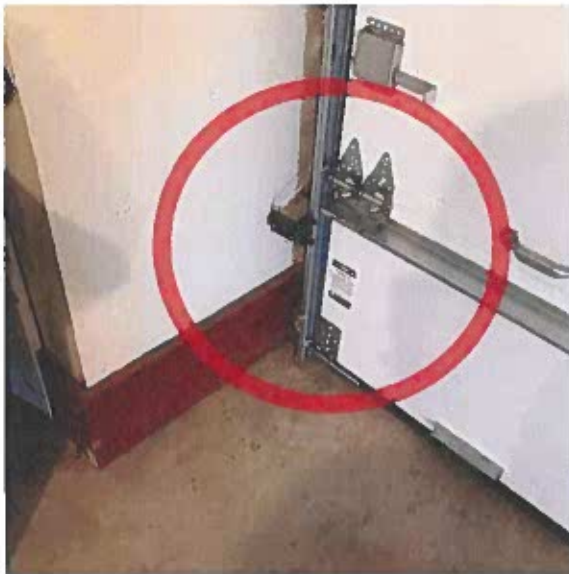
6.6.2 Photo eye sensors installed greater than 6" from floor. Recommend adjusting photo eye sensors height to proper 4"-6" from floor to reduce personal injury/property damage

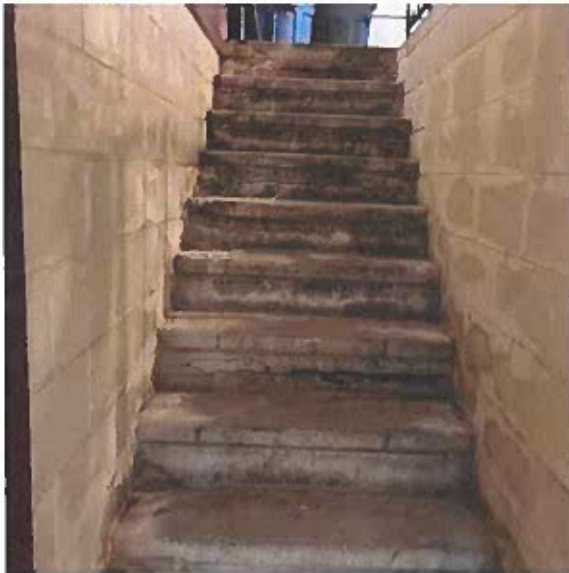
11.7.1 Recommend installing handrail to minimize fall and safety hazards. **(Basement)**

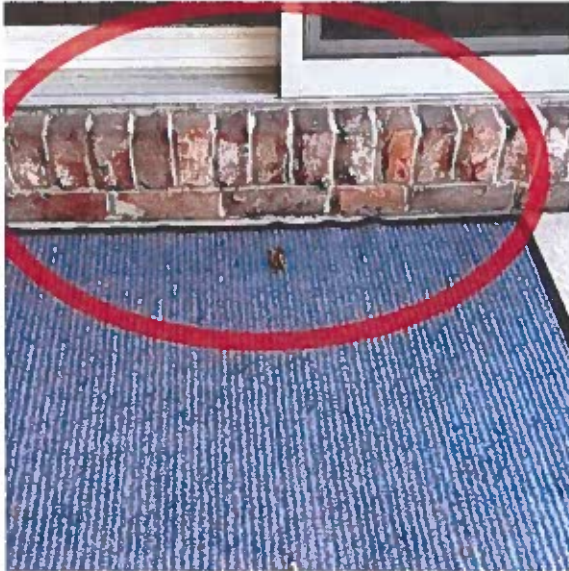
3.7.2 Recommend installing platform on Family Room patio door to patio to minimize hazards

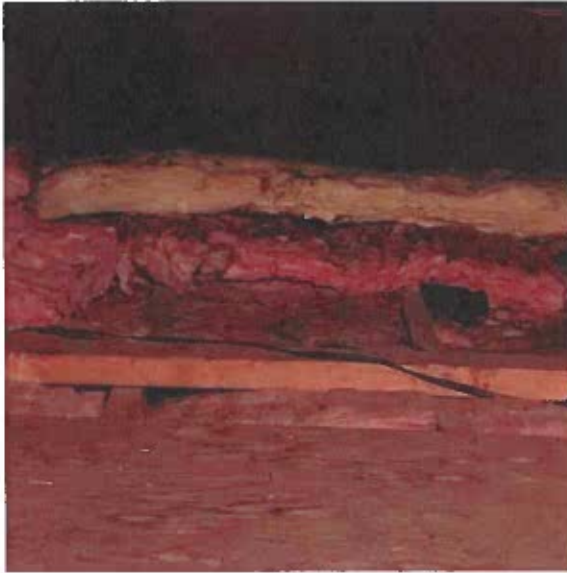
5.4.1 Estimated depth 6"

5.5.1 **Soffit vents blocked with insulation. Recommend installing baffles to allow proper ventilation into attic area**

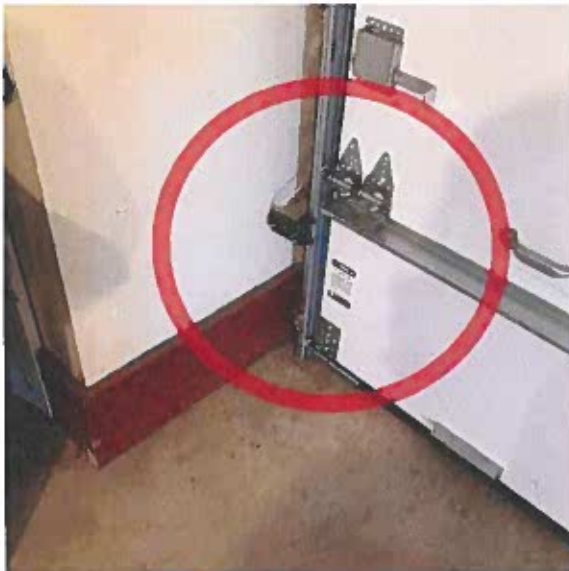
6.6.2 **Photo eye sensors installed greater than 6" from floor. Recommend adjusting photo eye sensors height to proper 4"-6" from floor to reduce personal injury/property damage**

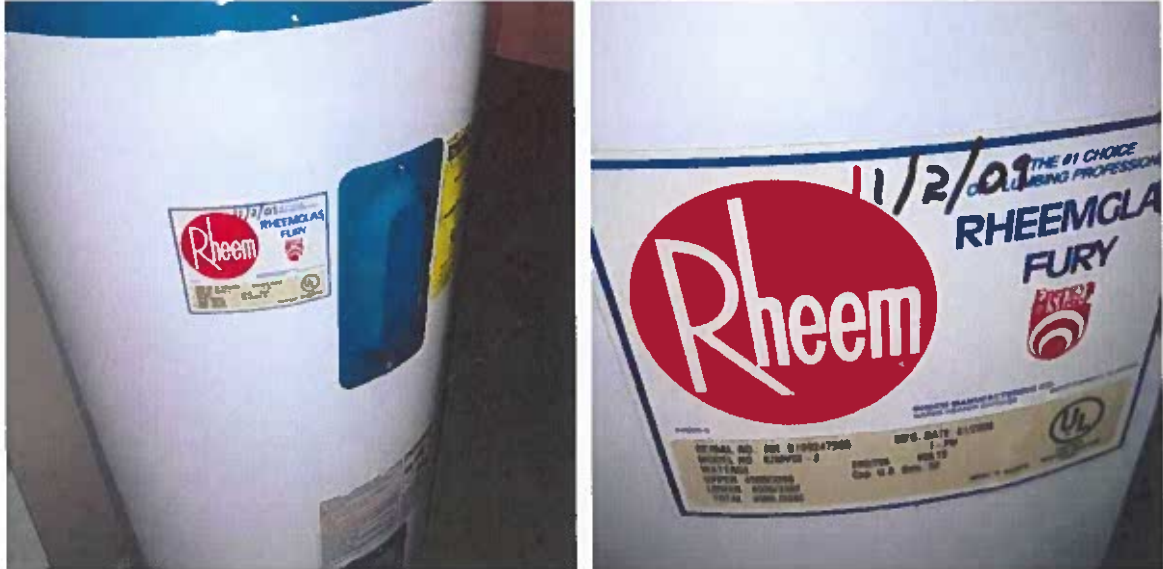
10.5.2 Rheem  
 Model 82MV52-2  
 S/N RH0109247565  
 50 gallons  
 Mfg 01/09  
 Installed 11/2/09  
 Estimated age 16 years

10.5.3 **Average life expectancy of hot water heater is 10 years. Based on age of appliance, it is recommended that unit be monitored for signs of leaks and budget for replacement when necessary**

10.5.4 **Recommend installing discharge tube on TPR valve to discharge within 12" of floor to minimize safety hazard as per current regulations**

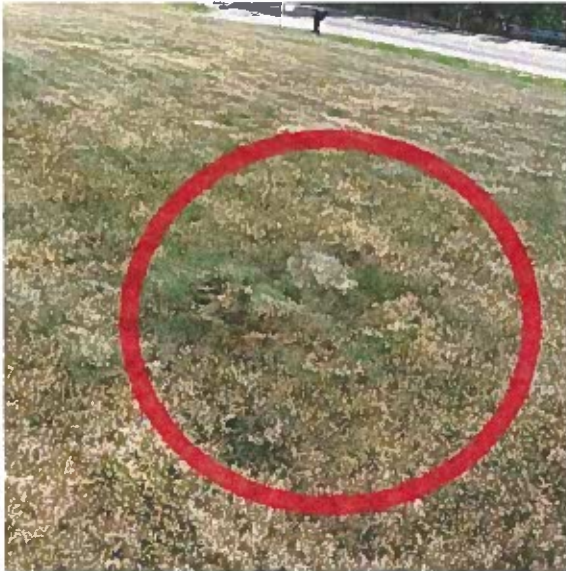
**10.12.1 Anticipated location of septic tank in front yard**

10.12.2 Recommend having septic tank pumped by qualified contractor every 3-5 years to minimize potential problems with sewage system.

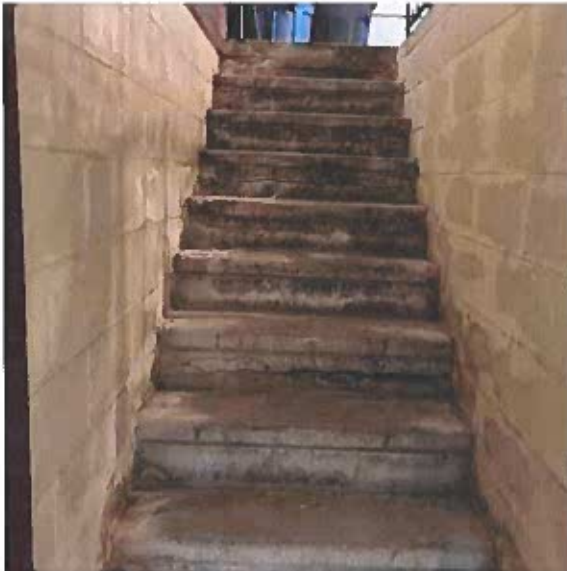
**11.7.1 Recommend installing handrail to minimize fall and safety hazards. (Basement)**
