Service: Pre-Listing Inspection

Prepared for: Amy Gulden

Aaron McBride

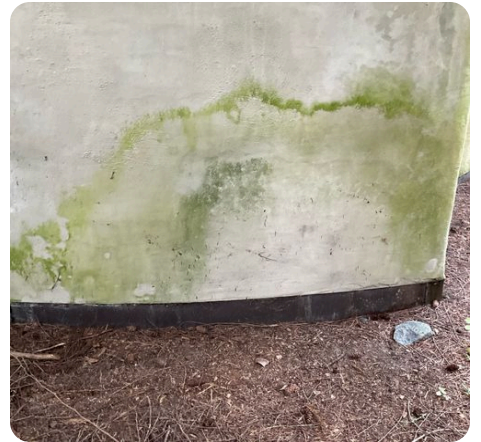
The presence of mildew and lichen on the siding can indicate excessive moisture levels, which may lead to degradation of the siding material over time. It is recommended to evaluate and address the moisture source to prevent further growth and potential damage. A qualified contractor can assist in properly cleaning and treating the affected areas to restore the exterior appearance of the property.

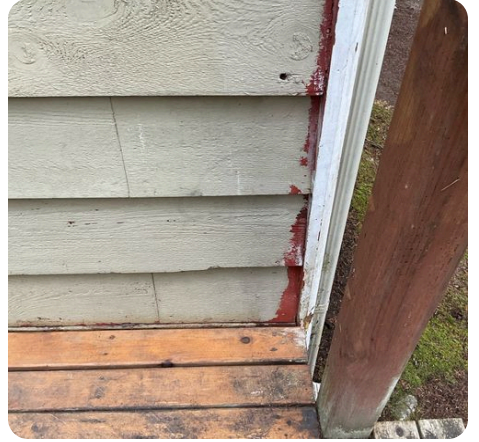
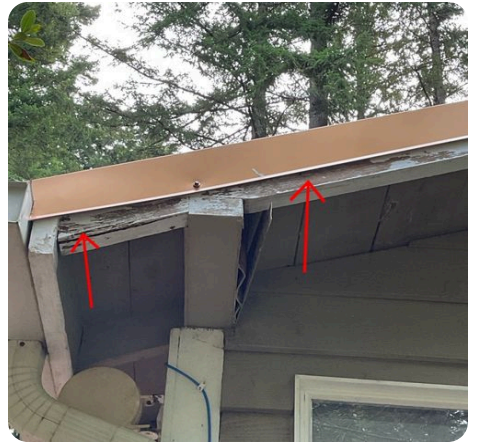
The exterior of the property shows signs of wear and tear with areas of chipped or faded paint observed. It is recommended to evaluate and repair the affected areas by touching up the paint to maintain the aesthetics and protect the surfaces from weather damage. Hiring a qualified painter for the paint touchup is advised for a professional finish.

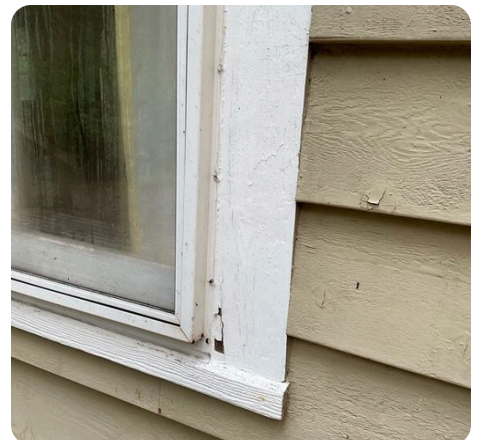
The storm windows show signs of a failed seals. This can lead to decreased energy efficiency and potential water leaks. It is recommended to replace the seal or consider recaulking around the edges to prevent further damage.

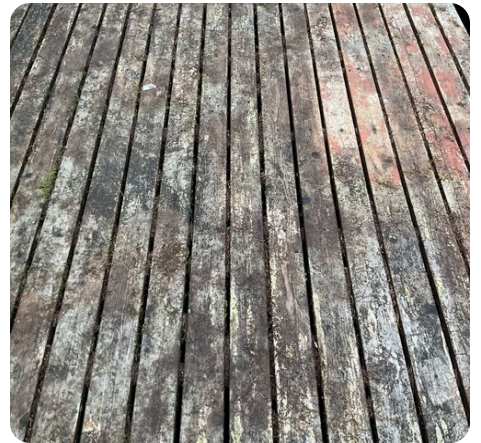
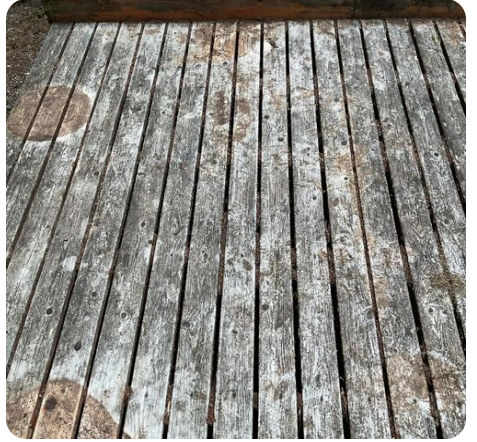
The inspector noted that the surface is in need of repairs. There were some deteriorated boards noted. We recommend evaluating all of the decks and replacing the deteriorated boards to prevent any further issues. Any repairs should be completed by a qualified professional.

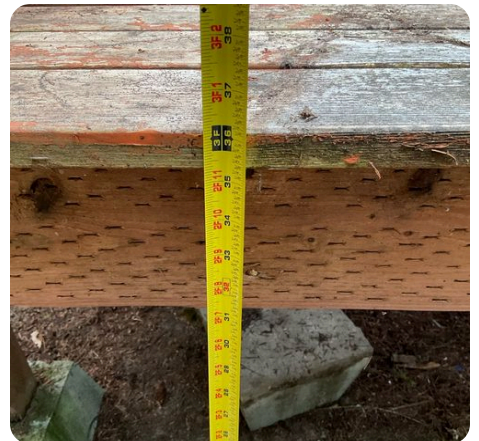
The missing railings pose a safety hazard by not providing necessary support and fall protection. It is recommended to install railings in compliance with building codes to ensure the safety of occupants, especially in elevated areas. Evaluation and repair by a qualified contractor are advised to prevent accidents.

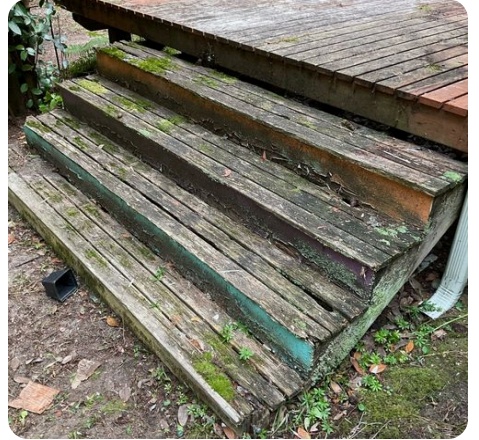
Damage to the steps was observed, which could present a safety hazard. It is important to have a qualified contractor evaluate and repair the damaged steps promptly to prevent accidents or further deterioration.

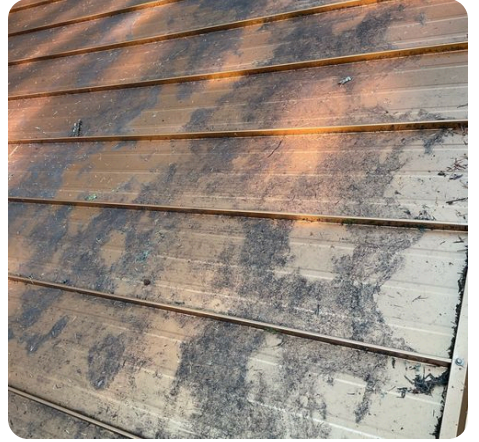
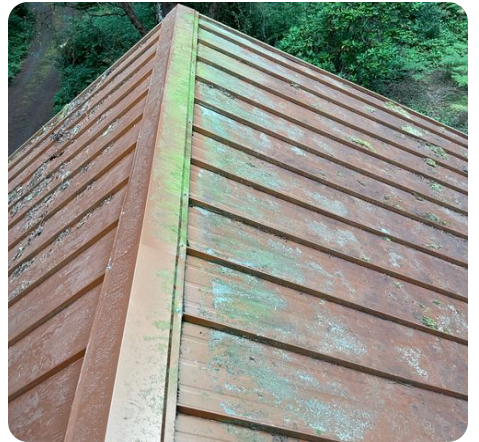
The presence of algae on the metal roof is noted. While algae growth does not typically pose an immediate threat to the roof's integrity, it can affect the aesthetics and longevity of the roof. Cleaning the algae off the metal roof can help improve its appearance and prevent any potential damage over time. It is recommended to address this issue by cleaning the roof surface using a solution of water and mild detergent, or by consulting with a qualified roofing contractor for professional cleaning services.

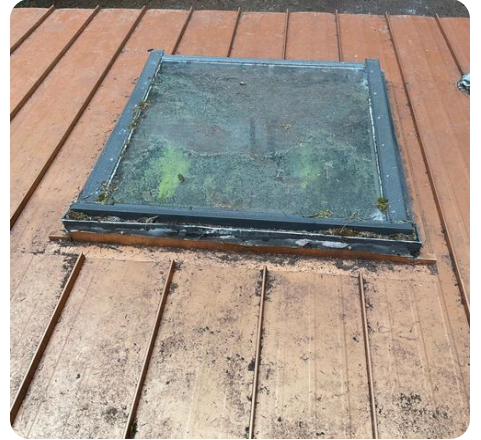
Organic debris is covering the skylight. It is recommended to clean the skylight to prevent potential blockage and ensure proper drainage. Use a gentle cleaner and a soft cloth to remove debris. Regular maintenance can help prolong the lifespan of the skylight.

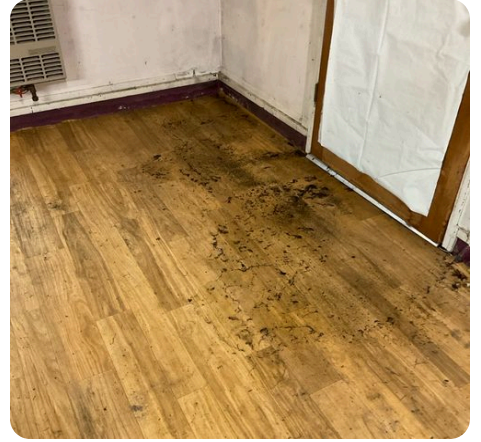
The presence of moisture on the garage floor could indicate a potential water leakage issue. It is recommended to evaluate the source of moisture and repair it promptly to prevent further damage and potential mold growth. A qualified contractor can assess the situation and suggest appropriate solutions.

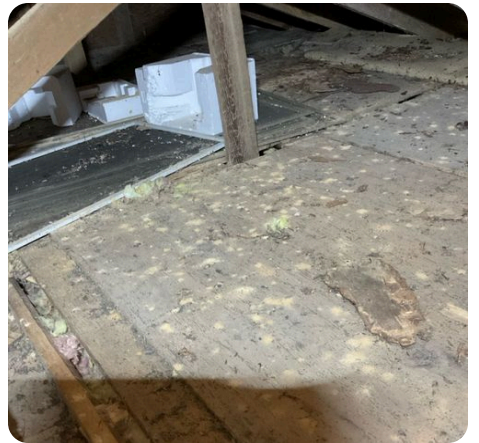
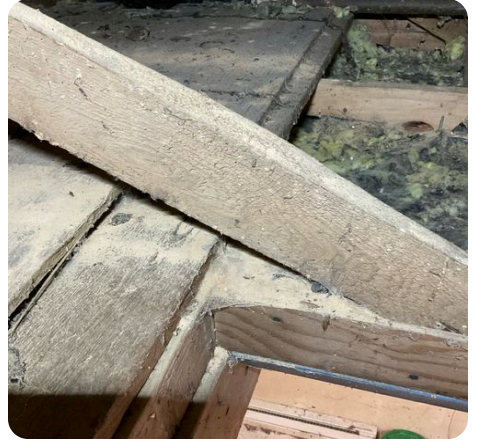
The presence of insect damage is observed in the garage. It is recommended to evaluate and repair the affected areas to prevent further damage and infestation. Hiring a qualified pest control professional can help address the issue effectively.

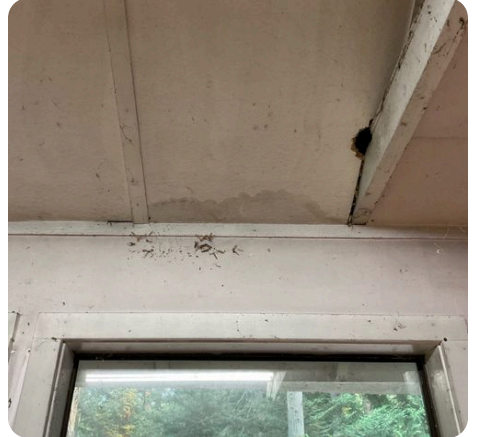
The presence of dry moisture stains on the ceiling may indicate a previous water leak or high humidity levels. It is recommended to evaluate the source of the moisture and repair accordingly to prevent any further damage. Depending on the extent of the issue, a qualified contractor may need to address the underlying cause and repair the affected area to ensure the structural integrity of the ceiling.

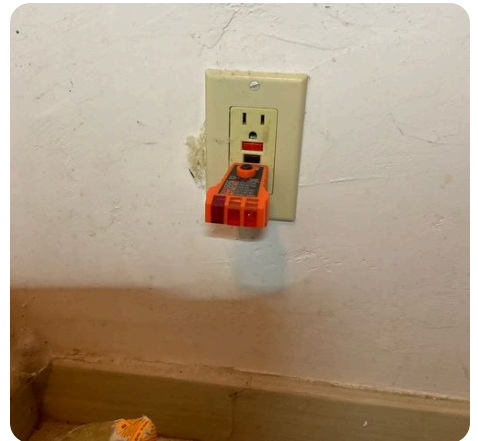
The GFCI receptacle did not operate properly or 'trip' when tested. GFCI receptacles are designed to protect against electrical shock and should be in proper working condition. It is recommended to have a qualified electrician evaluate and repair or replace the receptacle.

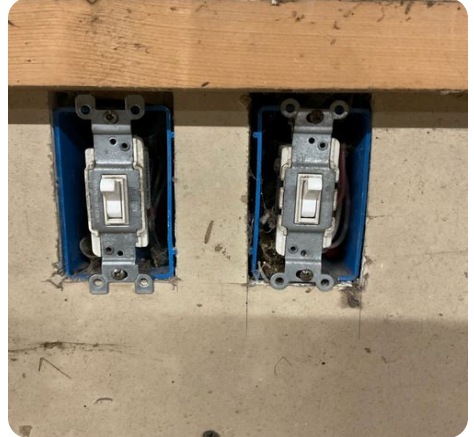
The outlet and switch covers are missing in multiple areas. It is recommended to install outlet and switch covers to prevent electrical hazards and to ensure the safety of the occupants. You can easily purchase covers at a hardware store and install them yourself following the manufacturer's instructions.

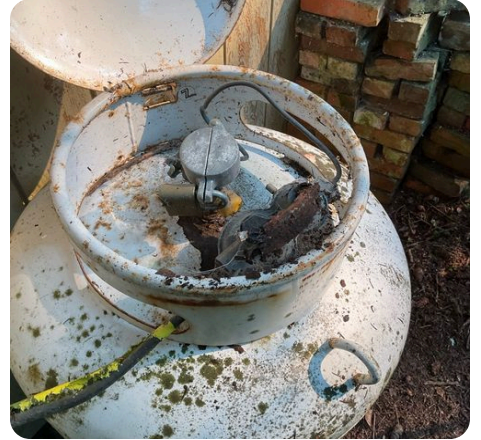
The propane tank(s) is/are not secured to prevent movement. Strapping the tank(s) to prevent it/them from tipping over is recommended. Contact a qualified professional to perform this maintenance.

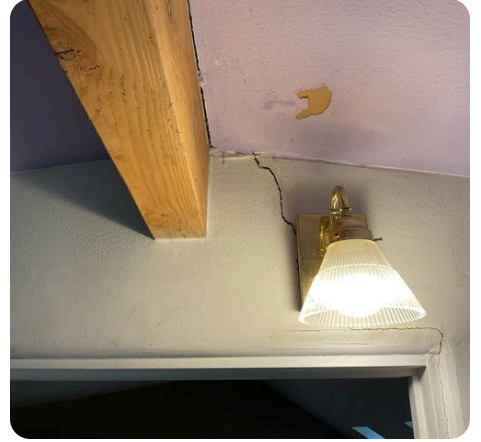
Areas of damaged or cracked drywall were observed in the walls. Evaluating and repairing these issues is recommended as they can impact the aesthetic appeal of the home and may lead to further damage if not addressed. Contacting a qualified drywall contractor to assess the extent of necessary repairs and to ensure proper repairs are made is suggested.

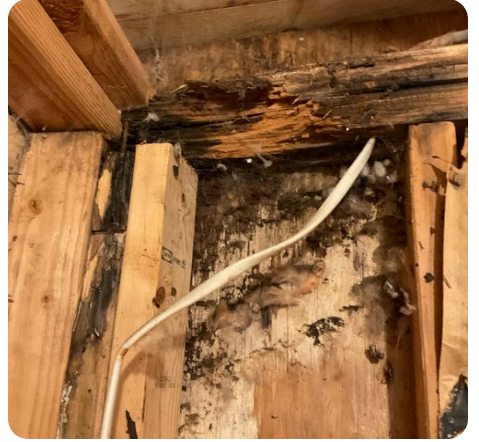
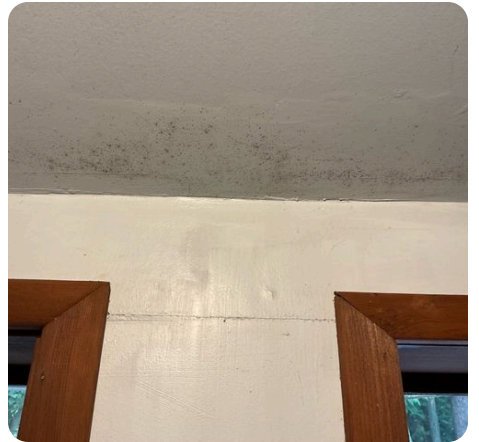
Mildew is present in multiple areas. It is recommended to address this issue promptly to prevent further growth and to maintain a healthy indoor environment. Evaluation and repair by a qualified mold remediation specialist may be necessary to effectively eliminate the mildew.

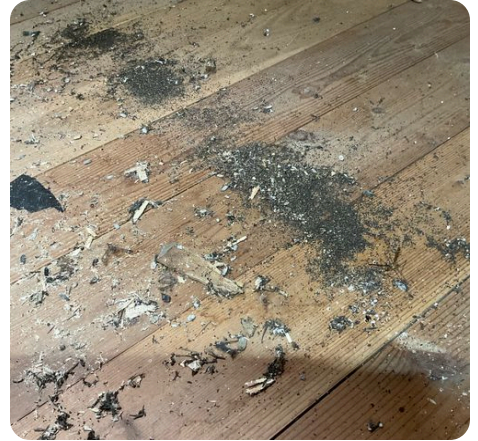
The presence of carpenter ant frass and carcasses indicates a possible infestation in the property. It is recommended to evaluate and address this issue promptly to prevent further damage to the structure. Hiring a licensed pest control professional can help in identifying the extent of the infestation and providing appropriate treatment to eliminate the ants.

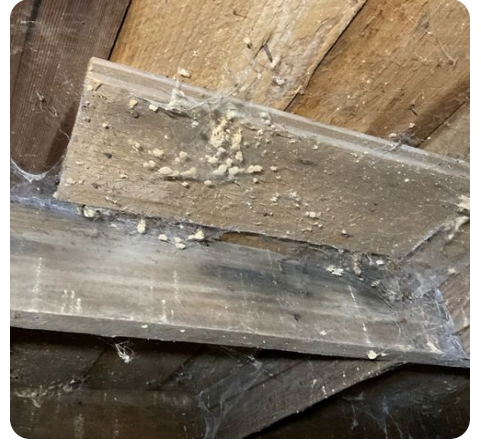
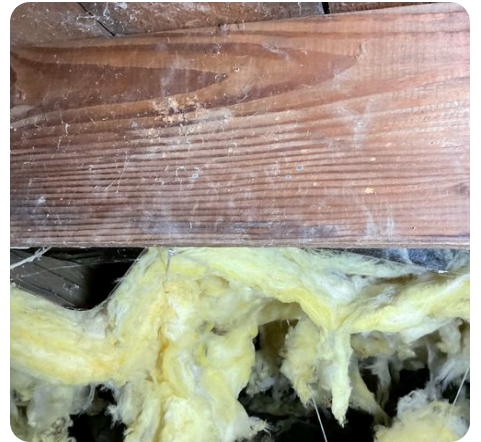
The presence of insect damage in the structural components should be evaluated and repaired promptly. Insect damage can weaken the integrity of the beams, columns, or posts, potentially compromising the stability of the structure. It is recommended to consult with a licensed pest control professional to address the infestation and repair any damage to prevent further structural issues.

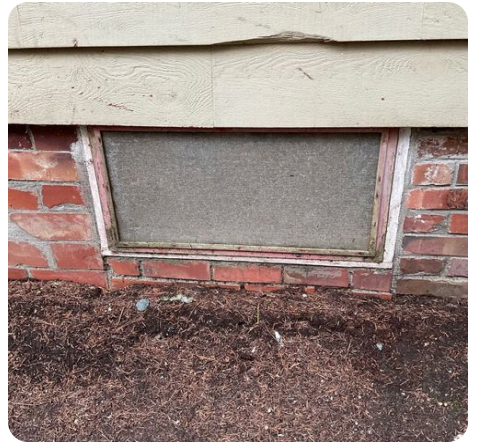
The Crawlspace access covers are not secure. This can lead to safety hazards, pest infestations, and energy inefficiency. It is recommended to secure the access covers properly to prevent these issues. You may consider installing locks or latches to ensure the covers are tightly sealed.

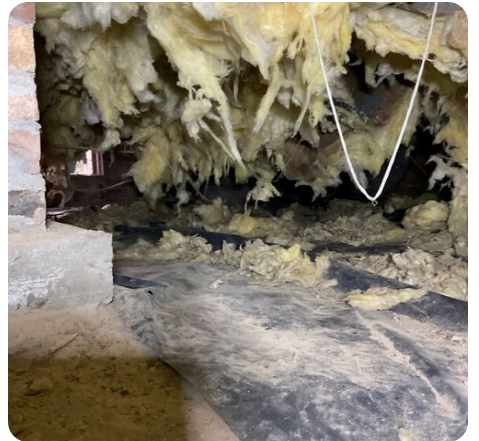
Evidence of rodent or small animal intrusion found in the crawl space. (Inspector visually saw raccoon in crawl space) This can lead to damage to insulation and potential health hazards. It is recommended to evaluate and repair any entry points or gaps in the crawl space to prevent further intrusion. Consider hiring a pest control professional to address the issue and ensure the crawl space is properly sealed to prevent future infestations.

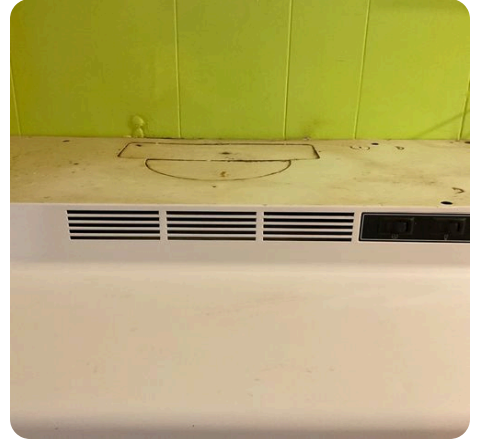
The vent fan should be properly vented to the outdoors to effectively remove cooking odors, moisture, and airborne grease. Recirculating the vent fan may not be as efficient in improving indoor air quality. It is recommended to evaluate the current setup and consider rerouting the vent to exhaust outside to enhance ventilation.

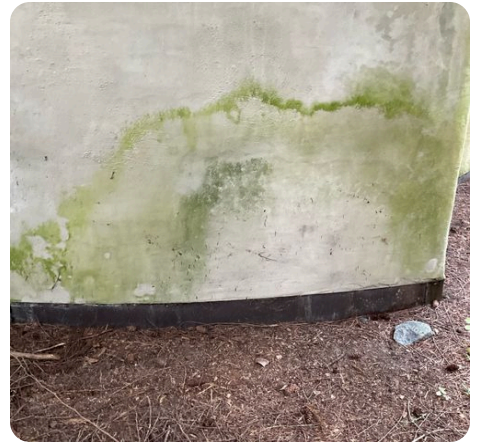
The presence of mildew and lichen on the siding can indicate excessive moisture levels, which may lead to degradation of the siding material over time. It is recommended to evaluate and address the moisture source to prevent further growth and potential damage. A qualified contractor can assist in properly cleaning and treating the affected areas to restore the exterior appearance of the property.

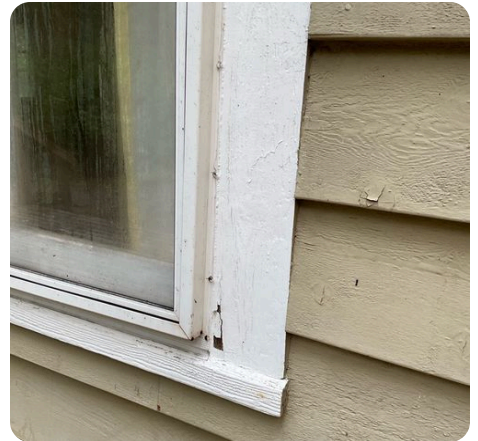
The storm windows show signs of a failed seals. This can lead to decreased energy efficiency and potential water leaks. It is recommended to replace the seal or consider recaulking around the edges to prevent further damage.

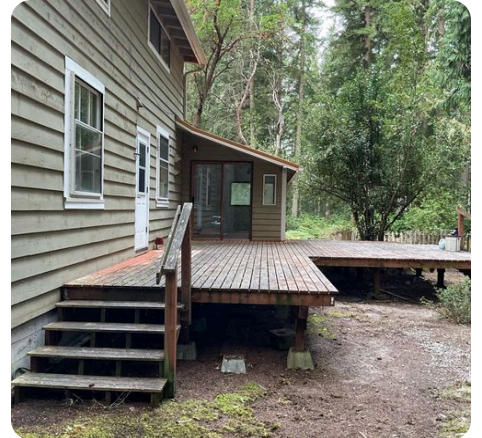
The grading around the perimeter of the foundation should be maintained to adequately drain excessive surface and roof runoff water away from the structure. Due to the soil type and/or amount of water from surrounding areas, even flat lots may hold water. It is recommended that the grade slope away from the structure at least 6" for the first 6'-10' away from the foundation.

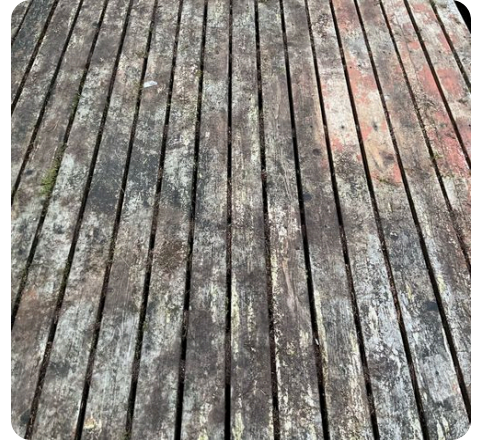
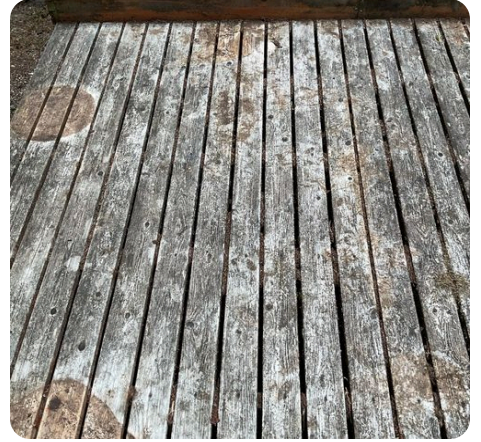
The inspector noted that the surface is in need of repairs. There were some deteriorated boards noted. We recommend evaluating all of the decks and replacing the deteriorated boards to prevent any further issues. Any repairs should be completed by a qualified professional.

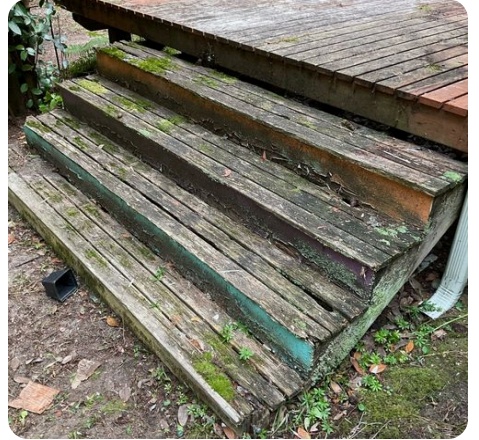
Damage to the steps was observed, which could present a safety hazard. It is important to have a qualified contractor evaluate and repair the damaged steps promptly to prevent accidents or further deterioration.

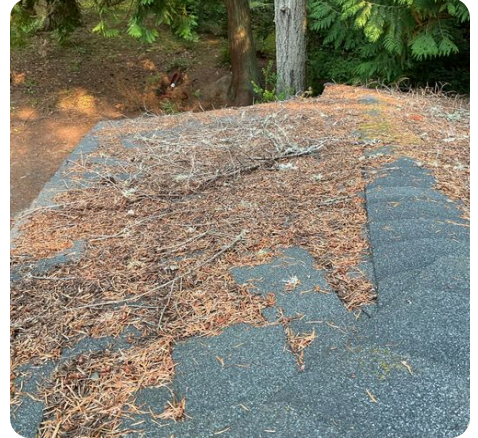
There is debris on the roof. Leaves, branches, or other material that should be removed. This debris will hold moisture and can cause damage to the roof system. Inspection of the areas under the debris is recommended after debris is removed.

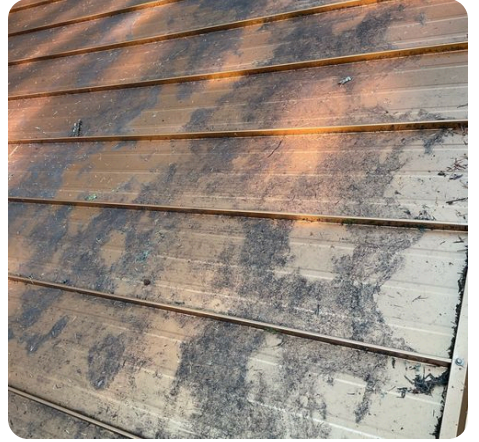
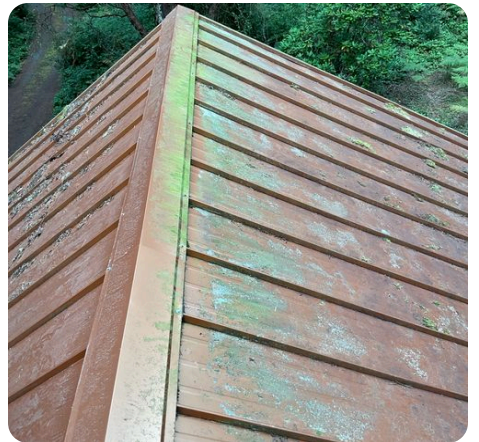
The presence of algae on the metal roof is noted. While algae growth does not typically pose an immediate threat to the roof's integrity, it can affect the aesthetics and longevity of the roof. Cleaning the algae off the metal roof can help improve its appearance and prevent any potential damage over time. It is recommended to address this issue by cleaning the roof surface using a solution of water and mild detergent, or by consulting with a qualified roofing contractor for professional cleaning services.

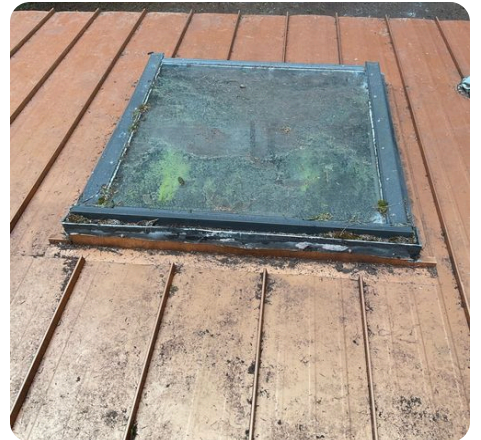
Organic debris is covering the skylight. It is recommended to clean the skylight to prevent potential blockage and ensure proper drainage. Use a gentle cleaner and a soft cloth to remove debris. Regular maintenance can help prolong the lifespan of the skylight.

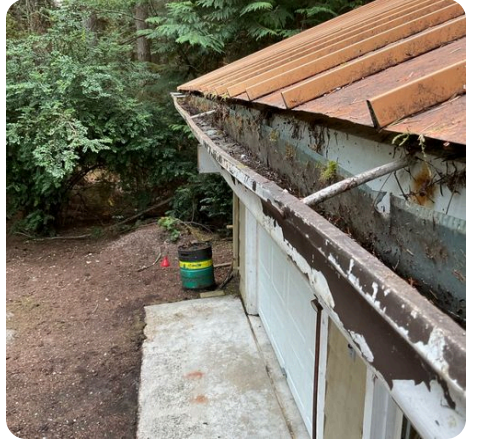
There is a loose gutter on the roof area, which may cause water overflow and potential damage to the surrounding areas. It is recommended to evaluate and repair the loose gutter to ensure proper functionality and prevent any future issues. A qualified gutter repair professional should be contacted for further assistance.

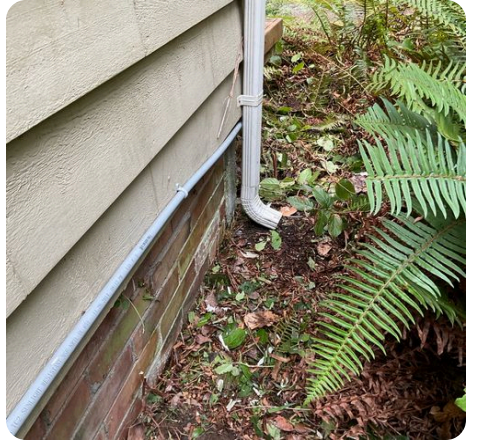
There were downspouts discharging near the structure. It is recommended that the downspouts are extended or rerouted at least 6 feet away from the structure to help reduce the chance of soil saturation next to the foundation. Extensions for downspouts can be purchased from many home improvement stores.

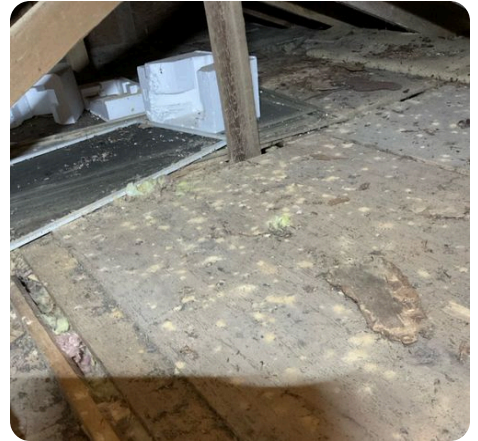
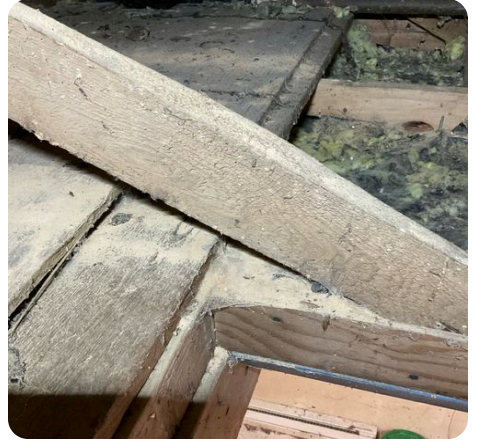
The presence of insect damage is observed in the garage. It is recommended to evaluate and repair the affected areas to prevent further damage and infestation. Hiring a qualified pest control professional can help address the issue effectively.

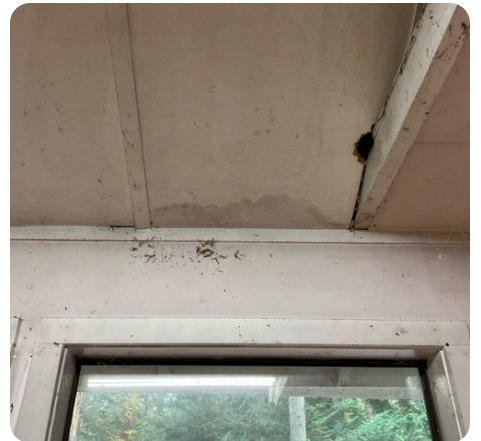
The presence of dry moisture stains on the ceiling may indicate a previous water leak or high humidity levels. It is recommended to evaluate the source of the moisture and repair accordingly to prevent any further damage. Depending on the extent of the issue, a qualified contractor may need to address the underlying cause and repair the affected area to ensure the structural integrity of the ceiling.

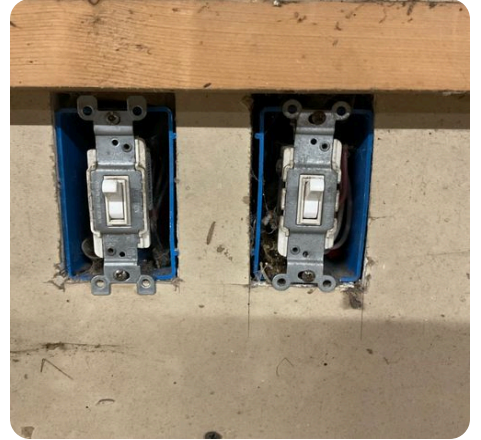
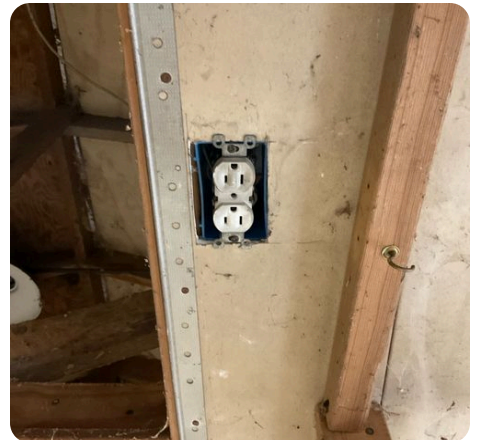
The outlet and switch covers are missing in multiple areas. It is recommended to install outlet and switch covers to prevent electrical hazards and to ensure the safety of the occupants. You can easily purchase covers at a hardware store and install them yourself following the manufacturer's instructions.

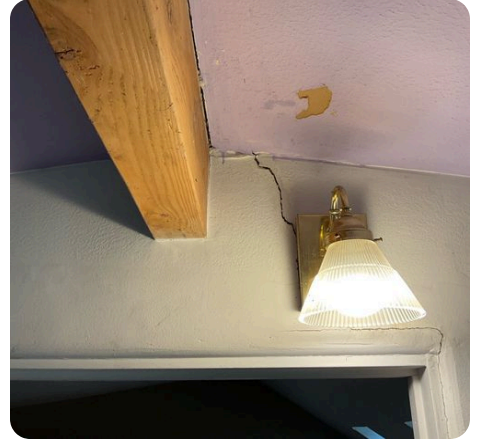
Areas of damaged or cracked drywall were observed in the walls. Evaluating and repairing these issues is recommended as they can impact the aesthetic appeal of the home and may lead to further damage if not addressed. Contacting a qualified drywall contractor to assess the extent of necessary repairs and to ensure proper repairs are made is suggested.

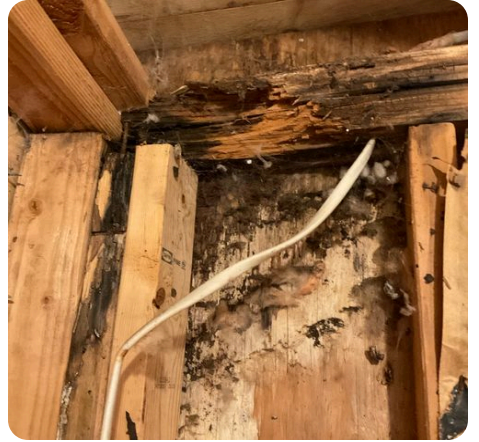
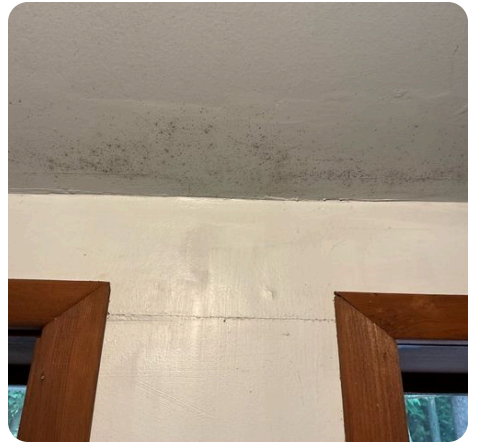
Mildew is present in multiple areas. It is recommended to address this issue promptly to prevent further growth and to maintain a healthy indoor environment. Evaluation and repair by a qualified mold remediation specialist may be necessary to effectively eliminate the mildew.

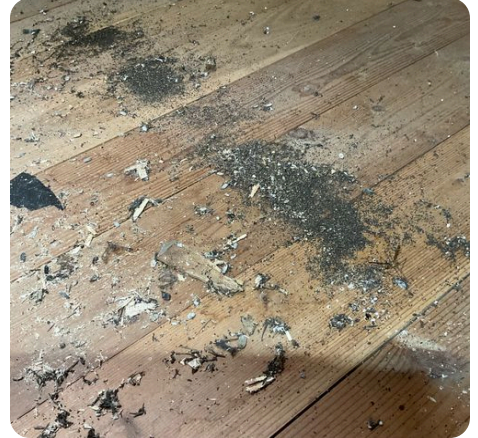
The presence of carpenter ant frass and carcasses indicates a possible infestation in the property. It is recommended to evaluate and address this issue promptly to prevent further damage to the structure. Hiring a licensed pest control professional can help in identifying the extent of the infestation and providing appropriate treatment to eliminate the ants.

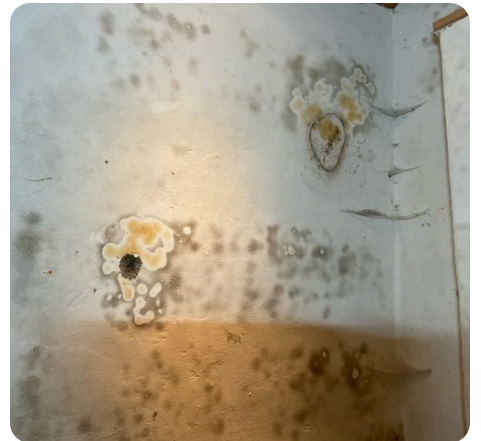
The presence of mildew and elevated moisture on the walls is a sign of excessive moisture levels within the property. This can lead to mold growth and potential structural damage if not addressed. It is recommended to evaluate the ventilation in the affected area and repair any leaks or sources of moisture. A qualified contractor can help in identifying the root cause and providing solutions to prevent further moisture issues.

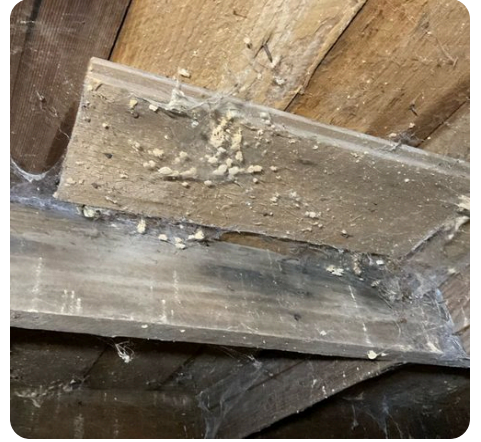
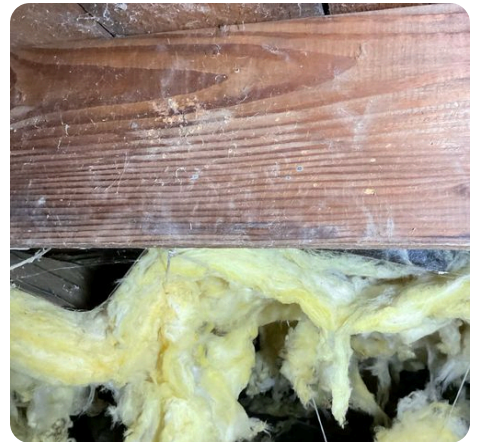
The presence of insect damage in the structural components should be evaluated and repaired promptly. Insect damage can weaken the integrity of the beams, columns, or posts, potentially compromising the stability of the structure. It is recommended to consult with a licensed pest control professional to address the infestation and repair any damage to prevent further structural issues.

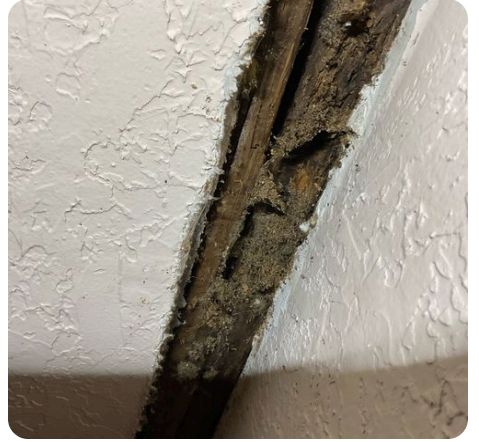
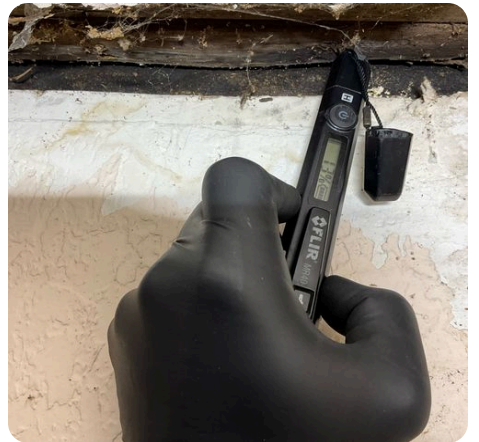
The rafter and framing in the roof show signs of deterioration. This can compromise the structural integrity of the roof and may lead to further damage if not addressed. It is recommended to evaluate the extent of the deterioration and repair or replace the affected components as necessary. A qualified contractor should be consulted to ensure the repairs are done properly.

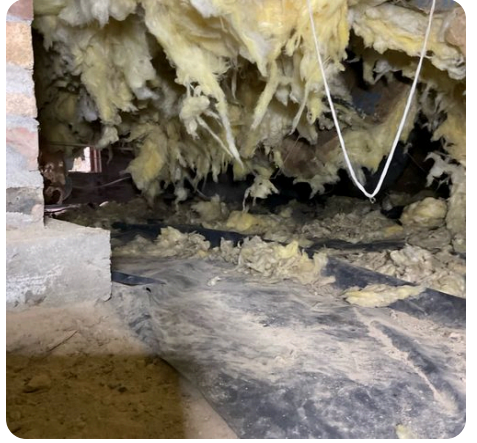
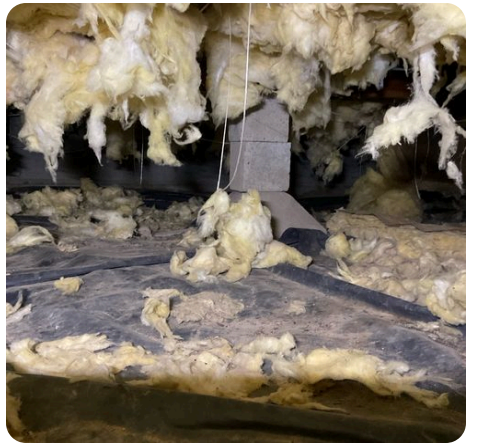
Evidence of rodent or small animal intrusion found in the crawl space. (Inspector visually saw raccoon in crawl space) This can lead to damage to insulation and potential health hazards. It is recommended to evaluate and repair any entry points or gaps in the crawl space to prevent further intrusion. Consider hiring a pest control professional to address the issue and ensure the crawl space is properly sealed to prevent future infestations.
