# **A-Z Tech**

## **Home Inspection Report**

**Roger & Charlene Goebel**

**Property:** 113 Silver Spring Trail  
Greensburg, PA 15601

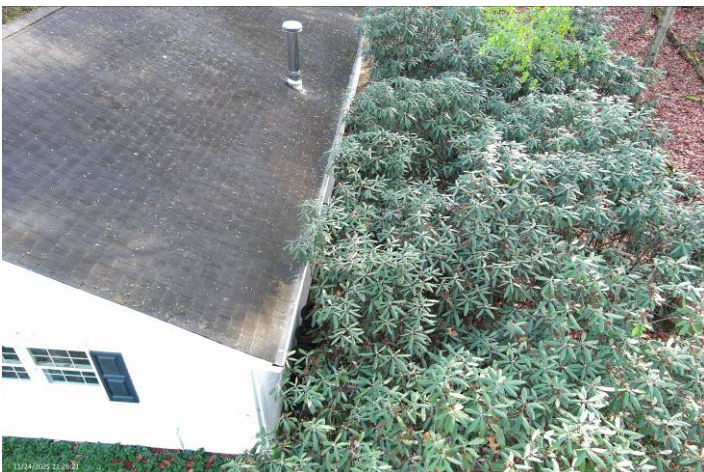
The rear of the garage is overgrown by Rhododendron bushes

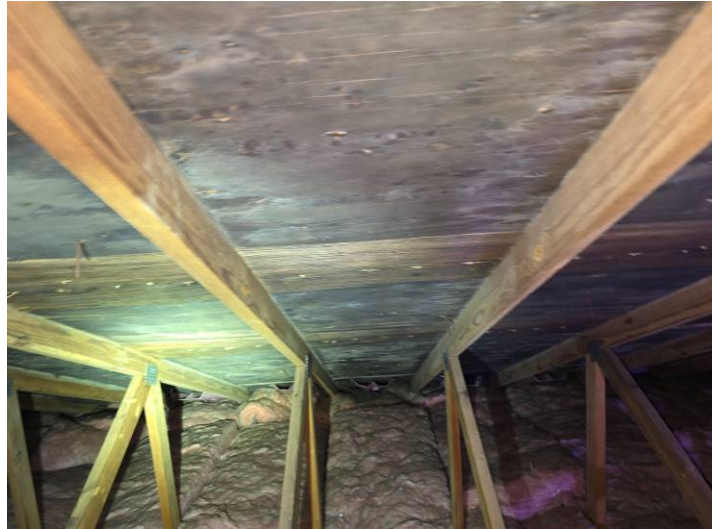
The plywood roof deck is blackened or stained. This may indicate a lack of proper ventilation in the past. It does appear that the ventilation of the area has been improved with eave and ridge vents as well exhausting the bathroom fans to the exterior. The attic was dry at the time of this inspection. Replacement of the plywood should be considered when the current roof is next replaced. ☒

Example of the stained or blackened roof plywood

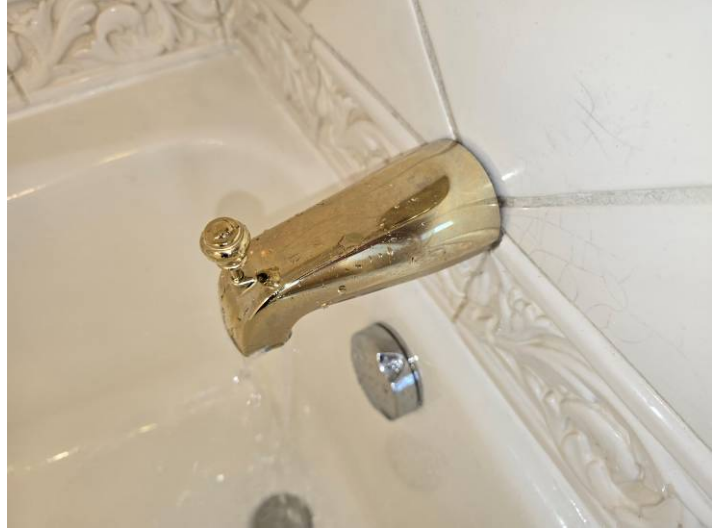
| The bathtub faucet should be sealed against the tub surround to prevent water infiltration through the wall. <input checked="" type="checkbox"/> | | | | | |

The primary bathtub faucet should be sealed

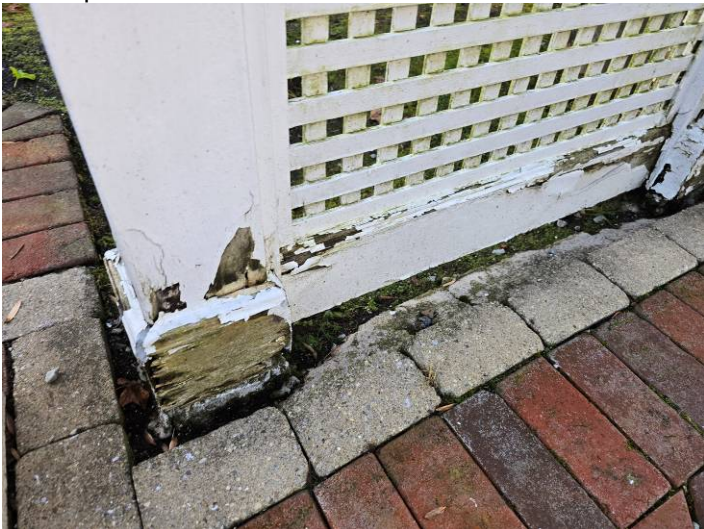
Rotting around the base of the archway to the rear patio
