# Inspection Report

## Property Address:

535 Courtney Lane

Callao, VA

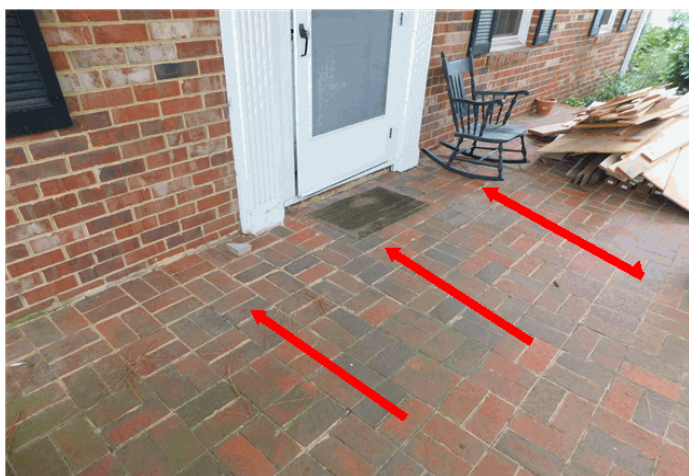
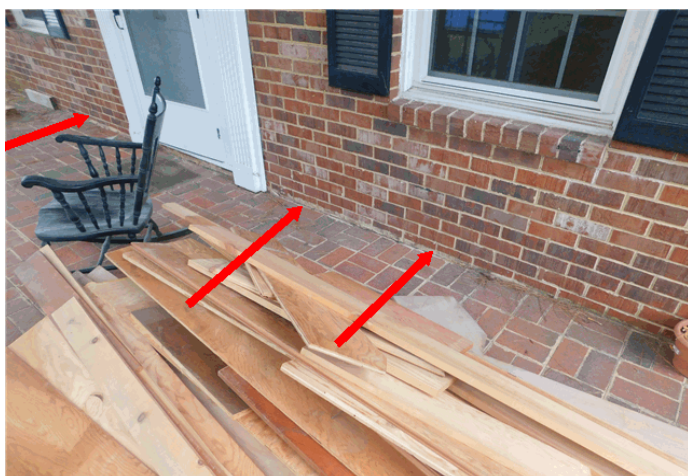
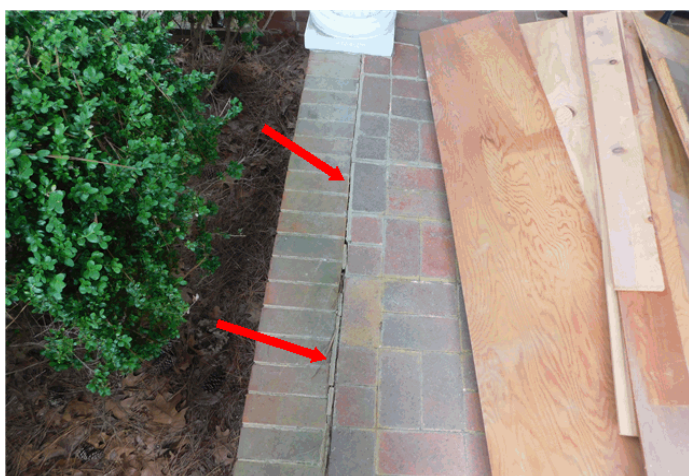
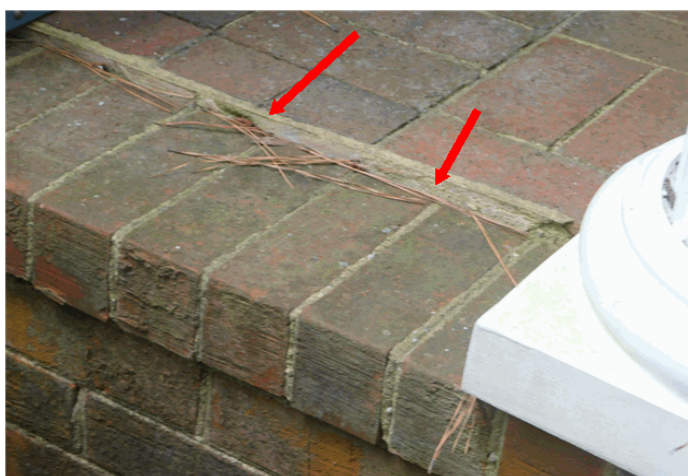
#### 4) Front Entrance Conditions

R

The floor of the front porch has settled significantly at the exterior wall. This settlement will allow storm water to drain towards the structure. Due to conditions observed, recommend further evaluation by a licensed structural engineer.

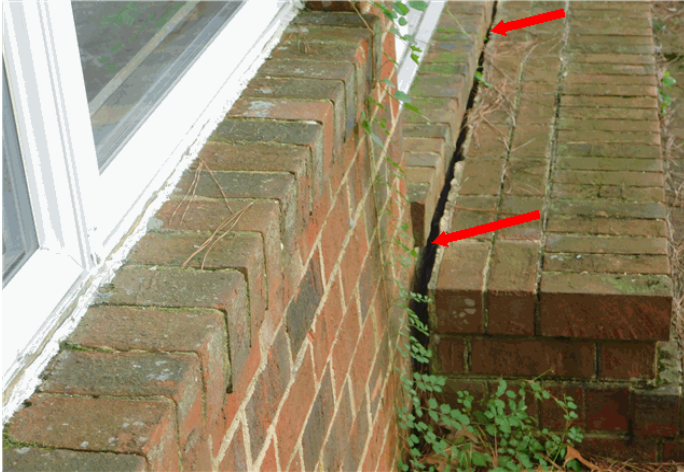
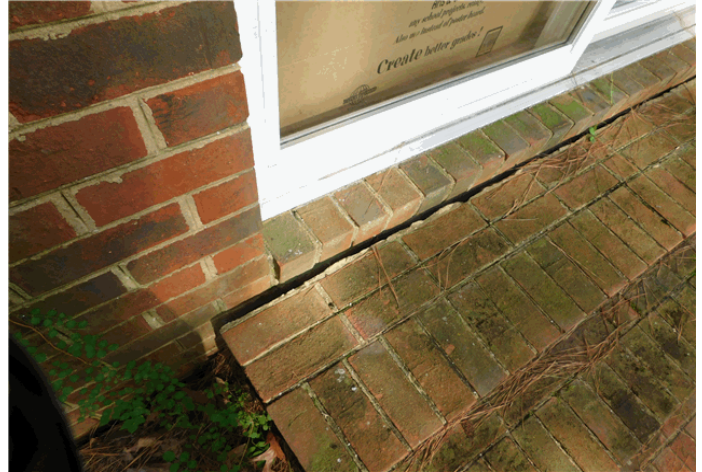
#### 5) Back Entrance Conditions

R

Settlement has occurred at the rear entry stairs and sun room. Due to conditions observed, recommend further evaluation by a licensed structural engineer.

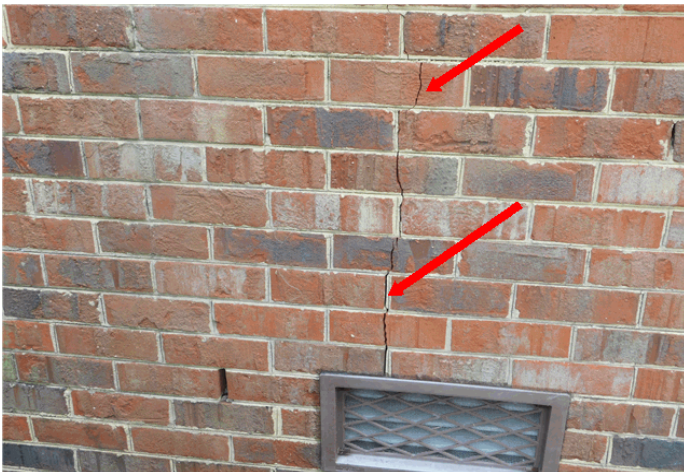
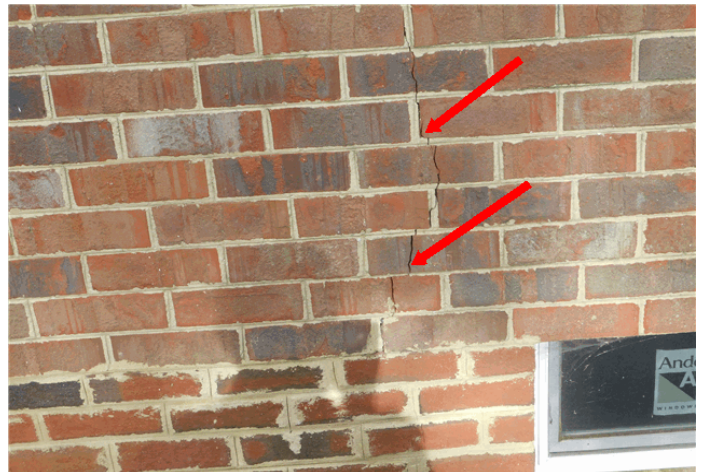
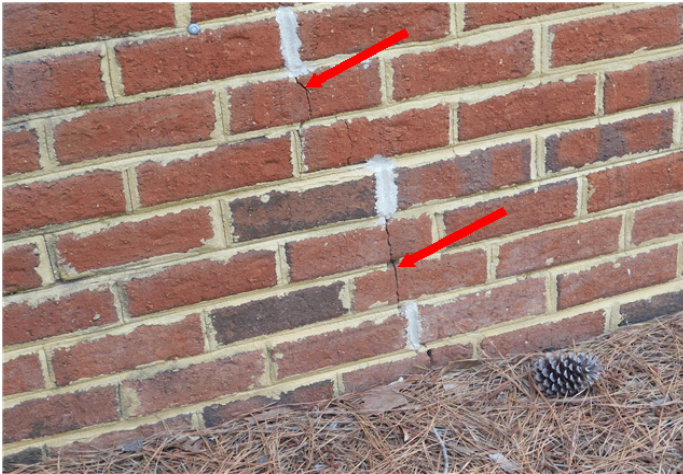
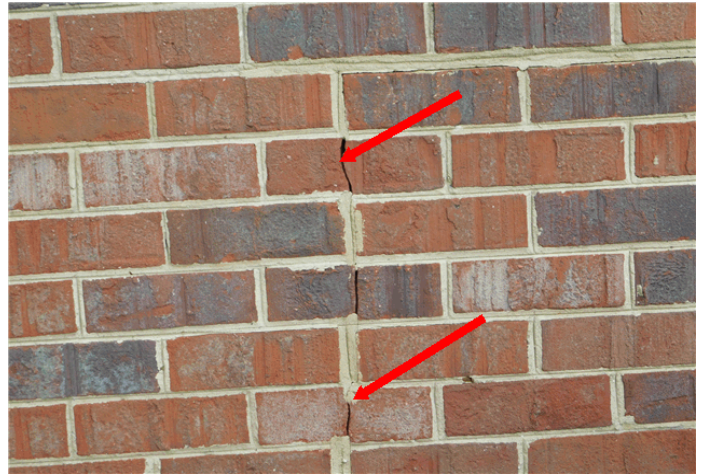
6) Exterior Wall Conditions

R

Settlement cracks were present at numerous locations of the brick veneer. Due to conditions observed, recommend further evaluation by a licensed structural engineer.

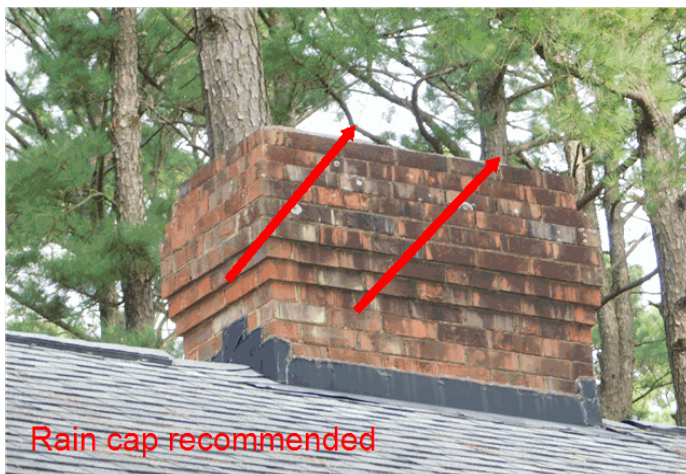
**Chimney****13) Chimney Conditions****AS**

The visible and accessible portions of the chimney(s) appeared to be in serviceable condition at the time of the inspection. The chimney and / or flue did not have a rain cap installed. Recommend a cap be installed during normal chimney maintenance. Due to height and / or conditions observed, chimney was viewed from the ground only using high-powered binoculars.

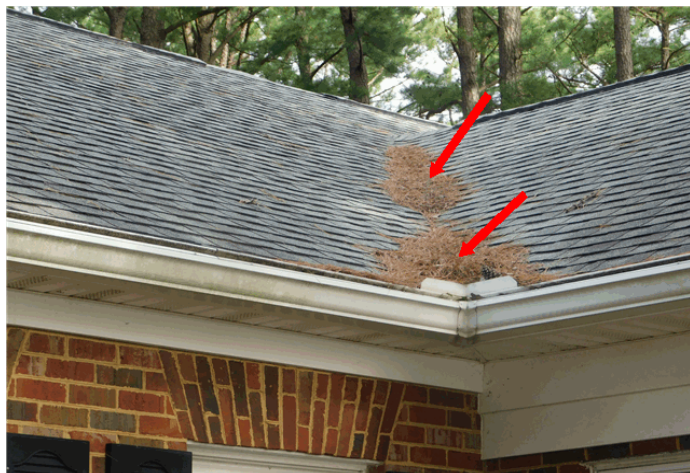
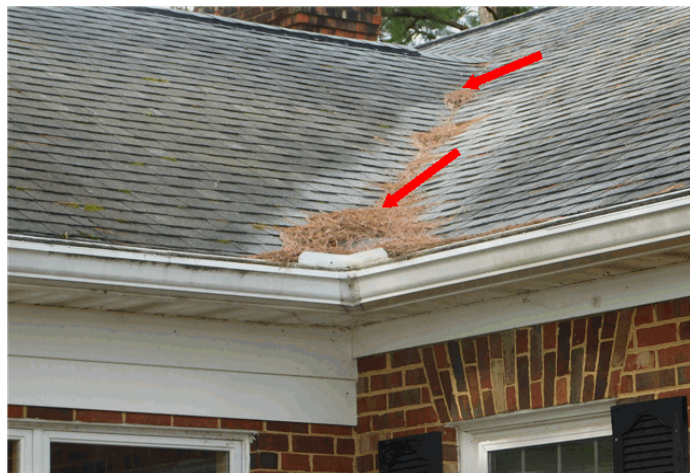
#### 14) Roof Covering Condition

**AS**

The roof covering shows normal wear for its age and appeared to be in serviceable condition at the time of the inspection. Recommend keeping valleys clear of debris.

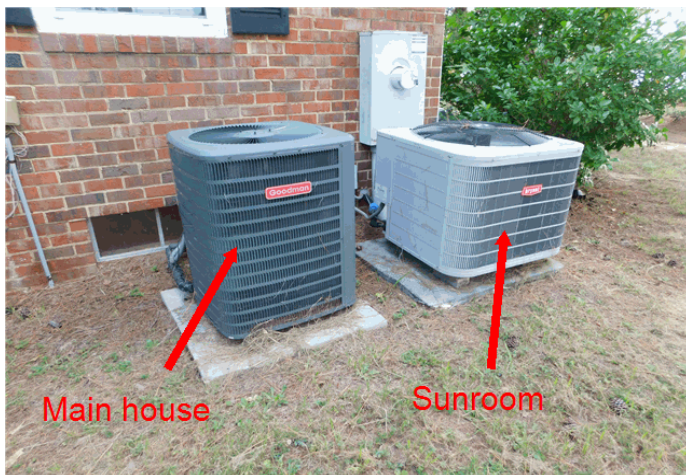
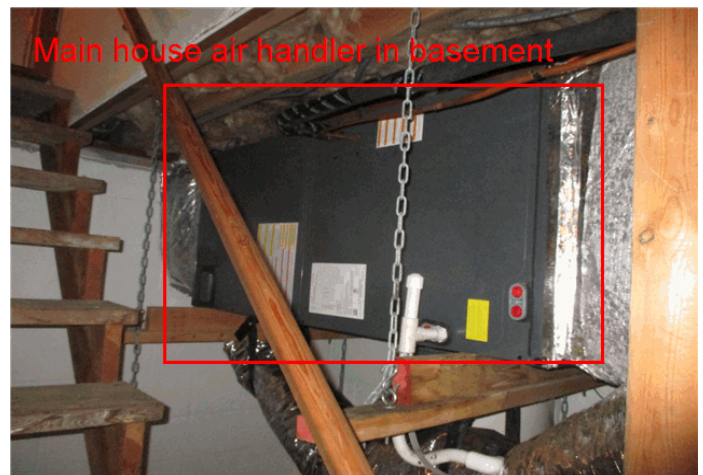
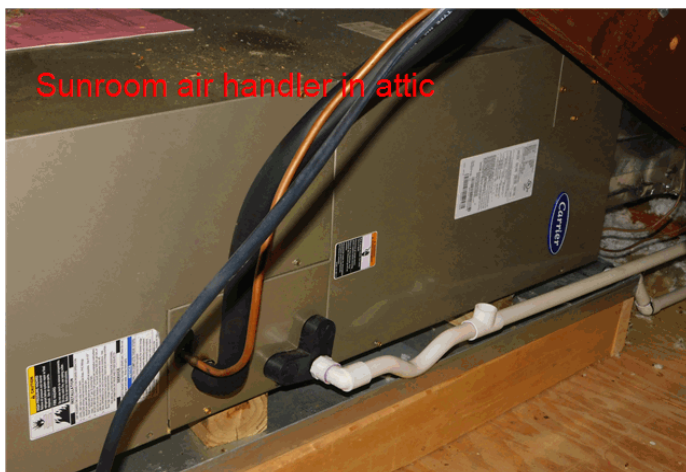
#### 19) Systems Conditions

**AS**

The HVAC systems were operational at time of inspection. This is not an indication of future operation or condition. Although operational, the age of the sun room system is past the average life expectancy for this type of system. It is recommended budgeting for replacement.

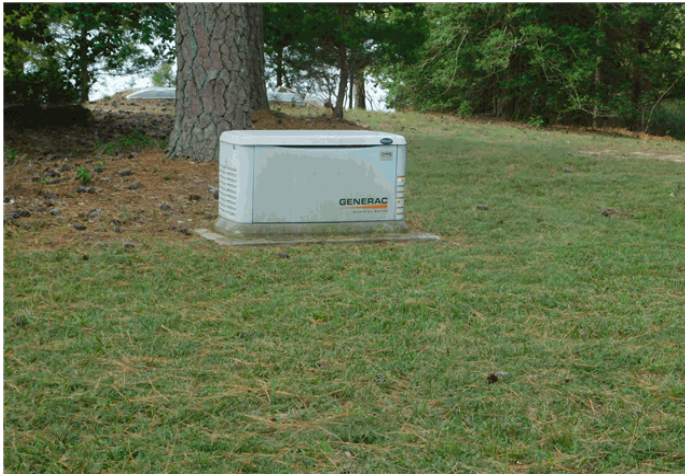
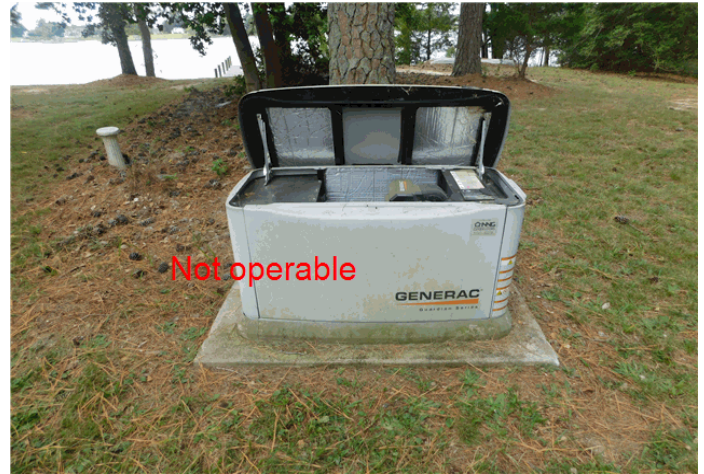
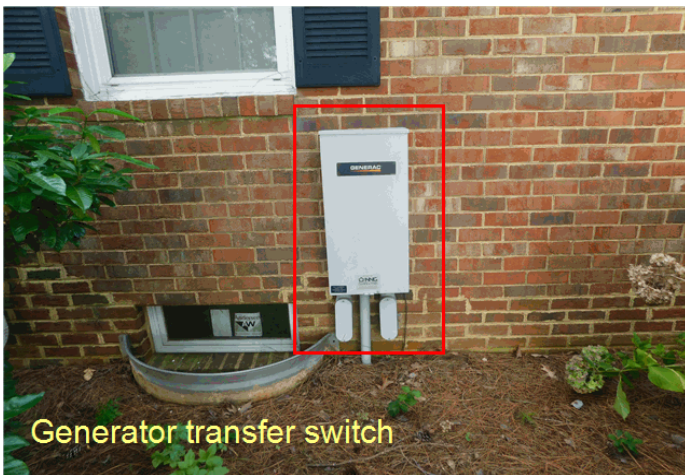
**25) Generator Conditions****R**

The generator was not operable at the time of the inspection. It is suggested that a "Licensed Electrical Contractor" be contacted for further evaluation and repair.

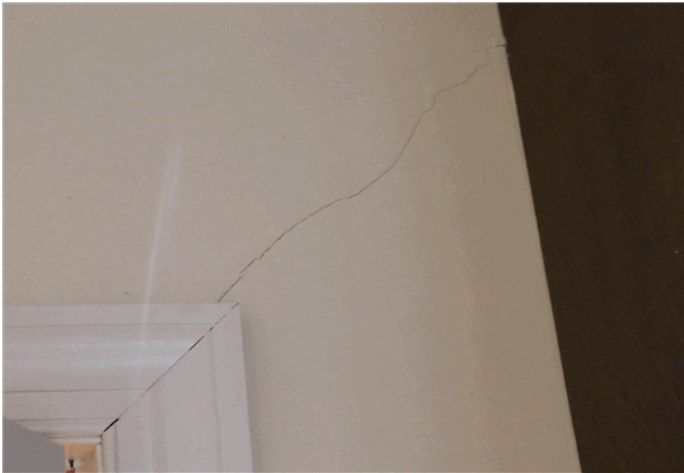
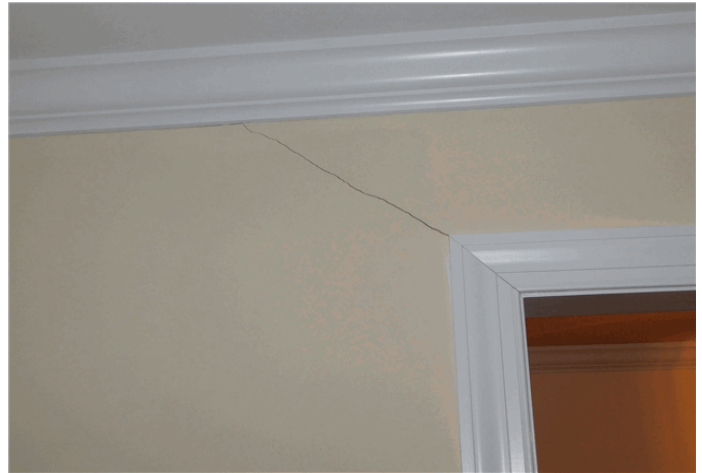
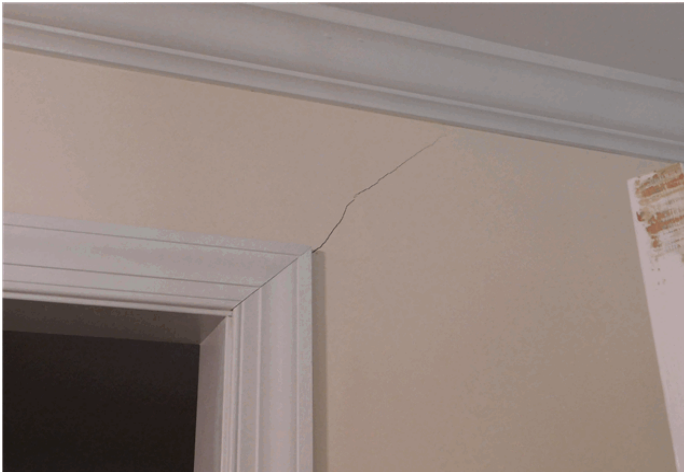
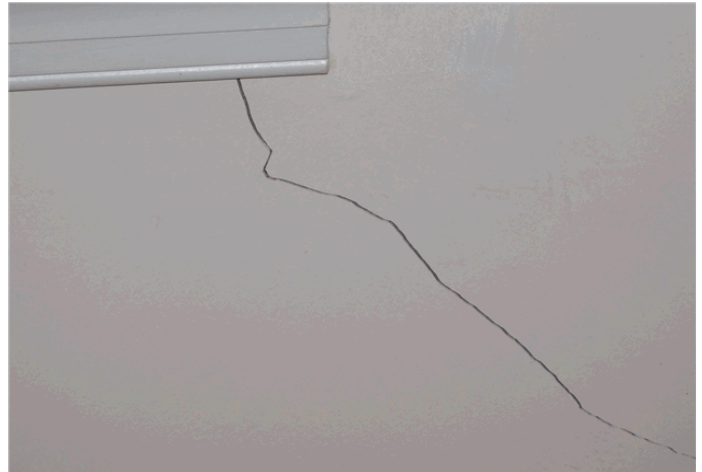
**7 Interiors****Walls - Ceilings - Floors****30) Wall Conditions****R**

Structural cracks were present at numerous locations. Several of these cracks appear to be just opposite the cracks in the exterior walls. Due to conditions observed, recommend further evaluation by a licensed structural engineer.

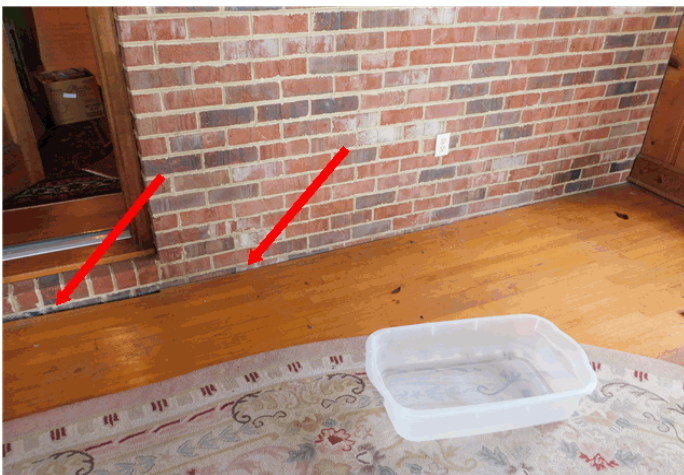
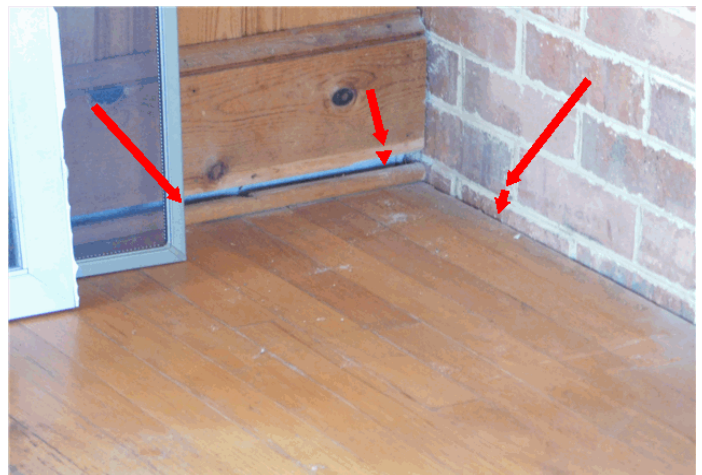
**33) Floor Conditions****R**

The general condition of the visible and accessible portions of the floors of the main house appeared to be in serviceable condition at the time of the inspection however the floor of the rear sun room has significant settlement at the main house wall. Due to conditions observed, recommend further evaluation by a licensed structural engineer.

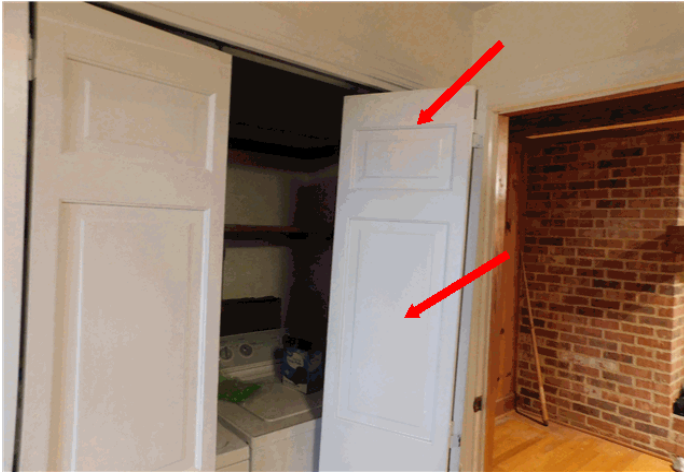
**AS = Appears Serviceable****R = Repair****S = Safety****NI = Not Inspected****35) Interior Door Conditions****R**

The majority of the interior doors appeared to be in serviceable condition at the time of the inspection. The right side bifold door of the laundry area was off it's track. Recommend maintenance as needed.

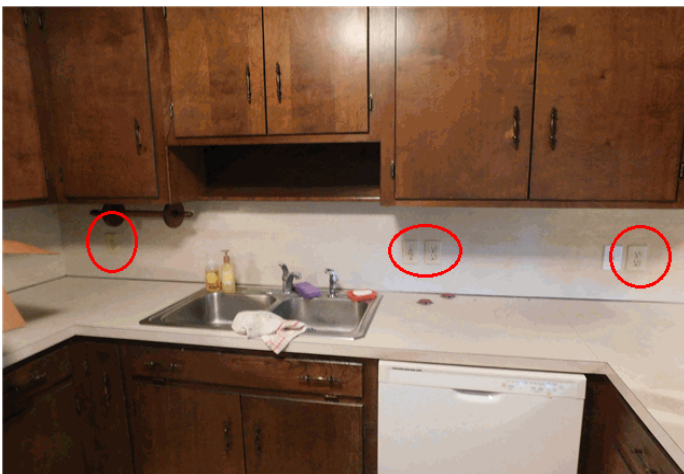
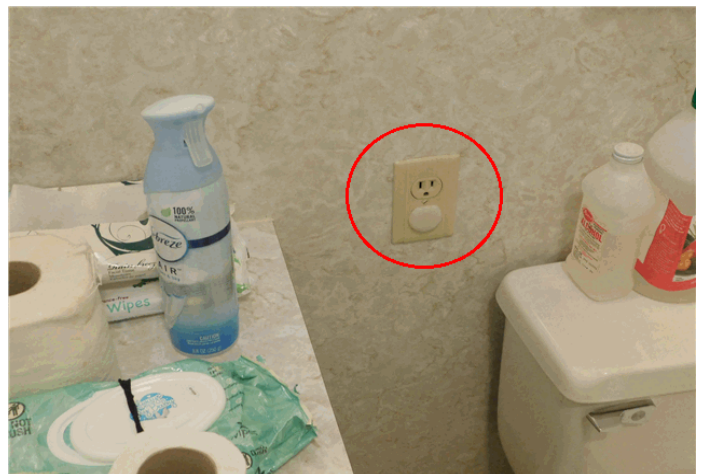
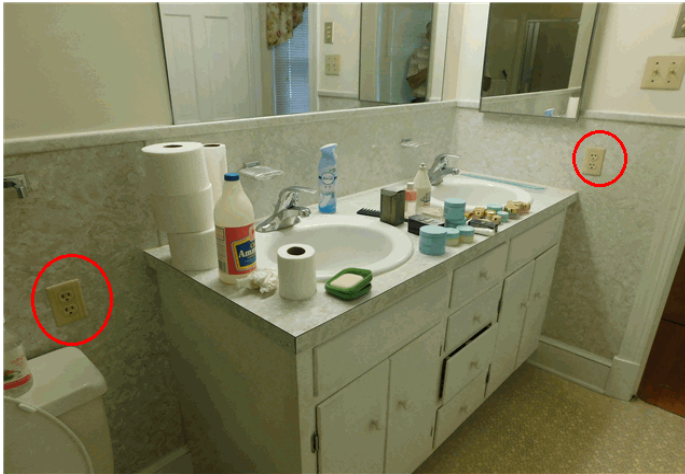
**Electrical Conditions****36) Electrical Conditions****S**

All outlets tested were properly functional at the time of the inspection. It is recommended installing GFCI outlets for safety near the sinks in the kitchen and baths. Ground Fault Circuit Interrupter outlets protect from electrical shock at wet locations.

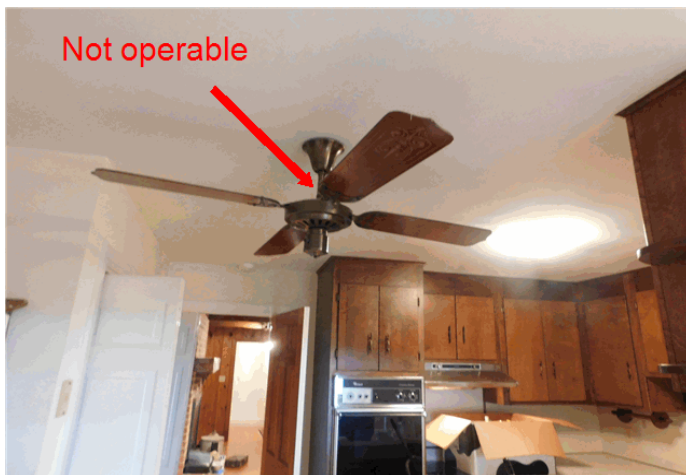
**38) Ceiling Fan Conditions****R**

The ceiling fan in the kitchen was not operable at the time of the inspection

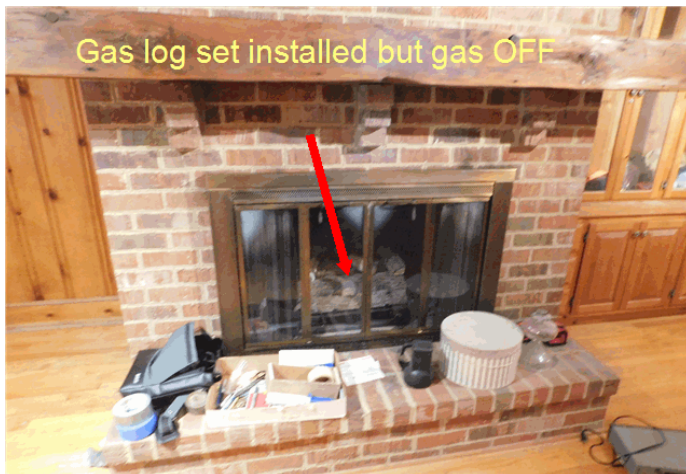
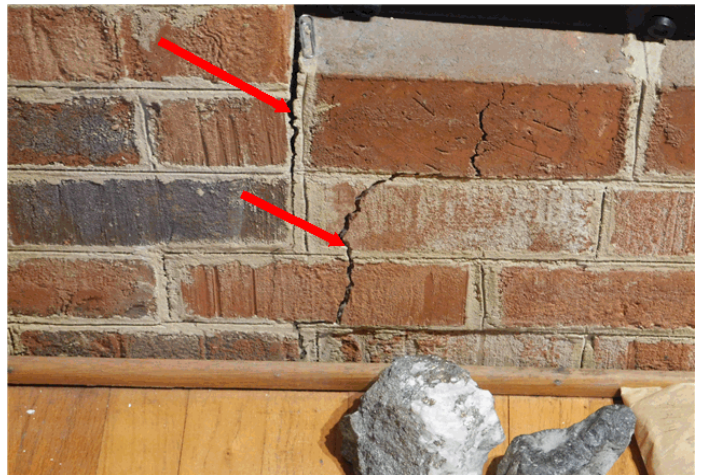
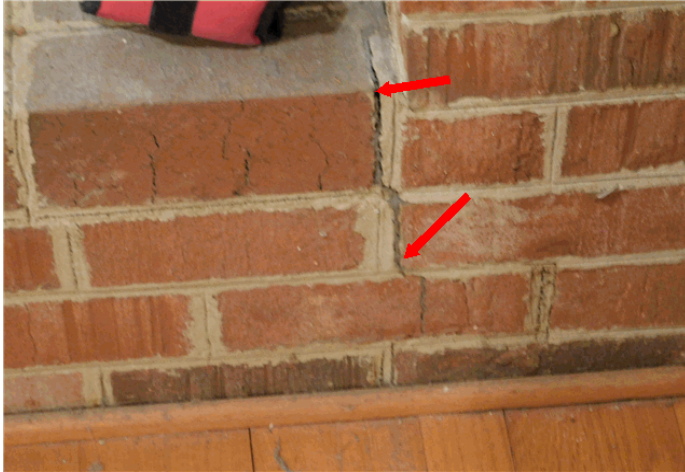
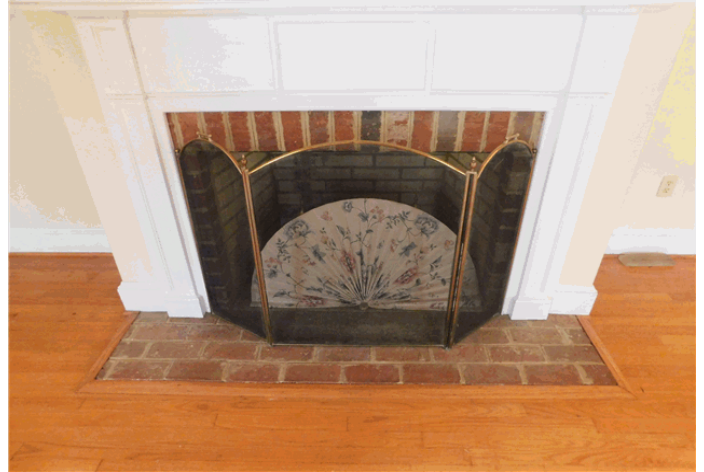
### 40) Fireplace Conditions

The general condition of the visible and accessible areas of the fireplace appeared to be in serviceable condition at the time of the inspection however it appears that the brick hearth has settled. This is consistent with the overall house settlement.

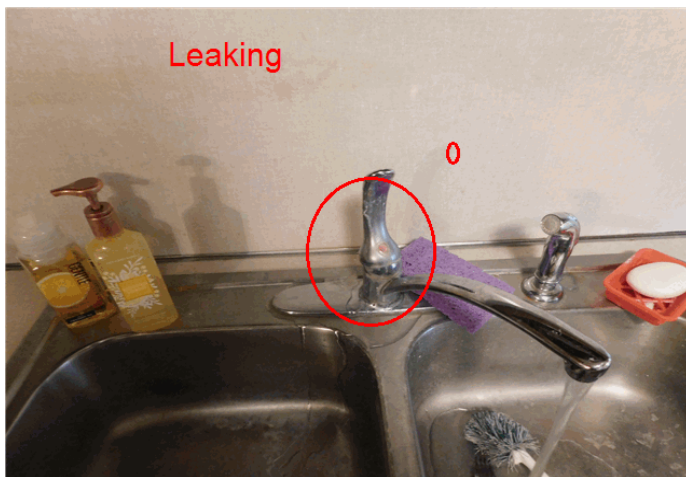
**43) Sink Plumbing Conditions**

R

The faucet leaked at the time of the inspection. Repair is recommended.

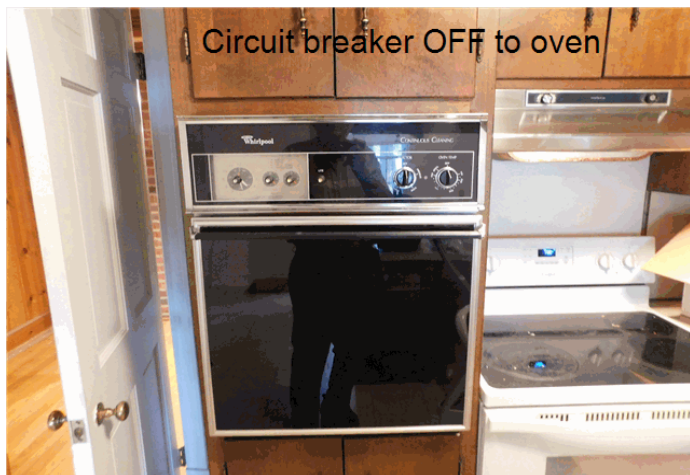
**44) Stove - Range Condition**

The range was operational at the time of the inspection however the wall oven was not operable at the time of the inspection. The circuit breaker was OFF.

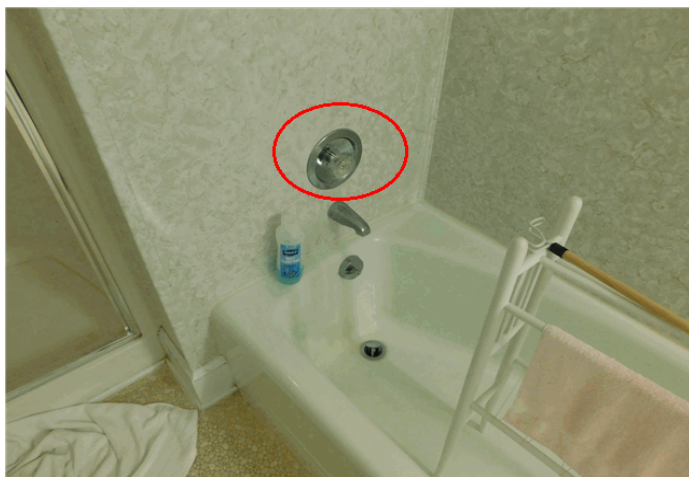
**Shower - Tub - Toilet****50) Shower - Tub Conditions**

The bathtubs, showers, faucets, and drains appeared to be in serviceable condition in all baths. The tub faucet in the primary bath has a slight leak. Recommend maintenance and/or repairs as needed.

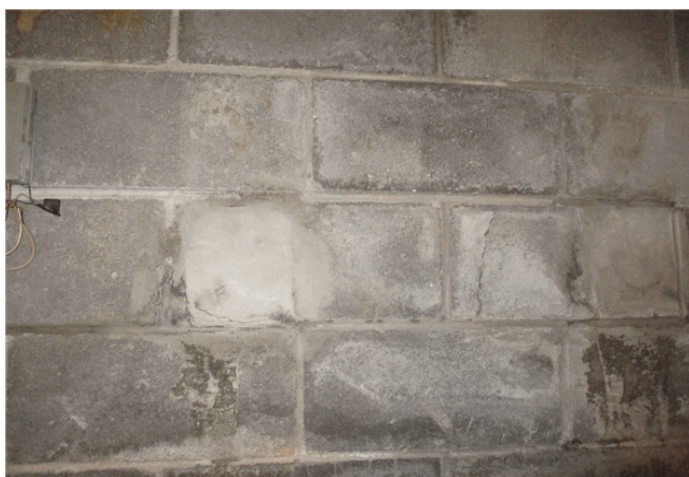
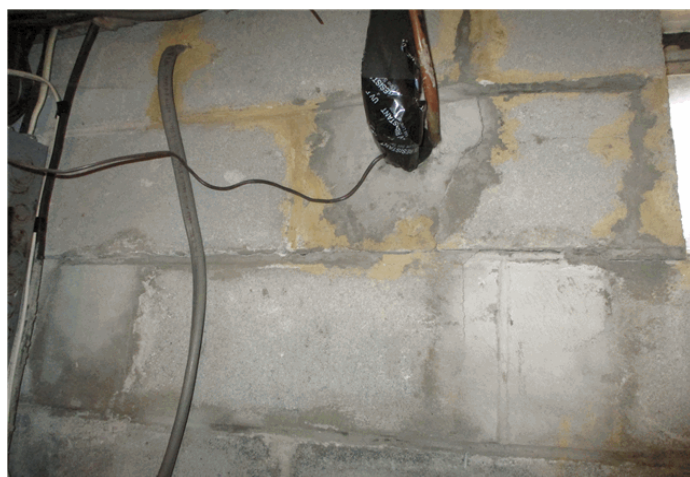
#### 53) Wall Conditions

The general condition of the walls appeared to be in serviceable condition at the time of the inspection. It appears that previous cracks have been repaired.

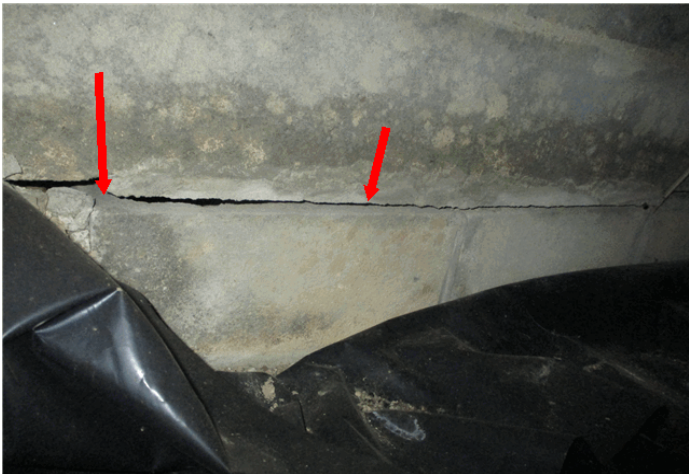
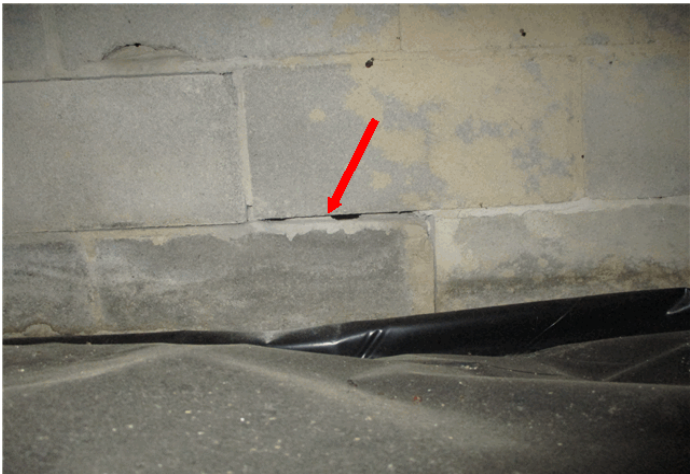
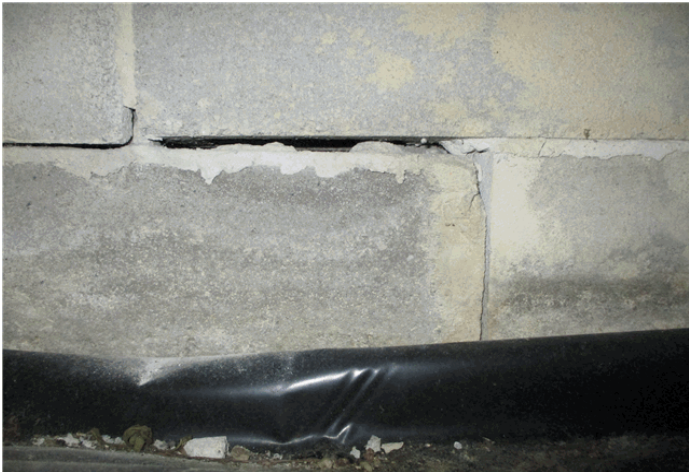
58) Foundation Conditions

R

Cracks of 1/4" or more was observed in the foundation wall at several locations.. The cracking implies that foundation movement has occurred. Recommend further review and inspection by a qualified foundation / masonry contractor and / or a qualified geo-technical or structural engineer. Past or future movement may be related to soils and geological issues, which are beyond the scope of our expertise.

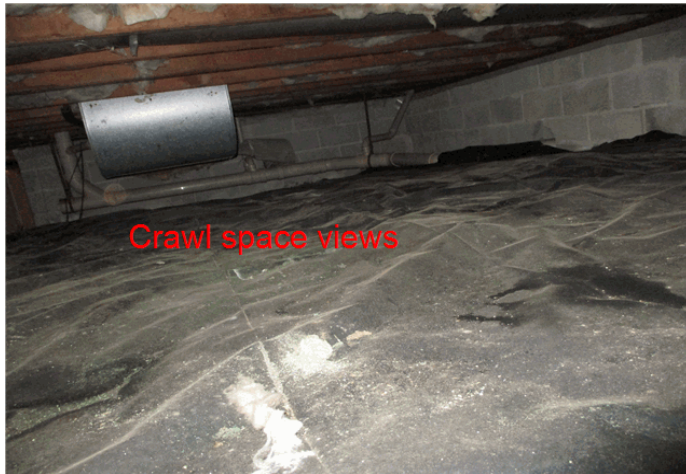
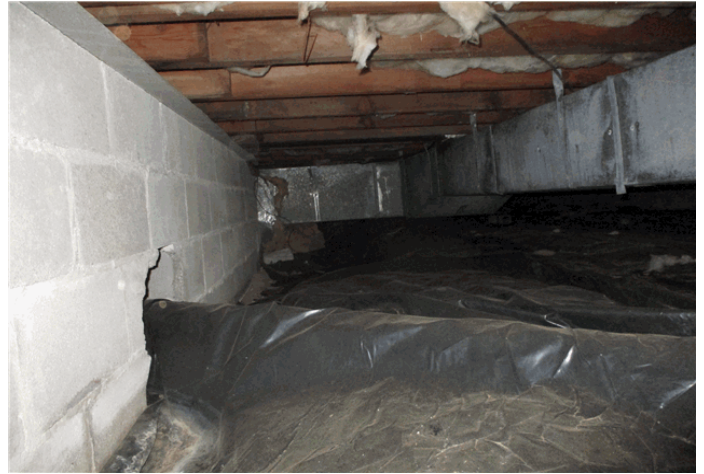
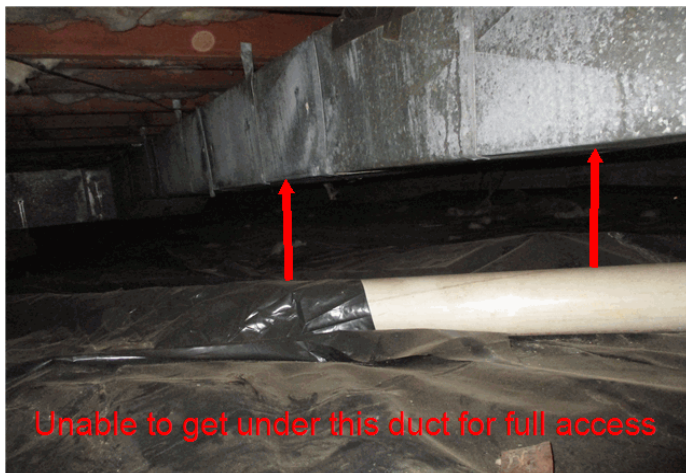
59) Crawl Space Conditions

The visible and accessible portions of the crawl space appeared to be in serviceable condition at the time of the

inspection. HVAC duct work prevented full access of the crawl space. Installing a new access at the right side of the crawl space is recommended.
