## SUMMARY

320 School House Rd, Efland, NC  
27243

Lisbeth Hickey  
10/07/2025

Brad Williams  
NCHILB License #4589  
360 Inspection Services, LLC  
984.244.1125  
[brad@360inspects.com](mailto:brad@360inspects.com)

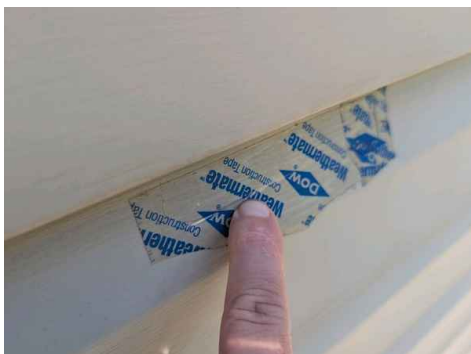
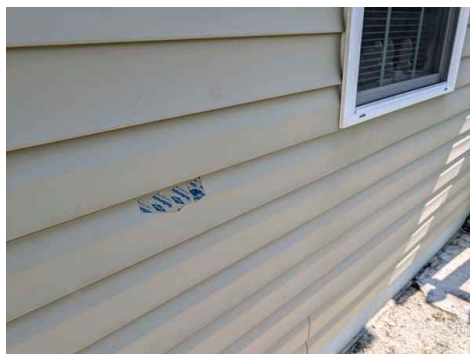
##### LEFT SIDE WALL

#### SIDING DAMAGED

Siding has been damaged at the noted location(s). Damaged siding should be repaired or replaced by a qualified contractor to prevent water penetration and damage to the home.

Contact a qualified siding specialist.

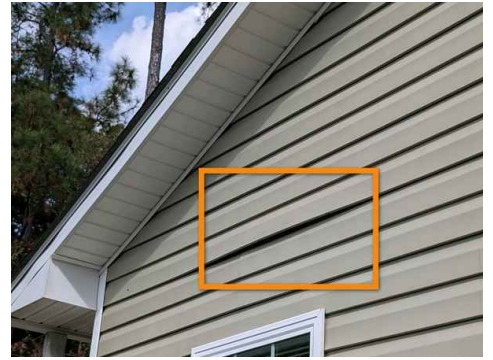
##### LEFT SIDE WALL

#### LOOSE SIDING

Siding is loose at the noted location(s). Concerns are that this can permit water intrusion into the wall and cause hidden damage to the building structure. Siding should be properly secured by a qualified vinyl siding contractor.

Contact a qualified professional.

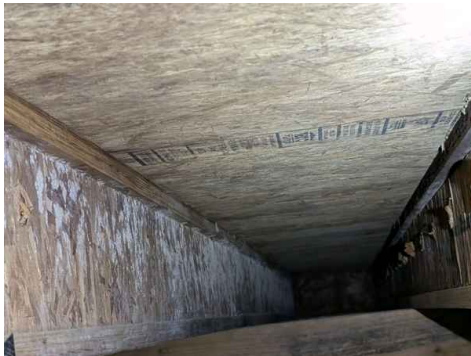
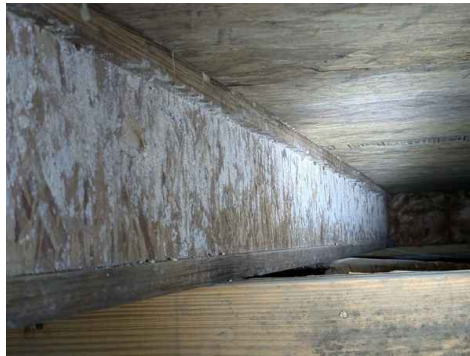
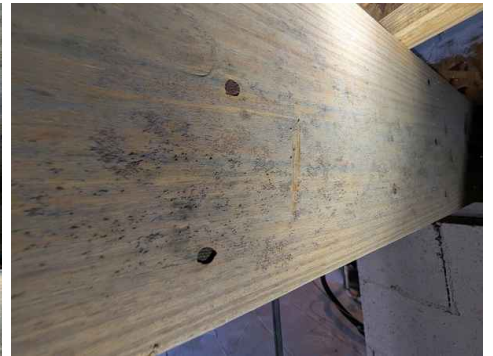
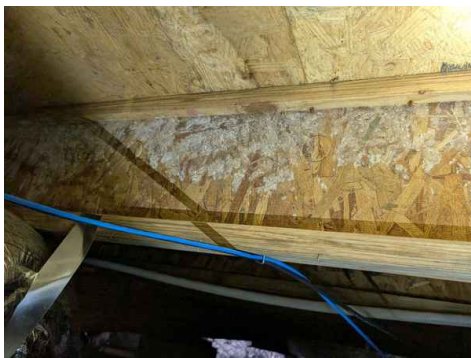
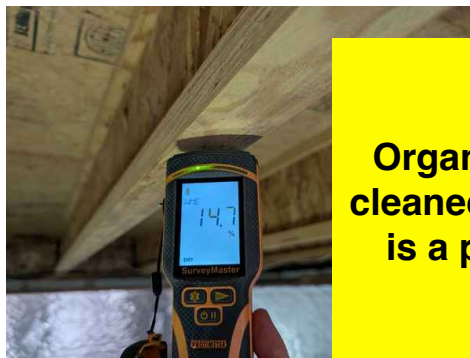
#### FLOOR STRUCTURE - LIGHT TO MODERATE ORGANIC GROWTH

Light to moderate organic growth was found on floor framing in the crawl space, with the more moderate accumulation noted on the left side of the crawlspace. Fungal growth is typically the result of past or present excessive moisture levels under the home. Moisture levels in floor framing were acceptable and no evidence of resulting damage was found, however if moisture is allowed to accumulate the growth of wood destroying fungus can result in significant damage to the building structure. If growth progresses, any significant growth should be removed by a qualified contractor.

Contact a qualified environmental contractor

**Organic growth has now been cleaned (10/21/25) by RCS which is a professional crawl space company.**

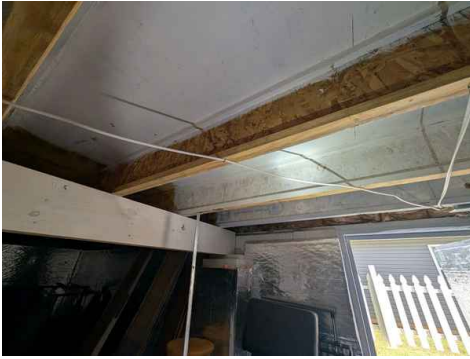
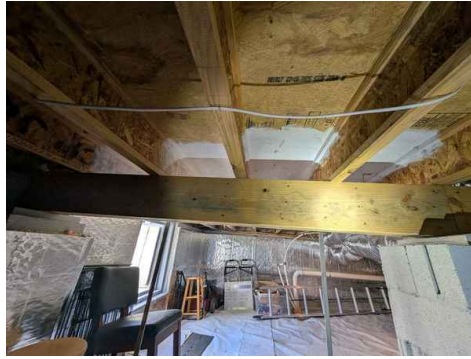
##### FRONT AND FRONT RIGHT CRAWLSPACE

#### FLOOR STRUCTURE - GENERAL COMMENTS

White paint was noted on i-joists and subfloor at the noted locations. The reason was not apparent. No signs of damage were noted, but you may want to inquire with the owner or the builder to determine why these areas are painted for your information so that you can convey that info to any potential buyer who may ask.

Recommendation  
Contact the seller for more info

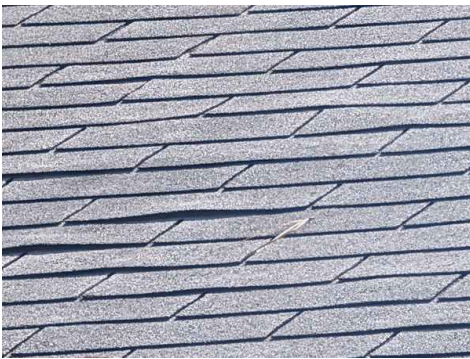
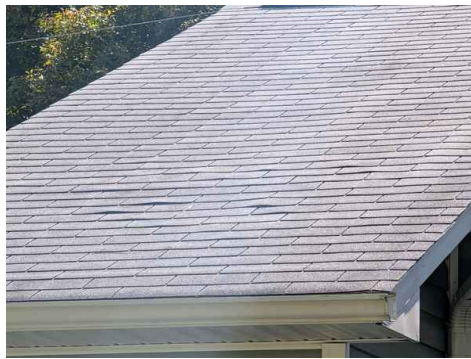
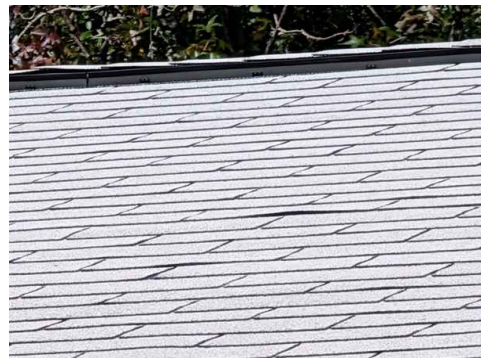
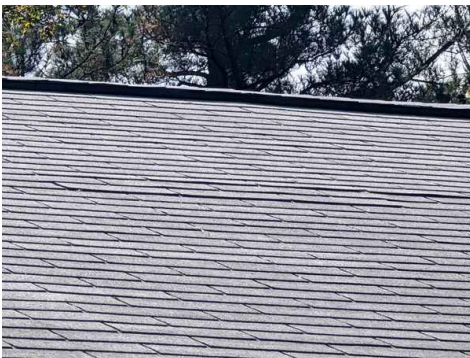
###### FRONT AND REAR ROOF

##### **ROOF - LIFTED SHINGLES (MINOR)**

Lifted shingles were found at the noted location(s) . The concern is that these can be subject to wind damage and leaks. Any lifted shingles should be repaired by a professional roofing contractor.

Recommendation  
Contact a qualified roofing professional.

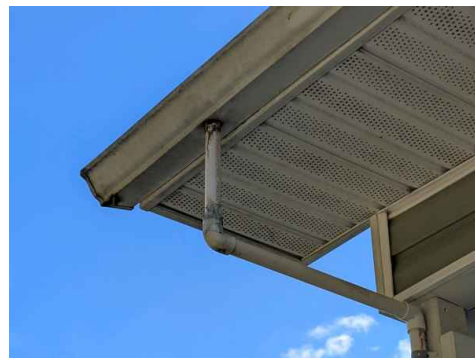
###### REAR WALL

##### **GUTTERS - DRAIN PIPES, GENERAL COMMENT**

A makeshift downspout made out of PVC pipes has been installed at the rear gutter. The reason is not known, but it is possible that the gutter without a downspout at that end was overflowing/dripping/not pitched properly to the downspout at the left rear and the homeowner added the makeshift downspout in response. The gutter should be evaluated by a qualified contractor to determine if the makeshift downspout can be removed and if the gutter itself is pitched properly to manage rainwater and roof drainage.

Contact a qualified professional.

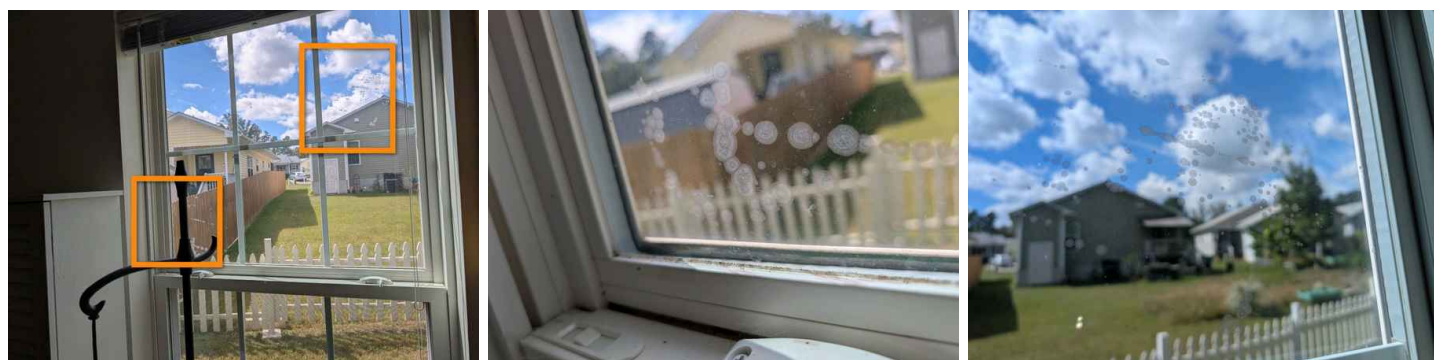
##### KITCHEN/DINING AREA

#### **WINDOWS - FAILED SEAL**

Thermal (hermetic) seals on insulated glass windows have failed on windows at the noted location(s). Lost seals can reduce the thermal efficiency of the windows and in extreme cases can reduce visibility through the glass. Any bad glass should be replaced by a window and glass professional. The detection of lost seals can be extremely difficult due to differences in temperature, lighting and the condition of the windows. It is not guaranteed that all lost seals can be found. For a more thorough evaluation of any suspect windows you should consult with a window and glass professional.

Contact a qualified window repair/installation contractor.

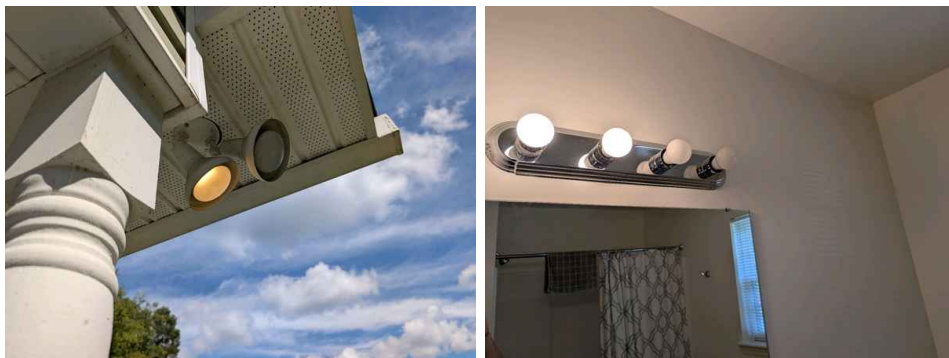
##### FRONT PORCH FLOODLIGHT, MULTIPLE BULBS IN BOTH BATH VANITY LIGHT FIXTURES

#### **LIGHT INOPERABLE**

The lights in the noted location(s) did not function when tested. Replace the bulbs and retest. If the lights do not function, the fixtures and associated wiring should be investigated by a licensed electrical contractor and repaired as needed for safe and proper operation.

Contact a qualified electrical contractor.

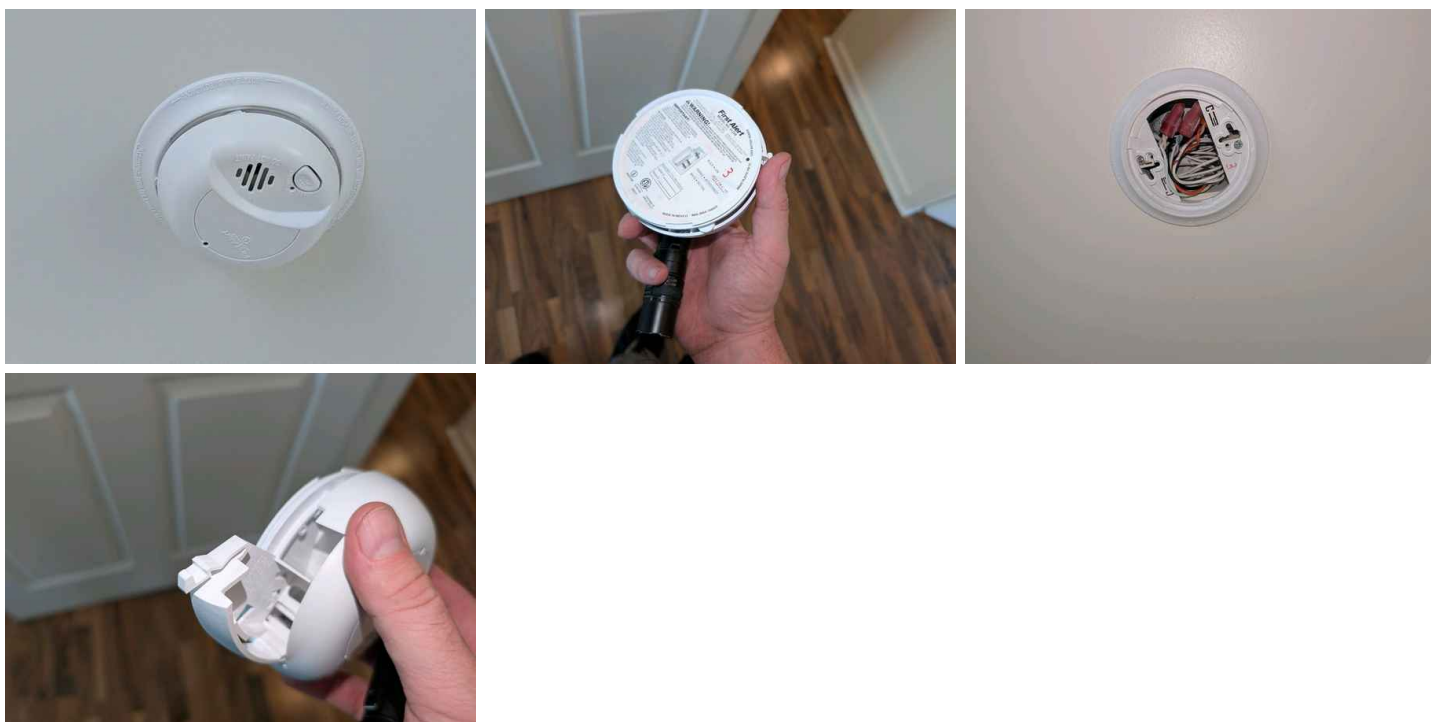
### **SMOKE ALARMS - NOT FUNCTIONAL, NOT POWERED**

A working smoke alarm was not found in the home. Smoke alarms are installed in bedrooms and hallways within 15 feet of bedrooms, but do not appear to have ever been connected to the circuit for power and no backup battery was ever installed, leaving the smoke alarms inoperable and occupants at risk. Smoke alarms should be connected to the powered circuit and have backup batteries installed for fire safety.

Contact a qualified electrical contractor.

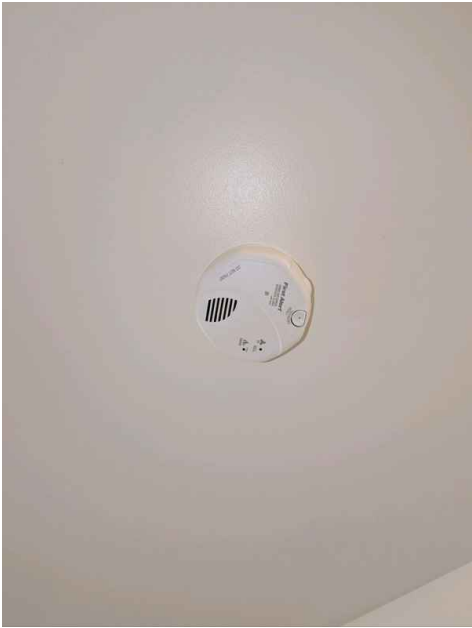
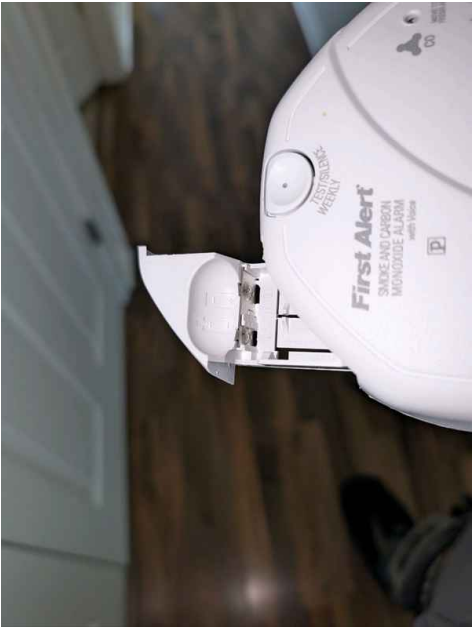
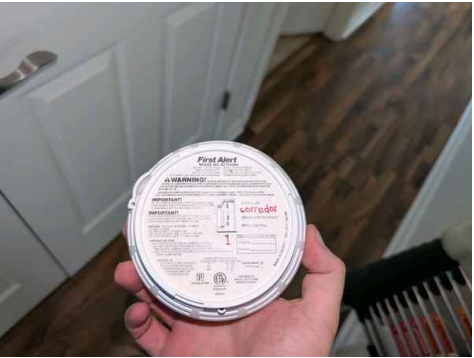
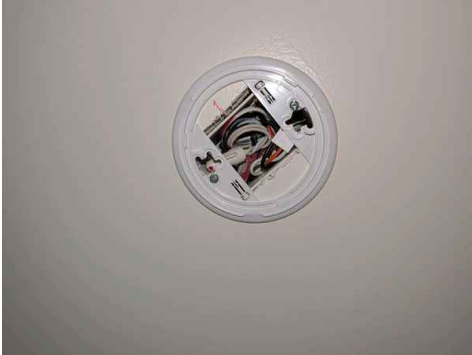
### **CARBON MONOXIDE ALARMS - NOT FUNCTIONAL, NOT POWERED**

A working carbon monoxide alarm was not found in the home. A combination Smoke/Carbon Monoxide alarms is installed in the hallway within 15 feet of bedrooms, but does not appear to have ever been connected to the circuit for power and no backup battery was ever installed, leaving the carbon monoxide alarm inoperable and occupants at risk. Carbon Monoxide alarms should be connected to the powered circuit and have backup batteries installed for fire safety.

Contact a qualified professional.
