# A Buyer's Choice **Home Inspections**

## PROPERTY INSPECTION REPORT

660 32nd Ave SE Apt 20, Albany, OR 97322

Date of Inspection: 11/1/2025 Time: 8:00 AM

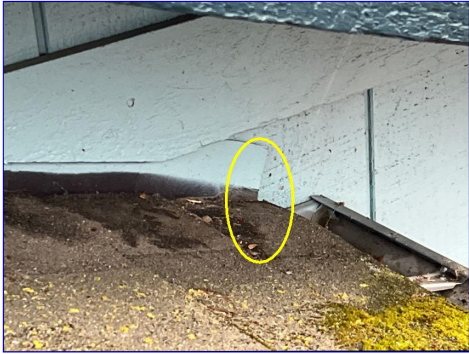
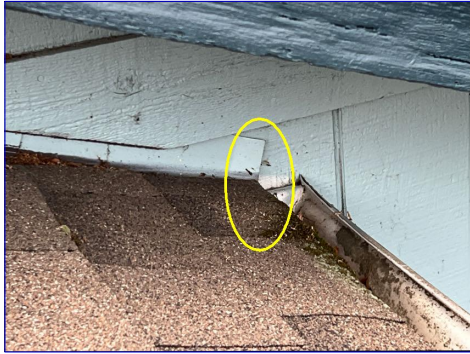
| Roof | | |
|---|---|---|
| Page 10 Item: 3 | Roof Flashing | <ul style="list-style-type: none"><li>Undersized kickout flashing (also called diverter flashing) noted. Kickout flashing should be present anywhere a roof and exterior wall intersect, where the wall continues past the lower roof-edge and gutter or where gutters terminate at the side of a chimney.</li></ul> |
| Undersized diverter flashing | Undersized diverter flashing | Proper diverter flashing example* |

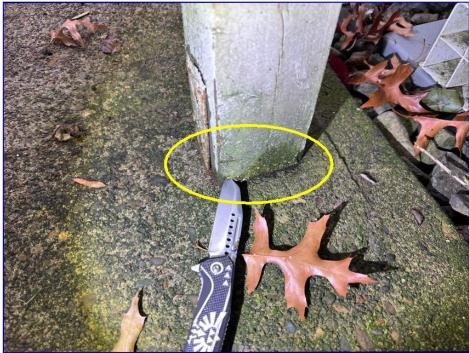
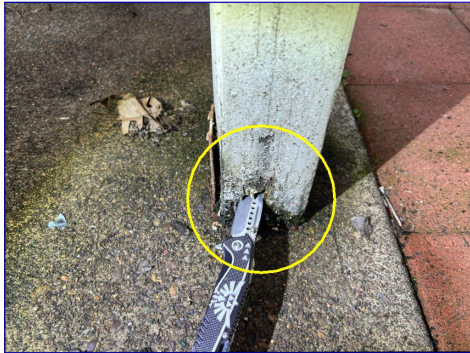
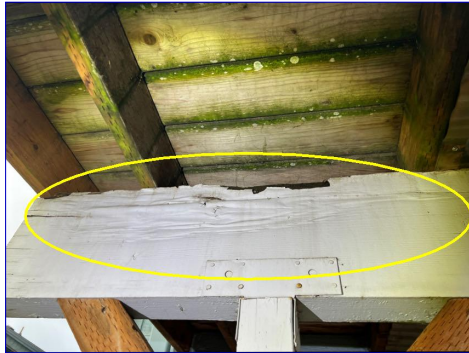
| Roof | | |
|---|---|---|
| Page 12 Item: 10 | Deck/Balcony | <ul style="list-style-type: none"><li>Moisture damage and wood rot were observed in multiple areas, which may be compromising the structural integrity of the balcony. Recommend evaluation by a licensed contractor to determine the extent of the damage and perform any necessary repairs or replacements.</li><li>Guardrail is loose and should be secured.</li></ul> |
| Moisture damage/wood rot | Moisture damage/wood rot | Moisture damage/wood rot |

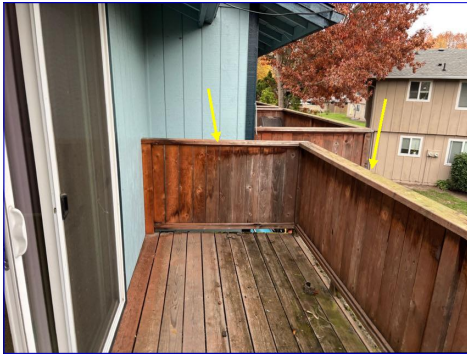
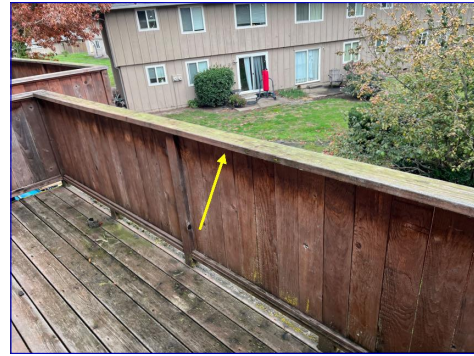
Loose guardrail

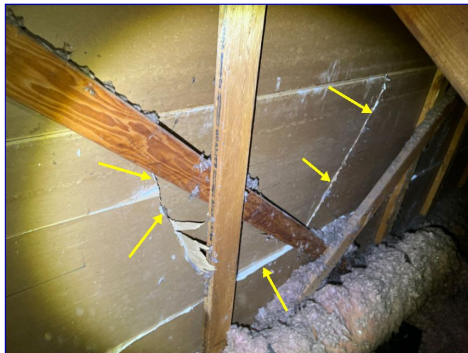
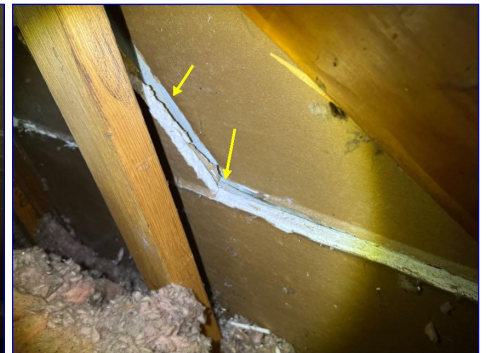
| Page 13 Item: 1 | Attic Observations | • Fire separation wall between units is damaged. Recommend review by a qualified, licensed contractor for repairs as necessary for safety. |

Fire separation between units is compromised

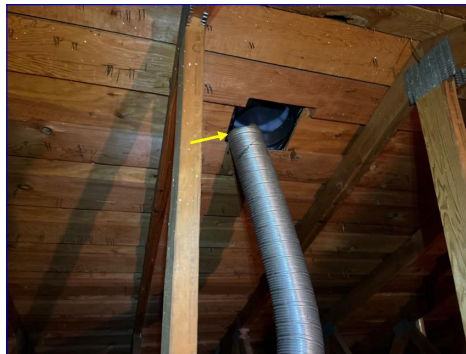
| Page 14 Item: 6 | Attic General Comments/Observations | • Second floor bathroom vent fan is improperly vented near or at a hooded roof vent. Bathroom exhaust vents should be sealed to the exterior and vented through hooded vents manufactured for this purpose. Correction advised. |

Bathroom exhaust vent

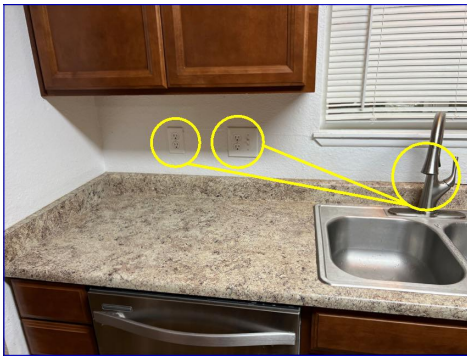
| Page 17 Item: 2 | 120 / 240 VAC Branch Circuits | • Electrical receptacle within six feet of a water source is not <b>GFCI</b> protected. Recommend having a licensed electrical contractor repair for safety. |

Not **GFCI** protected (kitchen)

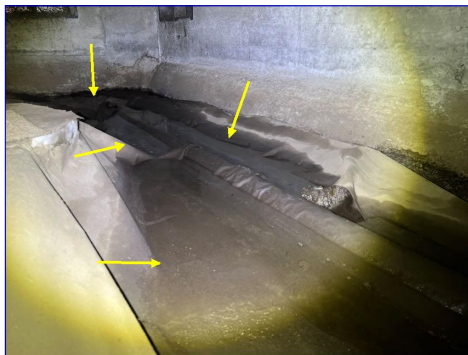
- Sitting water observed in the crawlspace at the main **DWV** waste disposal line. The inspector was unable to determine the cause of the water at the time of inspection. It is possible that there is or was a waste disposal line leak. Recommend referring to sellers disclosure and/or having a licensed and qualified plumber evaluate to determine the cause and prevent any further issues.

Sitting water

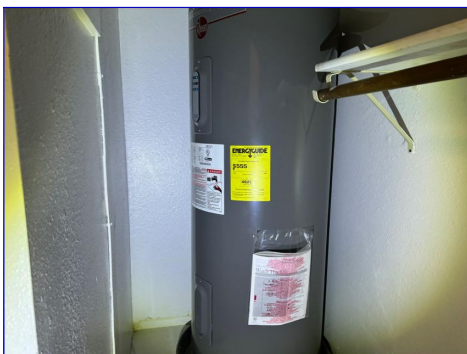
- The water heater was observed leaning and is not equipped with the required seismic strapping. Current standards require water heaters to be properly secured with seismic straps to prevent movement or tipping during an earthquake. Recommend correction and securing of the unit by a qualified plumber or contractor.

Missing seismic straps

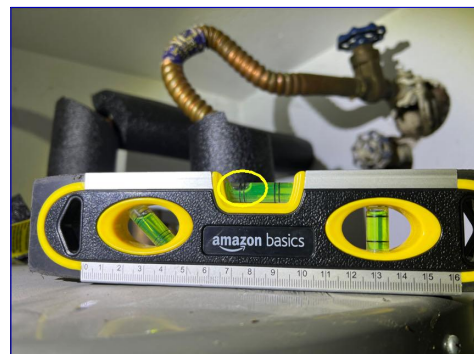
Unit is leaning

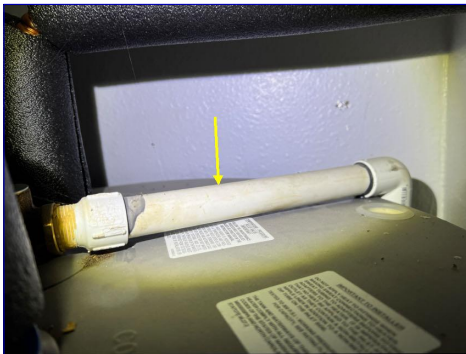
| Page 23 Item: 5 | TPR Valve | <ul style="list-style-type: none"> <li>• <b>TPR valve</b> / piping should be constructed of an approved material, such as CPVC, copper, polyethylene, galvanized steel, polypropylene, or stainless steel. <b>PVC</b> and other non-approved plastics should not be used since they can easily melt.</li> <li>• TPR discharge pipe was observed to be misaligned with the drip pan. In the event the unit needs to utilize the Temperature Pressure Relief (TPR) valve, the water will most likely spray to the surrounding areas. Recommend having a licensed contractor replace the discharge pipe with proper material and realign with drip pan.</li> </ul> |

PVC discharge pipe

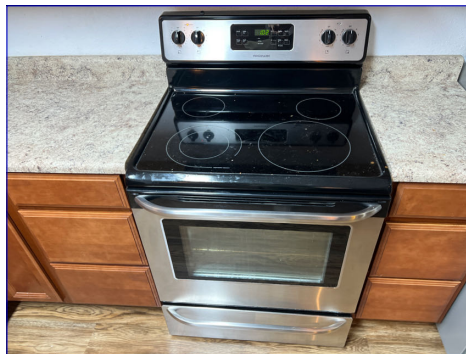
| Page 25 Item: 8 | Cooktop/Range | <ul style="list-style-type: none"> <li>• Range tips which is a safety hazard. Recommend installing anti-tip device for safety.</li> </ul> |

Range tips

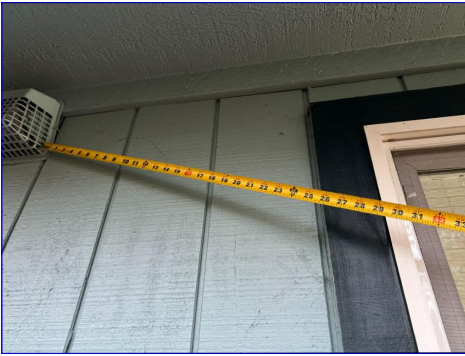
| Page 28 Item: 4 | Dryer Supply & Vent | <ul style="list-style-type: none"> <li>• Dryer vents shall terminate not less than 3 feet in any direction from openings into buildings.</li> <li>• Dryer exhaust vents should not terminate with a screen, as this can lead to lint accumulation and restrict airflow. Recommend removing the screen and cleaning the dryer exhaust to help reduce the risk of a potential fire hazard.</li> </ul> |

Dryer vent termination too close to opening

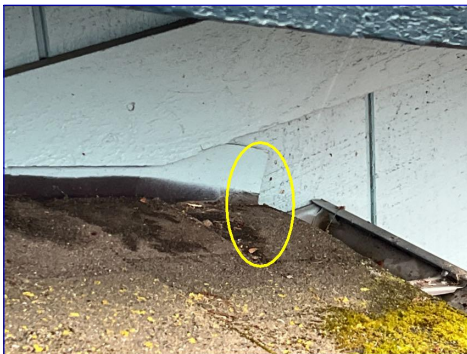
- **Drip edge** and diverter (a/k/a kickout) flashing present.
- **Undersized kickout flashing** (also called diverter flashing) noted. Kickout flashing should be present anywhere a roof and exterior wall intersect, where the wall continues past the lower roof-edge and gutter or where gutters terminate at the side of a chimney.

Undersized diverter flashing

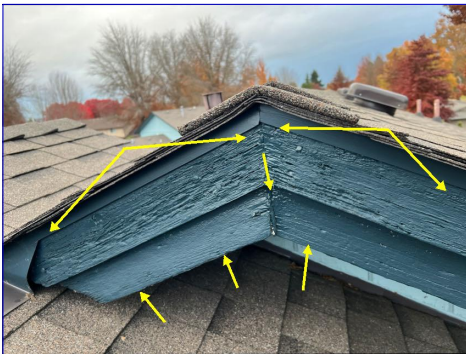
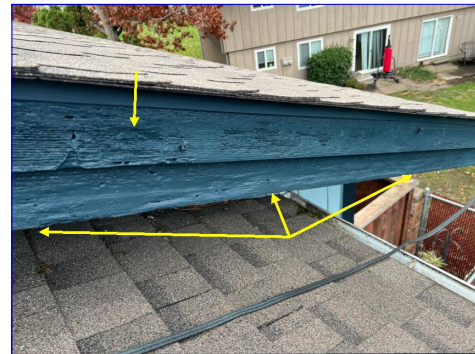
- Moisture damage, wood rot, observed. Recommend review for repair as necessary.

Moisture damage

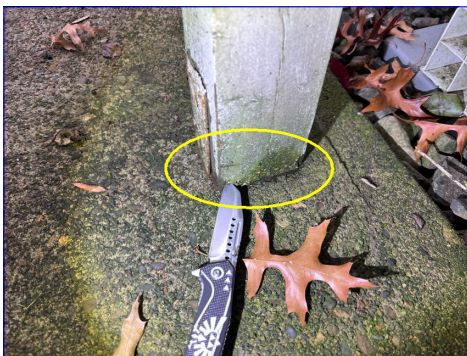
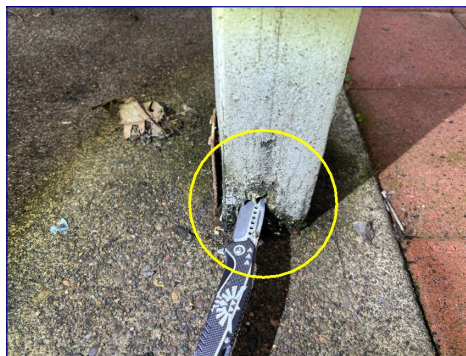
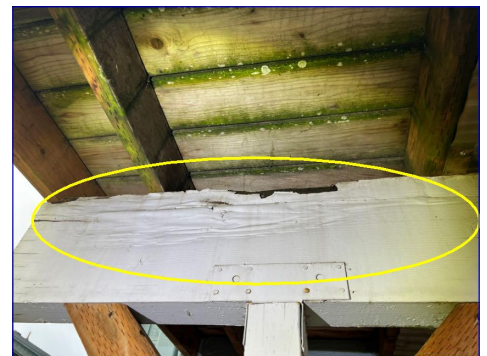
- Moisture damage and wood rot were observed in multiple areas, which may be compromising the structural integrity of the balcony. Recommend evaluation by a licensed contractor to determine the extent of the damage and perform any necessary repairs or replacements.
- Guardrail is loose and should be secured.

Moisture damage/wood rot

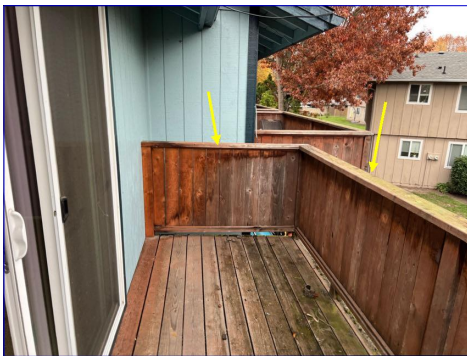
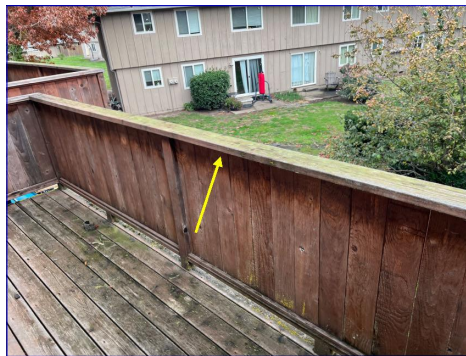
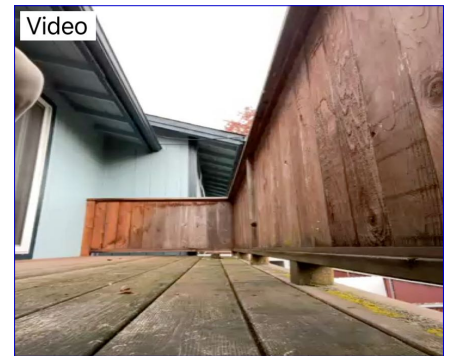
Loose guardrail

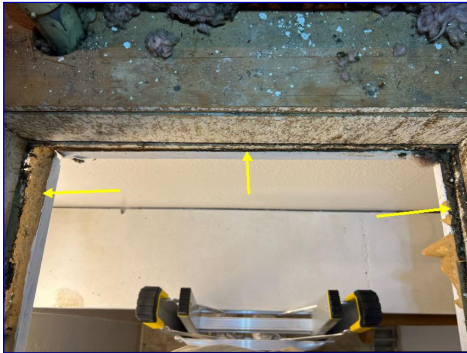
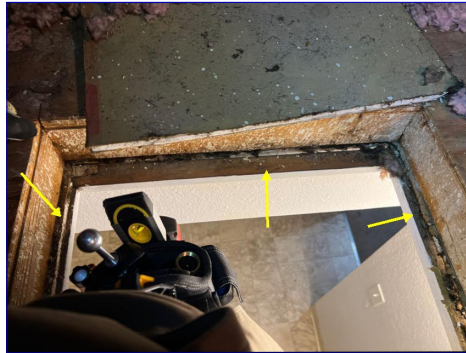
- No weatherstripping present around access panel. Recommend installing weatherstripping between the access hatch opening and trim. Without proper weatherstripping, warm, moist air escapes into the attic through the hatch greatly increasing the possibility for mildew and/or mold growth in the attic, particularly around the hatch opening.
- Fire separation wall between units is damaged. Recommend review by a qualified, licensed contractor for repairs as necessary for safety.

Missing weatherstripping

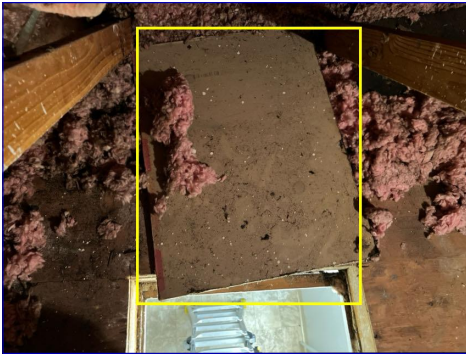
- Missing insulation over hatch door can cause enormous energy loss. Recommend adding insulation to cover hatch door and add weatherstripping around opening to maximize energy efficiency.
- Second floor bathroom vent fan is improperly vented near or at a hooded roof vent. Bathroom exhaust vents should be sealed to the exterior and vented through hooded vents manufactured for this purpose. Correction advised.

Missing insulation

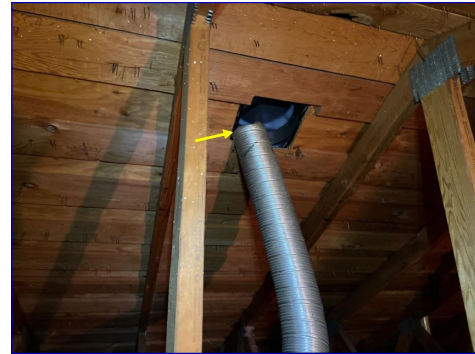
Bathroom exhaust vent

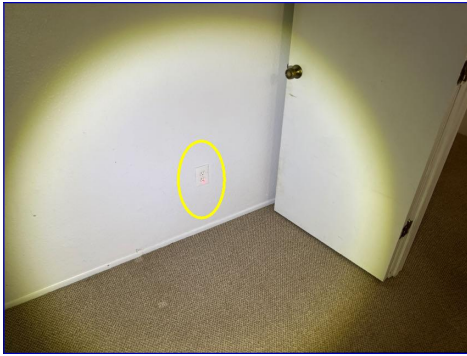
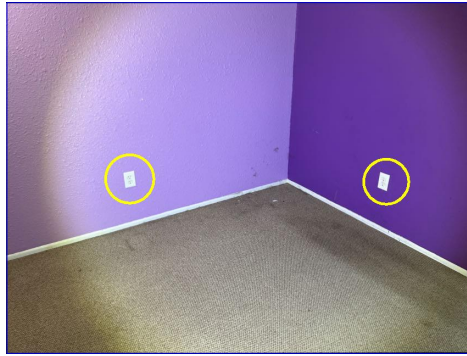
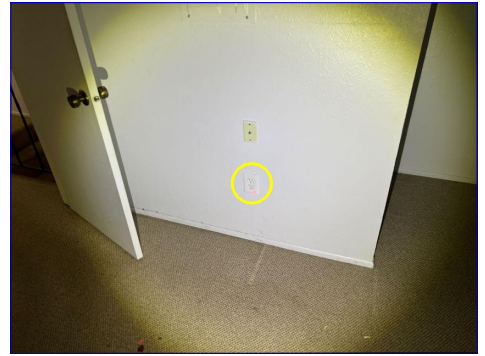
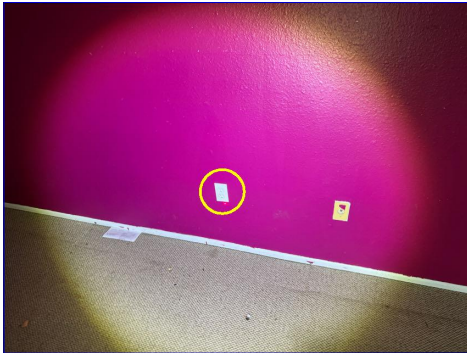
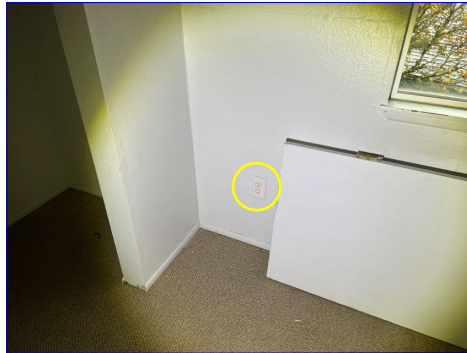
- Electrical receptacle in areas noted is/are loose and should be secured.
- Electrical receptacle within six feet of a water source is not **GFC** protected. Recommend having a licensed electrical contractor repair for safety.

Loose receptacle(s) (Bedroom 1)

Loose receptacle(s) (Bedroom 2)

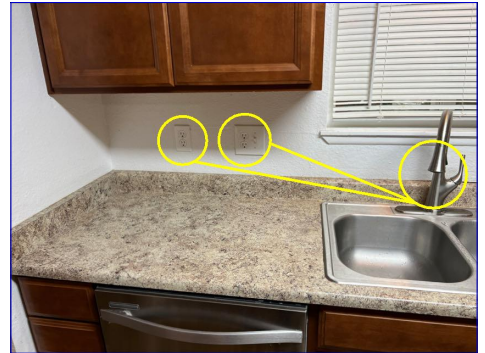
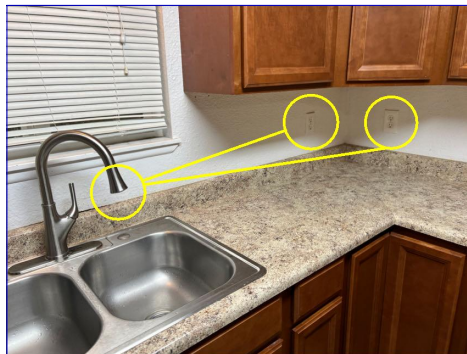
Not **GFC** protected (kitchen)

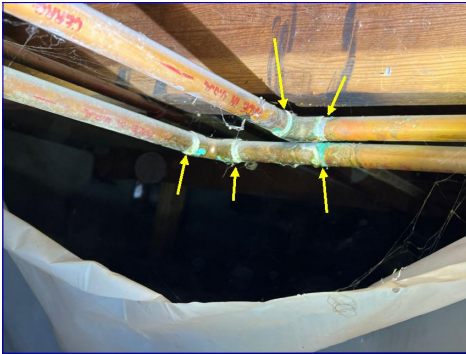
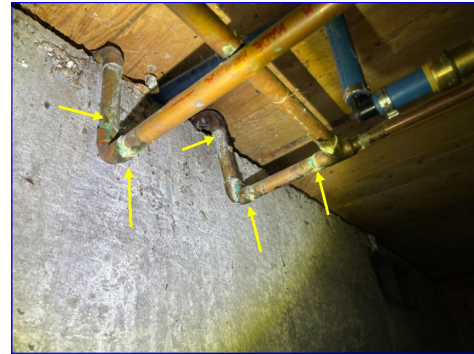
- Minor corrosion noted on supply lines in basement. Recommend monitoring.

Minor corrosion

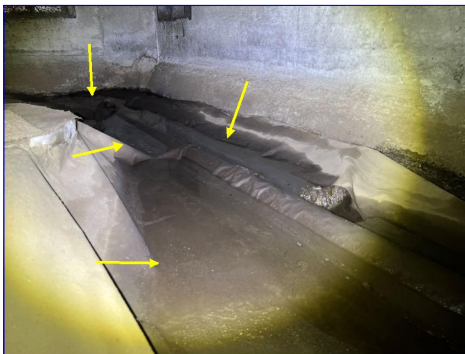
- Sitting water observed in the crawlspace at the main DWV waste disposal line. The inspector was unable to determine the cause of the water at the time of inspection. It is possible that there is or was a waste disposal line leak. Recommend referring to sellers disclosure and/or having a licensed and qualified plumber evaluate to determine the cause and prevent any further issues.

Sitting water

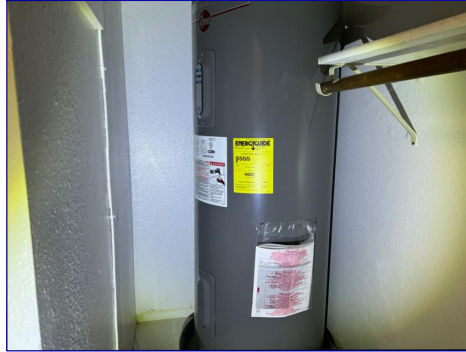
- The water heater was observed leaning and is not equipped with the required seismic strapping. Current standards require water heaters to be properly secured with seismic straps to prevent movement or tipping during an earthquake. Recommend correction and securing of the unit by a qualified plumber or contractor.

Missing seismic straps

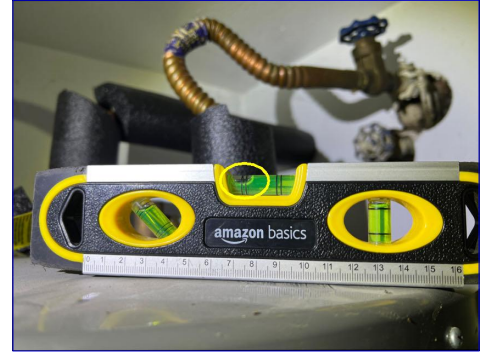
Unit is leaning

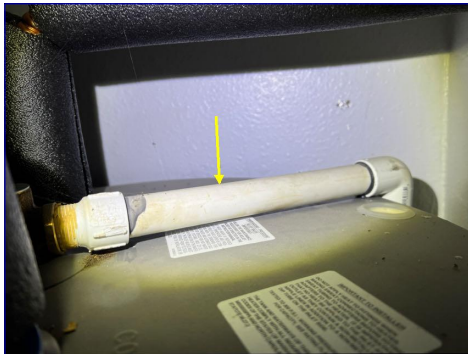
- **TPR valve** and extension/discharge pipe present.
- **TPR valve** / piping should be constructed of an approved material, such as CPVC, copper, polyethylene, galvanized steel, polypropylene, or stainless steel. **PVC** and other non-approved plastics should not be used since they can easily melt.
- TPR discharge pipe was observed to be misaligned with the drip pan. In the event the unit needs to utilize the Temperature Pressure Relief (TPR) valve, the water will most likely spray to the surrounding areas. Recommend having a licensed contractor replace the discharge pipe with proper material and realign with drip pan.

**PVC** discharge pipe

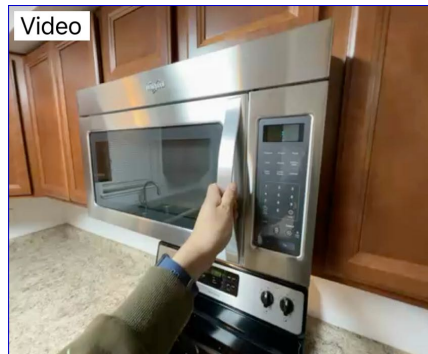
- Operated normal at the time of inspection.
- Loose or damaged handle and other components.

Loose/damaged components

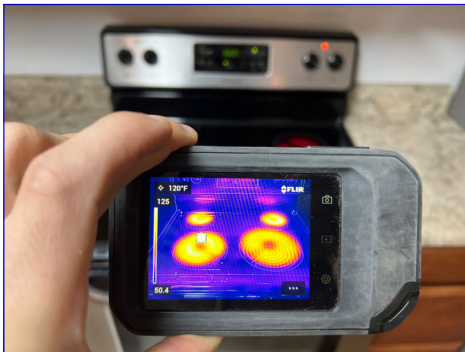
- Operated normal at the time of inspection.
- Range tips which is a safety hazard. Recommend installing anti-tip device for safety.

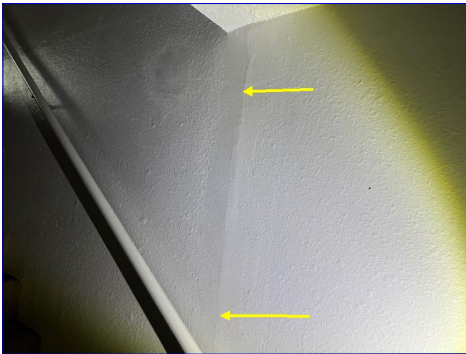
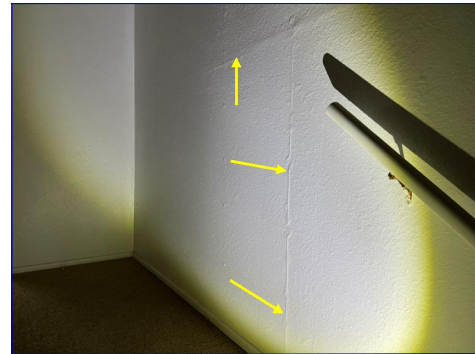
- Common cracks noted.

Common cracks

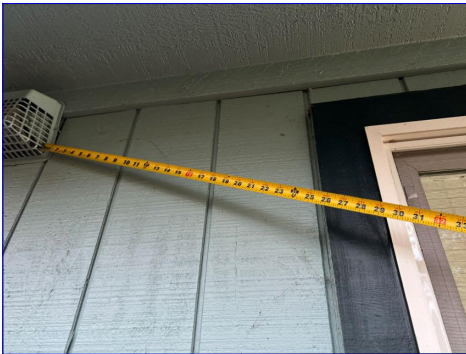
- Dryer vents shall terminate not less than 3 feet in any direction from openings into buildings.
- Dryer exhaust vents should not terminate with a screen, as this can lead to lint accumulation and restrict airflow. Recommend removing the screen and cleaning the dryer exhaust to help reduce the risk of a potential fire hazard.

Dryer vent termination too close to opening

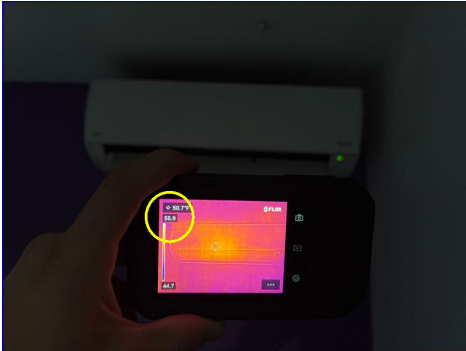
- Mini split system would not produce heat at the set temperature at the time of inspection. Recommend having a licensed and qualified contractor evaluate and make any necessary repairs.

Mini split not heating

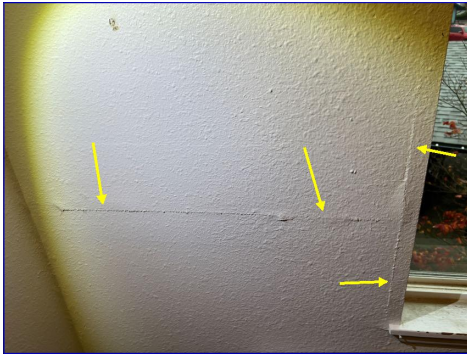
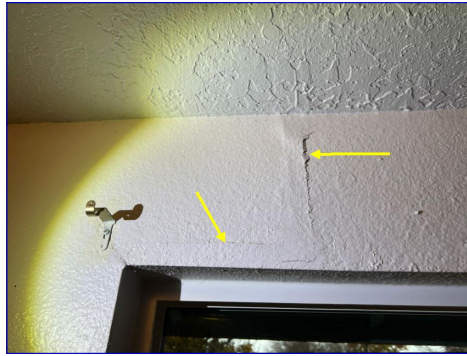
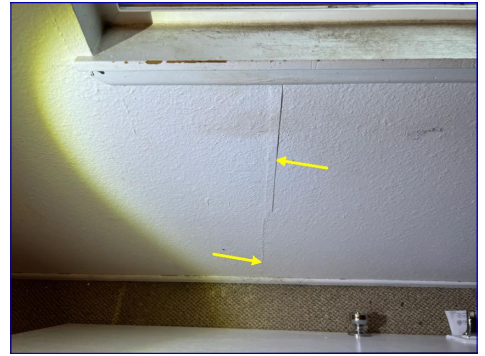
- Common cracks noted.

Common crack

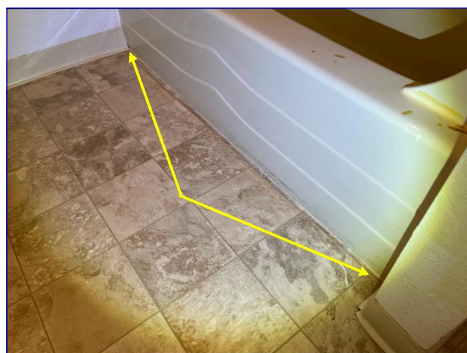
- Caulk needed around tub to prevent moisture intrusion to the floor and surrounding.

Caulking needed

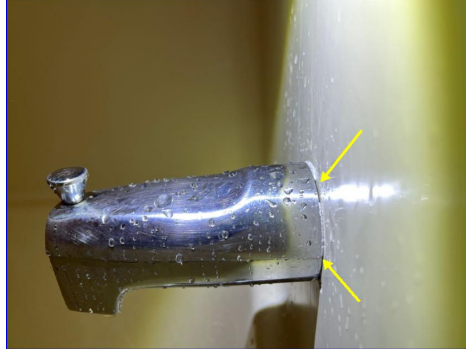
- Faucet drips.
- Faucet is not flush to the wall, which may result in water penetration to the interior structure and deterioration of the wall.

Tub faucet is not flush with wall

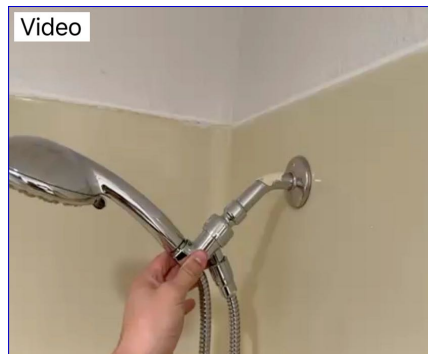
- Serviceable condition
- Faucet is loose in the wall.

Loose showerhead
