Subject: Structural Foundation Inspection Report (Level B)
Slab Foundation
1261 Emerald Circle, Southlake

1261 EMERALD CIRCLE, SOUTHLAKE, TX. 76092

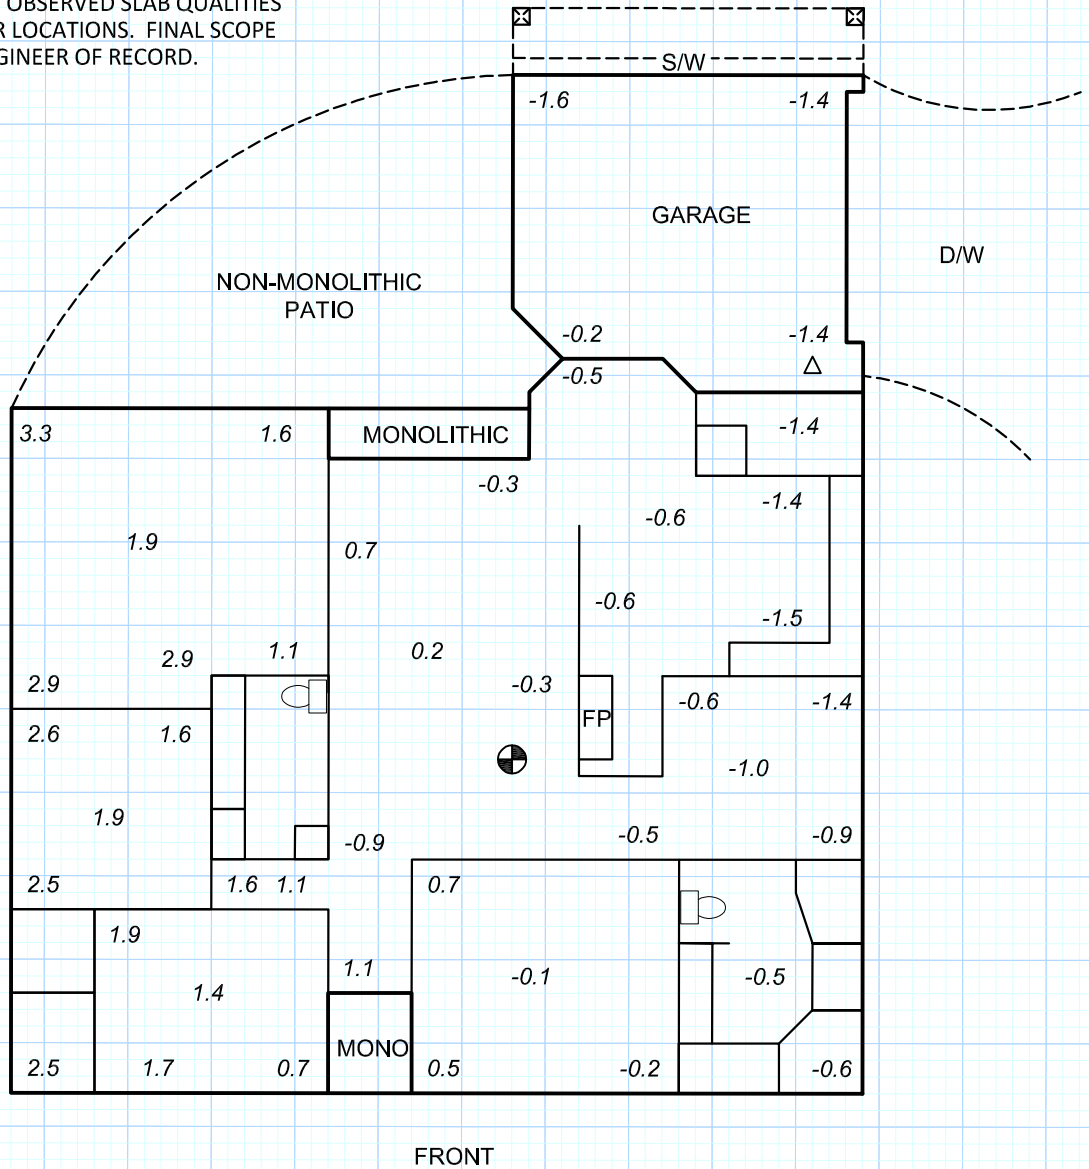
LIMITED REPAIR PLAN

Based on our visual observations of the structure and our review of the elevation map, it is our opinion that the structure is experiencing seasonal movement and the foundation is performing as intended. The home has not experienced any significant movement/settling since our last inspection in 2023.

- NO FOUNDATION REPAIRS RECOMMENDED AT THIS TIME.
- ADD ONE DOWNSPOUT EXTENSIONS TO THE CURRENT GUTTERING SYSTEM.
