Home Inspection Report

PROPERTY INSPECTED:
**4001 South Elliott Prairie Road
Woodburn, OR 97071**

Date of Inspection: 01/16/2026

Inspection No. 44631-2-5828

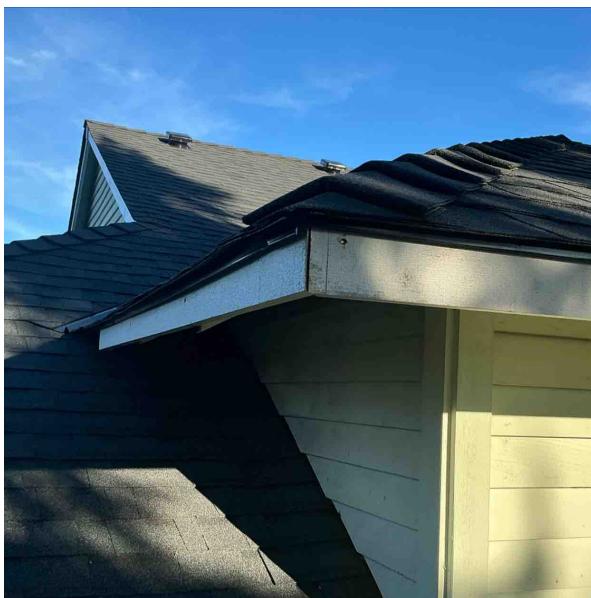
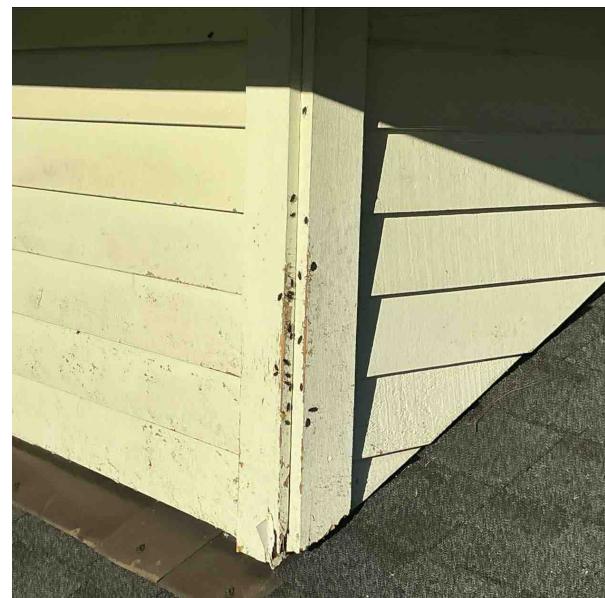
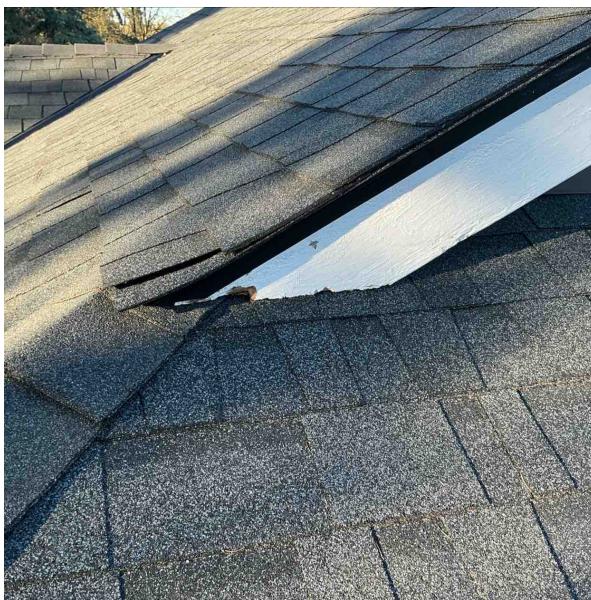
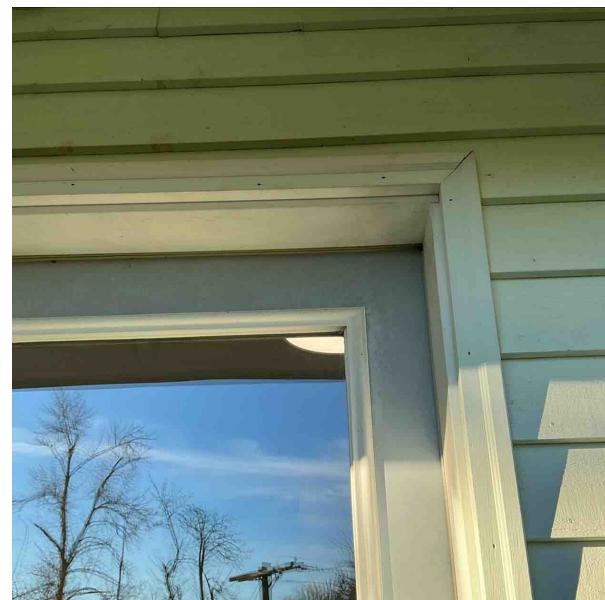
3.3 Wall Surface

3.3.1 Minor chipping/flaking paint was observed in various locations throughout the exterior, as well as minor cracked caulking and trim damage. Additionally, there were a number of trim nails that have not been sealed. Recommend caulking and paint touchup as needed to ensure exterior components are well sealed.

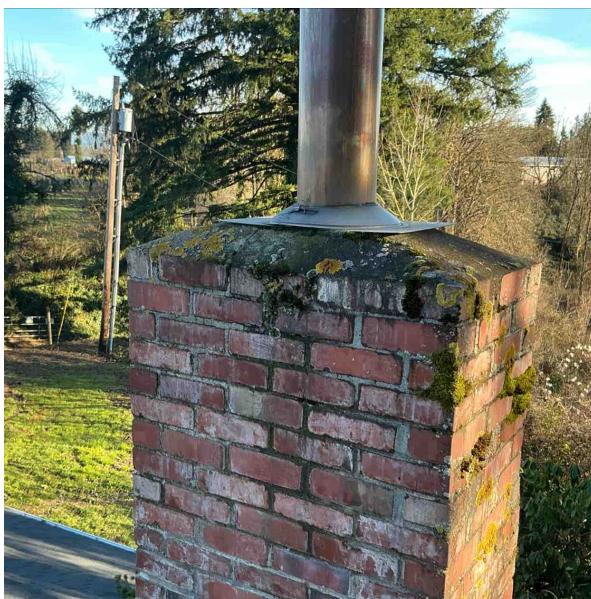
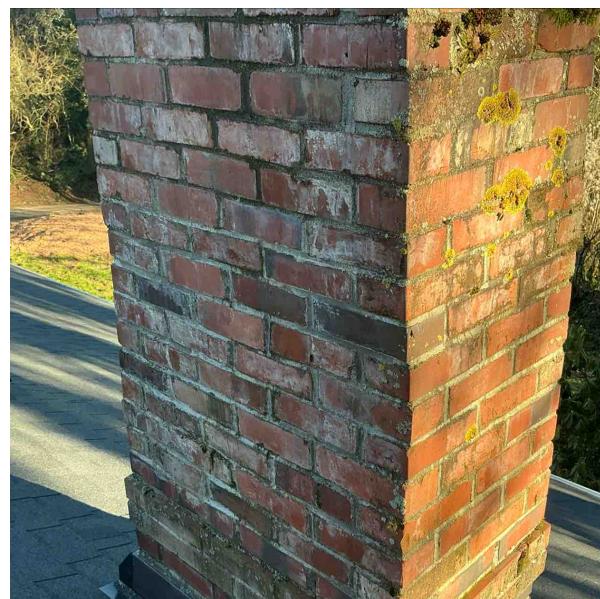
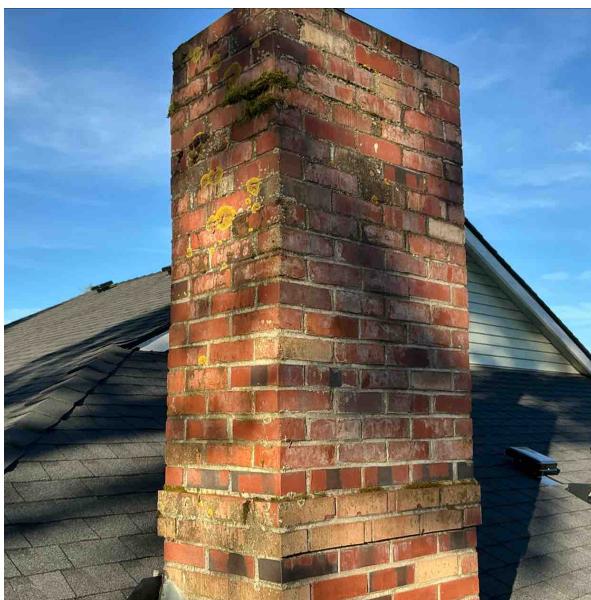
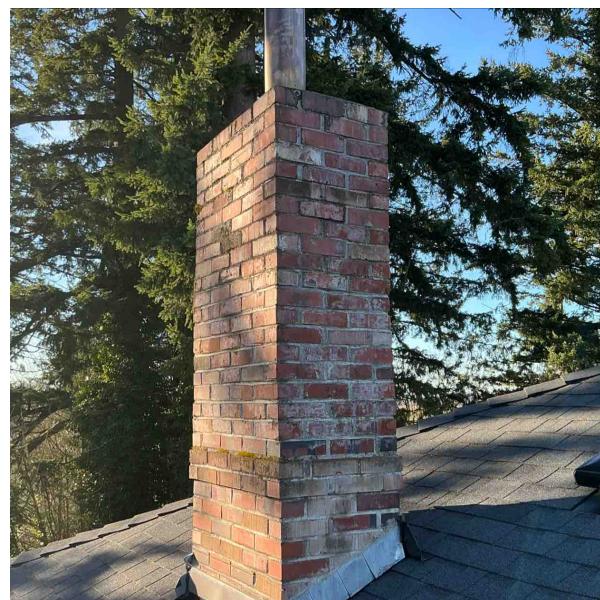
4.6 Chimney(s)

4.6.1 Chimney shows signs of general wear and deterioration. Cracking was observed in the mortar joints and crown, minor moss growth was observed, and wearing/cracking sealant noted around chimney flashing. Recommend further evaluation and correction by a licensed chimney professional.

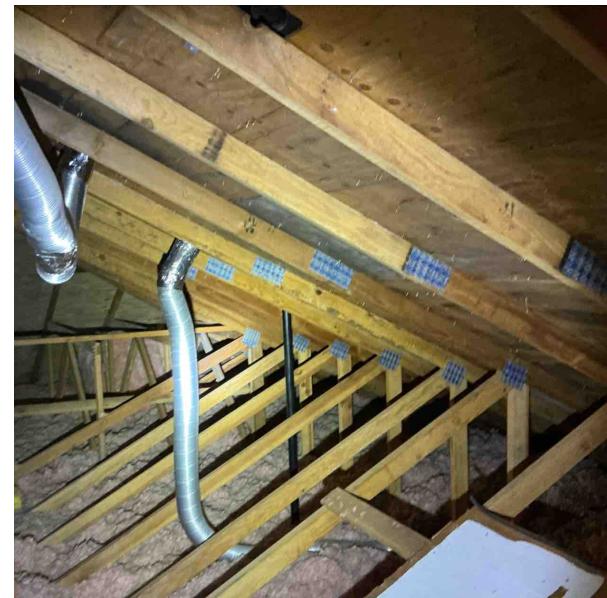
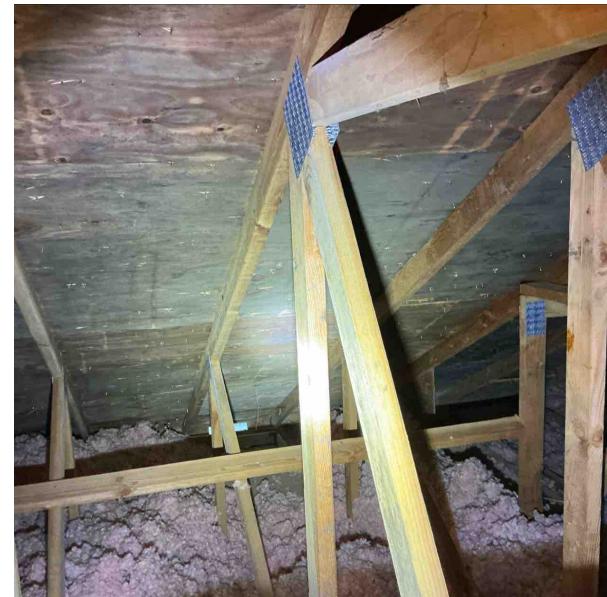
5.6 Sheathing

5.6.1 Mildew growth was noted on the interior roof sheathing in the attic, which is often times caused by a lack of proper ventilation throughout the attic. Have the ventilation checked by a qualified and licensed contractor, and the necessary corrections made to reduce the chance of further/future mildew growth or other ventilation related problems. The existing mildew growth should be treated and removed, post ventilation corrections, for health reasons. (The roof itself does appear to be newer, which may have corrected the ventilation issue.)

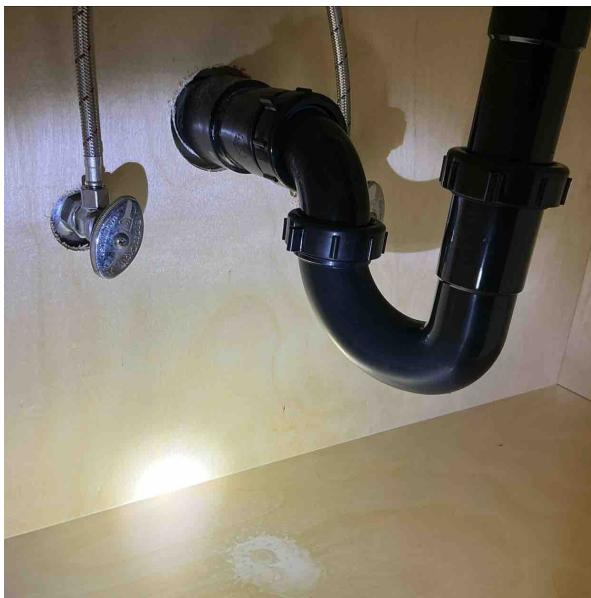
9.8.1 A leak was noted at the sink drain. Recommend correction by a qualified professional. (**Half Bathroom**)

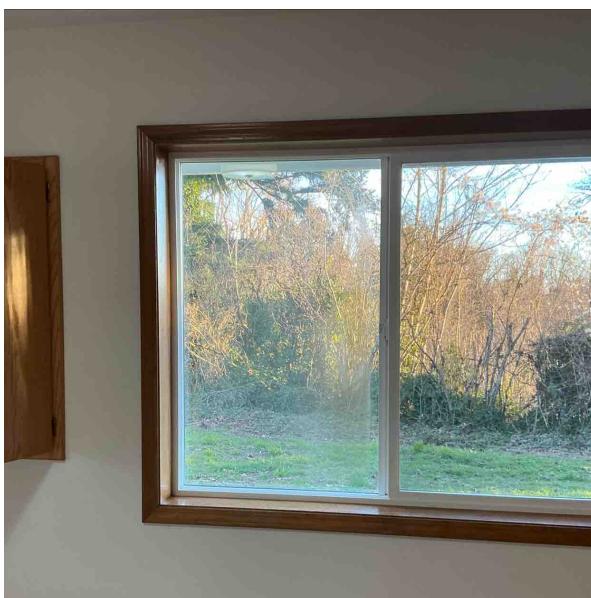
10.3.3 The south window has a broken thermopane seal causing moisture staining and discoloration. Recommend repair or replacement by a licensed contractor. (**South East Bedroom**)

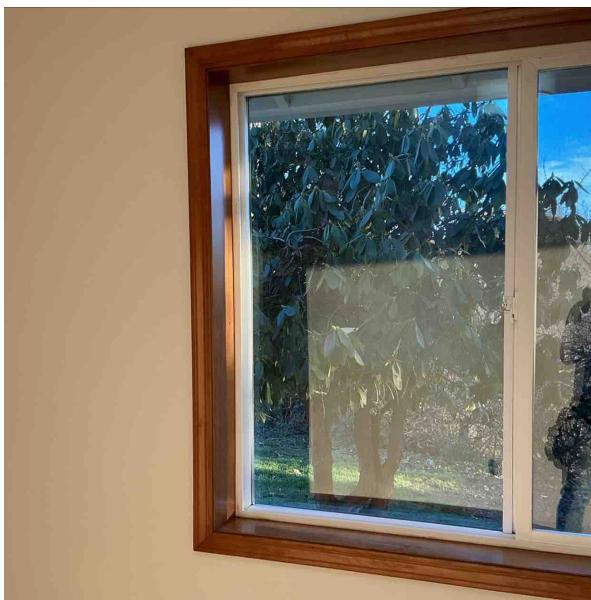
10.3.4 The south window has a broken thermopane seal causing moisture staining and discoloration. Recommend repair or replacement by a licensed contractor. (**South West Bedroom**)

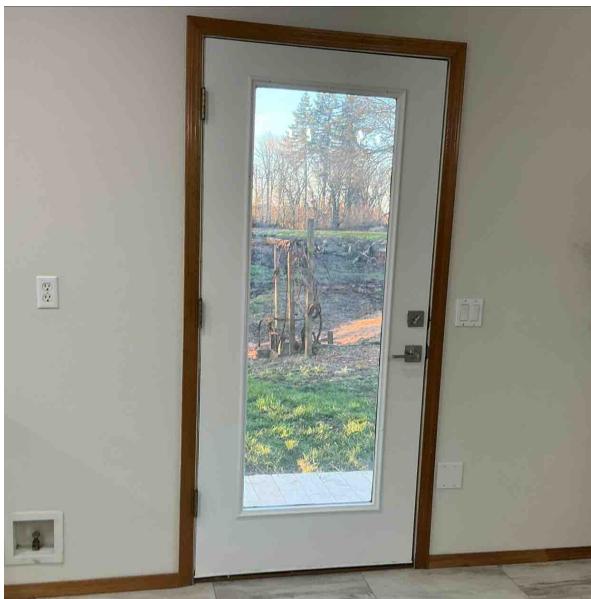
10.5.1 North dining room exterior door has a broken thermal pane window seal, causing fogging in between the panes of glass. Recommend repair or replacement by a qualified contractor. (**Dining room**)

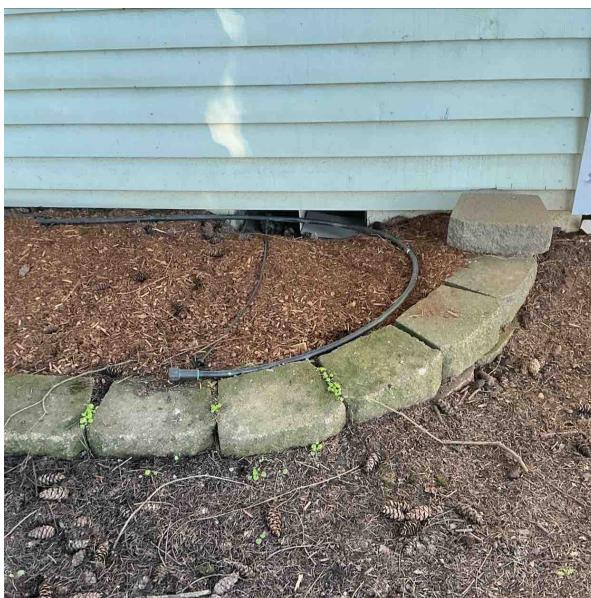
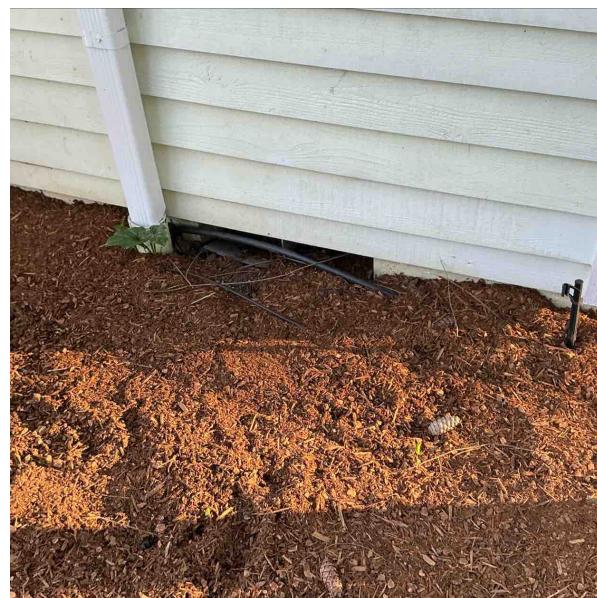
3.2.2 Some foundation vents are at or below ground level. This can allow water to enter the crawlspace. Grades require lowering approx 6" under these foundation vents & vent wells installed where necessary to hold back the dirt and allow water to flow away from foundation and not into the crawlspace.

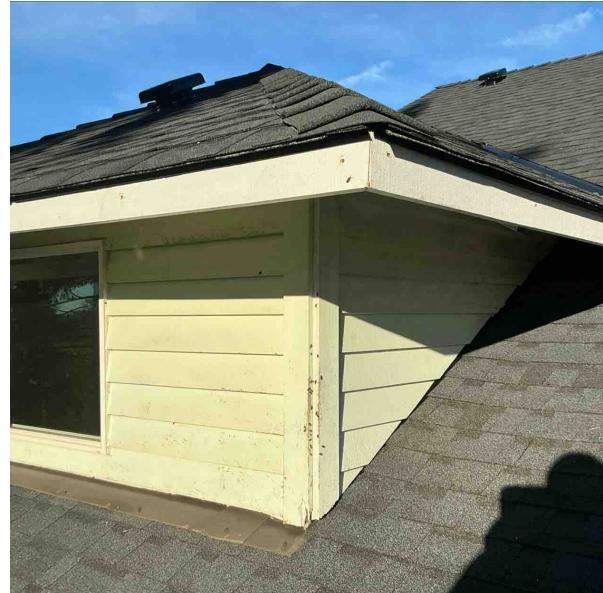
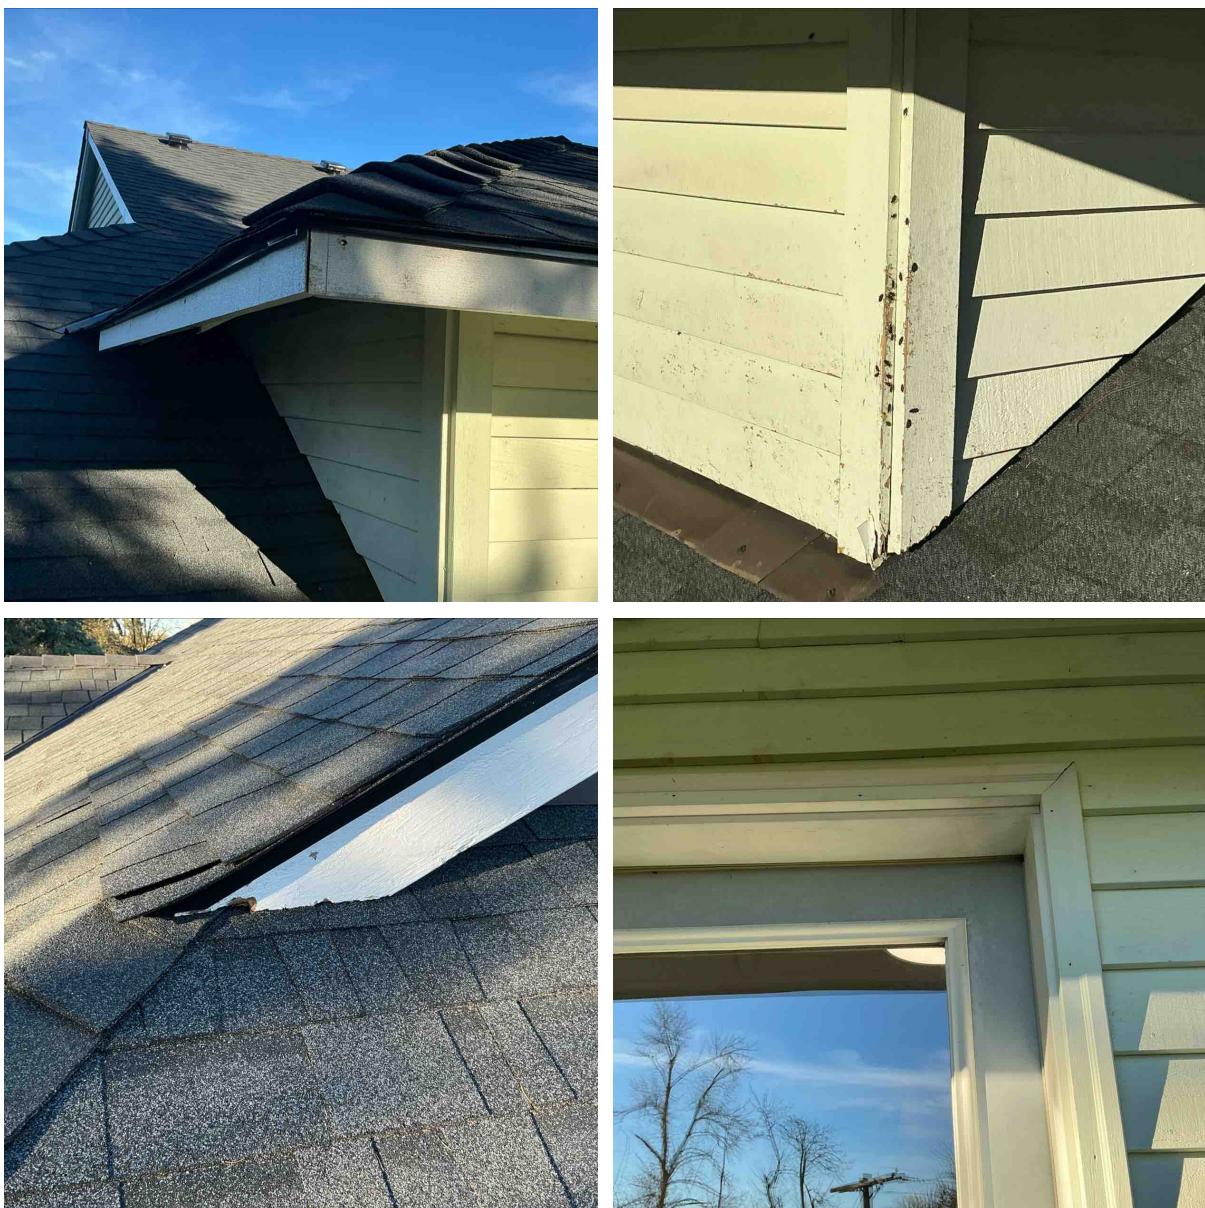
3.3 Wall Surface Wood siding

3.3.1 Minor chipping/flaking paint was observed in various locations throughout the exterior, as well as minor cracked caulking and trim damage. Additionally, there were a number of trim nails that have not been sealed. Recommend caulking and paint touchup as needed to ensure exterior components are well sealed.

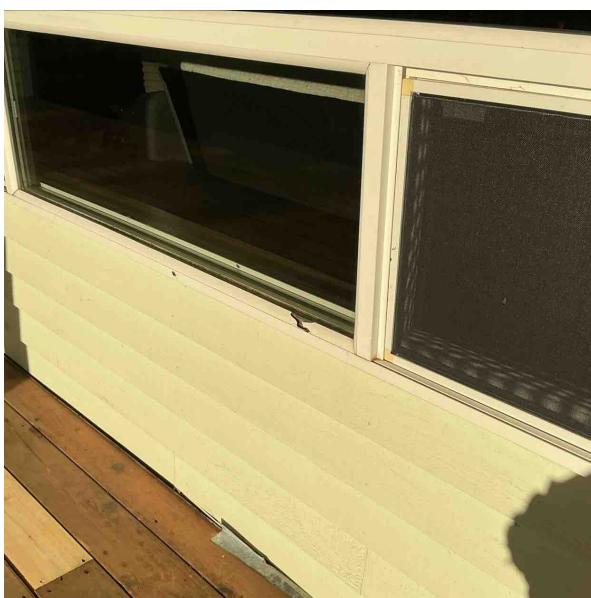
3.4.1 Damage was noted to the window frame of the large picture window on the west facing exterior wall. Recommend repair.

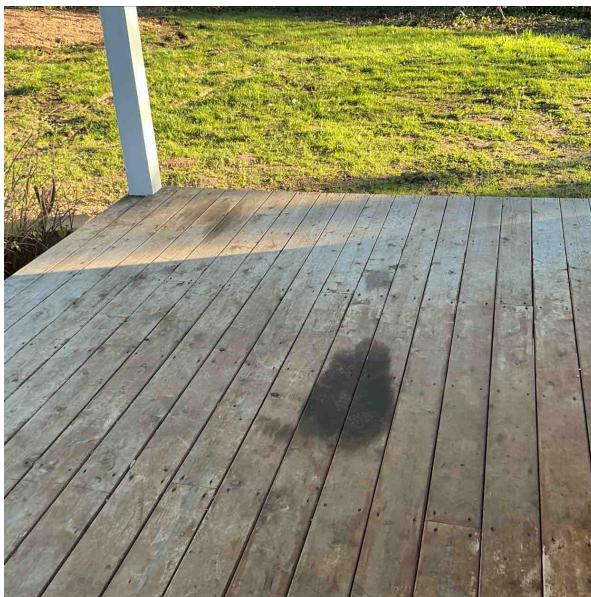
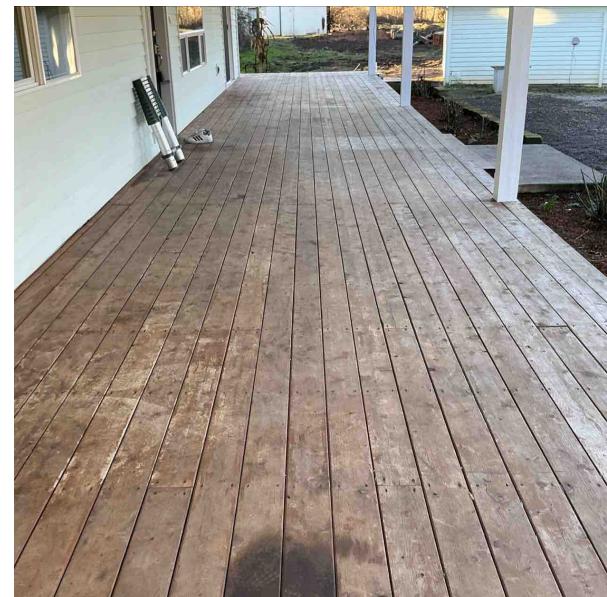
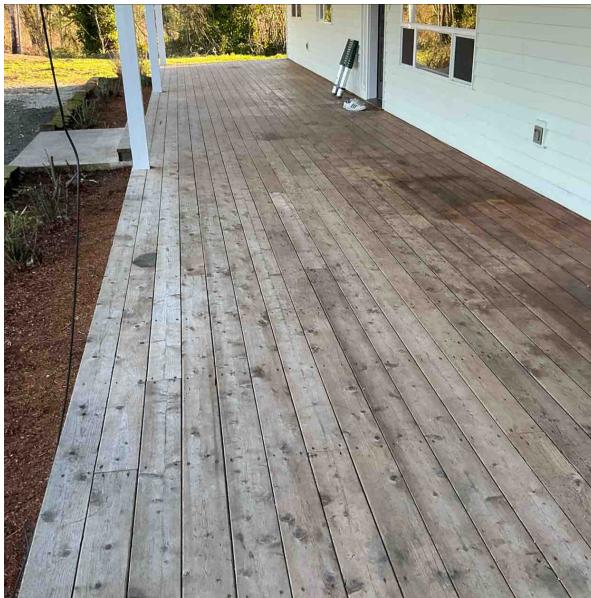
3.5.1 Porch is in typical shape for its age. The sealant is wearing off in several locations, as well as some minor deterioration noted starting at the board edges. Recommend routine maintenance be done now to extend the porch's life expectancy. Repair or replace components as needed.

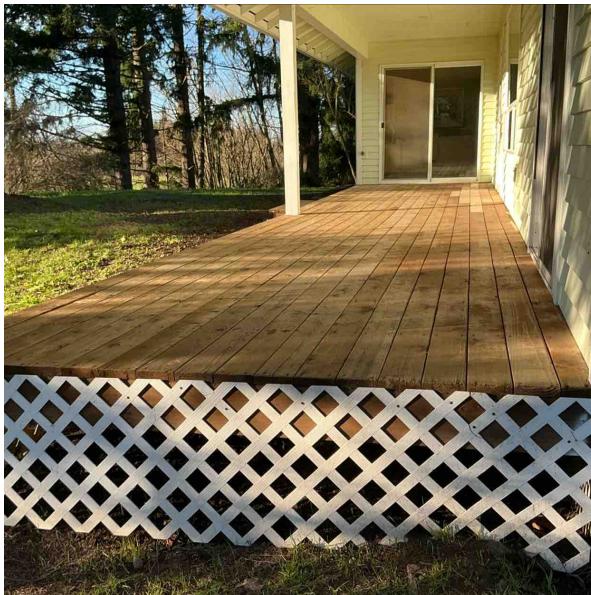
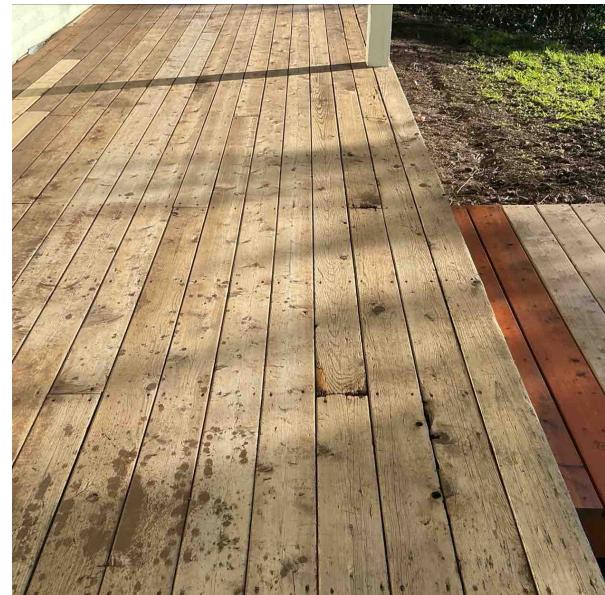
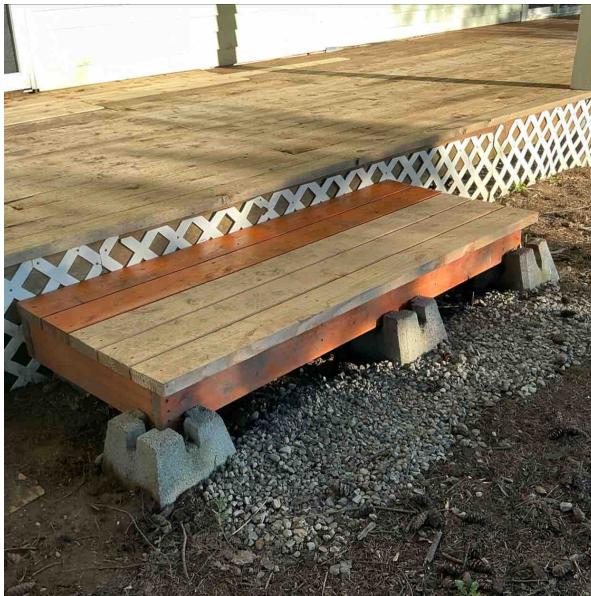
3.6.1 Deck is in typical shape for its age. General wear and some minor deterioration noted starting at the board edges. Recommend routine maintenance as needed to extend the deck's life expectancy. Also recommend installing a handrail and additional step off of the lower step for added safety.

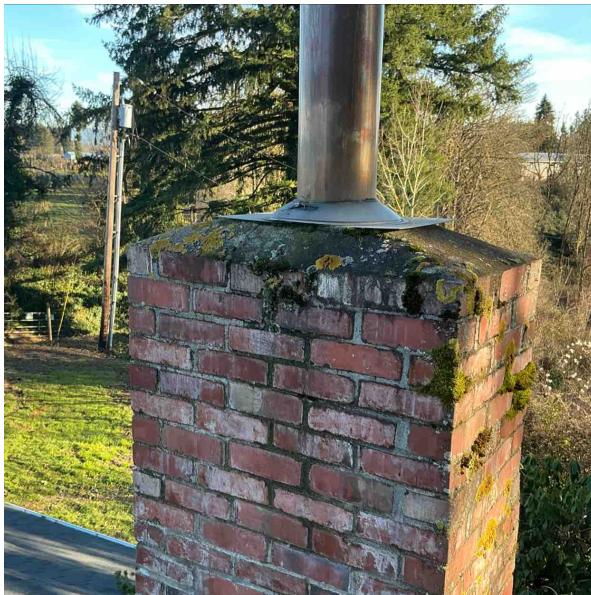
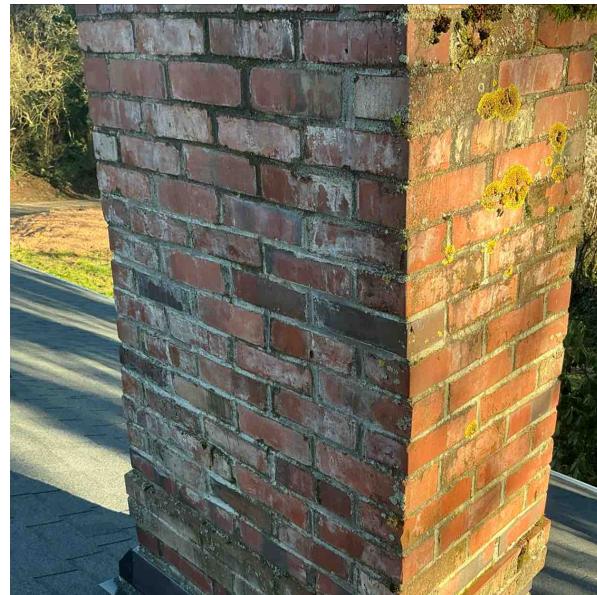
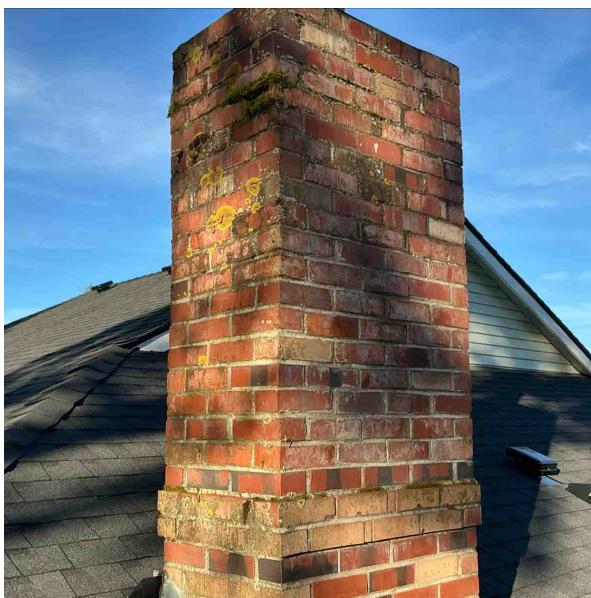
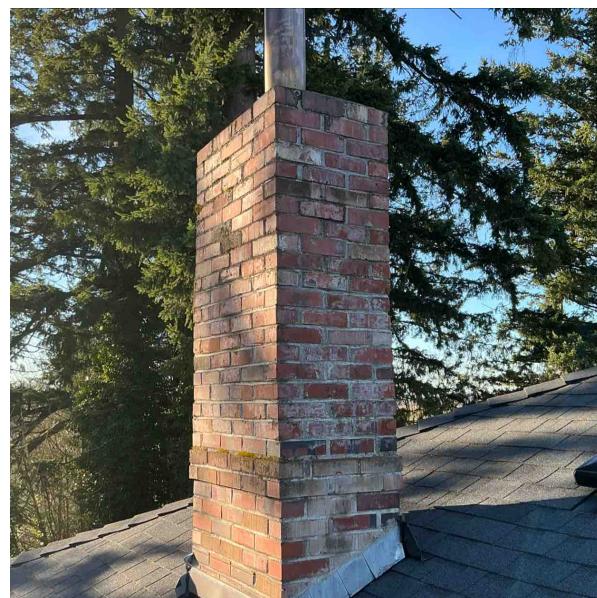
4.6 Chimney(s)

4.6.1 Chimney shows signs of general wear and deterioration. Cracking was observed in the mortar joints and crown, minor moss growth was observed, and wearing/cracking sealant noted around chimney flashing. Recommend further evaluation and correction by a licensed chimney professional.

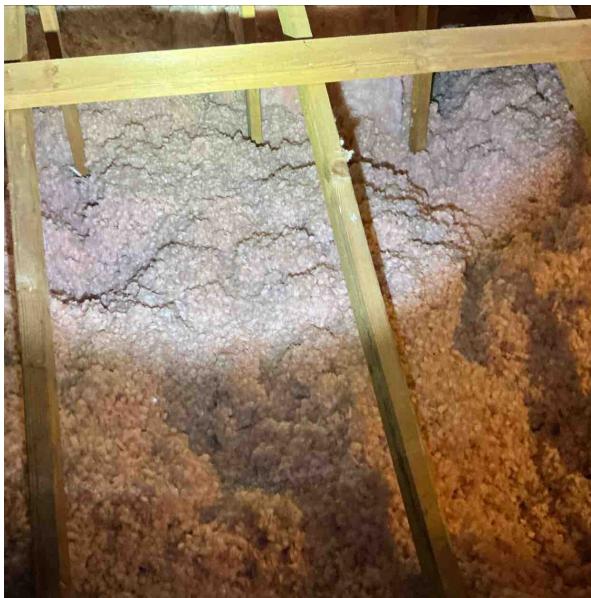
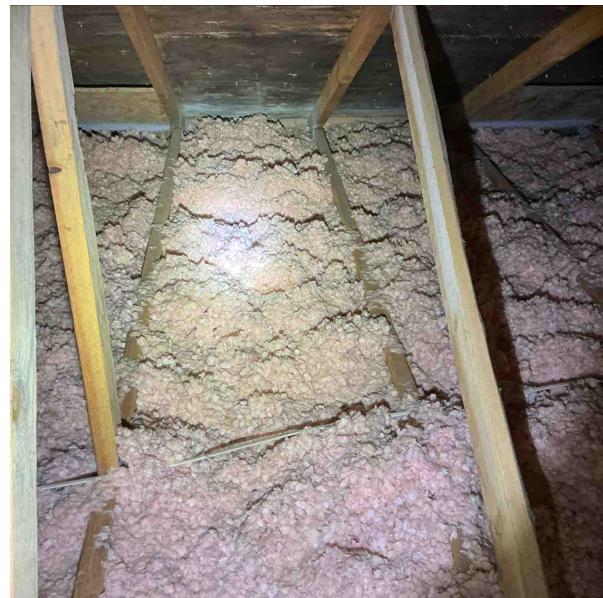
5.1.2 Evidence of rodent activity was noted in the attic, recommend elimination of rodents and sealing all possible entry points by a licensed pest control professional.

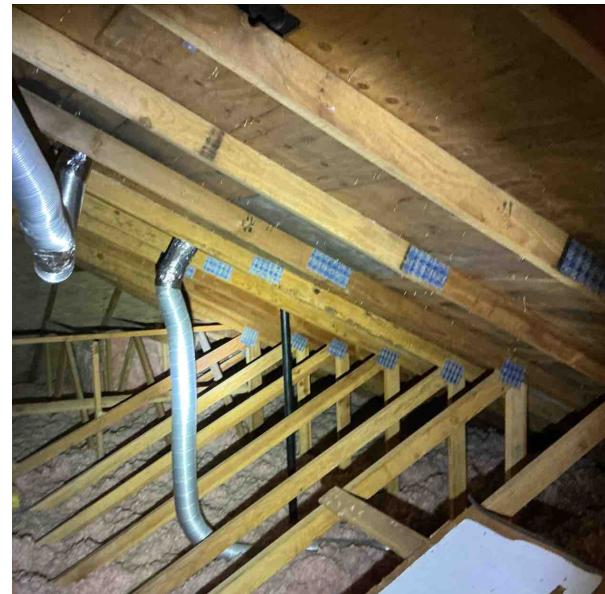
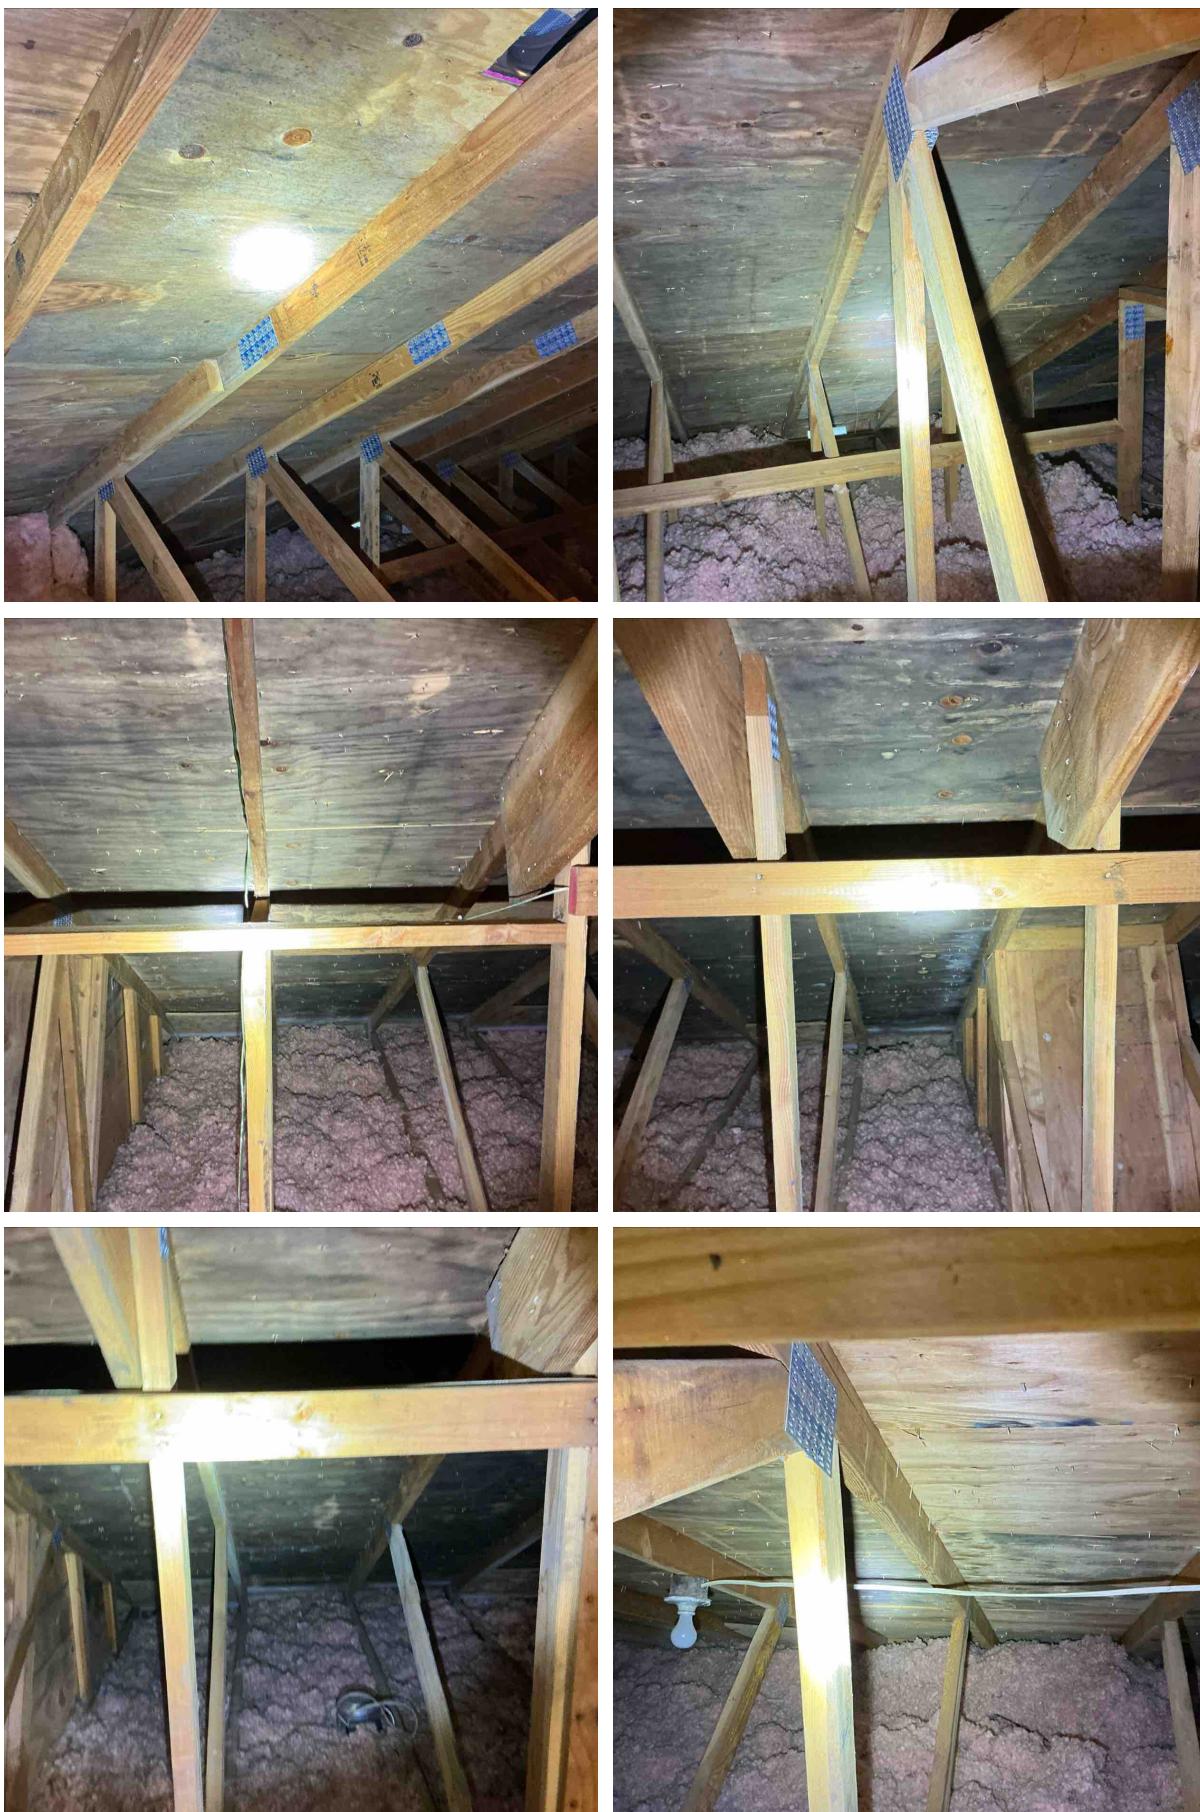
5.6 Sheathing

5.6.1 Mildew growth was noted on the interior roof sheathing in the attic, which is often times caused by a lack of proper ventilation throughout the attic. Have the ventilation checked by a qualified and licensed contractor, and the necessary corrections made to reduce the chance of further/future mildew growth or other ventilation related problems. The existing mildew growth should be treated and removed, post ventilation corrections, for health reasons. (The roof itself does appear to be newer, which may have corrected the ventilation issue.)

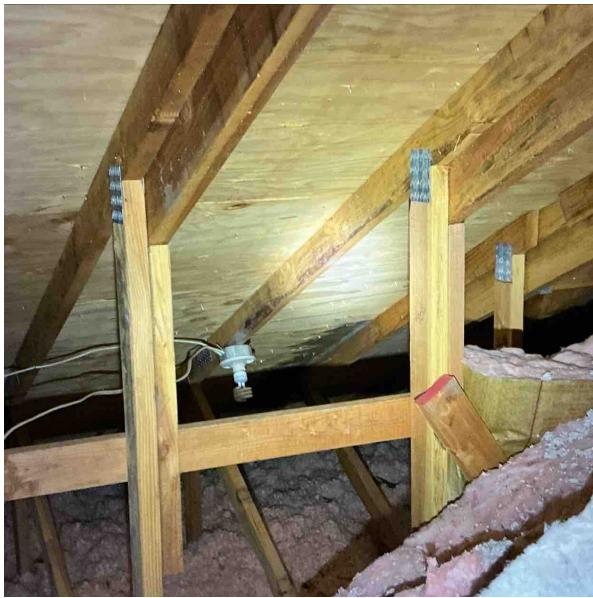
5.6.2 Staining was observed on attic components, from what appears to be previous moisture intrusion, however, they show no evidence of active leakage or of any damage. Monitor for future leaks and correct as needed.

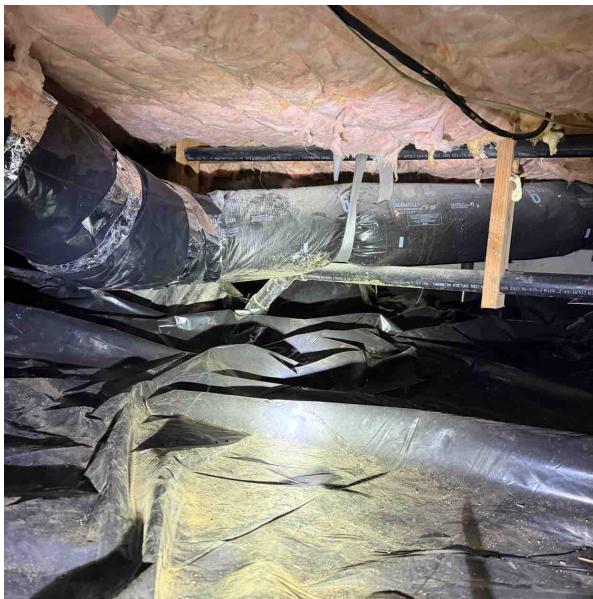
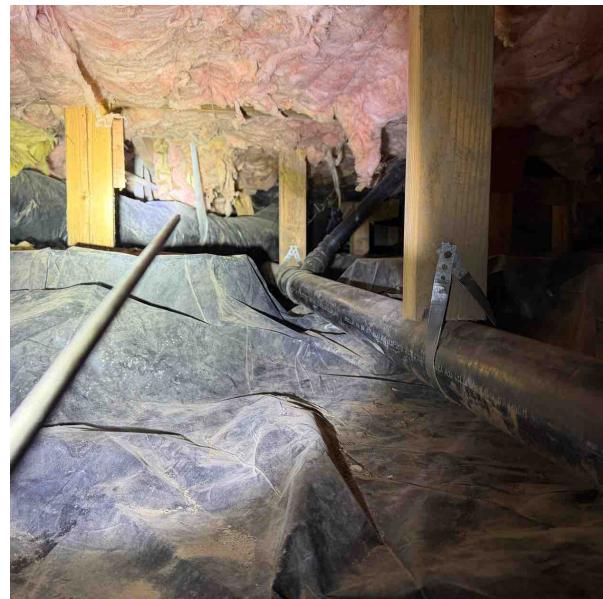
6.1.2 Crawlspace was inspected and in good working order. Evidence of past water noted (staining on the vapor barrier) but unable to determine where it came from or if it happens regularly. Monitor regularly and take any steps necessary to achieve a dry crawlspace.

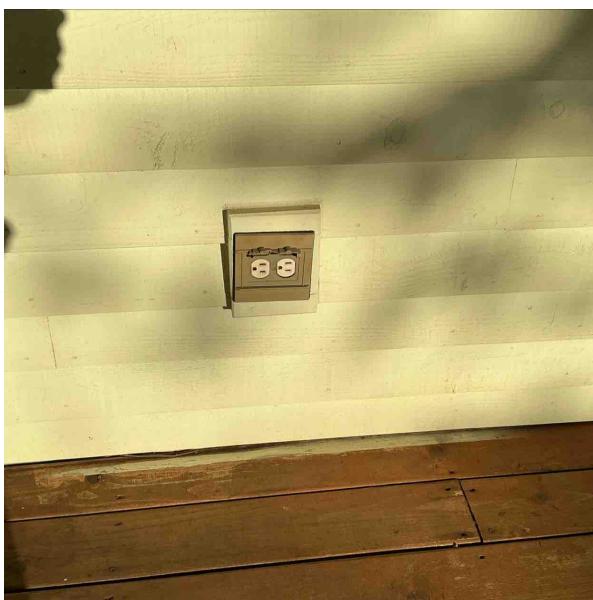
7.7.1 West exterior deck outlet cover is damaged. Recommend replacement.

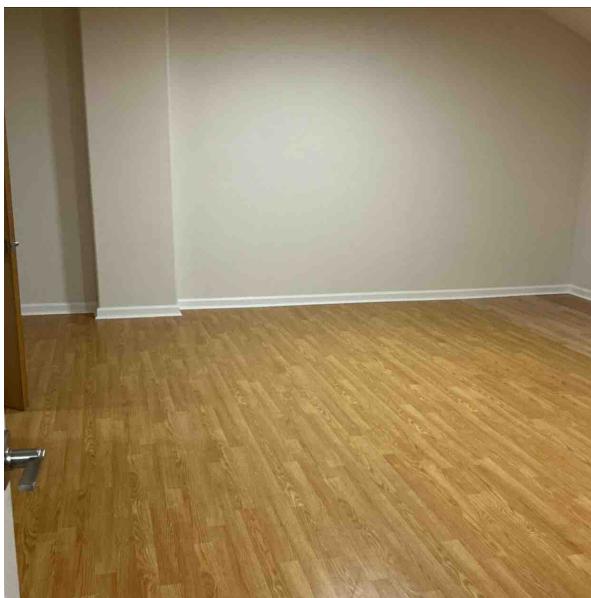
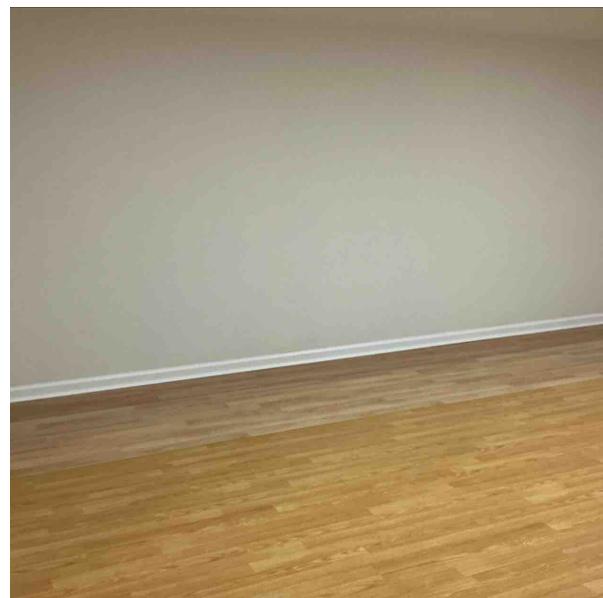
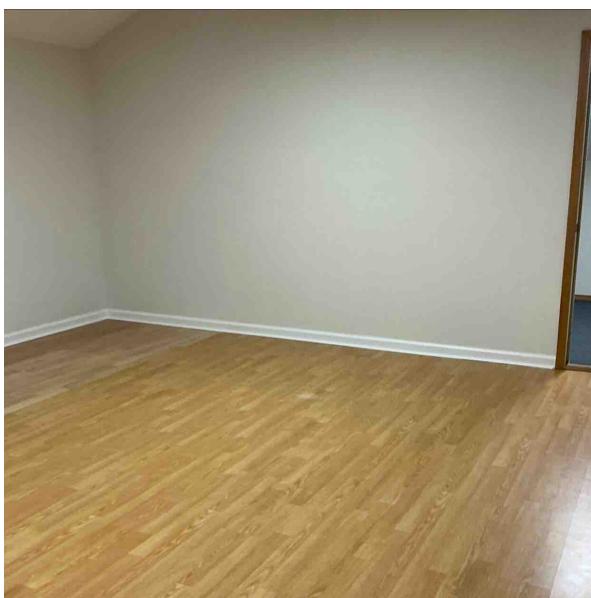
7.7.2 Upper bonus room only has receptacles on the west wall. Recommend installing additional receptacles to meet today's current electrical code on all walls. **(Bonus Room)**

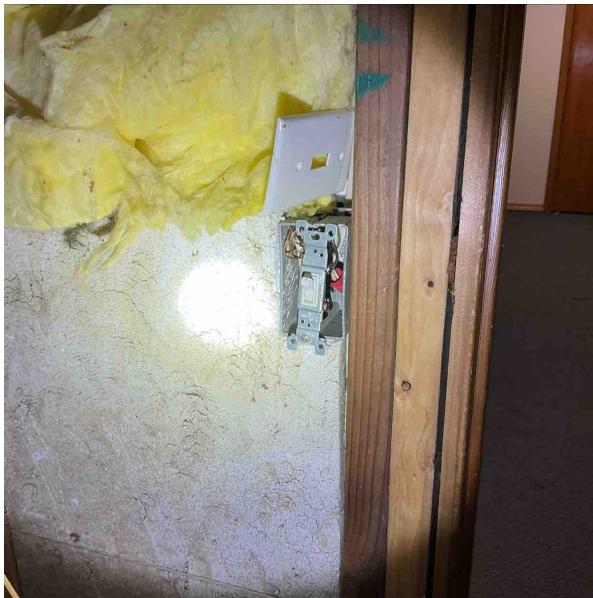
7.7.3 East side attic light switch is partially disconnected and missing a cover. Recommend correction.

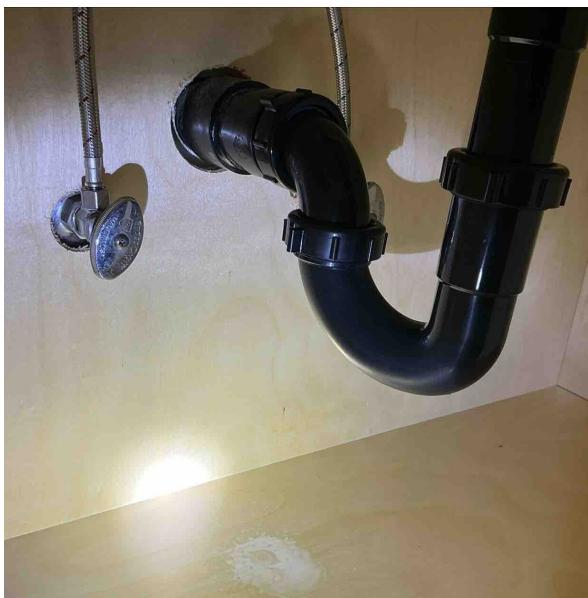
9.8.1 A leak was noted at the sink drain. Recommend correction by a qualified professional. **(Half Bathroom)**

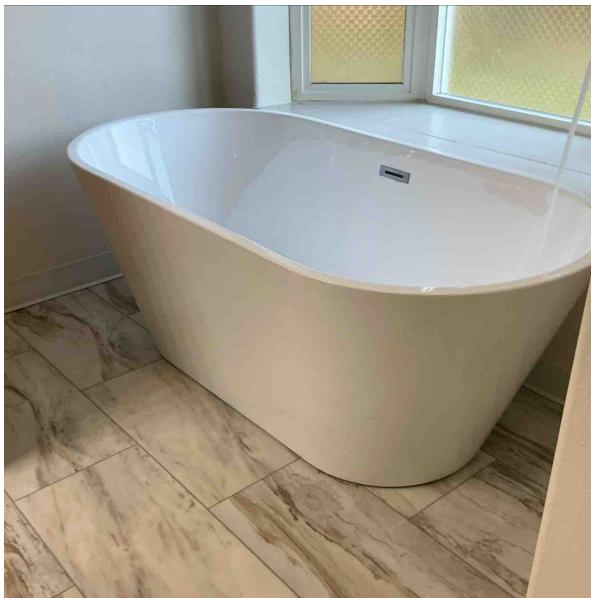
9.10.1 The large soaker tub has not been secured to the floor. This can allow it to move, which may cause strain on plumbing components and lead to potential leaks. Recommend correction. (**Primary Bathroom**)

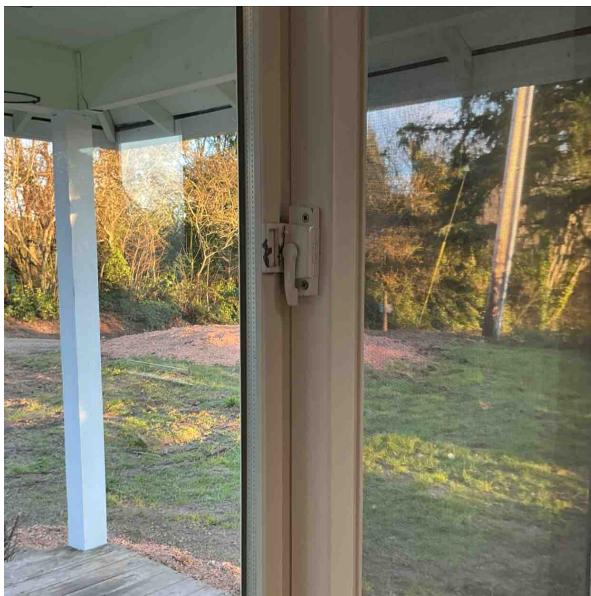
10.3.2 The east window lock, of the south east bedroom, is loose. Recommend correction. (**South East Bedroom**)

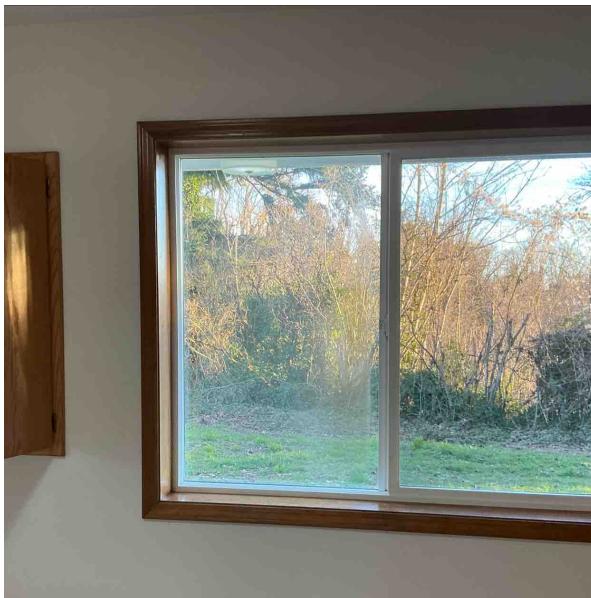
10.3.3 The south window has a broken thermopane seal causing moisture staining and discoloration. Recommend repair or replacement by a licensed contractor. (South East Bedroom)

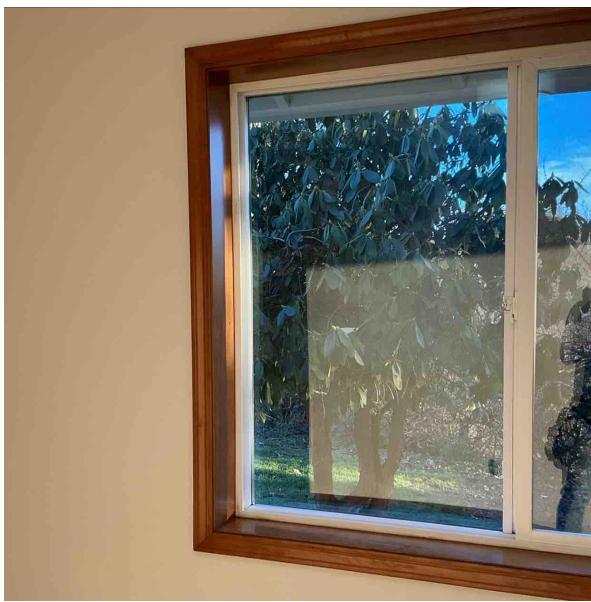
10.3.4 The south window has a broken thermopane seal causing moisture staining and discoloration. Recommend repair or replacement by a licensed contractor. (South West Bedroom)

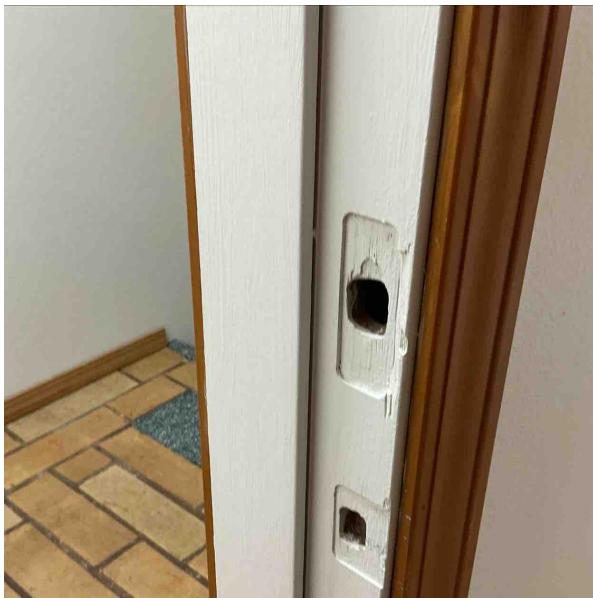
10.4.1 South primary bedroom pass-through door is missing. It's striker plates. Recommend replacement.
(Primary Bedroom)

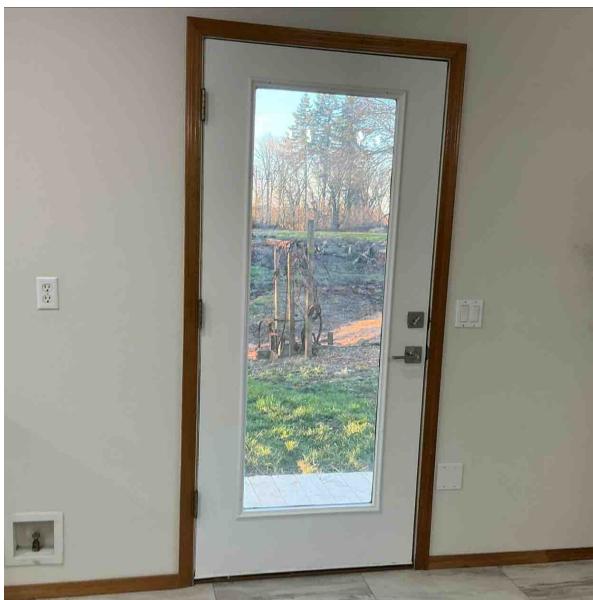
10.5.1 North dining room exterior door has a broken thermal pane window seal, causing fogging in between the panes of glass. Recommend repair or replacement by a qualified contractor. (Dining room)

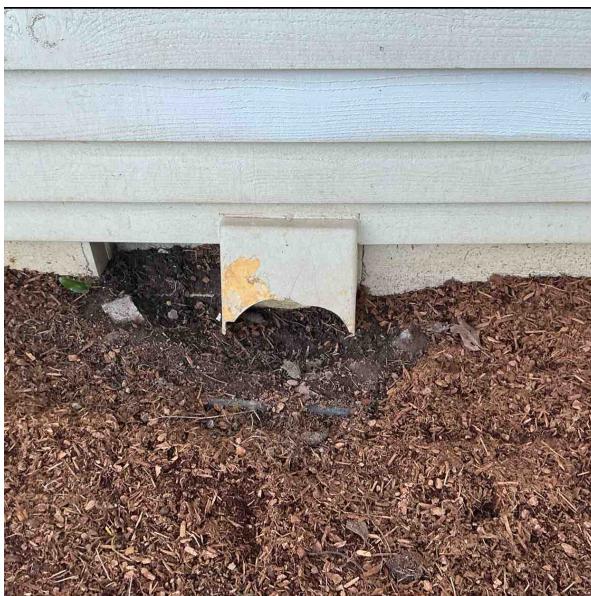
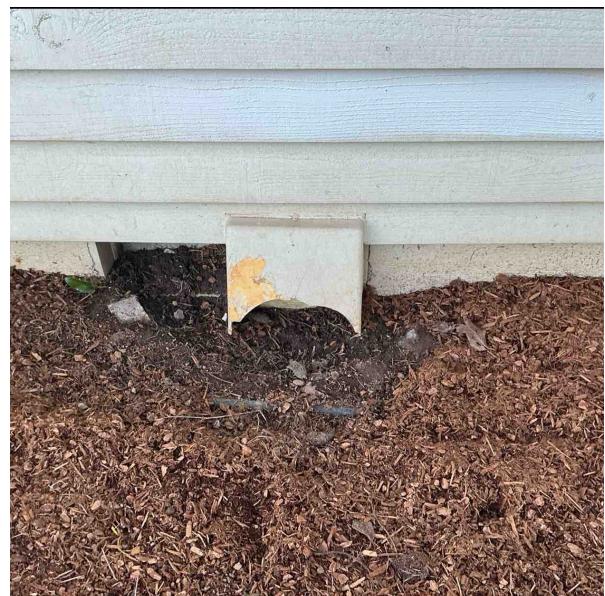
12.3.1 Damage was observed to the downdraft exhaust cover. Recommend replacement.
