Inspection Report

**James Christopher Balderson
Carolyn Reiner
15460 Kings Hwy
Montross VA 22520**

**Shannon Lewis
PO Box 244
Lively, VA 22507
(804) 724-4468**

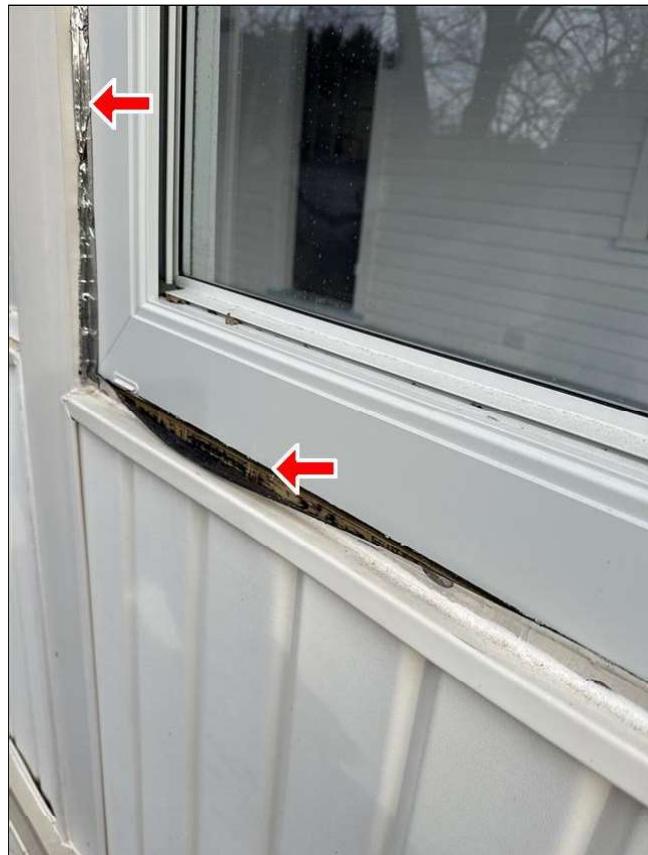
2.0 (1) The windows at the rear sun porch were improperly flashed. Flashing tape was exposed to the elements and was peeling away, exposing the wood wall sheathing. This could lead to wood rot. Further evaluation by a qualified carpenter is recommended.

2.0 Item 1(Picture) Exposed flashing tape, not rated for exposure

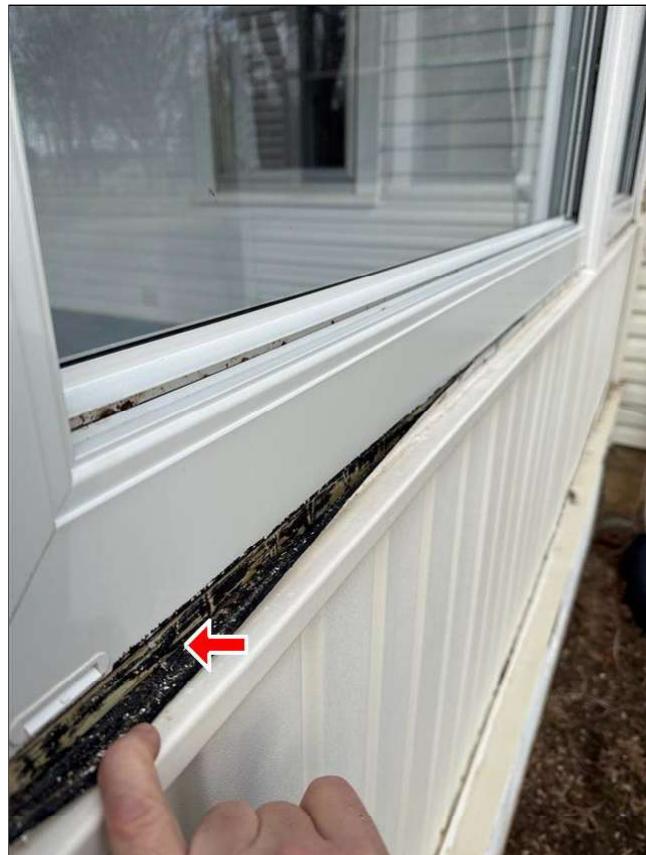
2.0 Item 2(Picture) Flashing tape, peeling away from wall sheathing

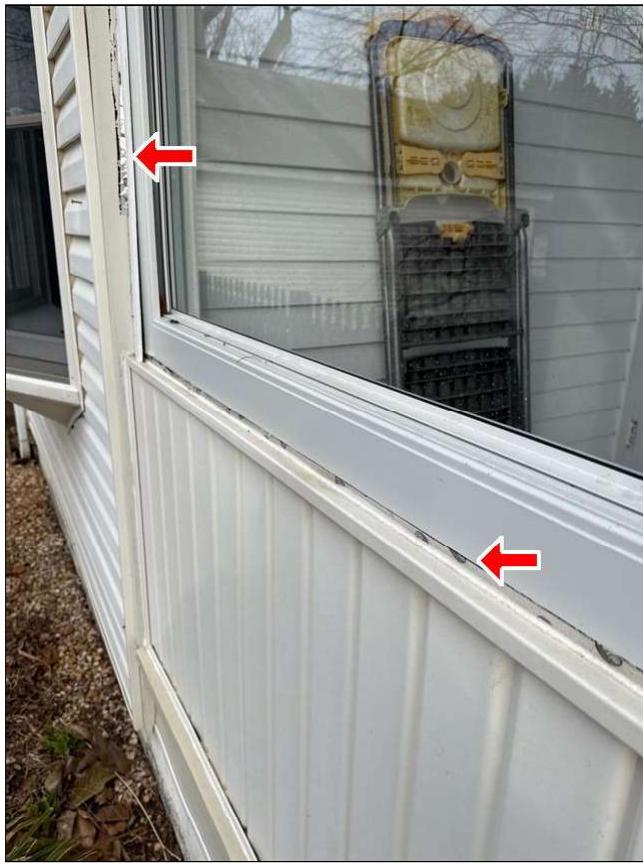
2.0 Item 3(Picture) Exposed flashing tape, not rated for exposure

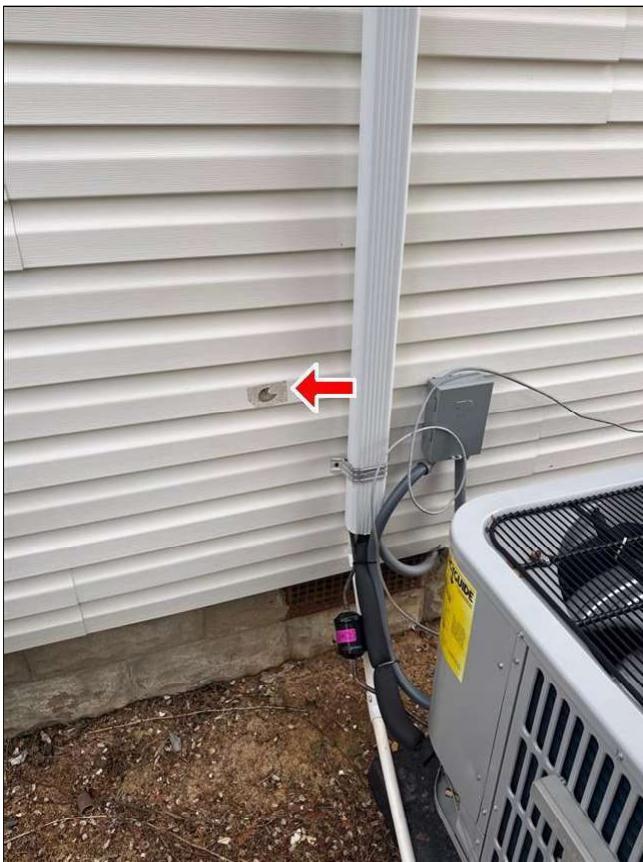
2.0 Item 4(Picture)

2.0 (2) A hole in the siding was observed. Repair by a handyman is recommended.

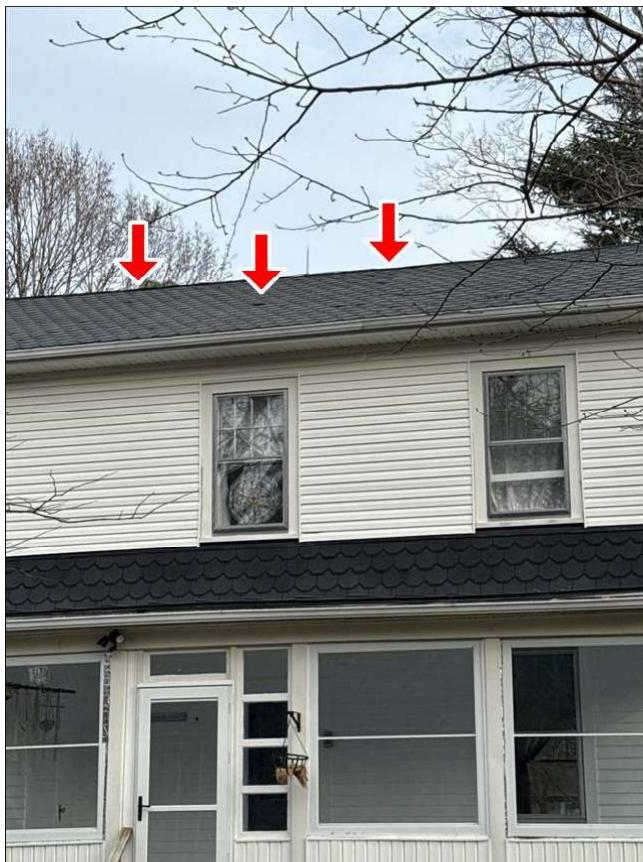
3.0 (1) Several lifted shingles were observed on the back side of the roof. This can be a sign of inadequate roof ventilation. Shingles should be refastened by a qualified roofer to prevent wind damage and evaluated to determine if future shingle lifting needs to be mitigated by improved ventilation.

3.0 Item 1(Picture) Lifted shingles on back side of roof

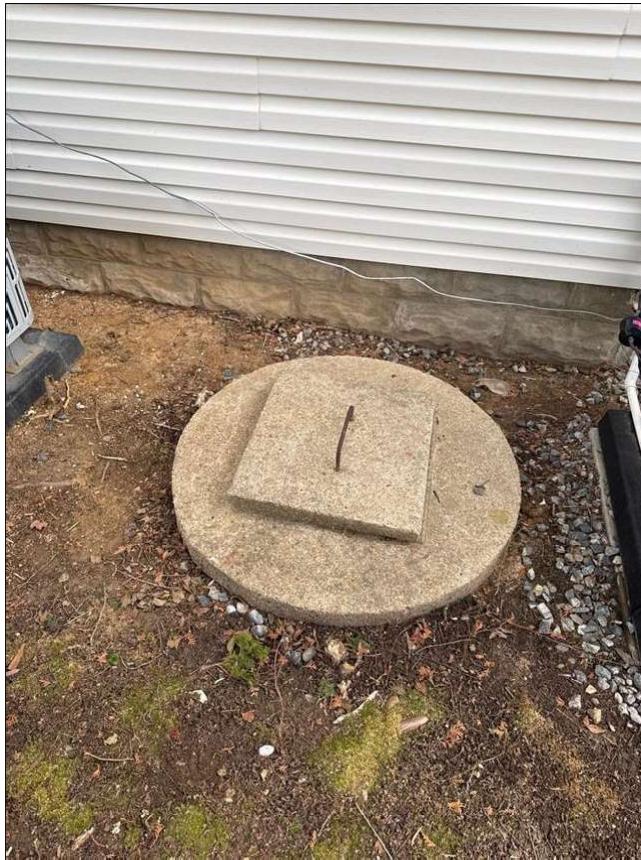
4.1 Item 1(Picture)

4.1 (2) A possible grease trap was observed on the side of the home, near the kitchen. This may have been part of the original gray water waste system and was likely abandoned. Questions about this should be directed to a licensed plumber.

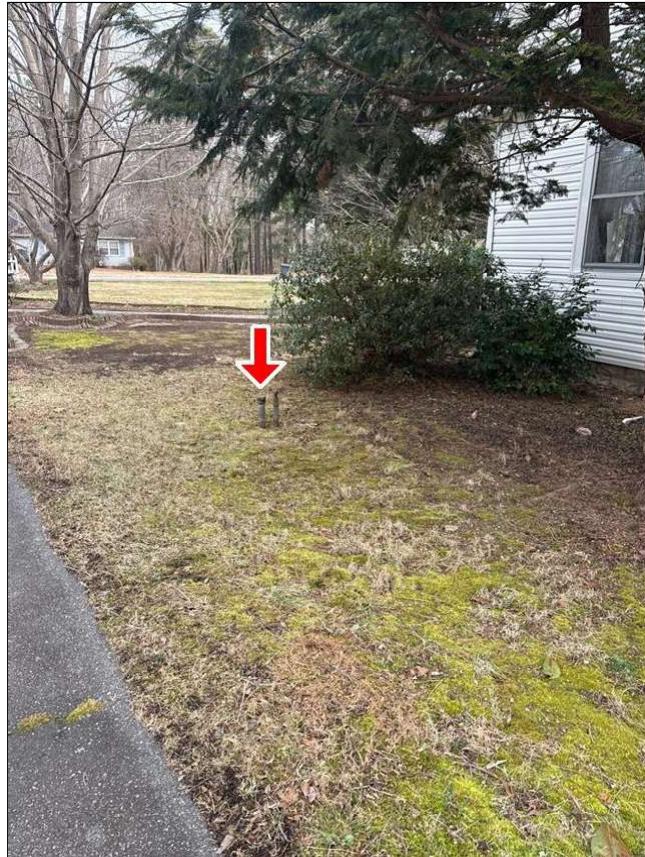
4.4 Item 1(Picture)

4.4 There was evidence of an abandoned underground fuel tank in the side yard. If available, documentation regarding the proper abandonment should be obtained and provided to prospective buyers. If the disposition of the tank is not known, inspection by a qualified inspector is recommended.

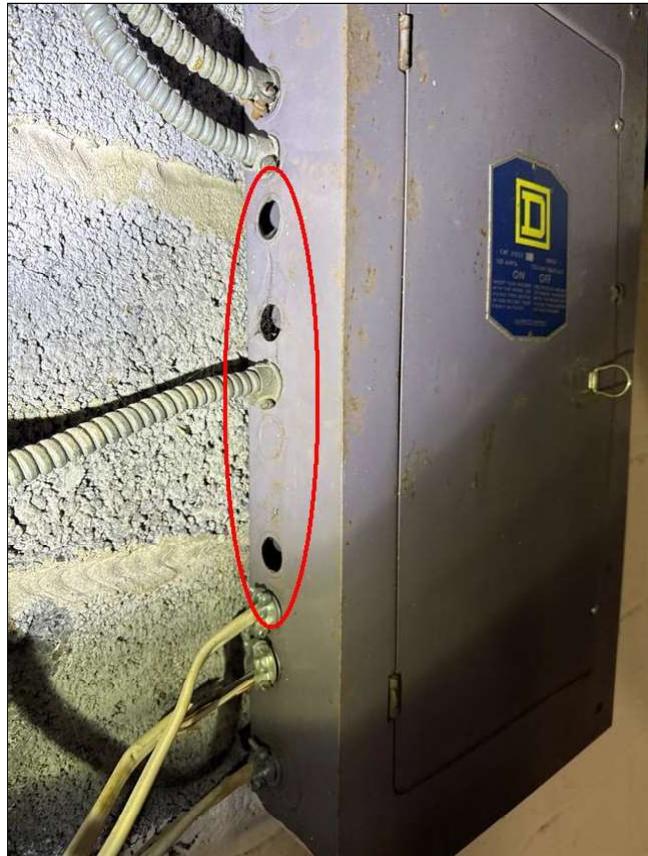
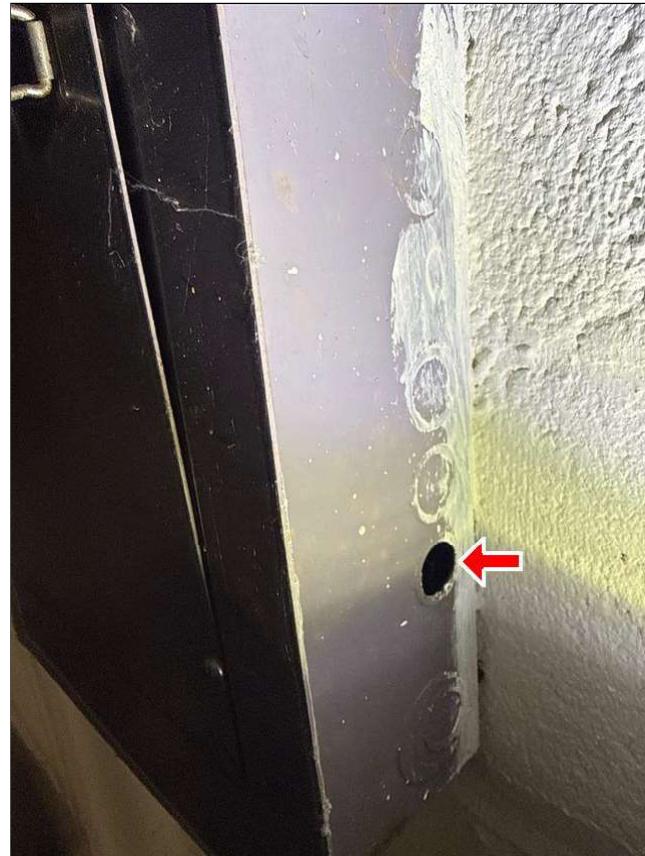
5.3 Open knockouts were observed at the junction box/former service panel in the basement. This could allow pest intrusion and was a shock hazard due to internal components being accessible. Installation of knockout cover blanks is recommended.

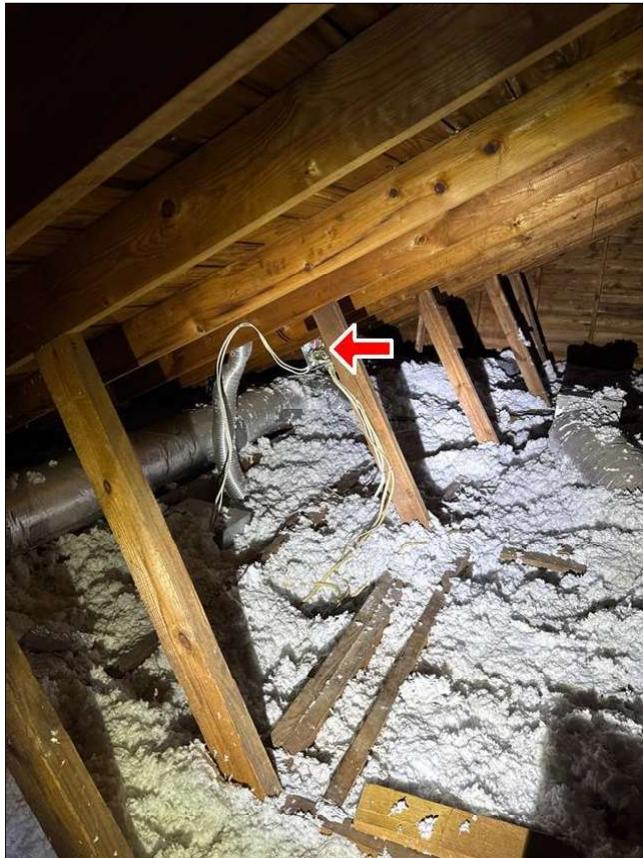
5.4 Item 1(Picture)

5.4 (1) An open junction box was observed in the attic. A cover should be installed by a licensed electrician to contain any potential overheating.

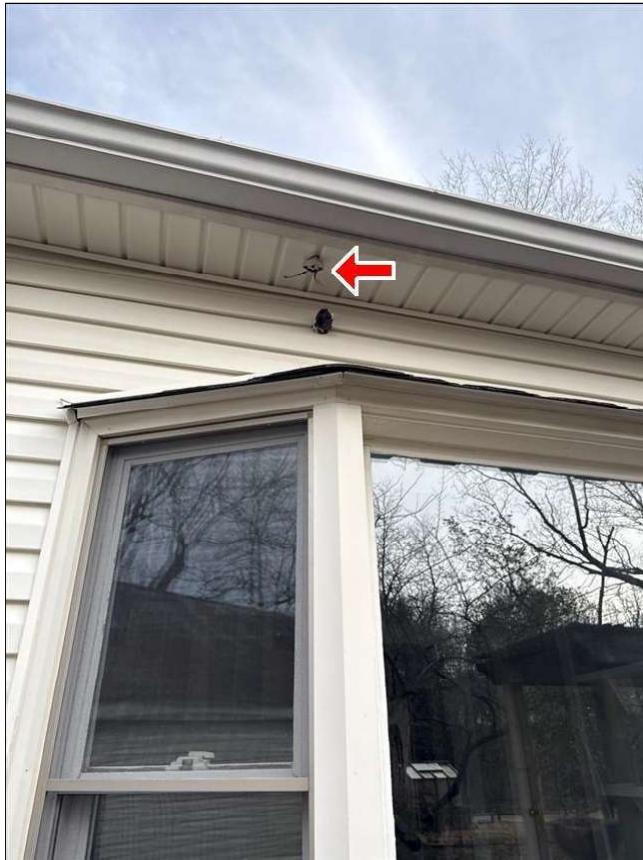
5.4 Item 2(Picture)

5.4 (2) Loose wiring from a missing fixture was observed at the exterior. Further evaluation by a licensed electrician is recommended.

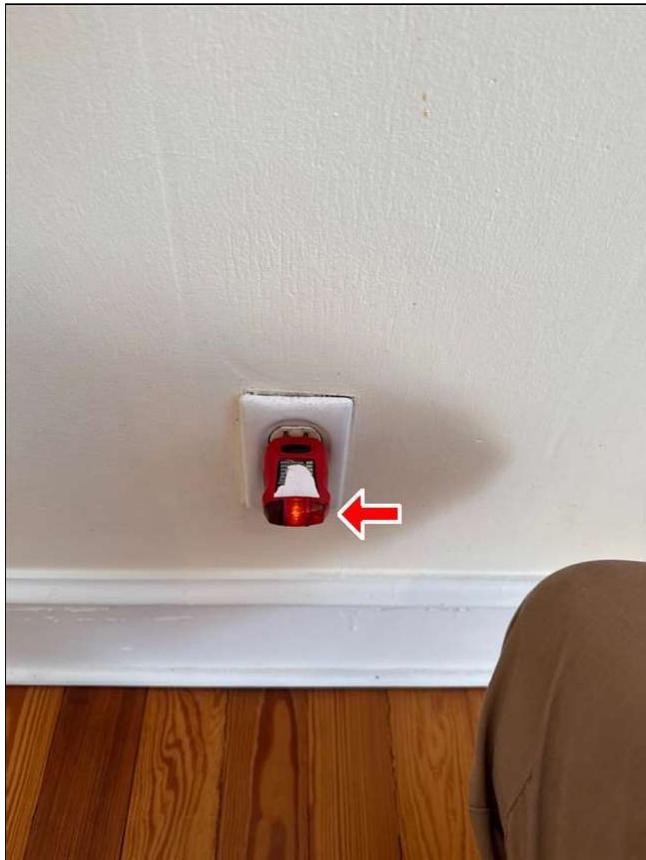
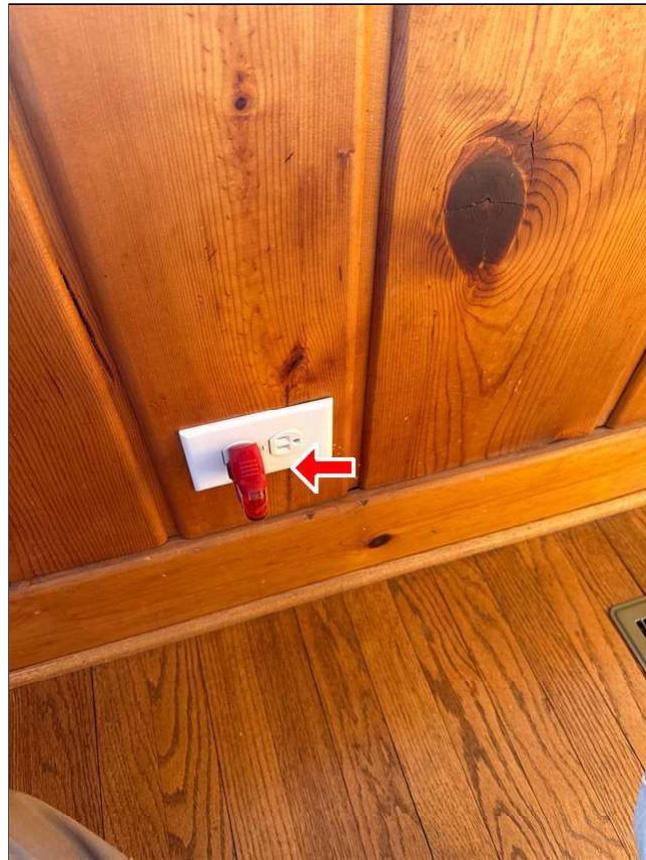
5.6 (1) Several of the outlets tested as having "open grounds". This is typical of older homes where the older, ungrounded receptacles replaced to accommodate grounded plugs. These receptacles, however, do not provide grounding protection required by some modern electronic equipment. A licensed electrician should be contacted about upgrading the open ground receptacles.

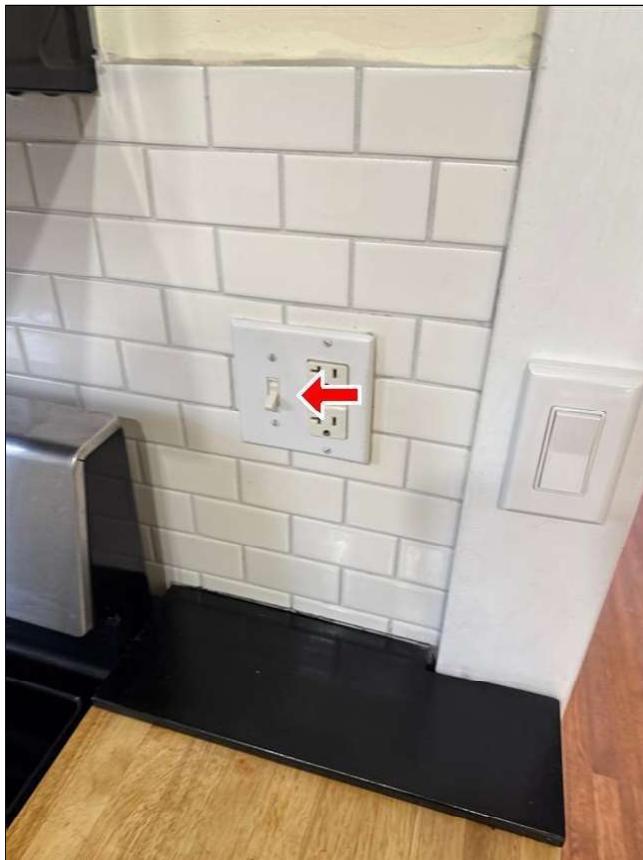
5.6 Item 3(Picture)

5.6 (2) Switches were observed alongside the kitchen counter receptacles. These switches did not appear to operate any fixtures. Further evaluation by a licensed electrician is recommended.

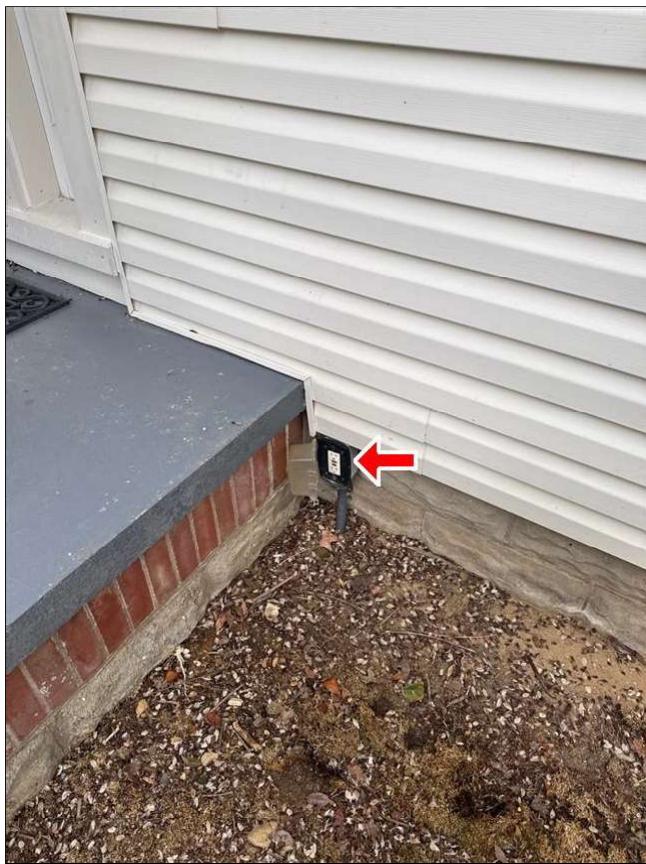
5.7 GFCI receptacles in the kitchen and at the exterior would not reset. GFCIs are safety devices that protect people against electric shock in potentially wet or damp locations. Further evaluation by a licensed electrician is recommended.

5.7 Item 1(Picture) Receptacle would not reset, was not functional

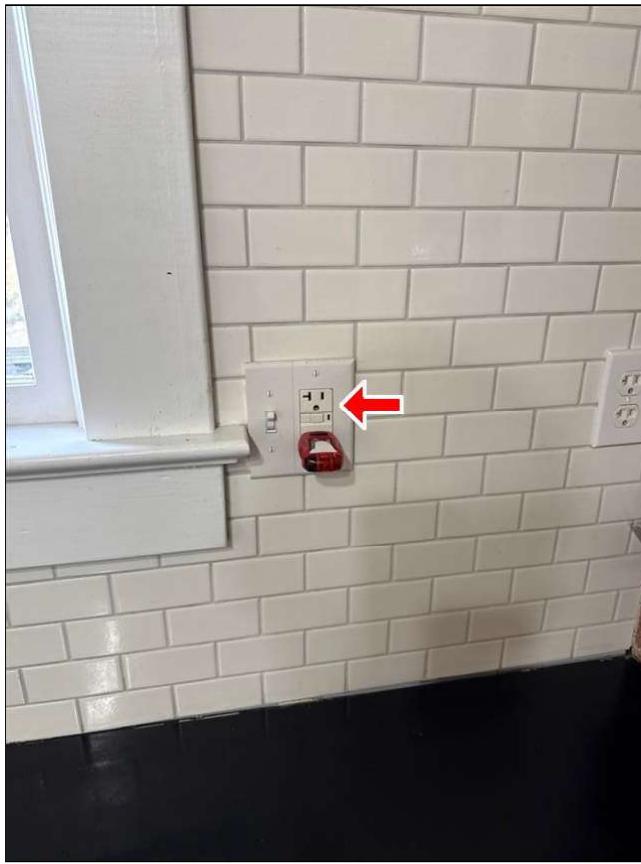
5.7 Item 3(Picture) Receptacle would not reset,
was not functional

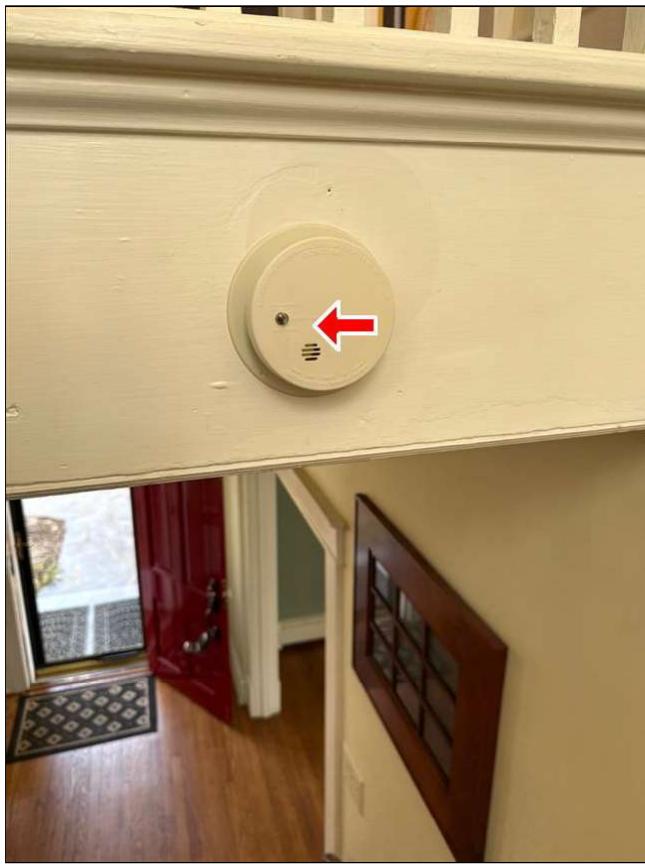
5.9 Some of the smoke detectors did not appear to be functional when tested. Smoke alarms that are properly installed and maintained play a vital role in reducing fire deaths and injuries. Smoke alarms should be installed in every bedroom, outside each sleeping area and on every level of your home. Test smoke alarms every month. Replace all smoke alarms in your home every ten years.

5.9 Item 1(Picture) Smoke alarm was not functional

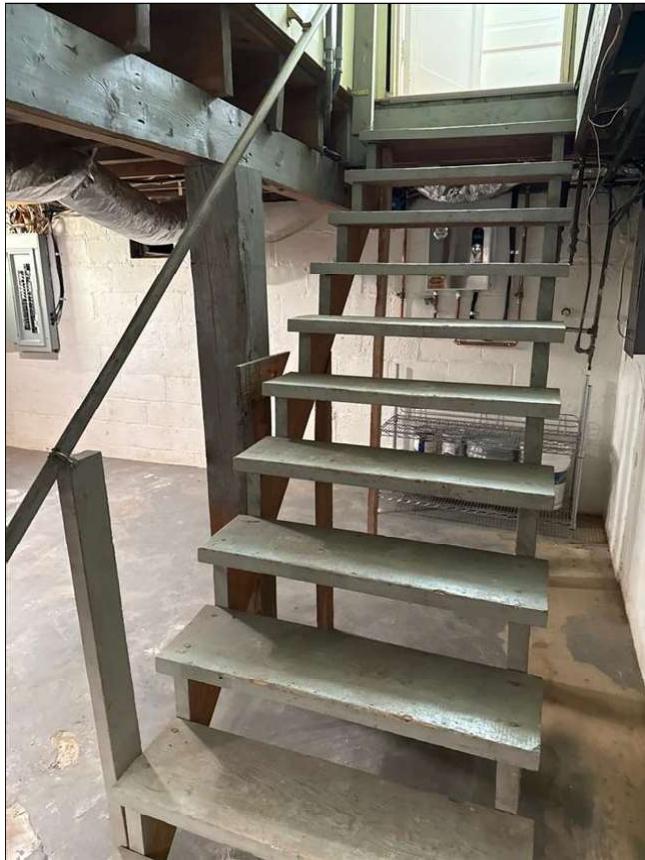
7.1 Item 1(Picture)

7.1 The steps to the basement did not have a proper, secure handrail and guardrail installed. This was a fall hazard. Further evaluation by a qualified carpenter is recommended.

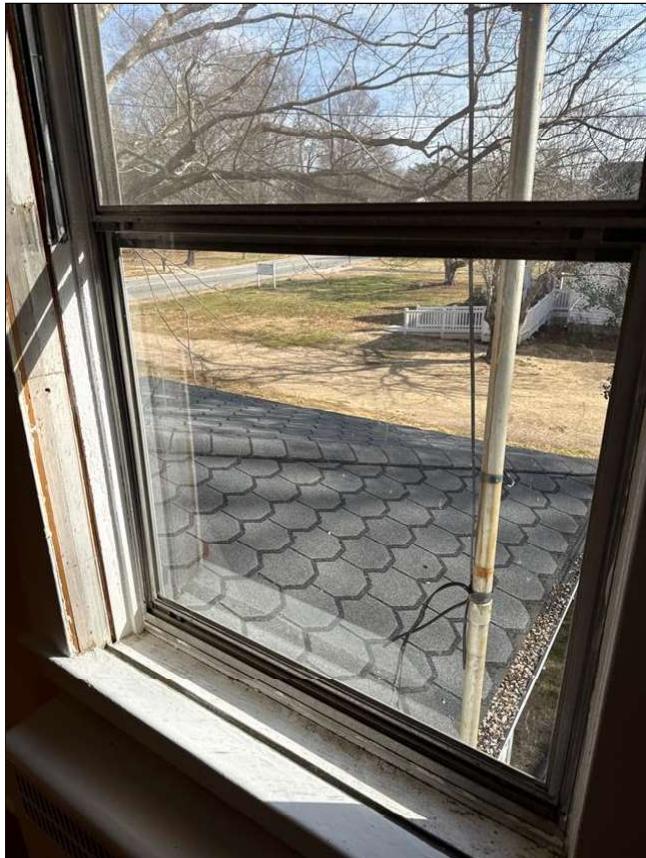
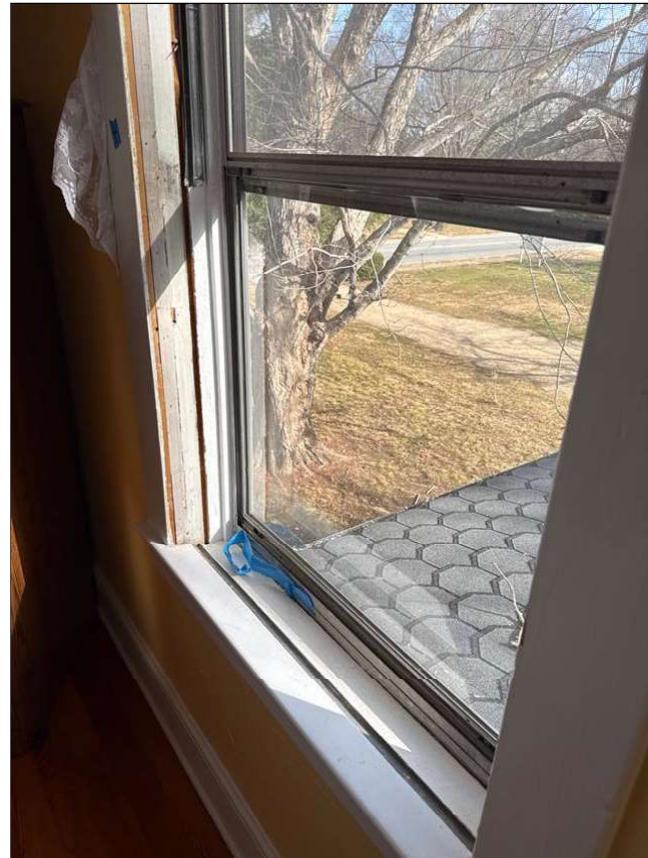
7.3 (1) Window sashes were missing in one of the upstairs bedrooms. Replacement by a qualified carpenter is recommended.

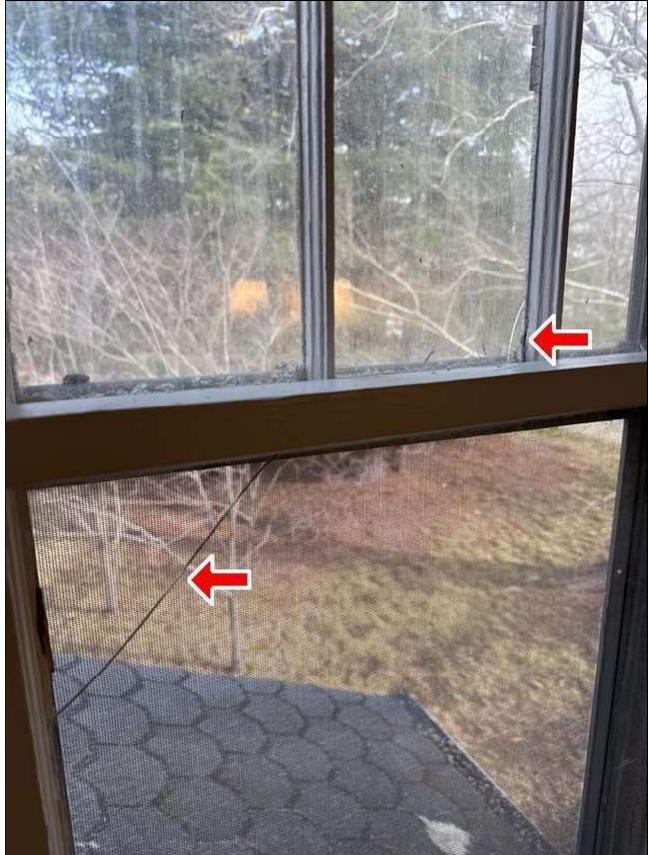
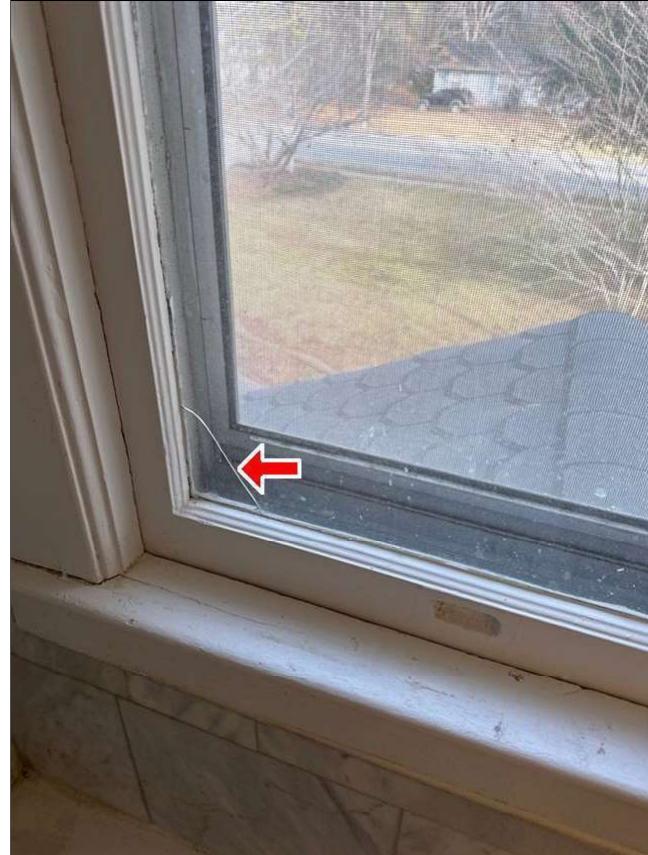
7.3 (2) Broken window panes were observed at some of the upstairs sashes. Repair by a qualified glazier is recommended.

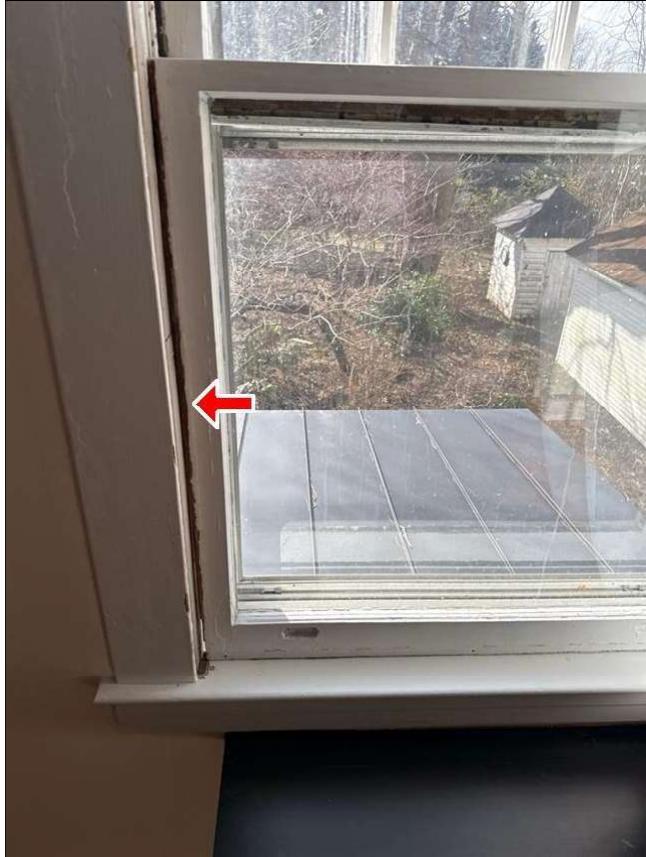
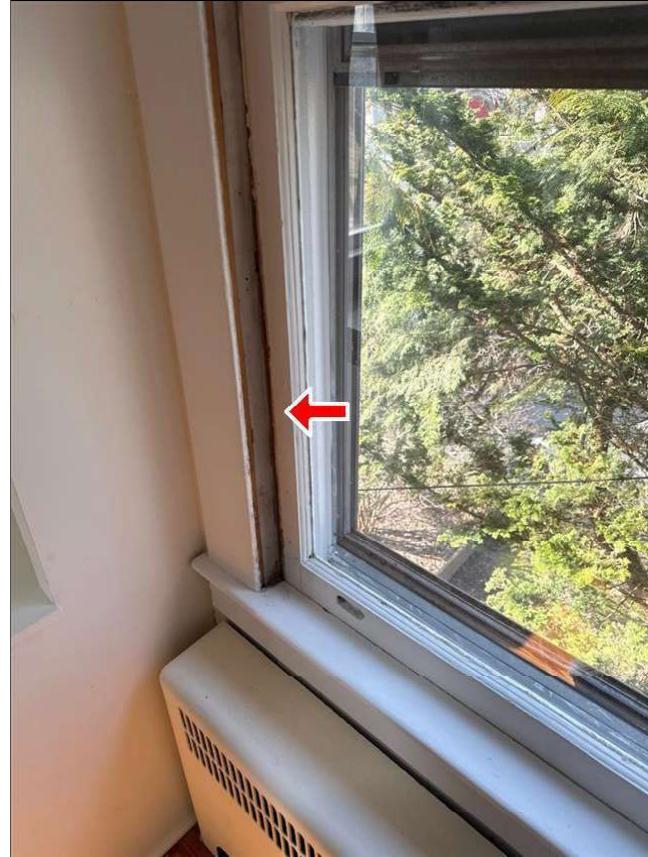
7.3 (3) There was no jamb stop moulding at some of the upstairs windows. This could cause the sashes to fall inward. Further evaluation by a qualified carpenter is recommended.

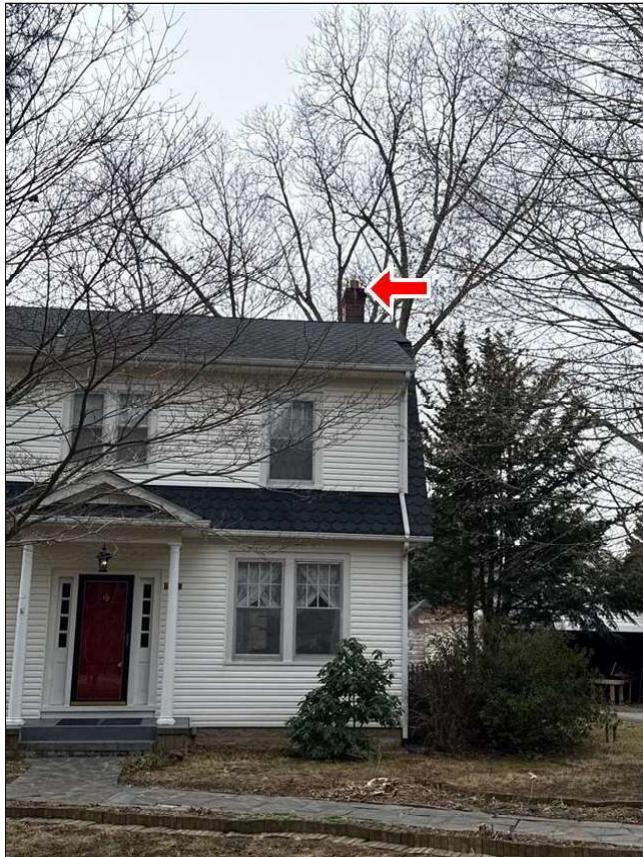
9.2 Item 1(Picture)

9.2 One of the chimneys (abandoned, not used) was missing a weather cap. Weather caps prevent animal and moisture intrusion which can lead to deterioration. Further evaluation by a qualified chimney service is recommended.
