STRUCTURAL INTEGRITY RESERVE STUDY
FOR
REGENT PLACE CONDOMINIUMS
663 LONGBOAT CLUB ROAD
LONGBOAT KEY, FLORIDA 34228

JANUARY 2025
REVISED: MAY 2025

REGENT PLACE CONDOMINIUMS – STRUCTURAL INTEGRITY RESERVE STUDY

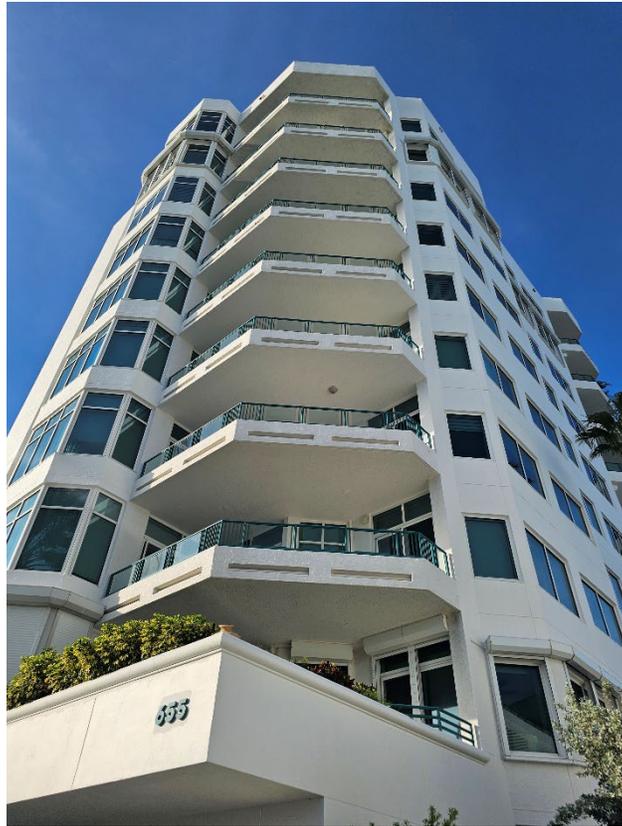
1. View of the typical stucco conditions for Building #655 at the subject property.

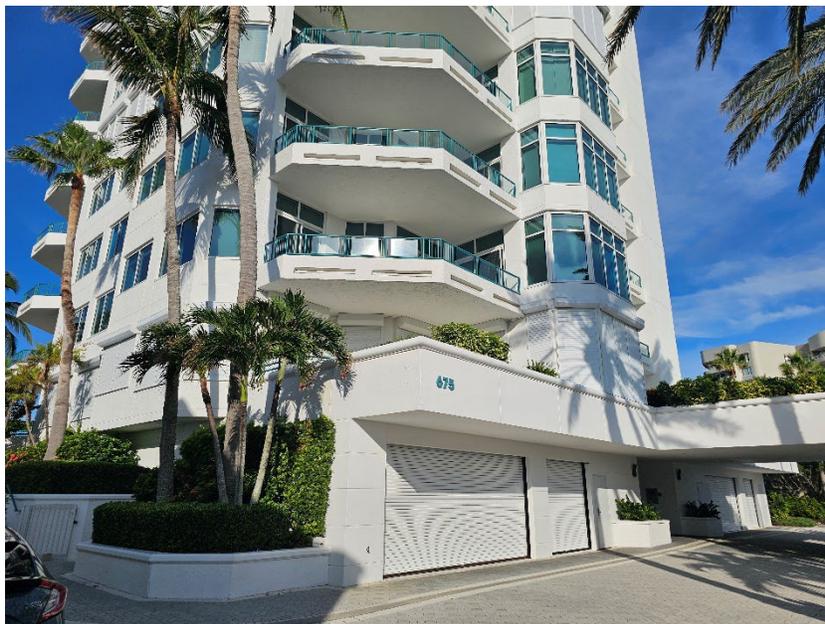
2. View of the typical stucco conditions for Building #675 at the subject property.

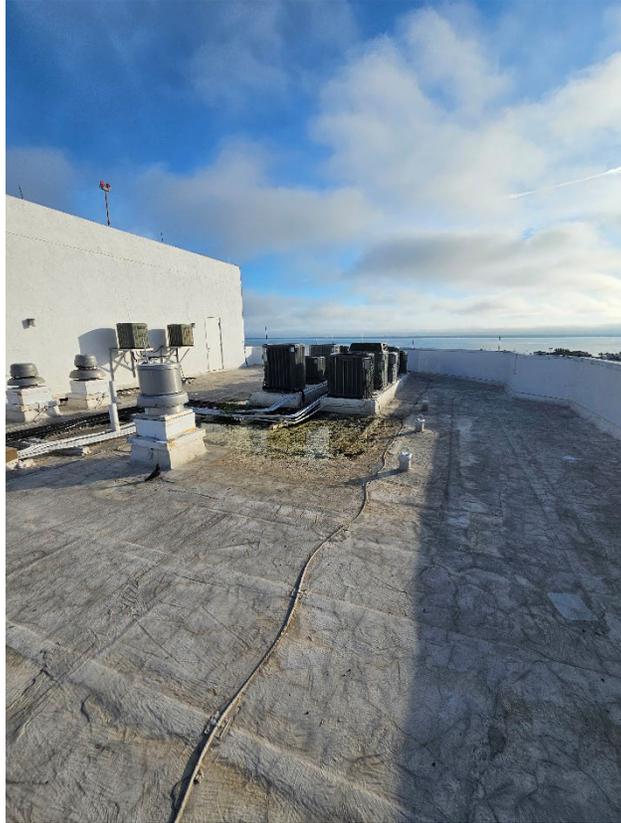
- Roofs: Portions of the roof coverings exhibited deteriorated and/or delaminated coating and unsealed edges of the membrane that can allow moisture infiltration. Several large repair areas to the tower roof covering indicate on-going issues. Areas of standing water were also observed on both flat roof areas at the subject property.

3. View of the typical roof and HVAC conditions for Building #655 at the subject property.

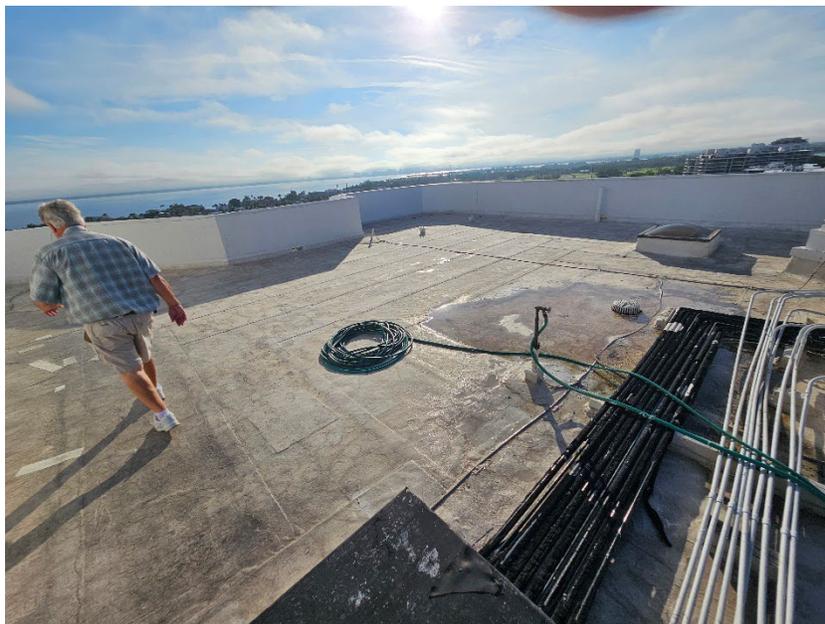
4. View of the typical roof conditions for Building #675 at the subject property.

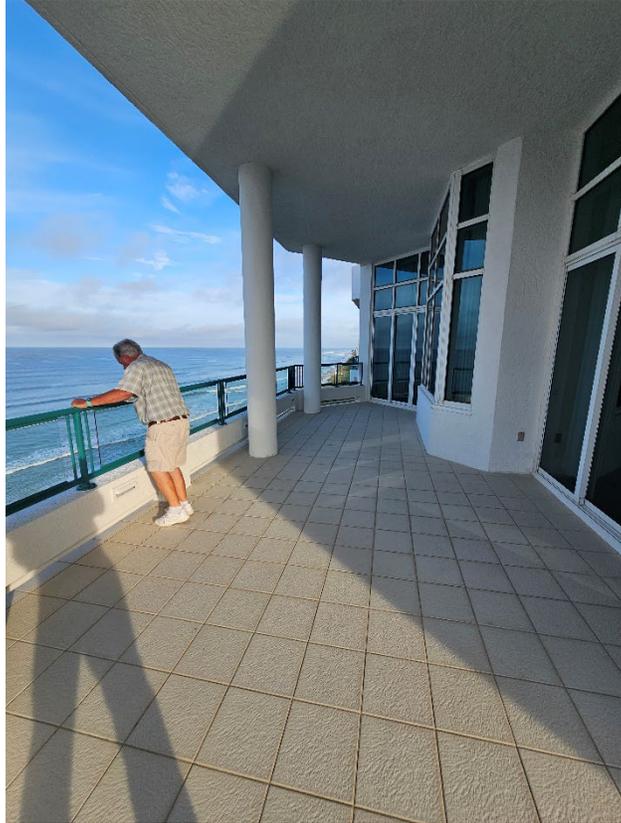
5. View of a typical balcony area at the subject property.

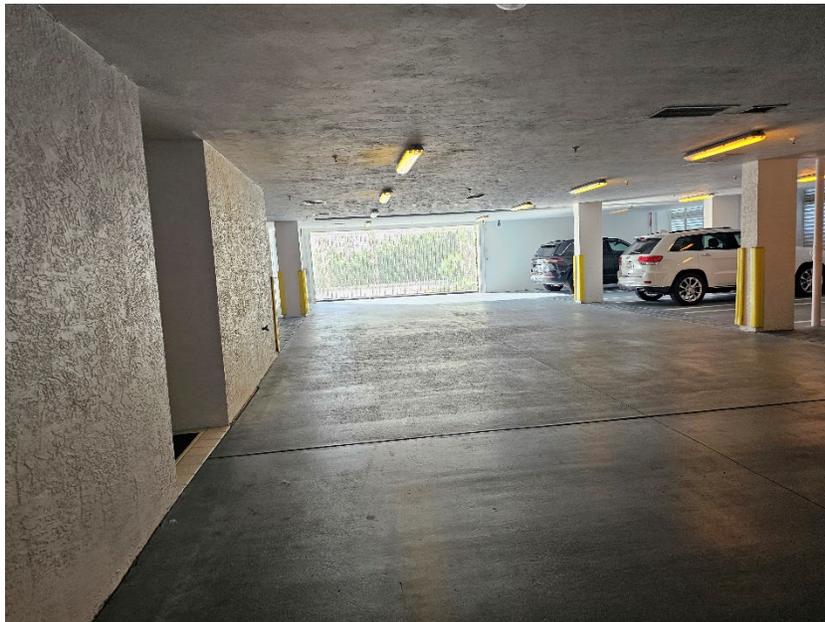
- Garages: Weathering was observed to the surfaces of the garage areas consistent with what is to be expected with a garage area of this age. It is our opinion that maintaining the property with the suggested maintenance schedule shall allow for the continued, safe, and serviceable life of the property.

6. View of the typical garage/parking area at the subject property.

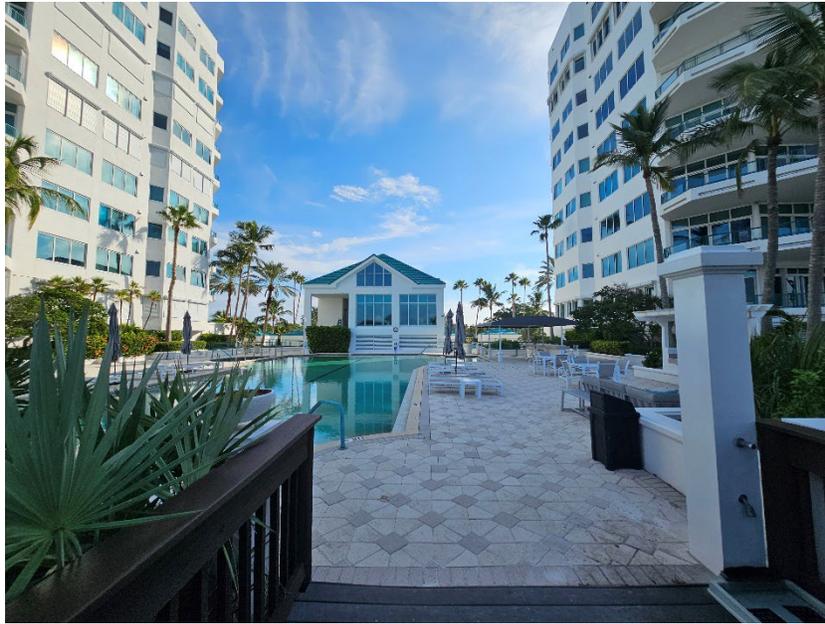
7. View of the shared pool/patio area located between the two buildings at the subject property.

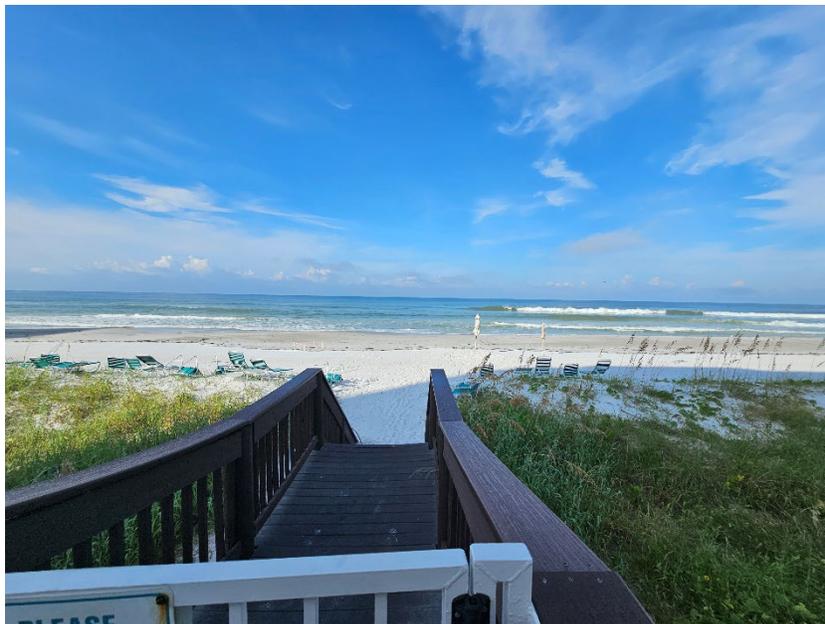
8. View of the beach located adjacent to the two structures at the subject property.

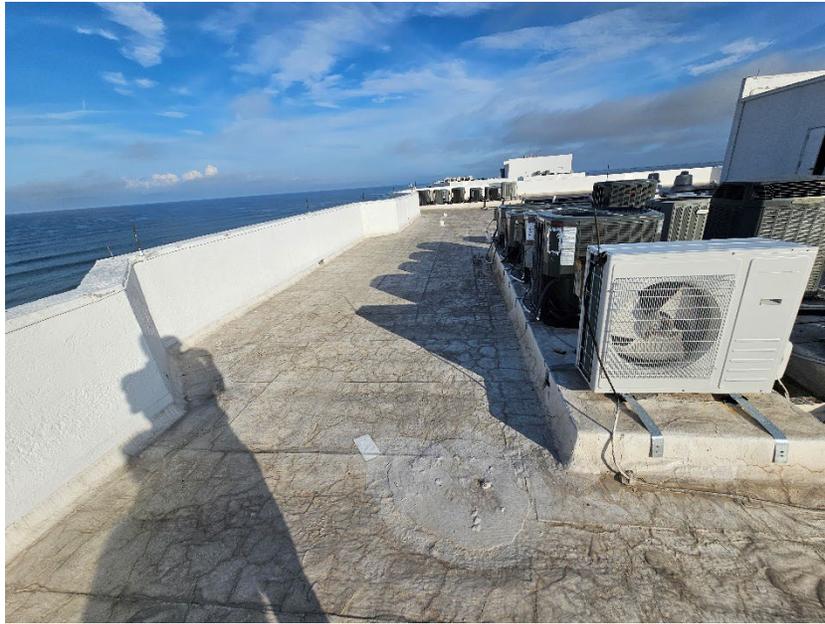
9. View of the typical HVAC systems and placement at the subject property.

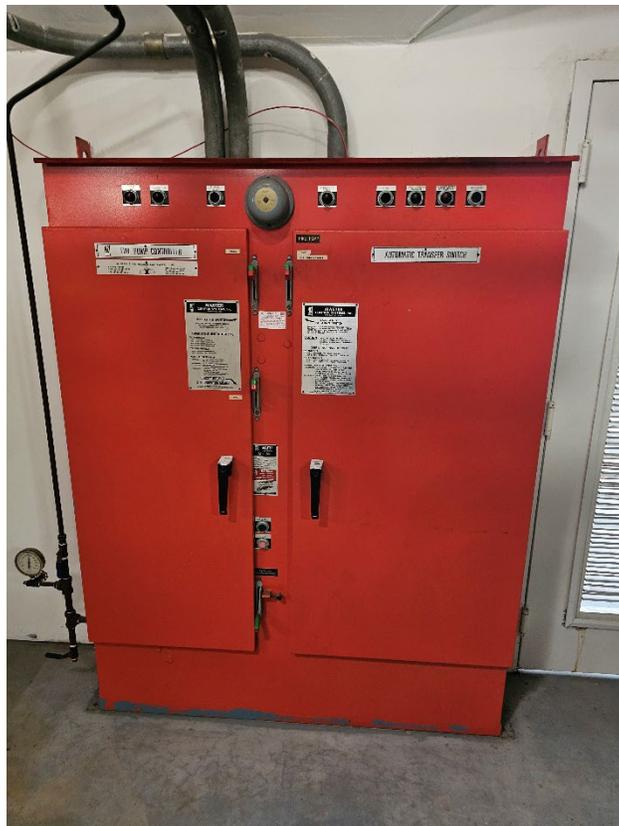
10. View of the typical equipment at the subject property.

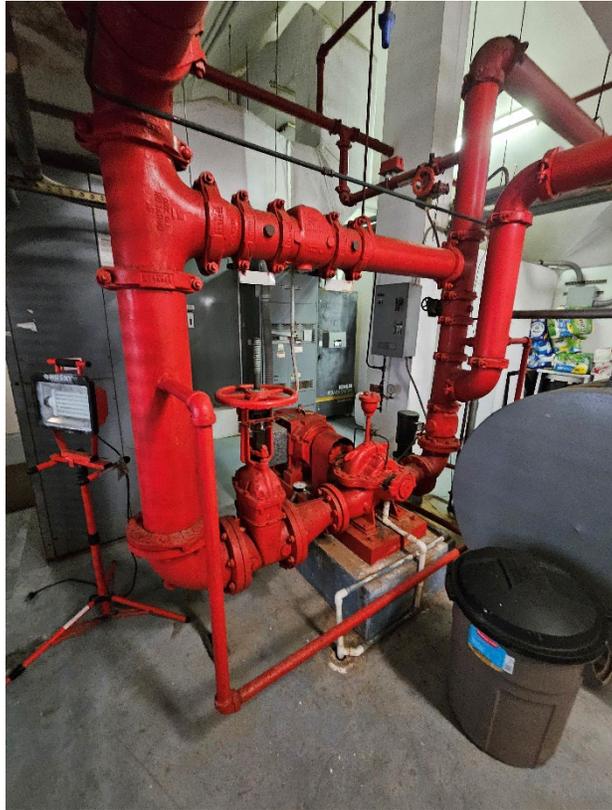
11. View of the fire safety plumbing at the subject property.

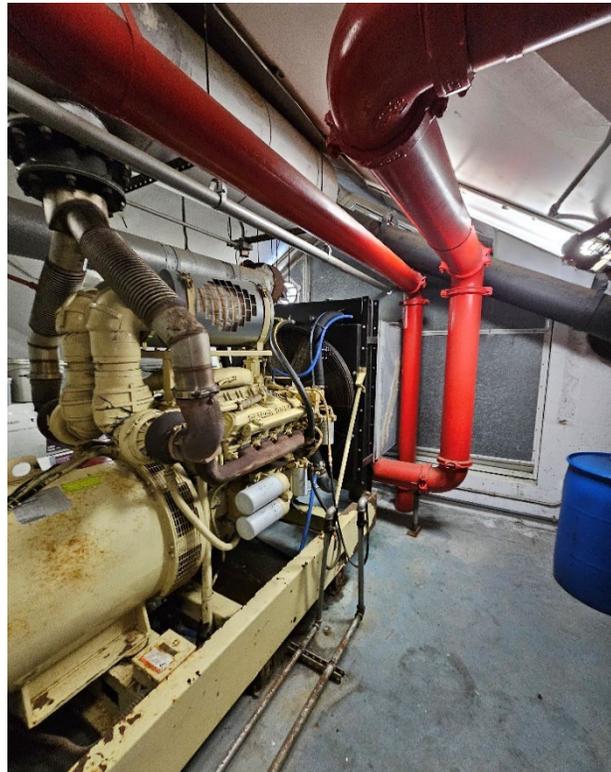
12. View of the fire line pump system at the subject property.
