# A Buyer's Choice Home Inspections

## PROPERTY INSPECTION REPORT

29460 Peoria Rd, Halsey, OR 97348  
Inspection prepared for: Andaman Rosse  
Real Estate Agent: -

Date of Inspection: 3/14/2026 Time: 8:00 AM  
Age of Home: 1971 Size: 1485  
Order ID: 225

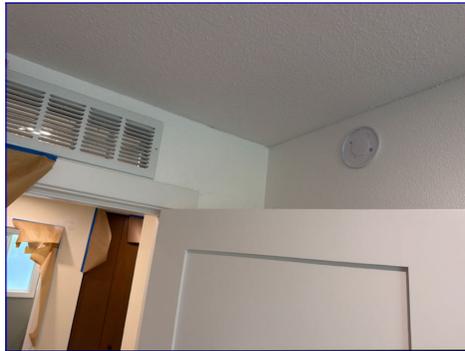
Page 10 Item: 1	CO/Smoke Detectors	<ul style="list-style-type: none"> <li>• No Carbon Monoxide (CO) detectors were noted in bedrooms, within an acceptable distance of the bedroom doors or in rooms with fuel burning appliances at the time of inspection. CO detectors should be installed whenever any of the following are present: 1) fuel burning appliances, 2) an attached garage, 3) fireplace</li> <li>• Smoke Detector(s) missing or not present in the Primary bedroom.</li> </ul>
-----------------	--------------------	--

Missing Smoke alarm in Primary bedroom

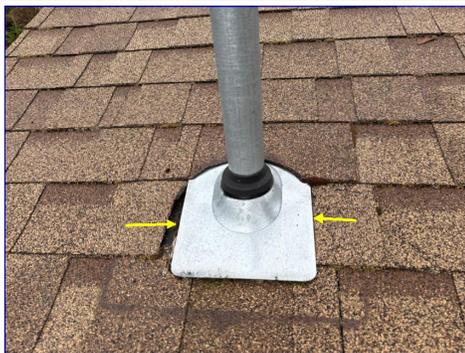
Page 12 Item: 3	Roof Flashing	<ul style="list-style-type: none"> <li>• The flashing around the electrical service entrance mast appears to be installed improperly. The sides of the flashing are installed on top of the shingles rather than beneath them. Flashing should be installed in a shingle-style manner so water is directed over the roofing materials and away from the penetration. This condition may allow water to enter beneath the roofing materials and increase the risk of moisture intrusion. Evaluation and correction by a qualified roofing contractor is recommended.</li> </ul>
-----------------	---------------	--

Flashing installed incorrectly

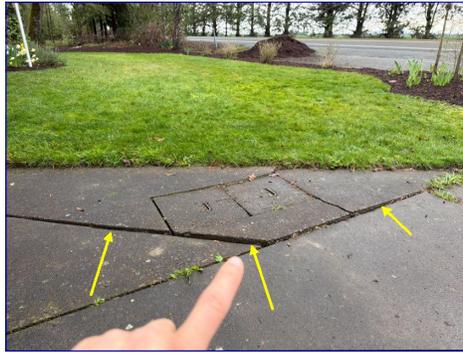
Page 15 Item: 2	Walkways	<ul style="list-style-type: none"> <li>• Possible trip hazard. This is a safety concern. Suggest repair/replacement as needed to ensure safety.</li> </ul>
-----------------	----------	--

Trip hazard

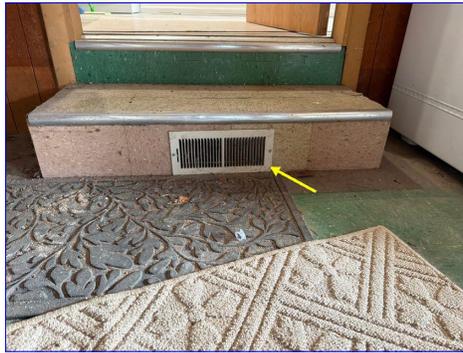
• HVAC registers noted in the garage. This is a safety hazard as this can allow a garage fire to spread quickly into the interior of the home. Recommend removing and sealing vent voids to maintain a proper fire separation wall.

Register in garage

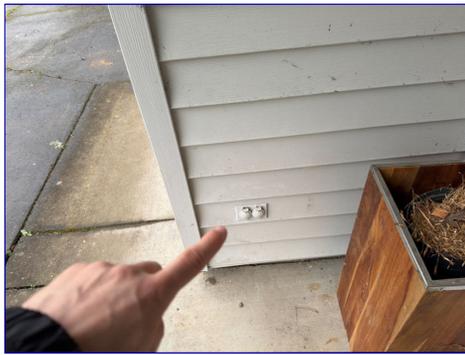
- Exterior electrical receptacles are not **GFCI** protected. Recommend installing **GFCI** receptacles for safety.
- Exposed electrical wiring observed in kitchen underneath the sink. This is a "Safety Concern" as it is used where it could be subject to "Physical Damage". Exposed electrical wires are normally encased in conduit to ensure safety. Recommend further evaluation of electrical system by a licensed electrical contractor for repair to ensure safety.
- Missing light switch cover observed in laundry room, garage and Primary bathroom. This is a shock hazard. Recommend installing covers for safety.
- Electrical receptacle within six feet of a water source is not **GFCI** protected. Recommend having a licensed electrical contractor repair for safety.

Not **GFCI** protected

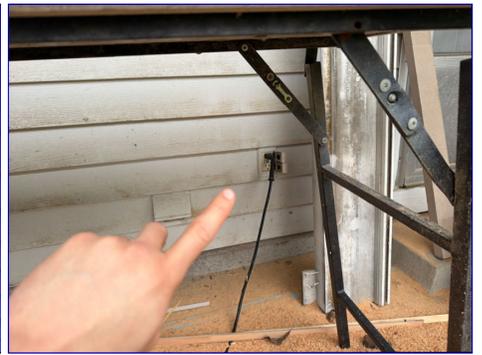
Not **GFCI** protected

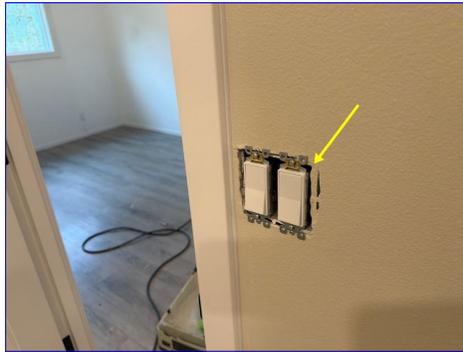
Missing light switch cover

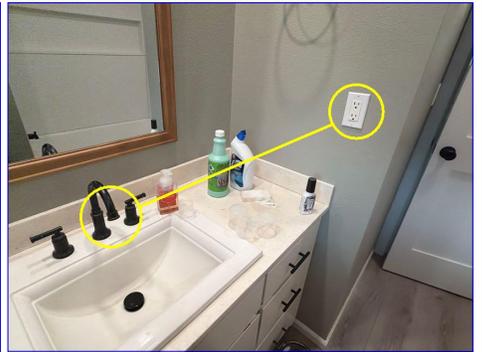
Receptacle within 6' water source is not **GFCI** protected

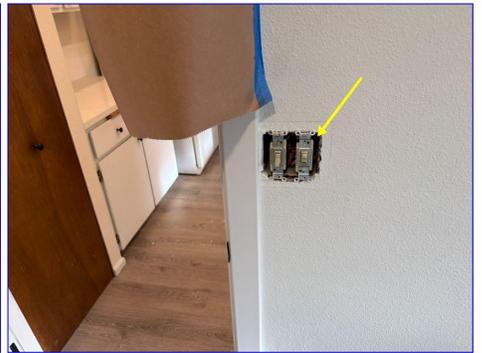
Missing light switch cover

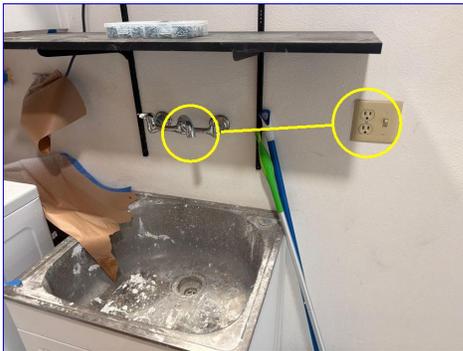
Receptacle within 6' of a water source is not **GFCI** protected

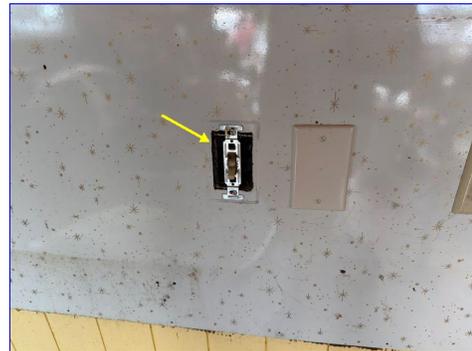
Missing light switch cover

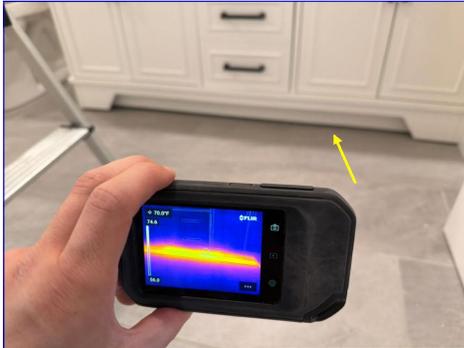
Page 30 Item: 7	Distribution/Ducting/Registers	<ul style="list-style-type: none"> <li>• The HVAC supply register in the primary bathroom is located beneath the vanity and is obstructed, which restricts proper airflow into the room. Recommend modifying the installation so the register is unobstructed to allow adequate air distribution.</li> </ul>
-----------------	--------------------------------	--

Register is blocked

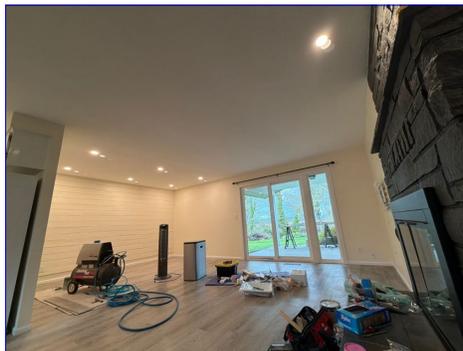
Page 33 Item: 3	Fireplace Comments/Observations	<ul style="list-style-type: none"> <li>• Carbon Monoxide detector required in the same room as fireplace / fire-burning appliance.</li> <li>• Smoke detectors required in the same room as fireplace / fire-burning appliance.</li> </ul>
-----------------	---------------------------------	---

Missing smoke and CO alarm

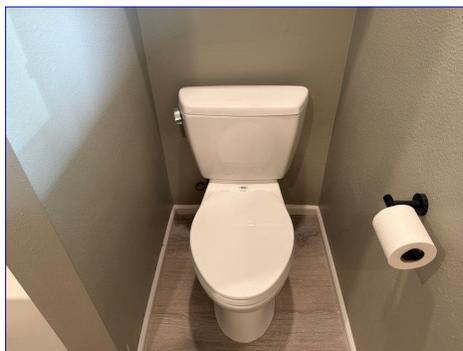
Page 42 Item: 15	Toilet	<ul style="list-style-type: none"> <li>• The toilet bowl is loose at floor anchor bolts. The wax ring inside the unit must have a snug, secure fit in order to keep from leaking. Properly resealing and re-securing this unit is suggested to prevent water leakage and damage to the sub-floor area. This type of damage is not always visible or accessible to the inspector at time of inspection. Thermal imaging used to help determine any damage and none was noted.</li> </ul>
------------------	--------	---

Loose toilet

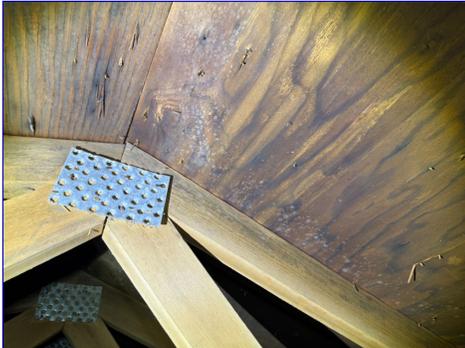
• Microbial growth or possible mold growth observed in several areas of the attic at the sheathing. Mold can only be confirmed with laboratory testing. Recommend having a qualified, contractor perform mold spore air testing and tape/swab sample of observed growth.

Microbial growth

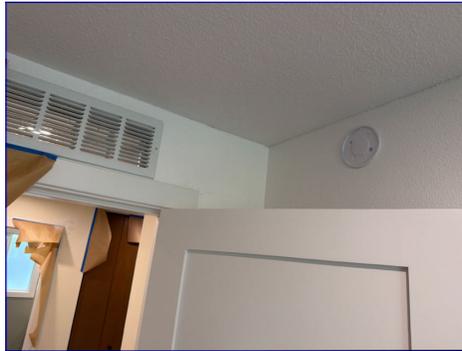
- Smoke Detectors present.
- No Carbon Monoxide (CO) detectors were noted in bedrooms, within an acceptable distance of the bedroom doors or in rooms with fuel burning appliances at the time of inspection. CO detectors should be installed whenever any of the following are present: 1) fuel burning appliances, 2) an attached garage, 3) fireplace
- Smoke Detector(s) missing or not present in the Primary bedroom.

Missing Smoke alarm in Primary bedroom

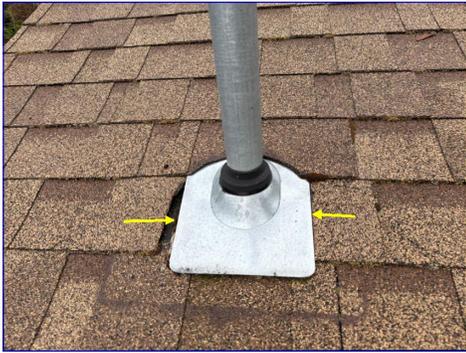
- The flashing around the electrical service entrance mast appears to be installed improperly. The sides of the flashing are installed on top of the shingles rather than beneath them. Flashing should be installed in a shingle-style manner so water is directed over the roofing materials and away from the penetration. This condition may allow water to enter beneath the roofing materials and increase the risk of moisture intrusion. Evaluation and correction by a qualified roofing contractor is recommended.

Flashing installed incorrectly

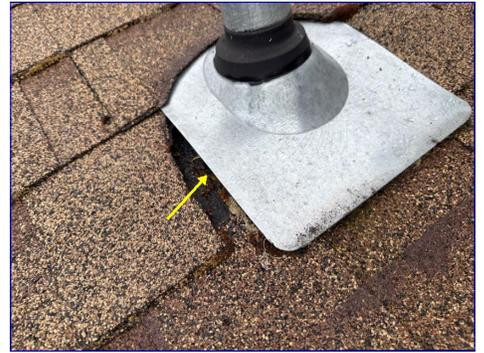
Flashing installed incorrectly

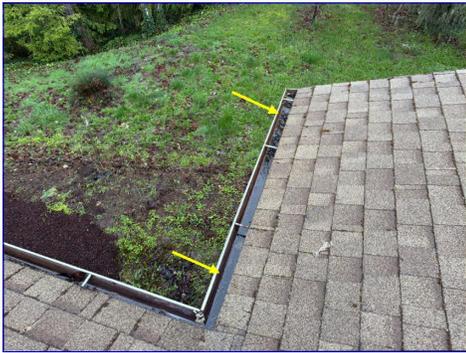
- Suggest cleaning gutters now, and as a normal part maintenance.
- Standing water observed in the gutters that are noted. Recommend correction to prevent any damage to the fascia board or gutter assembly.

Standing water in gutter

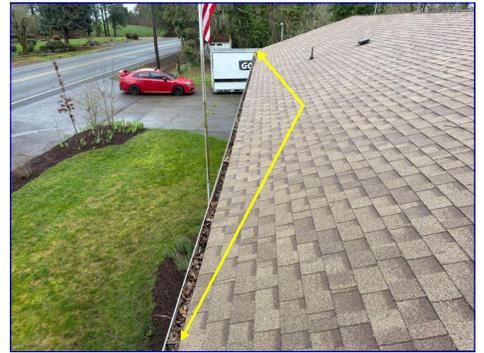
Suggest cleaning gutters

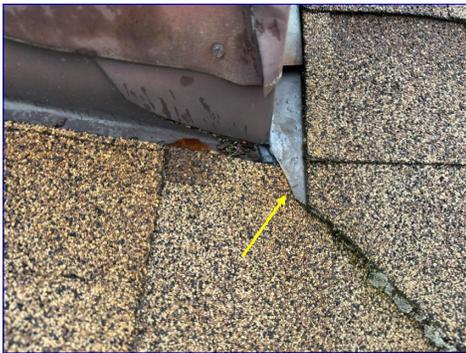
• The chimney flashing appears to be installed in a manner that may direct water beneath the shingles and into the roof **valley** rather than shedding water properly over the roofing surface. Flashing should be installed in a layered, shingle-style configuration so that water is directed away from the chimney and onto the roof covering. The current configuration increases the risk of water intrusion and concealed roof damage.

Possibly incorrect flashing installation

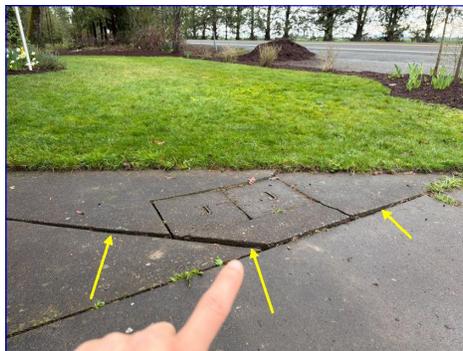
- Possible trip hazard. This is a safety concern. Suggest repair/replacement as needed to ensure safety.

Trip hazard

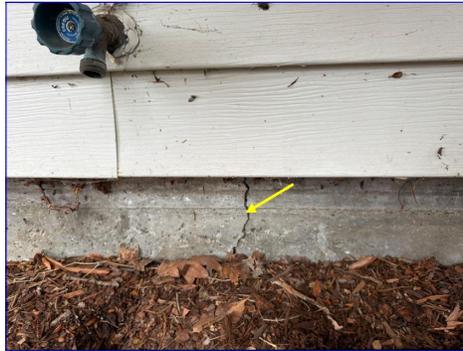
- Common cracks noted, which may leak at any time.

Foundation crack

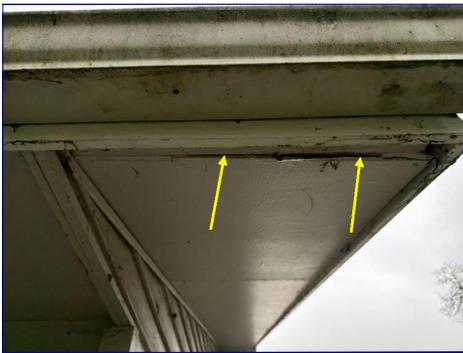
- Moisture damage, wood rot, observed. Recommend review for repair as necessary.

Moisture damage (southwest)

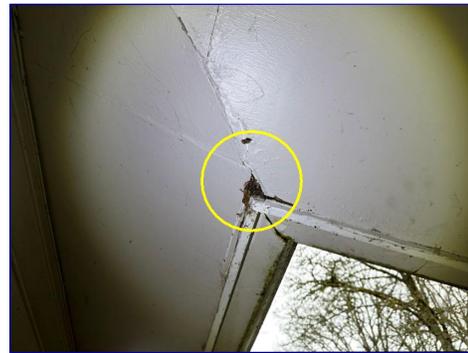
Moisture damage (Northwest)

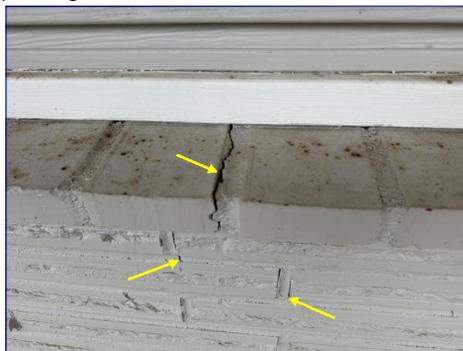
- Caulk and seal all gaps, cracks, and openings.

Caulking needed

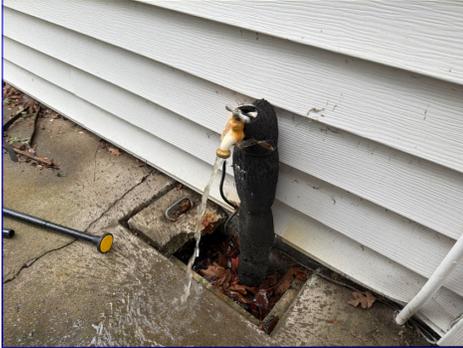
- Exterior faucet at the west side of the home is loose in the wall and has no water flow.

Exterior faucet

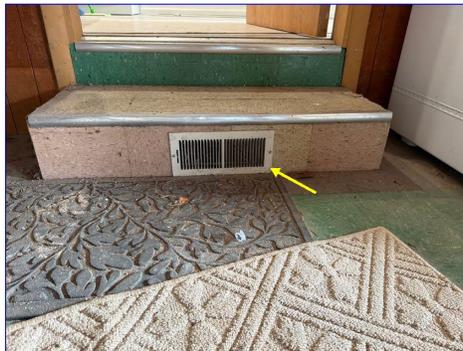
• HVAC registers noted in the garage. This is a safety hazard as this can allow a garage fire to spread quickly into the interior of the home. Recommend removing and sealing vent voids to maintain a proper fire separation wall.

Register in garage

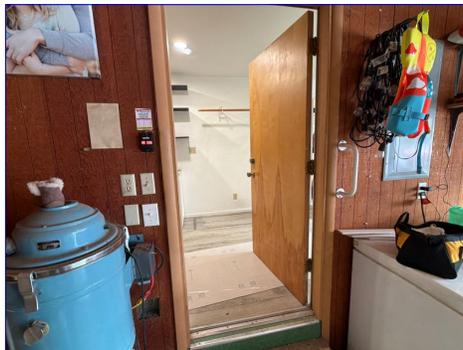
• Door does not close automatically as self closer is disconnected or not present. This is to act as a fire stop, keep exhaust and storage fumes out of the interior home. Recommend reconnecting/installing self closer for safety.

Door does not close automatically

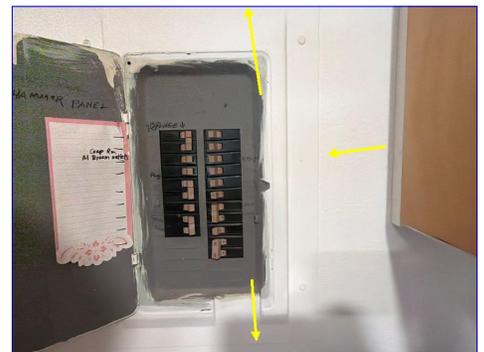
Panel is sealed via paint

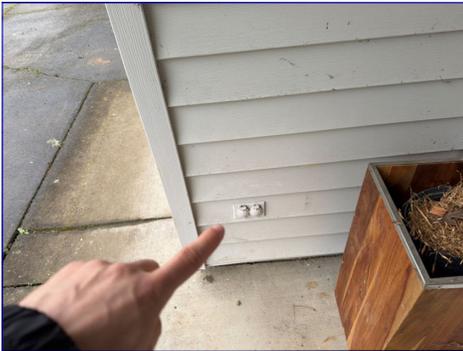
- Garage receptacles should all be **GFCI** protected.
- Exterior electrical receptacles are not **GFCI** protected. Recommend installing **GFCI** receptacles for safety.
- Exposed electrical wiring observed in kitchen underneath the sink. This is a "Safety Concern" as it is used where it could be subject to "Physical Damage". Exposed electrical wires are normally encased in conduit to ensure safety. Recommend further evaluation of electrical system by a licensed electrical contractor for repair to ensure safety.
- Missing light switch cover observed in laundry room, garage and Primary bathroom. This is a shock hazard. Recommend installing covers for safety.
- Electrical receptacle within six feet of a water source is not **GFCI** protected. Recommend having a licensed electrical contractor repair for safety.

Not **GFCI** protected

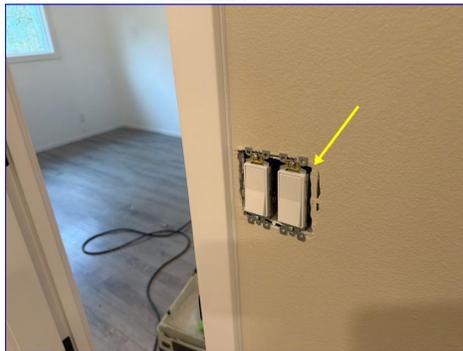
Missing light switch cover

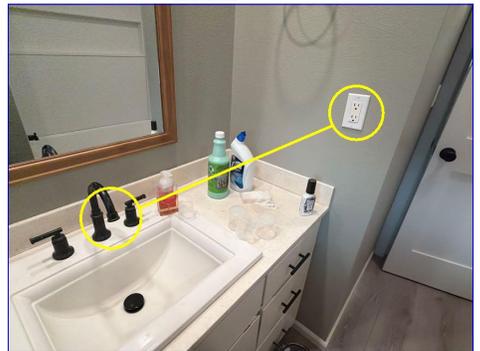
Receptacle within 6' water source is not **GFCI** protected

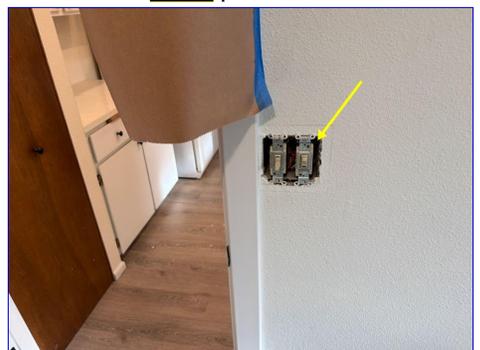
Missing light switch cover

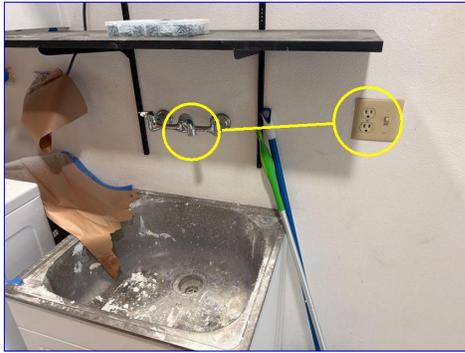
Receptacle within 6' of a water source is not **GFCI** protected

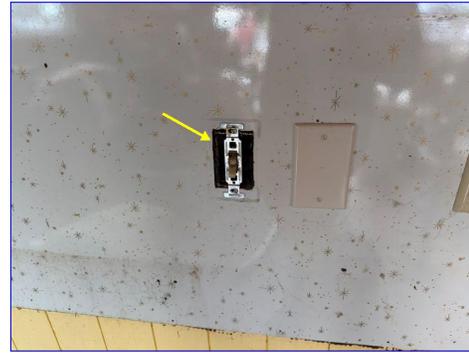
Missing light switch cover

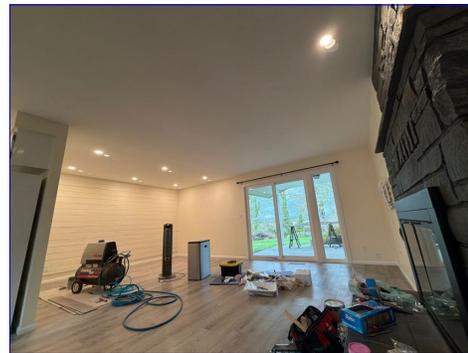
- All fireplaces, fuel burning stoves and chimneys should be inspected by a certified chimney sweep prior to use and no less than annually. Recommend further review and cleaning by a certified chimney sweep.
- Carbon Monoxide detector required in the same room as fireplace / fire-burning appliance.
- Smoke detectors required in the same room as fireplace / fire-burning appliance.

Missing smoke and CO alarm

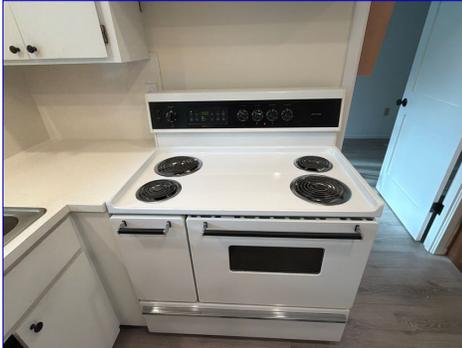
Missing anti-tip device

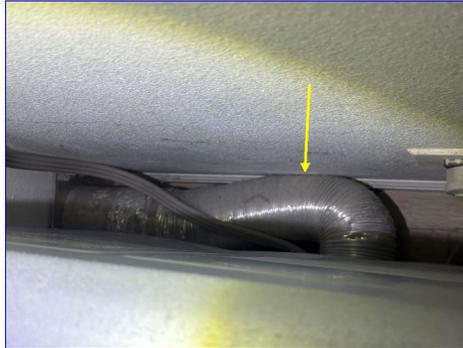
**Dryer Supply:** Electric  
**Dryer Vent Materials:** Flexible Foil  
• Although once considered acceptable, flexible, ribbed vents are a potential fire hazard and should be replaced.

Flexible foil

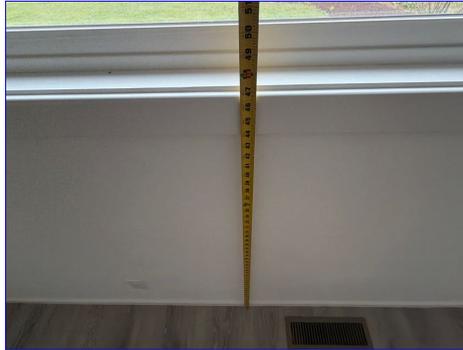
• The bedroom windows are installed at a height that would not meet current emergency egress standards. However, this condition was common in older construction and may have been acceptable at the time the home was built. While not necessarily required to be upgraded, lower sill heights are recommended in sleeping rooms to improve emergency escape and rescue access.

Window exceeds 44"

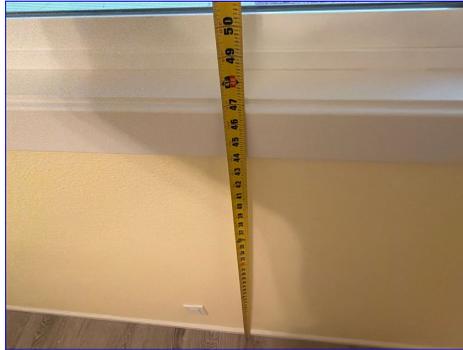
- The bedroom windows are installed at a height that would not meet current emergency egress standards. However, this condition was common in older construction and may have been acceptable at the time the home was built. While not necessarily required to be upgraded, lower sill heights are recommended in sleeping rooms to improve emergency escape and rescue access.

Window exceeds 44"

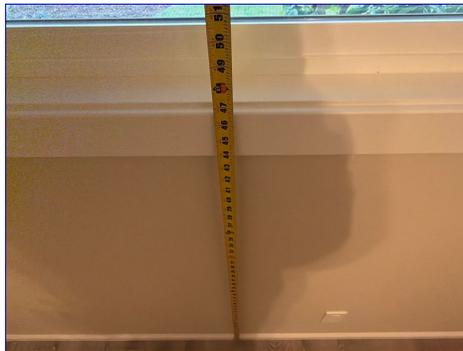
- The bedroom windows are installed at a height that would not meet current emergency egress standards. However, this condition was common in older construction and may have been acceptable at the time the home was built. While not necessarily required to be upgraded, lower sill heights are recommended in sleeping rooms to improve emergency escape and rescue access.

Windows exceeds 44"

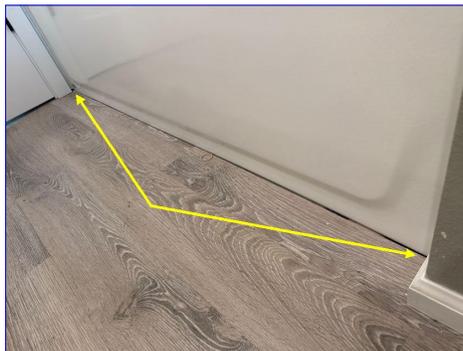
- Caulk needed around tub to prevent moisture intrusion to the floor and surrounding.

Caulk needed

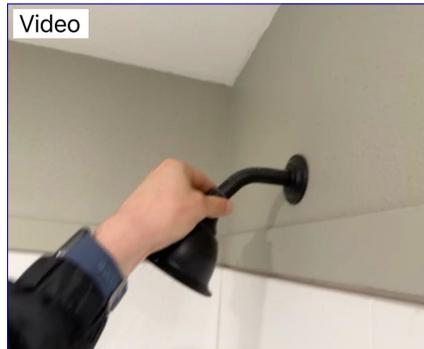
- Serviceable condition
- Faucet is loose in the wall.

Showerhead is loose

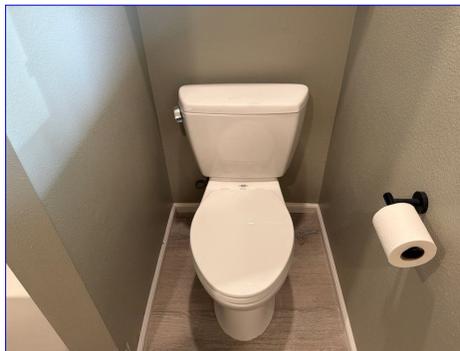
- Operated when tested.
- The toilet bowl is loose at floor anchor bolts. The wax ring inside the unit must have a snug, secure fit in order to keep from leaking. Properly resealing and re-securing this unit is suggested to prevent water leakage and damage to the sub-floor area. This type of damage is not always visible or accessible to the inspector at time of inspection. Thermal imaging used to help determine any damage and none was noted.

Loose toilet

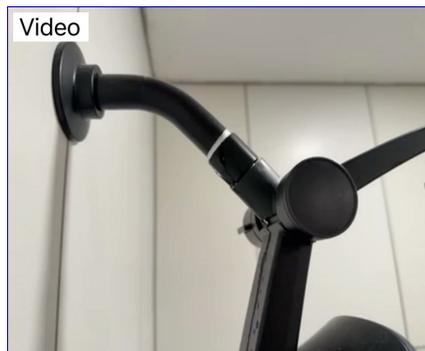
- Shower head leaks.

Showerhead leaks

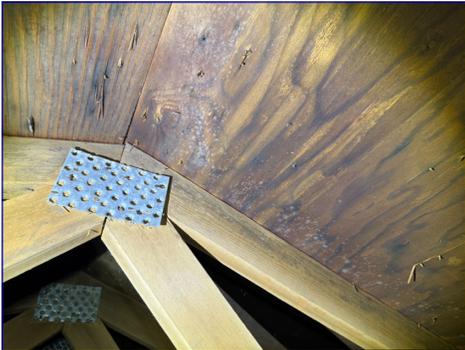
- Microbial growth or possible mold growth observed in several areas of the attic at the sheathing. Mold can only be confirmed with laboratory testing. Recommend having a qualified, contractor perform mold spore air testing and tape/swab sample of observed growth.

Microbial growth
