## Milestone Inspection Report

Project # 22RS-0822  
February 12, 2024  
**FINAL COPY**

*The Water Club  
Milestone Inspection*

*1261 Gulf of Mexico Drive  
Longboat Key, FL 34228*

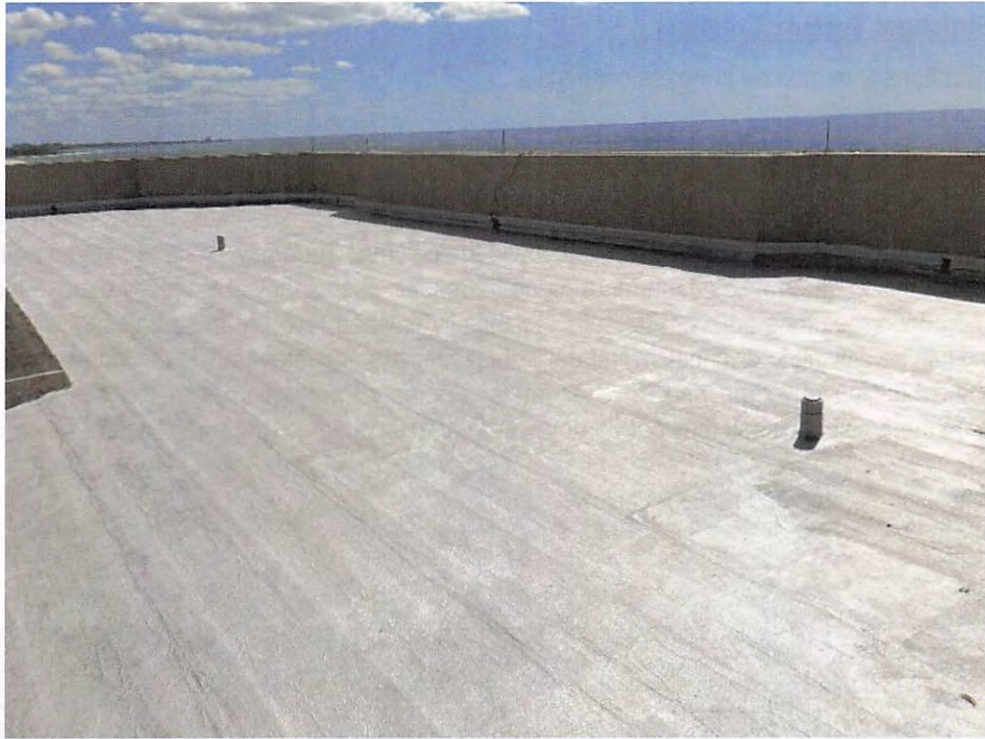
Figure 1 – North Tower Roof Deck

Mechanical equipment & supports were observed on the roof of WC. The stands for the A/C condensers appear to be in good condition. The condensing units range from good to poor, dependent on their date of installation. Elevator equipment was observed to be in excellent condition. Some equipment located on the roof are showing signs of corrosion. The majority of deficiencies were found at the parapet walls. Things such as paint blisters, hairline cracks, and damaged overflow scuppers were noted (recommended to be addressed immediately as poses a threat to life-safety). See Figures and notes as follows:

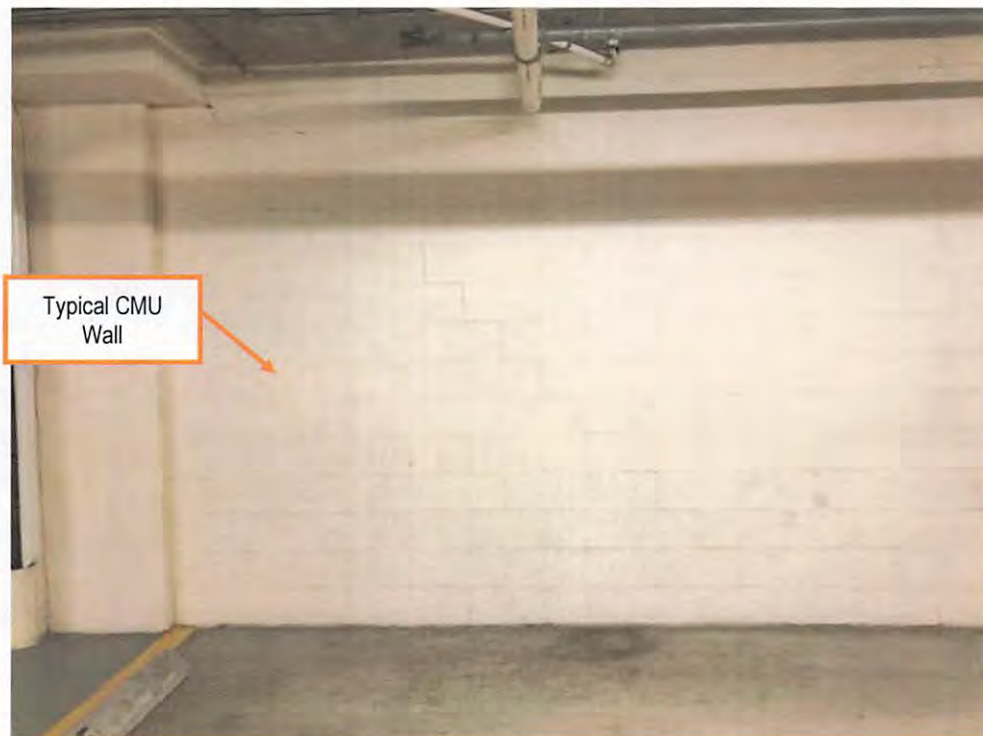
Figure 4: Garage

Observations: There was stairstep cracking observed at the CMU breakaway wall. This wall is non-structural in nature and was designed to collapse under specific lateral loading forces, such as storm surges. See Figures and notes as follows:

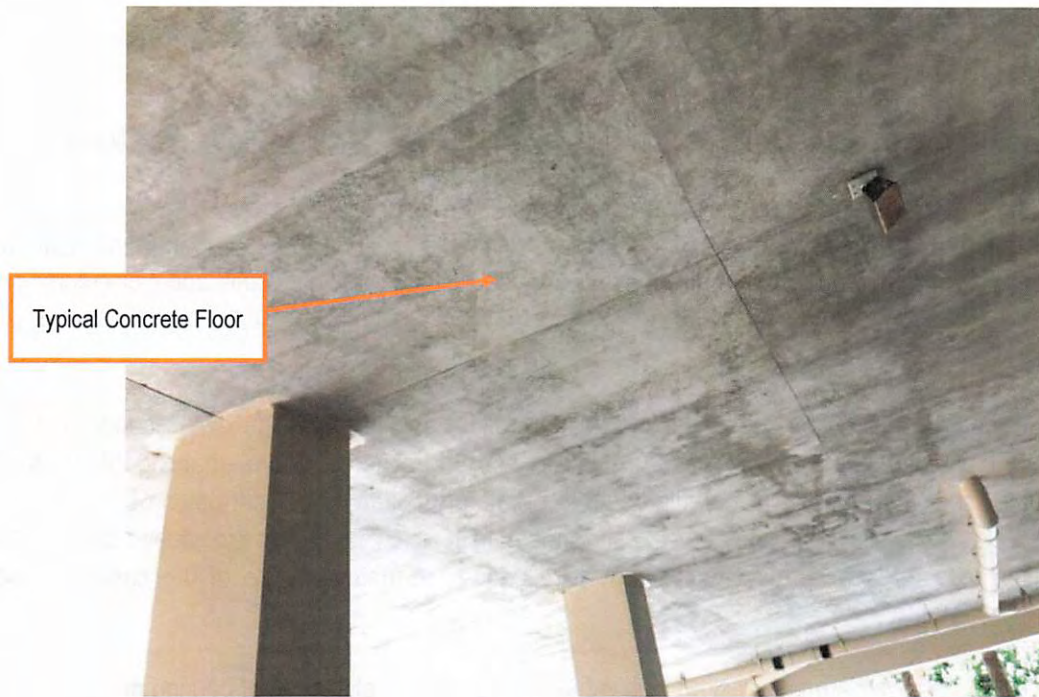
Figure 5: North Tower

Observations: KEG observed area of cracked slab located in the northeast section of parking garage area. It may be possible to remediate this area by pressure injecting the cracks to prevent further crack propagation. KEG observed areas in the parking garage where makeshift drain pans were installed to divert water away from parked vehicles or other undesirable areas. Water appears to be permeating into the parking garage area from differing locations above (leak may be a result of failed expansion joint). See Figures and notes as follows:

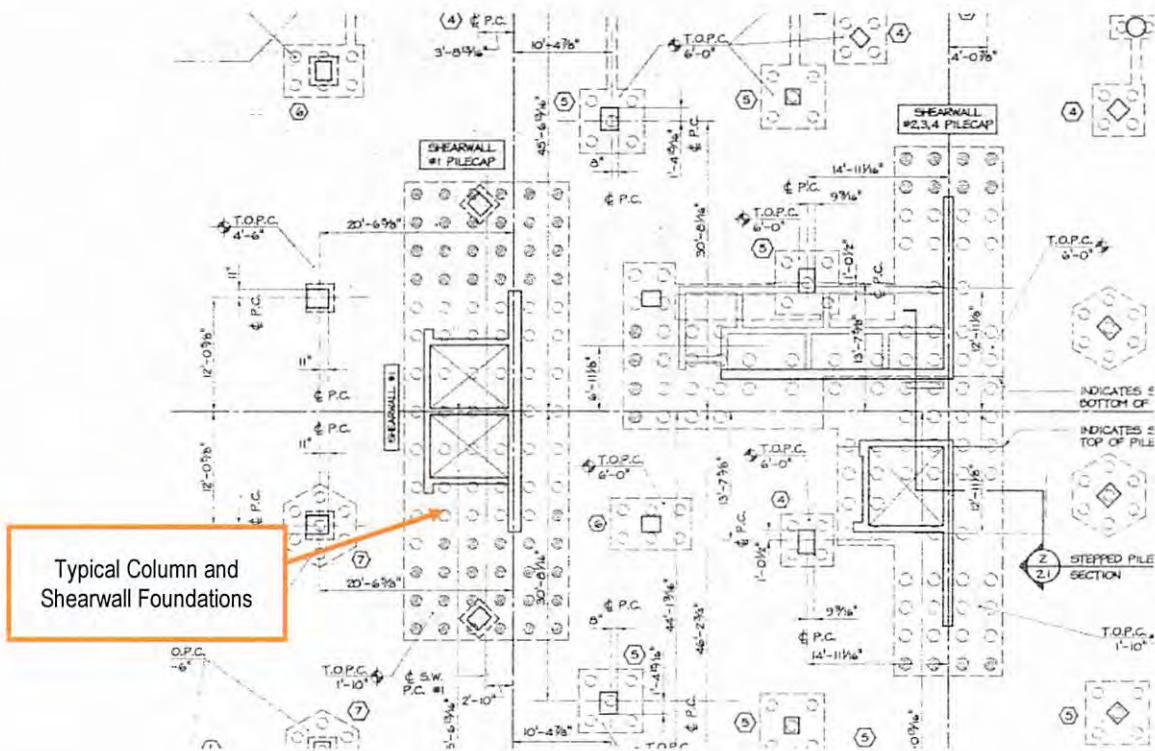
### Figure 7: Structural Drawings

Observations: The exposed 4" concrete slab w/ welded wire mesh (W.W.M.) vapor barrier and clean compacted fill was observed at the parking garage area. The slab on-grade good condition with some typical "plastic shrinkage cracks" observed around the bases of columns observed. Plastic shrinkage cracks almost always happen at reentrant corners (corners that point into the slab) or with objects in the middle of a slab (pipes, plumbing fixtures, drains, and manholes, columns). Since concrete cannot shrink around a corner, stress will cause the concrete to crack from the point of that corner. This is not an immediate structural concern. See Figures and notes as follows:

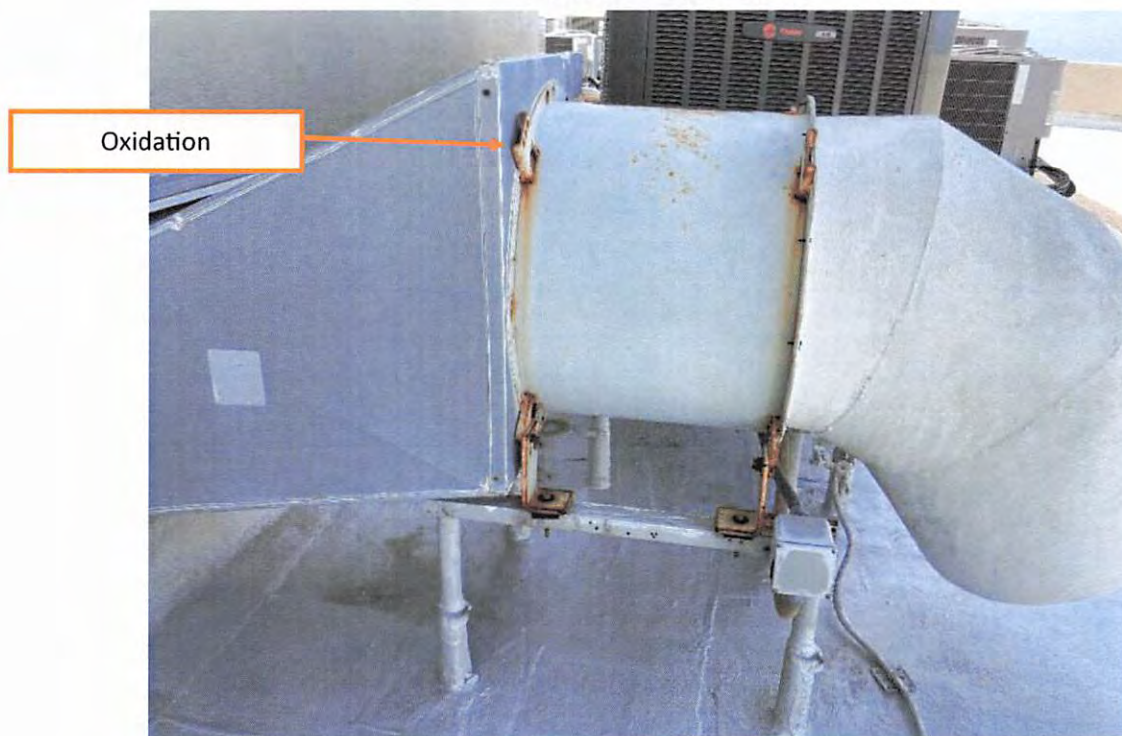
Figure 5 – Onset of Corrosion at Rooftop Equipment.

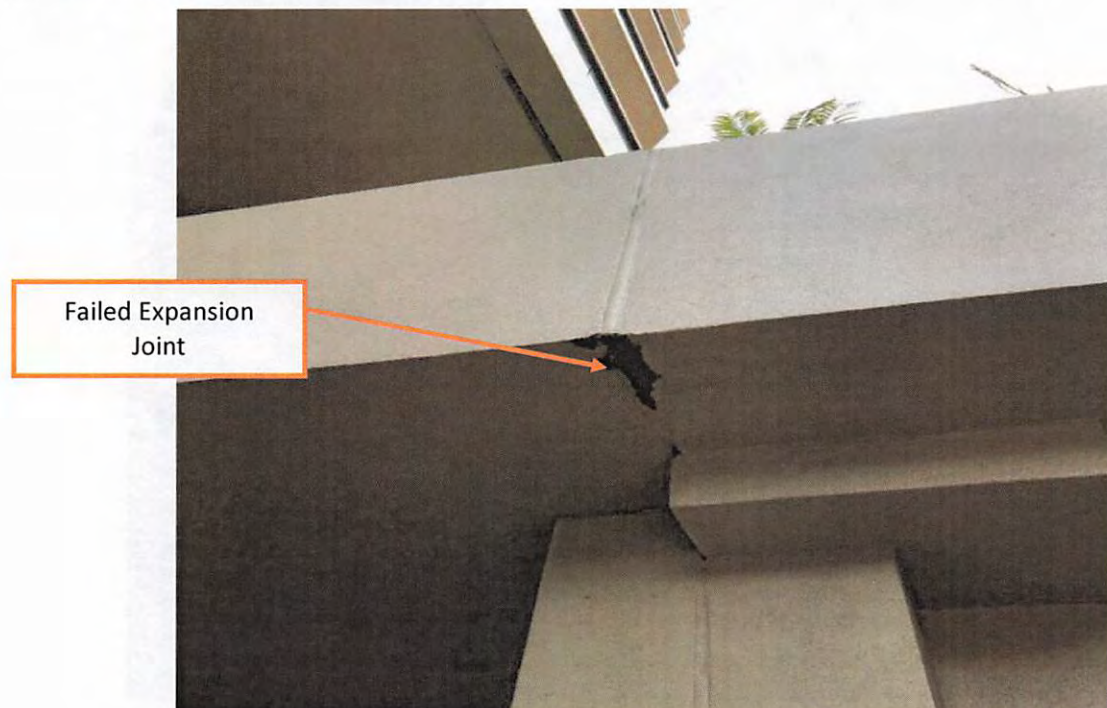
Failed Expansion  
Joint

Figure 11 – Planter Expansion Joint at Parking Garage Exit.

- Repair failed locations of expansion joints. WC is currently under contract with KE to investigate and provide a repair procedure for the areas of failed expansion joints.
- Repair all concrete spalls, raveling, and cracks.
- Replace/repair all failed sealant joints.
- Repair broken and damaged stucco.
- Fix blistering, chalking, and deteriorated paint.
- Replace corroded Components.
- Replace broken tiles.
- Isolate and resolve leaks.
- Periodically remove organic growth.
- Periodically remove debris at SGD's weep holes.
- Periodically verify main roof drains are clear of excessive debris and drain efficiently.
- Periodically verify balcony drains clear of excessive debris and drain efficiently.

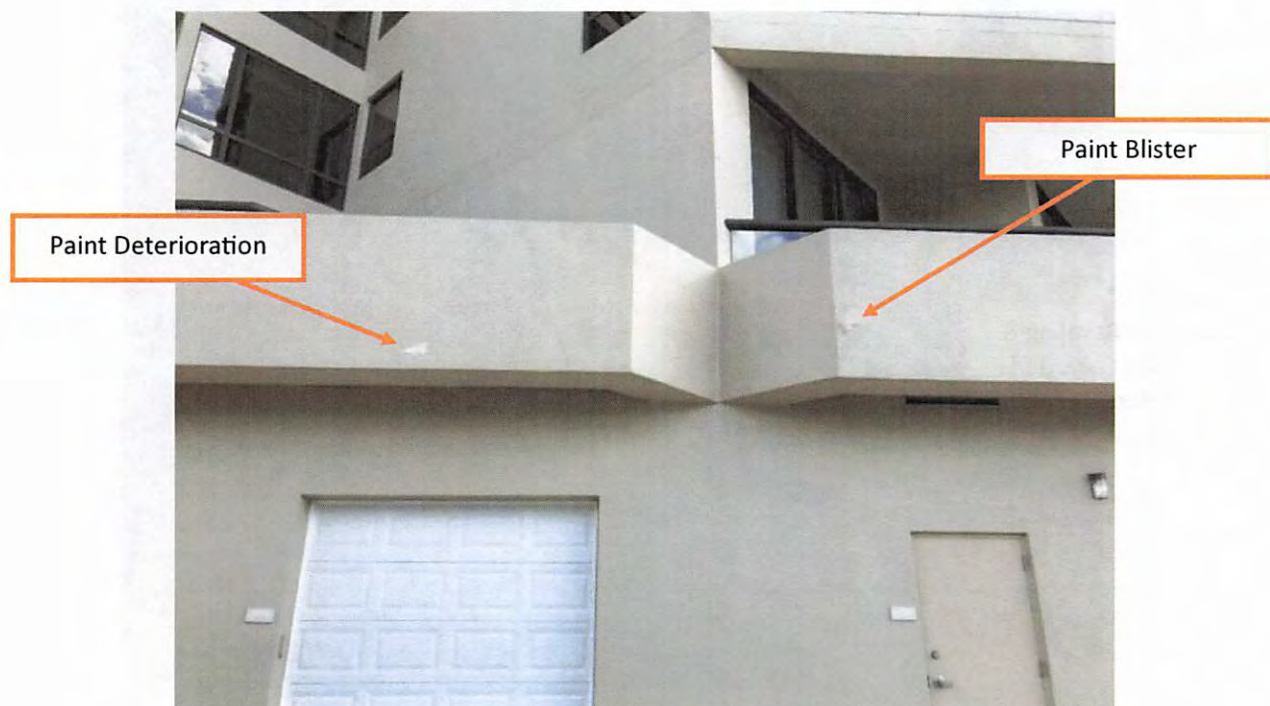
Figure 12 - North Tower.

Paint Deterioration

Paint Blister

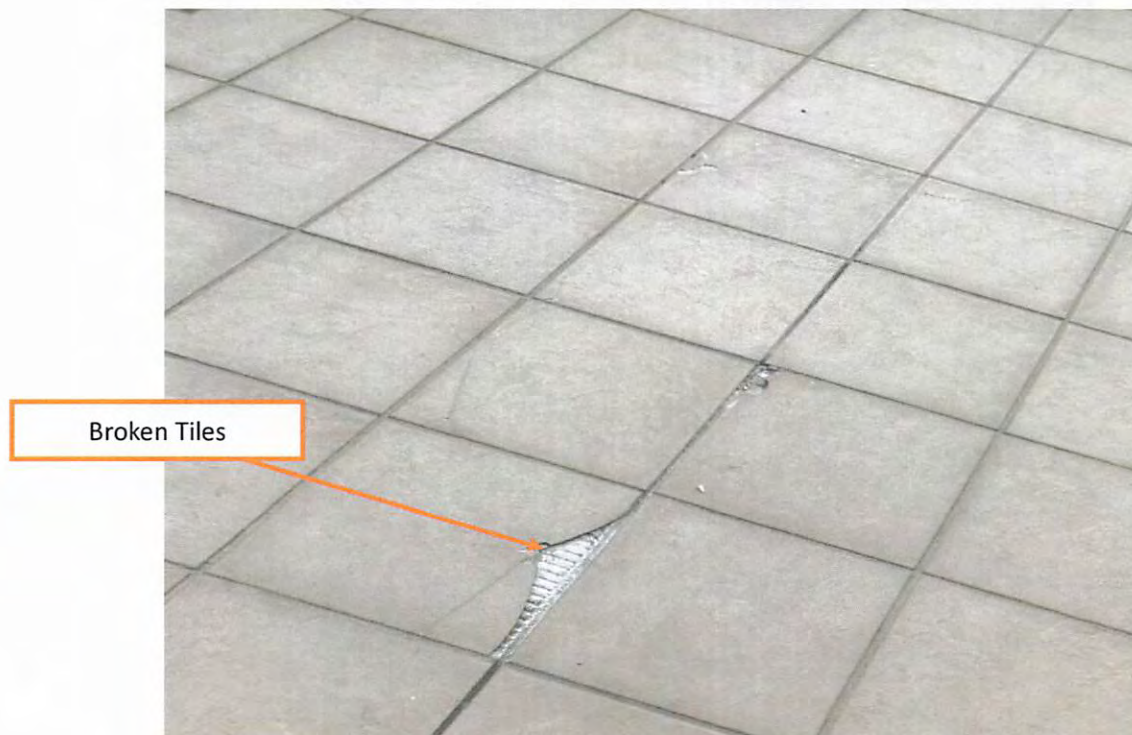
Figure 24 - Broken Tiles
