# A Buyer's Choice Home Inspections

## PROPERTY INSPECTION REPORT

859 Mule Deer Pl NW, Salem, OR 97304  
Inspection prepared for: Andaman Rosse  
Real Estate Agent: -

Date of Inspection: 1/27/2026 Time: 8:00 AM  
Age of Home: 2002 Size: 2474  
Order ID: 212

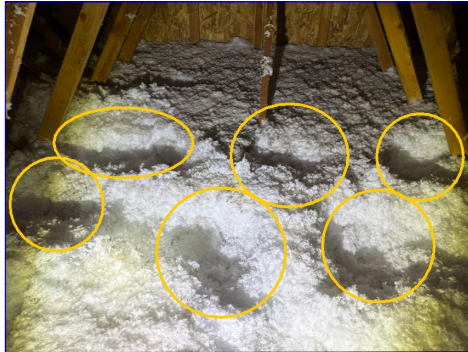
<b>Attic</b>		
Page 15 Item: 4	Insulation	<ul style="list-style-type: none"> <li>Insulation has been compressed or relocated in the specified areas. This will decrease the R value of that insulation area, leading to temperature regulation issues. Recommend correction.</li> </ul>

Disturbed insulation

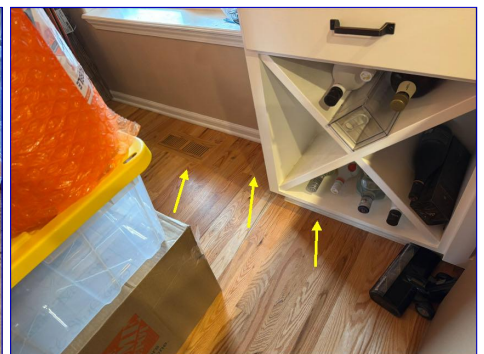
Page 31 Item: 2	Floors	<ul style="list-style-type: none"> <li>Floor is not level in west side of dining area. Suggest further evaluation by a licensed contractor.</li> </ul>
-----------------	--------	--------------------------------------------------------------------------------------------------------------------------------------------------------

Floor is not level

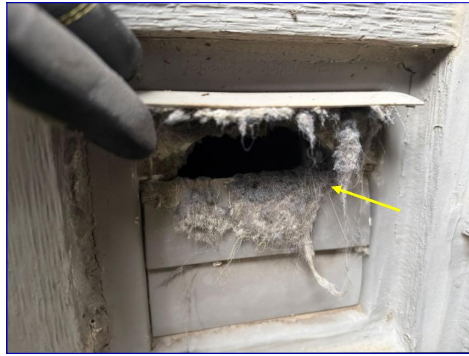
Page 33 Item: 9	Dryer Supply & Vent	<ul style="list-style-type: none"> <li>Lint build-up noted. Suggest cleaning ducting regularly to prevent lint build-up, which is a serious fire hazard.</li> </ul>
-----------------	---------------------	---------------------------------------------------------------------------------------------------------------------------------------------------------------------

Lint buildup

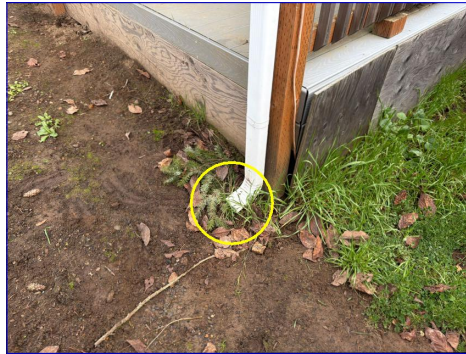
- Downspout(s) discharge water at foundation. Recommend installation of extension to ensure proper drainage away from foundation to prevent seepage.

Downspout discharges at foundation

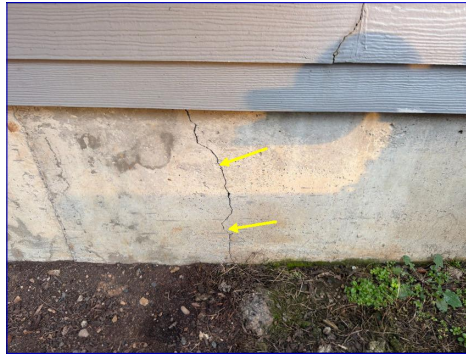
- Common cracks noted, which may leak at any time.

Foundation crack south

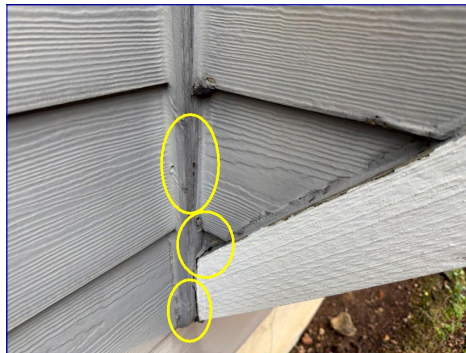
**Materials:** Composition wood or composition cement siding; "Hardi-Board"  
• Moisture damage to siding noted. Seal or replace to prevent further damage.

Moisture damage south

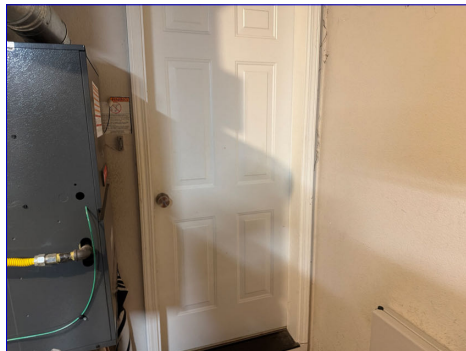
• Door does not close automatically as self closer is disconnected or not present. This is to act as a fire stop, keep exhaust and storage fumes out of the interior home. Recommend reconnecting/installing self closer for safety.

Door does not close automatically

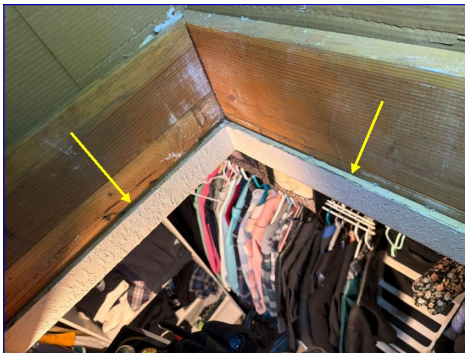
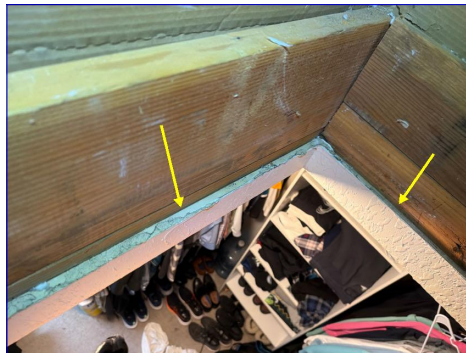
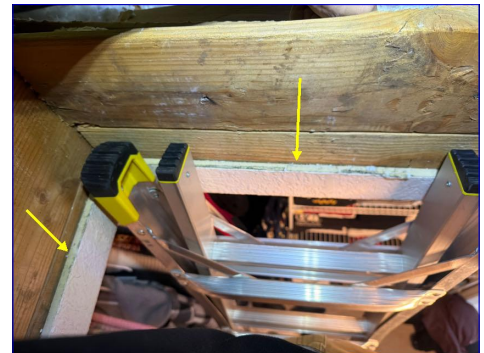
- No weatherstripping present around access panel. Recommend installing weatherstripping between the access hatch opening and trim. Without proper weatherstripping, warm, moist air escapes into the attic through the hatch greatly increasing the possibility for mildew and/or mold growth in the attic, particularly around the hatch opening.

Missing weatherstripping

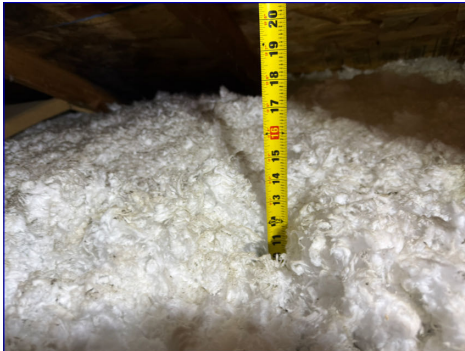
• Insulation has been compressed or relocated in the specified areas. This will decrease the R value of that insulation area, leading to temperature regulation issues. Recommend correction.

Insulation depth

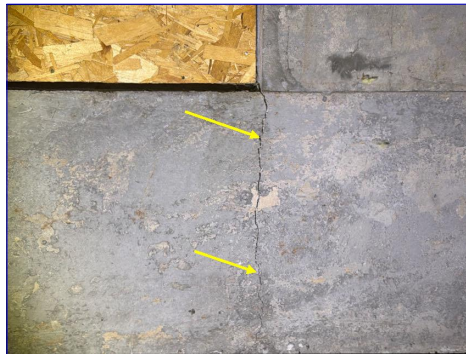
- Common cracks observed. Cracks may leak at any time.

Foundation crack

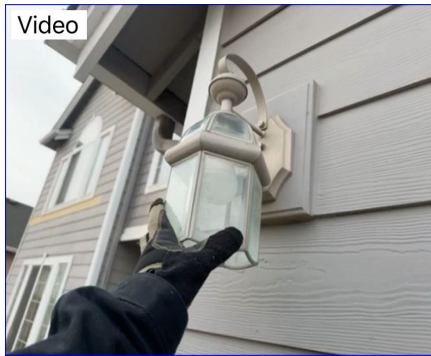
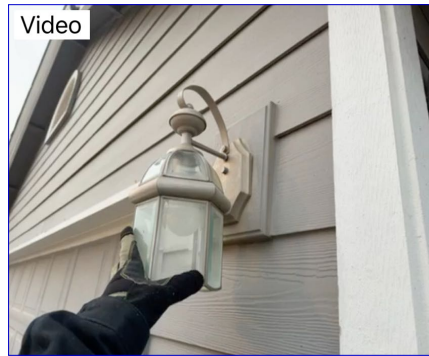
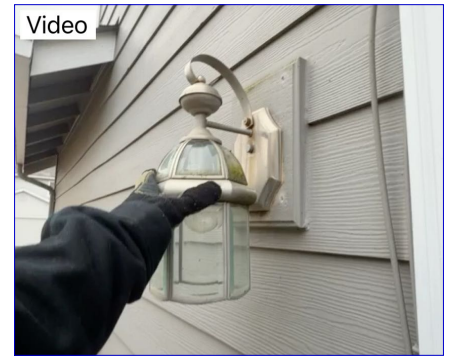
- Electrical receptacle in areas noted are loose and should be secured.
- Exterior light fixtures are loose where noted and should be secured.

Loose exterior light fixture east

Loose exterior light fixture north

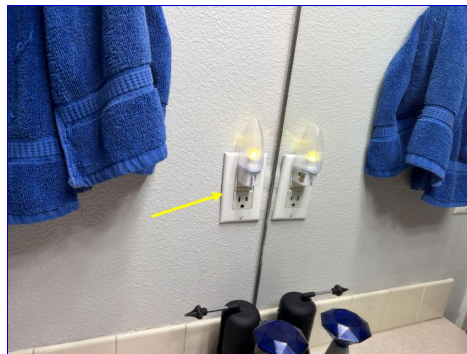
Loose receptacle 2nd story hall bathroom

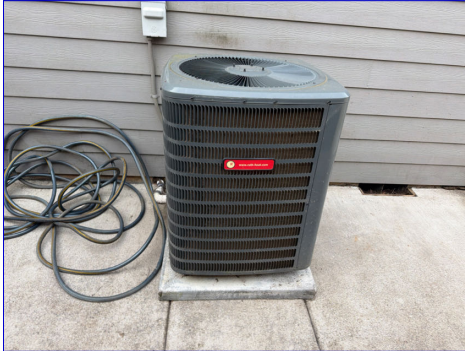
• Condenser fins are dirty or full of debris, suggest cleaning coils regularly for proper operation.

Condenser unit

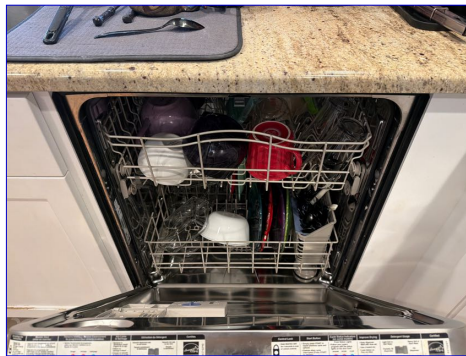
• Dishwasher was full of dishes and/or other personal belongings. Unit was not operated to prevent accidental damage to contents. Recommend confirming proper operation prior to closing.

Unit contains dishes

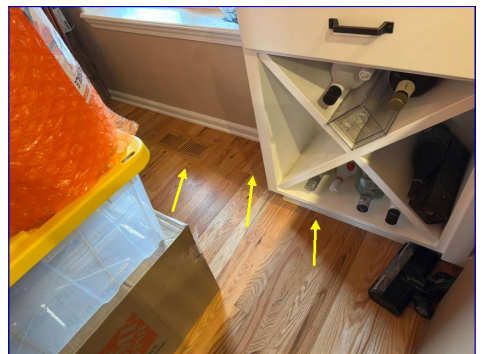
Floor is not level

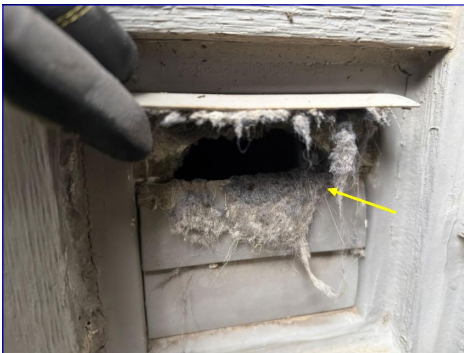
- Although once considered acceptable, flexible, ribbed vents are a potential fire hazard and should be replaced.
- Lint build-up noted. Suggest cleaning ducting regularly to prevent lint build-up, which is a serious fire hazard.

Lint buildup

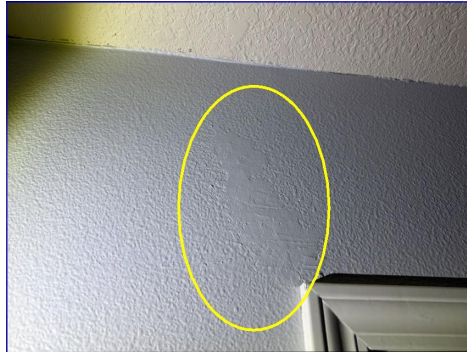
- Evidence of patching observed where a common crack is. Recommend monitoring for any movement.

Patched crack

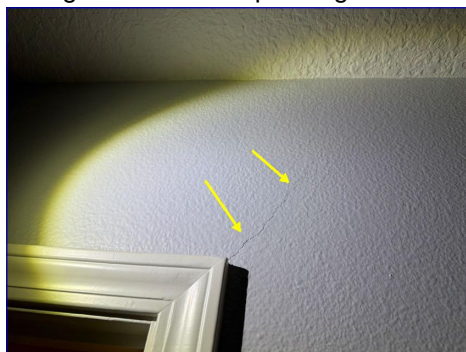
- Common cracks noted. Recommend sealing all cracks and painting in order to monitor for any future movement.

Common crack

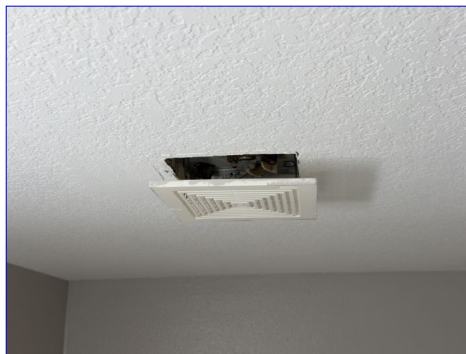
- Operated normally when tested.
- Exhaust fan cover is loose and should be secured.

Loose exhaust fan cover

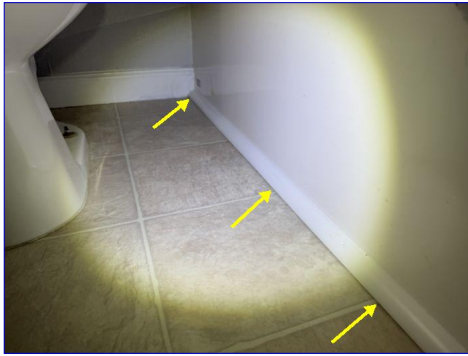
- Caulk needed around tub to prevent moisture intrusion to the floor and surrounding.

Needs caulking

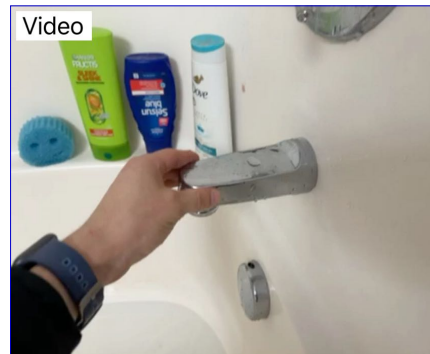
- Serviceable
- Faucet is loose in the wall.

Loose tub faucet

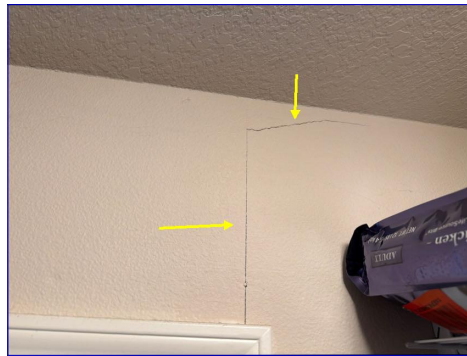
- Common cracks noted in closet. Recommend sealing all cracks and painting in order to monitor for any future movement.

Common crack

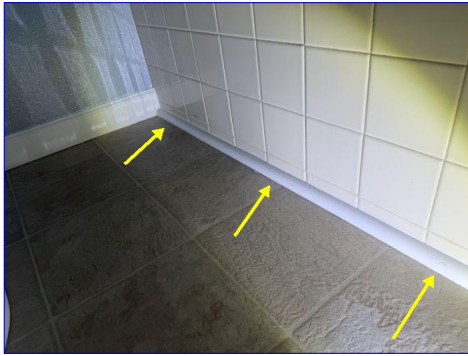
- Debris was ejected from the jets during operation, recommend having circulation system professionally cleaned prior to use.
- Caulk needed around tub to prevent moisture intrusion to the floor and surrounding.

Needs caulking
