# A Buyer's Choice Home Inspections

## PROPERTY INSPECTION REPORT

3077 NW Lisa Pl, Corvallis, OR 97330  
Inspection prepared for: Andaman Rosse  
Real Estate Agent: Andaman Rosse -

Date of Inspection: 5/7/2026 Time: 9:00 AM  
Age of Home: 1976 Size: 3360  
Order ID: 275

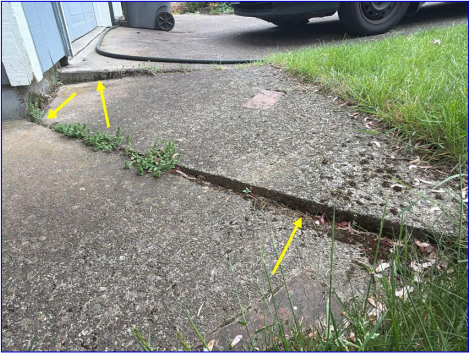
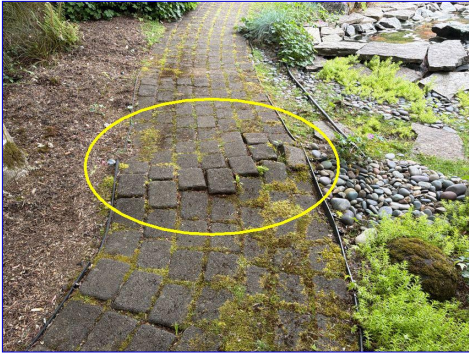
| Exterior | | |
|---|---|---|
| Page 12 Item: 2 | Walkways | <ul style="list-style-type: none"> <li>• Possible trip hazard. This is a safety concern. Suggest repair/replacement as needed to ensure safety.</li> </ul> |
| Trip hazards | | Trip hazard |

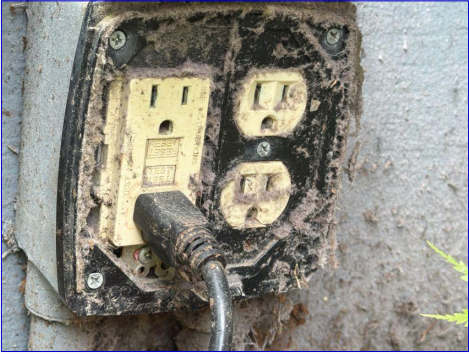
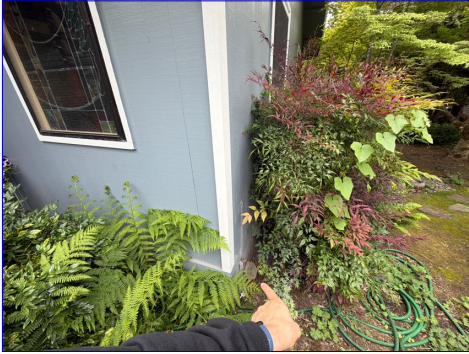
| Exterior | | |
|---|---|---|
| Page 16 Item: 15 | General Exterior Comments | <ul style="list-style-type: none"> <li>• Lint accumulation from the dryer exhaust termination was observed partially covering the nearby exterior receptacle. This condition may present a potential fire hazard and can contribute to moisture retention or improper operation of the receptacle. Recommend cleaning the area and monitoring the dryer exhaust termination for excessive lint discharge.</li> </ul> |
| Lint covering exterior receptacle (front) | | Lint covering exterior receptacle (front) |

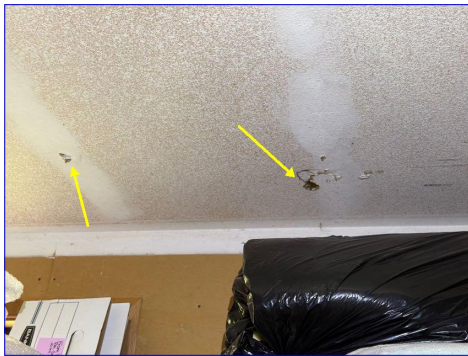
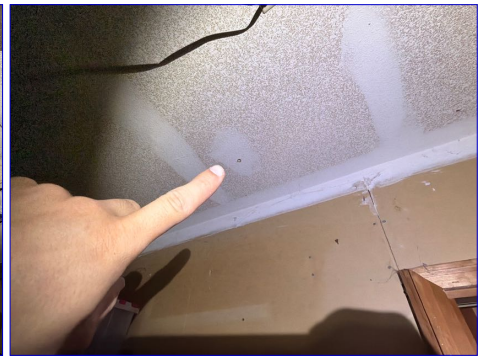
| Exterior | | |
|---|---|---|
| Page 17 Item: 4 | Fire Separation Wall | <ul style="list-style-type: none"> <li>• Attic access panel/hatch cover is plywood which is flammable. Recommend replacing access panel with a fire rated panel for safety.</li> <li>• Holes observed, suggest sealing to restore fire rating.</li> </ul> |

Hole in fire separation wall

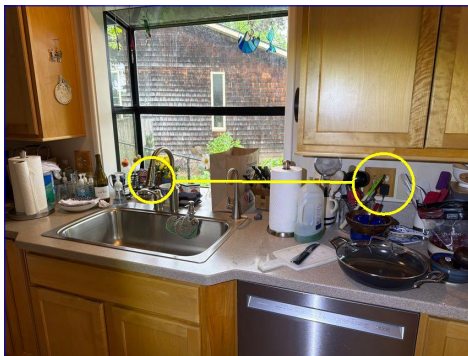
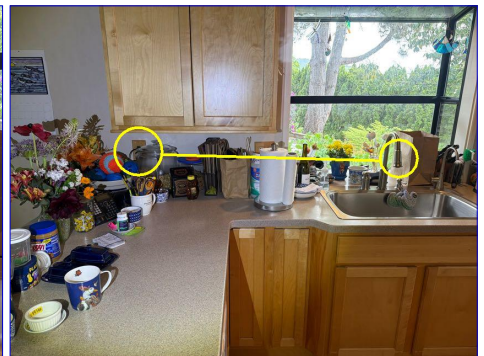
• Electrical receptacle within six feet of a water source is not **GFC** protected. Recommend having a licensed electrical contractor repair for safety.

Receptacle within 6' of water source is not **GFC** protected

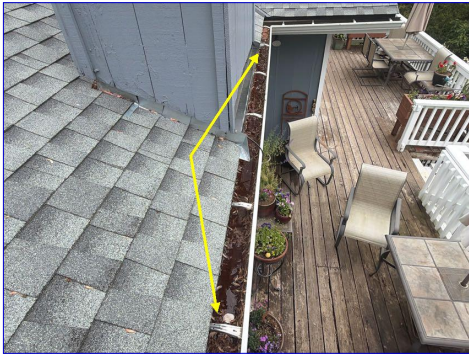
- **Drains to underground drain piping which was not tested.**
- Gutters appear to be improperly pitched and have standing water in the areas noted. Recommend correction to avoid possible damage to the gutter and fascia boards.

Standing water

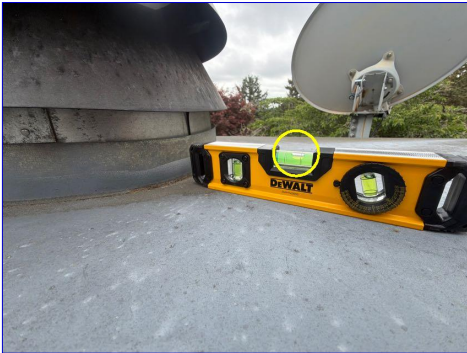
- The metal chimney crown was observed to have a negative slope in one or more areas. This condition can allow water to pond on the surface rather than drain properly away from the chimney, which may contribute to premature deterioration, corrosion, and possible moisture intrusion into the chimney structure over time.

Negative slope

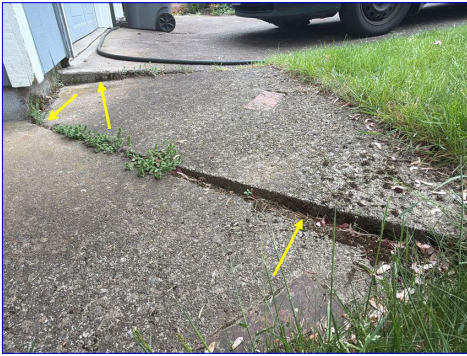
- Possible trip hazard. This is a safety concern. Suggest repair/replacement as needed to ensure safety.

Trip hazards

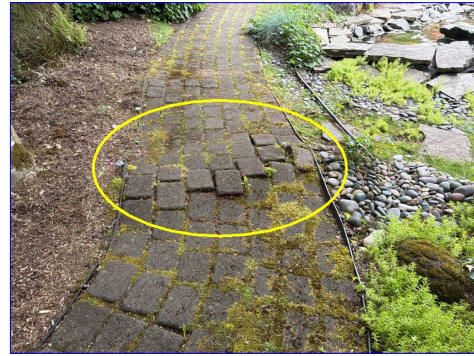
Trip hazard

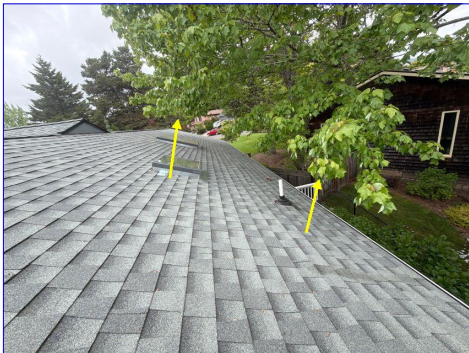
- Maintenance Tip: When landscaping, keep plants (even at full growth) at least 12-18 inches from house siding and windows. Plants in proximity to home can provide pathways for wood destroying organisms as well as abrade and damage siding, screens, and roofs.
- Tree limbs within 10 feet of roof should be trimmed away to provide air and sunlight to roof, while minimizing abrasion, debris and dampness.
- Vegetation too close or in contact with wall cladding. Recommend trimming or removal as necessary.

Tree limbs are too close to roof

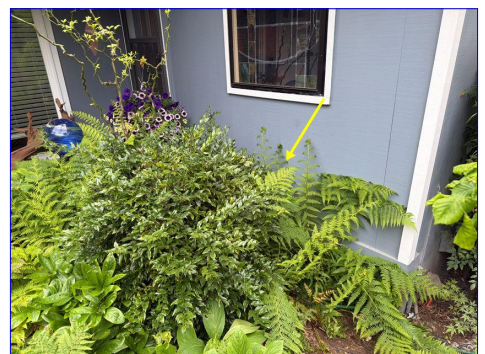
Vegetation is in contact with wall cladding

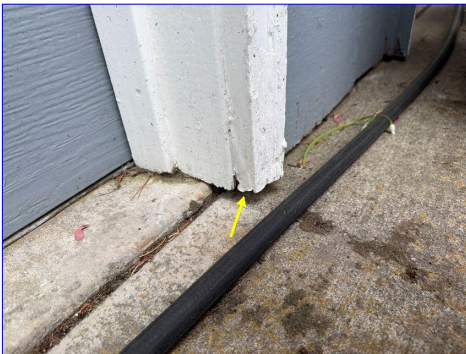
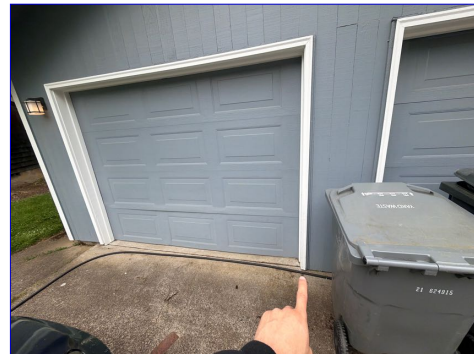
- Moisture damage, wood rot, observed. Recommend review for repair as necessary.

Moisture damage

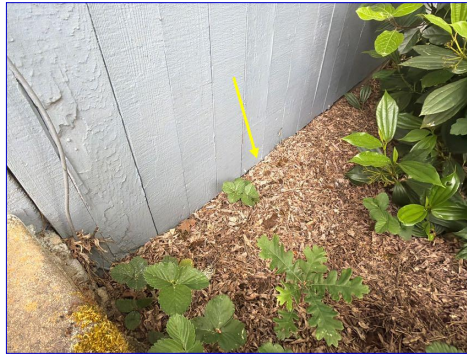
- Siding-Soil contact or proximity. This may provide entrance of moisture or insects to siding. Recommend grading soil so there is at least 6" of space (where practical) between the siding and the soil below and checking for any damaged trim and siding materials.

Soil is in contact with wall cladding (south)

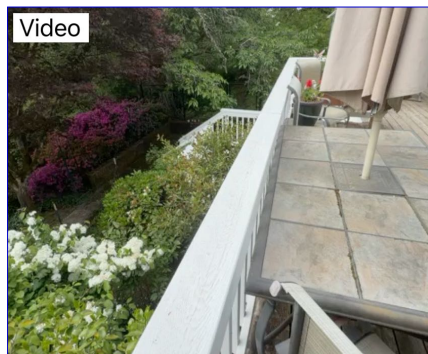
- Deck is weathered, suggest cleaning as necessary and treating with an oil based water repellent preservative to protect and extend the remaining life of the deck.
- The guardrail in areas noted is loose and should be secured.

Loose guardrail

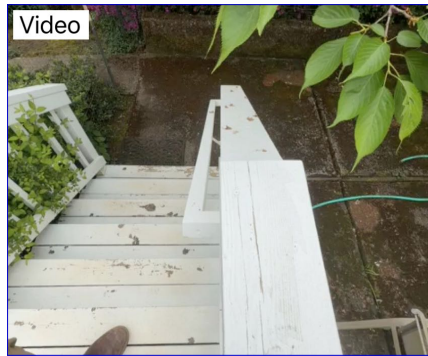
- The handrail is loose and should be secured.

Loose handrail

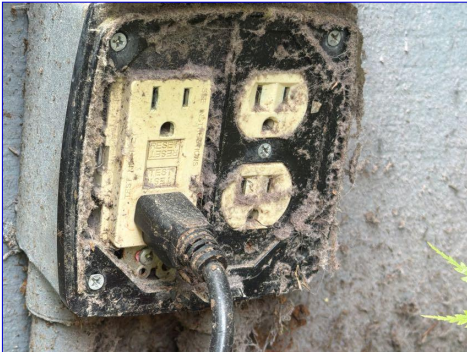
- Lint accumulation from the dryer exhaust termination was observed partially covering the nearby exterior receptacle. This condition may present a potential fire hazard and can contribute to moisture retention or improper operation of the receptacle. Recommend cleaning the area and monitoring the dryer exhaust termination for excessive lint discharge.

Lint covering exterior receptacle (front)

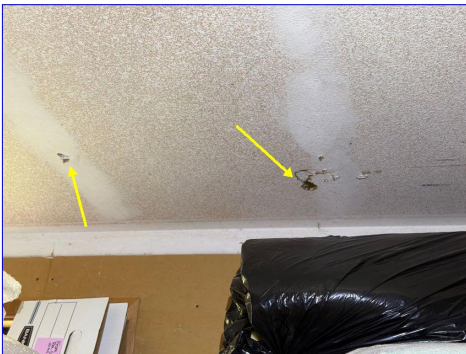
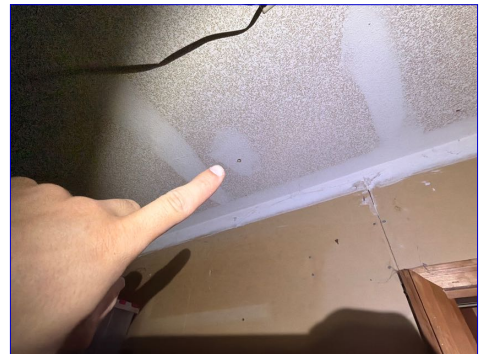
- Present
- Attic access panel/hatch cover is plywood which is flammable. Recommend replacing access panel with a fire rated panel for safety.
- Holes observed, suggest sealing to restore fire rating.

Hole in fire separation wall

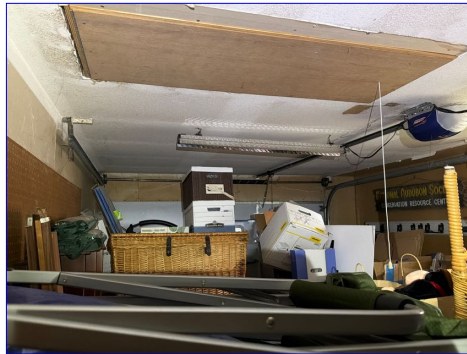
- The north garage door was not tested due to personal storage obstructing the door's path of travel. A complete evaluation of the door's operation and safety features could not be performed at the time of inspection.

North garage door

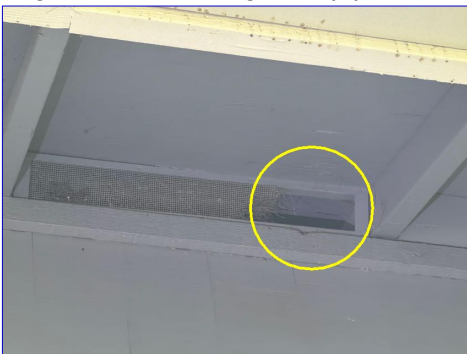
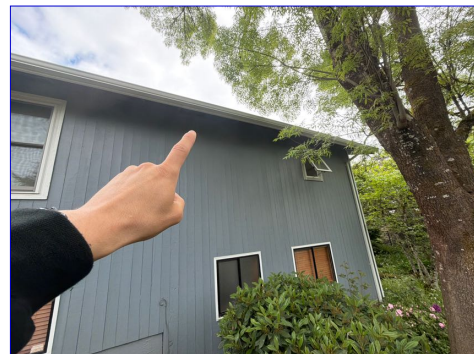
• One or more soffit vent screens were observed damaged or deteriorated at the time of inspection. This condition can allow pests, rodents, or other unwanted animals to enter the attic or roof structure. Recommend repair or replacement of the damaged vent screening to help prevent intrusion.

Damaged soffit vent screen (south)

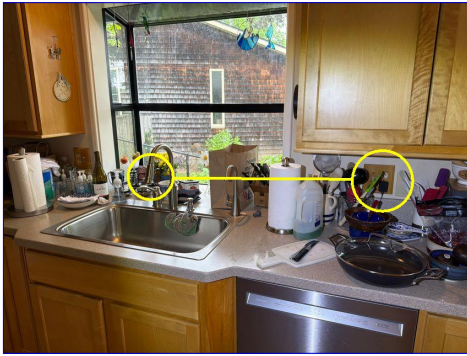
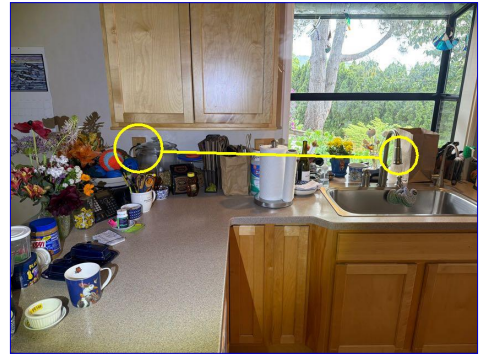
- Electrical receptacle in areas noted are loose and should be secured.
- Light(s)/light fixture(s) located in Basement is/are inoperable. Unable to determine if bulb(s) burnt out or if faulty fixture(s). Suggest client verify proper operation prior to closing.
- Basement and Garage receptacles should all be **GFCI** protected.
- The washing machine receptacle was not **GFCI** protected at the time of inspection. Although this condition may have been permitted at the time the home was constructed, current safety standards recommend **GFCI** protection in garage areas to reduce the risk of electrical shock. Upgrading is recommended for improved safety.
- Electrical receptacle within six feet of a water source is not **GFCI** protected. Recommend having a licensed electrical contractor repair for safety.

Receptacle within 6' of water source is not **GFCI** protected

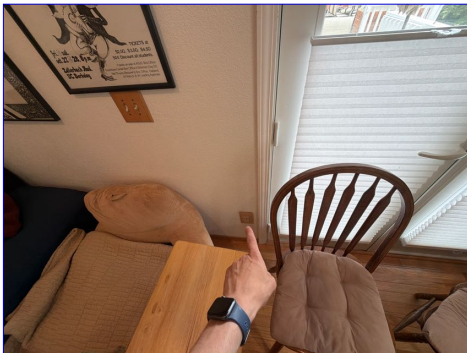
Loose receptacle in Bedroom 3

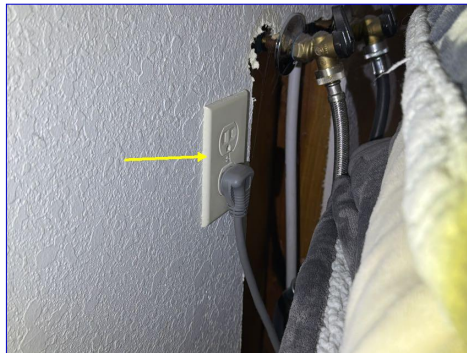
Washing machine receptacle is not **GFCI** protected

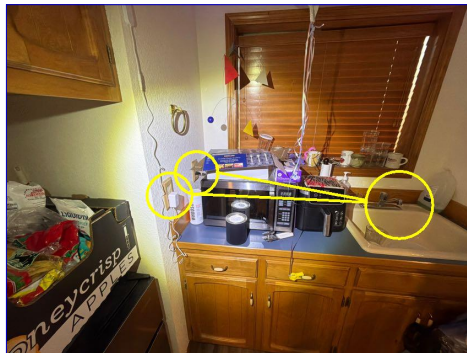
Basement receptacles within 6' of water source are not **GFCI** protected

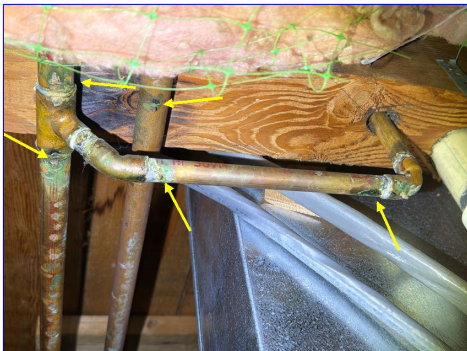
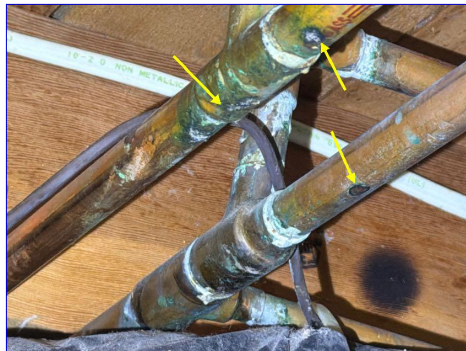
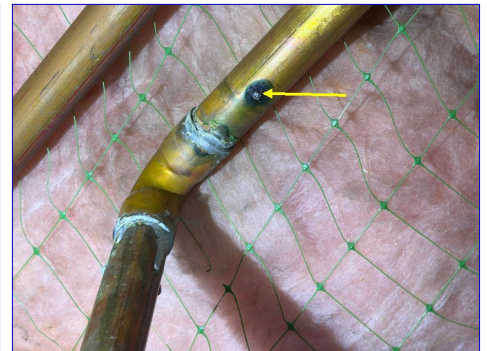
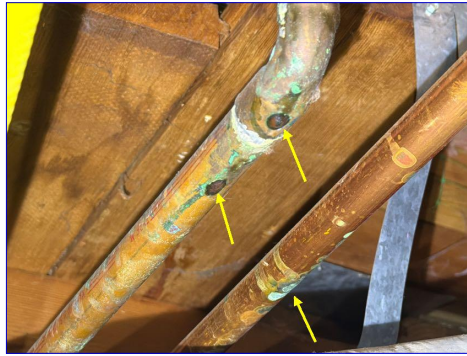
**Material(s):** Copper • PEX  
• Minor corrosion noted on supply lines in basement. Recommend monitoring.

Minor corrosion

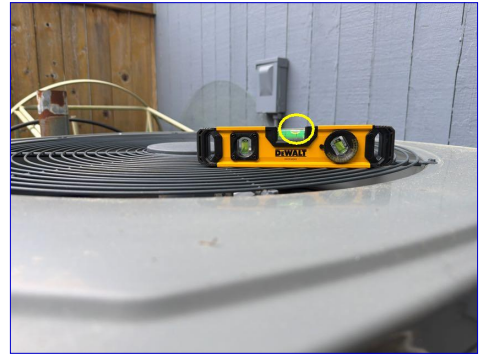
• Condenser is tilted, excessive uneven settlement can cause fractures in refrigerant line fittings and loss of refrigerant as well as shorten the life of the compressor. Unit should be leveled.

Unit is not level

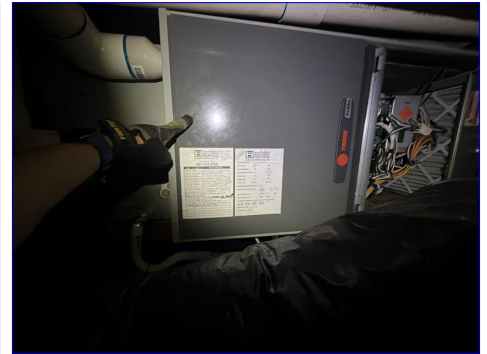
Panel is difficult to remove

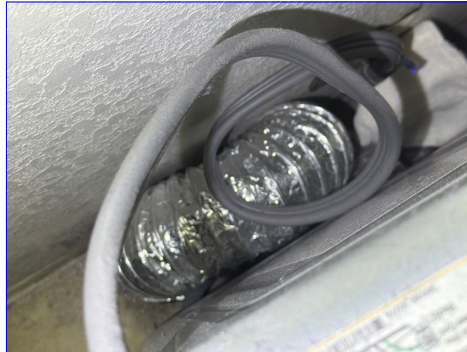
- Although once considered acceptable, flexible, ribbed vents are a potential fire hazard and should be replaced.

Flexible foil

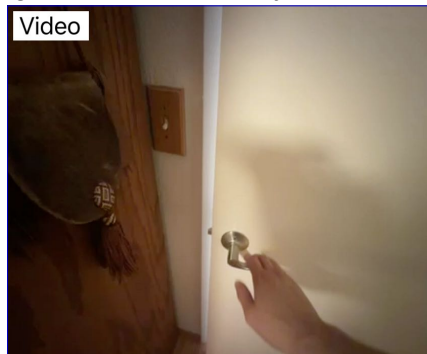
- Door doesn't open / close properly.
- Door stops missing; recommend installing to avoid unnecessary wall and/or door damage.

Door does not close properly

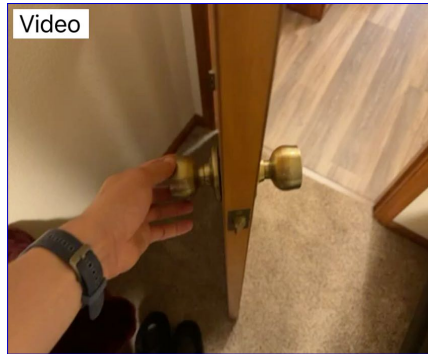
- Door handle loose.

Loose door handle

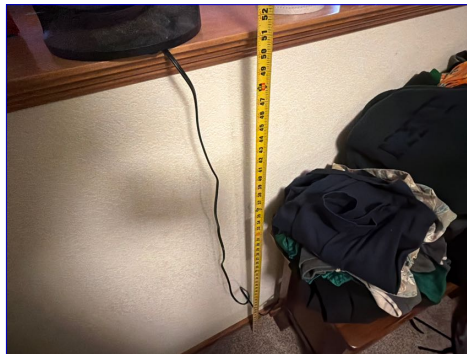
- The basement bedroom window sill height exceeded the current recommended maximum height of 44 inches above the finished floor. A higher sill height may hinder emergency escape or rescue access during an emergency.

Window sill exceeds 44"

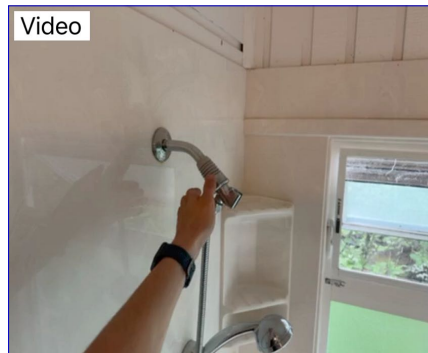
- Serviceable condition
- Faucet is loose in the wall.

Loose showerhead

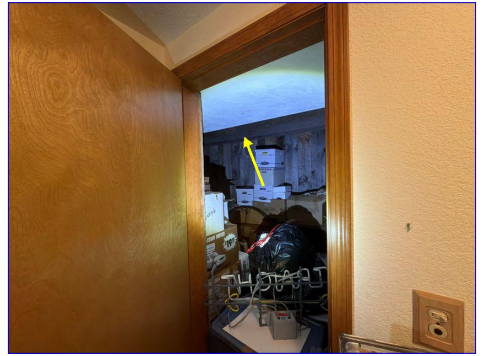
- Microbial growth or possible mold growth observed in the areas noted. Mold can only be confirmed with laboratory testing. Recommend having a qualified, contractor perform mold spore air testing and tape/swab sample of observed growth.

Possible microbial growth (basement closet)
