# McBrayer Home Inspections

## PROPERTY INSPECTION REPORT FORM

Address of Inspected Property: 321 Calistoga Ct Austin, TX 78732

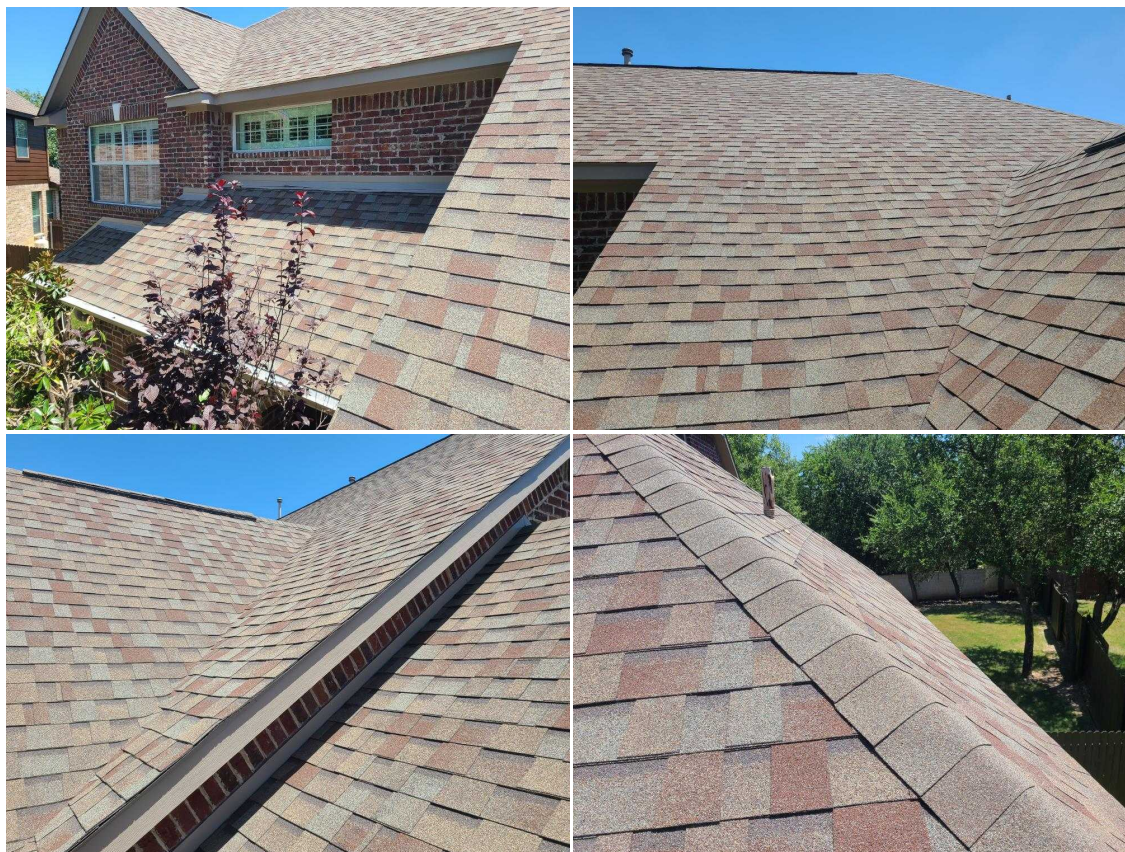
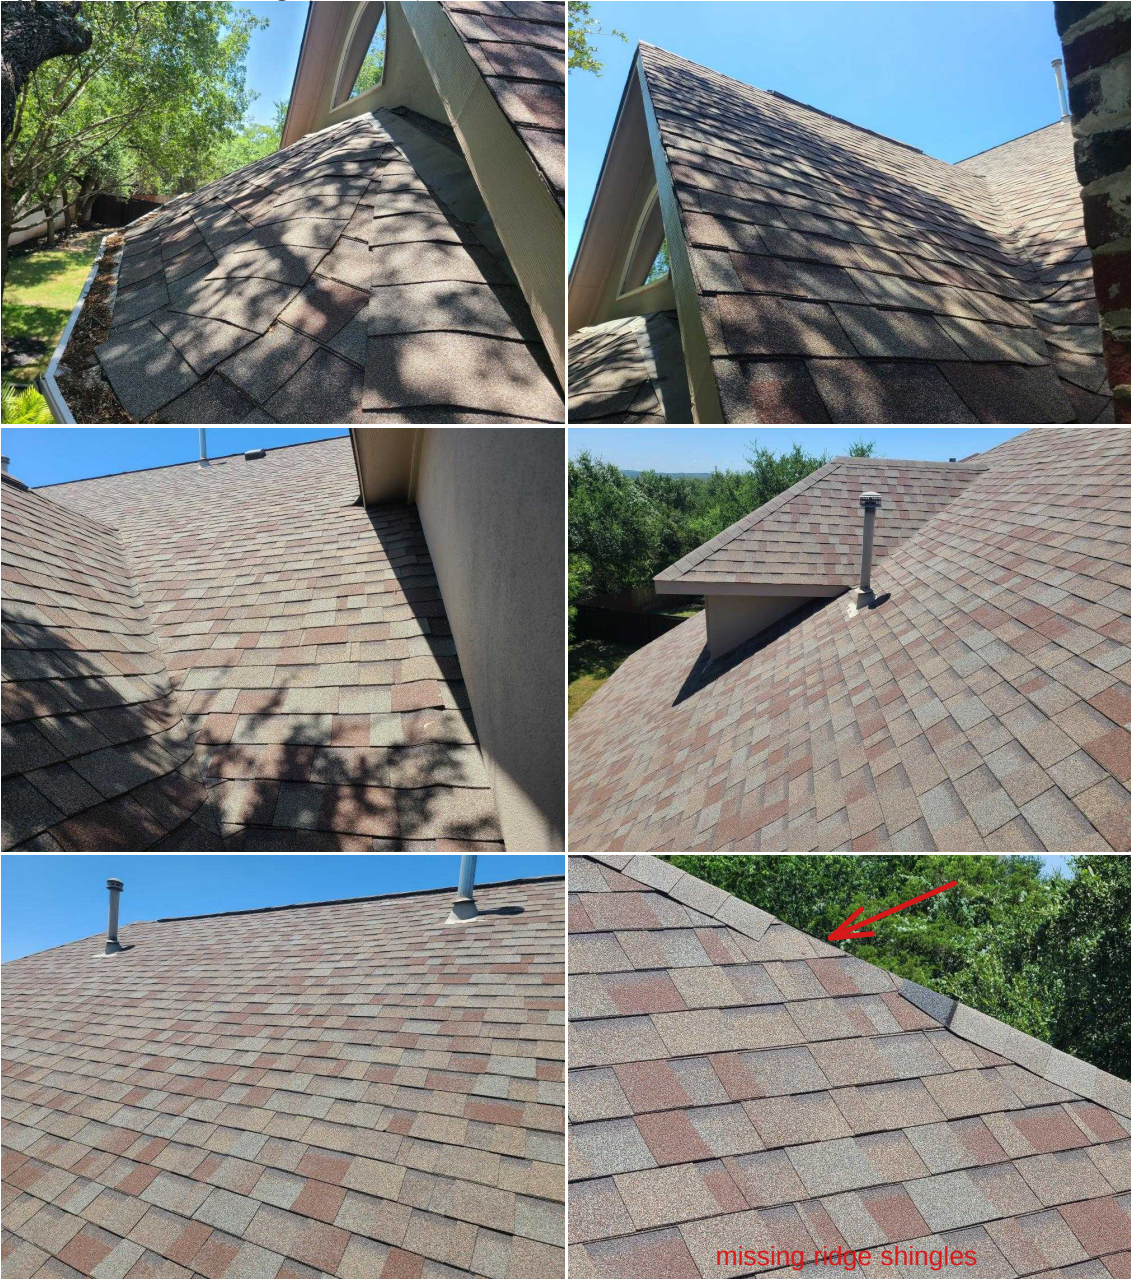
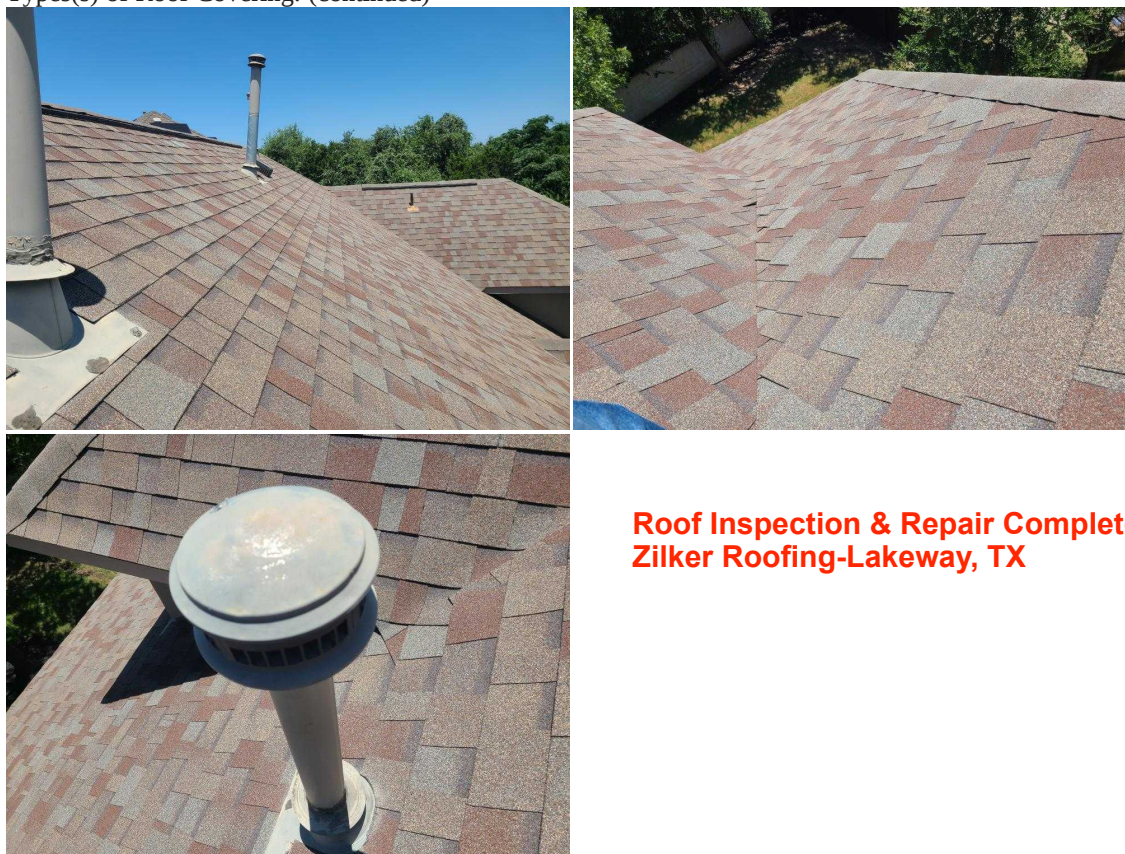
The overall condition of the roof covering was found to be in acceptable and functional condition, with the following deficiency:

Replace a few missing hip-ridge shingles at the back of the house. Shingles were lying on the roof, nearby.

**Roof Inspection & Repair Completed 7-30-26  
Zilker Roofing-Lakeway, TX**

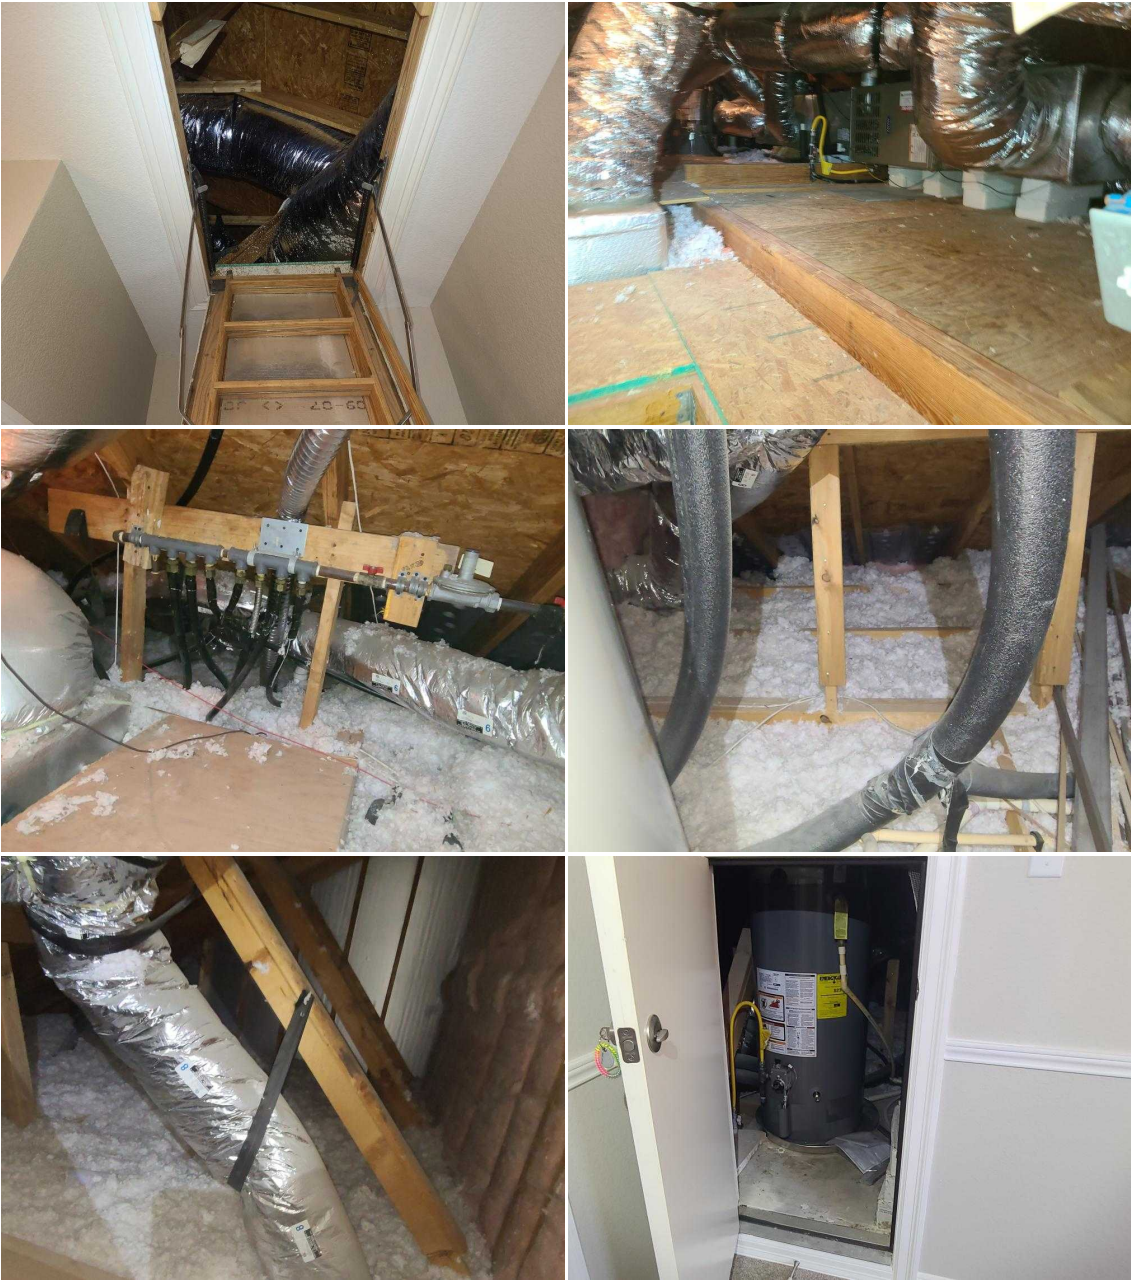
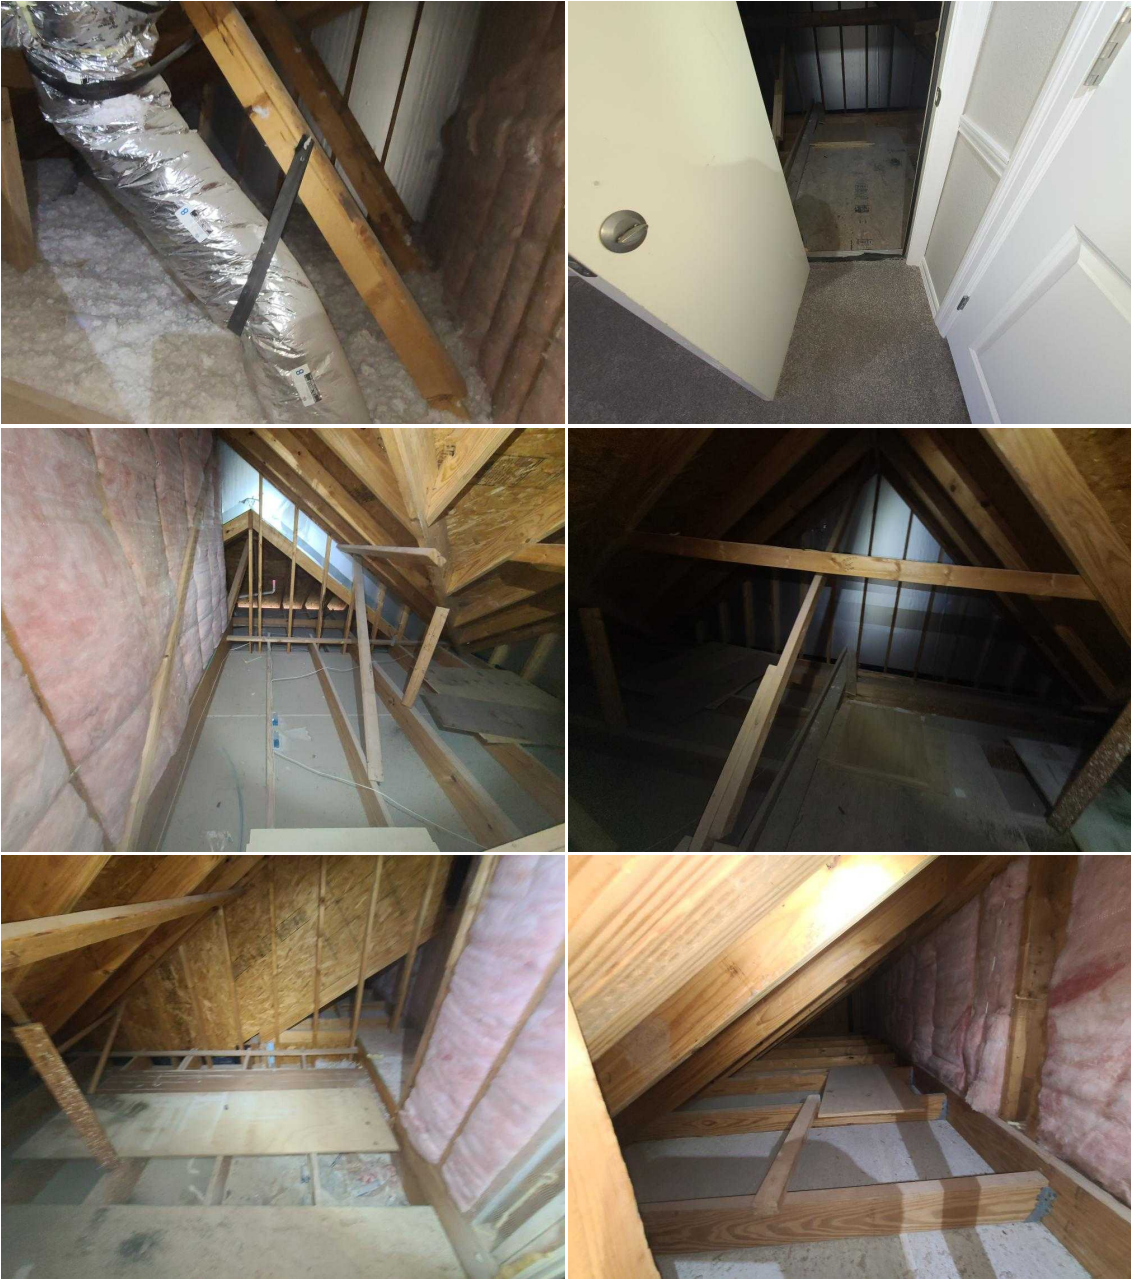
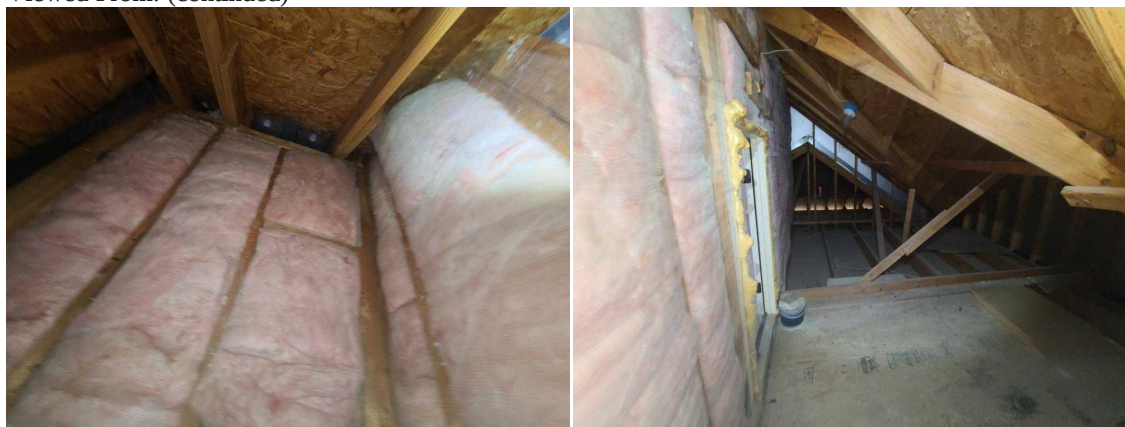
Pull down attic ladder not labeled as fire rated, as per most recent standards.

Pull down attic ladder fasteners not of approved type. 1/4" lag bolts and/or 16D nails are the only approved type fasteners for attic ladder.

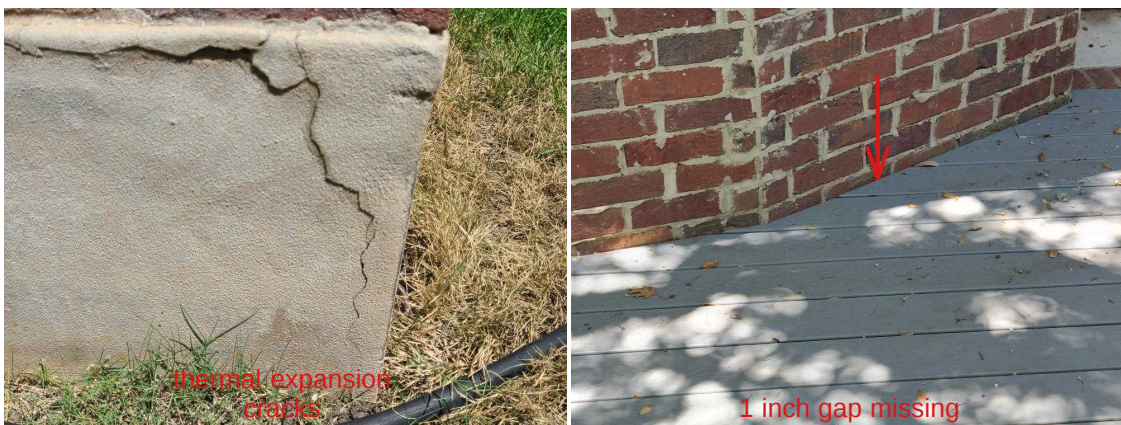
- Back deck.

Exterior walls/siding should have at least 1 inch clearance above porch/deck surfaces.

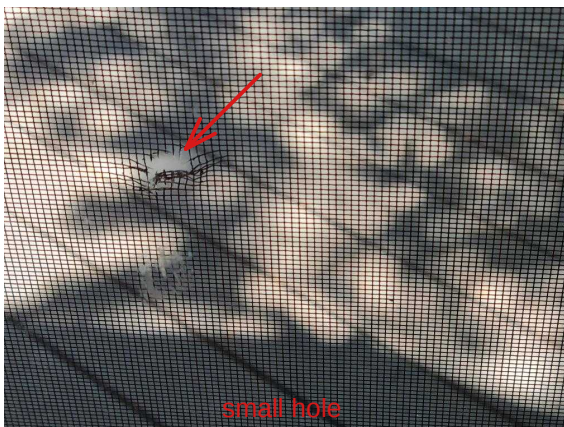
- Bay window.

Small hole in window screen.

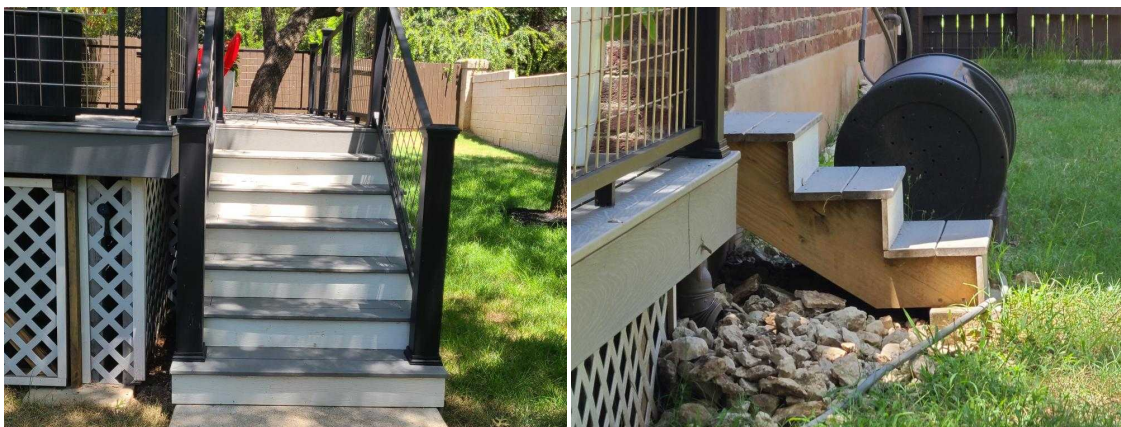
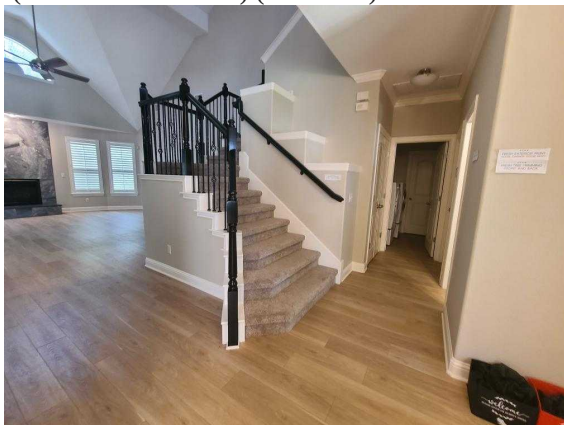
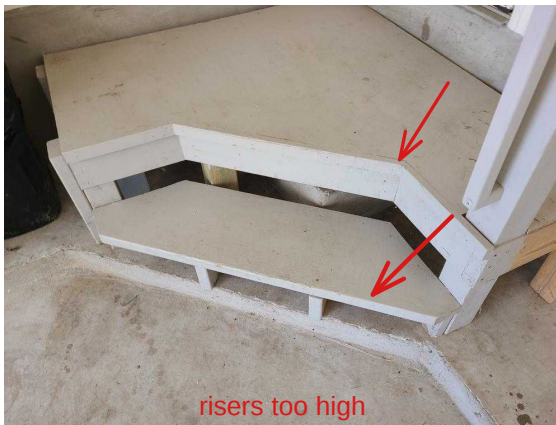
- Garage steps.

Comments:  
Handrail should extend completely to the nose of the last tread.  
- Back deck.

Handrail needed at the small back steps.

Climbable Handrail assembly at back deck.

The sloped handrail assembly at this stairway had components which made it climbable by children. This condition is a potential fall hazard.

Riser height exceeds the current standard of 7 3/4 inches.

The Inspector recommends that steps be taken to alter the handrail assembly so that it is no longer climbable by children.

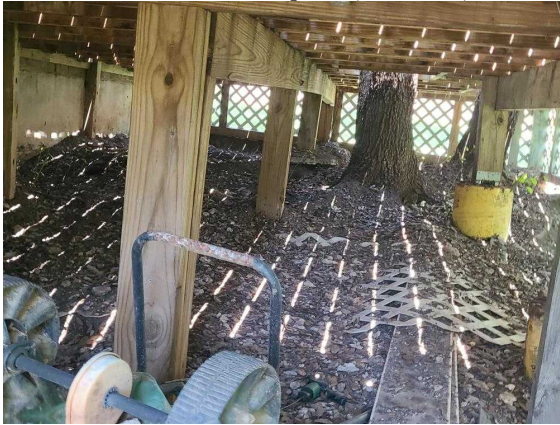
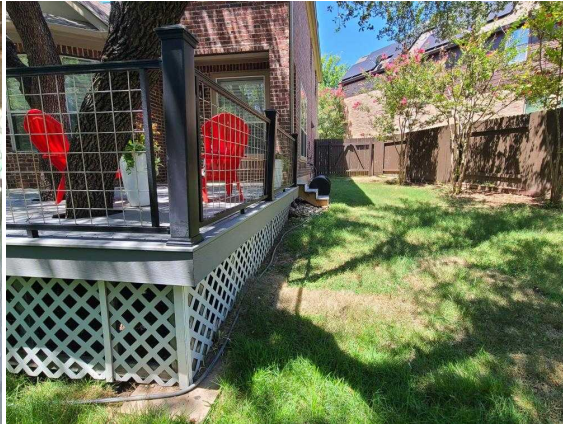
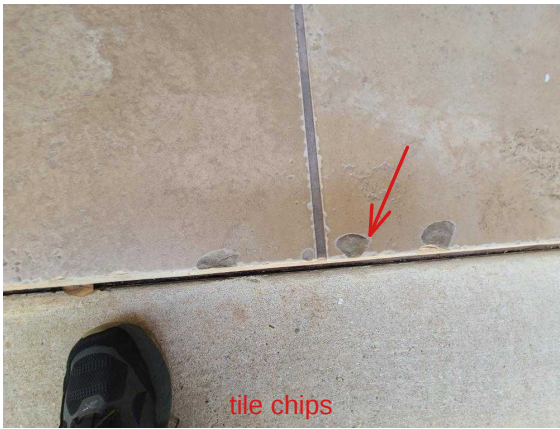
Wood deck posts and skirting were in contact with soil, in places. This is conducive to unseen moisture/insect intrusion.

Climbable guardrail assemblies are considered fall hazards for children.

Chips at the front porch ceramic tile.

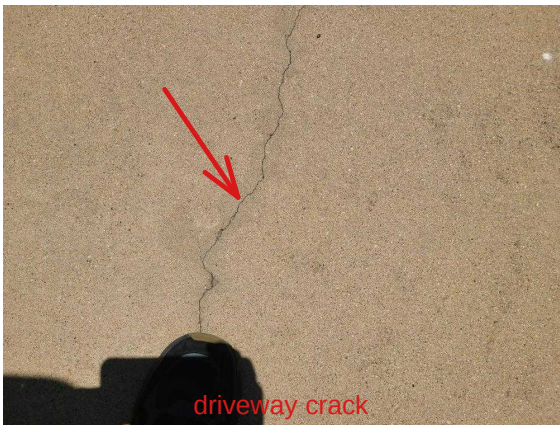
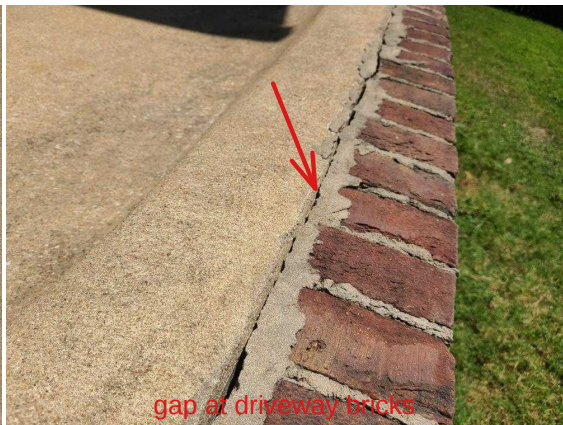
Comments:  
Cracks in drive.

Gap at the driveway/brick connection. This was not affecting the performance of the driveway.

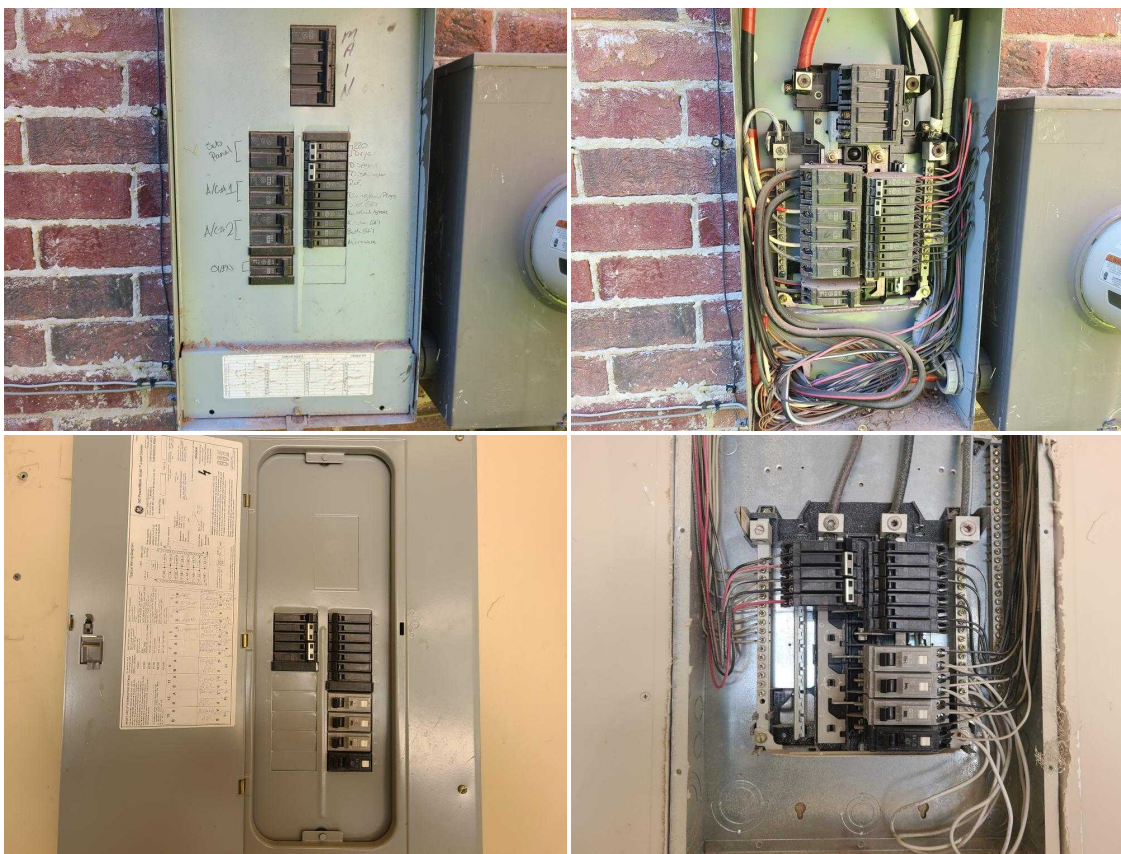
HVAC breakers oversized.

The breakers for the outside HVAC condensers exceeds the maximum size stated by the label on the units. It will not trip at recommended over-current rating, which could cause damage to the HVAC unit. This situation is sometimes created when an older HVAC unit is replaced by a newer, more efficient unit that requires less power to operate, but the breaker was not replaced with the newly required size. The inspector recommends a qualified electrician properly size the breaker to the unit.

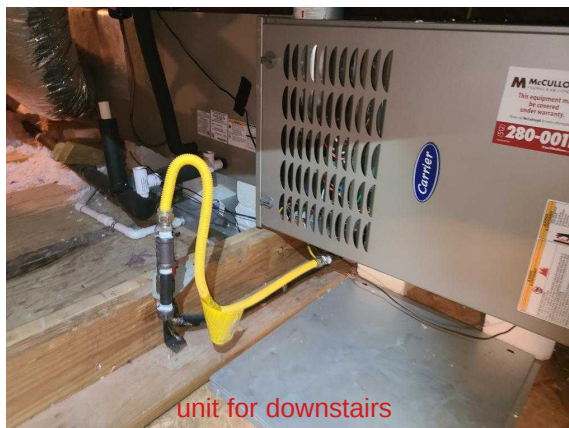
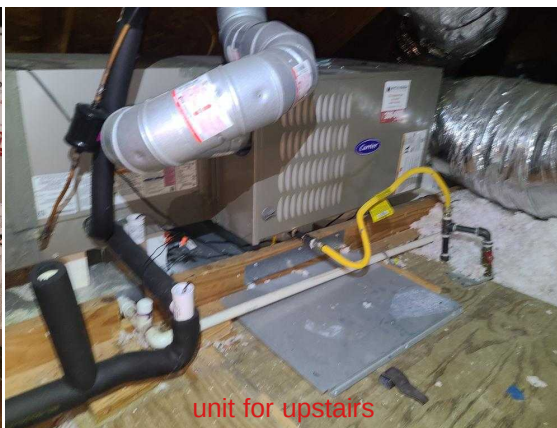
Furnace did not turn on, when testing the downstairs unit. Further evaluation by qualified contractor recommended.

**Full Service & Inspection performed by McCullough Heating & Air Conditioning Co.-7-29-26-both HVAC units as well as furnace have all been inspected and are working properly-see photos & Invoice attached at end of report-Also to note- these systems have had a full time service plan on them with regularly scheduled checks and maintenance by McCullough.**

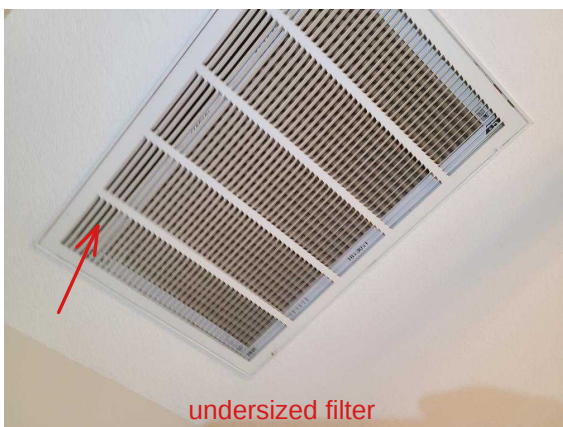
Undersized air filter in upstairs intake grill. Unfiltered air bypassing the filter. Recommend replacing with proper size.

**Has been changed out with an appropriate sized filter 7-30-26**

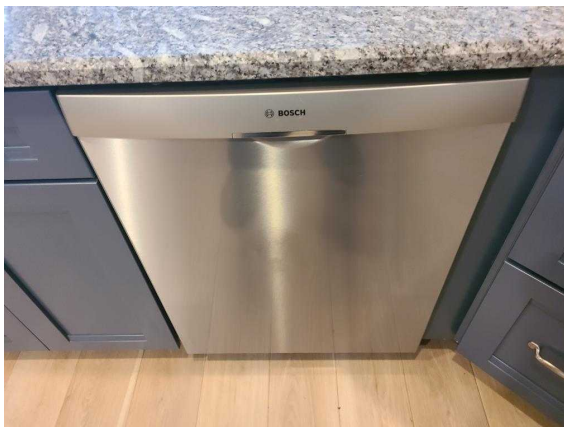
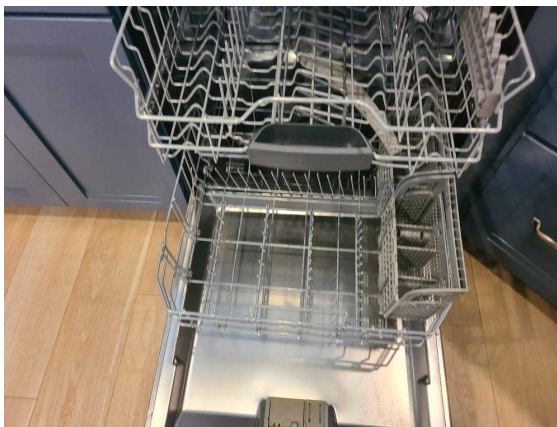
Drain line not elevated above bottom of the sink, to prevent backflow into dishwasher.

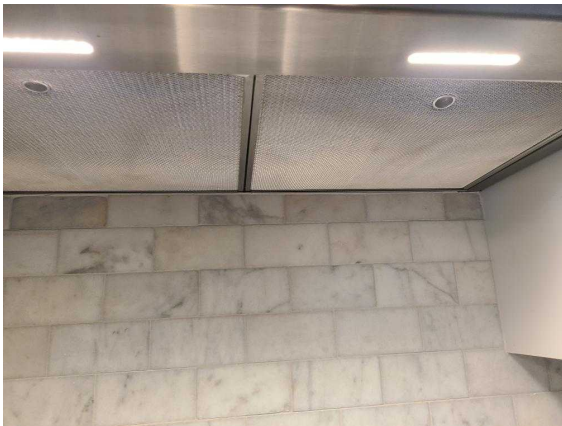
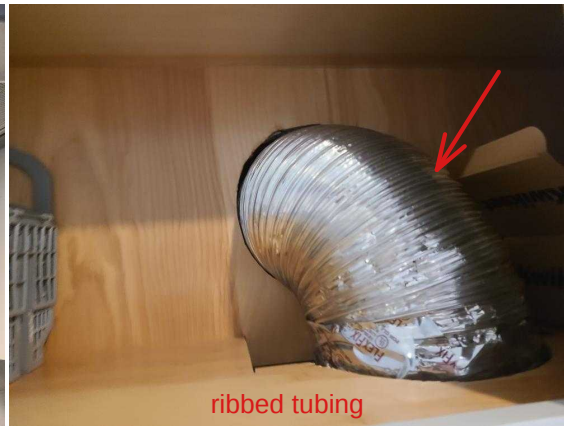
Ribbed vent tubing tends to collect grease and is not recommended.

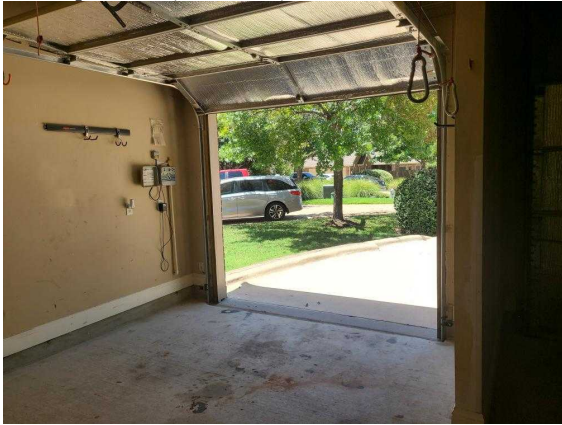
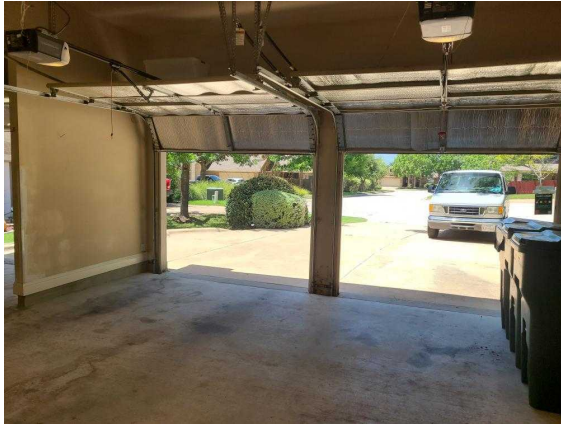
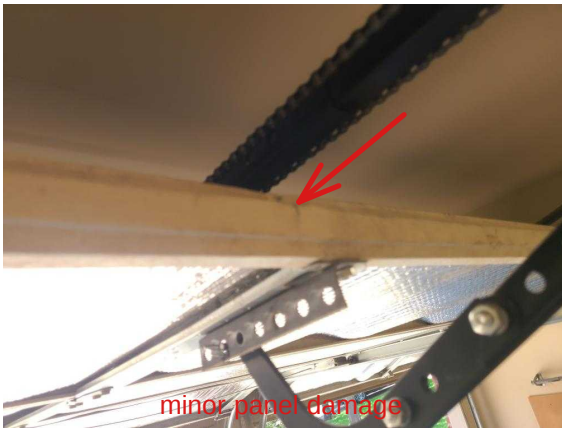
Door was somewhat noisy and squeaky when rolling up/down. Recommend qualified overhead door contractor investigate further and perform any needed maintenance or repairs.

**Garage door hardware was lubricated to address squeaking 7-30-26**

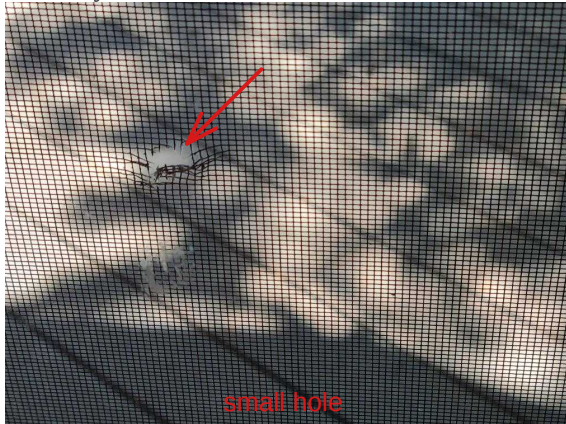
- Bay window.

Small hole in window screen.

**Screen Patched 7-30-26**

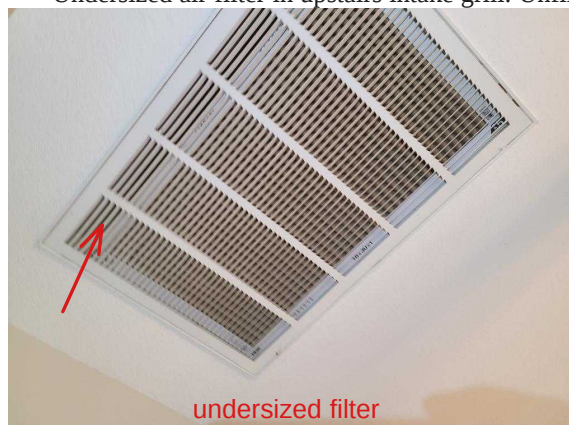
Undersized air filter in upstairs intake grill. Unfiltered air bypassing the filter. Recommend replacing with proper size.

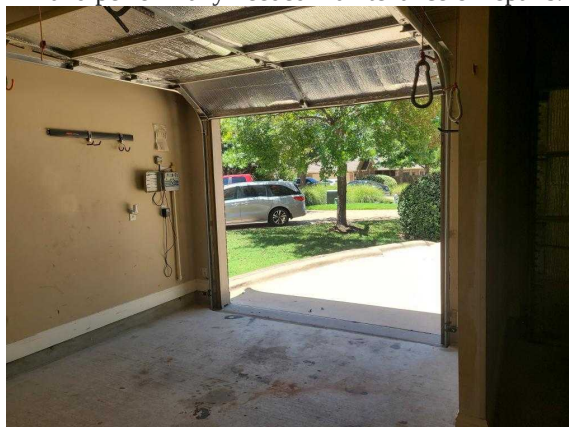
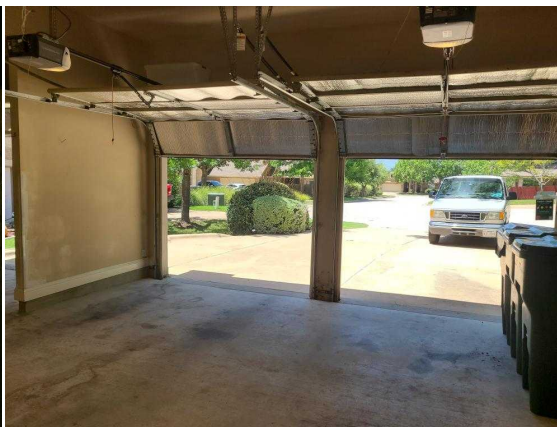
Door was somewhat noisy and squeaky when rolling up/down. Recommend qualified overhead door contractor investigate further and perform any needed maintenance or repairs.
