# ***Cornerstone Inspection***

## **Property Inspection Report**

***339 Partridge Ave, Paso Robles, CA 93446***

***Date of Inspection: 4/22/2026 Time: 1:30 PM***

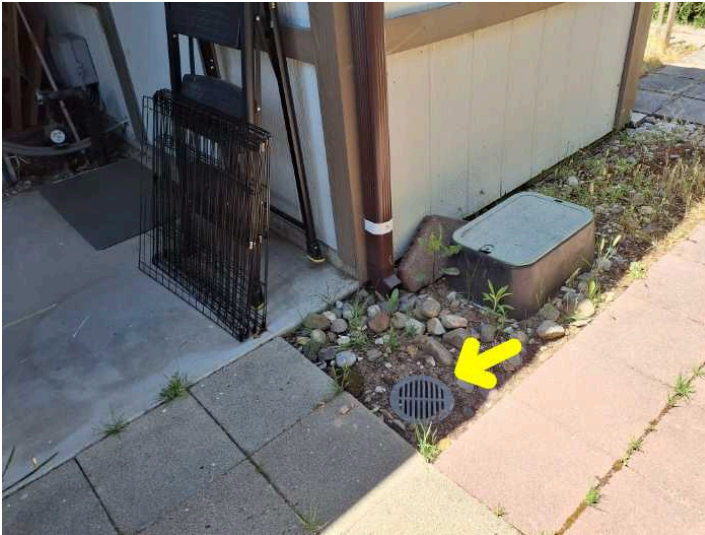
There are area drains in planter beds or yards that will be subject to contamination by dirt and debris, and these drains should be periodically monitored and cleaned.

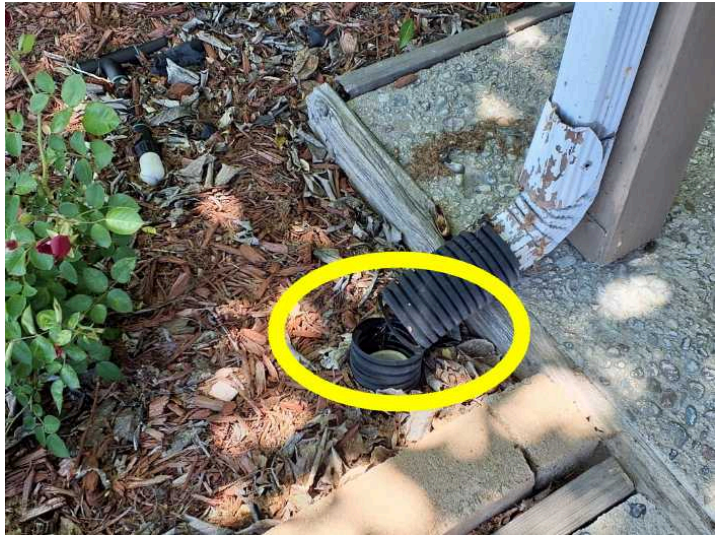
There are missing or broken area drain covers. This could have allowed leaves and other debris to enter the drain lines and contribute to blockages. Therefore, it would be prudent to have the lines flushed through to the street or to their termination point before the broken covers are replaced.

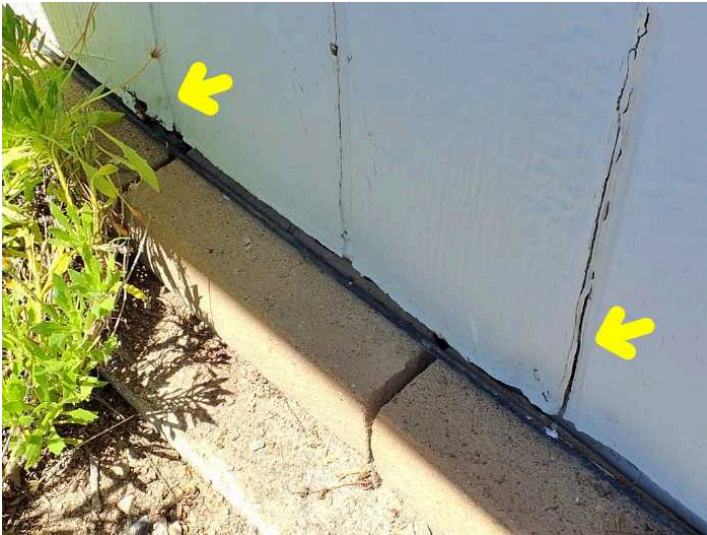
Portions of the siding have dry rot or are moisture damaged, and should be evaluated by a pest inspector.

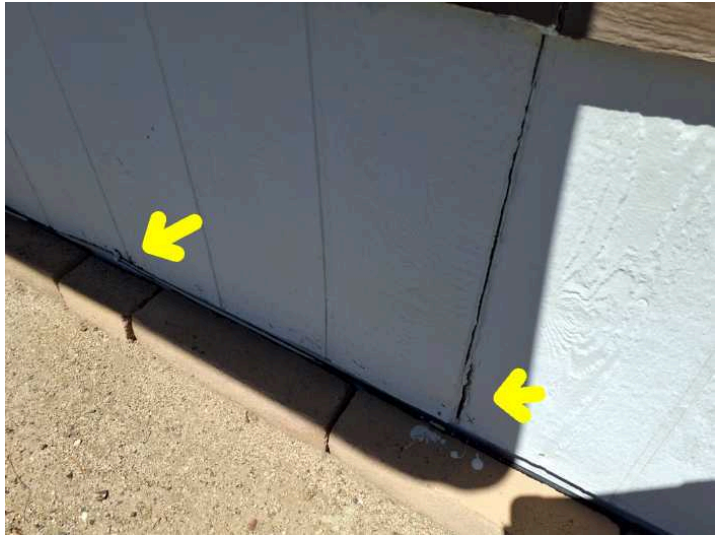
Portions of the siding have dry rot or are moisture damaged, and should be evaluated by a pest inspector.

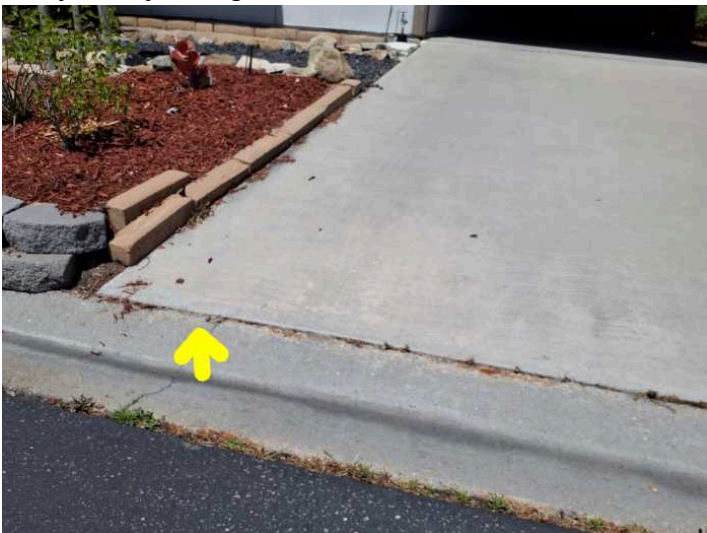
There are one or more offsets in the driveway that could prove to be trip-hazards.

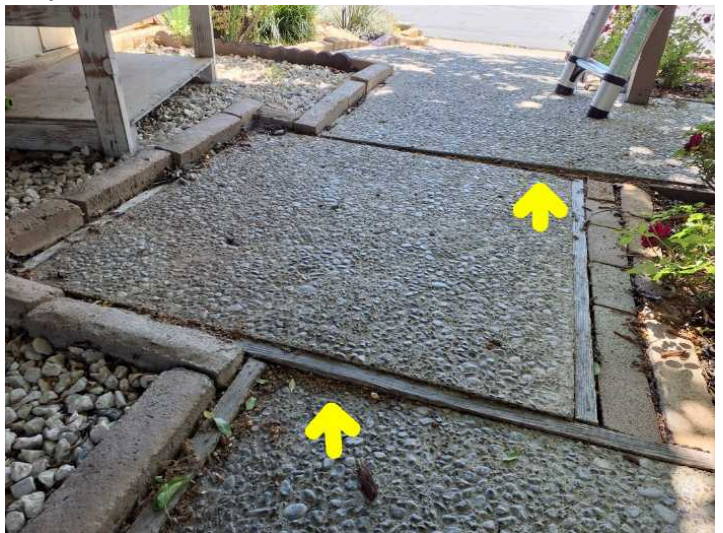
There are one or more offsets in the walkways or patio that could prove to be trip-hazards.

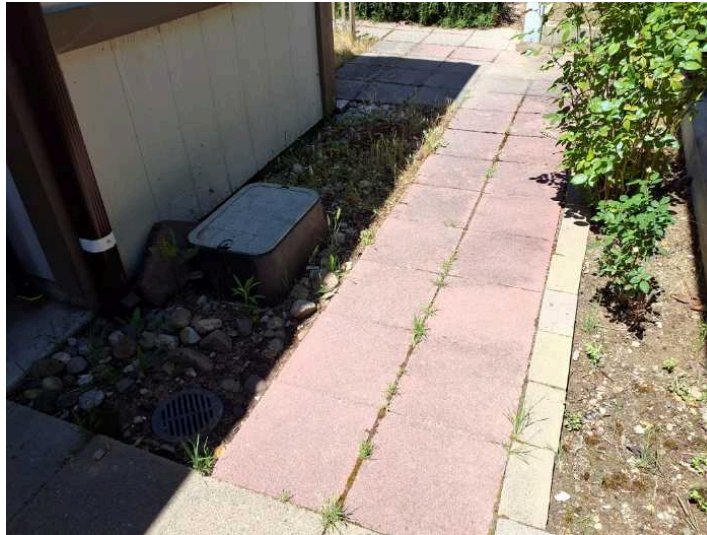
The paver patio or walkway has one or more offsets that may prove to be trip-hazards. This may be by design or due to unsuitable soil below the pavers.

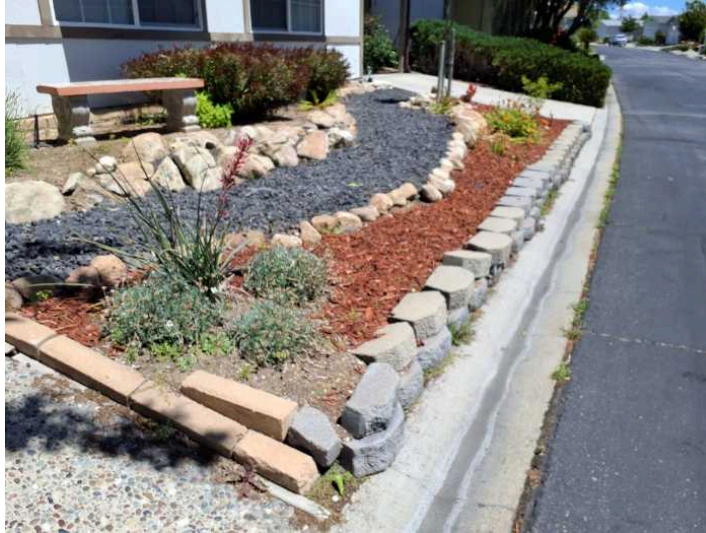
The stacked masonry or natural stone yard walls, though functional, have no value as retaining walls and will need to be periodically monitored for movement.

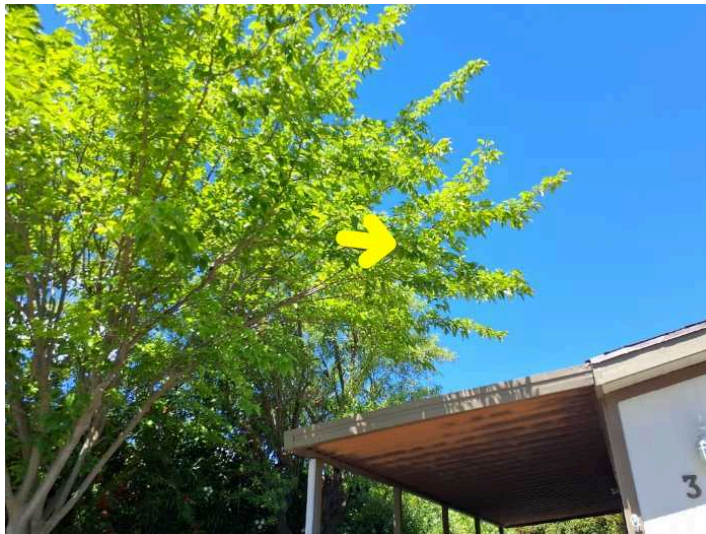
There are tree limbs over growing the residence that should be trimmed or monitored to ensure that they do not impact or damage the roof or its components.

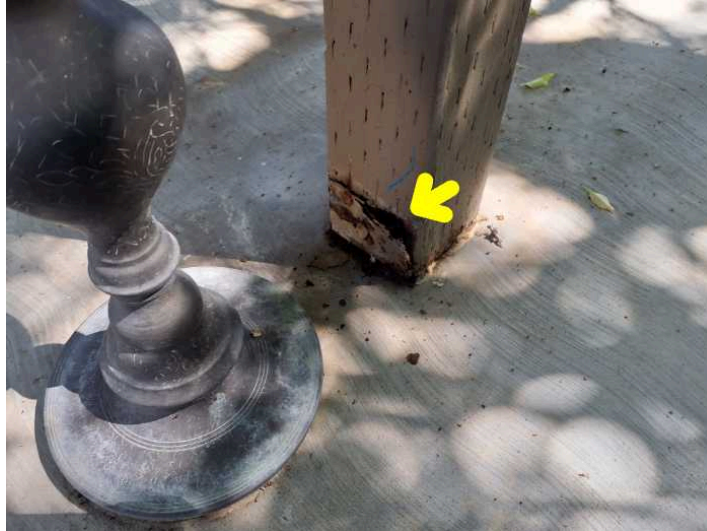
There is damage to the wooden supports that should be evaluated by a pest inspector.

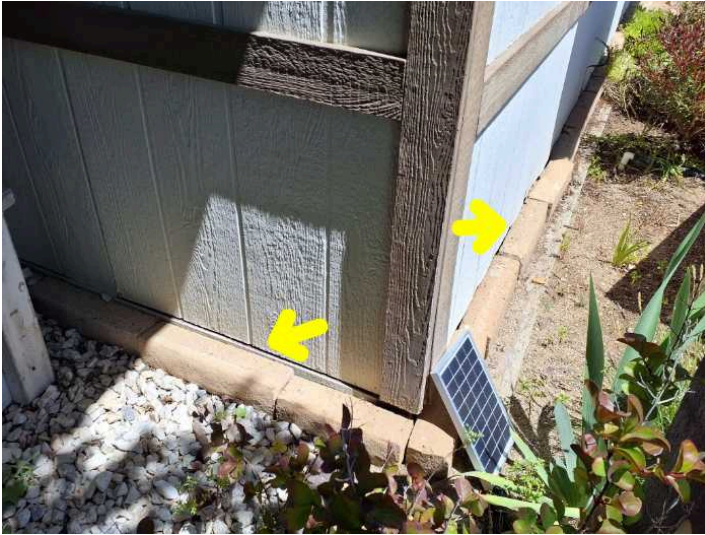
1.10. The crawlspace is not adequately ventilated, which is allowing condensation to form. This will accelerate the deterioration of the framing, and generally contribute to unhealthy conditions. The termite inspector should comment on this issue, but this condition should be further evaluated by a qualified tradesperson.

The crawlspace is not adequately ventilated, which is allowing condensation to form. This will accelerate the deterioration of the framing, and generally contribute to unhealthy conditions. The termite inspector should comment on this issue, but this condition should be further evaluated by a qualified tradesperson.

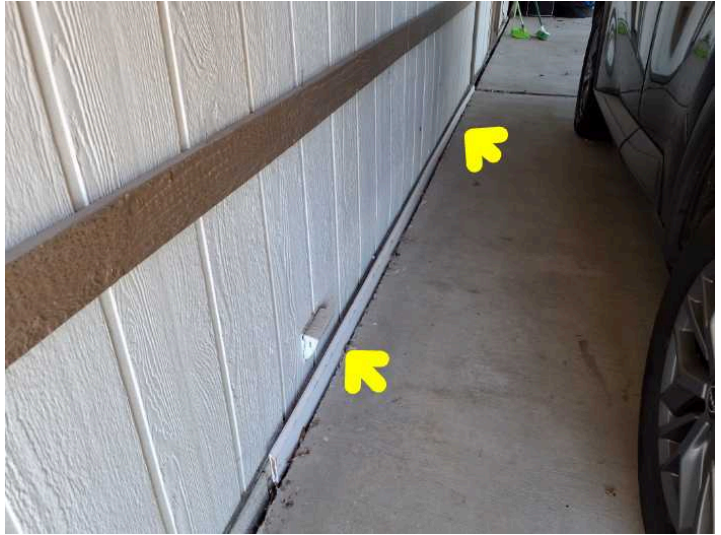
The crawlspace is not adequately ventilated, which is allowing condensation to form. This will accelerate the deterioration of the framing, and generally contribute to unhealthy conditions. The termite inspector should comment on this issue, but this condition should be further evaluated by a qualified tradesperson.

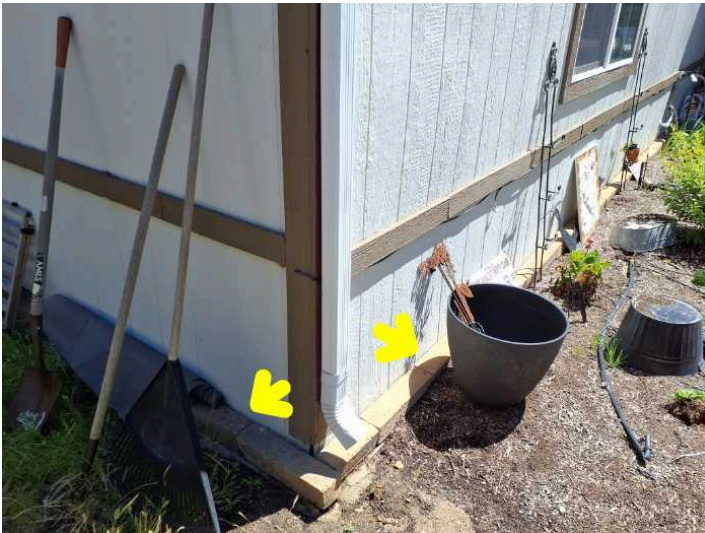
The crawlspace is not adequately ventilated, which is allowing condensation to form. This will accelerate the deterioration of the framing, and generally contribute to unhealthy conditions. The termite inspector should comment on this issue, but this condition should be further evaluated by a qualified tradesperson.

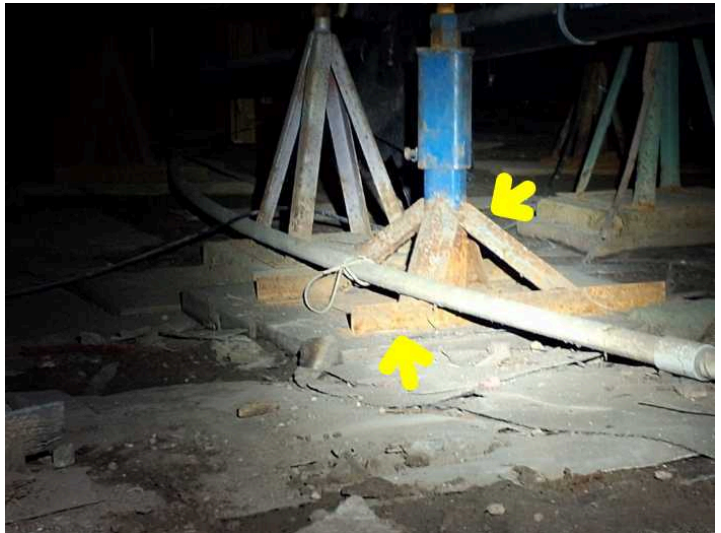
The metal piers are beginning to deteriorate and should be monitored closely. They are serviceable but have corrosion and deterioration that is commensurate with their age. It would be wise to have them evaluated and serviced by a qualified specialist in the near future.

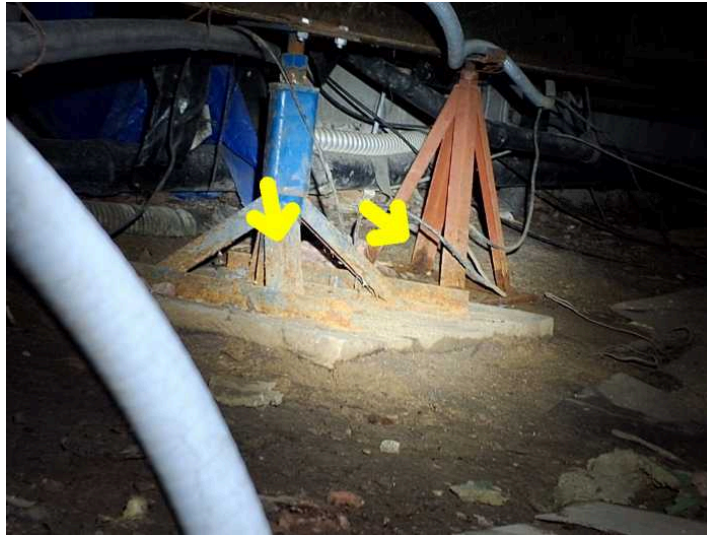
The metal piers are beginning to deteriorate and should be monitored closely. They are serviceable but have corrosion and deterioration that is commensurate with their age. It would be wise to have them evaluated and serviced by a qualified specialist in the near future.

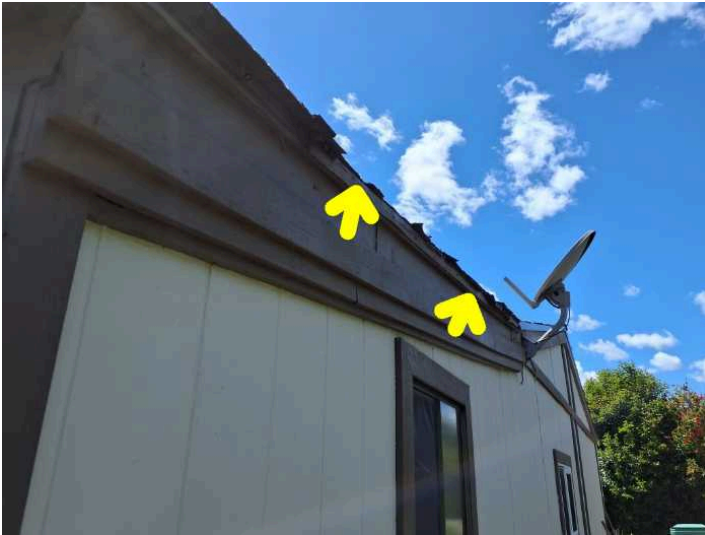
The roof has one or more damaged or missing shingles that should be repaired or replaced by a licensed roofing contractor.

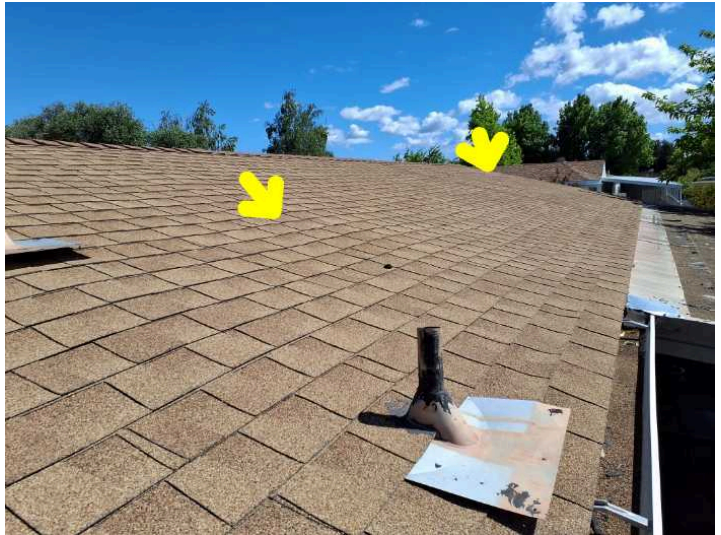
The ridge or roof-line appears to be wavy in silhouette. We will elaborate on the possible reasons for this, but you should have a qualified roofing contractor evaluate the roof or comment on this specific feature.

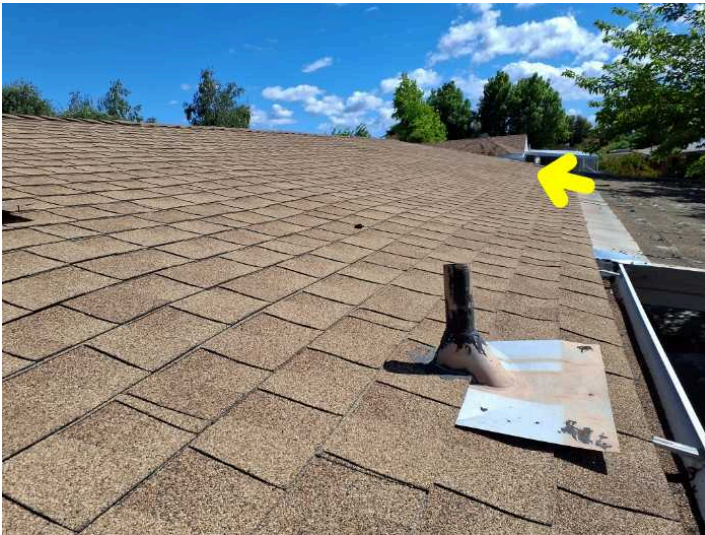
The ridge or roof-line appears to be wavy in silhouette. We will elaborate on the possible reasons for this, but you should have a qualified roofing contractor evaluate the roof or comment on this specific feature.

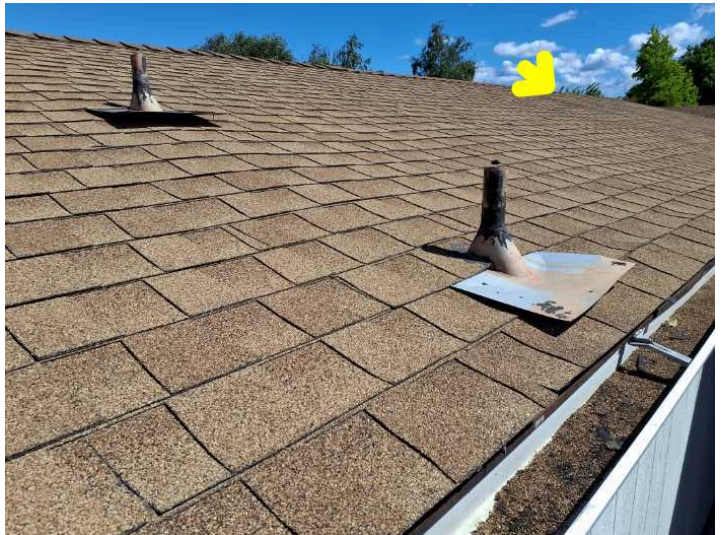
The ridge or roof-line appears to be wavy in silhouette. We will elaborate on the possible reasons for this, but you should have a qualified roofing contractor evaluate the roof or comment on this specific feature.

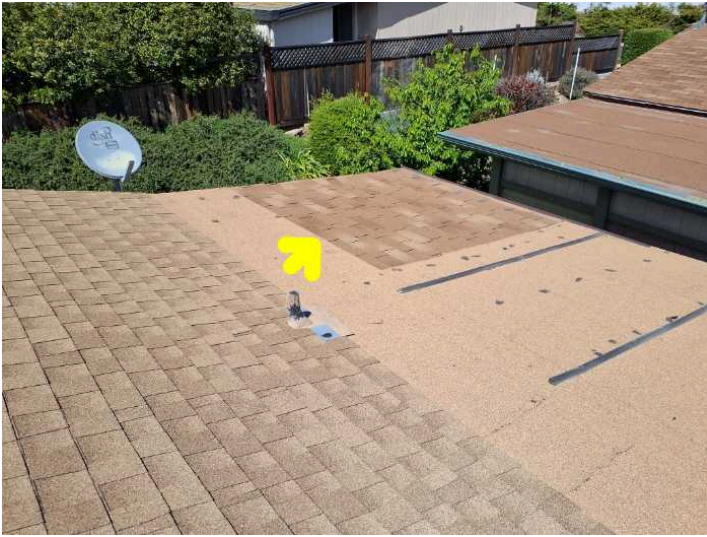
We observed repairs done to the roof. You should have the sellers disclose the reason that the repairs were completed, as well as any documentation of any warranty or guarantee from the roofer.

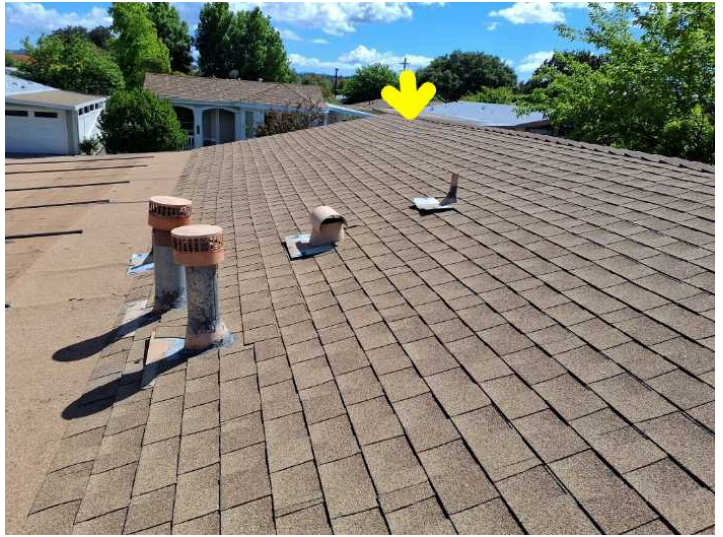
The ridge or roof-line appears to be wavy in silhouette. We will elaborate on the possible reasons for this, but you should have a qualified roofing contractor evaluate the roof or comment on this specific feature.

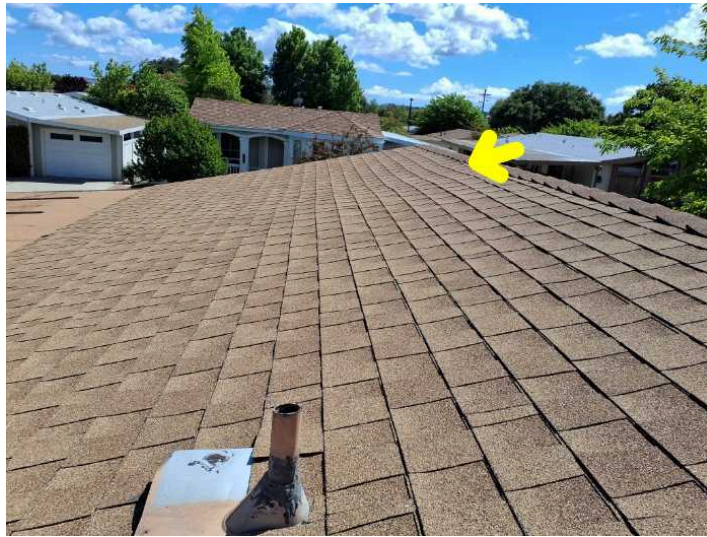
The ridge or roof-line appears to be wavy in silhouette. We will elaborate on the possible reasons for this, but you should have a qualified roofing contractor evaluate the roof or comment on this specific feature.

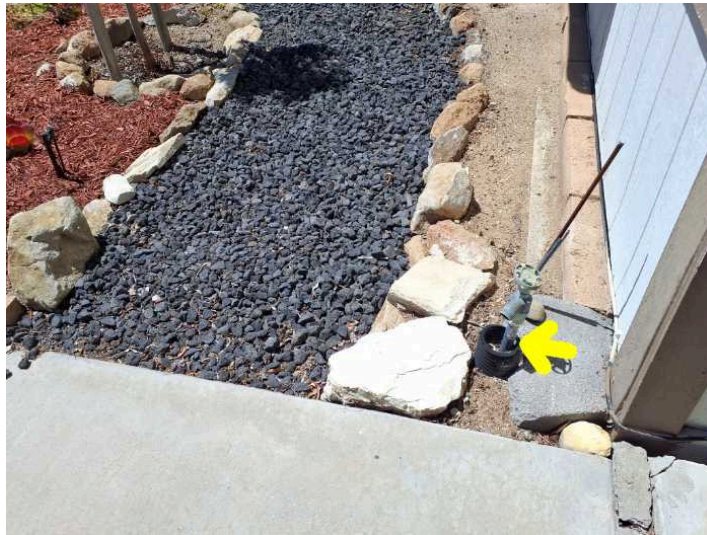
A hose bib on the front is not functional or has been abandoned.

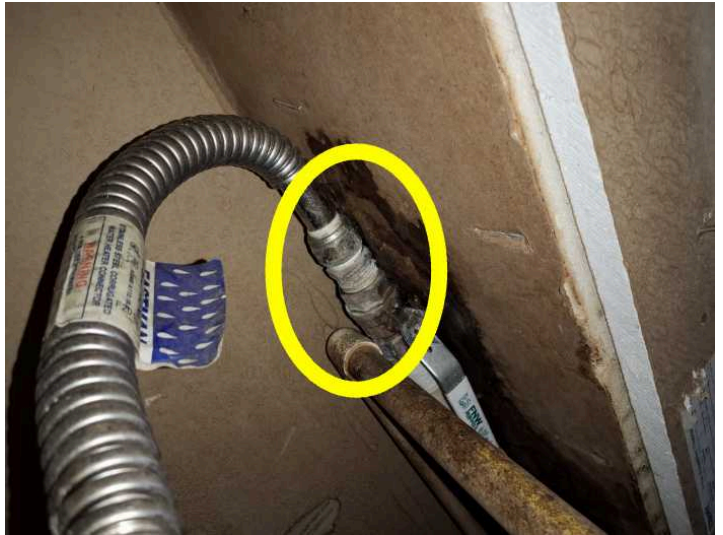
There is a leak at the water connector on the inlet side of the gas water heater, which should be repaired by a qualified tradesperson.

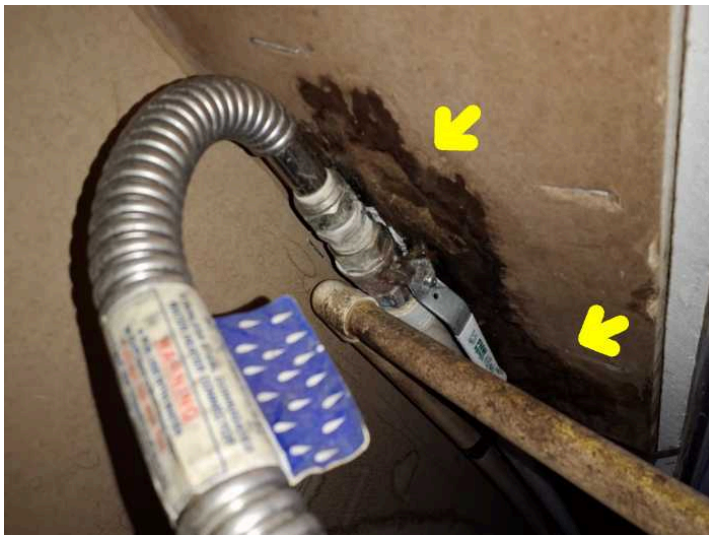
There is a mold-like substance present, which should be evaluated by a specialist and serviced as necessary. All molds flourish in a damp environment and many are commonplace, but some are toxic and may represent a health threat.

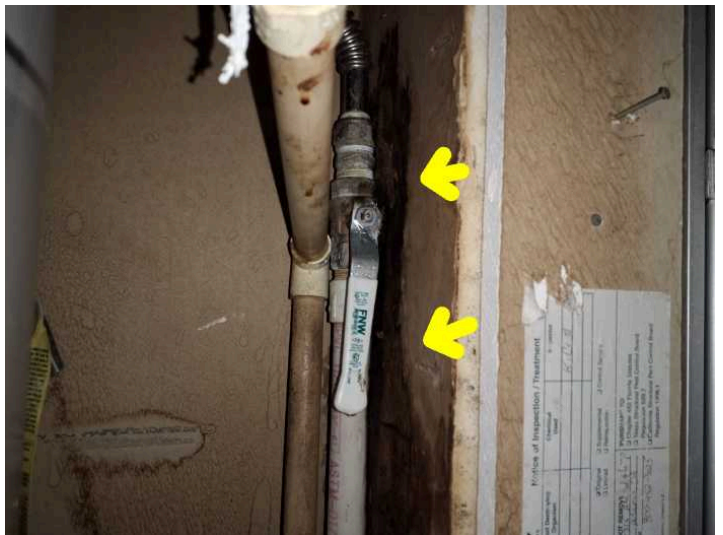
There is a mold-like substance present, which should be evaluated by a specialist and serviced as necessary. All molds flourish in a damp environment and many are commonplace, but some are toxic and may represent a health threat.

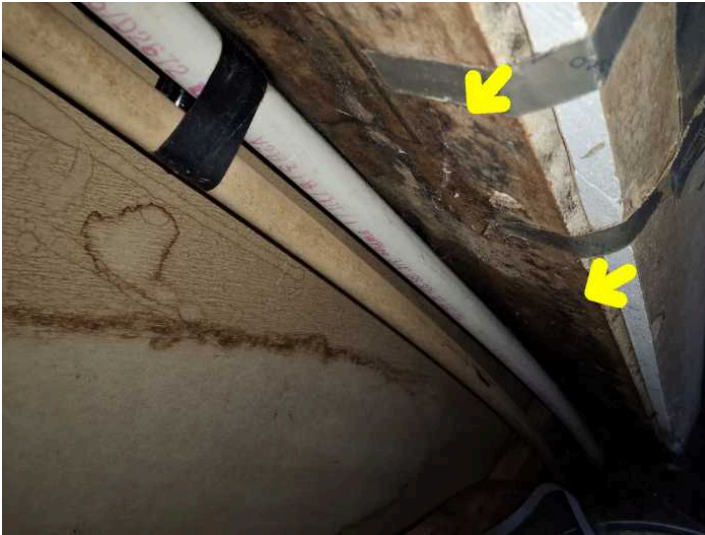
There is a mold-like substance present, which should be evaluated by a specialist and serviced as necessary. All molds flourish in a damp environment and many are commonplace, but some are toxic and may represent a health threat.

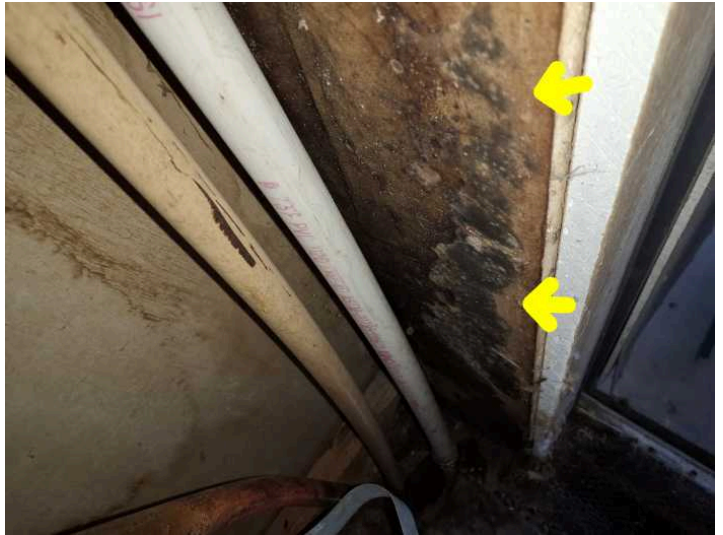
There is a mold-like substance present, which should be evaluated by a specialist and serviced as necessary. All molds flourish in a damp environment and many are commonplace, but some are toxic and may represent a health threat.

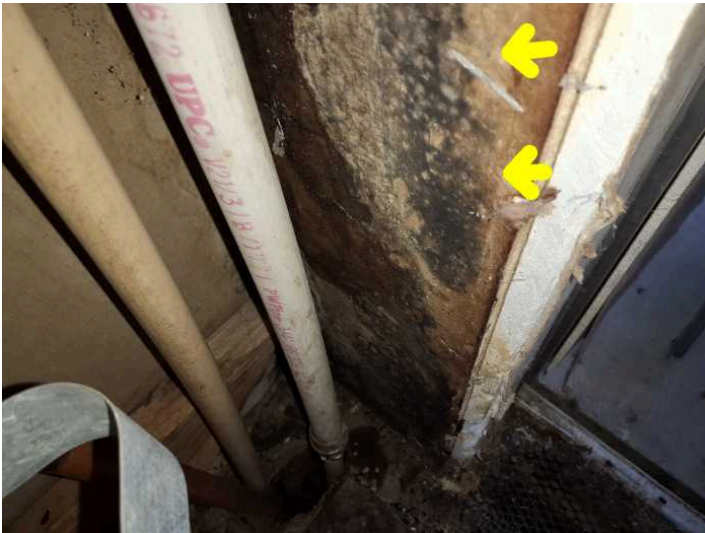
There is a mold-like substance present, which should be evaluated by a specialist and serviced as necessary. All molds flourish in a damp environment and many are commonplace, but some are toxic and may represent a health threat.

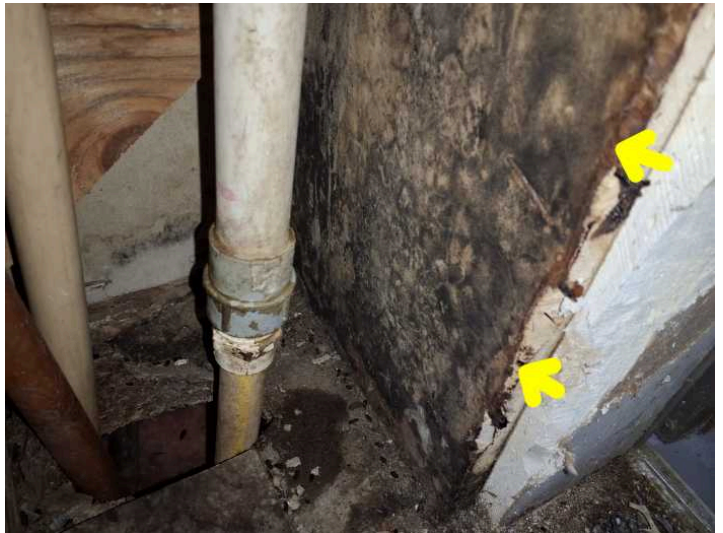
There is a mold-like substance present, which should be evaluated by a specialist and serviced as necessary. All molds flourish in a damp environment and many are commonplace, but some are toxic and may represent a health threat.

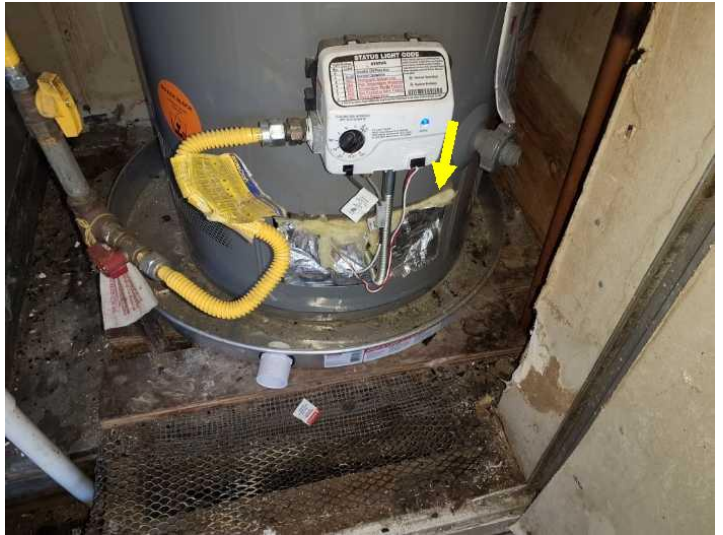
The exterior flame cover is missing and should be replaced.

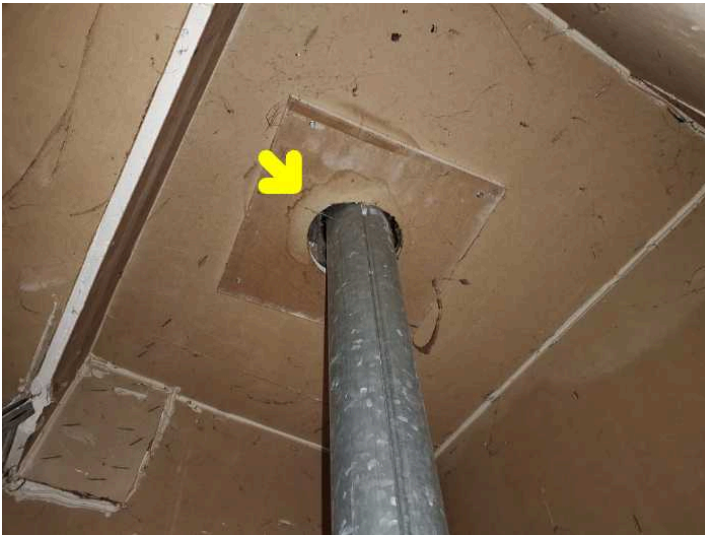
There are moisture stains on the ceiling at the vent pipe which should be explained or further explored. It could indicate the roof vent flashing is not properly sealed.

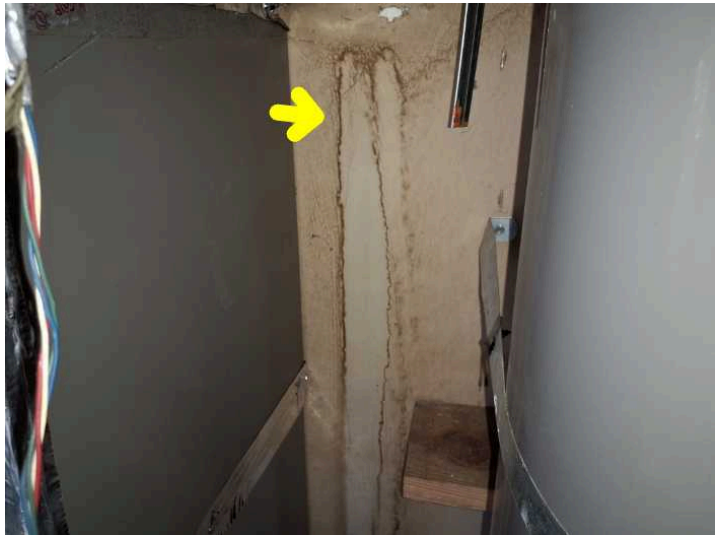
There is a moisture stain on the wall or ceiling that should be explained or explored further.

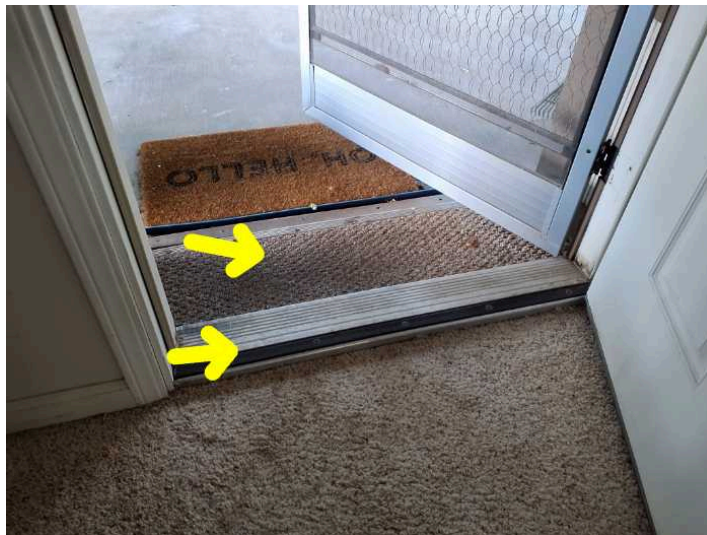
There is damage to the threshold that should be evaluated by a qualified specialist and serviced as necessary.

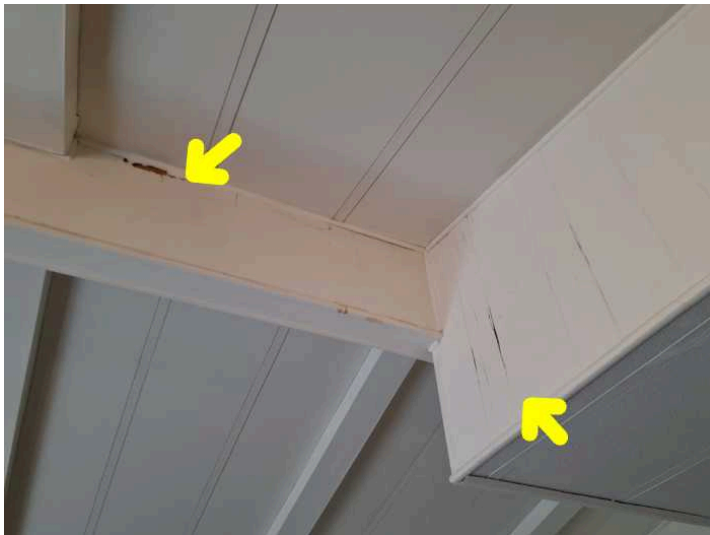
There is a moisture stain/damage on the ceiling that should be explained or explored further.

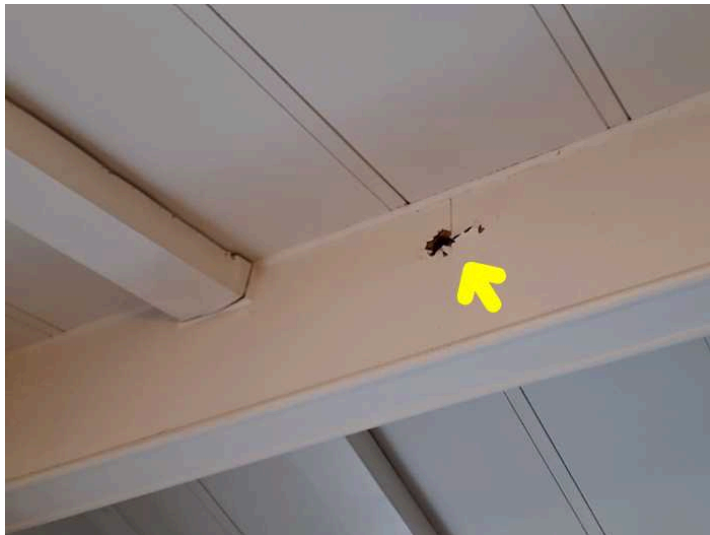
There is a moisture stain/damage on the ceiling that should be explained or explored further.

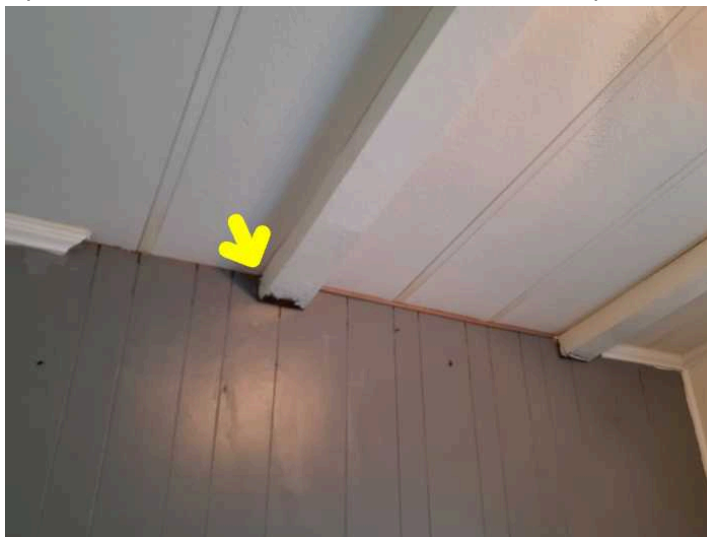
There is a moisture stain/damage on the ceiling that should be explained or explored further.

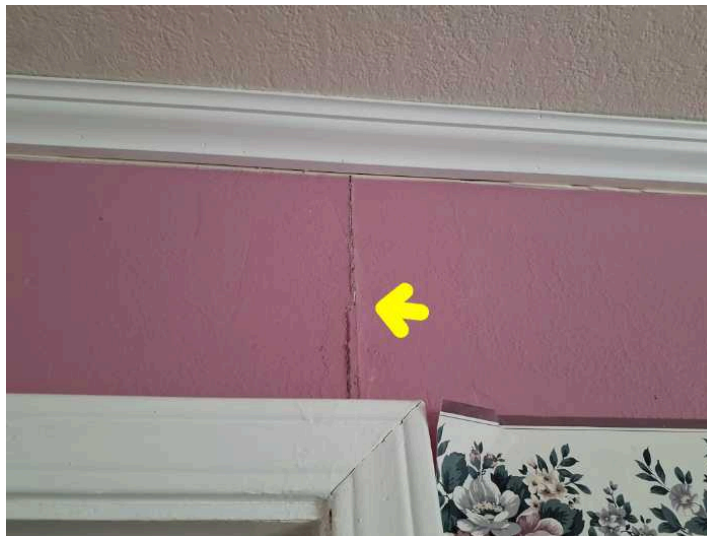
The walls have stress fractures which may have resulted from movement. I can elaborate on this issue, but you should have a specialist comment, and be aware that such cracks can reappear, and typically if they are not repaired correctly.

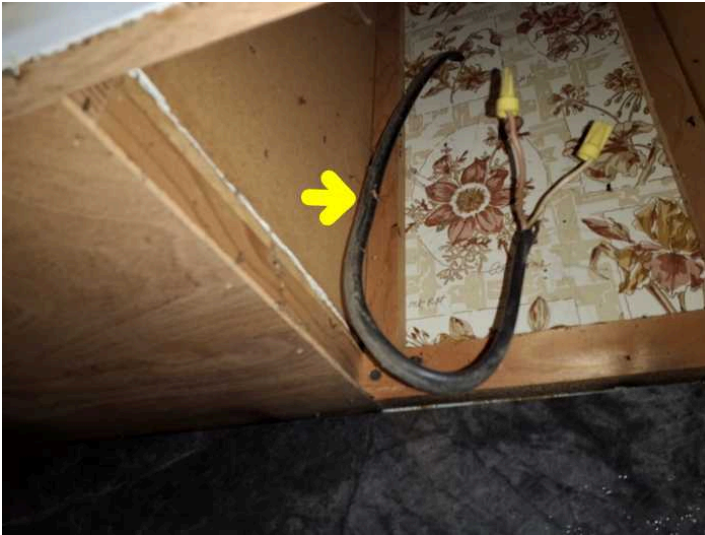
There is exposed romex present, which is a potential safety hazard. We recommend having it evaluated and serviced by a licensed electrician, possibly by installing the romex inside the wall cavity or into conduit.

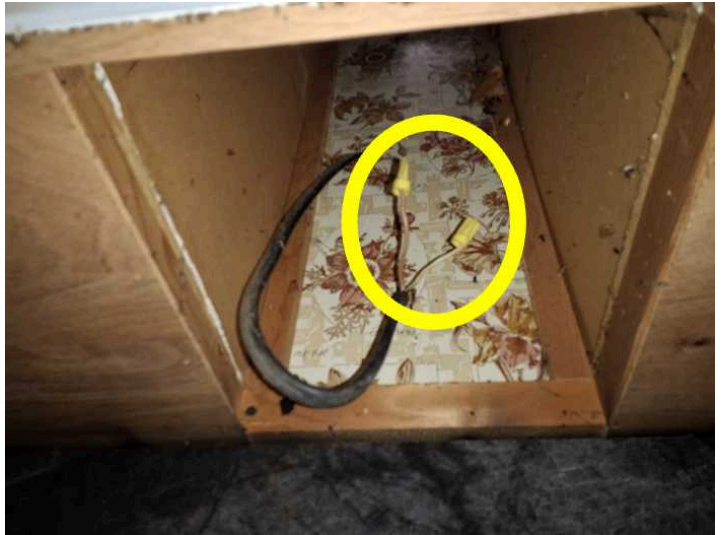
There is an electrical connection that has been improperly made outside of a junction box which should be rewired by a licensed electrical contractor.

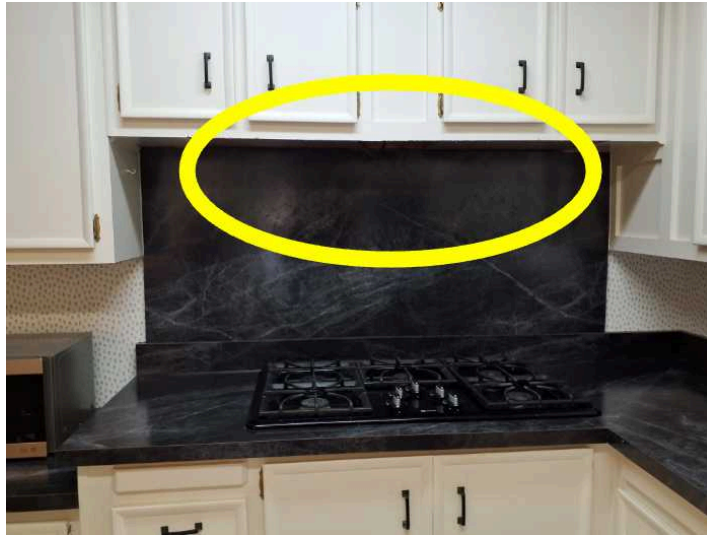
There is no provision for an exhaust fan, which is recommended for optimal safety.

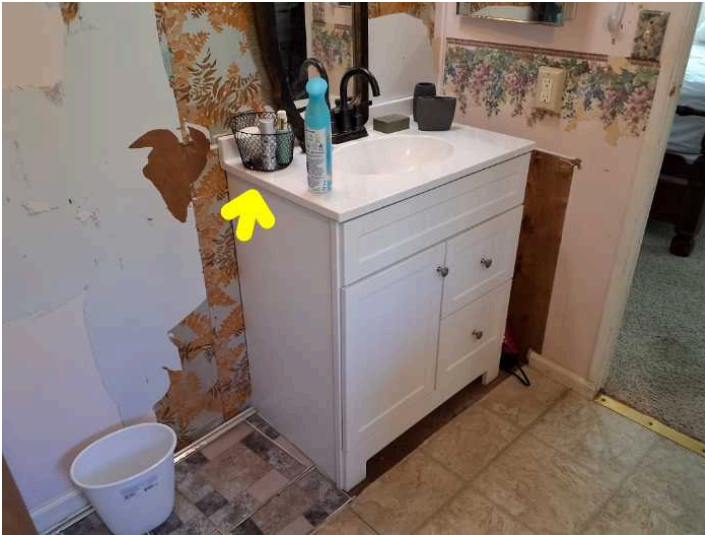
The sink countertop is not secure, and should be serviced.

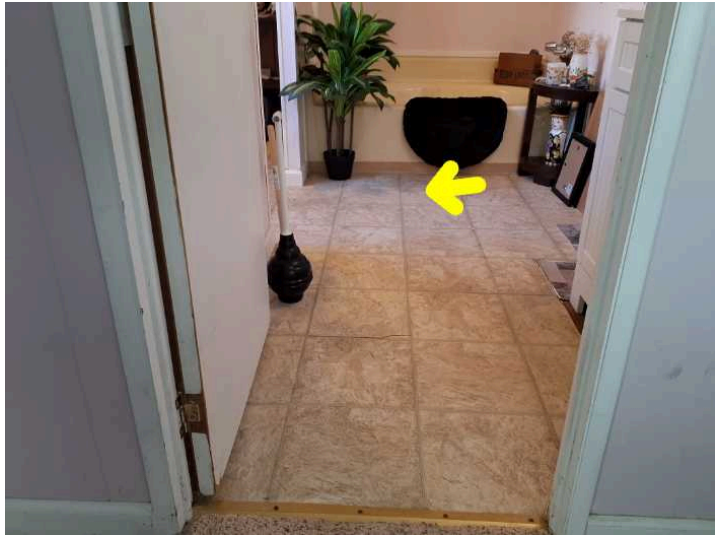
The floor is out of level. We can elaborate, but this condition should be evaluated by a qualified tradesperson.

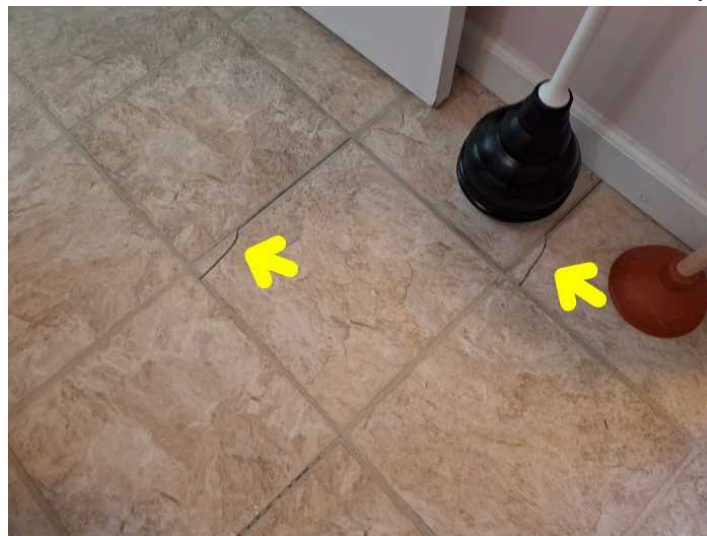
The floor is worn or cosmetically damaged, which you should view for yourself.

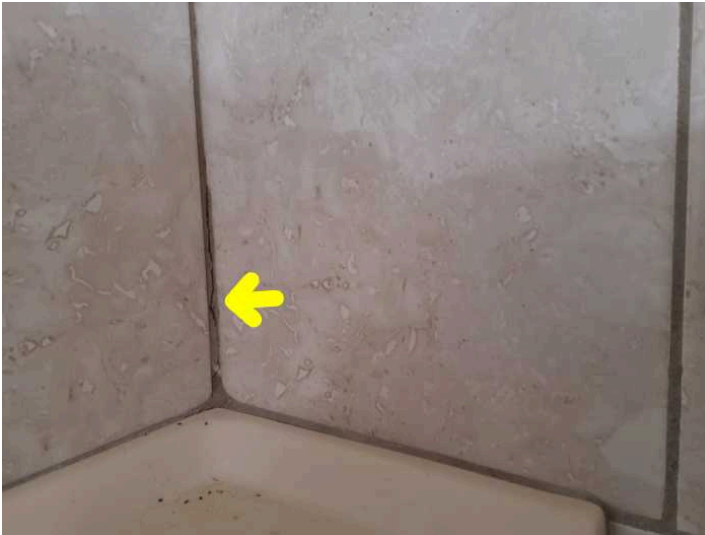
There are stress fractures in the walls/ceiling that have resulted from movement. Such cracks can reappear if the movement is caused by expansive soils, and particularly if the cracks are not repaired correctly. However, only a geologist could predict the likelihood of further movement.

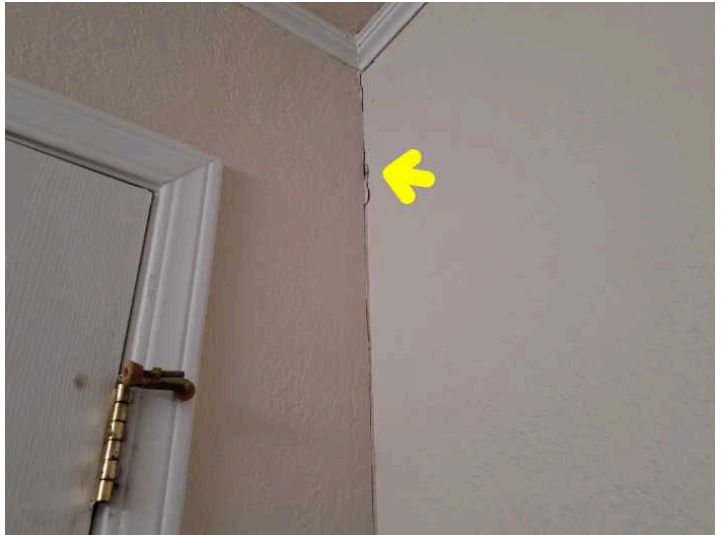
There are stress fractures in the walls/ceiling that have resulted from movement. Such cracks can reappear if the movement is caused by expansive soils, and particularly if the cracks are not repaired correctly. However, only a geologist could predict the likelihood of further movement.

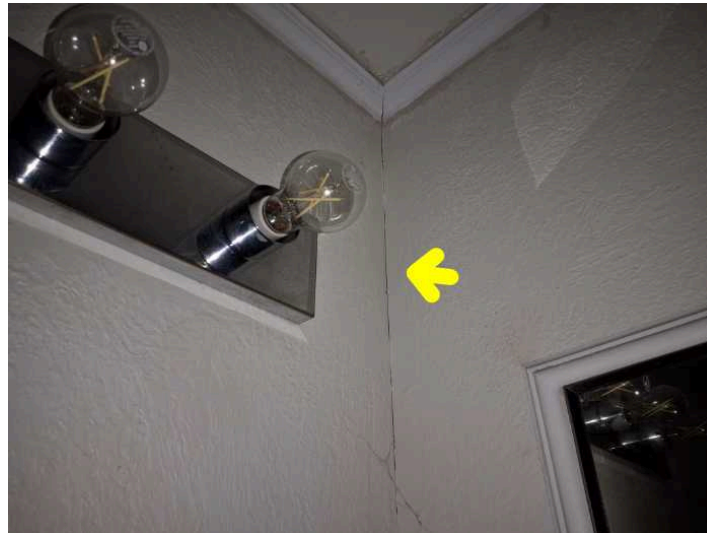
There are stress fractures in the walls/ceiling that have resulted from movement. Such cracks can reappear if the movement is caused by expansive soils, and particularly if the cracks are not repaired correctly. However, only a geologist could predict the likelihood of further movement.

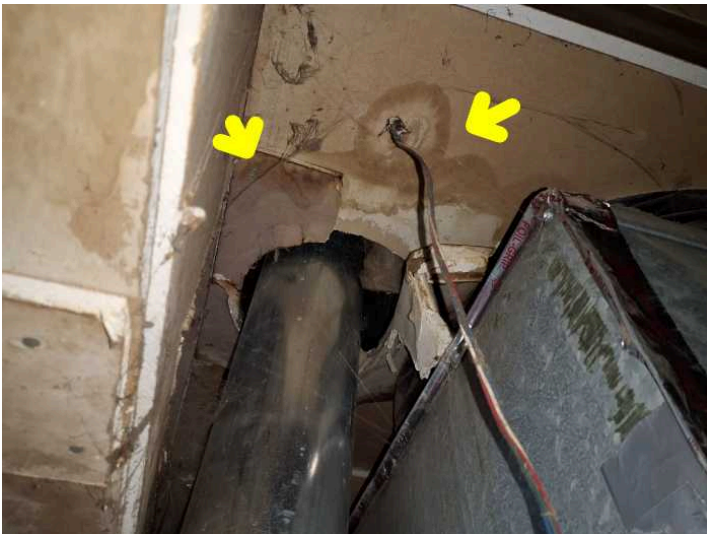
There are moisture stains on the ceiling at the vent pipe which should be explained or further explored. It could indicate the roof vent flashing is not properly sealed.

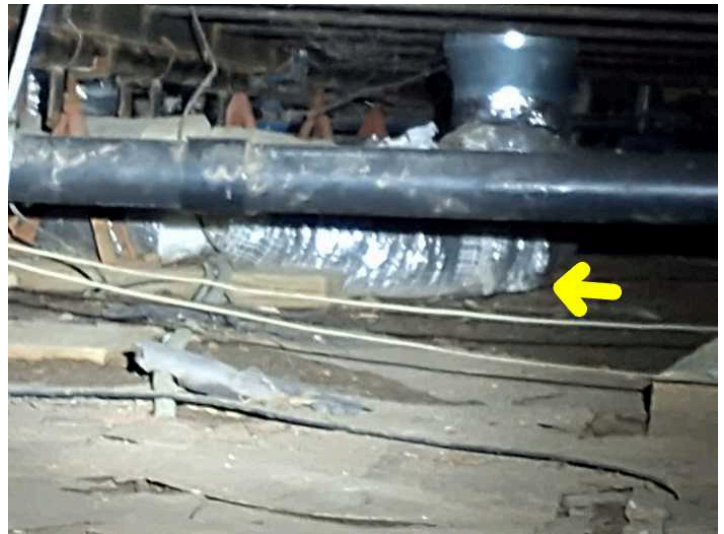
The flexible ducts in the crawlspace are in contact with the soil and should be a minimum of 4" off the ground. The plastic covering will deteriorate when in contact with the soil.

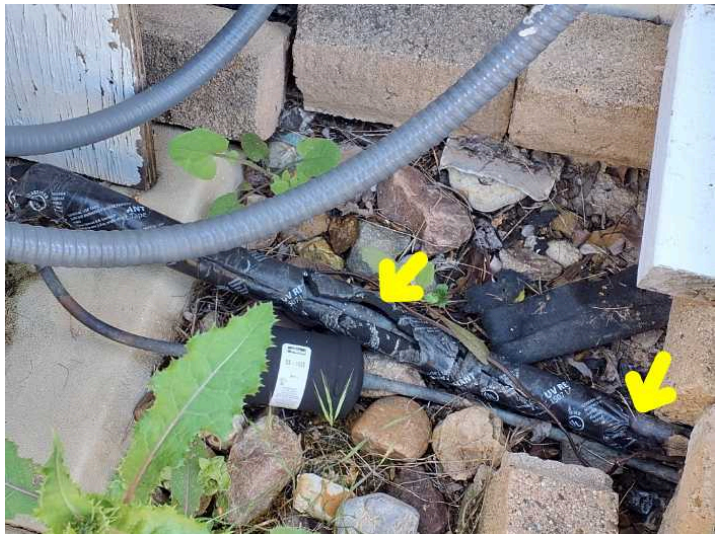
Insulation is missing from the refrigerant lines at the evaporator coil, which will allow condensation to form and drip, and should be installed.
