## **Property Inspection Report**

***630 E Cook St, Santa Maria, CA 93454***

***Date of Inspection: 7/15/2026 Time: 1:00 PM***

***Inspector: Greg Hines***

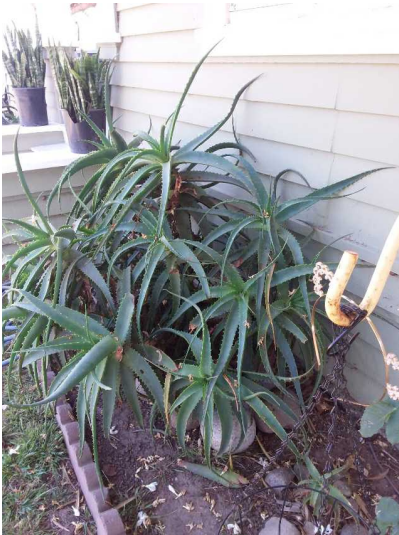
Vines, shrubs or bushes are growing on the house walls and although they are attractive they can introduce pests and rodents and accelerate deterioration. Therefore, you may wish to consider having them removed or cut back to 12 inches away from the home.

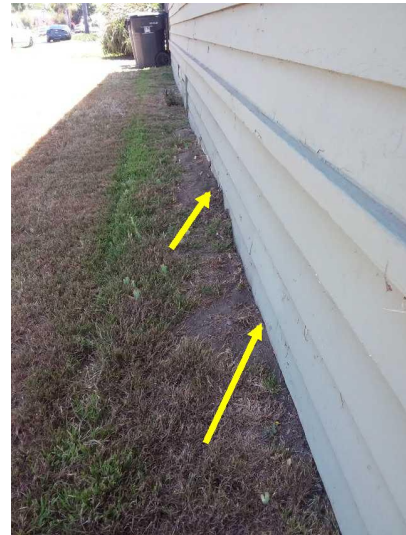
There are areas where the wooden siding is close to or touching the ground and is subject to moisture damage. These areas should be monitored closely and sealed frequently to prevent moisture damage. Wooden siding should be a minimum of 4 inches from soil and 2 inches from hard surfaces.

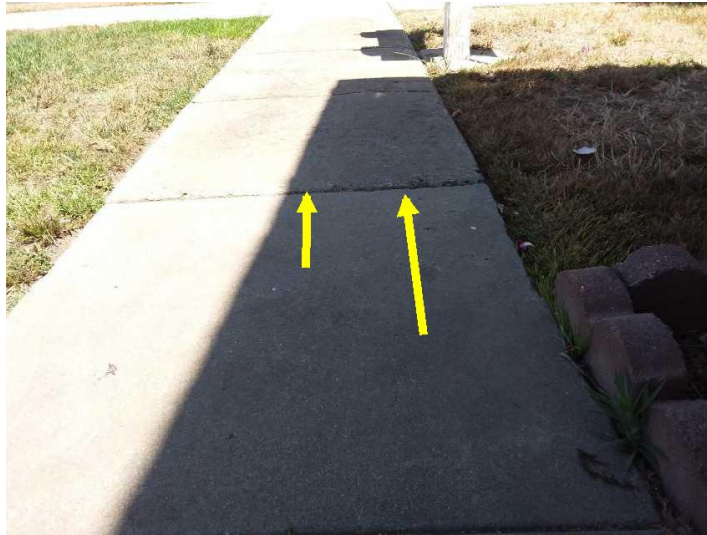
There is one or more offsets in the walkways that could prove to be trip-hazards.

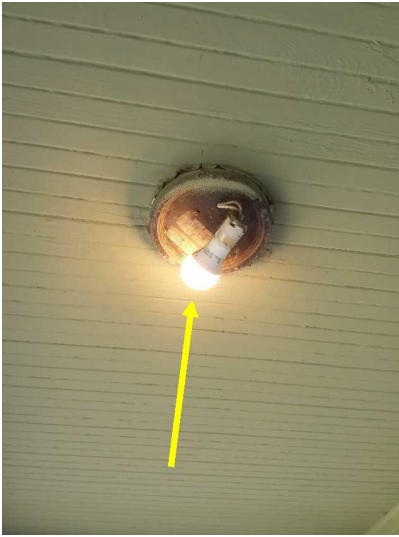
A light is missing its globe or cover and should be serviced.

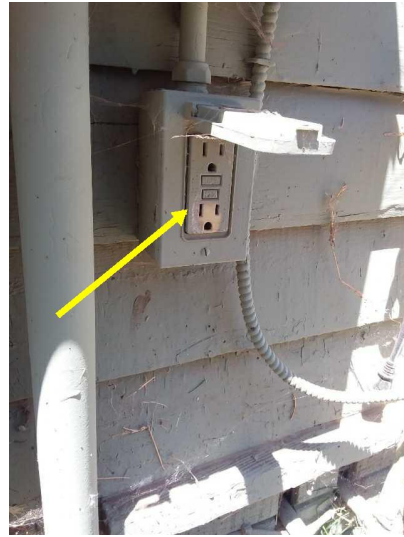
A ground-fault protected outlet in the rear of the house does not trip on test, and should be serviced.

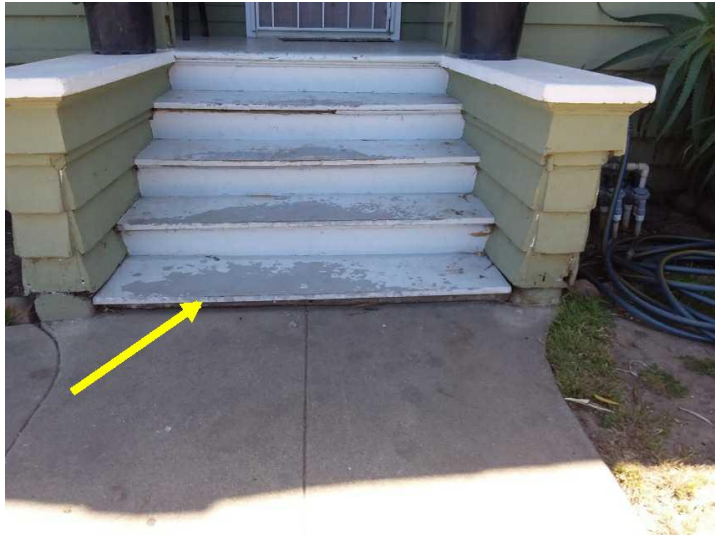
Some of the steps have unequal treads or risers. Steps are required to be uniform to prevent trip-hazards. The rise of any step should be no less than four inches and no greater than seven inches, and the run should be no less than eleven inches. Also, the dimensions of the largest step should not exceed that of the smallest by more than three-eighths of an inch.

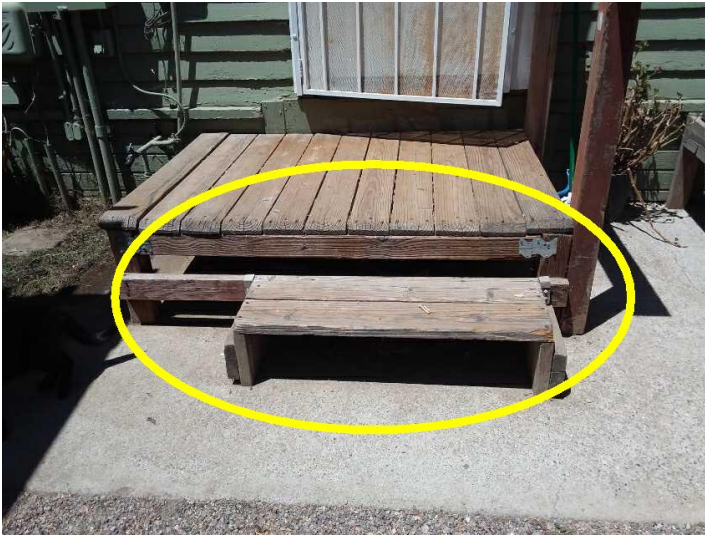
Some of the steps have unequal treads or risers. Steps are required to be uniform to prevent trip-hazards. The rise of any step should be no less than four inches and no greater than seven inches, and the run should be no less than eleven inches. Also, the dimensions of the largest step should not exceed that of the smallest by more than three-eighths of an inch.

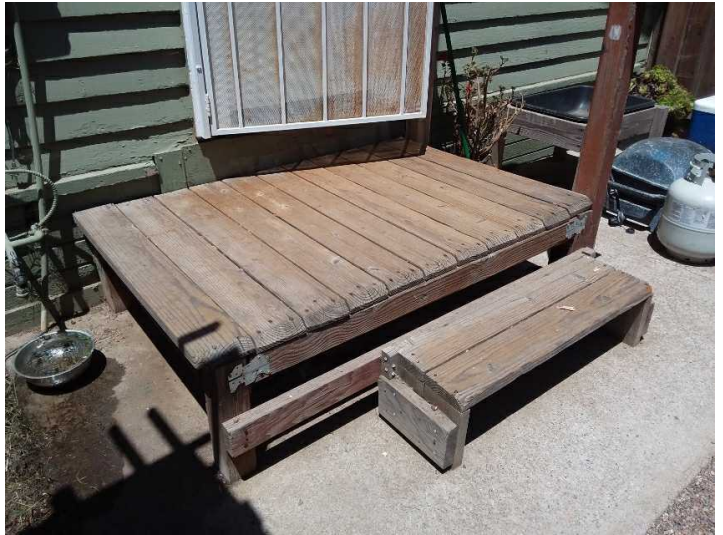
The wood stairs need maintenance-type service, such as securing loose planks, setting nails, sanding, or sealing, all of which will prolong the life of the stairs.

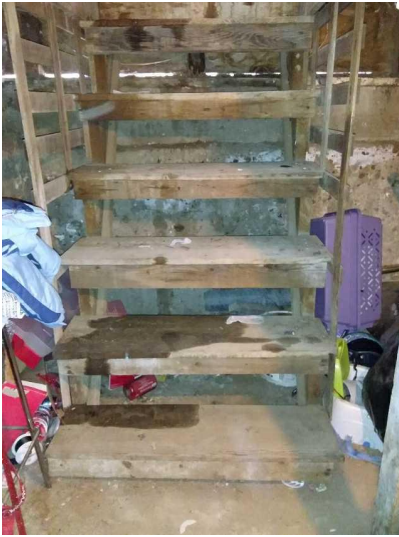
Some of the steps have unequal treads or risers.

Steps are required to be uniform to prevent trip-hazards. The rise of any step should be no less than four inches and no greater than seven inches, and the run should be no less than eleven inches. Also, the dimensions of the largest step should not exceed that of the smallest by more than three-eighths of an inch.

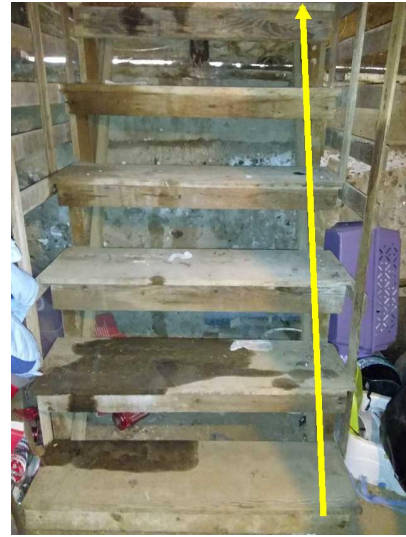
Current building standards require handrails to be installed on steps which have 4 or more risers, and particularly if children or the elderly visit or occupy this property.

The openings in the stair risers are more than 4 inches apart and does not meet current standards. You may want this condition serviced to meet current standards.

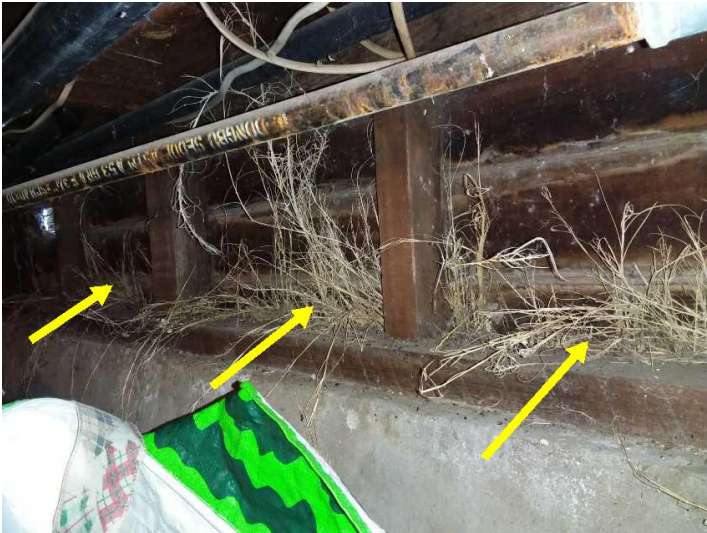
There is evidence that vegetation has migrated under or through the stem walls of the raised foundation and stood in the crawlspace. We recommend having this condition evaluated and serviced by a licensed specialist.

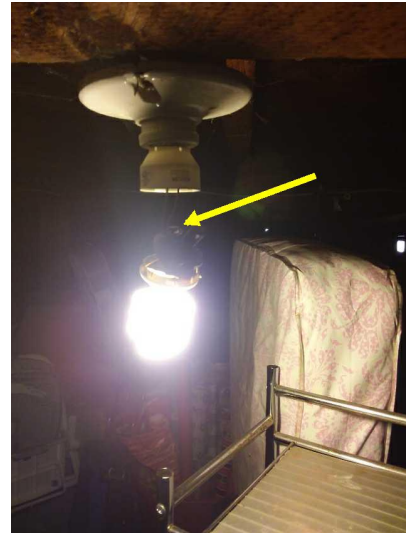
A light in the crawlspace is damaged and should be serviced.

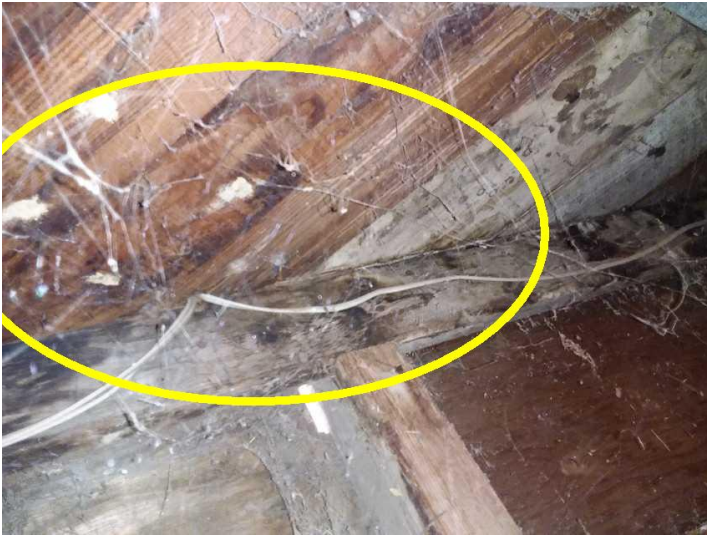
There are stains or moisture damage to the sub-floor beneath the residence. The termite inspector is responsible for pressure testing shower pans, and will evaluate and comment on the condition of the shower pan and any resulting damage to the intermediate floor framing.

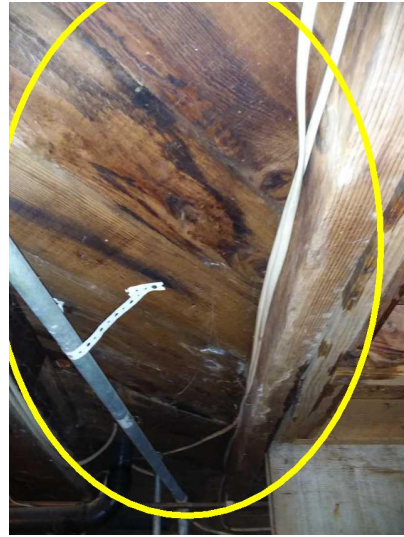
There are stains or moisture damage to the sub-floor beneath the residence. The termite inspector is responsible for pressure testing shower pans, and will evaluate and comment on the condition of the shower pan and any resulting damage to the intermediate floor framing.

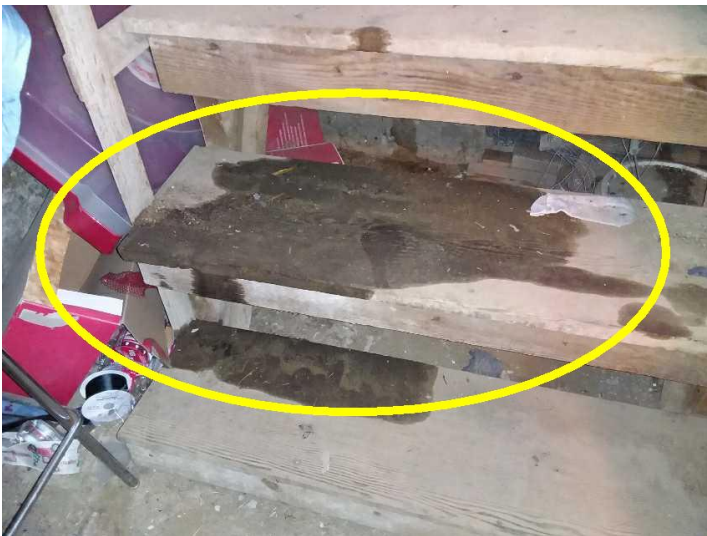
There are stains or moisture damage to the sub-floor beneath the residence. The termite inspector is responsible for pressure testing shower pans, and will evaluate and comment on the condition of the shower pan and any resulting damage to the intermediate floor framing.

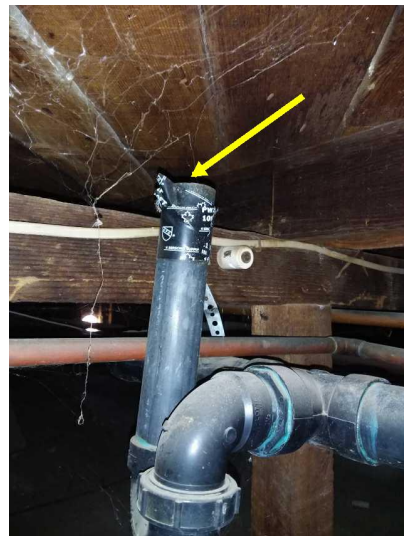
A drain and waste vent terminates in the crawlspace which should be evaluated and serviced by a licensed specialist.

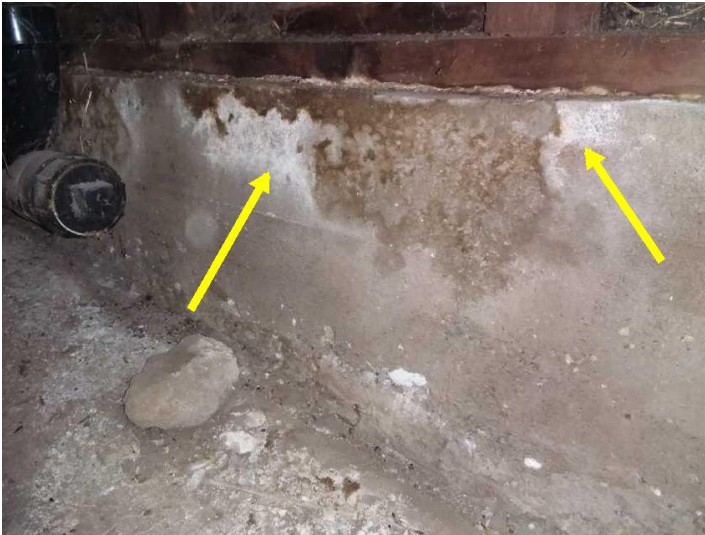
Moisture has entered the crawlspace, as is evident by salt crystal formations around the base of the stem walls. However, this is a common phenomenon that does not necessarily indicate a chronic or serious problem. The soils are currently dry, but it would be prudent to monitor this area.

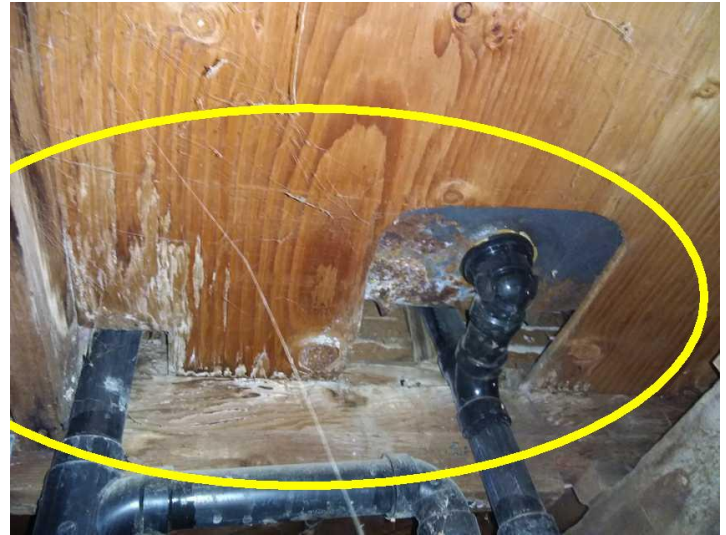
There are stains or moisture damage to the sub-floor beneath the residence. The termite inspector is responsible for pressure testing shower pans, and will evaluate and comment on the condition of the shower pan and any resulting damage to the intermediate floor framing.

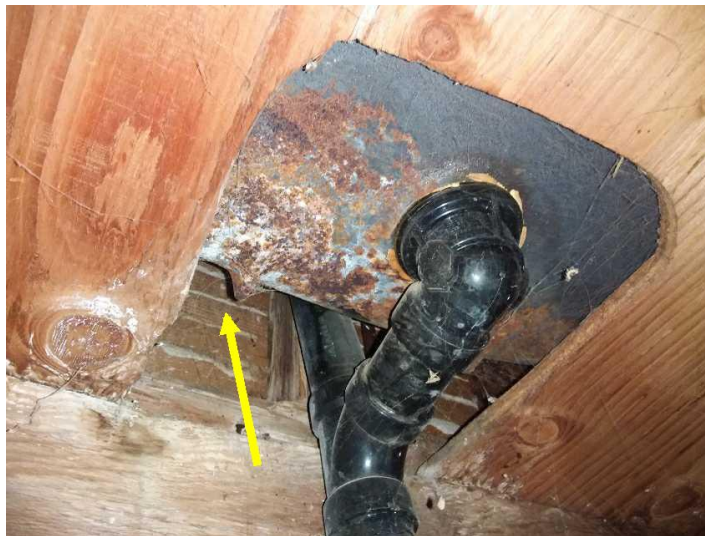
The rodent barrier or sub floor has voids or openings that should be sealed. This could also imply that there has been some leaks or plumbing repairs done in the past. You may want to ask the seller regarding this issue.

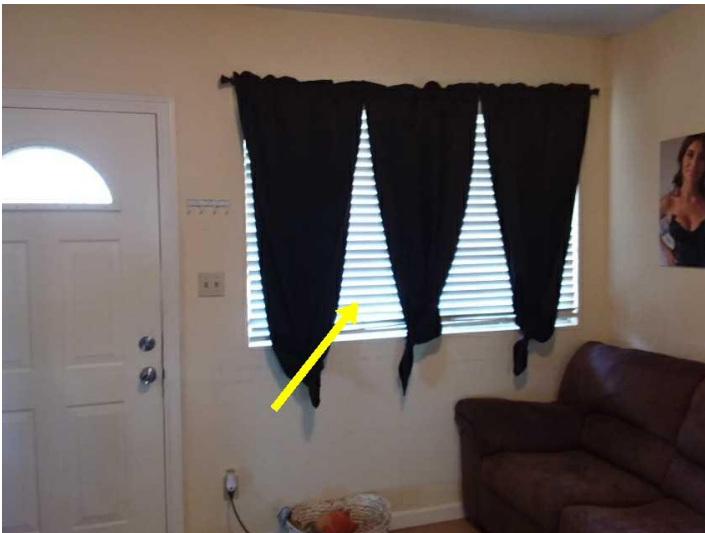
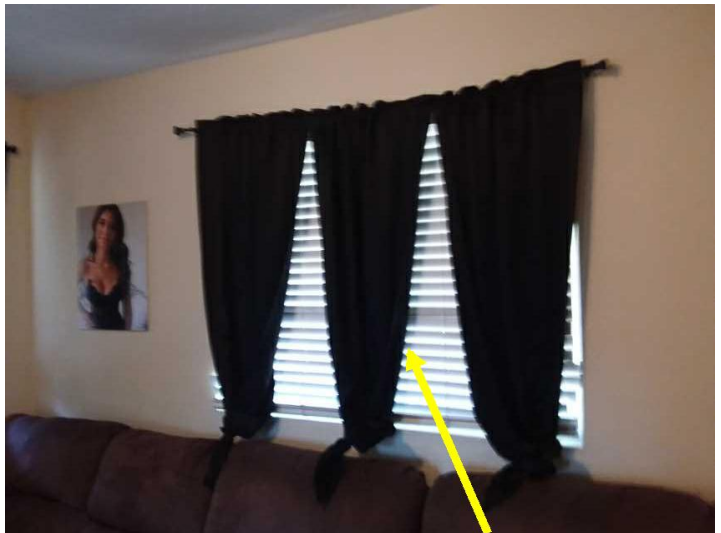
A window lock is missing or damaged and needs to be serviced to be functional.

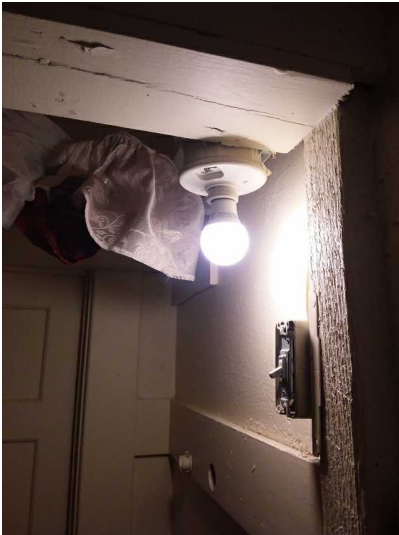
The closet employs a light bulb that should have a cover.

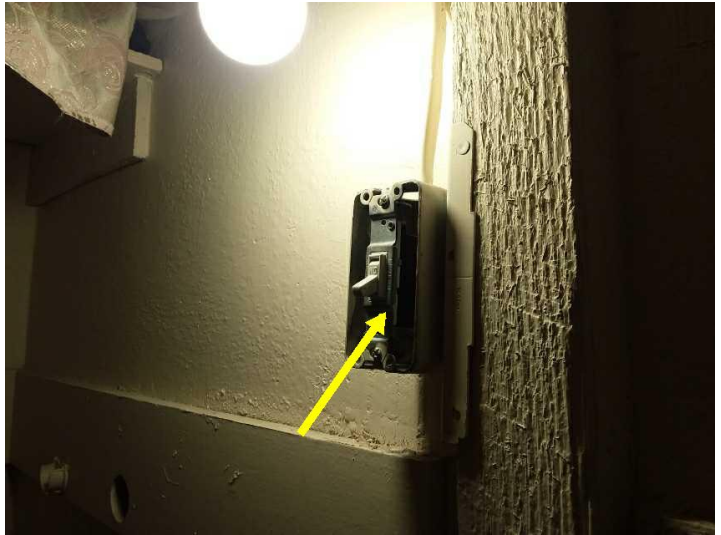
One or more light switch covers are missing and should be installed.

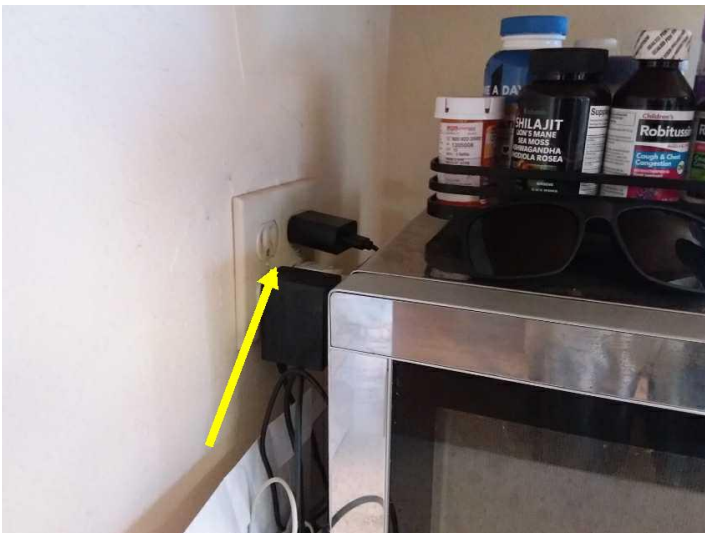
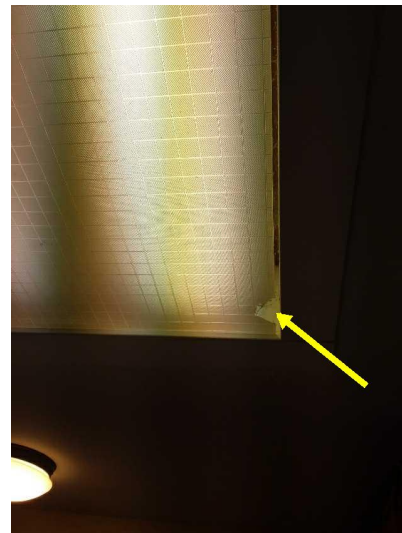
Some of the outlets at the kitchen counter top are not GFCI protected as required by today standards. A ceiling light panel is missing or broken and you may wish to have it replaced.

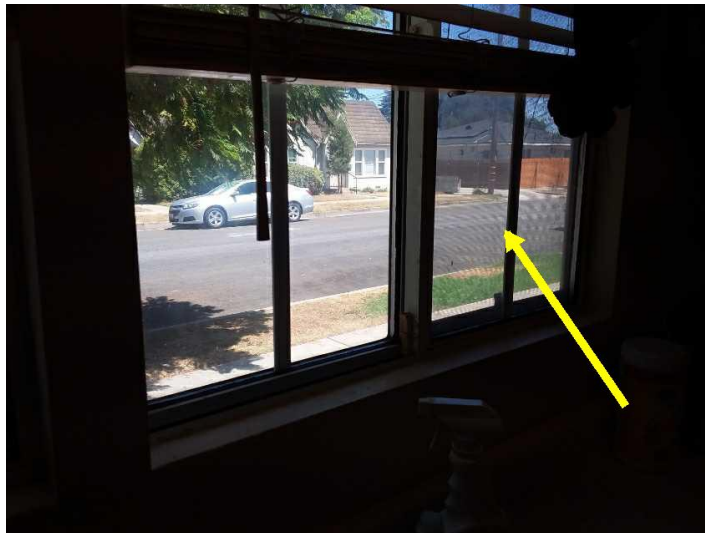
A window lock is missing or damaged and needs to be serviced to be functional however a secondary lock is installed.

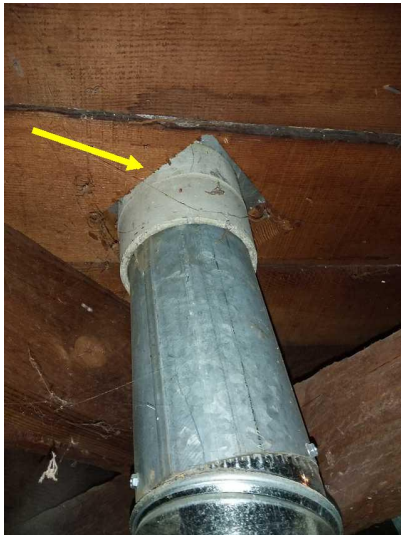
The double-walled vent pipe should be one inch away from the floor framing, or it could create pyrophoric conditions and a fire-hazard, and should be serviced by an HVAC contractor.

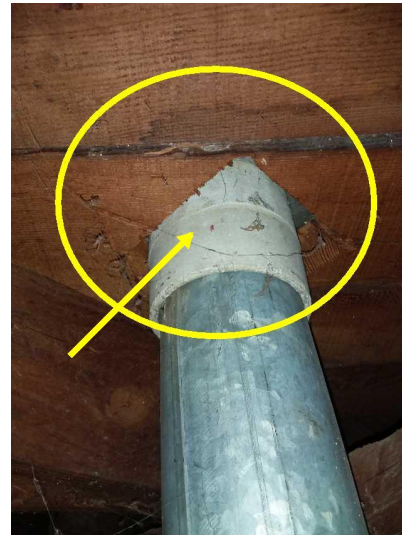
The furnace vents through a transite pipe. This could become problematic inasmuch as exhaust gases cause corrosive condensation to form within the pipe, which then drip and corrode the metal vent pipe. Regardless, with the advent of high efficiency furnaces around 1992, vent pipes have been required to be a double-walled metal type, which you may wish to have installed, or you should seek a second opinion from an HVAC contractor.

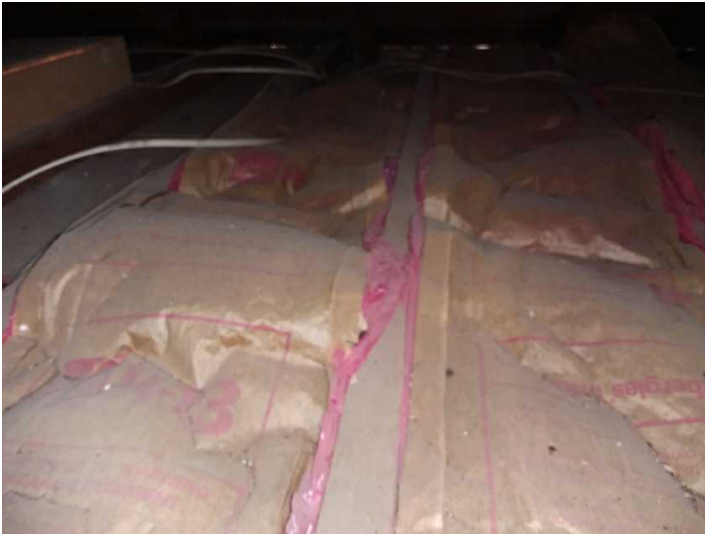
Some paper-faced, batt, insulation in the attic has been installed upside down. This is of no serious consequence, but the paper-face is intended to be installed toward the heated area or inside of the residence.

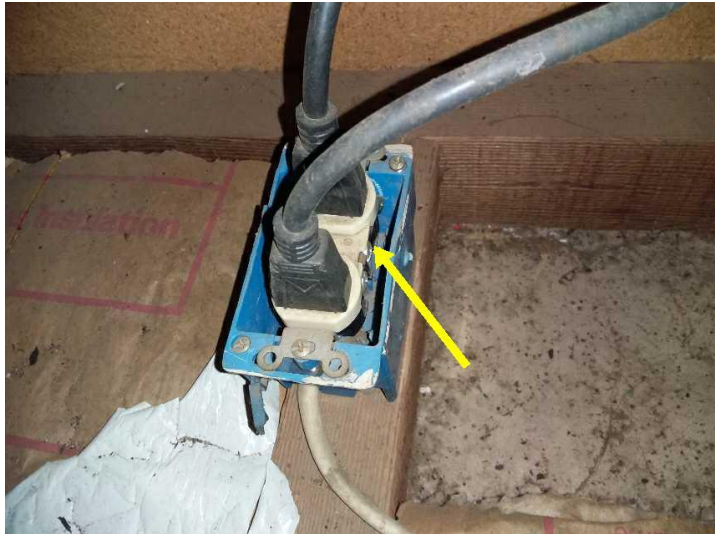
One or more outlets is missing a cover which should be installed.

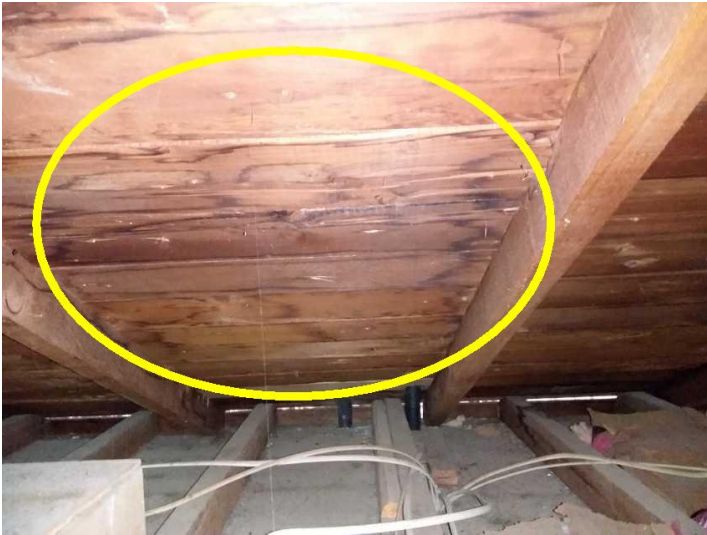
There are water stains on the ceiling that implies that a leak has occurred. Since it was not raining during our inspection, we were unable to determine if the leak is currently leaking, or, it is an old leak that has been repaired. You should ask the sellers for information regarding this issue.

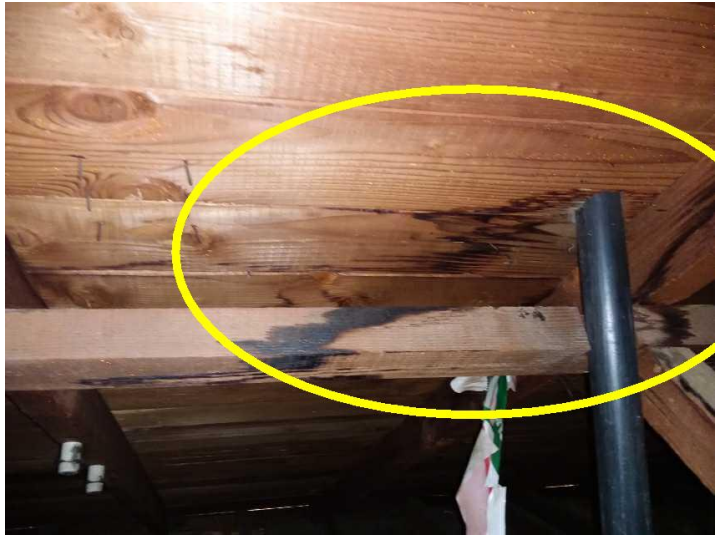
There are moisture stains on the attic ceiling at a roof penetration that indicate a past or present leak. This is a common area for leaks. We are unable to determine if the leak is current, or a past leak, in any case it should be further investigated or explained.

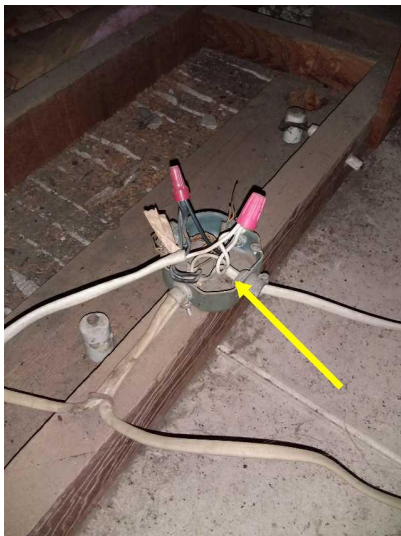
There is an open electrical junction box, which should be sealed so that any arcing or sparking would be contained within the box.

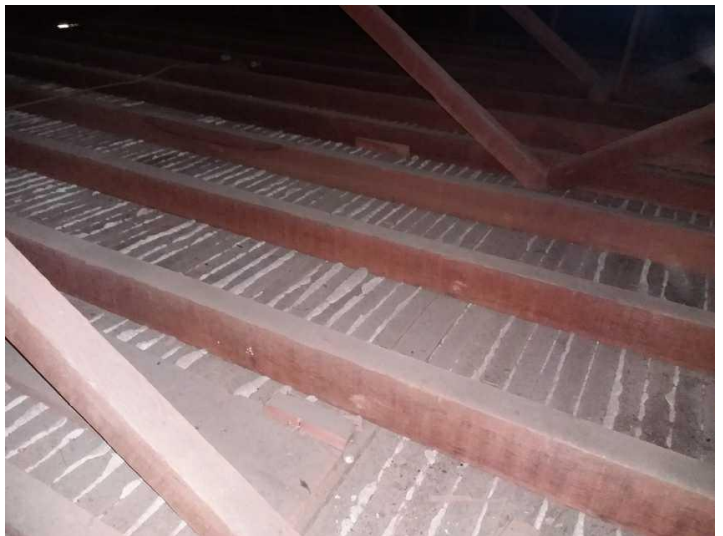
The attic has missing insulation over the some areas, which should be installed to meet current standards.

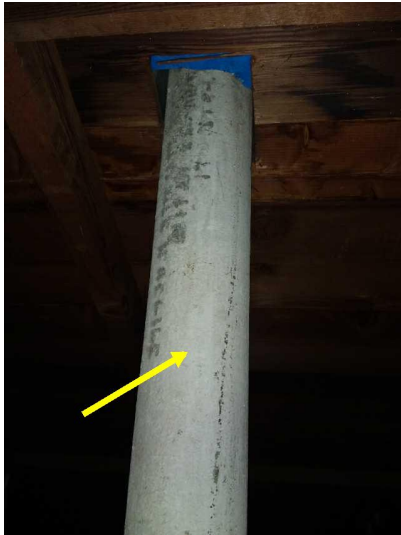
The vents include a clay-based type, known as a transite pipe that contains asbestos fibers, but which are encapsulated and thereby do not pose any viable health threat.

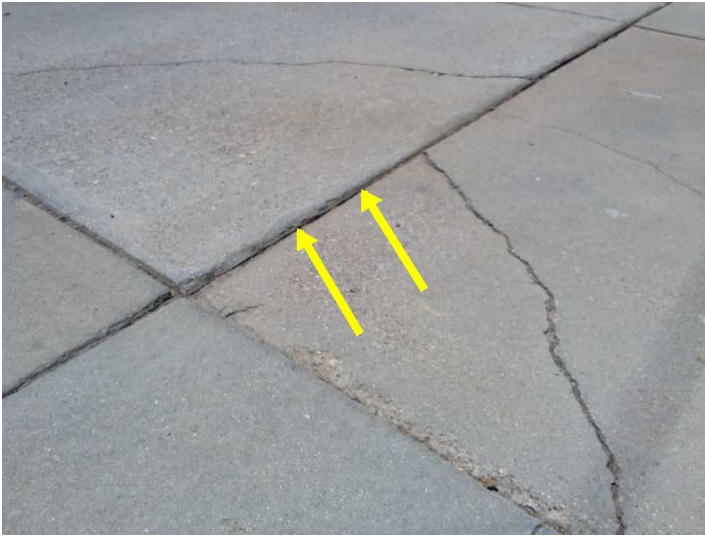
There is one or more offsets in the driveway that could prove to be trip-hazards.

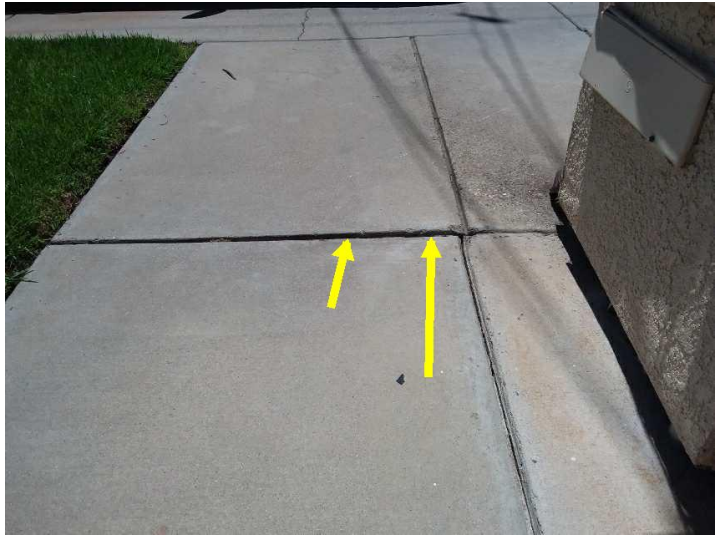
There is one or more offsets in the walkways that could prove to be trip-hazards.

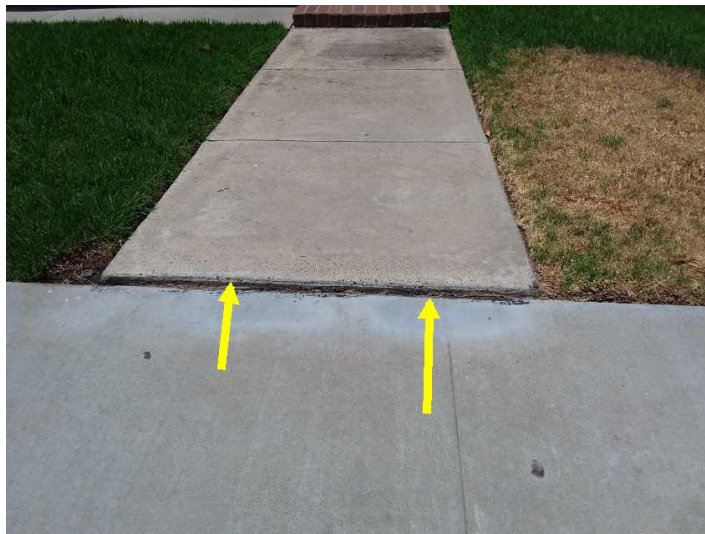
There is one or more offsets in the walkways that could prove to be trip-hazards.

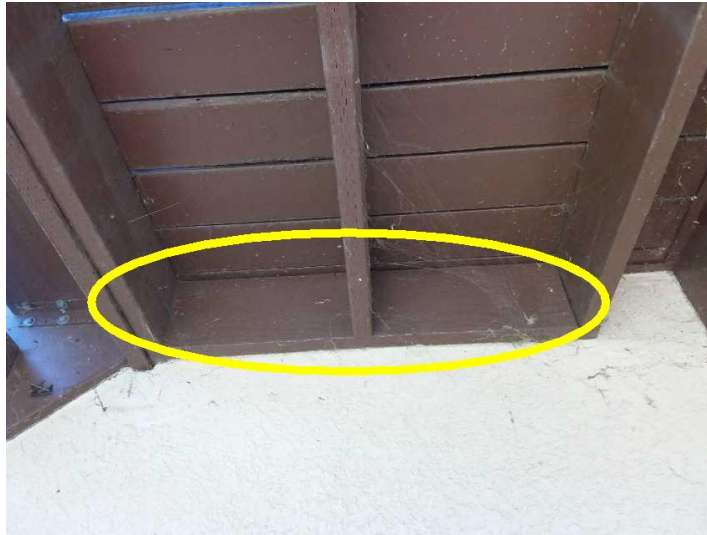
The ledger board that supports the stair deck has been improperly attached and should be lag-bolted, structurally screwed or attached per current standards.

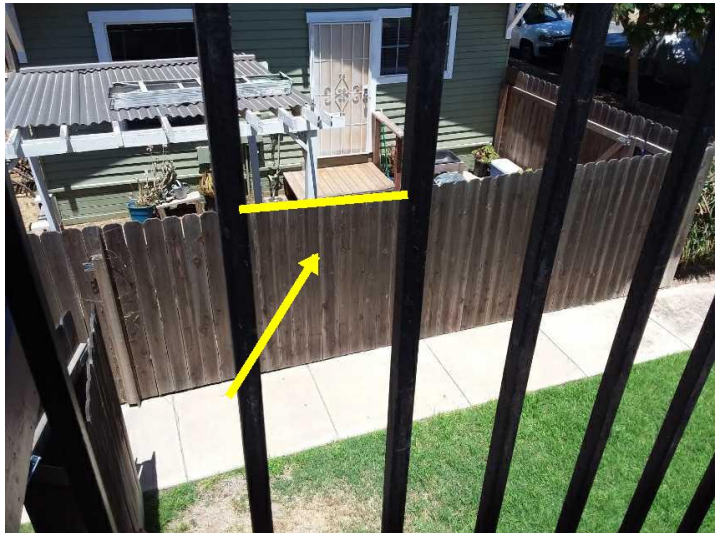
The balusters in the guardrail are more than 4" apart and are not child safe. Therefore, you may wish to add a protective barrier.

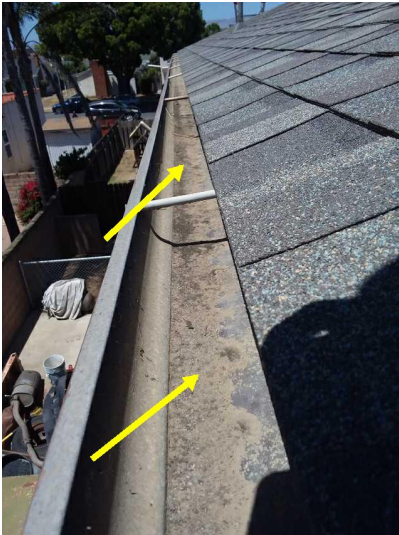
Some of the gutters need to be cleaned to drain properly.

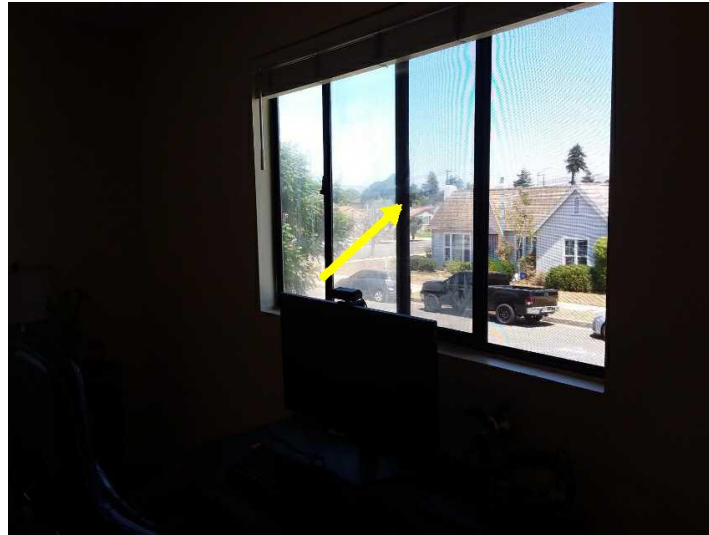
A lock on the window is missing or does not engage and should be serviced.

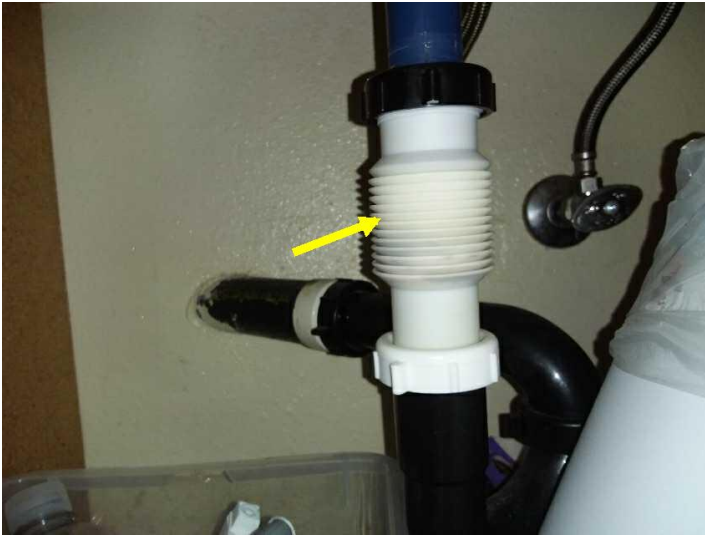
The sink employs an unconventional flexible drainpipe that could contribute to blockages.

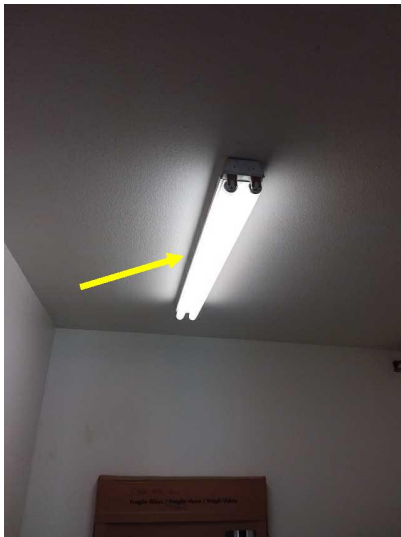
A light is missing its globe or cover and should be serviced.

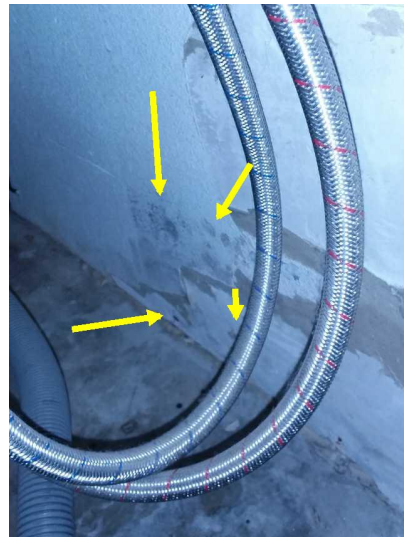
There is a mold-like substance that we will point out, which should be evaluated by a specialist. All molds flourish in a damp environment and many are commonplace, but some are toxic and represent a health threat.

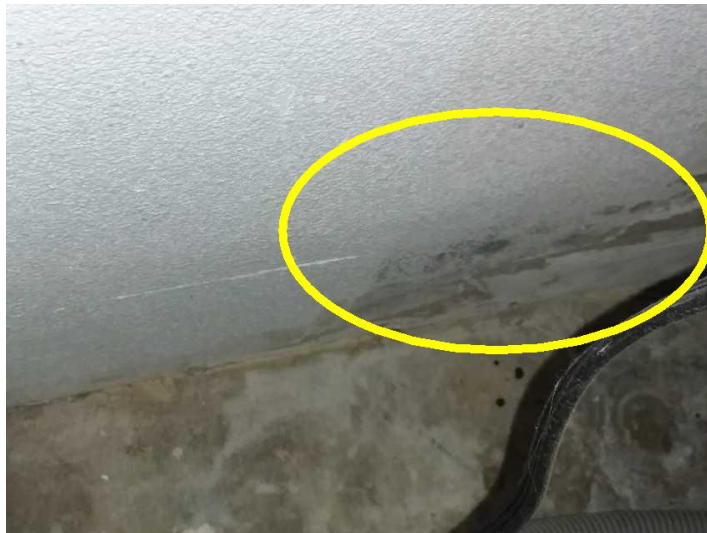
There is a mold-like substance that we will point out, which should be evaluated by a specialist. All molds flourish in a damp environment and many are commonplace, but some are toxic and represent a health threat.

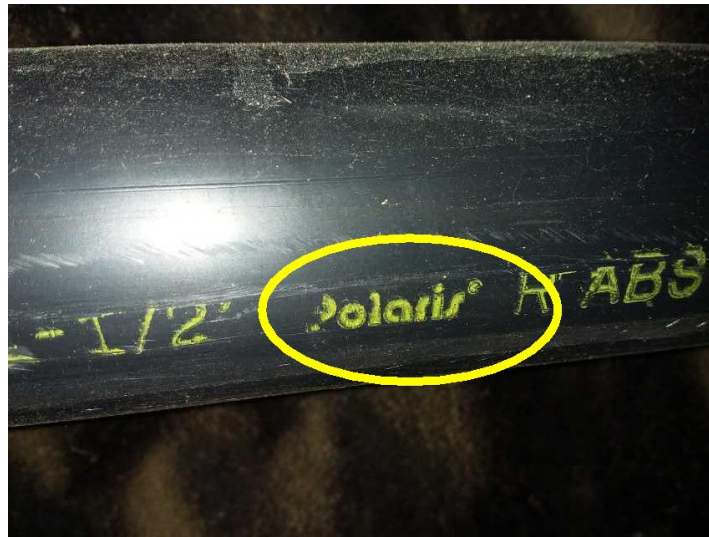
There are visible ABS drainpipe vents that are alleged to be defective. They include those manufactured between 1984 and 1990 under the trade names of Centaur, Gable, Phoenix, Polaris, and Apache. I can elaborate on this issue, but you should seek the opinion of a plumber who is familiar with these allegedly defective pipes.

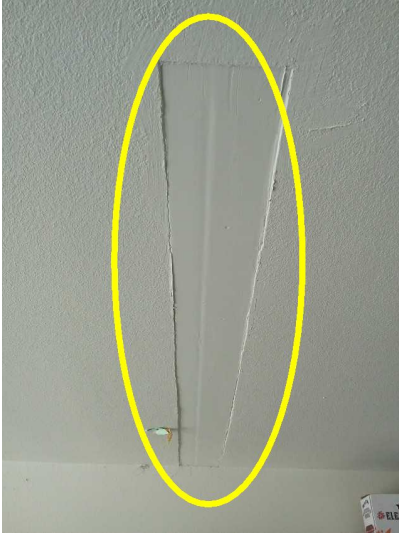
The voids in the ceiling firewall must be repaired, in order to maintain the necessary firewall separation between the garage and the residence.

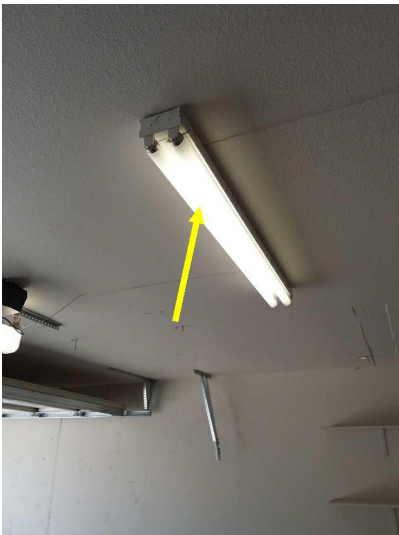
A light is missing its globe or cover and should be serviced.

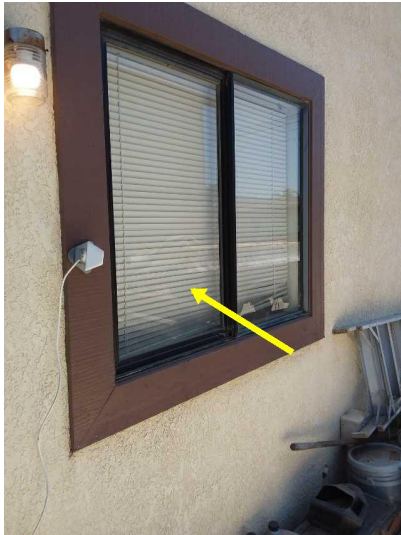
A window screen is missing, which you may wish to have replaced.

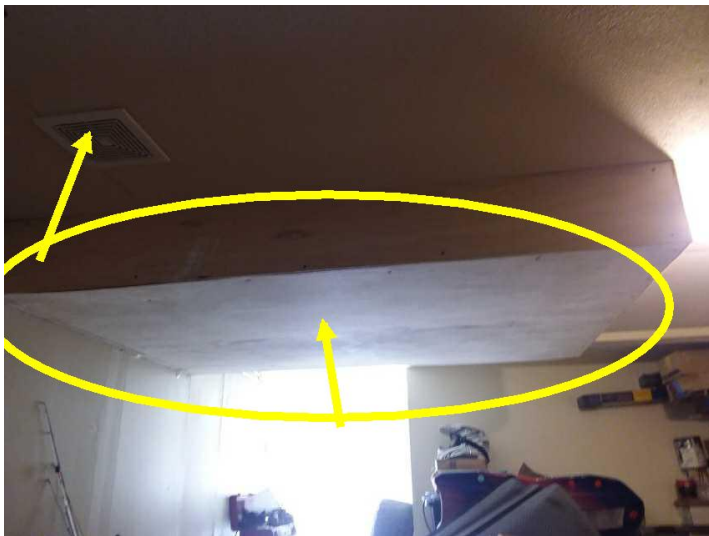
The voids in the ceiling firewall must be repaired, in order to maintain the necessary firewall separation between the garage and the residence.

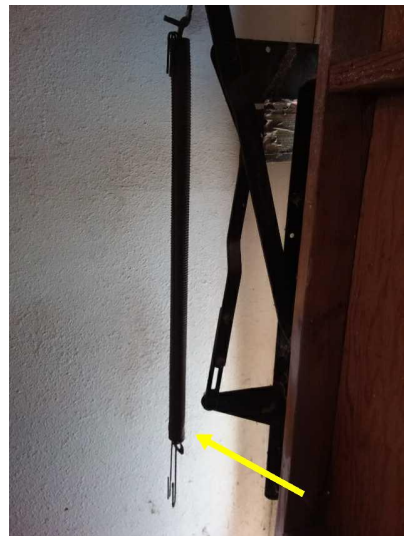
A door spring is missing or broken, and should be replaced.

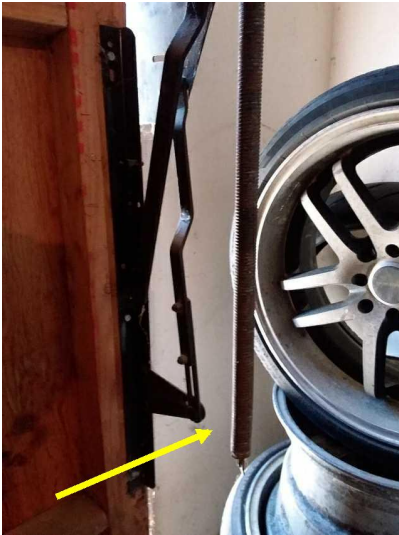
A door spring is missing or broken, and should be replaced.

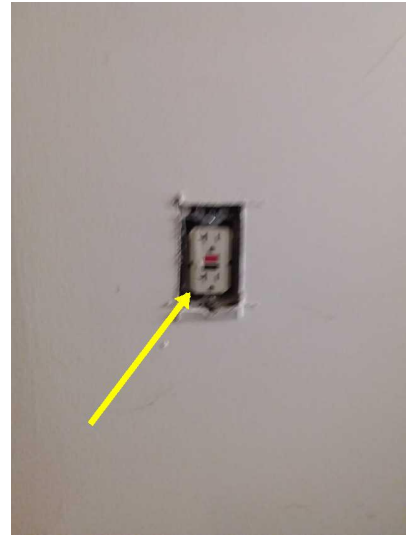
One or more outlet covers is missing and should be installed.
