# A Buyer's Choice Home Inspections

## PROPERTY INSPECTION REPORT

329 Moonlight Ave SE, Salem, OR 97302

Date of Inspection: 7/9/2026 Time: 9:00 AM

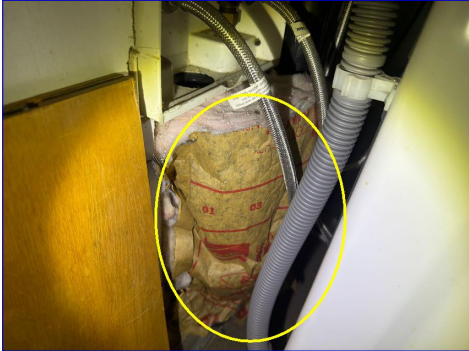
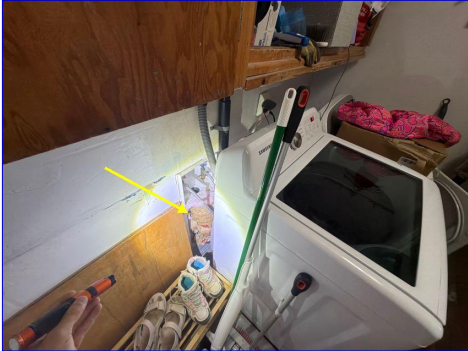
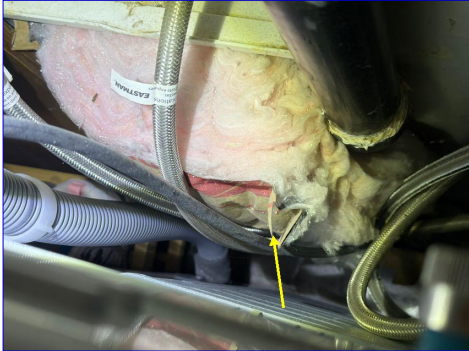
| General Information | | |
|---|---|---|
| Page 7 Item: 9 | Limitations / Observations | <ul style="list-style-type: none"><li>• The paper facing of the insulation is exposed in the laundry area. Exposed kraft-faced insulation is combustible and should not be left uncovered in occupied spaces. Recommend covering the insulation with an approved thermal barrier, such as drywall, to reduce the potential fire hazard.</li></ul> |
| Exposed paper side of insulation | Exposed paper side of insulation | Exposed paper side of insulation |

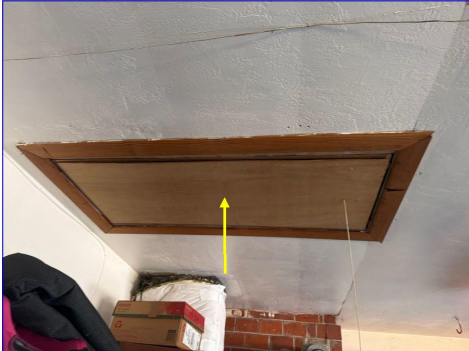
| General Information | | |
|---|---|---|
| Page 13 Item: 4 | Fire Separation Wall | <ul style="list-style-type: none"><li>• Attic access panel/hatch cover is plywood which is flammable. Recommend replacing access panel with a fire rated panel for safety.</li><li>• Holes observed, suggest sealing to restore fire rating.</li></ul> |
| Attic access is flammable | Hole in fire separation wall | Hole in fire separation wall |

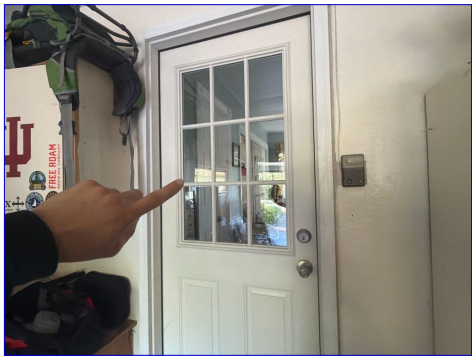
| General Information | | |
|---|---|---|
| Page 14 Item: 5 | Occupant/Fire Door | <ul style="list-style-type: none"><li>• Fire rating is compromised due to a window. This is a safety concern. Recommend replacing door with a fire rated door.</li></ul> |

Window present at occupant door

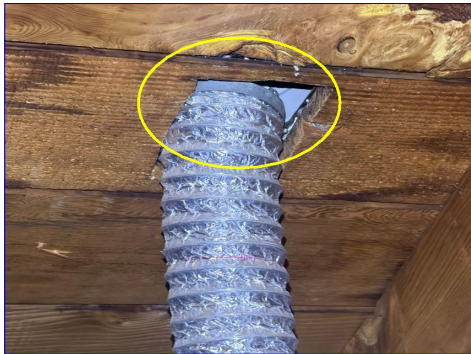
| Page 17 Item: 6 | Attic General Comments/Observations | <ul style="list-style-type: none"><li>The hall bathroom vent fan is improperly vented near or at a hooded roof vent. Bathroom exhaust vents should be sealed to the exterior and vented through hooded vents manufactured for this purpose. Correction advised.</li></ul> |

Bathroom exhaust

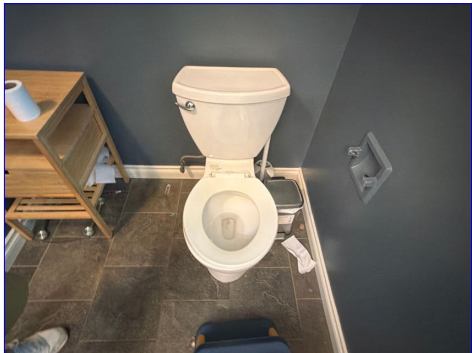
| Page 38 Item: 16 | Toilet | <ul style="list-style-type: none"><li>The toilet bowl is loose at floor anchor bolts. The wax ring inside the unit must have a snug, secure fit in order to keep from leaking. Properly resealing and re-securing this unit is suggested to prevent water leakage and damage to the sub-floor area. This type of damage is not always visible or accessible to the inspector at time of inspection. Thermal imaging used to help determine any damage and none was noted.</li></ul> |

Loose toilet

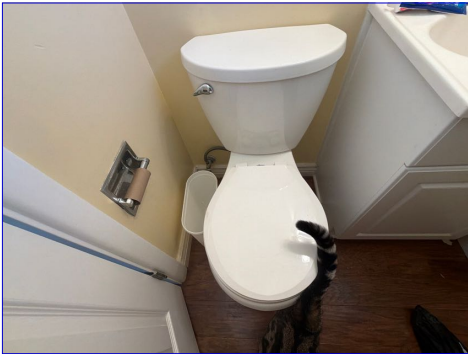
| Half Bathroom | | |
|---|---|---|
| Page 40 Item: 10 | Toilet | <ul style="list-style-type: none"><li>• The toilet bowl is loose at floor anchor bolts. The wax ring inside the unit must have a snug, secure fit in order to keep from leaking. Properly resealing and re-securing this unit is suggested to prevent water leakage and damage to the sub-floor area. This type of damage is not always visible or accessible to the inspector at time of inspection. Thermal imaging used to help determine any damage and none was noted.</li></ul> |
| <div></div> <div>Loose toilet</div> | | |

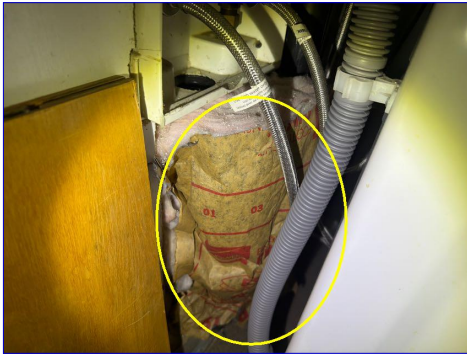
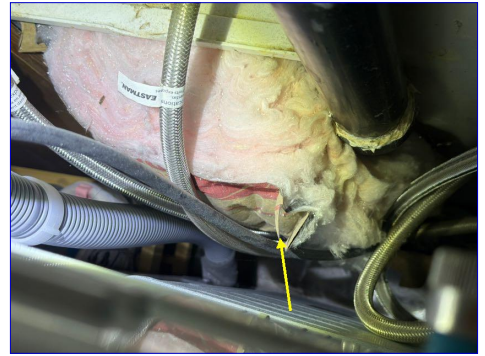
• **The paper facing of the insulation is exposed in the laundry area. Exposed kraft-faced insulation is combustible and should not be left uncovered in occupied spaces. Recommend covering the insulation with an approved thermal barrier, such as drywall, to reduce the potential fire hazard.**

Exposed paper side of insulation

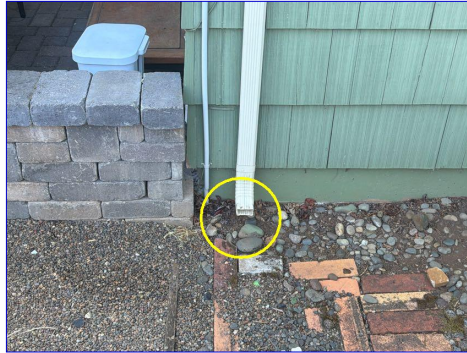
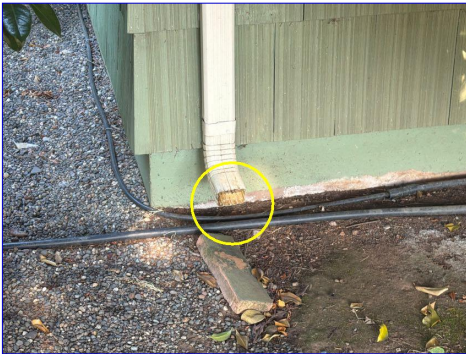
- Downspout(s) extension is too short and downspout(s) discharge water at foundation. Recommend installation of extension to ensure proper drainage away from foundation to prevent seepage.

Downspout discharges near foundation

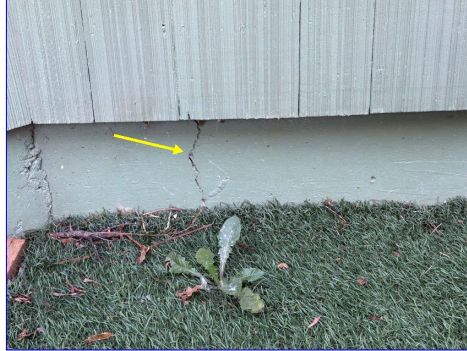
- Common cracks noted, which may leak at any time.

Foundation crack (north)

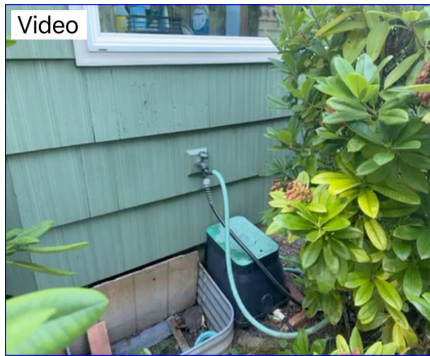
- The north exterior faucet was observed to be leaking at the time of inspection. Recommend having a licensed and qualified contractor make necessary corrections.

North exterior faucet leaks

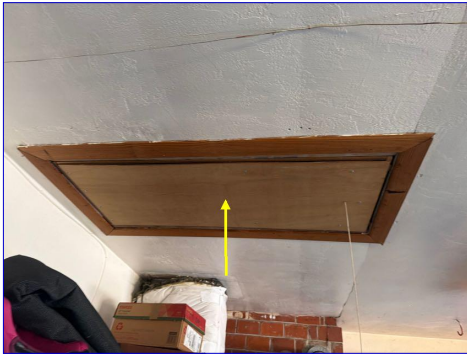
- Present
- Attic access panel/hatch cover is plywood which is flammable. Recommend replacing access panel with a fire rated panel for safety.
- Holes observed, suggest sealing to restore fire rating.

Attic access is flammable

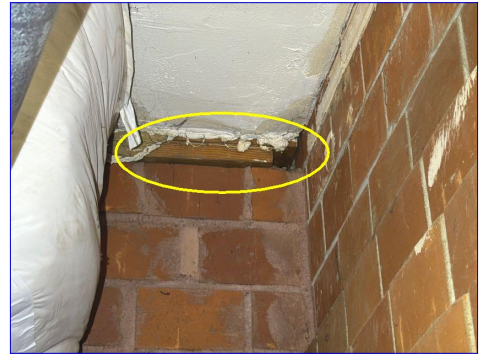
Hole in fire separation wall

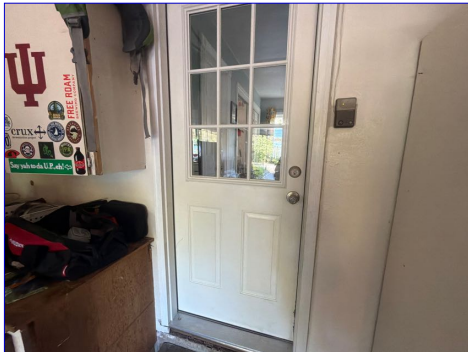
- Door does not close automatically as self closer is disconnected or not present. This is to act as a fire stop, keep exhaust and storage fumes out of the interior home. Recommend reconnecting/installing self closer for safety.
- Fire rating is compromised due to a window. This is a safety concern. Recommend replacing door with a fire rated door.

Door does not automatically close

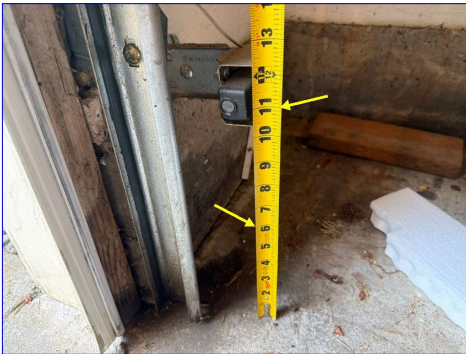
- Auto reverse photo eye sensors should be no more than 6" above floor. Suggest lowering these sensors for safety
- "Safety (force activated) reversal system" did not respond to test. Excessive force will damage the top door section. This garage door opener appears to be equipped with a safety reversal system which did not operate correctly when tested. Safety reversal system should be adjusted and/or repaired to increase sensitivity as well as enhance safety, especially should there be children in area.

Photo eye sensor is too high

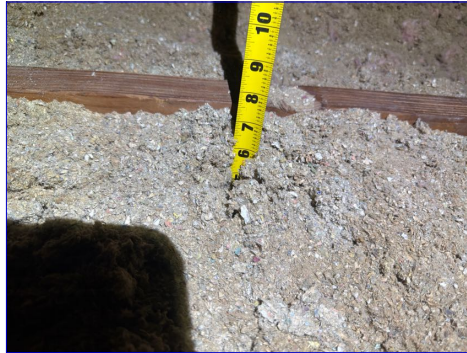
**Insulation Thickness:** Averages ~4-6 inches in depth. Recommend installing additional insulation.

Insulation depth

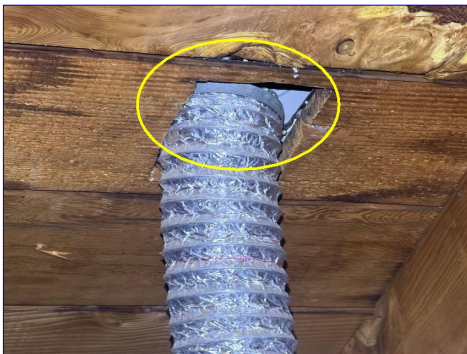
- Although it may be permissible by local code, InterNACHI Standard of Practice states all exhaust vents should exhaust to the exterior to prevent damage and/or deterioration from moisture and/or condensation.
- The hall bathroom vent fan is improperly vented near or at a hooded roof vent. Bathroom exhaust vents should be sealed to the exterior and vented through hooded vents manufactured for this purpose. Correction advised.

Bathroom exhaust

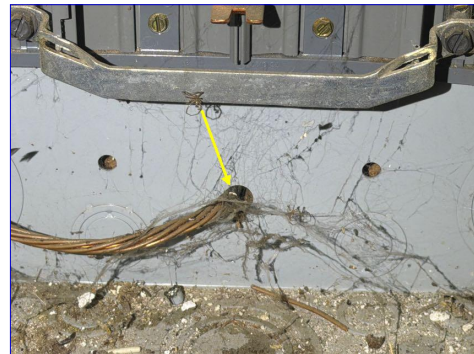
- Combination Service Entrance Device (CSED) with Main Breaker
- The main service disconnect is approximately 200 amps, 240 volts.
- Service entrance cables are aluminum.
- Branch circuit wiring is a mix of copper and aluminum wiring. Buyer is advised that periodic maintenance of aluminum wiring is recommended to prevent "creeping" at electrical connections.
- **AFC** protection in bedroom branch circuits not present in this house. Although **AFC** protection may not have been required when this house was built, recommend consider upgrading all living space circuits by a licensed electrical contractor for safety.
- Strain relief or bushing is missing. Recommend having a licensed electrical contractor further evaluate electrical system and install a strain relief or bushing for safety.
- No thermal anomalies were observed.

Missing bushing

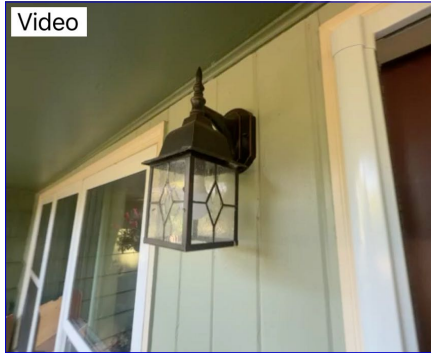
Loose exterior light fixture (front)

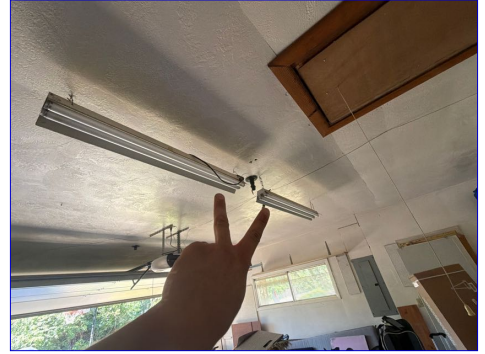
- Light(s)/light fixture(s) located in areas noted is/are inoperable. Unable to determine if bulb(s) burnt out or if faulty fixture(s). Suggest client verify proper operation prior to closing.
- Exterior light fixtures are loose in areas noted and should be secured.
- The north exterior receptacle is a **GFCI** receptacle; however, testing indicated an open ground condition. While a **GFCI** can still provide shock protection without an equipment ground if it is wired correctly, the lack of a grounding path may reduce protection for certain equipment and should be properly identified.

Inoperable/not plugged in light fixtures (garage)

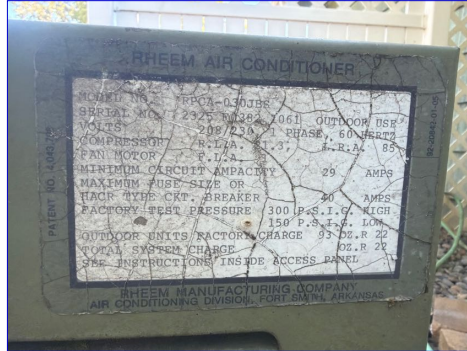
• The lifespan of an air conditioner is about 15 to 20 years. Based on the age of this unit plan for future replacement.

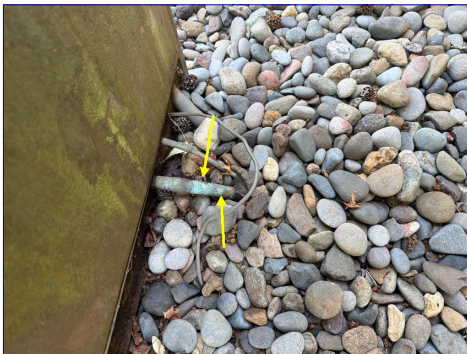
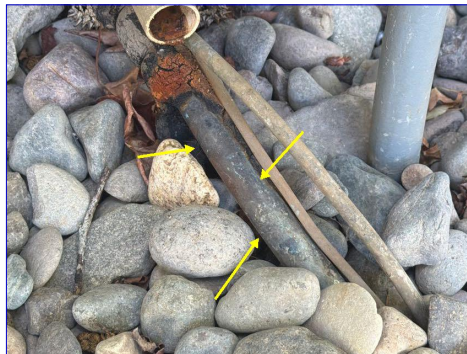
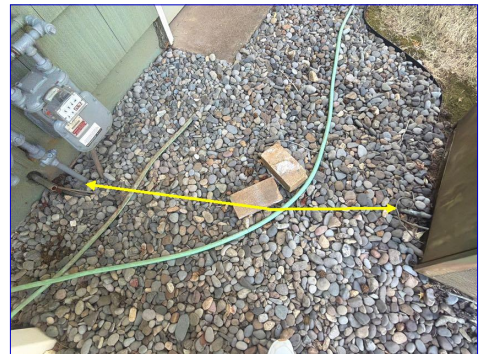
• Missing insulation on suction line at **A/C** unit.

Missing insulation

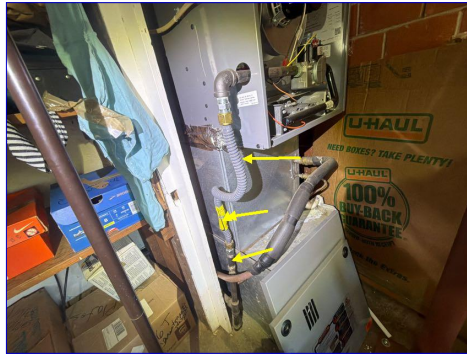
• No sediment trap or drip leg present. Suggest having a licensed plumbing contractor install a sediment trap or drip leg downstream of the gas shutoff valve, as close to the appliance as possible to help prevent moisture and/or debris from effecting combustion and burner operation.

Missing sediment trap

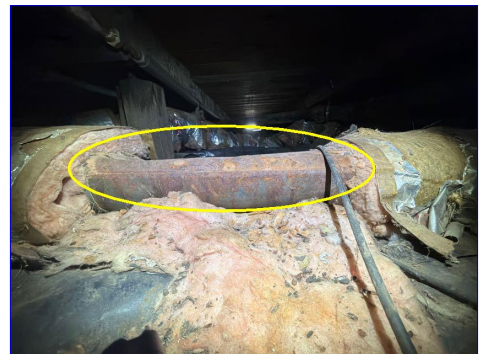
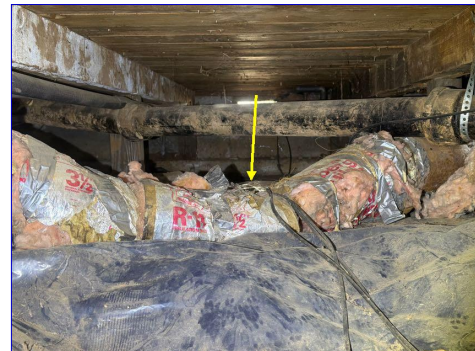
• Some of the ductwork in the crawlspace appears to be damaged, corroded/rusted, and partially disconnected at some joints. This may allow conditioned air to escape and could impact the efficiency and performance of the HVAC system. Recommend having the ductwork evaluated and repaired as needed by a qualified HVAC contractor.

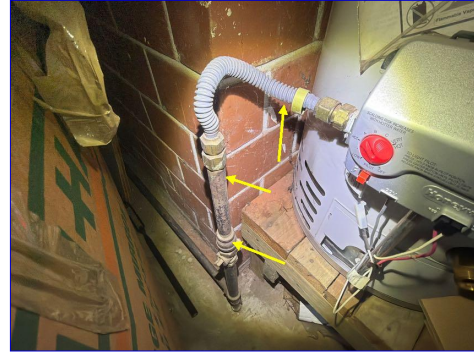
- No drip leg or sediment trap present. Recommend having a licensed plumbing contractor install a drip leg or sediment trap downstream of the gas shutoff valve, as close to the appliance as possible to help prevent moisture and/or debris from effecting combustion and burner operation.

Missing sediment trap

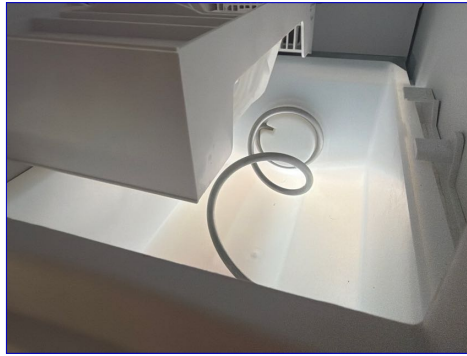
- Ice maker not on or not functioning. Recommend confirming proper operation prior to closing.

Icemaker

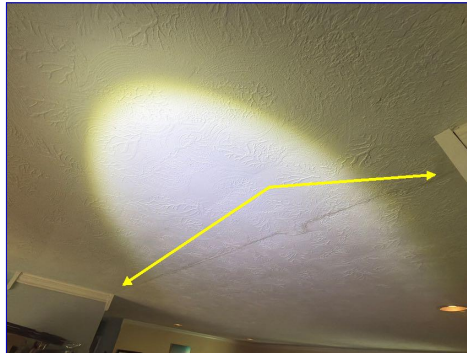
- Common cracks noted. Recommend sealing all cracks and painting in order to monitor for any future movement.

Ceiling crack (living room)

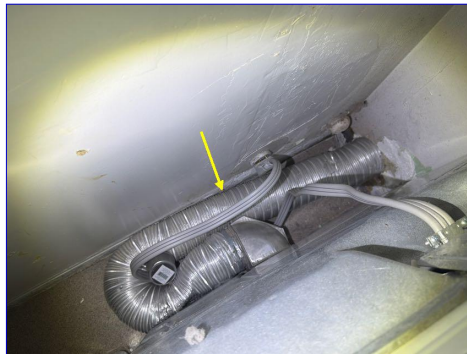
- Although once considered acceptable, flexible, ribbed vents are a potential fire hazard and should be replaced.

Flexible foil

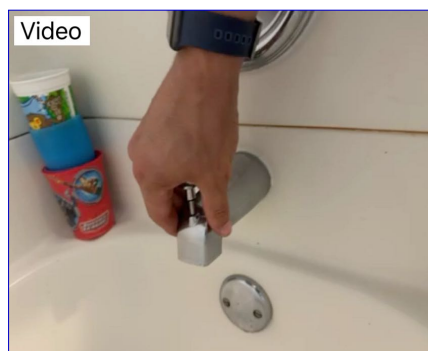
- Serviceable
- Faucet is loose in the wall.

Loose tub faucet

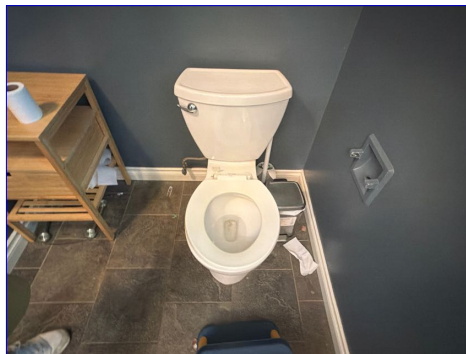
• The toilet bowl is loose at floor anchor bolts. The wax ring inside the unit must have a snug, secure fit in order to keep from leaking. Properly resealing and re-securing this unit is suggested to prevent water leakage and damage to the sub-floor area. This type of damage is not always visible or accessible to the inspector at time of inspection. Thermal imaging used to help determine any damage and none was noted.

Loose toilet

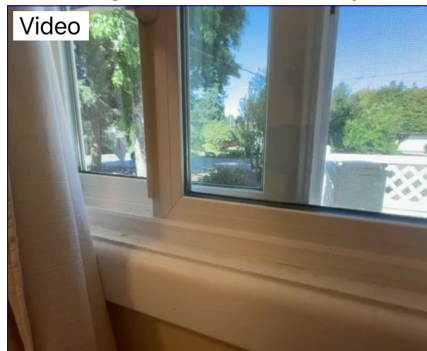
- Window is loose in its frame. Opening and locking functions are still operable.

Loose window

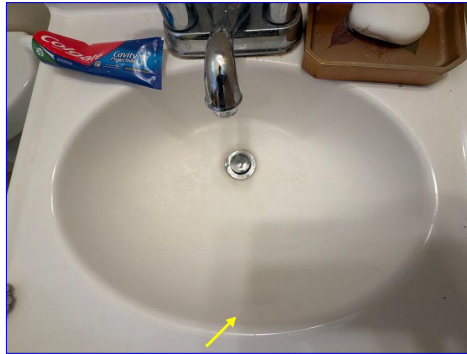
- Older style metal traps noted. Buyer is cautioned that these can leak at any time due to rust/corrosion.
- Slow draining
- The sink is equipped with a stopper but does not have an overflow drain. If the stopper is left closed while the water is running, the sink can overflow and cause water damage.
- The sink exhibited low water flow at the time of the inspection. This may be due to a clogged aerator, mineral buildup, a partially closed shutoff valve, or another plumbing issue.

Missing overflow drain

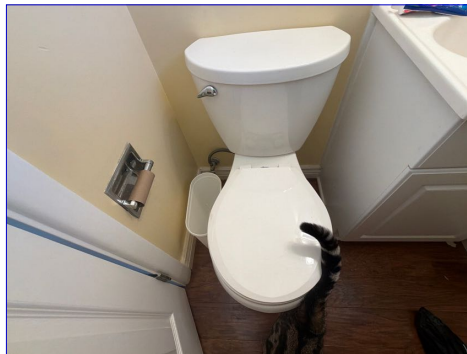
- The toilet bowl is loose at floor anchor bolts. The wax ring inside the unit must have a snug, secure fit in order to keep from leaking. Properly resealing and re-securing this unit is suggested to prevent water leakage and damage to the sub-floor area. This type of damage is not always visible or accessible to the inspector at time of inspection. Thermal imaging used to help determine any damage and none was noted.

Loose toilet
