# ***Cornerstone Inspection***

## **Property Inspection Report**

***1400 Blackberry Avenue, Arroyo Grande, CA 93420***  
***Inspection prepared for: Bill Ready and Debra Strawhun***  
***Real Estate Agent: Shannon Bowdey - Keller Williams***

***Date of Inspection: 7/24/2026 Time: 9:00 AM***

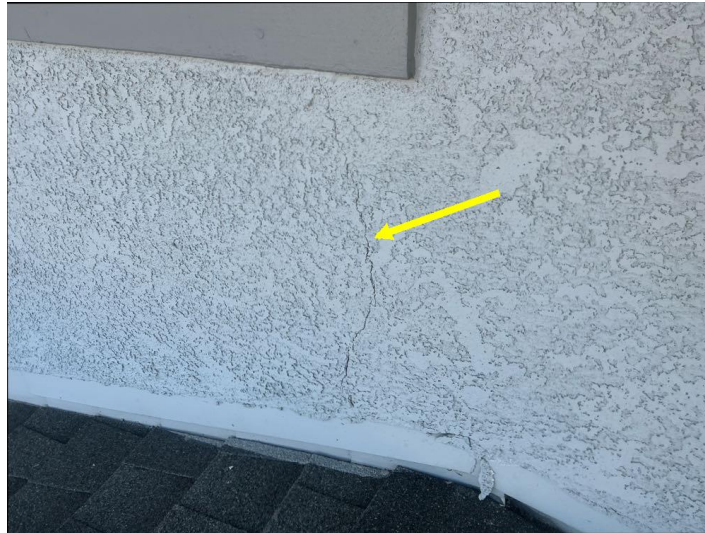
3.3. There are "expected" cracks in the stucco around some windows and doors that result from movement, and are quite common. Stress fractures can reappear after they have been repaired, and particularly if they have not been repaired correctly.

There are "expected" cracks in the stucco around some windows and doors that result from movement, and are quite common. Stress fractures can reappear after they have been repaired, and particularly if they have not been repaired correctly.

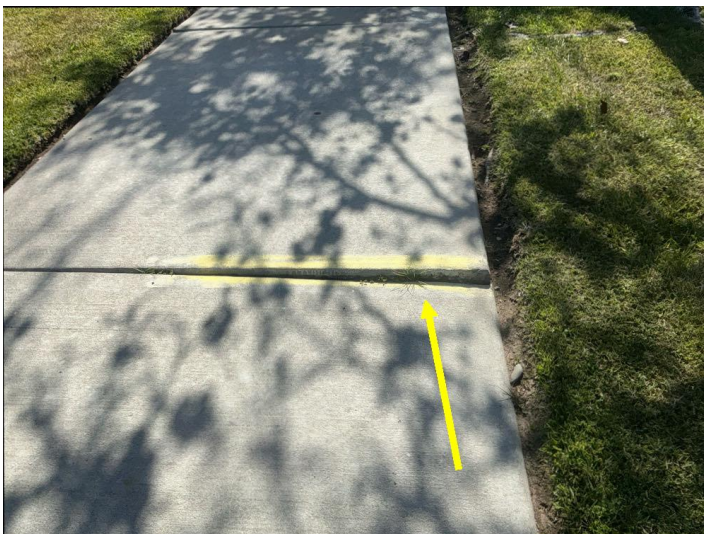
There is one or more offsets in the sidewalks that could prove to be trip-hazards.

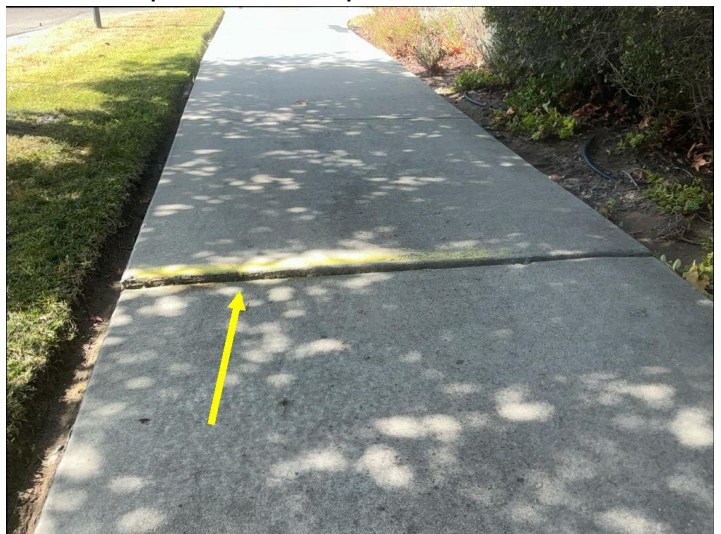
There is one or more offsets in the sidewalks that could prove to be trip-hazards.

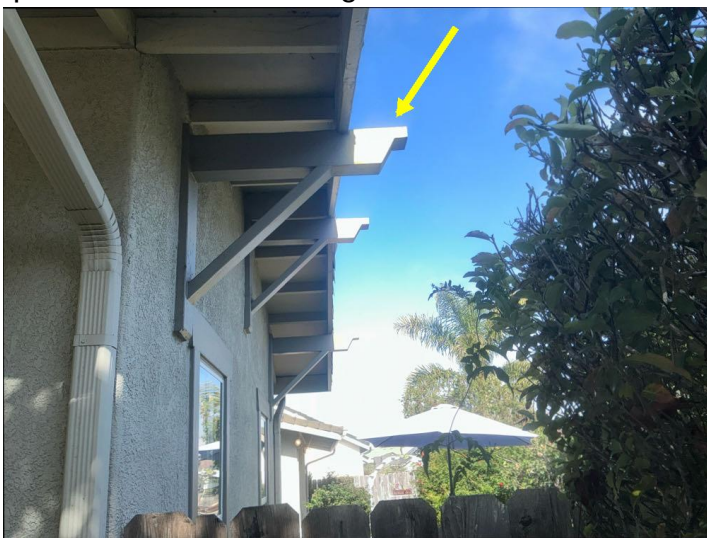
As a recommended upgrade, we recommend that the exposed wood that extends beyond the eave area, such as beams, columns or other wood members should be sealed and flashed to prevent moisture damage.

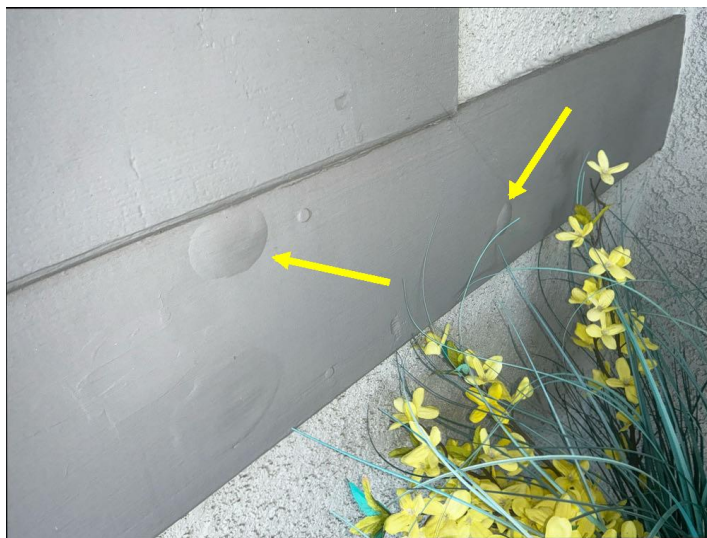
Sections of the fascia, trim and eave need maintenance type service such sealing and painting.

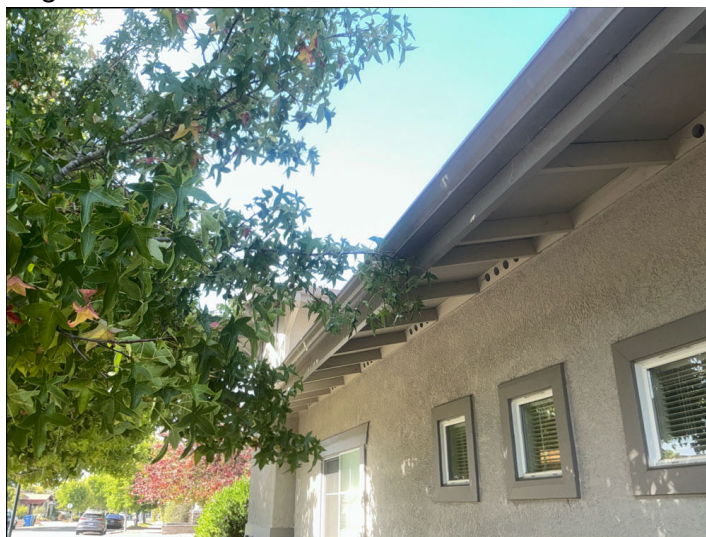
10.1. There are tree limbs overgrowing the residence that should be trimmed or monitored, to insure that they do not impact of damage the roof or its components.

There are tree limbs overgrowing the residence that should be trimmed or monitored, to insure that they do not impact of damage the roof or its components.

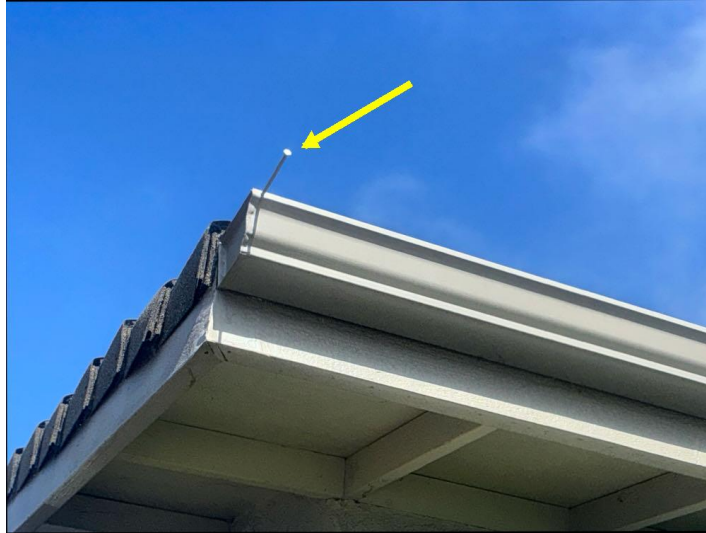
1.2. The gutters need to be serviced as well as being cleaned such as securing them or sealing separated seams.

The gutters need to be serviced as well as being cleaned such as securing them or sealing separated seams.

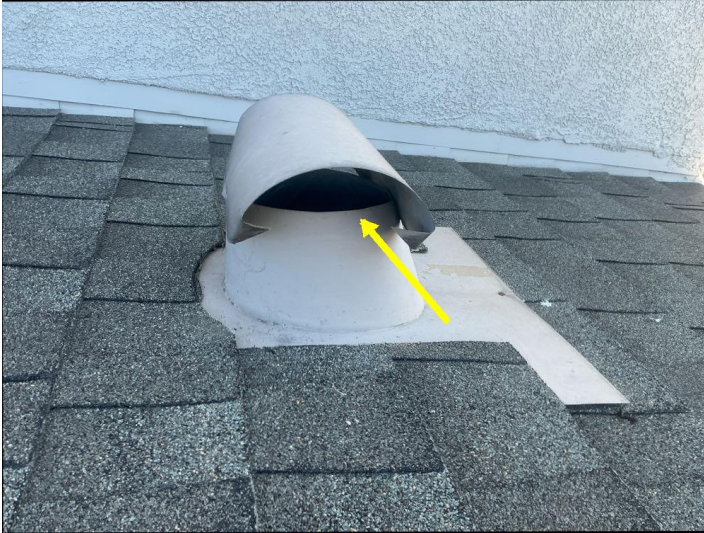
2.5. The roof tee top terminations do not include screens as required by current standards. While this wasn't required at the time of construction, we recommend screens be added to these terminations.

The roof tee top terminations do not include screens as required by current standards. While this wasn't required at the time of construction, we recommend screens be added to these terminations.

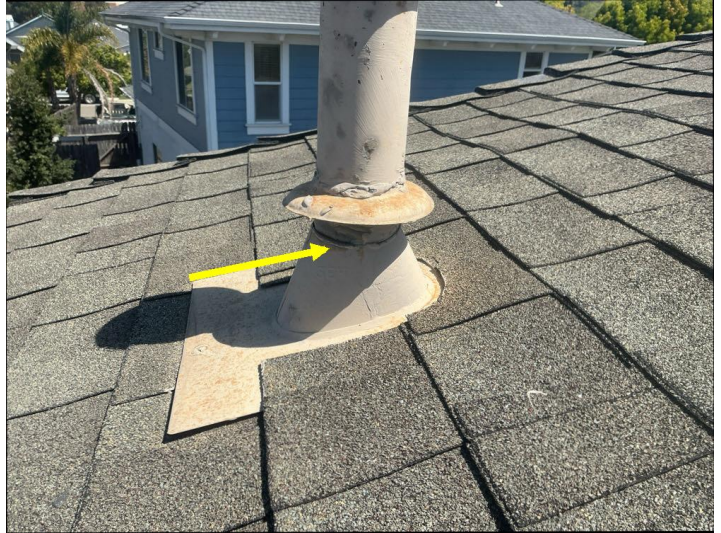
2.6. Some roof flashings need to be sealed or serviced. They are comprised of metal **valley**s, vents and other roof penetrations, which are the most common point of leaks. This is particularly true of the flashing on a layered roof, which are covered by the roofing material and which are even more susceptible to leaks. We recommend The flasings be evaluated further by a qualified licensed roofer and serviced as required.

Some roof flashings need to be sealed or serviced. They are comprised of metal **valleys**, vents and other roof penetrations, which are the most common point of leaks. This is particularly true of the flashing on a layered roof, which are covered by the roofing material and which are even more susceptible to leaks. We recommend The flasings be evaluated further by a qualified licensed roofer and serviced as required.

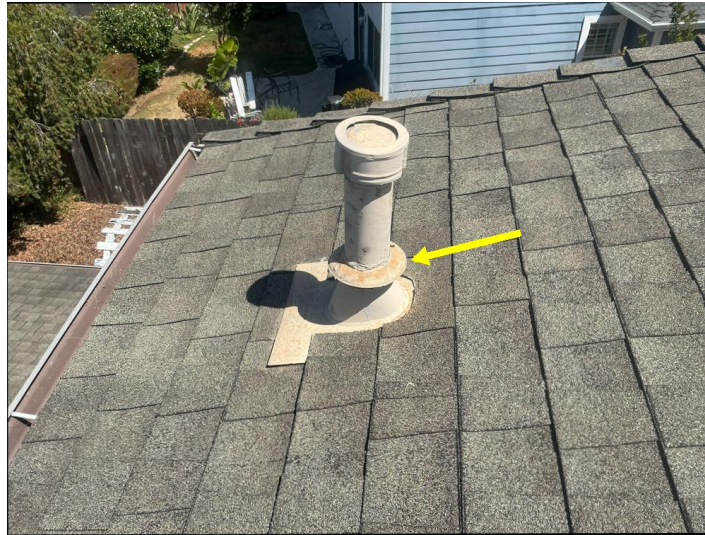
2.7. A rain-collar is improperly installed and should be serviced.

A rain-collar is improperly installed and should be serviced.

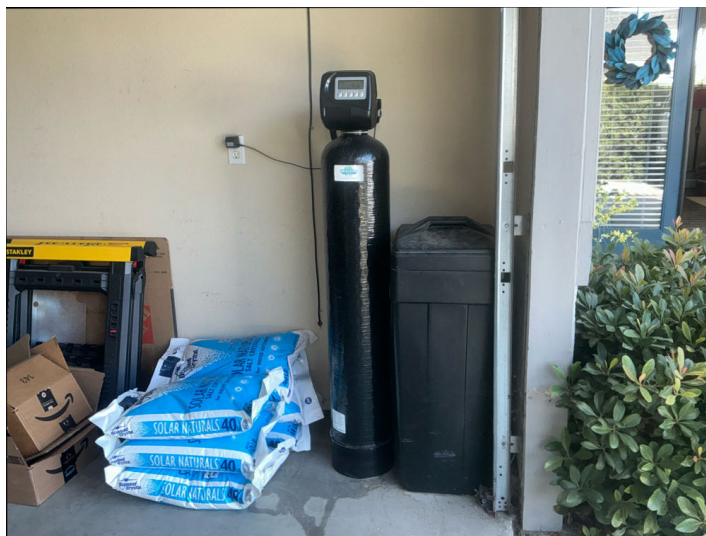
A water softener is present that we do not have the expertise to evaluate except for visible leaks. We recommend you ask the sellers if the unit was professionally installed and its service history.

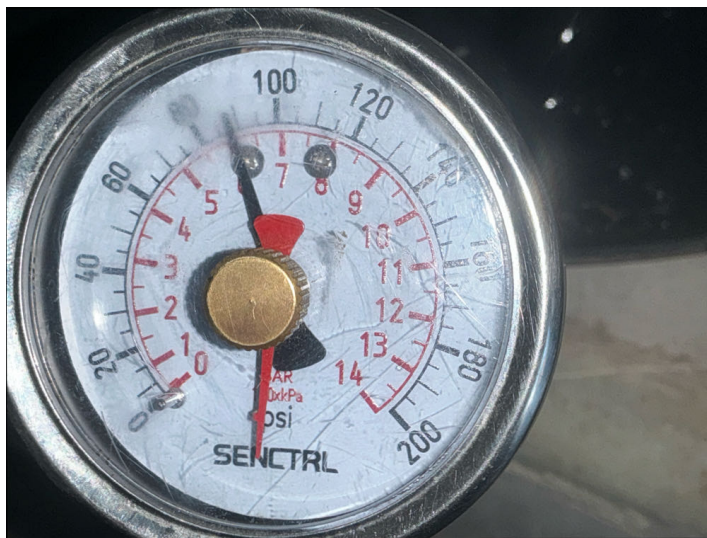
| Page 15 Item: 2 | Water Supply Comments | 2.3. The pressure inside the residence is above 80 PSI and will stress components of the system. A licensed plumber should reduce the pressure at the regulator to sixty pounds per square inch, which is optimum. However, the regulator may have failed and would need to be replaced. |

2.3. The pressure inside the residence is above 80 PSI and will stress components of the system. A licensed plumber should reduce the pressure at the regulator to sixty pounds per square inch, which is optimum. However, the regulator may have failed and would need to be replaced.

The pressure inside the residence is above 80 PSI and will stress components of the system. A licensed plumber should reduce the pressure at the regulator to sixty pounds per square inch, which is optimum. However, the regulator may have failed and would need to be replaced.

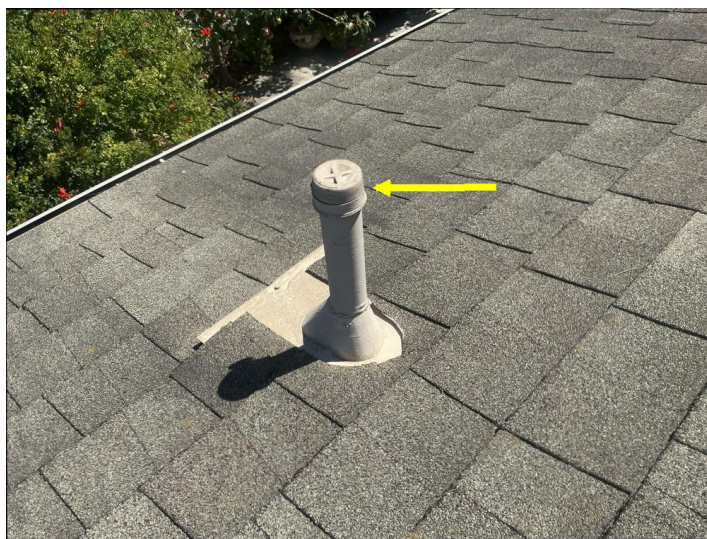
6.5. The plumbing vent over the laundry room has been capped. We recommend a qualified plumbing contractor evaluate this and service or correct as needed.

The plumbing vent over the laundry room has been capped. We recommend a qualified plumbing contractor evaluate this and service or correct as needed.

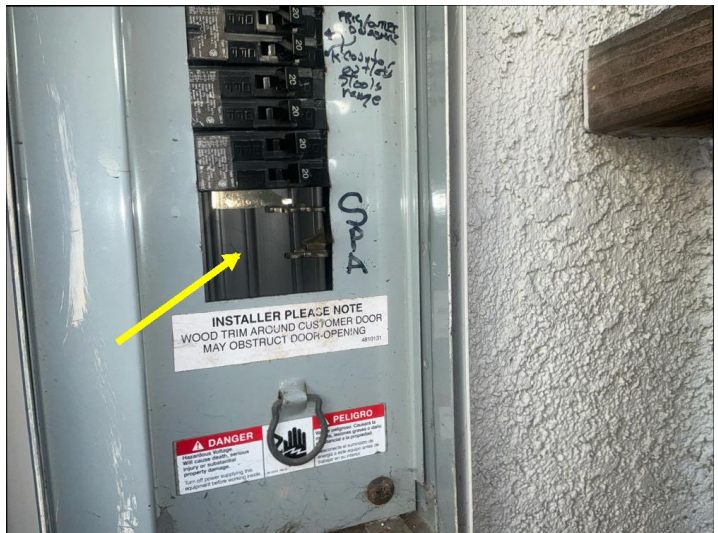
There are voids or open knockouts in the interior cover of the main electrical panel that should be covered.

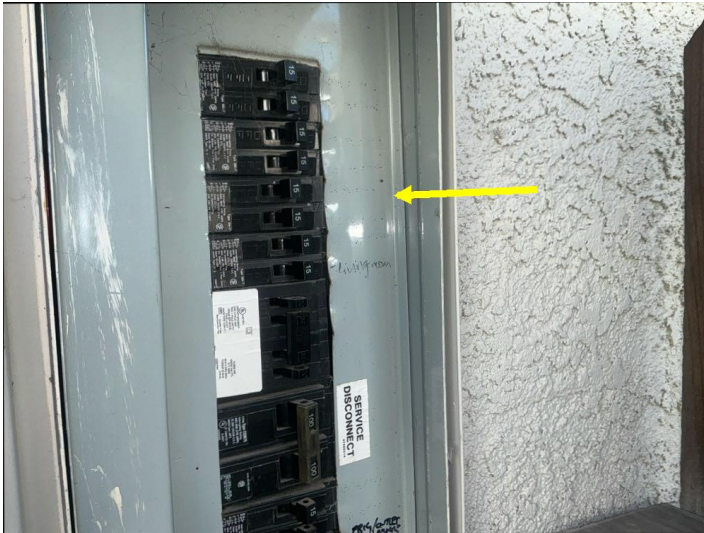
1.9. Various circuits are not labeled, which is recommended.

Various circuits are not labeled, which is recommended.

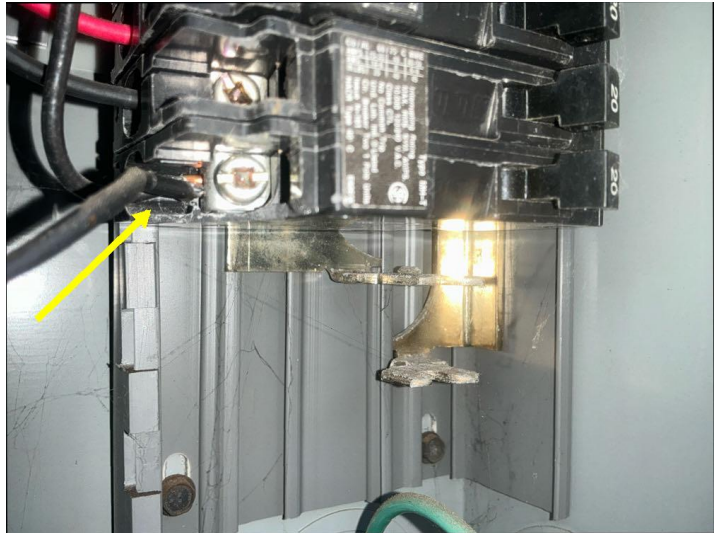
1.10. A 20 amp breaker is serving two circuits. This condition should be evaluated by an electrician.

A 20 amp breaker is serving two circuits. This condition should be evaluated by an electrician.

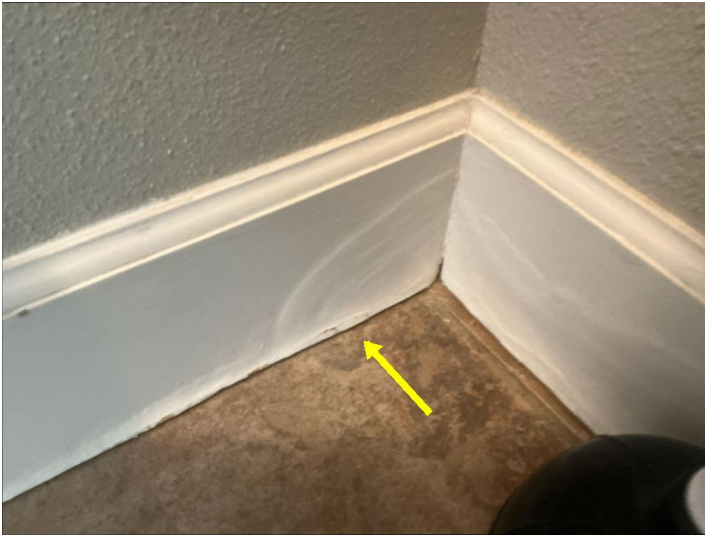
- 1.14. The tub is functional.
- 1.15. The baseboards adjacent the toilet and shower are moisture damaged. We recommend they be removed and further evaluated to insure the moisture damage does not extend deeper into the wall. The area is currently dry.

The baseboards adjacent the toilet and shower are moisture damaged. We recommend they be removed and further evaluated to insure the moisture damage does not extend deeper into the wall. The area is currently dry.

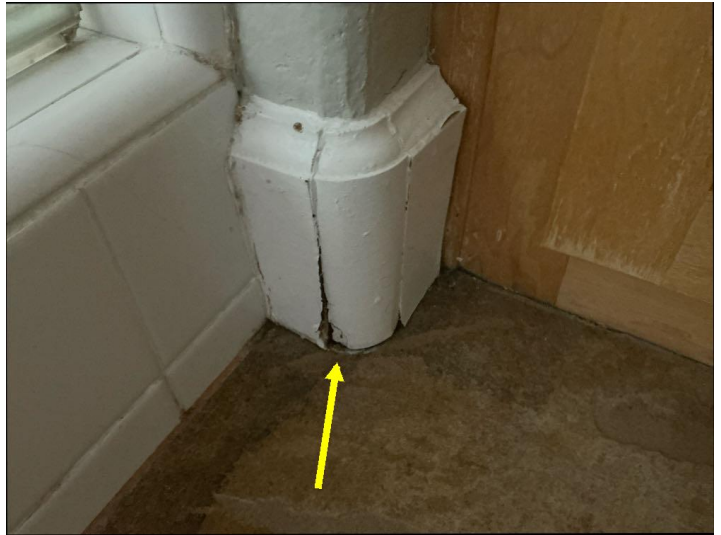
The baseboards adjacent the toilet and shower are moisture damaged. We recommend they be removed and further evaluated to insure the moisture damage does not extend deeper into the wall. The area is currently dry.

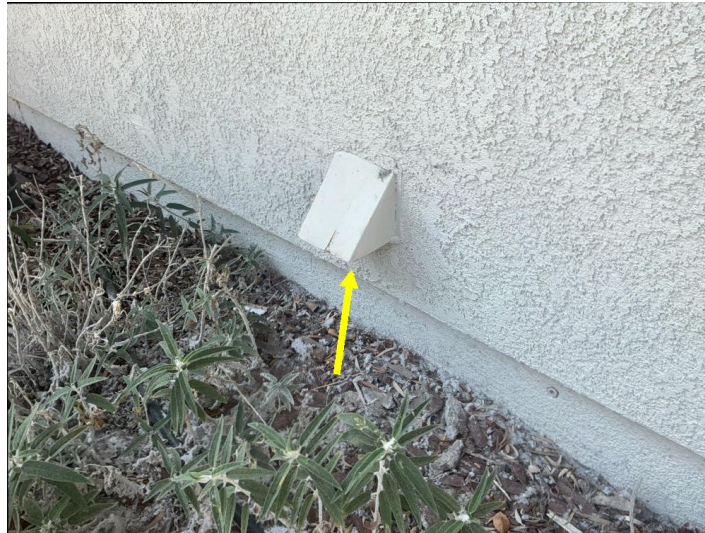
The back-draft on the exterior dryer vent cover is missing, incomplete or non functional and should be repaired or replaced.

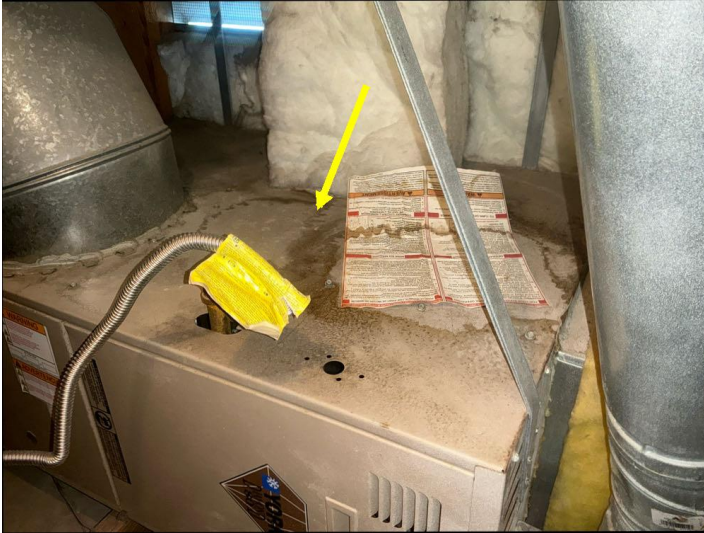
There are water stains on the furnace that implies that a leak has occurred. Since it was not raining during our inspection, we were unable to determine if the leak is currently leaking, or, it is an old leak that has been repaired. You should ask the sellers for information regarding this issue.

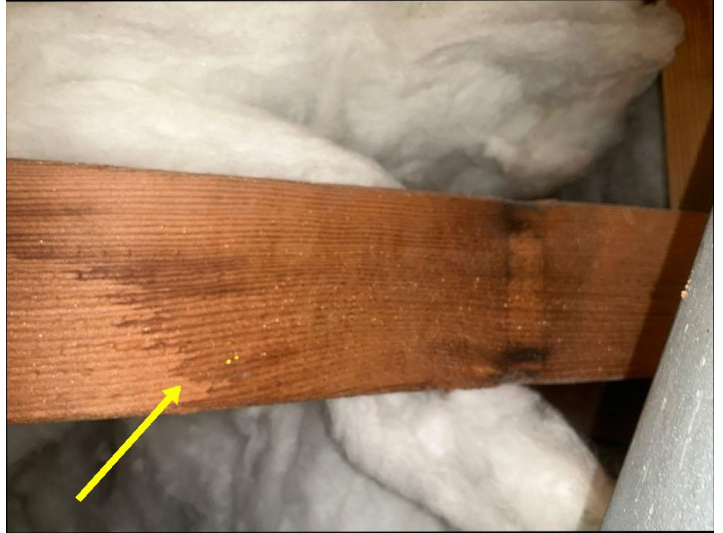
There are water stains on the ceiling that implies that a leak has occurred. Since it was not raining during our inspection, we were unable to determine if the leak is currently leaking, or, it is an old leak that has been repaired. You should ask the sellers for information regarding this issue.

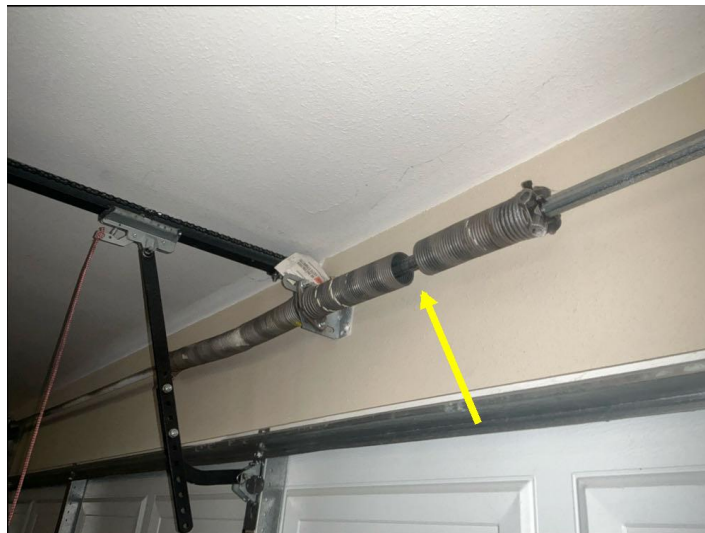
| Page 33 Item: 1 | Double-Car Garage | <p>1.8. The door spring is broken and will not support nether weight of the door. It should be replaced. We recommend not using the door until replaced.</p> <p>1.9. The garage door opener and infa-red sensors are functional, but it does not auto-reverse with an obstruction. We recommend the opener be evaluated by a specialist and serviced or replaced as required. Often the solution is a simple adjustment.</p> |

- 1.7. The lights are functional.
- 1.8. The door spring is broken and will not support nether weight of the door. It should be replaced. We recommend not using the door until replaced.

The door spring is broken and will not support nether weight of the door. It should be replaced. We recommend not using the door until replaced.
