## Home Inspection Report

PROPERTY INSPECTED:  
296 Drum Bay Road  
Hague, VA 22469

Date of Inspection: 08/19/2026

Inspection No. 28188-12314

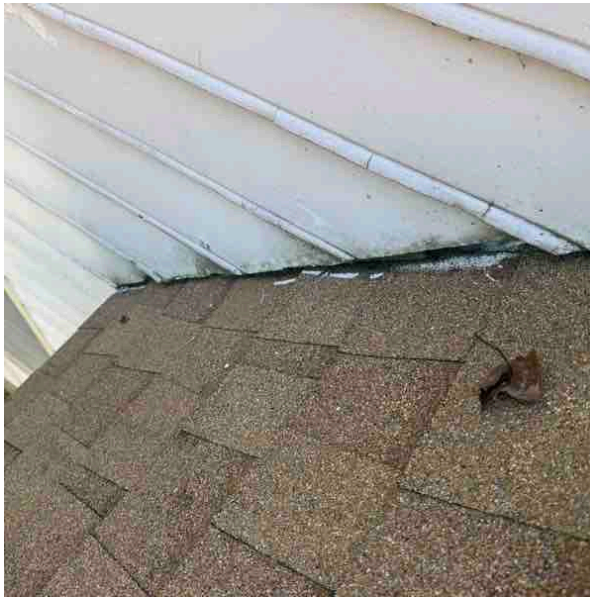
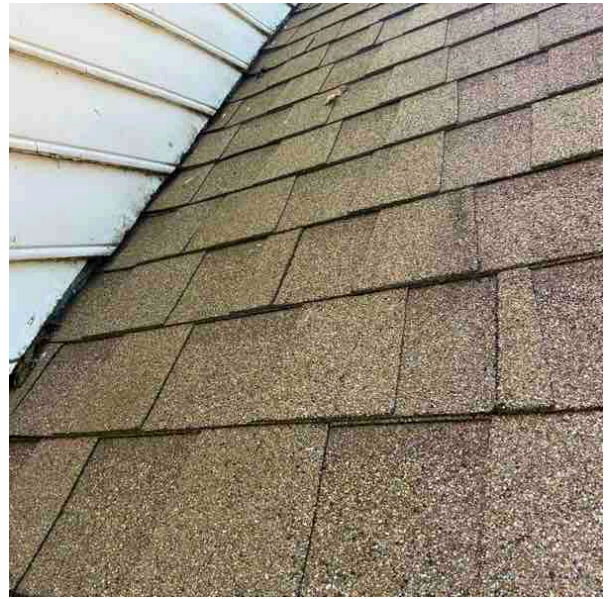
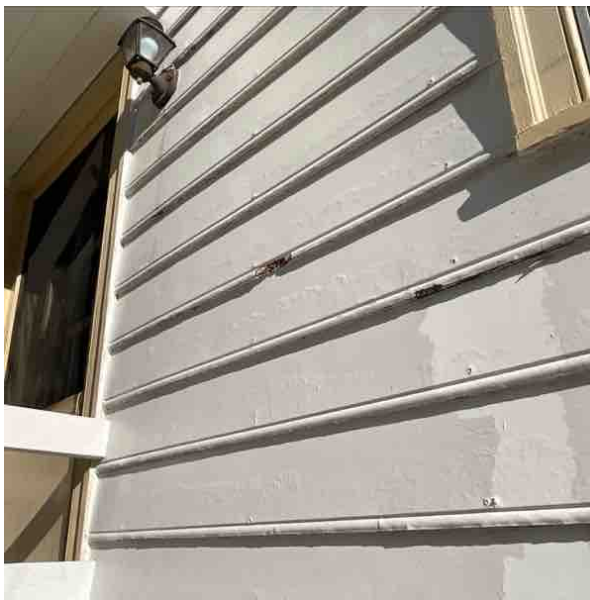
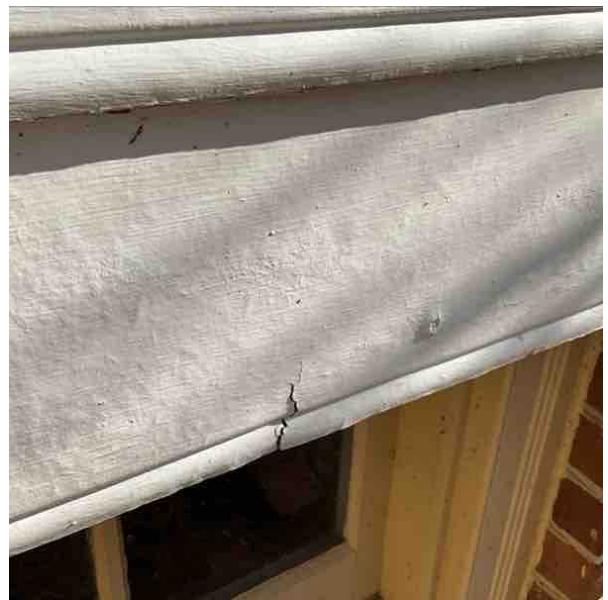
3.2.2 Visible damage noted

3.2.3 Hardboard siding material has been installed on the house exterior. Moisture damage is visible on the hardboard siding materials throughout the house exterior. Recommend having a qualified siding installer evaluate to determine extent of damage and course of action needed for replacement of damaged materials.

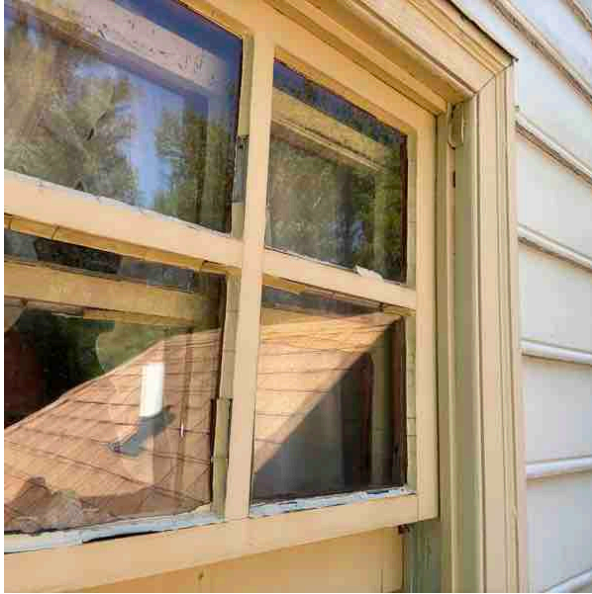
3.4.2 Wood framed windows and sashes are in need of and require regular paint and caulk maintenance. Recommend maintenance and repair as needed. Monitor periodically for signs of damage and repair as needed. Consider replacement as an upgrade to limit maintenance concerns and for improved efficiency.

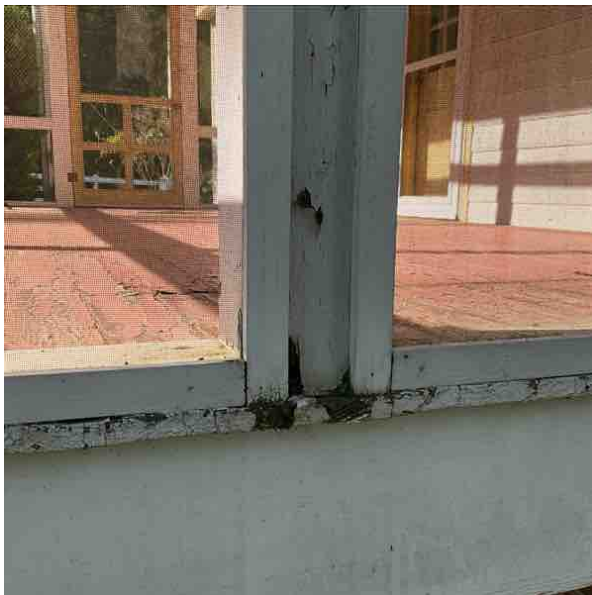
3.6.2 Screened Porch - moisture damage is visible on post at floor boards on the side of the screened porch. Recommend replacement of damaged materials. **(Exterior Rear)**

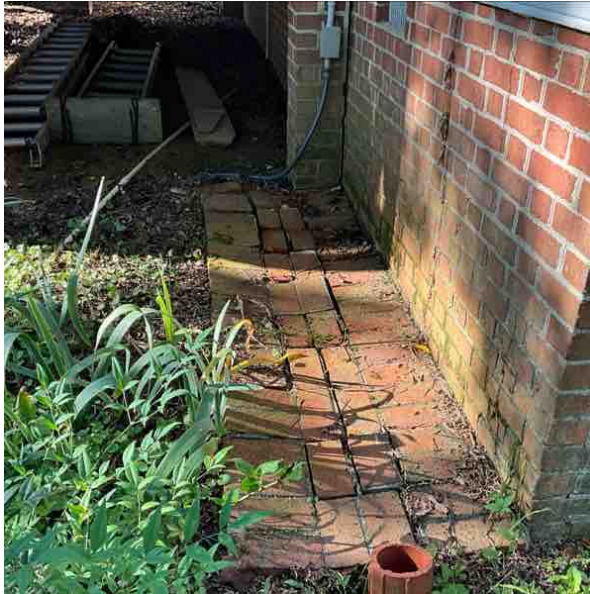
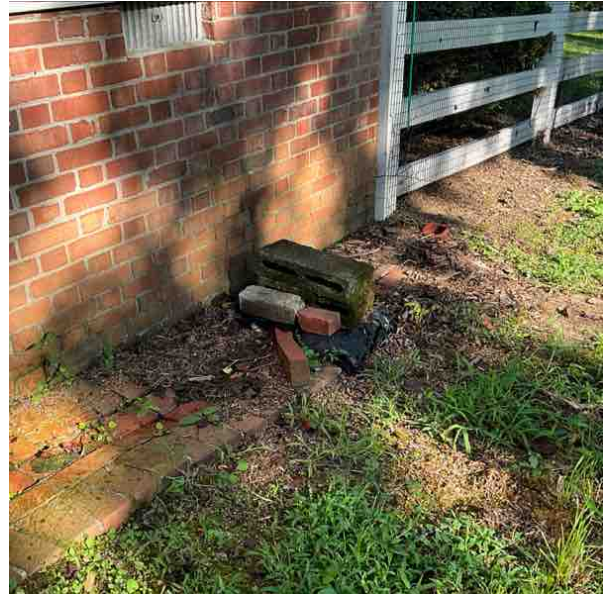
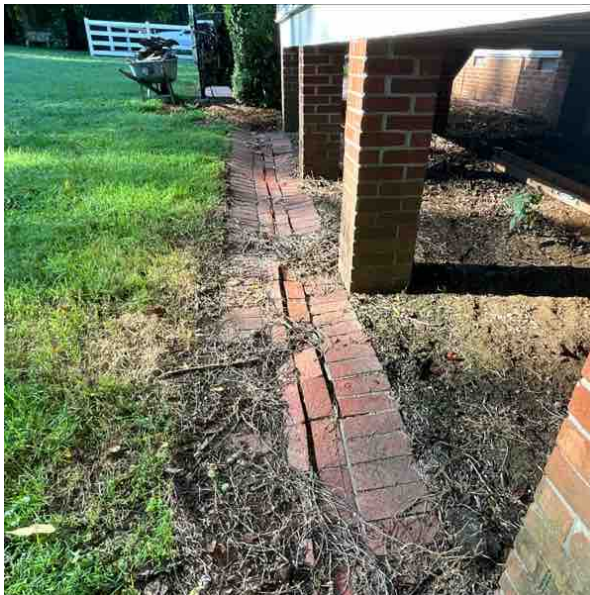
4.6.1 No gutters/downspouts are present on the house. Brick grade gutters are present at front and rear. Recommend installing gutters and downspouts as the best way to manage storm water from the roof and away from the structure.

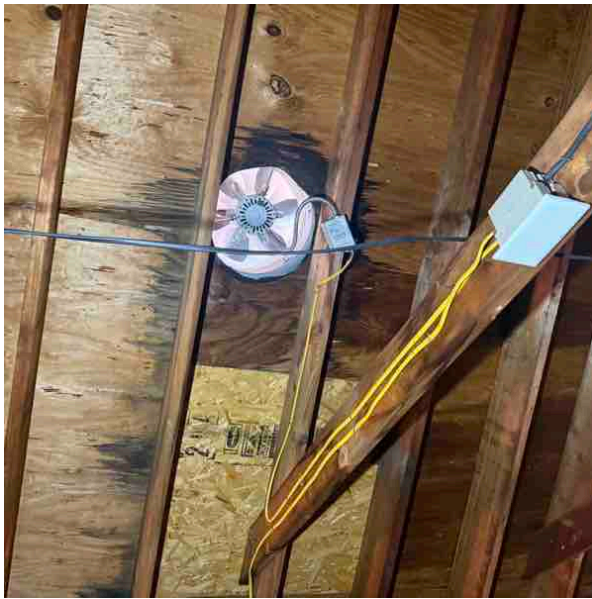
5.5.2 A powered vent fan is present in the attic. Unit appears to be inoperable, recommend repair/replacement.

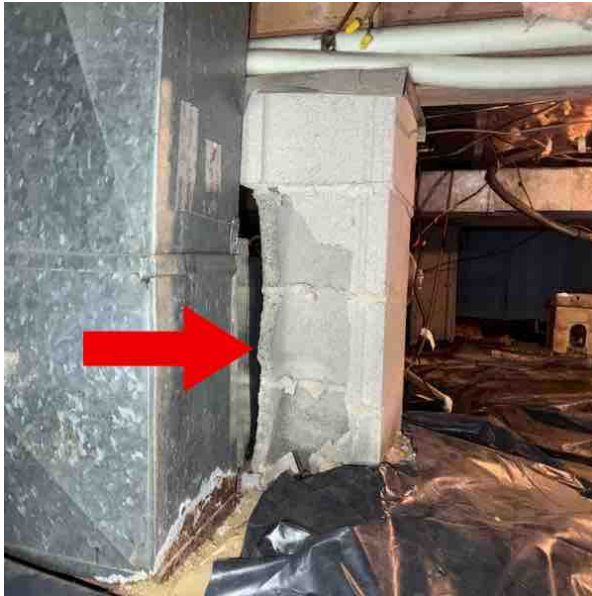
7.4.2 One masonry column has been modified to make room for ductwork in crawlspace. Recommend repair of the masonry column to provide proper support for beam. **(Main House Crawlspace)**

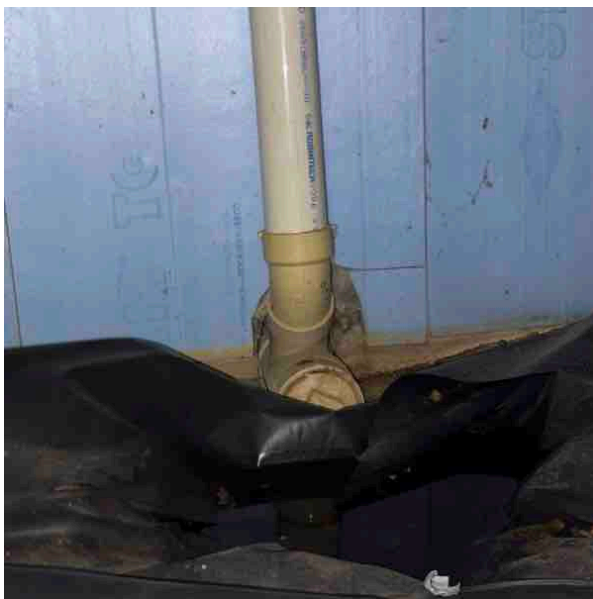
8.2.2 Standing water is present in the crawlspace below the guest bathroom. Water appears to be entering the front foundation wall (around sewer lines below exit at front wall). Limit water entry by improving surface drainage on the house exterior to ensure proper movement of storm water away from the structure. **(Main House Crawlspace)**

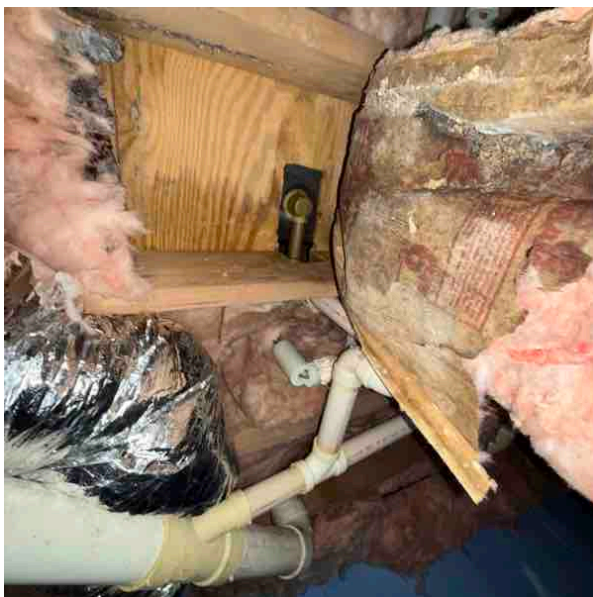
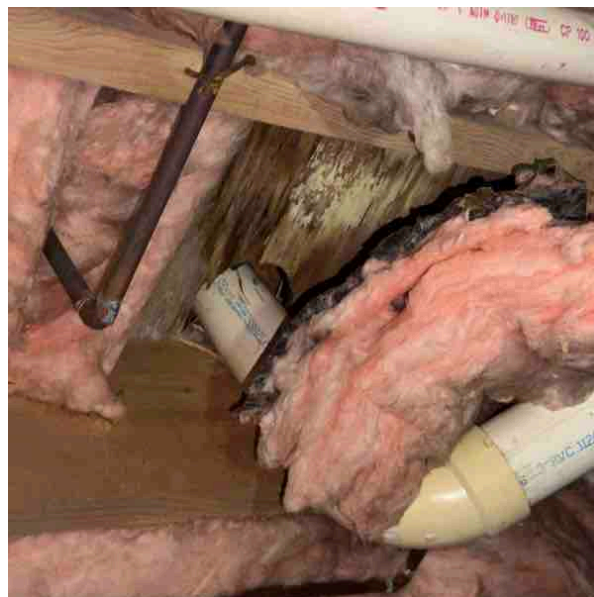
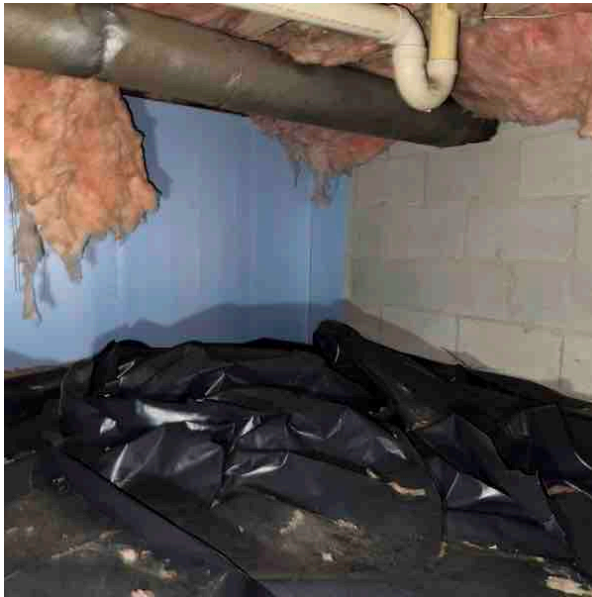
8.5.2 Insulation is loose/damaged and has fallen in several areas throughout the crawlspace interior. Recommend removal of all insulation that has fallen, secure insulation where loose and install new insulation in areas where missing. **(Main House Crawlspace)**

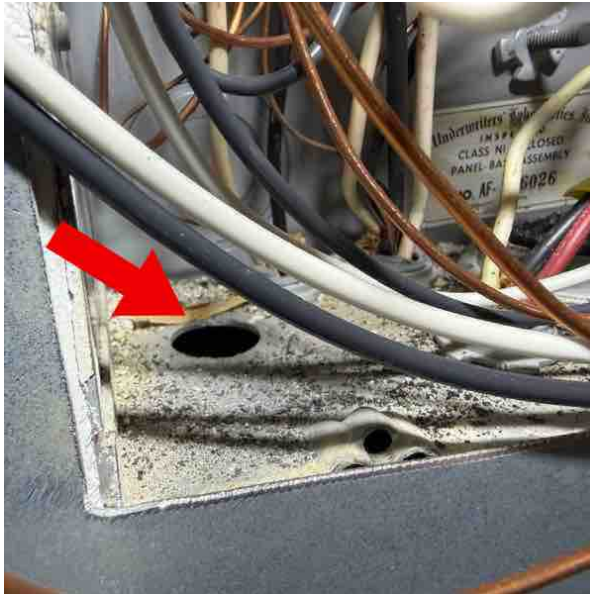
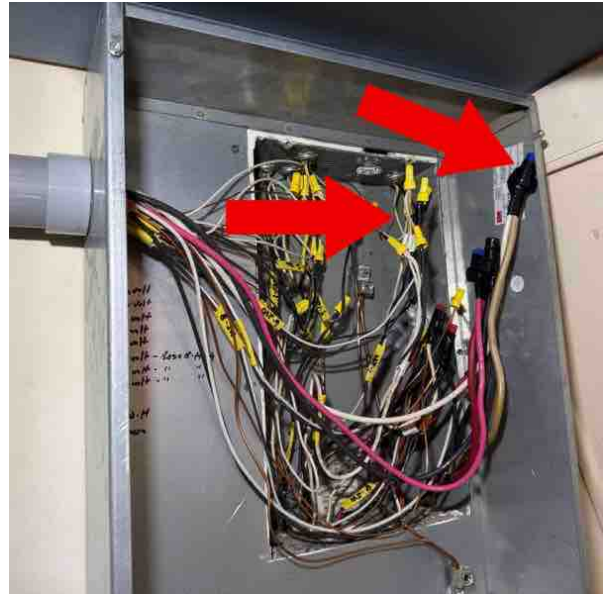
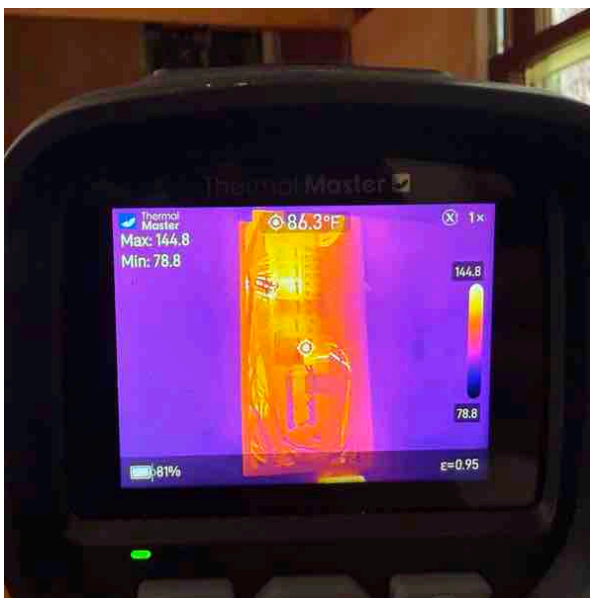
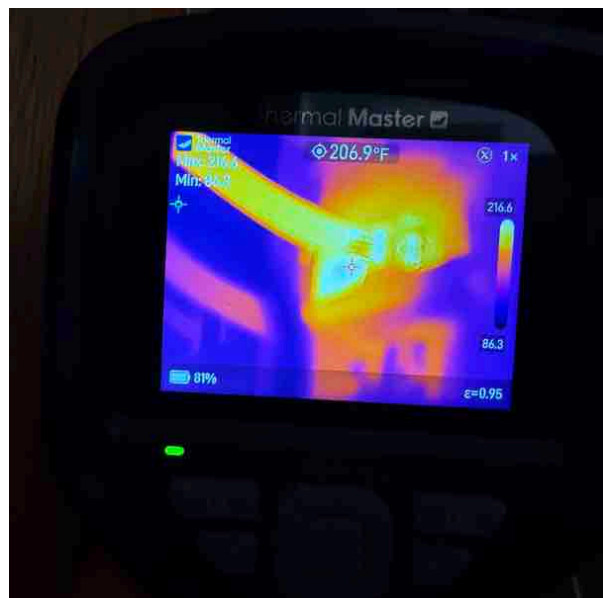
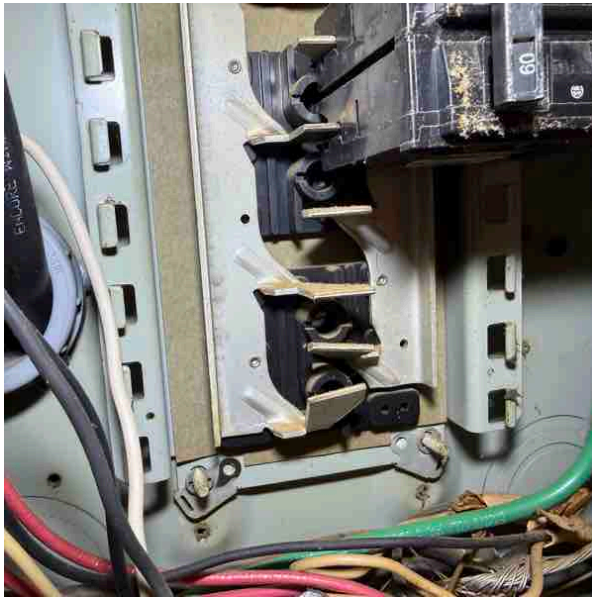
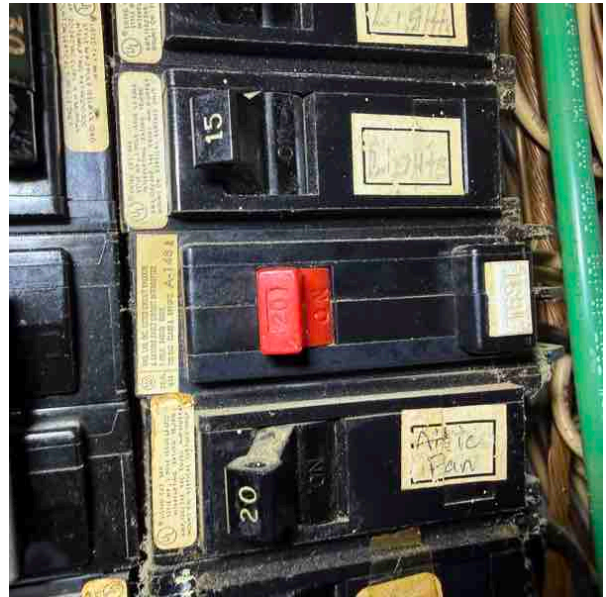
- knockout is missing at bottom of junction box enclosure and a wire connection is in contact with the junction box enclosure

- high heat condition noted on wire connection at breaker for range unit
- cable clamps and knockouts are missing at bottom of panel
- damage is visible on terminals on buss bar in main panel
- improper fasteners are in use to secure cover to panel
- open wiring and open junction boxes are visible at several areas in the attic and crawlspace
- ensure replacement breakers are rated for use in this brand panel

9.1.2 Recommend further evaluation and repair of the following electrical related observations (listed in the electrical section of the inspection report) by a qualified electrical contractor:

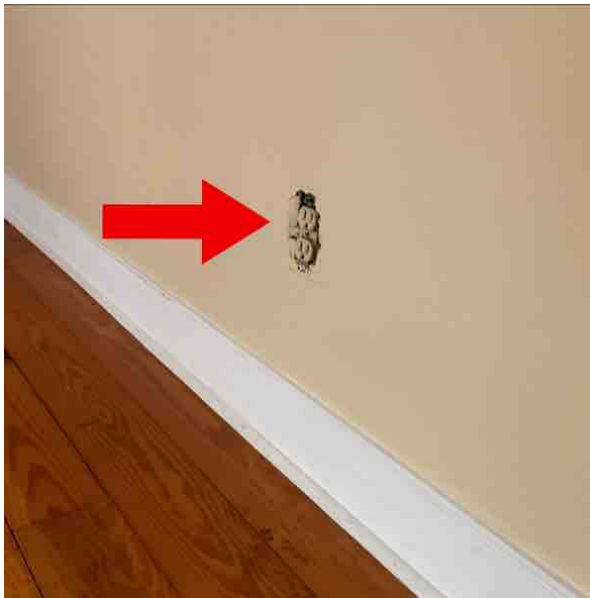
9.8.2 Open ground is present on outlet, the unit is not properly secured to wall and cover is missing, recommend repair (Guest Bedroom)

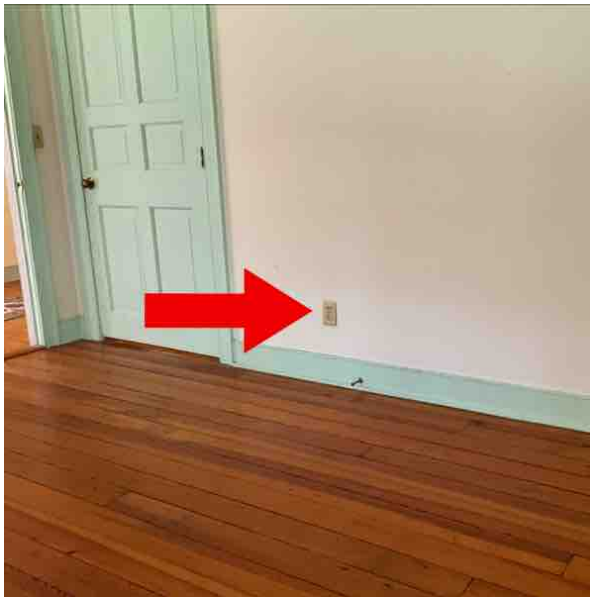
9.8.3 Receptacle is loose, recommend repair to limit movement and risk of damage\shock. (Primary Bedroom)

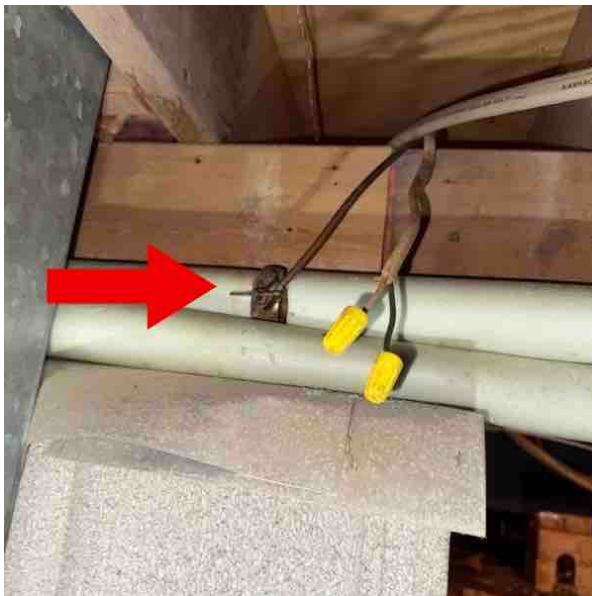
10.9.3 Water is supplied to the humidifier unit through a saddle valve that is tapped into the copper supply line in the crawlspace. Saddle valves are prone to leak over time and should be monitored periodically for corrosion and leaks.

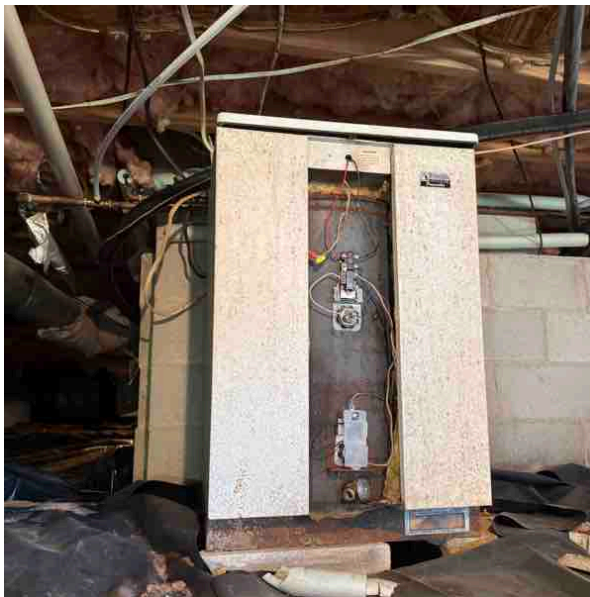
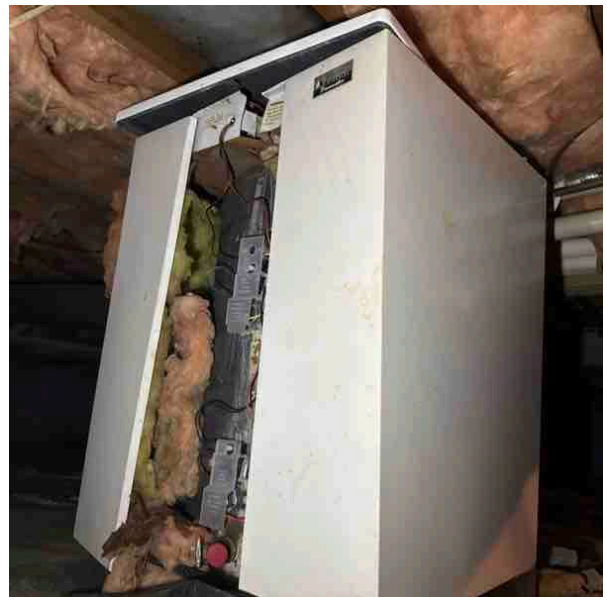
Water heaters are older units and appear to be beyond their typical service lives. Recommend budgeting for replacement.

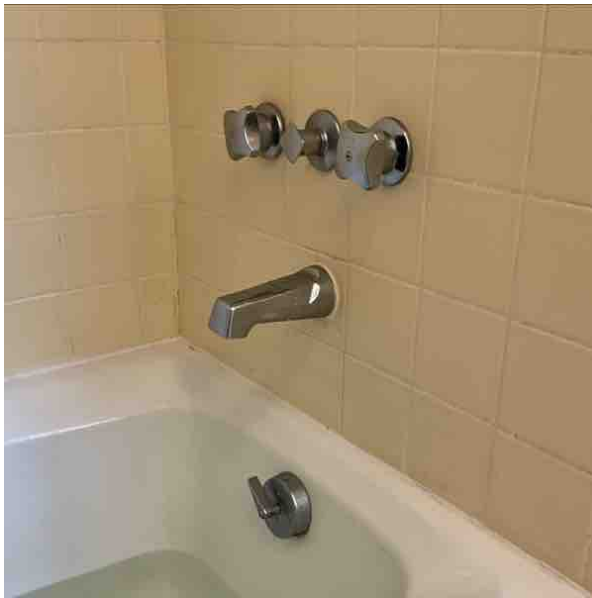
**11.7.2 An active leak is visible on faucet valve(s) and diverter at tub recommend repair. (Primary Bathroom/Laundry)**

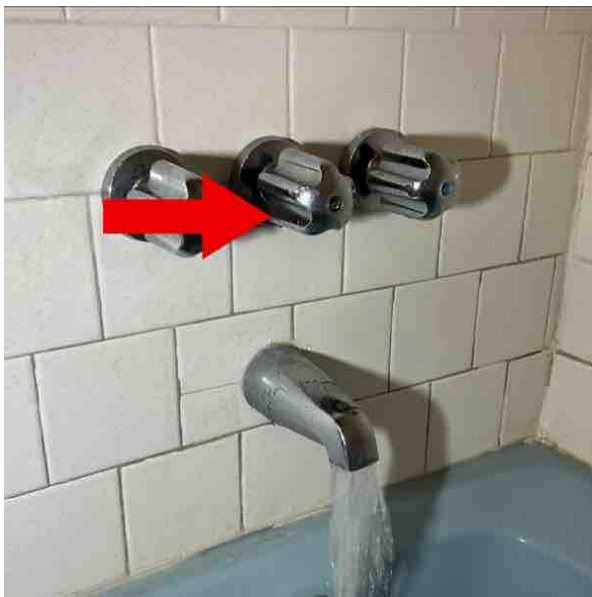
**11.7.3 An active leak is visible on the shower diverter and faucet drips when valves are in the off position, recommend repair. (Guest bathroom)**

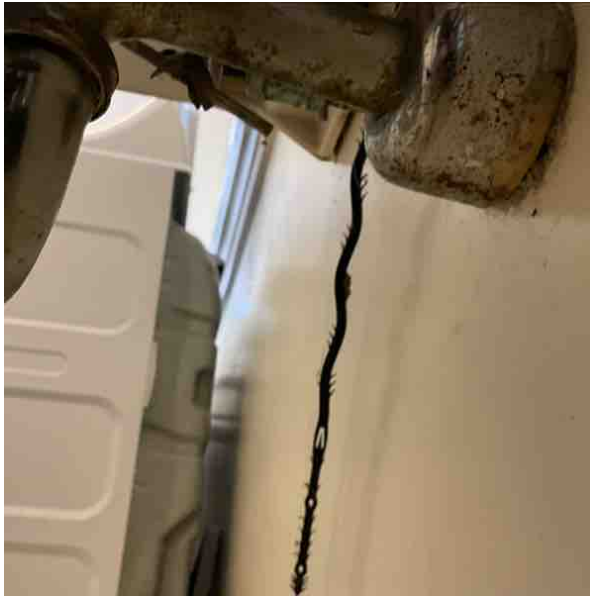
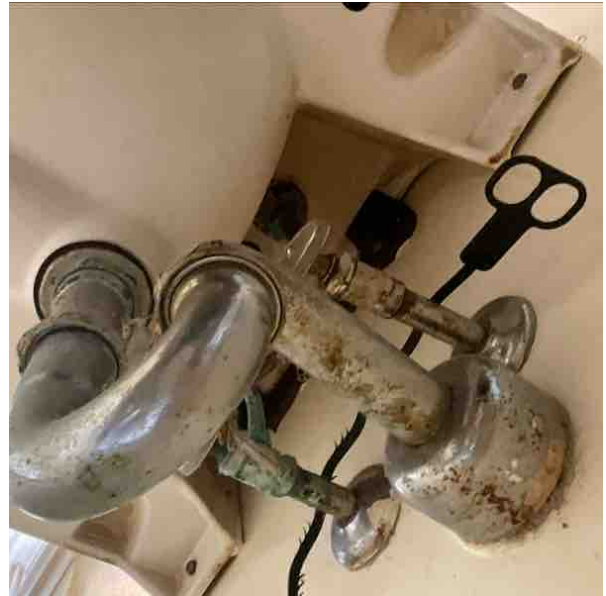
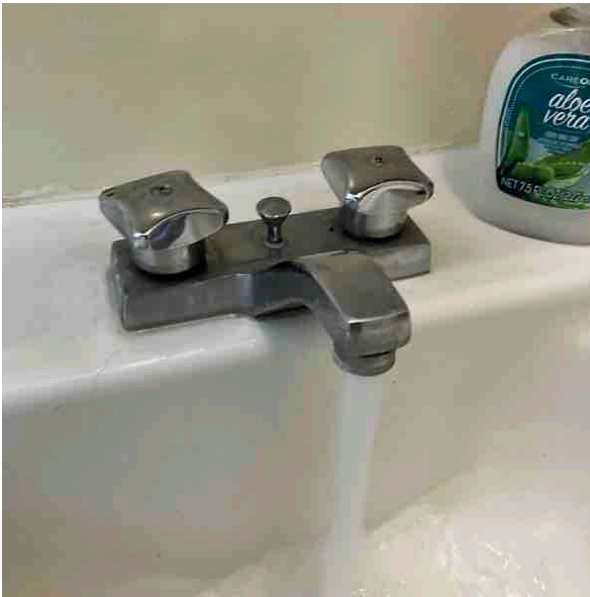
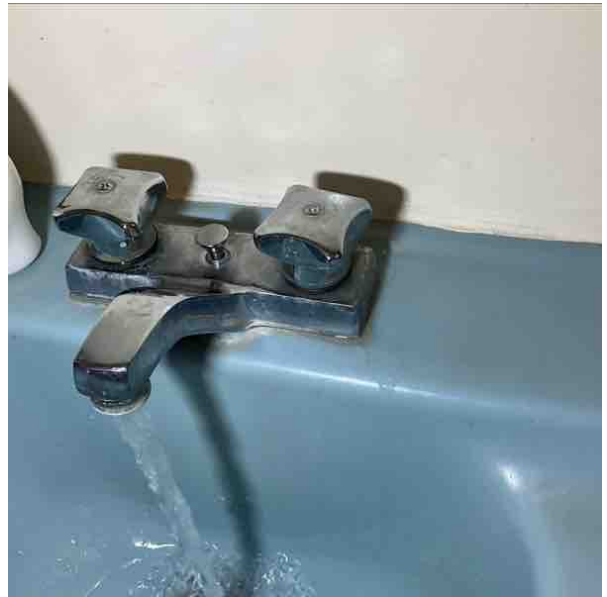
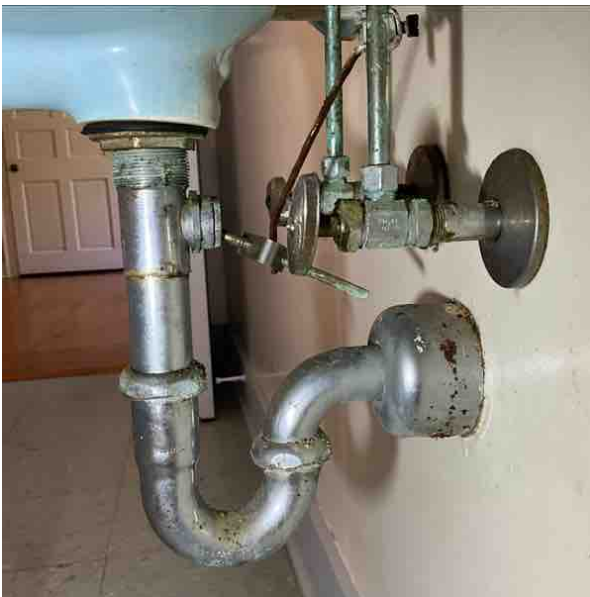
11.8.2 **Active leaks are visible on faucet valves and corrosion is visible on water supply lines/valves/drain, recommend replacement of all old/corroded materials and repair/replacement of faucet valves to limit risk of leaks.**

- Guest bathroom
- Primary Bathroom/Laundry

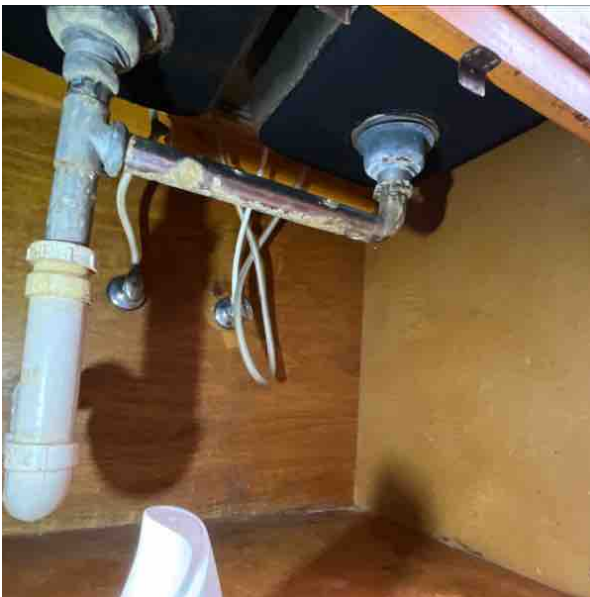
11.8.3 Drain lines are corroded and leaking, recommend replacement to limit leaks. (Kitchen)

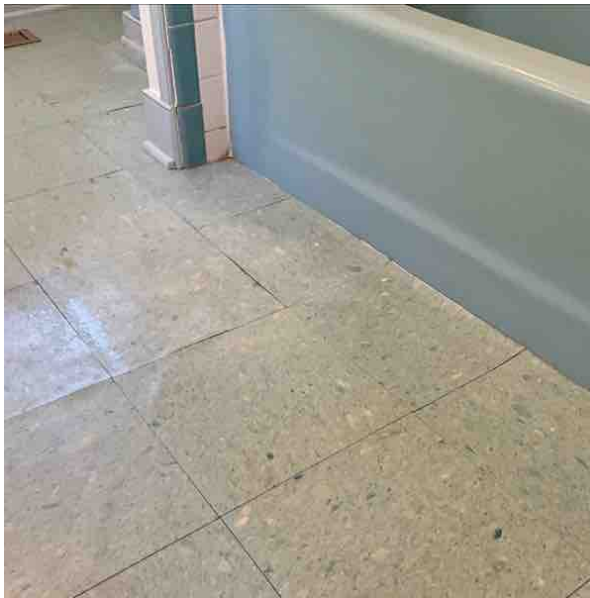
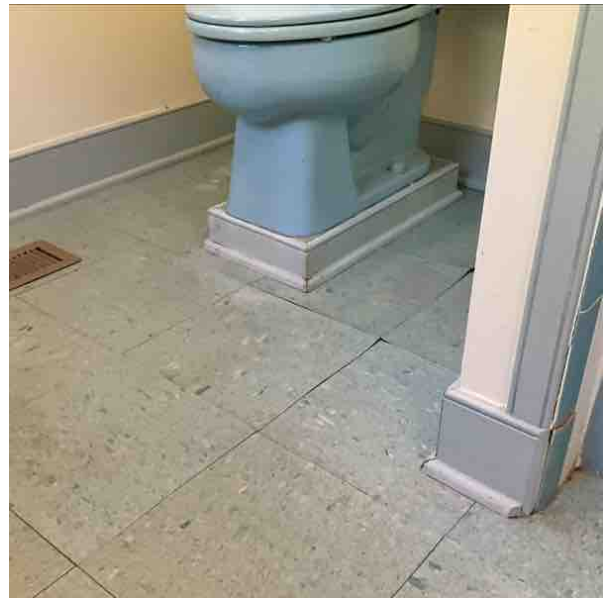
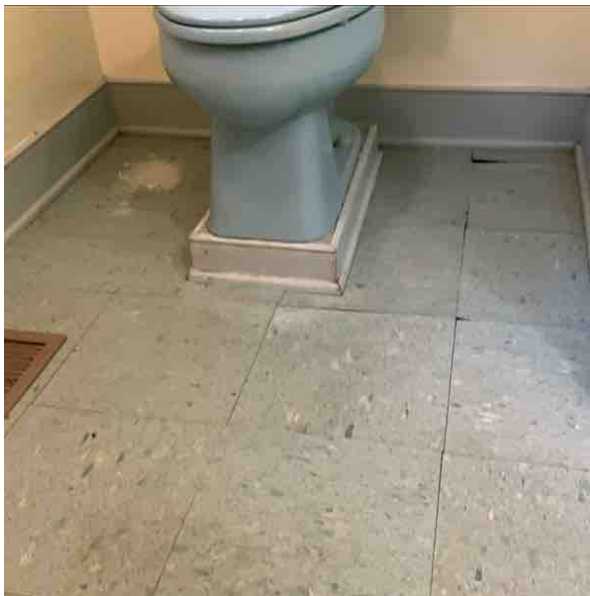
12.1.2 **Damage/curl is visible on floor tiles at the tub and toilet. Recommend further investigation to determine if any hidden damage is present on the floor and repair/replace as needed. (Guest bathroom)**

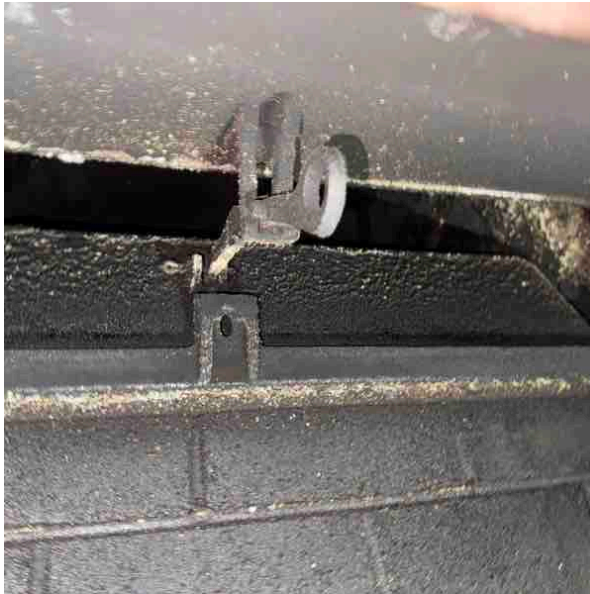
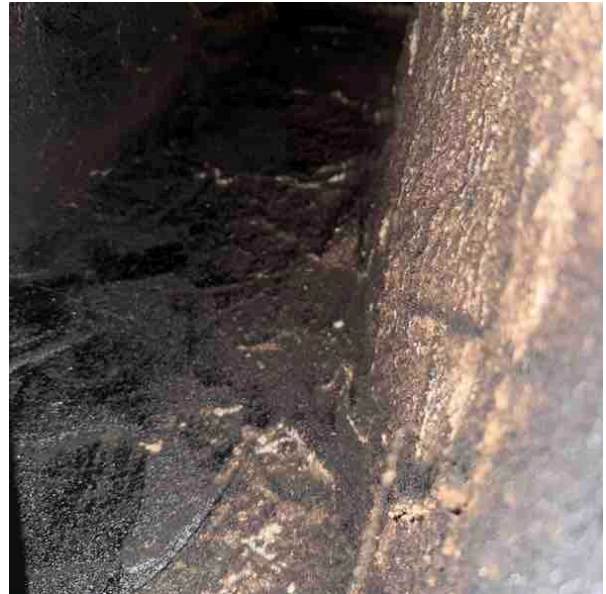
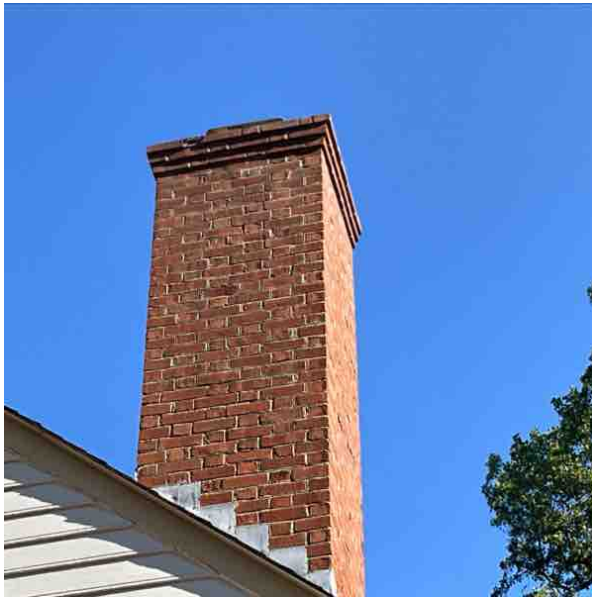
- Interior flue liners are not visible to the inspector therefore outside the scope of the inspection
- Soot buildup visible on the interior of the firebox and on the flue liner indicates need for cleaning.
- Deterioration is visible on bricks on the chimney exterior (Family Room)

13.3.2 Recommend further evaluation of the chimney and fireplace by a qualified chimney sweep:
