## ASBESTOS INSPECTION REPORT

2568 Eaton St. Denver CO 80214

Home Test, LLC Project No. 26795-2568

**RE: Asbestos Inspection Report, Home Test, LLC Project No: 26795-2568**

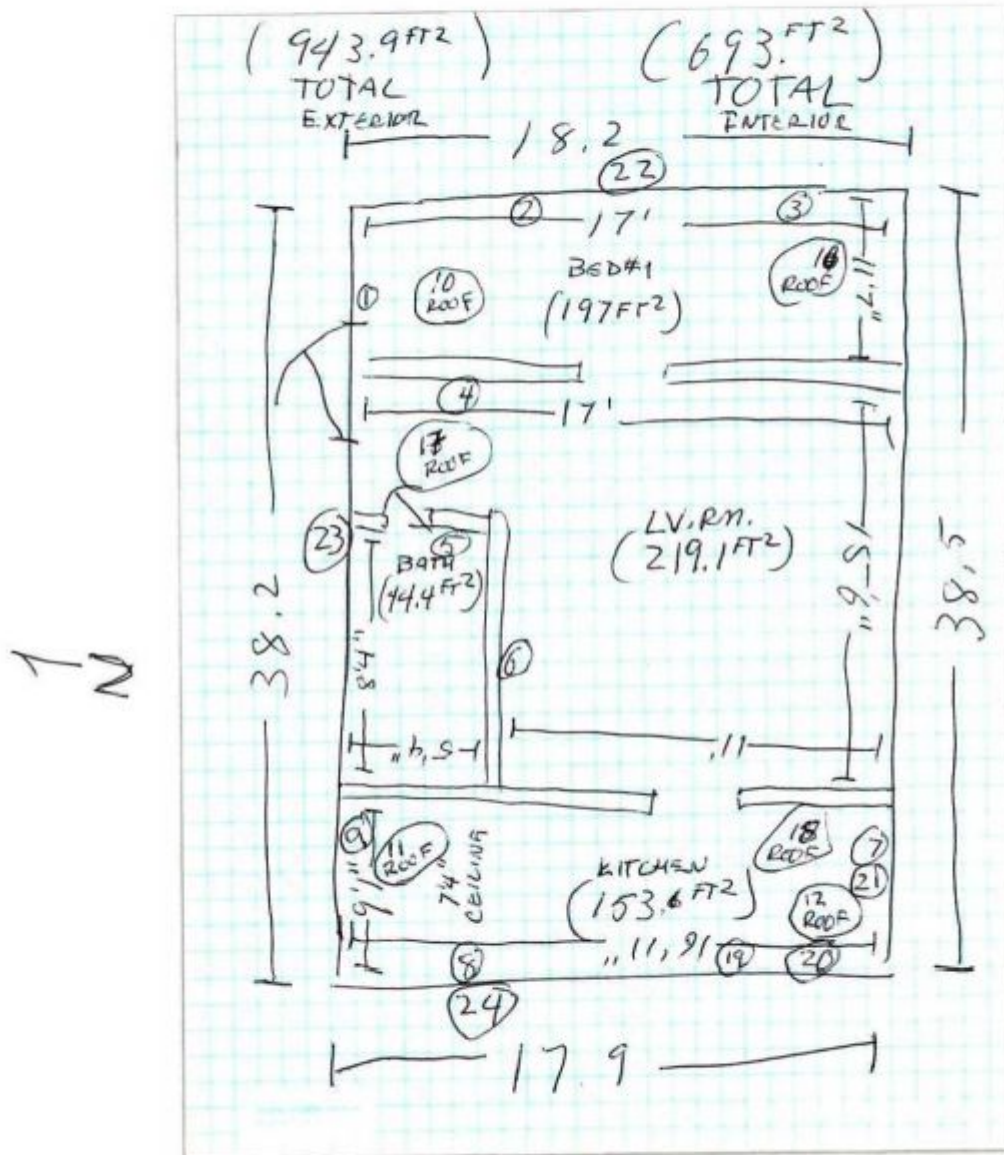
JOB# 26795-2568 ROOM EXT. STUCCO AREA EXT. WALLS

| Client ID | Lab ID | Layer | Sample Description | Asbestos % |
|---|---|---|---|---|
| 2568-22 | 3309030 | Layer A | Beige/white surface material | None Detected |
| | | Layer B | White stucco | None Detected |
| | | Layer C | Gray stucco | None Detected |

| Client ID | Lab ID | Layer | Sample Description | Asbestos % |
|---|---|---|---|---|
| 2568-23 | 3309031 | Layer A | Beige/white stucco | None Detected |
| | | Layer B | Gray stucco | None Detected |
| 2568-24 | 3309032 | | Beige/white stucco | None Detected |

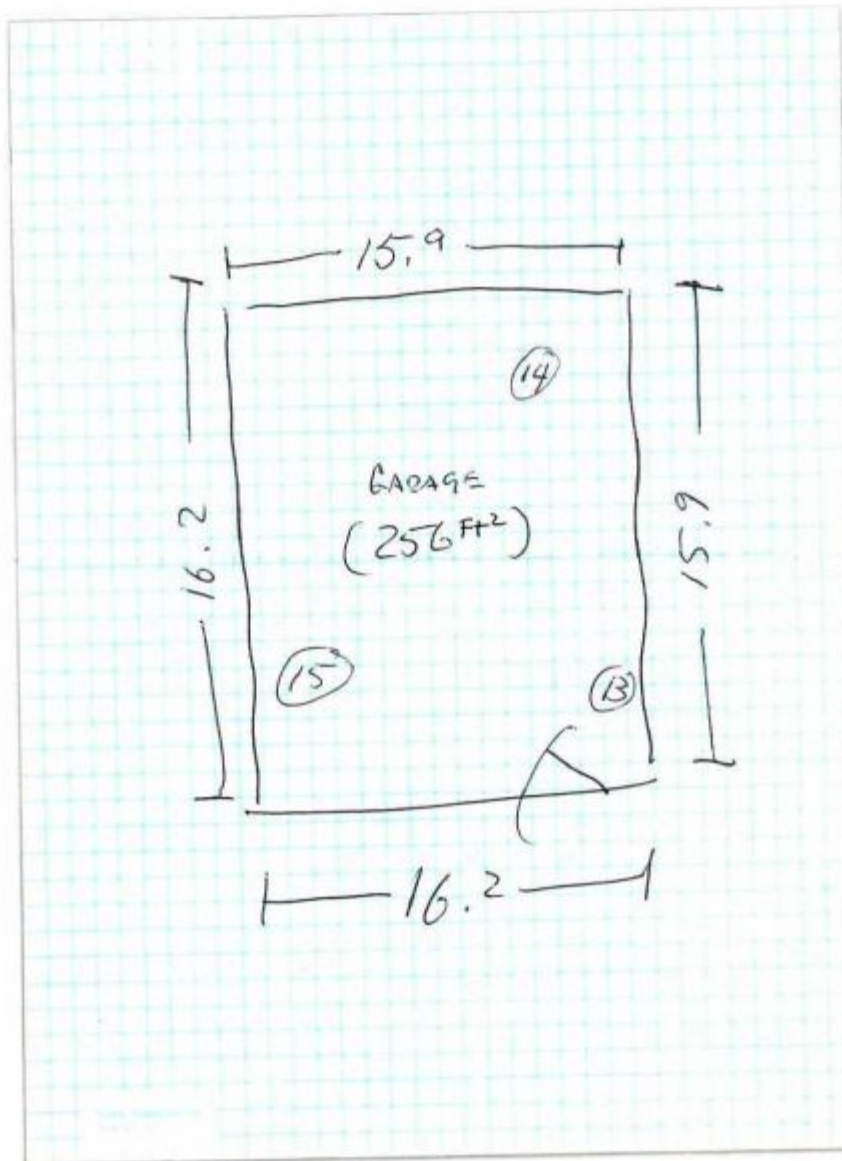
JOB# 26795-2568 ROOM GARAGE AREA ROOF

| Homogenous Areas | | | | | | | |
|---|---|---|---|---|---|---|---|
| HA#5 | Sample 13,14,15 | Roof shingles | Miscellaneous | Garage roof | friable | 256 SF | good |

| Client ID | Lab ID | Layer | Sample Description | Asbestos % |
|---|---|---|---|---|
| 2568-13 | 3309021 | | Tan shingle | None Detected |
| 2568-14 | 3309022 | | Tan shingle | None Detected |
| 2568-15 | 3309023 | | Tan shingle | None Detected |
