# ***Cornerstone Inspection***

## **Property Inspection Report**

***6455 Cormorant Way, Avila Beach, CA 93424***  
***Inspection prepared for: Jim Hilferty***  
***Real Estate Agent: Holly Tibbles - Coast & County Brokers***

***Date of Inspection: 8/25/2026 Time: 9:00 AM***  
***Age of Home: 1994 Size: 1912***  
***Weather: Clear***  
***Order ID: 14158***

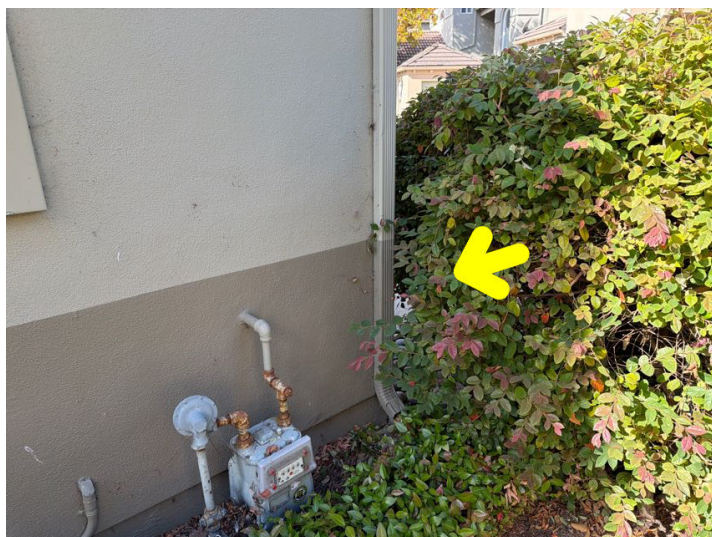
Vines, shrubs or bushes are growing on the house walls and although they are attractive they can introduce pests and rodents and accelerate deterioration. Therefore, you may wish to consider having them removed or cut back to 12 inches (30 cm) away from the home.

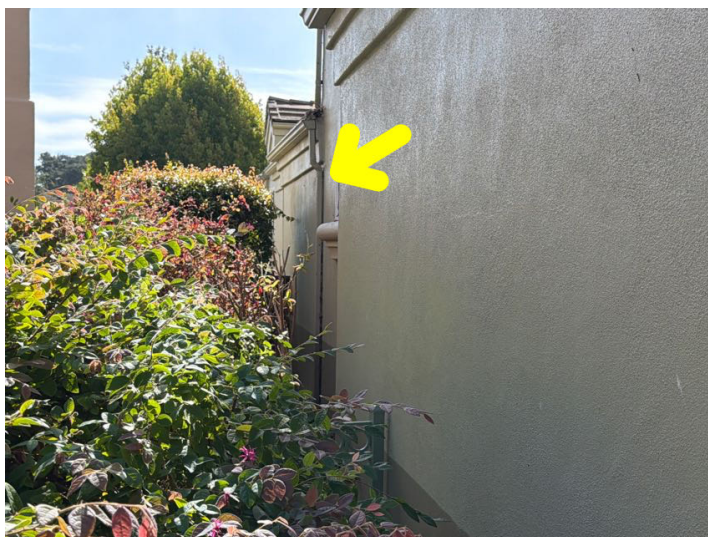
We were unable to view part of the exterior as it is within the neighbors' yard, to which we did not have access.

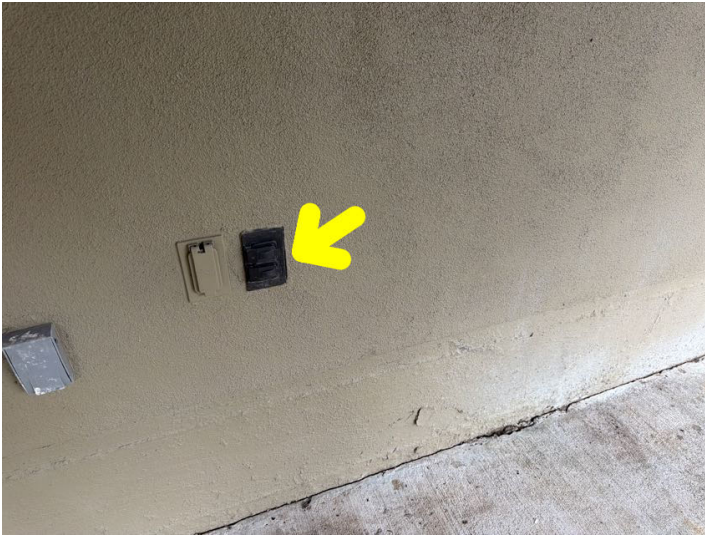
Some of the exterior outlets do not have ground-fault protection, and should be upgraded to include this important safety feature.

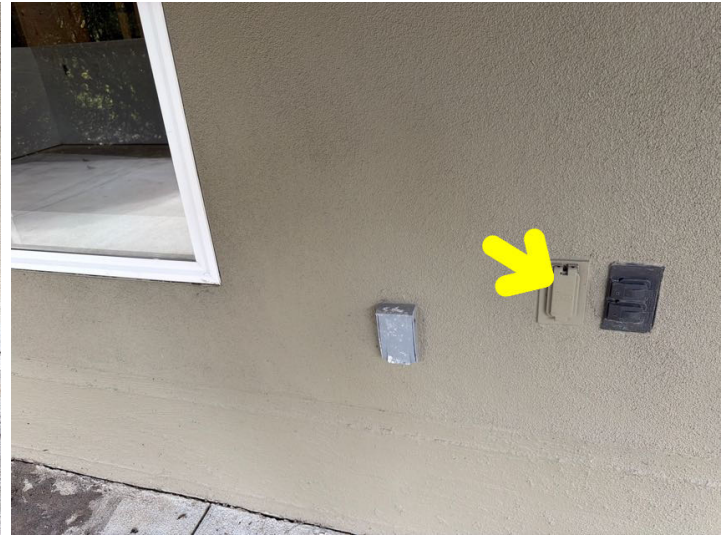
A ground-fault protected outlet on the rear does not reset when activated, and should be serviced.

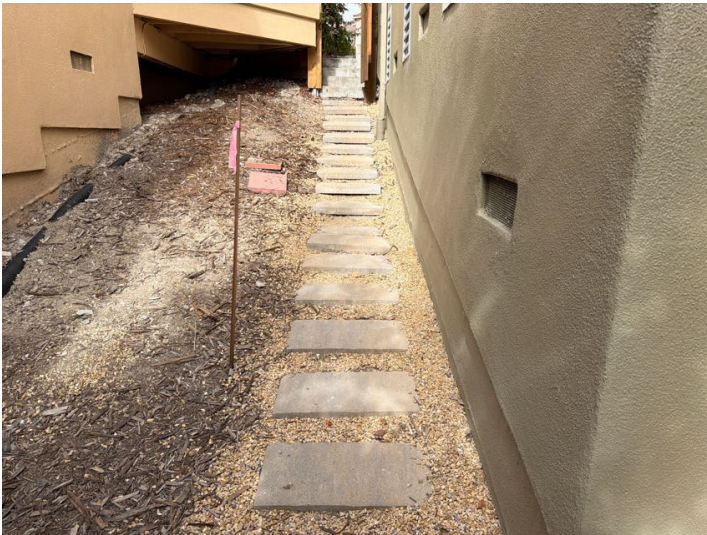
The railroad tie, paver, or natural stone steps are landscape components and would not conform to common standards requiring certain dimensions, handrails, guardrails, etcetera.

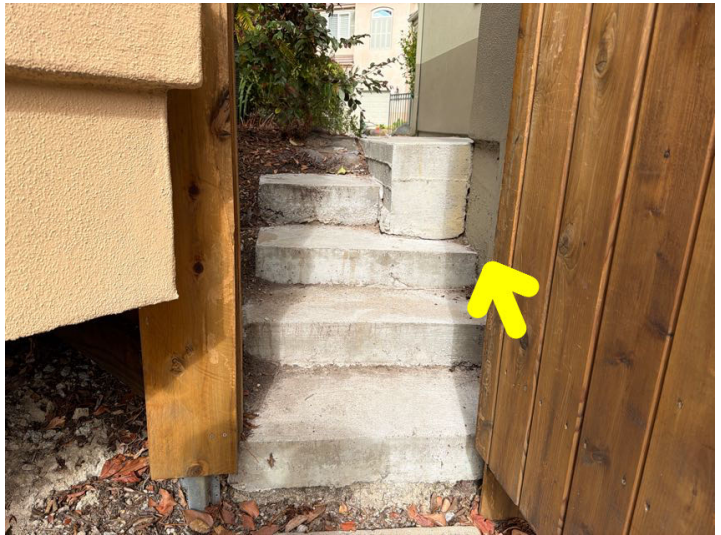
Current building standards require handrails to be installed on steps which have 4 or more risers, which is particularly important if children or the elderly visit or occupy this property.

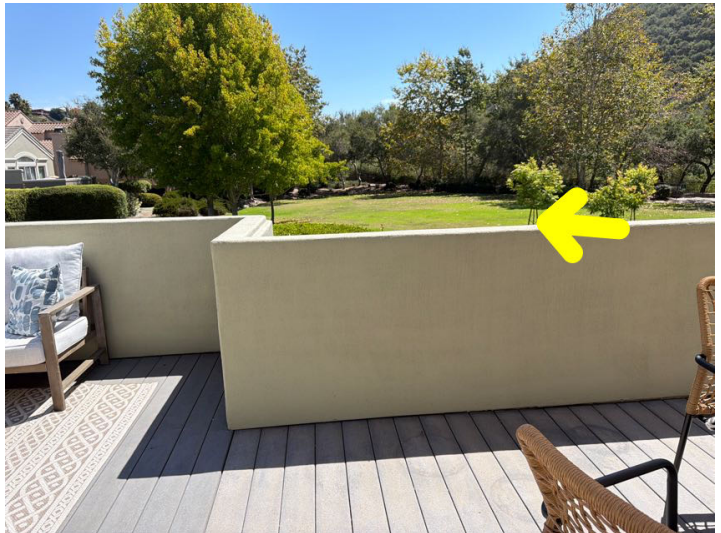
One or more guardrails do not conform to common safety standards. Common safety standards require them to be a minimum of 42 inches high when the standing surface is 30 inches or more above grade. Also, guardrail pickets should be no more than 4 inches apart for child safety.

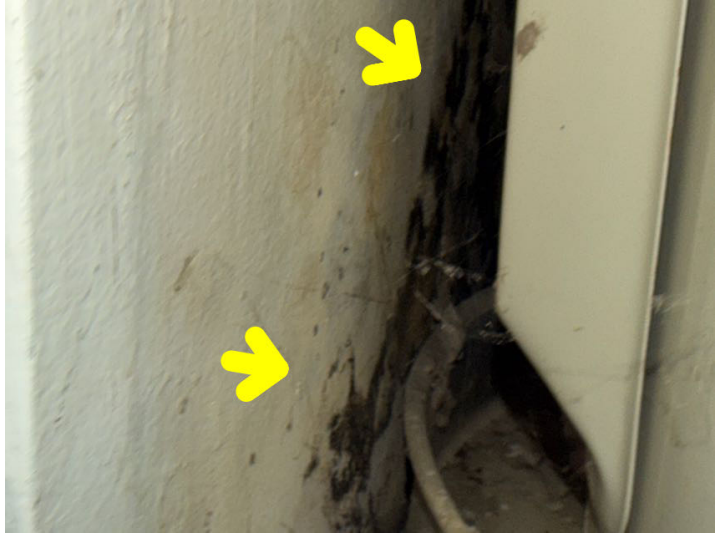
There is a mold-like substance present in the sink cabinet, which should be evaluated by a specialist and serviced as necessary. All molds flourish in a damp environment and many are commonplace, but some are toxic and may represent a health threat.

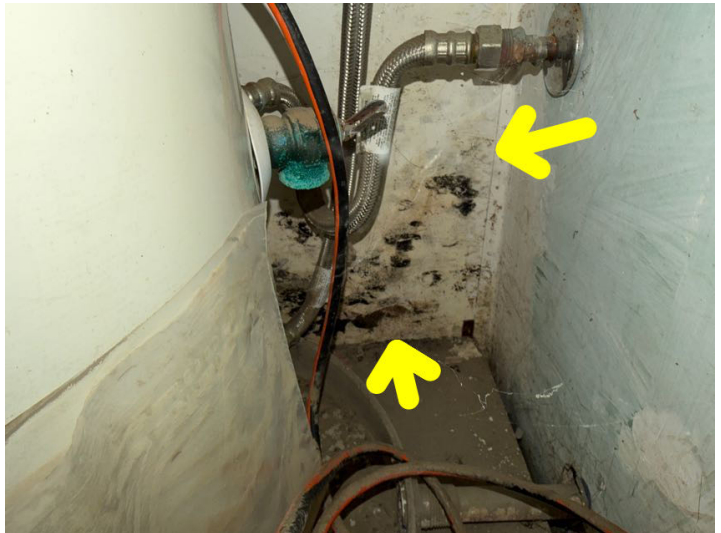
There is a mold-like substance present in the sink cabinet, which should be evaluated by a specialist and serviced as necessary. All molds flourish in a damp environment and many are commonplace, but some are toxic and may represent a health threat.

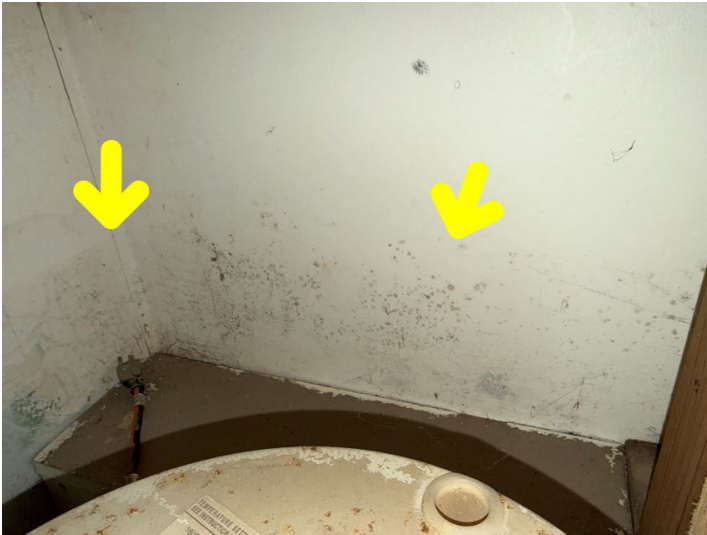
There is a mold-like substance present in the sink cabinet, which should be evaluated by a specialist and serviced as necessary. All molds flourish in a damp environment and many are commonplace, but some are toxic and may represent a health threat.

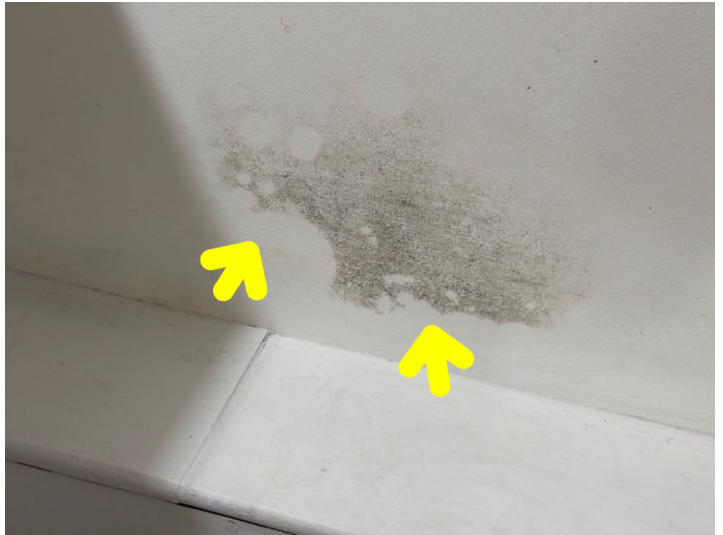
There is a mold-like substance present in the sink cabinet, which should be evaluated by a specialist and serviced as necessary. All molds flourish in a damp environment and many are commonplace, but some are toxic and may represent a health threat.

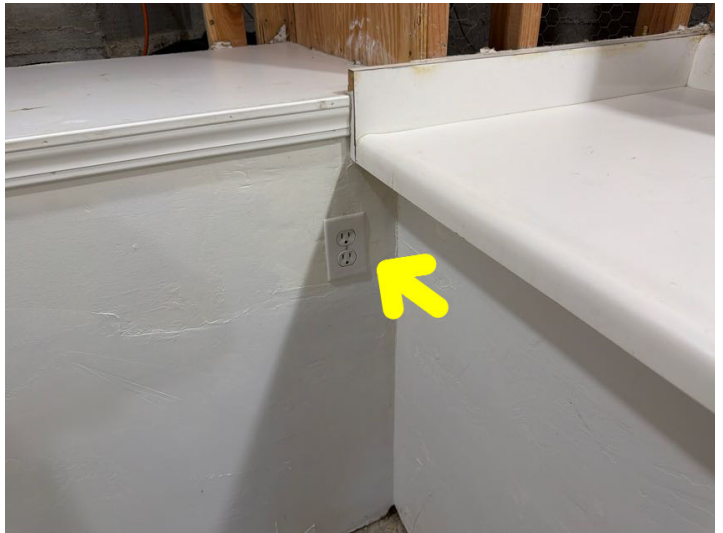
One or more outlets have an open-neutral, and should be evaluated and serviced by a licensed electrical contractor.

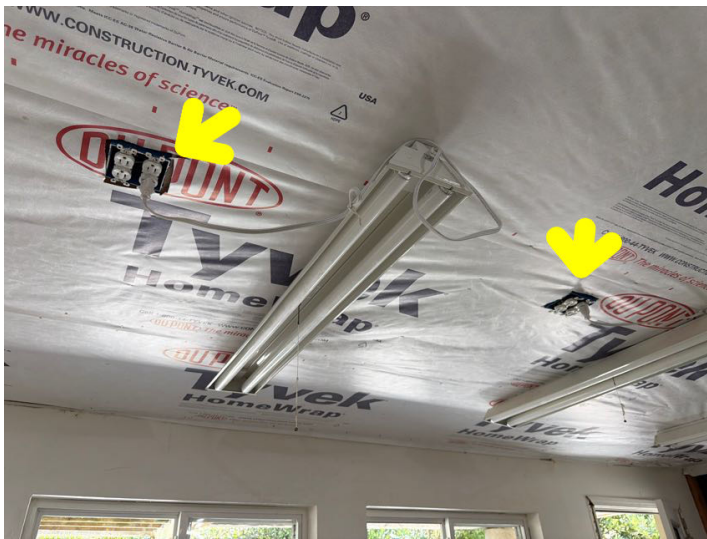
One or more outlet covers are missing and should be installed.

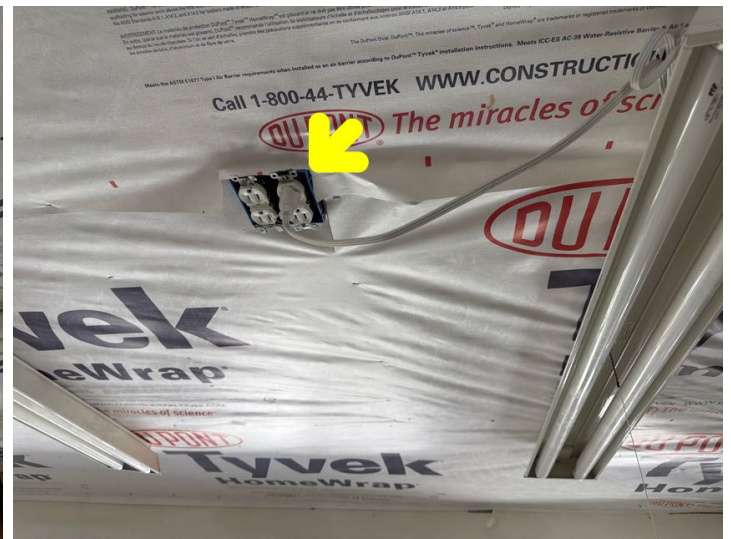
One or more outlet covers are missing and should be installed.

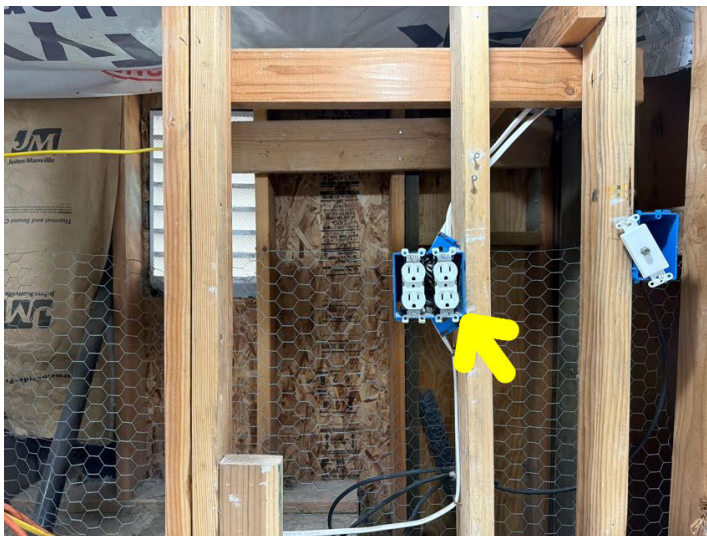
One or more outlet covers are missing and should be installed.

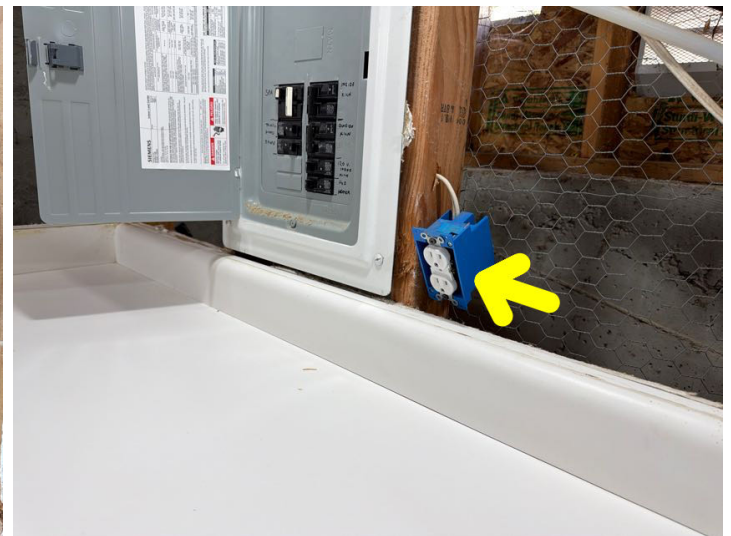
One or more outlet covers are missing and should be installed.

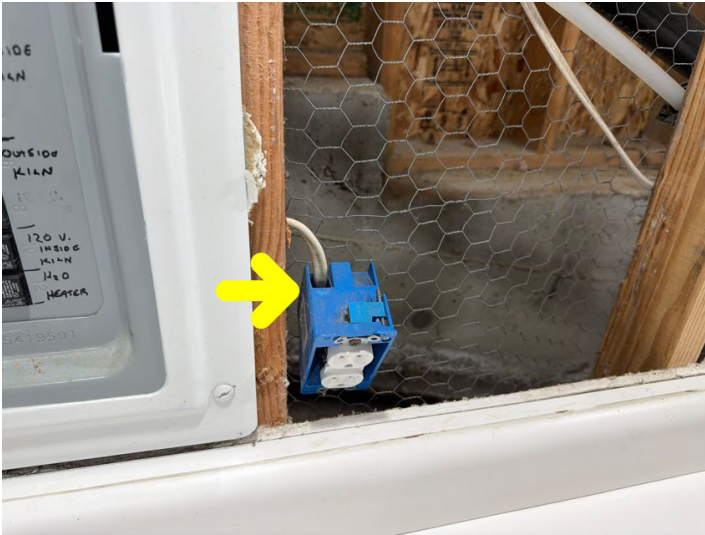
One or more outlets are not secure, and should be evaluated and serviced by a licensed electrical contractor.

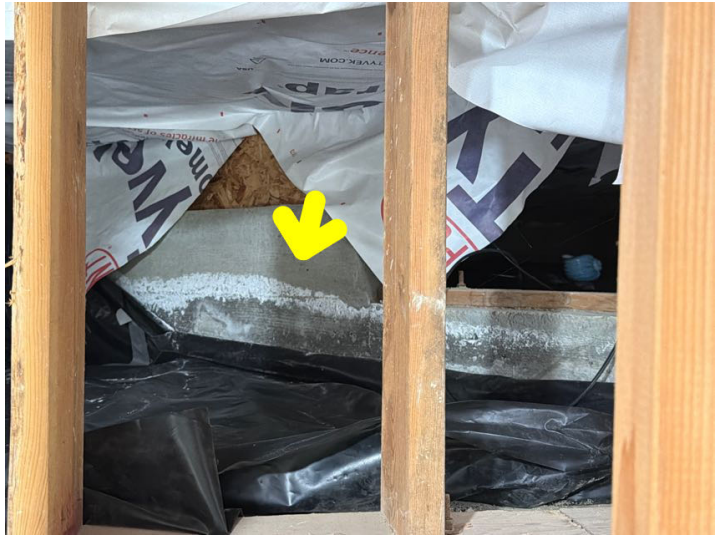
Moisture has entered the crawlspace, as is evident by salt crystal formations around the base of the stem walls. However, this is a common phenomenon that does not necessarily indicate a chronic or serious problem. The soils are currently dry, but it would be prudent to monitor this area.

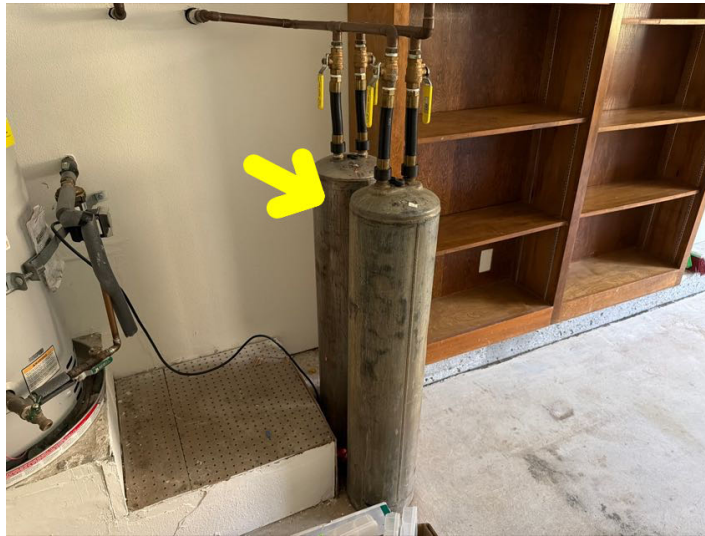
A water softener is present that we do not have the expertise to evaluate except for visible leaks. We recommend having the seller disclose its operation, maintenance history, and relevant documentation.

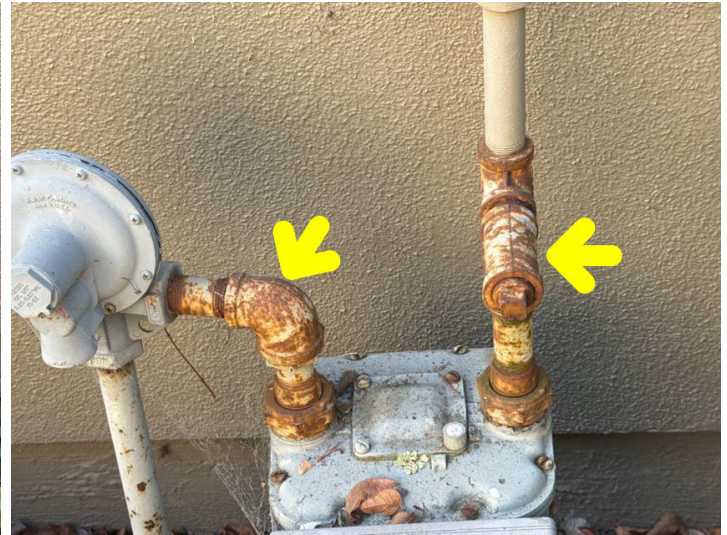
One or more of the gas pipes at the meter are rusted and should be painted to prevent further corrosion.

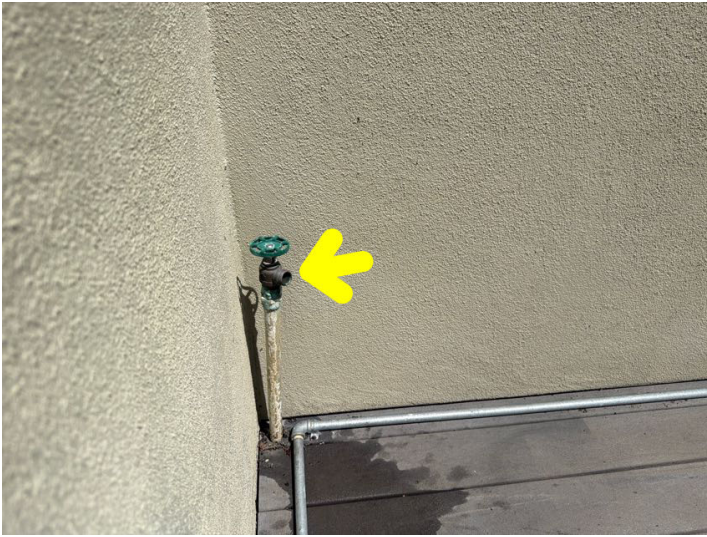
A hose bib at the rear is leaking and should be evaluated and serviced by a qualified plumbing contractor.

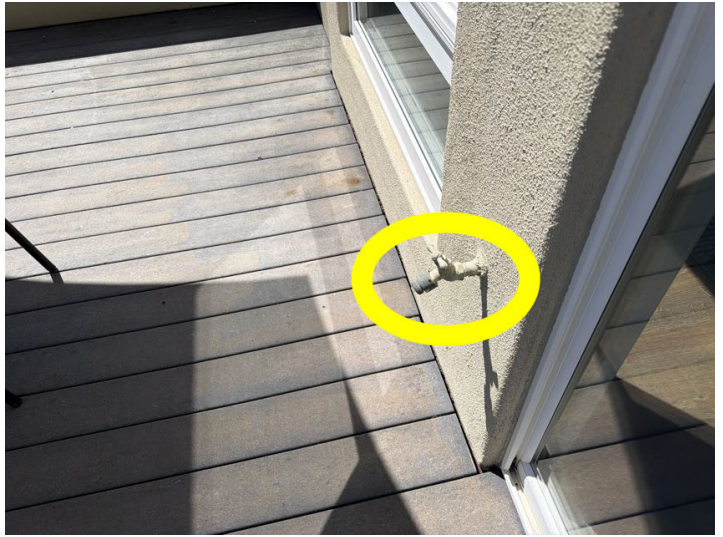
A hose bib on the rear is not functional or has been abandoned.

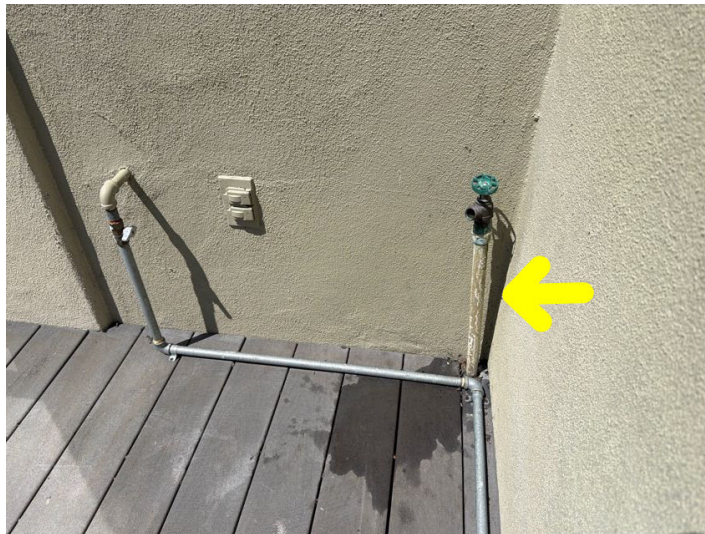
A PVC hose bib pipe should be braced with a metal stake to reduce the possibility of leaks.

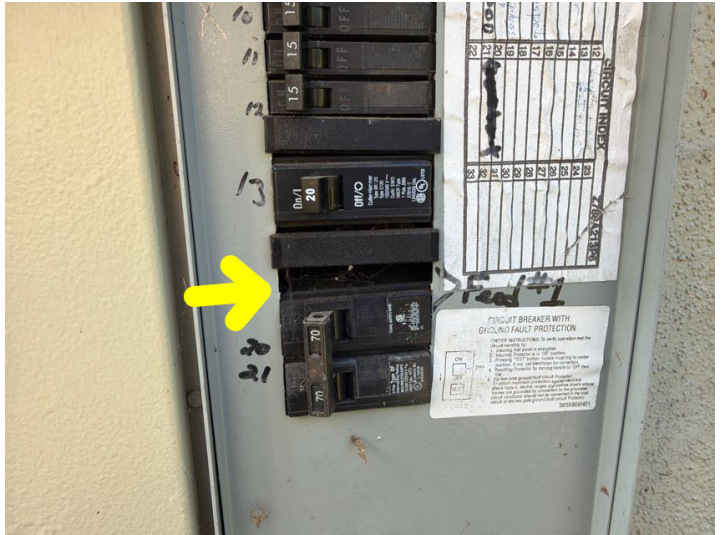
There are voids or open knockouts in the cover of the main electrical panel that should be covered.

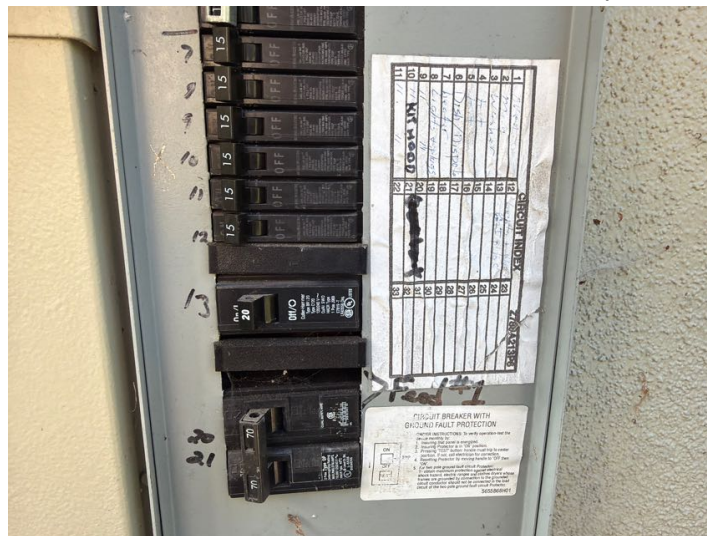
Various circuits within the main electrical panel are not labeled, and this condition should be serviced by a qualified electrical contractor so that the appropriate load calculations and breaker sizes can be determined.

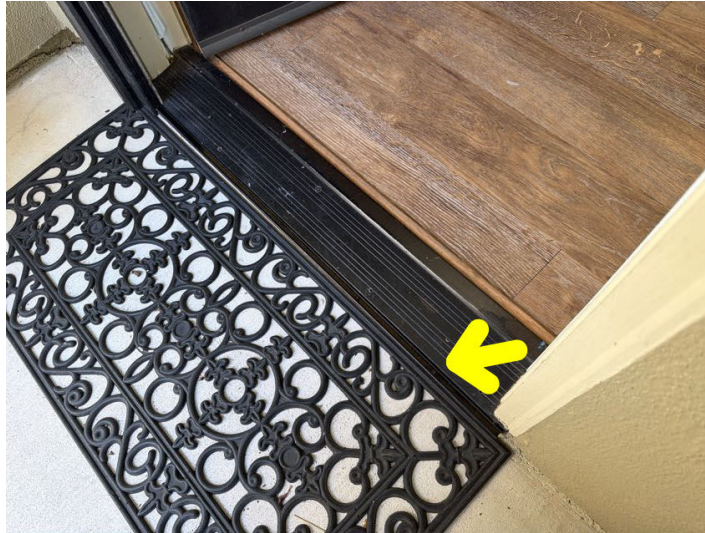
The threshold is loose or damaged and should be serviced.

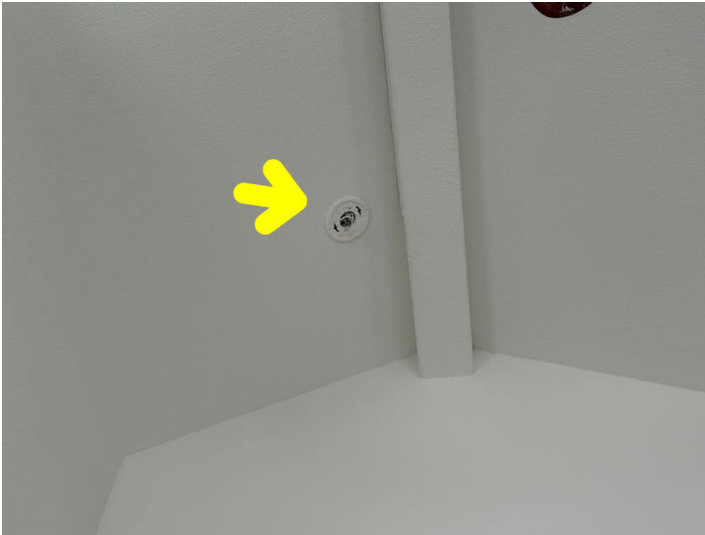
| Page 27 Item: 2 | Living Room | 2.5. A pre-wired smoke detector is missing and should be replaced. |

A pre-wired smoke detector is missing and should be replaced.

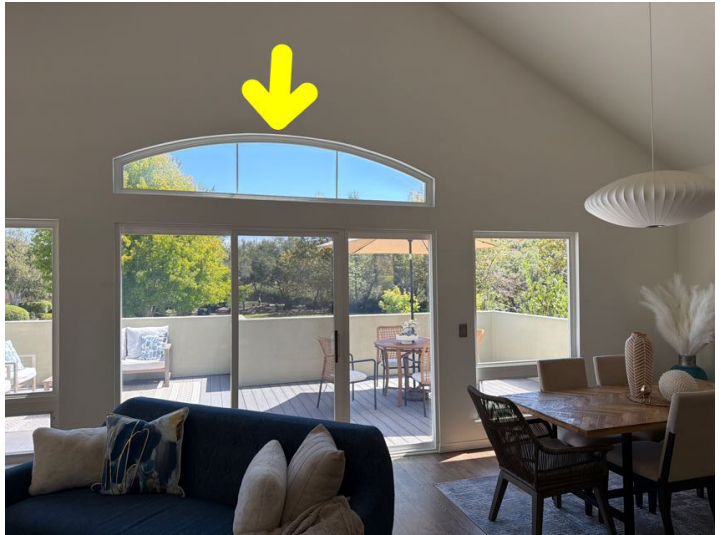
One or more windows may have a broken hermetic seal, which you may wish to have replaced. This is evident from fogging or condensation forming between the panes of glass, which implies that the seal has failed.

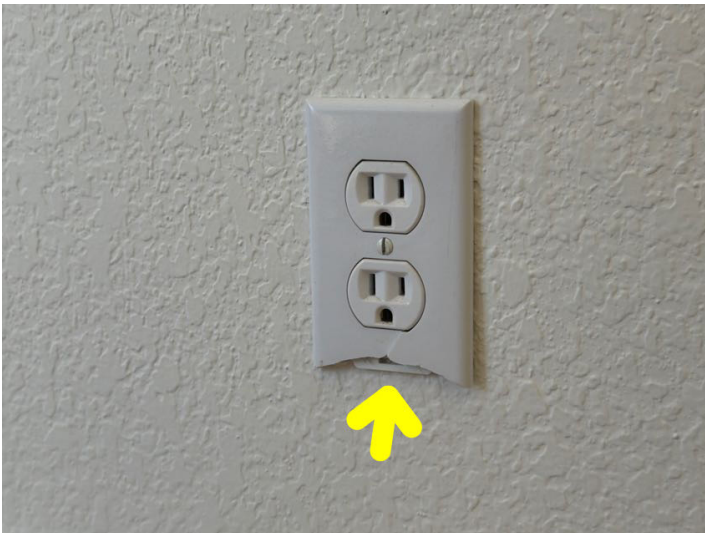
| Page 28 Item: 3 | Dining Room | 3.3. One or more outlet covers are cracked or broken and should be serviced. |

One or more outlet covers are cracked or broken and should be serviced.

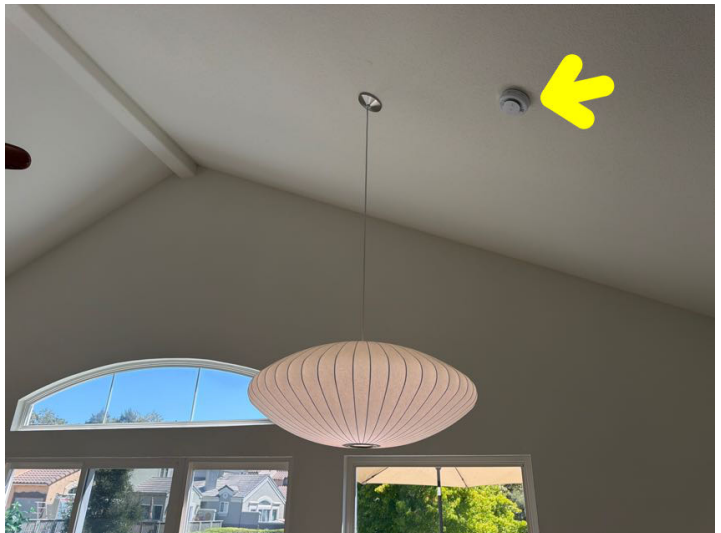
The smoke detector may not be in the location recommended by the manufacturer. We can elaborate but you may wish to verify this.

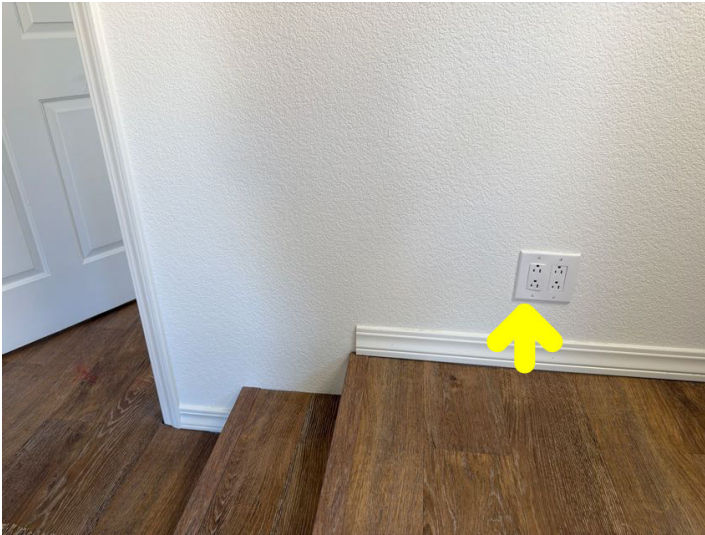
One or more outlets have an open-ground, and should be evaluated and serviced by a licensed electrical contractor.

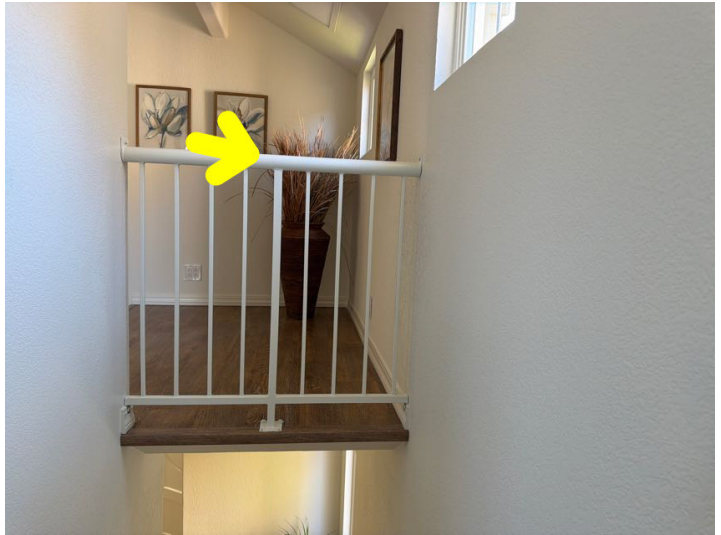
The guardrail is not the recommended 42 inches high when the standing surface is more than 30 inches below.

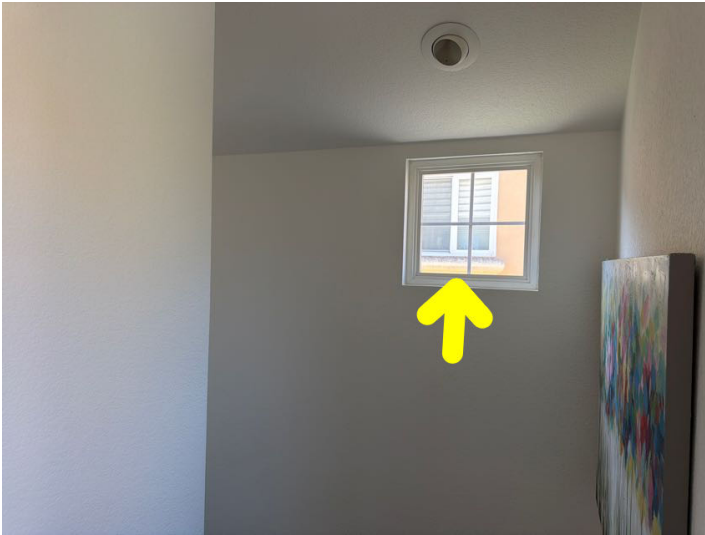
One or more windows may have a broken hermetic seal, which you may wish to have replaced. This is evident from fogging or condensation forming between the panes of glass, which implies that the seal has failed.

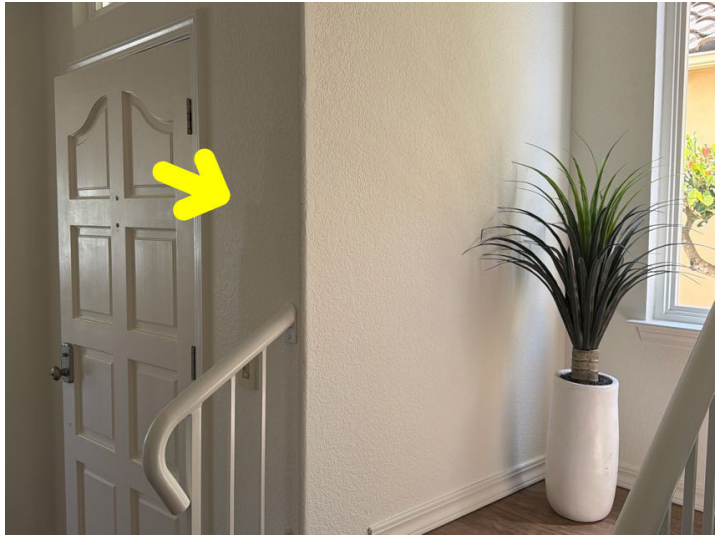
There has been a drywall/plaster repair that should be explained by the seller.

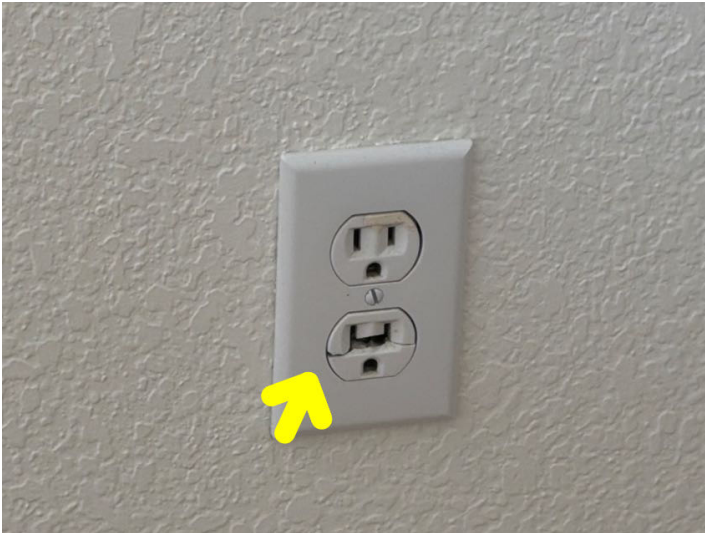
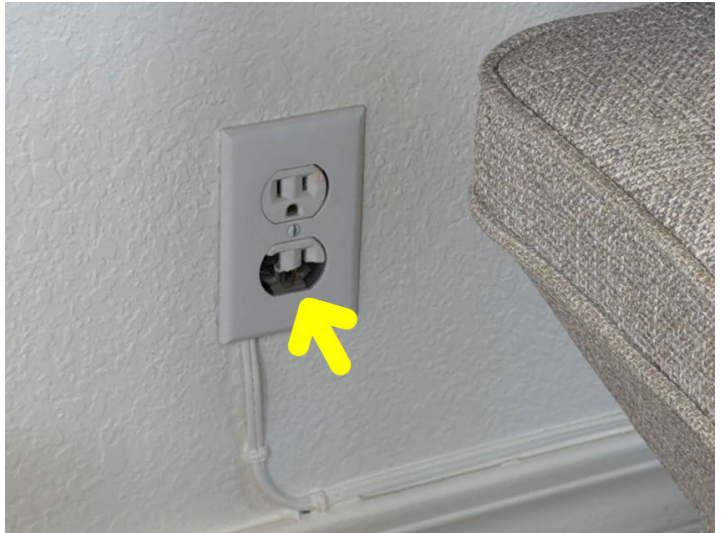
| Page 31 Item: 2 | Bedroom 2 | 2.6. One or more outlets are damaged, and should be evaluated and serviced by a licensed electrical contractor. |

One or more outlets are damaged, and should be evaluated and serviced by a licensed electrical contractor.

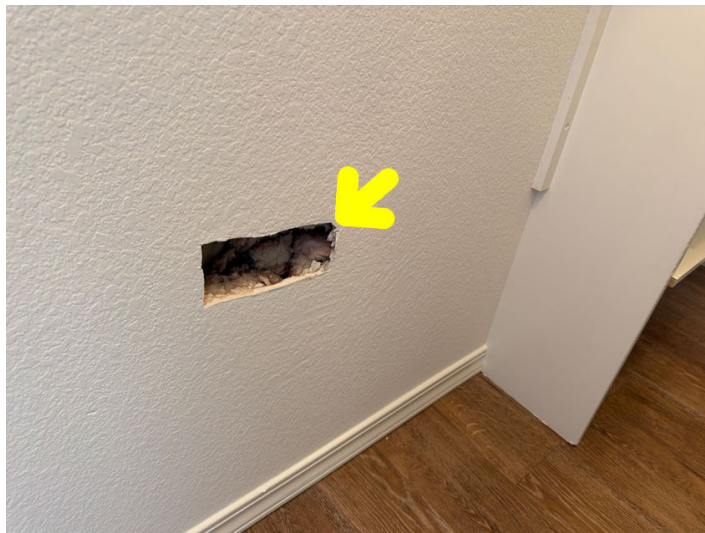
The walls or ceiling have cosmetic damage, which you may wish to view for yourself.

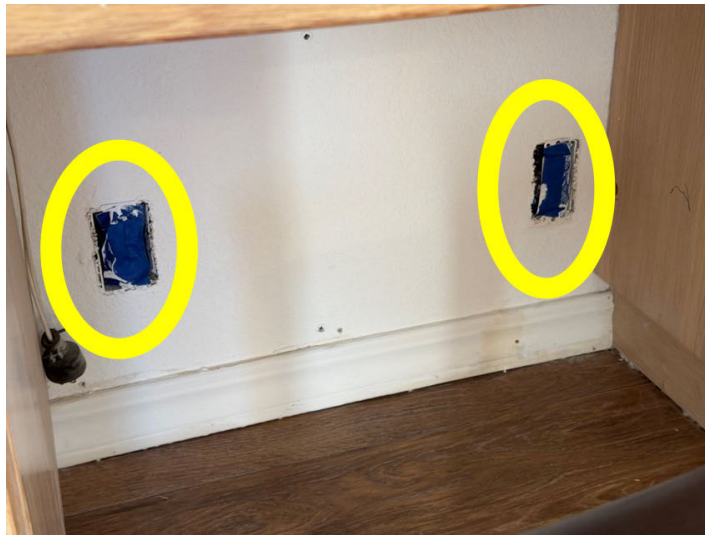
| Page 32 Item: 3 | Bedroom 3 | 3.5. One or more outlet covers are missing and should be installed. |

One or more outlet covers are missing and should be installed.

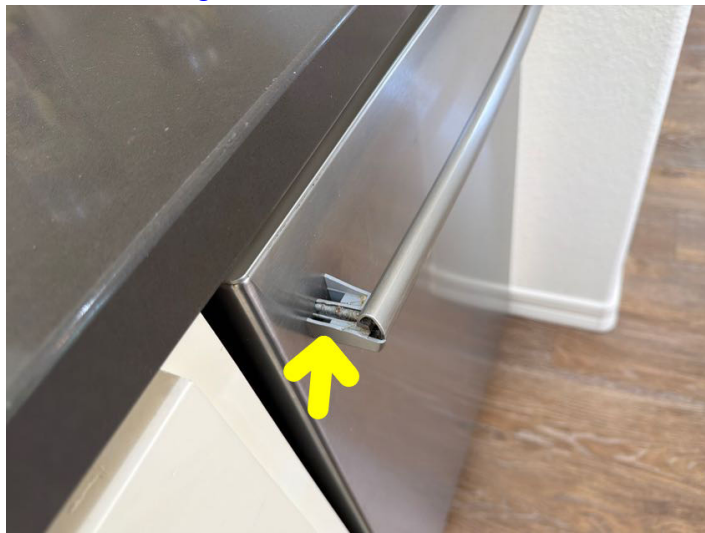
The door handle is loose or damaged and should be secured.

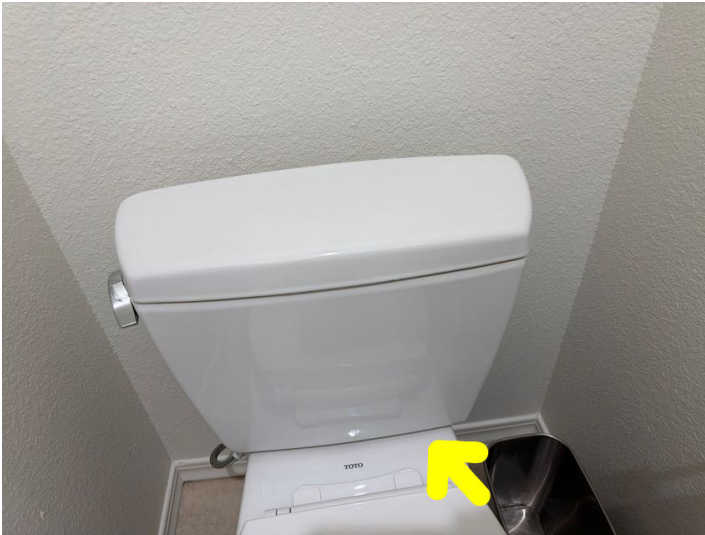
The toilet tank is loose, and should be secured, as this could be a safety hazard.

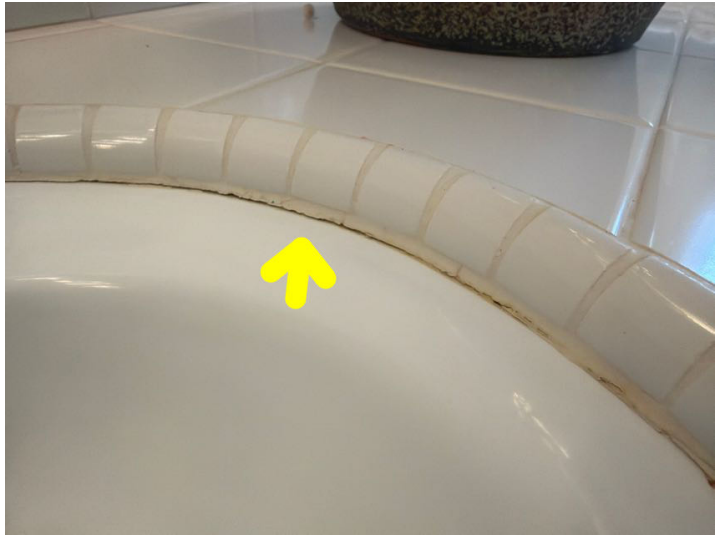
There is a separation between the sink and the countertop, which should be sealed to forestall moisture intrusion.

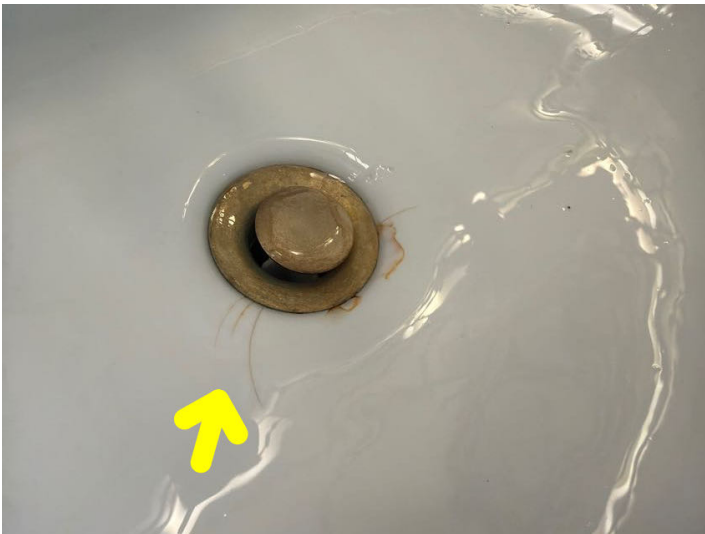
The bathroom sink is cracked but not leaking, but will obviously be susceptible to leaks.

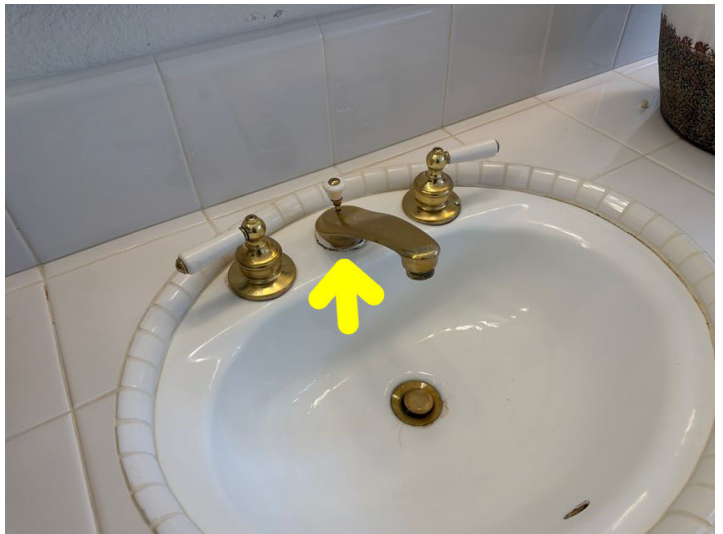
The left sink faucet is loose, and should be secured.

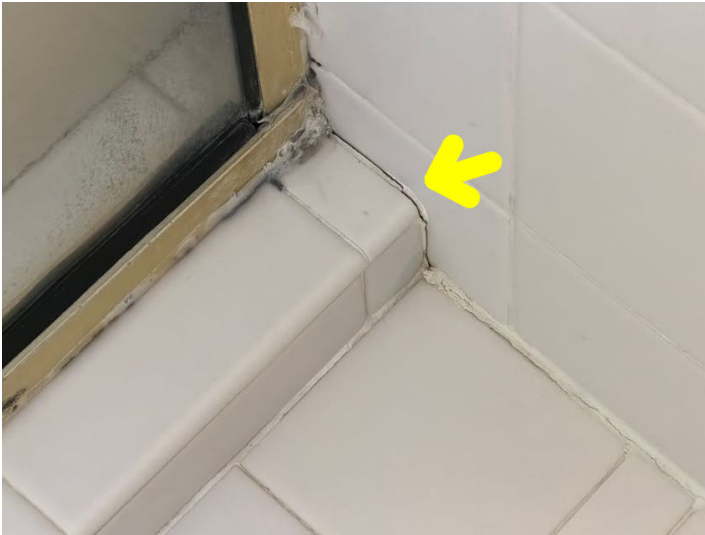
One or more open seams in the shower area need to be caulked or re-grouted to forestall moisture intrusion.

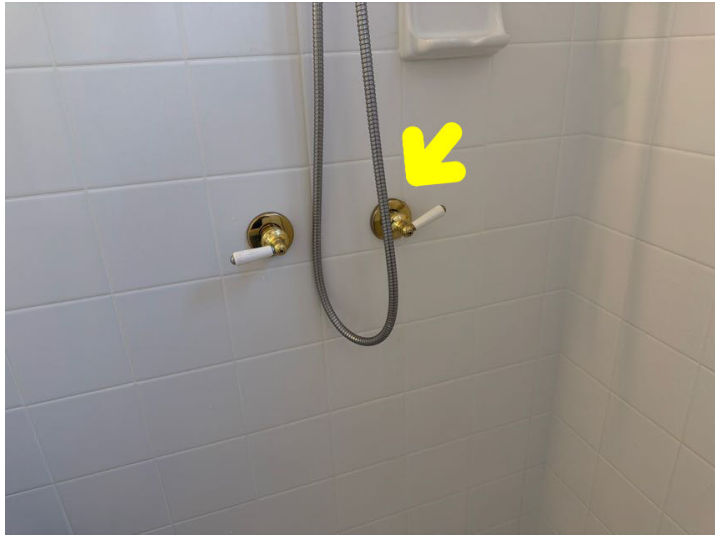
The shower faucet leaks around the stem while in use, and should be repaired.

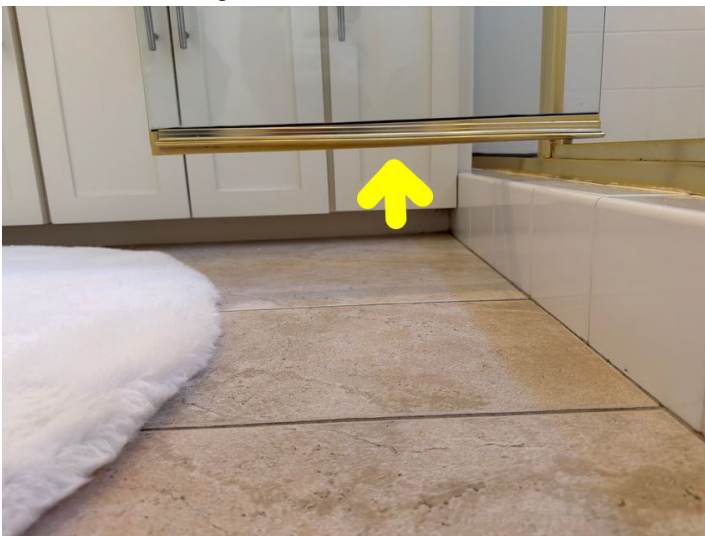
The shower door seal is missing or damaged, and should be serviced.

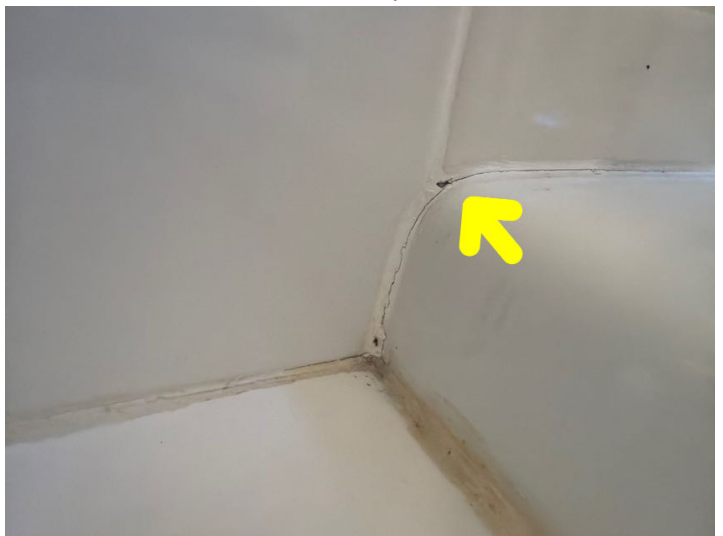
One or more open seams in the tub area need to be caulked or re-grouted to forestall moisture intrusion.

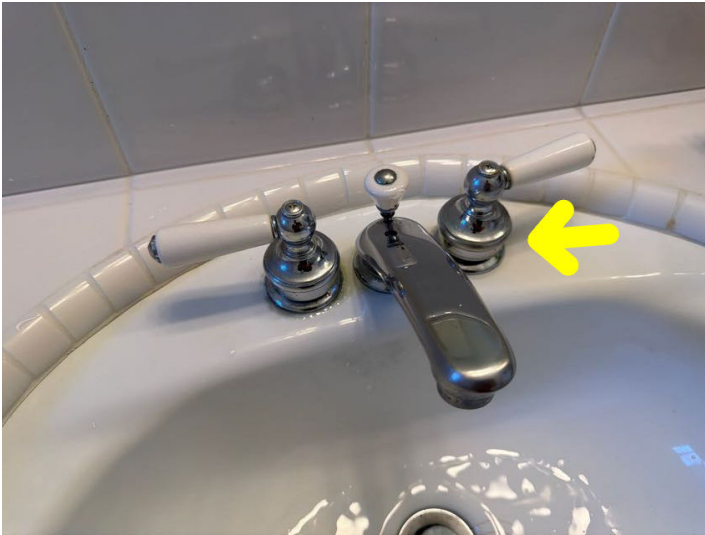
The sink faucet leaks around the stem and should be repaired.

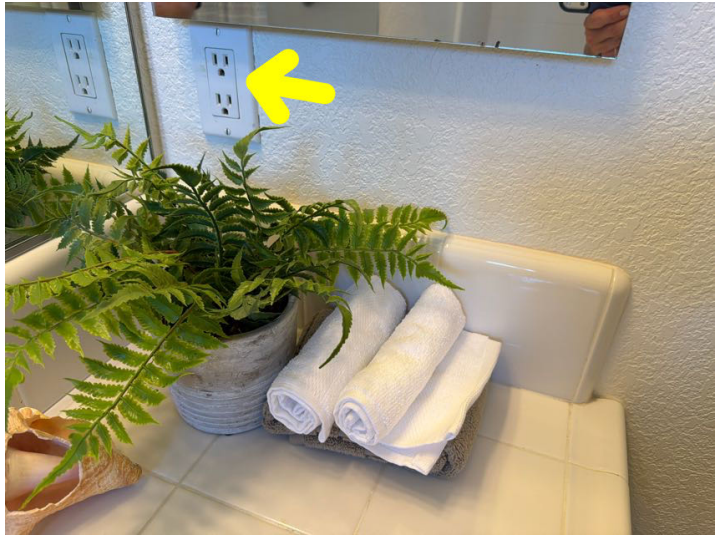
One or more bathroom sink outlets have an open-ground, and should be evaluated and serviced by a licensed electrical contractor.

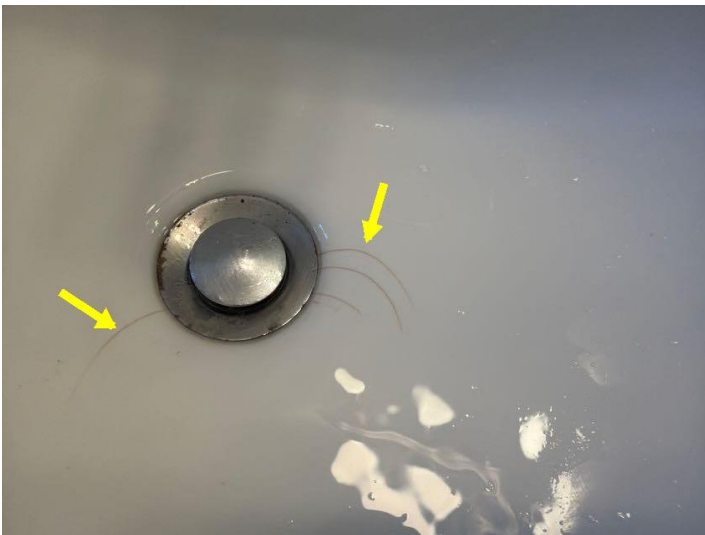
The bathroom sink is cracked but not leaking, but will obviously be susceptible to leaks.

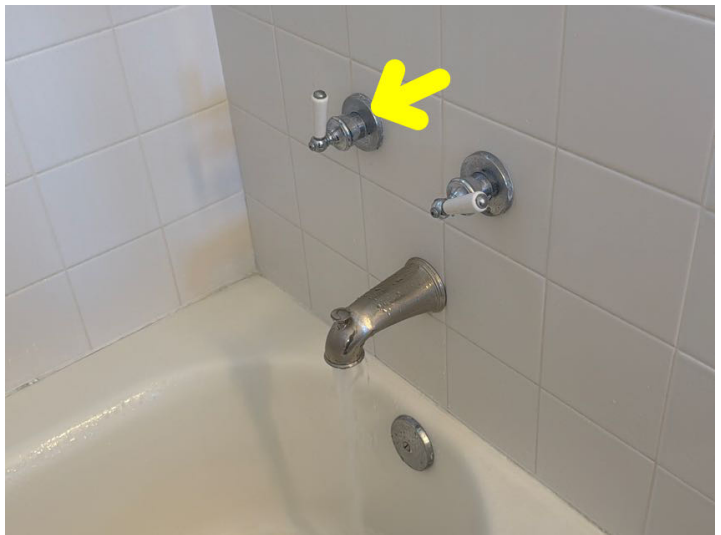
The shower valve handle is loose or does not function properly and should be serviced.

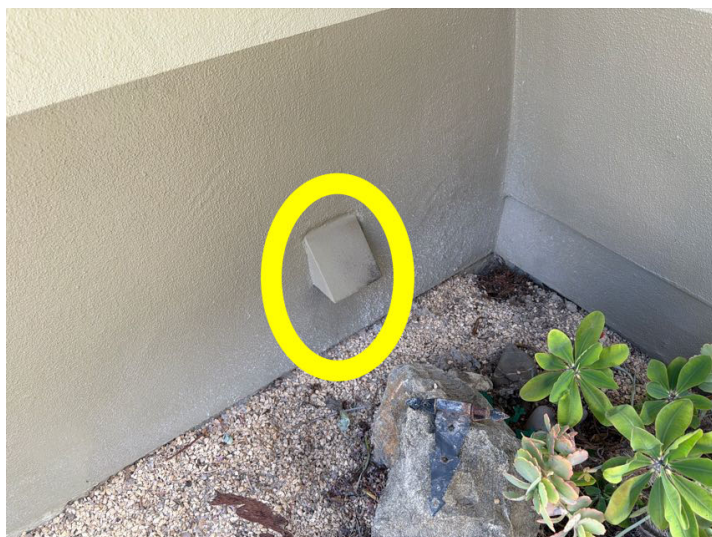
The back-draft on the exterior dryer vent cover is missing, stuck open, or incomplete and should be cleaned, repaired, or replaced.

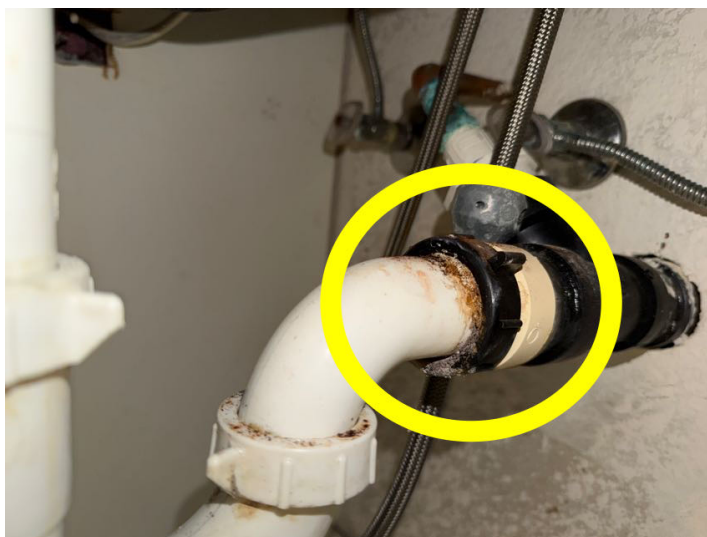
There is a leak at the drain trap arm below the sink, which should be repaired.

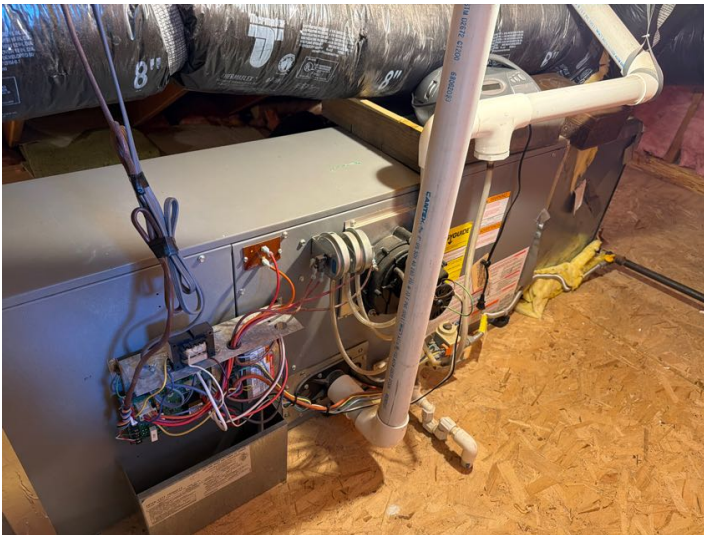
| Page 42 Item: 1 | Forced Air Furnace | 1.10. The furnace is functional. However, it is beyond the commonly accepted design life of twenty years, and will need to be monitored more closely for evidence of metal fatigue. We recommend that you have it serviced and evaluated by an HVAC contractor prior to the close of the inspection period. |

The furnace is functional. However, it is beyond the commonly accepted design life of twenty years, and will need to be monitored more closely for evidence of metal fatigue. We recommend that you have it serviced and evaluated by an HVAC contractor prior to the close of the inspection period.
