# ***Cornerstone Inspection***

## **Property Inspection Report**

***6455 Cormorant Way, Avila Beach, CA 93424***  
***Inspection prepared for: Jim Hilferty***  
***Real Estate Agent: Holly Tibbles - Coast & County Brokers***

***Date of Inspection: 8/25/2026 Time: 9:00 AM***  
***Age of Home: 1994 Size: 1912***  
***Weather: Clear***  
***Order ID: 14158***

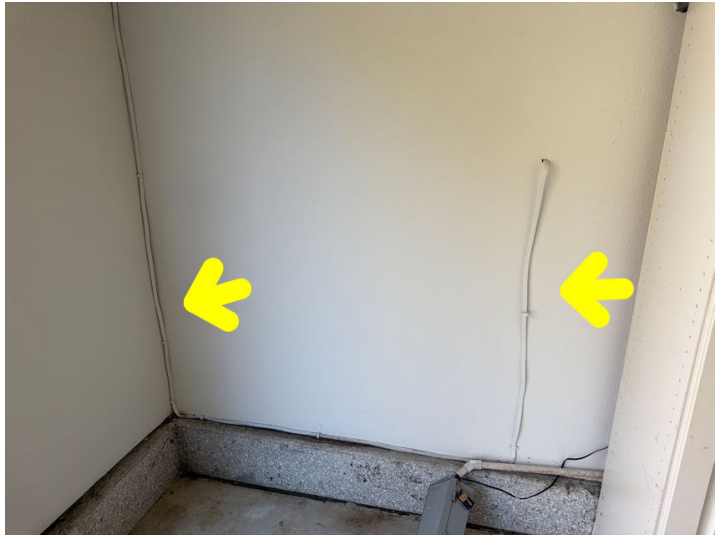
We have noted that an extension cord or extension cord material is being used for permanent wiring, which is not allowed in most jurisdictions, and you may want to have it evaluated and serviced by a licensed electrical contractor.

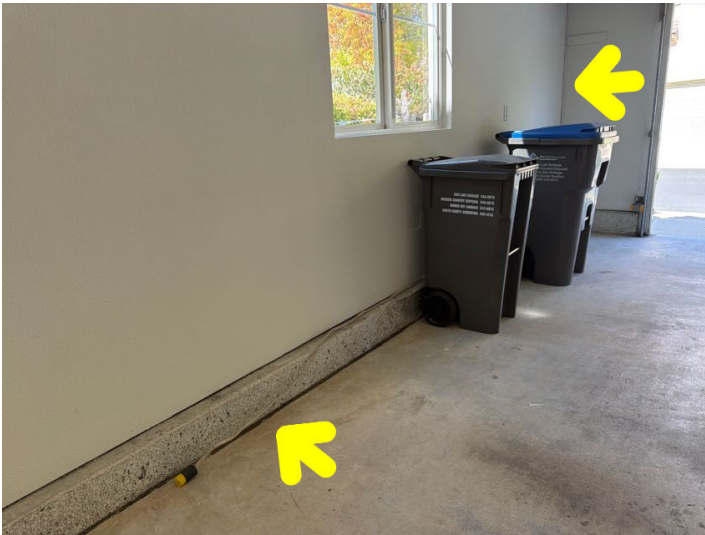
We have noted that an extension cord or extension cord material is being used for permanent wiring, which is not allowed in most jurisdictions, and you may want to have it evaluated and serviced by a licensed electrical contractor.

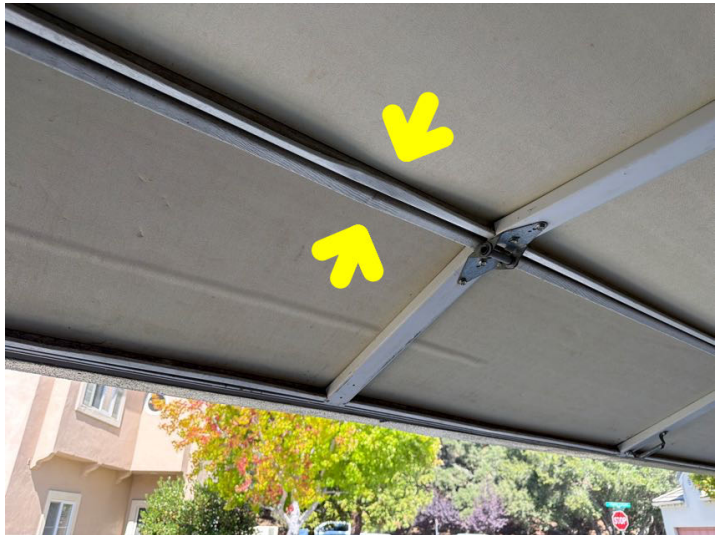
The garage door has structural damage that should be evaluated by a garage door specialist.

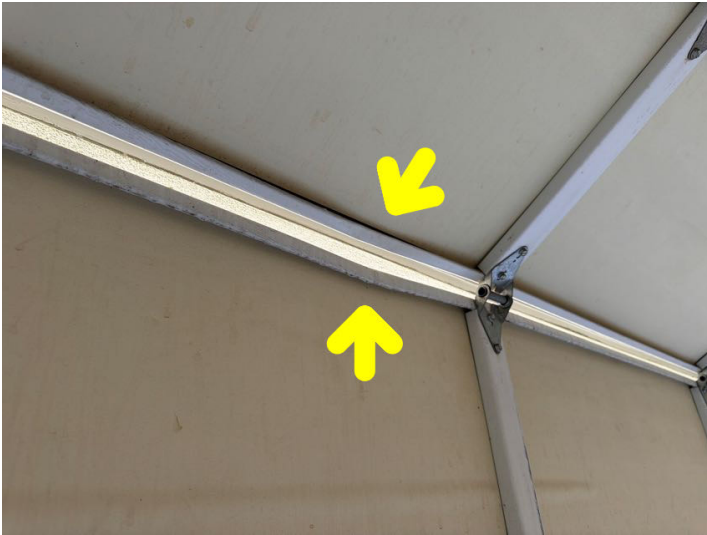
The garage door has structural damage that should be evaluated by a garage door specialist.

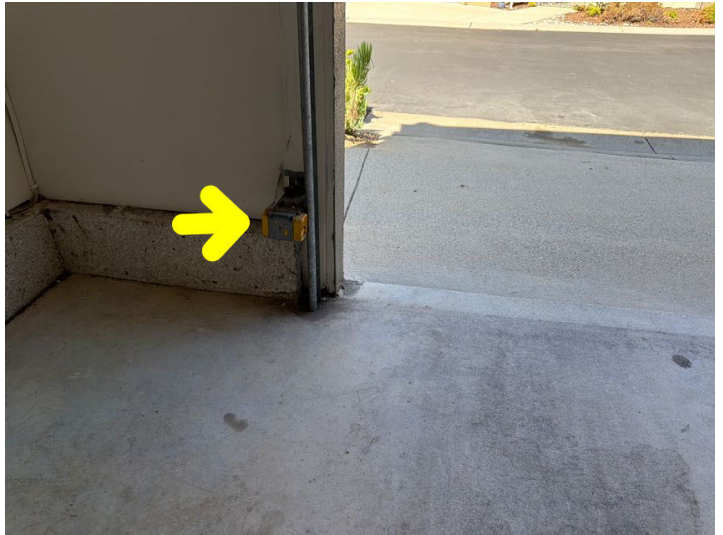
The infrared auto-reversing sensor mechanisms are functional but located higher than the recommended six inches above grade.
