## Home Inspection Report

**123 Davis Drive  
Reedville, VA 22539**

**Date of Inspection: 09/03/2026**

Inspection No. 28188-12371

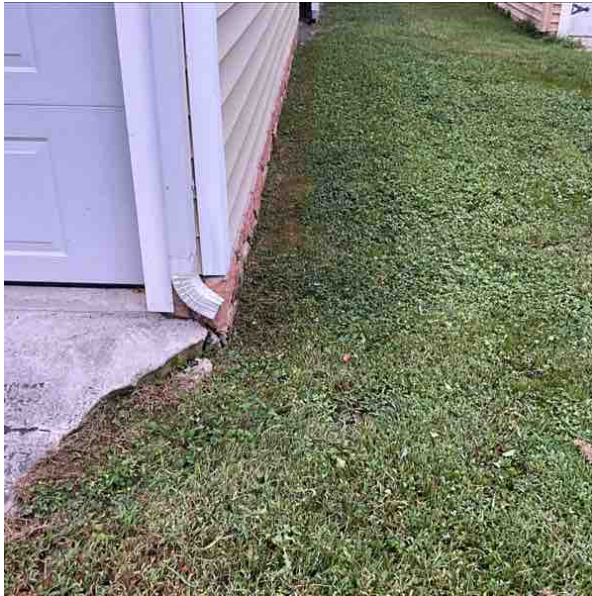
2.1.2 Low areas are present on soil along foundation. Recommend improvement of the landscape grade to slope away from foundation to ensure proper drainage of storm water away from the structure.

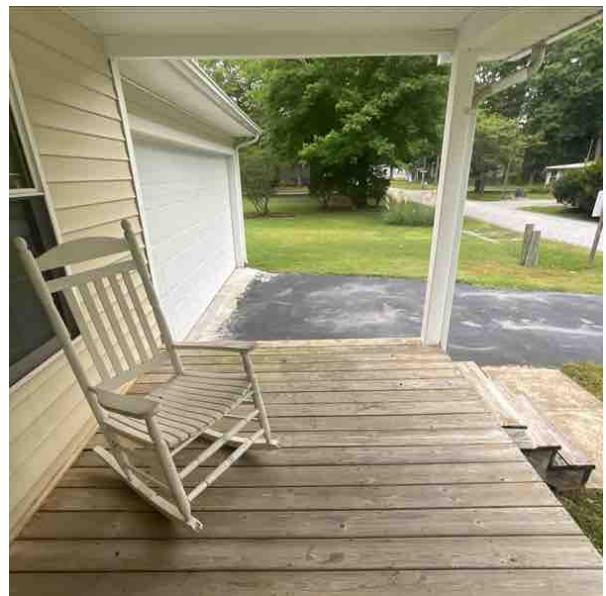
3.6.3 No rail/guard is installed at the front/sides of the porch (typical for a house this age). Recommend installing g an appropriate rail/guard as a safety upgrade.

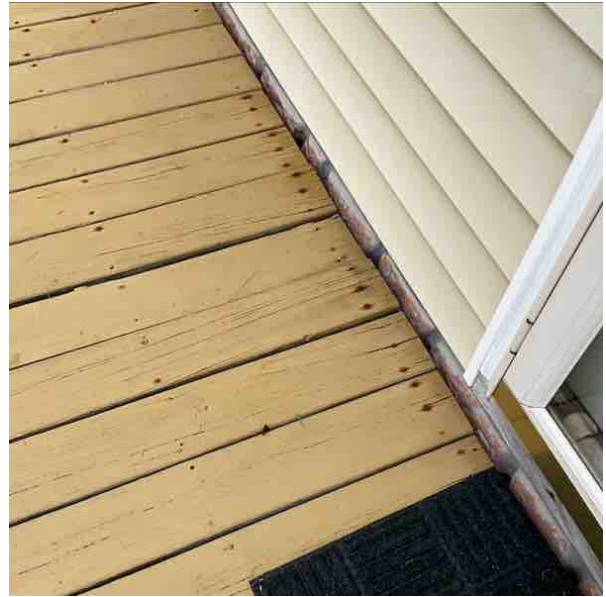
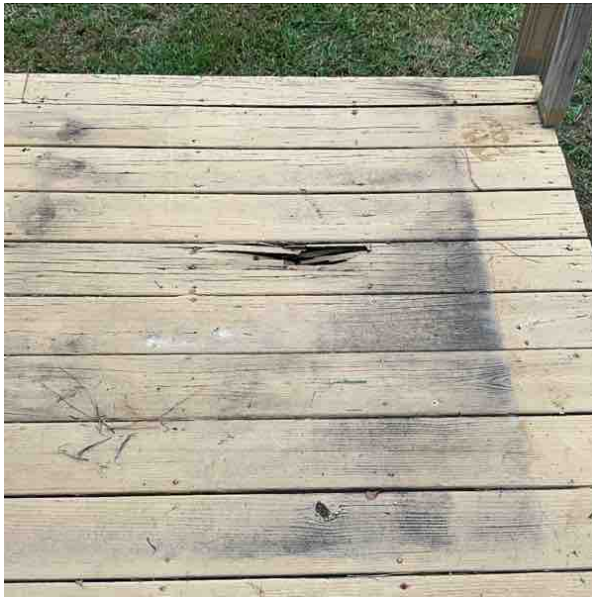
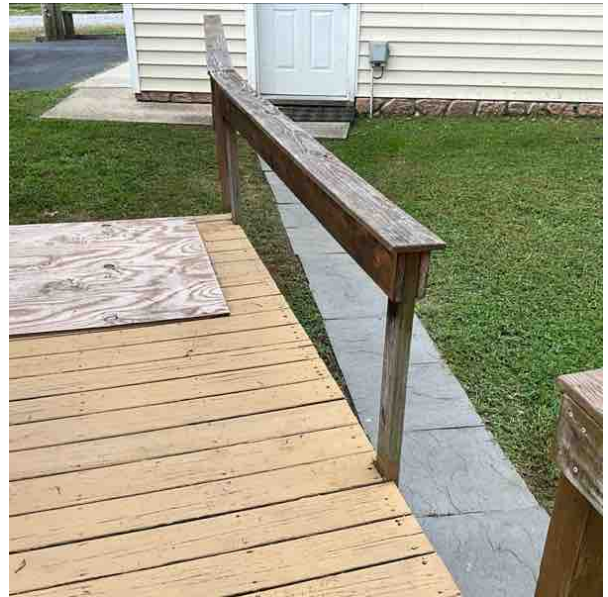
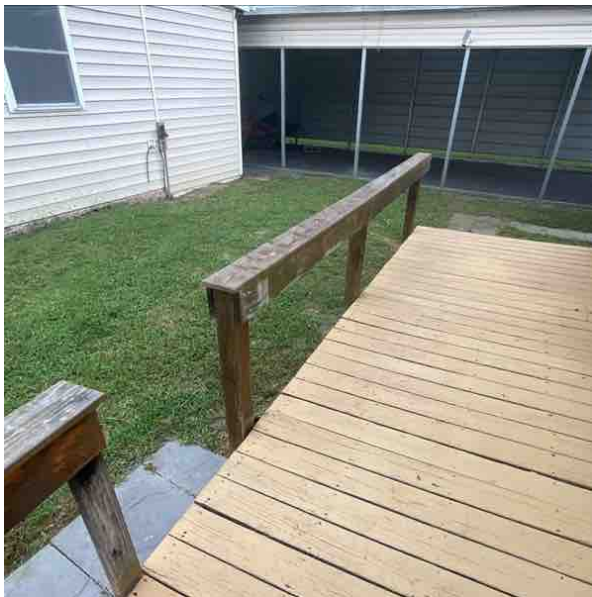
- moisture damage/deterioration is visible on several floorboards
- guardrails are loose

**3.7.1 Inspected****3.7.2 Recommend maintenance/repair of the deck by a qualified contractor:**

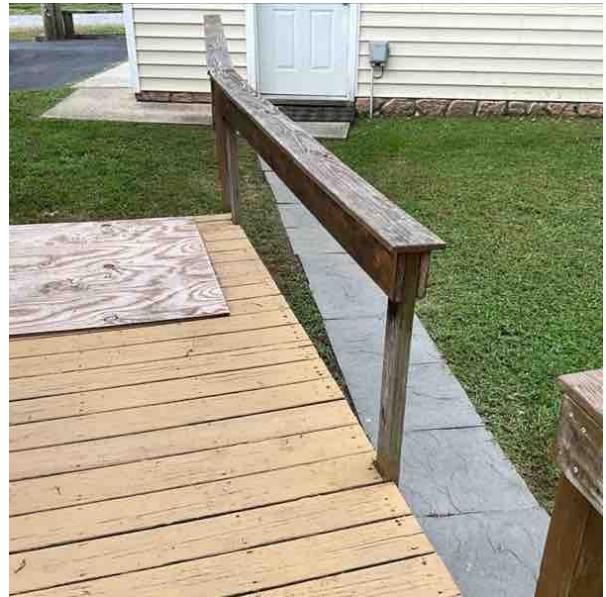
3.7.3 Although some deck building practices present may have been acceptable at the time of construction, new design applications, hardware and building practices have been developed for improvement for deck safety including but not limited to:

- height of guardrails at deck is considered low
- no balusters are present on guardrails

Recommend contacting a qualified deck builder to determine costs associated with improvements as a safety upgrade.

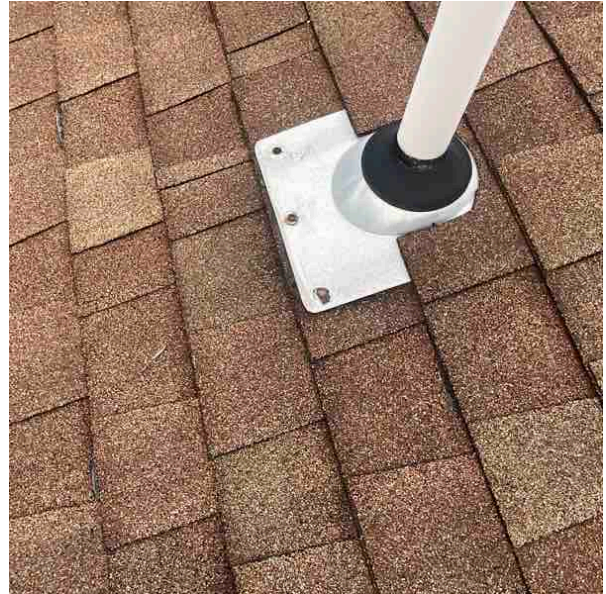
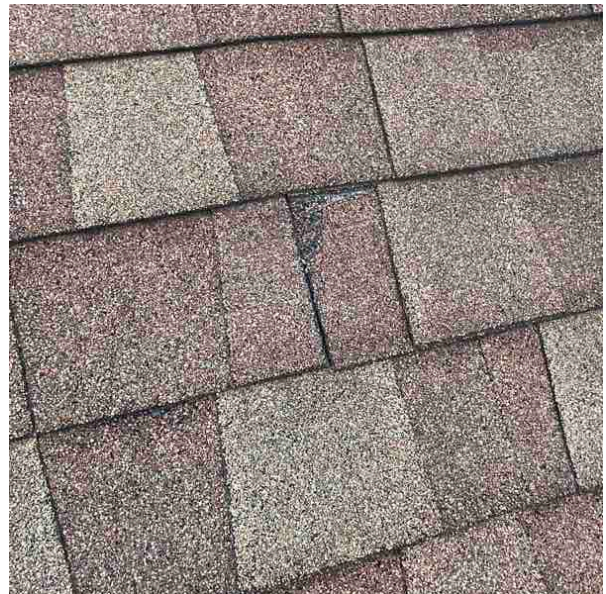
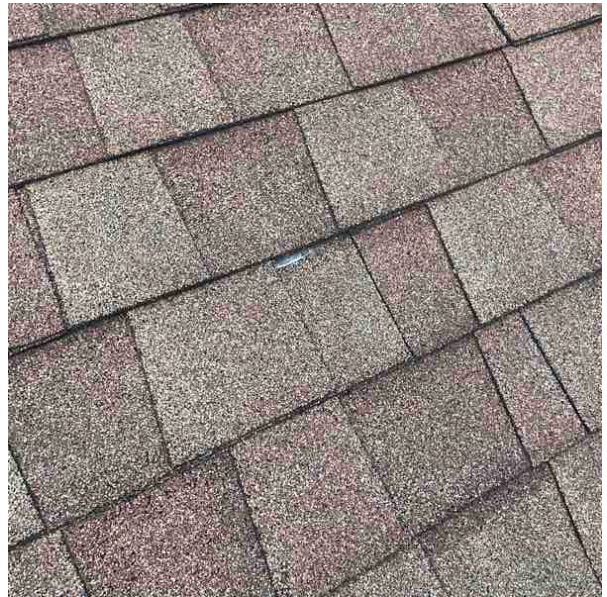
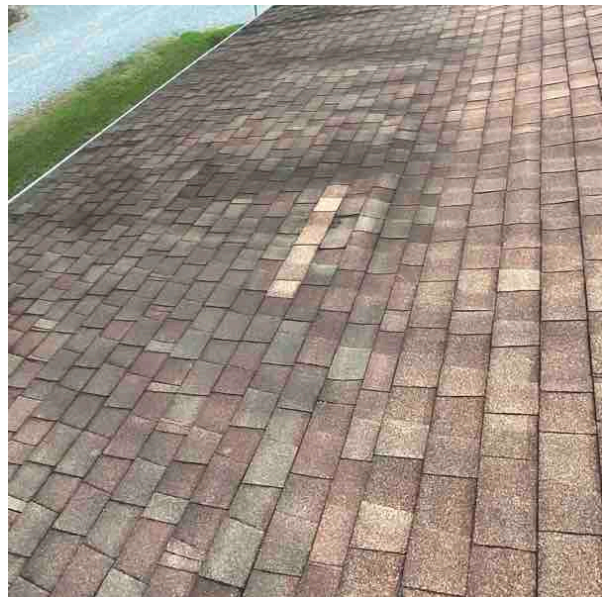
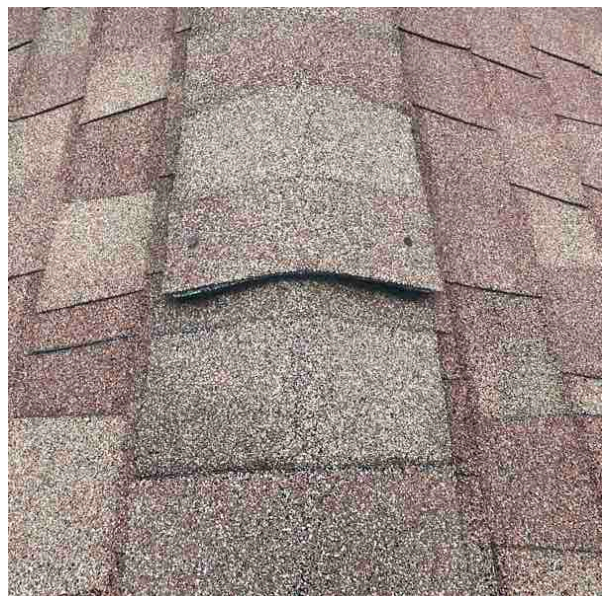
- sheathing is uneven at front roof section, previous repairs on shingles are visible
- Exposed fasteners are visible on flashings/ridge vents
- Wear/damaged shingles are present at several areas on the roof covering, roof appears to be at the end of its typical service life
- Determine if shingles are rated for the low slope section at front of house
- Raised shingle/nail pop is visible at front roof section
- Moisture stains are visible on the roof sheathing at several areas (visible in attic)

**4.3.2 Recommend maintenance and repair of the roof by a qualified roofing contractor:**

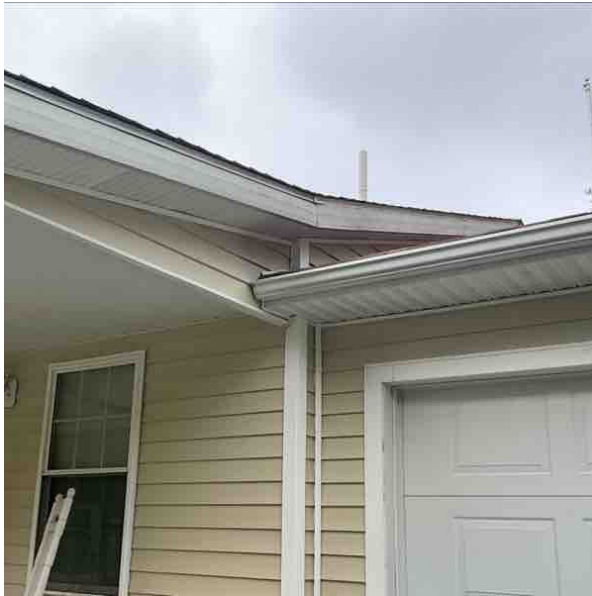
4.4.2 No kick out flashing is present at roof to wall contact. Recommend installing kick out flashings at roof terminations to walls to limit risk of water entry behind siding and subsequent moisture related damage over time.

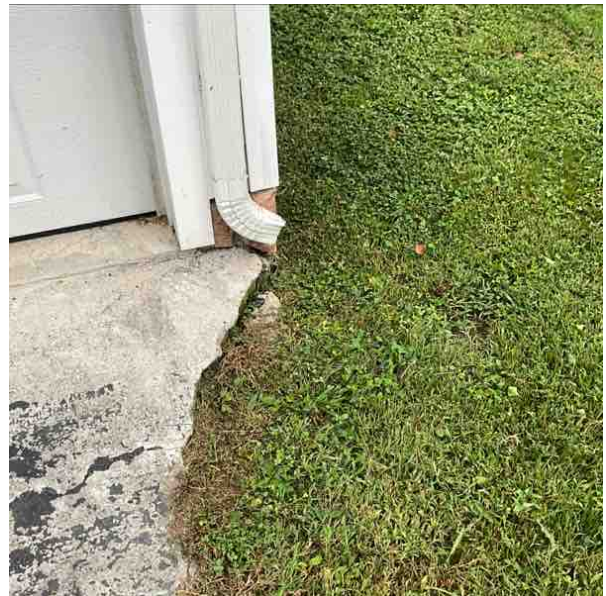
4.5.2 Downspout(s) discharge at or near the foundation. Recommend extending downspouts to discharge storm water away from the foundation.

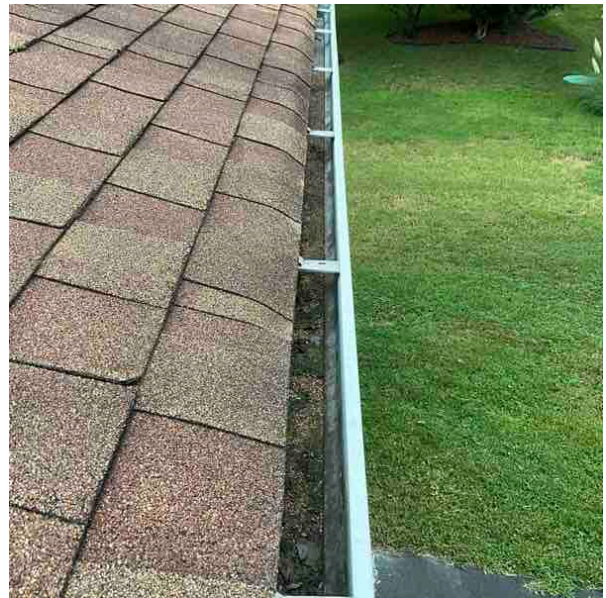
4.5.3 Gutters are full of debris, recommend maintenance\cleaning as needed for proper drainage of storm water from the roof.

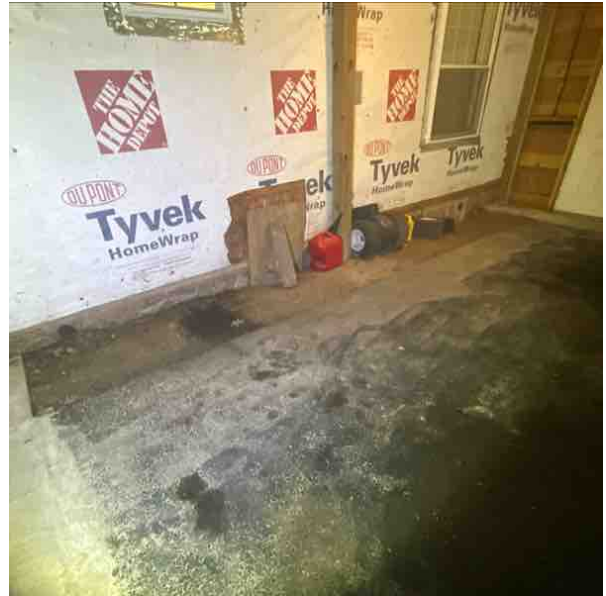
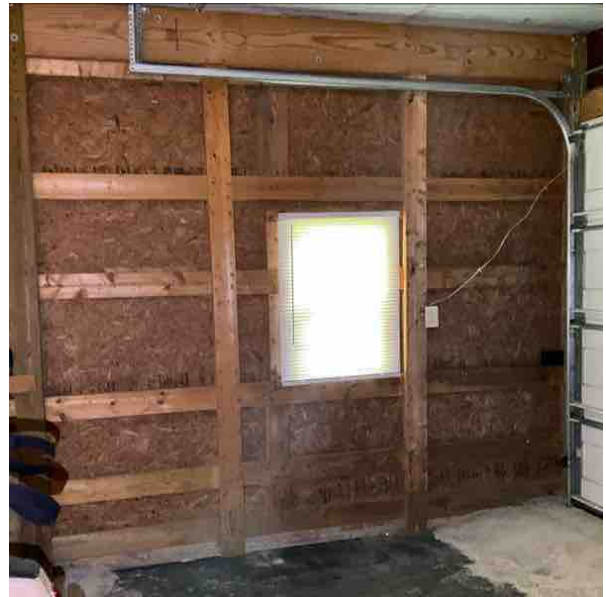
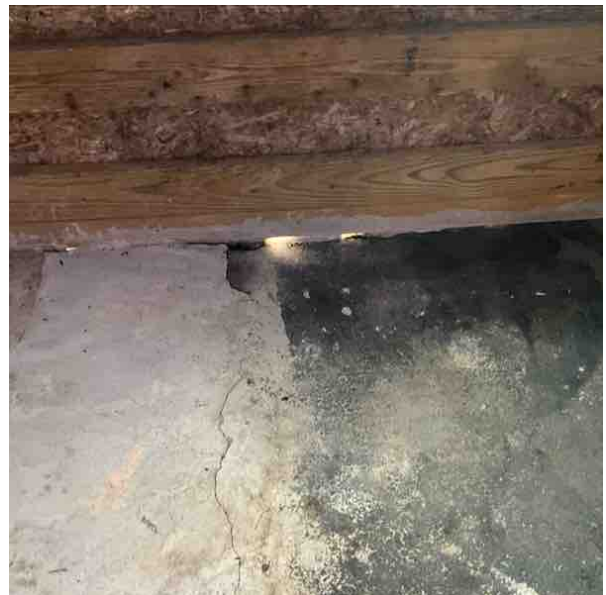
6.1.2 **Garage has been constructed over existing asphalt driveway, which is unusual. Several construction practices are nonstandard (header has been cut/modified above garage door, windows do not appear to be properly supported, openings/gaps are visible around bottom of perimeter at several areas), recommend repair by a qualified contractor. If available obtain any permits that may be obtained from the local county records.**

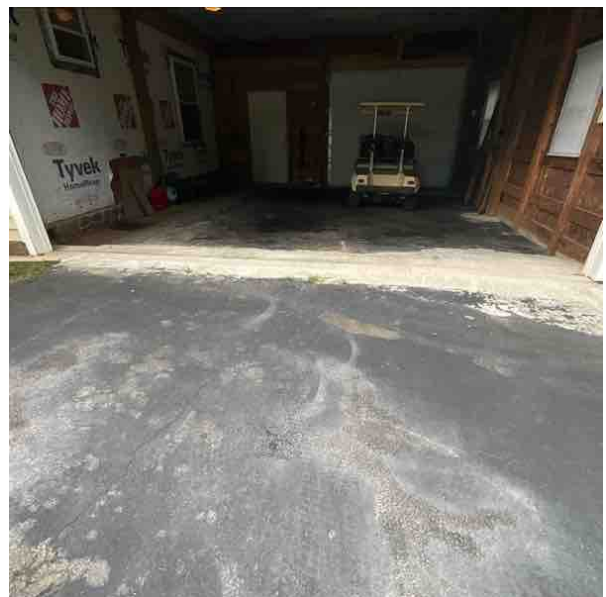
6.1.3 Concrete apron at garage is uneven, which may allow water to enter into the garage/crawlspace, recommend repair as needed.

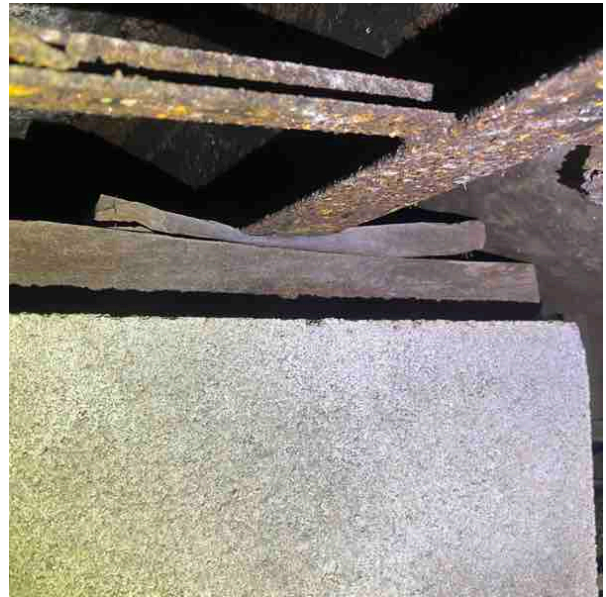
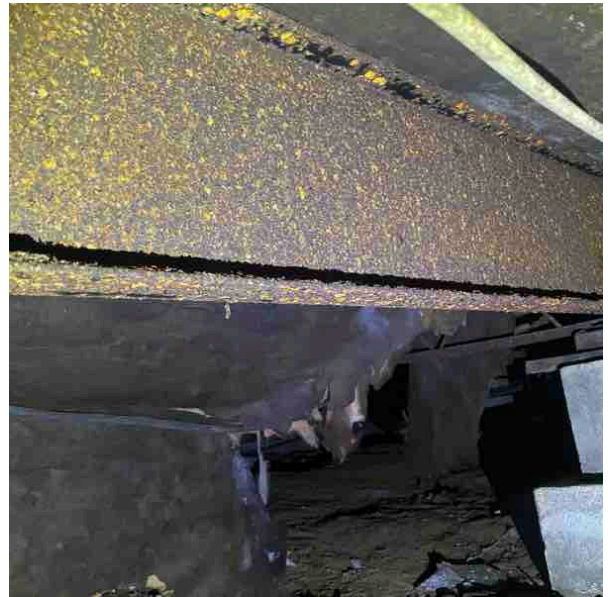
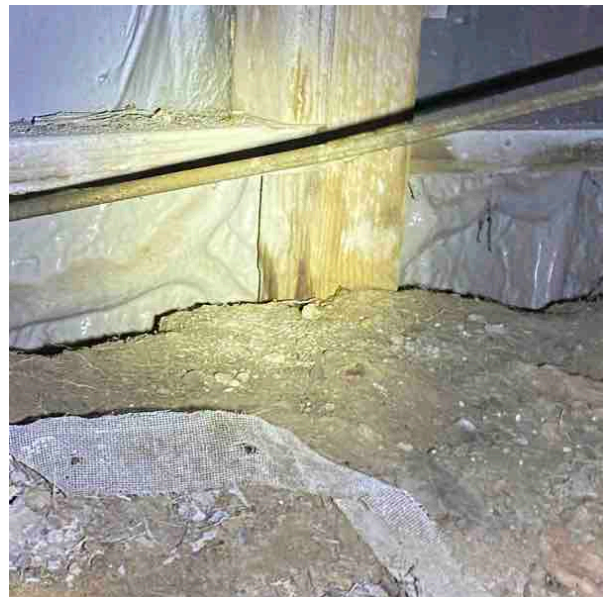
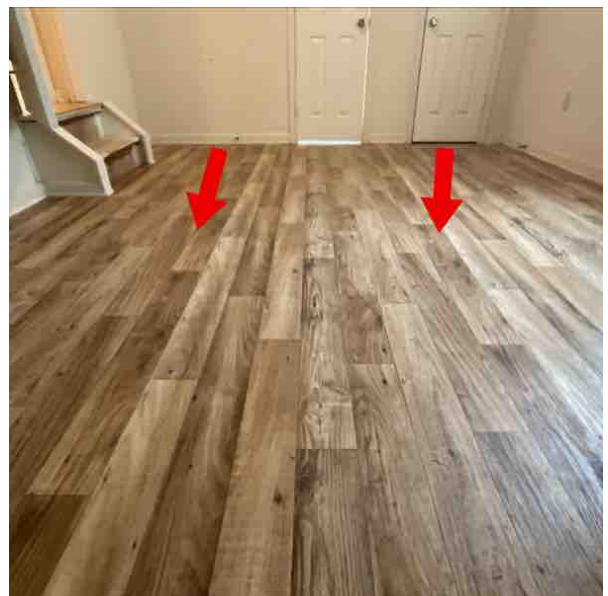
- masonry columns are leaning/out of plumb
- Wood shims are decompressed and do not appear to be effective, floors are uneven at house interior
- Rust/corrosion is visible on steel frame/chassis
- No hurricane tie downs were visible in the crawlspace
- Wood in contact with soil may increase risk of termite activity

**7.2.2 Recommend further evaluation of the foundation/crawlspace by a qualified contractor, the following was observed:**

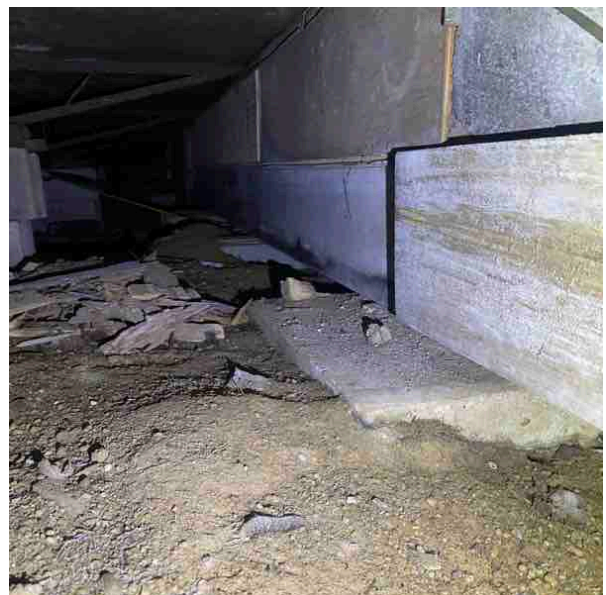
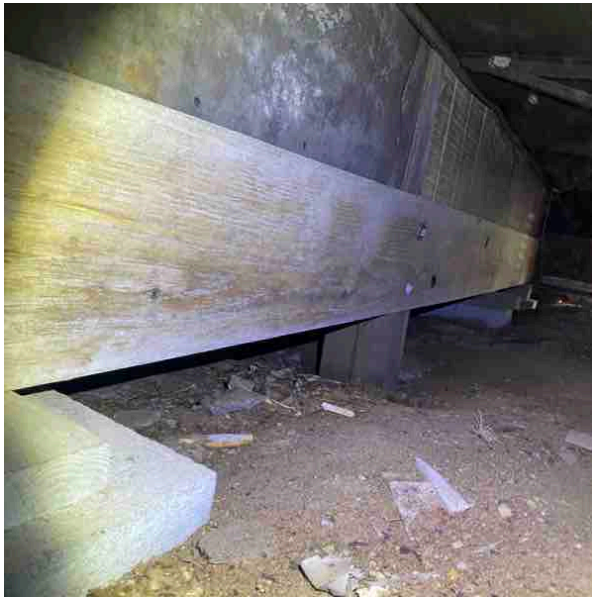
8.4.2 **Crawlspace access is present in the garage. The crawlspace was accessible along the front of the house. Beam sections along the middle of the house/low clearance restricted access to the rear half of the crawlspace. No accessible crawlspace access was present for the rear of the house. Recommend installing access for monitoring/service purposes.**

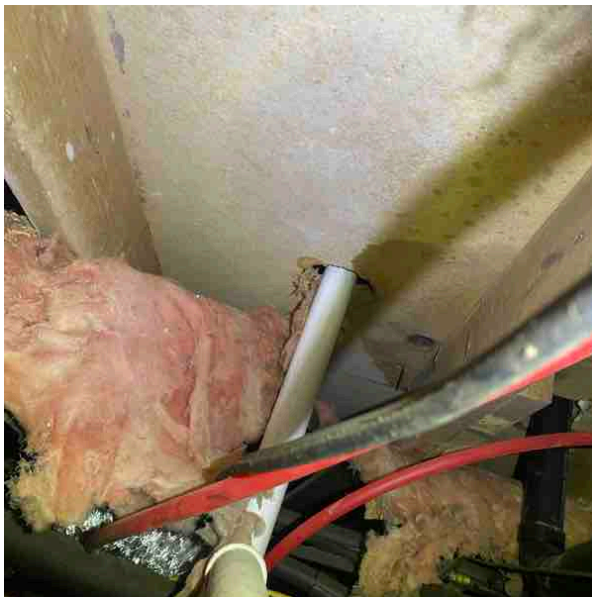
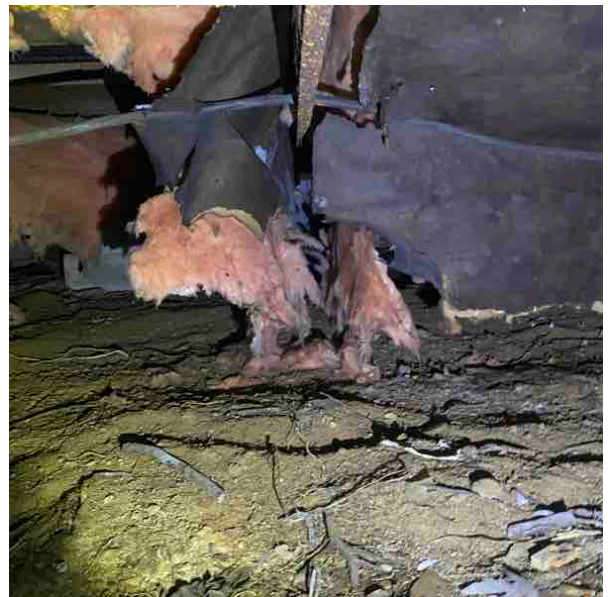
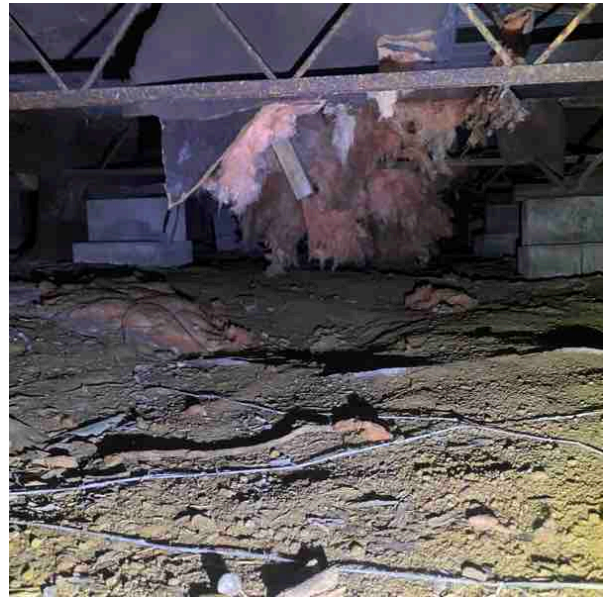
8.6.2 **Insulation is loose/damaged and has fallen in several areas throughout the crawlspace interior. Recommend removal of all insulation that has fallen, secure insulation where loose and install new insulation in areas where missing.**

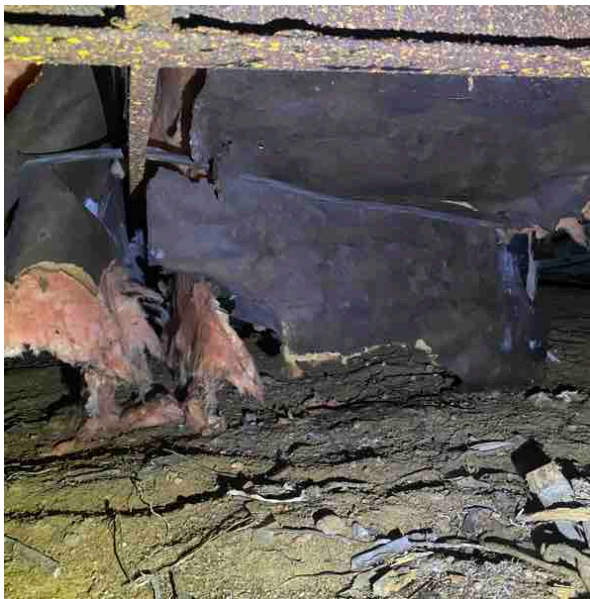
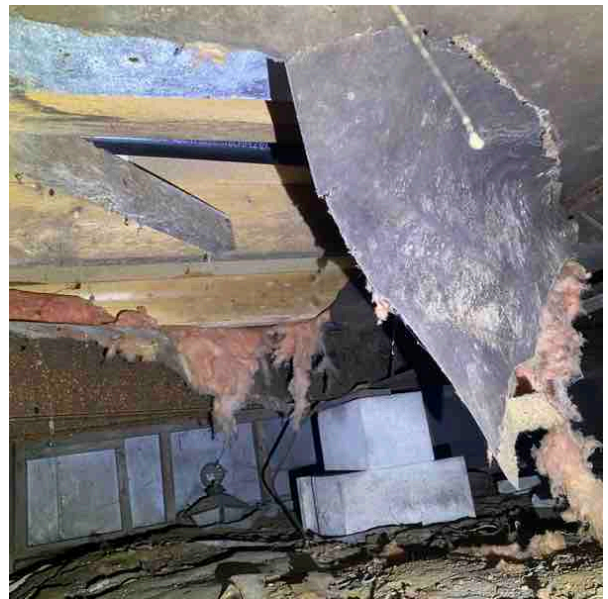
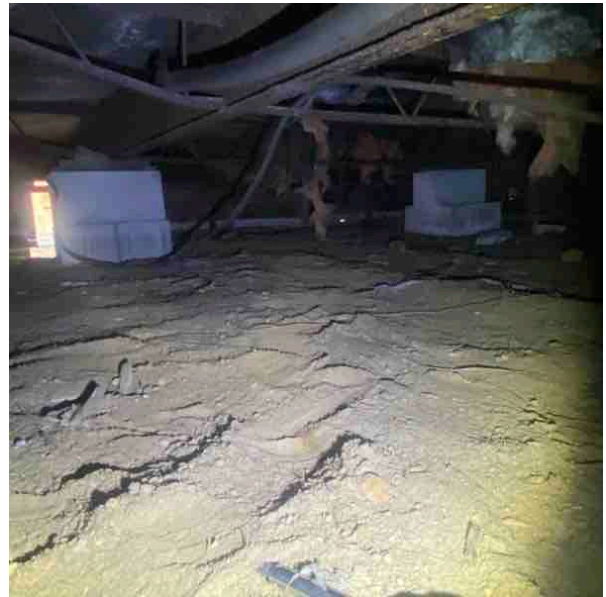
8.7.2 **Belly wrap/vapor barrier is damaged/fallen/missing at several areas throughout the crawlspace, recommend repair/replacement to seal all of the underside of the house to limit risk of moisture related issues over time.**

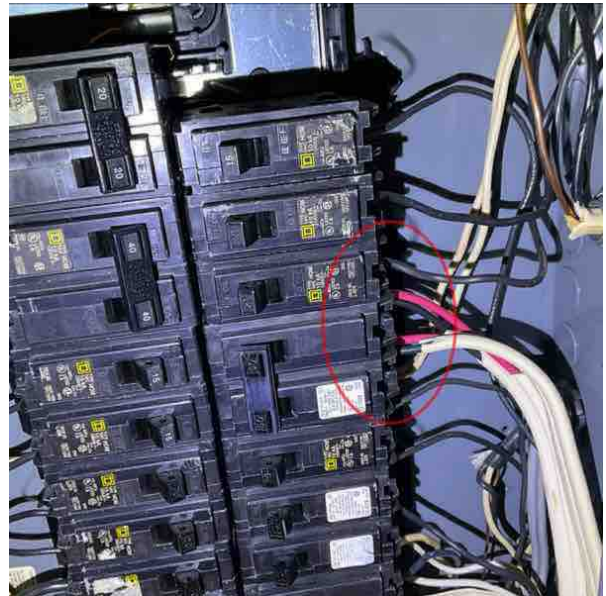
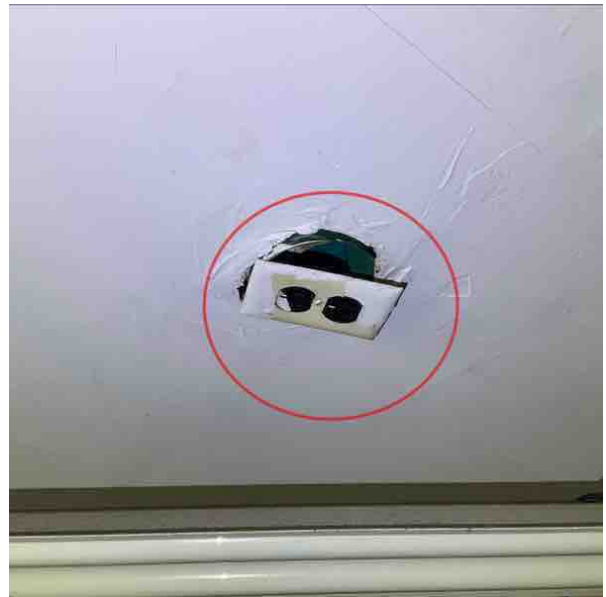
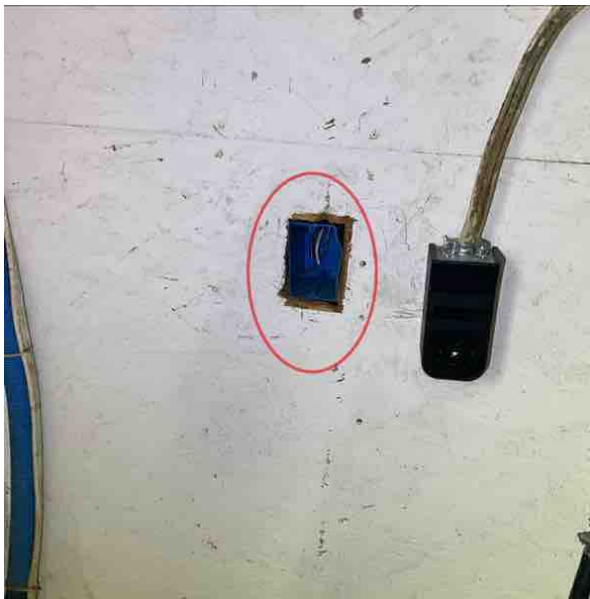
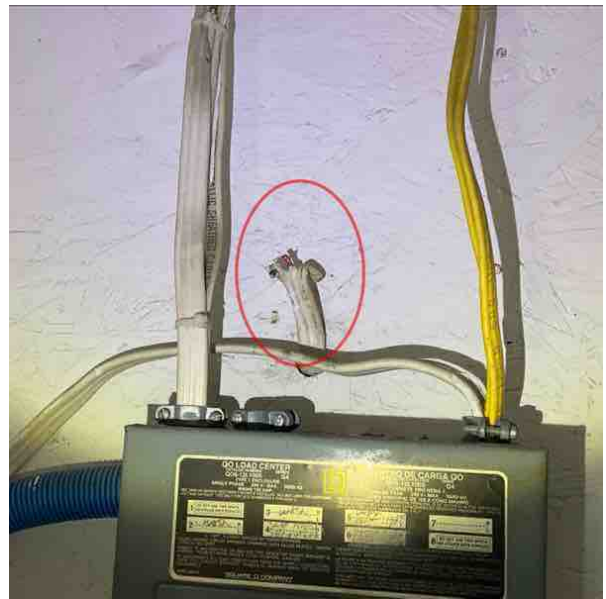
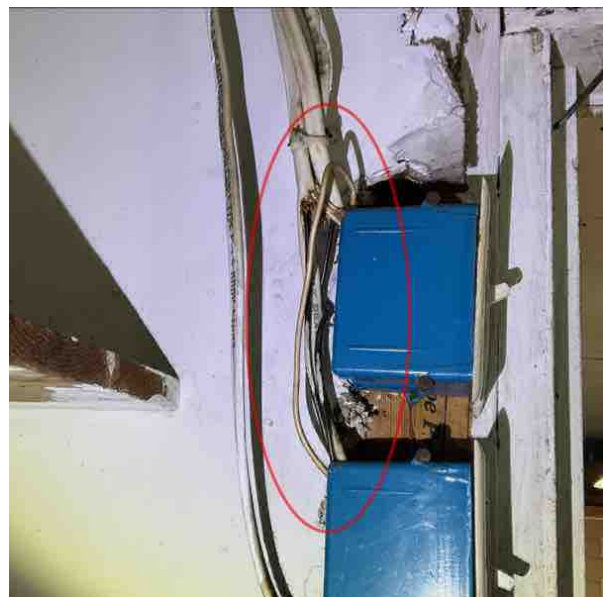
- note states "breaker #5 has a broken neutral between panel and hallway switch"
- double tapping is present on breaker(s) at main electrical panel and detached garage sub panel
- junction box is not properly secured/installed at workshop and crawlspace (below office/den)
- Cover is missing on junction box at workshop
- Open wiring is visible above subpanel at workshop
- Block tab is missing on subpanel at work shop
- Sheathing has been excessively removed at outlet in workshop

9.5.2 Recommend further evaluation of the electrical system by a qualified electrical contractor, the following items were observed:

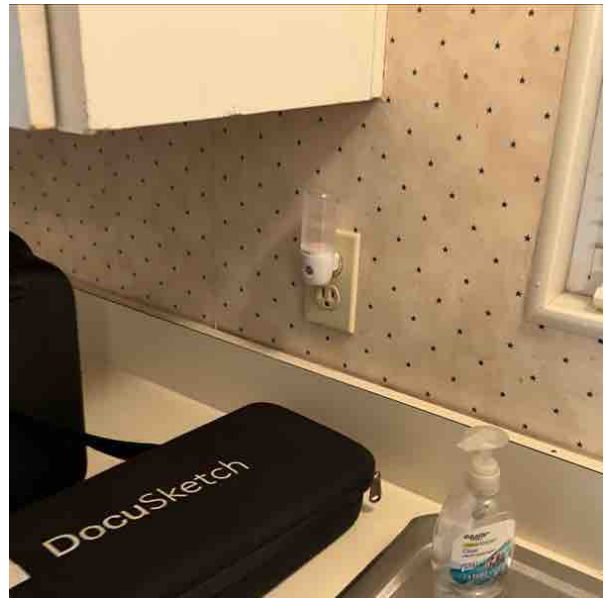
9.10.2 No GFCI protection is present on the receptacles in the garage\kitchen\hall bathroom, which is typical for a house this age. Recommend installation of GFCI protection as a safety upgrade.

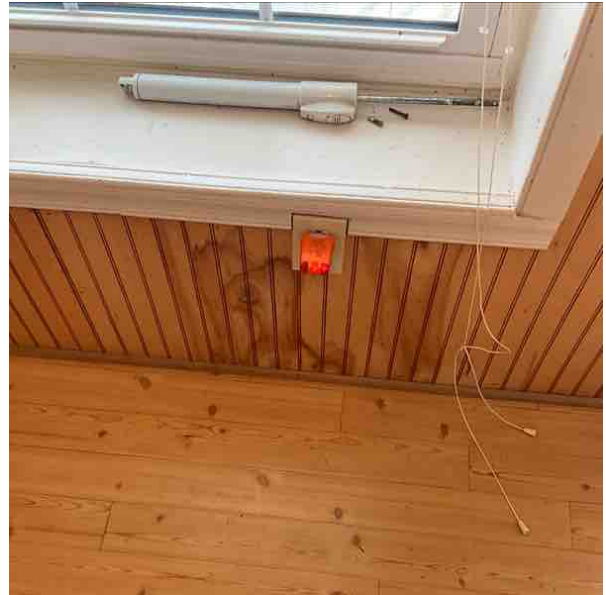
9.10.3 Wiring is reversed on kitchen receptacle below window, recommend repair to limit risk of shock.

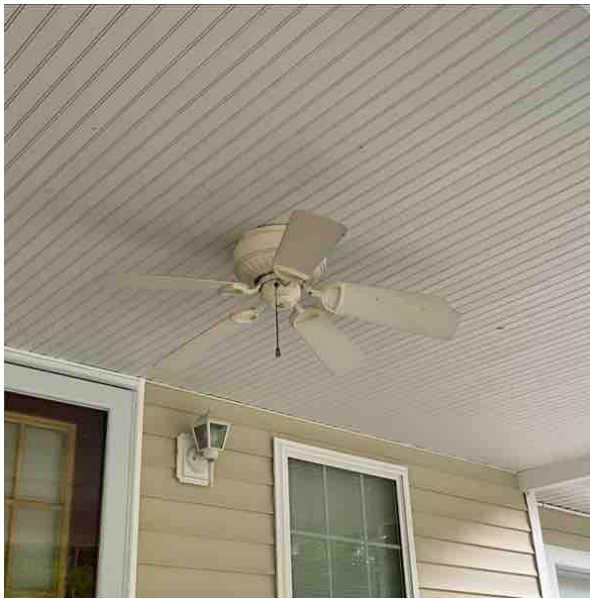
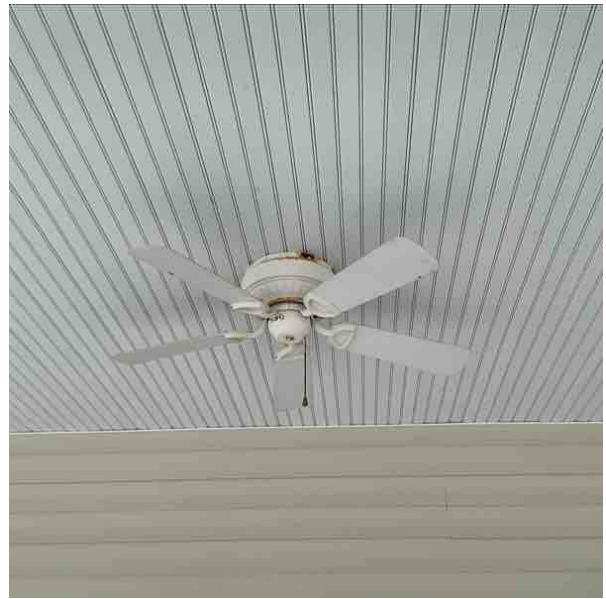
9.11.2 Corrosion is visible on exterior ceiling fans at front porch, recommend maintenance/repair.

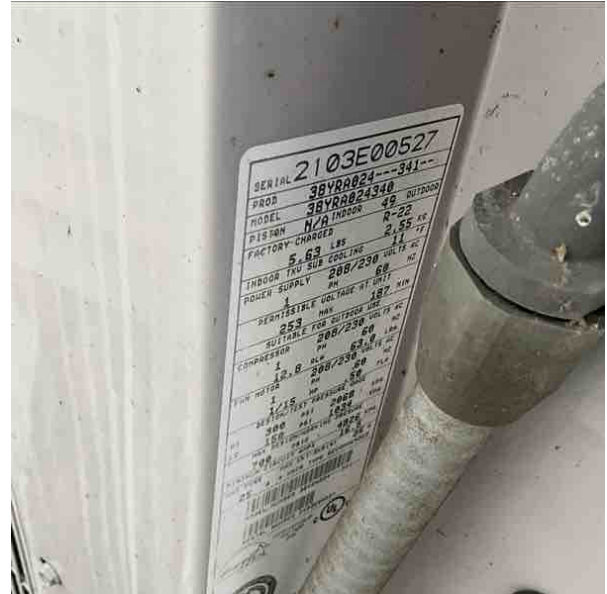
Refrigerant in use for the HVAC system is R-22. This refrigerant has ceased manufacture in 2020 which is likely to increase the cost of repairs. Recommend inquiring with a qualified HVAC contractor for estimate of costs associated with system replacement.

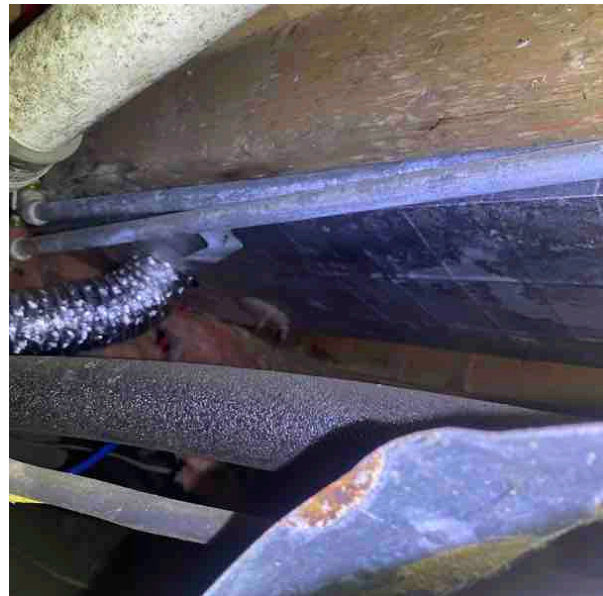
11.3.2 Older Homes - The water supply system is a combination of older galvanized pipe with some replacement copper and PEX pipes. This is typical of a house of this age. Galvanized supply piping eventually corrodes causing a drop in water flow & pressure. Recommend inquiring with a qualified plumbing contractor to determine costs associated with replacement of the pipe.

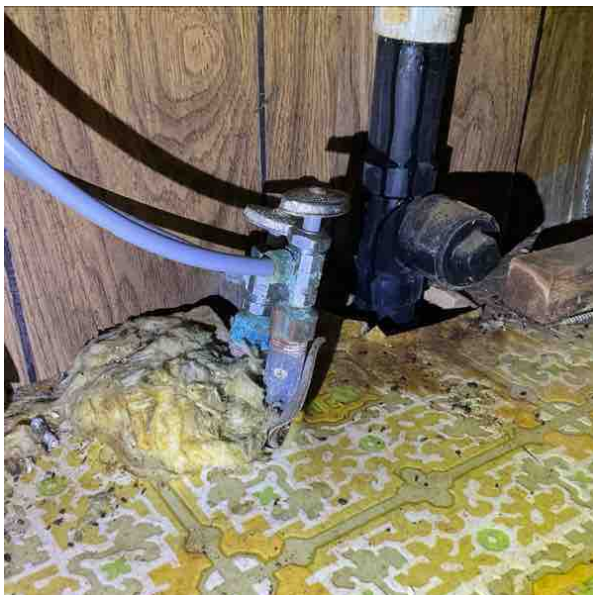
11.3.3 Corrosion is visible on water supply lines/connections below several sinks. Recommend maintenance/repair to limit risk of leaks.

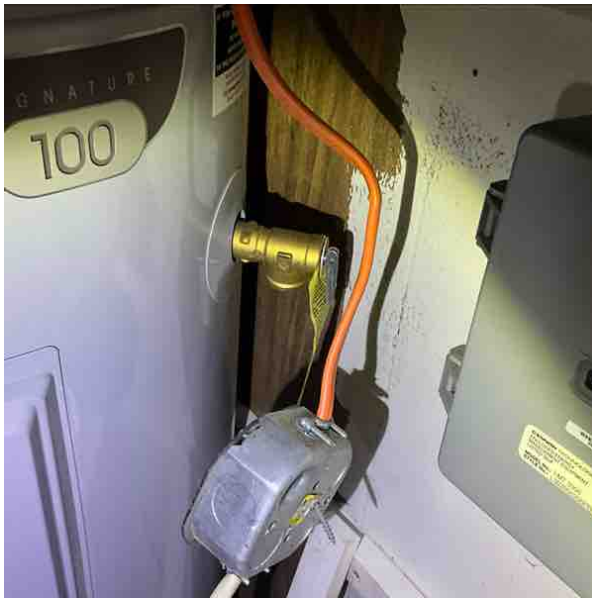
11.5.3 No discharge tube installed at the temperature\pressure relief valve for the water heater.  
Recommend installing appropriate discharge tube as required.

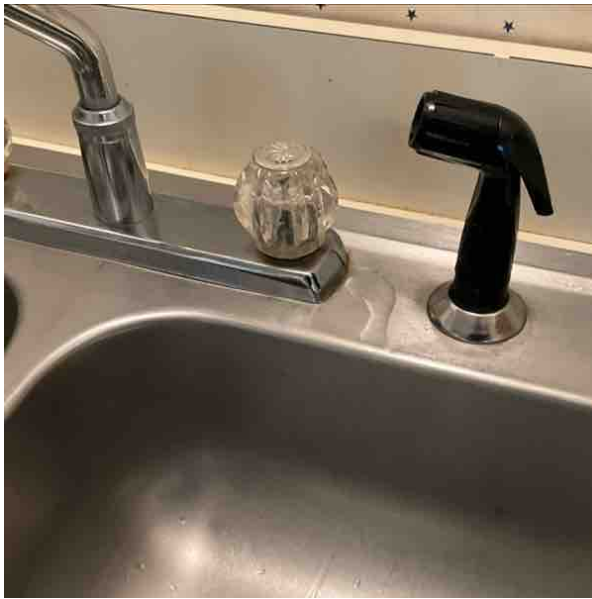
11.7.2 An active leak is visible on the faucet valve at sink, recommend repair.

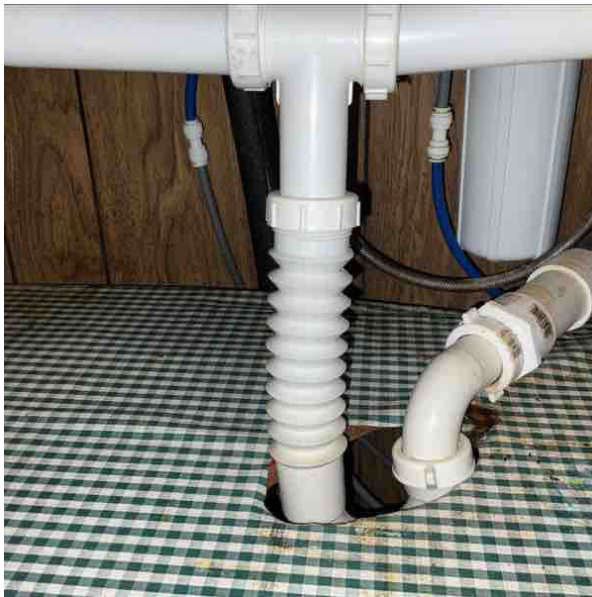
11.8.2 Flexible drain line in use below the sink is nonstandard. Flexible drain lines are prone to clog/leak. Recommend installing solid drain line to promote drainage and limit risk of leaks.

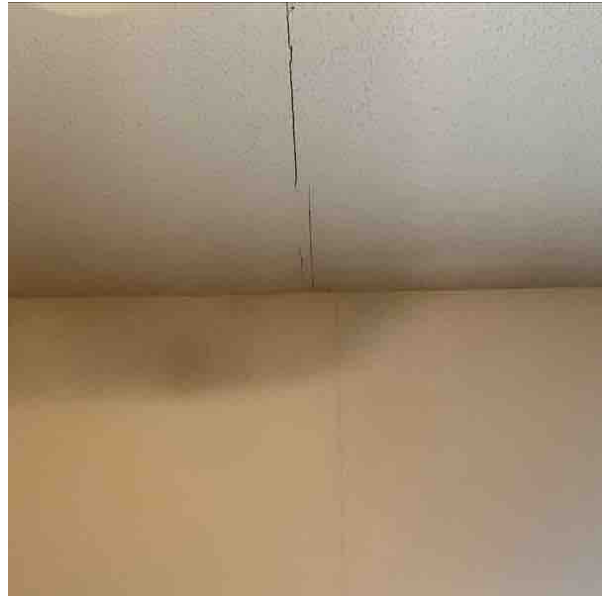
12.2.2 Minor cracks and open seams are visible on walls\ceilings at several areas on the house interior.  
Recommend repair.

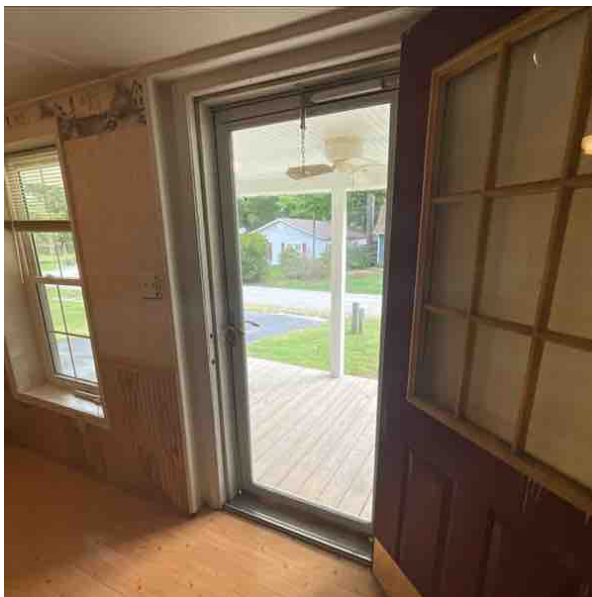
- storm door

Recommend repair to promote proper function.

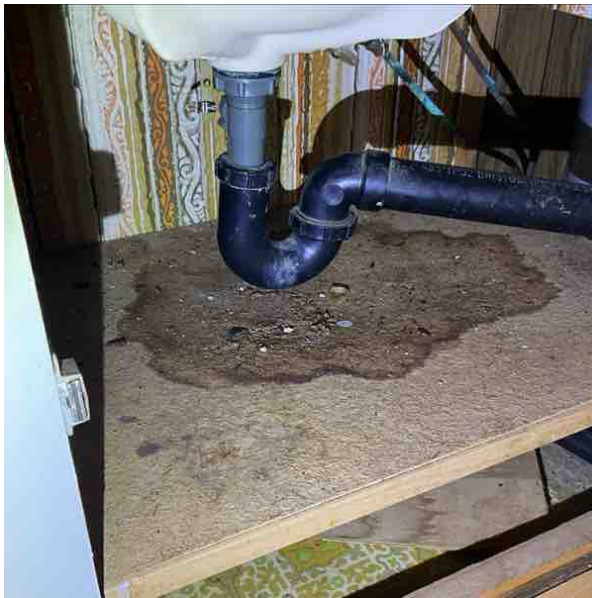
12.6.2 Stains/damage is present on shelf/cabinet below hall bathroom sink, recommend replacement of damaged materials.

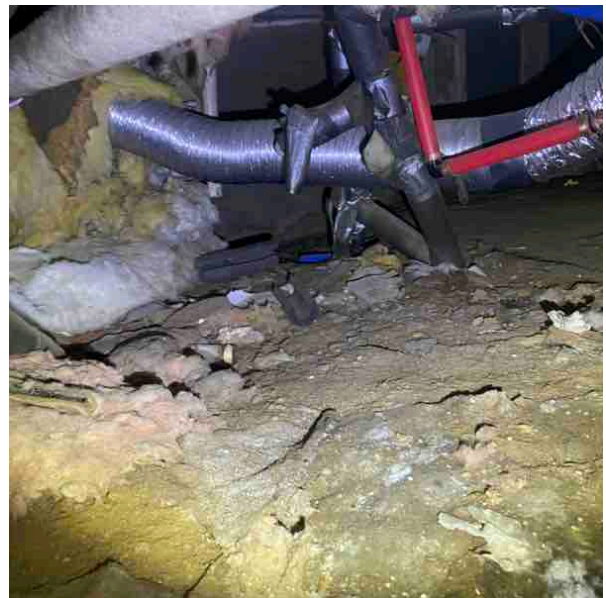
14.6.2 Flexible foil exhaust material is generally not recommended for use for dryer exhaust, recommend replacement with appropriate duct materials for safety.

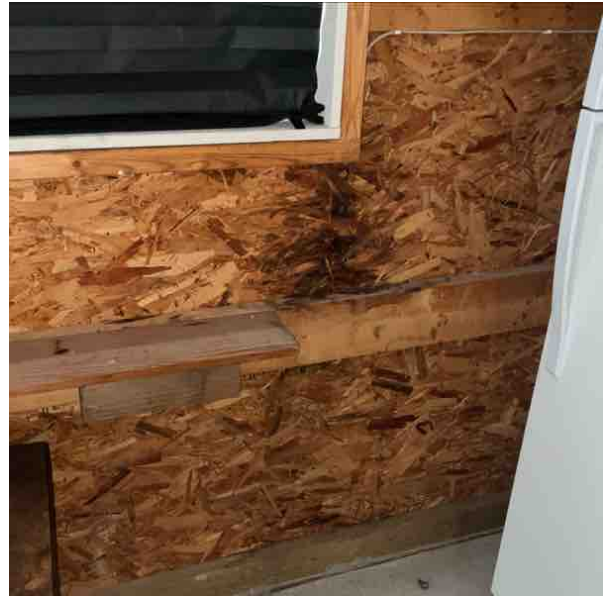
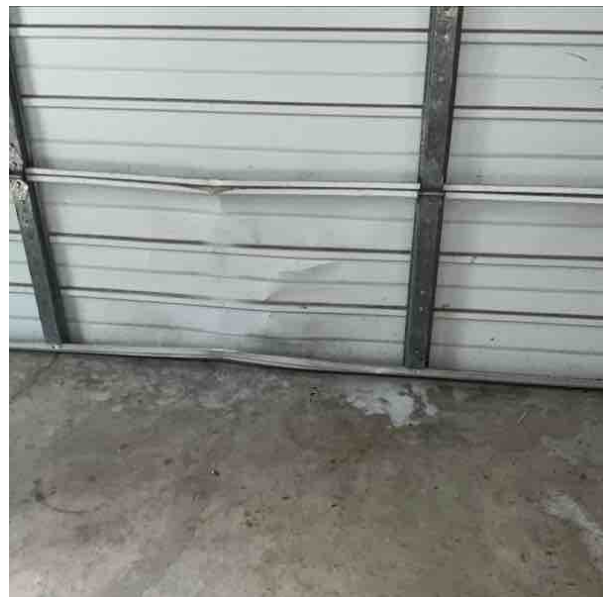
- moisture stains are visible at bottom corner of windows, which indicates water entry
- Determine if windows are properly framed/installed
- Damage is visible on detached garage door

**15.1 Detached Building****15.1.1 Recommend further evaluation and repair of the detached garage by a qualified contractor:**

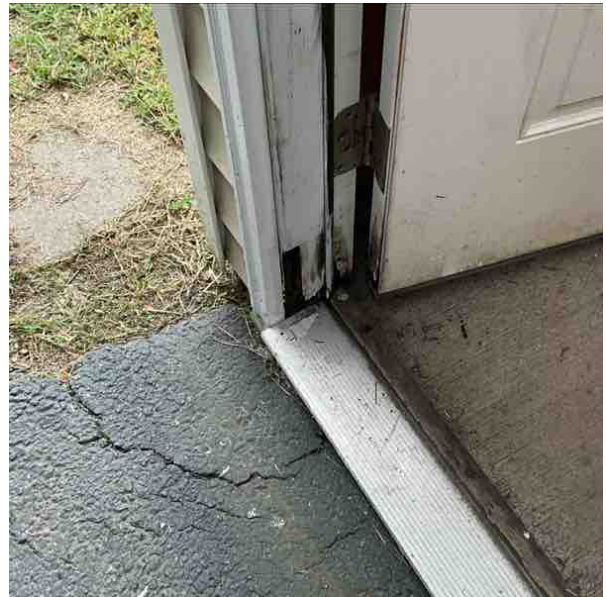
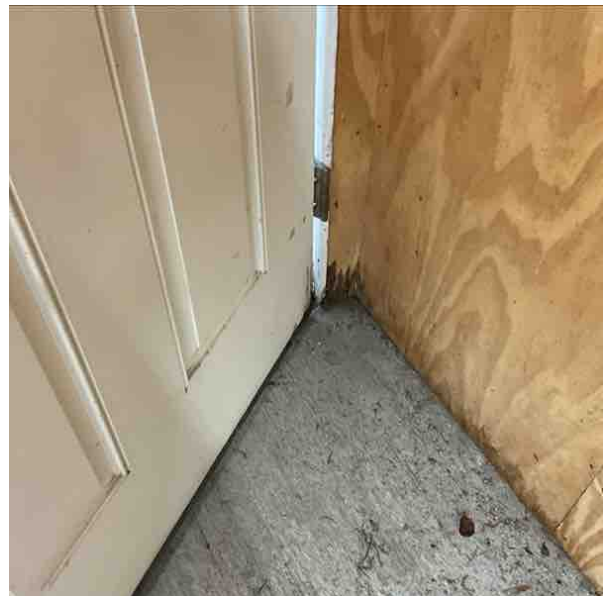
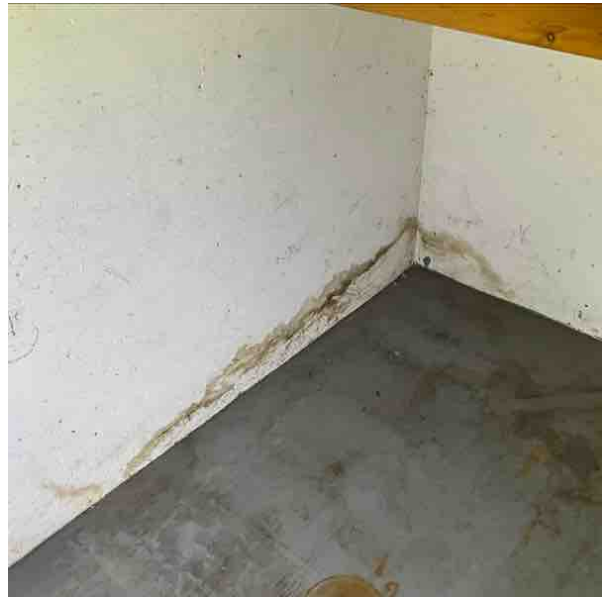
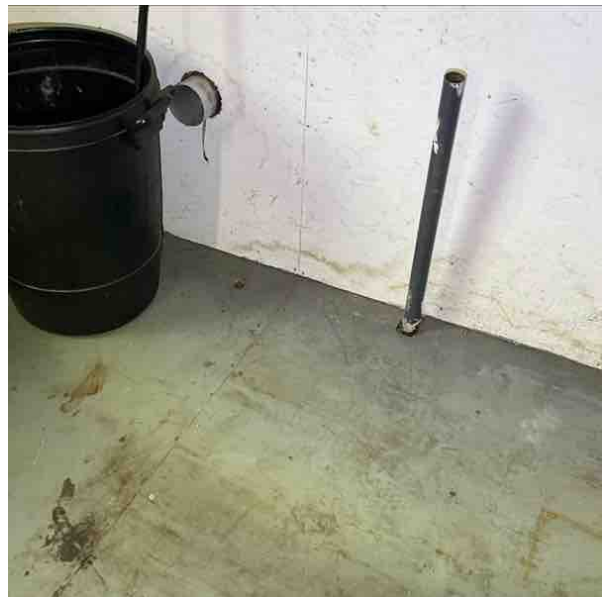
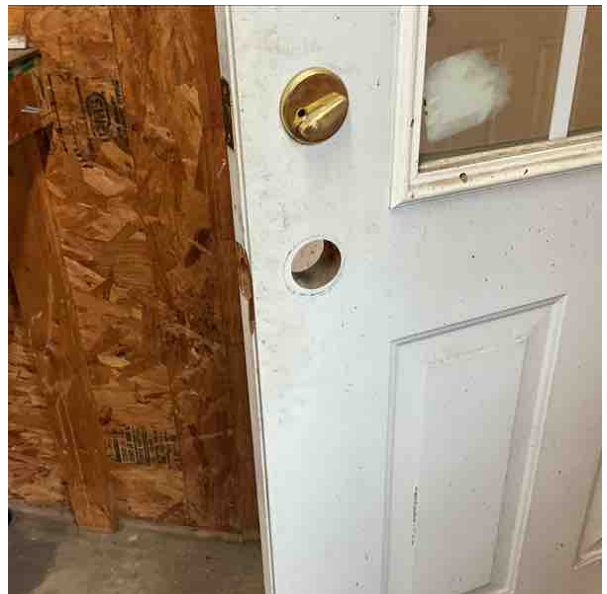
- moisture damage is visible on the frame/trim/core at the entry door
- Moisture stains are visible on walls/floors/ceiling at several areas throughout the building, which indicates water entry
- Door hardware is missing
- Ceiling fan/light is inoperable at room 2

15.1.2 Recommend further evaluation and repair of the workshop by a qualified contractor, the following items were observed:
