# ***Cornerstone Inspection***

## **Property Inspection Report**

***2191 Canvasback Pl, Avila Beach, CA 93424***  
***Inspection prepared for: Jim Efird Jeanette Efird***  
***Real Estate Agent: Holly Tibbles - Coast & County Brokers***

***Date of Inspection: 10/3/2026 Time: 9:00 AM***

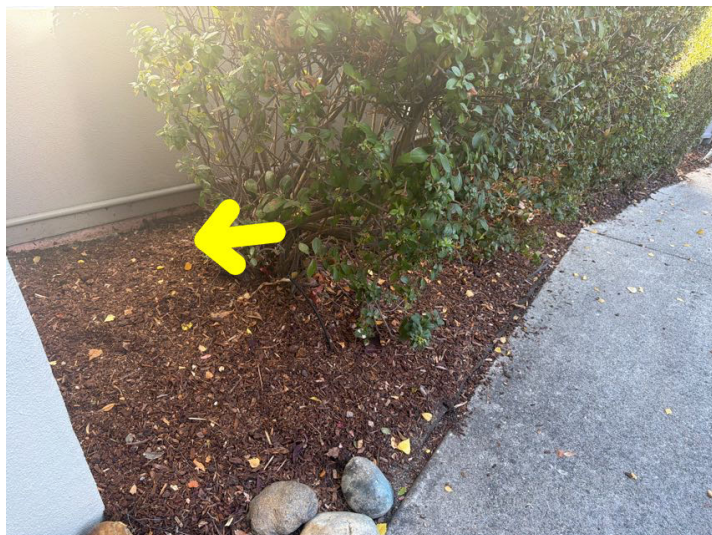
There are areas at the left side where water will be directed toward the house instead of away from it, as is recommended. This not only allows for the possibility of moisture intrusion but also for differential settling.

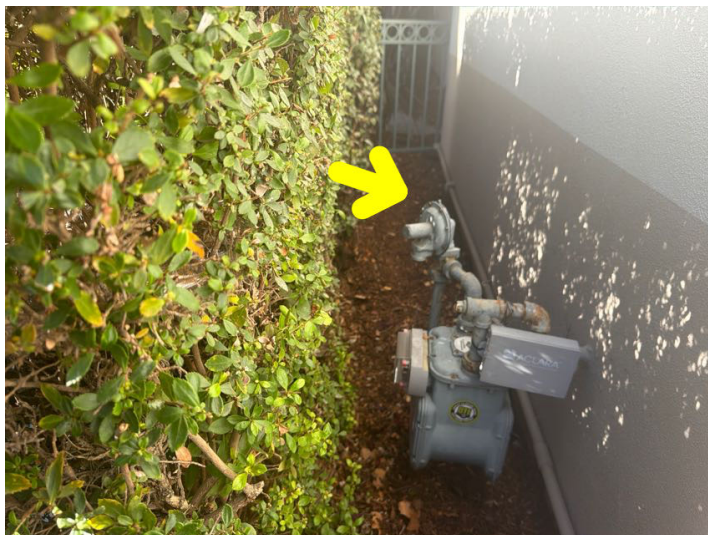
There are areas at the left side where water will be directed toward the house instead of away from it, as is recommended. This not only allows for the possibility of moisture intrusion but also for differential settling.

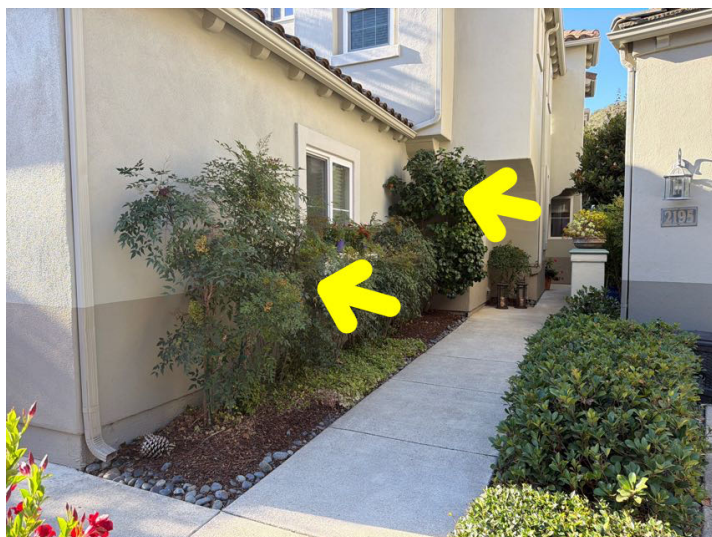
Vines, shrubs or bushes are growing on the house walls and although they are attractive they can introduce pests and rodents and accelerate deterioration. Therefore, you may wish to consider having them removed or cut back to 12 inches (30 cm) away from the home.

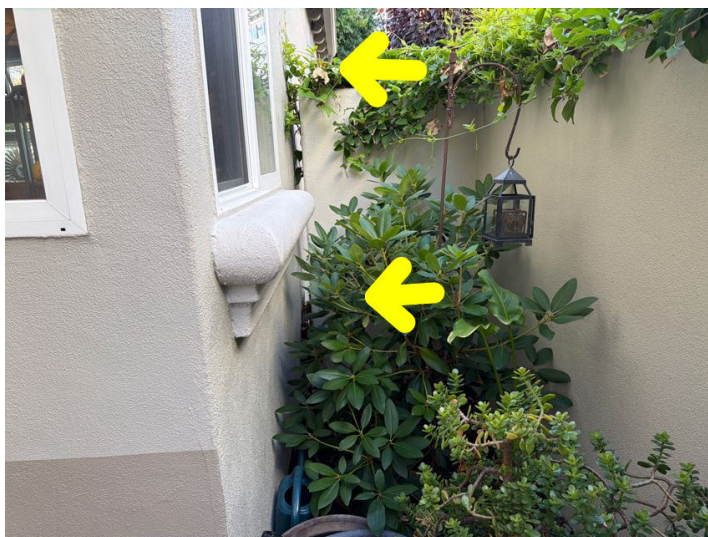
Vines, shrubs or bushes are growing on the house walls and although they are attractive they can introduce pests and rodents and accelerate deterioration. Therefore, you may wish to consider having them removed or cut back to 12 inches (30 cm) away from the home.

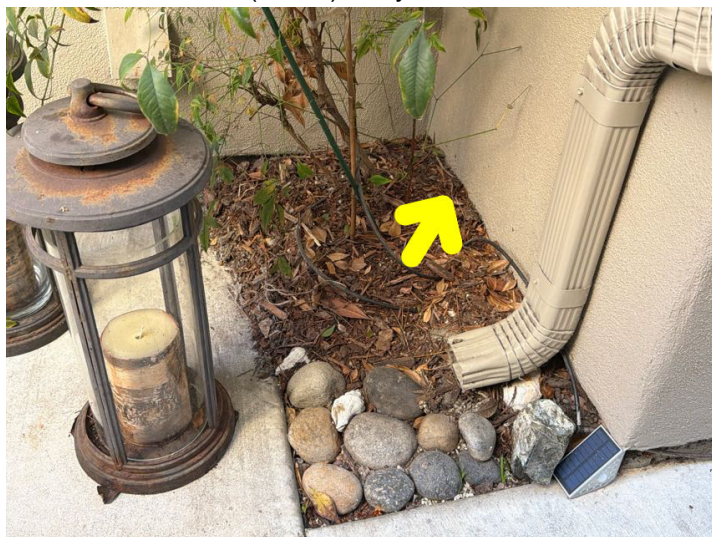
The soil is too high against the home at various areas around the residence, which should be serviced.

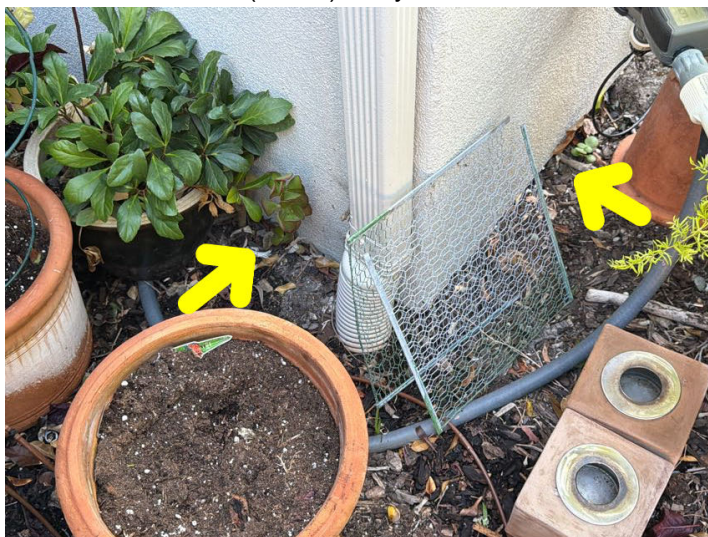
The soil is too high against the home at various areas around the residence, which should be serviced.

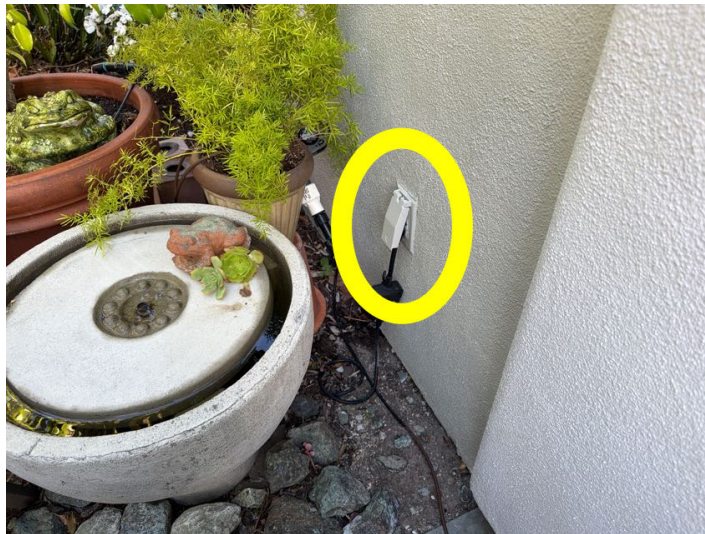
Some of the exterior outlets do not have weather-rated 'in-use' covers, which are a recommended upgrade.

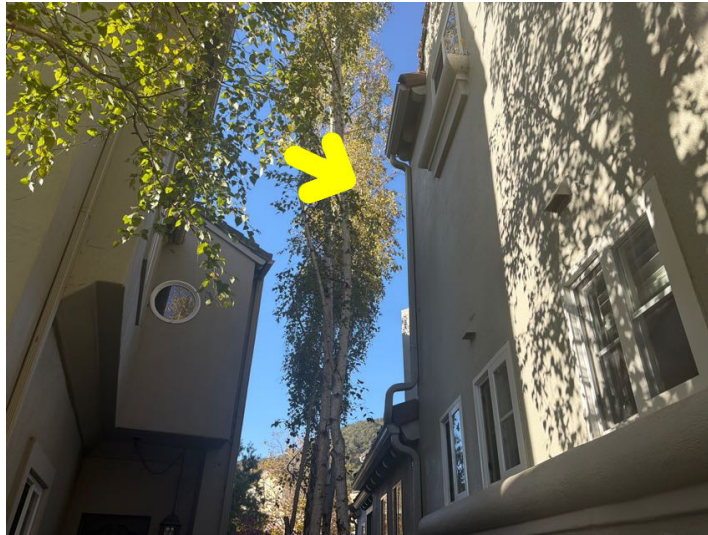
There are tree limbs growing over the residence that should be trimmed or monitored to ensure that they do not impact or damage the roof or its components.

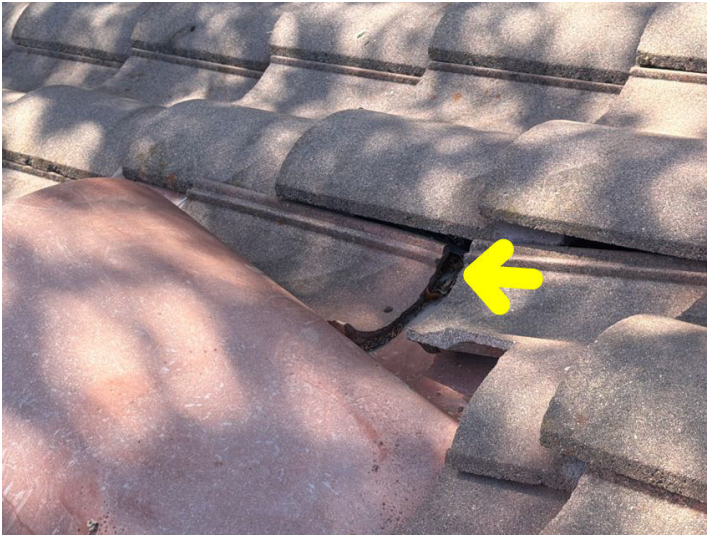
There are one or more cracked or broken tiles that should be serviced by a licensed roofing contractor.

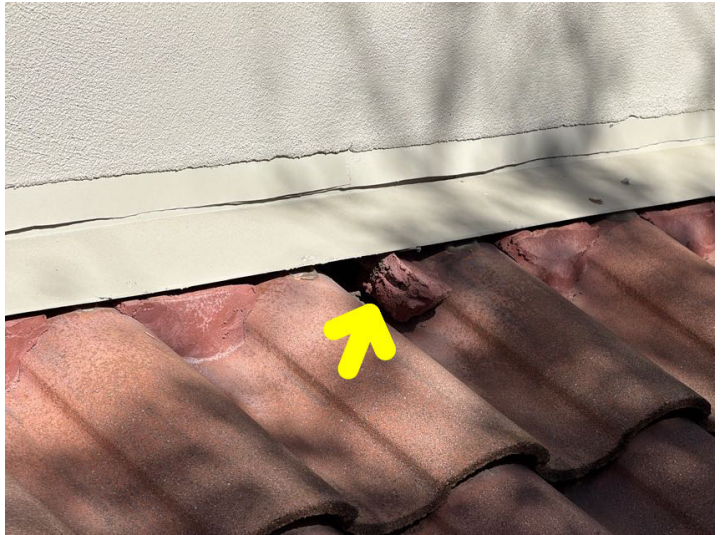
There are one or more cracked or broken tiles that should be serviced by a licensed roofing contractor.

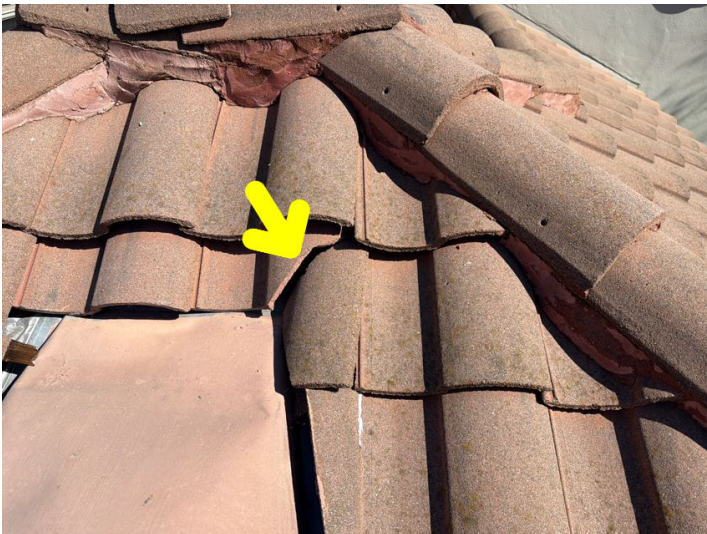
There are one or more cracked or broken tiles that should be serviced by a licensed roofing contractor.

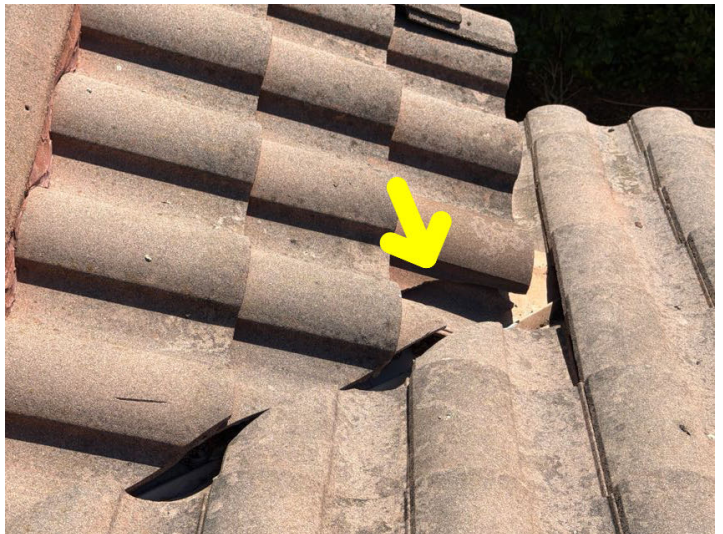
There are one or more cracked or broken tiles that should be serviced by a licensed roofing contractor.

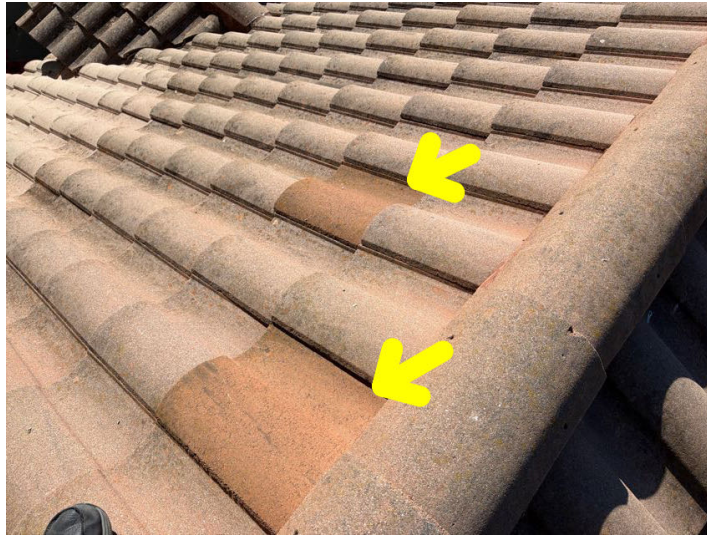
We observed repairs done to the roof. You should have the sellers disclose the reason that the repairs were completed, as well as any documentation of any warranty or guarantee from the roofer.

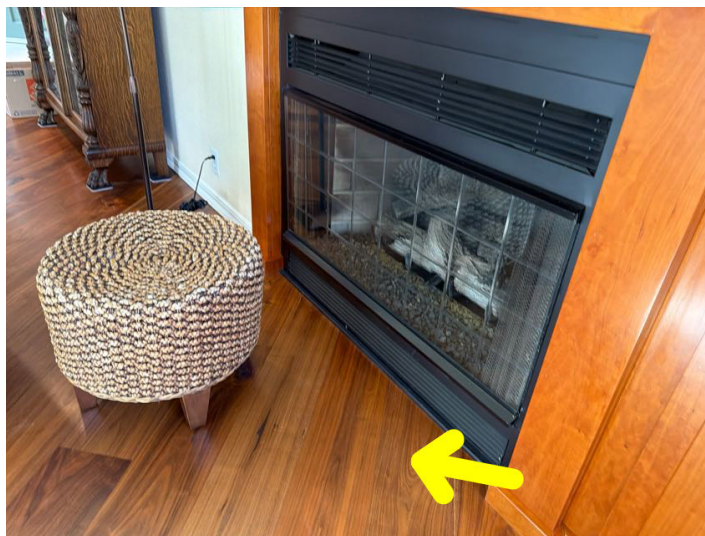
The fireplace does not have a hearth, which is mandated by current safety standards, and you may wish to have a specialist comment on this feature.

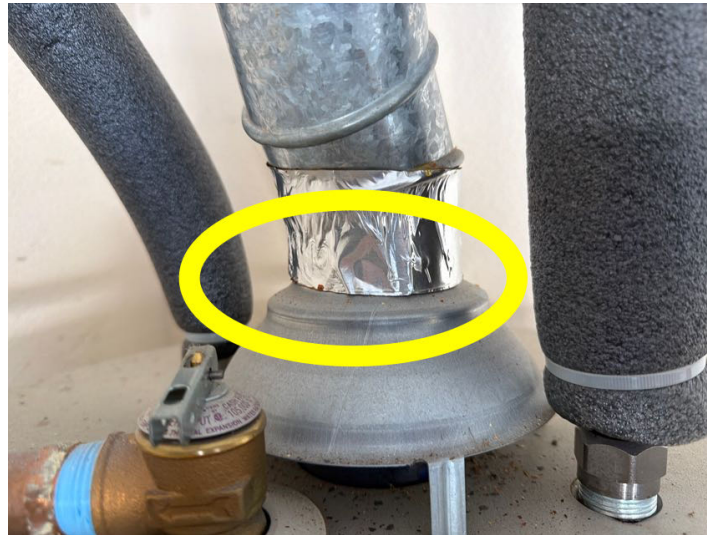
The vent pipe is not properly connected. It is required to have a minimum of 3 fasteners where the pipe connects to the draft hood or other single wall vent pipes.

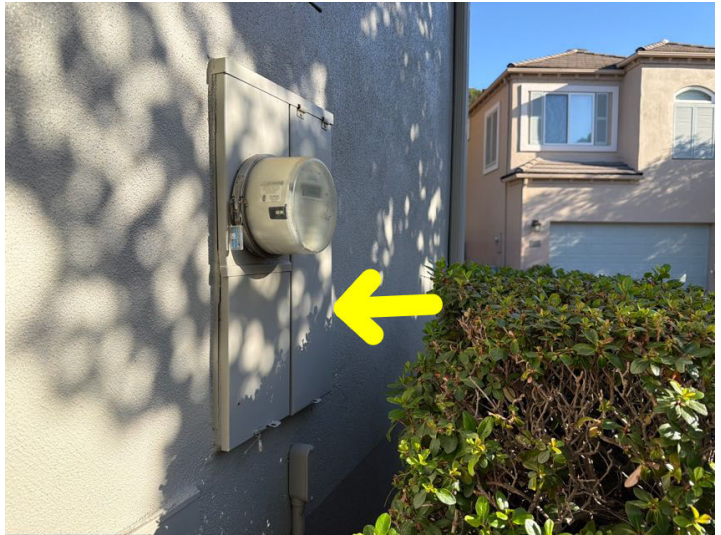
The main panel does not have thirty-six inches of clear space in front of it to facilitate an emergency disconnect, a condition which should be corrected.

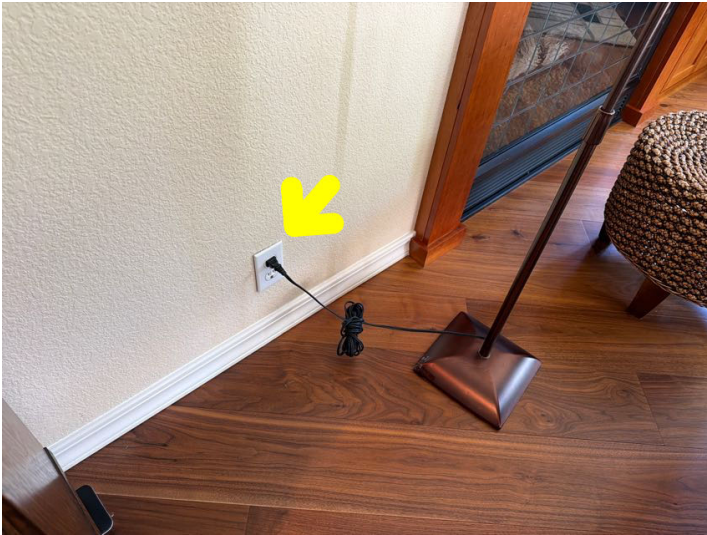
One or more outlets are not secure, and should be evaluated and serviced by a licensed electrical contractor.

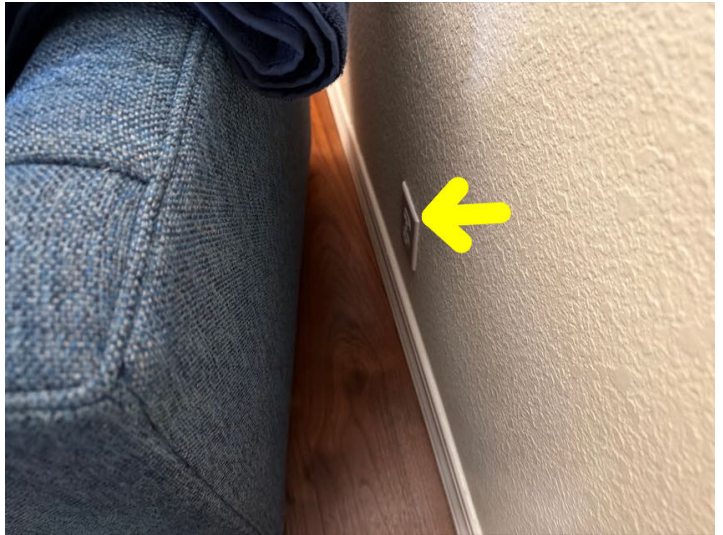
One or more outlets are not secure, and should be evaluated and serviced by a licensed electrical contractor.

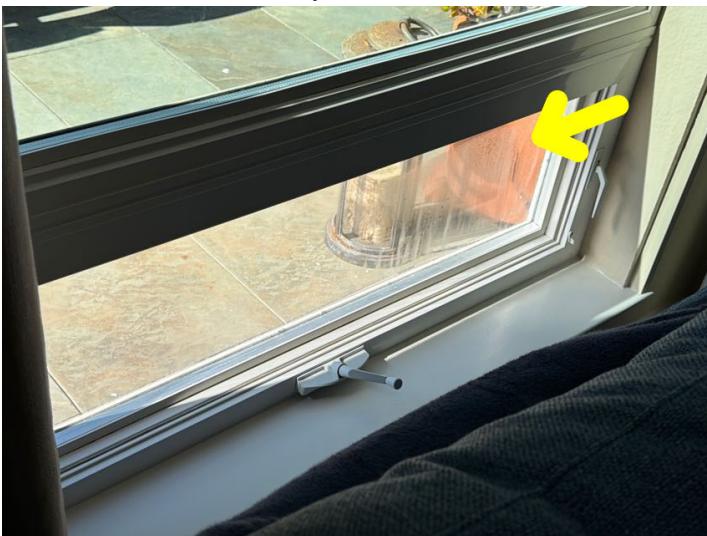
One or more windows may have a broken hermetic seal, which you may wish to have replaced. This is evident from fogging or condensation forming between the panes of glass, which implies that the seal has failed.

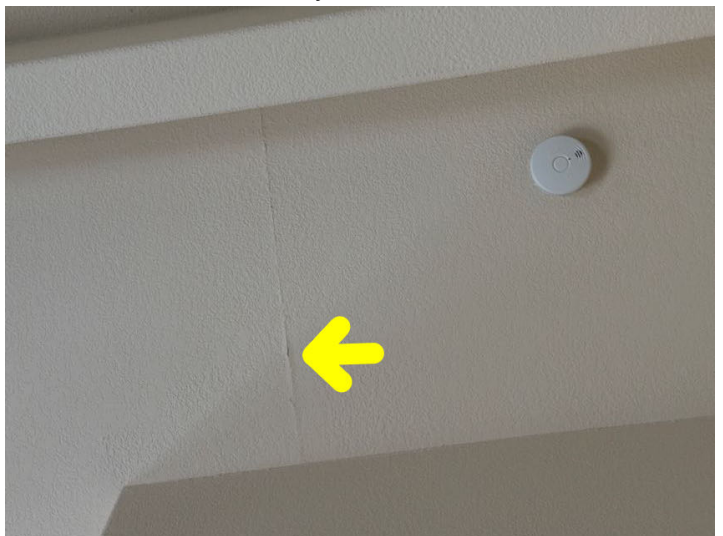
The walls/ceiling have stress fractures which may have resulted from movement. I can elaborate on this issue, but you should have a specialist comment, and be aware that such cracks can reappear, and typically if they are not repaired correctly.

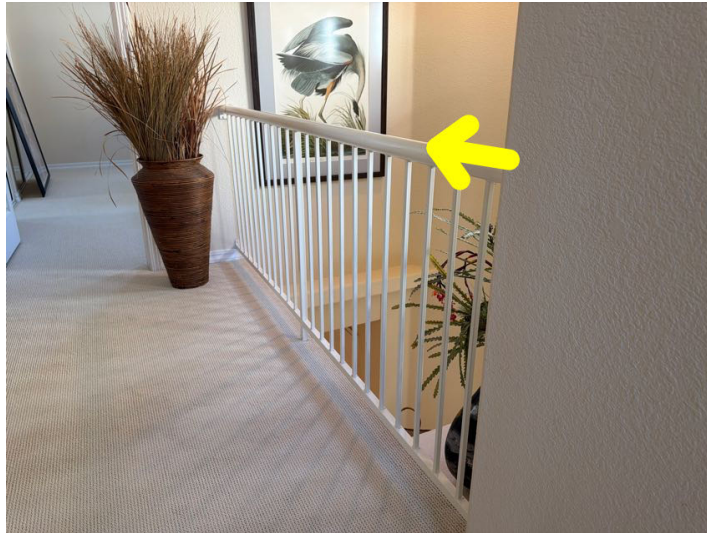
The guardrail is not the recommended 42 inches high when the standing surface is more than 30 inches below.

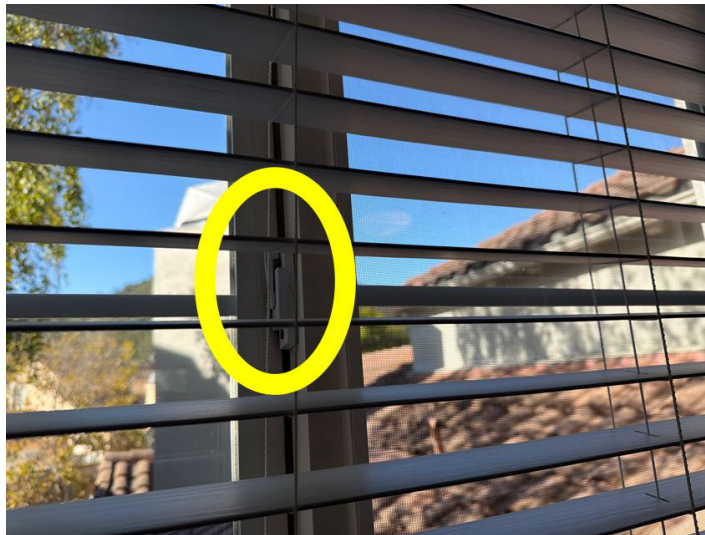
A window lock is missing, damaged, or does not engage, and needs to be serviced to be functional.

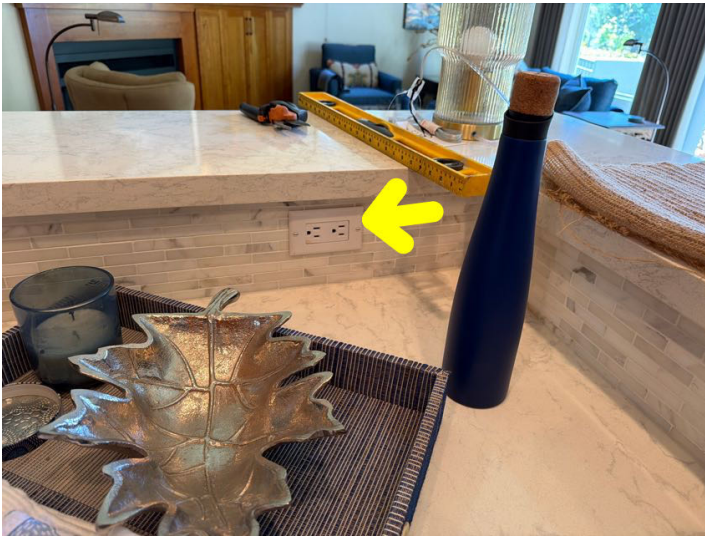
One or more of the outlets in the kitchen are not GFCI protected, although such protection is mandated by current standards and is an important safety feature.

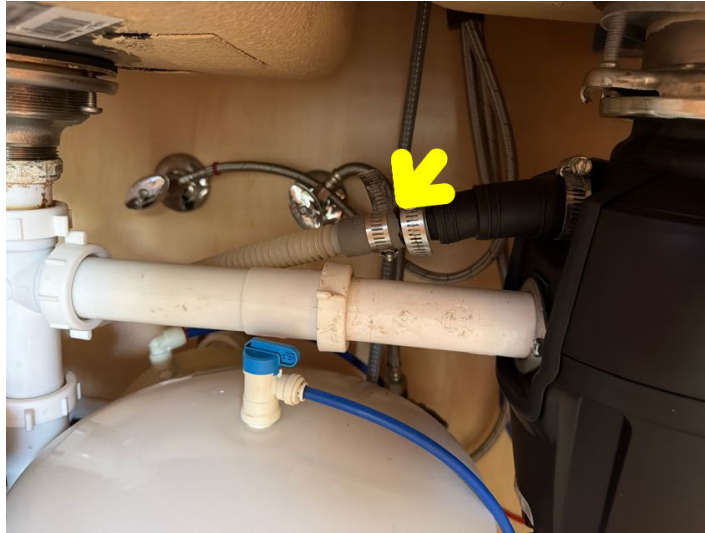
The dishwasher is functional but discharges without a mandated anti-siphon valve, which is contrary to the installation instructions, and which also creates a potential drainage problem and a health hazard.

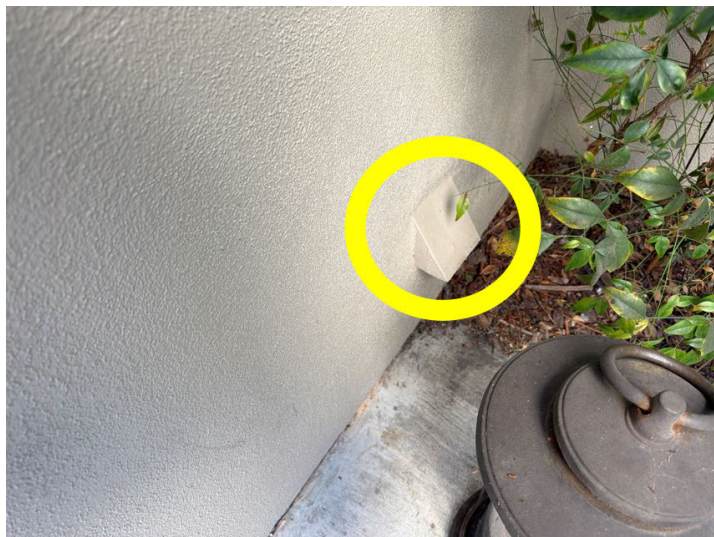
The back-draft on the exterior dryer vent cover is missing, stuck open, or incomplete and should be cleaned, repaired, or replaced.

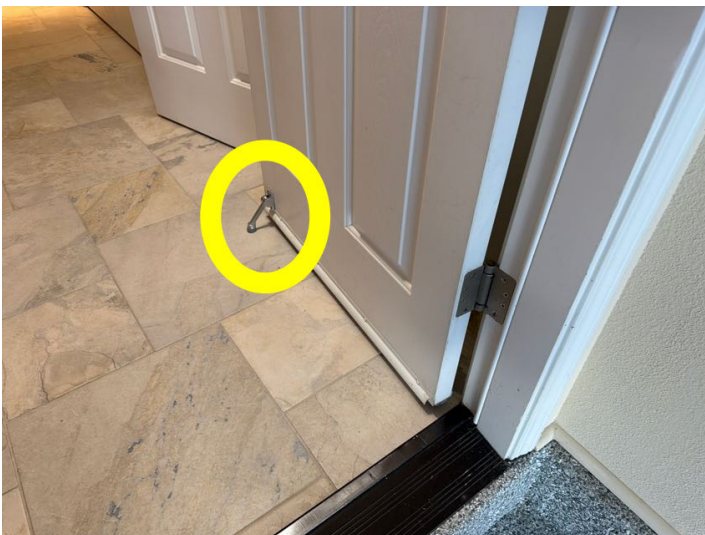
The fire rating of the house entry door has been nullified by the addition of a foot operated door stop, and you may wish to have the door stop removed for optimal safety.

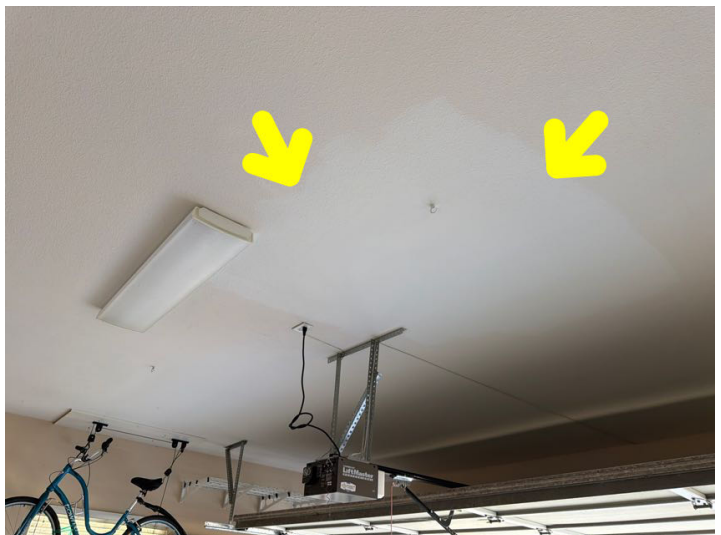
There has been a drywall/plaster repair that should be explained by the seller.

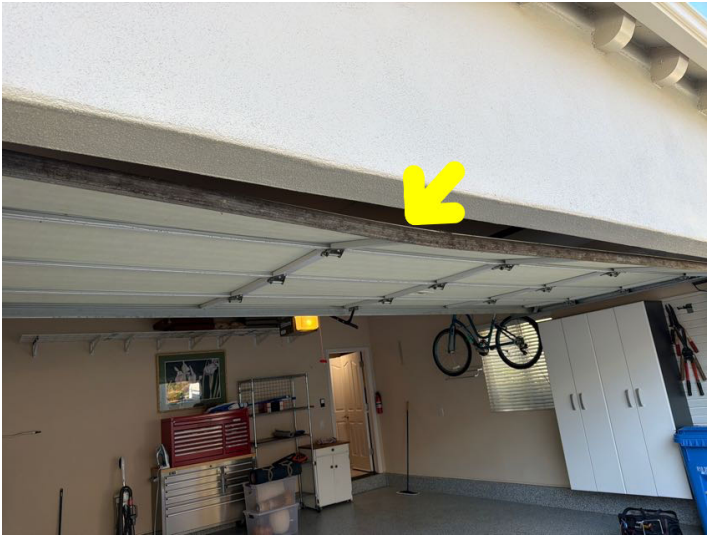
The garage door has cosmetic damage that you should view for yourself.

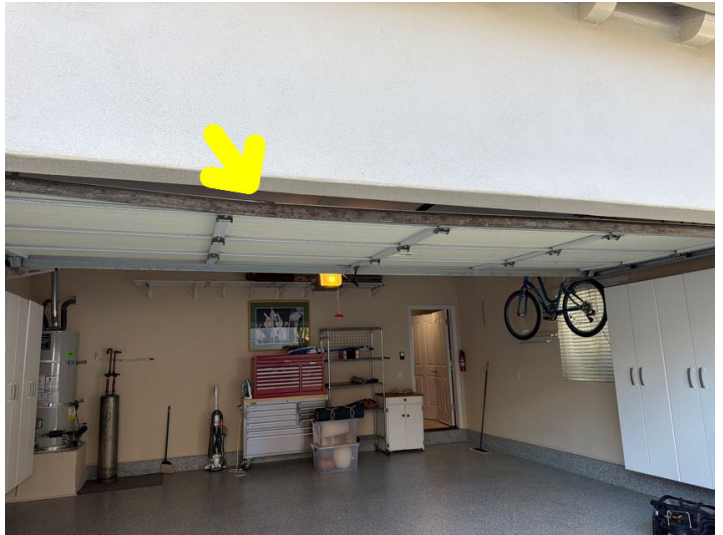
The garage door has cosmetic damage that you should view for yourself.

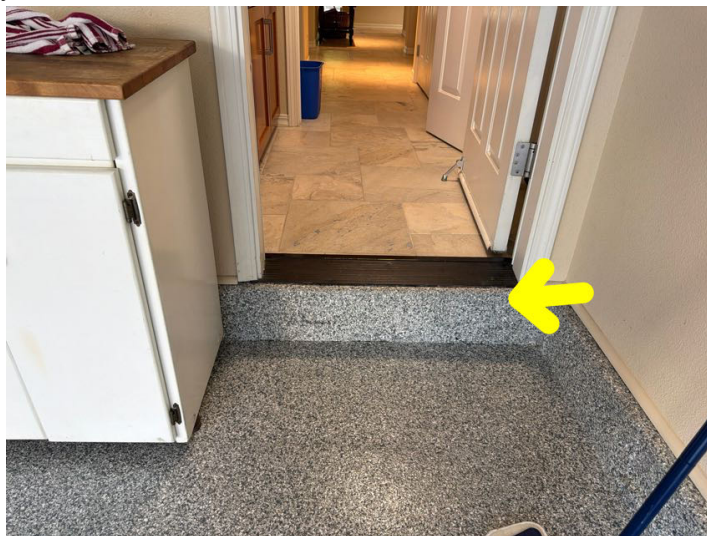
The step is non-standard in depth or height, and could prove to be a trip hazard. The rise should not be less than 4 inches, nor greater than 7 3/4 inches, and the tread should not be less than 11 inches.
