# Alliance Inspections

**Report:** Sample Report 1585 E. Anywhere Dr. Altadena, CA

## Confidential Inspection Report

**1585 E. Anywhere Dr.  
Altadena, CA 91001**

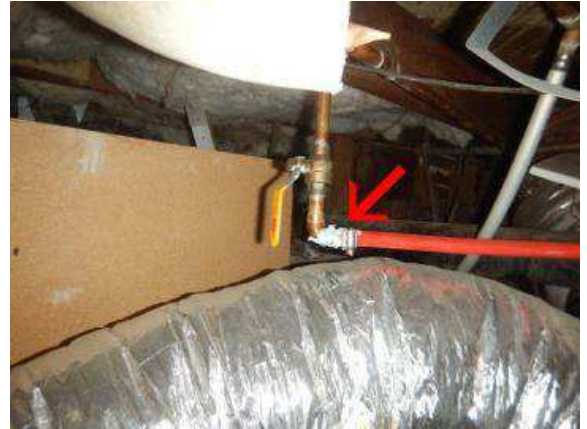
### 3.9 CONDITION:

**Unsatisfactory**-Improper installation of Pex material. Existing leaks seen as a result. Immediate evaluation and repairs is needed by plumber who is qualified to install this plastic pipe.

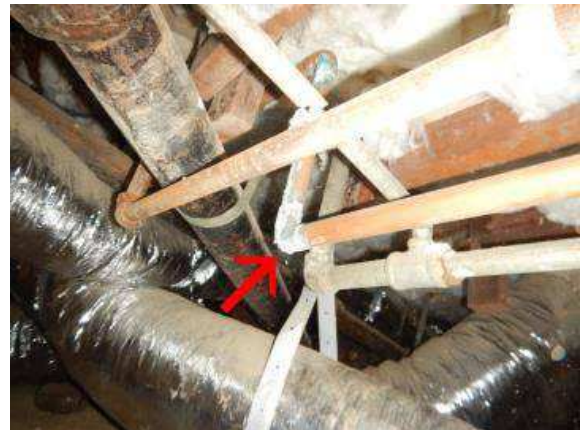
There is at least one or two leaks in the supply system. Services of a qualified licensed plumber may be required.

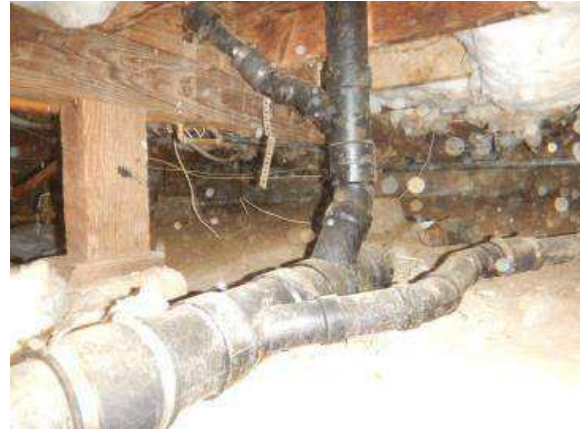
### 3.13 CONDITION:

Seeing plastic pipe in the waste pipe system does indicate prior repairs and it also indicates that the older waste lines are starting to become problematic.

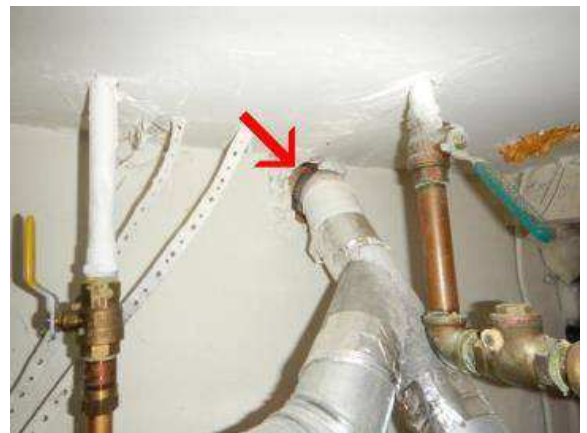
### 3.23 VENT PIPE CONDITION:

**Attention Needed** - The vent pipe is connected to an older clay transite pipe (Possibly asbestos). Manufacturers and some jurisdictions recommend that this not be done as it can affect proper drafting of gases and can pose some health risk. There is evidence of poor drafting. This means that the gases are spilling back down rather than expelling to the exteriors.

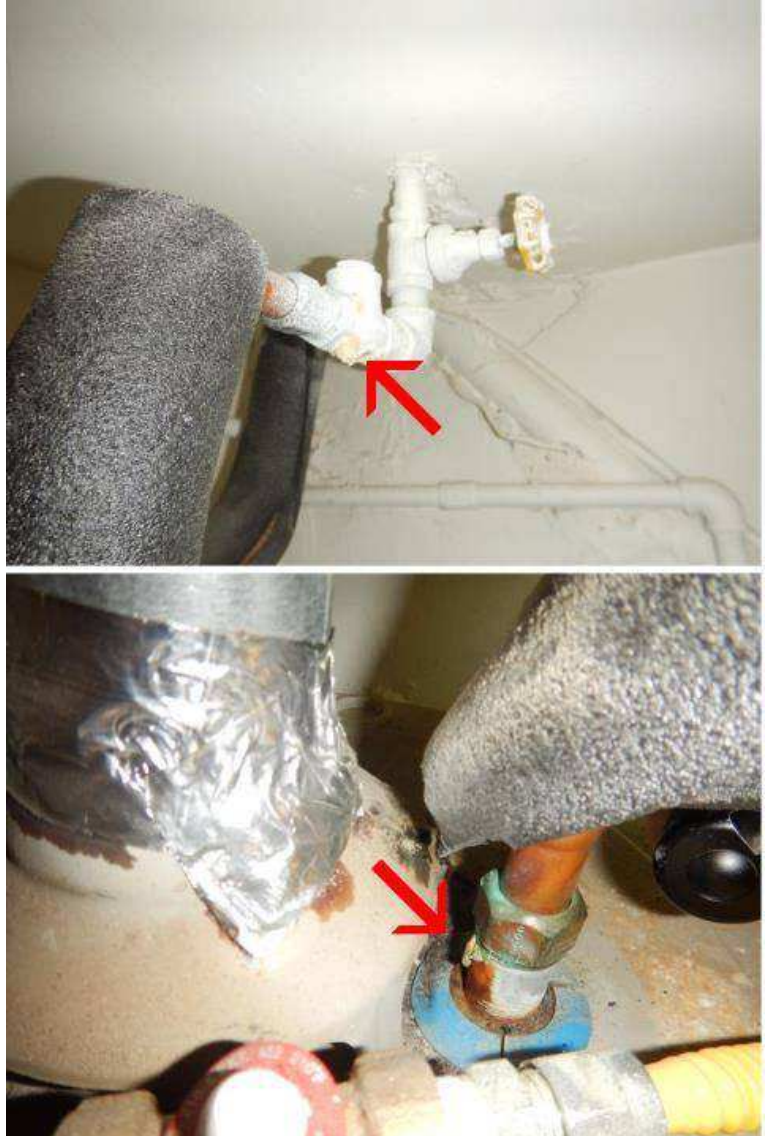
**Attention Needed-** There is evidence of encrustation and/or mineral deposits that may be signs of deterioration. However, no leaks are visible.

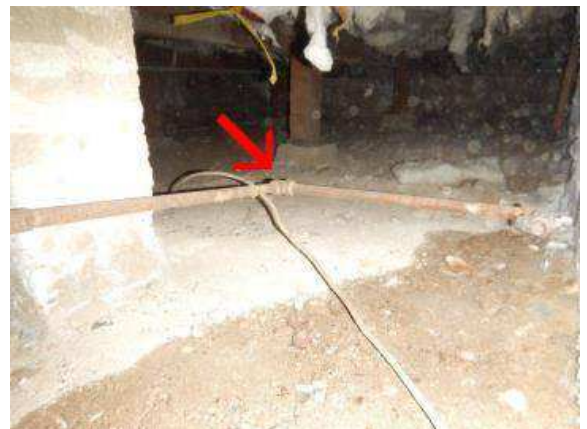
### 3.42 CONDITION:

**Attention Needed-** Some section of the gas pipes, such as in crawl area, are not supported properly in areas. This is an unsafe condition and should be corrected at this time. Contact licensed plumber for corrections.

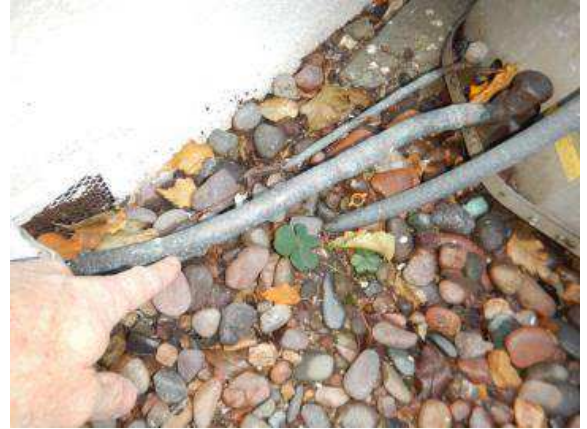
The insulation wrap on the suction line to the condenser/compressor is in need of attention due to deteriorated or missing insulation.

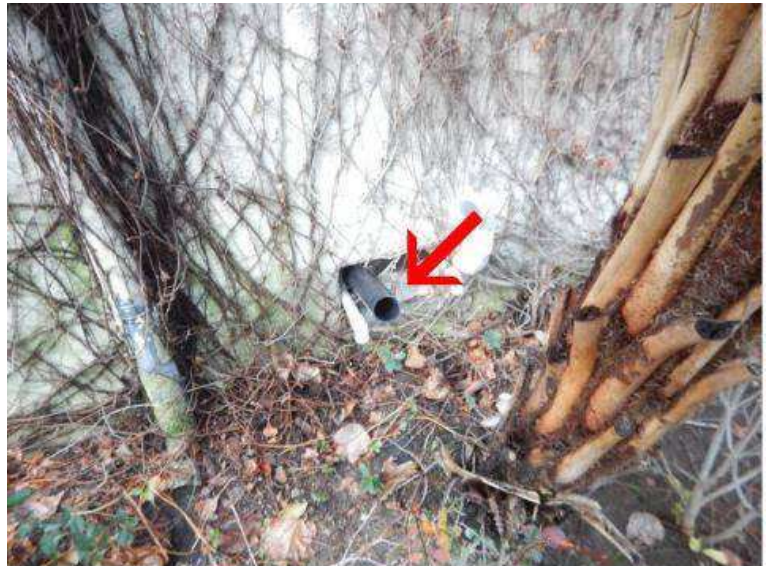
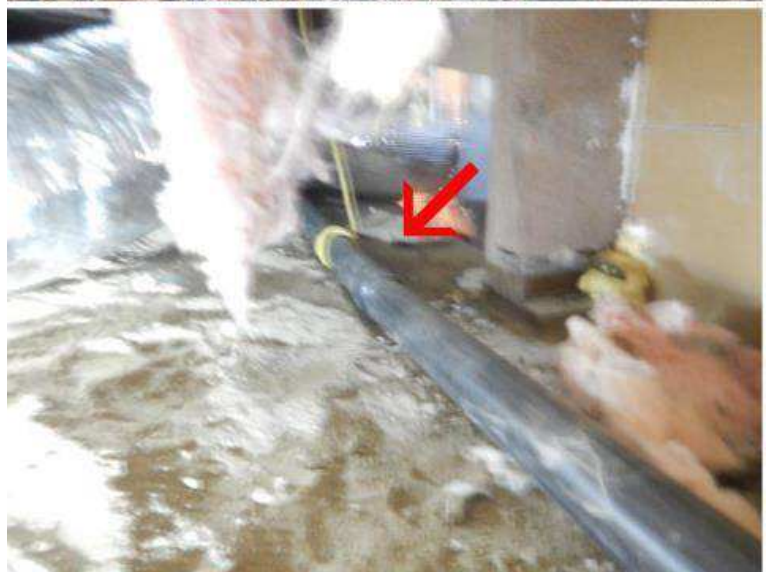
#### 4.28 VENT CONDITION:

**Attention Needed**-Corrections needed. Vent is situated to where water may enter and affect proper drafting. This vent pipe is poorly supported as it runs through the crawl space.

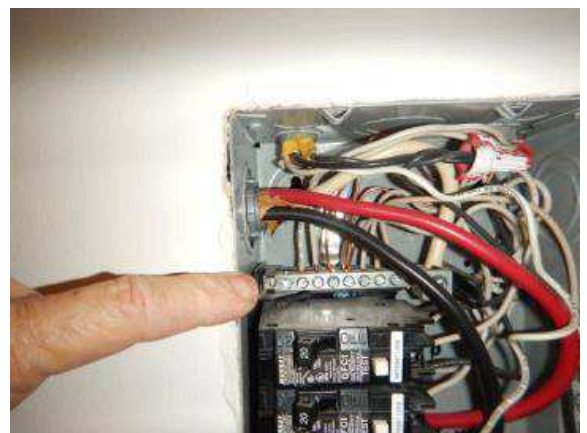
### 5.9 PANEL CONDITION:

**Unsatisfactory**- The neutral bus bar, (this is the bar within the panel that have all the white coated conductors, neutral, connected to it) is bonded or has a grounding wire connected to it. These bars, when in a sub panel should be isolated from any grounding conductor, bond wire and/or the metal box itself.

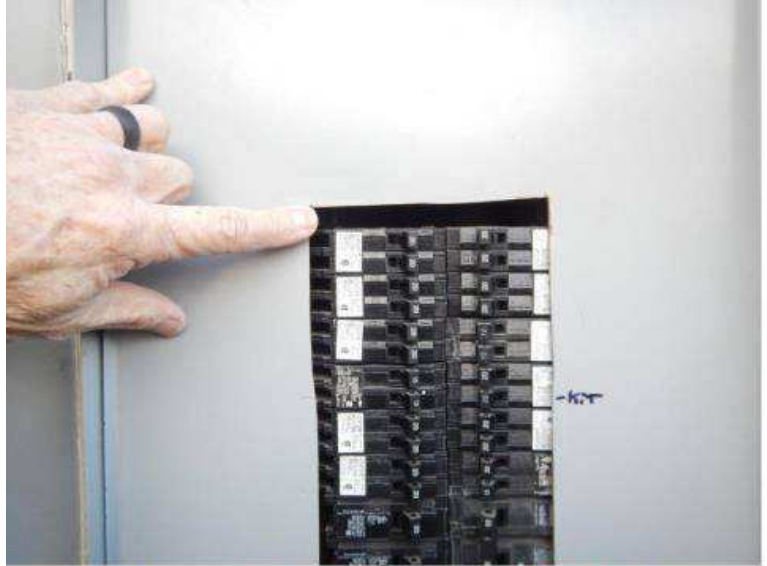
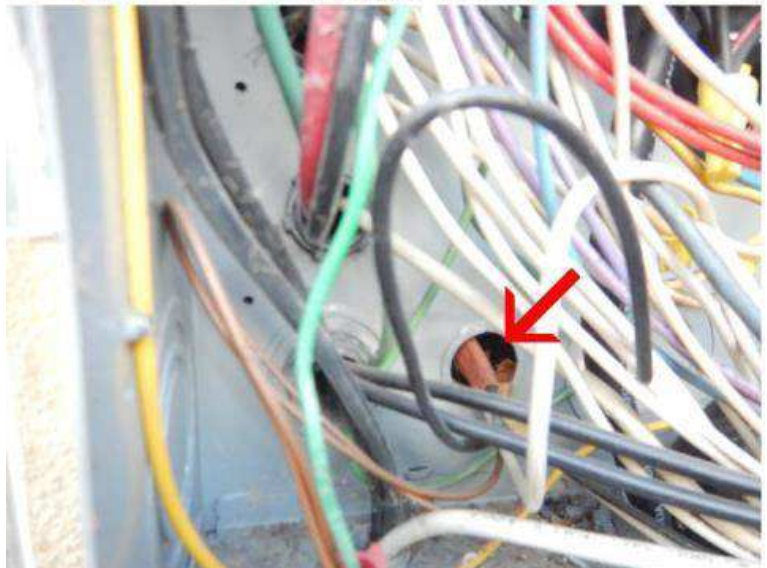
### 5.12 PANEL CONDITION:

**Attention Needed-**Dead front cover is poorly fitted and knock out clamp was not used at one of the conductors entering panel box.

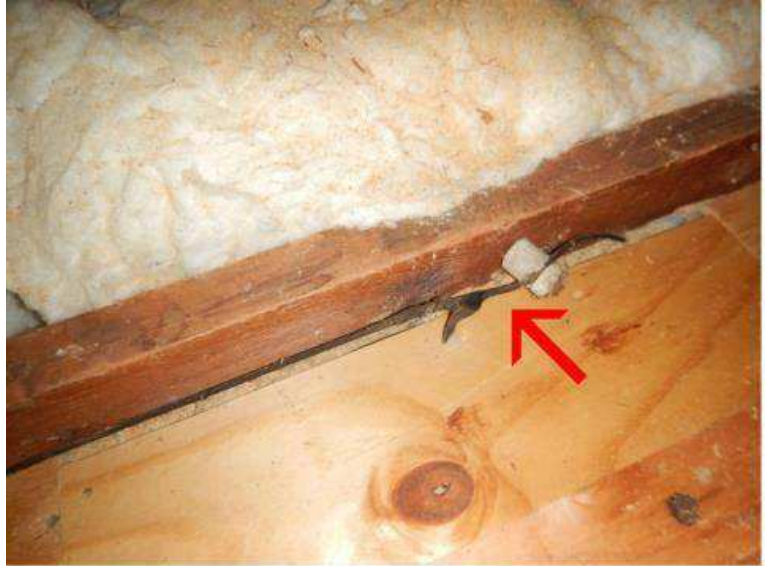
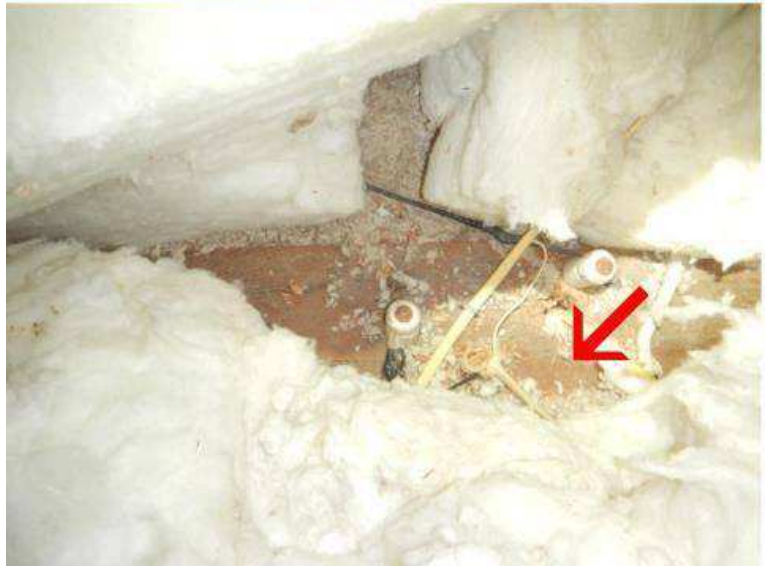
### 5.17 CONDITION:

**Unsatisfactory**- The existing knob and tube wiring is covered with structural insulation. This can be a hazardous condition. Action is required to remove the insulation. The existing knob and tube wiring also shows unallowed splices or routing and damage. Further investigation is needed. Repair or replacement may be necessary.

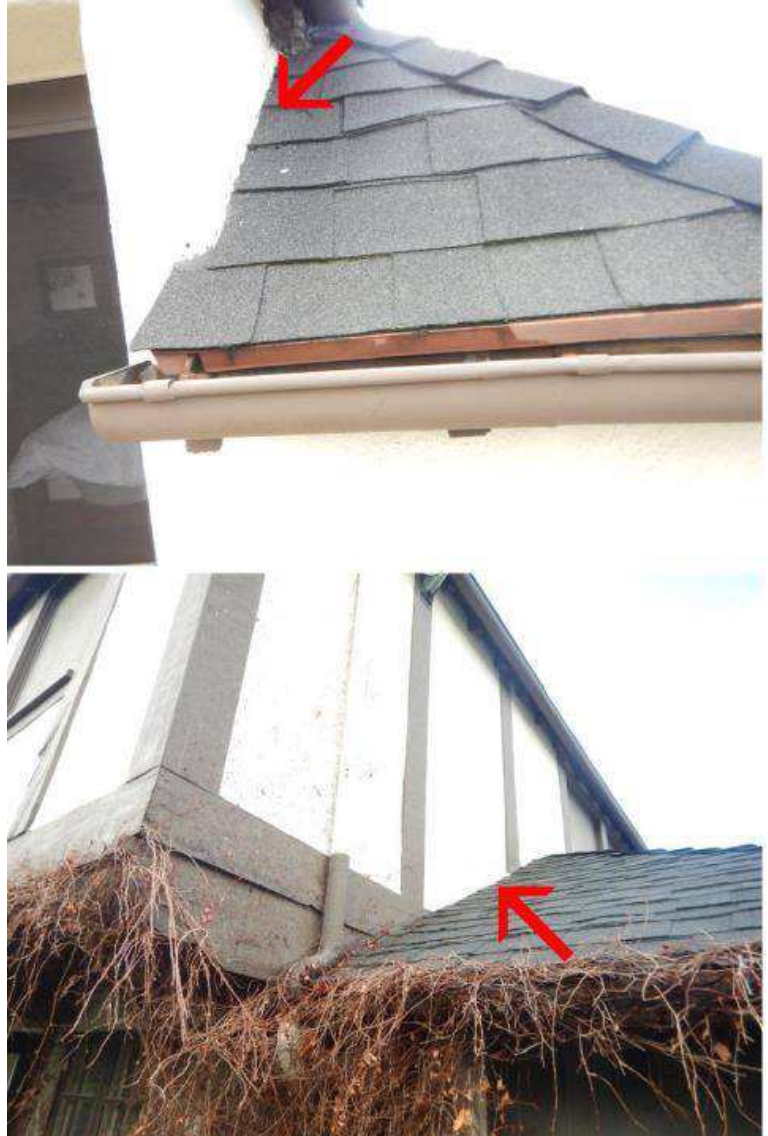
**Attention Needed** - Some portion of the roof flashing needs to have some repair. The flashing where the roof intersects with a wall needs some repair or replacement.

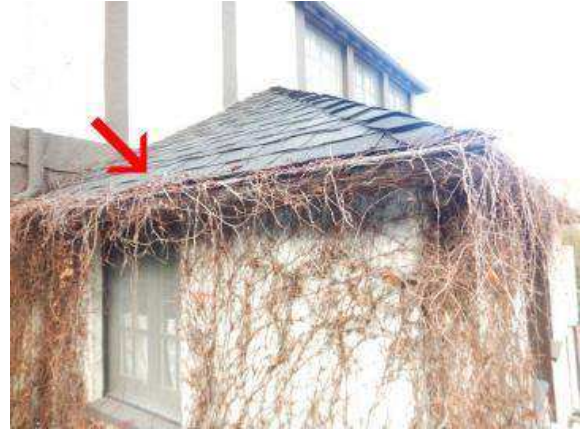
Gutters and spouts are full of debris and in need of maintenance at this time. Extend down spouts farther away from the foundation to reduce potential settlement of the structure.

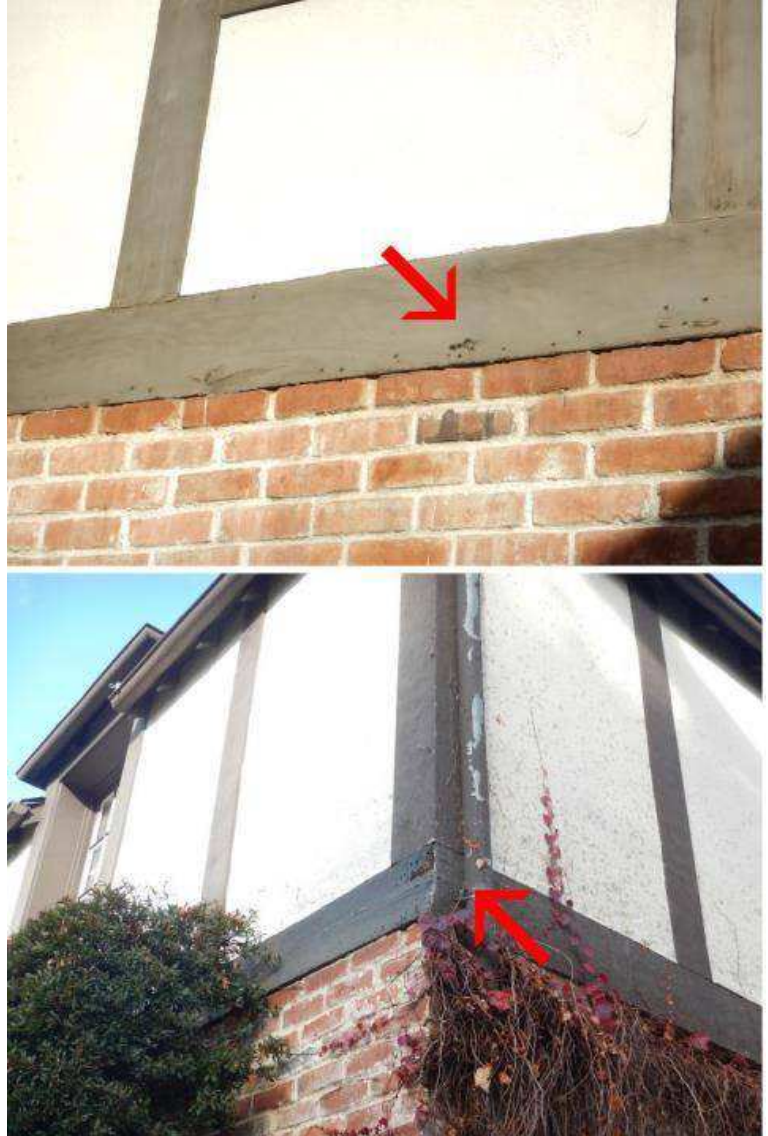
#### 7.4 TRIM CONDITION:

**Attention Needed** - Overall fair though some weather and wear noted and apparent water damage. Consult a termite agency for additional inspection.

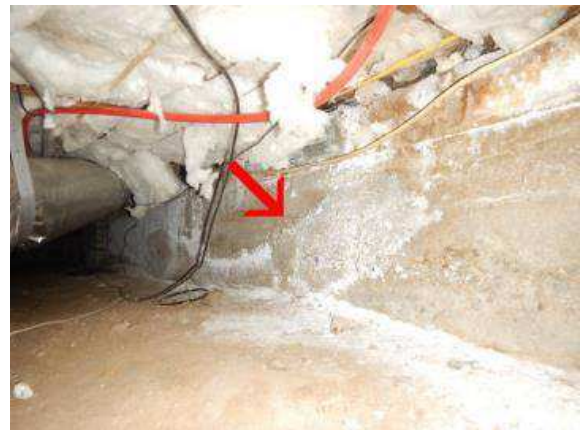
Efflorescence (This is the white chalk-like substance) is seen on areas of concrete indicating past water infiltration. Corrections are needed to adjacent grade as this can promote decay.

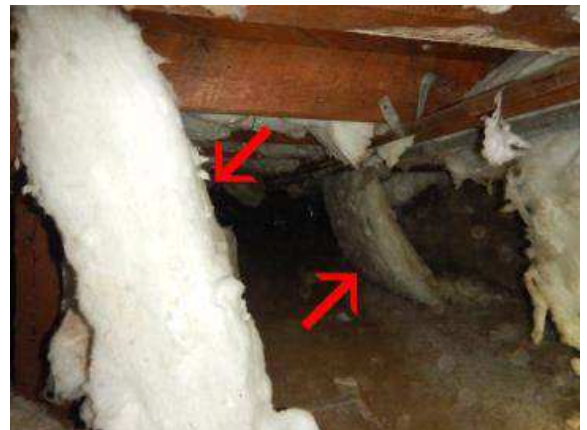
### 8.16

Client should be aware that portions of the insulation in foundation crawl area are falling off. Expect repairs.

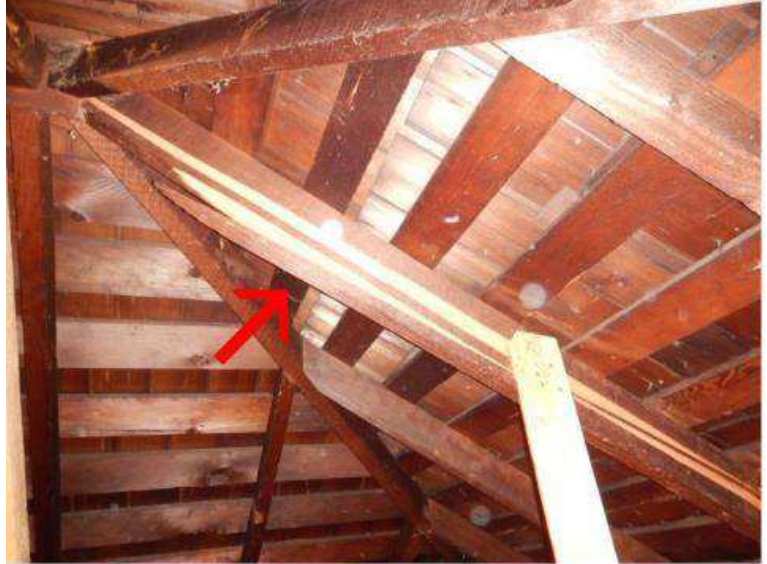
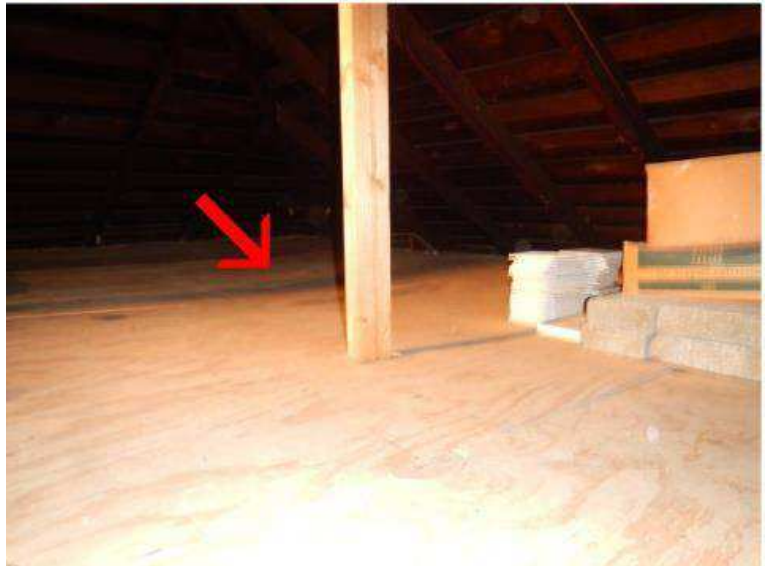
**Attention Needed-**Damaged rafter noted and sag seen at ceiling. Immediate repairs are needed. Contact a licensed framing contractor.

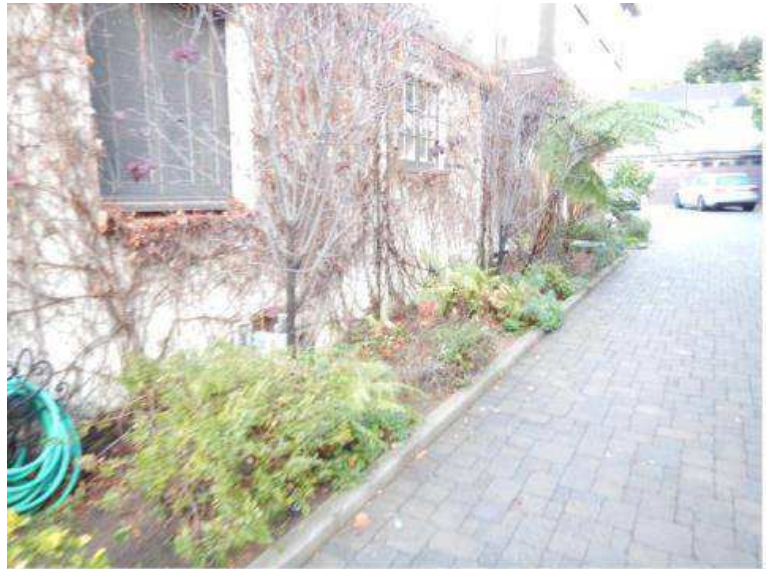
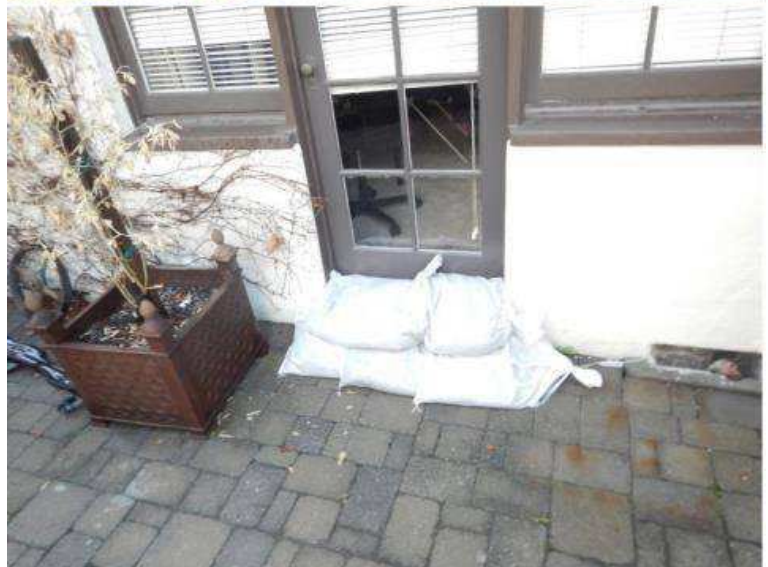
There is some evidence that drainage had been problematic in the past. Some improvements should be anticipated, such as along back side, front and right sides. Improving site drainage can prevent water entry into the crawl area and reduce settlement of the structure.

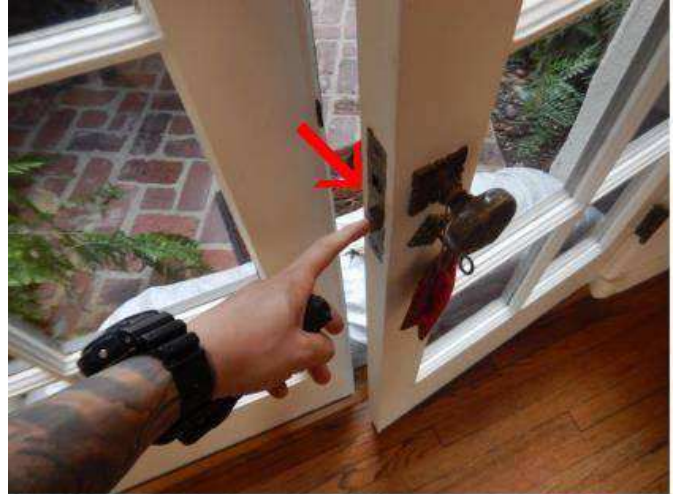
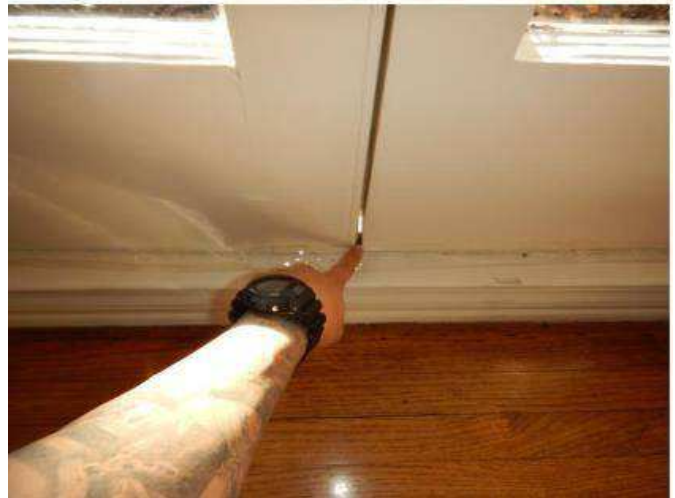
#### 2.2 OTHER EXIT DOORS:

**Attention Needed-** At least one of the exit door locks did not retract as intended, repairs needed. Such as in the living room. Recommend installing weather stripping at all exit doors to prevent loss of conditioned air or entry of exterior air.

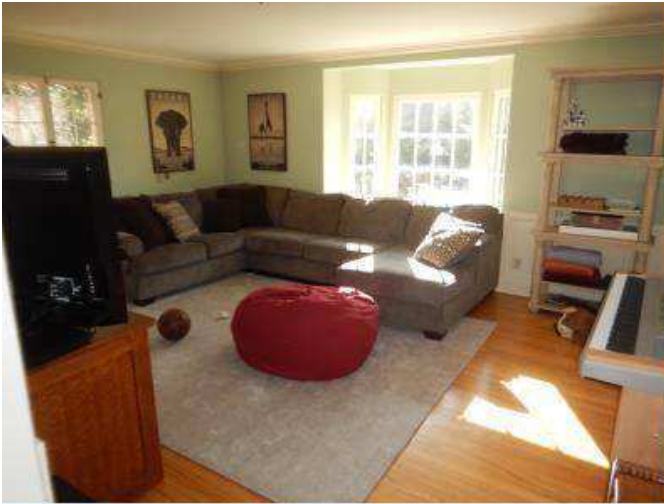
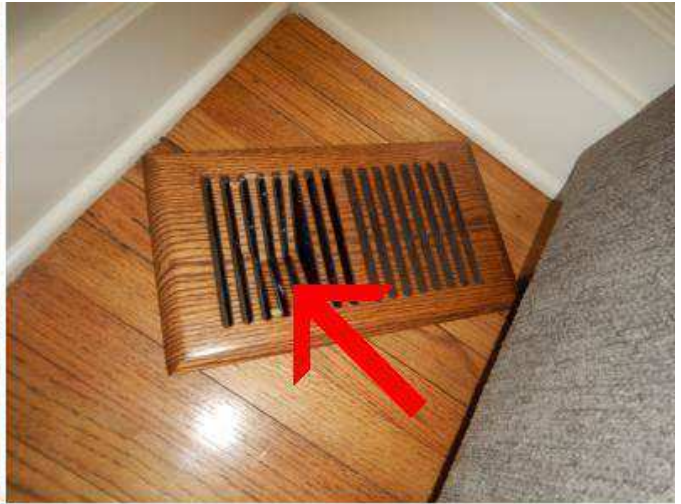
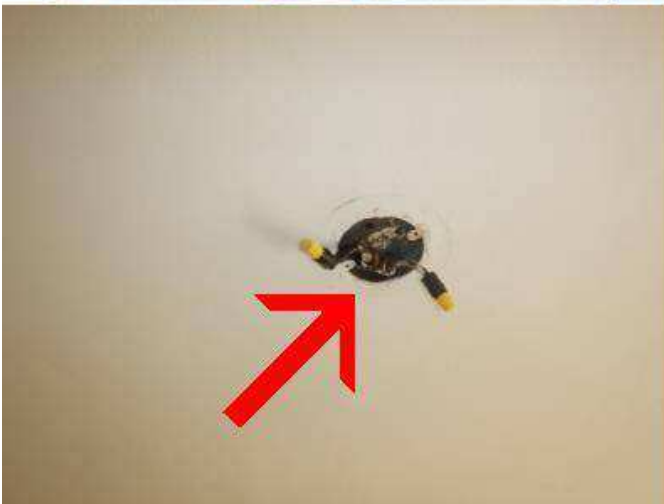
### 2.7 FAMILY ROOM:

**Attention Needed-** Exposed electrical wires were seen where light fixtures were removed. Have a licensed electrician installed desired lighting or cap off for safety. The grille cover is damaged, such as at the front right corner.

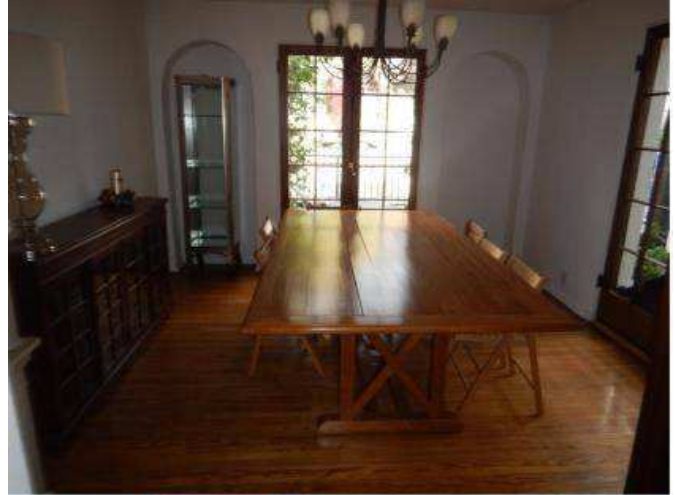
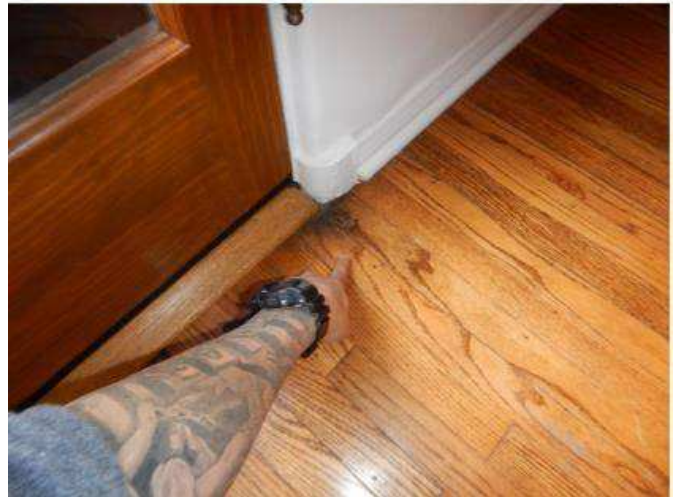
## 2.8 DINING ROOM:

**Attention Needed-** Evidence of water intrusion seen in the vicinity of the East exit door. Recommend further evaluation.

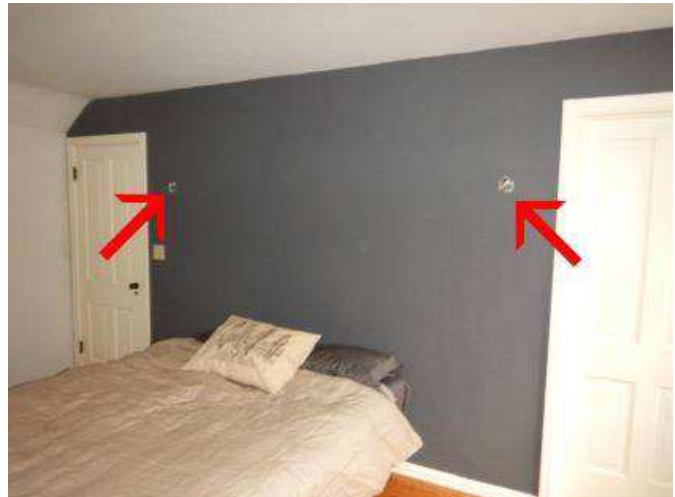
### 2.12 BEDROOM 2 UPPER FRONT RIGHT:

**Attention Needed-** Exposed electrical wires were seen where light fixtures were removed. Have a licensed electrician installed desired lighting or cap off for safety.

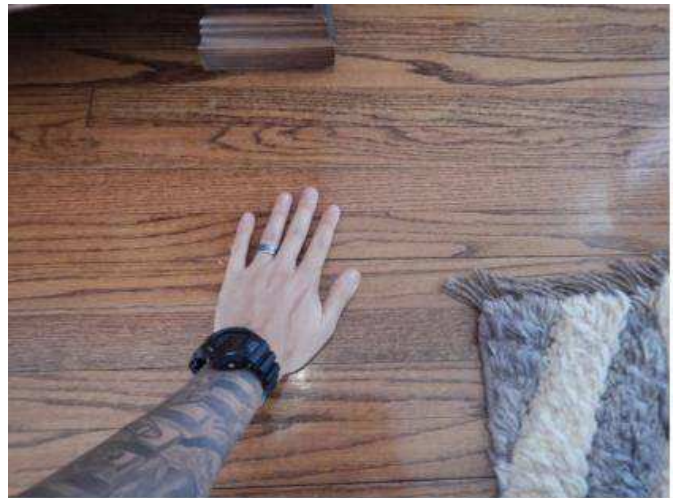
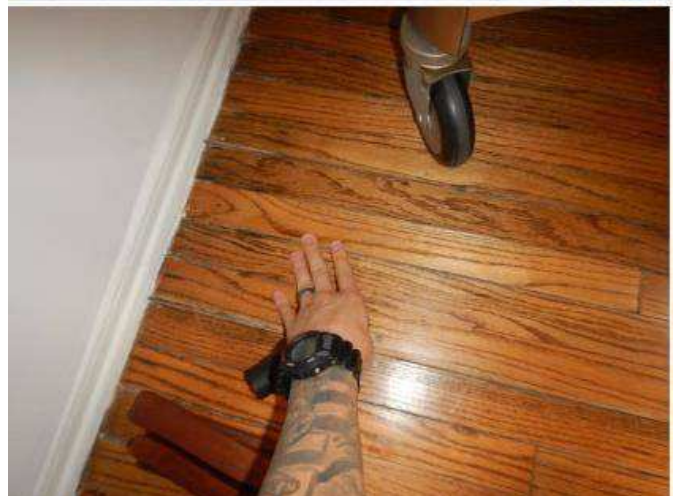
**Attention Needed-** There is general wear and areas of loose or damaged boards noted. Expect maintenance. Also, some cupping or warping of hardwood flooring noted, such as in the living room and formal dining area. There could be many reasons for this occurring, such as moisture from crawl area, poorly prepped sub flooring or even the wood itself. Consult a hardwood flooring contractor for further evaluation.

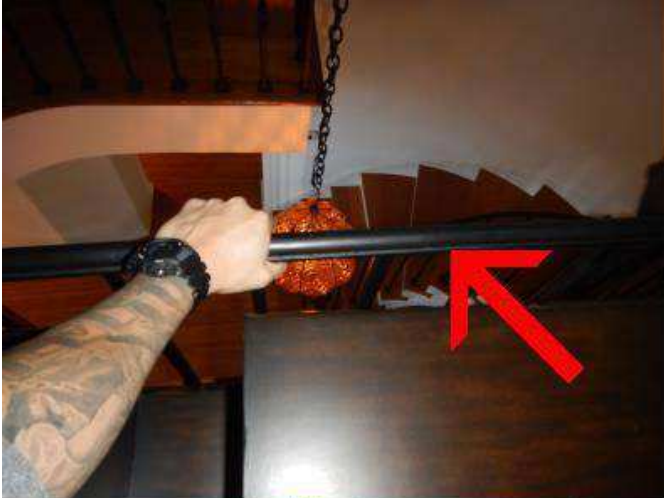
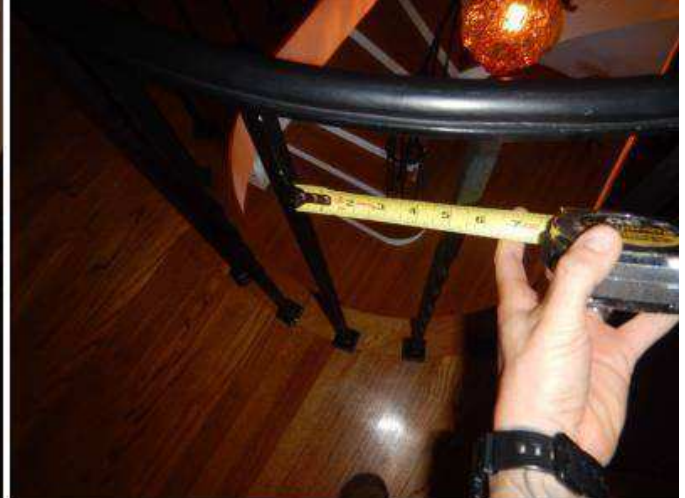
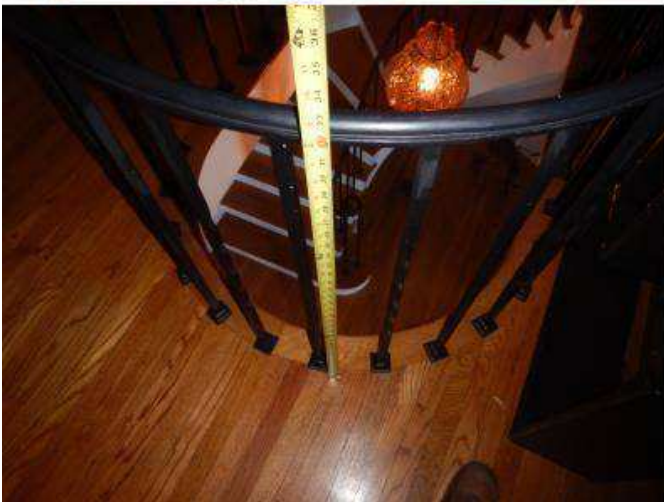
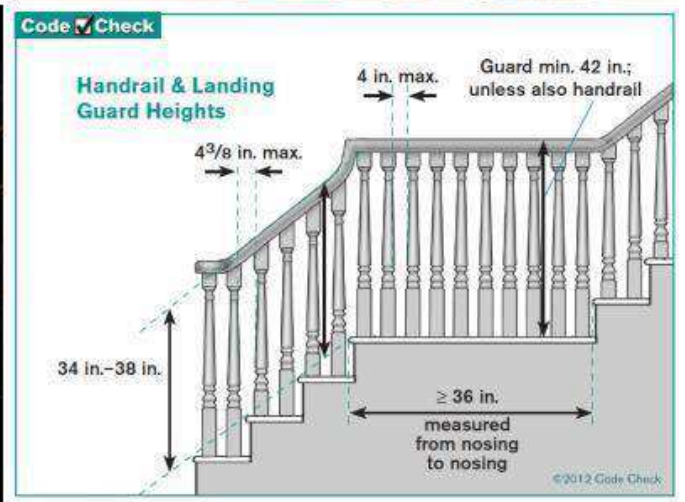
## 2.18 CONDITION:

**Attention Needed-** Loose railing noted. Repairs are advised to ensure safe stair use. The client should also be aware that the height of the rail and the spacing of the railings is not to current child safety standards. Consider improvements.

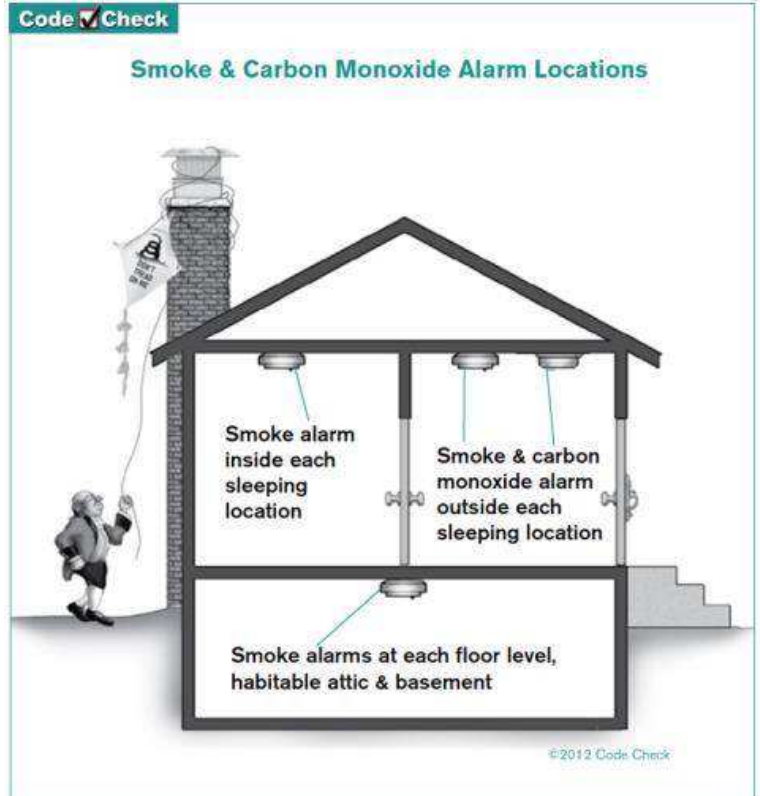
**Attention Needed-** Detectors are missing in all areas. Carbon monoxide detectors are not installed either. Smoke detectors are usually required, depending on the municipality, in each sleeping area, hallways outside sleeping areas and kitchen or basements. Consult a retrofitting specialist as to your area. Carbon monoxide detectors are required in hall areas upper and lower floors.

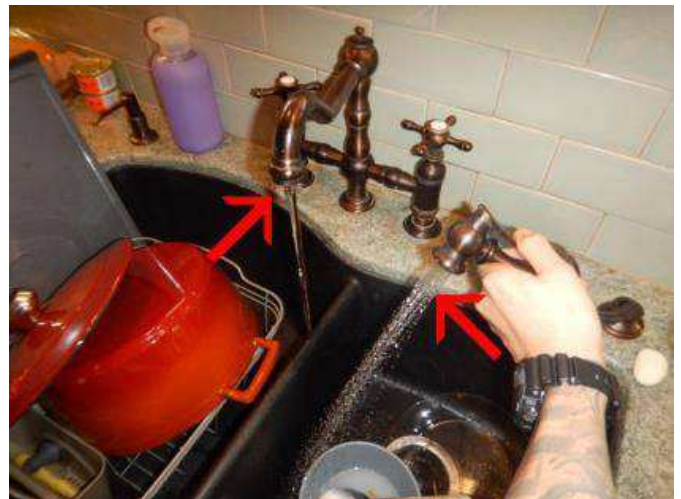
**Attention Needed-** The faucet continues to flow water when the sprayer is activated, repairs needed.

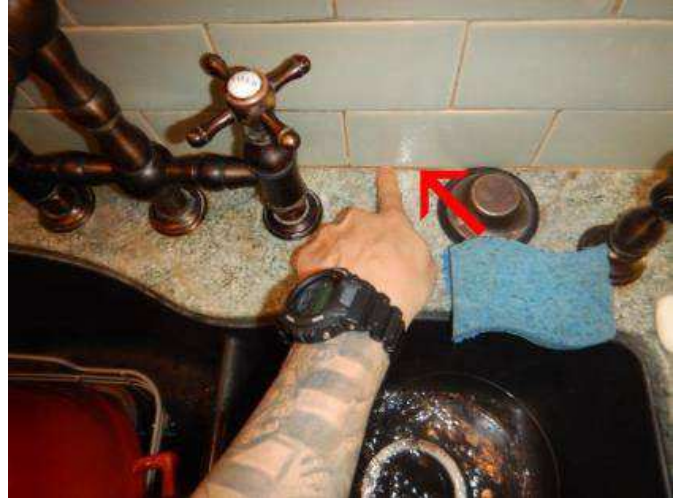
**Attention Needed-** The caulking in water contact areas appear to need attention. If left unsealed, water can cause costly damage, such as along where counter top meets splash wall.

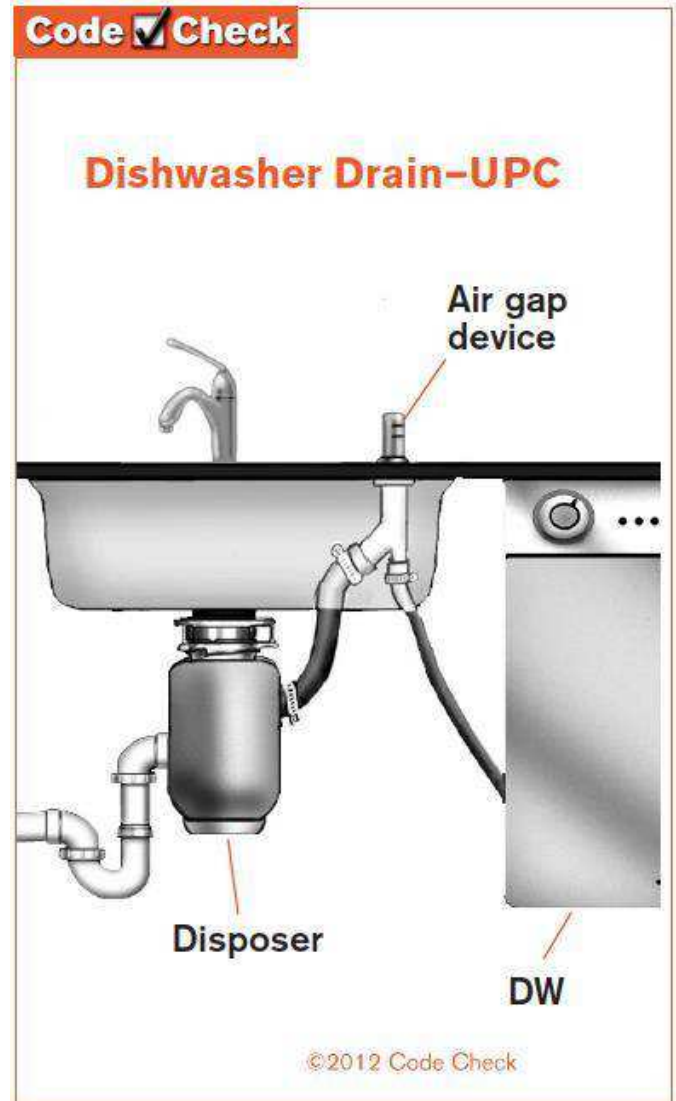
**Attention Needed-** The drain line from the dishwashers are not to industry standards. There is no air gap to prevent cross contamination of potable water with waste water. Contact a licensed plumber for repairs.

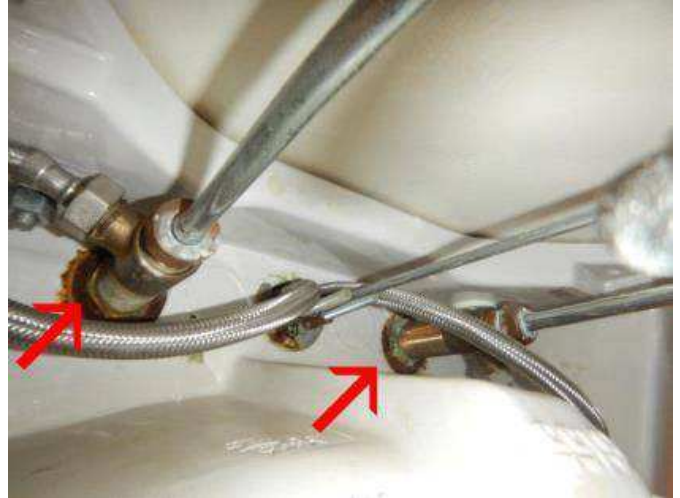
**Attention Needed** - The fixtures appear rusted, seen from the under side. However, no current leakage noted at this time.

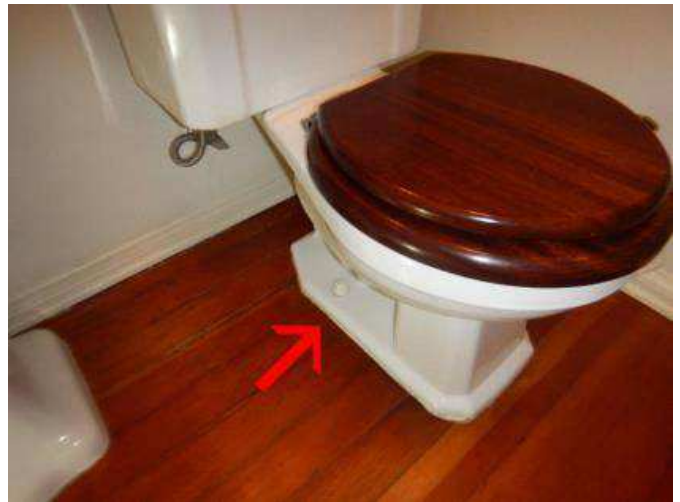
### 5.5 TOILET:

**Attention Needed-** The toilet is not secure to the floor, allowing it to wobble and possibly leak. Action should be taken to re-secure it to the floor.

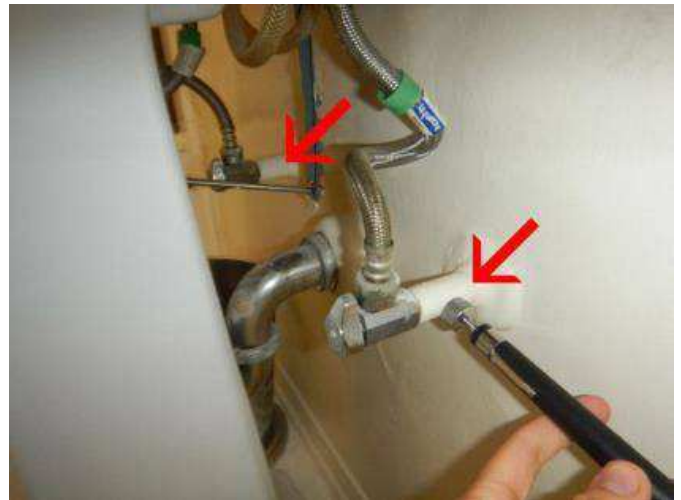
**Attention Needed** - Older galvanized water supply pipes noted in the bathroom. Upgrades to copper is advised. Refer to plumbing section for more information.

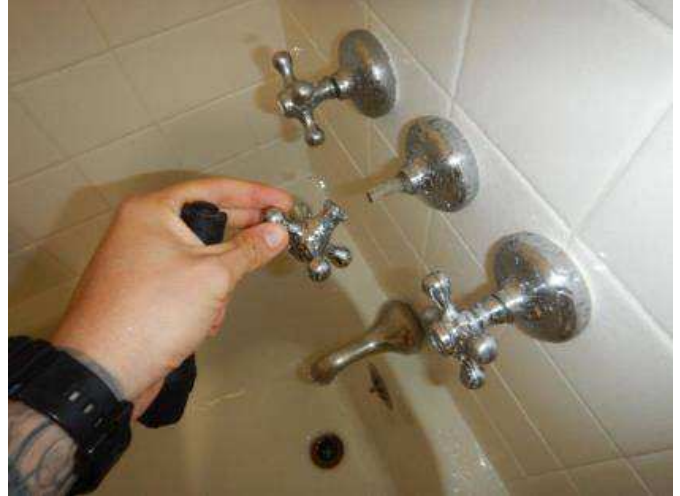
**Attention Needed** - Fixtures are loose. Have a licensed plumber secure as needed to prevent potential damage.

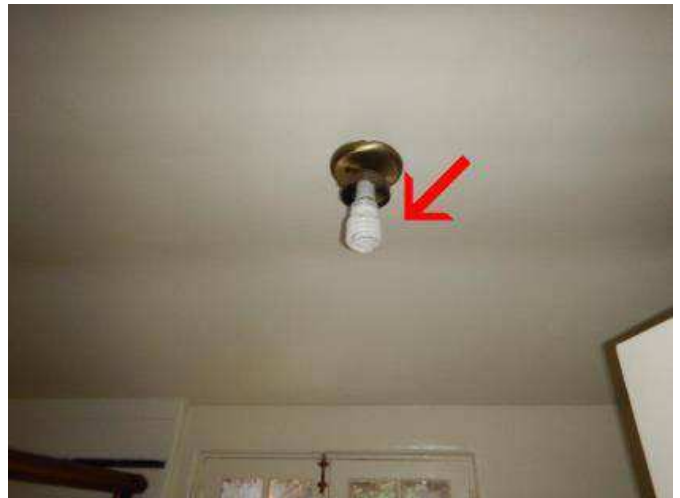
Globe cover missing at ceiling light.

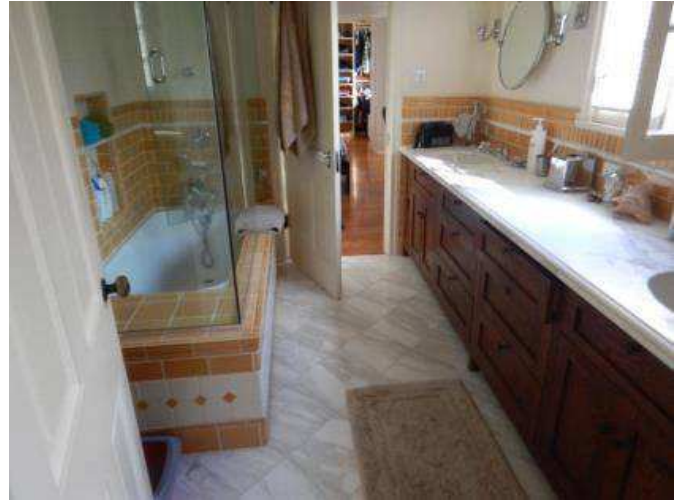
The water pressure drops when more than two fixtures are operated simultaneously.

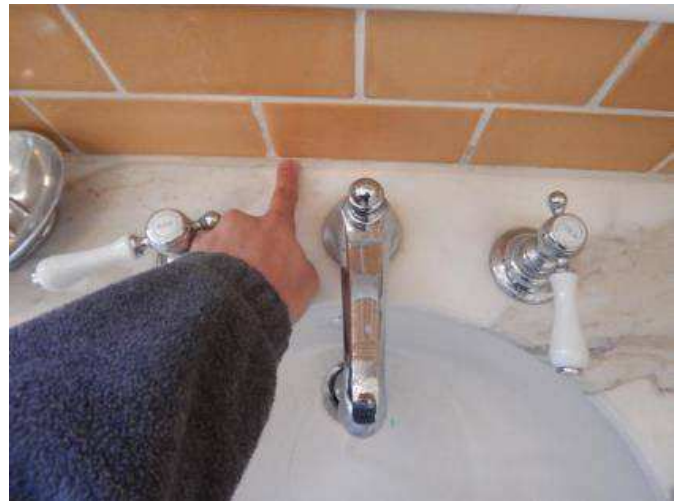
### 5.26 VANITY CABINET

**Attention Needed** - Silicon caulking should have been used along where sink counter top meets splash wall and not cement grout. Cement grout makes for an inadequate seal as material tends to break up in time resulting in a poor water tight seal.

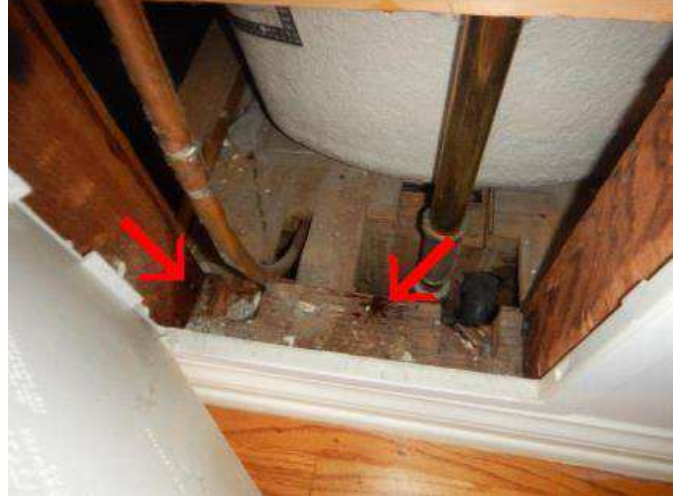
**Attention Needed-** The tub drain or tub/ shower fixtures leak within the access hatch in adjacent room. Immediate repairs needed by a licensed plumber. Also, tub fixtures are not adequately sealed to the wall. This could allow water to enter substrate. Improvements needed.

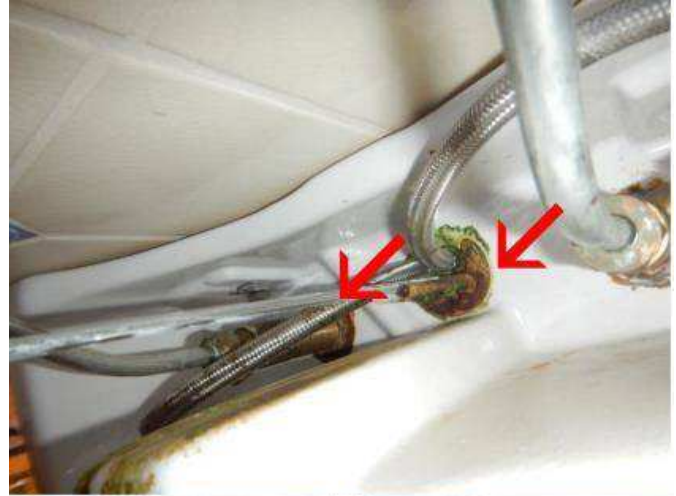
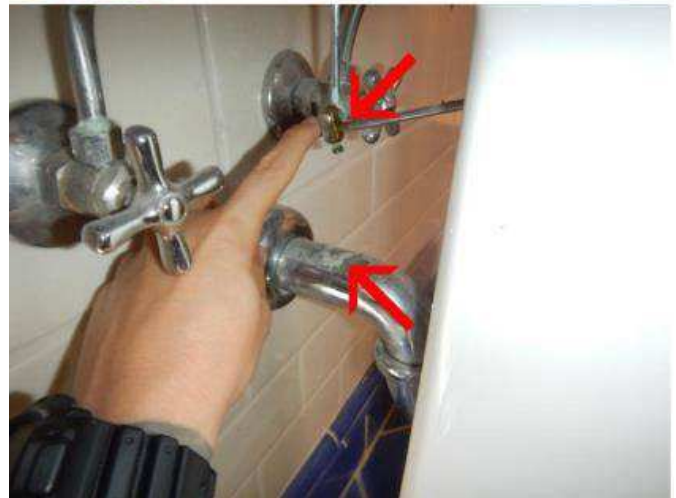
**Attention Needed** - The fixtures appear rusted, seen from the under side. However, no current leakage noted at this time. The diverter appeared to be previously leaking.

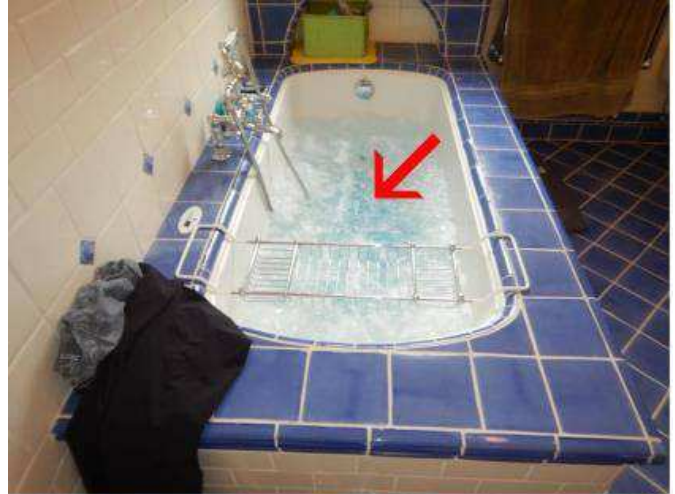
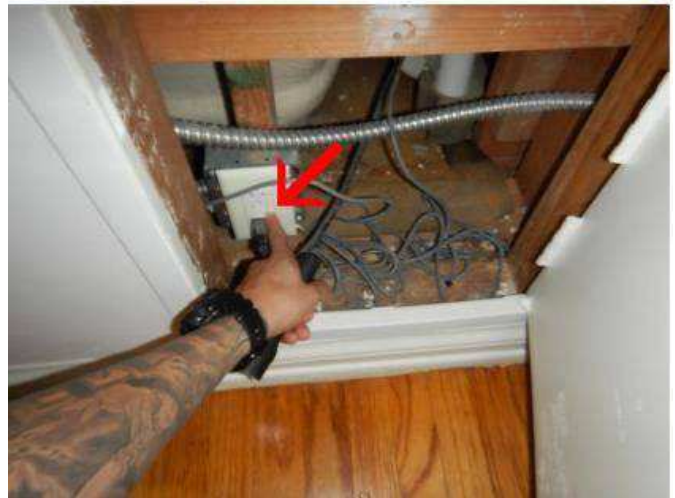
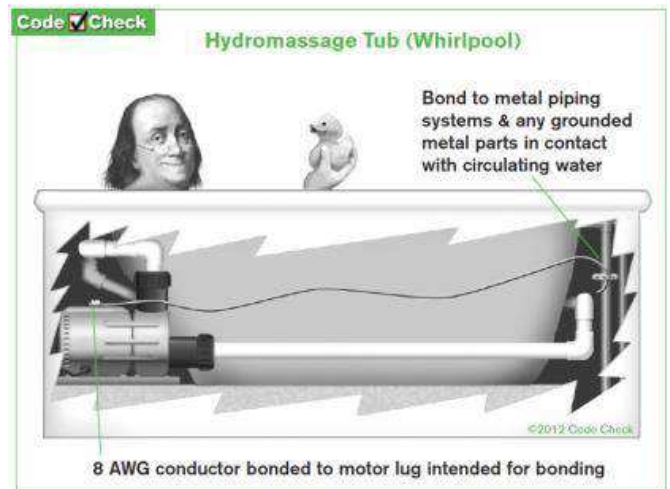
**Attention Needed-** Contaminated water filled the tub when unit was put into operation. This dirty water more than likely comes from the jet tubs from previous baths. These tubes are not draining adequately resulting in an unsanitary condition. The jet tub motor is connected to a Ground Fault Circuit Interrupter, however, it failed to trip when tested. Replacement needed. Jet tub motor does not appear to be bonded with a bonding wire that connects to the motor and attaches from there to a fixed water pipe or the like. This is to ensure grounding continuity and provides a safer path for current in the event of a fault. Contact a licensed electrician for further evaluation.
