# Alliance Inspections

**Report:** Sample Report 1585 E. Anywhere Dr. Altadena, CA

## Confidential Inspection Report

**1585 E. Anywhere Dr.  
Altadena, CA 91001**

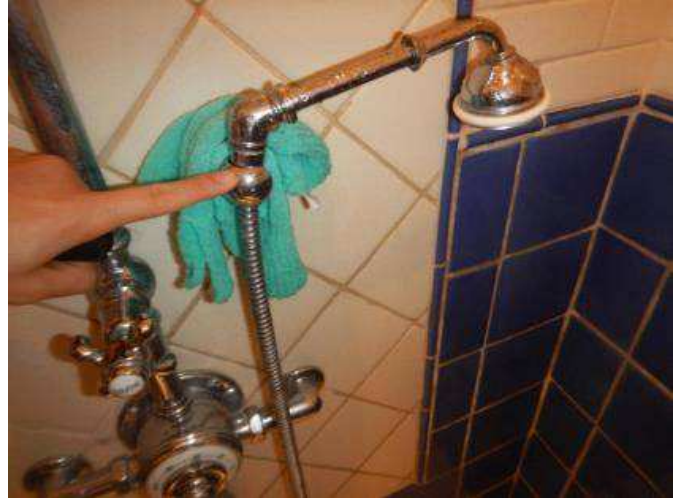
#### 5.44 SHOWER FIXTURES:

**Attention Needed** - The shower sprayer leaks and needs adjustment.

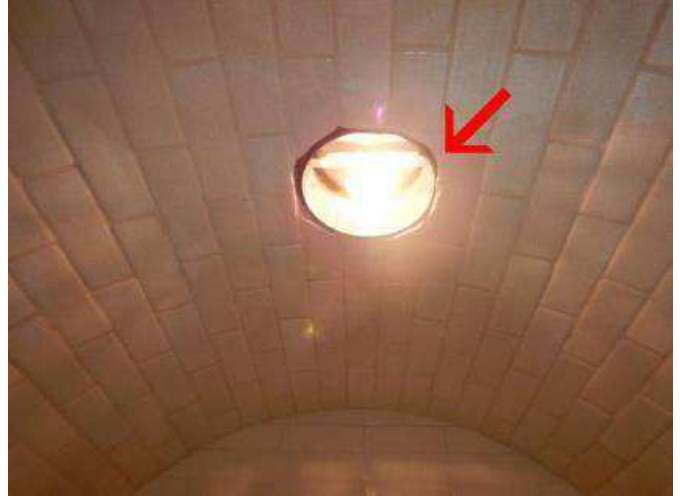
**Attention Needed** - Light cover is missing over light within the shower stall. Replacement needed.

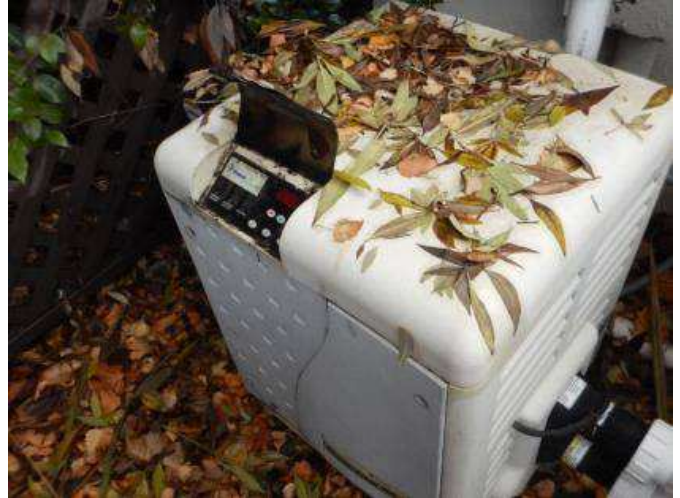
**Attention Needed-** Pool heater failed to operate.  
Contact pool contractor for further evaluation.

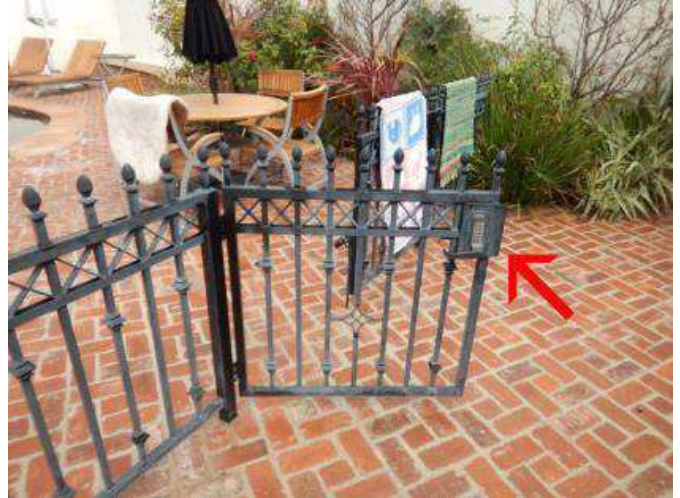
**Attention Needed-** Gates are not self closing and latching properly. Check with the local town Building Department as to fencing requirements with regard to the swimming pool.
