INSPECTION SERVICES NORTHWEST

**CONFIDENTIAL INSPECTION REPORT FOR THE PROPERTY LOCATED
AT:**

44325 181th Ave SE, Bellevue, WA

INSPECTION COMPLETED ON: JANUARY 10, 2017

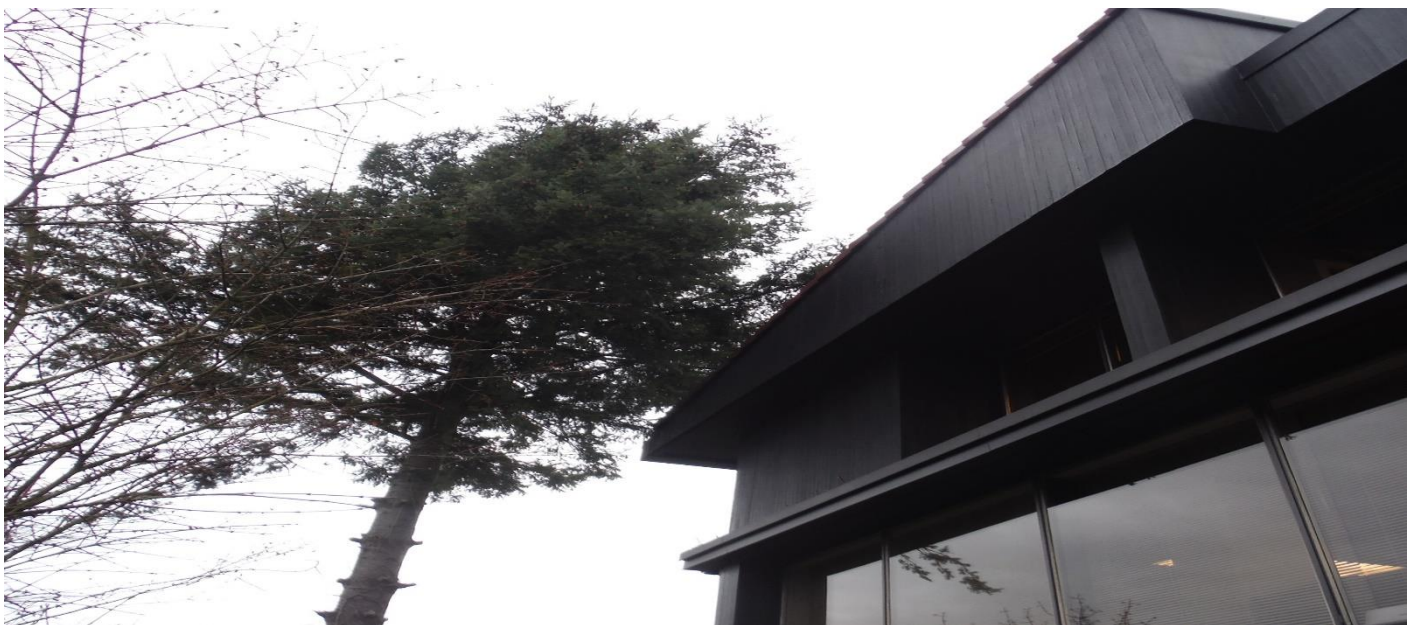
Trees overhanging the roof surface and against siding: Trees overhanging the roof surface increase roof maintenance and may be a safety concern. All branches overhanging the roof surface should be removed.

TRIM ALL TREES AND SHRUBS BACK TO PROVIDE A MINIMUM OF EIGHTEEN INCHES OF SEPARATION FROM THE SIDING AND TEN FEET FROM THE ROOF.

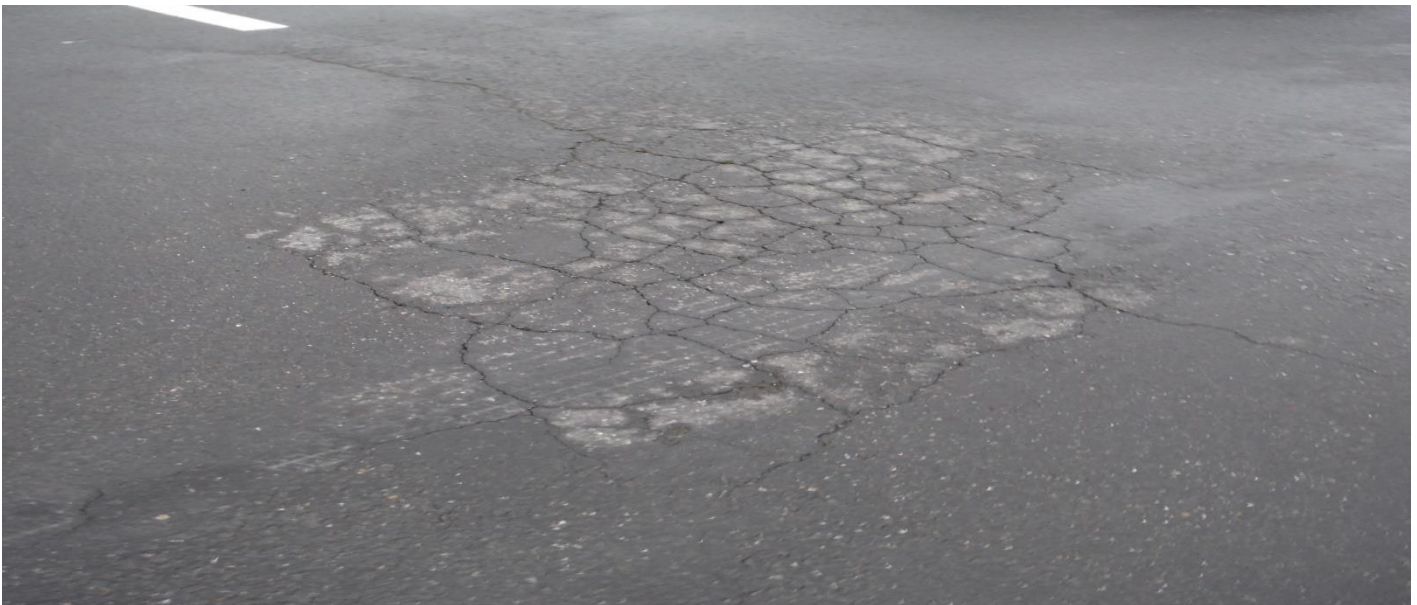
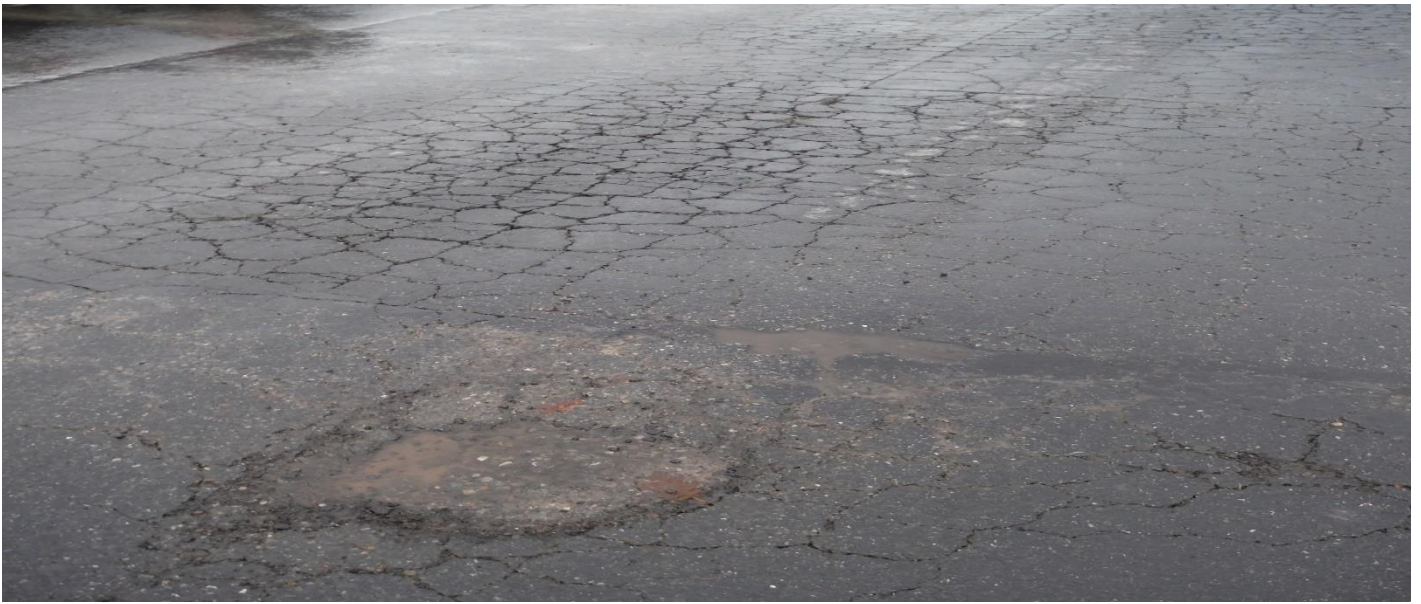
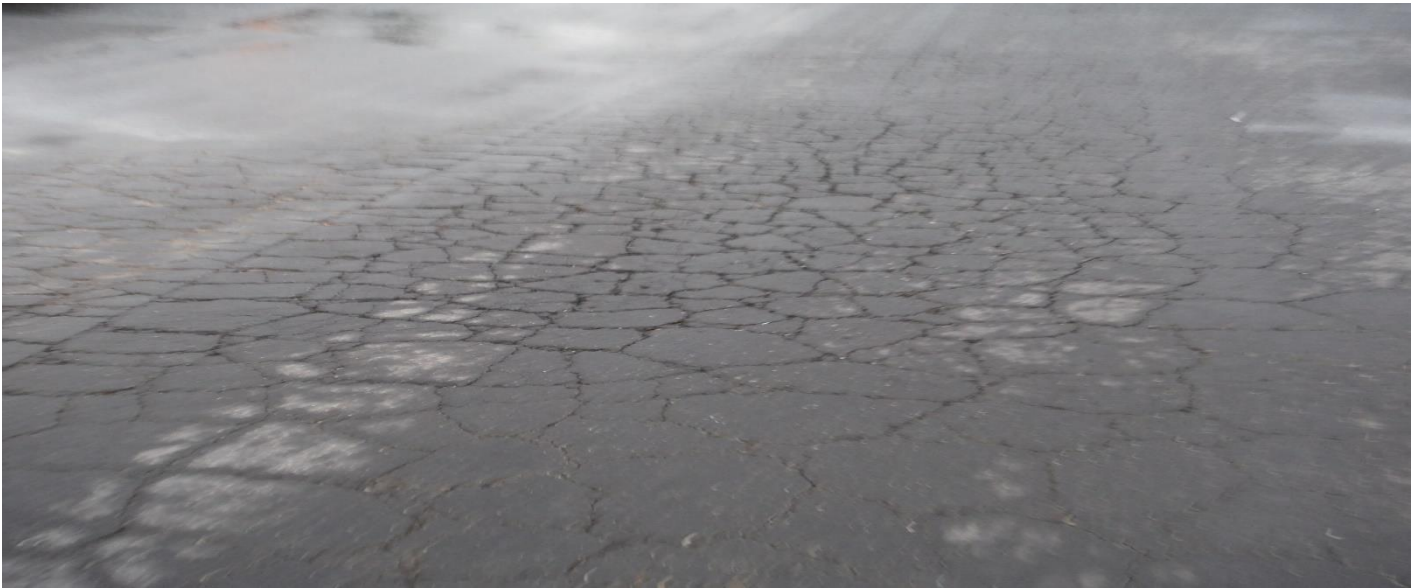
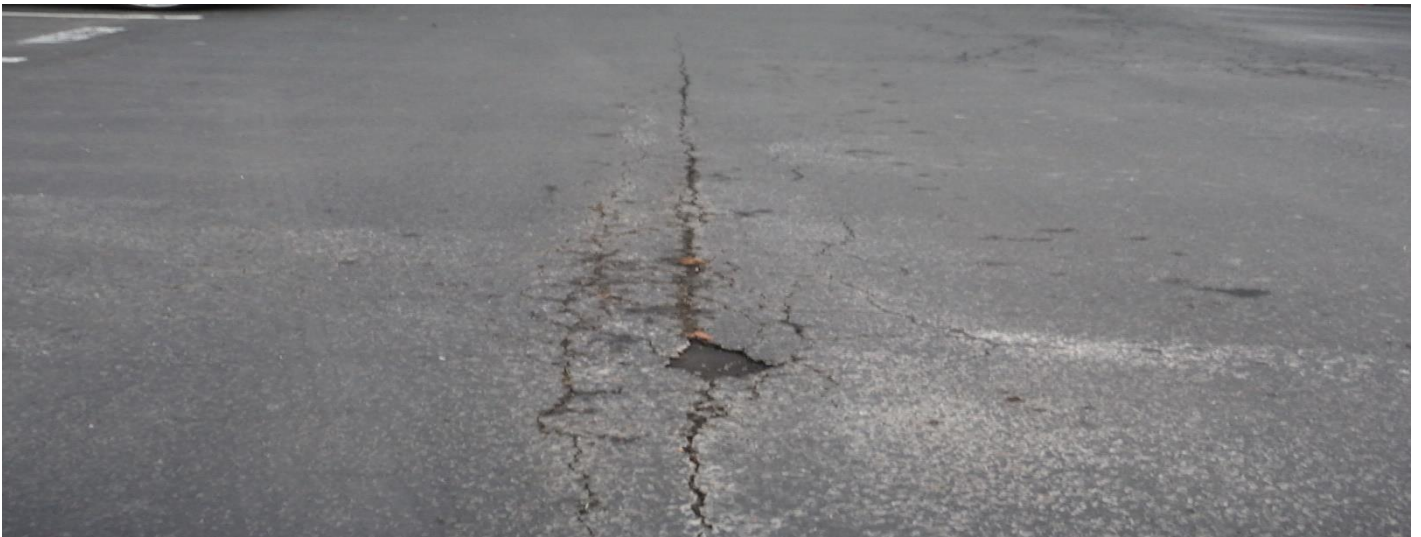
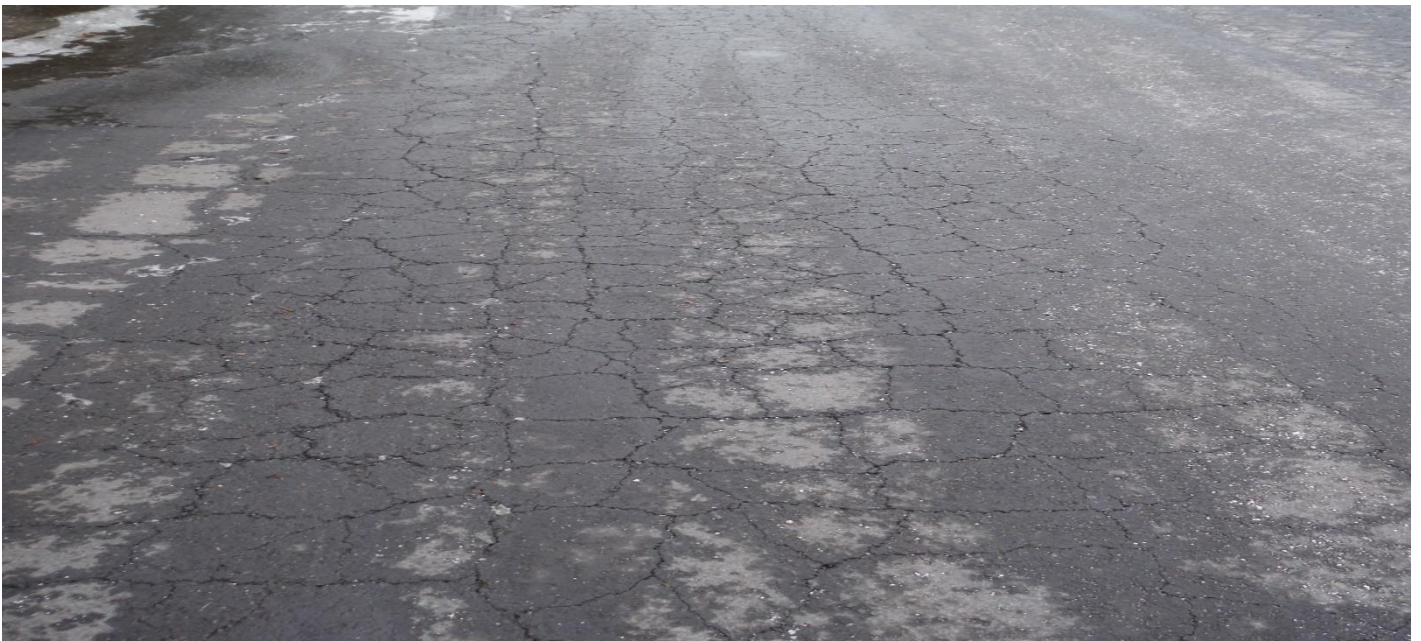
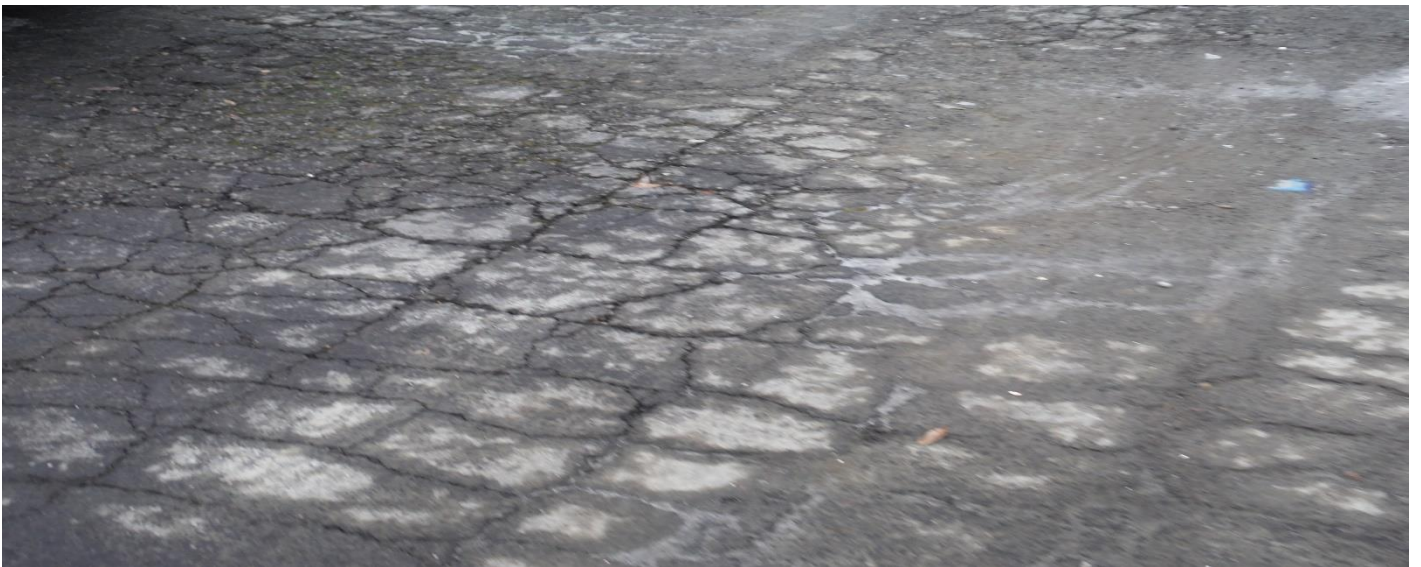
SEVERAL AREAS OF DAMAGED ASPHALT AND CURBING WERE LOCATED IN THE PARKING LOT. SMALL AREAS OF CRACKED AND DAMAGED SIDEWALK WERE ALSO LOCATED. THE PARKING LOT AREA SHOULD BE PROPERLY GRADED. ALL DAMAGED PAVING MUST BE REPLACED, THE PARKING STALLS REPAINTED AND EXISTING CURBING SHOULD BE REPLACED AS NEEDED. CRACKED AND DAMAGED SIDEWALKS SHOULD ALSO BE INSPECTED AND REPAIRED OR REPLACED AS NEEDED. REPAIR ALL TRIP HAZARDS AND ENSURE ALL RUNOFF IS PROPERLY ROUTED AWAY FROM THE STRUCTURE.

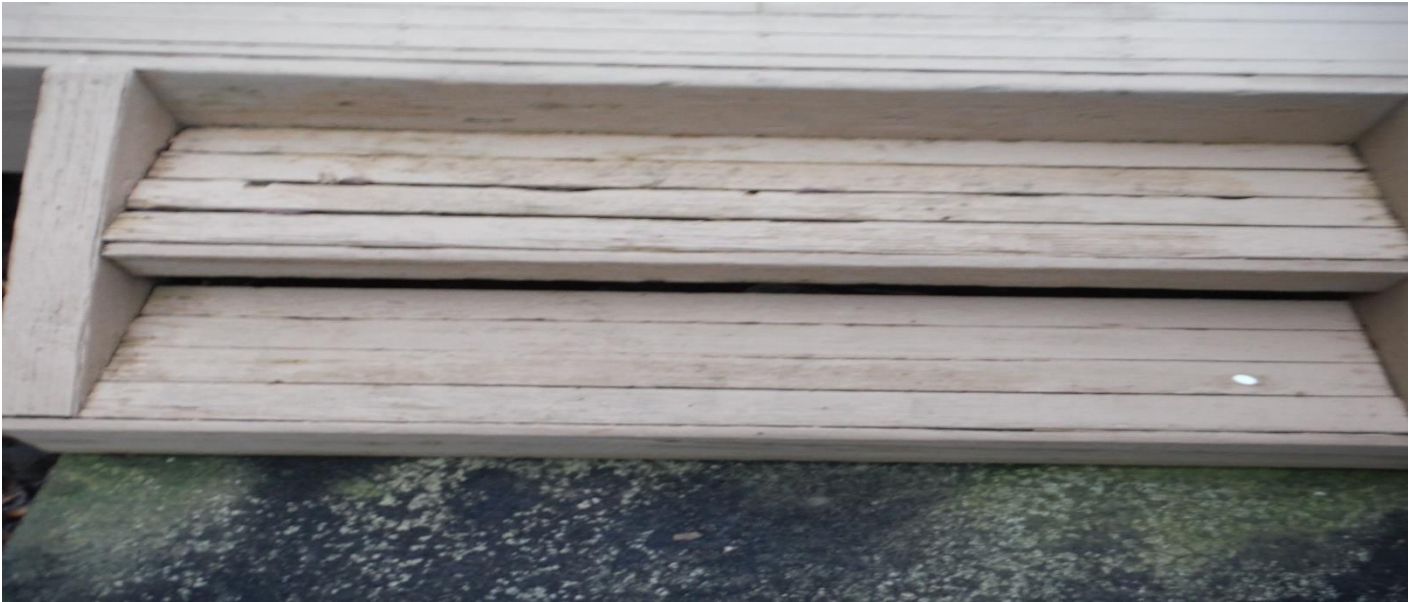
Decayed deck / porch and stair material located: Decayed material was located at the south side and front porches during the course of the inspection. The exact extent of the damaged material and repair required cannot usually be determined until the area has been dismantled to reveal the underlying structure.

LOCATE AND REPLACE ANY AND ALL DAMAGED AND OR DECAYED DECKING AND FRAMING MATERIAL AT THE DECK BETWEEN THE NORTH AND SOUTH BUILDINGS AS FOUND TO BE REQUIRED.

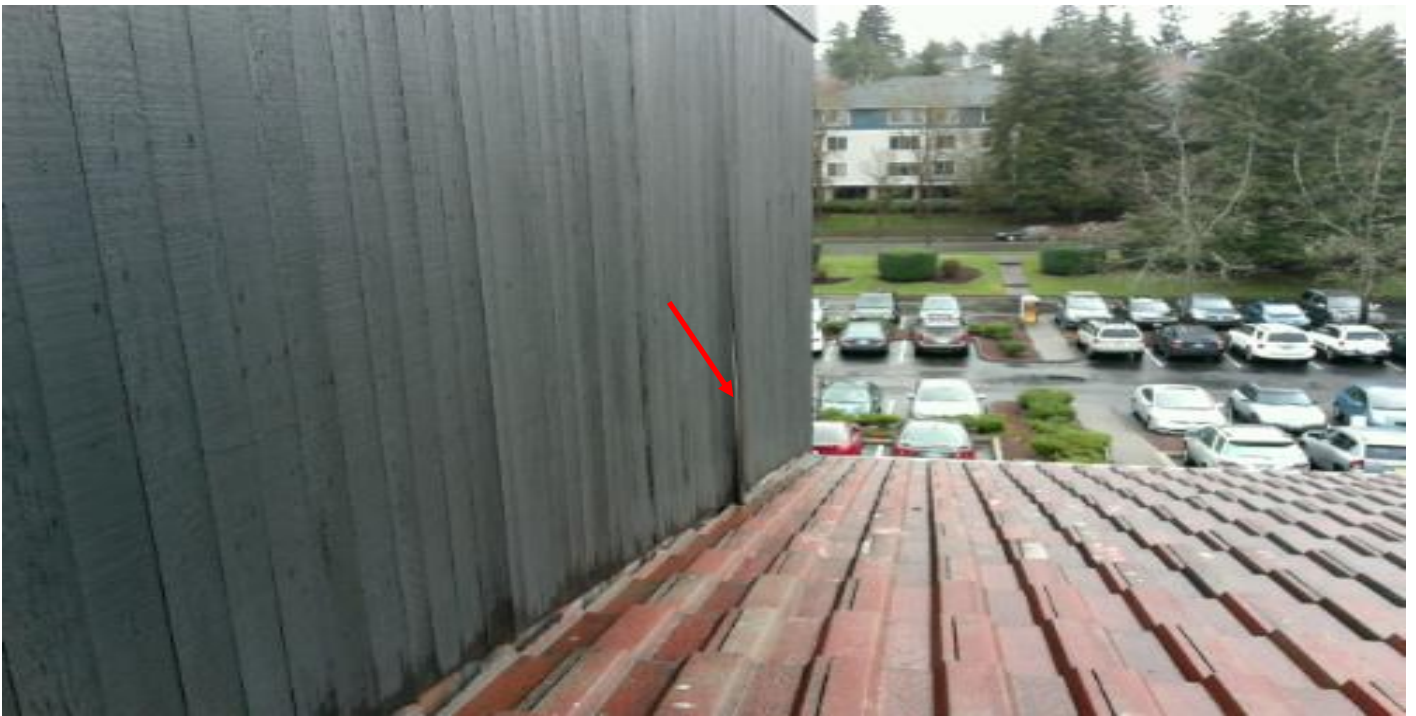
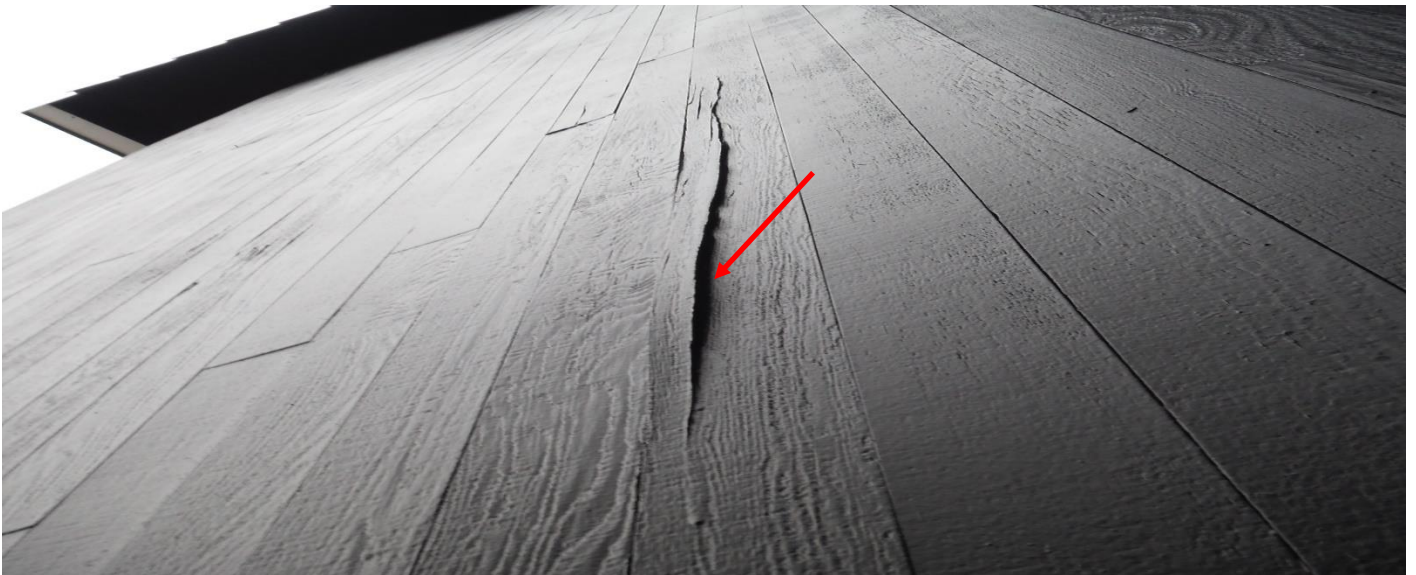
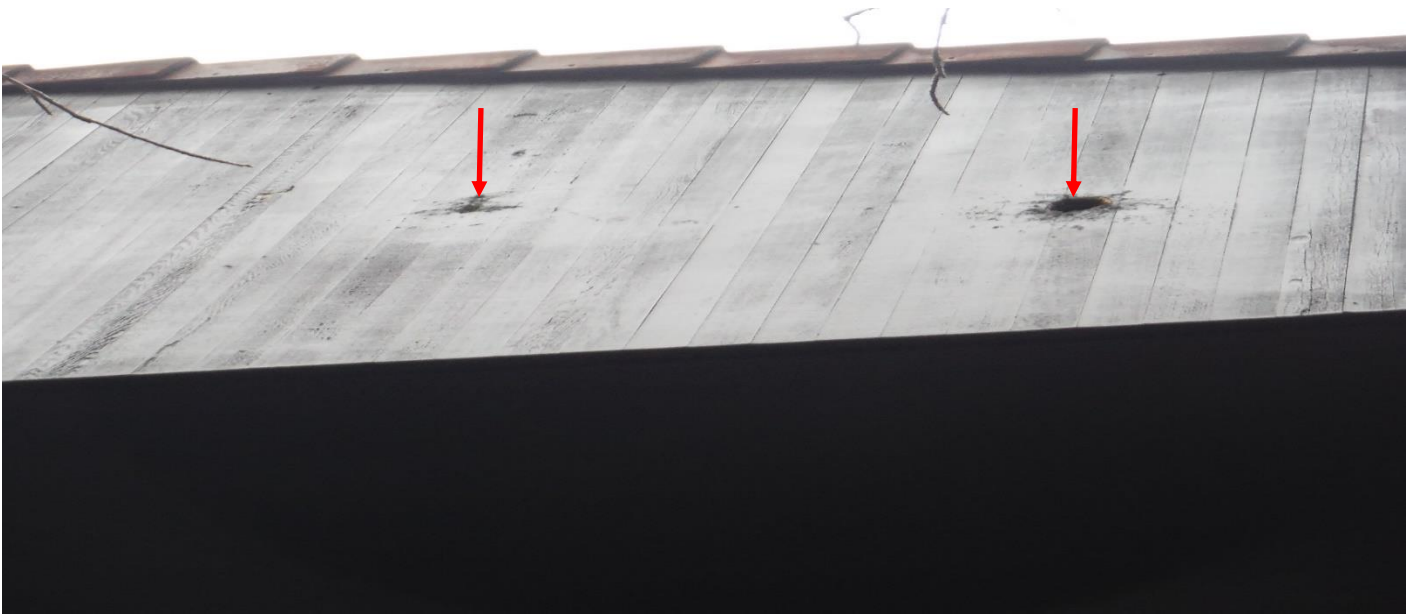
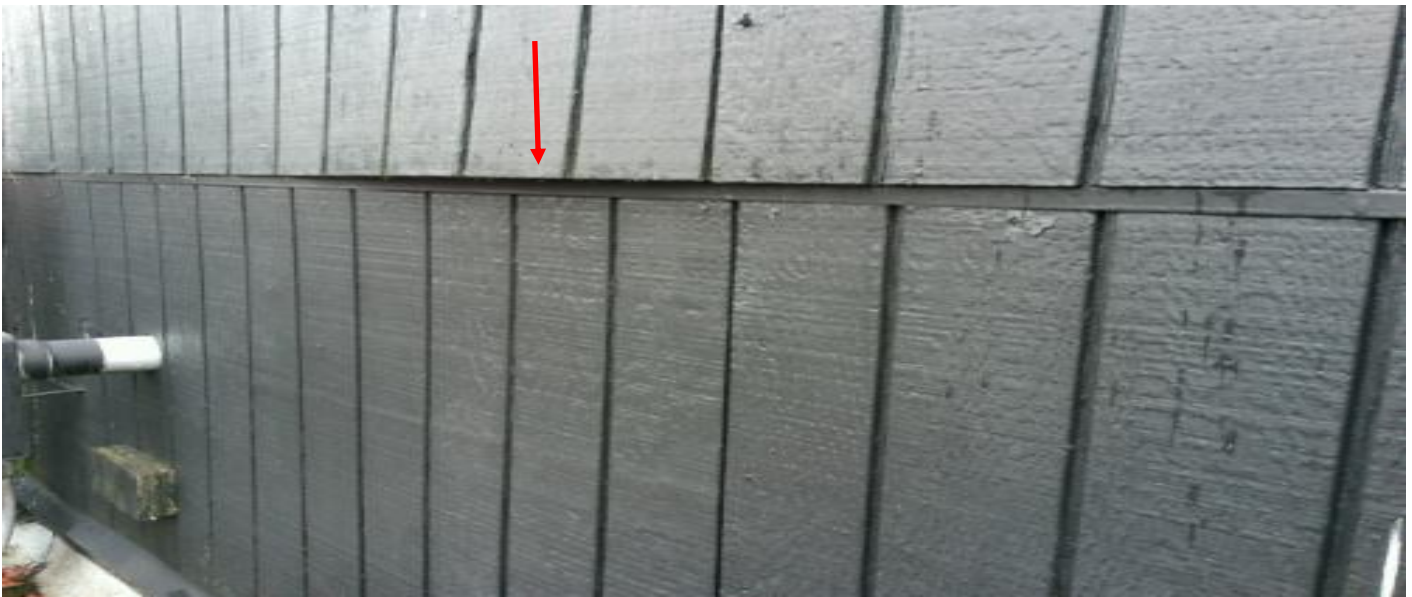
Decayed siding material located: Decayed siding material was located during the course of the inspection. The exact extent of the damaged material and repair required cannot usually be determined until the area has been dismantled to reveal the underlying structure. All damaged material that is located during the process of repair must be replaced.

LOCATE AND REPLACE ANY LOOSE, DAMAGED AND OR DECAYED VERTICAL SIDING AND T-111 SIDING MATERIAL AT THE SIDEWALL AREAS AS FOUND TO BE REQUIRED ON THE ROOF, SOUTH END OF THE BUILDING AND WOOD PECKER DAMAGED MATERIAL AT THE SOUTH END OF THE BUILDING. ANY FURTHER DAMAGE THAT IS REVEALED AFTER THE SIDING IS REMOVED MUST ALSO BE REPLACED AS FOUND TO BE REQUIRED.

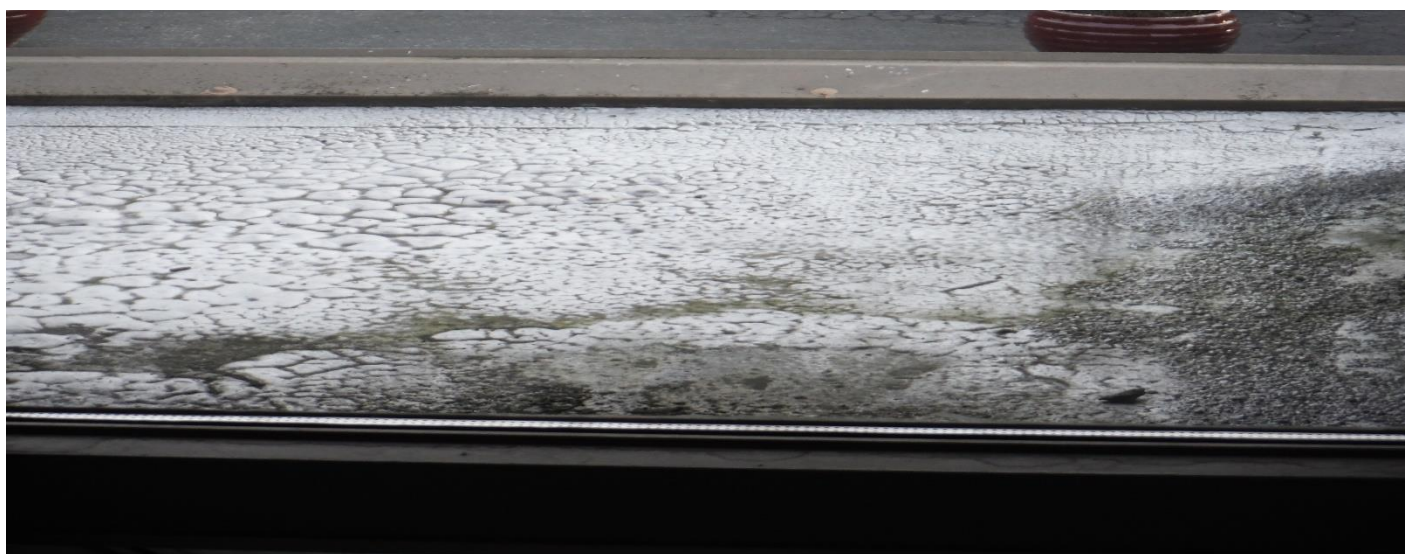
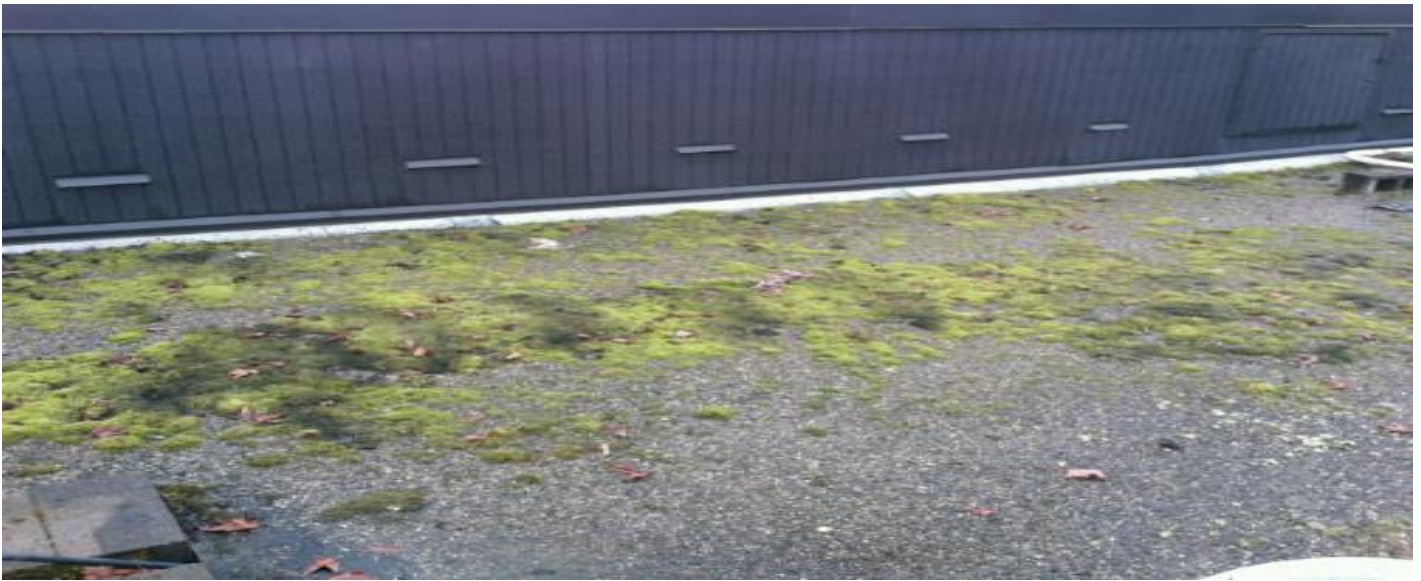
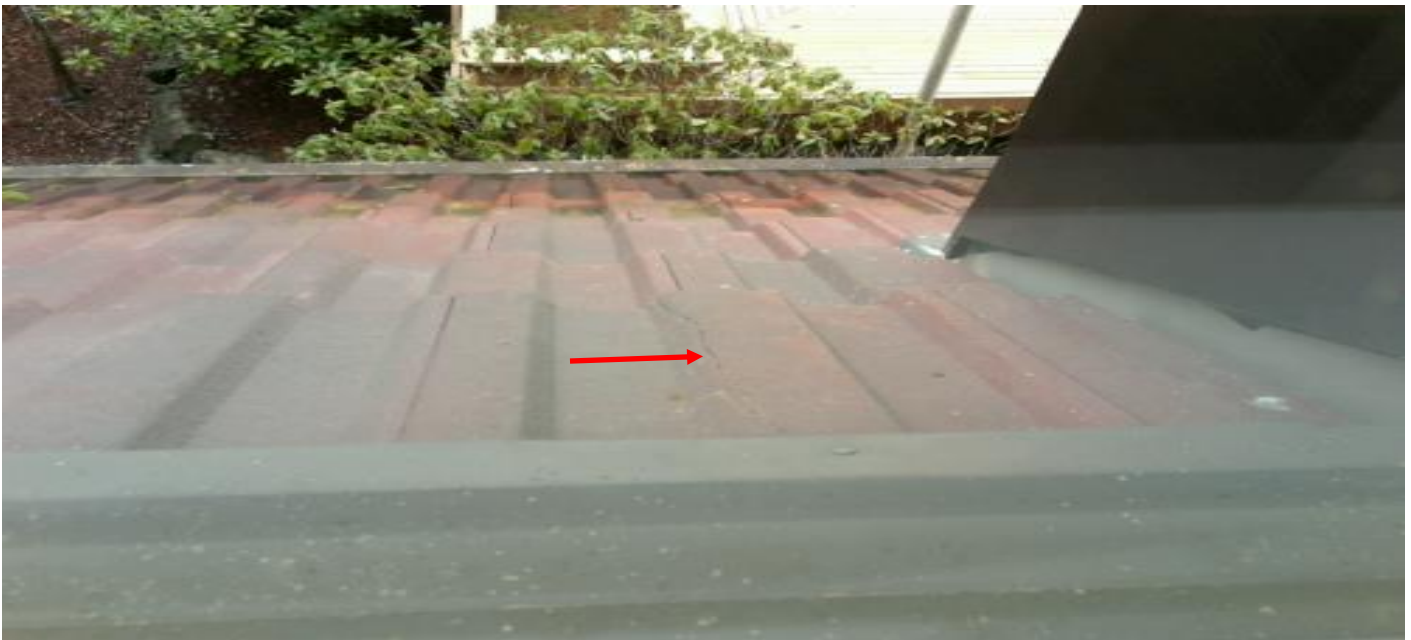
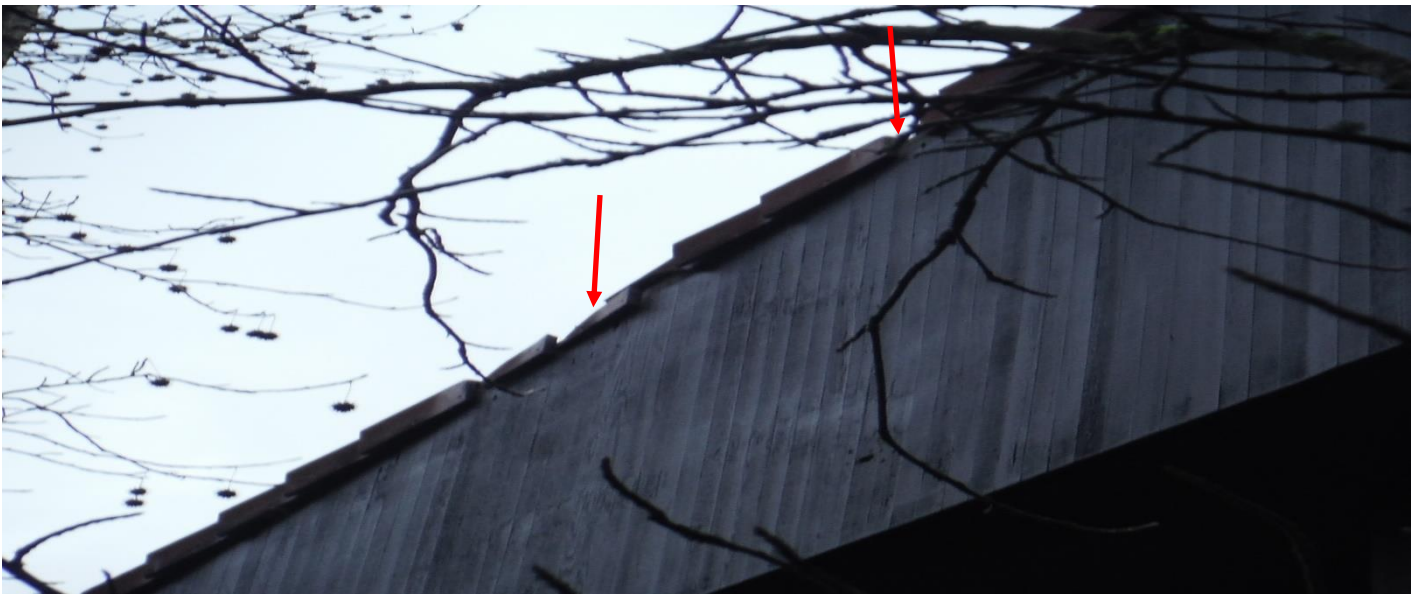
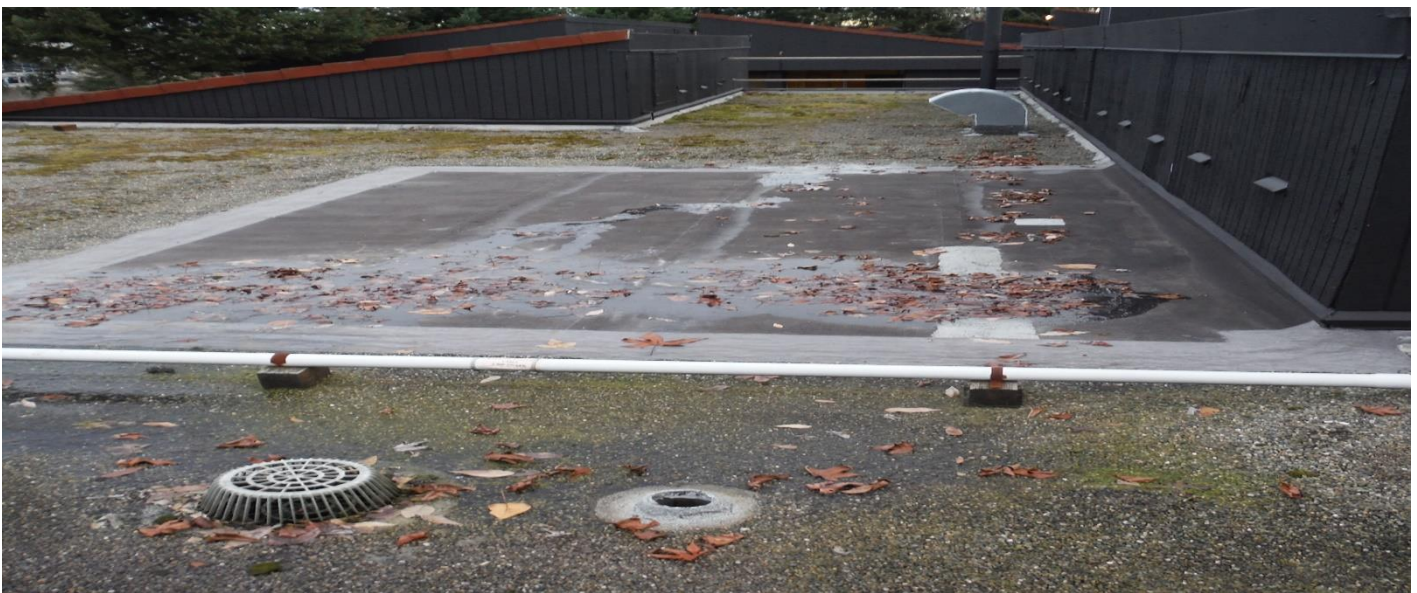
Decay and Wear and damage noted at roofing surface: The roofing surface is showing signs of wear in limited areas. A roof in this condition must be analyzed by a licensed roofing contractor and repaired as found to be required to warranty a minimum expected life of five years.

THE TAR AND GRAVEL ROOFING MATERIAL ON THE LOW SLOPE SECTIONS AND TORCHDOWN MATERIALS OVER THE FRONT ENTRANCES SHOWS SIGNS OF WEAR AND PATCHING AND ARE AT OR NEAR THE END OF ITS USEFUL LIFE AND DAMAGED CEMENT TILES WERE LOCATED IN SEVERAL LOCATIONS. THE ROOFING MATERIALS, DOWNSPOUTS, GUTTERS AND FLASHING MATERIAL MUST BE ANALYZED BY A LICENSED ROOFING CONTRACTOR AND REPAIRED AS FOUND TO BE REQUIRED TO WARRANTY THE ROOF FOR A MINIMUM OF FIVE YEARS. THE REPAIRS MUST INCLUDE BUT NOT BE LIMITED TO REPLACING ALL DAMAGED OR DECAYED ROOFING MATERIAL, REPAIRING AND REPLACING ALL DAMAGED FLASHING AND CAULKING, LOW PRESSURE WASHING THE ROOF TO REMOVE MOSS GROWTH AND WIND BLOWN DEBRIS, REPAIRING OR REPLACING ALL DAMAGED OR MISSING GUTTERS AND DOWNSPOUTS, PROPERLY DIRECTING THE ROOF RUNOFF AWAY FROM THE STRUCTURE AND COMPLETING ANY OTHER REPAIRS AS RECOMMENDED BY THE ROOFING CONTRACTOR.

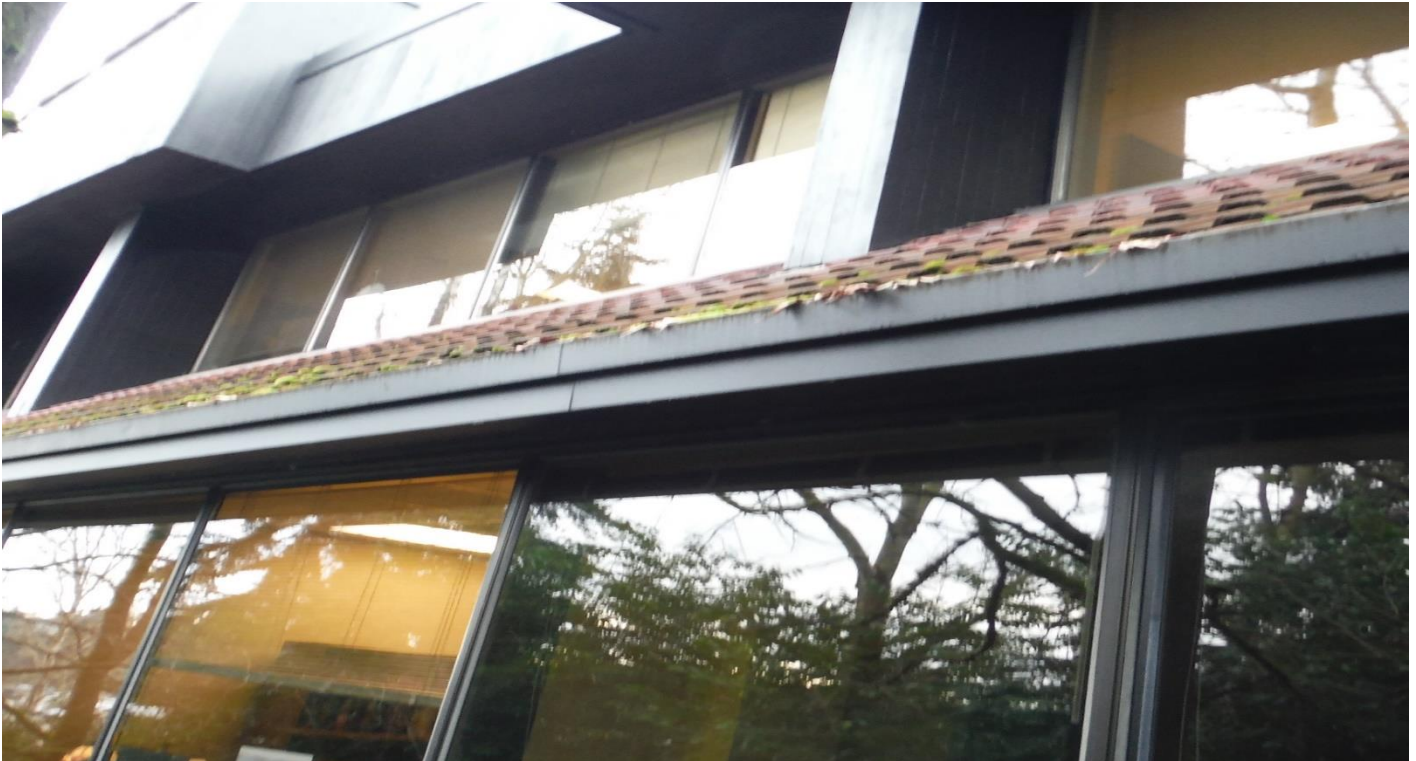
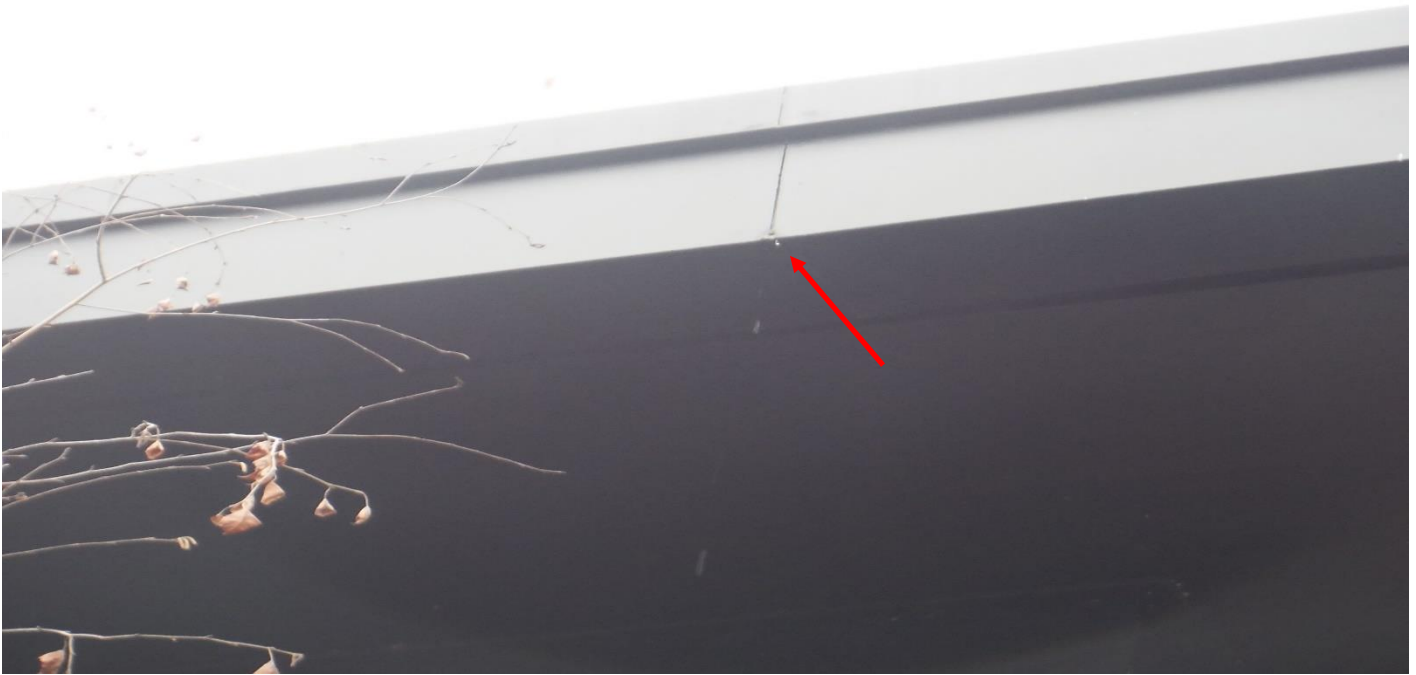
Gutters and downspouts: The gutters and downspouts were not in operating condition because of a build up of debris in the system. Gutters and downspouts must be maintained to ensure proper operation at all times. Water damage to the eaves and sidewalls will occur if the systems are not maintained.

CLEAN THE GUTTERS, DOWNSPOUTS AND THE TIGHTLINES, REPAIR ALL LEAKS AND ENSURE THE SYSTEM IS PROPERLY DRAINING AND DIRECTING ALL ROOF RUNOFF AWAY FROM THE STRUCTURE.
