INSPECTION SERVICES NORTHWEST

**CONFIDENTIAL INSPECTION REPORT FOR THE PROPERTY LOCATED
AT:**

44325 181th Ave SE, Bellevue, WA

INSPECTION COMPLETED ON: JANUARY 10, 2017

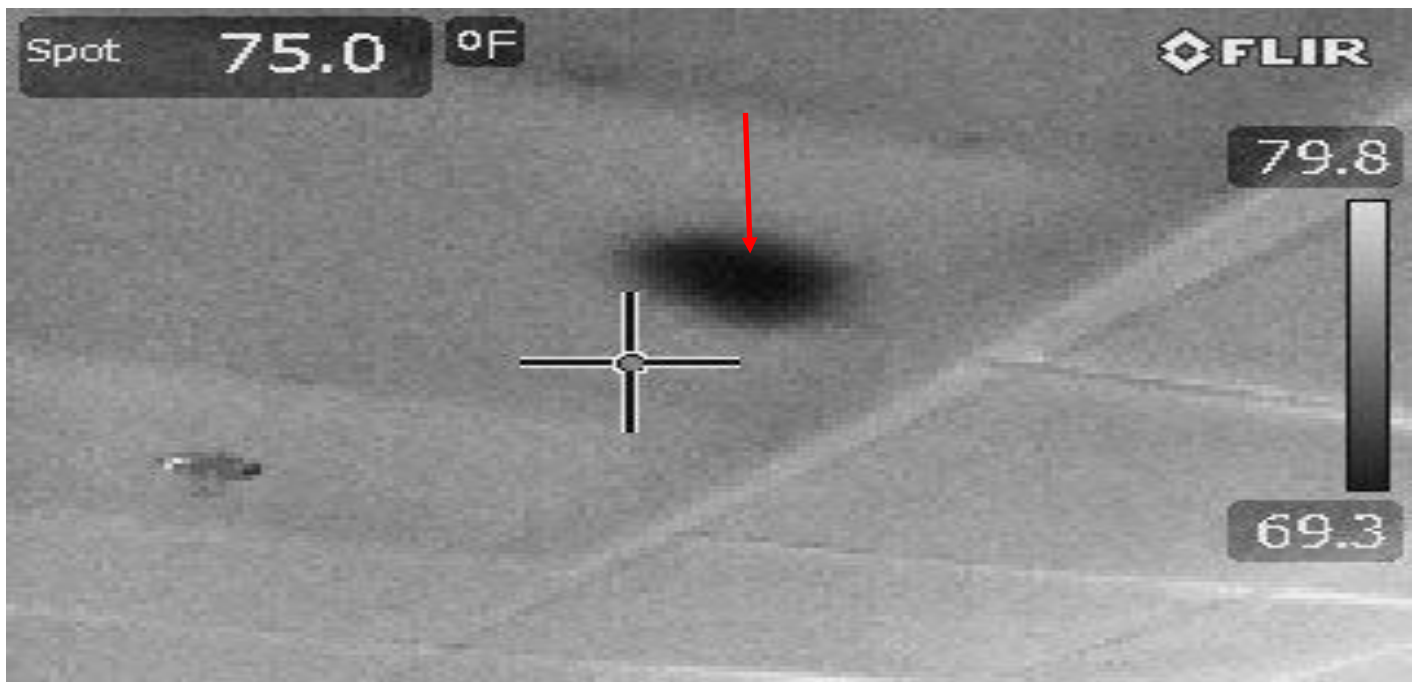
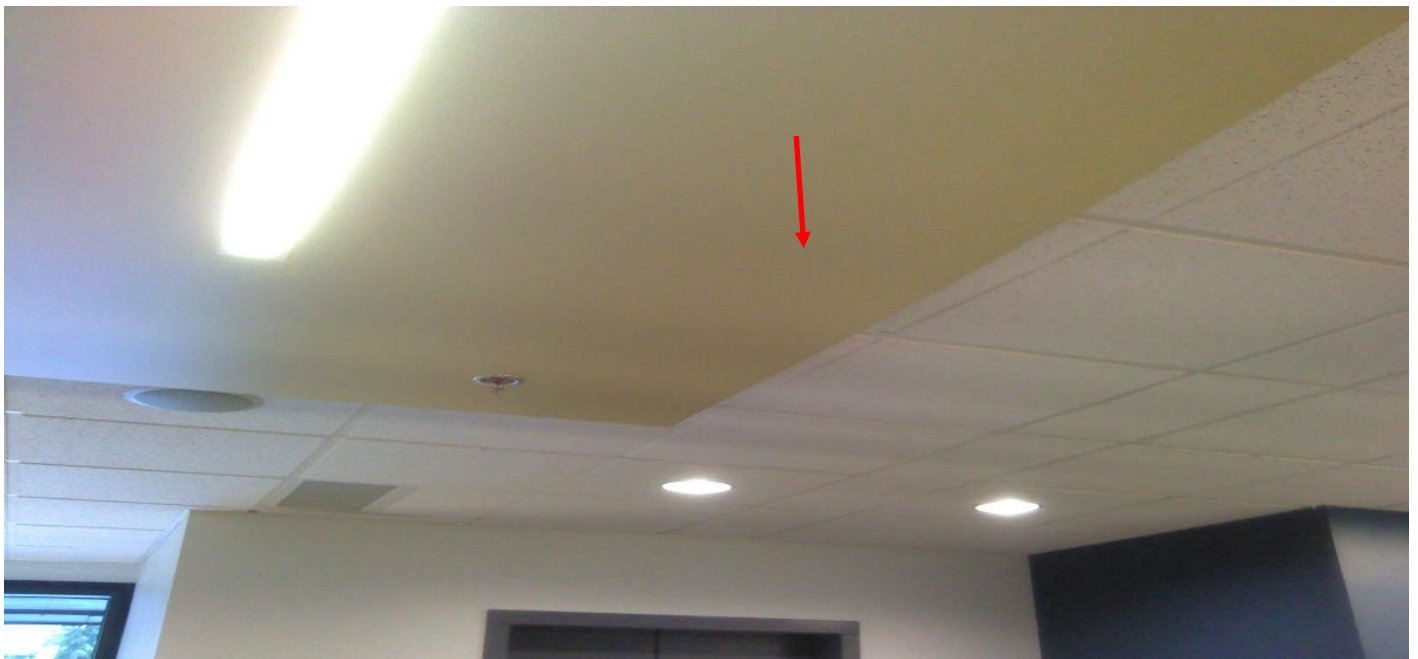
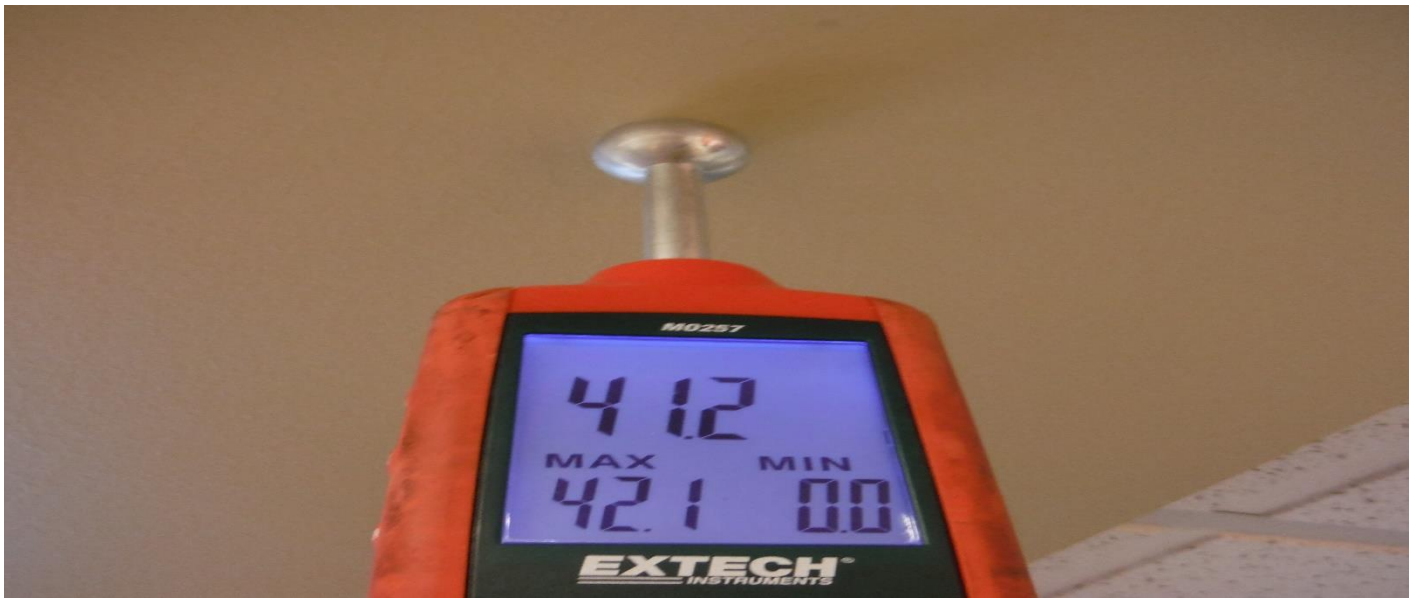
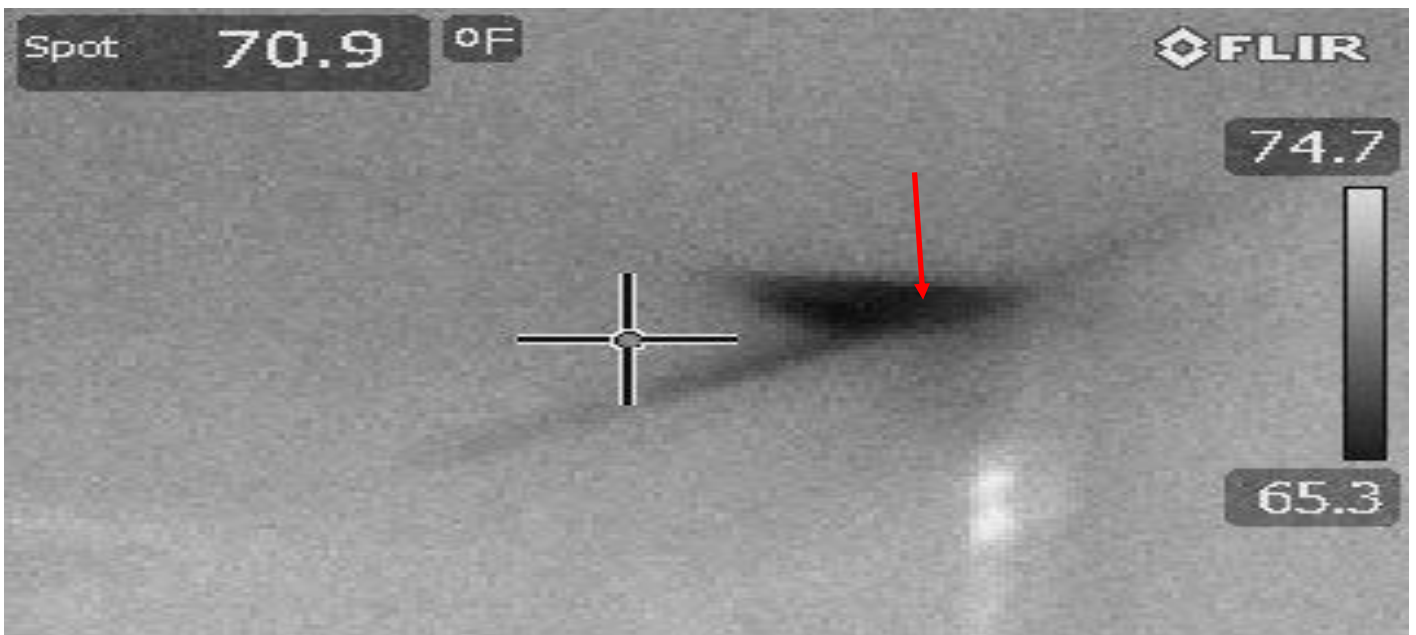
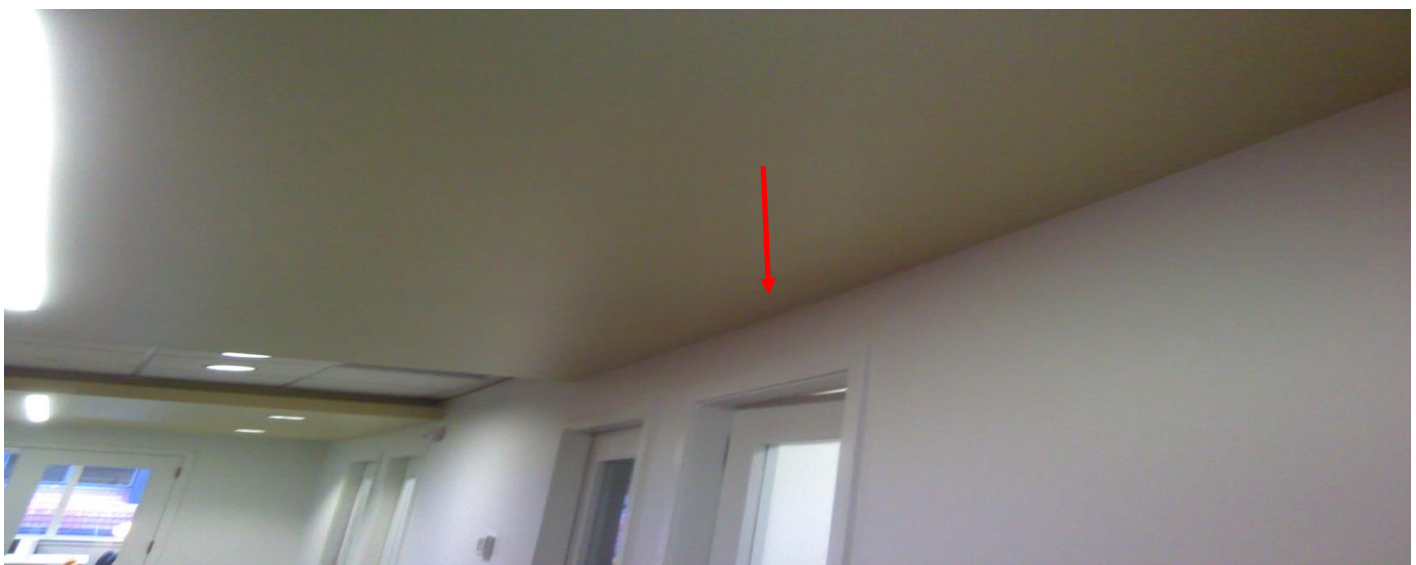
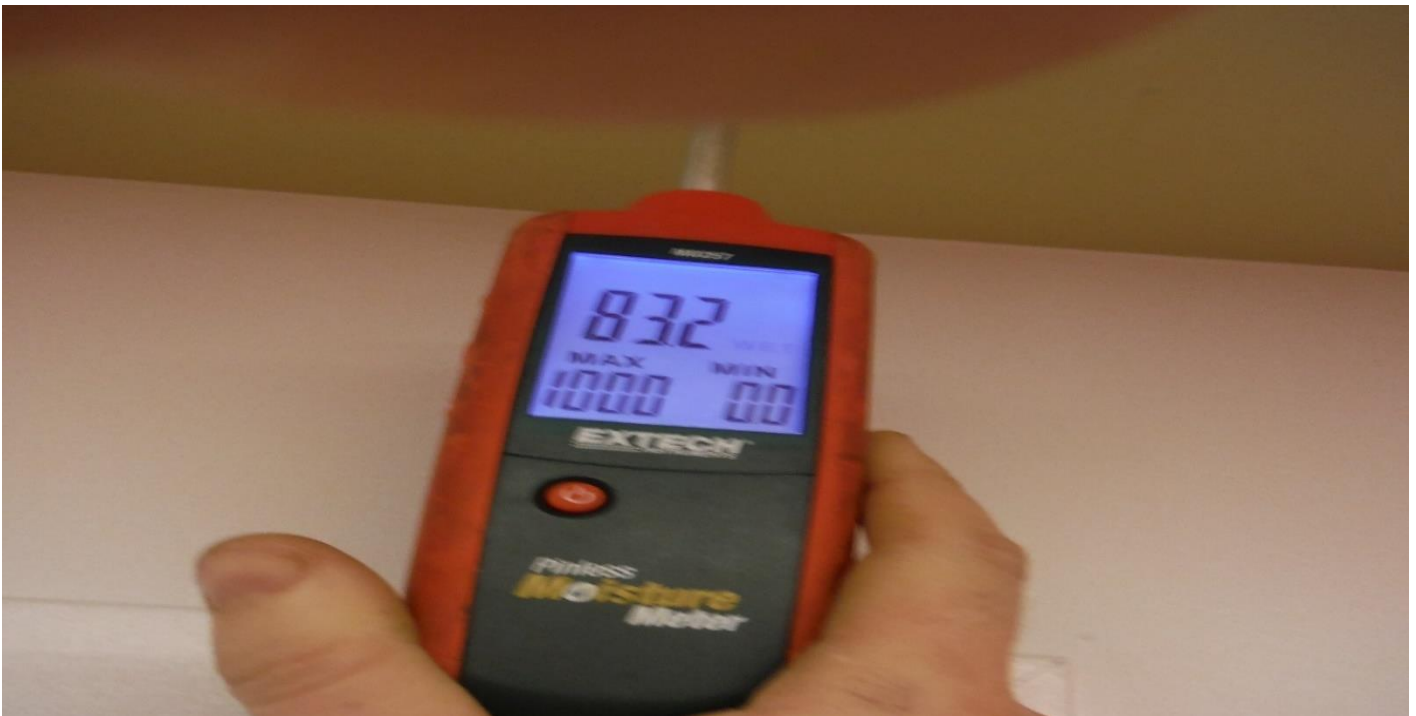
ACTIVE LEAKS WERE LOCATED ON THE CEILING NEAR THE EAST SPRINKLER HEAD AT THE 3RD FLOOR RECEPTION DESK AND ABOVE THE DOOR TO THE 1ST ROOM NORTHWEST OF THE RECEPTION DESK AREA USING THERMOGRAPHY (SEE PHOTOS) AND CONFIRMED WITH A MOISTURE METER BUT THE CAUSE WAS UNKNOWN. REMOVE THE DRYWALL IN THESE AREAS TO DETERMINE THE CAUSE OF THE LEAK, IF IT IS A ROOF LEAK HAVE A LICENSED ROOFING CONTRACTOR INSPECT THE ROOFING SYSTEMS AND COMPLETE ALL REPAIRS FOUND TO BE REQUIRED TO ENSURE THERE ARE NO ACTIVE ROOF LEAKS IF IT IS A PLUMBING LEAK HAVE A PLUMBING CONTRACTOR MAKE ALL REPAIRS FOUND TO BE REQUIRED TO ENSURE THERE ARE NO ACTIVE PLUMBING LEAKS. REPLACE ALL DAMAGED OR DECAYED BUILDING MATERIALS AS LOCATED AND COMPLETE ANY OTHER NECESSARY REPAIRS AS FOUND TO BE REQUIRED.

EVIDENCE OF WATER STAINING WAS LOCATED ON THE WALL OF THE SOUTH STAIRWELL TO THE ROOF AND AT SEVERAL CEILING TILES BUT WAS DRY AT THE TIME OF THE INSPECTION. THESE AREAS SHOULD BE MONITORED ONCE THE AIR CONDITIONING SYSTEMS ARE ACTIVE. REFER TO THE HVAC SYSTEMS SECTION FOR FURTHER INFORMATION.

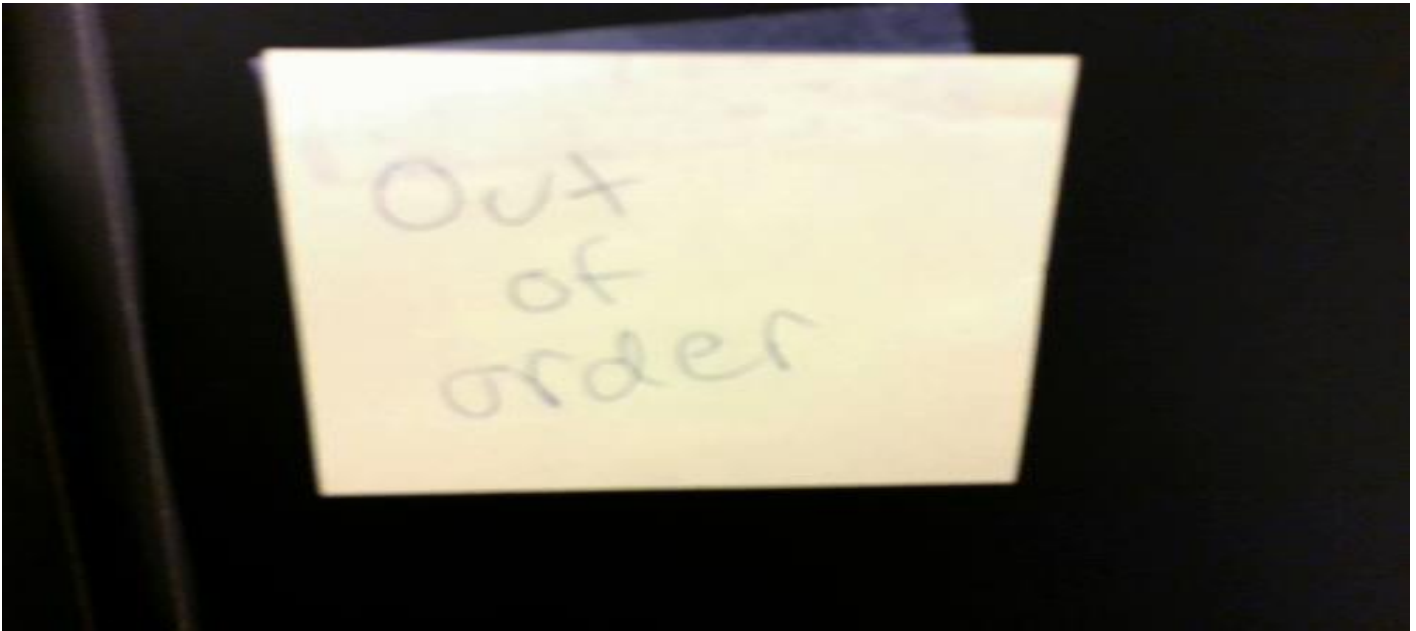
THE HANDICAP STALL IN THE 3rd FLOOR MENS BATHROOM IS MARKED OUT OF ORDER. PERFORM ALL REPAIRS AS FOUND TO BE REQUIRED.

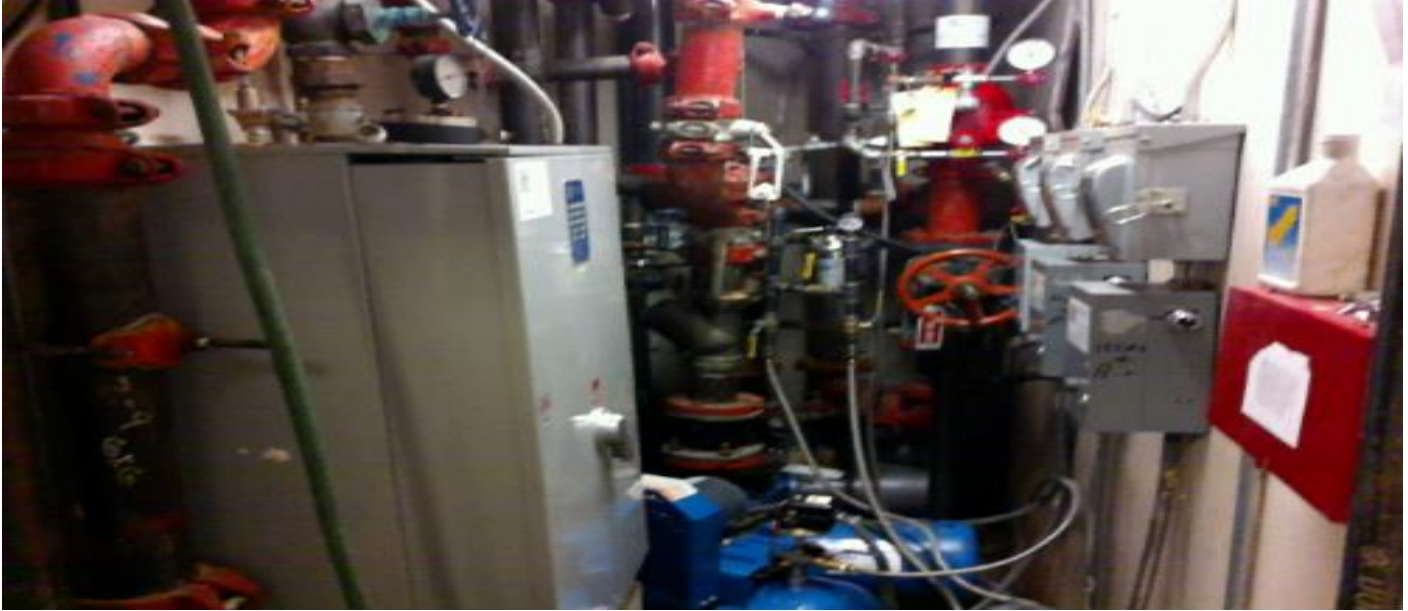
Older boiler systems: The life expectancy of older boiler systems cannot be determined. The requirement for repair or replacement can occur at any time. It is highly recommended that the purchaser contract for an annual repair contract through the local heating company.

Monitor this item: This component is likely to require substantial repair or replacement at any time. Although in working condition and not requiring, any known or visible repair at this time its status may change at any time. It is impossible during the course of the inspection to determine when repair or replacement will be required.

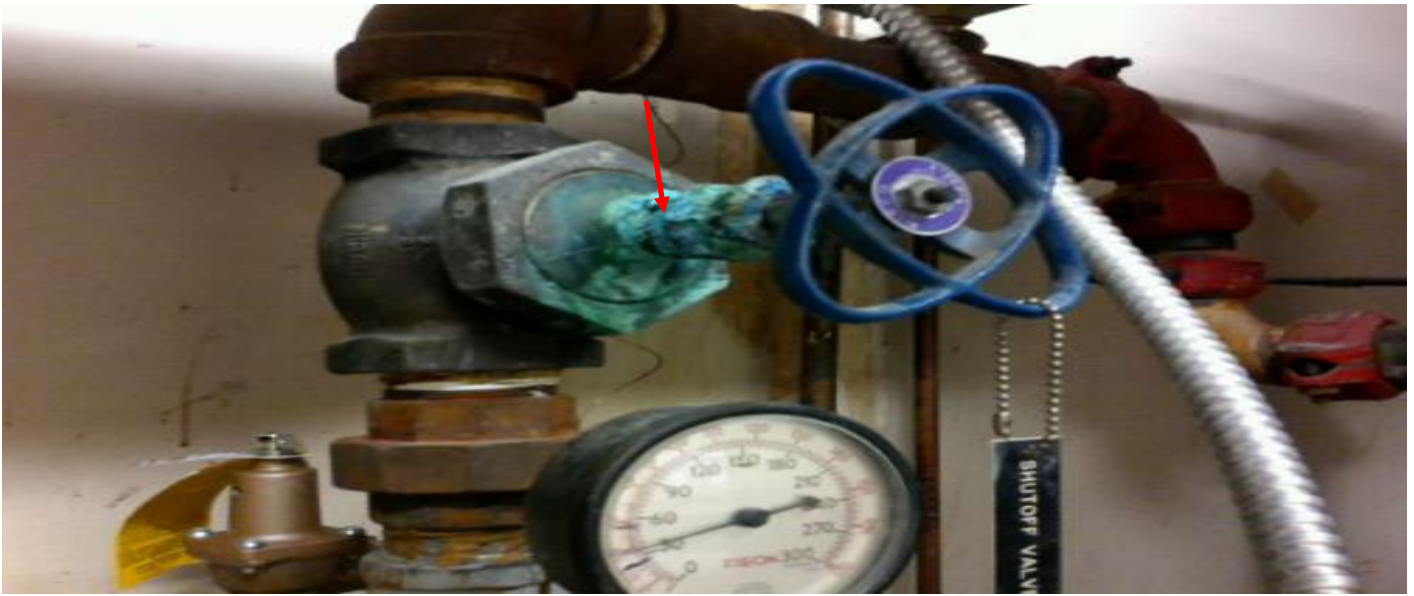
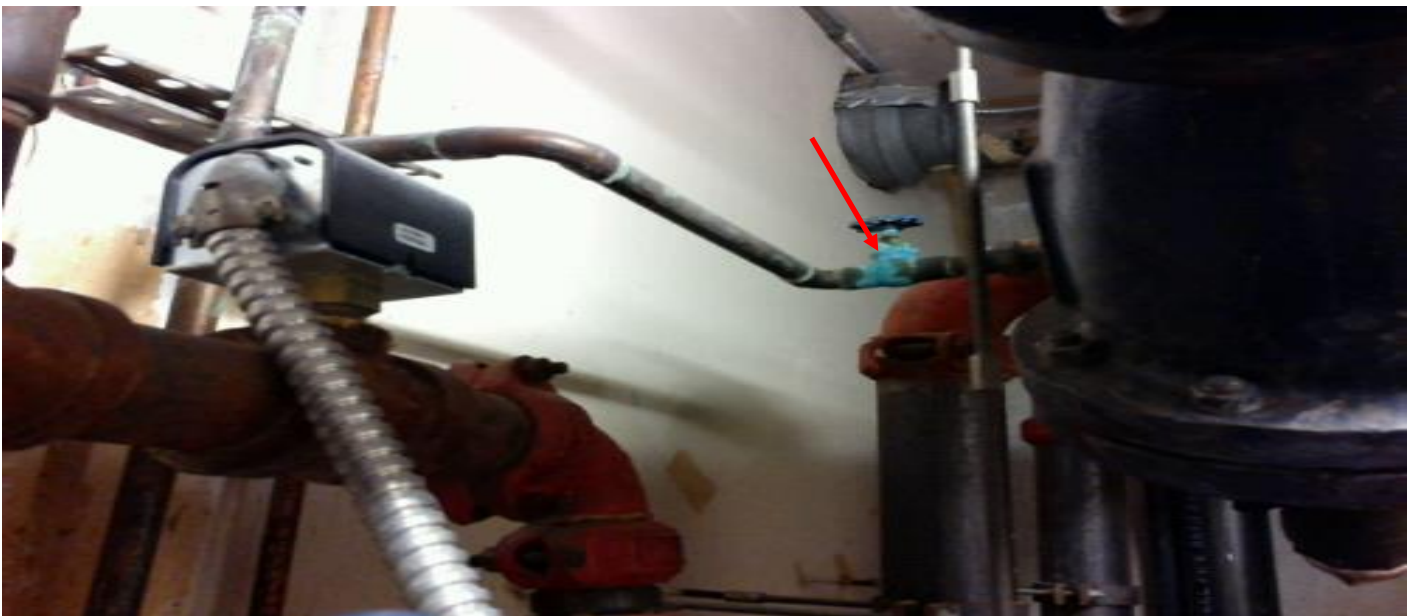
SIGNS OF CORROSION WERE LOCATED AT SHUTOFF VALVES IN THE BOILER ROOM ON THE 1ST FLOOR. REFER TO THE MECHANICAL SECTION OF THE REPORT FOR FURTHER INFORMATION.

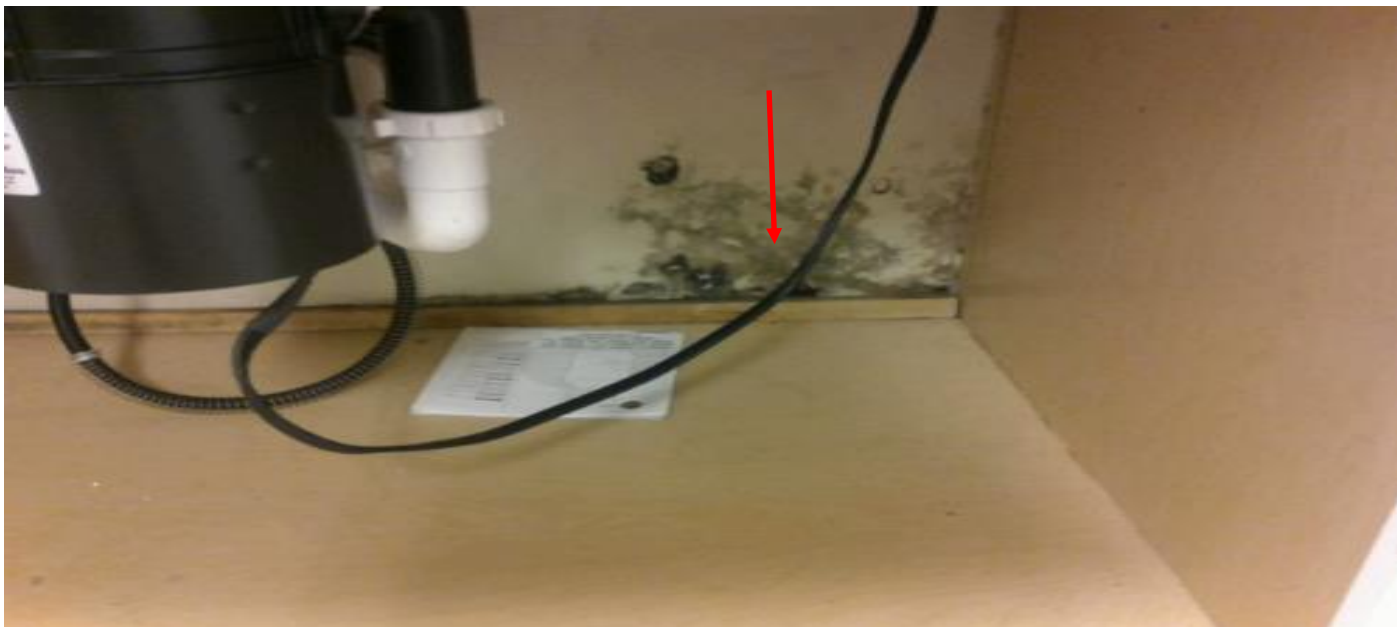
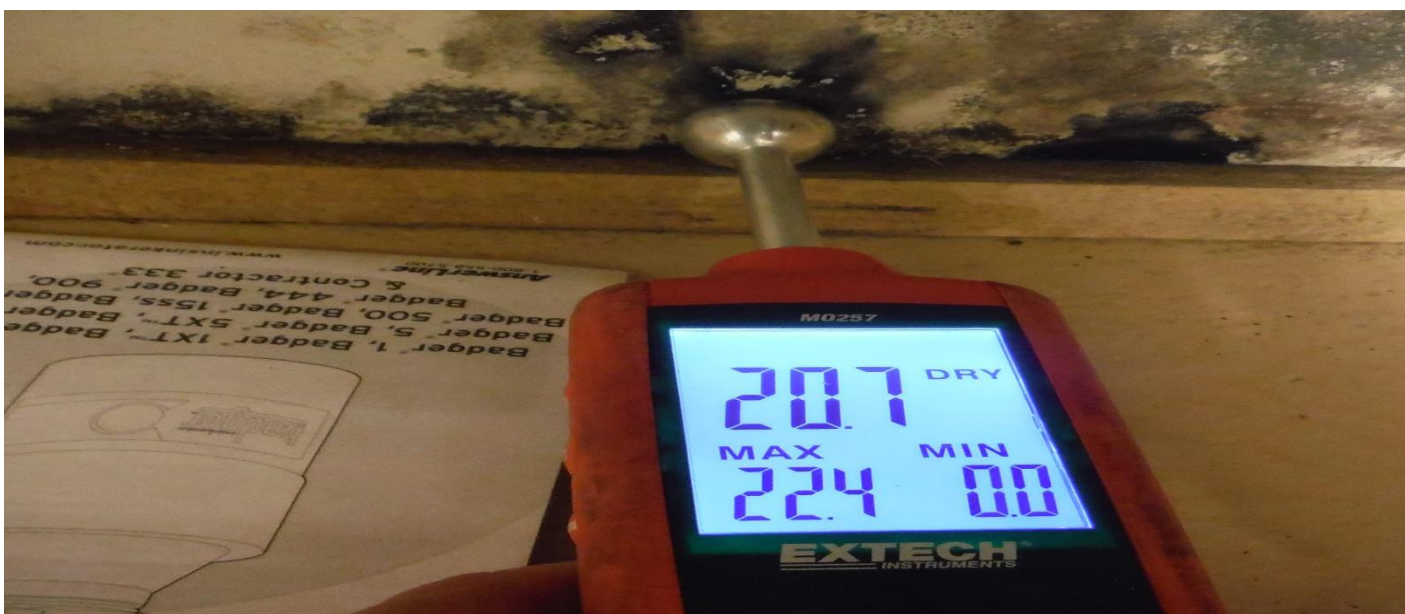
Plumbing supply line leak: A supply line leak was located at the time of the inspection. If possible we will call out the fixture and line involved. Some leak sources may be hidden from view.

EVIDENCE OF HIGH MOISTURE METER READINGS AND MOLD WERE LOCATED ON THE WALL BELOW THE NORTH BREAK ROOM SINK ON THE FIRST FLOOR. REMOVE THE DRYWALL, REPAIR THE LEAK AND REPLACE ALL DAMAGED MATERIALS AS FOUND TO BE REQUIRED.

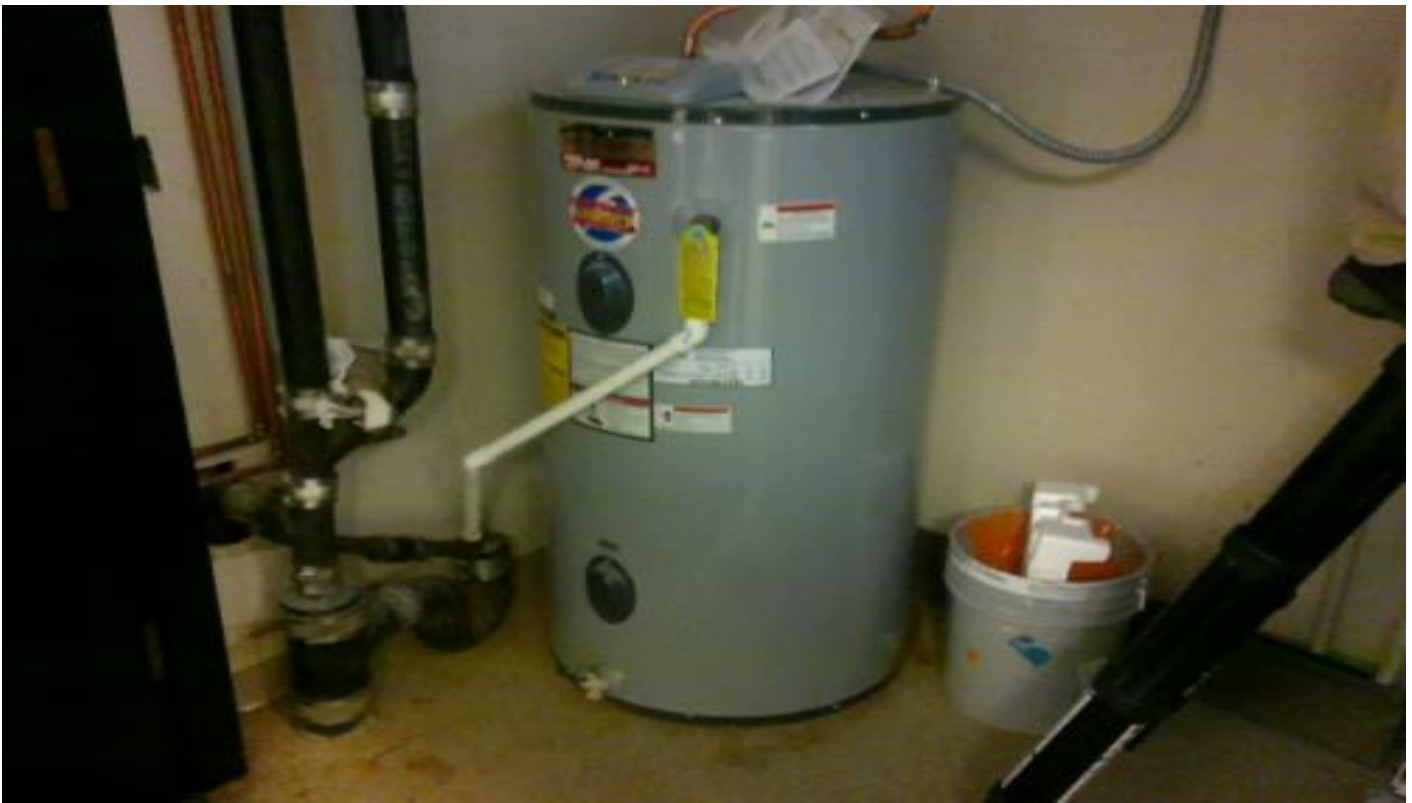
The hot water tank has reached the end of its life: Hot water tanks at or near the end of their effective life (15+ years) should be replaced as soon as possible to avoid the water damage caused by a tank failure.

THE HOT WATER TANK IN THE NORTH 1ST FLOOR OFFICE IS 12 YEARS OLD, 106 IS 10 YEARS OLD AND THE WATER HEATER IN SUITE 104 IS 17 YEARS OLD AND IS PAST ITS EXPECTED LIFE. THE TANKS MUST BE REPLACED AT THIS TIME TO AVOID THE CHANCE OF WATER DAMAGE FROM THE TANKS FAILURE.
