November 26, 2025

**SUBJECT: Soil and Hazardous Building Materials Investigation Report per 9-11-25
DTSC Letter, 1583 & 1657 El Centro Avenue, Napa, California.**

**RE: Pre Demolition Hazardous Building Materials Inspection Report
Residence and Outbuildings
1583 EL Centro Avenue, Napa, CA**

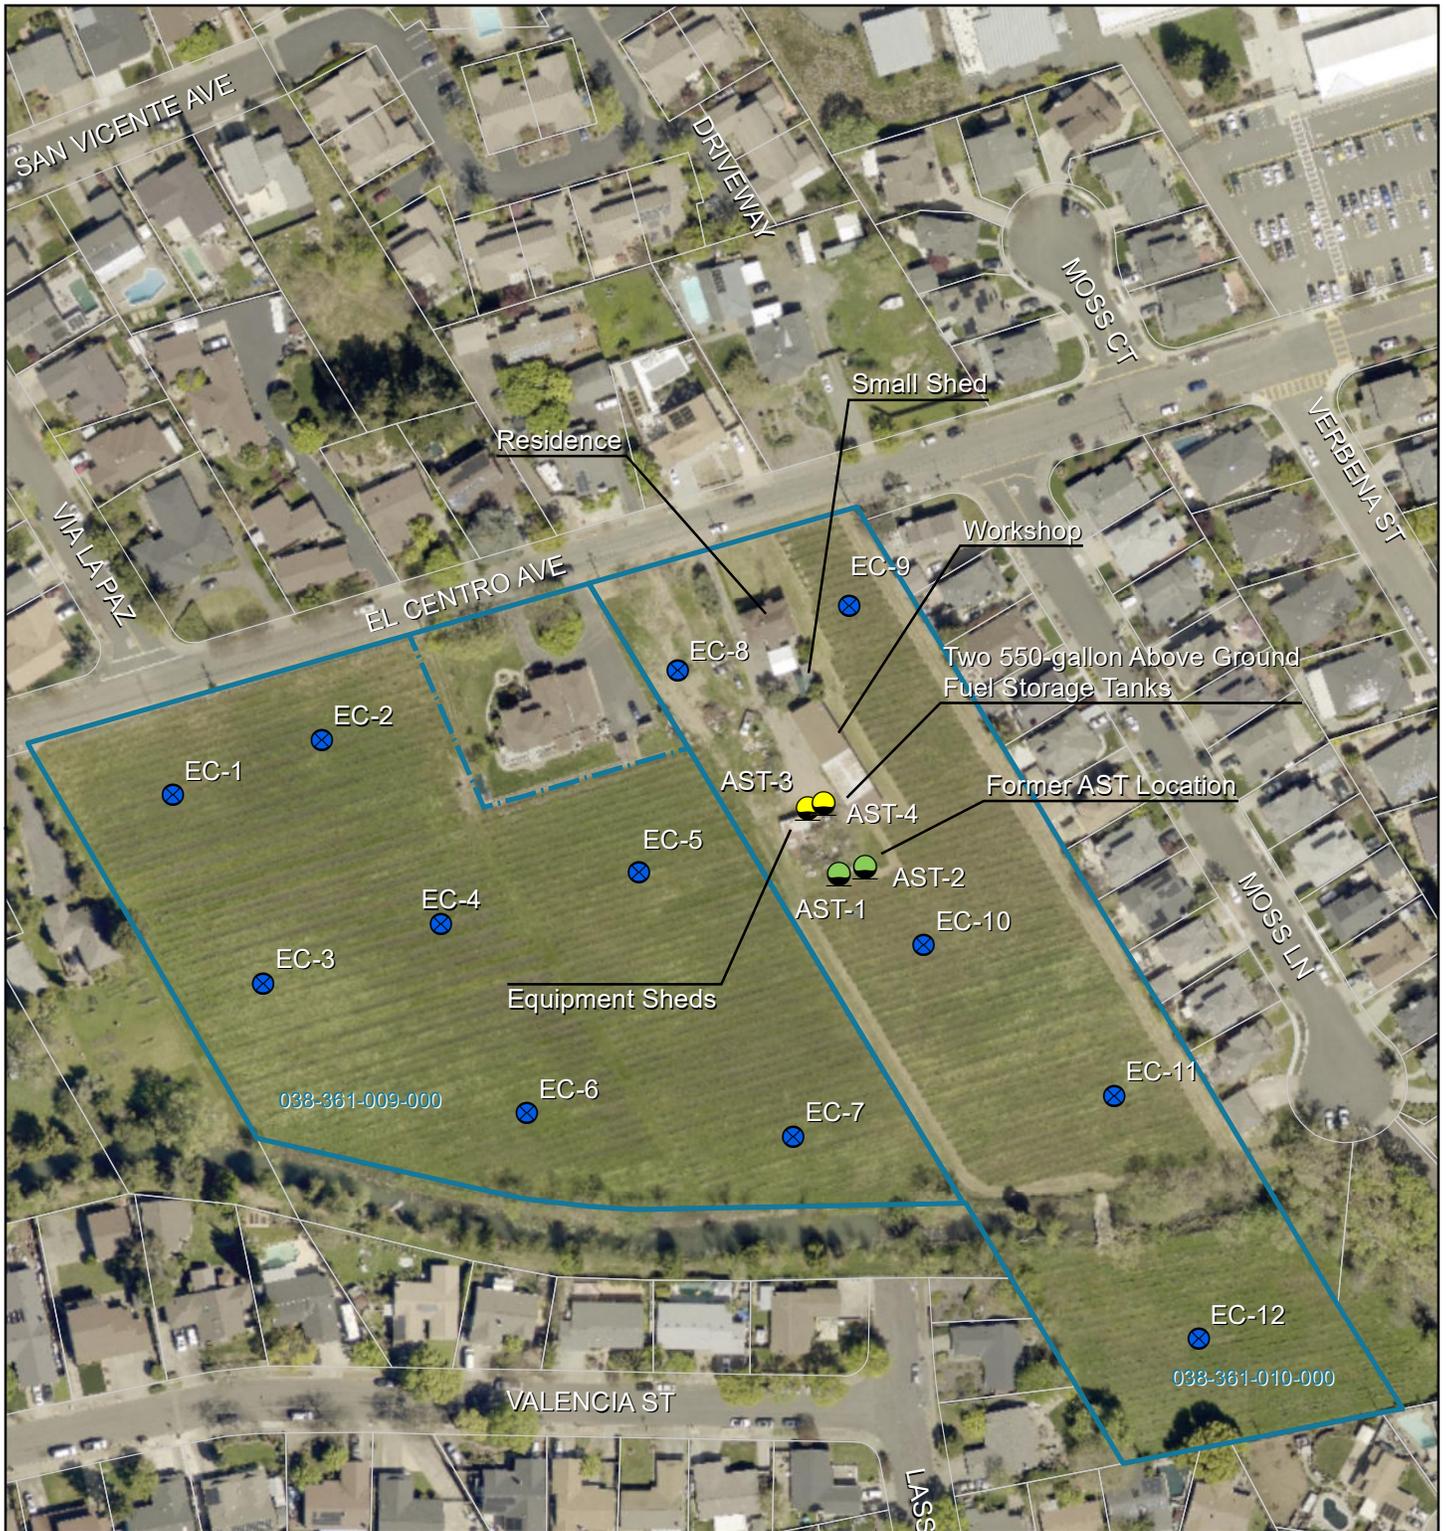
Site Plan & Property Location Map
1583 & 1657 El Centro Avenue
Napa, CA

CKG Environmental, Inc. (CKG) is pleased to provide this report of the findings of a shallow soil investigation at the Biale property at 1583 and 1657 El Centro Avenue in Napa, California. The soil investigation was completed to address comments received in a letter dated September 11, 2025, from the State of California Department of Toxic Substances Control (DTSC) regarding the property at 1583 & 1657 El Centro Avenue in Napa, California, (Plate 1).

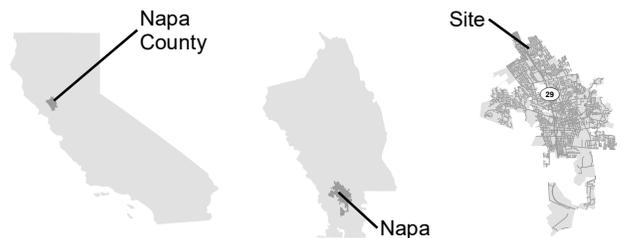
Site

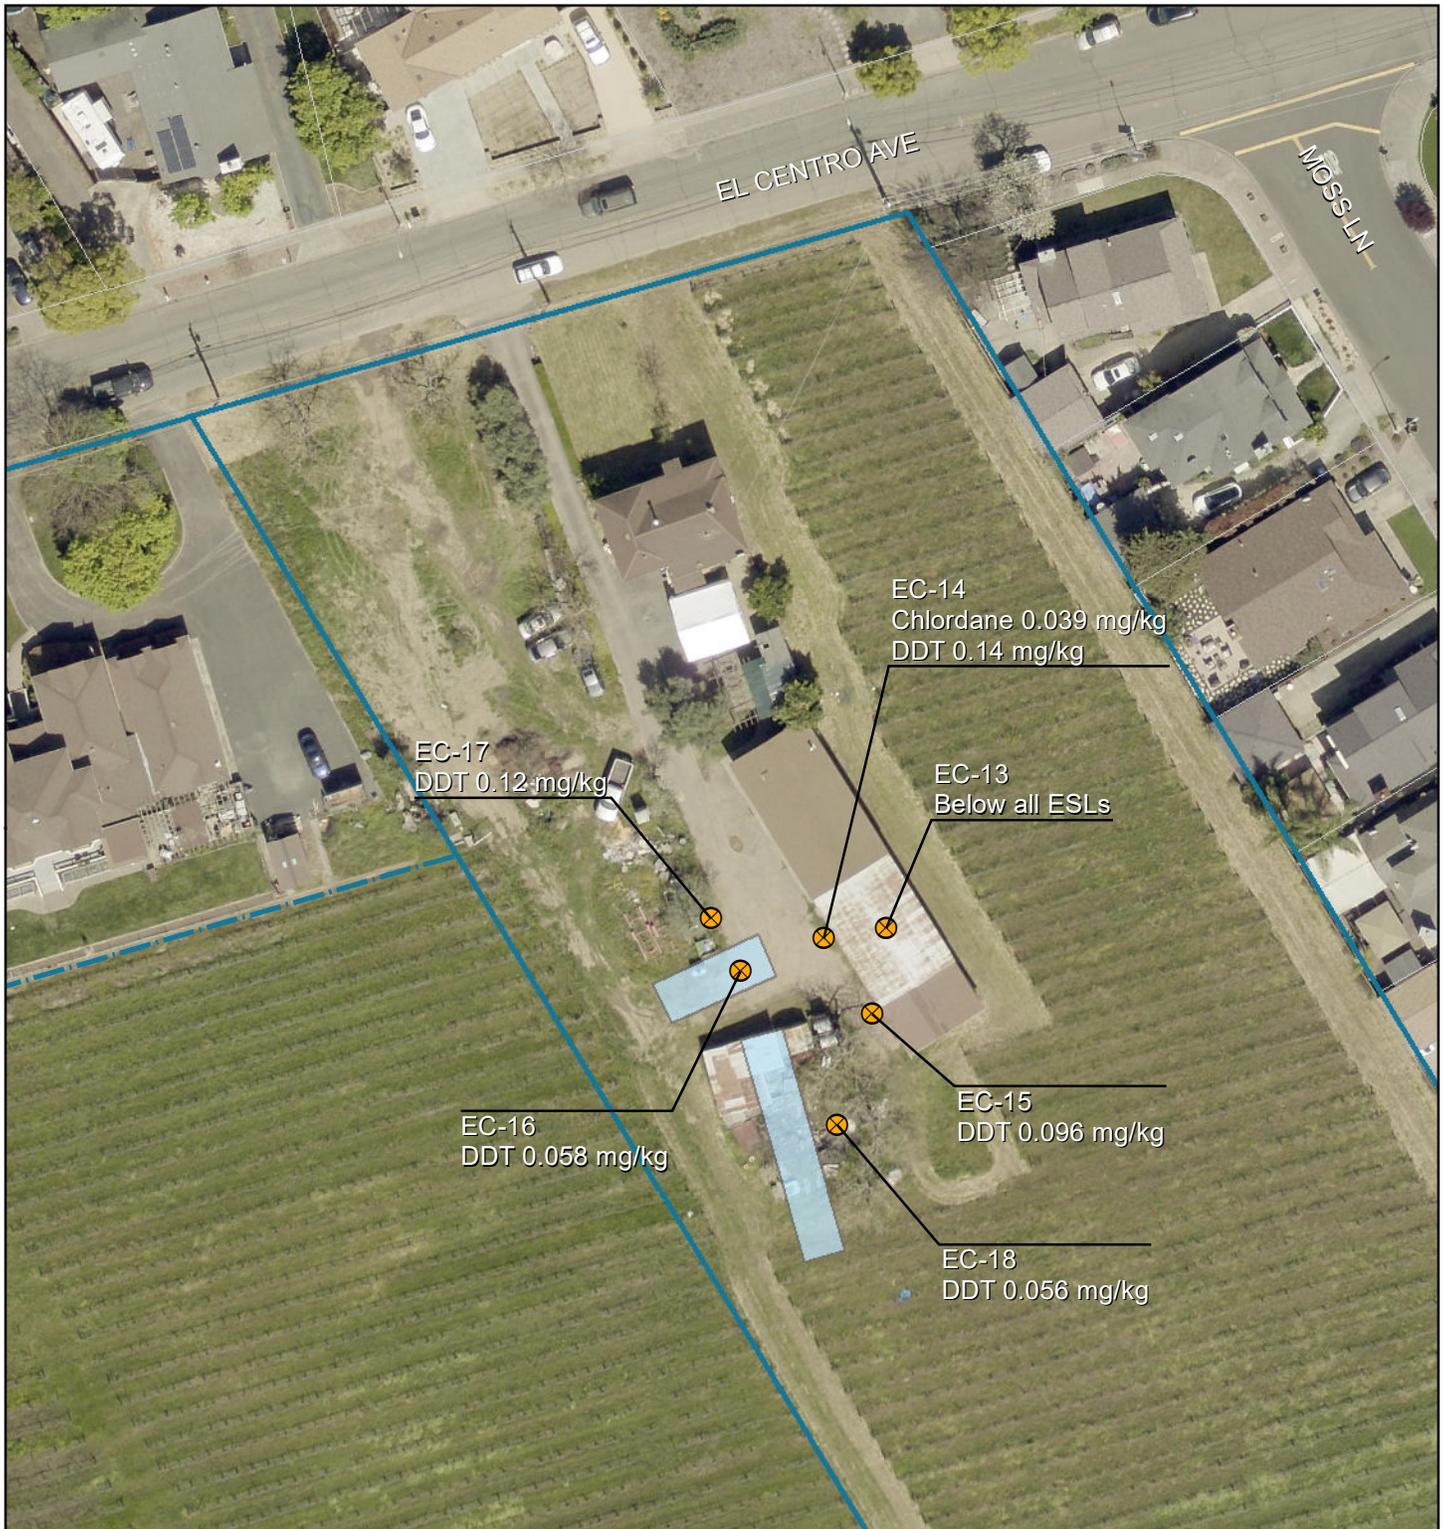
PLATE

CKG reviewed historical aerial photographs and observed that the existing workshop building and the residence (or at least a residence on the same footprint) have been present since at least 1959. The residence was present before 1947. Another storage structure was located just north of the present aboveground storage tanks from at least 1947 to the late 1960s. Also, from at least 1947 to the late 1960s, a long narrow building was located perpendicular to the former storage structure to the west of the present above ground storage tanks as shown on Plate 2.

On October 2, 2025, CKG collected six shallow soil samples in the vicinity of the storage sheds (existing and former as shown on Plate 2). Samples were collected by scooping shallow (0–2-inch depth) soil directly into laboratory supplied clean 4-ounce glass jars. The samples were placed in an iced cooler and transported to McCampbell Analytical Laboratory of Pittsburg, California for the following analyses:

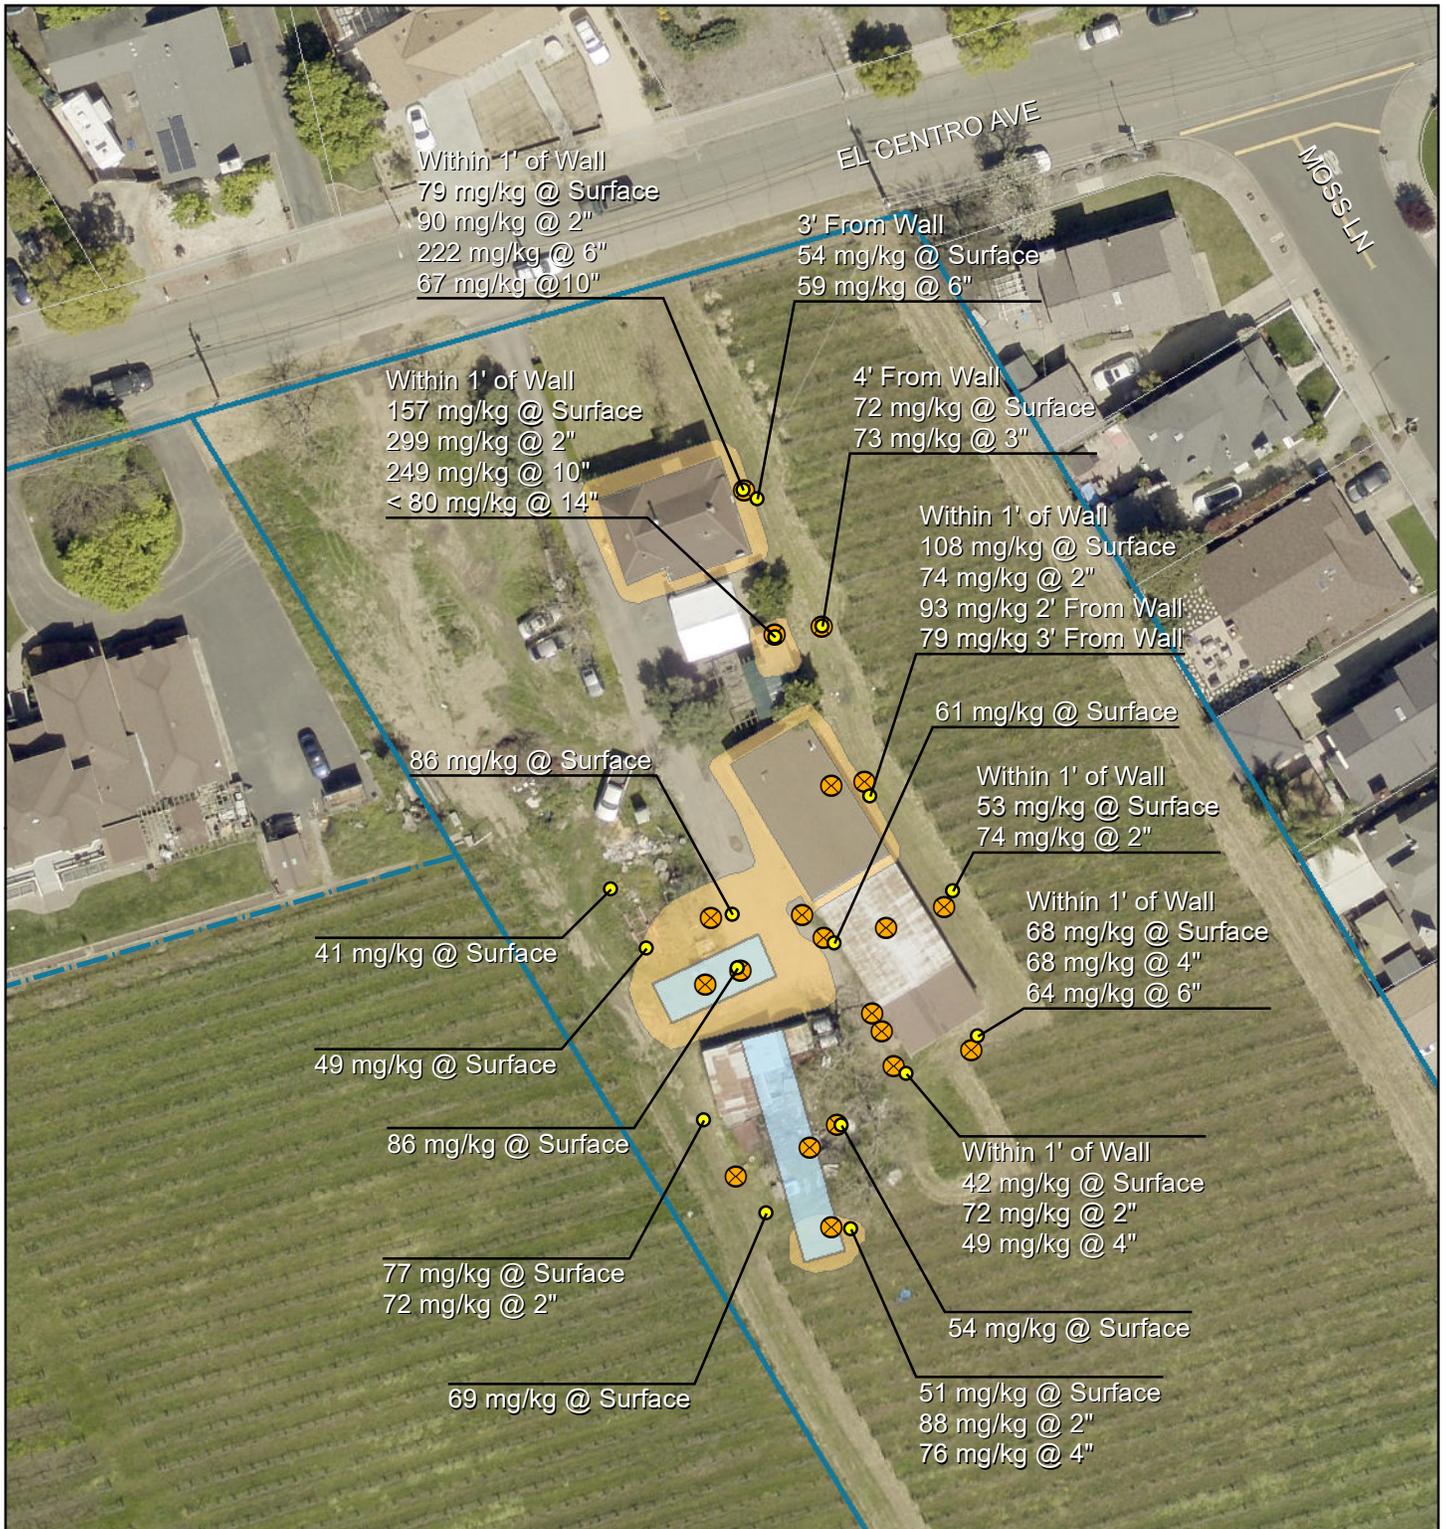
The pink outlines on Plate 3 show buildings where lead probably from old paint has collected in shallow soil at concentrations that are over residential ESL of 80 mg/kg. With one exception the elevated lead is only in the upper 2-6 inches. At most the impacted soil extends 2-3 feet out from the walls. Only the oldest buildings seem to be affected.

The exception is behind the small shed next to the car port (Samples EC-38-EC-40). That building is definitely old enough to have lead paint, but the lead could also be from the spilled oil. The spilled oil area is not that big, probably just the length of the back of that building and a few feet out toward the vineyard. Samples EC-38 through EC-40 also were analyzed for halogenated volatile organics with none detected above laboratory reporting limits (Appendix A); and total petroleum hydrocarbons quantified as diesel and motor oil as summarized below:

There are limited areas where shallow soil contains elevated lead concentrations likely due to lead based paint on older buildings (existing and former) as shown on Plate 3. In compliance with Title 17, California Code of Regulations, Division 1, Chapter 8, Sections 36000 and 36100, the EPA Lead Renovation, Repair and Painting Program, and Cal/OSHA, CKG recommends that the site developer work with Napa County Environmental Health to oversee and accept a soil mitigation plan to address the elevated lead. CKG suggests that after buildings are demolished and slabs removed a thin layer of soil (up to 6 inches in most areas and up to 12-14 inches in selected areas as shown on Plate 3) be scraped into a stockpile. The stockpile should then be sampled and profiled for disposal at an appropriate facility depending on the results of that sampling. Soil sampling should be completed to confirm that the soil with elevated lead has been removed.

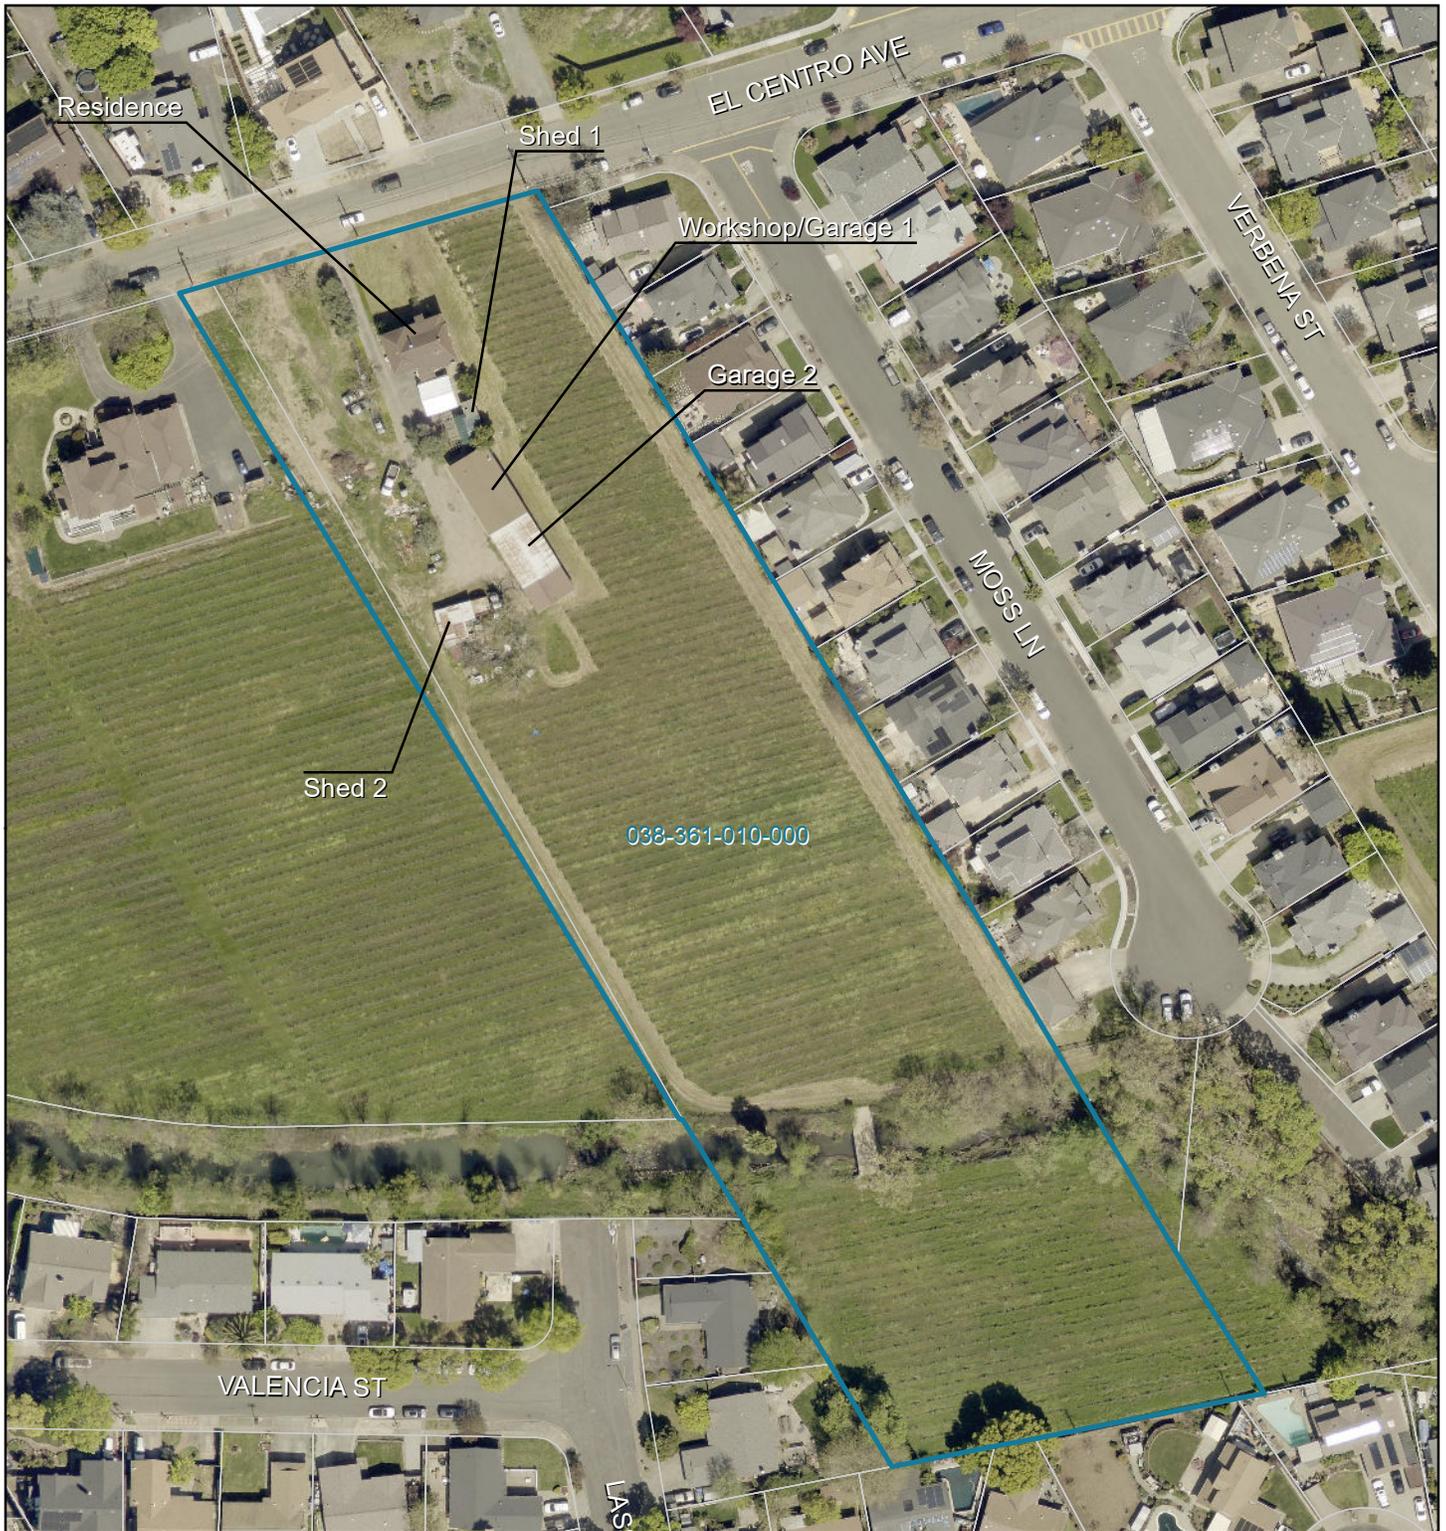
Site Plan & Property Location Map
1583 El Centro Avenue
Napa, CA

CKG Environmental (CKG) is pleased to submit the following Hazardous Building Materials Inspection Report for the residence and outbuildings located at 1583 El Centro Avenue in Napa, CA.

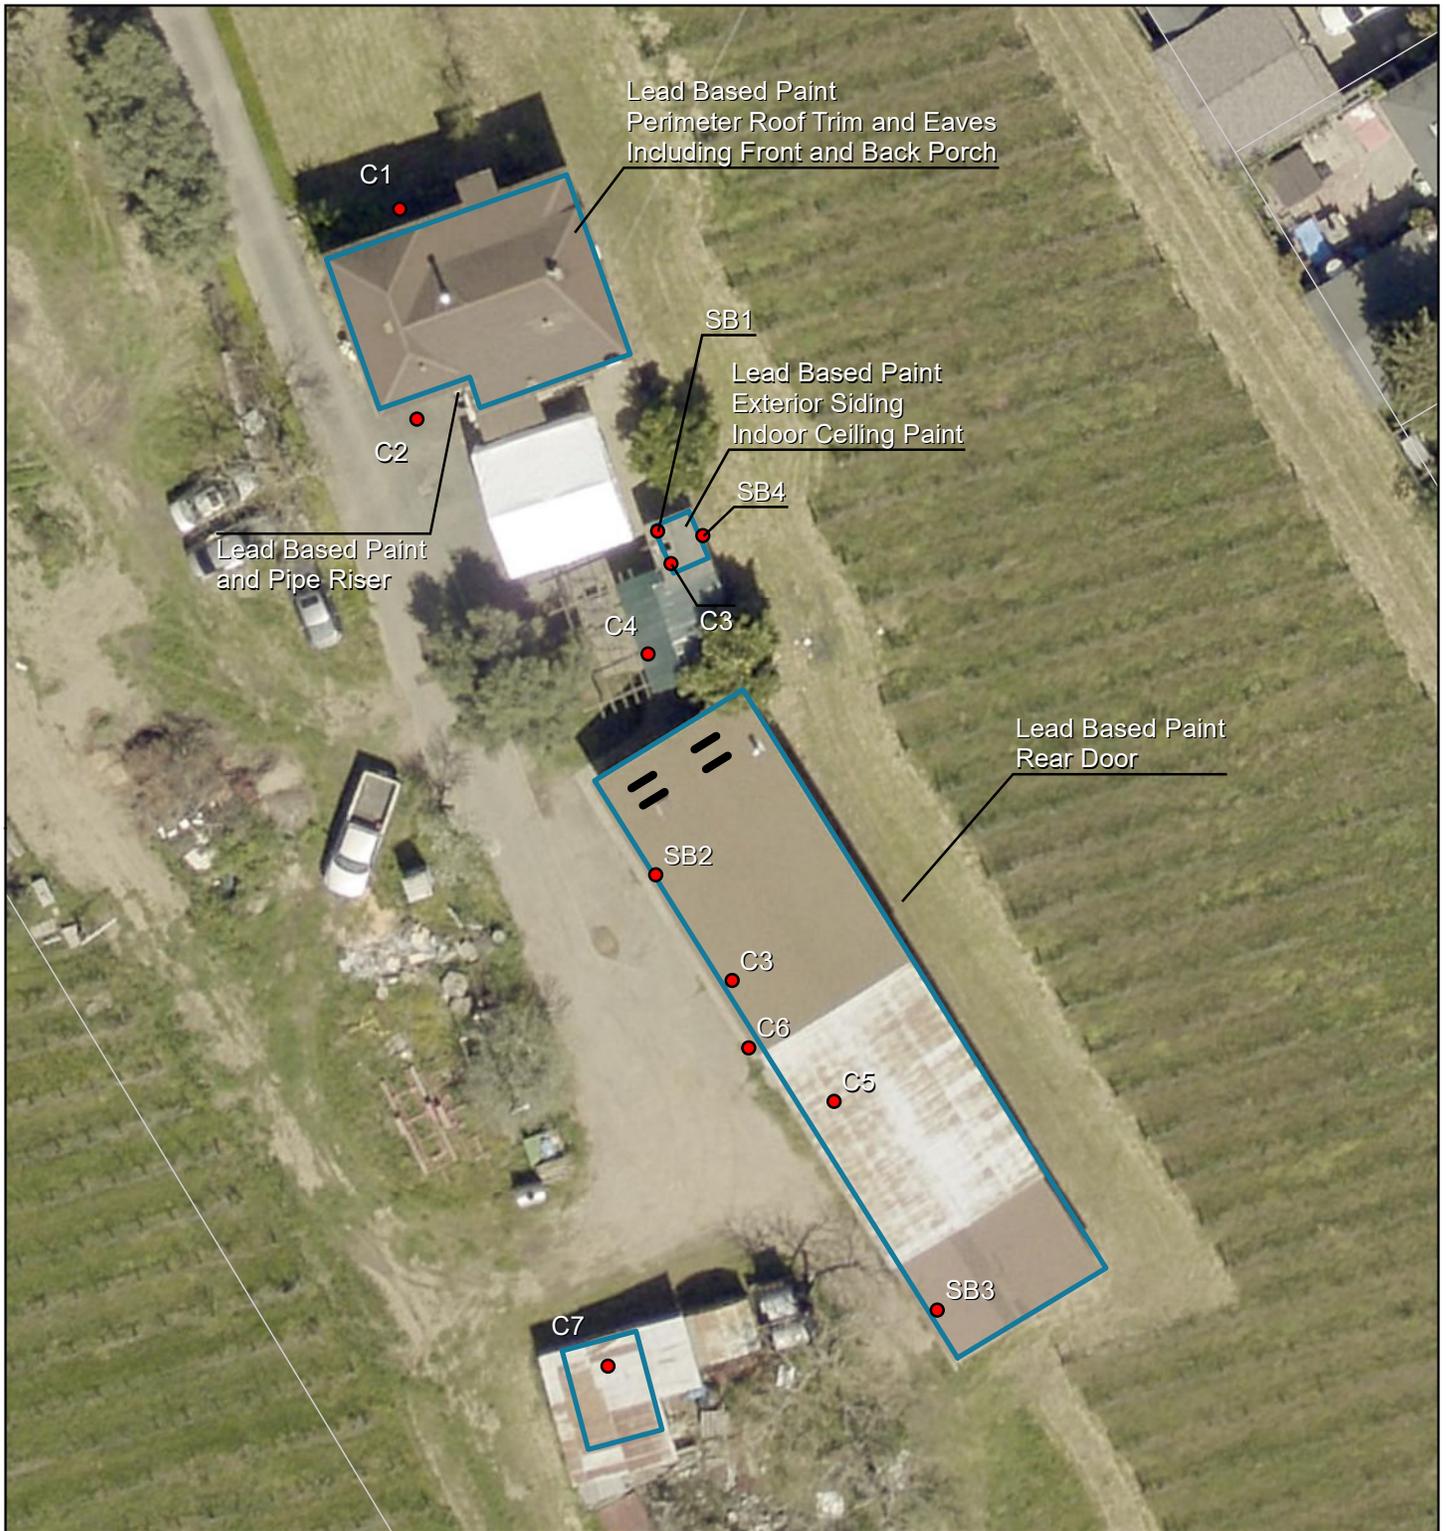
- Building Material Sample
- Building Footprint
- Fluorecent Light
