Inspection Report

Property Address:

110 Lightfoot Drive

Montross, VA

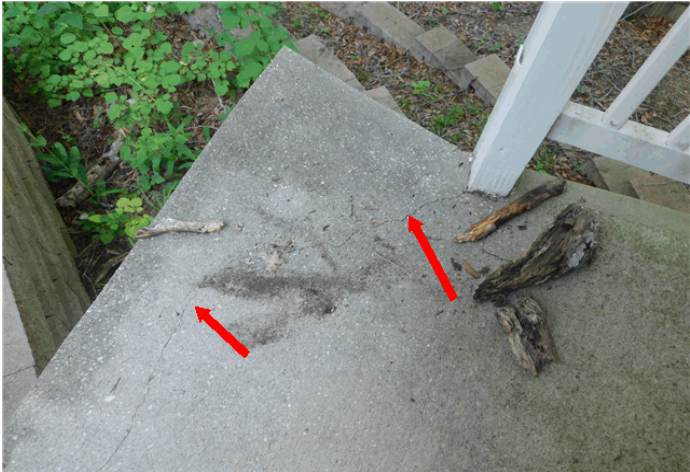
Sidewalk Material Concrete Pavers and Concrete

3) Sidewalk Conditions **AS** The visible areas of the sidewalk appeared to be in serviceable condition at the time of the inspection. Common cracks of up to ¼ inch were observed. Recommend sealing and monitoring all cracks for further movement.

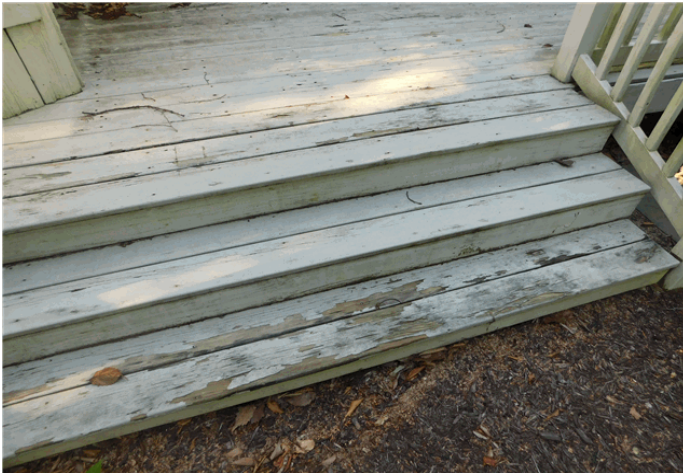
5) Entrance Conditions

The visible and accessible areas of the entrances appeared to be in serviceable condition at the time of the inspection. The front entrance deck appeared weathered and may require some maintenance.

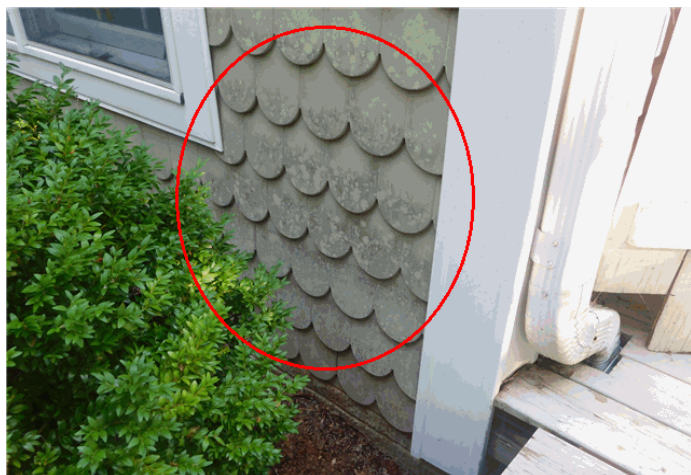
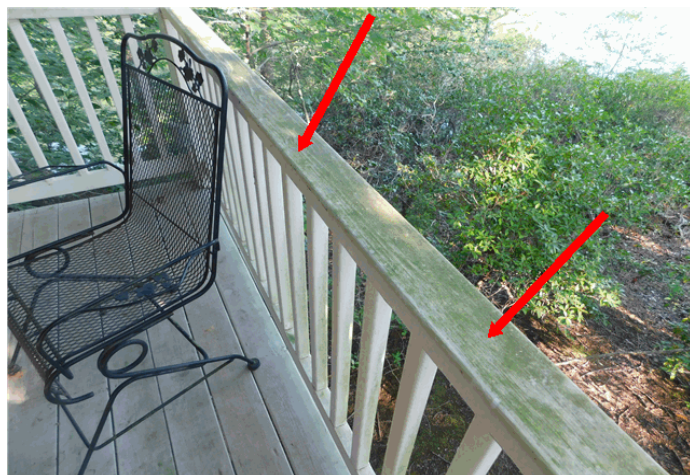
6) Exterior Wall and Trim Conditions

The visible and accessible portions of the exterior wall coverings and trim appeared to be in serviceable condition at the time of the inspection. Mildew was present on the siding, trim and wood railings. Recommend maintenance such as pressure washing.

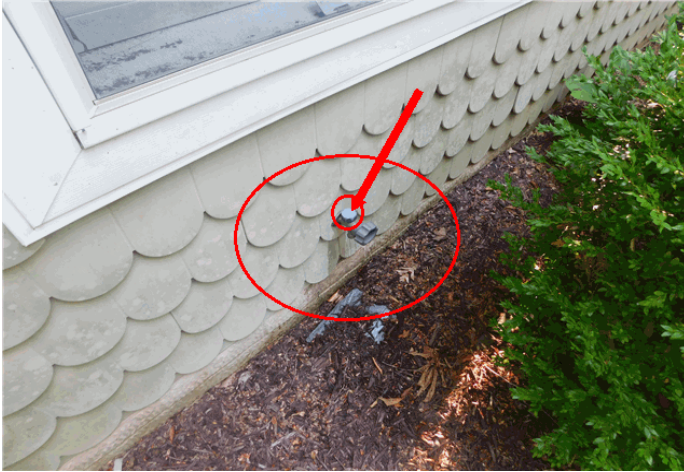
9) Faucet Conditions

The front faucet was leaking at the anti-siphon valve at the time of the inspection. Recommend repairs or replacement as

needed. The rear hose faucet appeared to be in serviceable condition at the time of the inspection. These should be drained prior to freezing temperatures.

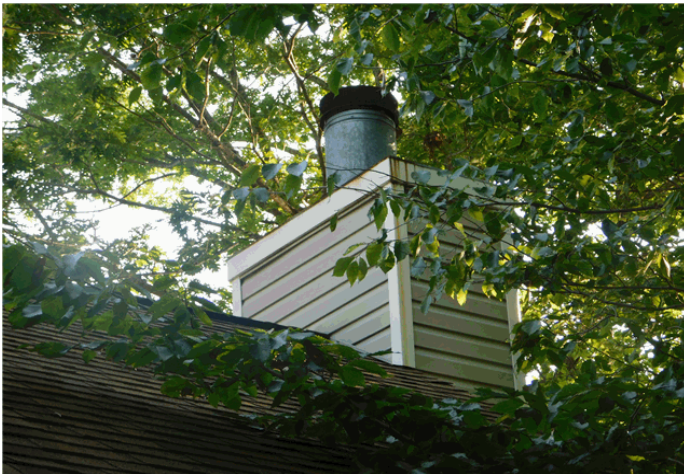
12) Roof Covering Condition

The roof covering shows normal wear for its age and appeared to be in serviceable condition at the time of the inspection. Tree branches were close to or in contact with roof surfaces. Recommend trimming branches back to prevent potential roof damage.

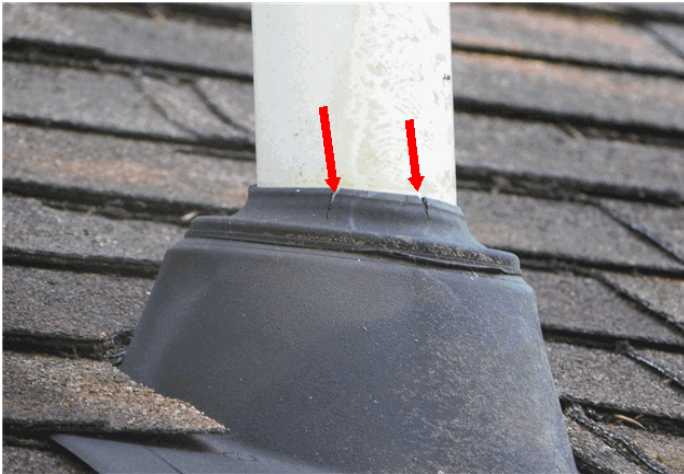
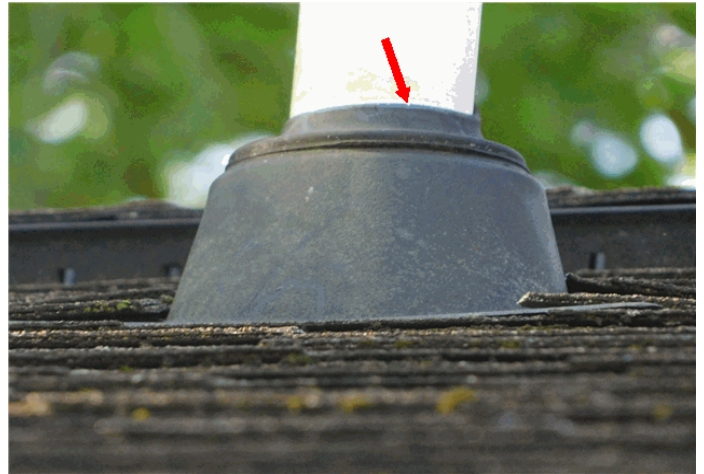
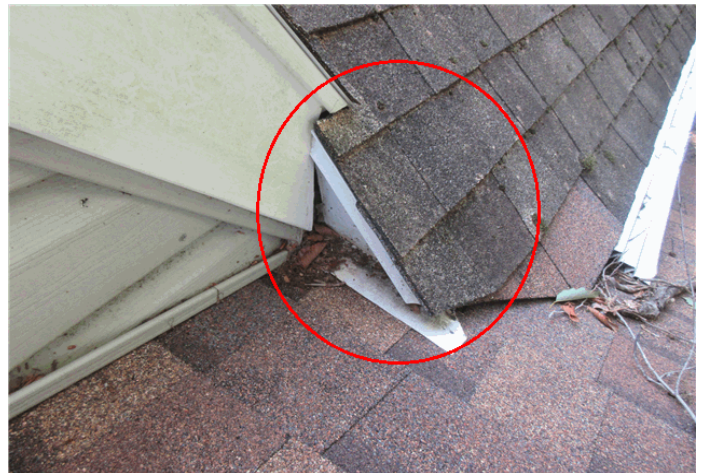
13) Flashing Conditions

The plumbing vent pipe flashing boots show signs of deterioration and need to be sealed or replaced. Also it appears that some of the roof sheathing has been damaged by moisture due to improper valley flashing. This is present on the upper rear left portion of the roof. It is suggested that a "Qualified Roofing Contractor" be contacted for further evaluation and repair.

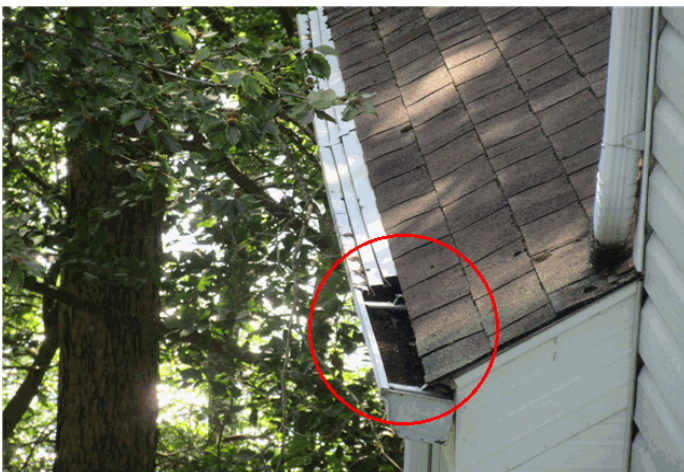
14) Gutter & Downspout Conditions

The majority of the gutter system appeared to be in serviceable condition at the time of the inspection. Gutter leaf guards were present in the gutter system however one section was missing at the right rear portion of the roof. Recommend maintenance and/or repairs as needed.

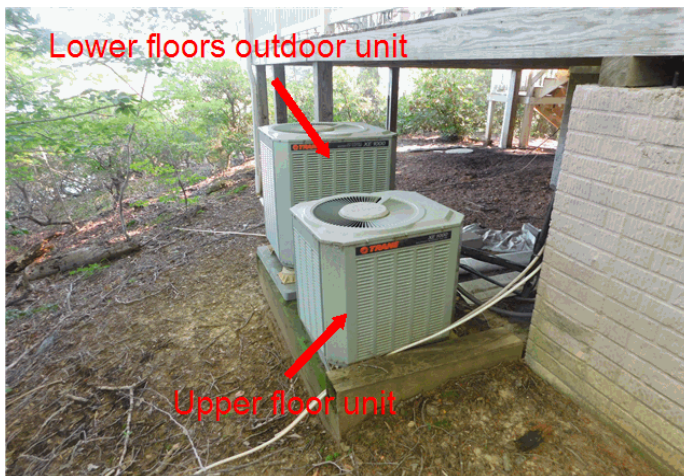
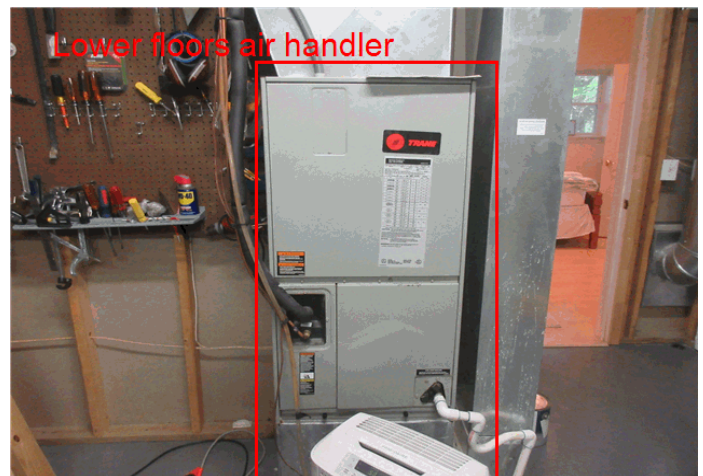
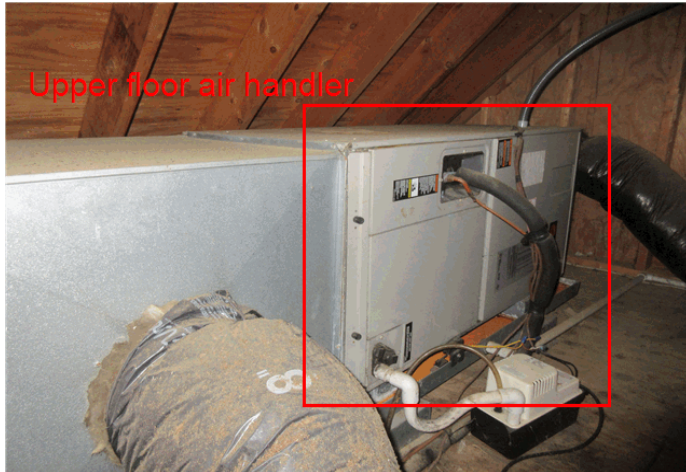
17) Systems Conditions

The HVAC systems were operational at time of inspection. This is not an indication of future operation or condition. Although operational, the age of the systems is past the average life expectancy for this type of system. It is recommended budgeting for replacement. The insulation on the refrigerant lines was missing or deteriorated. Recommend installing this rather inexpensive pipe insulation to improve efficiency. Pipe insulation is available at most hardware stores.

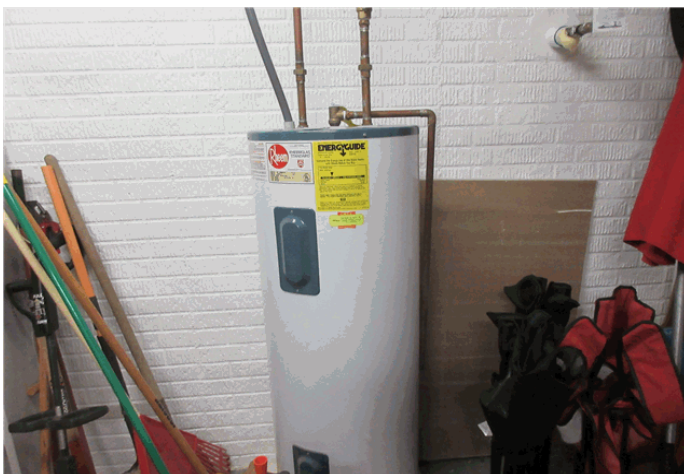
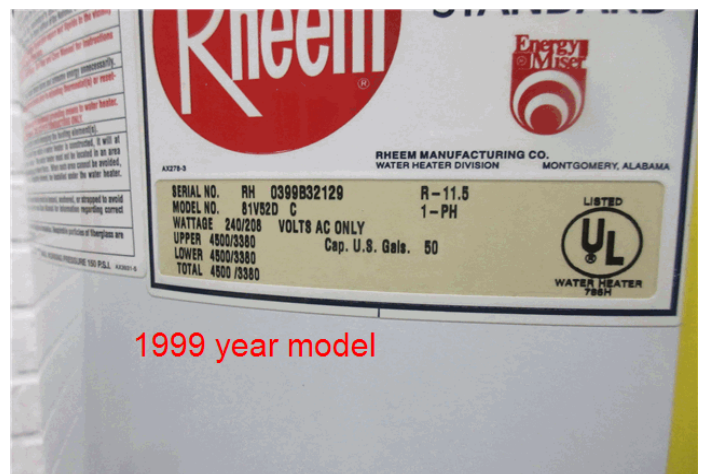
28) Water Heater Conditions

The water heater was off at the time of inspection.
Recommend unit be powered a few days prior to close and tested for operation.

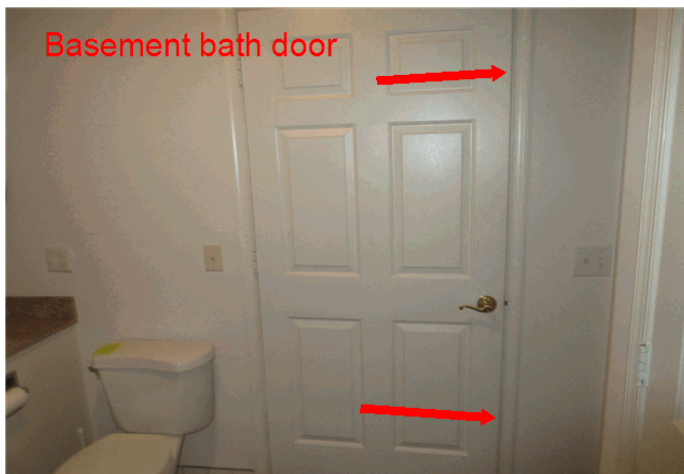
33) Interior Door Conditions

The majority of the interior doors appeared to be in serviceable condition at the time of the inspection. The basement bath door and double doors to the basement bedroom do not shut or latch properly. Repairs and / or adjustments are recommended.

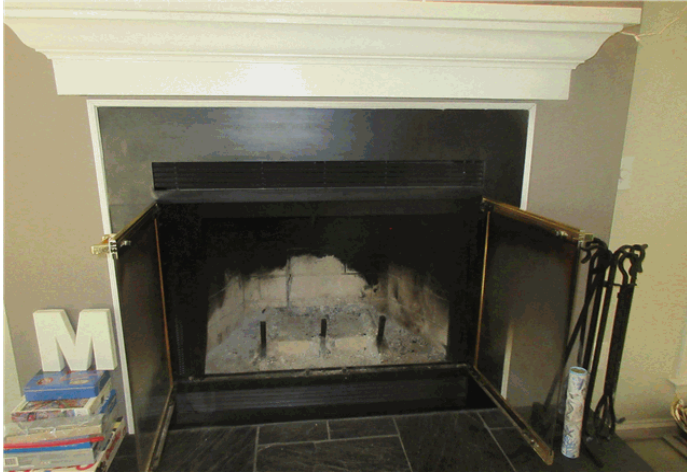
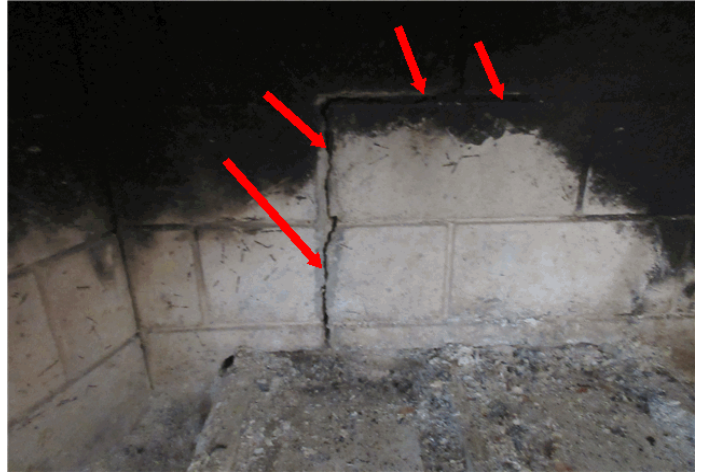
38) Fireplace Conditions

At the fireplace, the rear prefabricated firewall was cracked with deterioration observed. Recommend further evaluation and repair by a masonry, fireplace, or chimney specialist.

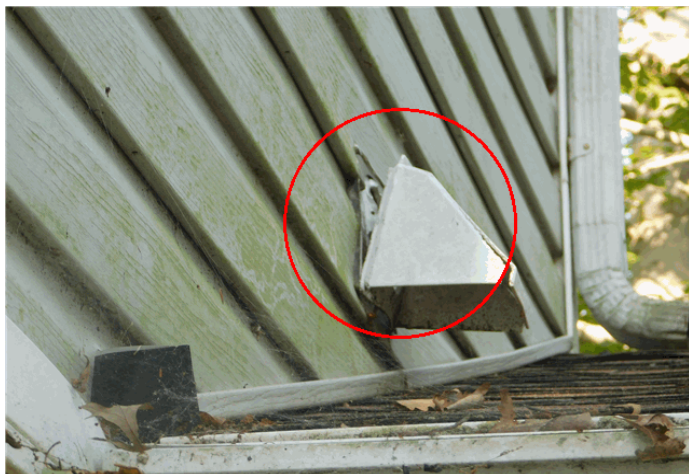
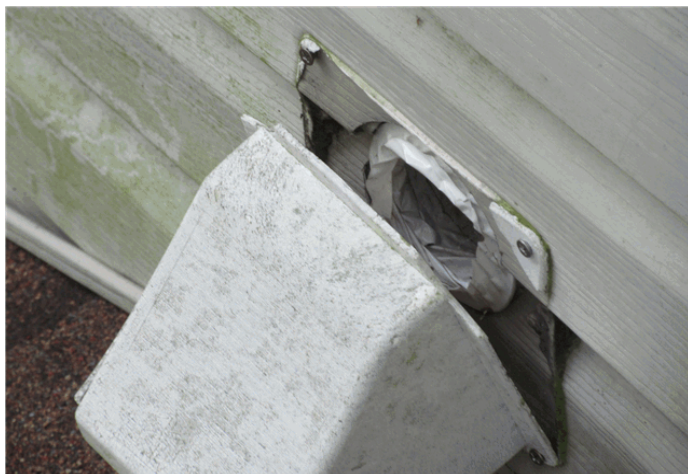
The exhaust fans appeared serviceable in all baths however the exterior exhaust termination for the lower level bath was broken and pulled away from the wall. Recommend repairs or replacement as needed.

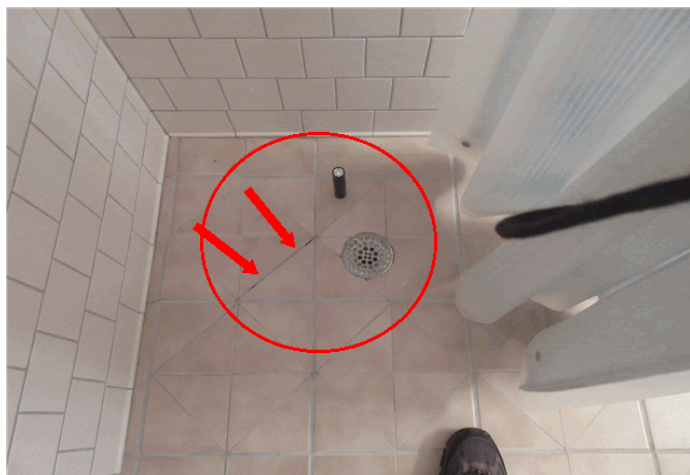
The bathtubs, showers, faucets, and drains appeared to be in serviceable condition in all baths. The basement shower floor appears to have a couple loose tiles and cracked grout joints. Recommend maintenance and/or repairs as needed.
