Inspection Report

BARRY SANDERS INSPECTIONS

14333 Kings Highway

Montross, VA

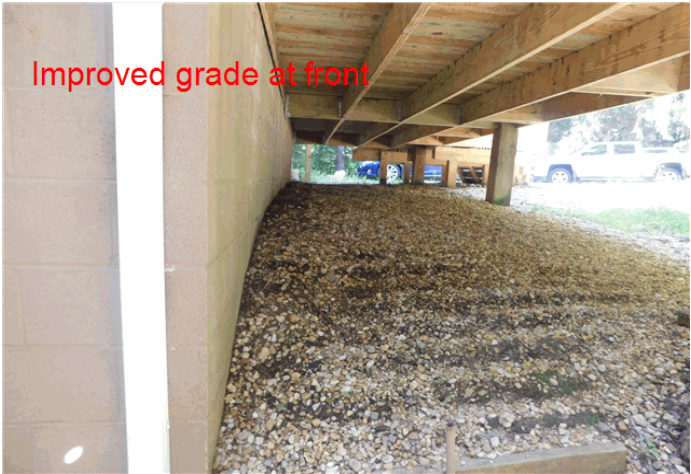
1) Grading Conditions **AS** Grading of the soil near the foundation appears to be in serviceable condition.

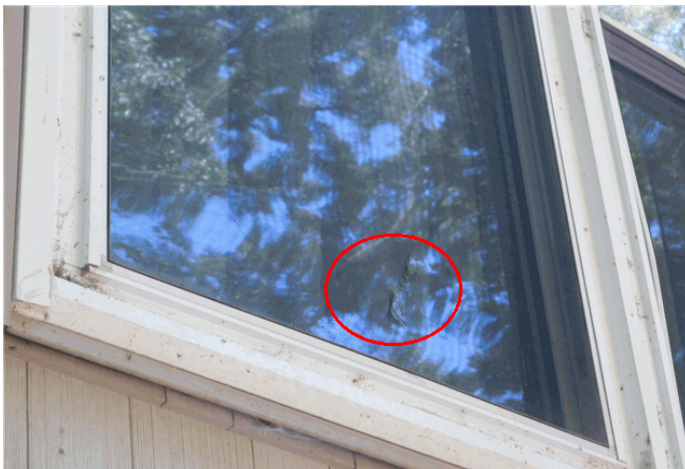
7) Window Conditions

The windows appeared to be in serviceable condition at the time of the inspection. Holes in the screens were present at several of the windows

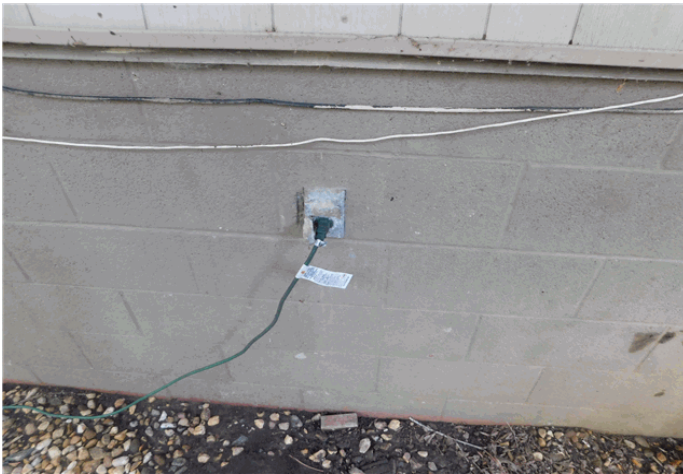
Exterior Electrical**10) Electrical Conditions****AS**

All exterior electrical conditions appeared to be in serviceable condition at the time of the inspection. The exterior outlets were not GFCI protected. Ground Fault Circuit Interrupter receptacles protect you from shock at wet or damp locations. Recommend installing GFCI outlets at these locations.

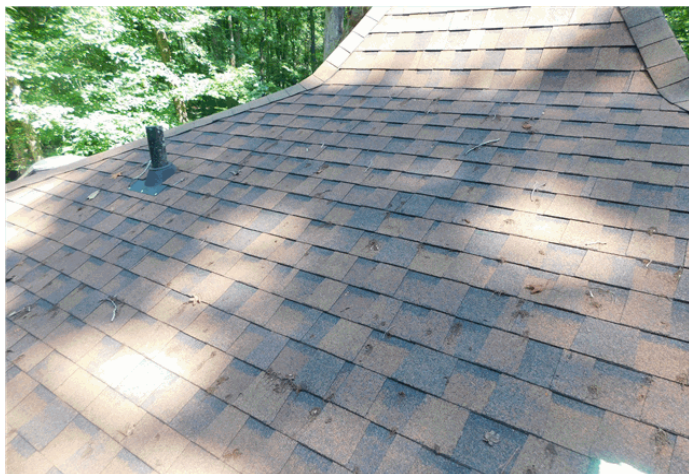
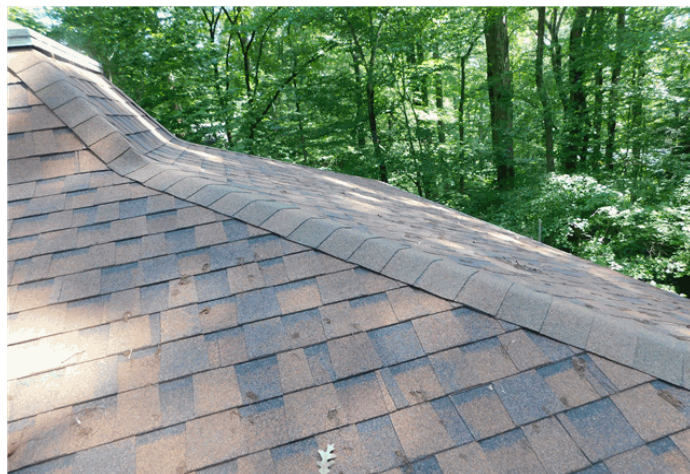
12) Roof Covering Condition

The roof covering shows normal wear for its age and appeared to be in serviceable condition at the time of the inspection. The age of the roof covering appeared to be +/- 5 year old.

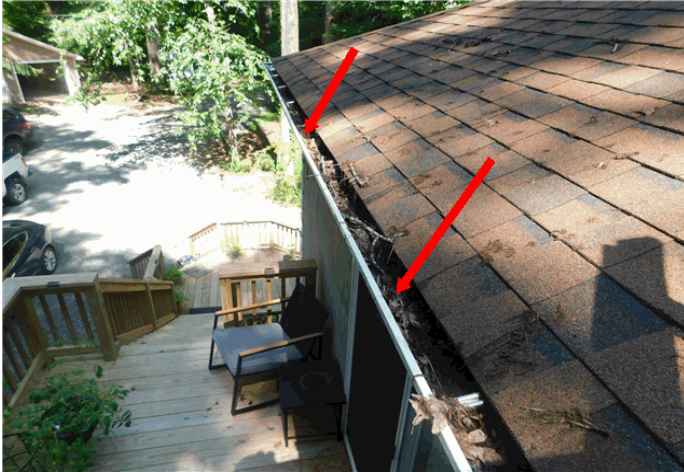
14) Gutter & Downspout Conditions

The gutters were filled with leaves and debris at the time of the inspection. Suggest cleaning and removal of debris on a regular basis. This condition can cause water penetration at the eave area. Due to the height of the gutter system, leaf guards are recommended.

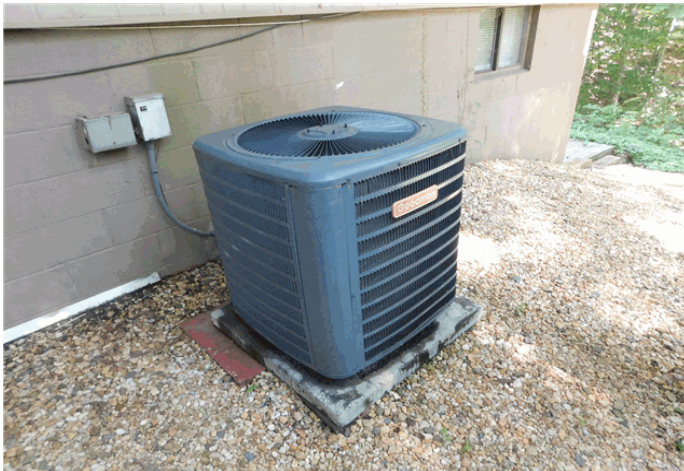
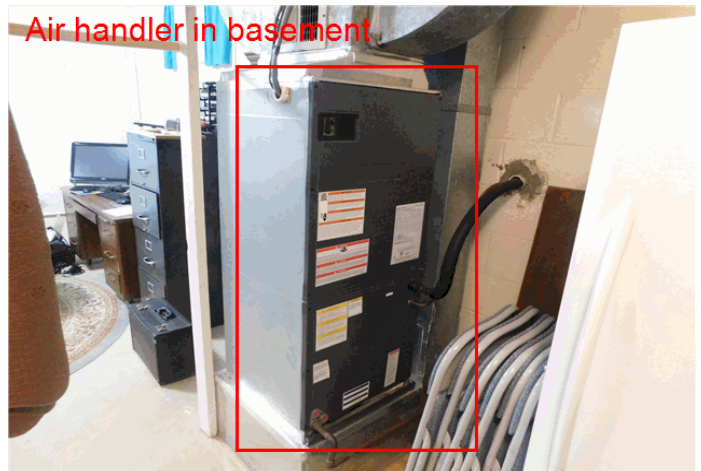
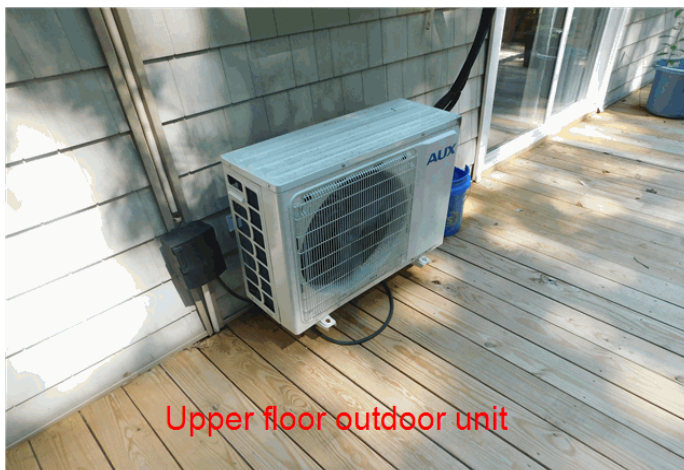
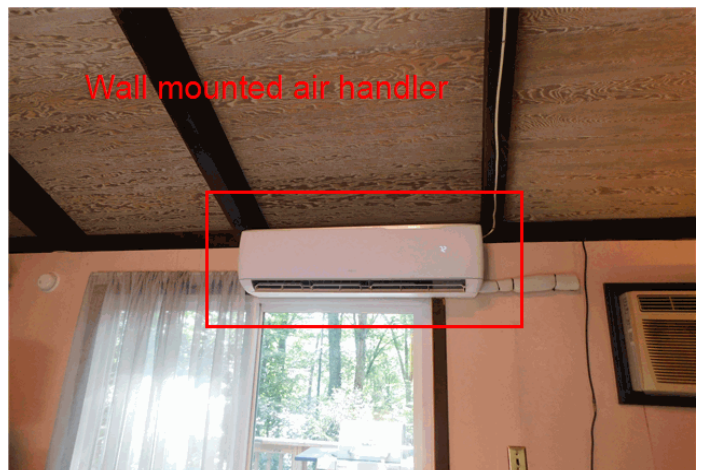
16) Systems Conditions

The air handler for the lower 2 floors is located in the basement. The upper floor system is a mini split type heat pump with a wall mounted air handler.

The system for the lower 2 floors is a 3 ton and 2013 year model. I could not determine the size or age of the mini split system.

The HVAC systems were operational at time of inspection. This is not an indication of future operation or condition.

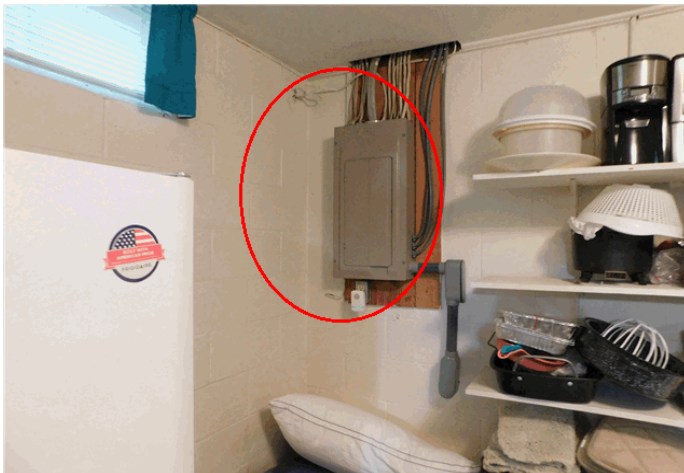
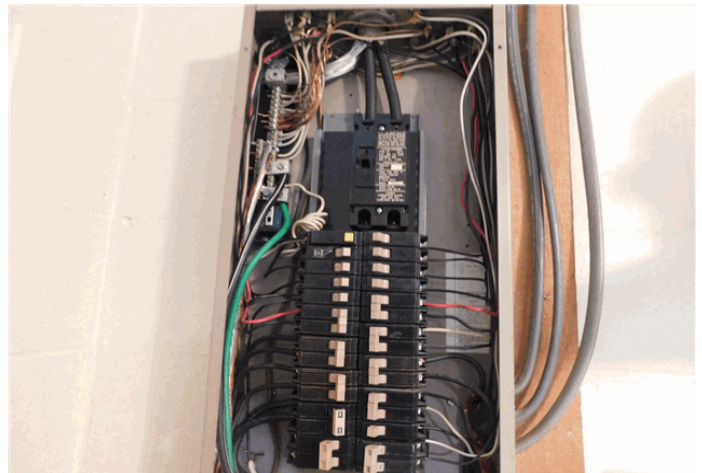
21) Electrical Panel Conditions**AS**

The main power cable is aluminum. The branch cables are copper.

The main panel appeared to be in serviceable condition at the time of the inspection.

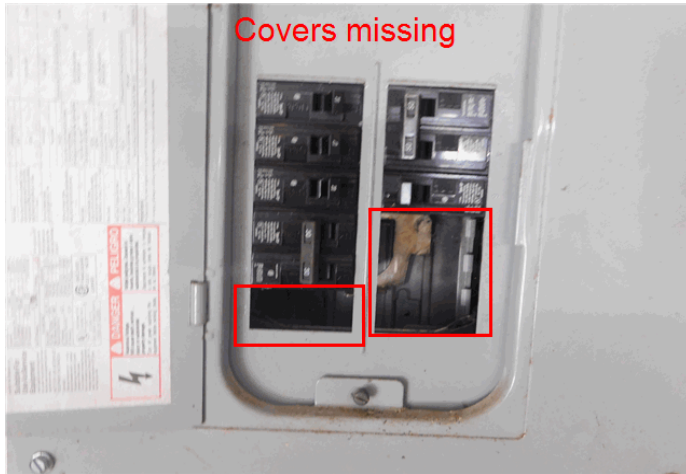
22) Subpanel Conditions**AS**

The subpanel appeared to be in serviceable condition at the time of inspection. The subpanel was missing covers where breakers were not installed. Recommend installation of standard plastic covers for safety.

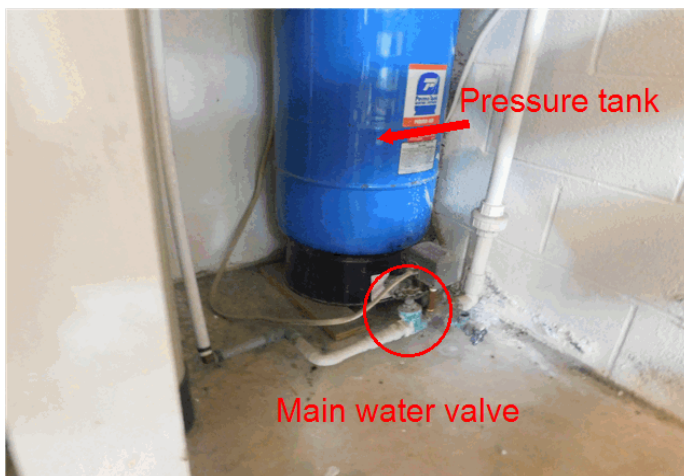
23) Main Line & Valve Conditions

The main valve is located at the basement under the stairway

The visible portion of the main pipe and valve appeared to be in serviceable condition at the time of the inspection.

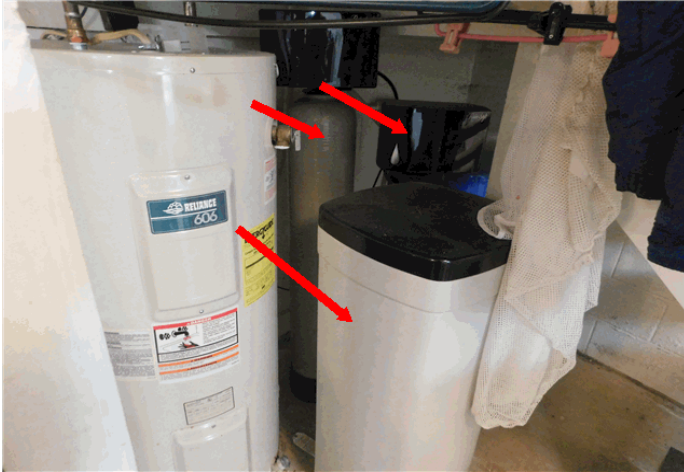
25) Other

A water conditioning system was present however it did not appear to be operational at the time of the inspection.

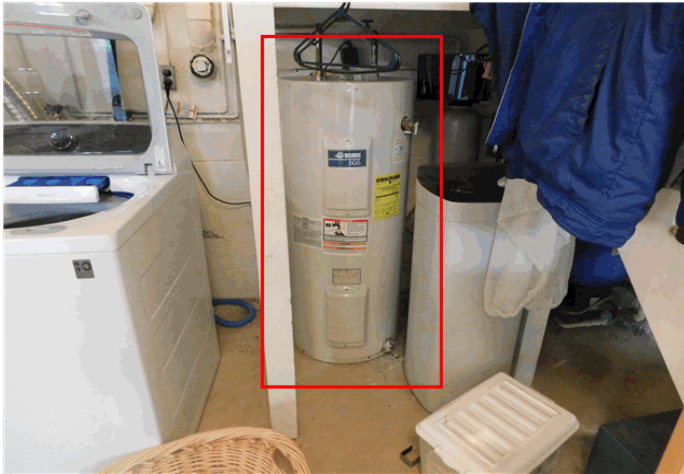
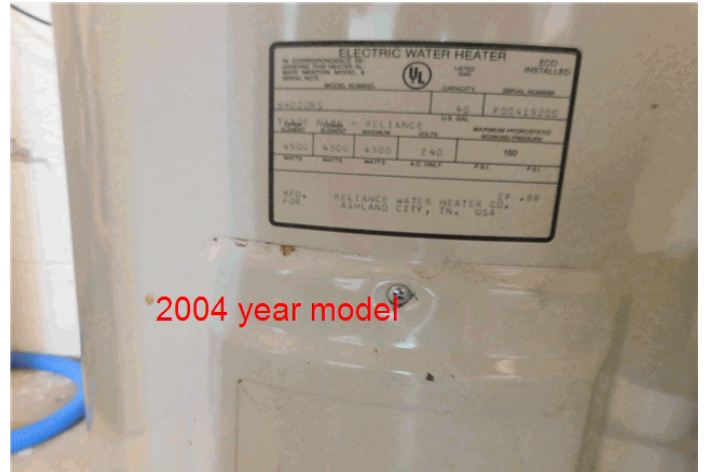
27) Water Heater Conditions

The water heater was operable at the time of inspection. This does not however guarantee future performance, operation, or condition.

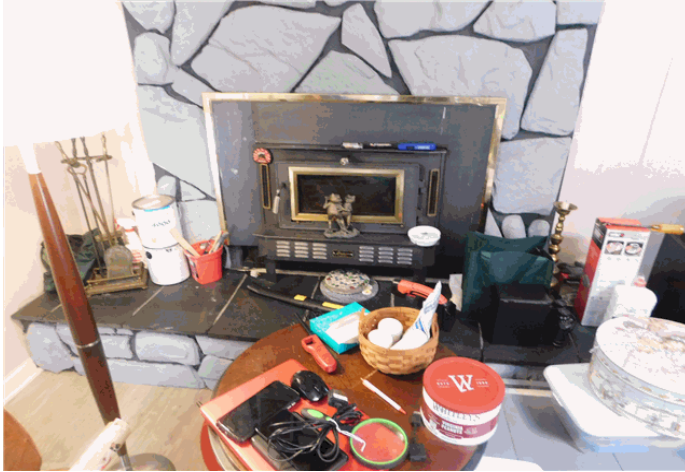
37) Fireplace Conditions

A wood burning insert was installed in the fireplace.
Recommend chimney flue inspection/ cleaning by a chimney
sweep specialist prior to use

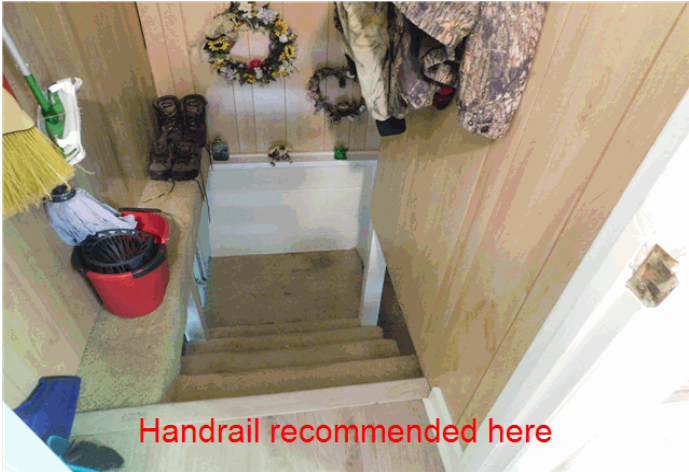
48) Basement Stair Conditions

A handrail is recommended at the top portion of the basement stairway for safety.

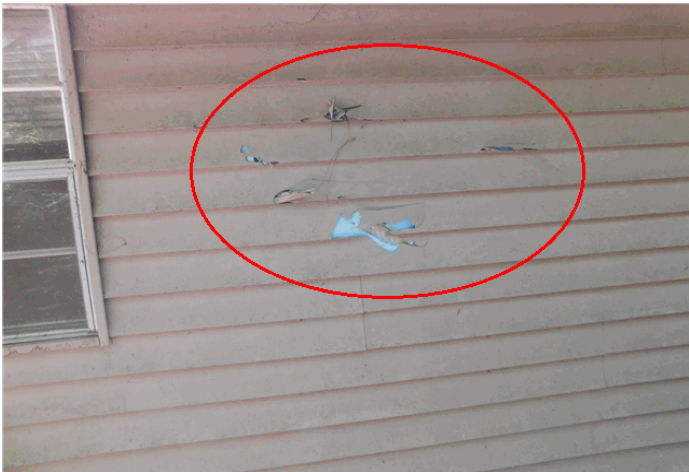
54) Siding Conditions (if detached)

The majority of the visible and accessible portions of the exterior wall coverings appeared to be in serviceable condition at the time of the inspection. A section of the siding was damaged at the right side. Recommend repairs as needed.

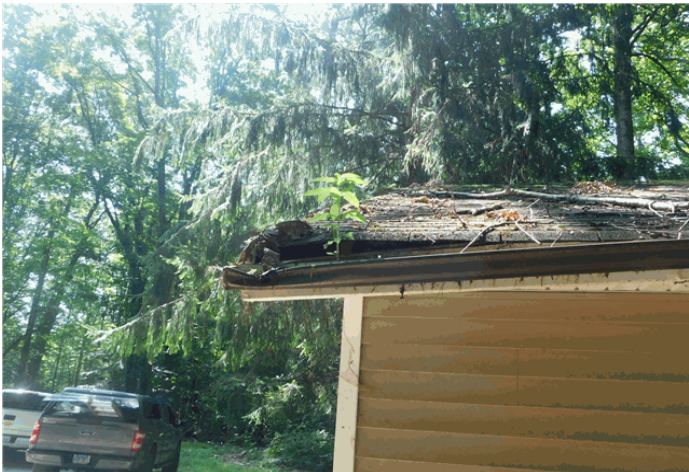
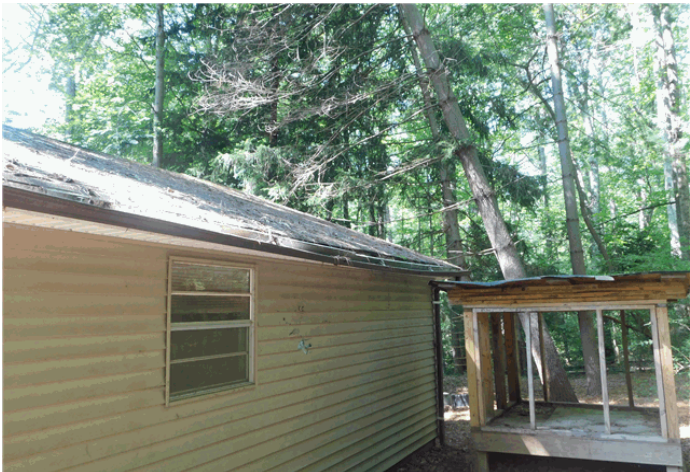
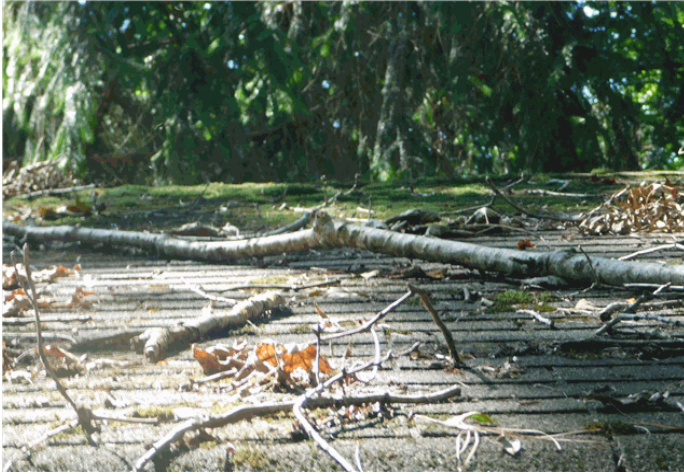
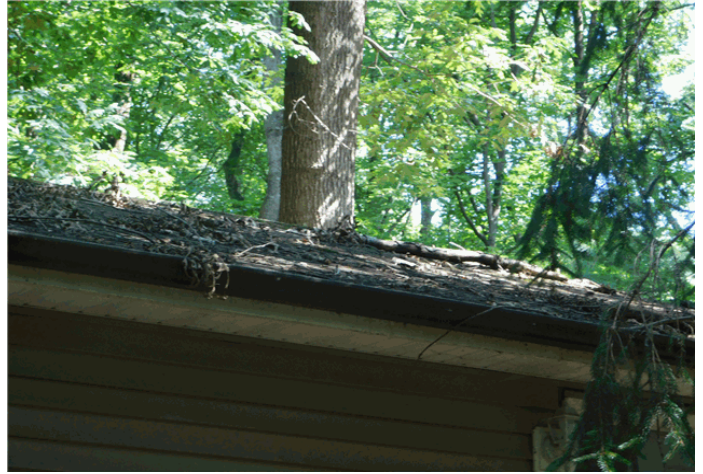
55) Roof Conditions (if detached)

The roof covering showed signs of cracking, curling, and loss of granules. This condition generally indicates that the roofing materials are approaching or close to the end of their useful life. Replacement will most likely be needed. I was unable to access the attic to check for leaks due to personal item storage. Also the gutters have been damaged and are full of debris. Recommend repairs or replacement as needed.

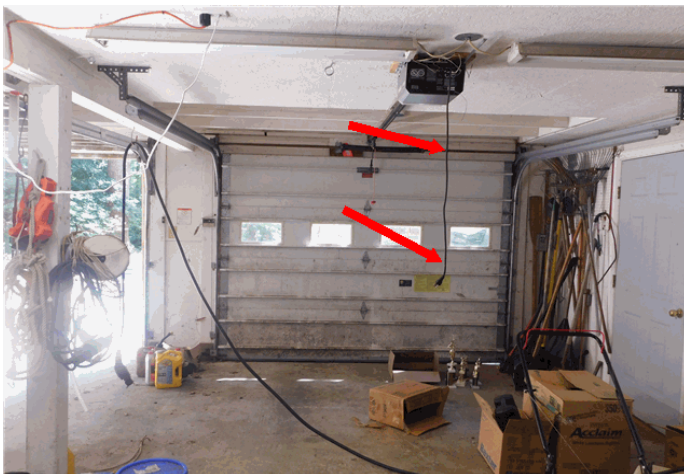
61) Vehicle Door Conditions

The right side vehicle door appeared to be in serviceable condition at the time of the inspection. The left side door opener was unplugged at the time of the inspection. The left door did open manually.

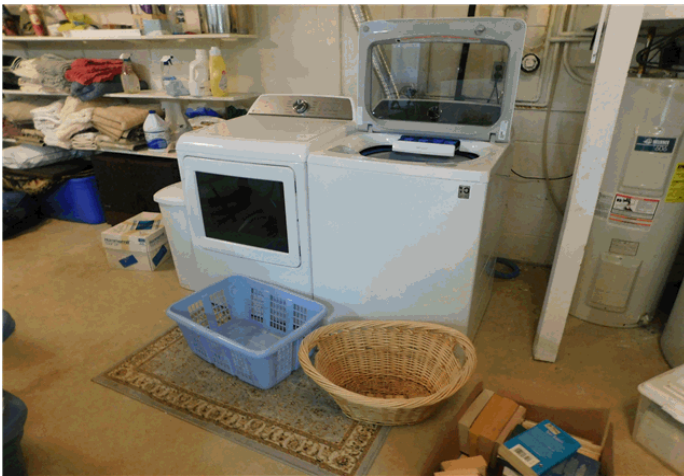
64) Laundry Room Conditions

The washer and dryer were both operable at the time of the inspection. The visible and accessible portions of the laundry plumbing components and dryer exhaust venting appeared to be in serviceable condition at the time of inspection.

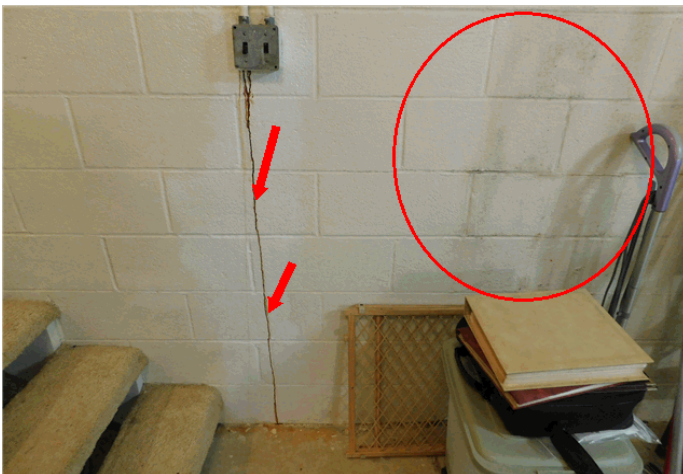
65) Foundation Conditions**AS**

The visible and accessible portions of the foundation appeared to be in serviceable condition at the time of the inspection. Minor moisture stains were observed on the foundation walls at the time of the inspection. While this is fairly common of a home in this area, this may also be an indication of occasional water penetration, which is not unusual for a block foundation.
