# Inspection Report

Inspector: Barry Sanders

BARRY SANDERS INSPECTIONS

394 Springview Road

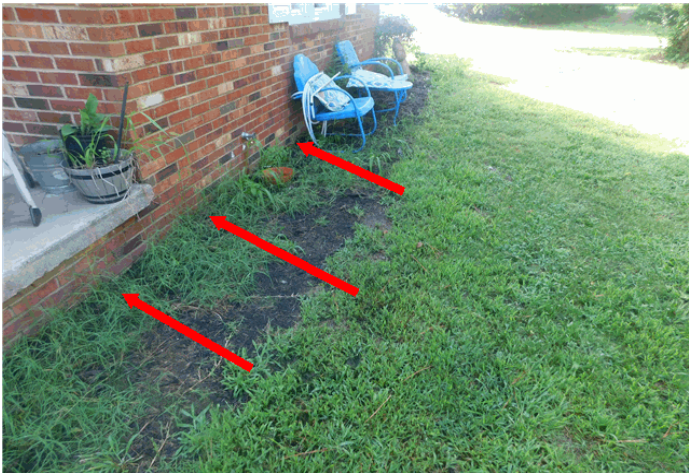
1) Grading Conditions

The grade around the home was neutral or slightly sloping towards the foundation. We recommend re-grading to assure all water drains away from the home's foundation. Failure to re-grade low-lying areas at the foundation can cause water seepage under slabs, into the crawlspace, and / or cracks or movement in the foundation.

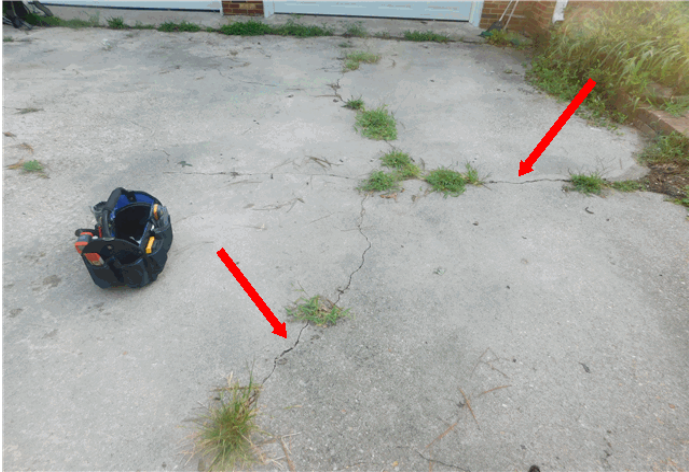
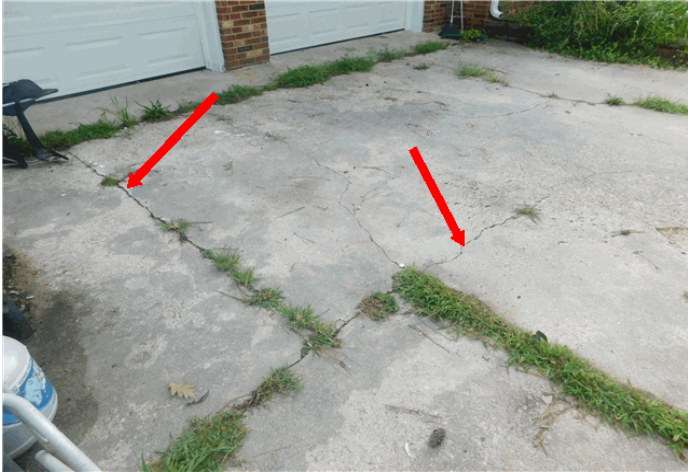
3) Sidewalk Conditions

Common cracks of up to ¼ inch were observed. After removing the grass, recommend sealing and monitoring all cracks for further movement.

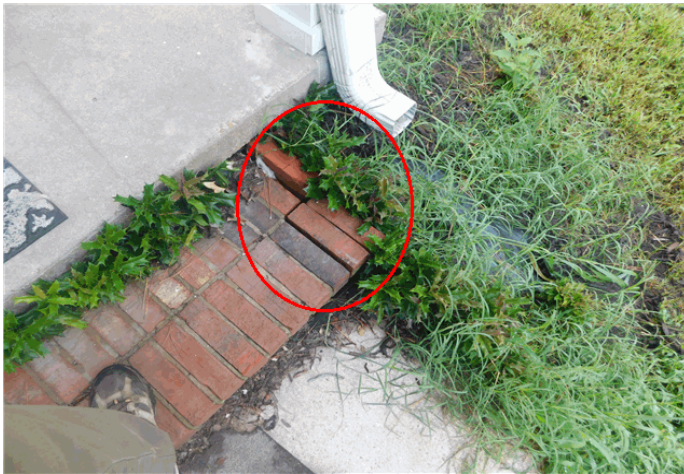
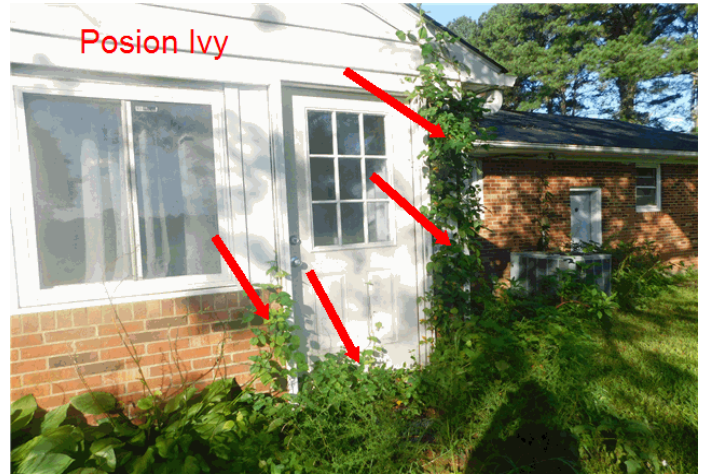
#### 4) Entrance Conditions

Loose bricks were present at the front entrance. Poison ivy was present at the rear entrance. Recommend maintenance and/or repairs as needed.

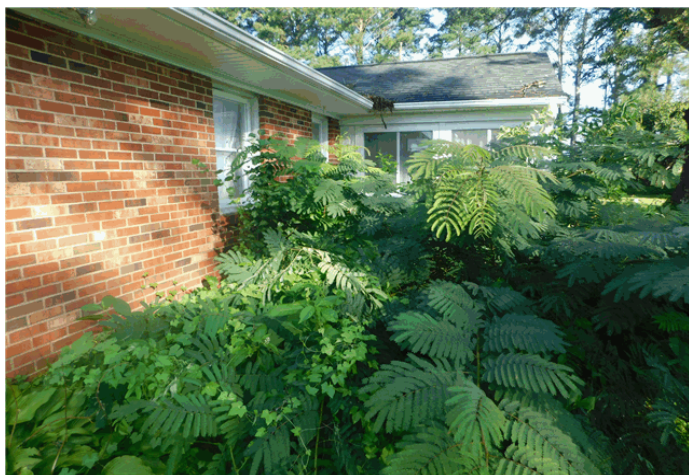
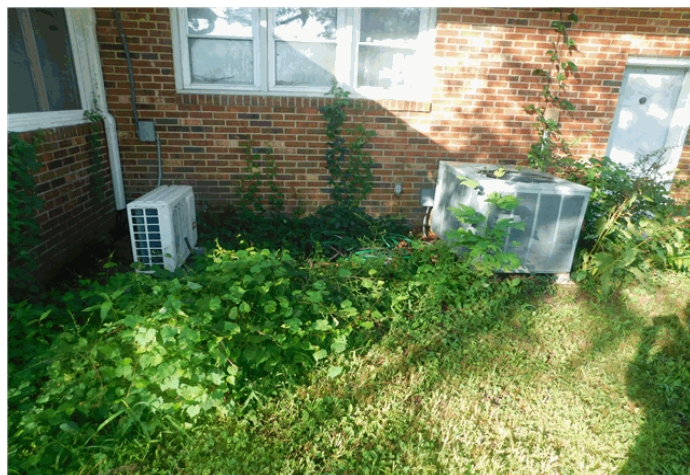
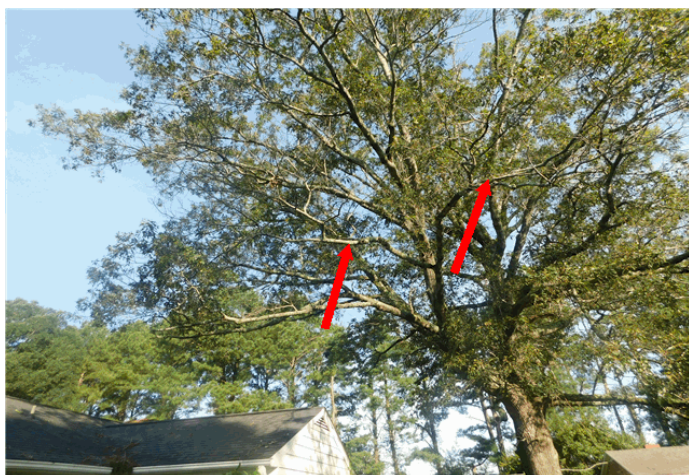
#### 5) Exterior Wall Conditions

The visible and accessible portions of the exterior wall coverings appeared to be in serviceable condition at the time of the inspection. Vegetation was in contact with the exterior walls. The vegetation should be trimmed away 1 - 2 feet from the wall. The exterior walls were not fully visible due to overgrown vegetation. Also dead tree limbs were overhanging the home at the rear. Recommend maintenance and/or repairs as needed.

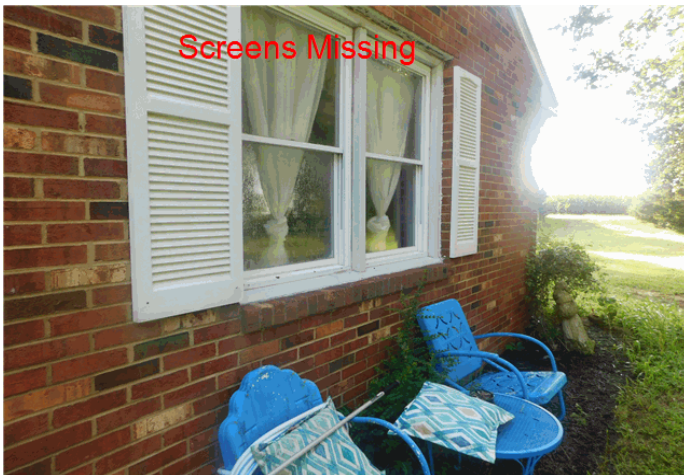
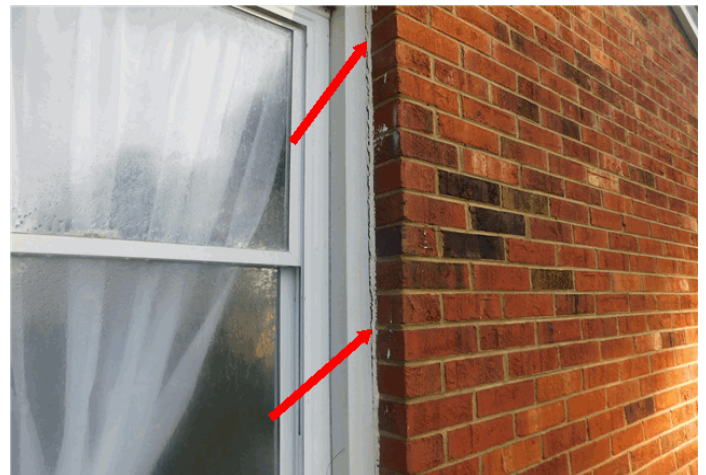
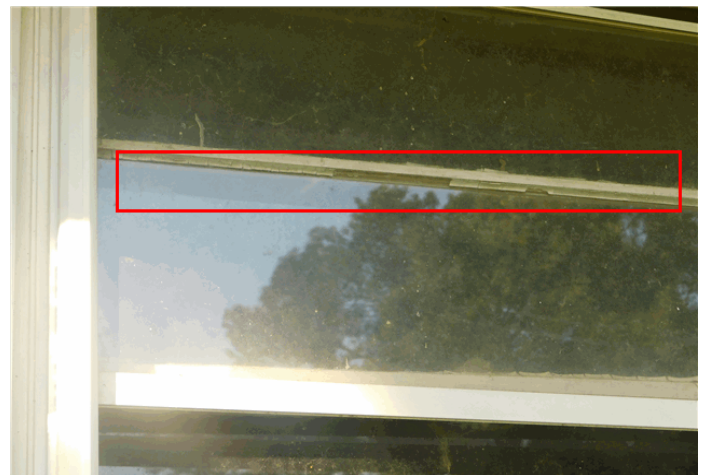
## 7) Window Conditions

The majority of the windows appeared to be in serviceable condition at the time of the inspection. Screens were missing at most of the windows and most also required caulking. The wood window(s) were in need of re-glazing and painting.

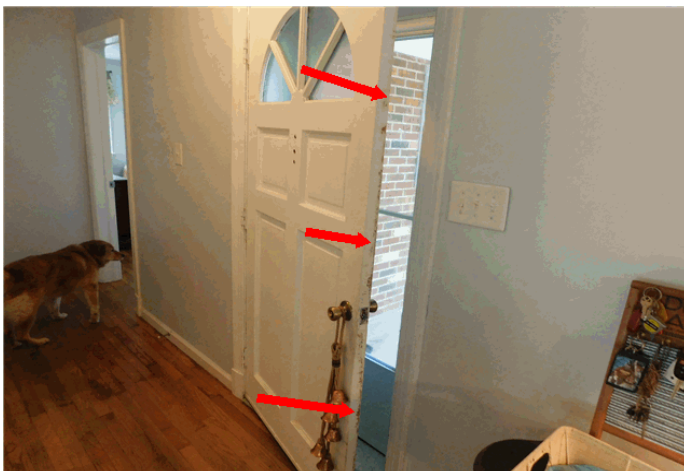
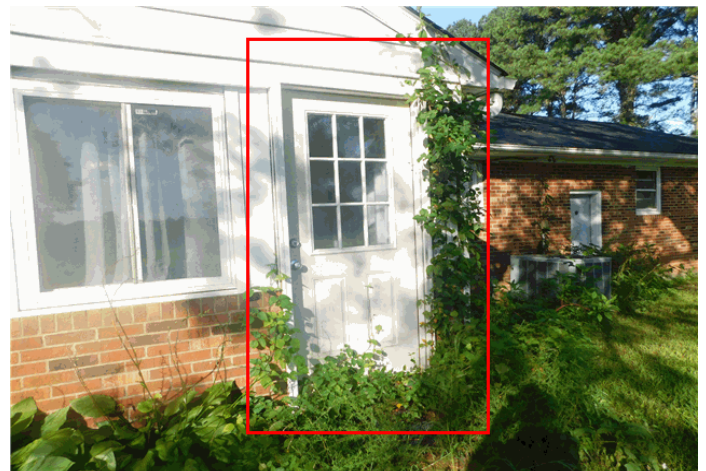
#### 8) Exterior Door Conditions

The front entry door would not close properly. Recommend repairs or adjustments as needed. As mentioned, the rear home entry door has poison ivy on 3 sides.

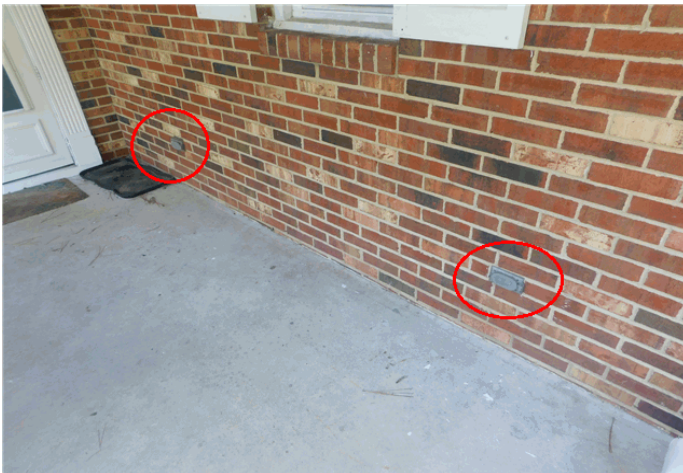
**Exterior Electrical****10) Electrical Conditions****AS**

All exterior electrical conditions appeared to be in serviceable condition at the time of the inspection. The exterior outlets were not GFCI protected. Ground Fault Circuit Interrupter receptacles protect you from shock at wet or damp locations. Recommend installing GFCI outlets at these locations.

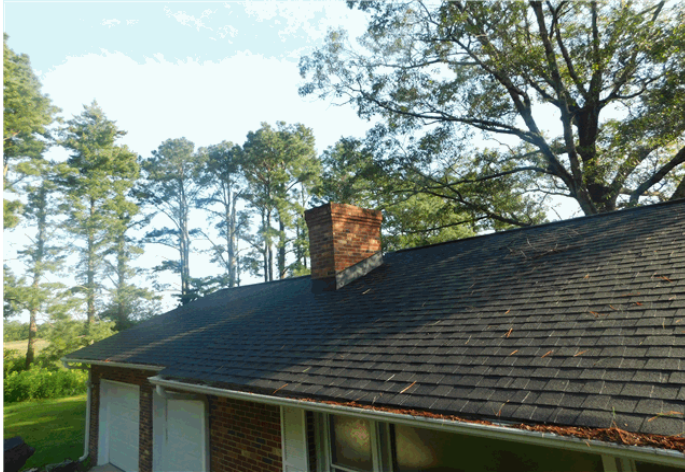
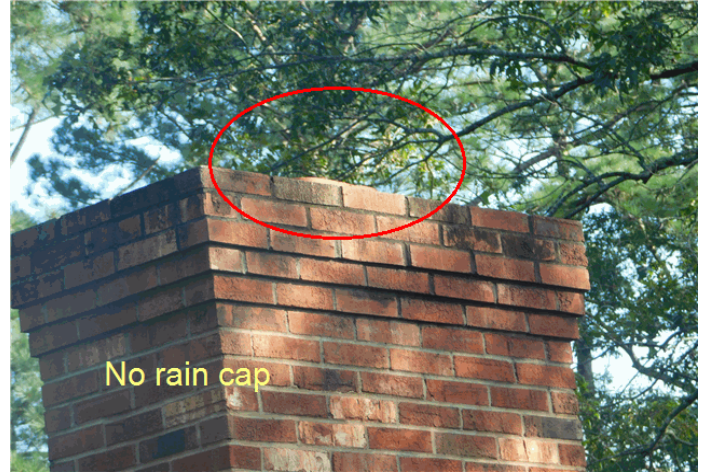
**Chimney****11) Chimney Conditions****AS**

The visible and accessible portions of the chimney appeared to be in serviceable condition at the time of the inspection. The chimney and / or flue did not have a rain cap installed. Recommend a cap be installed during normal chimney maintenance.

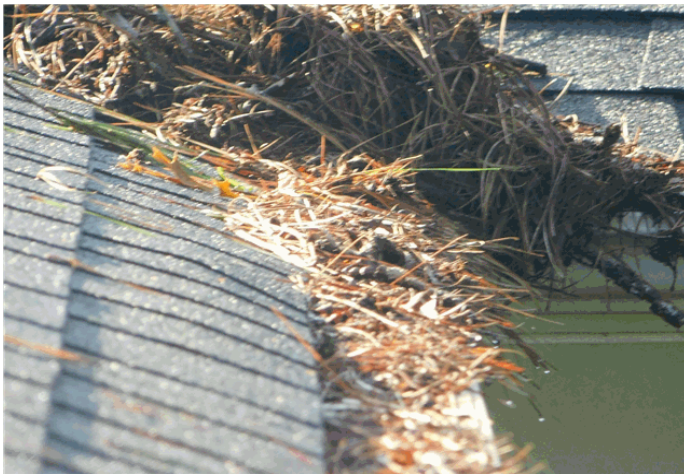
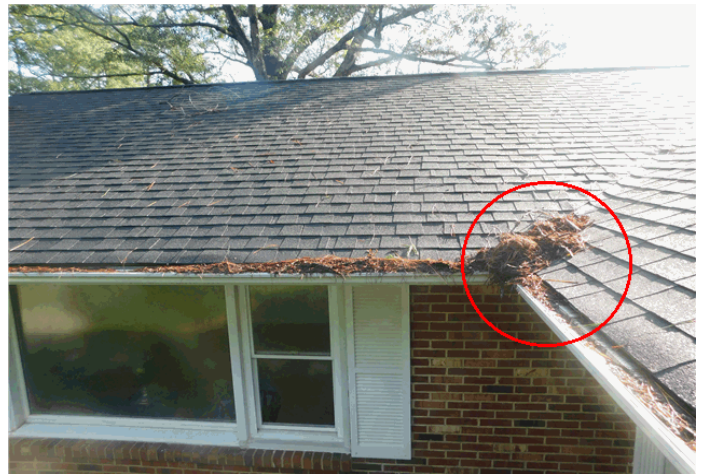
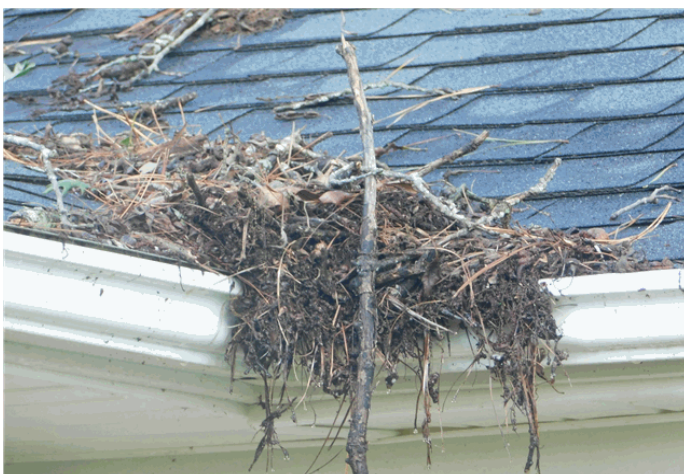
**12) Roof Covering Condition****AS**

The roof covering shows normal wear for its age and appeared to be in serviceable condition at the time of the inspection. Leaves and debris were present at the valleys. Recommend keeping these areas clear of debris

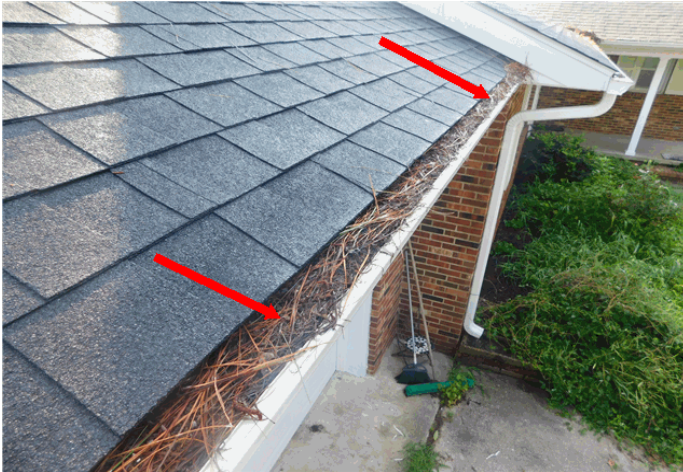
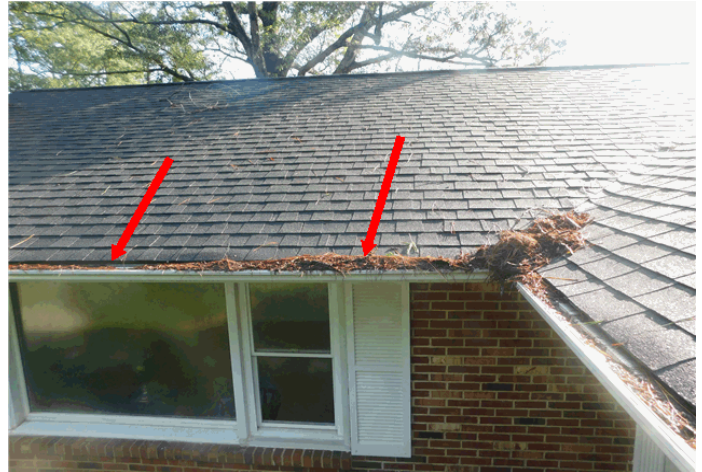
**14) Gutter & Downspout Conditions****R**

The gutter system has leaf guards however the majority were completely blocked with pine needles and debris. Suggest cleaning and removal of debris on a regular basis. This condition can cause water penetration at the eave area.

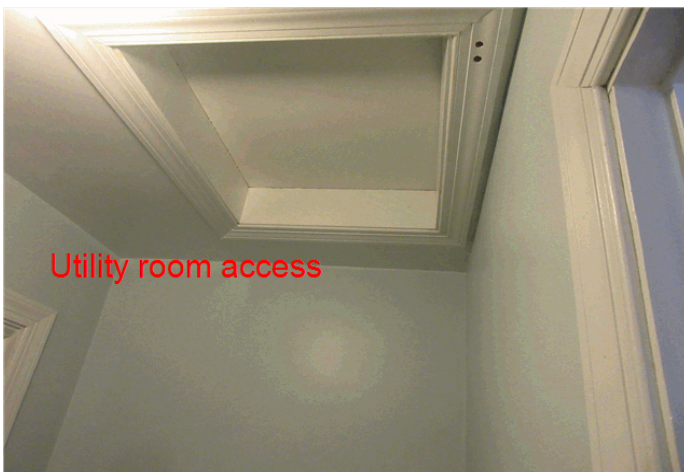
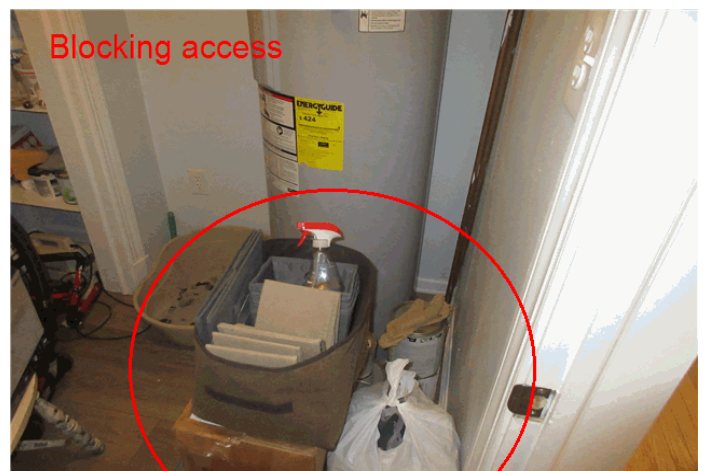
**15) Attic Conditions****NI**

I was unable to access the attic due to personal items blocking the utility room access and not being able to open the garage access due to the weight of the access door.

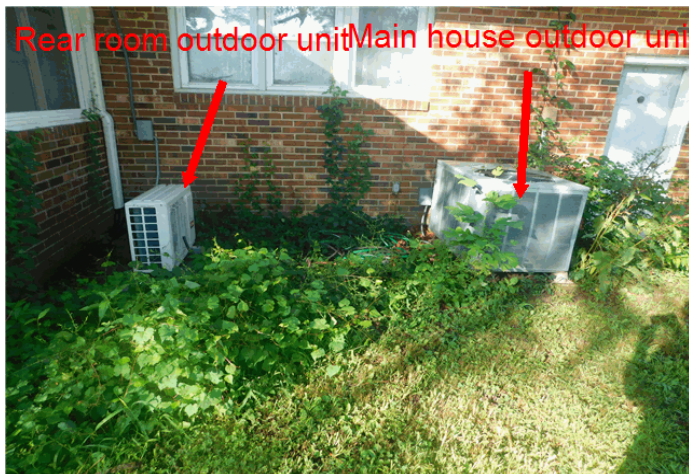
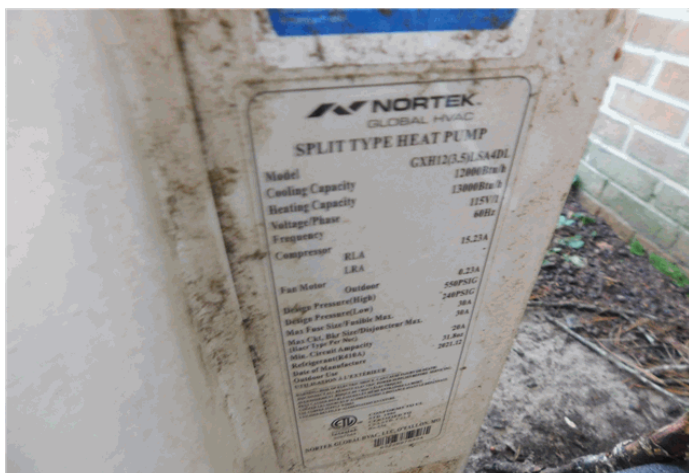
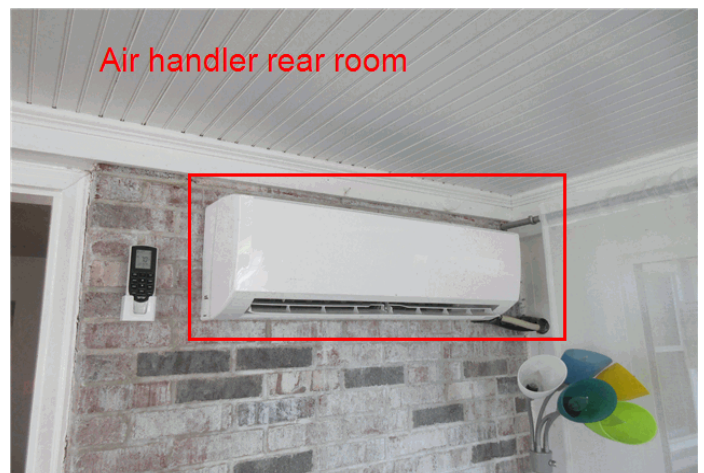
#### 17) Systems Conditions

The HVAC systems were was operational at time of inspection. This is not an indication of future operation or condition. I was unable to inspect the main house air handler in the attic. Although operational, the age of the main house system is past the average life expectancy for this type of system. It is recommended budgeting for replacement.

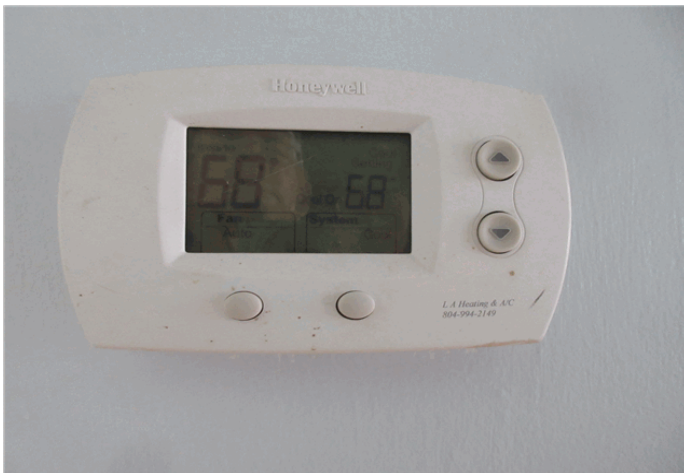
The normal operating controls appeared to be serviceable at the time of the inspection.

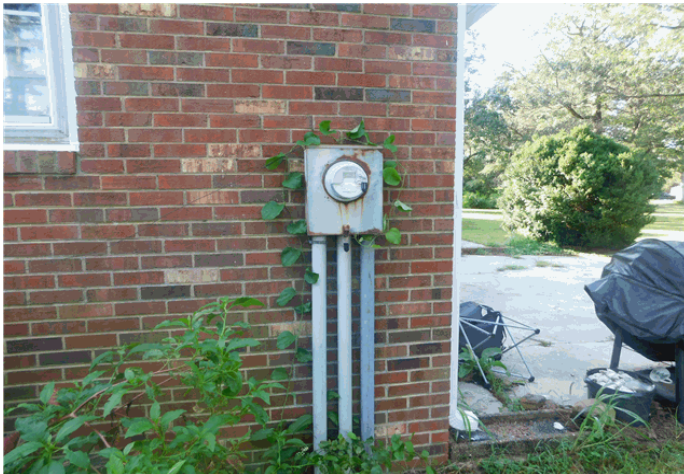
**20) Electrical Service Conditions****AS**

The main service entry appeared to be in serviceable condition at the time of inspection.

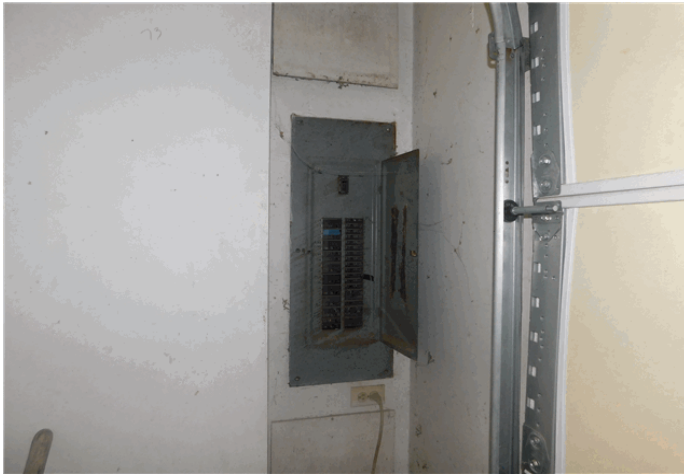
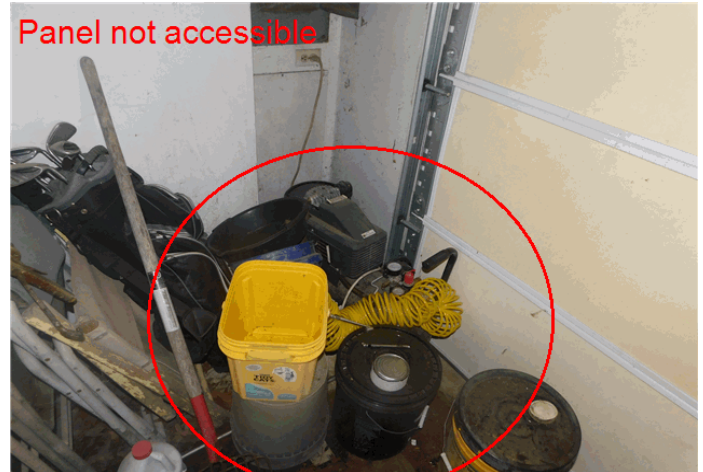
The panel was inaccessible due to personal items.

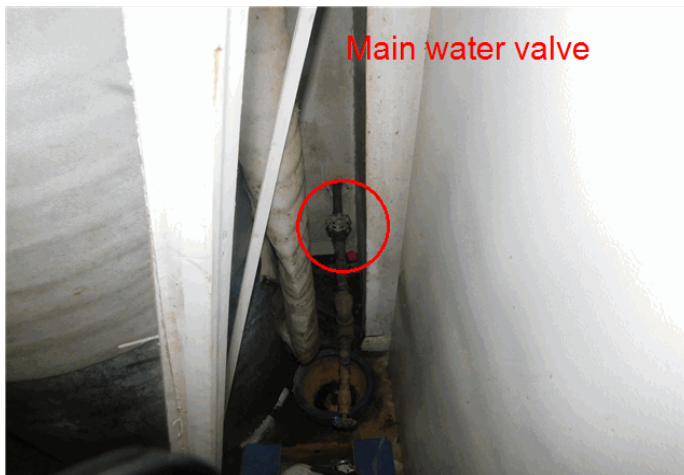
The visible portion of the main pipe and valve appeared to be in serviceable condition at the time of the inspection.

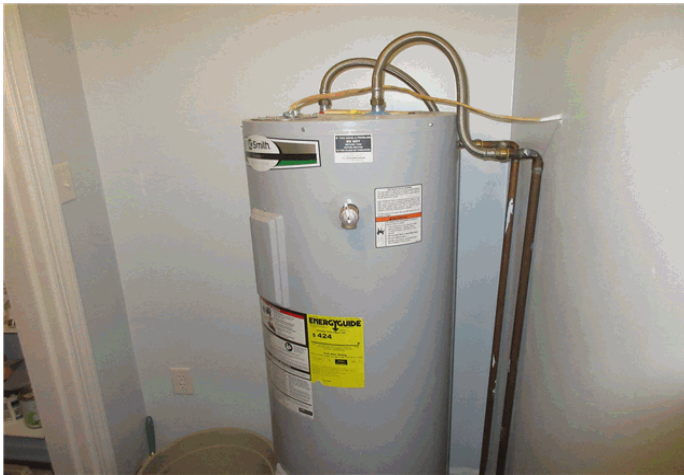
**26) Water Heater Conditions****AS**

The water heater was operable at the time of inspection. This does not however guarantee future performance, operation, or condition.

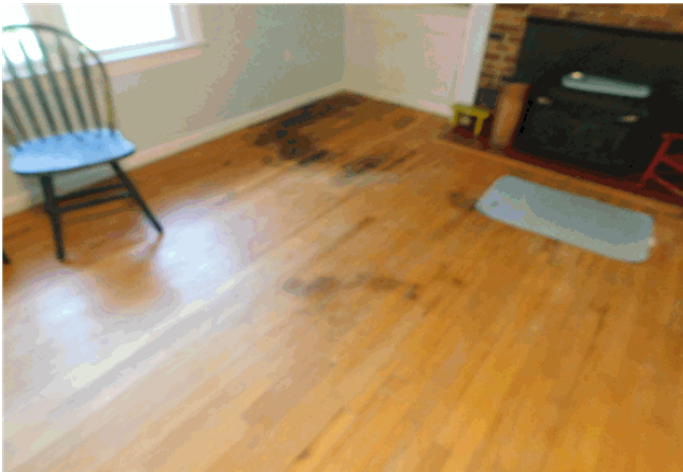
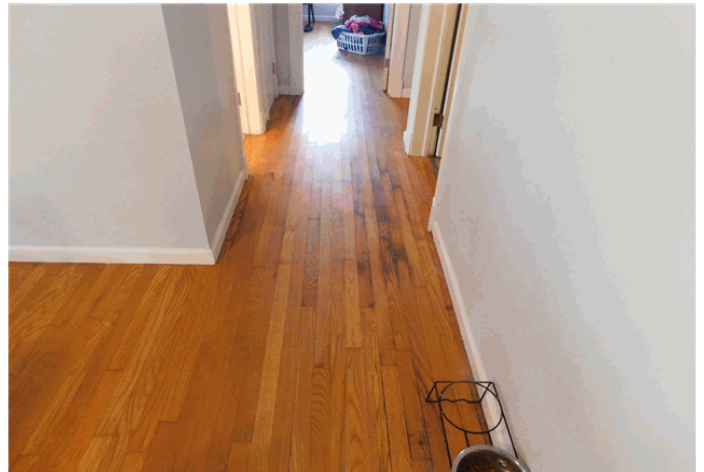
#### 29) Floor Conditions

The general condition of the visible and accessible portions of the floors appeared to be in serviceable condition at the time of the inspection. Quite a few stains were present on the wood flooring.

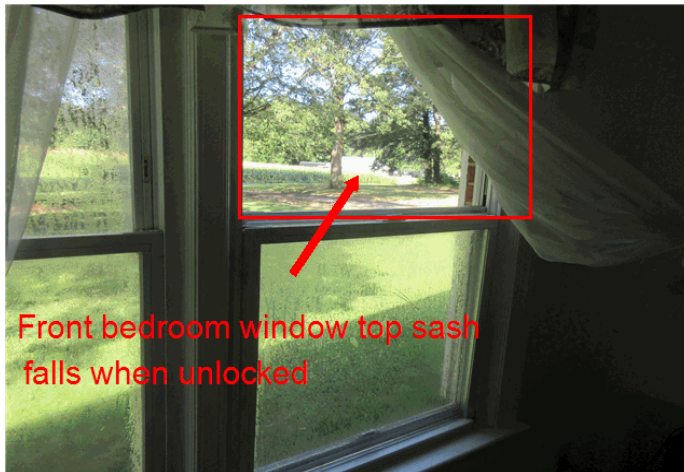
The majority of windows tested were operational at the time of the inspection. There were several bedroom windows that were difficult to open and at least one of the windows top sash would fall when unlocked. This could cause injury. Recommend maintenance and/or repairs as needed.

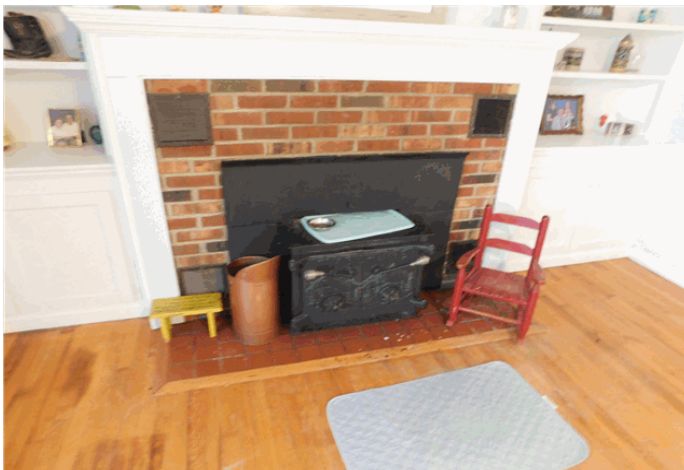
**36) Fireplace Conditions****NI**

A wood burning insert was present in the fireplace at the time of the inspection. Recommend chimney flue cleaning by a chimney sweep specialist prior to use. Creosote can accumulate and become a fire hazard if the fireplace and flue are not cleaned regularly.

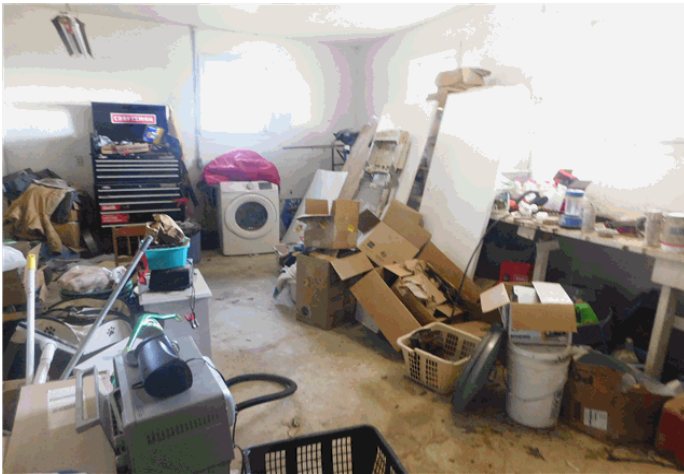
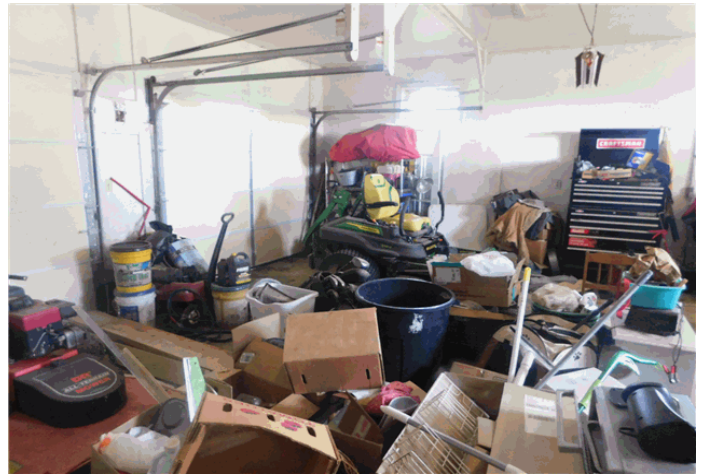
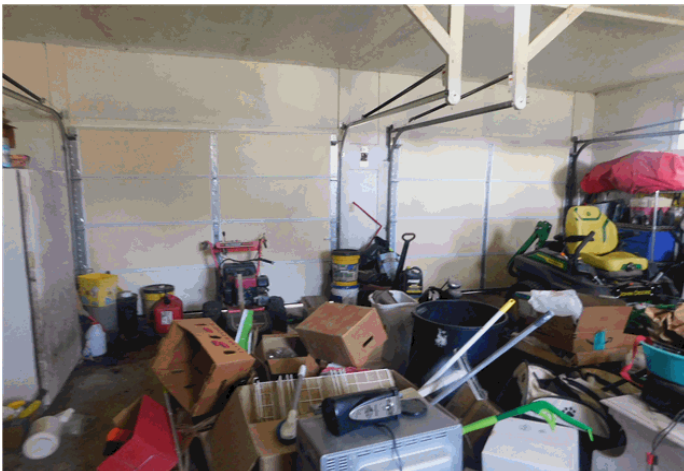
The general condition of the walls appeared to be in serviceable condition at the time of the inspection. Personal belongings and / or shelving prevented a full inspection of the entire wall. Moving or disturbing homeowner personal property is outside the scope of our inspection.

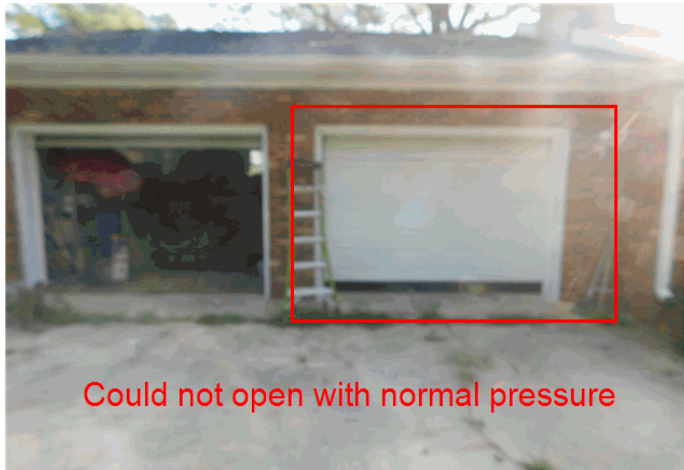
**52) Vehicle Door Conditions****AS**

The right side vehicle door could not be opened with normal pressure. The left side vehicle door appeared to be in serviceable condition at the time of the inspection.

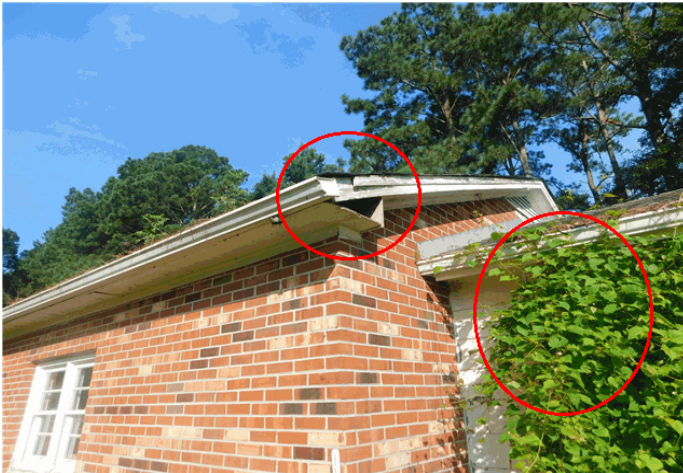
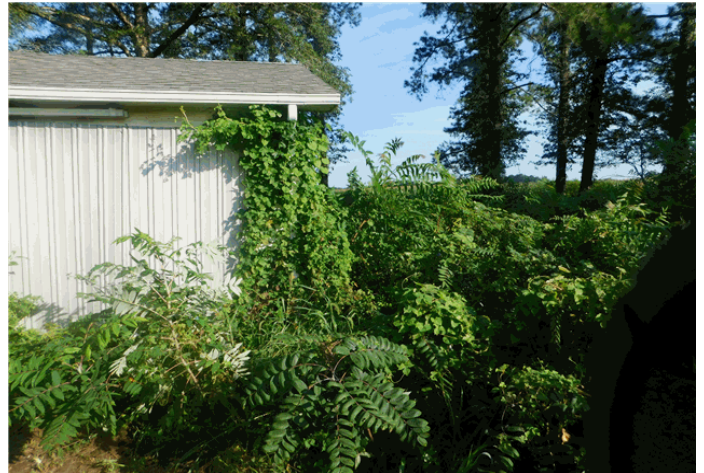
The soffit was open and damaged. This can allow moisture and critters to enter the structure. Also vegetation was in contact with the exterior covering. Recommend maintenance and/or repairs as needed.

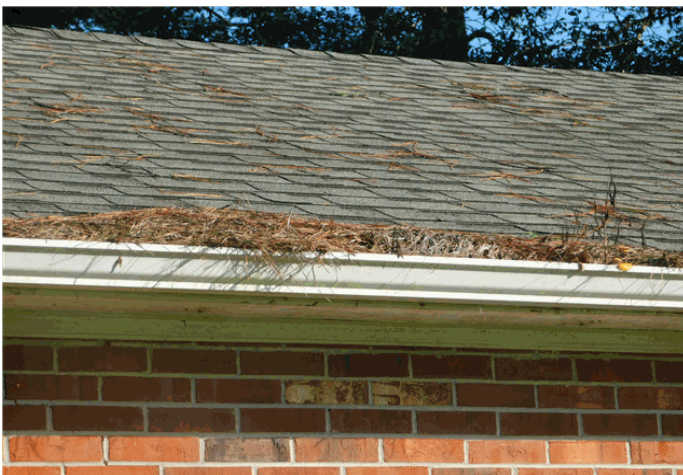
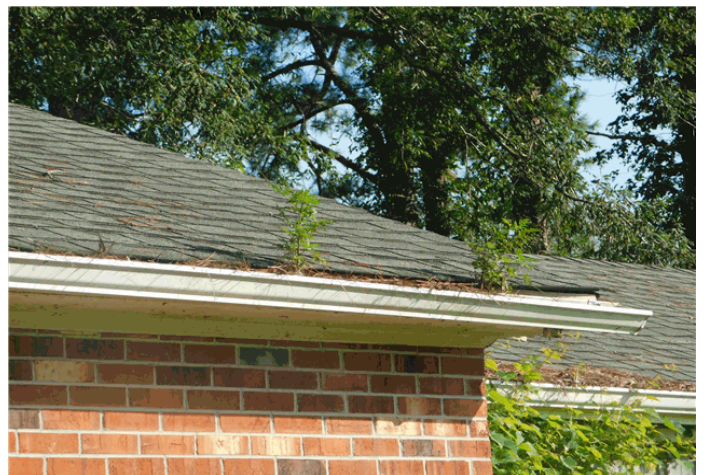
#### 57) Roofing and Gutters

The visible and accessible areas of the roof covering appeared to be in serviceable condition for its age. I was unable to view the rear roof areas due to poison ivy and other vegetation. The gutters were filled with leaves and debris and downspouts were missing. Recommend maintenance and/or repairs as needed.

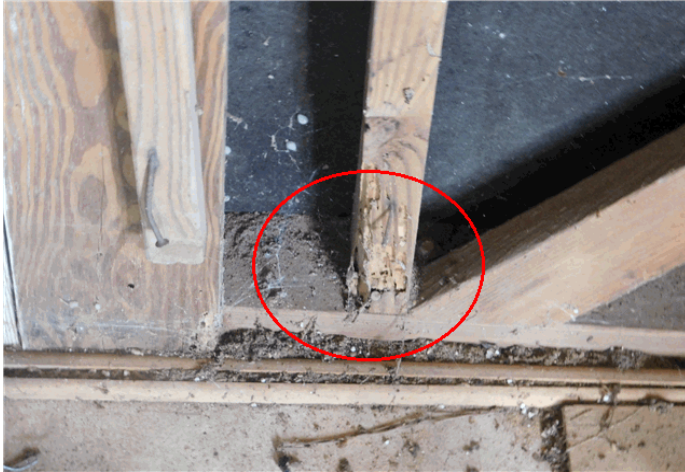
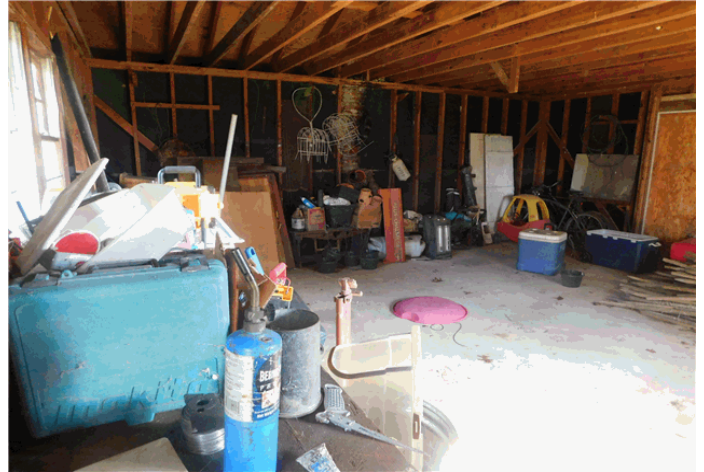
**59) Wall Conditions****R**

Evidence of termite damage was present at a lower wall area. The majority of the interior walls were blocked by storage and personal items.

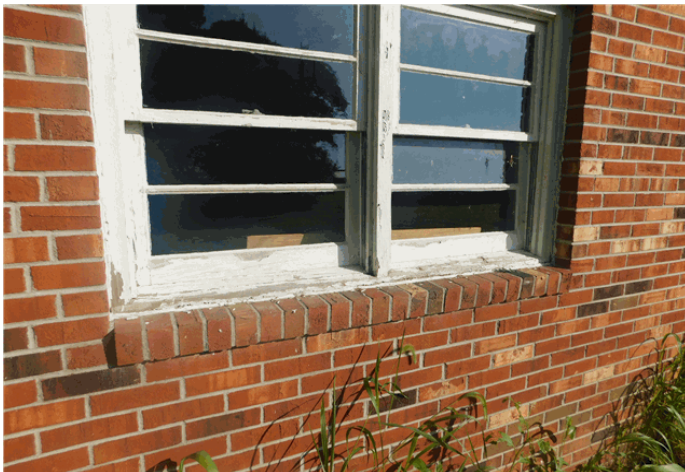
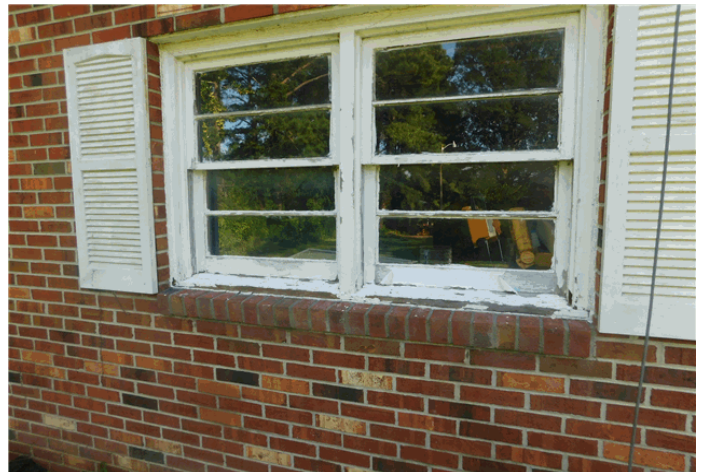
**60) Windows Conditions**

The wood windows are in need of re-glazing and painting.

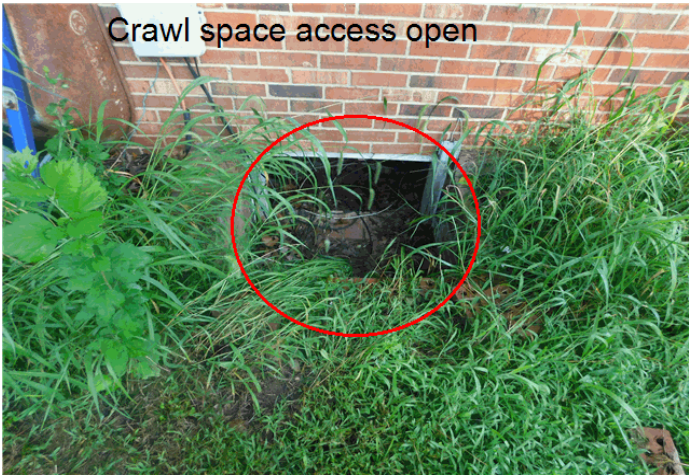
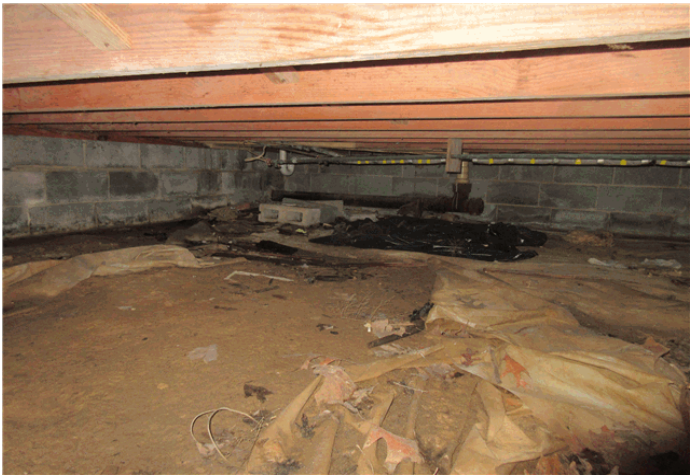
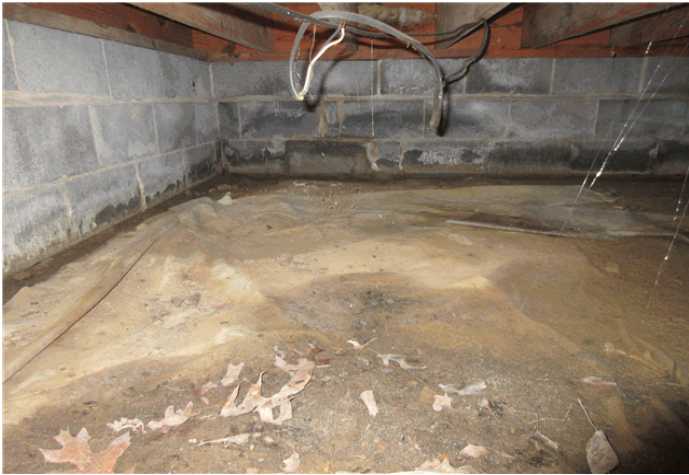
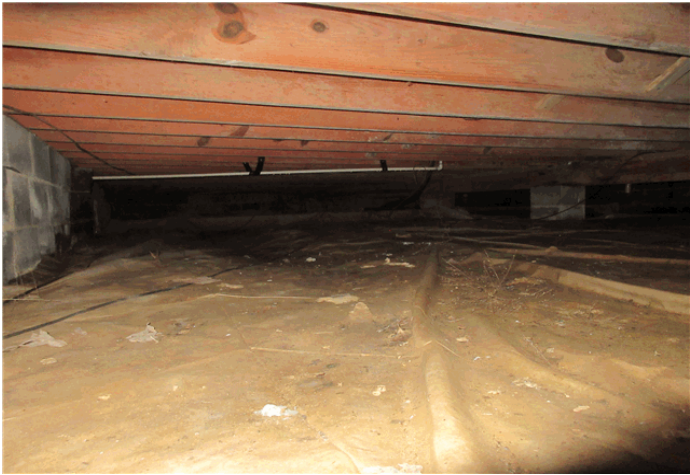
62) Crawl Space Conditions           **R**    Areas of moisture were observed in the crawl space. The crawl space access was open at the time of the inspection. Also the humidity was extremely high in this area(96%). Steps should be taken to reduce moisture. The conditions observed are conducive to wood rot, mold, rust and corrosion to pipes and wires. A mold inspection or testing was not performed as part of this general home inspection.

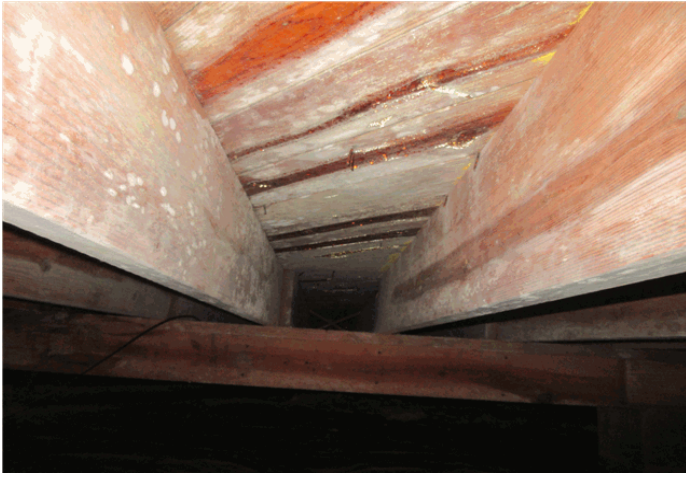
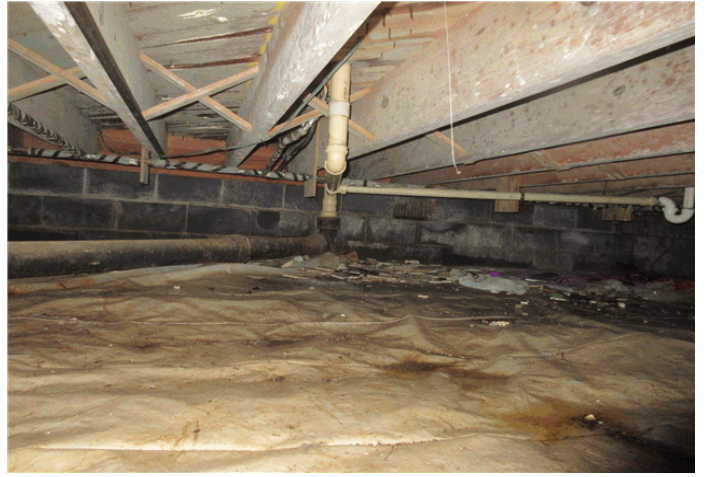
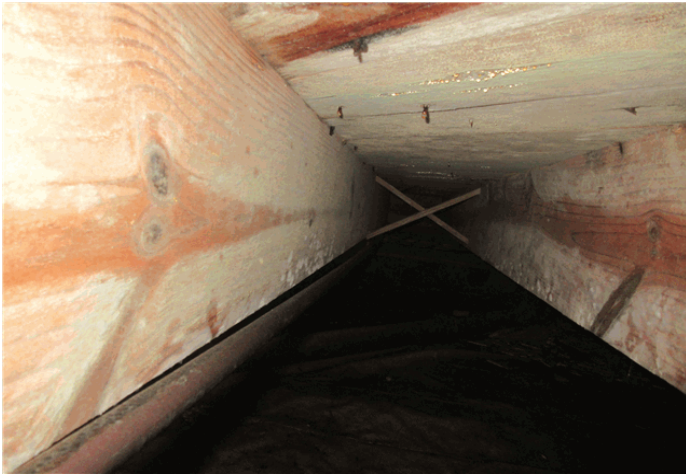
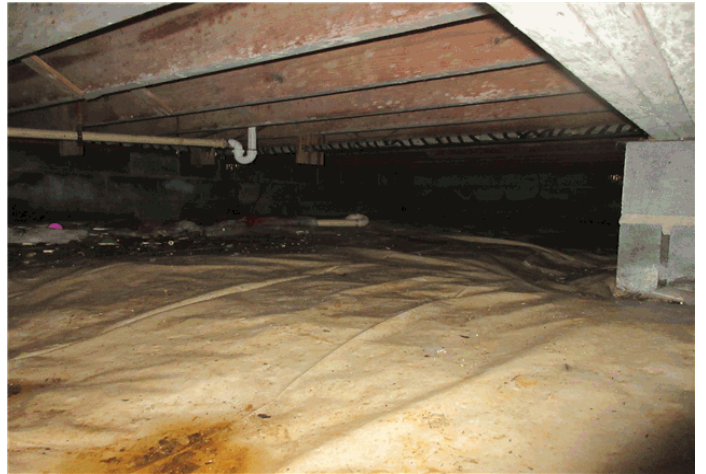
Significant microbial growth was present on the floor framing, especially at the rear of the crawl space. This growth is probably due to the high humidity in the crawl space. It is suggested that a Qualified Crawl Space Contractor be contacted for further evaluation.
