SANDIA HOME INSPECTIONS

HOME INSPECTION REPORT

5 Pine Rd
Placitas, NM 87043

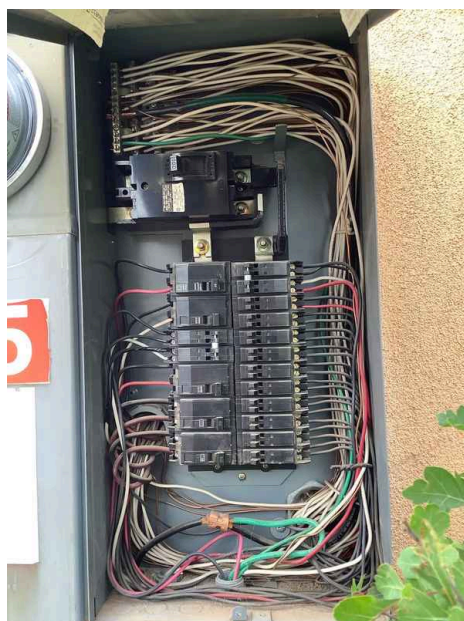
main electrical panel

All electrical work has been performed by JPO Electrical in Placitas. They indicated the service panel is in good condition and not one of the brands that is problematic.

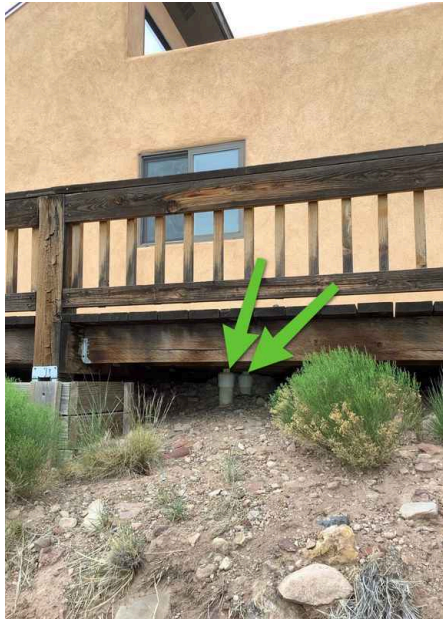
septic cleanout(s)

Septic inspection performed in August & no issues noted. We have never had any septic issues. Fiberglass tank is sound.

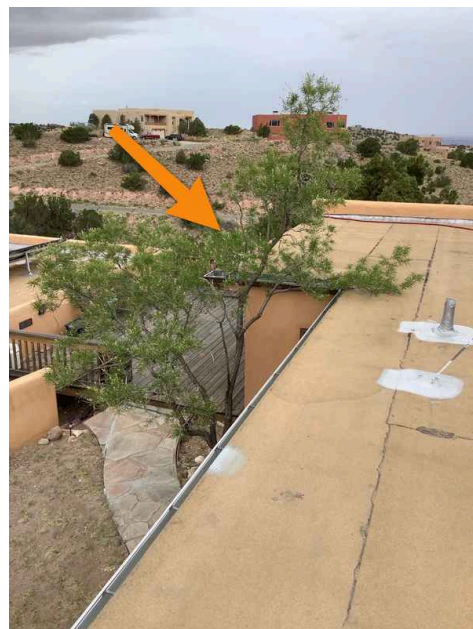
3.4.1 Landscaping

TREE IN CONTACT

Tree branches and/or shrubbery in contact with structure. Recommend pruning back any vegetation so it cannot cause damage to building or roof.

This was repaired by trimming the tree on June 2, 2025. Photographs were taken.

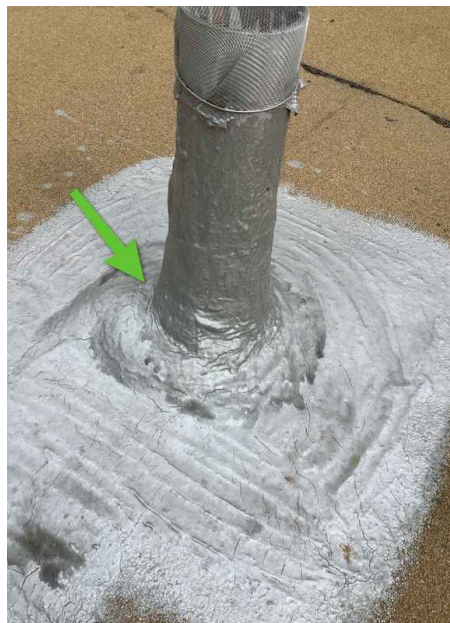
Roof penetrations should be sealed every couple years to prevent moisture from entering through cracks/gaps in sealant. Penetrations are in good condition at time of inspection.

example of roof penetrations

Roof penetrations are inspected and sealed annually, under a maintenance contract with BMC Roofing.

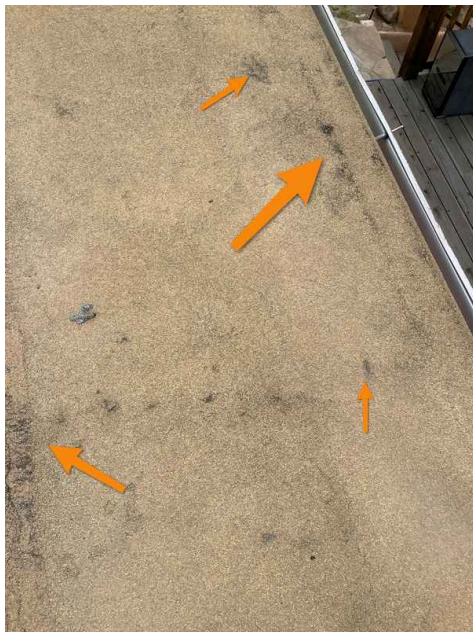
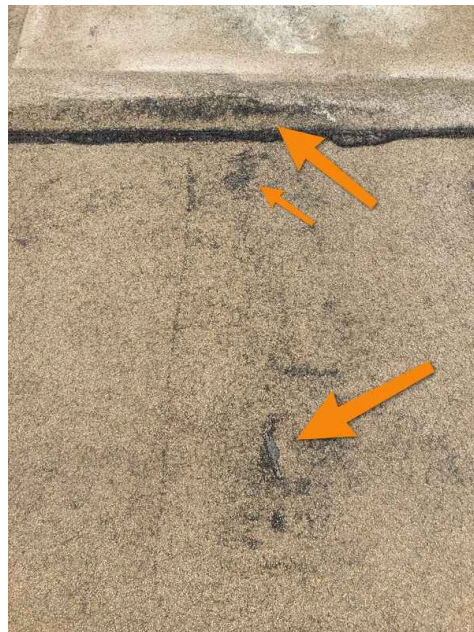
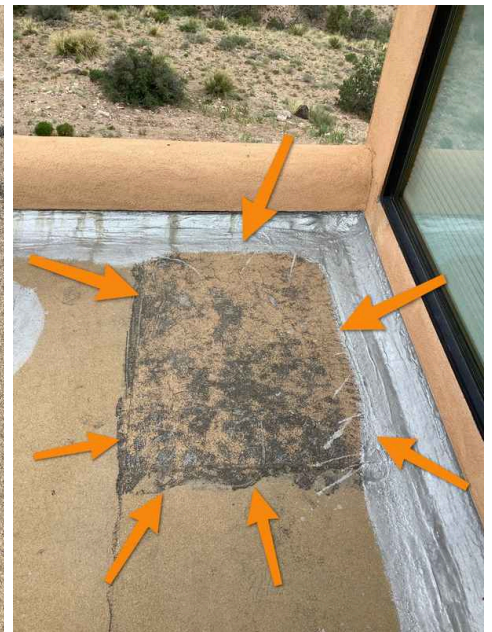
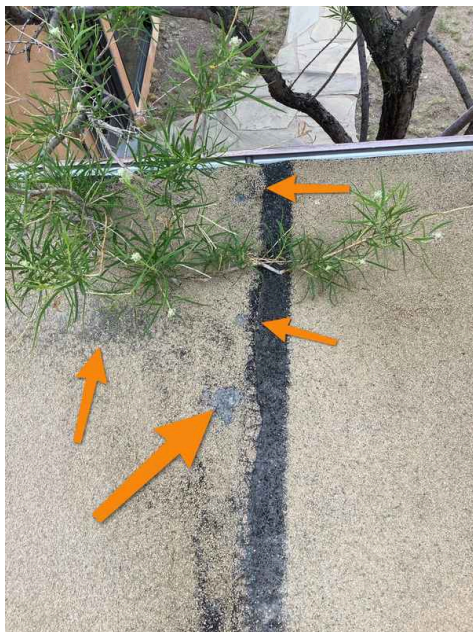
5.2.1 Coverings

DEGRANULATION

The rolled asphalt roof shows signs of degranulation. Degranulation is separation of the surface layer of asphalt and is an indicator of age/wear or it can be the result of hail damage. Recommend a qualified roofing contractor evaluate for repair to prevent further deterioration that could result in leaking and moisture intrusion.

examples of degranulation

We are on an annual roof inspection plan with BMC Roofing. We had them do annual maintenance of penetrations. We have never had a problem with leakage developing and have had annual maintenance of penetrations since the roof was installed in 2011.

They explained to address degranulation present at locations other than penetrations, we would have to apply an entire roof coating, which was performed in September. The coating has a 5-year warranty but is expected to last longer if annual maintenance of penetrations continues to be performed.

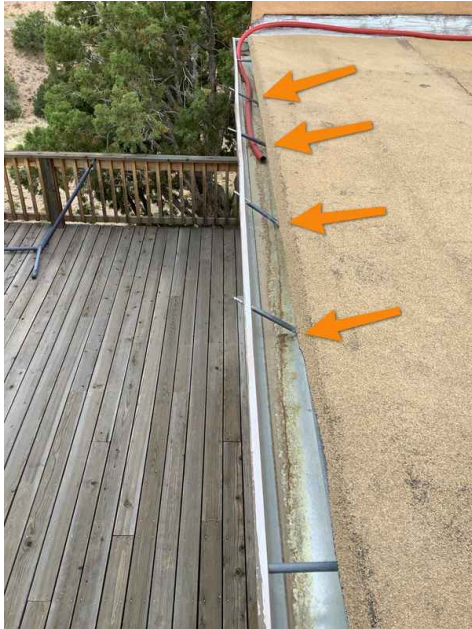
5.3.1 Roof Drainage Systems

GUTTER LOOSE

The gutter(s) is loose and needs to be re-fastened to fascia and pitched properly.

This was addressed when the fascia was upgraded with a no-maintenance treatment, in November. (We purchased the product in May, but ABC Seamless has a significant backlog and the work wasn't performed until 6 months later. We had the wood repaired in the interim.)

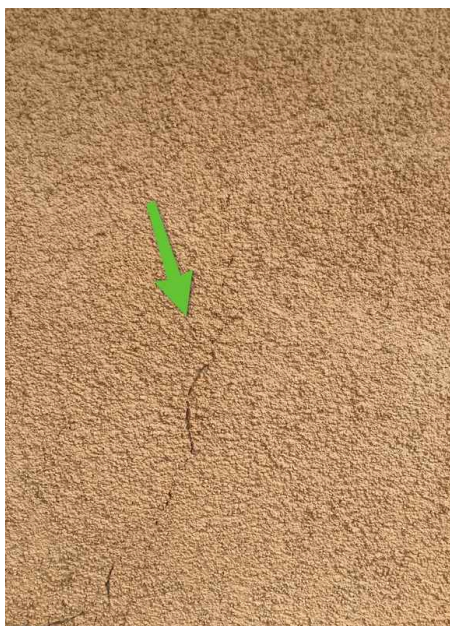
Stucco observed to be in good shape for age and wear. No deficiencies noted. *Small cracks that are less than 1/16 inch are common and can be easily repaired with minor filling and repainting, if needed. This level of maintenance is expected with stucco homes, and these cracks don't undermine the integrity of the exterior finish.*

We had the stucco cracks repaired where needed.

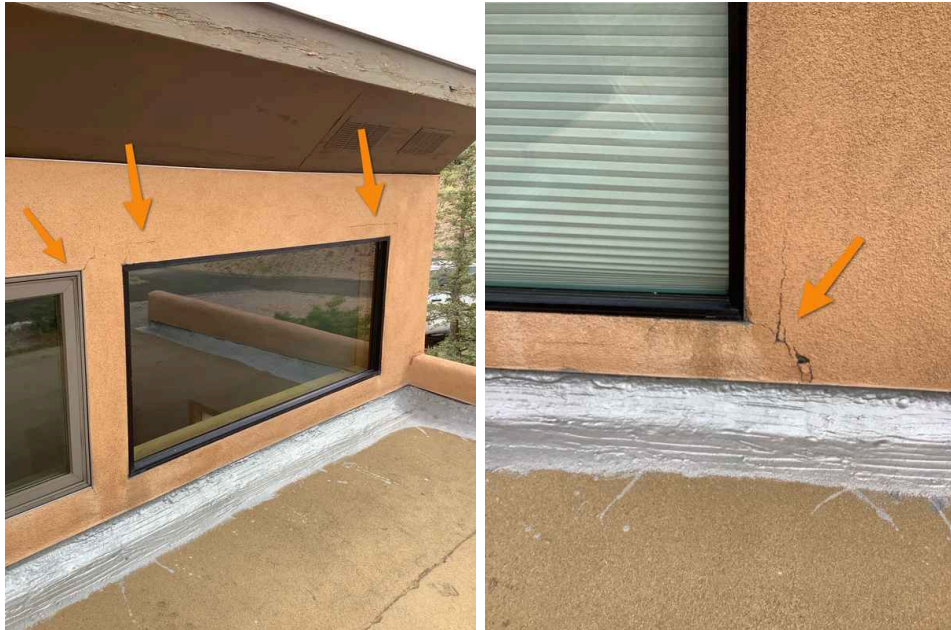
6.1.1 Wall Covering, Flashing & Trim

LARGE STUCCO CRACKS

Larger than typical cracks observed in stucco; water/insects can enter through these larger cracks. Recommend stucco patching/repair.

examples of stucco cracking

These repairs were made.

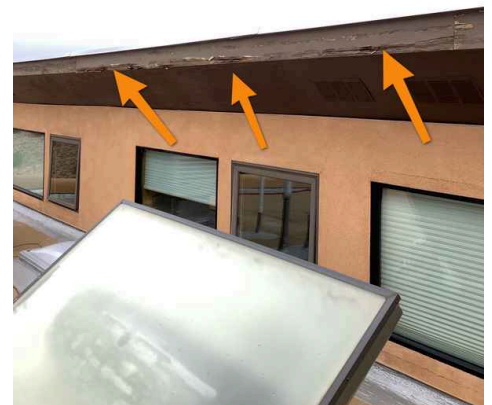
6.2.1 Eaves/Soffits/Fascia

FASCIA - ROTTED

One or more sections of the south fascia are rotted. Recommend qualified roofer evaluate & repair.

This has been addressed by both repair of the wood, and installation of a no-maintenance fascia.

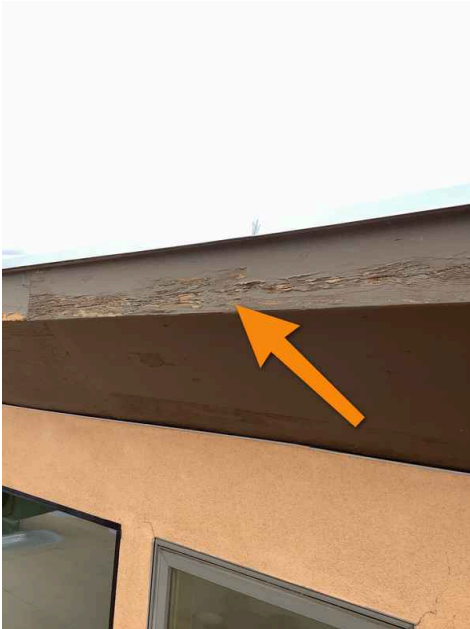
6.2.2 Eaves/Soffits/Fascia

PAINT/FINISH FAILING

The paint or finish is failing. This can lead to deterioration and rot of the material. Recommend that the areas be properly prepared and painted / finished.

The contractor who performed the repairs before fascia covering was installed noted it wasn't dry rot, but sun damage. Our house is oriented within 5 degrees of sun south.

example of failing paint

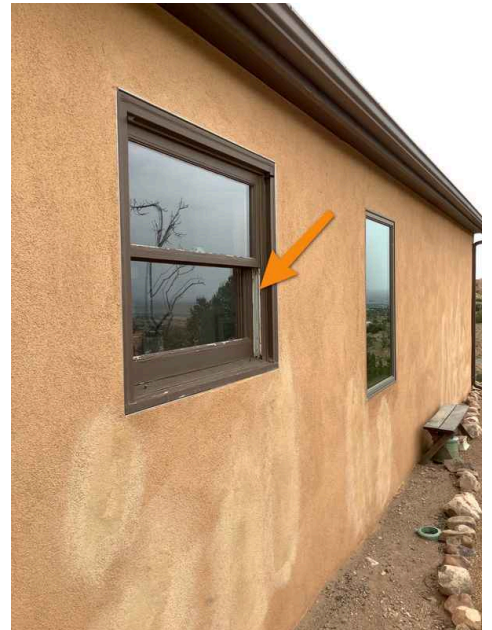
6.5.1 Exterior of Windows

DAMAGED/MISSING SCREENS

Window screens were observed to be missing and/or damaged. Recommend repair/replacement.

example of missing screens

The screen was replaced and the window was repainted.

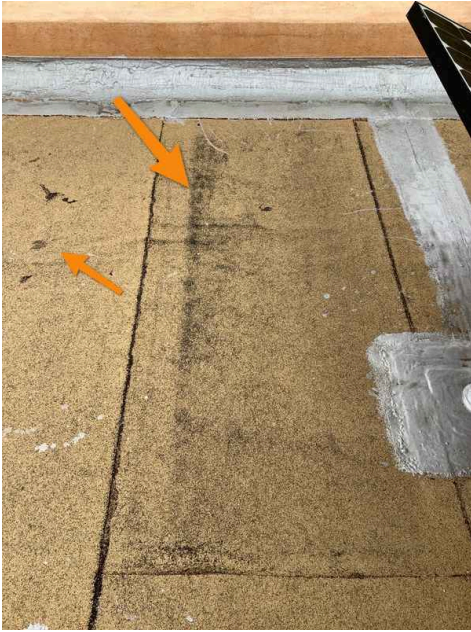
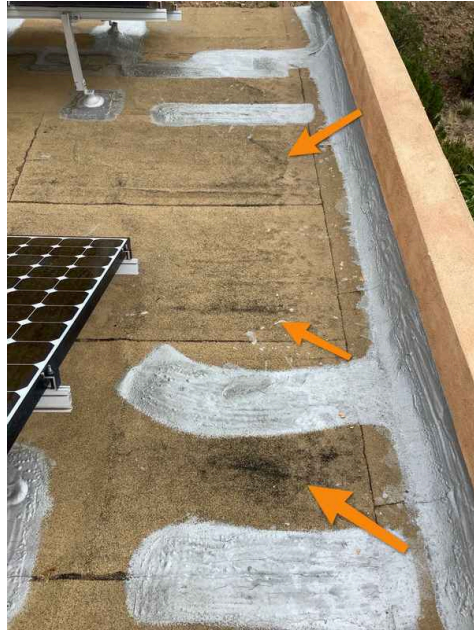
The asphalt shingle roof shows signs of degranulation. Degranulation is separation of the surface layer of asphalt. Recommend a qualified roofing contractor evaluate and repair to prevent further deterioration that results in leaking and moisture intrusion.

examples of degranulation

BMC Roofing explained to address degranulation present at locations other than penetrations, we would have to apply an entire roof coating, which was performed in September. The coating has a 5-year warranty but is expected to last longer if annual maintenance of penetrations continues to be performed.

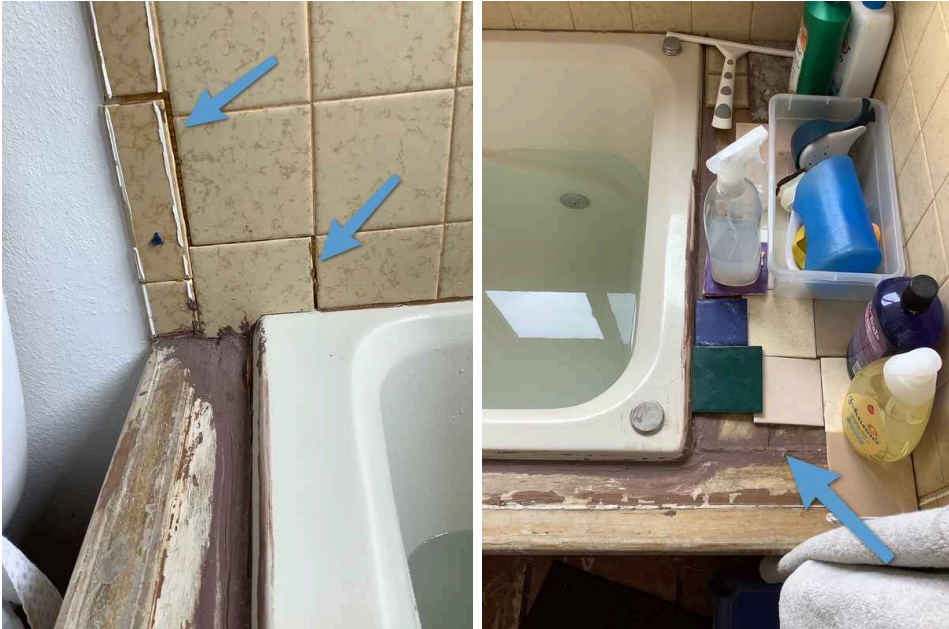
DETERIORATED CAULKING/GROUT

Caulking and/or grout is deteriorated and in need of repair. Recommend resealing.

The grout needs more work. The condition of the wood was addressed. We did locate the grout mix and it is in the garage.

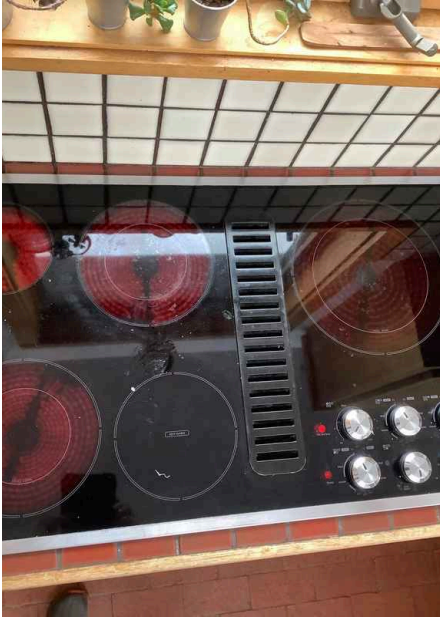
all burners functional

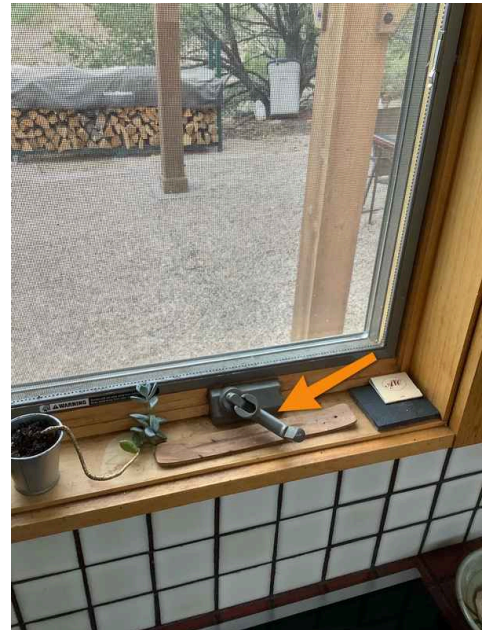
Window does not operate properly due to stripped crank mechanism. Recommend repair.

This repair was made. New crank ordered.
