Inspection Report

Property Address:

66 Geogia Ave

Warsaw, VA

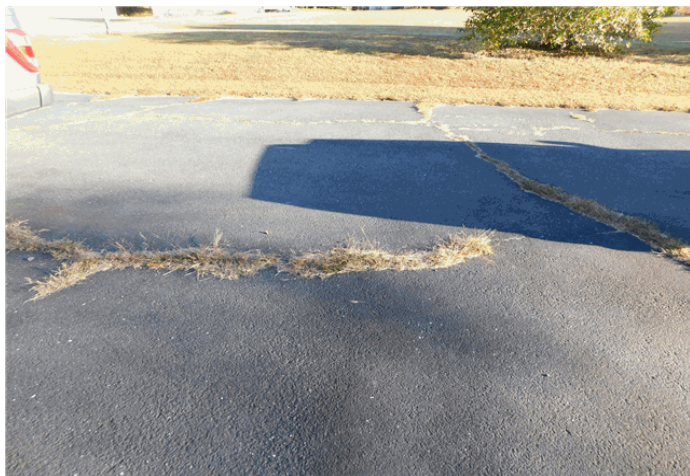
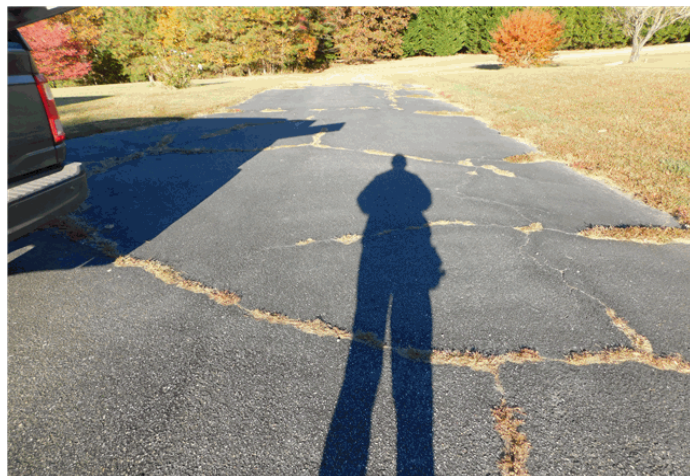
2) Driveway Conditions

The driveway appeared to be in serviceable condition at the time of the inspection. Common cracks were observed in the driveway. Recommend sealing and monitoring all cracks for further movement.

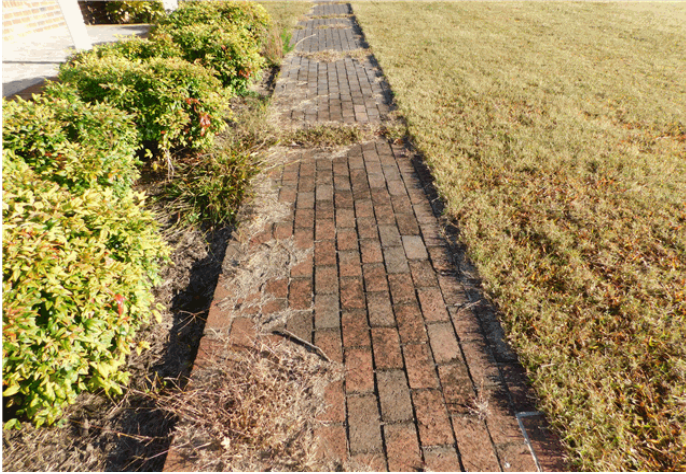
3) Sidewalk Conditions

The visible areas of the sidewalk appeared to be in serviceable condition at the time of the inspection. Common cracks of up to ¼ inch were observed. Recommend sealing and monitoring all cracks for further movement.

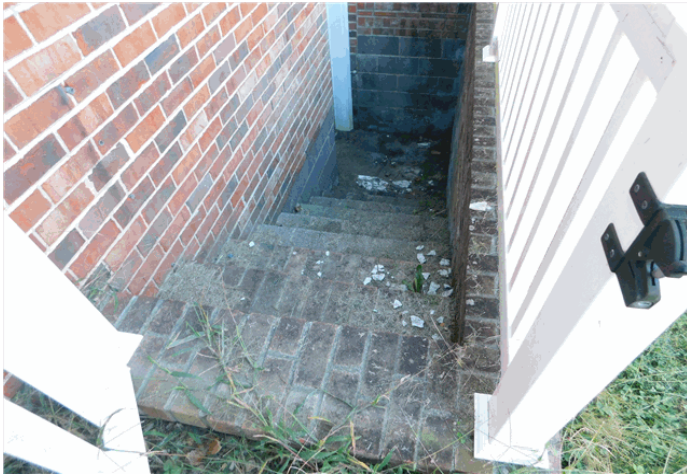
4) Entrance Conditions

The majority of the visible and accessible areas of the entrances appeared to be in serviceable condition at the time of the inspection. A handrail is recommended for the rear basement entrance stairway.

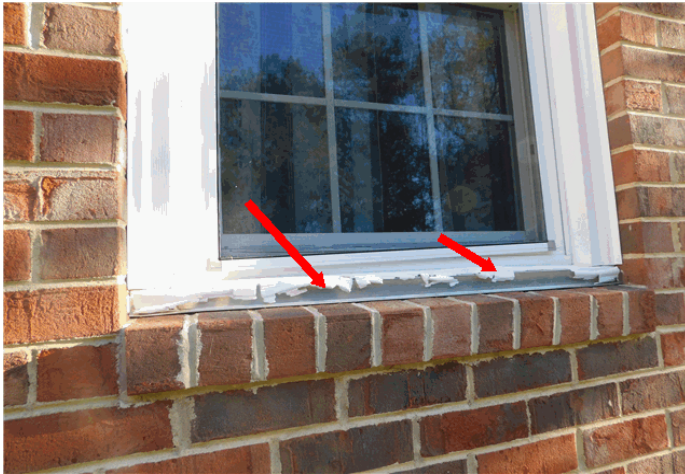
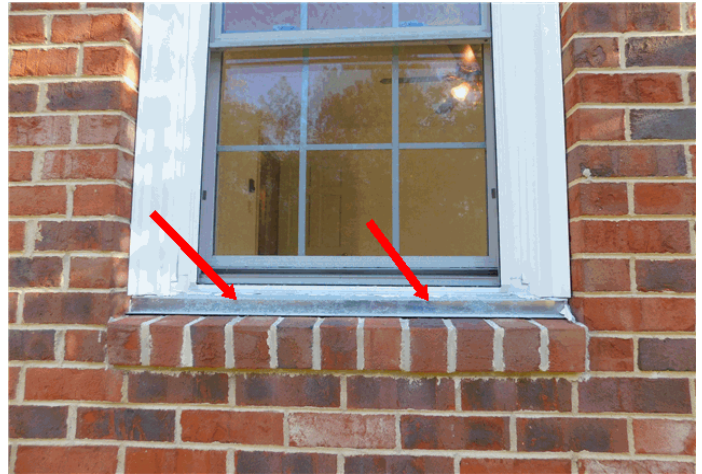
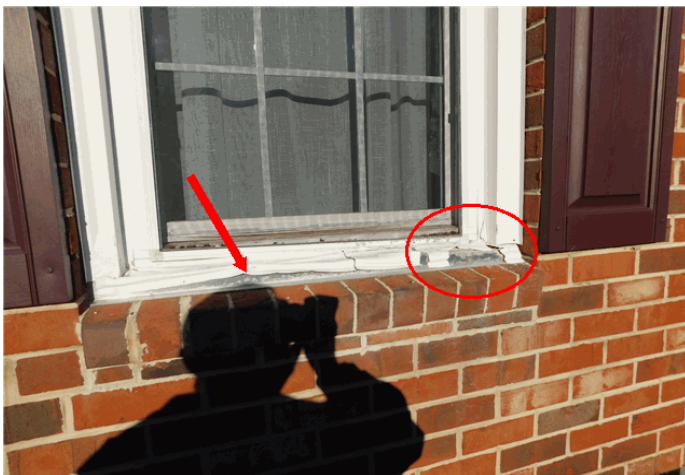
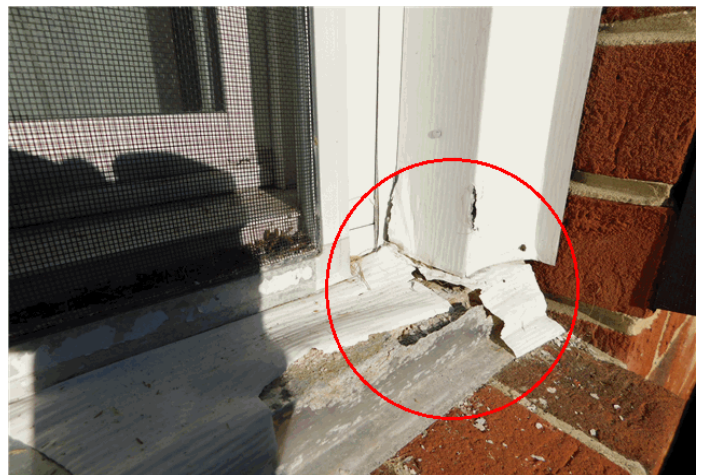
6) Exterior Trim Conditions

The majority of the exterior trim appeared to be in serviceable condition at the time of the inspection. The painted finish on some of the aluminum window trim cladding was peeling with some deterioration. Recommend maintenance and/or repairs as needed.

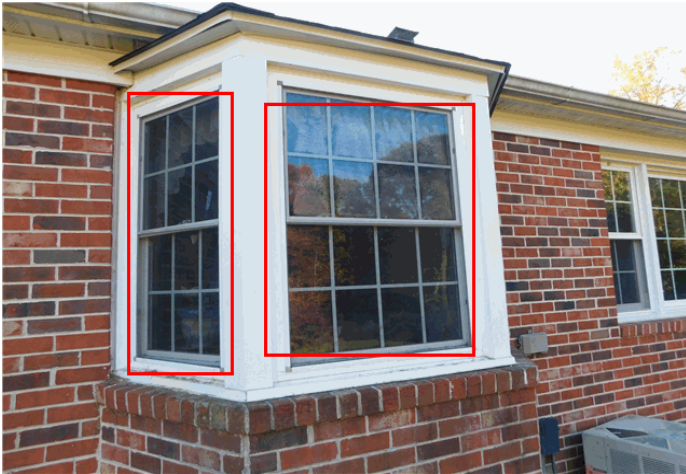
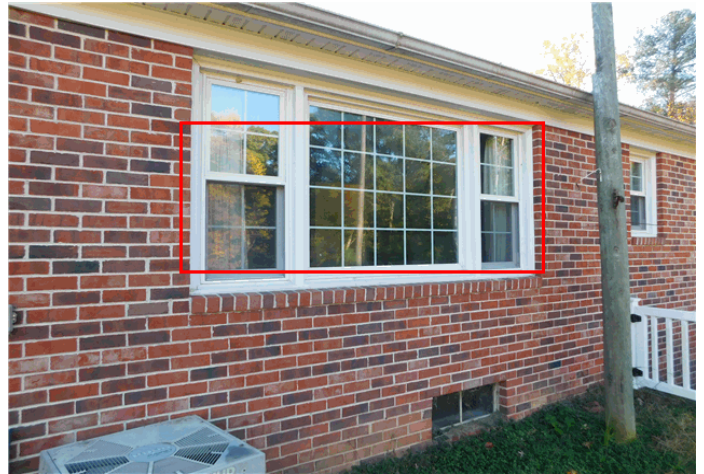
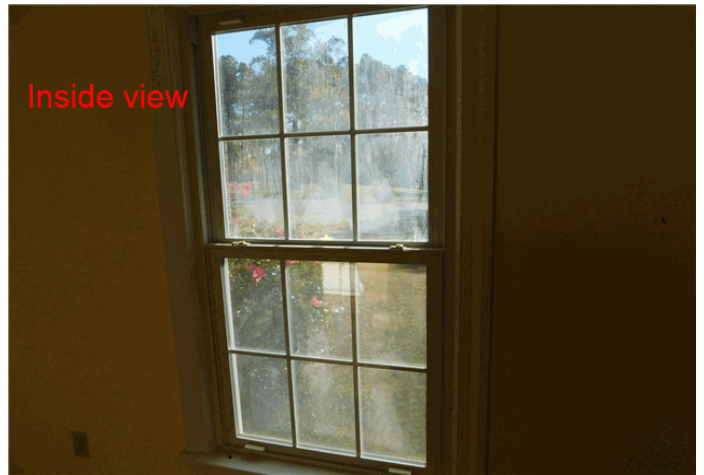
7) Window Conditions

There appeared to be two different brands and ages of replacement windows installed. The majority of the older windows(7) have lost their thermal seal. Moisture, fogging, and hazing are common signs of this condition. While mostly cosmetic, this condition is generally not repairable. Correction would require replacement of the window(s) or window pane(s).

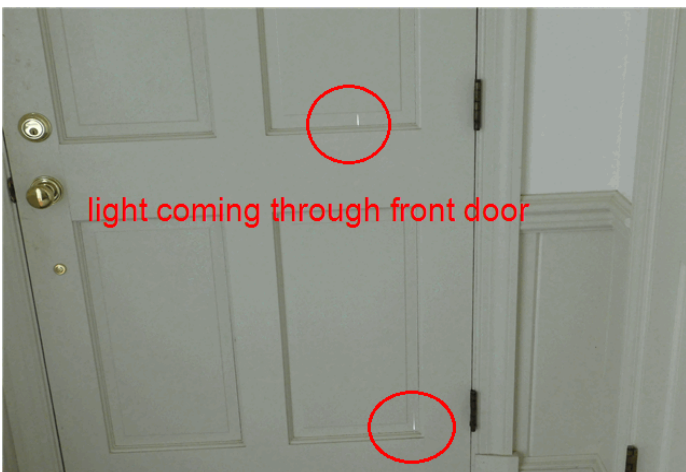
8) Exterior Door Conditions

The doors appeared to be in serviceable condition at the time of the inspection. The front entry door is wood and appears to need caulking and painting on the exterior due to the morning sun exposure.

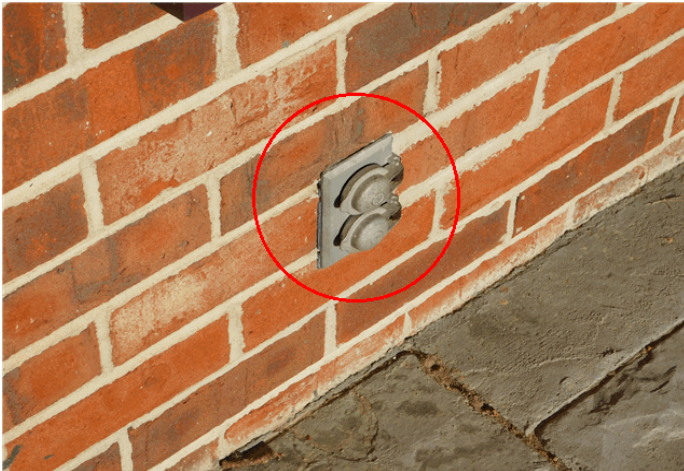
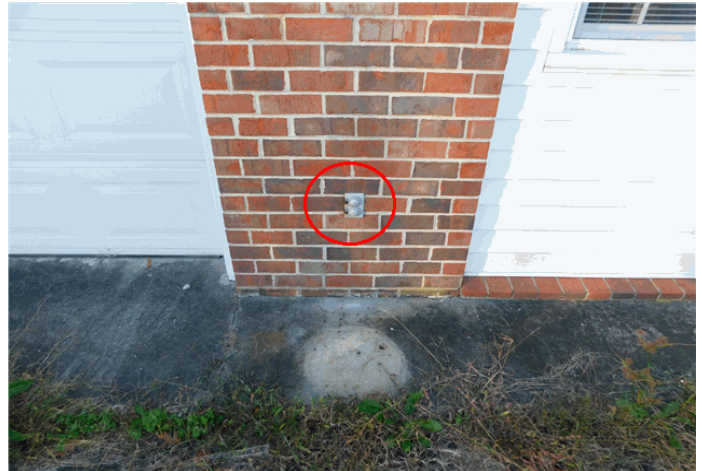
Exterior Electrical**10) Electrical Conditions****S**

The exterior outlets were not GFCI protected. Ground Fault Circuit Interrupter receptacles protect you from shock at wet or damp locations. Recommend installing GFCI outlets at these locations. Also several of the exterior lights were not operable at the time of the inspection. This may only be bad bulbs.

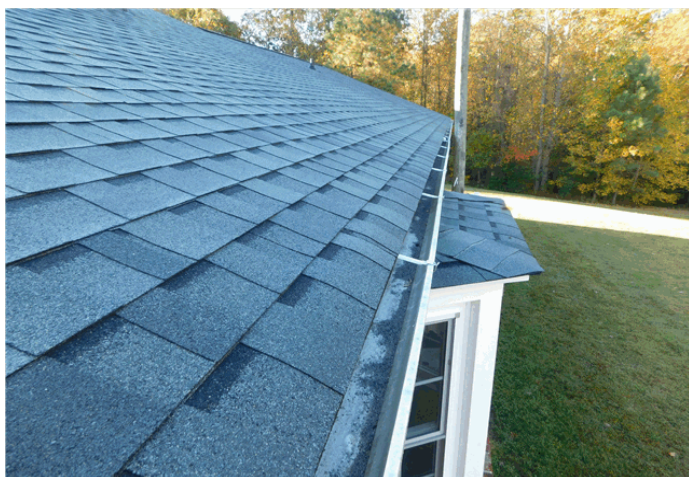
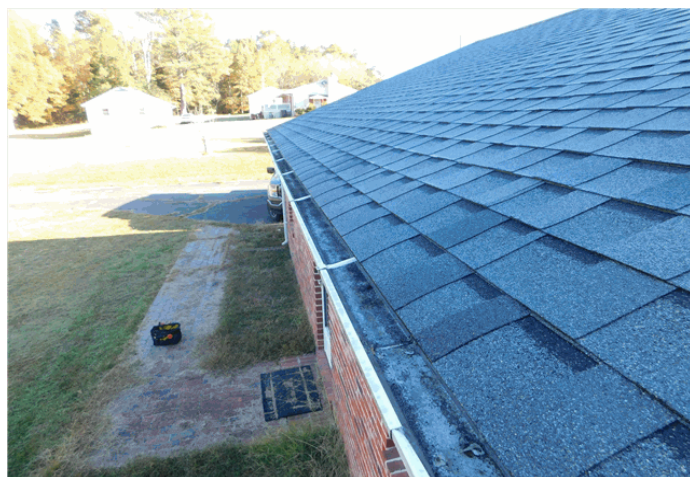
14) Gutter & Downspout Conditions AS The gutter system appeared to be in serviceable condition at the time of the inspection.

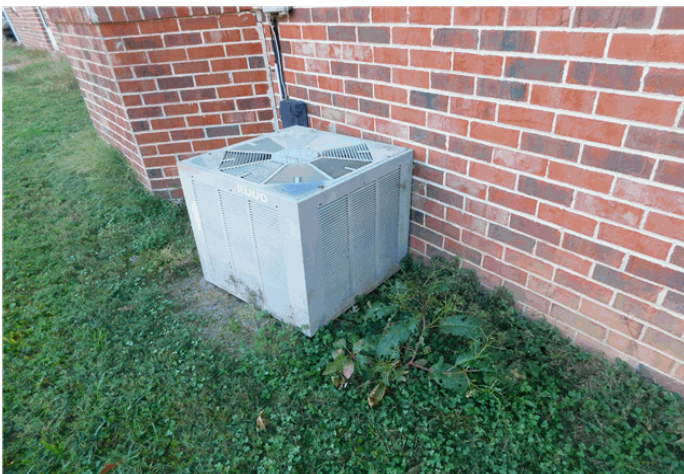
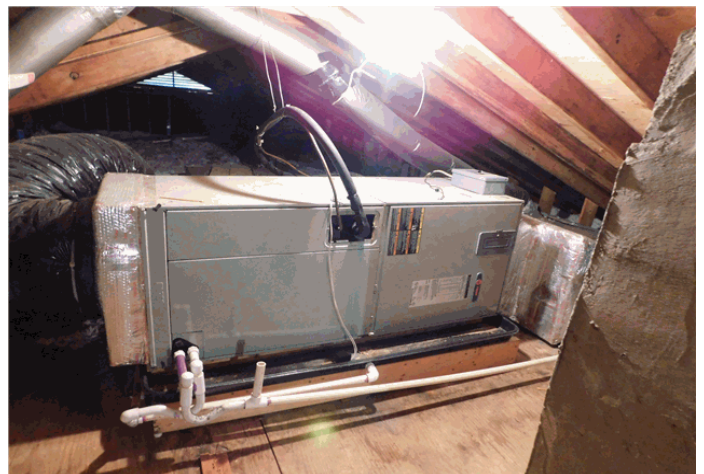
19) AC Unit Conditions

The outside air temperature was below 65 degrees within 48 hours of the inspection. Operating the system at this temperature could damage the system, therefore the inspector was unable to operate and test the system at the time of inspection. The outdoor unit (compressor) is a 1990 year model Ruud. The air handler, located in the attic, is a 2006 year model Trane. Due to the age of these units, it is recommended to budget for replacement. You may want to consider a heat pump as a replacement.

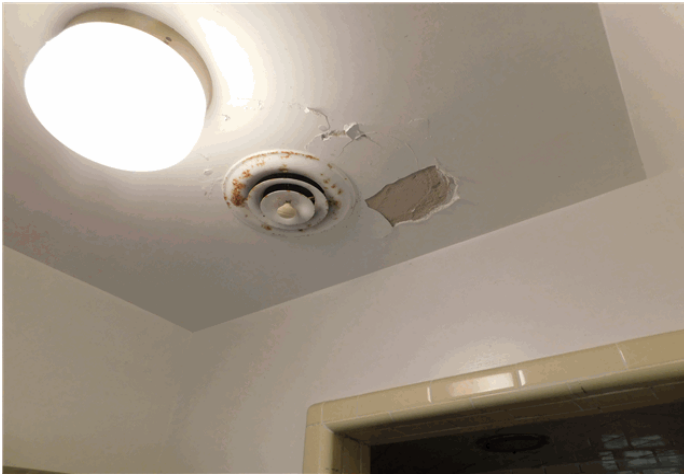
29) Ceiling Conditions

The general condition of the ceilings appeared to be in serviceable condition at the time of the inspection. There is a small amount of damage to the ceiling at the master bath. Recommend repairs as needed.

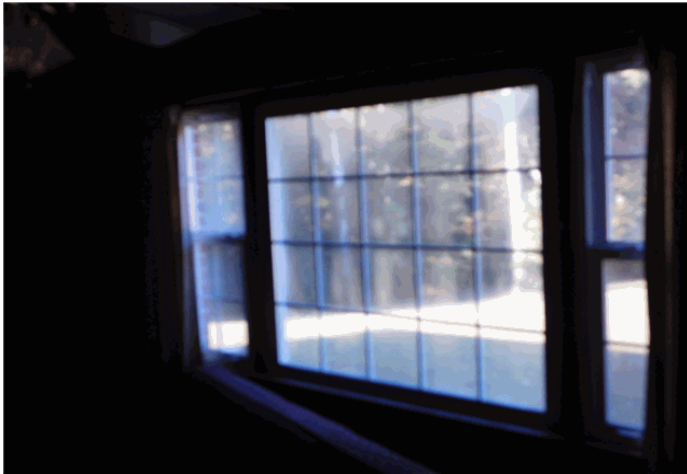
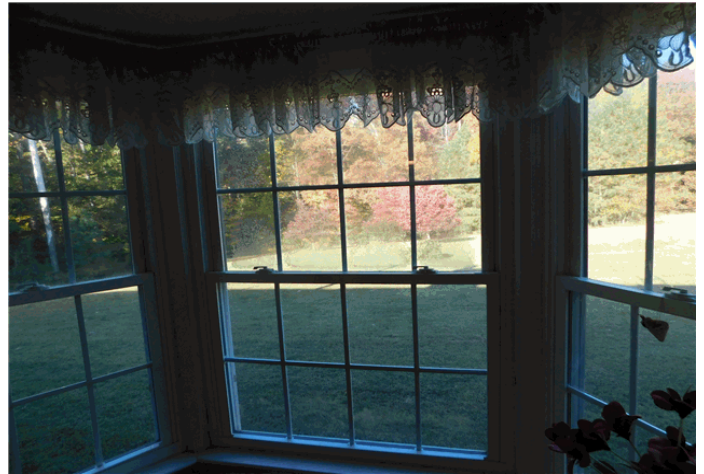
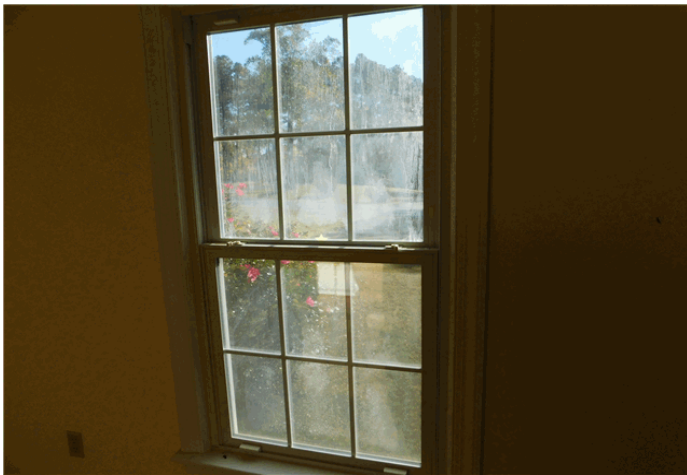
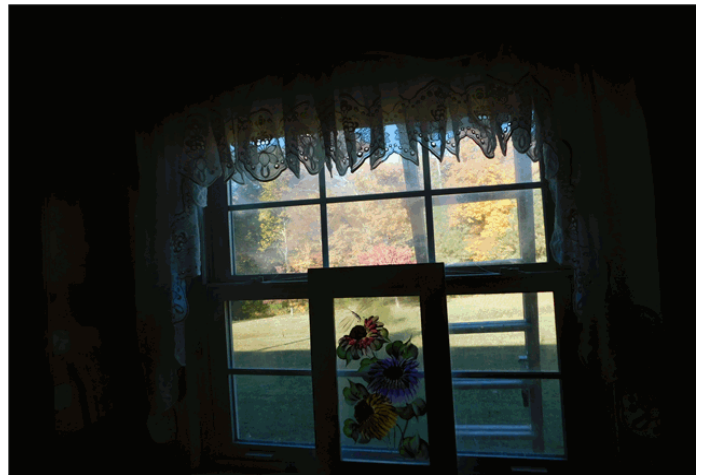
31) Interior Window Conditions

The sample of windows tested were operational at the time of the inspection. As mentioned, the majority of the older vinyl replacement windows appear to have lost their thermal seal. Moisture, fogging, and hazing are common signs of this condition. While mostly cosmetic, this condition is generally not repairable. Correction would require replacement of the window(s) or window pane(s).

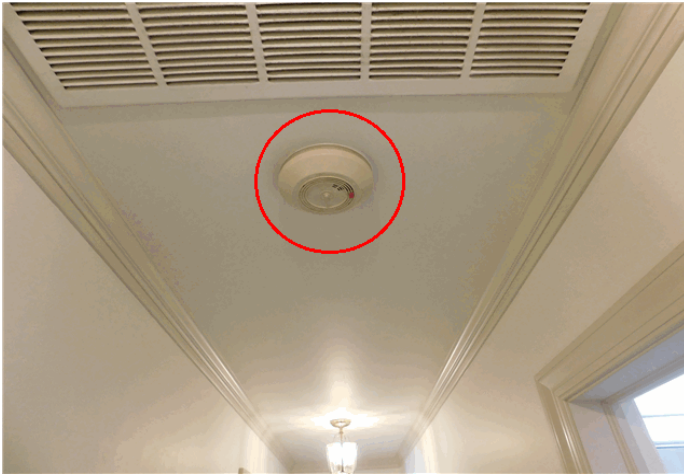
36) Smoke Detector Conditions

The smoke detector did not respond to the test button. Recommend smoke detectors on each level and near or in each bedroom.

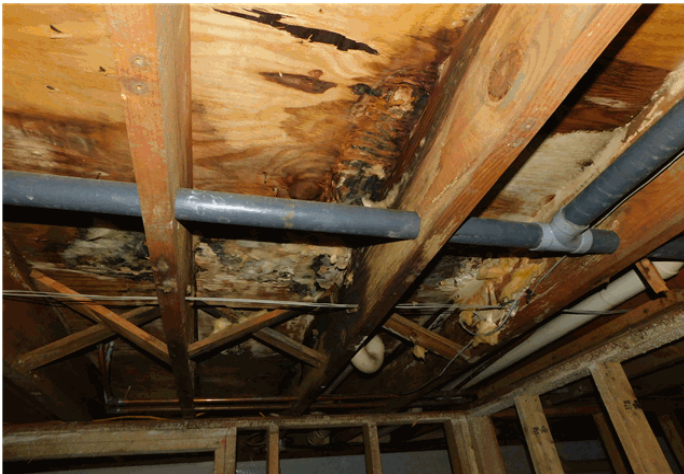
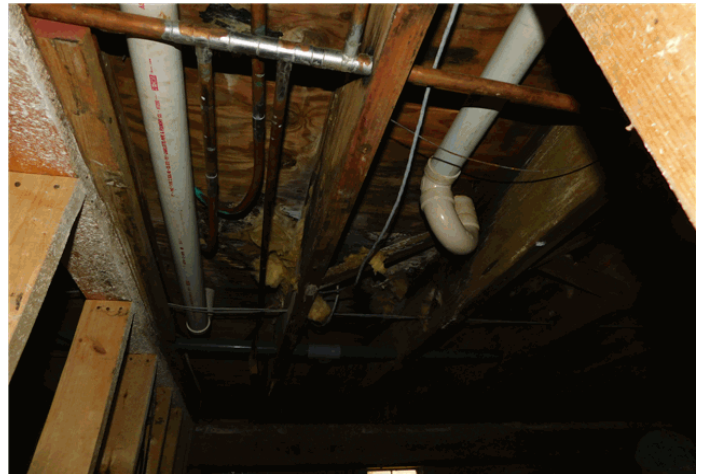
46) Shower - Tub Conditions

The bathtubs, faucets, and drains appeared to be in serviceable condition in all baths. Again, no hot water supply provided. The tile shower stall at the master bath appears to be leaking causing considerable damage to the subflooring which is visible in the basement. Recommend repairs as needed.

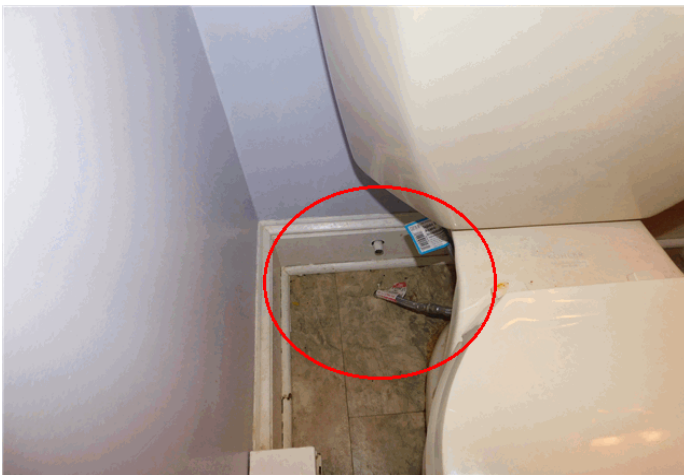
47) Toilet Conditions

The majority of the toilets appeared to be in serviceable condition at the time of inspection in all baths. The water supply valve had been removed at the half bath toilet. Recommend maintenance and/or repairs as needed.

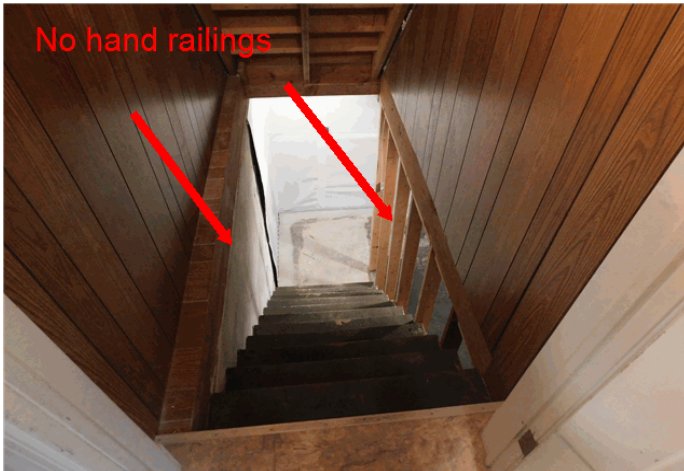
48) Basement Stair Conditions

No hand railing were present. Recommend installation of railings as a safety measure.

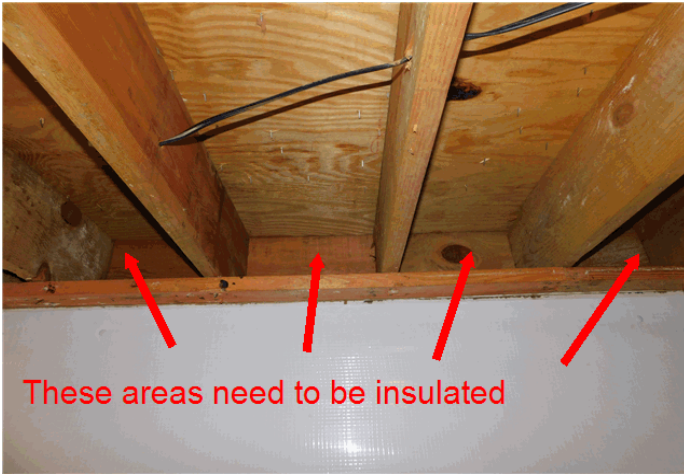
50) Ceiling Conditions

The general condition of the ceilings appeared to be in serviceable condition at the time of the inspection. The rim joist around the perimeter of the exterior should be insulated with at least an R-15 insulation.

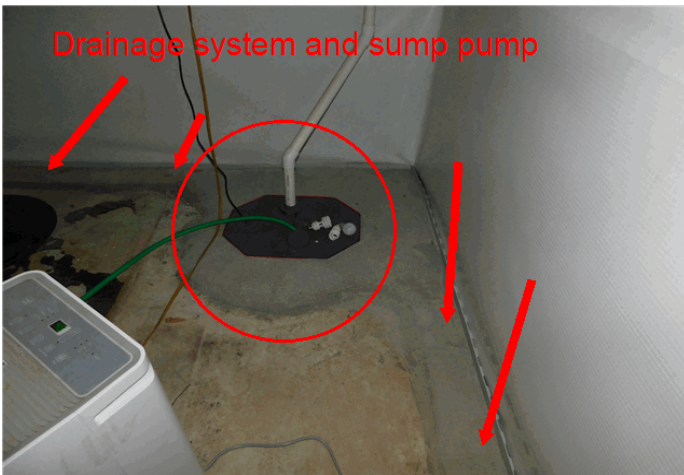
The general condition of the visible and accessible portions of the floors appeared to be in serviceable condition at the time of the inspection. A perimeter floor drainage system has been installed which drains to a sump pump.

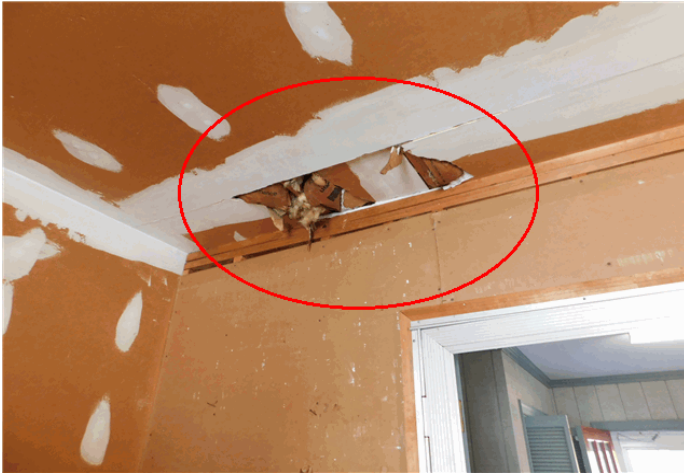
55) Ceiling Conditions

A small section of the ceiling has been removed or damaged. Recommend repairs as needed.

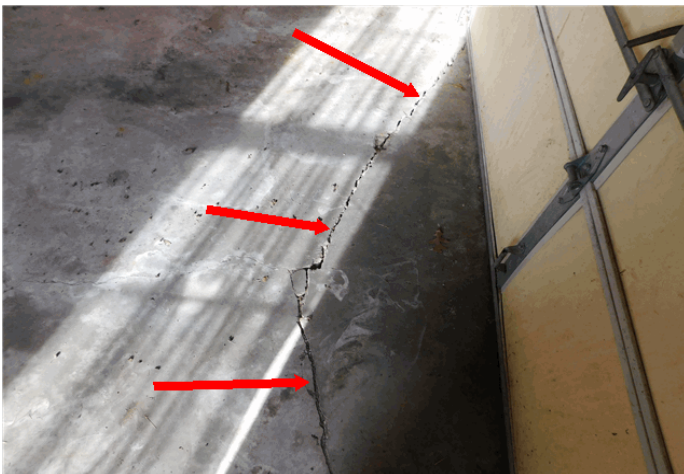
56) Floor Conditions

Cracks and settlement were observed to the concrete flooring near the vehicle door. Recommend sealing and monitoring all cracks for further movement.

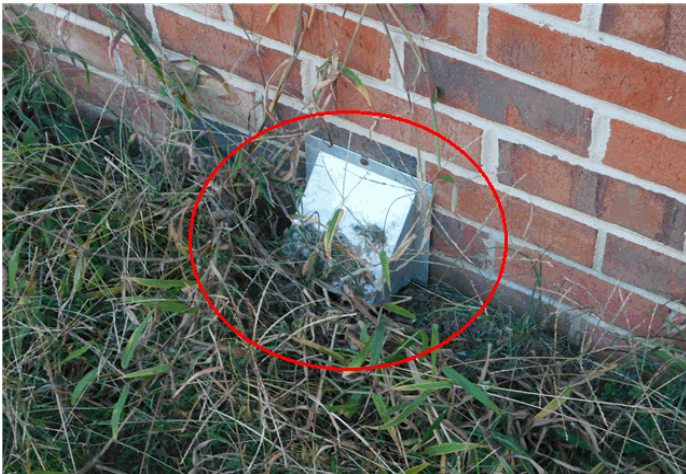
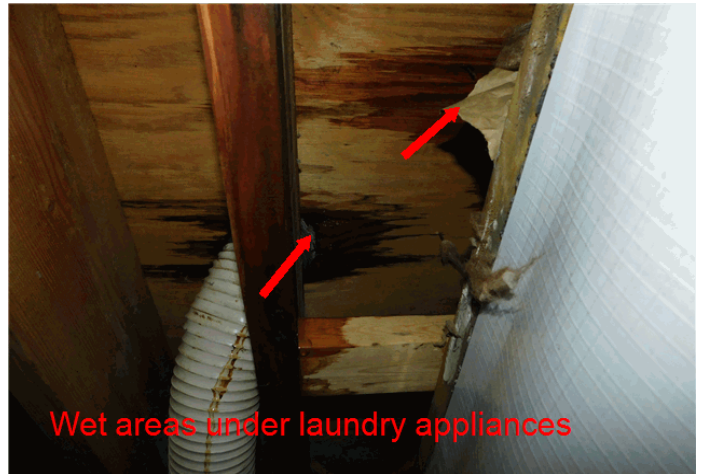
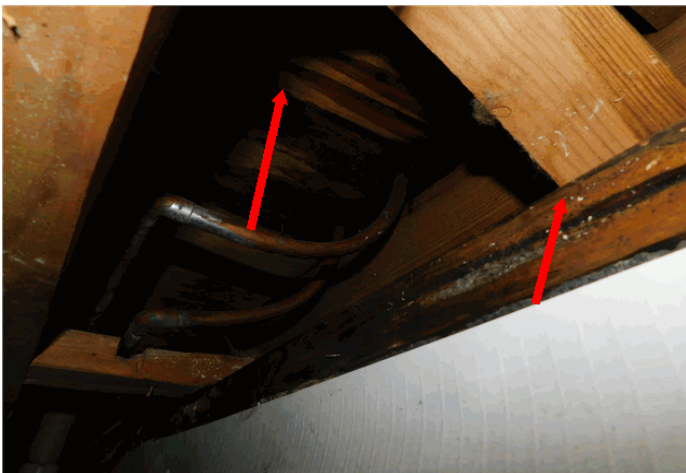
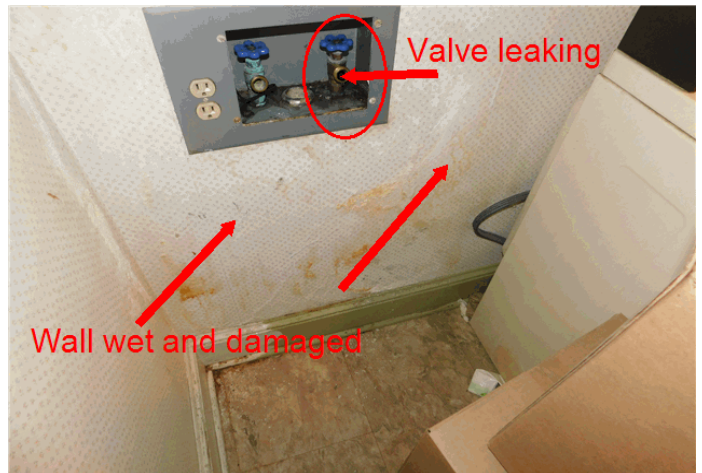
60) Laundry Room Conditions

There were no appliances present for proper testing of plumbing components. The exterior dryer exhaust cover was too close to the ground to provide proper air flow. This may create a fire hazard. The cold water valve in the laundry plumbing box was dripping and would not shut off. This appears to have caused damage to the wall behind the washer and dryer as well as the subfloor beneath this area. Recommend repairs as needed.
