HOME CHECK INSPECTION SERVICE

INSPECTION REPORT

2251 Lathen Wy
Eugene, OR 97408

04/15/2026

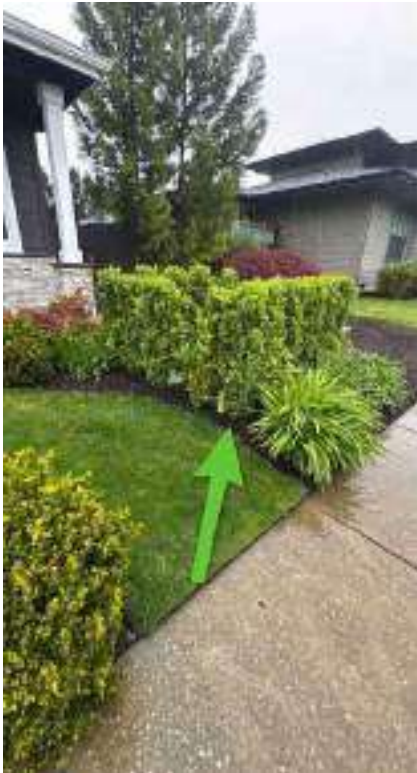
Water Meter Main shut off

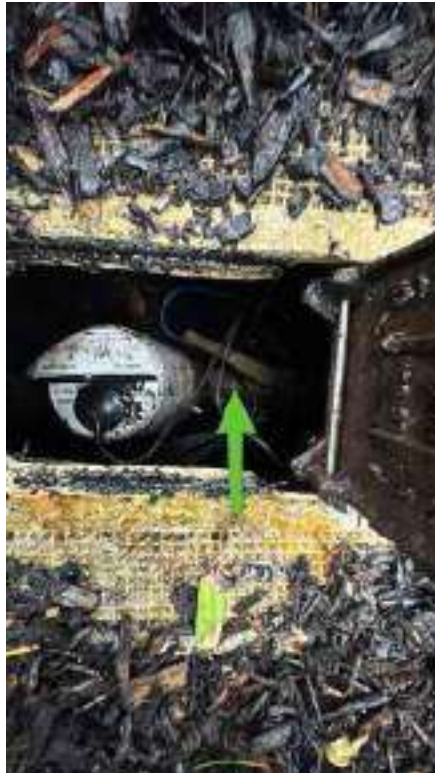
Water Main shut off

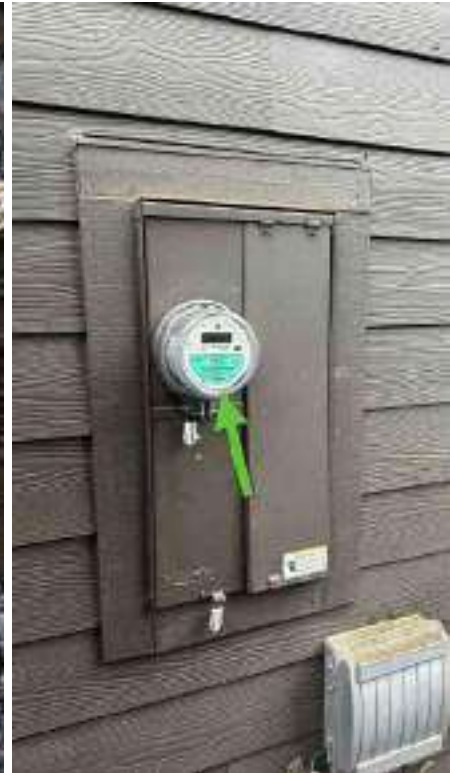
Electric Meter Right side

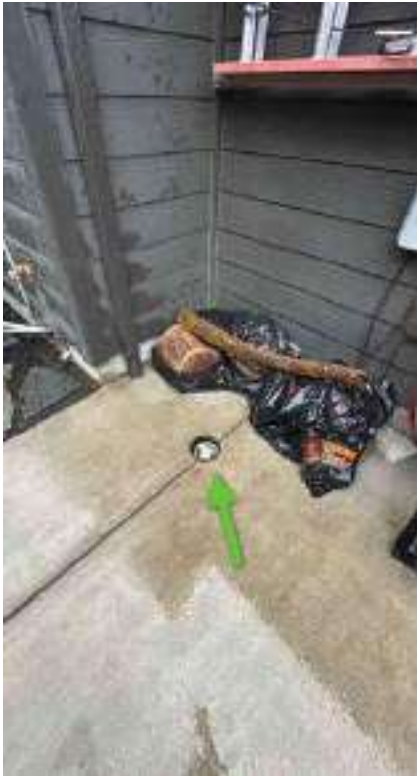
Clean out Left side

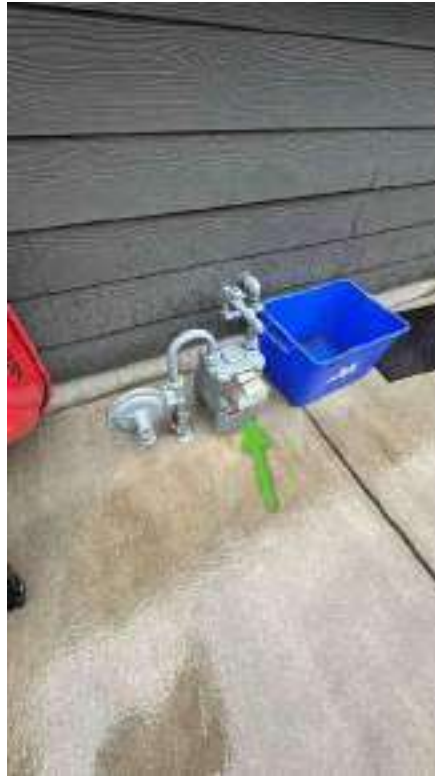
Gas Meter Left side

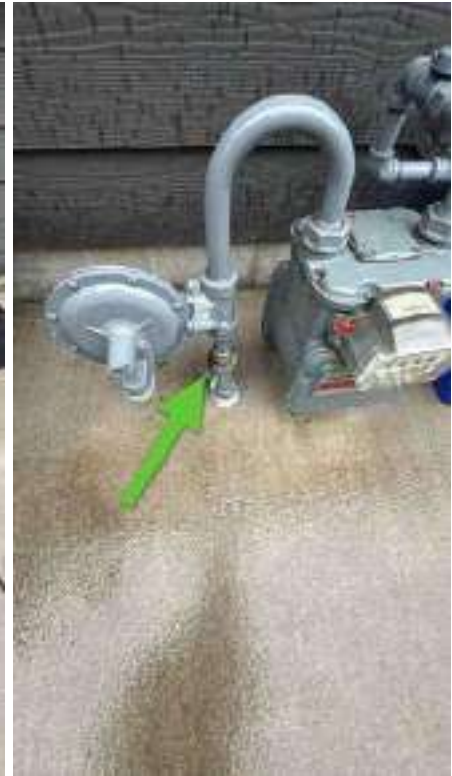
Gas Main shut off

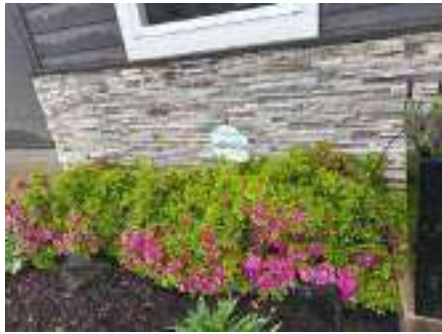
2.3.1 Vegetation, Grading, Drainage

There was vegetation near or against the siding and structure at the time of the inspection. The vegetation around the home may conceal defects. I recommend cutting the vegetation away from the siding and structure for further evaluation, and as part of routine maintenance to prevent premature damage.

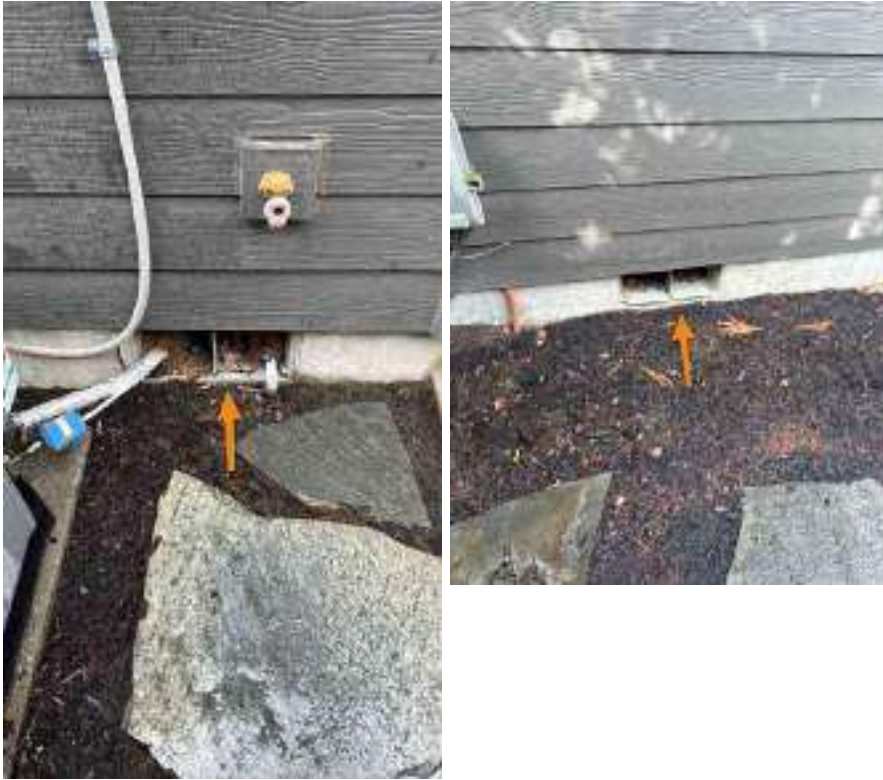
2.3.2 Vegetation, Grading, Drainage
FAULTY GRADE

Faulty grade was observed. The grade of dirt/rock/bark should be kept a minimum of 4 to 6 inches below the bottom of foundation vents, siding/trim, windows, crawlspace access, etc. Vent wells (if installed) should be routinely cleaned to maintain proper grade. I recommend lowering the grade and/or installing approved wells to prevent water entry.

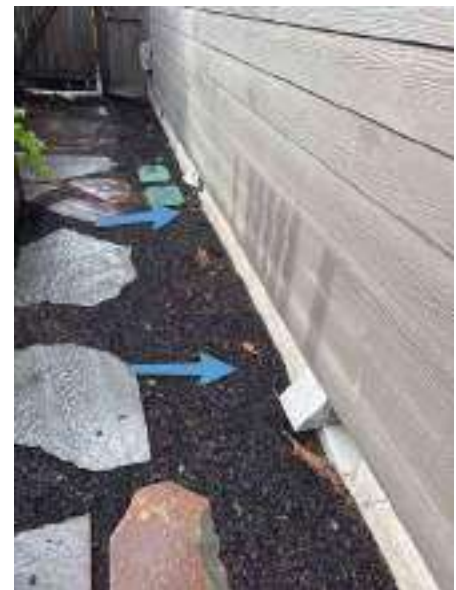
2.3.3 Vegetation, Grading, Drainage

IMPROPER SLOPE-MONITOR

The grade slopes towards the home in one or more areas. Although no standing water was observed at the time of the inspection, these areas should be monitored during rainy conditions to be sure water is moving away from the home and there is no standing water. The grade of soil/dirt/bark should maintain a proper slope away from the structure to maintain proper water flow away from the structure.

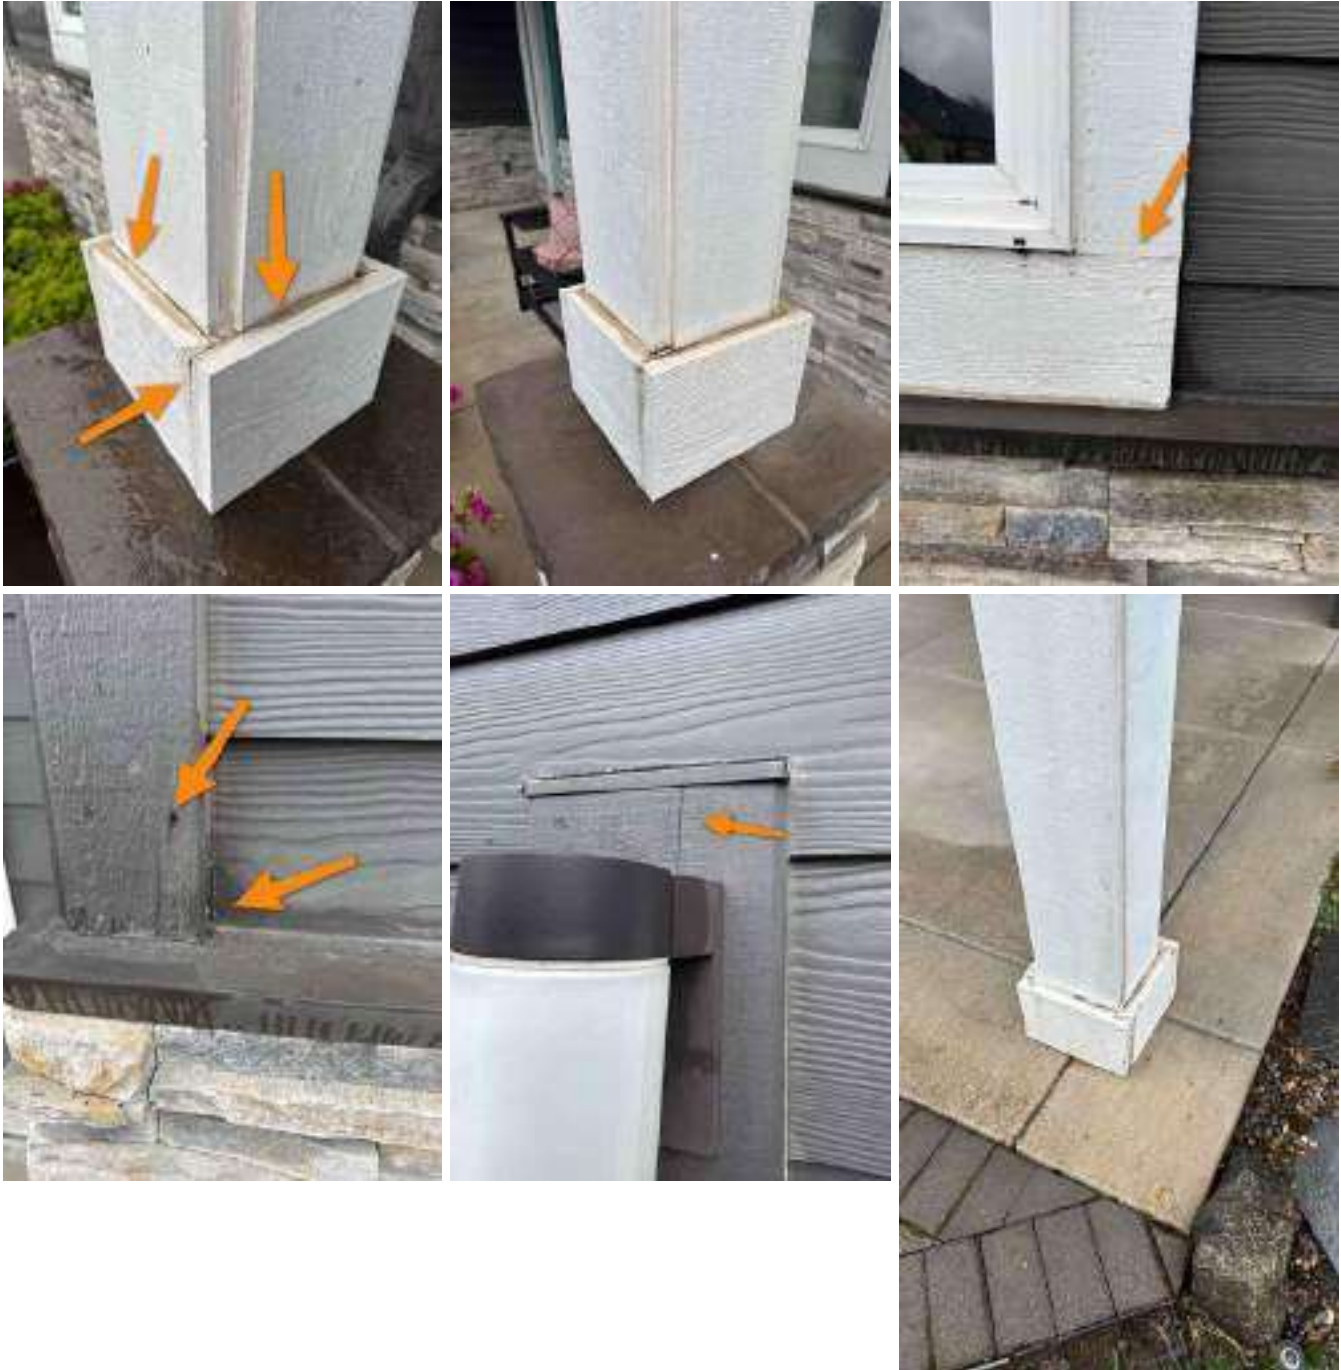
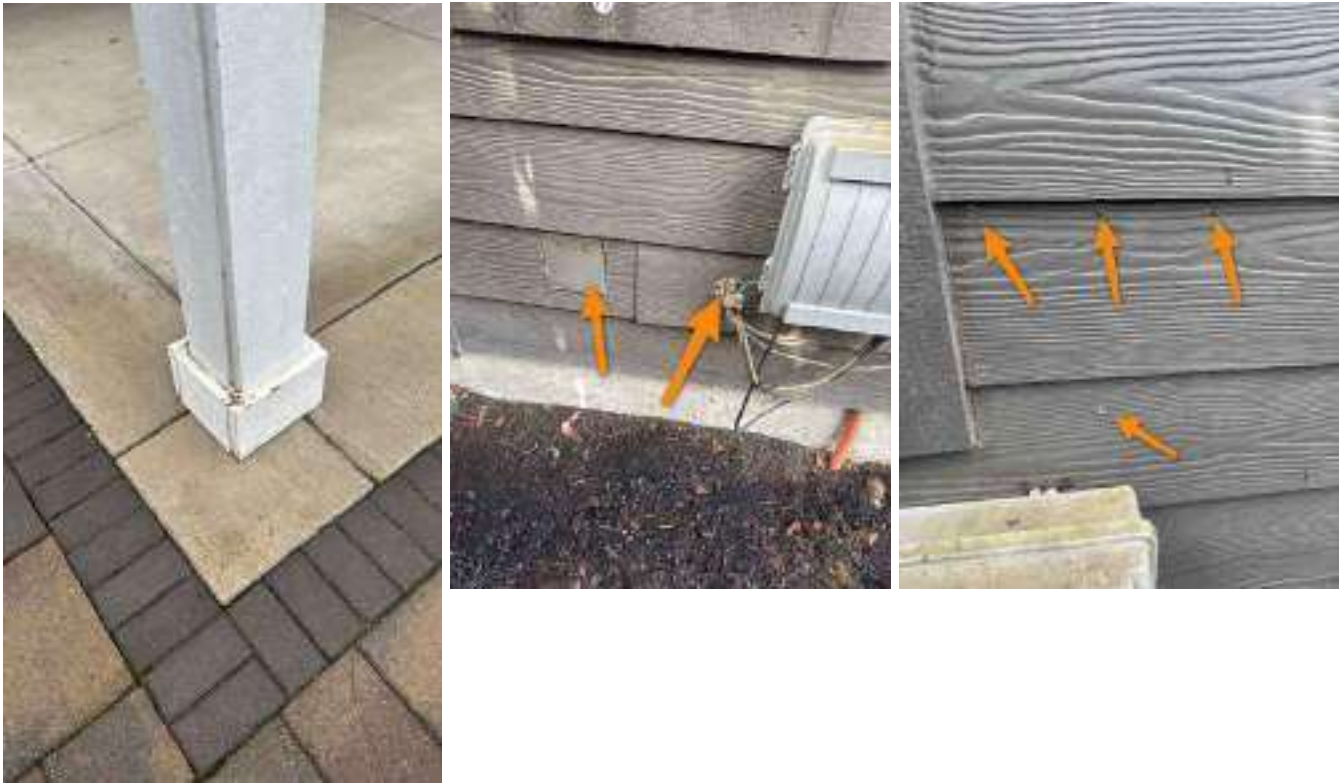
2.4.1 Siding, Trim

**INADEQUATE CAULKING - EXTERIOR**

The caulking on the exterior of the home is inadequate and is separating and/or starting to crack. All penetrations/openings on the exterior should also be kept well sealed (fasteners, windows, doors, cables, gas lines, plumbing pipes, fixtures, etc.). Not all areas will be pictured or documented. I recommend caulking the exterior of the home as part of routine maintenance to prevent water entry/damage.

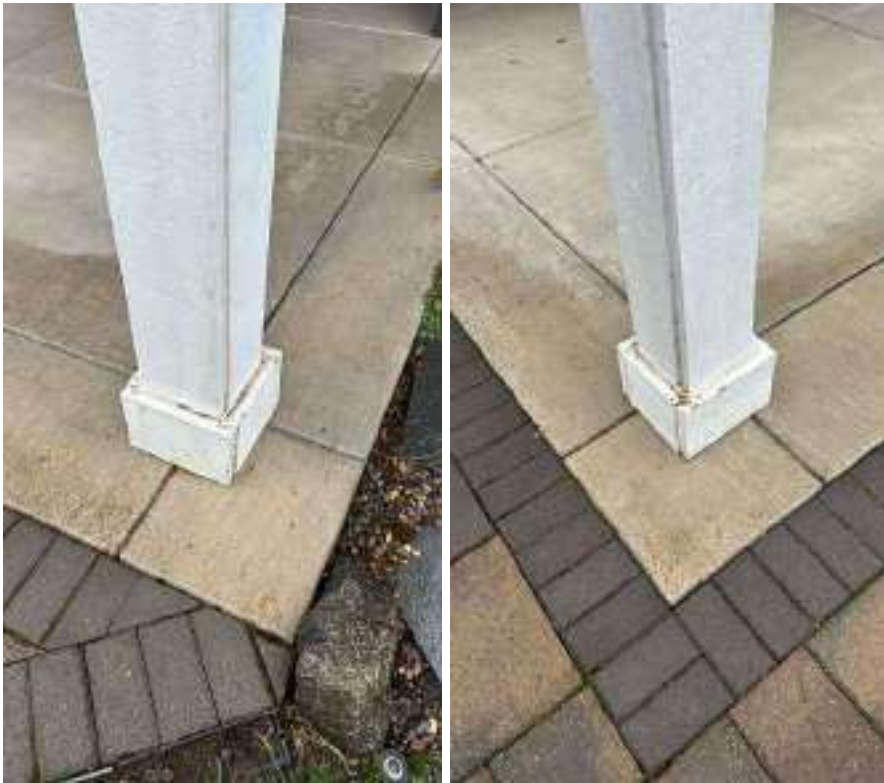
2.4.2 Siding, Trim

PAINT NEEDED IN AREAS

The cosmetic condition of exterior and interior paint/stain is beyond the scope of this inspection. There was peeling paint, un-painted and/or un-sealed material observed on the exterior of the home. I recommend properly scraping/sanding, painting/staining, and sealing all exterior material as part of ongoing maintenance to prevent deterioration.

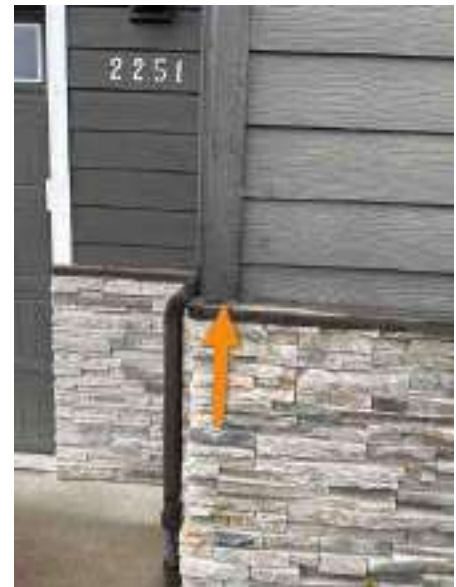
2.4.3 Siding, Trim

WATER DAMAGE - SIDING/TRIM

Water damage was observed at the siding/trim at one or more areas. The extent of the damage was not determined. I recommend a qualified contractor remove all damaged material for further evaluation and make all necessary repairs.

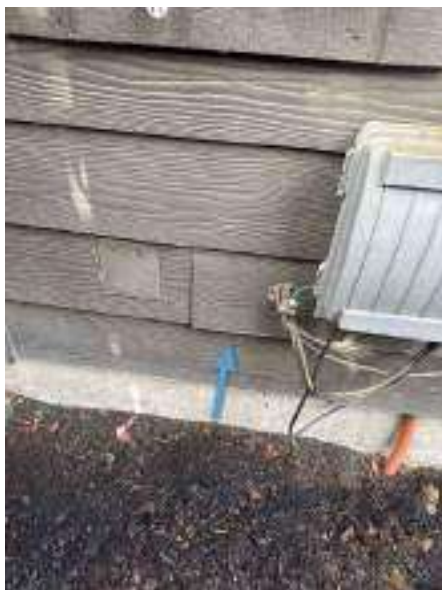
2.4.4 Siding, Trim

LOOSE SIDING/TRIM

There were one or more pieces of siding/trim that were loose and not secure at the time of this inspection. The siding/trim should be secured to prevent water entry/damage.

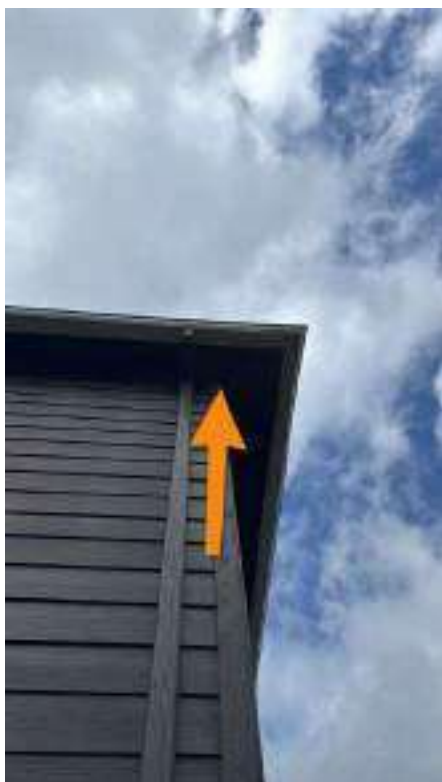
Back right

POSSIBLE BIRD ENTRY OBSERVED AT THE SOFFIT/FASCIA/GABLE

SPRAY FOAM OBSERVED

There appeared to be spray foam at the back-right corner of the home. This may be an indication of past bird entry, or was just preventative maintenance. This area should be monitored. A qualified contractor can be consulted, if this is a concern. Please note that this was not a pest inspection, and this is mentioned as a courtesy only.

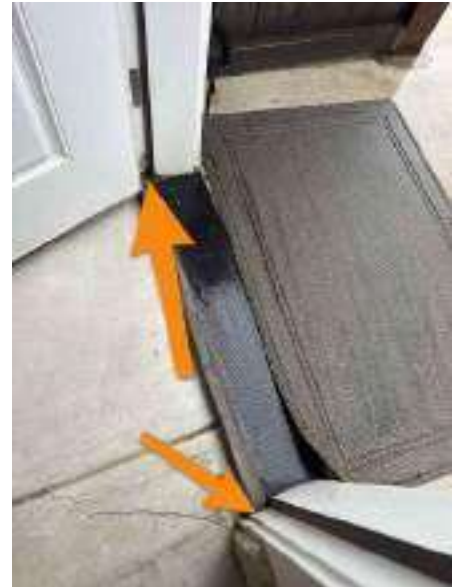
Garage

There was inadequate or missing weather stripping observed at one or more of the exterior doors. Weather stripping is needed to prevent water entry/pest entry. Properly installing weather stripping may increase the overall energy efficiency of the home and prevent water entry/damage. Please note that energy efficiencies and pests are beyond the scope of this inspection. I recommend properly installing weather stripping to prevent water entry/damage.

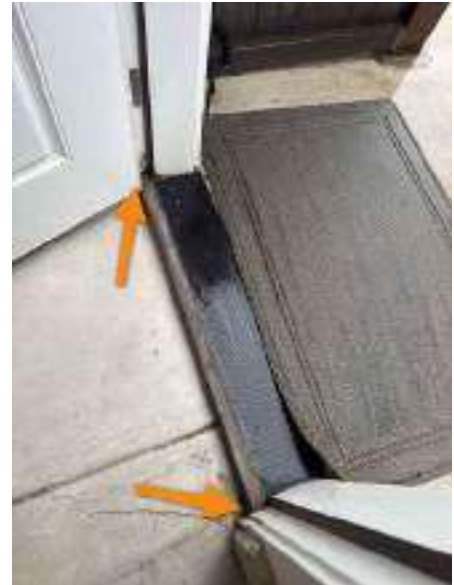
Garage

There was evidence of water entry at one or more of the exterior doors. I recommend further evaluation and repair by qualified contractor.

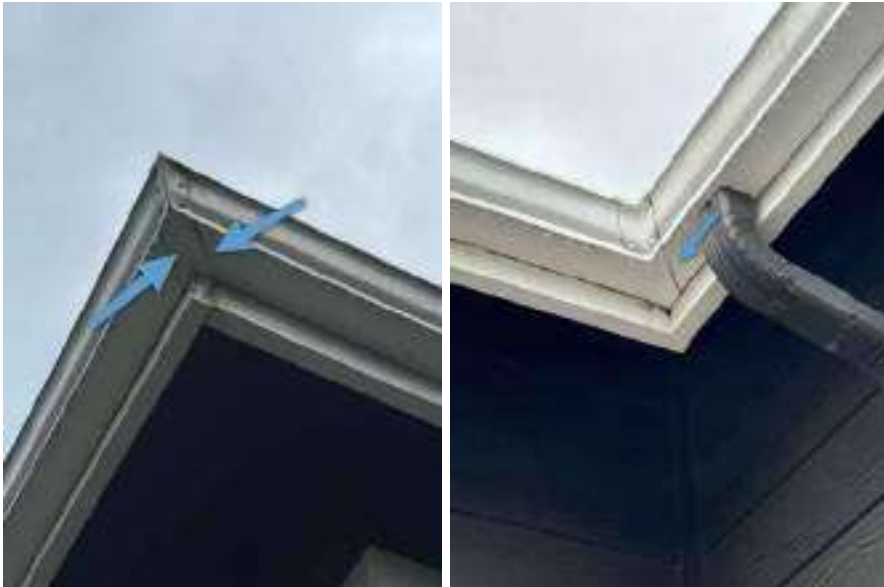
2.10.1 Gutter/Roof Drainage Systems

**GUTTER - LEAKS - SEAL**

The gutter system appeared to be leaky at the corners/joints/downspouts. I recommend sealing the gutter system as part of routine maintenance to prevent dripping next to the structure, and to maintain proper water flow away from the home.

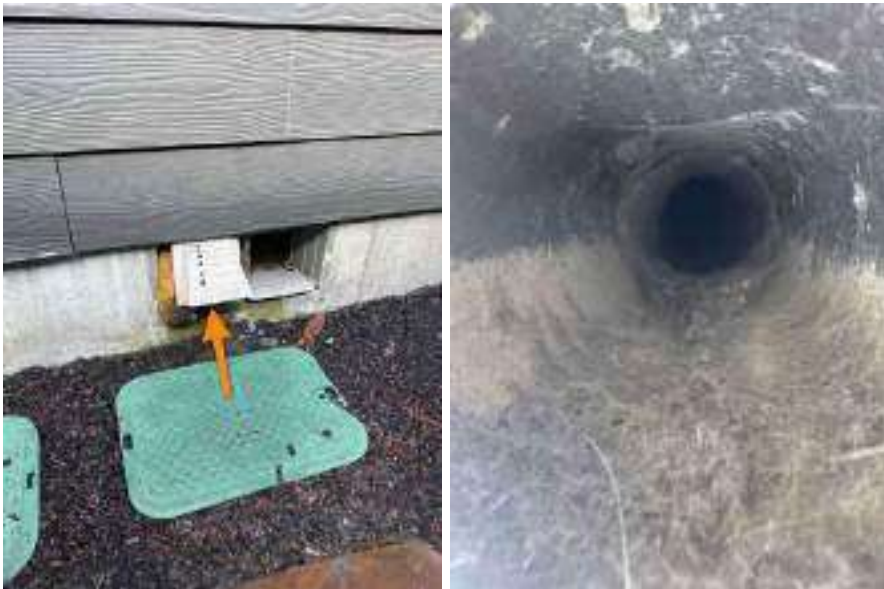
2.11.1 Exterior-Misc.

DRYER VENT - NEEDS CLEANING

The dryer vent was in need of cleaning at the time of this inspection. Lint buildup in a dryer vent can reduce the efficiency of the dryer and is a fire danger. I recommend cleaning the dryer vent as part of routine maintenance and for overall safety.

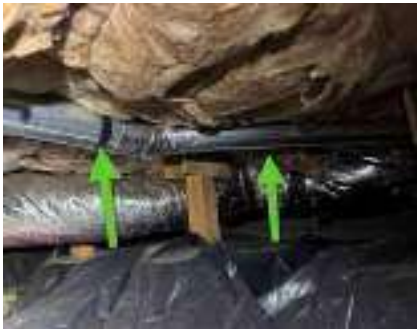
Dryer vent

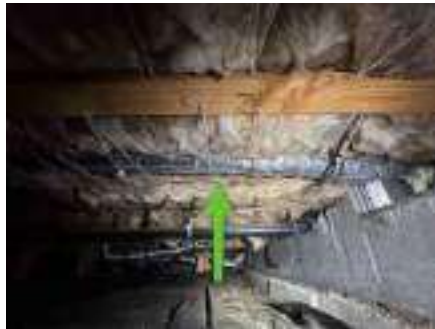
Dryer vent

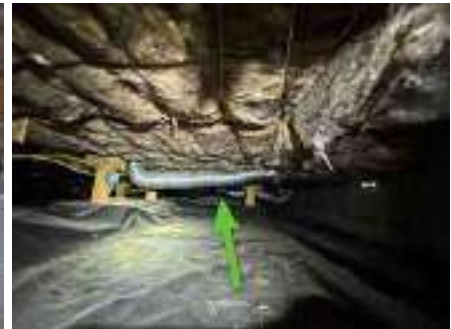
Down draft vent

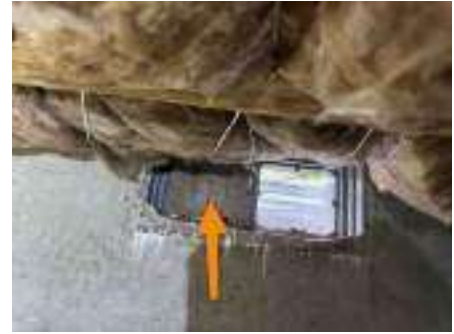
BLOCKED FOUNDATION VENTS

One or more of the foundation vents are blocked. Foundation vents should be left uncovered to provide proper ventilation for the crawlspace. Foundation vents should only be covered if the outside air temperature drops below freezing for a period of time. The foundation vent screens should be further evaluated after the vents have been unblocked. I recommend unblocking the foundation vents to maintain proper ventilation and to further evaluate the vent screens. Click the link for more information on crawlspace venting [Should I block foundation vents](#)

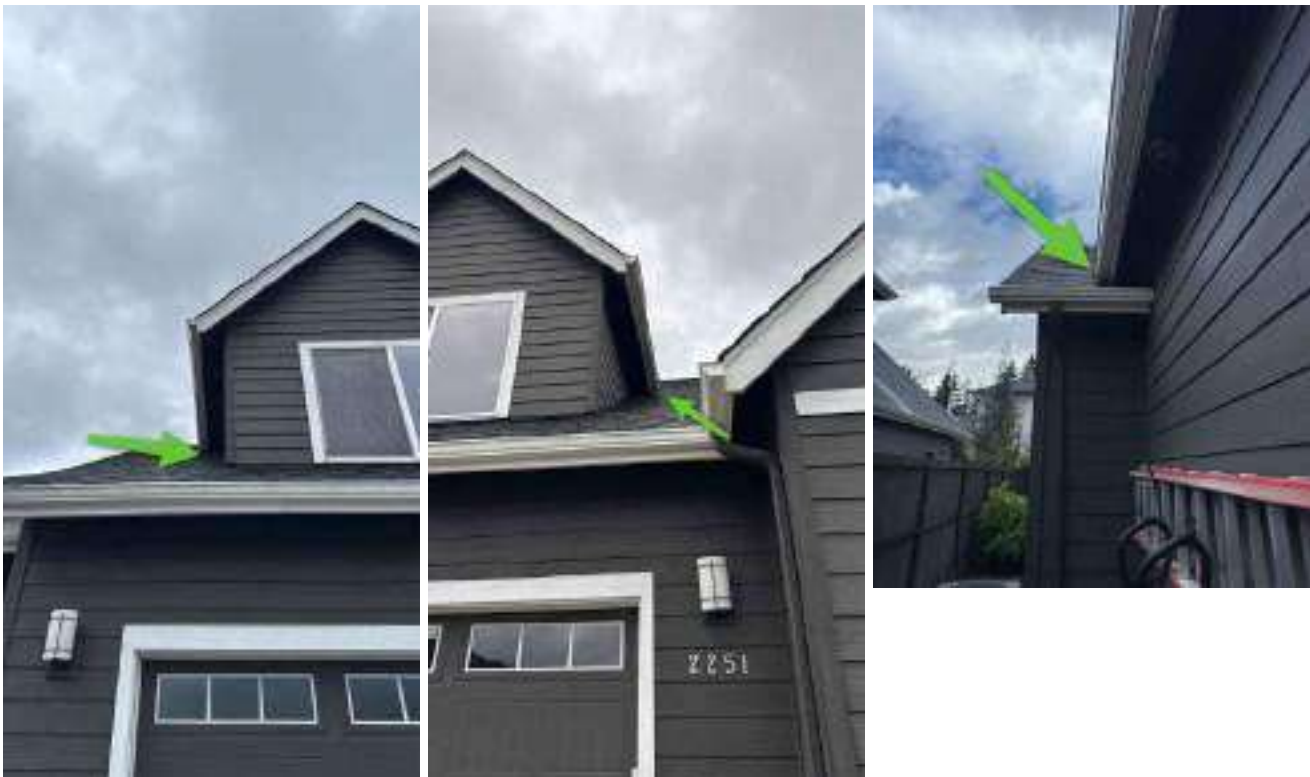
Coverings: Gutter Flow on Roof

One or more of the downspouts or gutters terminate on the roof surface. This is normal for our region. The roof shingles are susceptible to premature wear and heavy moss/mildew in these areas. The downspout/gutter should be re-configured, if this is a concern.

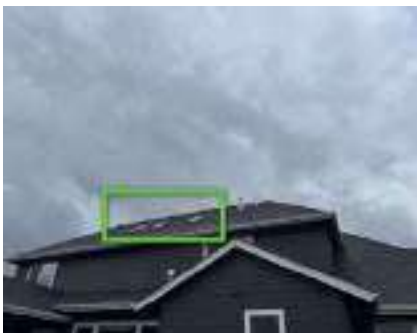
Skylight(s): Skylight(s) Inaccessible due to Height and Pitch

The skylight(s) could not be fully viewed from the exterior, due to the height and pitch of the roof surface. A qualified roofing contractor can be consulted for further evaluation from the exterior, if this is a concern.

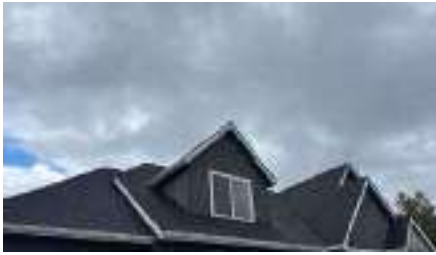
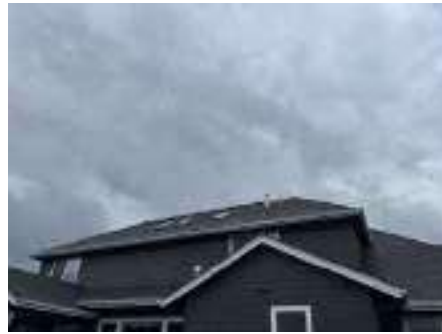
4.2.1 Coverings

Due to the height and pitch of the roof surface, this roof could not be walked on safely and was viewed from the ground, top of a ladder, and (if available) from the interior windows. There were inaccessible areas on the roof surface. I recommend consulting a qualified roofing contractor (who carries all appropriate safety harnesses and equipment) for further evaluation, due to inaccessible areas on the roof surface.

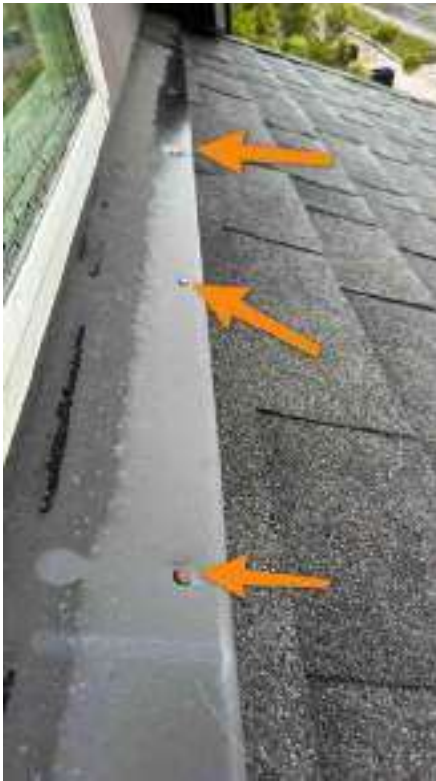
4.2.2 Coverings

There were unsealed staple/nail penetrations observed on the roof surface at the time of this inspection. All penetrations on the roof surface should be kept well sealed at all times to prevent water entry. I recommend sealing the exposed staple/nail penetrations.

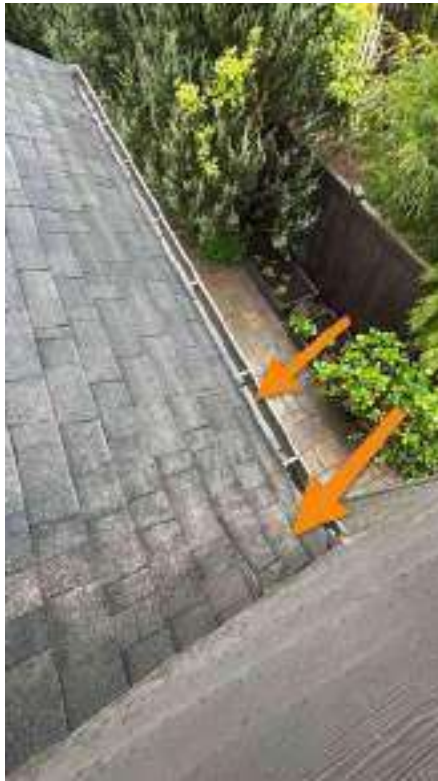
Back right

Damaged roofing material was observed at one or more areas of the roof surface. I recommend a qualified roofing contractor further evaluate the roof surface and make all necessary repairs to prevent leaks/damage.

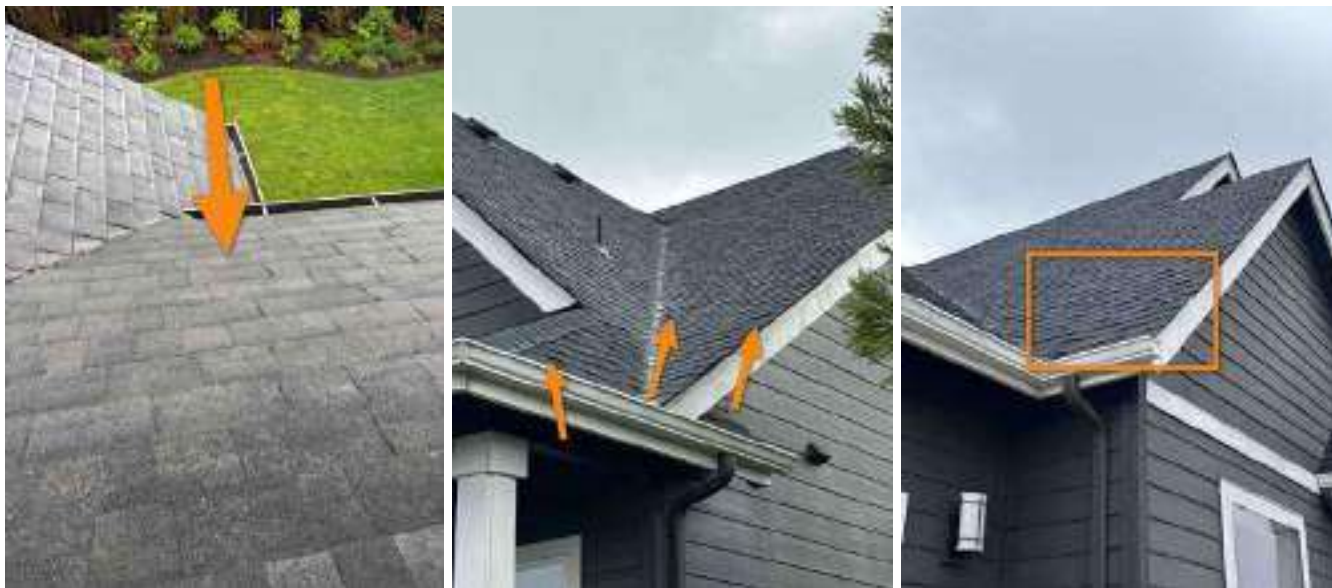
Rear

There were one or more uplifted shingles observed at the time of this inspection. I recommend further evaluation by a qualified roofing contractor.

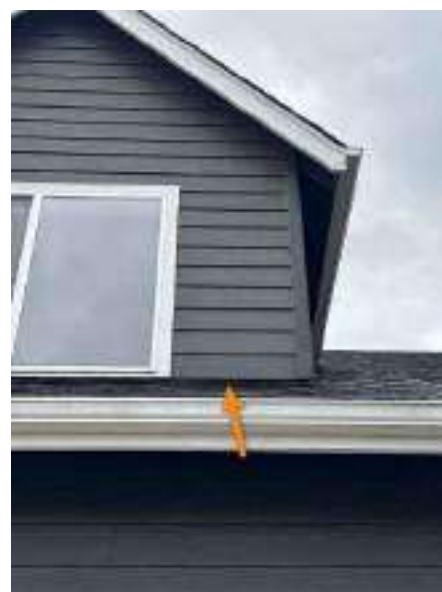
One or more of the flashings appear to be loose. I recommend having a qualified contractor further evaluate the flashing and make all necessary repairs to prevent water entry/damage.

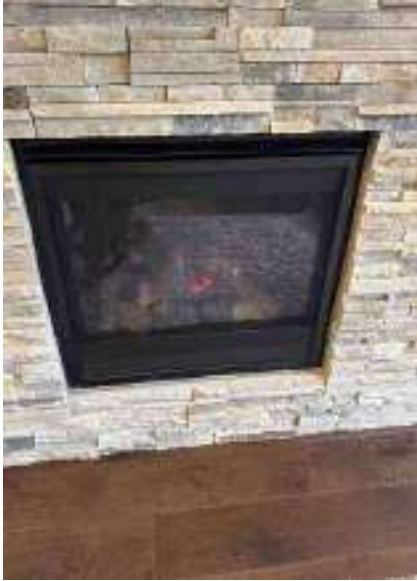
NOTE: Without removing the burners and glass doors, a thorough inspection is not possible. A majority of the metal flue was not accessible.

Gas fireplaces and chimneys/vents should be serviced once a year by a qualified chimney/fireplace professional for safety. I recommend obtaining maintenance records from the homeowner. I recommend having a qualified contractor service the gas fireplace for safety, if this has not been performed within a year.

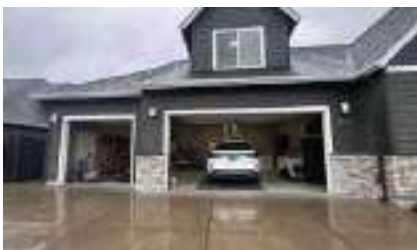
Overhead Garage Door(s): Garage Door Operable

The overhead garage door was functional at the time of this inspection. Overhead garage doors will need routine maintenance. Here is a link [General garage door maintenance](#)

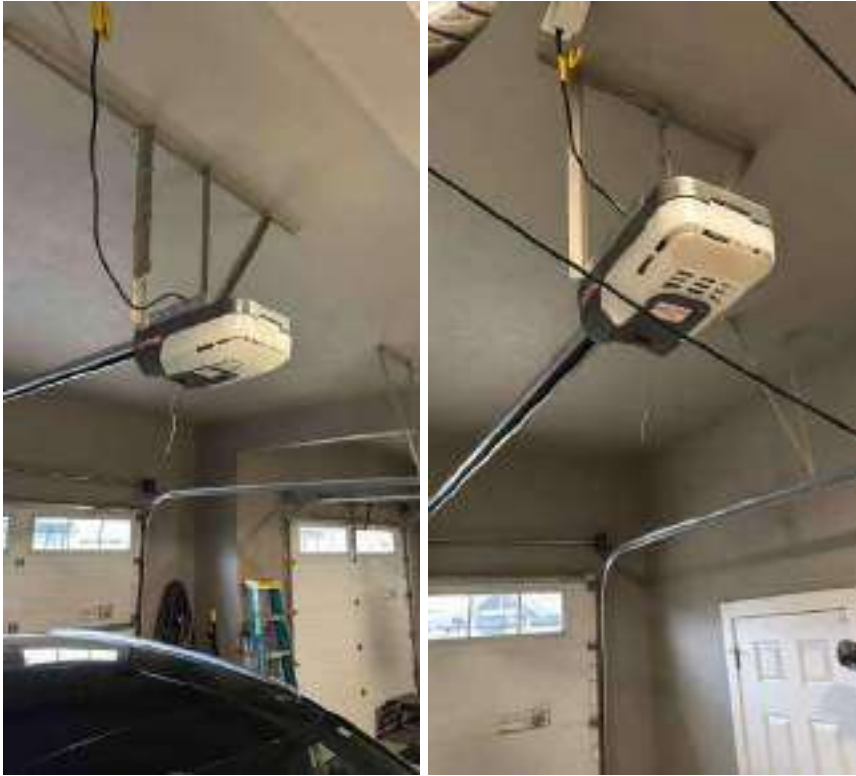
Garage Door Operators : Operator Functional

The garage door operator(s) was/were functional at the time of this inspection.

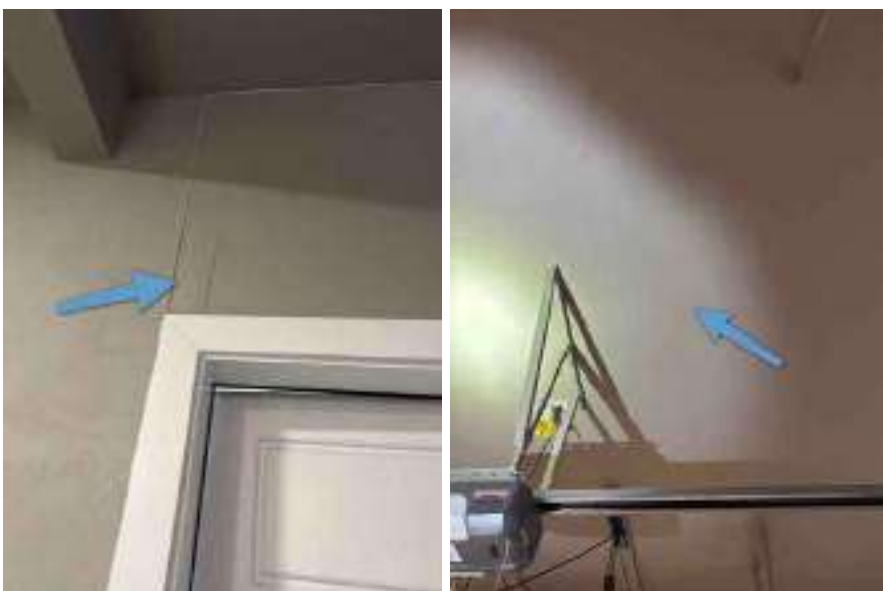
There were settling/shrinkage cracks observed on the walls/ceilings at one or more locations in the garage. These cracks appeared to be normal at the time of this inspection. I recommend monitoring all cracks and making repairs as needed.

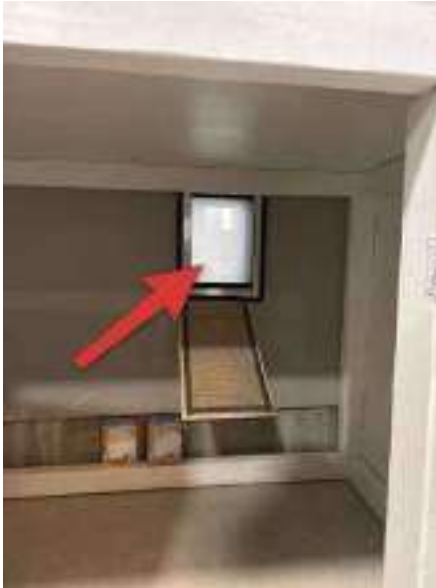
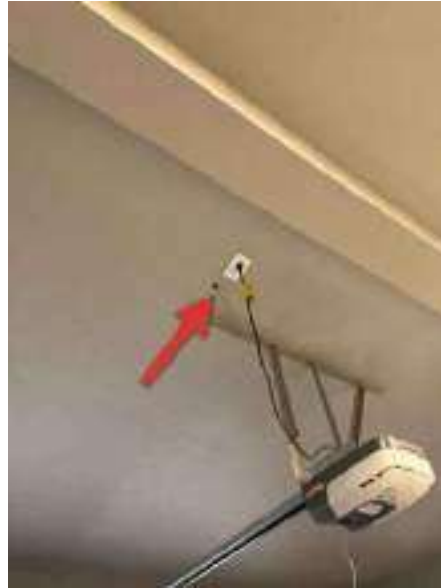
Seal openings

An incomplete firewall or ceiling was observed in the garage. There were penetrations and/or openings in the garage firewall or ceiling. The garage firewall/ceiling should be repaired for overall safety. Please note that this is included as a courtesy, as firewall protection is beyond the scope of this inspection. I recommend further evaluation and repair by a qualified contractor for safety. [Link for more info.](#)

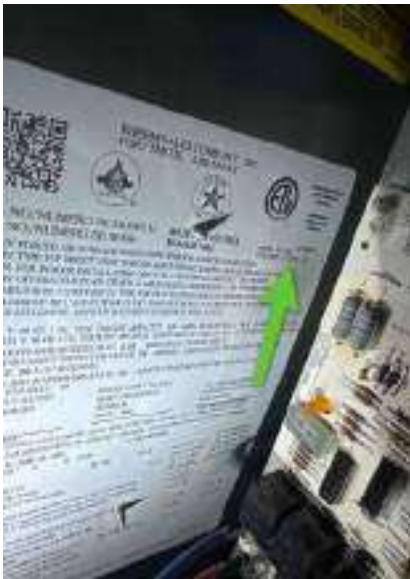
Heating Equipment : Heating System - Operable

The heating system was found to be functional at the time of this inspection. The system was adequate for a fifteen degree temperature differential between the start and the finish of operating the system.

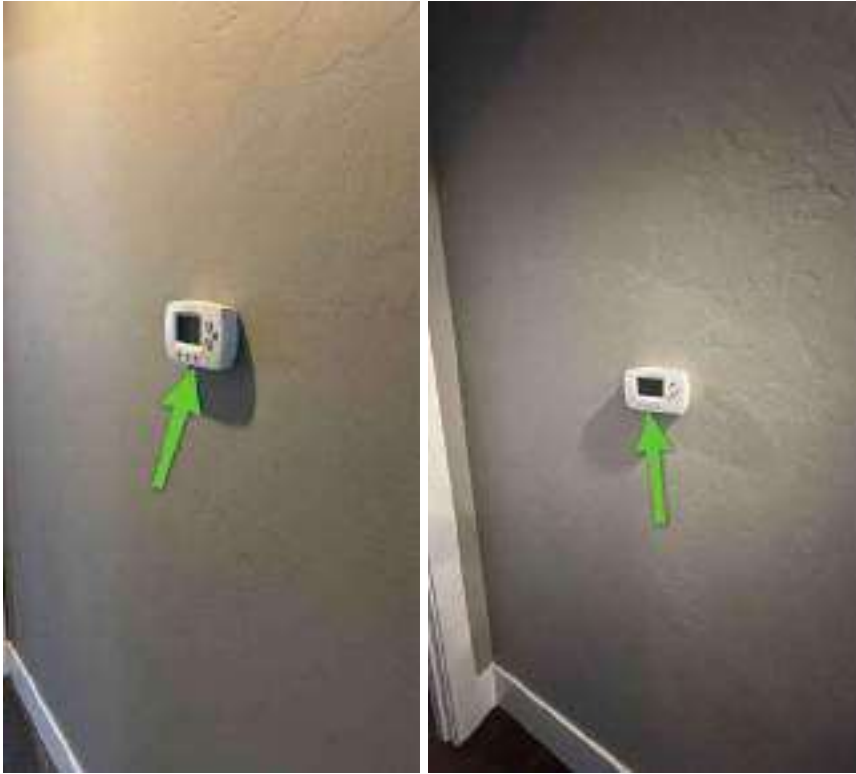
Normal Operating Controls : Functional Thermostat (s)

The thermostat(s) was/were functional at the time of this inspection.

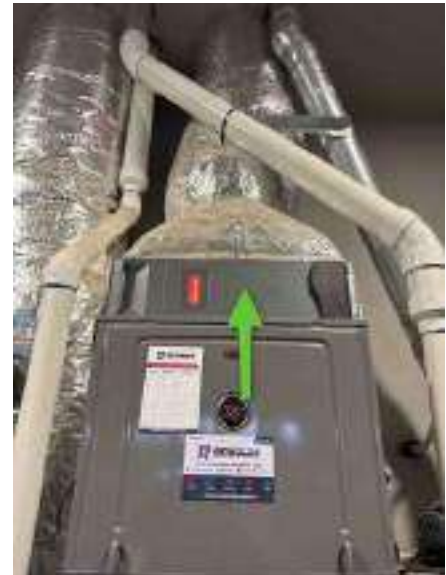
Distribution Systems: Ductwork
Insulated, Flexible, Metal

Distribution Systems: Filter Type
Disposable

Distribution Systems: Filter Size
20x25x4, Must use a Honeywell brand filter

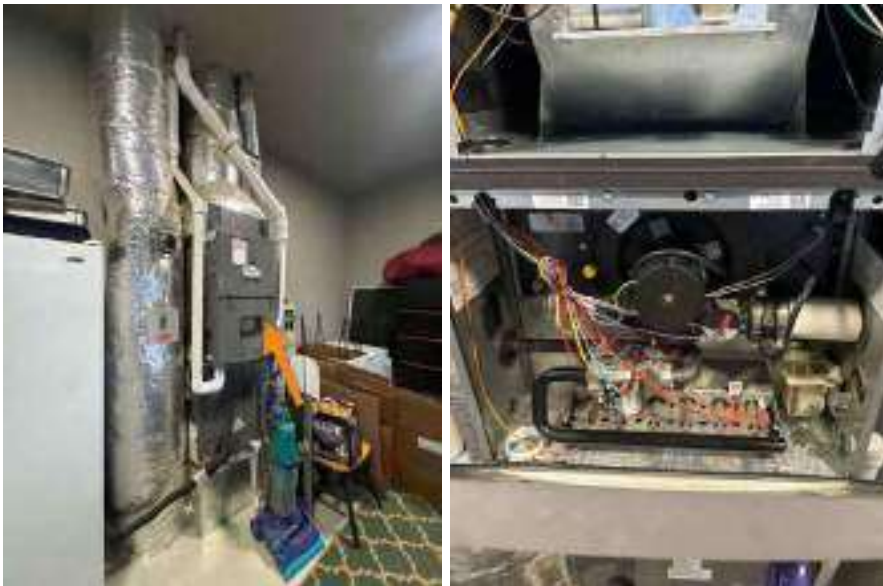
The HVAC system was in need of maintenance at the time of the inspection. Further inspection should be performed at the time of the maintenance. I recommend a qualified HVAC contractor service the HVAC system as part of routine maintenance to maintain proper operation. [Here is a resource](#) on the importance of furnace maintenance.

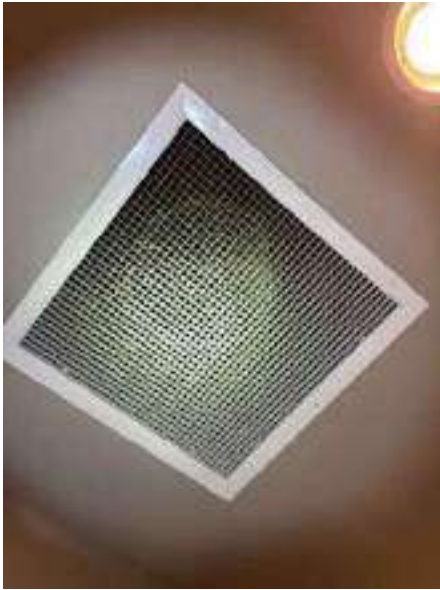
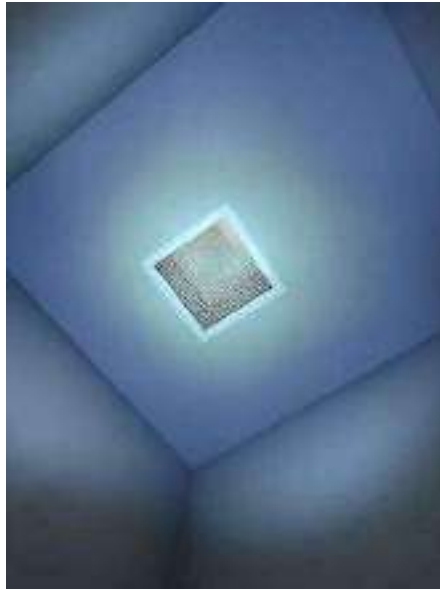
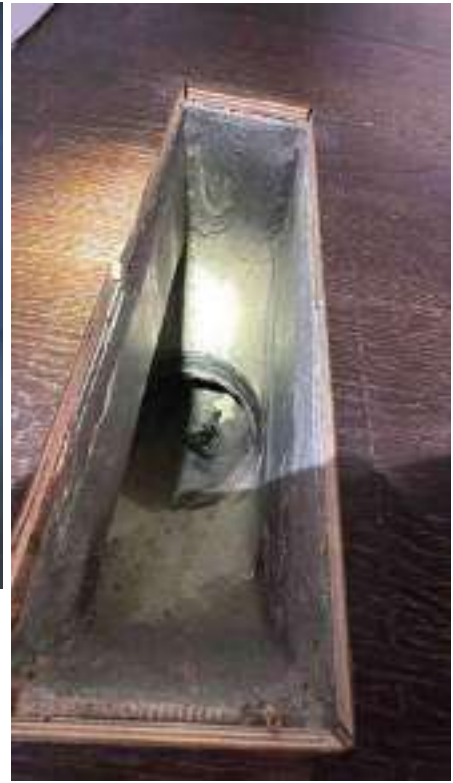
7.3.1 Distribution Systems

The HVAC ducts were in need of cleaning at the time of this inspection. I recommend having a qualified HVAC contractor clean the air ducts to maintain proper operation of the HVAC system.

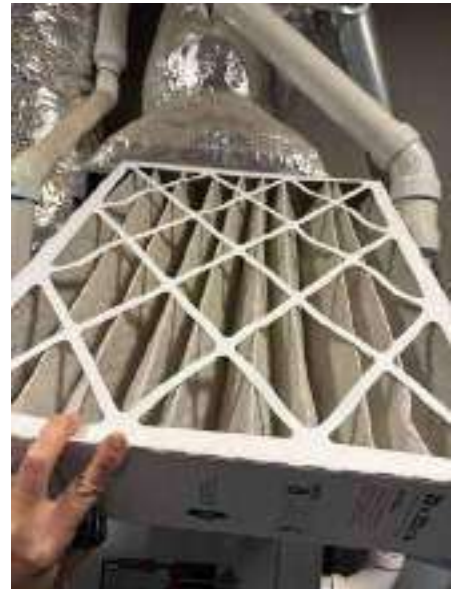
Maintenance/Monitor

FILTER DIRTY -REPLACE

The air filter is dirty and in need of replacement. I recommend replacing the air filter as part of routine maintenance to maintain proper operation of the HVAC system.

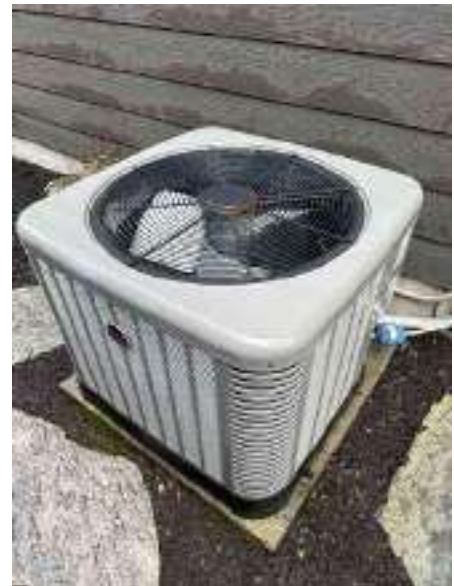
The HVAC system was in need of maintenance at the time of the inspection. Further inspection should be performed at the time of the maintenance. I recommend a qualified HVAC contractor service the HVAC system as part of routine maintenance to maintain proper operation.

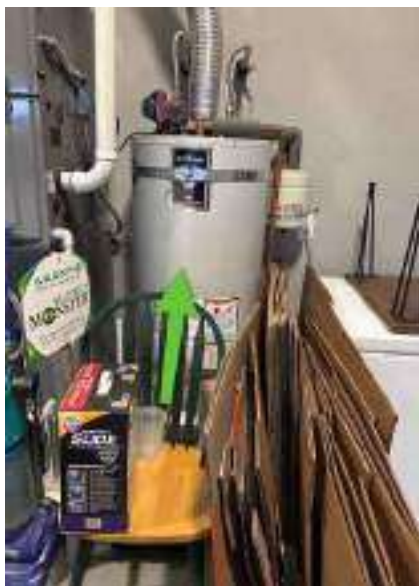
Garage

Water heaters are inspected for operation and leaks. The adequacy and efficiency of this system is not inspected.

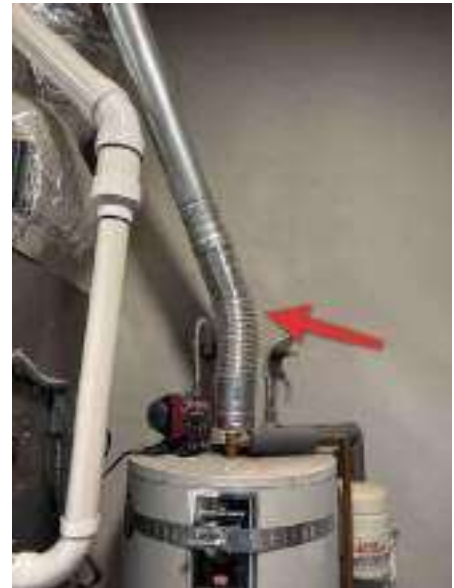
A flexible vent pipe was used at the top of the water heater. Flexible vent pipes are easily damaged. I recommend that the flexible pipe is replaced with a solid double-wall "B" vent pipe for overall safety. I recommend further evaluation and repair by a qualified contractor for safety.

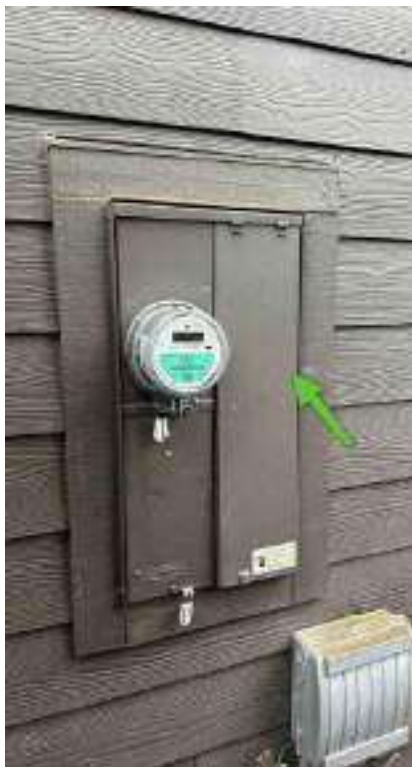
Main Electrical Panel, Main Disconnect : Main Panel - Location(s)

Exterior at Meter

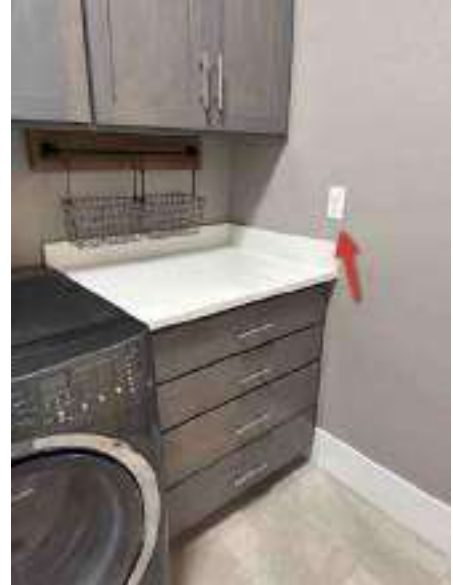
Laundry

There were one or more missing GFCI protected receptacles at the time of this inspection. I recommend having a qualified electrician install GFCI protected receptacles within six feet of wet fixtures/wet areas for safety (bathroom(s), kitchens, utility rooms, garages, carports, exteriors, pool rooms, crawlspaces, basements, etc.).

A single non GFCI protected receptacle can be installed at the clothes washer, so no other electrical equipment can be plugged in. GFCI protected receptacles should not be installed where a refrigerator will be plugged in.
