HOME CHECK INSPECTION SERVICE

INSPECTION REPORT

2251 Lathen Wy
Eugene, OR 97408

04/15/2026

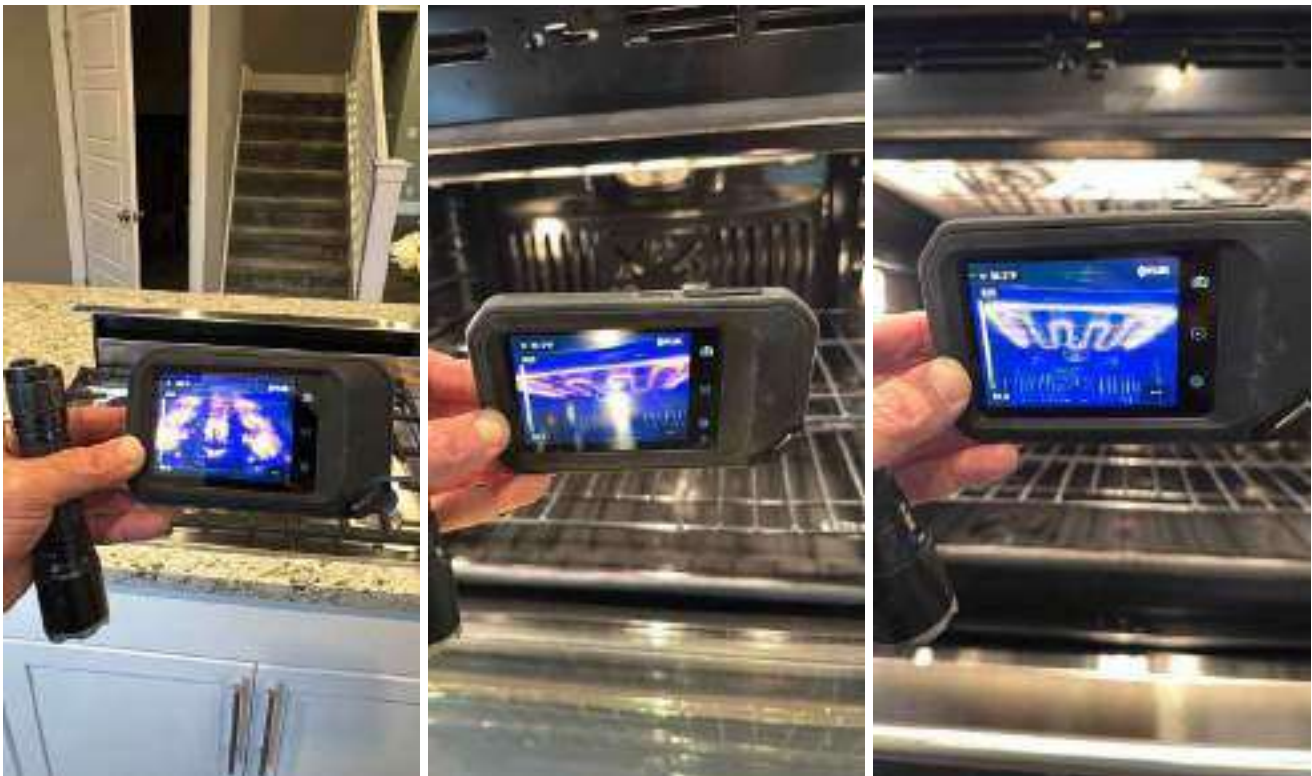
Ranges/Ovens/Cooktops: Oven/Cooktop Operable

The cooktop and oven were inspected and were found to be functional at the time of this inspection.

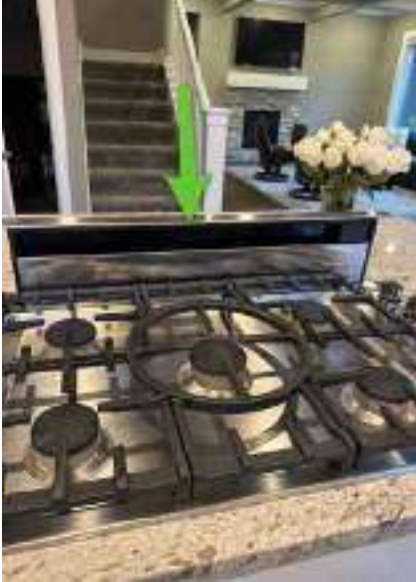
Exhaust Fan: Exhaust Fan Operable

The exhaust fan was tested for operation only and was found to be functional at the time of this inspection.

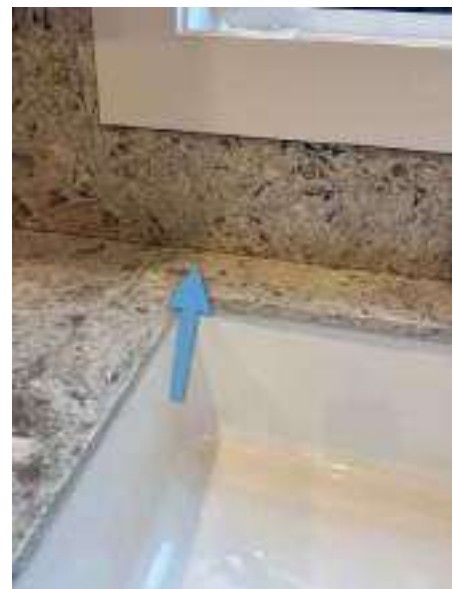
The caulking/grout is missing, starting to crack, and/or inadequate at one or more of the backsplashes. I recommend routinely caulking/grouting these areas to prevent water entry/damage. [Here is a helpful DIY video on caulking gaps.](#)

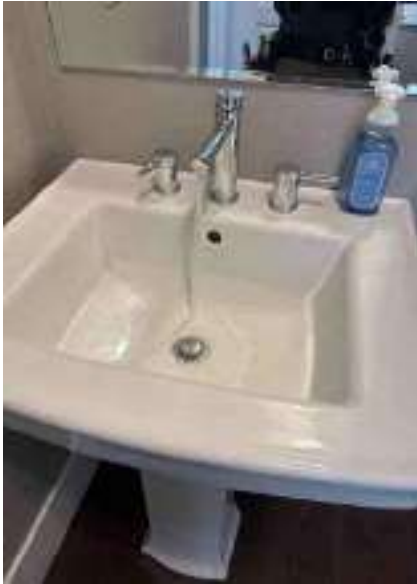
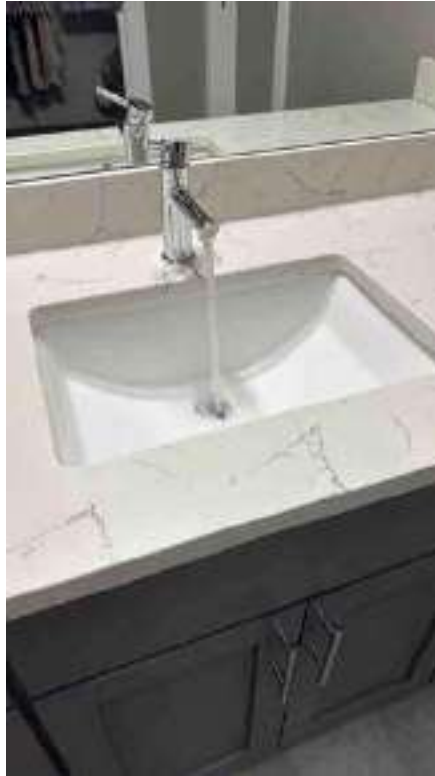
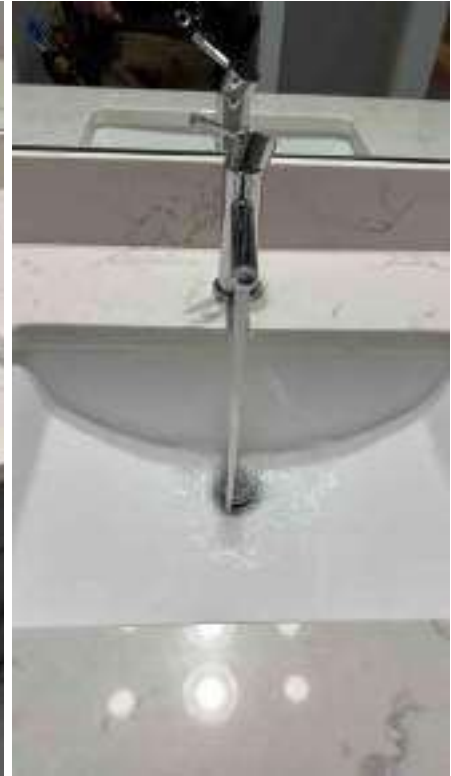
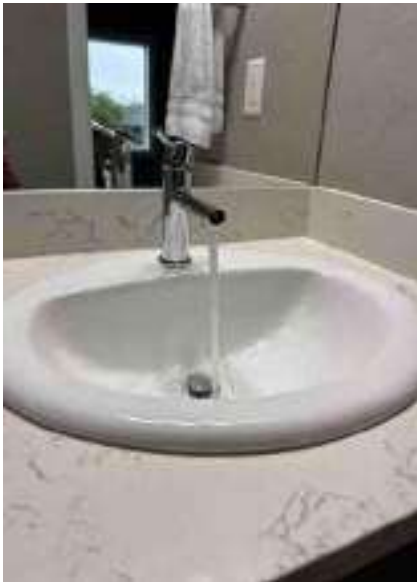
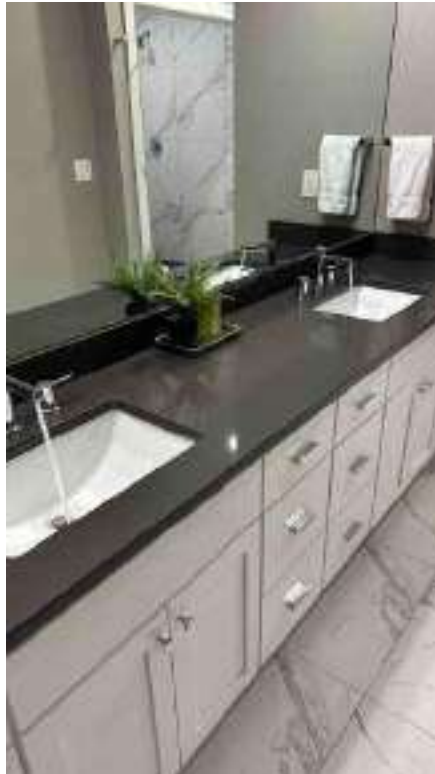
Sink(s), Faucet(s), Drain(s): Sink(s)

Adequate water flow and drainage, No leak observed

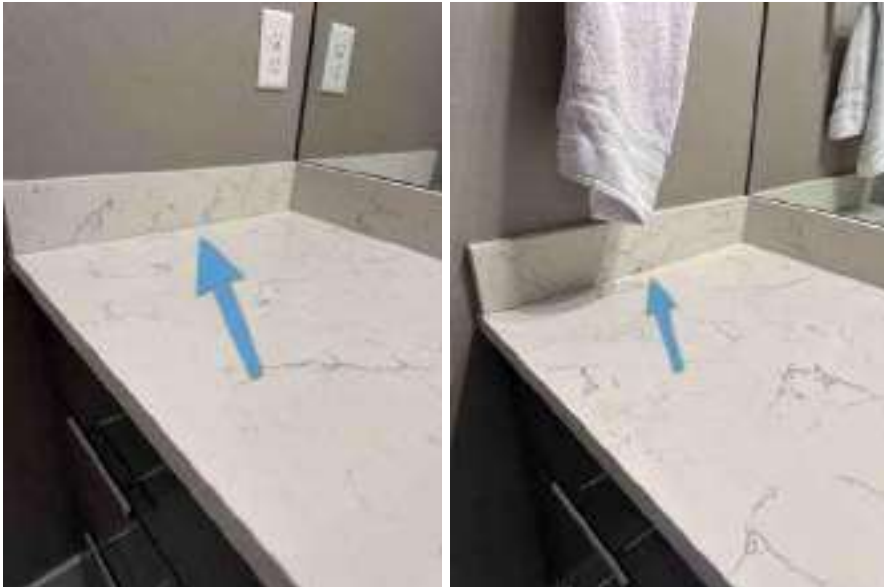
12.2.1 Counters/Cabinets (Representative number of cabinets)

INADEQUATE CAULKING/GROUT AT BACKSPASHES

The caulking/grout is missing, starting to crack, and/or inadequate at one or more of the backsplashes. I recommend routinely caulking/grouting these areas to prevent water entry/damage. [Here is a helpful DIY video on caulking gaps.](#)

Maintenance/Monitor

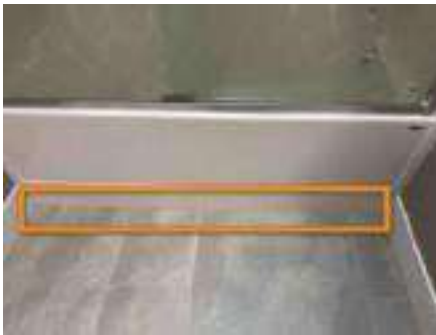
Jack and Jill

12.3.1 Floors/Walls/Ceilings

INADEQUATE CAULKING/GROUT

The caulking/grout at the base of the bathtub or shower is inadequate or is starting to crack. I recommend re-caulking as part of routine maintenance to prevent water entry/damage.

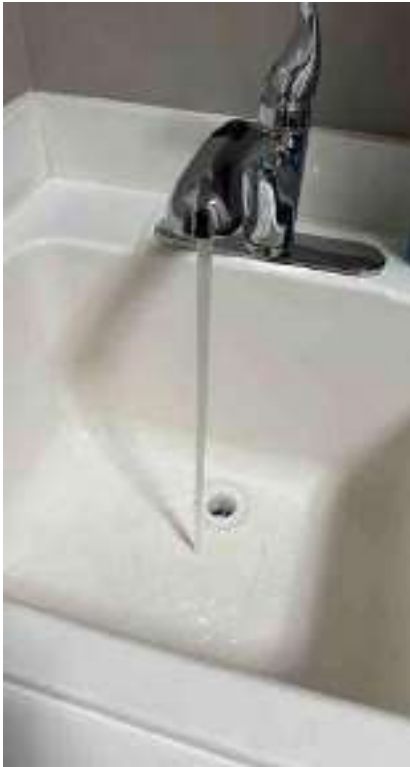
Sink(s), Faucet(s), Drain(s): Sink(s)

Adequate water flow and drainage, No leak observed

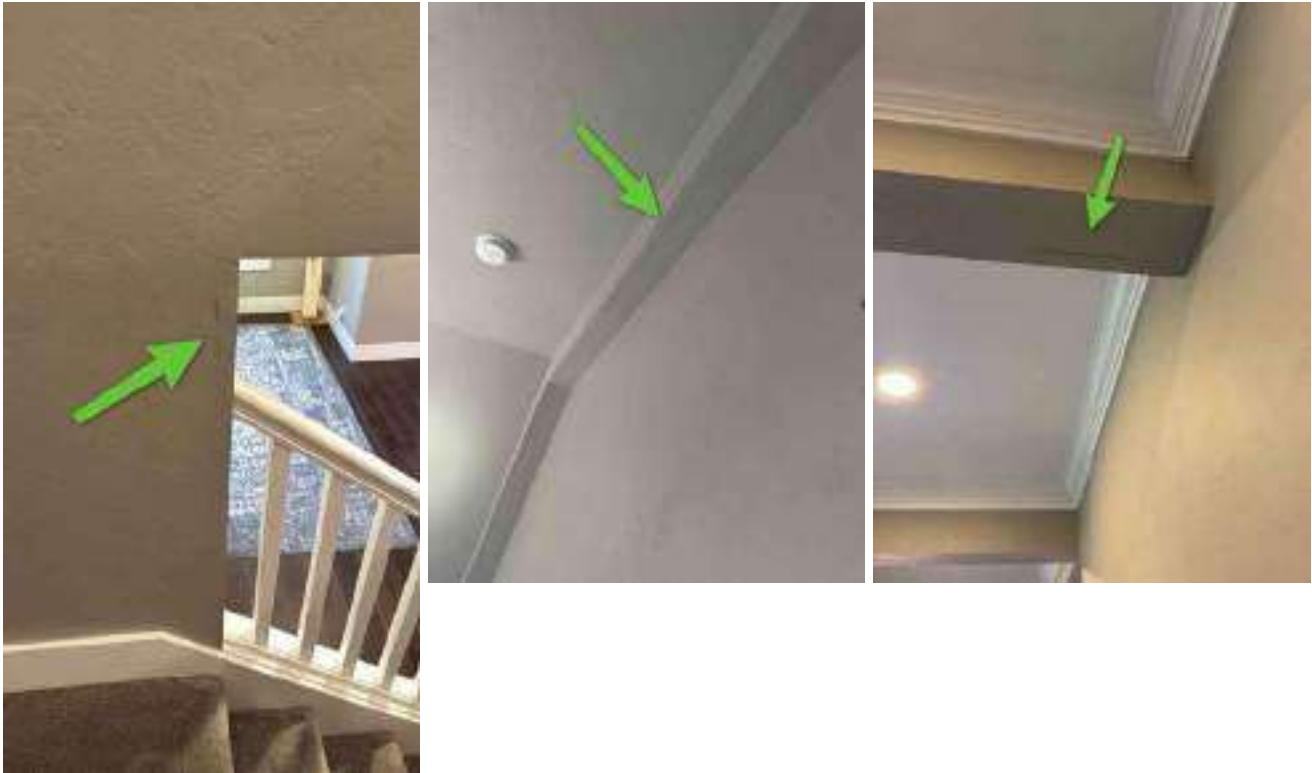
Ceilings/Walls: Visible Tape Lines/corner bead

There were one or more visible tape lines or popped corner bead observed at the interior ceilings/walls. These areas appeared to be cosmetic and are mentioned as a courtesy. The drywall/tape, corner bead lines can be repaired, if this is a concern.

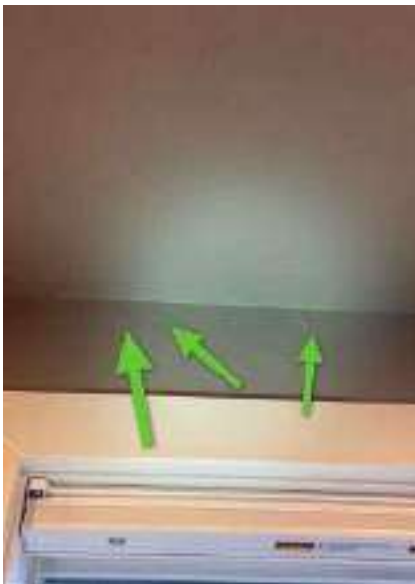
Ceilings/Walls: "Nail Pops" Observed

There were one or more nail "pops" observed at the interior ceilings/walls. These areas appeared to be cosmetic and are mentioned as a courtesy. Generally, this is caused by a rusty fastener or moisture in contact with the fastener during construction. The fasteners can be pulled and the drywall repaired, if this is a concern. Here is a [link on how to repair nail "pops"](#)

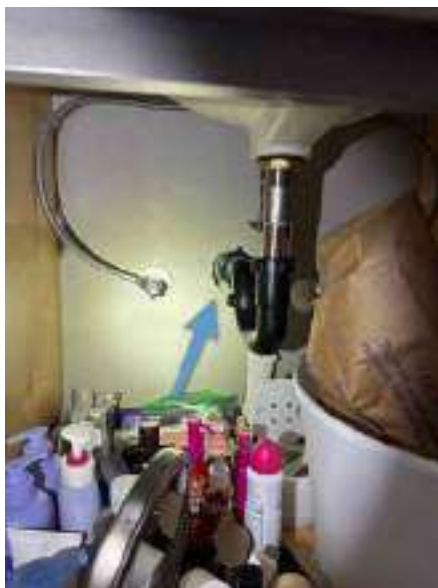
Jack and Jill

Areas where plumbing pipes or other items enter the interior walls (including under sinks) should be sealed to maintain proper separation of space. I recommend properly sealing these areas to prevent drafts/pest entry.

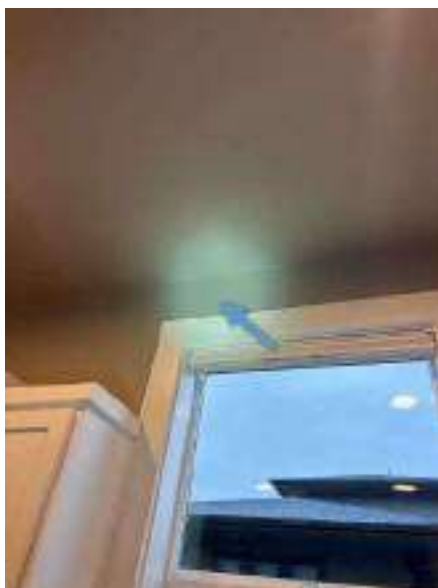
Kitchen

There were settling/shrinkage cracks observed on the ceilings/walls at one or more locations in the home. Unless otherwise noted, these cracks appeared to be normal at the time of this inspection. I recommend monitoring all cracks and making repairs as needed. A qualified contractor can be consulted for repairs, if this is a concern.

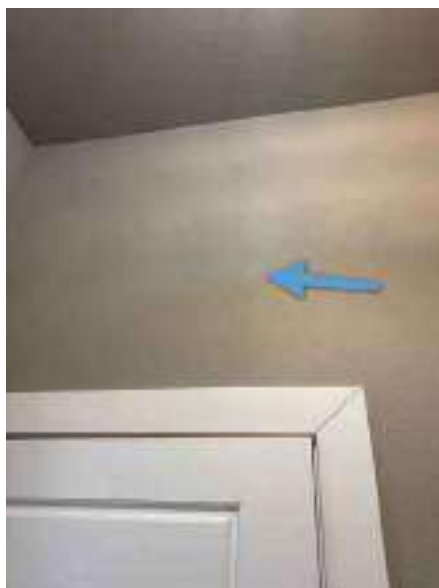
1/2 bathroom

SETTLING CRACKS - MONITOR

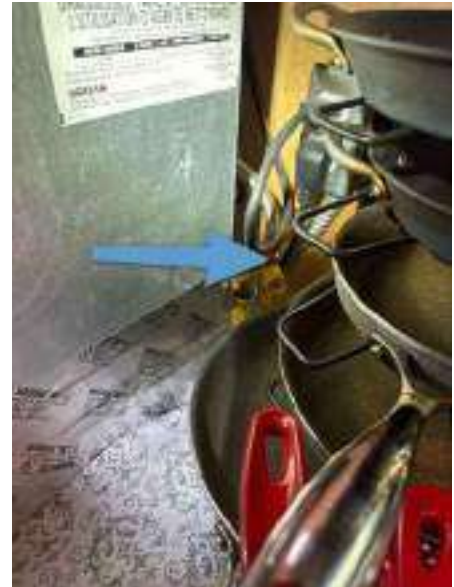
Below cooktop

Areas where pipes/conduits/etc. enter the floors (including below sinks) should be sealed to maintain proper separation of space. This is noted as a courtesy only, as energy efficiencies and pests are beyond the scope of this inspection. I recommend properly sealing these areas to prevent drafts and pest entry.

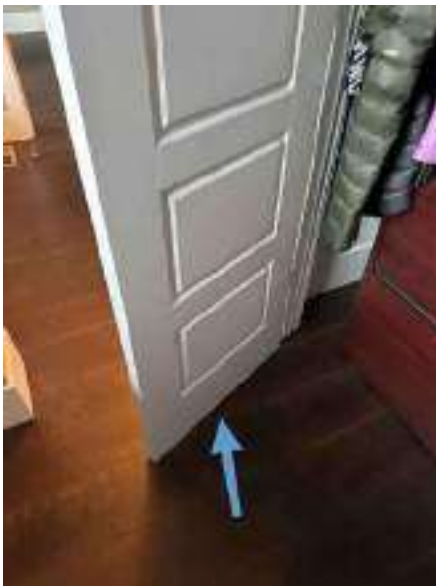
One or more of the interior doors were in need of adjustment/repair to maintain normal operation. The doors should be adjusted as needed to maintain normal operation. [Here is a helpful DIY article](#) on how to fix a sticking door. [Here is a DIY article](#) on fixing loose hinges. A qualified contractor should be consulted for adjustment/repair if this is a concern.

Entry closet door rubs on the floor

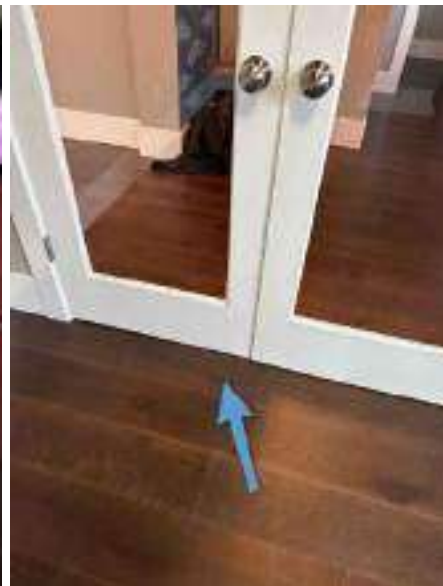
Office door rubs on the floor

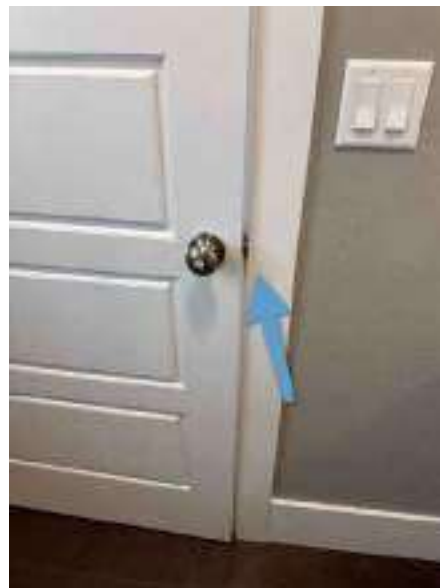
There were one or more door latches and/or handles that need to be adjusted to maintain normal operation. The latches/handles should be adjusted as needed to maintain normal operation.

1/2 bathroom does not properly latch

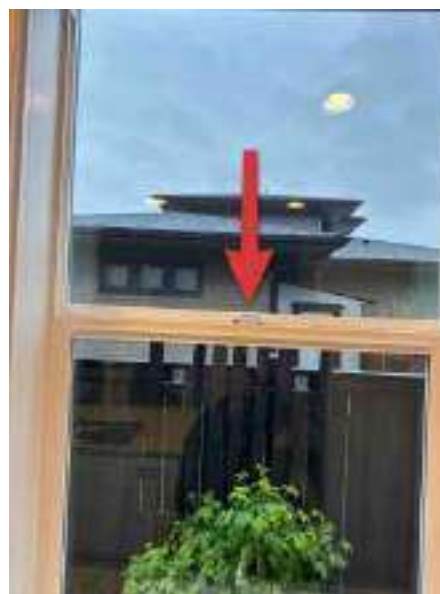
Kitchen

One or more of the window locks are missing/damaged or in need of adjustment. I recommend further evaluation and repair by a qualified contractor to maintain proper operation and safety.

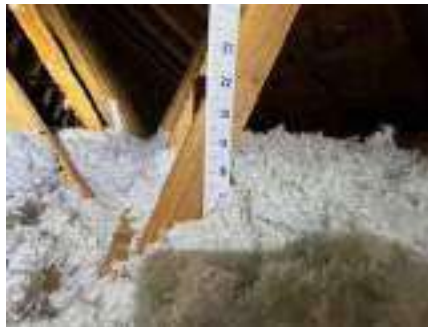
Attic Insulation : Approximate Depth

16 to 18 inches
