# HOME INSPECTION REPORT

8930 Sides Ct  
Saint Louis, MO 63136

**Inspection Date:**  
2/21/2026 3:00 PM

**Report Number:**  
022126DE

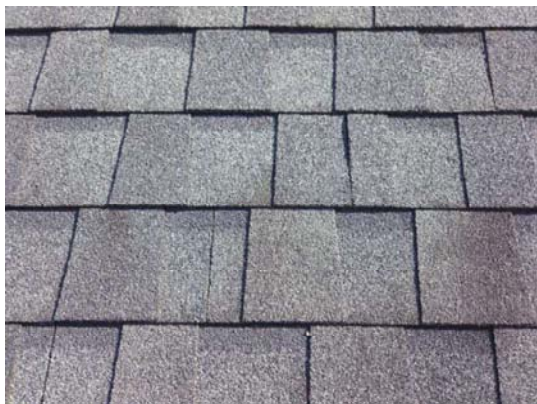
Photo #1

- **Monitor:** The roofing is considered to be in good condition. Typical maintenance should be expected. See **Photo 1**

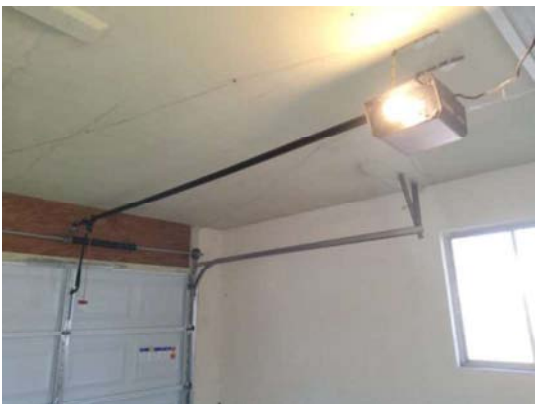
Photo #2

- **Improve:** The overhead garage door operation was rough when testing automatic opener. Repairs or adjustments should be made as necessary to ensure smooth operation of the door. **See Photo 2**

- **Improve:** The overhead garage door operation was rough when testing automatic opener. Repairs or adjustments should be made as necessary to ensure smooth operation of the door. **See Photo 2**

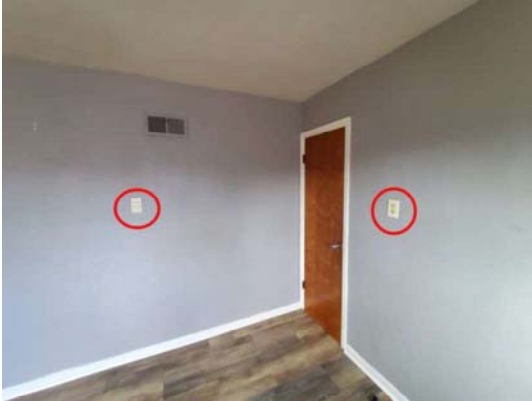
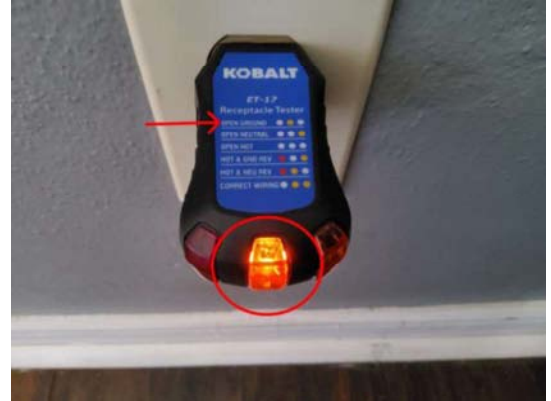
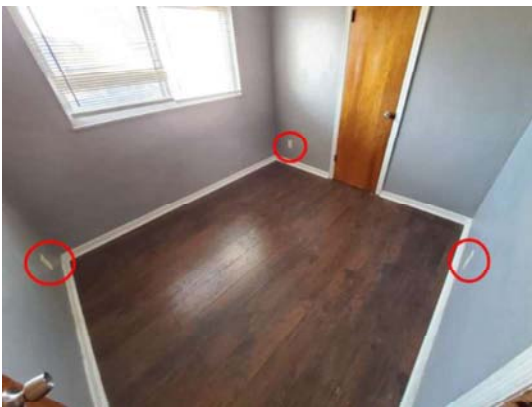
- **Improve:** Ungrounded 3-prong outlets should be improved in the right bedroom and in the kitchen. See Photos 3-5

Photo 3: Ungrounded 3-prong Outlet.

Photo 4: Ungrounded 3-prong Outlet.

Photo 5: Ungrounded 3-prong Outlet.

- **Improve:** Ungrounded 3-prong outlets should be improved in the right bedroom and in the kitchen. **See Photos 3-5**

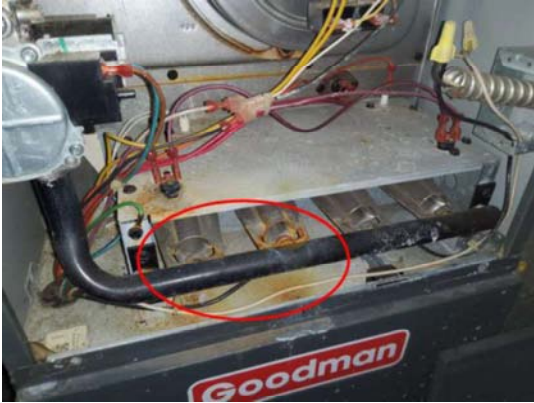
- **Improve:** The heating system requires servicing. There is no evidence of recent servicing of the equipment. It would be advisable to inquire with the existing homeowner as to its last servicing. If it has been longer than twelve (12) months than it is wise to engage a qualified HVAC technician to service and check the system. See Photo 6

Photo 6: Service Heat/Maintance Lacking.

Furnace will be operational prior to close.

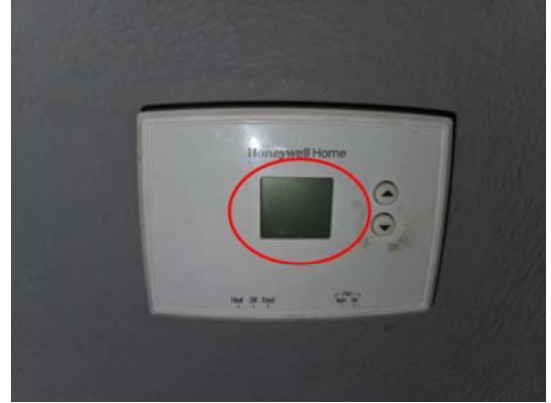
- **Improve:** The thermostat was inoperative at time of inspection. As such the heating system could not be tested. See Photo 7

Photo 7: Thermostat Inoperative .

- **Improve:** The thermostat was inoperative at time of inspection. As such the heating system could not be tested. **See Photo 7**

Furnace will be operational prior to close.  
New AC condenser and A-Coil to be installed prior to close.

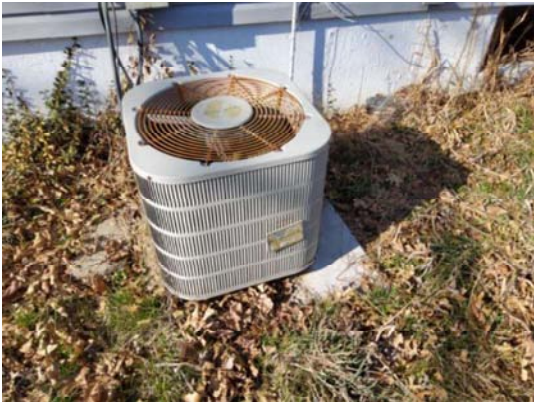
Photo #8

- **Monitor:** The air conditioning system(s) was not tested due to cold outdoor temperatures. The air conditioner(s) should be tested once the outside temperature permits and any necessary repairs completed prior to closing.
- **Monitor:** As is not uncommon for homes of this age and location, the air conditioning system is older. It may require a slightly higher level of maintenance, and may be more prone to major component breakdown. Predicting the frequency or time frame for repairs on any mechanical device is virtually impossible. See **Photo 8**

New AC condenser and A-Coil to be installed prior to close.

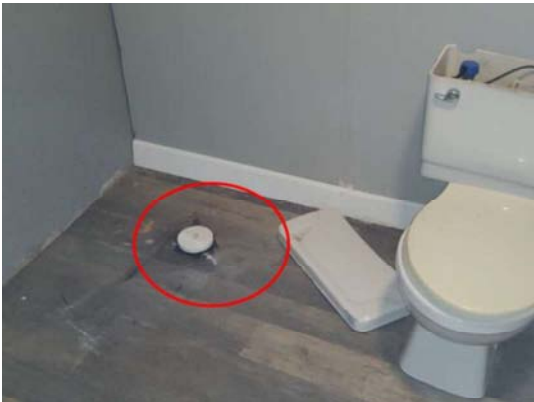
Photo #9

- **Improve:** The toilet was not installed during the inspection. It should be tested once it is re-installed. See **Photo 9**

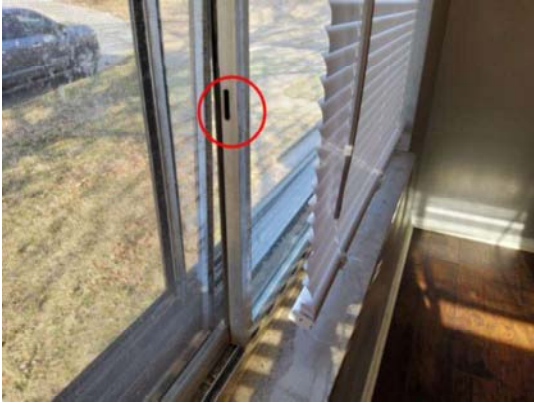
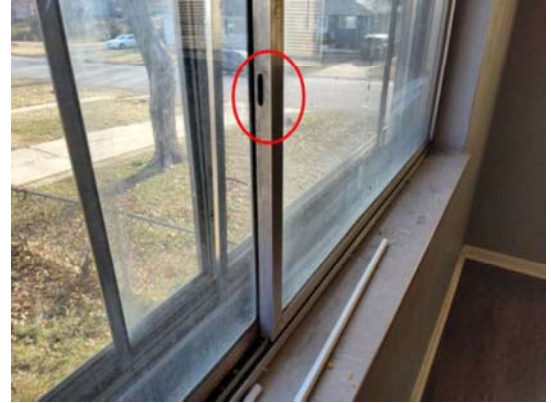
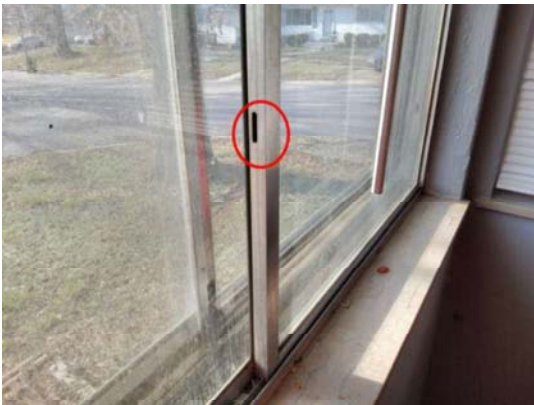
- **Safety Issue:** Windows will not lock in the left bedroom and in the rear bedroom. **See Photos 10-12**
- **Improve:** The windows in the garage and in the basement are broken. **See Photos 13-15**

Photo 10: Windows Will Not Lock.

Photo 11: Windows Will Not Lock.

Photo 12: Windows Will Not Lock.

- **Safety Issue:** Windows will not lock in the left bedroom and in the rear bedroom. **See Photos 10-12**

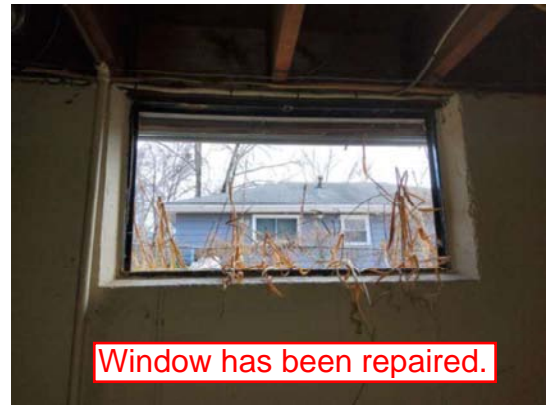
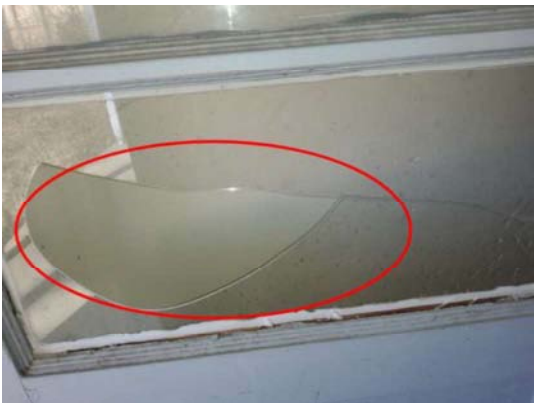
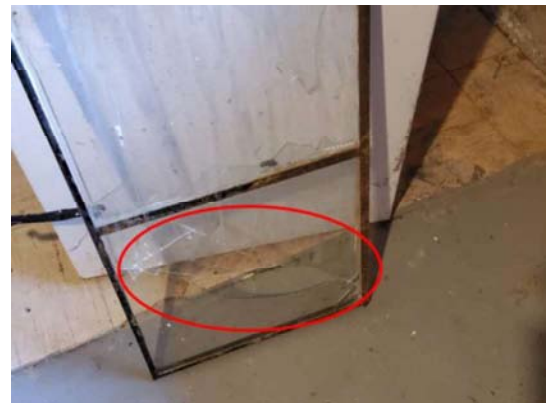
Photo 13: Window Broken.

Photo 14: Window Broken.

Photo 15: Window Broken.

Broken window in basement has been repaired.

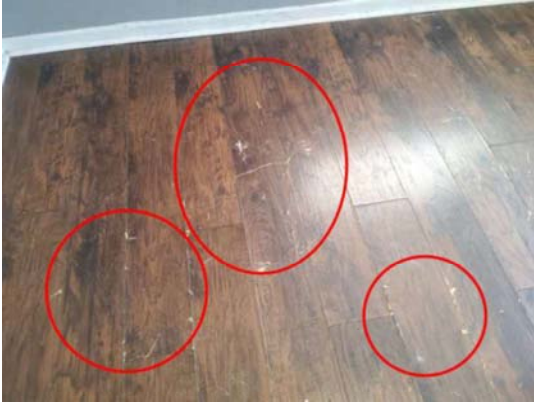
- **Improve:** The laminate flooring in the left bedroom is damaged. It should be repaired or replaced as necessary. **See Photo 16**

Photo 16: Laminate Floor Damage .

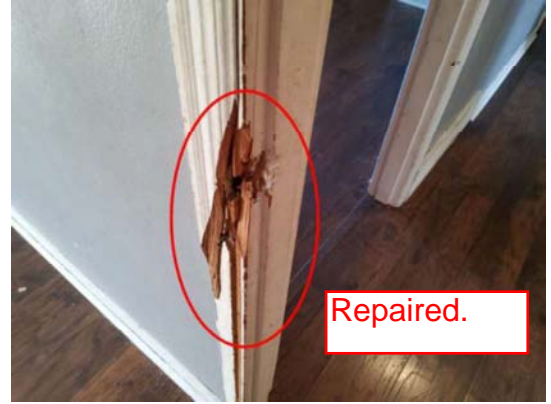
- **Improve:** Damage was observed to the door frame in the left bedroom. Repairs should be undertaken as necessary. **See Photo 17**

Photo 17: Frame Damage.

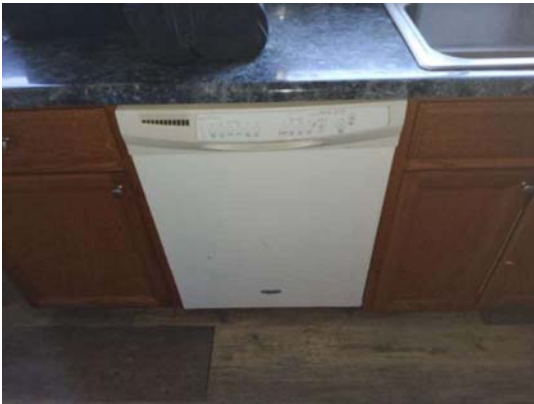
Photo #18

- **Improve:** The dishwasher is inoperative. See **Photo 18**
