# Inspection Report

**Amy Ross  
Sarah Knoll  
98 Presley Dr  
Heathsville VA 22473**

**Date:** 5/11/2026**Start Time:** 09:45 AM**EndTime:** 12:00 PM**Property:**  
98 Presley Dr  
Heathsville VA 22473**Customer:**Amy Ross  
Sarah Knoll**Real Estate Professional:**

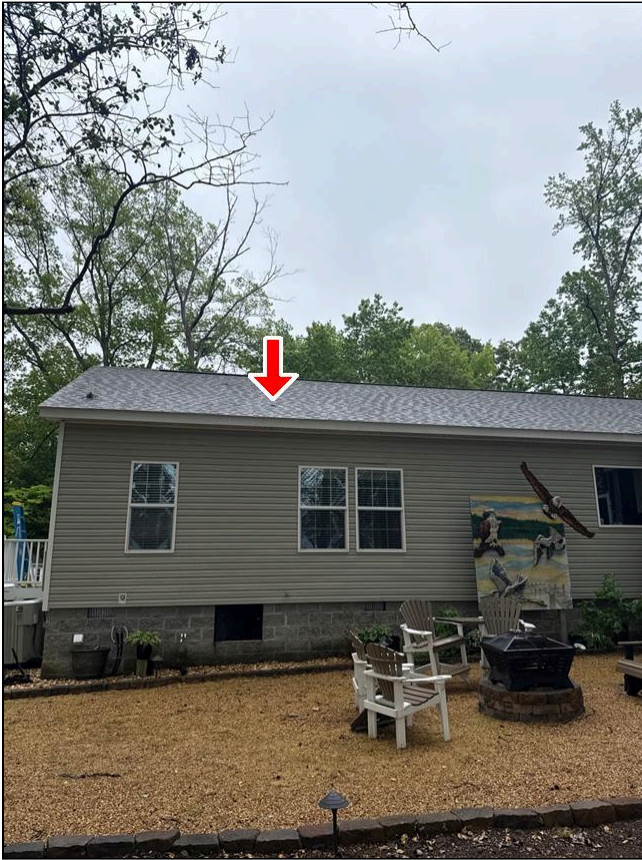
3.0 Item 1(Picture) Small nail pop on back side of roof should be monitored for future repair

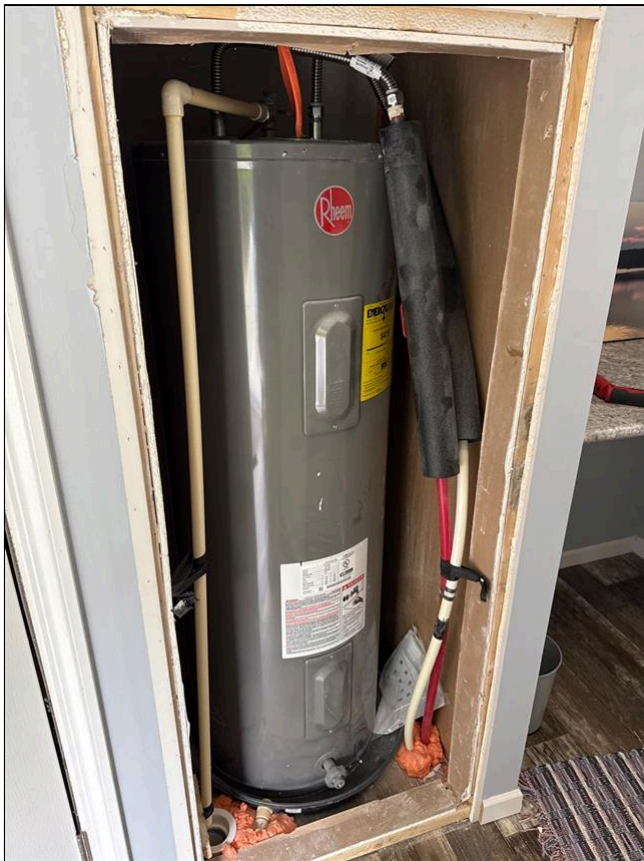
Water heater

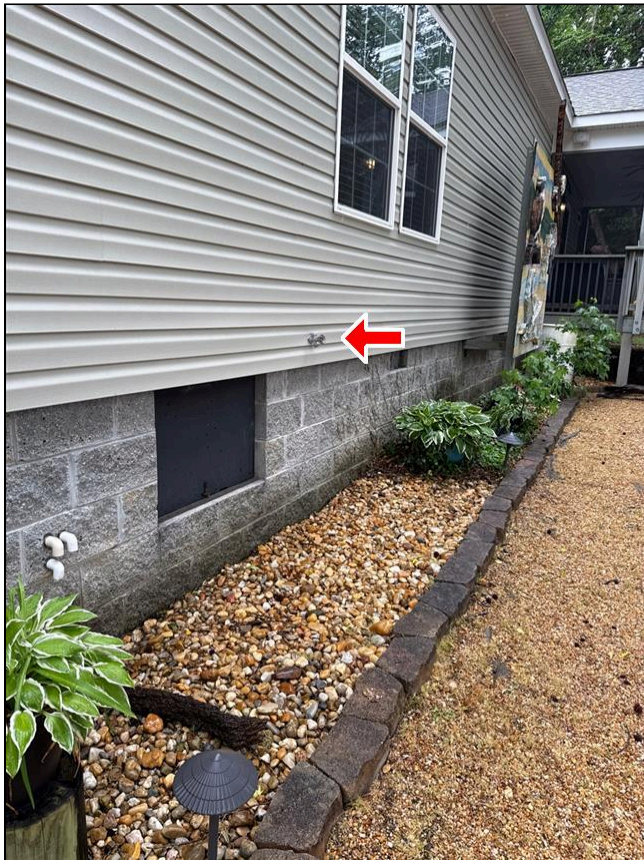
4.0 Item 1(Picture)

**4.0** One of the rear hose bibbs was not functional at time of inspection and may have been winterized.

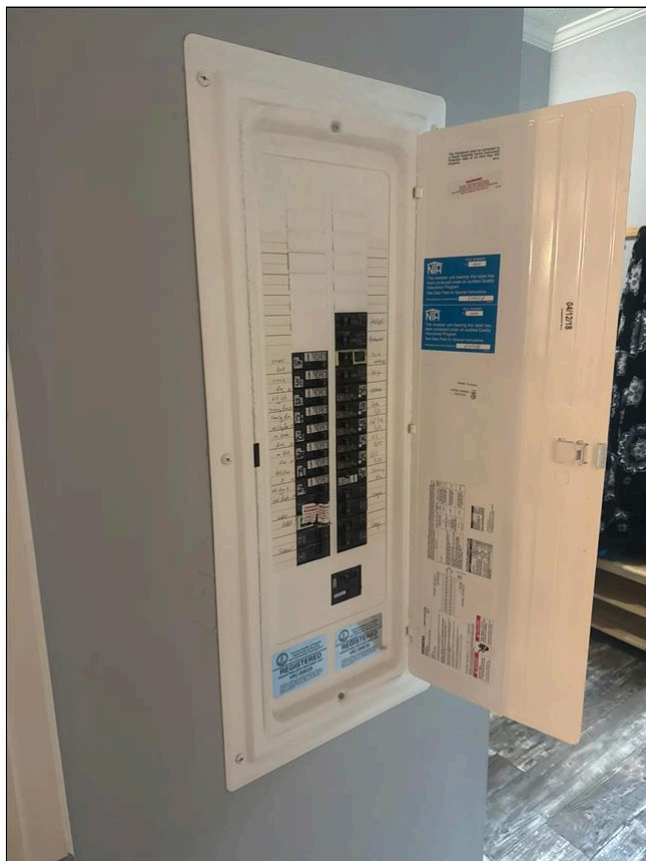
Service panel and main disconnect

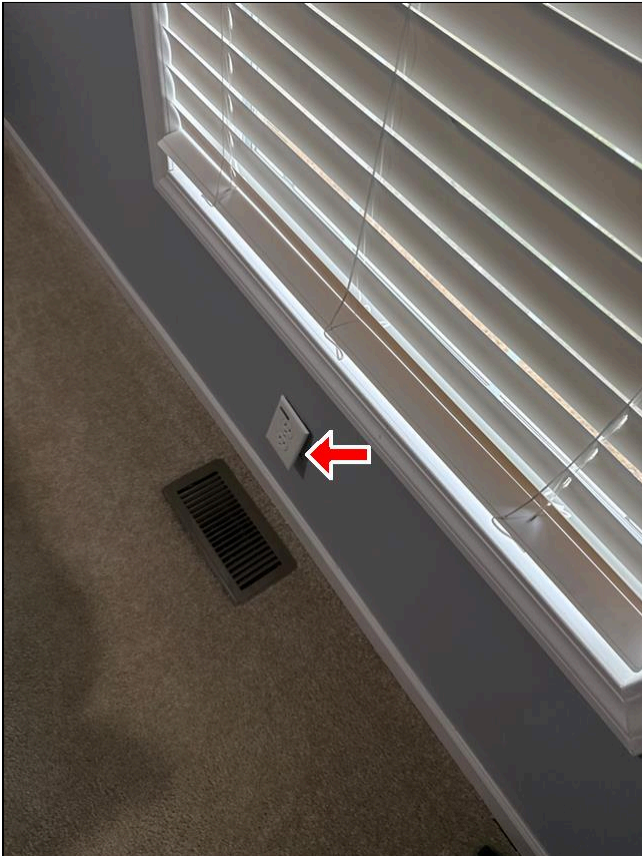
5.6 Item 1(Picture)

**5.6** A loose receptacle was observed in the front corner bedroom. Repair by a licensed electrician is recommended.

A loose receptacle was observed in the front corner bedroom. Repair by a licensed electrician is recommended.

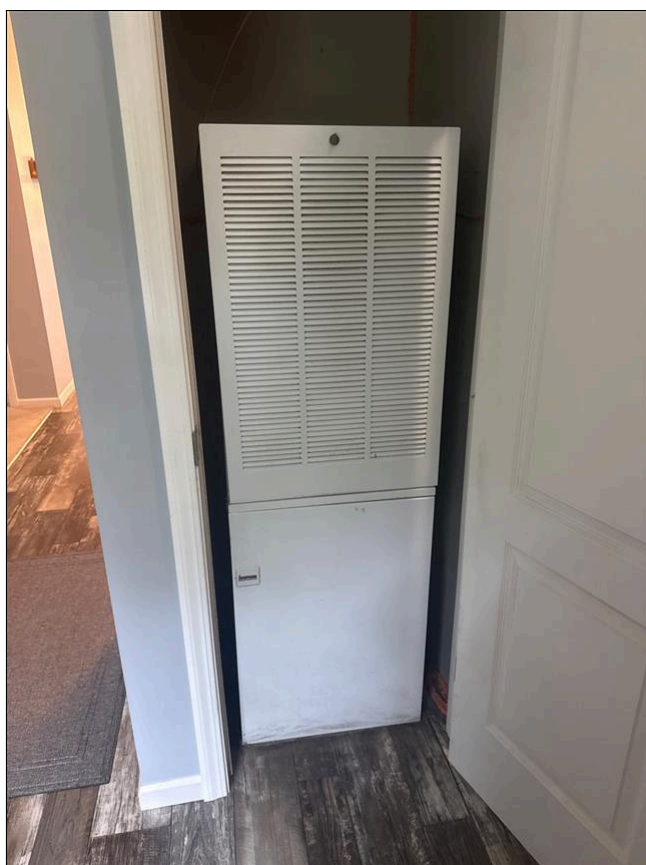
Air handler, filter located on top of unit

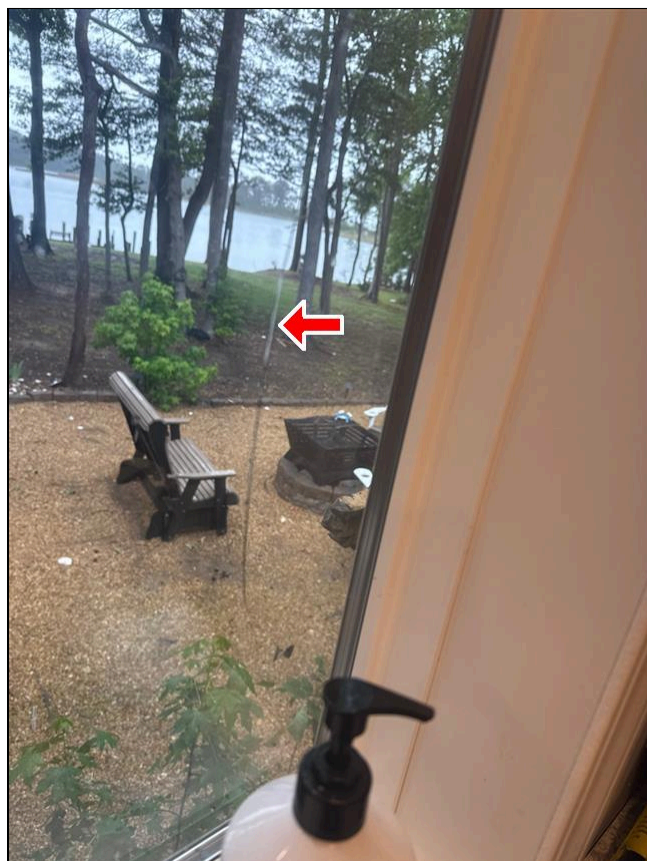
**7.3** There was a cracked window pane at the kitchen. Repair by a qualified glazier is recommended.

7.3 Item 1(Picture) Cracked pane

There was a cracked window pane at the kitchen. Repair by a qualified glazier is recommended.

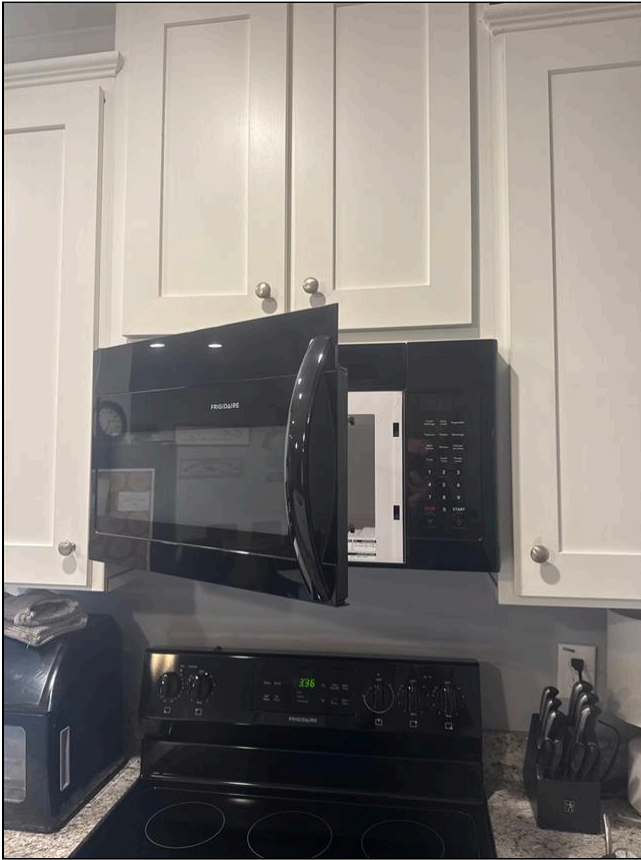
**7.6** Operation of the microwave caused the circuit breaker to trip. The breaker was reset multiple times and tripped each time the microwave was started. A wet paper towel was used in the oven for testing. Further

evaluation by a qualified appliance technician and/or licensed electrician is recommended.

7.6 Item 1(Picture) Microwave was not functional

Operation of the microwave caused the circuit breaker to trip. The breaker was reset multiple times

and tripped each time the microwave was started. A wet paper towel was used in the oven for testing. Further evaluation by a qualified appliance technician and/or licensed electrician is recommended.

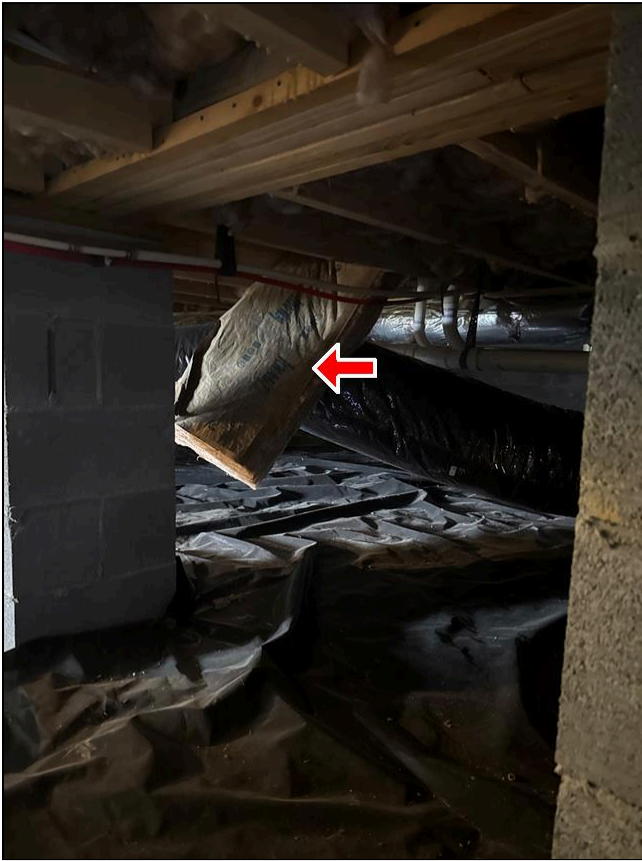
8.0 Item 1(Picture)

**8.0** Some batts of insulation had fallen down in the crawlspace. This reduces the energy efficiency of the home and can increase heating and cooling costs. Re-installation of the fallen insulation in the crawlspace by a handyman is recommended.

Some batts of insulation had fallen down in the crawlspace. This reduces the energy efficiency of the home and can increase heating and cooling costs. Re-installation of the fallen insulation in the crawlspace by a handyman is recommended.

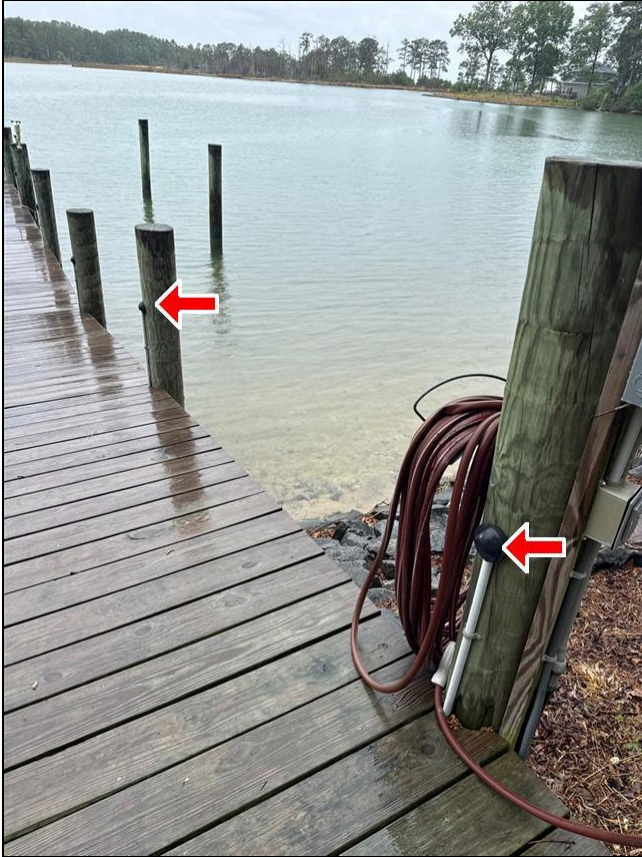
10.2 Item 1(Picture)

**10.2** The dock lighting appeared to be low voltage lighting and was not functional at inspection. Further evaluation by a licensed electrician is recommended.
