# ***The Inspector***

## **Property Inspection Report**

1761 Kt Ave., Atwater, CA 95301  
Inspection prepared for: Joe Delatorre & Cecelia Delatorre  
Date of Inspection: 8/3/2026 Time: 9:05 am  
Age of Home: 12yrs (2014) Size: 2389 sqft  
Weather: 85F Sunny  
H260801

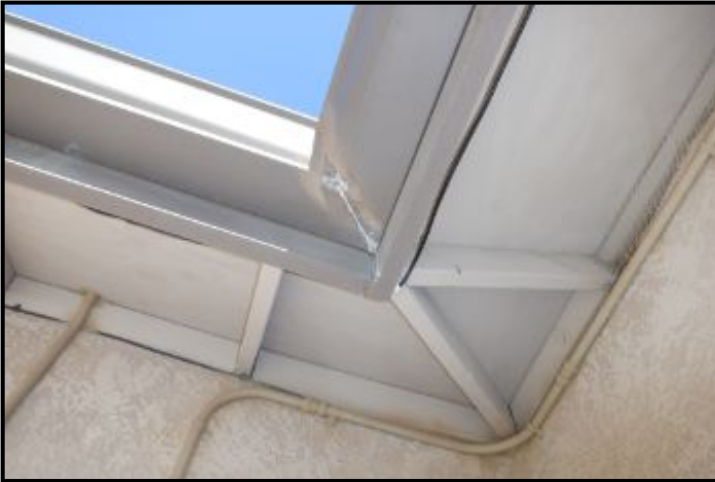
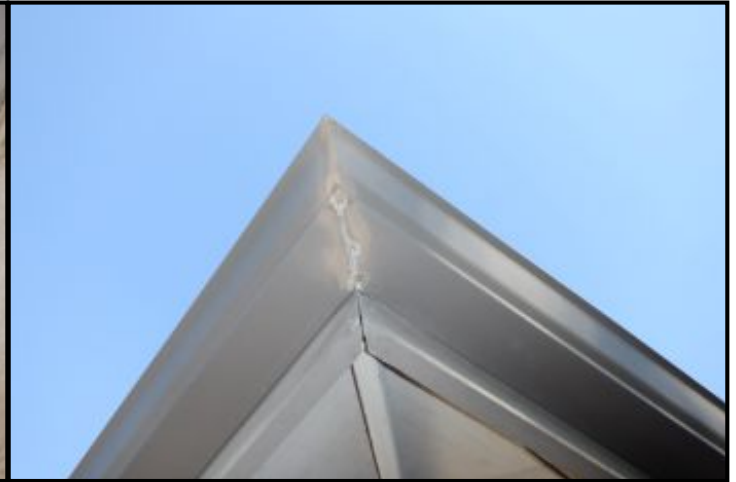
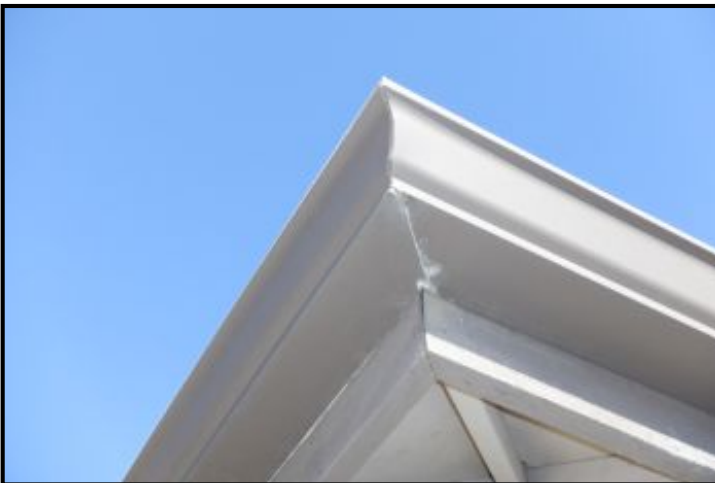
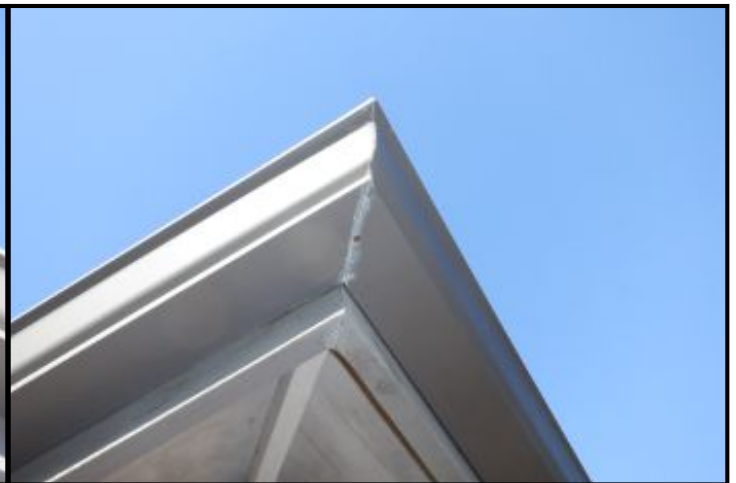
- The property has full gutter system noted at the time of the inspection.
- Sub surface drains noted at down spouts at the time of the inspection.
- ***The gutter system shows signs of leakage at the time of the inspection. Gutters need to be sealed at joints and corners. \****

Gutter leaks noted

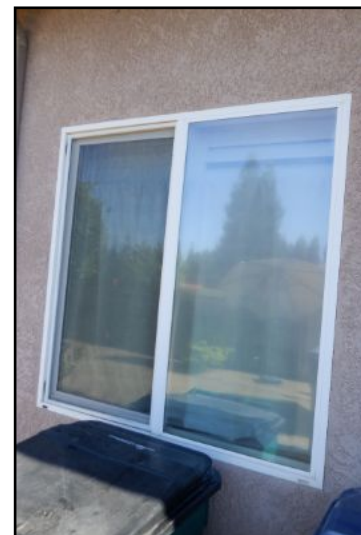
- ***The left side primary bathroom window presented symptoms (moisture between glass panes) of a breached seal, or failed "Thermopane". This suggests a failure of the factory seal between the twin pieces of glass. "Fogged" glass can still perform their function for ventilation and light admittance, but can become so opaque that visibility is impaired. Any insulated glass units which display symptoms of breached seals should be repaired or replaced. (2)***

Primary bathroom window is fogged & UV discoloration

- ***Recommend having all windows inspected by a qualified glass/window contractor for imperfections, operation and damage.***
- ***Recommend having a qualified glass contractor inspect ALL windows and glass doors for evidence of failed/breached seal. Also for any window and/or door deficiencies that need repair or replacement. (2)***

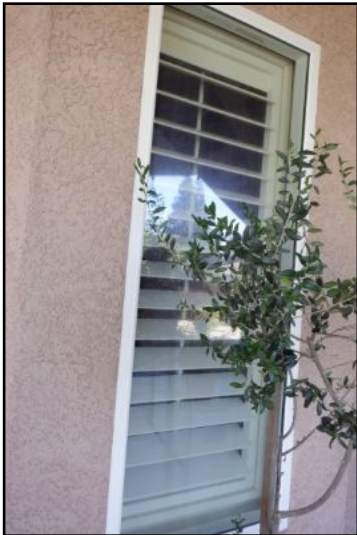
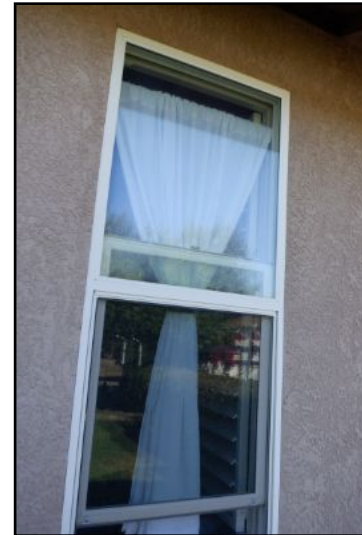
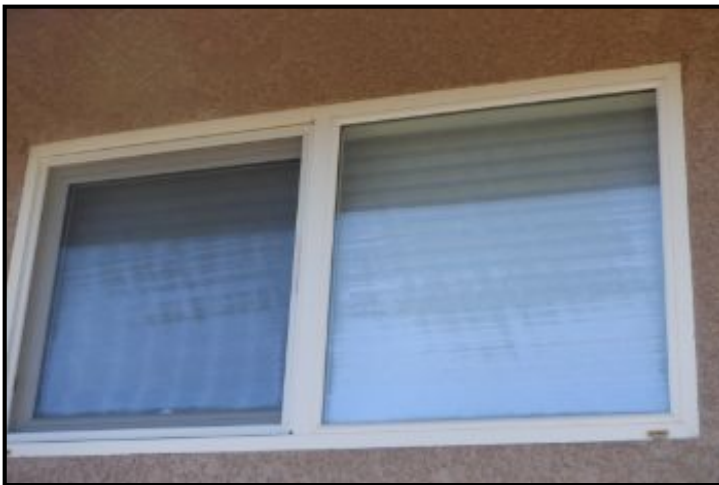
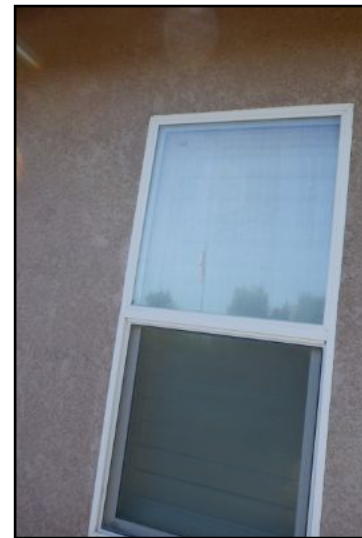
- ***Discoloration noted at window glass. Appears the UV film is separating from glass. This is a manufacturing defect. The window still is functional it just loses some aesthetic value as it appears cloudy/discolored. This condition noted at left side primary bathroom window / back left primary bedroom window / dining area back left window / front right bedroom right side window / hall bathroom window. \****

UV discoloration noted at window

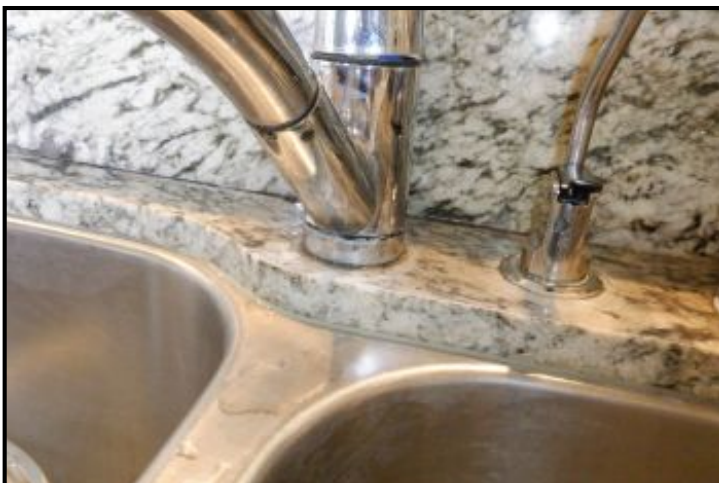
- The kitchen sink(s) appeared to be in serviceable condition at the time of the inspection.
- The faucet appeared to be in serviceable condition at the time of the inspection.
- Plumbing under the kitchen sink appeared to be in serviceable condition at the time of the inspection.
- Limited review due to personal property stored in undersink cabinet.
- ***The main kitchen sink faucet was leaking at base at the time of the inspection. \****

Kitchen sink faucet was leaking

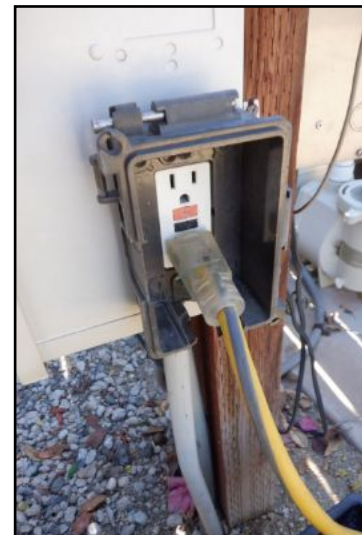
- ***GFCI outlet on side of pool sub panel did not trip off when tested at time of inspection. Recommend evaluation for repair/replacement by licensed electrician. (2) (4)***

Pool GFCI outlet does not trip off

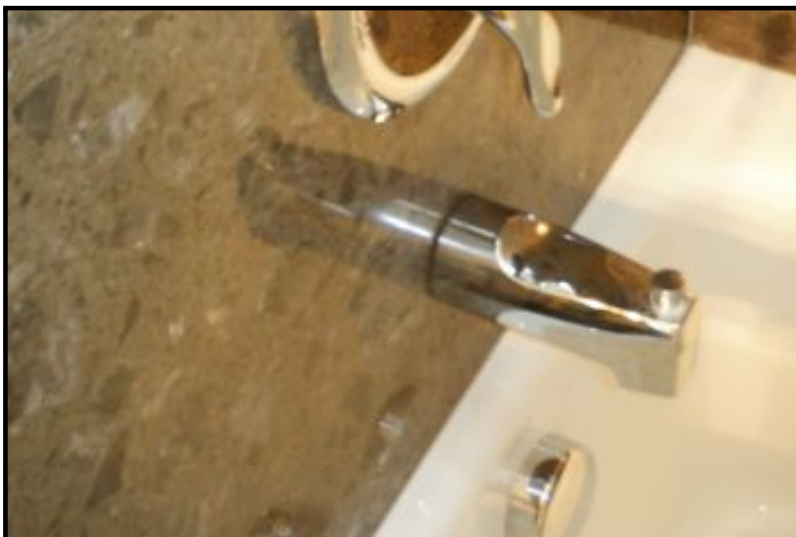
- The bathtub appeared to be serviceable in: A & B
- The bathtub drain appeared to be serviceable in: A & B
- The bathtub faucet appeared to be serviceable condition in: A & B
- **Caulking needed at bathtub spout to wall in: \* B**

Caulking needed at bathtub spout to wall
