# Wood Destroying Insect Inspection Report

11 Lee St

Montross, VA, 22520

House, basement, shed

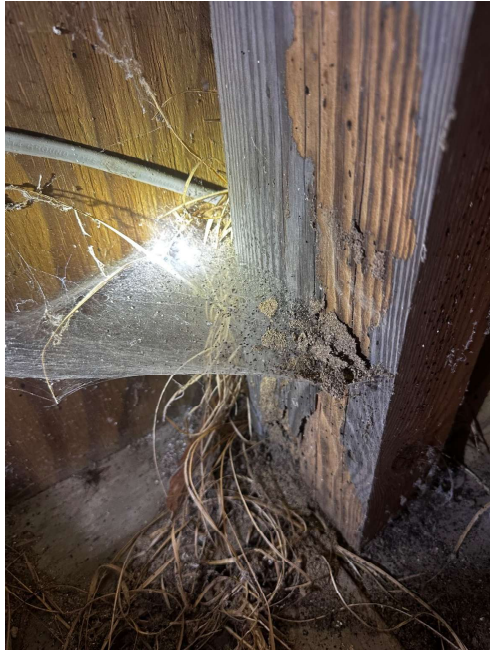
**IMG\_8743.jpeg**

**Section V. Additional Comments and Attachments** (these are an integral part of the report) No signs of live Termites or other wood Destroying insects inside house. Shed has old carpenter ant damage and evidence in wood base and front corner trim. Conducive conditions; Wood to soil contact at fences and shed base.
