## "Full" Reserve Study

### Hawk Ridge Estates Lafayette, CO

**Report #: 38411-0**  
**For Period Beginning: January 1, 2020**  
**Expires: December 31, 2020**  
**Date Prepared: February 11, 2020**

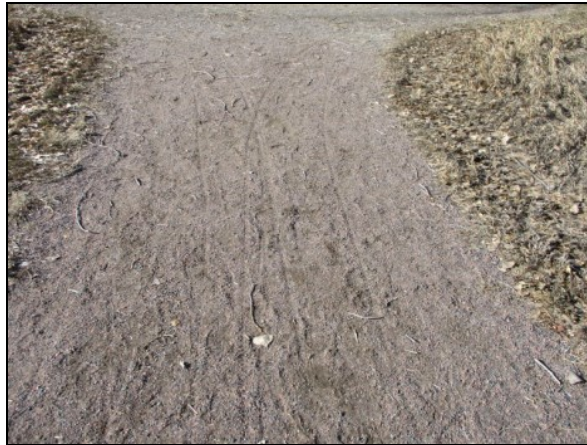
Comments: Paths should be inspected regularly for trip hazards and any other safety concerns (ponding water potholes etc.) in order to limit liability exposure. Replenishing will eventually be required but costs for this project are expected to be included in the client's Operating budget not as a Reserve expense. This component may be re-evaluated during future Reserve Study updates based on conditions observed and any new information provided.

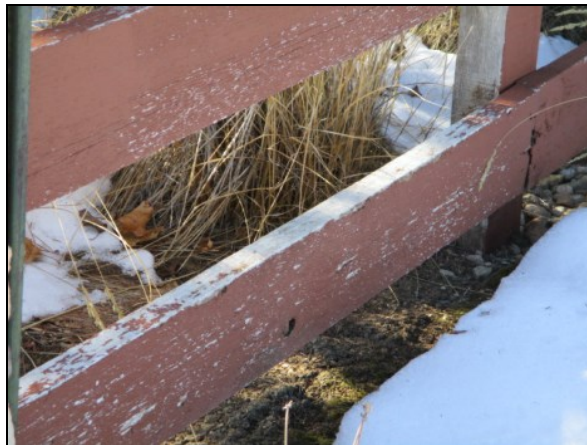
**Comp #: 21320 Site Rail: Wood - Repair/Paint****Quantity: ~ 1800 LF**

History: Stained in 2017

Comments: Wood fencing determined to be in poor condition typically exhibits more advanced deterioration of coating with notable wear possibly resulting in rotting of wood structure in places. Poor inconsistent curb appeal. Regular uniform professional paint or sealer applications are recommended for appearance protection of wood and maximum design life. Repair as needed and clean prior to application. Plan for regular applications as shown below. Timing of repair/paint cycles may need to be coordinated with eventual fence replacement.

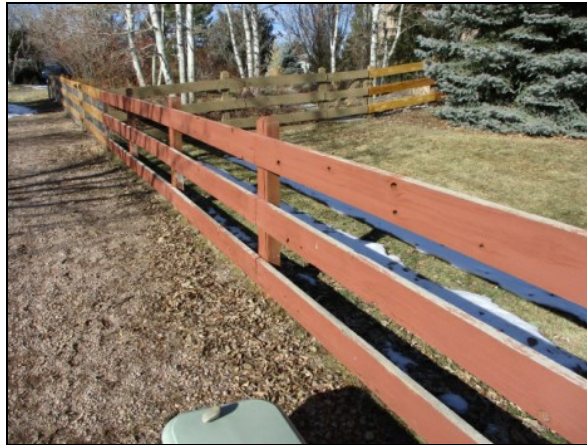
**Comp #: 21340 Site Fencing: Split Rail - Replace****Quantity: ~ 1800 LF**

Comments: Wood fencing determined to be in fair condition typically exhibits some minor to moderate amounts of surface wear and other signs of age which may include a small percentage of warped split rail and/or rotted sections. In general appearance is consistent but declining. As routine maintenance inspect regularly for any damage repair as needed and avoid contact with ground and surrounding vegetation wherever possible. Regular cycles of uniform professional sealing/painting will help to maintain appearance and maximize life. In our experience wood fencing will typically eventually break down due to a combination of sun and weather exposure which is sometimes exacerbated by other factors such as irrigation overspray abuse and lack of preventive maintenance. Recommendation and costs shown here are based on replacement with similar style and material. However the client might want to consider replacing with more sturdy lower-maintenance products like composite vinyl etc. Although installation costs are higher total life cycle cost is lower due to less maintenance and longer design life expectancy.

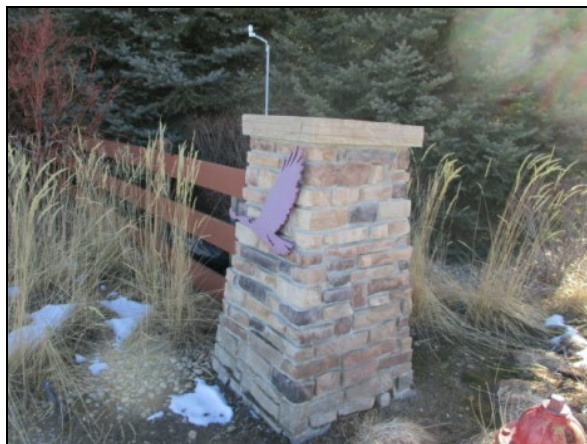
**Comp #: 21400 Pillars – Repair/Replace****Quantity: Pillars**

Comments: No significant or widespread cracking settling or other problems observed. Assumed to have been properly designed and installed with adequate base and surrounding drainage. Inspect regularly repair as needed from Operating budget. If shifting cracking etc. are observed consult with civil or geotechnical engineer for repair scope. At this time no expectation of large scale repairs or replacement no Reserve funding recommended. An allowance for partial repairs/replacements may be added during future Reserve Study updates if warranted by client history.

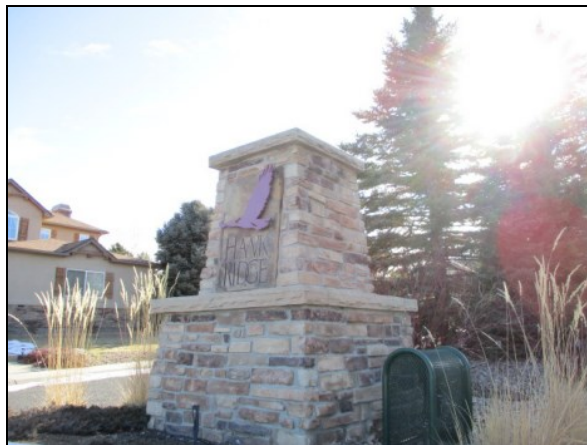
**Comp #: 21610 Sign/Monument - Refurbish/Replace****Quantity: ~ (1) Monument**

Comments: Monument signage determined to be in good condition typically exhibits good appearance and aesthetics in keeping with local area. Generally uniform and attractive finishes. If present lettering is clean complete and legible and any surrounding landscaping lighting etc. is attractive and functioning. As routine maintenance inspect regularly clean/touch-up and repair as an Operating expense. Plan to refurbish or replace at the interval below. Timing and scope of refurbishing or replacement projects is subjective but should always be scheduled in order to maintain good curb appeal. In our experience most clients choose to refurbish or replace signage periodically in order to maintain good appearance and aesthetics in keeping with local area often before signage is in poor physical condition. If present concrete walls are expected to be painted and repaired as part of refurbishing but not fully replaced unless otherwise noted. Costs can vary significantly depending on style/type desired and may include additional costs for design work landscaping lighting water features etc. Reserve Study updates should incorporate any estimates or information collected regarding potential projects.

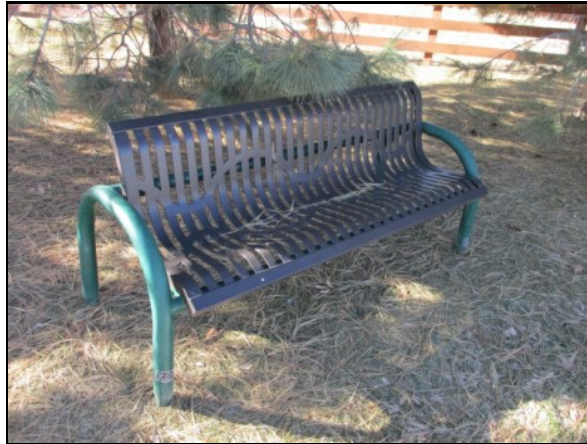
**Comp #: 21690 Bench - Replace****Quantity: ~ (1) Bench**

Comments: In general costs related to furniture replacement are expected to be included in the client's Operating budget. No recommendation for Reserve funding at this time. However any repair and maintenance or other related expenditures should be tracked and this component should be re-evaluated during future Reserve Study updates based on most recent information and data available at that time. If deemed appropriate for Reserve funding component can be included in the funding plan at that time.

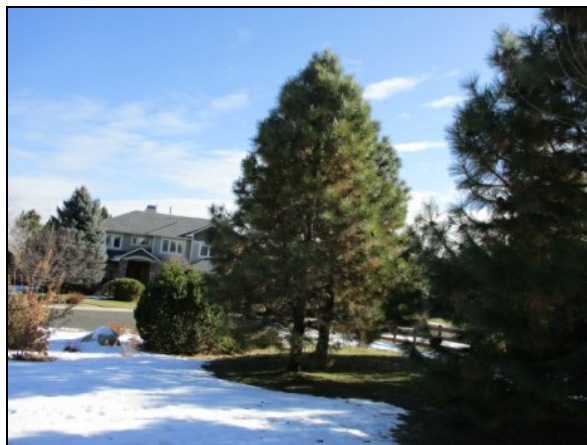
Comments: In general costs related to this component are expected to be included in the client's Operating budget. No recommendation for Reserve funding at this time. However any repair and maintenance or other related expenditures should be tracked and this component should be re-evaluated during future Reserve Study updates based on most recent information and data available at that time. If deemed appropriate for Reserve funding component can be included in the funding plan at that time.

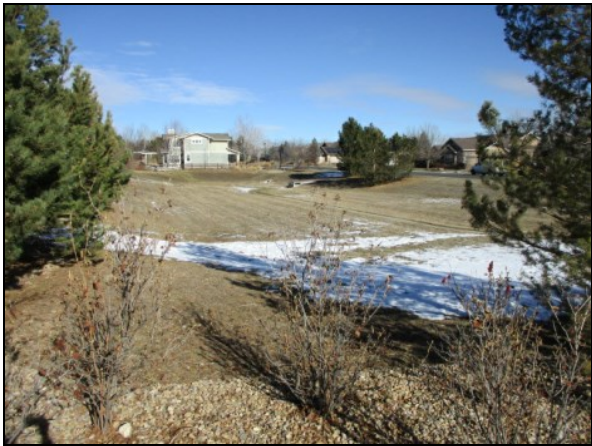
Comments: Under normal circumstances, well-maintained detention ponds should not require major repair/refurbishing projects. In some cases, large projects such as erosion control, weed abatement or dredging may be required, but the scope and frequency of such projects is very unpredictable. As a precaution, the association may want to budget an allowance for repairs to the ponds. The association should consult with pond service vendor on a regular basis to identify any necessary projects, which may be included within future Reserve Study updates as needed.

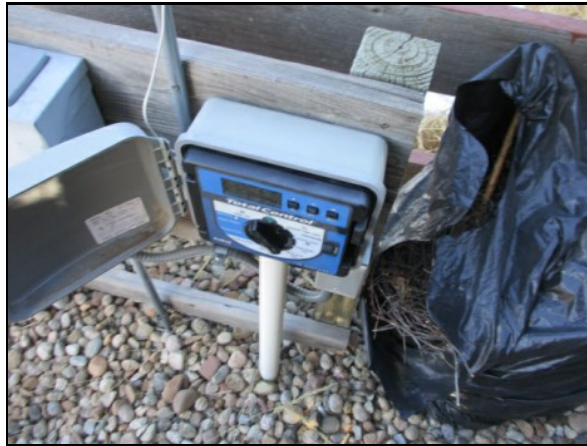
### Comp #: 25570 Irrigation Clocks - Replace

Comments: Client requested that we include funding for a smart clock. Vendor provided costs for a smart clock replacement. If the client would like to install a smart clock, the vendor noted that the specs would include - Hunter Pro-C Irrigation Controller w/solar sync ET sensor and WiFi must be available.

Minimal or no subjective/aesthetic value for this component. Useful life is based primarily on normal expectations for service/performance life in this location. Unless otherwise noted remaining useful life expectancy is based primarily on original installation or last replacement/purchase date our experience with similar systems/components and assuming normal amount of usage and good preventive maintenance. Irrigation controllers should have a relatively long life expectancy under normal circumstances. Replacement is often required due to lack of available replacement parts lightning strikes etc. as opposed to complete failure of existing equipment. Exposure to the elements can affect overall life expectancy and controllers should be located in protected areas or within protective enclosures whenever possible. When evaluating replacement options the client should consider replacement with smart" models (i.e. respond to projected weather data) to minimize unnecessary water usage. Payback period for efficient controllers that minimize water use is typically very short
